ILLAWARRA COAL

**DENDROBIUM MINE AND
CORDEAUX COLLIERY**

**ANNUAL REVIEW
FY18**

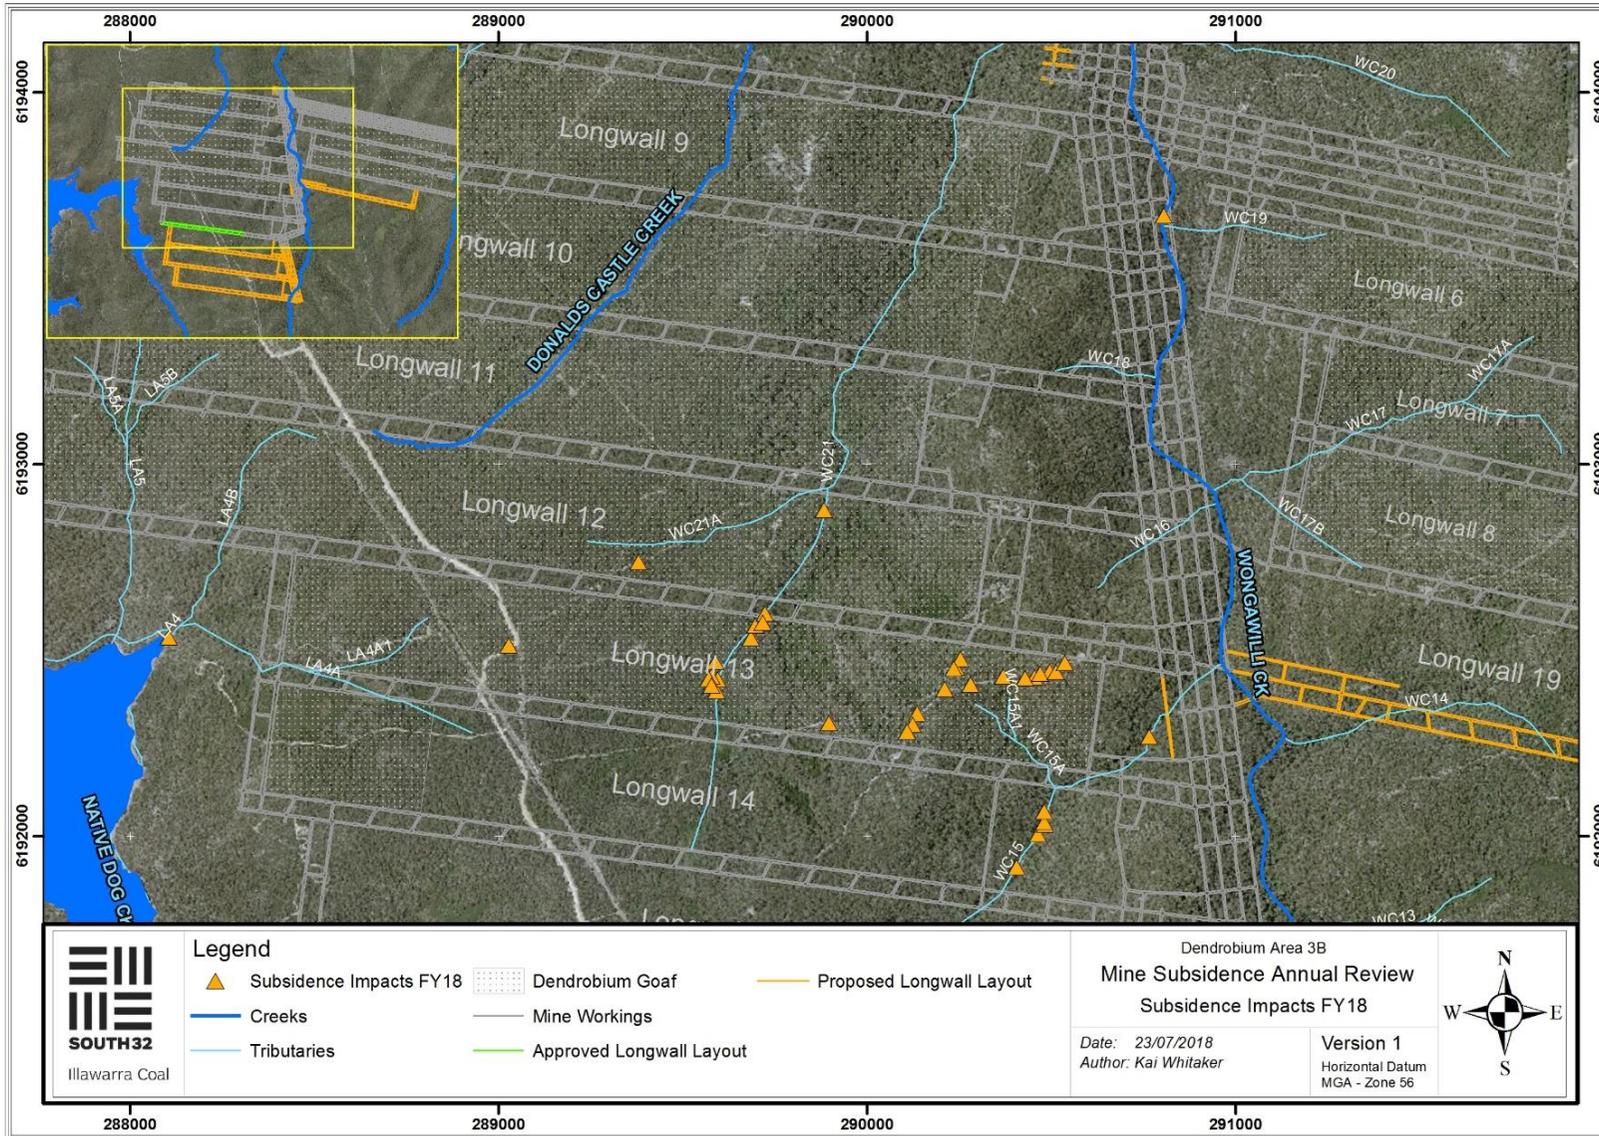
Figure 11: Subsidence impacts observed during the Reporting Period.

Thirty-Four surface impacts were identified by the ICEFT during the 2018 financial year. Seventeen of these impacts were observed within watercourses, and Twenty-One impacts were observed to landscape features such as access tracks, cliff lines and steep slopes. For further information please refer to the Longwall 13 End of Panel Report or relevant impact reports.

Site ID	Impact Type	Identification Date	Impact Level	Description	Actions Taken
DA3B_LW13_004	Surface Cracking	14/07/2017	1	Discontinuous surface cracking on <i>FR6A</i> , 3m length, 0.01m width, uplift of 0.2m.	No remediation required.
DA3B_LW13_005	Surface Cracking	19/07/2017	2	Surface cracking on <i>Access Track 6AA</i> , 2.3m long, average width 0.05m, 0.2m max width, 2.34m depth.	No remediation required.
DA3B_LW13_006	Rock Fracturing	25/09/2017	2	Rock fracture to the base of <i>WC21_Pool 48</i> . 5m length, 0.03m width. Also associated with an absence of water in pool.	Specialist report completed. Remediation Plan to be approved.
DA3B_LW13_007	Iron Staining	03/10/2018	1	Iron staining at subsurface outflow, downstream from <i>WC21_Pool 38</i> , at BF37.	No remediation required.
DA3B_LW13_008	Surface Cracking	10/10/2017	1	Consists of two small zones of surface cracking and uplift on access track adjacent to <i>WC21</i> . Max length 1.4m, width 0.06m, depth 0.1m.	No remediation required.

DA3B_LW13_009	Rock Fracturing	23/10/2017	1	Rock fracturing to the downstream extent of <i>WC21_Pool 54</i> , 0.38m long, 0.22m wide, 0.37m deep.	No remediation required.
DA3B_LW13_010	Rock Fracturing	23/10/2017	2	Rock fracturing to the step at the upstream extent of <i>WC21_Pool 53</i> , 2.5m long, 0.01m wide, and 0.03m deep.	Specialist report completed. Remediation Plan to be approved.
DA3B_LW13_011	Rock Fracturing	23/10/2017	2	Rock fracturing to the base of <i>WC21_Pool 47</i> .	Specialist report completed. Remediation Plan to be approved.
DA3B_LW13_012	Surface Cracking	30/10/2017	1	Surface cracking on access track adjacent to <i>WC21</i> . Max 1m long, 0.05m wide and 0.12m wide.	No remediation required.
DA3B_LW13_013	Surface Cracking	30/10/2017	1	Surface cracking on access track adjacent to <i>WC21</i> . Max 2m long, 0.02m wide and 0.1m wide.	No remediation required.
DA3B_LW13_014	Surface Cracking	13/11/2017	1	Surface cracking on access track adjacent to <i>WC21</i> . Max 0.64m long, 0.1m wide and 0.16m deep.	No remediation required.

DA3B_LW13_015 (Wongawilli Creek) (Addressed in	Pool Level	20/11/2017	3	<i>WC_Pool 43a</i> water level below baseline. Fracture was identified in the pool during LW9.	Specialist report completed. Additional assessment

Surface and Shallow Groundwater Assessment)					presented in Longwall 13 End of Panel Report
DA3B_LW13_016	Surface Cracking	20/11/2017	1	Surface cracking and minor slumping on access track adjacent to WC21. Max 2m long, 0.03m wide and 0.1m deep.	No remediation required.
DA3B_LW13_017	Rock Fracturing	08/01/2018	2	Rock fracturing across Pool 45 in tributary WC21, 2m long, 0.03m wide and 0.22m at its deepest measurable point.	Specialist report completed. Remediation Plan to be approved.
DA3B_LW13_018	Rock Fracturing	12/02/2018	2	Rock fracturing across Pool 46 in tributary WC21. Max, 0.5m long, 0.01m wide and 0.05m.	Specialist report completed. Remediation Plan to be approved.
DA3B_LW13_019	Surface Cracking	02/03/2018	2	Surface cracking on FR6P, 8.5m long, 0.45m max depth 0.45m, max width 0.15m.	Remediation works completed – cracking filled in.
DA3B_LW13_020	Surface Cracking	16/03/2018	1	Soil cracking on seismic track adjacent to FR6P, 0.35m long, 0.12m max depth, 0.07m width.	No remediation required.
