Our ref: 125.89220

**Appin Area 7 and Area 9, Extraction Plan
Appin Longwalls 709-711 and Longwall 905
GHD response to Approval Conditions**

ILLAWARRA METALLURGICAL COAL
APPIN COLLIERY - LW905
STEEP SLOPES

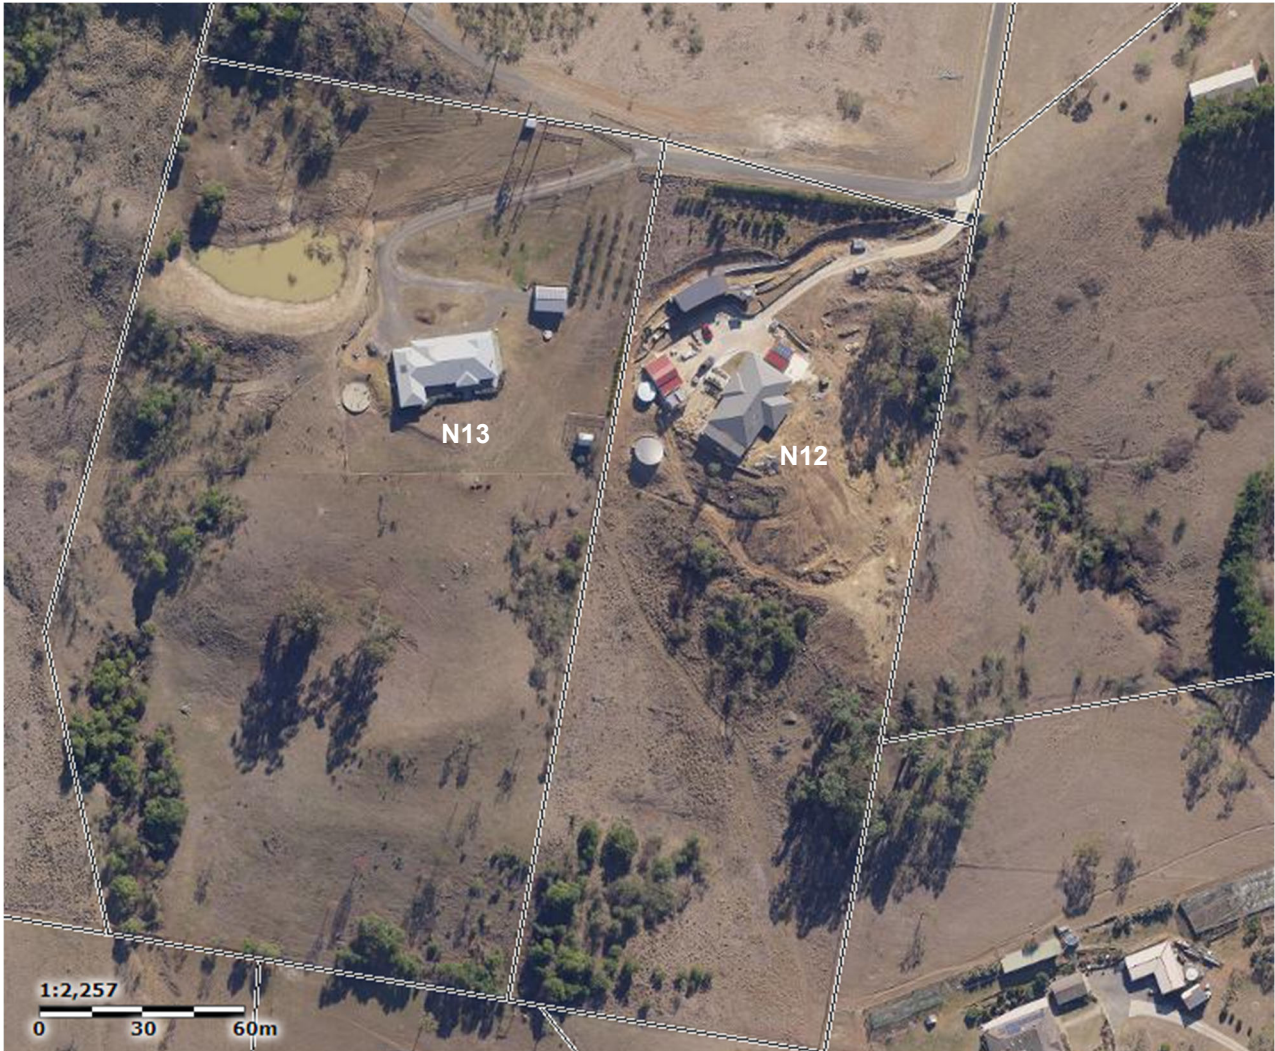
Figure 01: Property setting for Structure References N13 and N12 (ref: SIX Maps)

Structure Identification	Indicative Cumulative Hazard Rating	Context of Rating
N13 and N12 [refer Figure 01]	High	Structures are situated upon steep slopes below crest of ridgeline, are immediately adjacent to or over the footprint of LW905, the landform has been significantly modified to develop the building platforms. Nature and form of structure foundation system to be determined. Nature and quality of earthworks to be determined.
N16 and N15 [refer Figure 02]	Low	Structures are situated upon the crests of relatively level rounded ridgelines with expectation of shallow depth to shale bedrock. Dwellings are situated about half a panel-width outside the footprint of LW905 and over footprint of previously mined LW904.
N18 [refer Figure 03]	Low	Structure situated upon lower slopes well away from the Razorback Escarpment cliff-lines and outside extent of previous debris flows associated with natural slope forming processes endemic to the study area. Dwelling is situated approximately one panel-width outside the footprint of LW905 at the starting end, and situated over previously mined LW904.

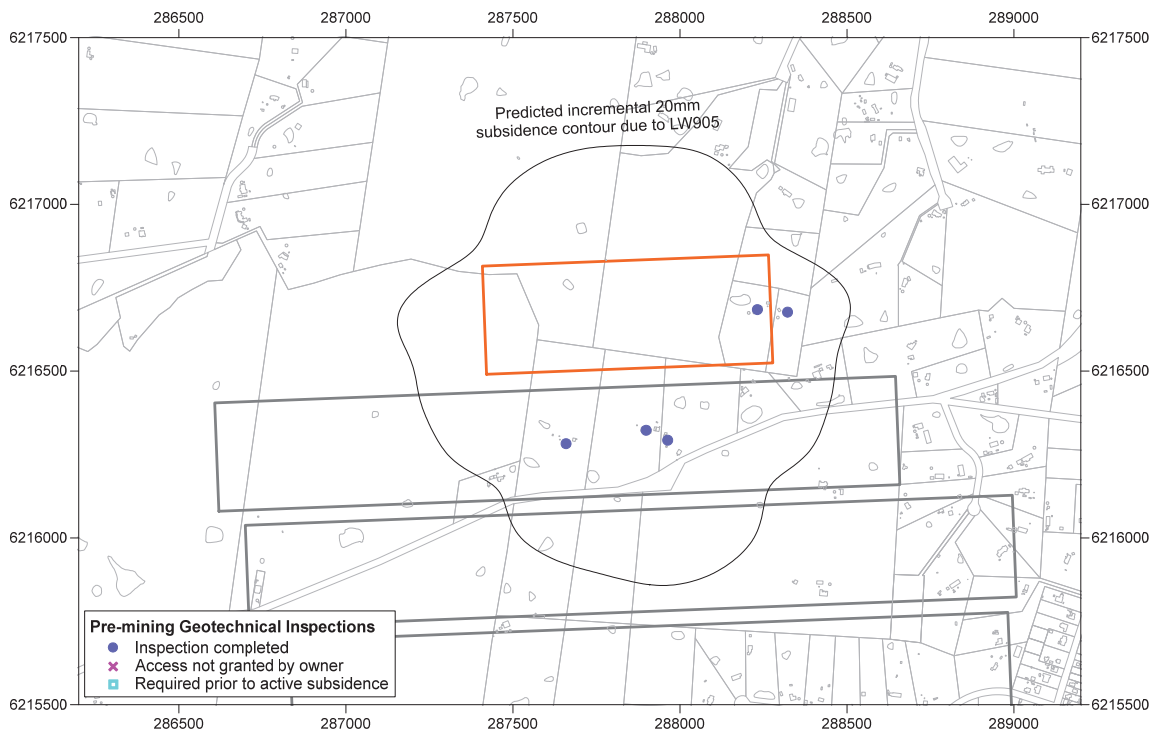
Fig. 6.1 Pre-mining geotechnical inspections

The pre-mining geotechnical inspections have been completed for five properties located within the Study Area (refer to Table 5.2). None have been declined or are pending. Geotechnical inspections are not required for the remaining properties within the Study Area because they are either not located on or near steep slopes or they are predicted to experience less than 150 mm total vertical subsidence after the mining of LW905.

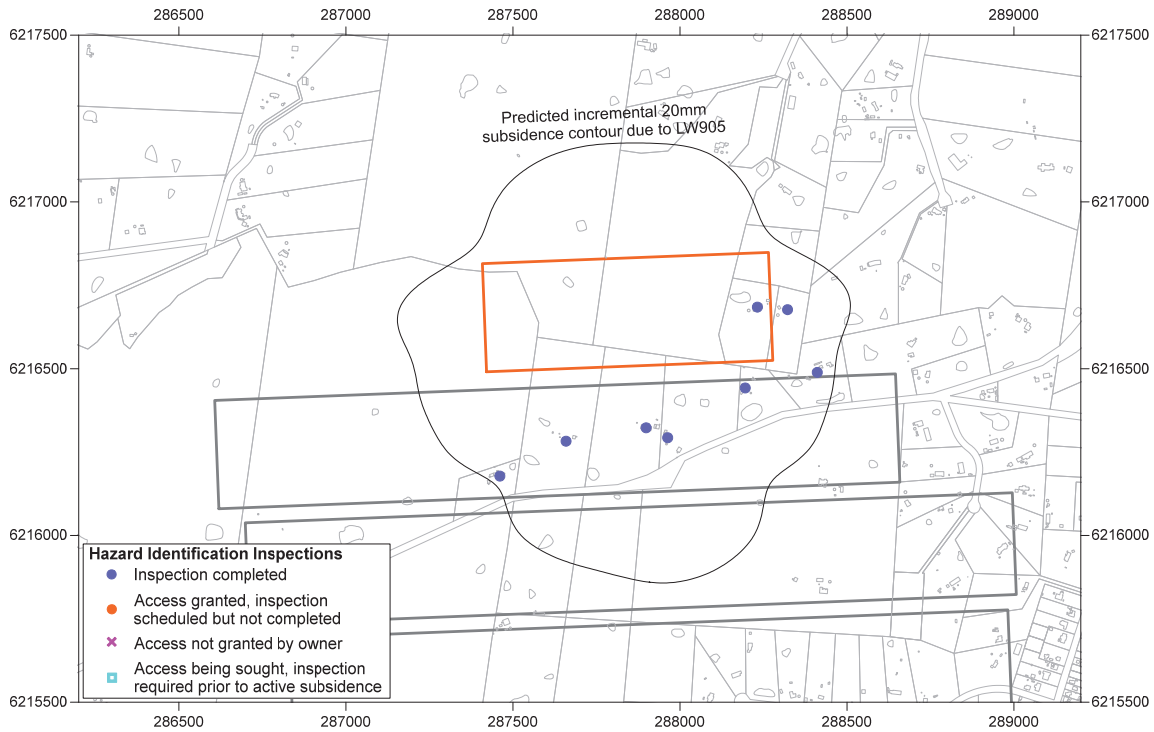
Fig. 6.2 Pre-mining hazard identification inspections

The hazard identification inspections have been completed for eight properties within the Study Area. None have been declined or are pending. Hazard identification inspections are not required for the remaining properties within the Study Area since they are predicted to experience less than 20 mm incremental vertical subsidence due to LW905.
