GEORGES RIVER REHABILITATION PLAN

| Document ID | APNMP0134 | Version | 1.0 | |

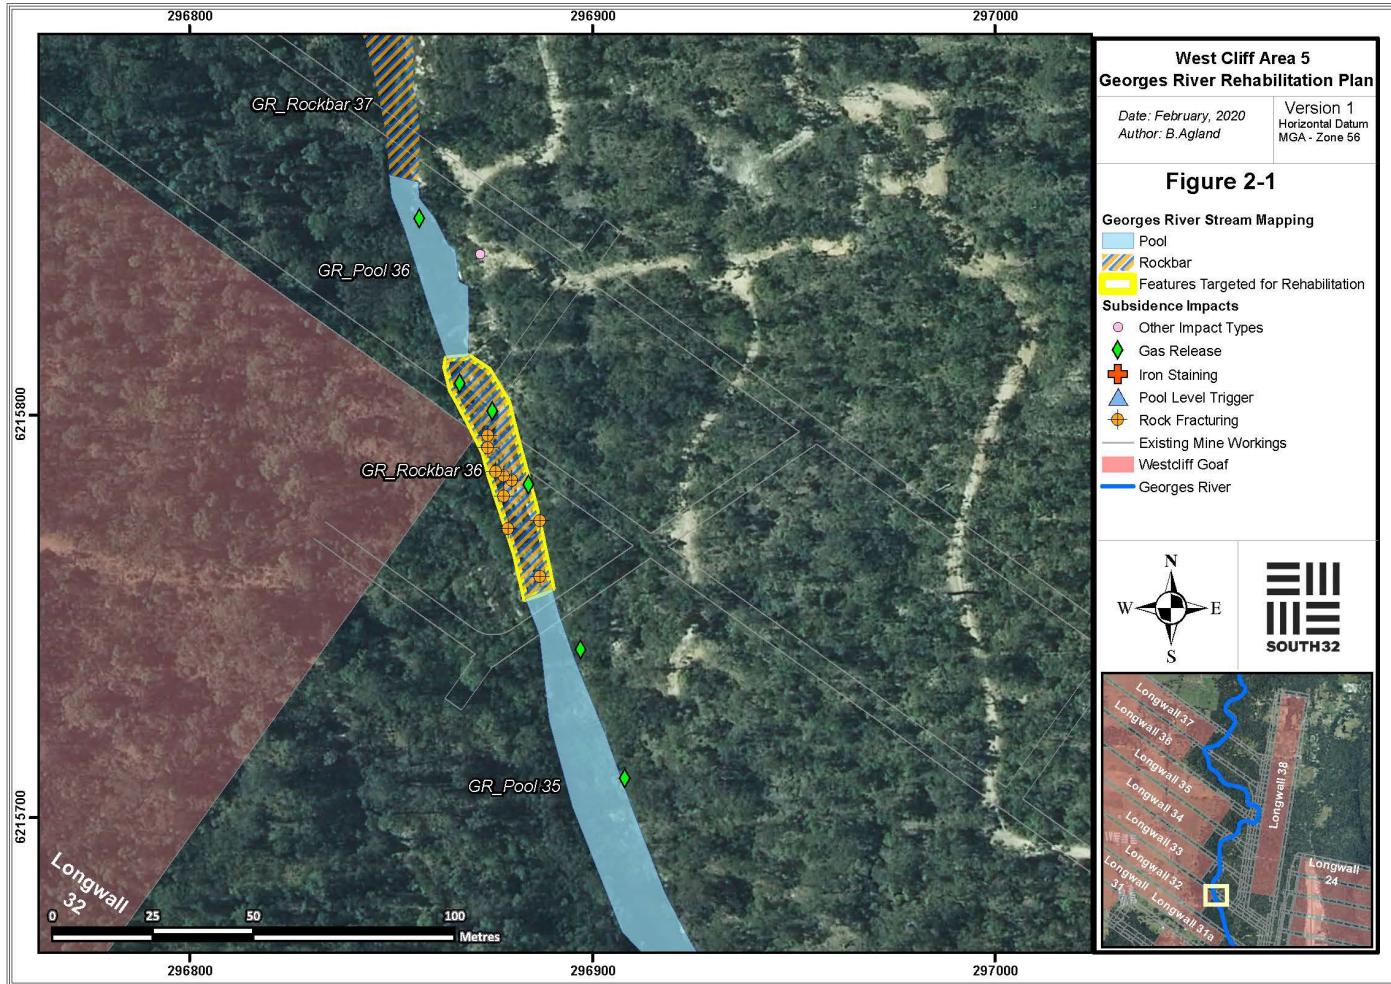
| Pool 26 | | |
|---|--|---|
| WCA5_Gas_001 | Gas zone observed in Pool 35 prior to completion of LW32. | Level 1 |
| WCA5_Gas_002 | Gas zone observed on Rockbar 36 prior to completion of LW32. | Level 1 |
| WCA5_Fracture_0 01 | Fracturing observed on Rockbar 36 prior to completion of LW32. No flow diversion observed. | Level 1 |
| WCA5_Fracture_0 02 | Fracturing observed on Rockbar 36 prior to completion of LW32. No flow diversion observed. | Level 1 |
| WCA5_Fracture_0 01(LW33) | Fracturing observed on Rockbar 36 prior to completion of LW32. Flow diversion was observed through fracturing. | Level 1 |

Figure 2-1 Location of Subsidence impacts from Pool 35 to Rockbar 37

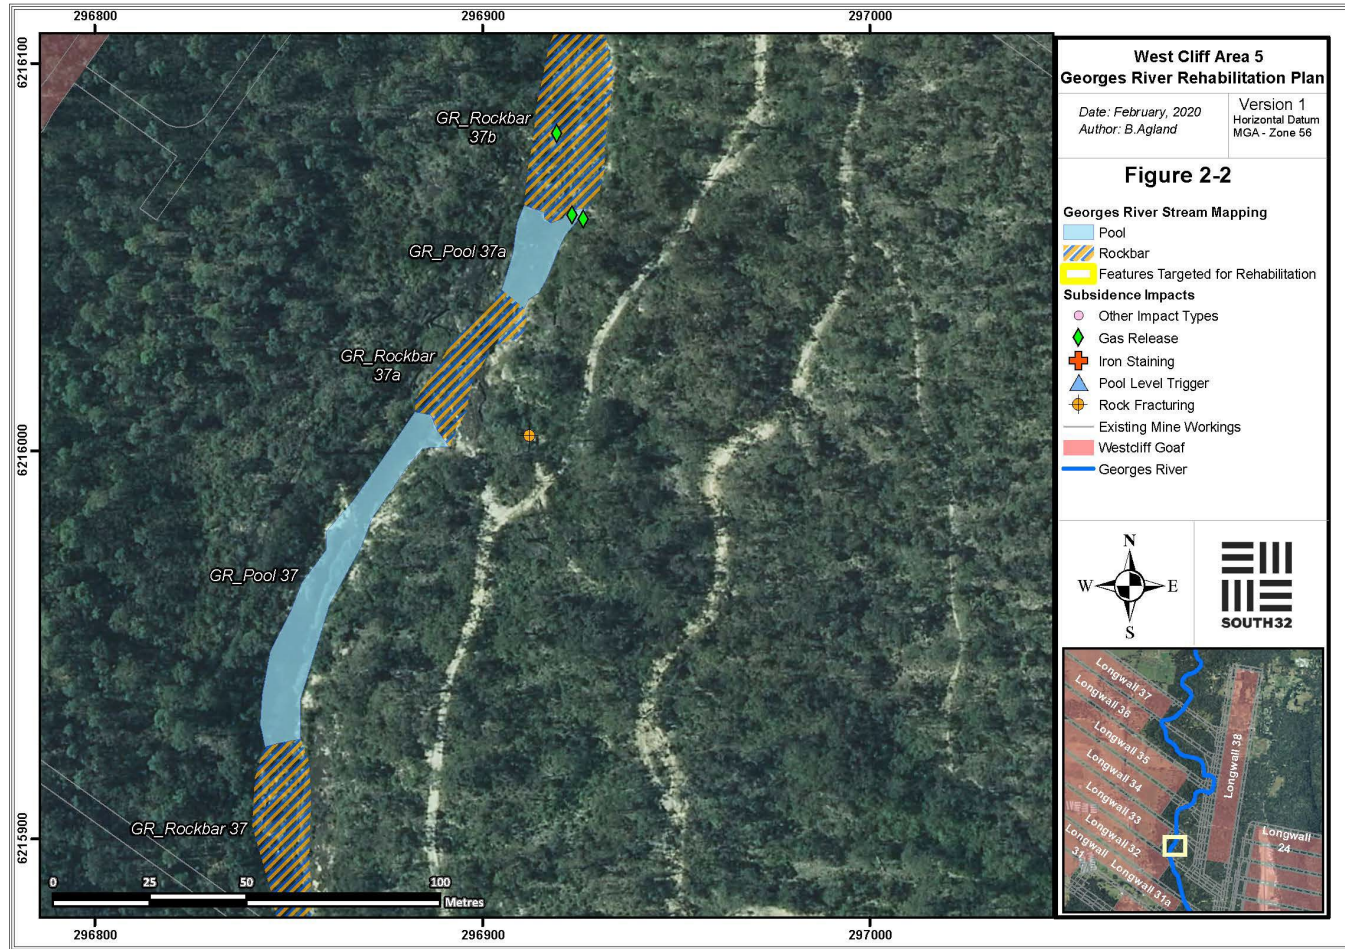
| Pool 36 | | |
|---|---|---|
| WCA5_Fracture_0 05 | Fracturing to the base of Pool 38 prior to completion of LW33. Proceeding flow diversions and below baseline pool water recorded at site. Maintenance of Pool 38 water level temporarily unattainable with additional BCD release. | Level 2 |

Figure 2-2 Location of impacts from Pool 37 to Rockbar 37b

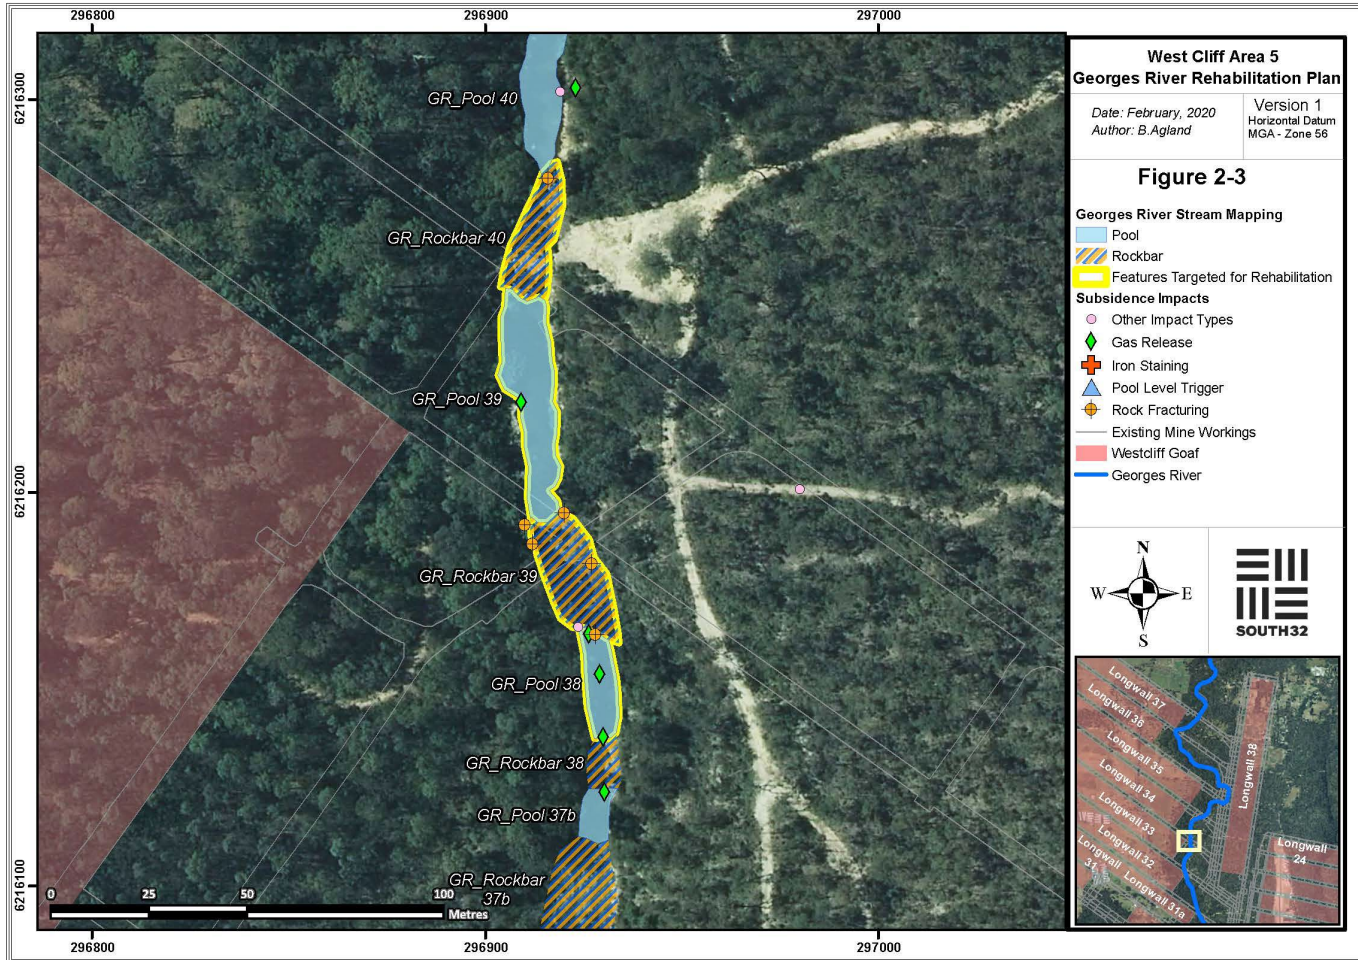
| Pool 36 | | |
|---|---|---|
| WCA5_Fracture_0 06 | Fracturing to Rockbar 39 identified prior to completion of LW33. Flow diversion observed through fracture following initial identification. | Level 1 |
| WCA5_Fracture_0 07 | Fracturing and uplift to Rockbar 39 identified prior to completion of LW33. Flow diversion observed through fracture following initial identification. | Level 1 |
| WCA5_Fracture_0 07a | Fracturing to the base of Pool 39 observed prior to completion of LW33. Outflow of upstream flow diversion observed through fracture. | Level 1 |

Figure 2-3 Location of impacts from Pool 37b to Pool 40

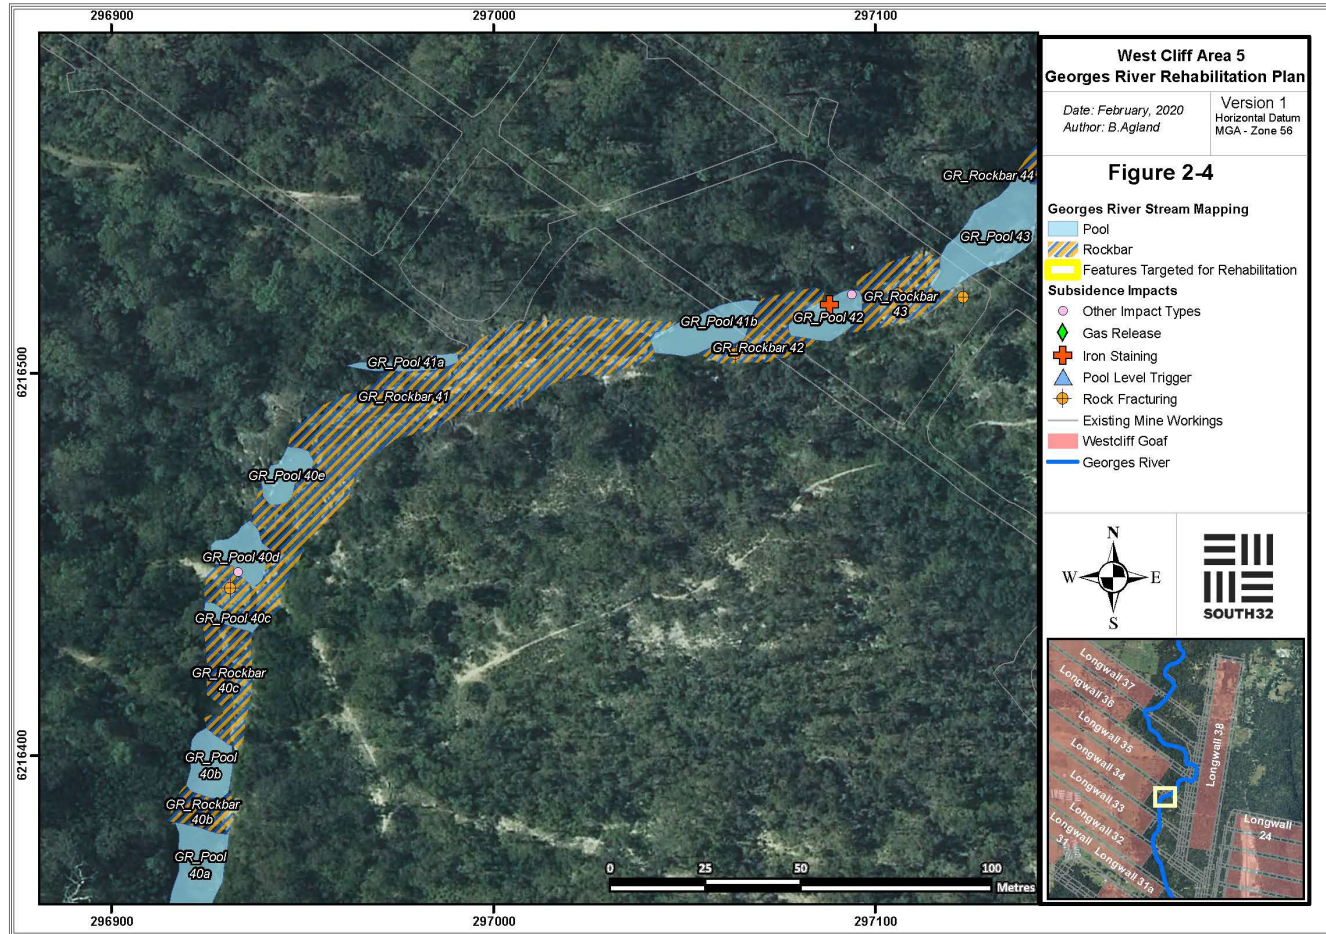
| Impact WCA5_LW35_016 | Fracturing to side of Pool 42. No observable flow diversion. | Level 1 |
| Impact WCA5_LW35_017 | Fracturing to Rockbar 43, directly downstream from Pool 42. Flow diversion observed through fracturing. | Level 1 |
| Impact WCA5_LW35_014 | Fracturing to rock shelf directly adjacent to Pool 43. No flow diversion observed. | Level 1 |

Figure 2-4 Location of impacts from Pool 40a to Pool 43

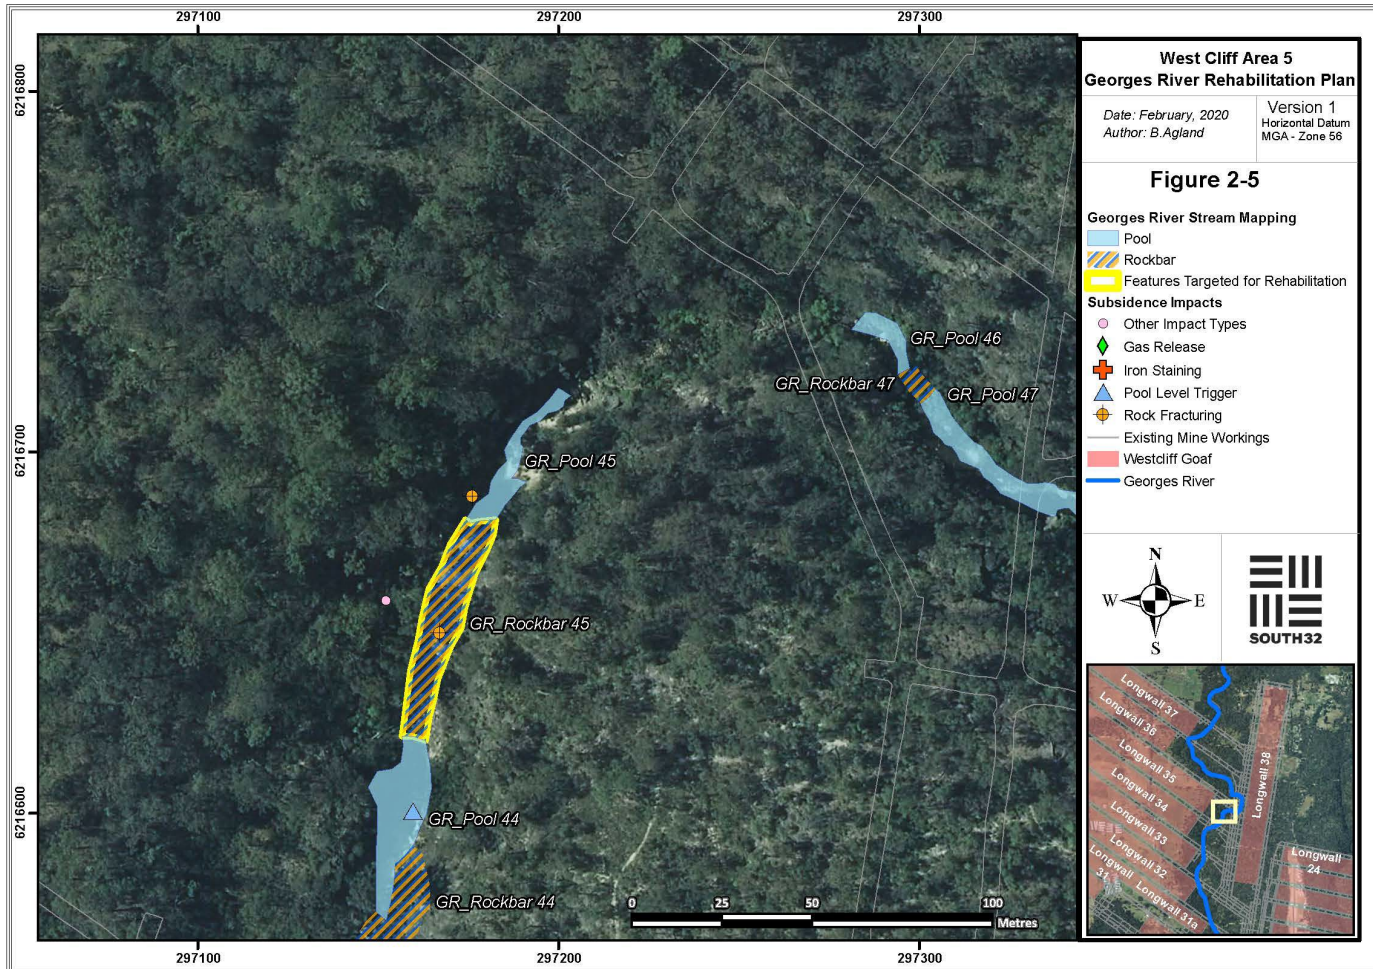
| Impact WCA5_LW35_013 | Extensive fracturing and uplift to Rockbar 45. Flow diversion observed through fracturing. | Level 1 |
| Impact WCA5_LW35_025 | 'Dry Below Benchmark' measurement recorded at various times during low flow conditions following completion of LW35. Maintenance of Pool 44 water level temporarily unattainable due restriction on BCD release (EPL 2504). | Level 2 |

Figure 2-5 Location of impacts from Rockbar 44 to Pool 46

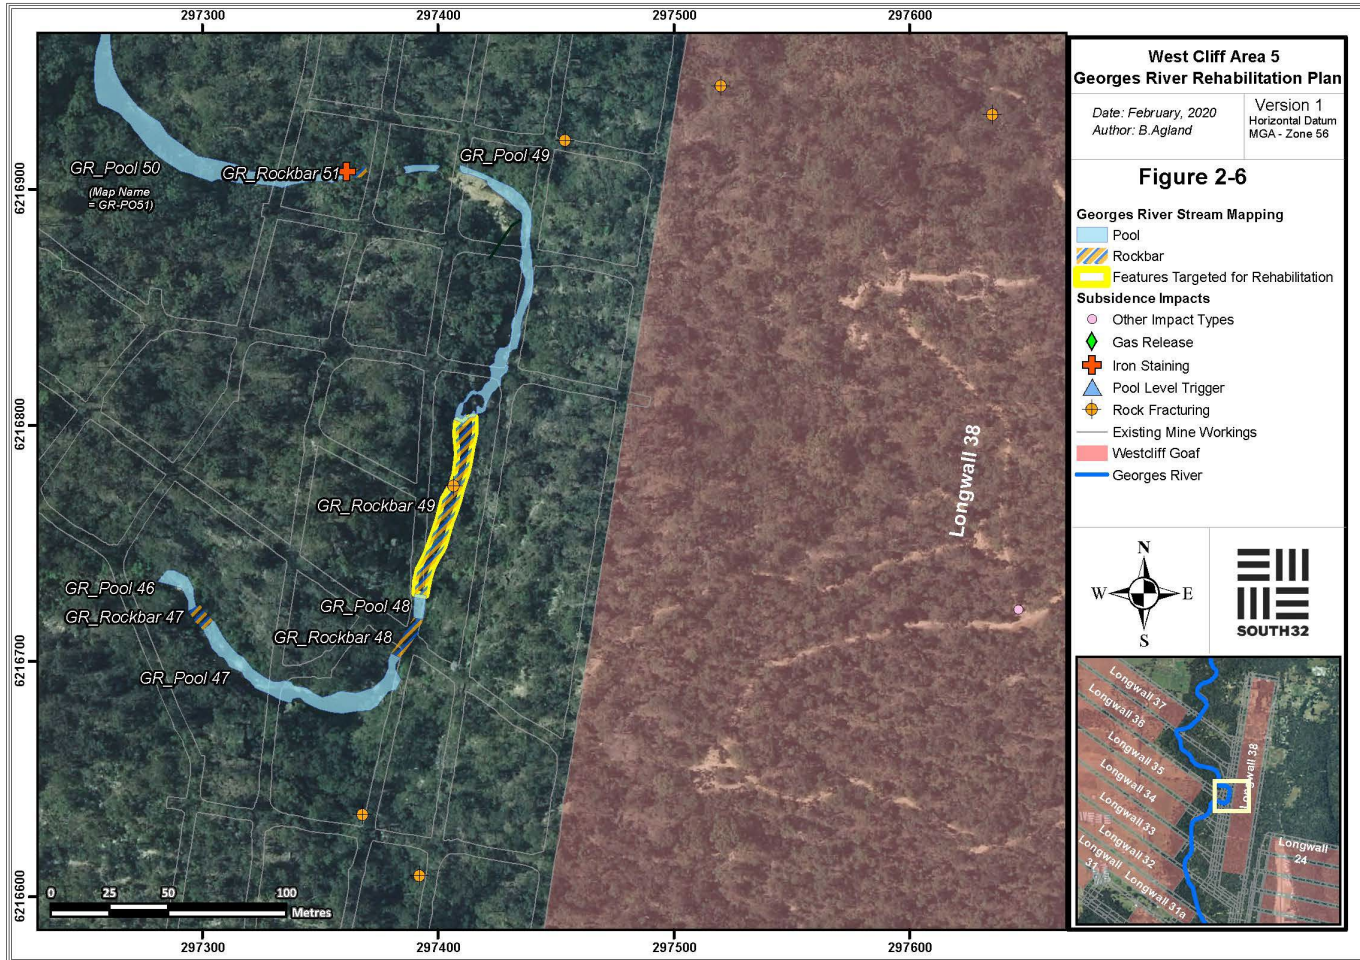
| Impact WCA5_LW38_008 | No surface impacts identified to Pool 47. No decline in water level below baseline levels. Rock fracturing and flow diversion at downstream Rockbar 49. Observed following passing of LW38. | Level 2 |
| Impact WCA5_LW38_009 | Decline in water level past measurable point. This semi-quantitative observation was experienced once during the baseline period. This observation was experienced multiple times following completion of LW35. Iron staining downstream from Pool 49. Observed following passing of LW38. | Level 1 |

Figure 2-6 Location of impacts from Pool 47 to Pool 51

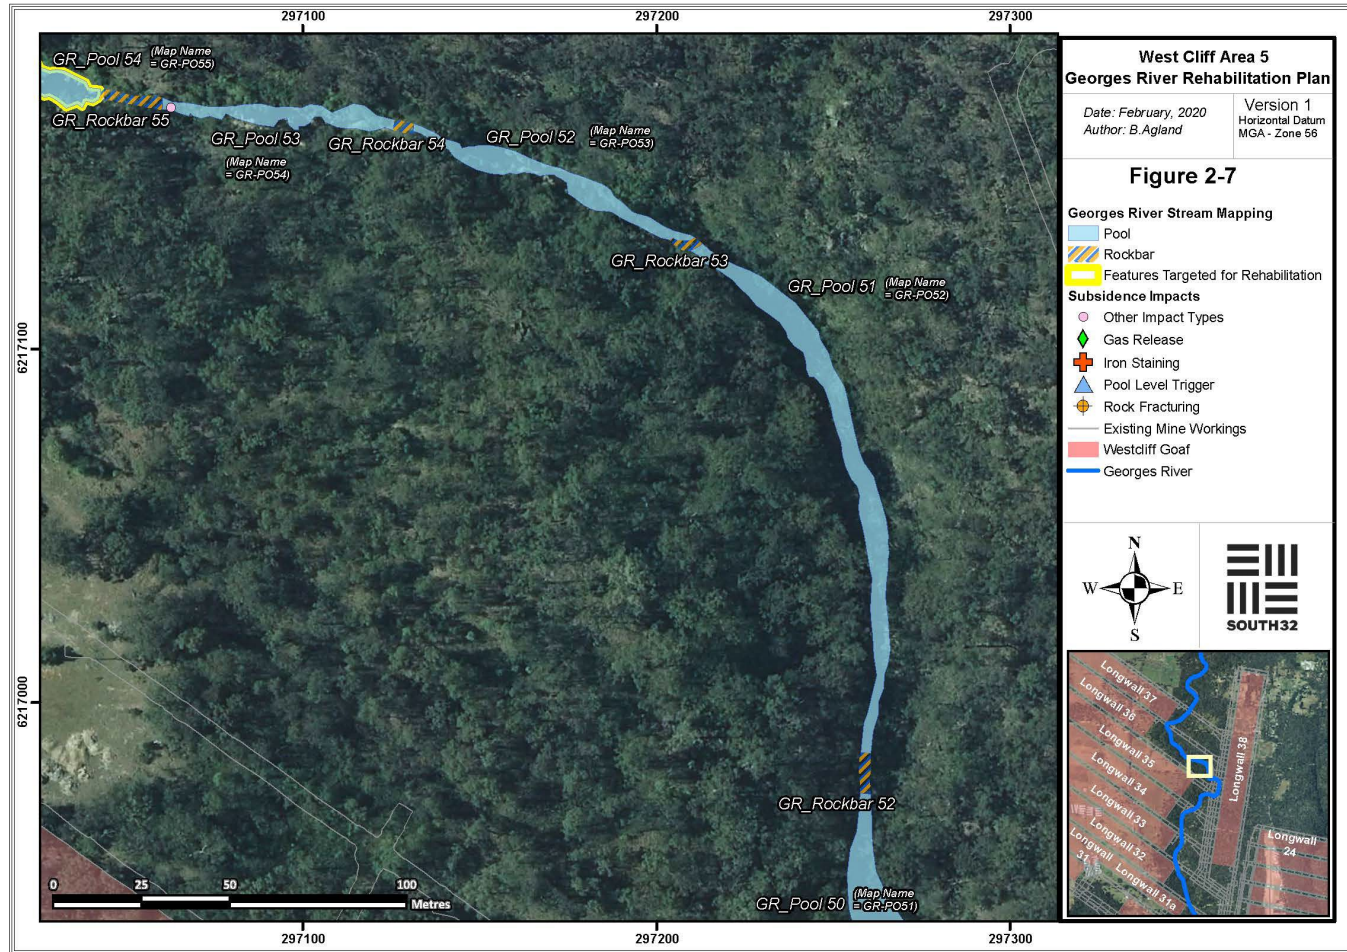
| Impact WCA5_LW35_007 | Fracturing to base of pool observed prior to completion of LW35, shortly followed by decline in pool water level below baseline levels. Active flow diversion later observed at site. Maintenance of Pool 54 water level temporarily unattainable due restriction on BCD release (EPL 2504). | Level 2 |

Figure 2-7 Location of impacts from Pool 51 to Pool 54

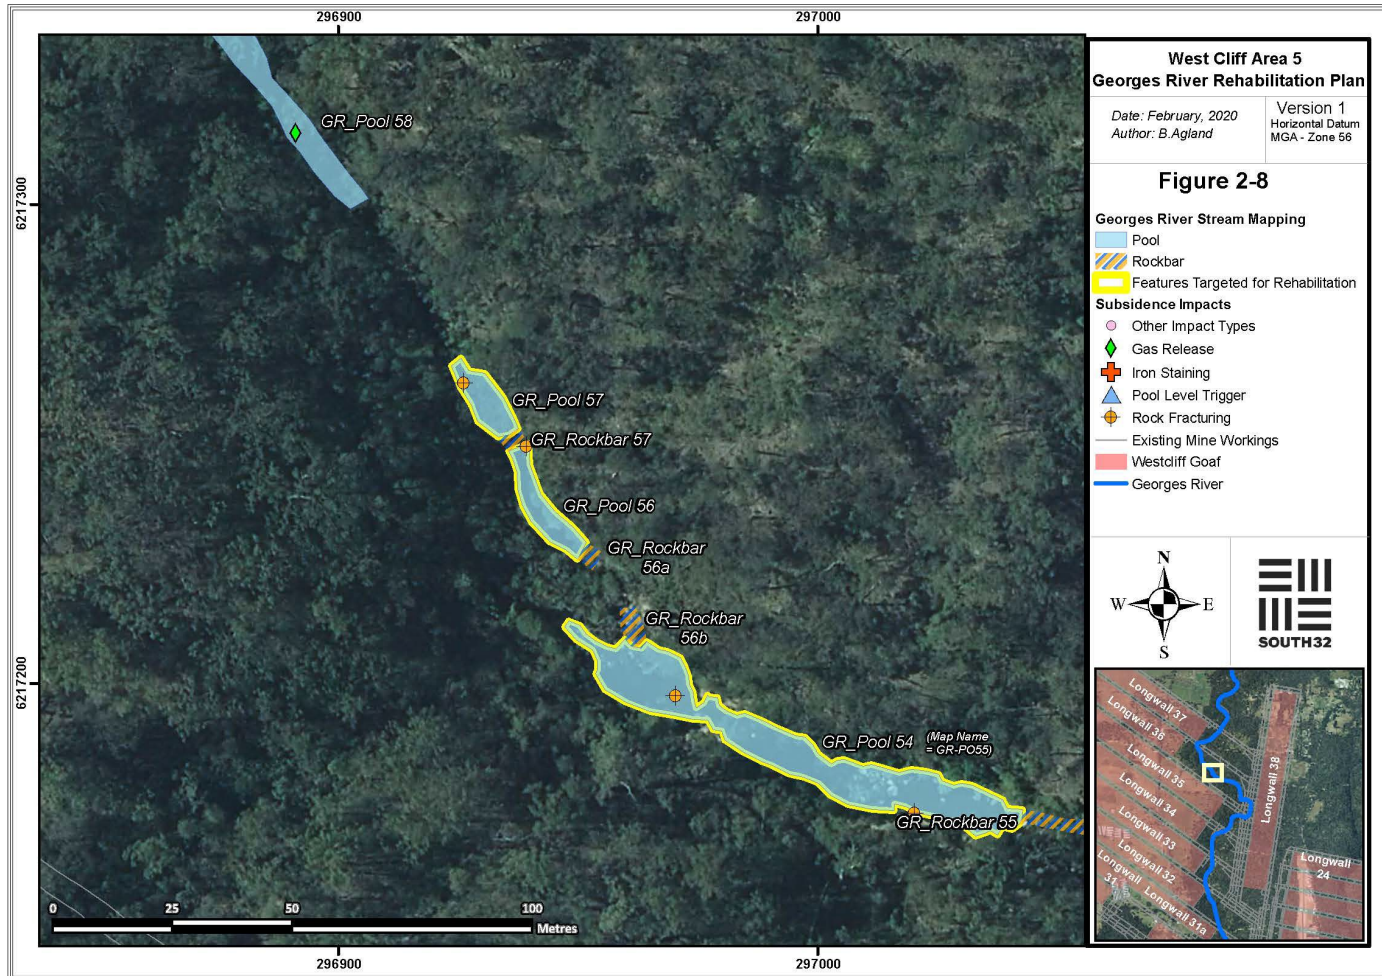
| Pool 56 | | |
|---|---|---|
| Impact WCA5_LW35_012 | Fracturing to pool base and rockbar as LW35 passed section of river Pool 56 recorded pool water level below baseline following completion of LW35 Below baseline pool water level observations recorded since during low flow conditions Maintenance of Pool 56 water level temporarily unattainable due to restriction on BCD release (EPL 2504). | Level 2 |
| Impact WCA5_LW35_019 | Fracturing to base of Pool 57 observed towards end of LW35 extraction Pool 57 recorded pool water level below baseline following completion of LW35 Below baseline pool water level recorded since during low flow conditions Maintenance of Pool 57 water level temporarily unattainable due restriction on BCD release (EPL 2504). | Level 2 |

Figure 2-8 Location of impacts from Pool 54 to Pool 57

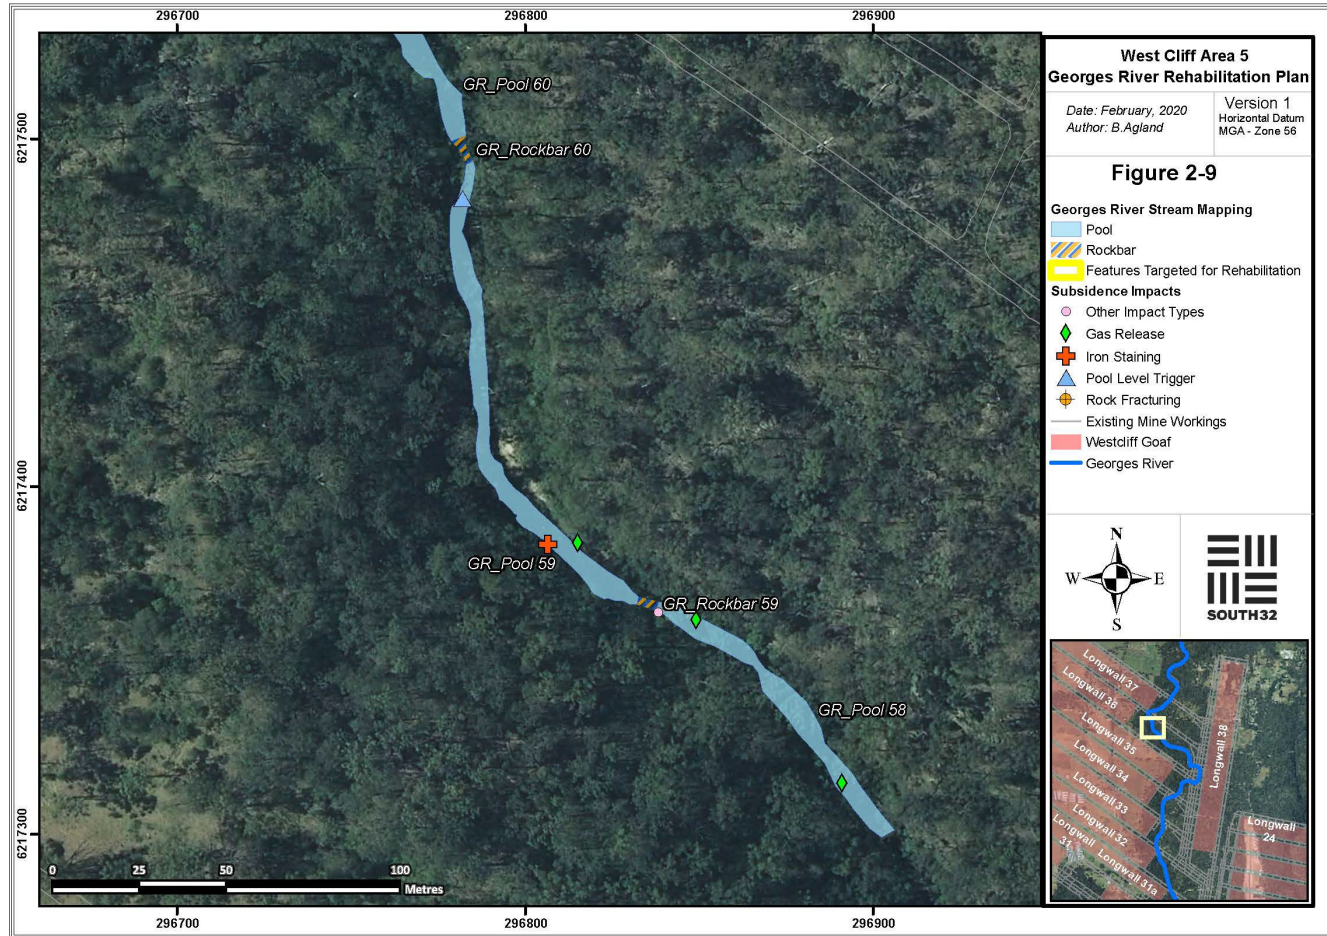
| Pool 56 | | |
|---|---|---|
| Impact WCA5_LW35_022 | Pool 58 recorded pool water level below baseline following completion of LW35 Below baseline pool water level recorded since during low flow conditions Maintenance of Pool 58 water level temporarily unattainable due restriction on BCD release (EPL 2504). | Level 2 |
| Impact WCA5_LW35_020 | Iron staining observed originating from Pool 58 Iron staining reappeared at various times- usually associated with low flow conditions. | Level 1 |

Figure 2-9 Location of impacts from Pool 58 to Pool 60

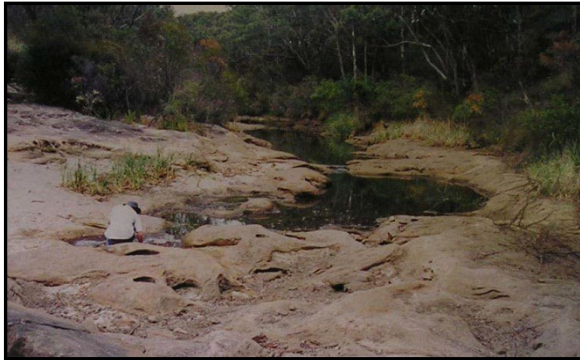
The works have proven successful, with flows and water levels during low flow conditions being restored in areas where remediation works have been completed. An example of the results of the work is shown in Photo 1 and Photo 2, which provides images of Georges River Pool 14 before and after remediation works.

Photo 1: Pool 14 on 22/11/02 following mining.

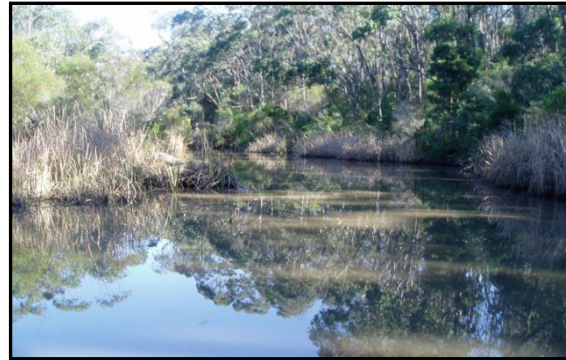
Photo 2: Pool 14 on 6/7/05 following remediation works.
