APPIN AREA 7  
LONGWALL 706 END OF  
PANEL REPORT

ATTACHMENT C2 –  
LW706 IMPACT  
REPORTS

APPIN AREA 7  
LONGWALL 706 END  
OF PANEL - IMPACT  
REPORTS

## **Nepean River Impact Report – Gas Release**

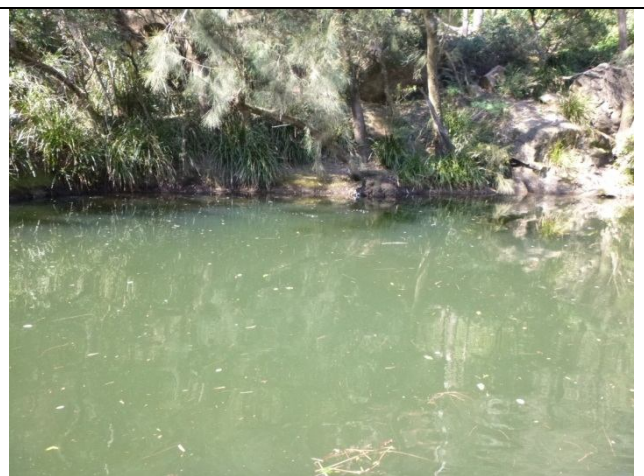
AA7\_LW706\_001 consists of 4 gas release sites in two 2m x 1m zones (Photos 1 & 2), approximately 6m apart. The releases are located over previously extracted Tower Mine Longwall 16, approximately 925 metres upstream of Gas Zone 15 (**Map 1**).

**Photo 2:** AA7\_LW706\_001 Gas Release 13<sup>th</sup> August 2014.

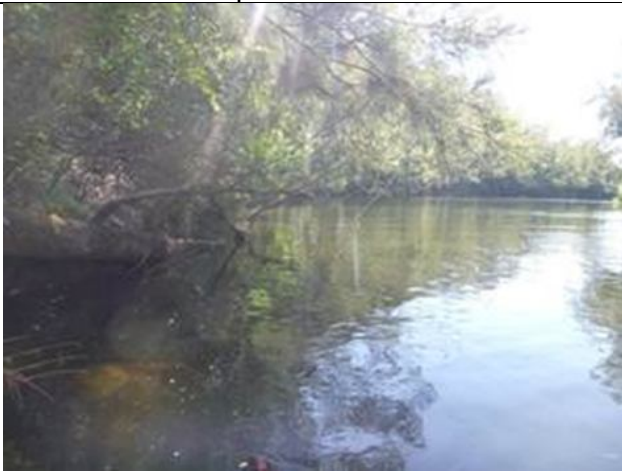
Gas Zone 16 was originally identified on 4<sup>th</sup> October 2012 and consisted of multiple releases in an approximate 60m x 5m area. The flow rate from Gas Zone 16 was estimated to be approximately 200L/min. This release has not been active since the 17<sup>th</sup> January 2014 (Photo 5).

**Photo 5:** AA7LW705 Gas Zone 16 looking downstream. Gas zone not active. Taken on 17/01/2014.

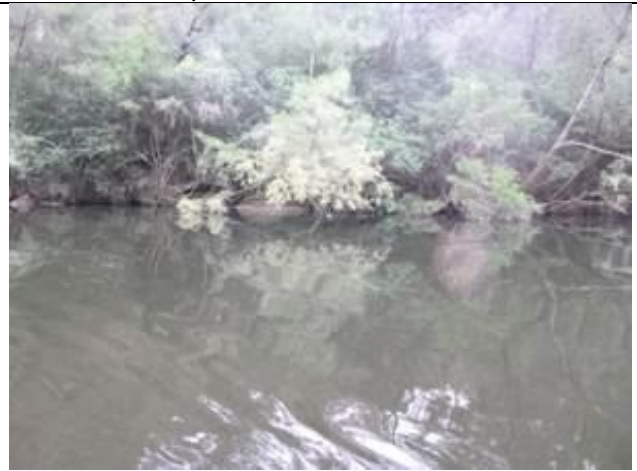
Gas Zone 17 was originally identified on 7<sup>th</sup> February 2013, consisting of up to seven releases at any one time. No activity has been identified since 19<sup>th</sup> February 2014 (Photo 6). Gas Zone 17 was too small to measure or estimate flow rates.

**Photo 6:** AA7LW705 Gas Zone 17 looking across stream. Gas zone not active. Taken on 19/02/2014.

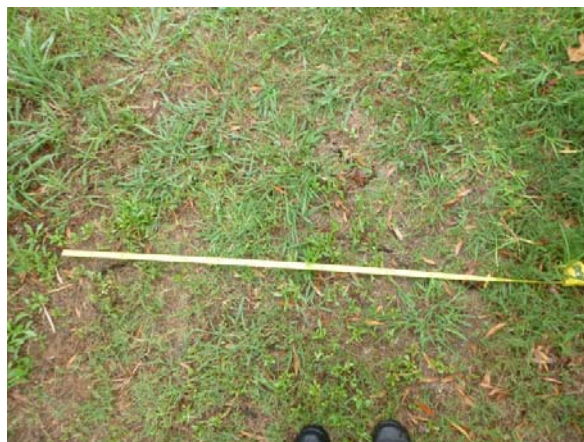
A soil crack was identified at the base of the north-western section of the Dam E16d01 wall (Photo 4). The crack was approximately 1.3m long, with a maximum width and depth of 0.02m and 0.03m respectively. The crack does not appear to pose a safety hazard and with no further movements is expected to self-remediate.

**Photo 4:** Cracking to base of dam wall. Taken on 04/01/2016.
