Lot 8 DP 804133 is located within the subsidence bowl of Longwalls 705, 706 and 707 (refer Figure 1). The property contains a dwelling, ancillary structures and a dam identified as E13d01 which is used for infrequent irrigation of vegetation on the property. The location of the dam is shown in Figure 1.

Appin Mine is currently mining Longwall 707 which commenced on 7<sup>th</sup> January 2016.

# Longwall 707 Post-Mining Property Inspection

Lot 73 DP883462

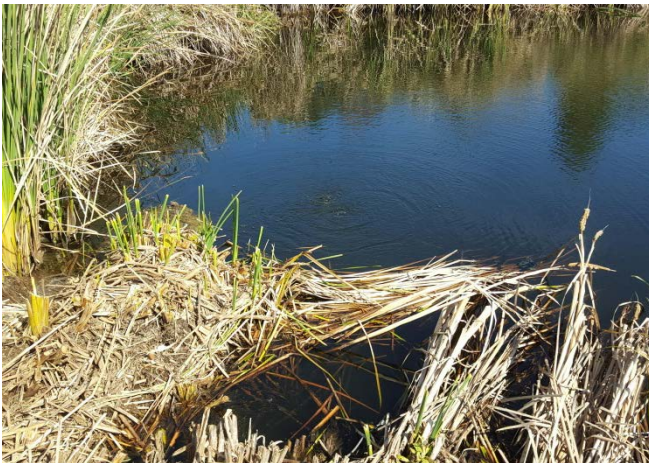
An inspection of the dam was undertaken on the 6th April 2016 by Illawarra Coal (IC) representatives in response to feedback from the landholder who had observed gas bubbling in the dam and lower dam water levels. The gas emission zone consists of four individual constant gas releases over an area approximately 4m<sup>2</sup>. Gas and water samples were taken at the time of the inspection, with lab testing confirming the presence of strata gas. This gas zone has been recorded as impact AA7\_LW707\_001 as shown in Figure 1.

**Photo 1:** Gas bubbling in dam as seen from edge of dam

Illawarra Coal installed a star picket to assist in determining any further water loss and will supply water to the property as and if required at the request of the landholder. Illawarra Coal will continue to work with the landholder to monitor any changes in the gas release.

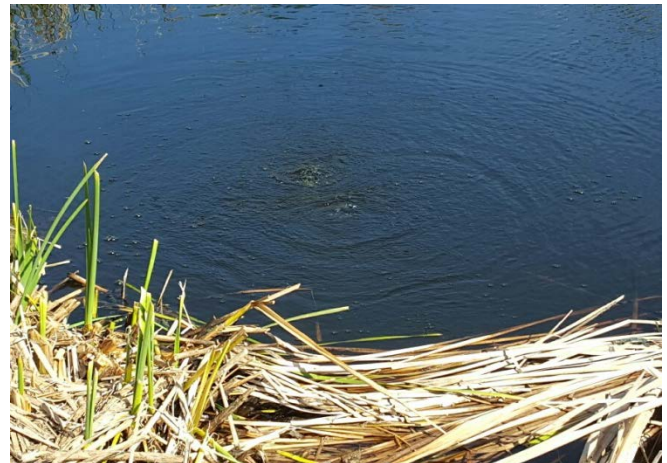
**Photo 2:** Close up of main gas release.

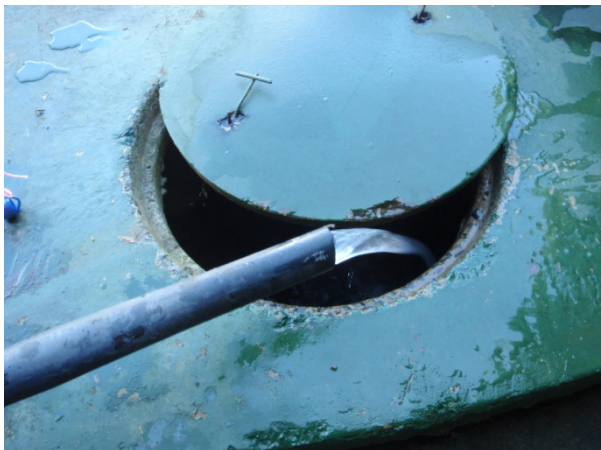
**Water Properties:** Sampled water from the bore was noted as being effervescent but clear at the time of the baseline inspection (Photo 1), this effervescence was observed in the inspection carried out on the 7/3/16 but not on the 14/5/14. In situ water quality parameters and water samples were taken from an outlet pipe. The borehole was purged prior to samples being taken. It was noted that prior to the 7/3/16 inspection the bore had been operated for approximately 12 hours over the previous three months as the landholders were overseas (Photo 3).

Photo 1: Flow from outlet pipe and storage tank during baseline inspection. Photo taken on the 11/10/13.

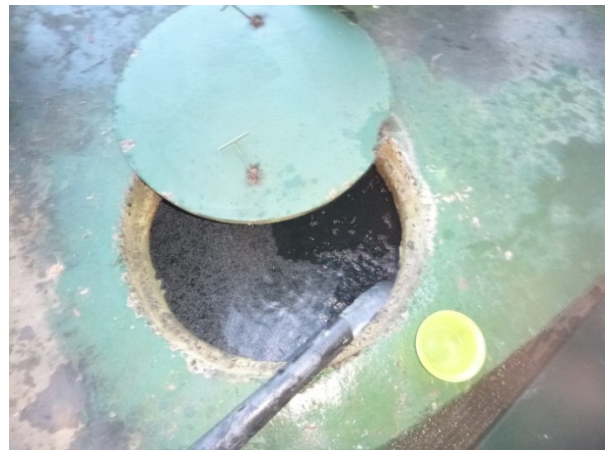
Photo 2: Flow from outlet pipe and storage tank during post-mining inspection. Photo taken on the 14/05/14.

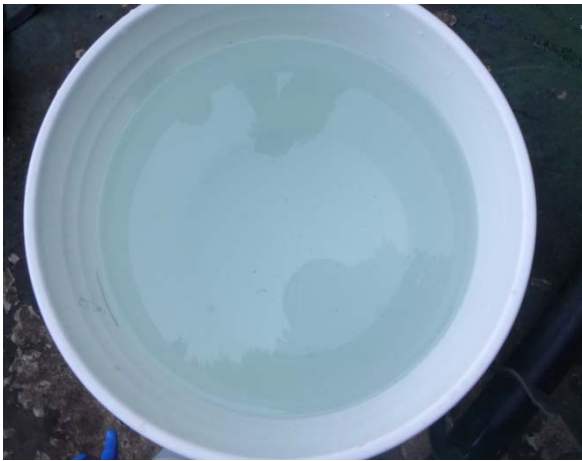
Photo 3: Collection of water from the bore after one hour of flushing. Photo taken on 7/3/16.

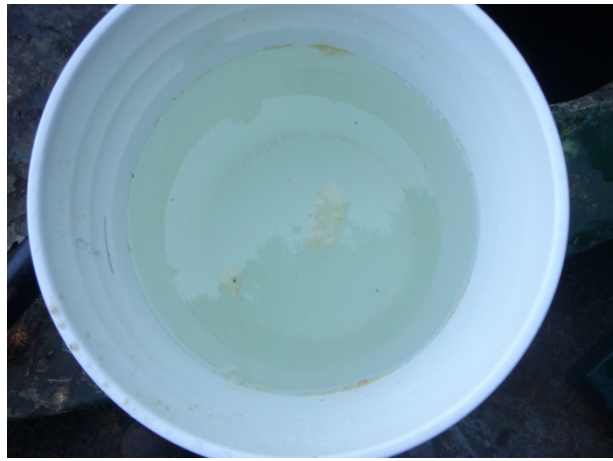
The holding tank showed evidence of iron staining compared to the post mining impact carried out on 7/3/16 (Photo 4 & 6). A sample of water in the tank was also taken for testing. The results of these analyses from baseline and post-mining inspections are included below (Tables 1 & 2 respectively). Results from the follow up inspection have not yet been received from the laboratory.

Photo 4: Collection of water from the holding tank with presence of orange film. Photo taken on 7/3/16.

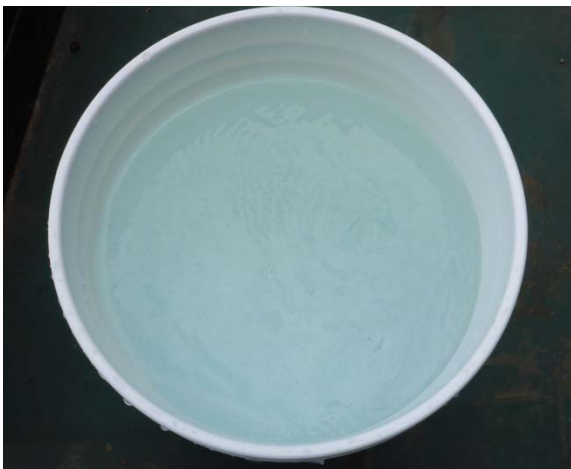
On the follow-up inspection 22/4/16 no signs of iron staining or salinity were visible in the water directly from the borehole (Photo 5). The area surrounding the borehole had a strata gas odour and there was the sound of bubbling coming from within the borehole. A gas detector confirmed the presence of combustible gases directly above the collar of the borehole.

Photo 5: Collection of water from the bore after 5 minutes of flushing. Photo taken on 22/4/16.

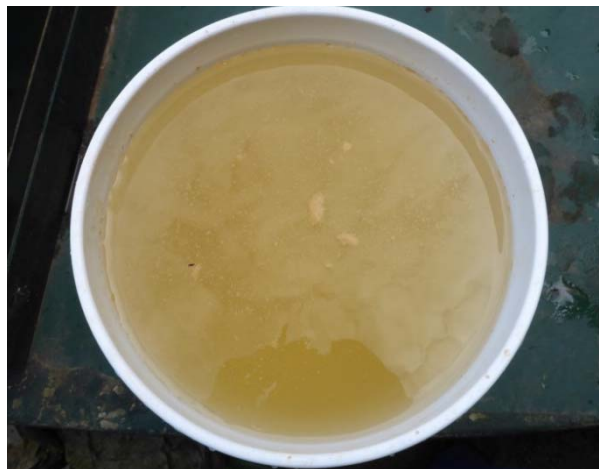
Photo 6: Collection of water from the holding tank with presence of orange film. Photo taken on 22/4/16.

The changes observed at borehole GW102584 have been recorded as impact AA9\_LW707\_002 (Figure 1). Illawarra Coal will continue to work with the landholder to monitor any further changes to the borehole and will supply water to the landholder if required. An Illawarra Coal representative advised the landholder to avoid using electrical equipment in the brick shelter where the borehole is located. Doors on the shelter were secured open to ensure good ventilation. During the inspection on 22/4/16 a gas detector did not record combustible gases in the shelter unless the detector was within 0.5m of the borehole.

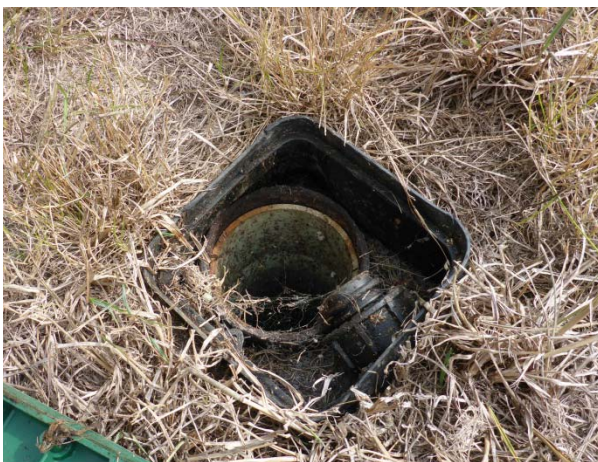
During this inspection the landholder stated that there was a second, inactive borehole (BH2) located on the property (Photo 7 & Figure 1). The cap to this borehole was removed and was giving off an odour, bubbling sound and low reading of combustible gas. The landholder stated that this borehole was not used.

Photo 7: Picture of second borehole located on follow up inspection on 22/4/16. Photo taken on 22/4/16.

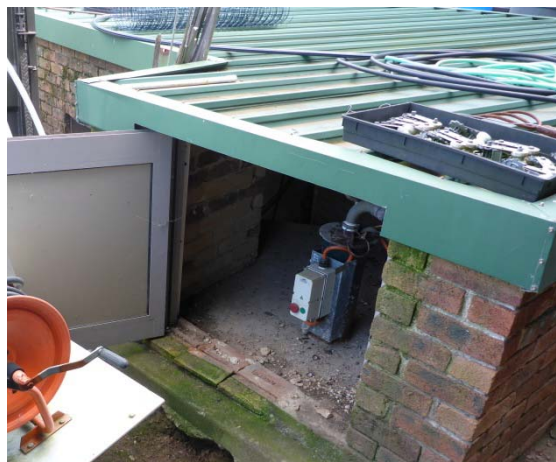
Photo 8: Borehole located in brick shelter. Photo taken on 22/4/16.

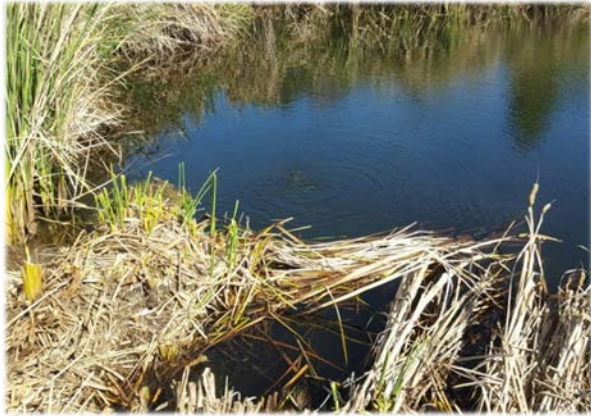
The initial inspection on the 6<sup>th</sup> April 2016 revealed gas bubbling from the dam (Photo 1 and 2). During the post-mining inspection, no gas release was observed. Observations showed that the dam was at a relatively low level (Photo 3 and Photo 4). Water samples collected from the dam were dark in colour and turbid (Photo 5).

*Photo 1: E13d01, gas bubbling from dam. Taken 6th April 2016.*

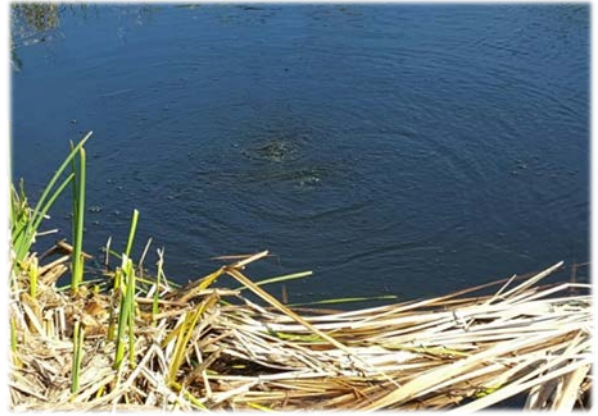
*Photo 2: E13d01, close up of gas bubbling. Taken 6th April 2016.*

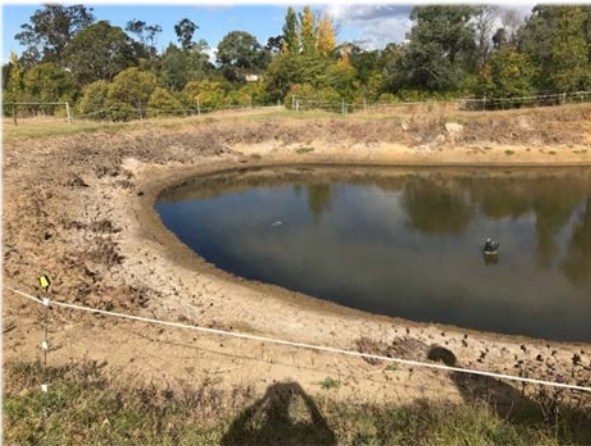
*Photo 3: E13d01, looking south-east. Taken 16th May 2018.*

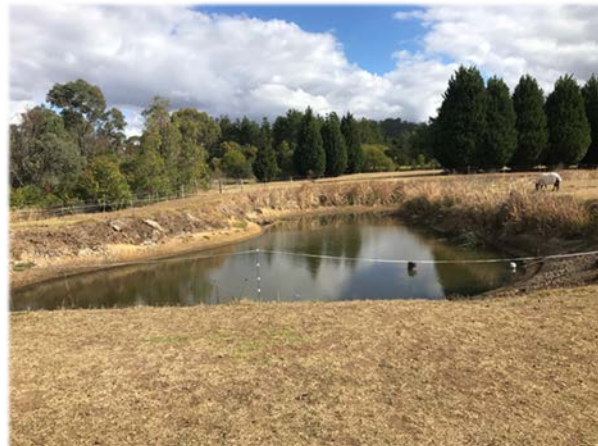
*Photo 4: E13d01, looking south-west. Taken 16th May 2018.*

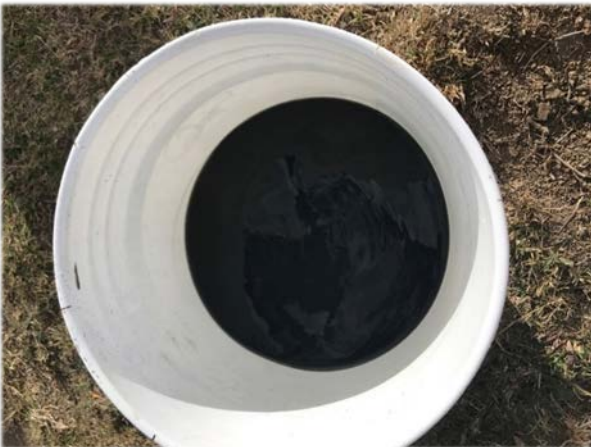
*Photo 5: Water sample from E13d01. Taken 16th May 2018.*

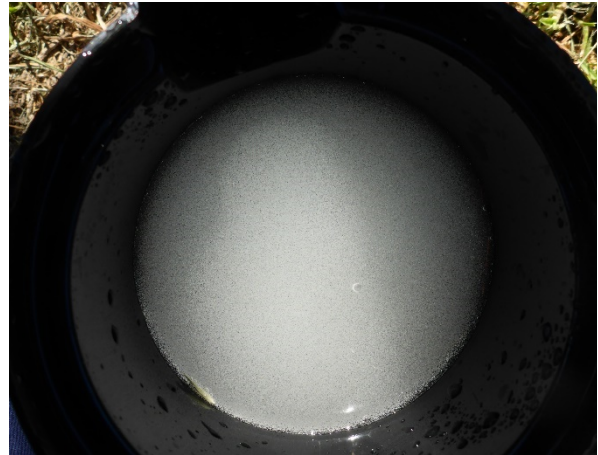
Water samples were collected from GW104602 via the pump (Photo 1 and Photo 2). There were no observable indicators of iron precipitate or hydrogen sulfide during sampling. (Photo 3). The water was noticeably effervescent during sampling (Photo 4).

*Photo 4: Closeup of water sample taken from borehole via the pump. The effervescent nature of the water is exhibited. Taken on 16/04/2018.*

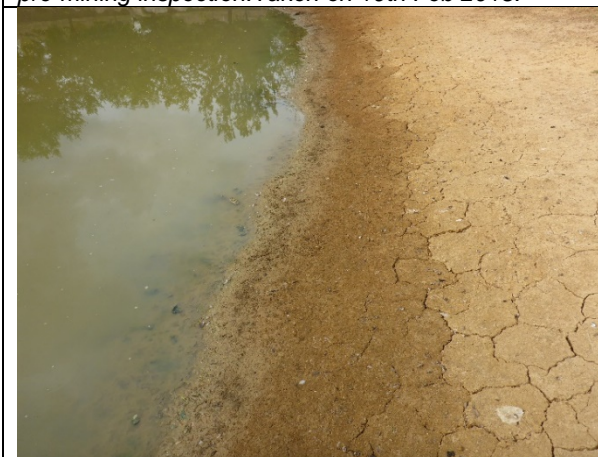
The dam is located to the northeast of the residence (Figure 1, Photo 3 and 4), and is routinely supplied with water from the borehole. During the pre-mining inspection the landholder advised that the dam was relatively low. Soil cracking was found around the extent of the dam and on the dam during the pre-mining inspection (Photo 5), with major soil cracking also found on the walls of the dam. No observable changes were found in the soil cracking during the post-mining inspection (Photo 4). Water quality parameters were measured in-situ and water samples were also taken from the dam located on the property during both inspections.

**Photo 5:** Soil cracking present around extent of dam edges observed during pre-mining inspection. Taken on 19<sup>th</sup> Feb 2018.

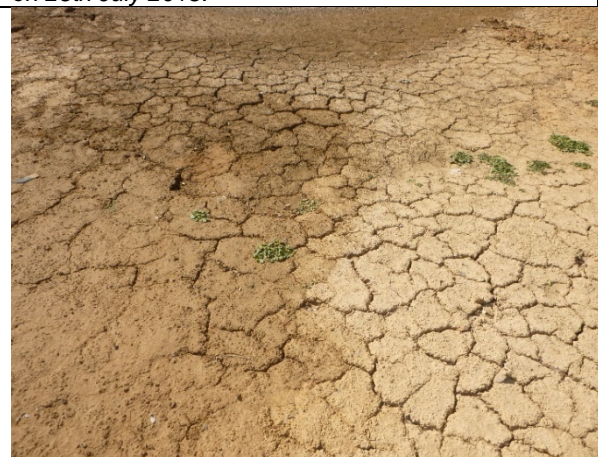
**Photo 6:** Soil cracking observed around dam during post-mining inspection. Taken 25<sup>th</sup> July 2018.
