This post-mining report includes observations and field data recorded for relevant features on Lot 900 DP1072947, including borehole GW101986 and property dam (MSEC ID: F17d01) (Figure 1).

This report includes pre- and post-mining observations and results gathered for borehole GW072874 and dam (MSEC ID: F11d01) on Lot 10 DP245756 (Figure 1).

This post-mining report includes observations and field data recorded for relevant features on Lot 73 DP883462, including borehole GW105376 and the property dam (MSEC ID: D21d01).

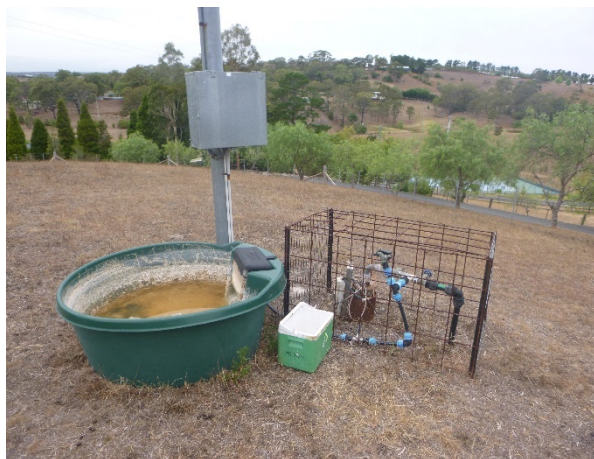
On 22 February 2018, a pre-mining inspection of property Lot 900 DP1072947 was undertaken. The borehole on the property was identified and inspected. During this inspection water quality was measured using the water in the tub (Photo 1). Water samples were collected from water that was pumped directly from the bore into a glass container (Photo 2).

Photo 1: Photo of GW101986 and pump. Taken 22/2/2018.

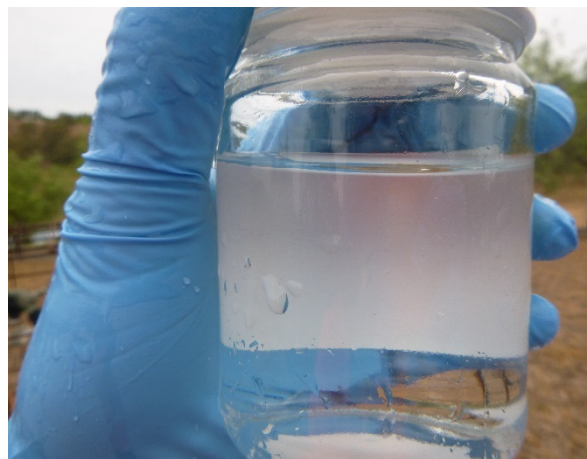
Photo 2: Photo of water sample taken from GW101986. Taken 22/2/2018.

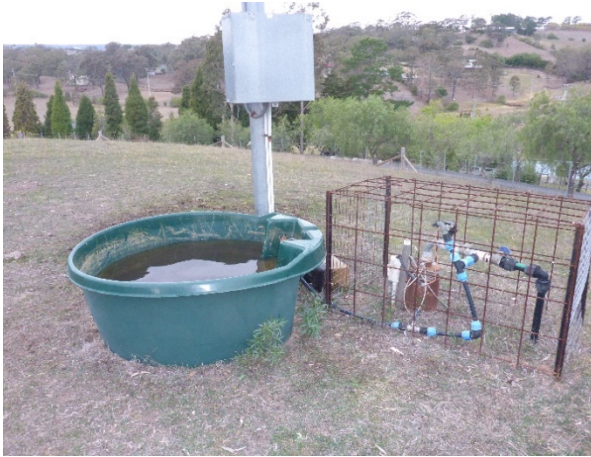
A Longwall 707 post-mining inspection of the property was conducted by IMCEFT on 6 August 2018 and a follow-up inspection undertaken on 14 September 2018. Water that was pumped directly from the bore into a bucket was used to measure water quality and to collect water samples. No observable changes to the borehole were identified.

Photo 3: Borehole GW101986 and pump. Taken on 6/08/2018.

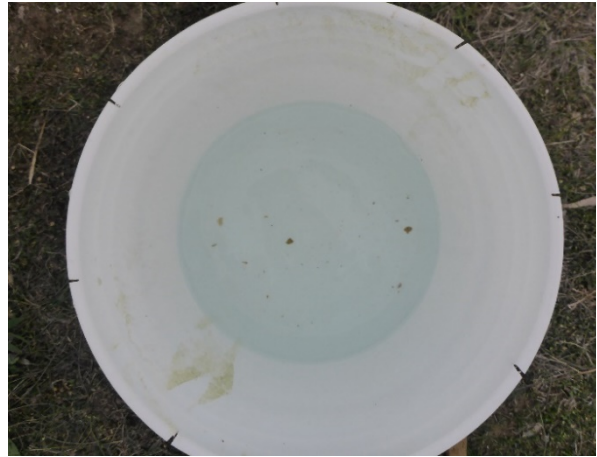
Photo 4: Water sample from borehole GW101986. Taken on 6/08/2018.

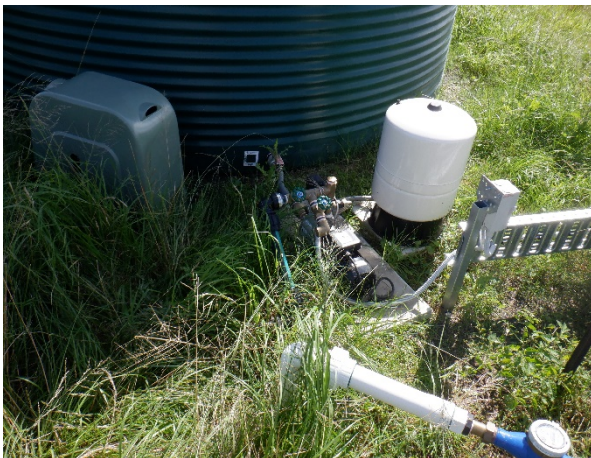
The most recent inspection was undertaken on 17 March 2022 following completion of Longwall 708. During this inspection the samplers were unable to use the borehole pump without the property owner and therefore a water sample was unable to be collected. No iron staining or salinity was observed around the pump. The property dam was inspected, water samples collected, and key observations recorded.

Water Properties: Water properties could not be assessed as water is stored in a tank and the landholder was not present at the time of inspection. No signs of iron, salinity staining or gas were observed around the borehole or around the outlet. Previous sample results from ALS for laboratory analysis are included below in Table 1.

Photo 5: Borehole GW101986 and pump. Taken on 17/03/2022.

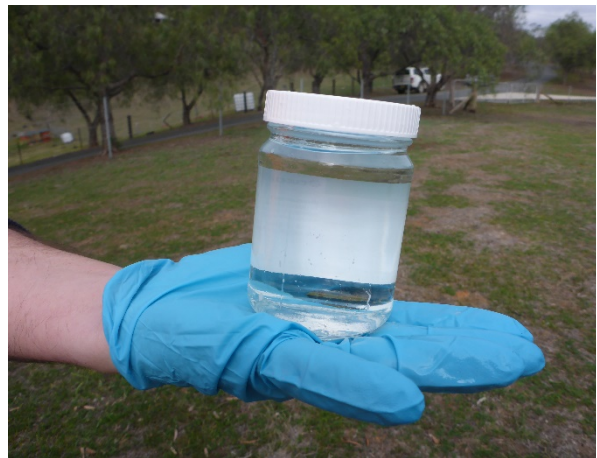
Photo 6: Water sample from borehole GW101986. Taken on 14/09/2018.

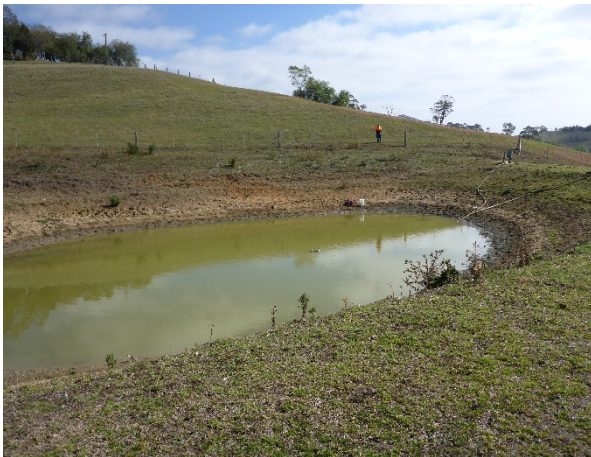
Photo 7: Property Dam. Taken on 14/09/2018

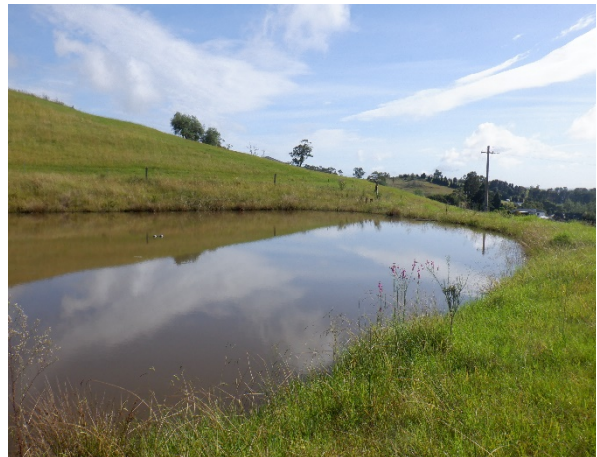
On 17 March 2022, the dam was full and surrounding grass was saturated, following recent heavy rainfall (Photo 8). The water was brown in colour. The dam wall appears to be in good condition. Field water quality was collected, and samples sent for laboratory analysis (Table 1 and Table 2).

Photo 8: Property Dam. Taken on 17/03/2022.

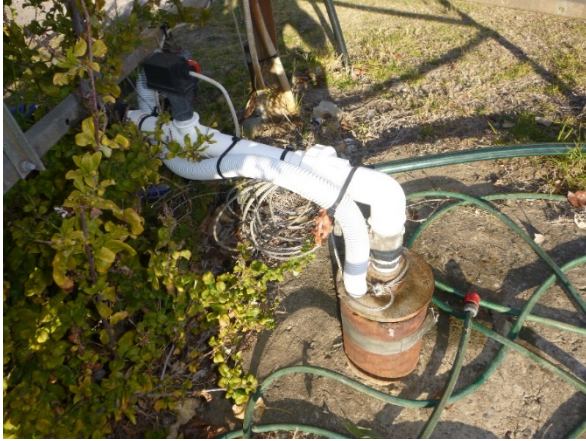
Borehole Water properties: During the pre-mining inspection, water appeared clear with no signs of iron staining or salt residue observed in the water, or around the borehole outlet (Photo 1). No gas was

Photo 1: Borehole GW072874 and pump located on the south-western side of the property. Taken 25/07/2018.

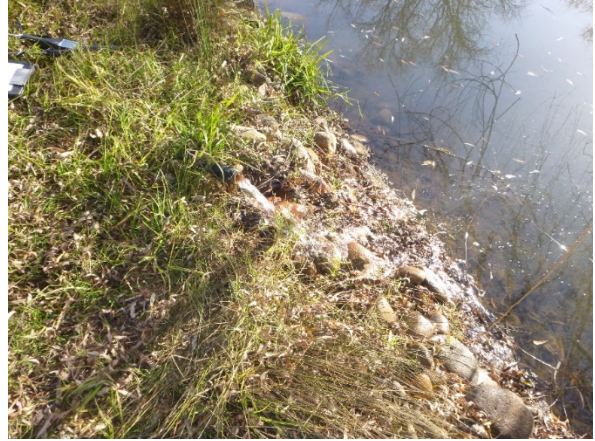
Bore Pumping Purpose and Performance: The water is pumped directly from the borehole into the dam. Water is used for irrigation and livestock purposes. On the pre-mining inspection, on 25 July 2018, an initial pumping rate was recorded at 1.88L/s. On the post-Longwall 708 inspection, the landholder advised the pump is not currently working due to high water levels in the dam.

Photo 2: Borehole GW072874 outlet discharge into dam. Taken 25/07/2018.

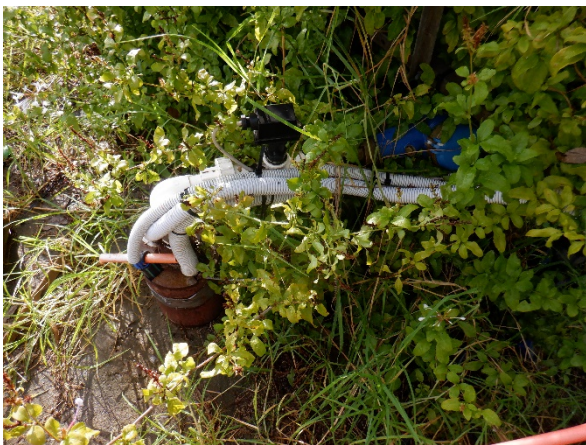
Field parameters and water samples were not able to be collected during the post-mining inspection due to high dam levels preventing access to the borehole outlet. No observable iron staining or salinity around the pump system was observed (Photo 3).

Photo 3: Borehole GW072874. Taken 16/03/2022.

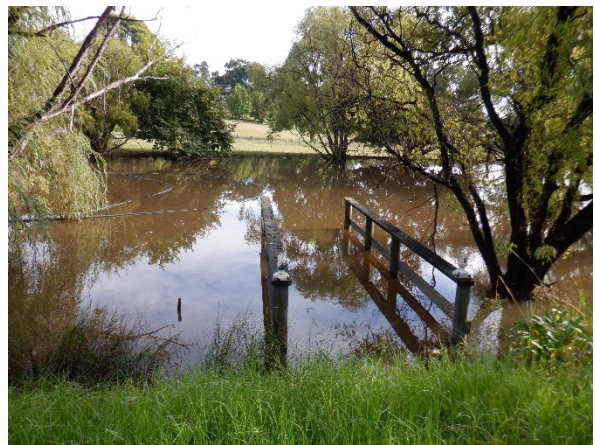
On the latest inspection on 16 March 2022, the dam was full (Photo 4). The water in the dam was turbid and brown in colour. Heavy rainfall was recorded in the area in the preceding weeks. A slight sheen was observed on the water surface (Photo 5). The dam wall was observed to be in good condition with water outflowing via the spillway. Water quality was recorded, and water samples sent for laboratory analysis (Table 1 and Table 2).

Photo 4: Property Dam. Taken 16/03/2022.

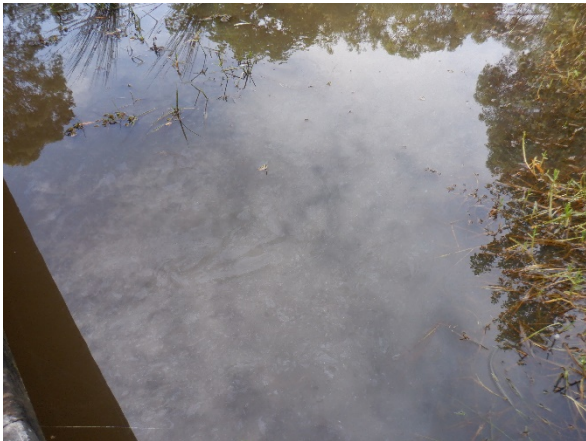
Photo 5: Sheen on water surface. Taken 16/03/2022.

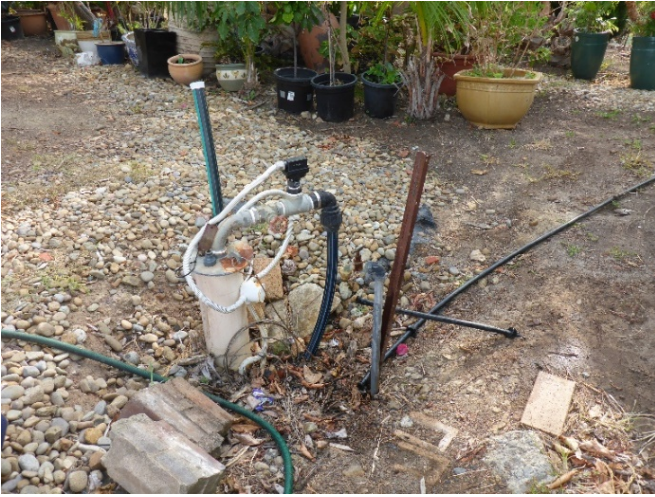
Borehole/Aquifer Properties: The borehole is located to the southeast of the residence and water is pumped around the property via several pipes (Figure 1 and Photo 1). The landholder has advised that the borehole was drilled in 2002 to a depth of 218m and had a standing water level of 76m following installation.

Photo 1: Borehole GW105376. Taken on 19/02/2018.

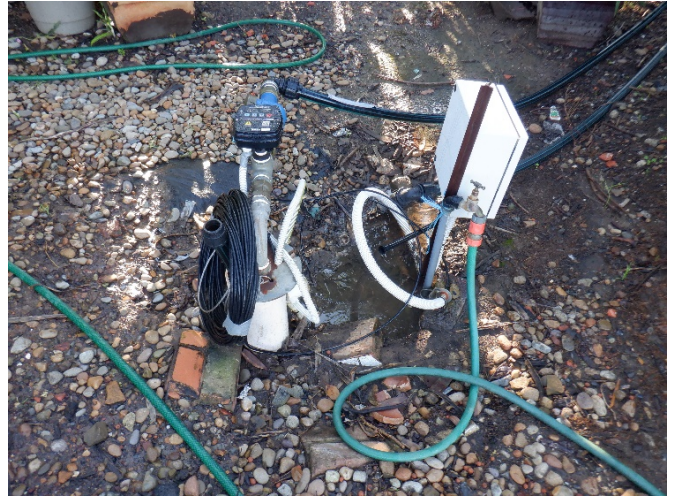
pressure of the borehole has generally been consistent since it's installation. During each inspection, water from the bore was allowed to purge for 5 - 10 minutes before water quality measurements, samples and observations were taken (Photo 2). Water samples and field parameters for the borehole were taken from the water tank, to which the borehole directly flows. This was due to restricted access to the bore directly.

Water Properties: No signs of iron, salinity staining, or gas were observed in the water or around the borehole on this inspection. Water quality parameters were measured in-situ and water samples were taken for laboratory analysis during both pre-mining and post-mining inspections (Table 1 and Table 2).

Photo 2: Borehole during post-mining inspection.
Taken on 17/03/2022

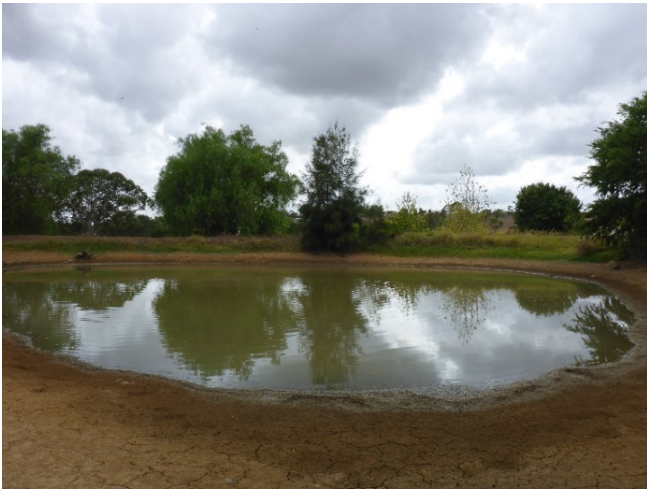
The dam is located to the northeast of the residence (Figure 1, Photo 3 and Photo 4), and is routinely supplied with water from the borehole. During the pre-mining inspection the landholder advised that the dam was relatively low. Soil cracking was found around the extent of the dam during the pre-mining inspection (Photo 5), with major soil cracking also found on the walls of the dam. In the post-mining inspection, on 17 March 2022, the water level was much higher compared to previous inspections. The soil cracking previously reported was engulfed by the dam's water (Photo 6). Water quality parameters were measured in-situ and water samples were taken for laboratory analysis.

Photo 3: Dam located east of the residence during pre-mining inspection. Taken on 19/02/2018

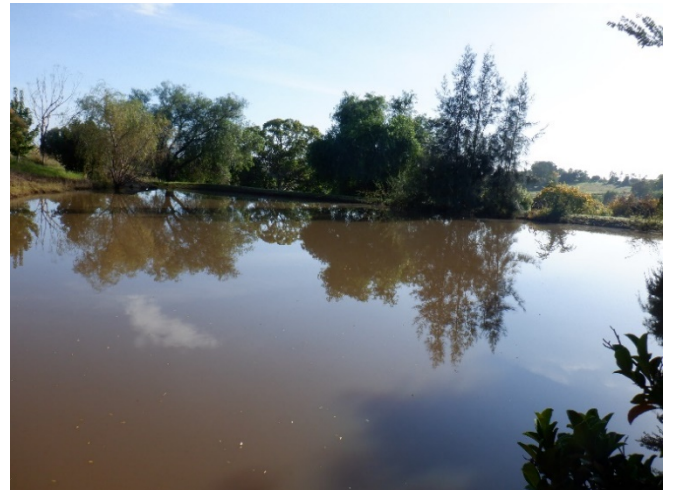
Photo 4: Dam during post-mining inspection. Taken on 17/03/2022

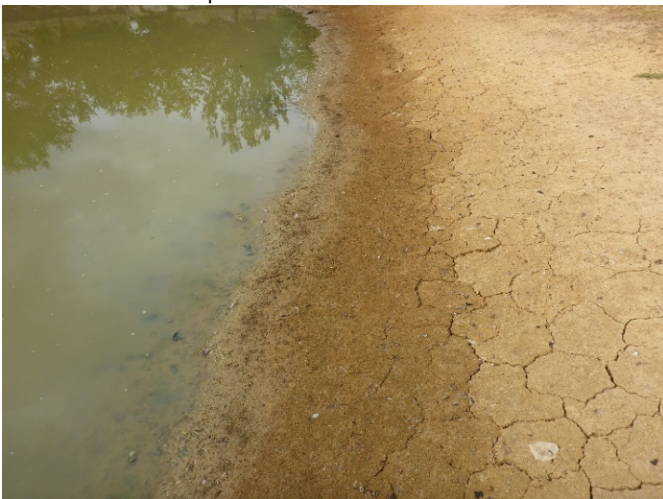
Photo 5: Soil cracking present around extent of dam edges observed during pre-mining inspection. Taken on 19/02/2018.

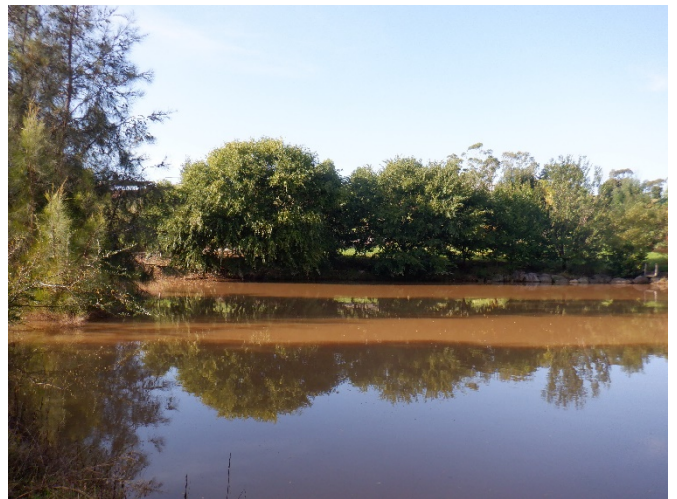
Photo 6: Soil cracking no longer visible due to high water level in dam, looking south. Taken on 17/03/2022

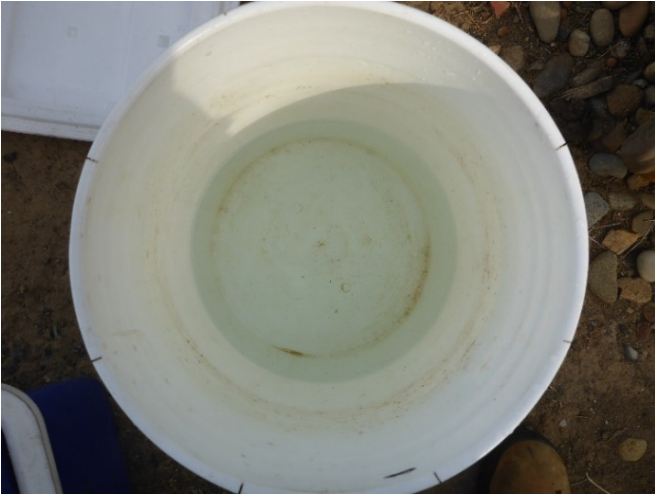
Photo 7: Water collected and sampled from GW105376 during pre-mining inspection. Taken on 19/02/2018.

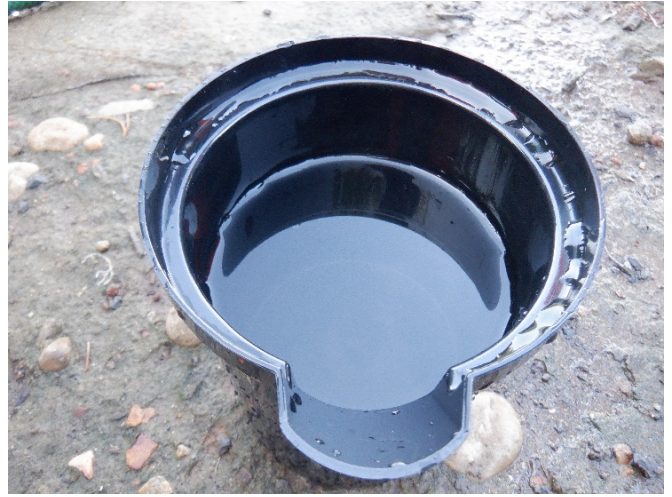
Photo 8: Water collected and sampled from GW105376 during post-mining inspection. Taken on 17/03/2022.

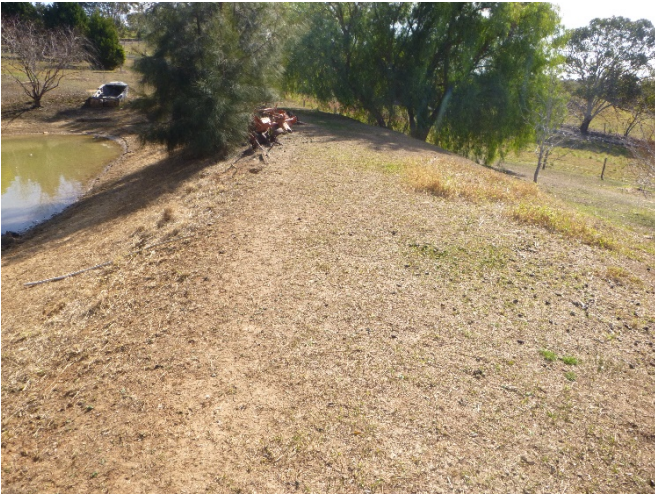
Photo 9: Dam wall during initial post-mining inspection, looking west. Taken on 25/7/2018

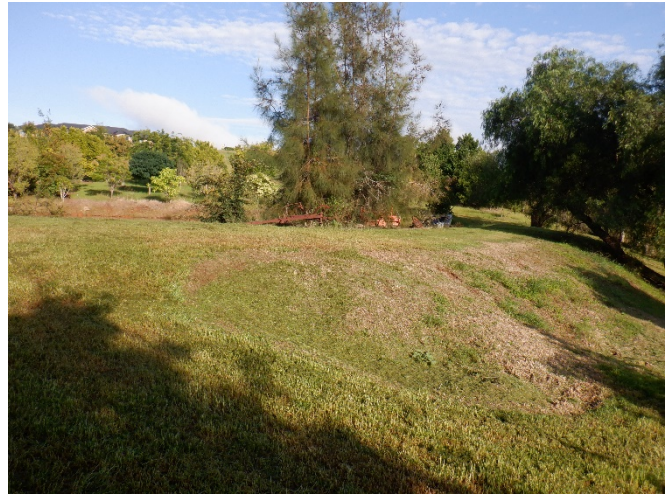
Photo 10: Dam wall during post-mining inspection, looking northwest. Taken on 17/03/2022
