Built Feature Management Plans (BFMPs) have been prepared by South32 Illawarra Metallurgical Coal for landholders above Appin Area 9 Longwalls 901 to 904. Inspections of dams, boreholes and natural features set out by the BFMPs are conducted by the Illawarra Coal Environmental Field Team (IMCEFT) with the consent of the relevant property/infrastructure owner and tenant (where applicable).

This report includes post-mining observations and data gathered for relevant features on Lot 1 DP810978. Additional inspections may be conducted by Illawarra Metallurgical Coal at the request of the landowner and/or if required by the various triggers in the Extraction Plan (EP). GW110671 is located approximately 230m north of LW903 (Figure 1).

Post-mining Inspection

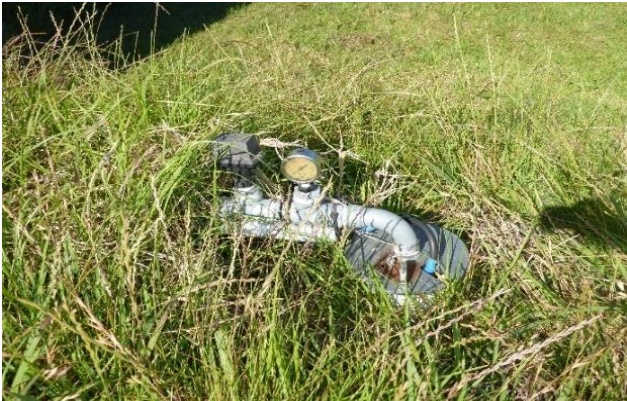
On 15 November 2017, a pre-mining inspection of property Lot 1 DP810978 was undertaken. Borehole GW110671 (Photo 1) and a small dam (Photo 4) were inspected. Water quality parameters and water samples, for laboratory analysis, were collected for the borehole. Observations of the dam were also recorded.

Photo 1: Borehole GW110671, taken on 15 November 2017 during pre-mining inspection.

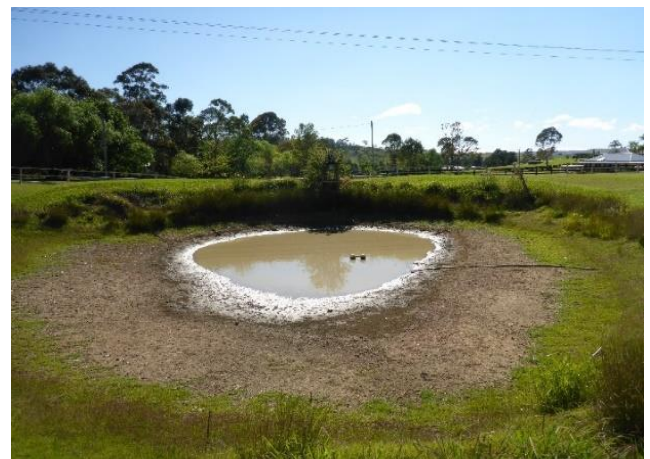
The dam is located towards the north-eastern corner of the property (Figure 1). Observations on 15 November 2017 showed that the dam level was relatively low and the water in the dam was considerably turbid (Photo 4).

Photo 4: Dam located on Lot 1 DP810978, photo taken on 15 November 2017.

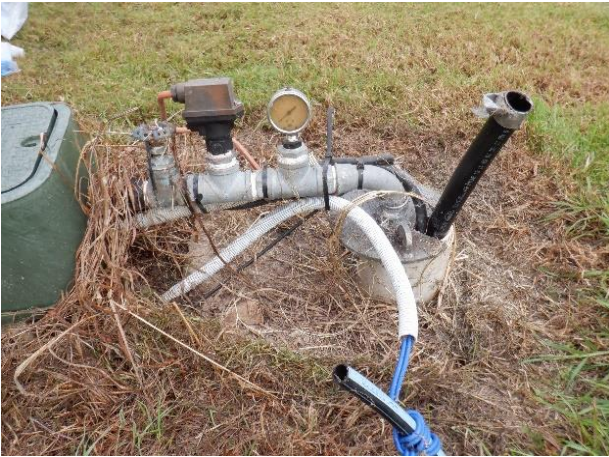
On 25 May 2021, a post-mining inspection of property Lot 1 DP810978 was undertaken. Borehole GW110671 (Photo 5) was inspected and sampled, and the dam was inspected with any key observations recorded (Photo 8).

Photo 5: Borehole GW110671, taken on 25 May 2021 during post-mining inspection.

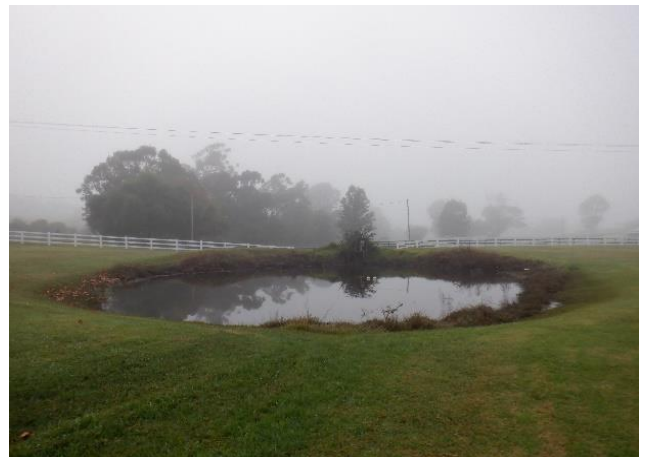
During the post-mining inspection on 25 May 2021, the dam level was close to full. The water in the dam was discoloured (dark brown/grey) and turbid. The dam walls remain in good condition, with no signs of leaks or slumping (Photo 8).

Photo 8: Dam located on Lot 1 DP810978, photo taken on 25 May 2021.

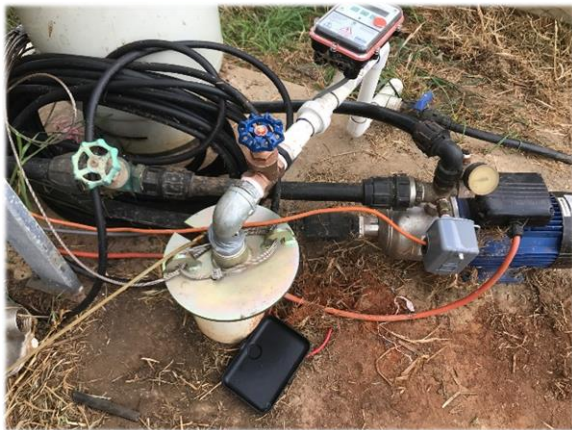
On 16 May 2018, a pre-mining inspection of Lot 3 DP1133989 was undertaken and one borehole, GW100673 was identified, inspected and sampled (Photo 1). Field observations were recorded, with samples collected and sent to Australian Laboratory Services (ALS) for analysis (Photo 2).

According to the landholder, approximately two weeks before the inspection, the pump ceased to operate due to a blockage with iron precipitate. Additionally, the landholder noted that the water from the settling tank (where the borehole water is pumped into) had an abnormal odour (Photo 3). The water level was measured at approximately 16m to 18m below the surface however the accuracy was deminished due to the presence of moist iron precipitate and 'mud' in the borehole.

Photo 1: The capped borehole GW100673. Taken 16 May 2018.

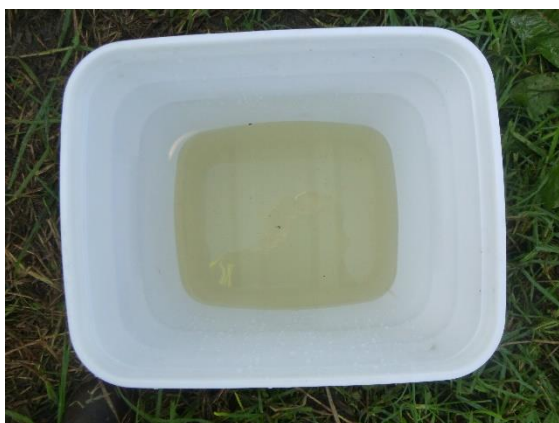
During the post-mining inspection on 29 April 2021, no gas or odours were detected, however the water had a slight brownish colouration (Photo 5). The landowner advised IMCEFT that an orange colour had previously been present within the borewater, but this was not observed by IMCEFT during the inspection. Additionally, the landowner advised that the pump had recently been replaced in the borehole, where they noticed a white substance covering parts of an old pipe. Before sampling, the bore was purged for 3 minutes before water samples were collected (Photo 5). The samples were analysed at a laboratory with results displayed below (Table 1).

Photo 5: Water sample taken from GW100673. Taken 29 April 2021.

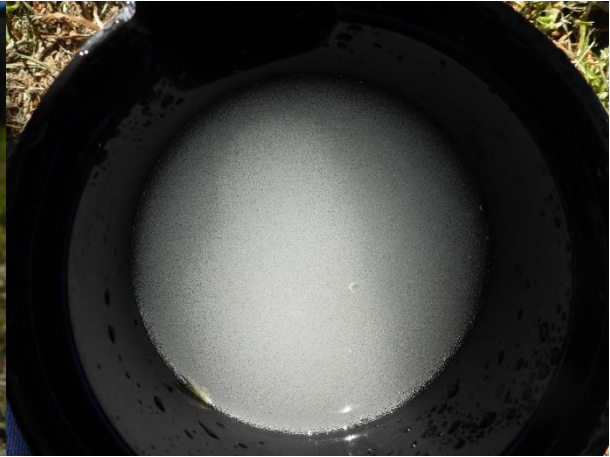
Water samples were initially collected from the borehole for a pre-mining water quality assessment on 16 April 2018 via the pump, which were sent to Australian Laboratory Services (ALS) for analysis. The borehole was purged for approximately 10 minutes before water samples and field parameters were collected. There were no observable indicators of iron precipitate or hydrogen sulfide during this inspection (Photo 3), however the water was noticeably effervescent after leaving the borehole outlet (Photo 4).

Photo 4: Closeup of water sample taken from borehole via the pump. The effervescent nature of the water is exhibited. Taken on 16 April 2018.

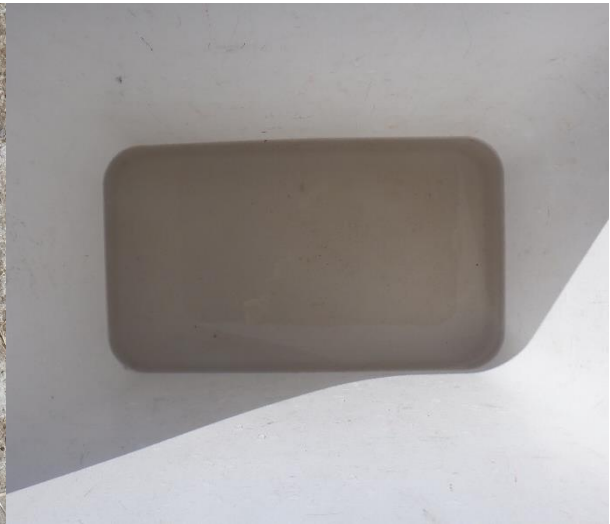
Photo 6: Closeup of water sample taken from borehole via bailing from borehole. Slight dark-brownish colour is visible in water sampled from borehole. Taken on 3 May 2021.

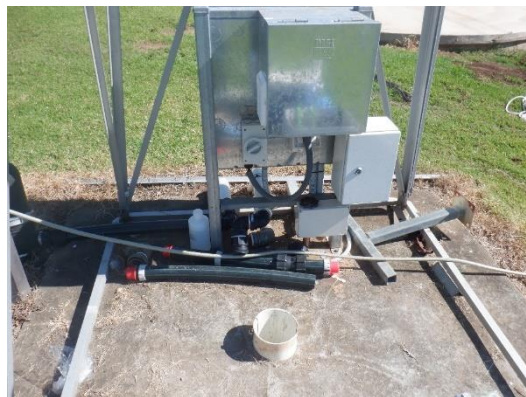
During the post-mining inspection on 3 May 2021, a hand bailer was used to collect water samples from the borehole as the pump had been removed (Photo 7). The borehole was therefore unable to be purged to the extent undertaken in the pre-mining inspection. A slight odour was identified, likened to hydrogen sulfide, when the water was removed from the borehole, however there were no signs of iron or salinity staining observed (Photo 5 and Photo 7). The water removed for sampling was slightly brown in colour (Photo 6). Field water quality parameters were recorded (Table 1) and samples sent to ALS for analysis, with results in Table 2.

Photo 7: Borehole GW104602 showing the current set-up and pump removed. Taken on 3/5/2021.

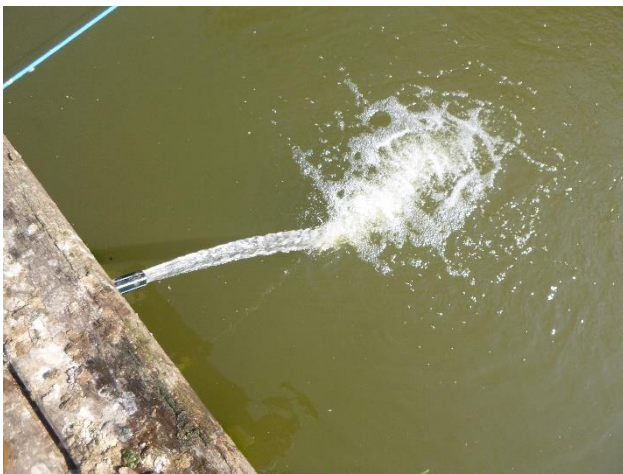
Water taken from GW112437 appeared clear with no signs of iron staining or salinity in the water, around the borehole or around the outlet (Photo 9 and Photo 10). Water taken from Dam 1 appeared discoloured and murky with evidence of algae growth but had no visible signs of iron staining or salinity (Photo 11 and Photo 12) and no gas or odours were identified. The landowner explained that water level in Dam 1 was lower than previous inspections, but this was due to the dam level being lowered to remove weed from dam.

Photo 9: Borehole outlet into Dam 1. Taken on 29 April 2021.

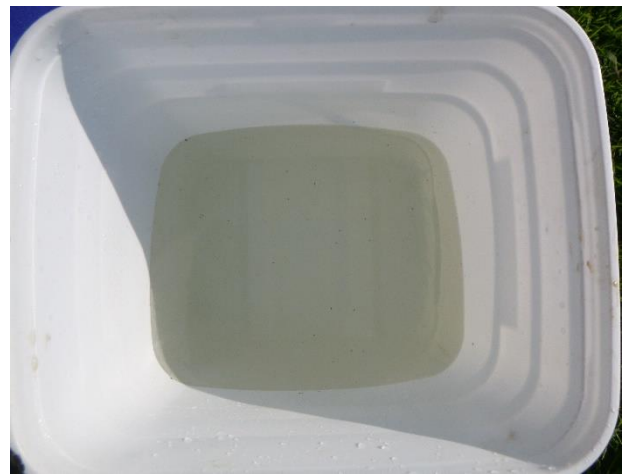
Photo 10: Image of water from borehole discharge. Taken on 29 April 2021.

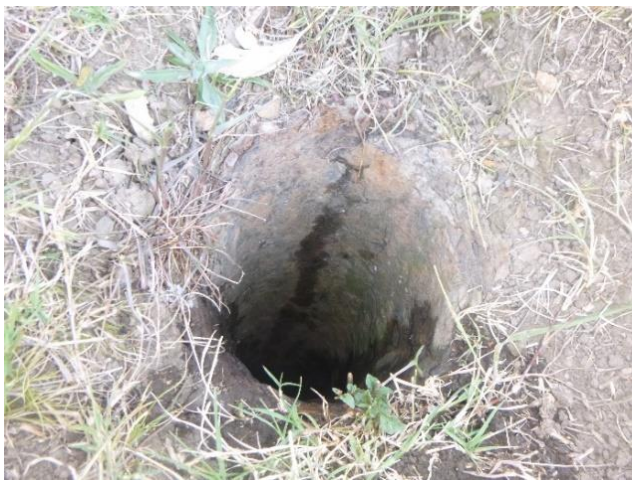
During the Longwall 902 post-mining inspection on 24 October 2019, no signs of iron or salinity staining were observed in the collected water or around the borehole (Photo 3). A slight odour (likened to hydrogen sulfide smell) and sheen was observed on the water surface once the water sample was extracted from the borehole, whilst vegetation and sediment were also observed in the borehole (Photo 1). This is likely a result of the recent removal of the borehole pump and it now being unsealed.

Photo 3: Looking in to borehole. Taken on 24 October 2019.

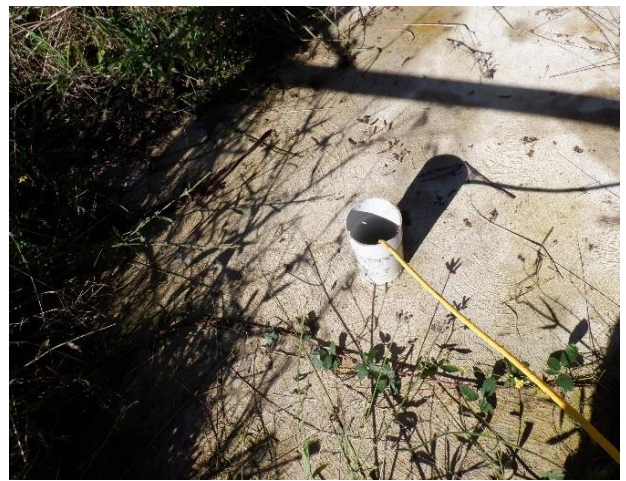
During the Longwall 903 post-mining inspection on 10 May 2021, no signs of iron or salinity staining were observed in the collected water or around the borehole (Photo 4). Some sediment and water discoloration were identified from the extracted water and is likely a result of the open nature of the borehole (Photo 2). Water quality parameters were recorded (Table 1), and water samples collected. Samples were sent to ALS for laboratory analysis with results included below (Table 2).

Photo 4: Looking at the borehole, with new collar. Taken on 10 May 2021.

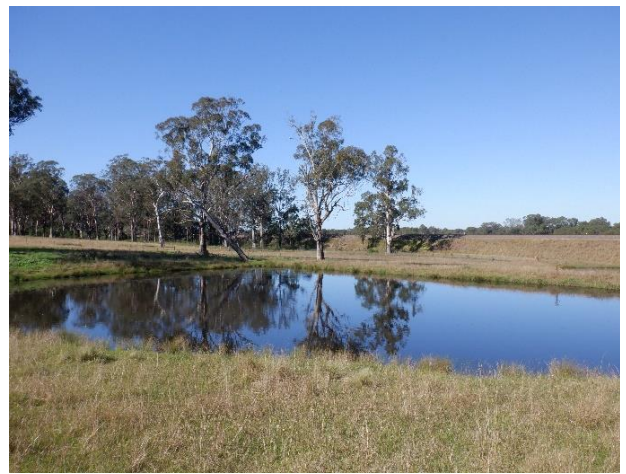
Dam 1 is located on the southern end of Lot 62 DP1321 and was passed by longwall 903 on 20 February 2020, approximately 250m north of Dam 1 (Figure 1). Previously the dam was mined beneath by Longwall 902 and passed by Longwall 901, approximately 110m to the south. No gas bubbling, slumping or signs of damage to the walls of Dam 1 were observed during the post Longwall 903 inspection on the 25 May 2021 (Photo 6). Water quality field parameters for Dam 1 are presented in Table 3.

Photo 6: Dam 1 looking across-stream from western bank, taken 10 May 2021.

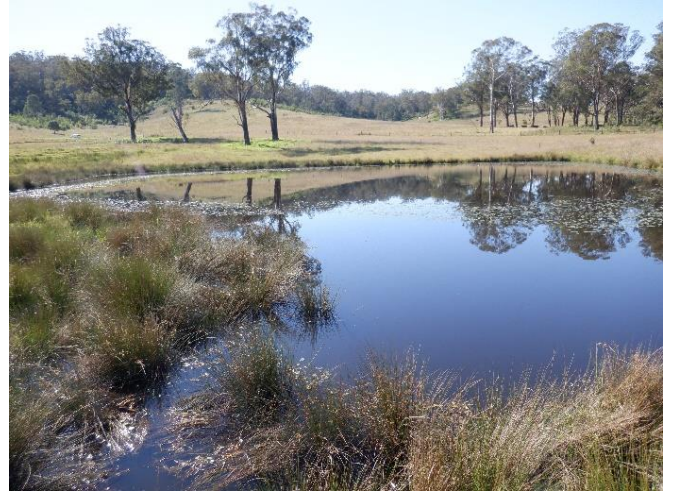
Dam 2 is located on the southern end of Lot 62 of DP1321, downstream of Dam 1 and was passed by Longwall 903 on 20 February 2020 at an approximate distance of 328 m (Figure 1). Previously the dam was mined beneath by Longwall 902 and passed by Longwall 901, 35m to the south. No gas bubbling, slumping or signs of damage to the walls of Dam 2 were observed during the post Longwall 903 inspection on 25 May 2021 (Photo 8).

Photo 8: Dam 2 looking across-stream from western bank, taken 10/05/2021.

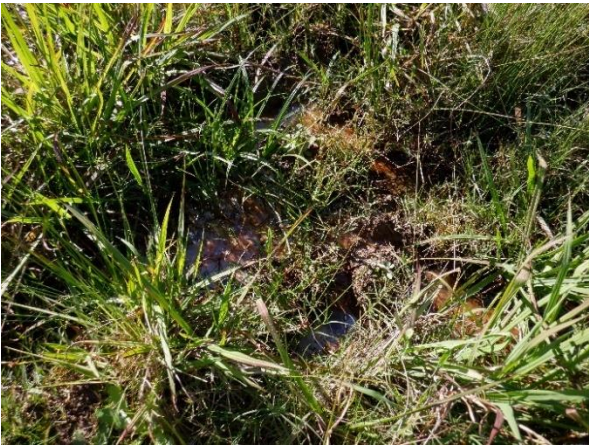
During the Longwall 901 end of panel inspection (29 September 2017), the property owner had advised that the area directly downstream of Dam 2 had substantially decreased in moisture and vegetation health. According to the landholder, this area is perennially moisture-laden even throughout drought conditions. During the Longwall 903 end of panel inspection, this area downstream of Dam 2 had increased in moisture levels becoming boggy with some iron staining present in surface pooling on the grass (Photo 9). Water quality field parameters for Dam 2 are presented in Table 4.

Photo 9: Iron staining downstream of Dam 2, taken 10/05/2021.
