Built Feature Management Plans (BFMPs) have been prepared by South32 Illawarra Metallurgical Coal (IMC) for landholders above Appin Area 9 Longwalls 901 to 904. Both pre- and post-mining inspections and reports of dams, boreholes and natural features set out by the BFMPs are conducted by the Illawarra Coal Environmental Field Team (IMCEFT) with the consent of the relevant property/infrastructure owner and tenant (where applicable).

This report includes both pre- and post-mining observations and data gathered for relevant features on Lot 1 DP810978, particularly the registered borehole GW110671. Additional inspections may be conducted at the request of the landowner or if required by various triggers in the Extraction Plan (EP). Borehole GW110671 is located approximately 50m east of Longwall 904 (Figure 1).

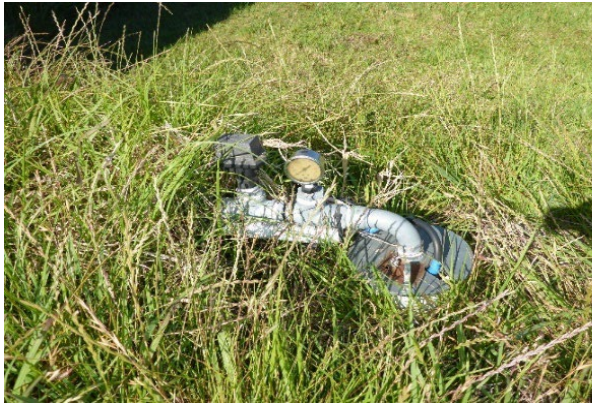
*Photo 1: Borehole GW110671, taken on 15 November 2017 during pre-mining inspection.*

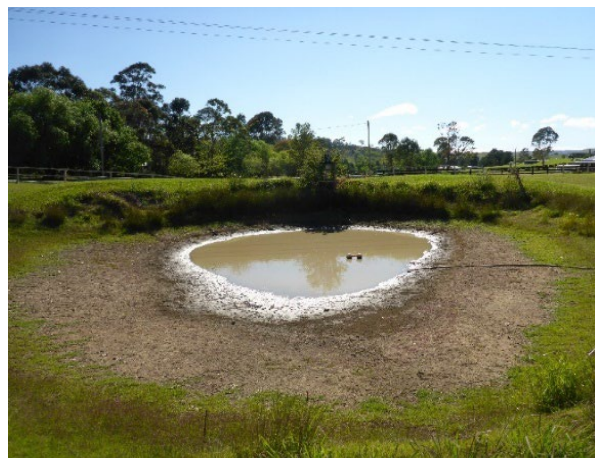
The dam is located towards the north-eastern corner of the property (Figure 1). Observations on 15 November 2017 show that the dam level was relatively low and the water in the dam was considerably turbid (Photo 4).

*Photo 4: Dam located on Lot 1 DP810978, photo taken on 15 November 2017.*

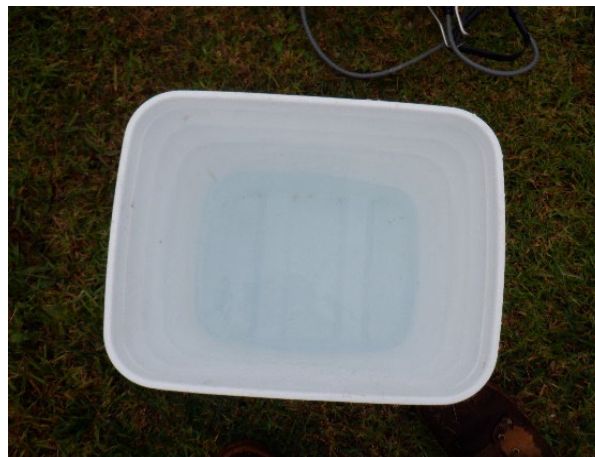
During the Longwall 903 post-mining inspection, an odour, likened to hydrogen sulphide, was noted when the bore pump was turned on (Photo 7). The bore was purged for 10 minutes then water samples and field parameters were collected (Photo 6). Results are presented in Table 1 and Table 2, respectively.

*Photo 6: Water from GW110671. collected into a bucket. Samples and field parameters were taken from the bucket, photo taken on 25 May 2021.*

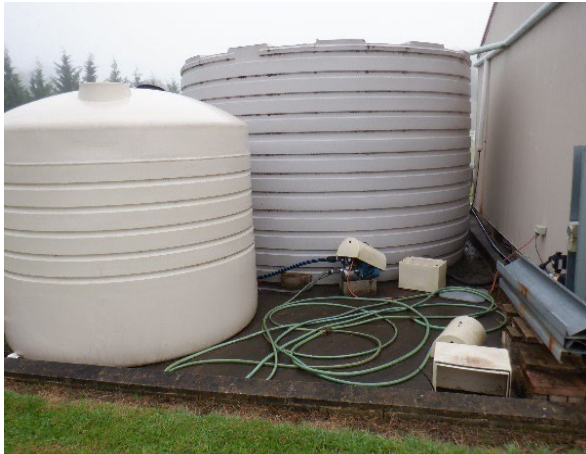
*Photo 7: Electric pump for GW110671, photo taken on 25 May 2021.*

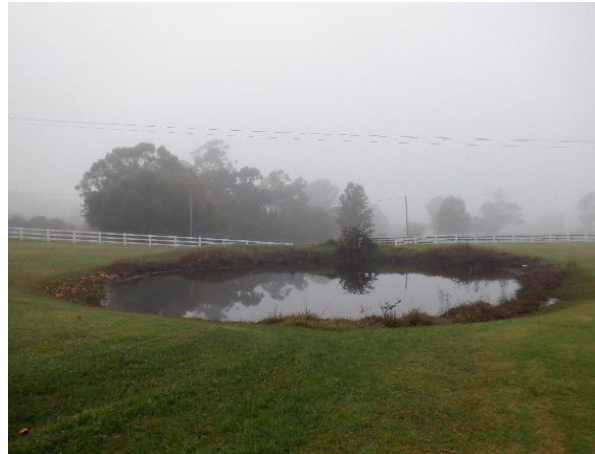
During the Longwall 903 post-mining inspection on 25 May 2021, the dam level was close to full. The water in the dam was discoloured (dark brown/grey) and turbid. The dam walls were in good condition, with no signs of leaks or slumping (Photo 8).

*Photo 8: Dam located on Lot 1 DP810978, photo taken on 25 May 2021.*

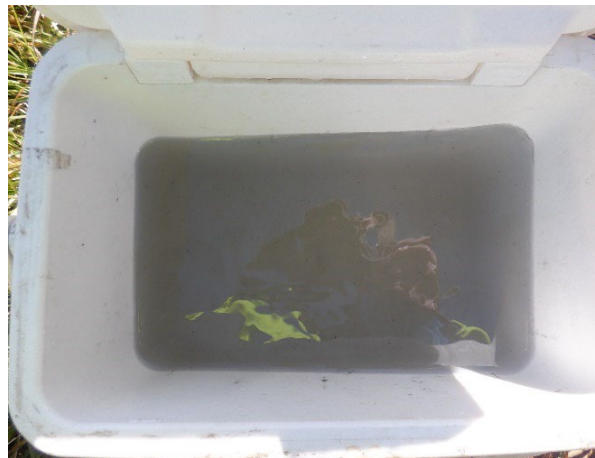
During the Longwall 904 post-mining inspection, an odour, likened to hydrogen sulphide, was noted when the bore pump was turned on (Photo 11). The bore was purged for 10 minutes then water samples and field parameters were collected (Photo 10). Results are presented in Table 1 and Table 2, respectively. The water from the bore pump had a slight brown colouration (Photo 10).

*Photo 10: Water from GW110671. collected into a bucket. Samples and field parameters were taken from the bucket, photo taken on 26 August 2022.*

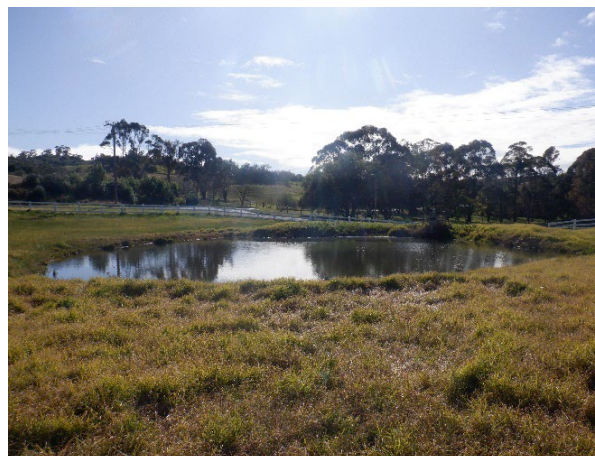
During the Longwall 904 post-mining inspection on 26 August 2022, the dam level was full. The water in the dam was discoloured (dark brown/grey) and turbid. The dam walls remain in good condition, with no signs of leaks or slumping (Photo 12).

*Photo 12: Dam located on Lot 1 DP810978, photo taken on 26 August 2022.*

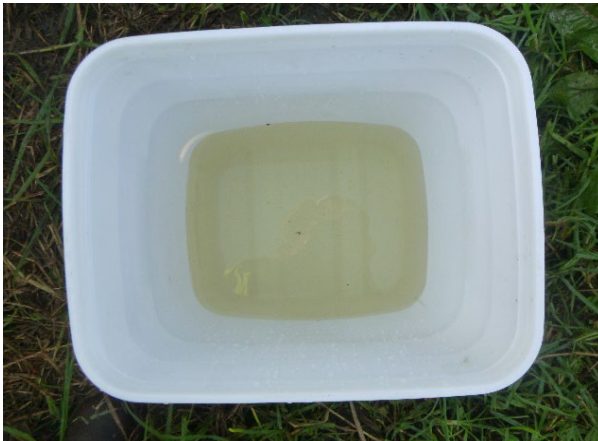
During the Longwall 903 post-mining inspection on 29 April 2021, no gas or odours were detected, however the water had a slight brownish colouration (Photo 5). The landowner advised IMCEFT that an orange colour had previously been present within the borewater, but this was not observed by IMCEFT during the inspection. Additionally, the landowner advised that the pump had recently been replaced in the borehole, where they noticed a white substance covering parts of an old pipe. Before sampling, the bore was purged for 3 minutes then water samples collected and field parameters recorded (Photo 5). Results are presented in Table 2 and Table 3, respectively.

*Photo 5: Water sample taken from GW100673. Photo taken on 29 April 2021.*

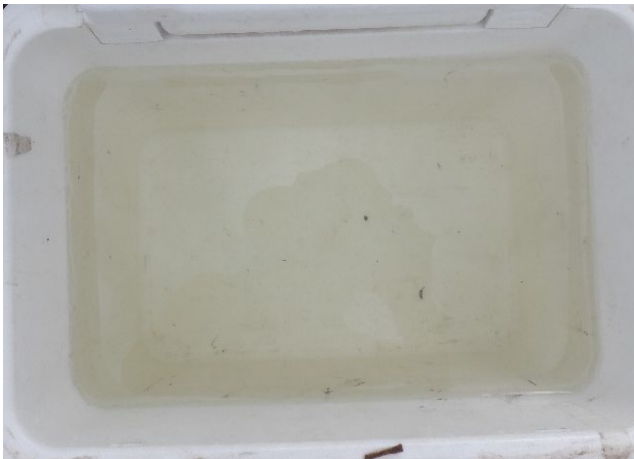
During the Longwall 904 post-mining inspection on 26 August 2022, no gas, odours or iron staining were detected. The water sample collected from GW100673 had a very slight brownish colouration but otherwise was clear (Photo 9). Water was sampled from a hose with a valve attached to the borehole pump (Photo 8) with samples collected after purging the borehole for approximately 5 minutes. Samples

*Photo 9: Water sample collected from GW100673. Photo taken on 26 August 2022.*

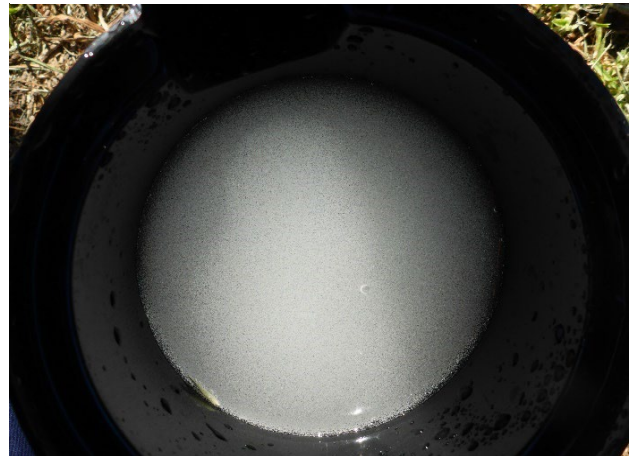
Water samples were initially collected from the borehole for a pre-mining water quality assessment on 16 April 2018 via the pump, which were sent to Australian Laboratory Services (ALS) for analysis. The borehole was purged for approximately 10 minutes before water samples and field parameters were collected. There were no observable indicators of iron precipitate or hydrogen sulfide during this inspection (Photo 3), however the water was noticeably effervescent after leaving the borehole outlet (Photo 4).

*Photo 4: Closeup of water sample taken from borehole via the pump. The effervescent nature of the water is exhibited. Taken on 16 April 2018.*

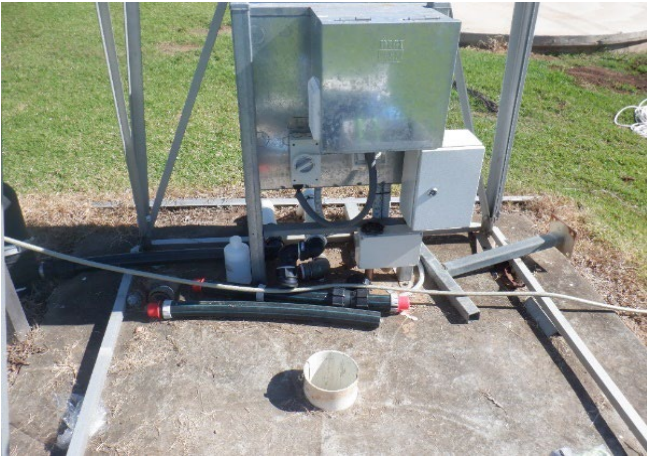
During the Longwall 903 post-mining inspection on 3 May 2021, a hand bailer was used to collect water samples from the borehole as the pump had been removed (Photo 7). The borehole was therefore unable to be purged to the extent undertaken in the pre-mining inspection. A slight odour was identified, likened to hydrogen sulfide, when the water was removed from the borehole, however there were no signs of iron staining or salinity observed (Photo 5 and Photo 7). The water removed for sampling was slightly brown in colour (Photo 6). Field water quality parameters were recorded (Table 1) and samples were analysed at ALS laboratory with results in Table 2.

*Photo 7: Borehole GW104602 showing the borehole with pump removed. Taken on 3 May 2021*

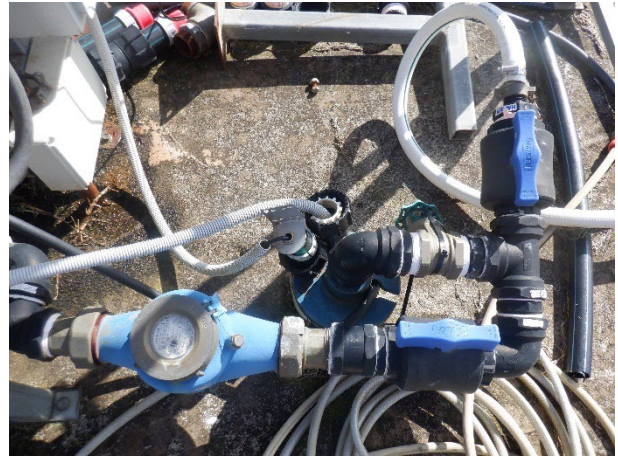
During the Longwall 904 post-mining inspection the landholder advised that the borehole pump hadn't been turned on in a few months due to high rainfall on the property. During this inspection it was identified that an electric pump system had been installed and was in working order (Photo 8).

*Photo 8: Closeup of borehole GW104602 and pump. Taken on 26 August 2022.*

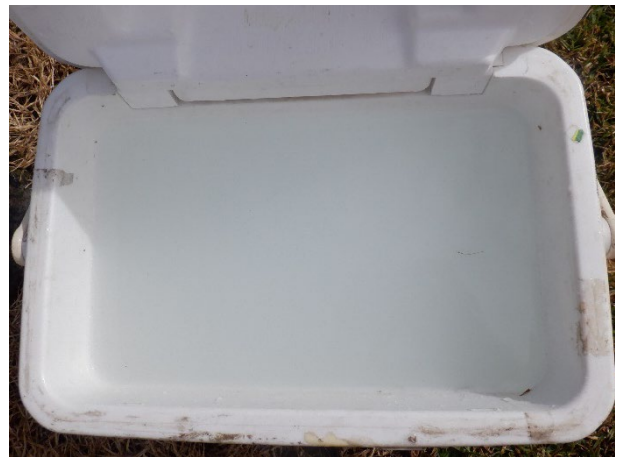
*Photo 10: Closeup of water sample taken from borehole via pump. Very cloudy water with white/grey colour is visible in water sampled from borehole. Taken on 26 August 2022.*

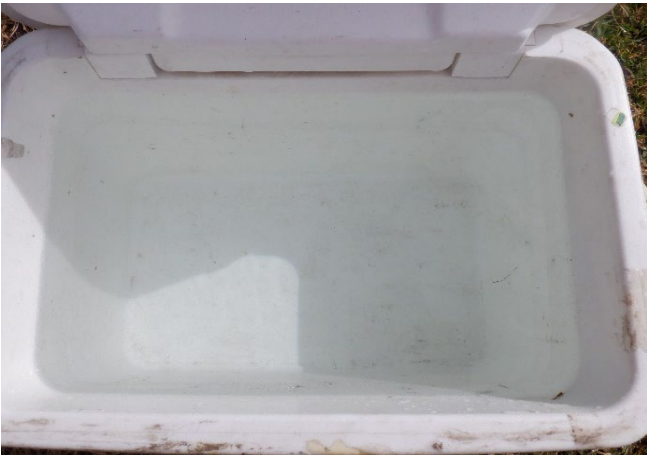
*Photo 11: Closeup of water taken from borehole via pump. Shows water after letting settle for 2 minutes. Water became very clear. Taken on 26 August 2022.*

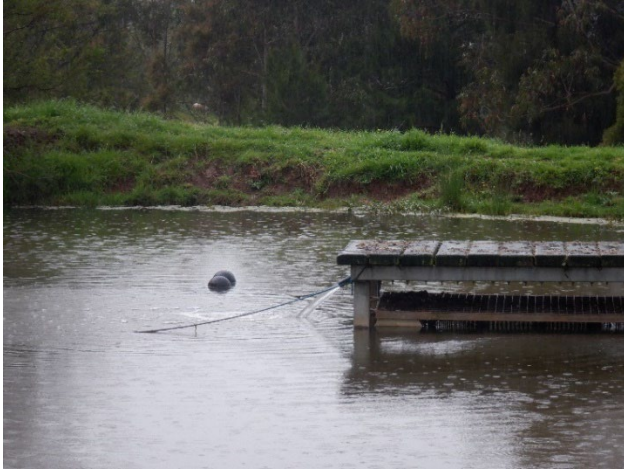
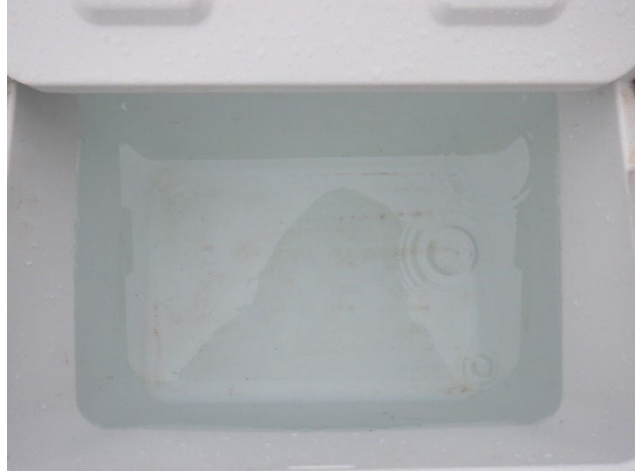
Water taken from borehole GW112437 appeared clear with no signs of iron staining or salinity in the water, around the borehole or around the outlet (Photo 13 and Photo 14). Water taken from Dam 1 appeared discoloured with evidence of algae growth around the perimeter of the dam and no visible signs of iron staining, salinity, or gas release (Photo 15). A sulfur-like odour was present from the dam pump outflow. In the 2021 post-mining inspection, Dam 1 was lower than previous inspections, due to the dam level being lowered to remove weed from dam. The water level in the Longwall 904 post-mining inspection was high.

Photo 13: Borehole outlet into Dam 1. Taken on 5 October 2022.

Photo 14: Image of water from borehole discharge. Taken on 5 October 2022.

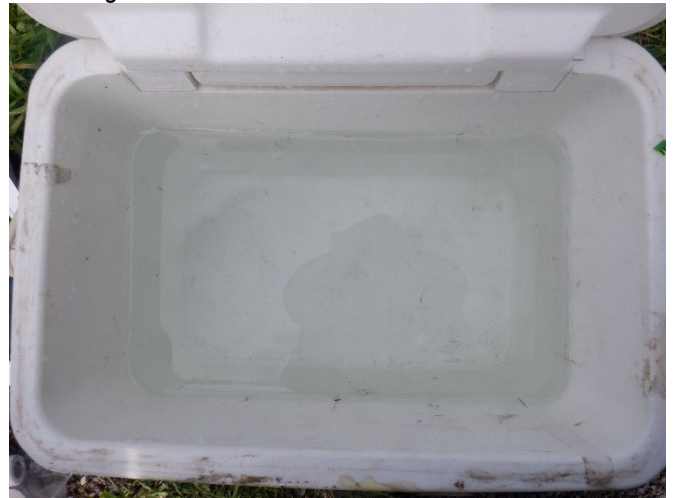
During the Longwall 904 post-mining inspection the water appeared clear (Photo 10). There were no signs of iron staining or salinity in the water, or around the borehole outlet. No gas or odours were identified during the inspection. In-situ water quality parameters were recorded (Table 1). A sample was taken from the borehole. The sample was sent to ALS for laboratory analysis and the results are included below (Table 2).

*Photo 10: Water collected from borehole tap after purging for approximately 2 minutes. Taken on 26 August 2022.*
