This post-mining report includes field observations and laboratory data recorded for relevant features on Lot 16 DP251063, including borehole GW105534 and property dam F08d01.

This post-mining report includes observations and field data recorded for relevant features on Lot 900 DP1072947, including borehole GW101986 and property dam (MSEC ID: F17d01) (Figure 1).

This report includes both pre- and post-mining observations and data gathered for relevant features on Lot 1 DP810978, particularly the registered borehole GW110671. Additional inspections may be conducted at the request of the landowner or if required by various triggers in the EP. Borehole GW110671 is located approximately 480m south-east of Longwall 905 (Figure 1).

This post-mining report includes observations and field data recorded for relevant features on Lot 22 DP803255, including borehole GW072249 (Figure 1).

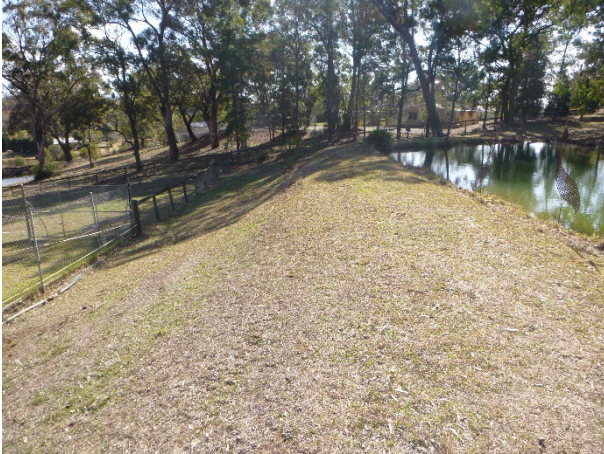
No signs of iron staining or salinity were observed in the water, or around the borehole outlet during the pre-mining inspection on 23 August 2017 or subsequent inspections (Photo 1 to Photo 6). A sulfur-type odour was present around the borehole outlet during the pre-mining inspection while it was dispelling water however this dissipated after approximately 10 minutes of use. No odour was present during the additional inspection on 25 July 2018. Field water quality was measured and samples were collected after the water was purged through the pump for approximately 5 minutes during both pre-mining and additional inspection on 25 July 2018 (Photo 3 and Photo 4; Table 1). No sign of subsidence impact was observed to the dam wall during the additional inspection on 25 July 2018 (Photo 7 and Photo 8).

Photo 7: Dam Wall. Taken at 010 degrees on 23 August 2017.

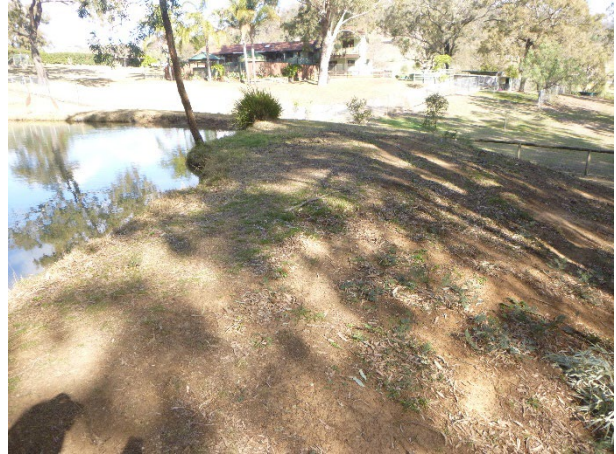
Photo 8: Dam Wall. Taken at 260 degrees on 25 July 2018.

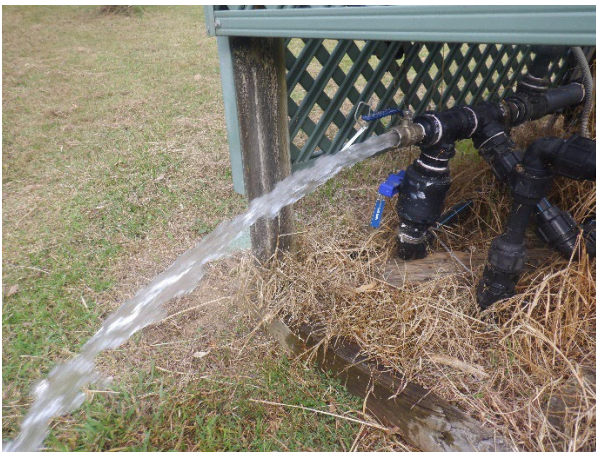
During the recent inspection on 20 April 2023 water was pumped directly from the borehole (Photo 15). A sulfur-type odour was present when pumping the bore, however dissipated after 5 minutes. The water was clear with no discolouration or cloudiness (Photo 16). Field water quality was measured, and water samples collected for laboratory analysis with results included below (Table 1 and Table 2, respectively). No sample was collected from the dam. No signs of subsidence impacts were observed to the dam wall during the inspection.

Photo 15: GW105534 discharge, new sample point direct from bore. Taken on 20 April 2023

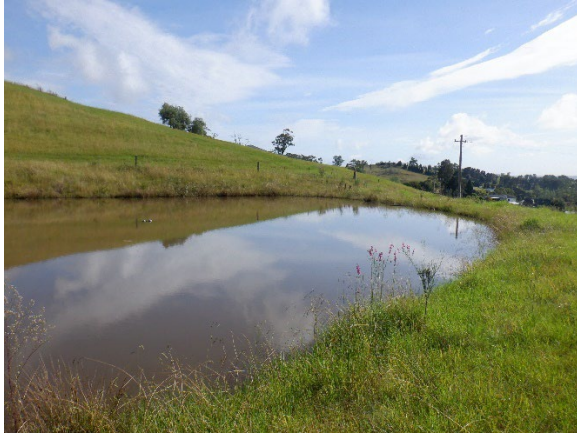
Photo 9: Property dam. Taken on 17/03/2022

On 17 March 2022, the dam was full and surrounding banks were saturated following recent heavy rainfall (Photo 9). The water was brown in colour. On 20 April 2023 the dam level was high, with the water a green/brown colour (Photo 10). The water was turbid, likely from recent rainfall runoff. The dam wall appeared to be in a good condition. Field water quality parameters were recorded and compared with results from previous inspections (Table 2).

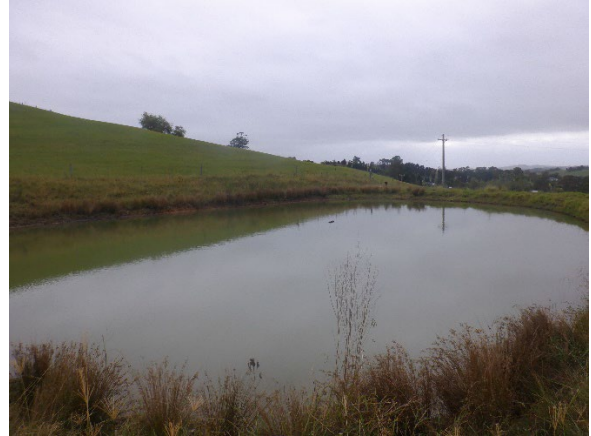
Photo 10: Property dam. Taken on 20/04/2023

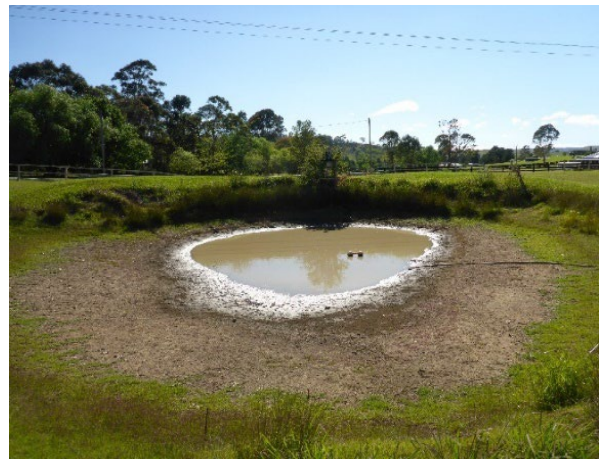
Photo 4: Dam located on Lot 1 DP810978, photo taken on 15 November 2017.

The dam is located towards the north-eastern corner of the property (Figure 1). Observations on 15 November 2017 show that the dam level was relatively low and the water in the dam was considerably turbid (Photo 4).

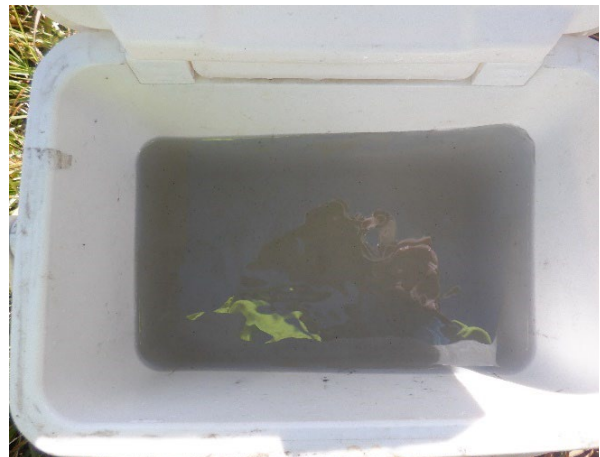
Photo 6: Water from GW110671. collected into a bucket. Samples and field parameters were taken from the bucket, photo taken on 26 August 2022.

During the Longwall 903 post-mining inspection, an odour, likened to hydrogen sulphide, was noted when the bore pump was turned on. The bore was purged for 10 minutes with field water quality measured and samples collected. During the Longwall 904 post-mining inspection, an odour, likened to hydrogen sulphide, was noted when the bore pump was turned on. The bore was purged for 10 minutes then water samples and field parameters were collected (Photo 5). The water from the bore pump had a slight brown colouration (Photo 6).

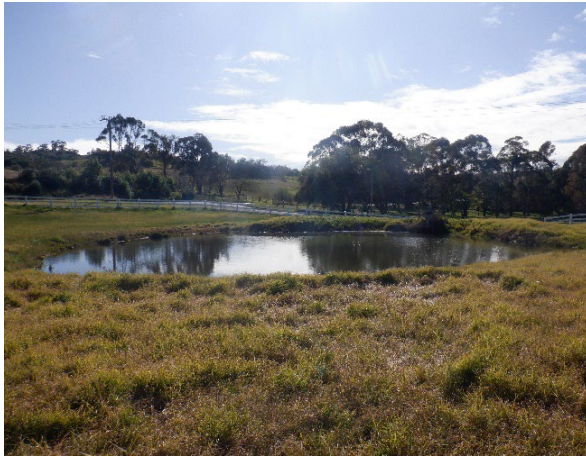
Photo 7: Dam located on Lot 1 DP810978, photo taken on 26 August 2022.

During the Longwall 903 post-mining inspection on 25 May 2021, the dam level was close to full. The water in the dam was discoloured (dark brown/grey) and turbid. The dam walls were in good condition, with no signs of leaks or slumping. During the Longwall 904 post-mining inspection on 26 August 2022, the dam level was full. The water in the dam was discoloured (dark brown/grey) and turbid. The dam walls were in good condition, with no signs of leaks or slumping (Photo 7).

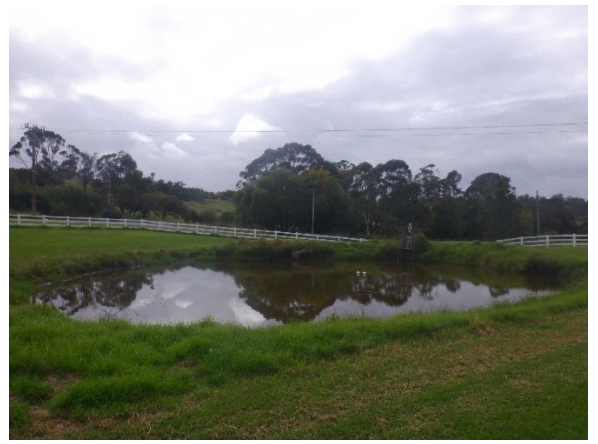
Photo 10: Dam located on Lot 1 DP810978, photo taken on 20 April 2023.

During the Longwall 905 post-mining inspection on 20 April 2023, the dam level was high. The water in the dam was dark brown and turbid, likely from rainfall run-off. The dam wall remains in good condition, with no signs of leaking or slumping (Photo 10).

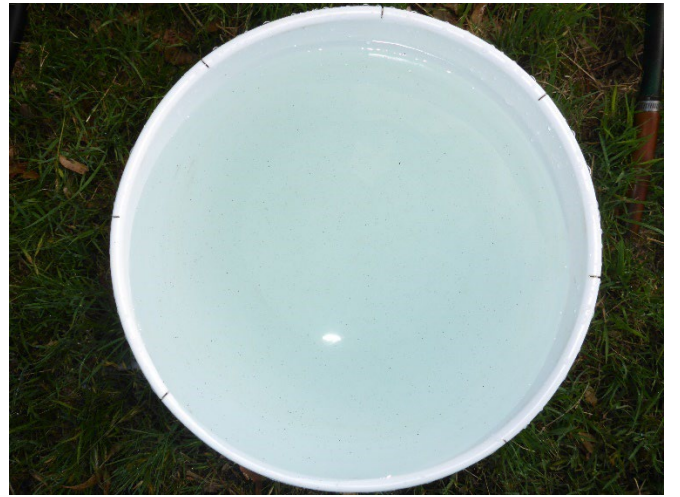
During the Longwall 902 post-mining inspection the water appeared to be slightly discoloured when compared to photos from the inspection on 2 November 2017 (Photo 4 and Photo 6). However, there were no signs of iron staining or salinity in the water, or around the borehole outlet. No gas or odours were identified during the inspection. During the Longwall 904 post-mining inspection the water appeared clear (Photo 10). There were no signs of iron staining or salinity in the water, or around the borehole outlet. No gas or odours were identified during the inspection.

Photo 4: Water collected from bore discharge. Taken on 2 November 2017.

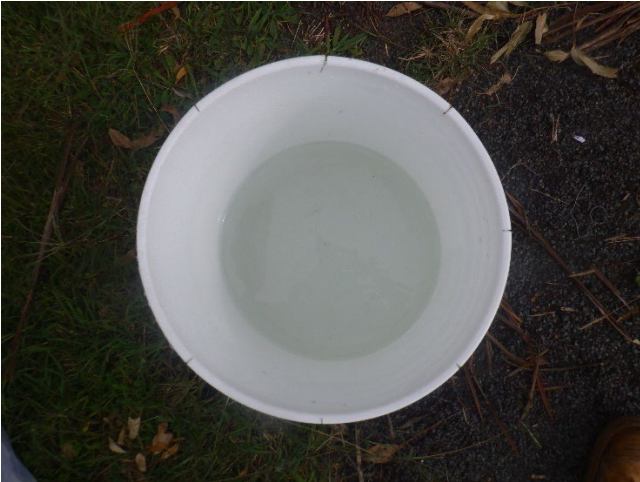
During the Longwall 905 post-mining inspection the water appeared clear with no discolouration (Photo 14). There were no signs of iron staining or salinity in the water, or around the borehole outlet. No gas or odours were identified during the inspection

Photo 14: Water collected from bore tap after purging for approximately 5 minutes. Taken on 20 April 2023.
