DENDROBIUM  
AREA 3B  
WC21  
REHABILITATION  
PLAN

DECEMBER 2015

# WC21 REHABILITATION PLAN

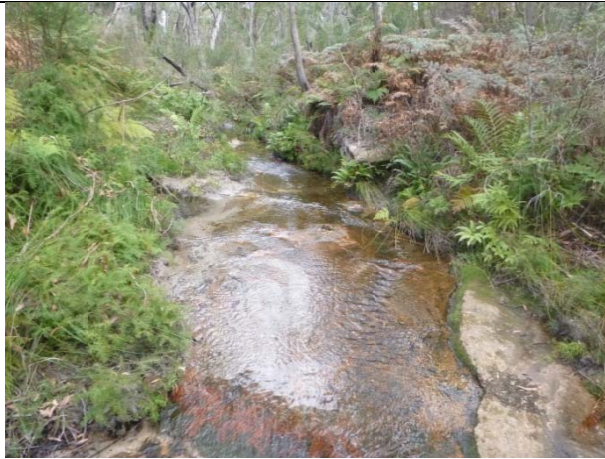
Photo 1: WC21\_Pool 30, looking upstream. Taken on 10/09/2015.

**Recommendation:** No remediation works are recommended at the site.

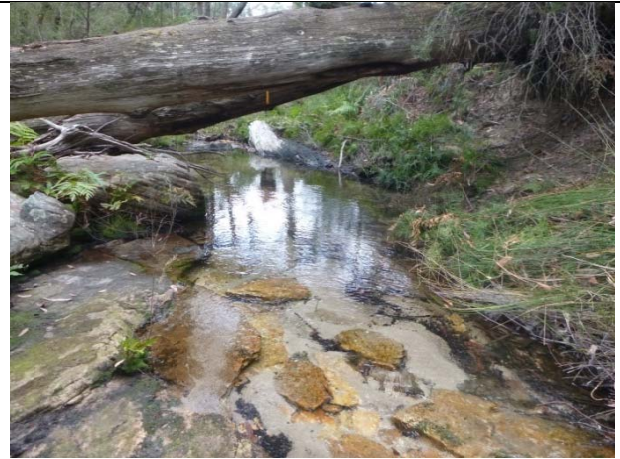
Photo 2: WC21\_Pool 30, looking downstream. Taken on 10/09/2015.

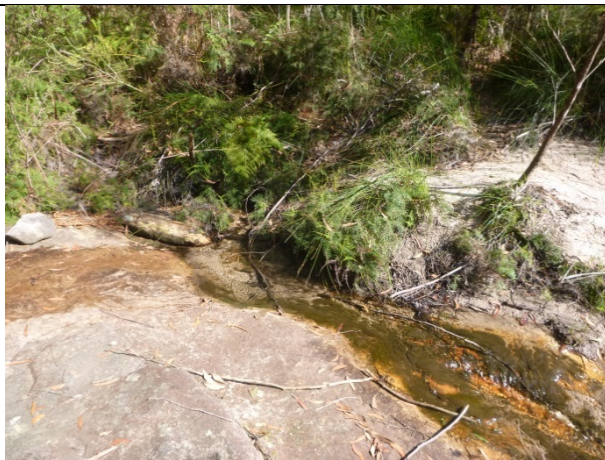
Photo 3: Re-emergence of flow from bank in to WC21\_Pool 28, looking across stream. Taken on 14/10/2015.

**Recommendation:** No works are recommended at this time as the pool is within the Longwall 11 mining area and subject to future subsidence movements.

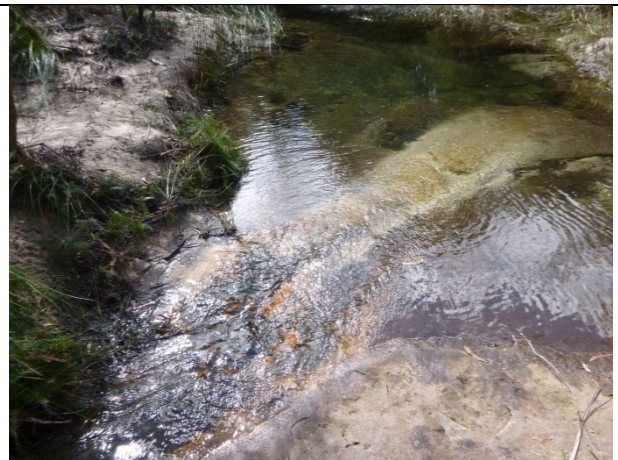
Photo 4: Inflow to WC21\_Pool 28, looking downstream. Taken on 10/09/2015.

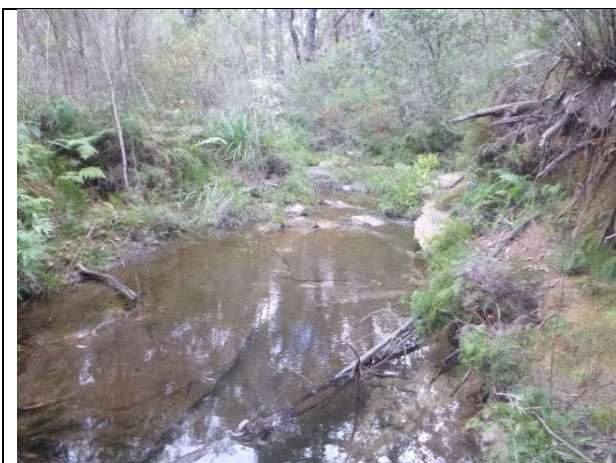
Photo 6: WC21\_Rockbar 27, looking upstream. Taken on 10/09/2015.

**Recommendation:** No works are recommended at this time.

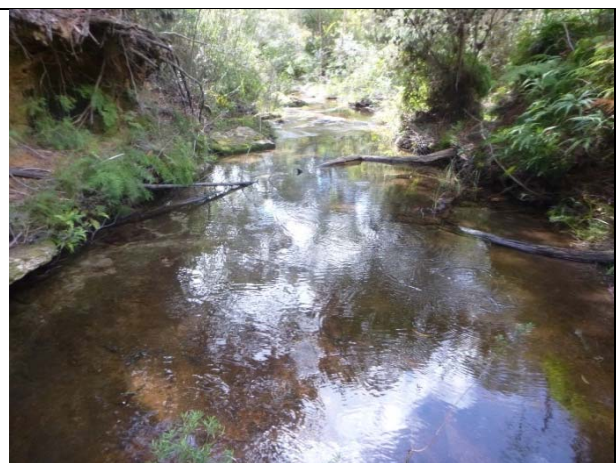
Photo 7: WC21\_Rockbar 27, looking downstream. Taken on 10/09/2015.

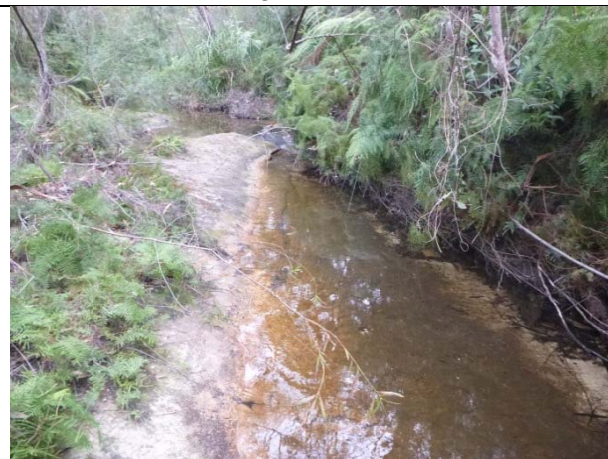
Photo 8: WC21\_Rockbar 26, looking upstream. Taken on 10/09/2015.

**Recommendation:** No works are recommended at this time as this site will be subject to movement from Longwall 11.

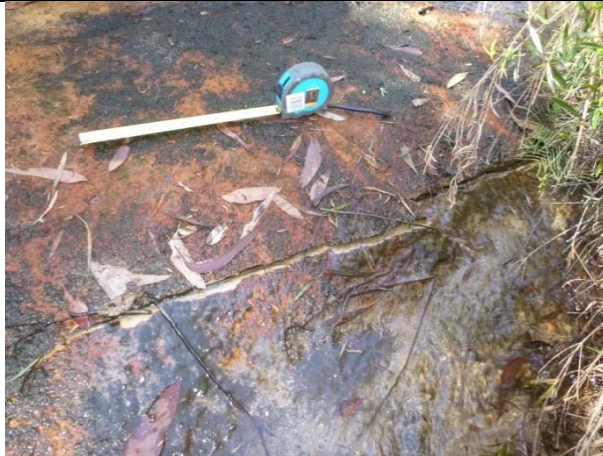
Photo 10: Impact LW10\_007- Fracturing to downstream end of Rockbar 26. Taken on 18/11/2014.

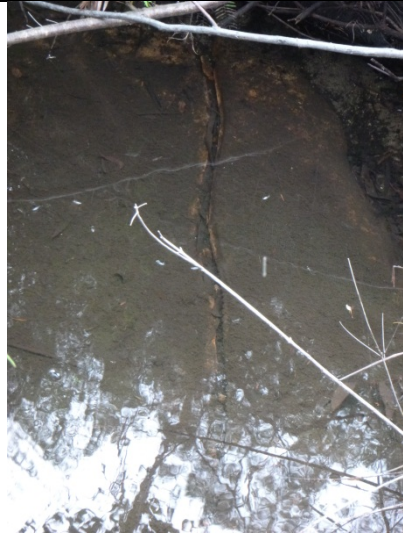
Photo 11: Impact LW10\_010- dilation of joint on base of pool, looking downstream. Taken on 25/11/2014.

**Recommendation:** Surface flow remains present through this section and as a result no works are recommended at this stage.

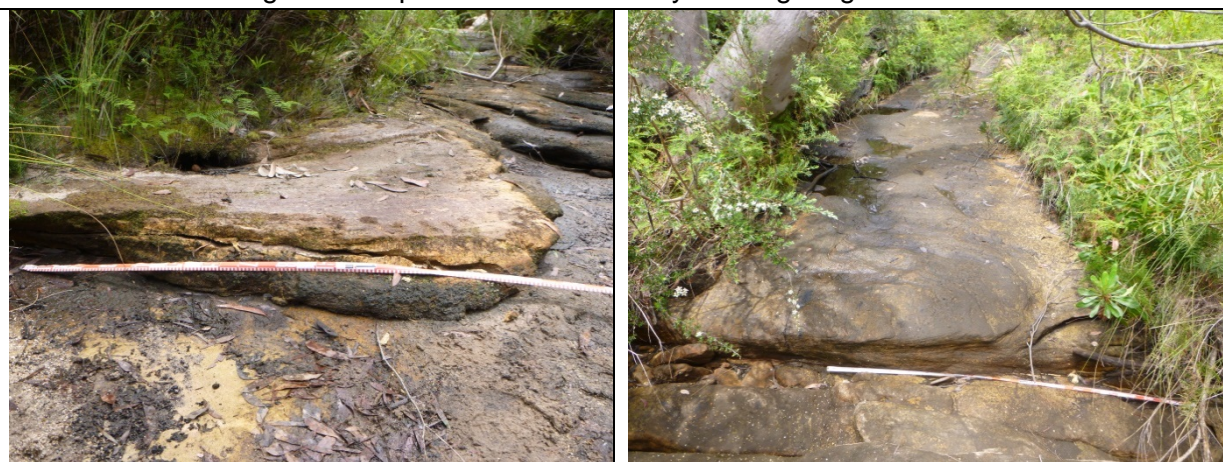
Photo 14: Impact LW10\_011- fracturing with dislodged fragment on Rockbar 24, looking downstream. Taken on 25/11/2014.

Photo 15: Impact LW10\_011- fracturing in joint and decline in surface flow, looking upstream. Taken on 25/11/2014.

A drill site is also proposed directly adjacent to Rockbar 24 (**Figure 4-6**). This is for the purpose of downhole investigations including packer testing, visual analysis using a downhole camera and installation of piezometers. These investigations aim at building a better understanding of the impacted strata and ways of targeting remediation works.

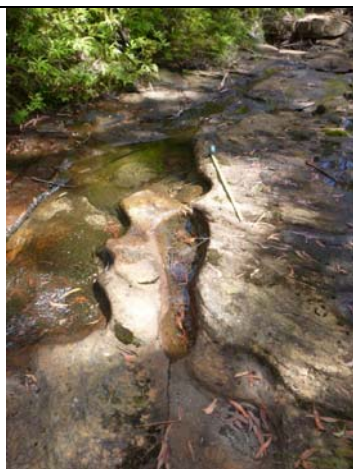
Photo 16: Impact LW10\_020- fracturing to downstream end of Rockbar 24, looking downstream. Taken on 30/01/2015.

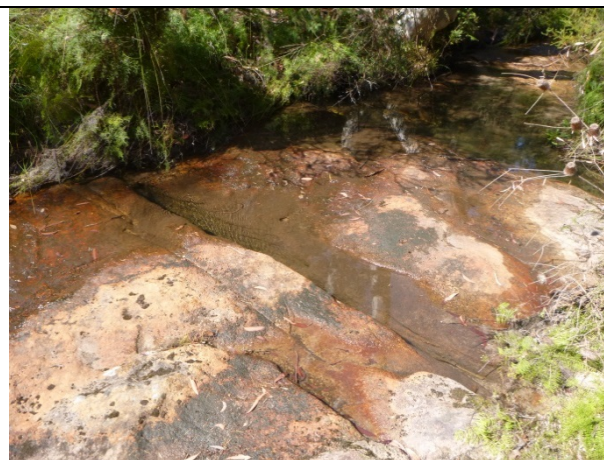
Photo 17: WC21\_Rockbar 24, looking upstream. Taken on 15/10/2015.

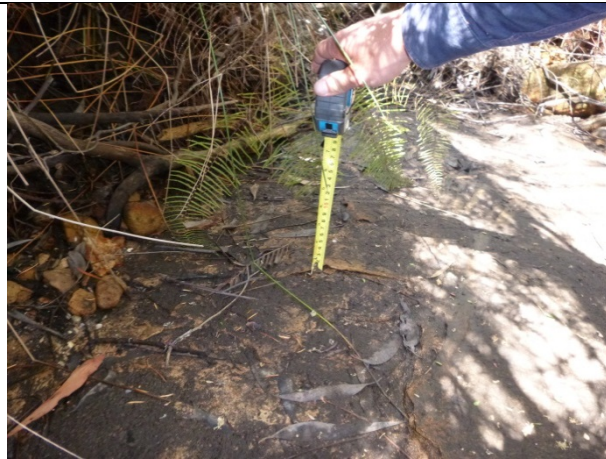
Photo 19: Impact LW10\_008- fracturing and decline in surface flow, looking upstream. Taken on 25/11/2014.

Reassessment of the downstream section of Pool 24 is recommended following the upstream works to the pool (**Figure 4-7**).

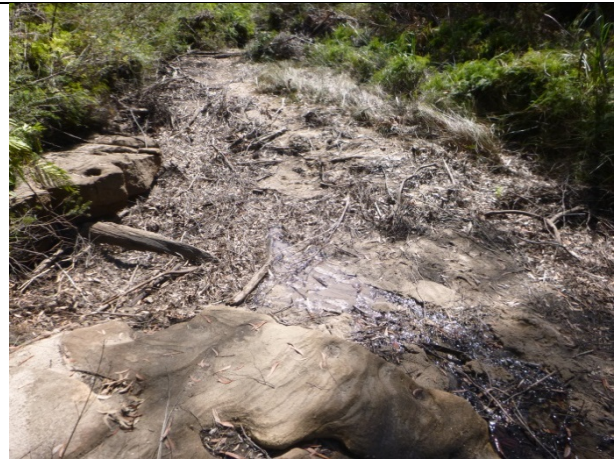
Photo 20: Upstream end of WC21\_Pool 24, without water in pool, looking downstream. Taken on 15/10/2015.

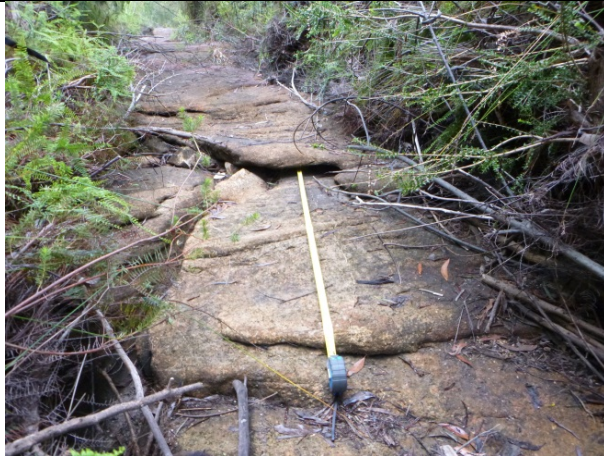
Photo 24: Impact DA3B\_LW10\_018. Taken on 18/12/2014

**Recommendations:** Reassessment of surface flow conditions on the rockbar are proposed following return of surface water flow to upstream features. Grouting of any flow diversion is recommended. It is recommended that remediation initially target Pool 23 should surface flow be delivered from upstream.

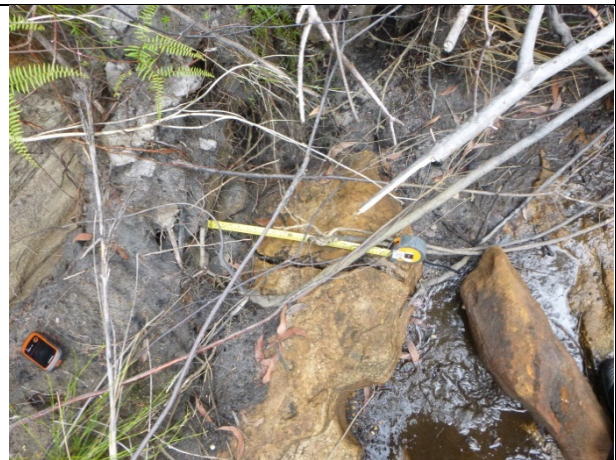
Photo 27: Impact DA3B\_LW10\_013. Taken on 4/12/2014

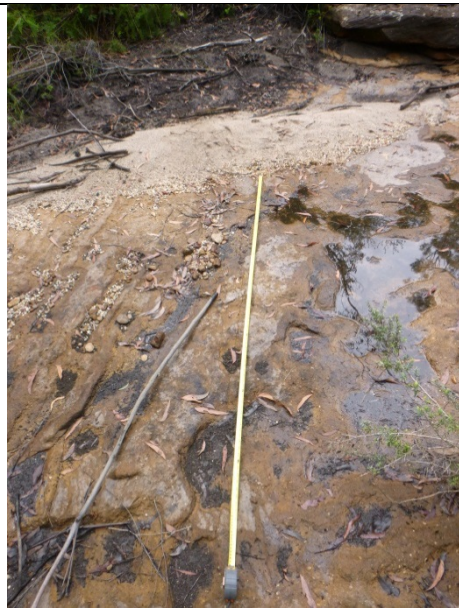
Photo 31: Impact DA3B\_LW10\_014-Fracture to base of WC21\_Pool 23, looking across stream. Photo taken on 4/12/2014.

A borehole is proposed for Staging Area 2 for the purposes of downhole investigations (**Figure 4-7**).

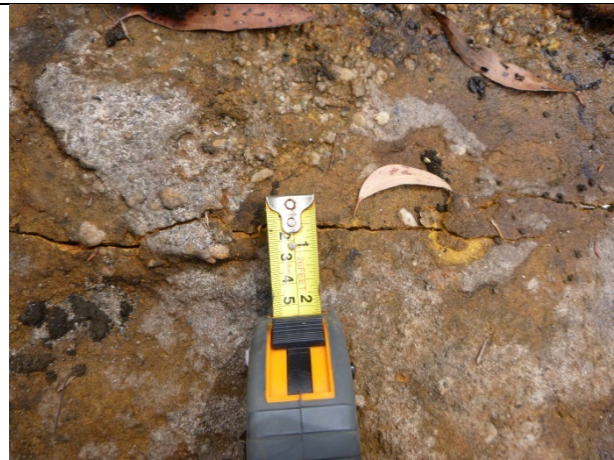
Photo 32: Impact DA3B\_LW10\_014-Fracture to base of WC21\_Pool 23. Photo taken on 4/12/2014.

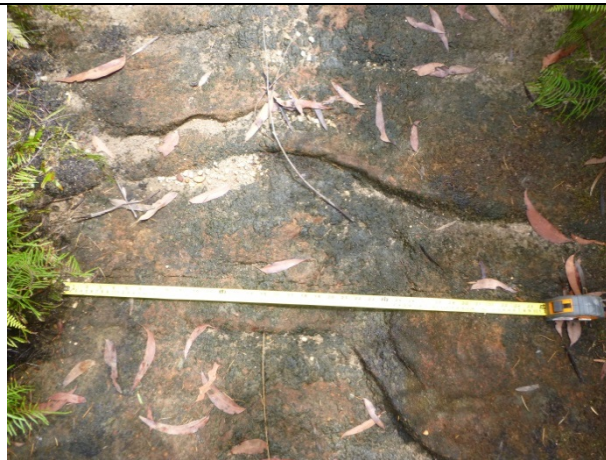
Photo 33: Impact DA3B\_LW10\_015-Fracturing downstream from WC21\_Pool 23, looking upstream. Photo taken on 4/12/2014.

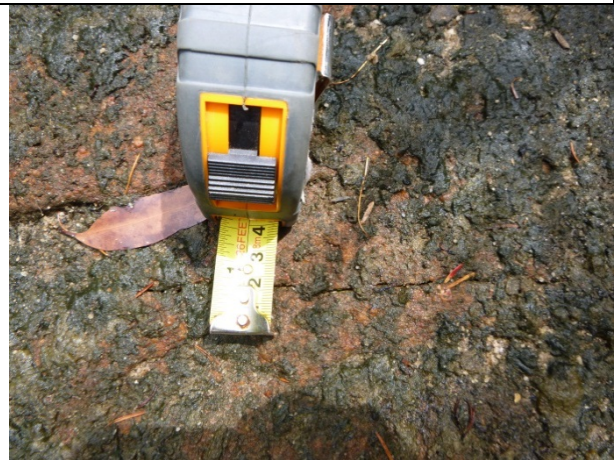
Photo 34: Impact DA3B\_LW10\_015-Fracturing downstream from WC21\_Pool 23. Photo taken on 4/12/2014.

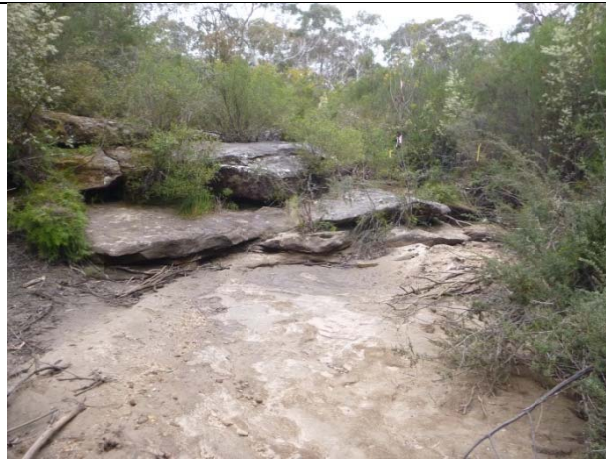
Photo 35: WC21\_Pool 23, looking upstream. Taken on 10/09/2015.

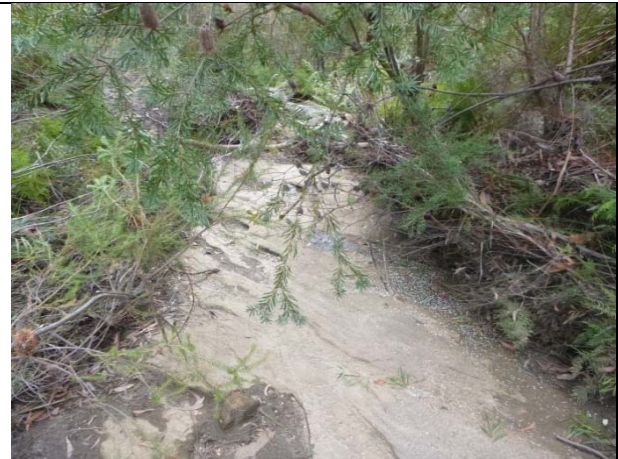
Photo 36: WC21\_Pool 23, looking downstream. Taken on 10/09/2015.

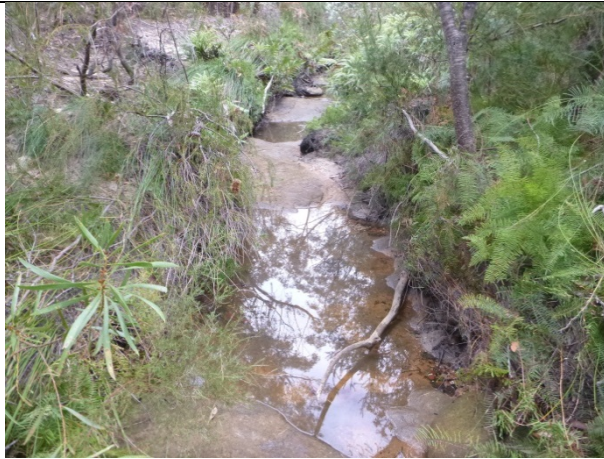
Photo 37: WC21\_Pool 22, looking upstream. Taken on 10/09/2015.

**Recommendation:** Reassessment of surface flow conditions at the site are proposed following the return of upstream surface water flow. The pool continues to hold areas of surface water. Grouting would target any observed flow diversion.

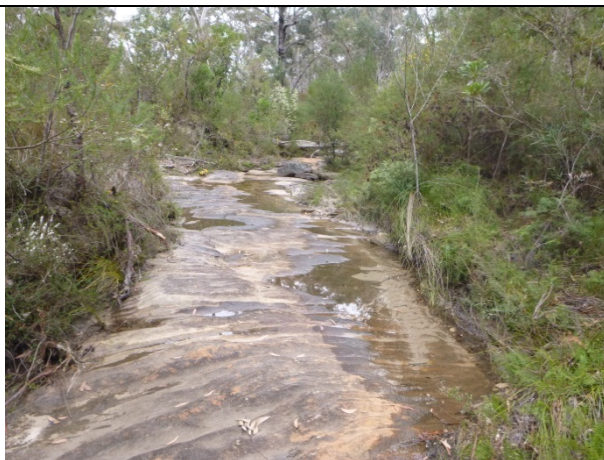
Photo 39: WC21\_Rockbar 21, looking upstream. Taken on 10/09/2015.

**Recommendation:** Reassessment of surface flow conditions at the site are proposed following the return of upstream surface water flow. The pool continues to hold areas of surface water. Grouting would target any observed flow diversion.

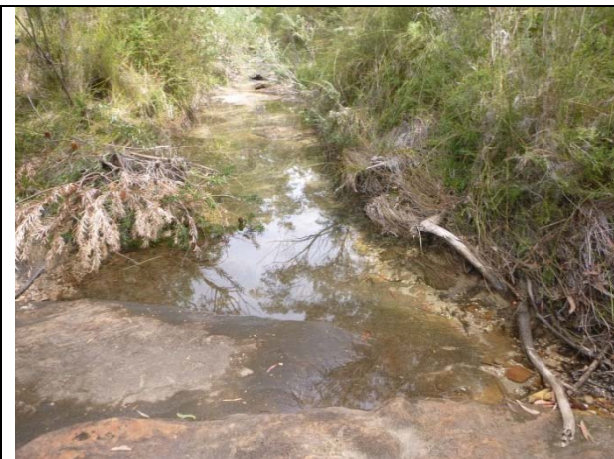
Photo 41: WC21\_Pool 21, looking upstream. Taken on 10/09/2015.

**Recommendations:** Reassessment of this area is proposed following return of upstream surface water flow. The pool continues to hold areas of surface water. Grouting would target any observed flow diversion.

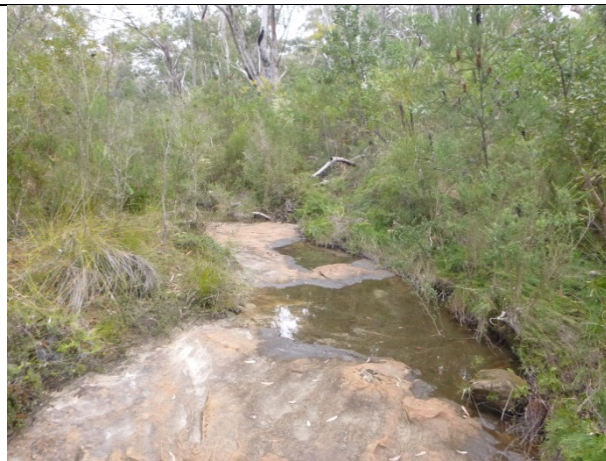
Photo 43: WC21\_Rockbar 20, looking upstream. Taken on 10/09/2015.

**Recommendations:** The rockbar continues to hold areas of surface water for periods after rainfall. Grouting would target any observed flow diversion through the rockbar. Remediation is proposed at the downstream Pool 20 (see following section).

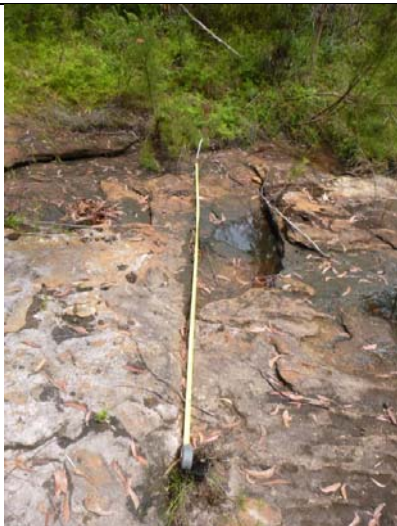
Photo 45: Impact LW10\_016- Rock fracture extending across rockbar and through joint, looking across stream. Taken on 04/12/2014.

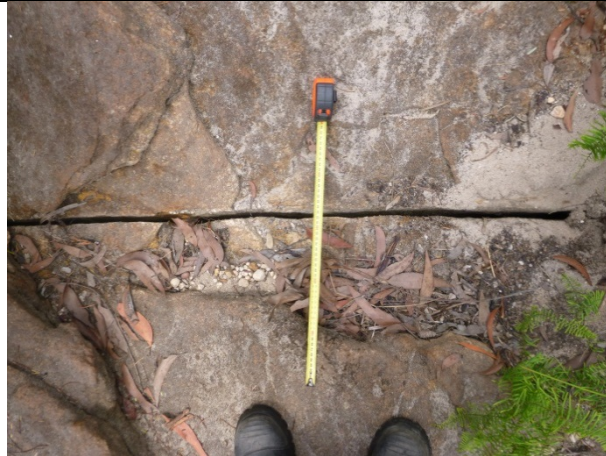
Photo 48: Impact LW9\_021- Rock fracturing to Rockbar 18. Taken on 2/01/2014.

**Recommendation:** Grouting of Impact DA3B\_021 is recommended due to the open nature of the fracture (**Figure 4-4**). Material will be carried from Staging Area 3 (**Figure 4-8**). Cofferdams and diversion piping will be used to temporarily divert surface flow if required.

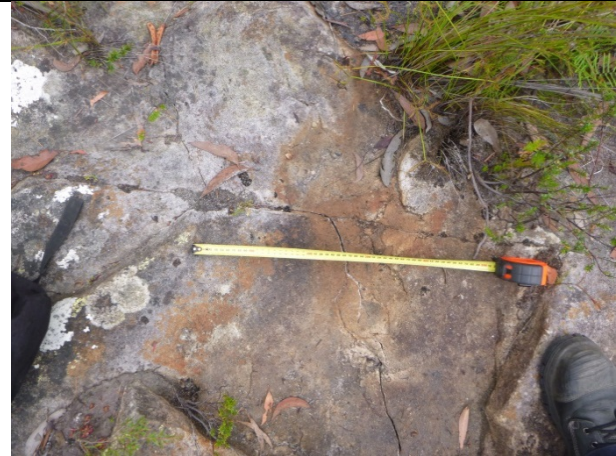
Photo 49: Impact LW9\_022- Rock fracturing to Rockbar 18. Taken on 2/01/2014.

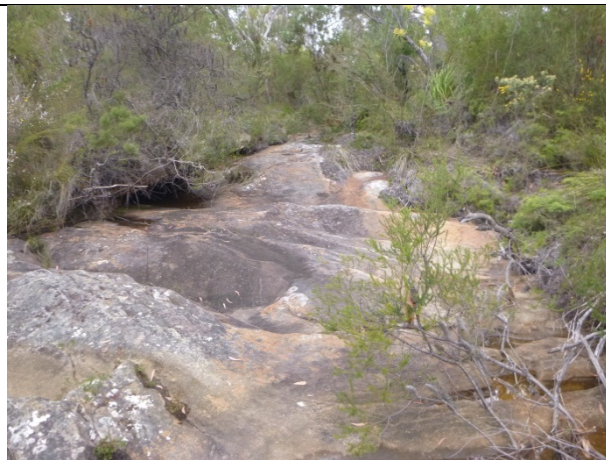
Photo 50: WC21\_Rockbar 18, looking upstream. Taken on 10/09/2015.

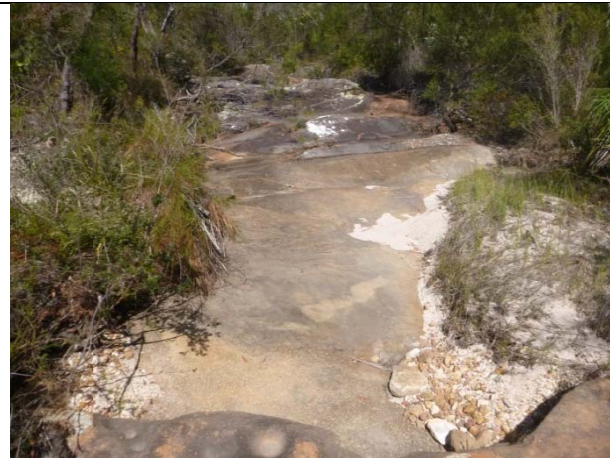
Photo 52: WC21\_Pool 18, looking upstream. Taken on 10/09/2015.

**Recommendation:** The successful return of upstream surface water flow will allow for a full assessment of the condition of Pool 18. The absence of any visible fracturing and observed flow diversion makes any initial remediation difficult at this pool. Should flow diversion be identified within this pool injection grouting is recommended. Grouting would target any observed flow diversion.

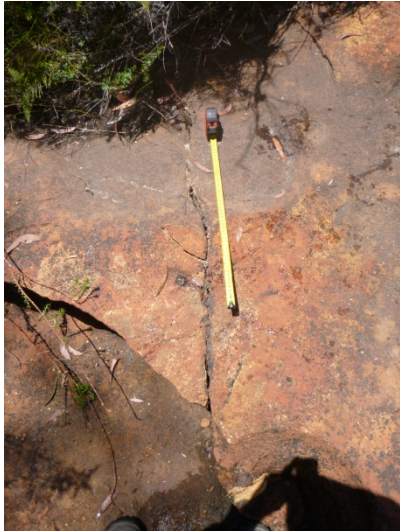
Photo 54: Impact LW9\_016, dilation of joint looking across stream. Taken on 17/12/2013.

**Recommendation:** Remediation is not currently proposed at this location due to the shallowness of the pool and the localised nature of flow diversion at the site. Surface flow at the site should be reassessed following successful return of flow upstream. It is recommended that remediation initially target Pool 16, approximately 10m downstream (Figure 4-9).

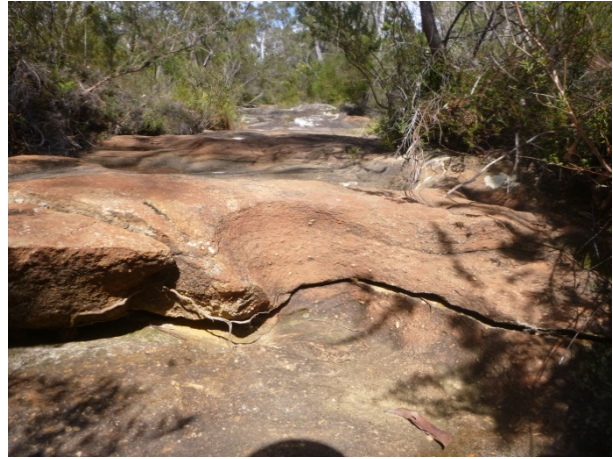
Photo 55: Rockbar 17, looking upstream at fracturing. Taken on 10/09/2015.

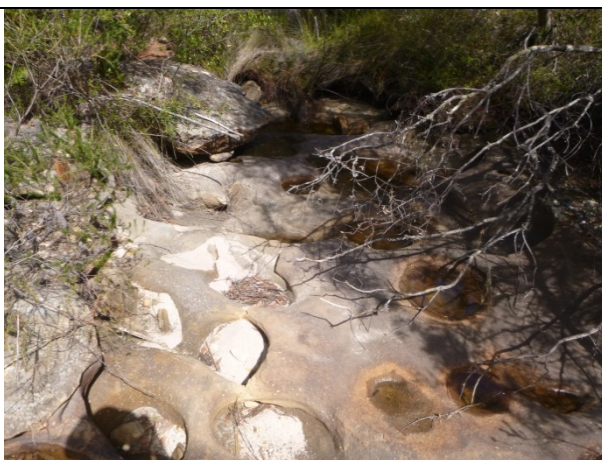
Photo 56: WC21\_Pool 17, looking upstream. Taken on 10/09/2015.

**Recommendation:** The absence of any visible fracturing or observation of flow diversion makes any initial remediation difficult at this pool. The pool's position directly upstream and 'above' Pool 16 suggests that any loss of water ultimately flows into Pool 16, where targeted remediation is proposed. Any flow diversion identified in Pool 17 would be targeted with grouting.

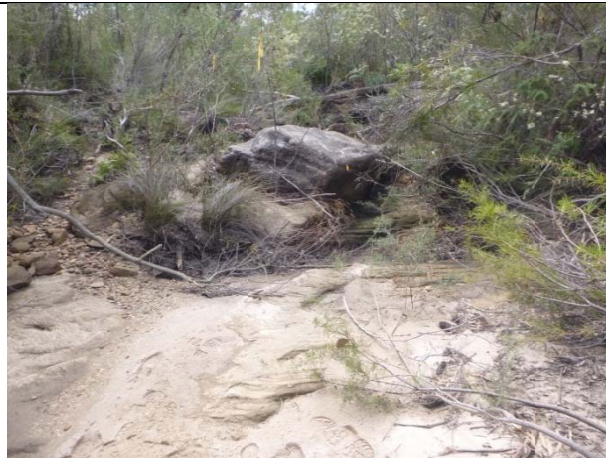
Photo 58: WC21\_Pool 16, looking downstream. Taken on 10/09/2015.

**Recommendation:** Injection grouting is recommended at the site (**Figure 4-9**). Cofferdams and diversion piping will be used to temporarily divert surface flow if required. Equipment and materials needed for remediation works will be stored at Staging Area 4. From this location, grout can be pumped approximately 20m to Pool 16. Primary clearing will be required to position Staging Area 4 directly adjacent to an existing, previously cleared seismic track. Secondary clearing of this track is required for vehicular access (**Figure 4-9**).

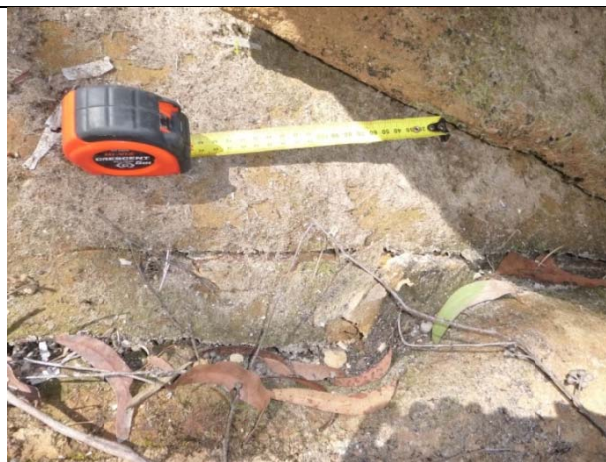
Photo 60: Impact DA3B\_LW9\_014- fracturing to rock shelf adjacent to WC21\_Pool 16. Taken on 10/12/2013.

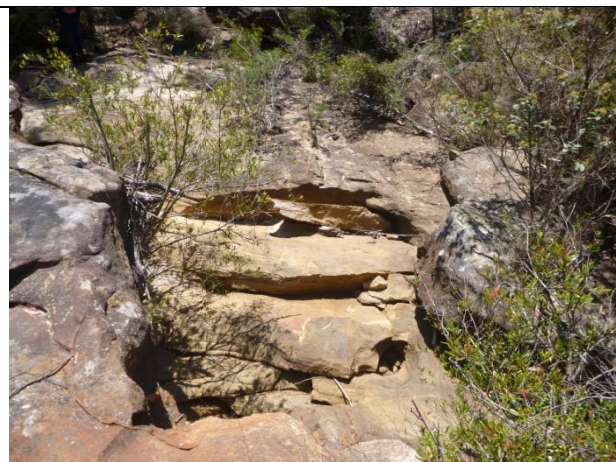
Photo 61: Impact DA3B\_LW9\_015- fracturing to base of WC21Pool 16, looking downstream. Taken on 15/10/2015.

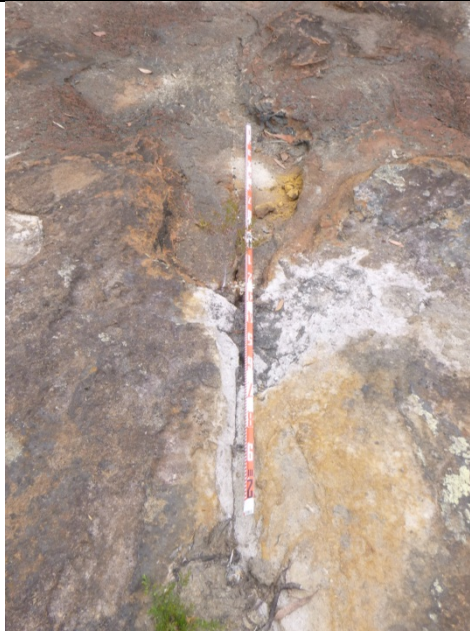
Photo 64: Impact LW9\_018, looking across stream. Taken on 24/12/2013.
