## WC21 AND DONALDS CASTLE CREEK REHABILITATION PLAN

<b>Document ID</b>	IMCMP0265	<b>Version</b>	4.0	Page i of 116
<b>Last Date Updated</b>	31/01/2023	<b>Next Review Date</b>	31/01/2026

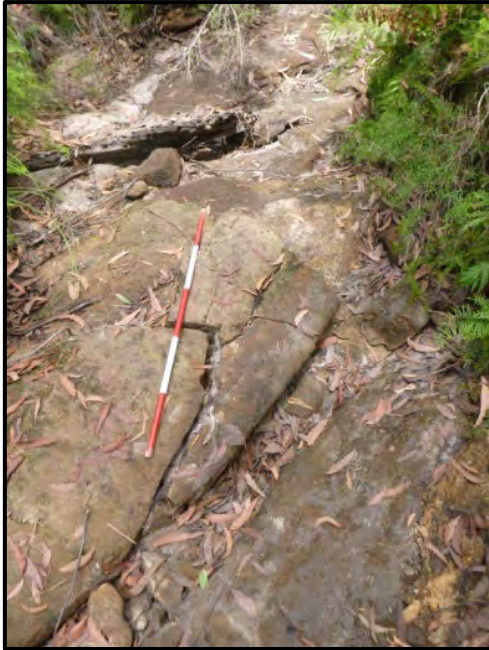
Photo 43: Impact LW11\_008- Rock fracturing to upstream from WC21\_Pool 30, looking upstream. Taken on 14 January 2016.

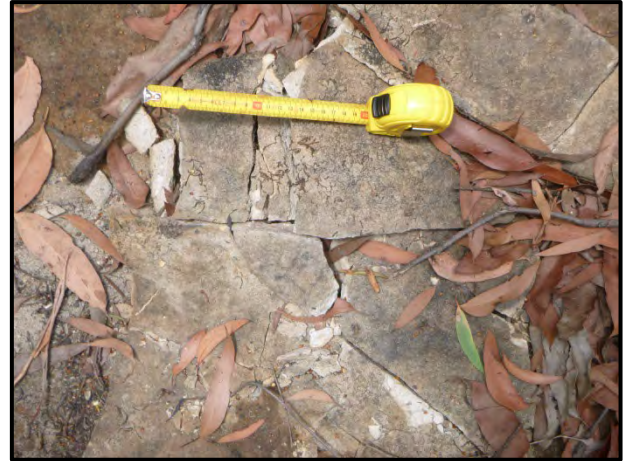
Photo 44: Impact LW11\_008- Rock fracturing to upstream from WC21\_Pool 30. Taken on 14 January 2016.

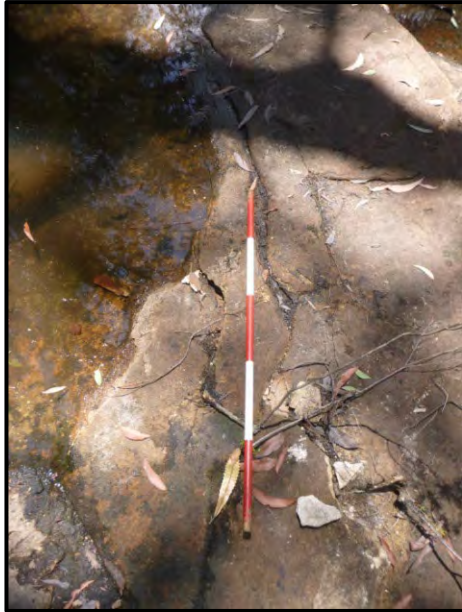
Photo 52: Impact LW11\_010- Fracturing to Rockbar 27. Taken on 11 February 2016.

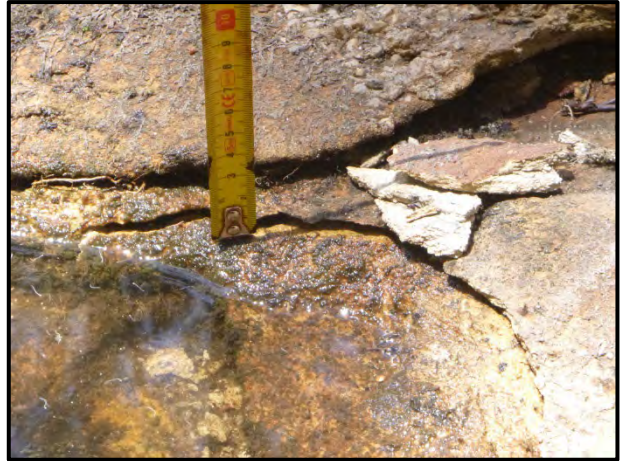
Photo 53: Impact LW11\_010- Fracturing to Rockbar 27. Taken on 11 February 2016.

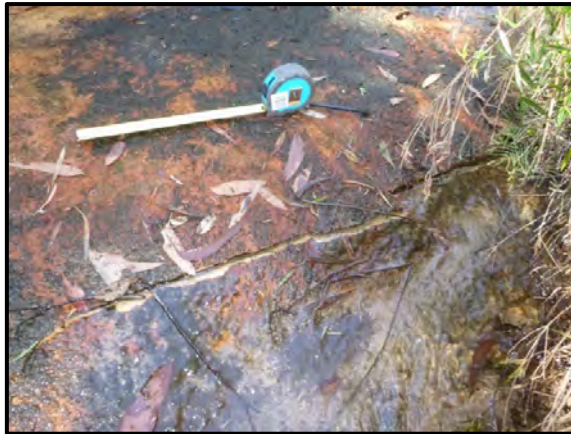
Photo 60: Impact LW10\_007- Fracturing to downstream end of Rockbar 26. Taken on 18 November 2014.

The morphology of the feature makes targeted remediation difficult at this site. No remediation is proposed at this stage.

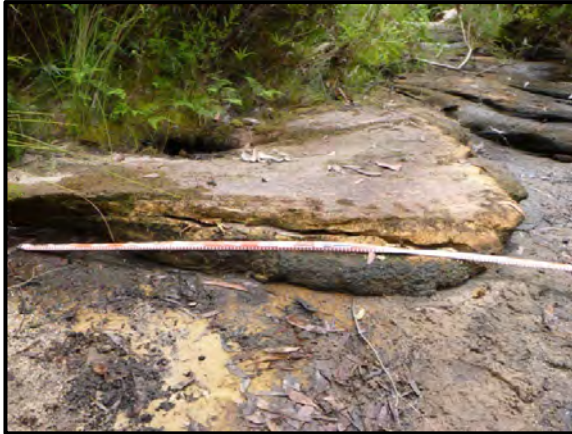
Photo 65: Impact LW10\_011- fracturing with dislodged fragment on Rockbar 24, looking downstream. Taken 25 November 2014.

Staging Area 1 is proposed as the site for the investigation hole. This location is already cleared and would require minimal secondary clearing.

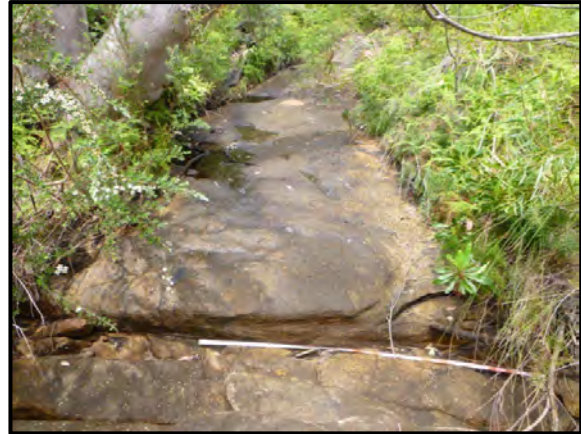
Photo 66: Impact LW10\_011- fracturing in joint and decline in surface flow, looking upstream. Taken on 25 November 2014.

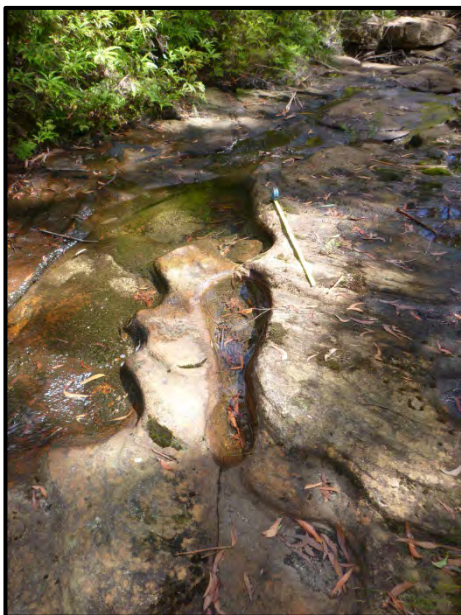
Photo 67: Impact LW10\_020- fracturing to downstream end of Rockbar 24, looking downstream. Taken on 30 January 2015.

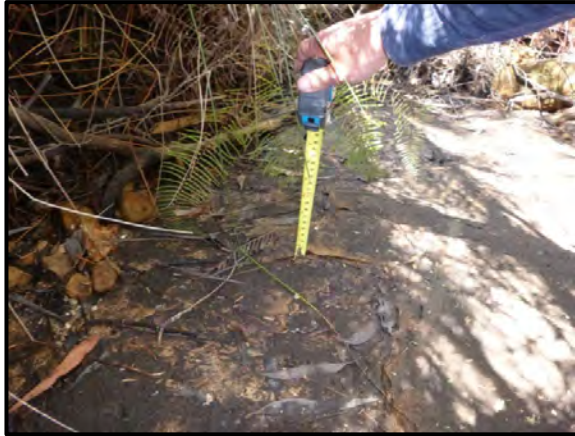
Photo 70: Impact LW10\_008- fracturing and decline in surface flow, looking upstream. Taken on 25 November 2014.

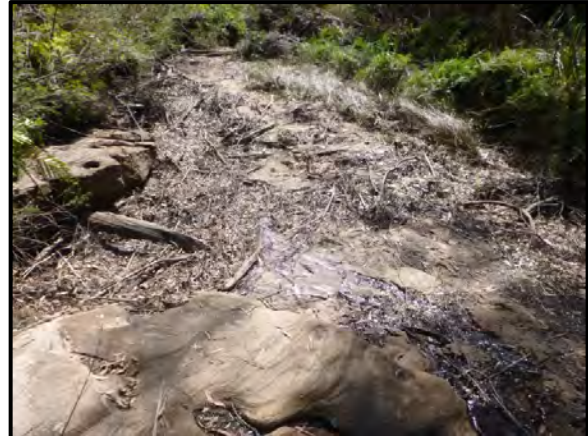
Photo 71: Upstream end of WC21\_Pool 24, without water in pool, looking downstream. Taken on 15 October 2015.

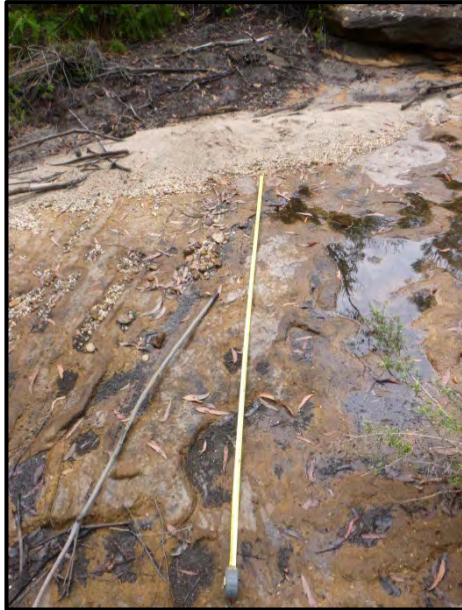
Photo 82: Impact DA3B\_LW10\_014- Fracture to base of WC21\_Pool 23, looking across stream. Photo taken on 4 December 2014.

Reassessment of surface flow conditions on the rockbar are proposed following return of surface flow to upstream features. Grouting of any flow diversion is recommended. It is recommended that remediation initially target Pool 23.

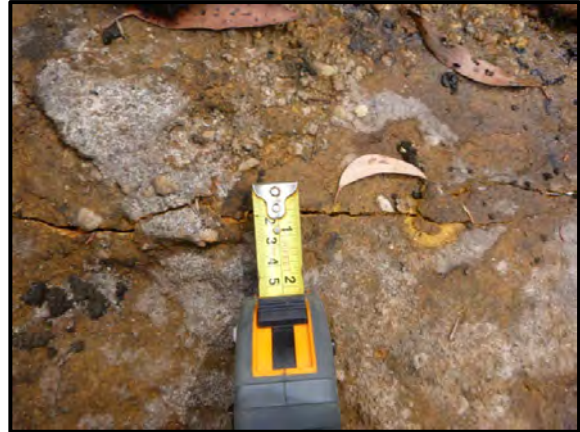
Photo 83: Impact DA3B\_LW10\_014- Fracture to base of WC21\_Pool 23. Photo taken on 4 December 2014.

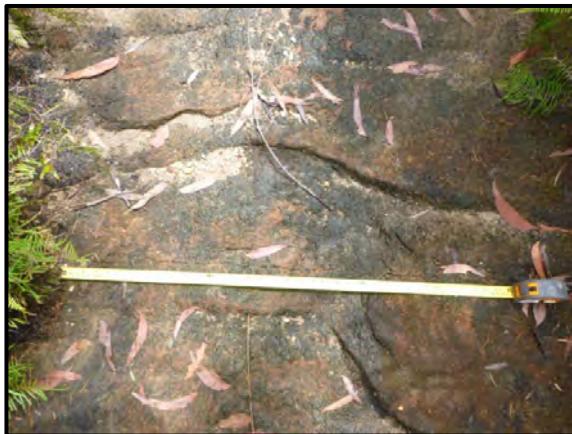
Photo 84: Impact DA3B\_LW10\_015- Fracturing downstream from WC21\_Pool 23, looking upstream. Photo taken on 4 December 2014.

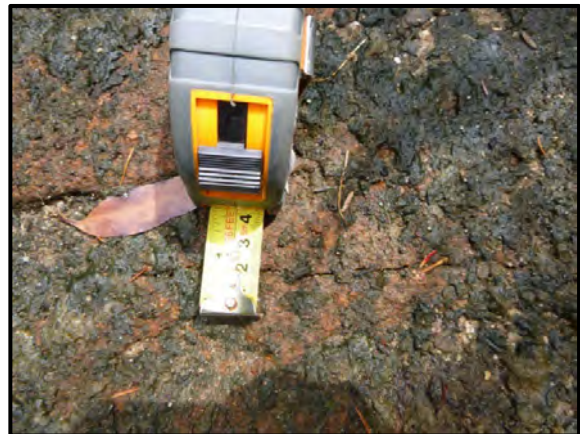
Photo 85: Impact DA3B\_LW10\_015- Fracturing downstream from WC21\_Pool 23. Photo taken on 4 December 2014.

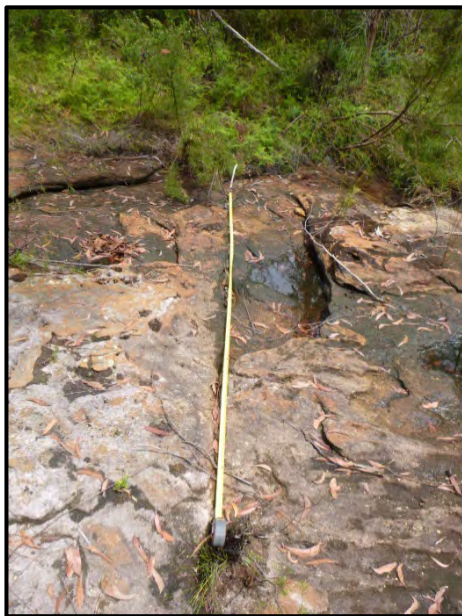
Photo 96: Impact LW10\_016- Rock fracture extending across rockbar and through joint, looking across stream. Taken on 4 December 2014.

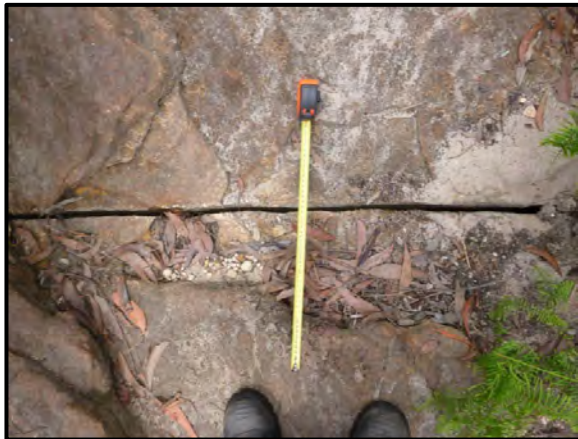
Photo 99: Impact LW9\_021- Rock fracturing to Rockbar 18. Taken on 2 January 2014.

Targeted remediation is proposed for the upstream end of Rockbar 18. Staging Area 3 will be used for works at the site.

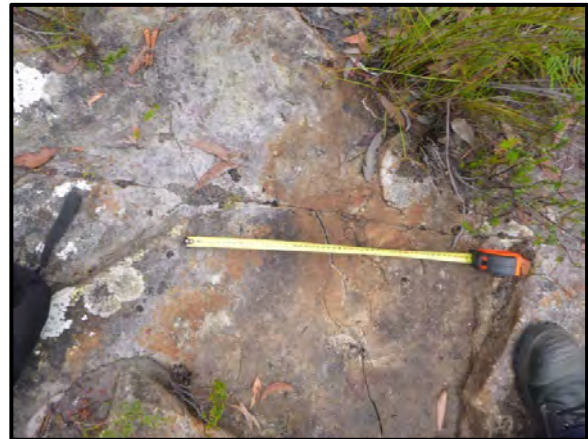
Photo 100: Impact LW9\_022- Rock fracturing to Rockbar 18. Taken on 2 January 2014.

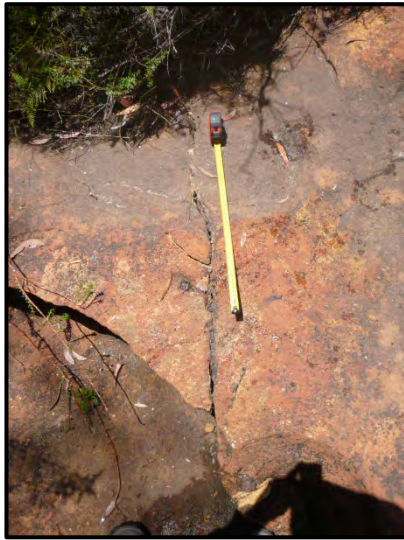
**Photo 105:** Impact LW9\_016, dilation of joint looking across stream. Taken on 17 December 2013.

Remediation is not currently proposed at this location due to the shallowness of the pool and the localised nature of flow diversion at the site.

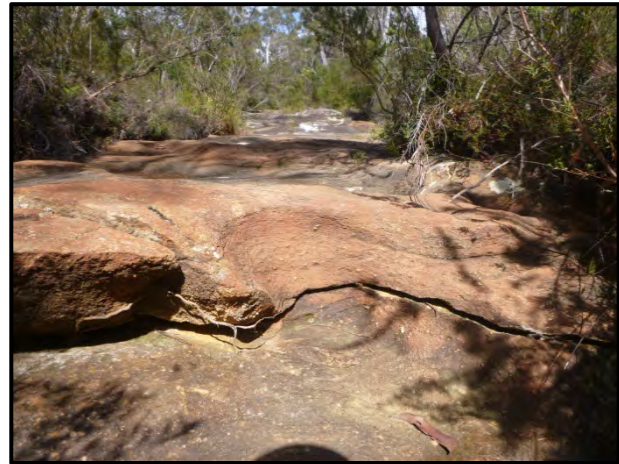
**Photo 106:** Rockbar 17, looking upstream at fracturing. Taken on 10 September 2015.

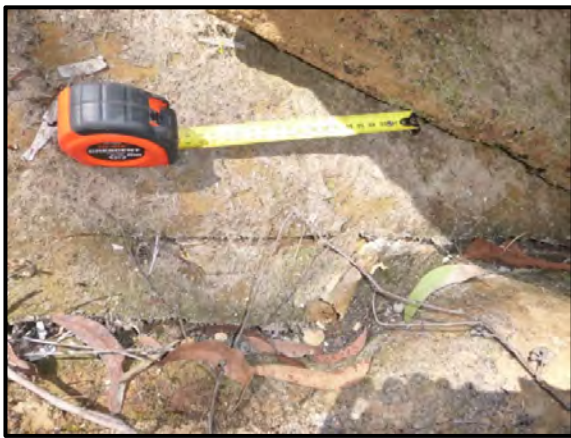
Photo 111: Impact DA3B\_LW9\_014- fracturing to rock shelf adjacent to WC21\_Pool 16. Taken on 10 December 2013.

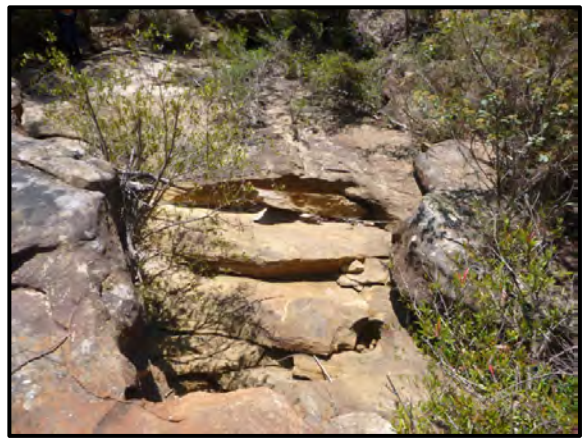
Photo 112: Impact DA3B\_LW9\_015- fracturing to base of WC21\_Pool 16, looking downstream. Taken on 15 October 2015.
