Illawarra Coal

Dendrobium Area 3B Longwall 10 End of Panel Report

May 2015

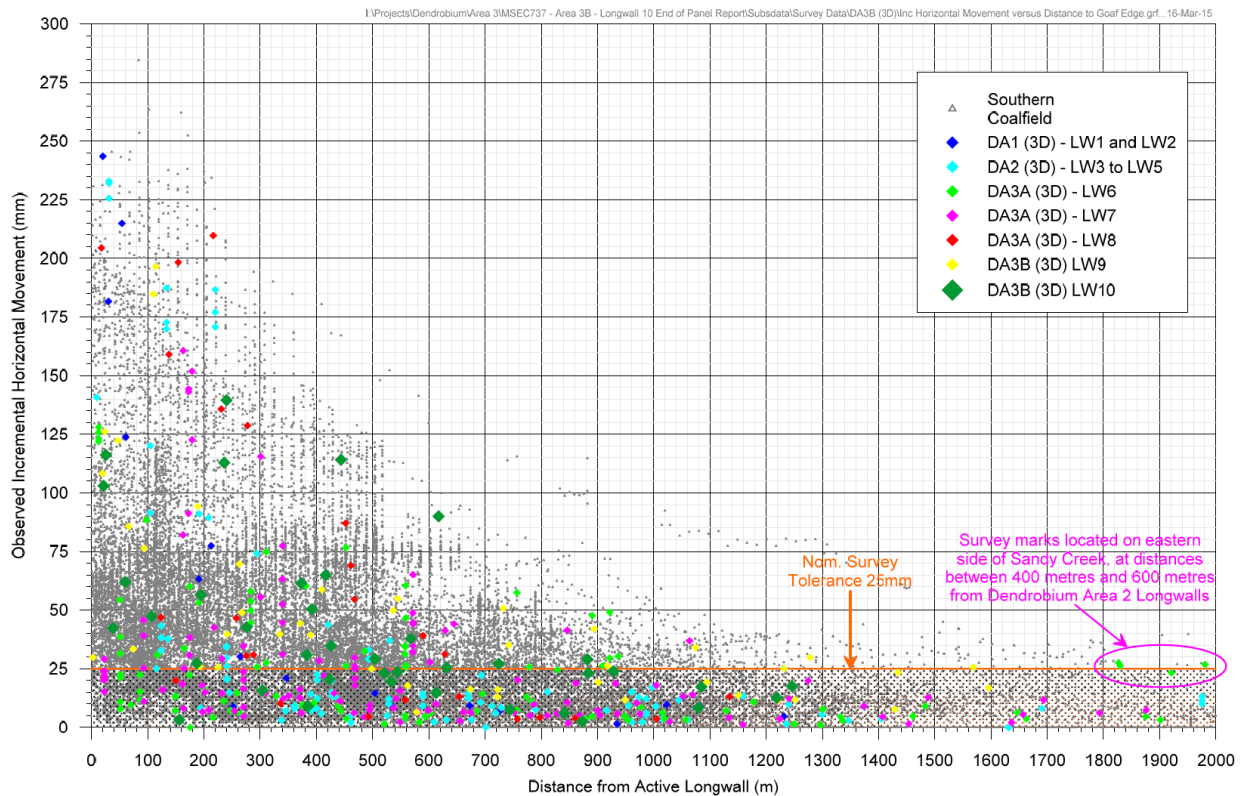
Figure 1: Observed Incremental Horizontal Movement for DA3B 3D Monitoring Points

The horizontal movement vectors for the marks located outside the extents of Longwall 10 were generally orientated towards the extracted goaf, but slightly orientated towards the longwall finishing end. The horizontal movement vectors for the marks located above the longwall were also generally oriented towards the finishing end.

The observed incremental horizontal movements at the DA3B 3D monitoring points, resulting from the extraction of Longwall 10 were within the range of those measured at similar distances from previously extracted longwalls at Dendrobium Mine and elsewhere in the Southern Coalfield. This is shown in Figure 1, Dendrobium longwalls are represented by colour.

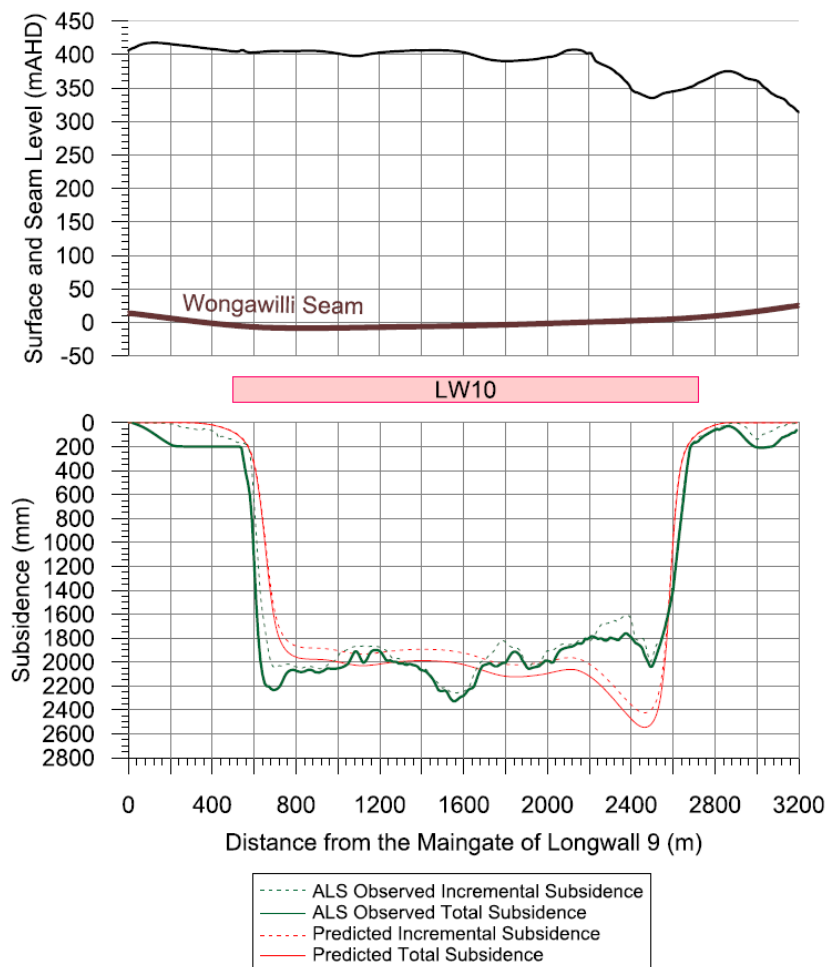
Figure 2: Observed Changes in Surface Level and Predicted Subsidence along Long-Section 1

The observed incremental and total subsidence along Long-section 1 are reasonably similar to those predicted along the centreline of Longwall 10. There are two locations along the base of the subsidence trough that are greater than predicted but are within the accuracy of modelling predictions of $\pm 15\%$ and the expected tolerance of the ALS / LiDAR for absolute vertical position of ± 300 mm. The observed subsidence has also exceeded predicted subsidence at the commencing and finishing ends of Longwall 10 with the observed subsidence profiles at the ends of the subsidence trough being closer to the commencing end and finishing end of Longwall 10. The profile at the commencing end is slightly steeper than predicted. It is noted that the largest predicted maximum subsidence along the long-section was not exceeded by the largest observed subsidence along the long-section.

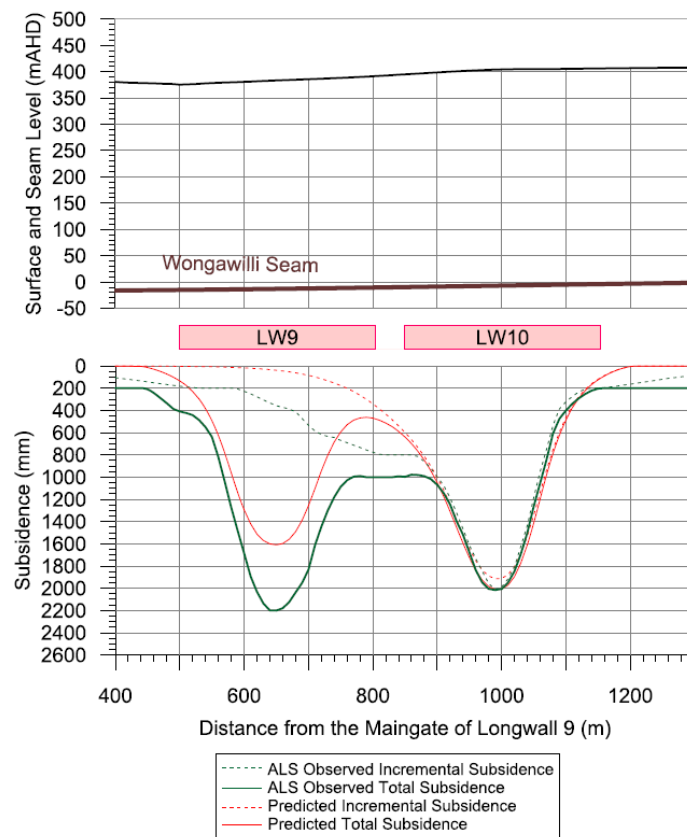
Figure 3: Observed Changes in Surface Level and Predicted Subsidence along Cross-section1

The profiles of the observed incremental and total subsidence along Cross-sections 1 and 2, after the extraction of Longwall 10, are shown by the green lines in Figure 3 and Figure 4 respectively. The profiles of predicted incremental subsidence are also shown in these figures as red lines for comparison.

It can be seen from the above figures, that the shapes of the observed profiles are reasonably similar to those predicted. The maximum observed incremental and total subsidence exceeded that predicted above Longwall 9 in Cross-section 1 and Cross-section 2. The maximum observed incremental and total subsidence slightly exceeded that above Longwall 10 in Cross-Section 1. The observed subsidence profiles in Cross-section 1 and Cross-section 2 also show greater subsidence and a flatter subsidence profile above the chain pillar between Longwall 9 and Longwall 10 indicating significant pillar compression.

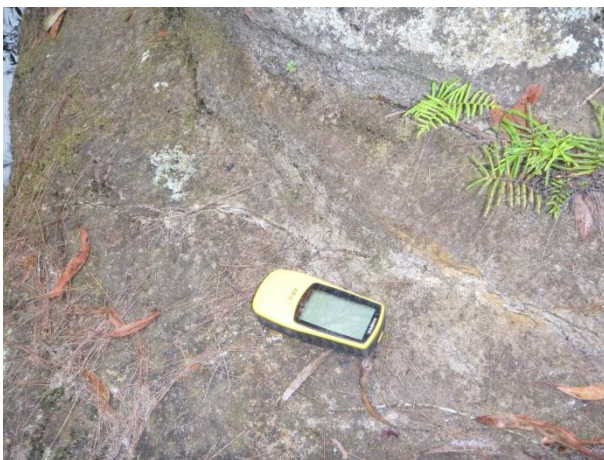
An extension of impact DA3B_LW9_017 was recorded during Longwall 10 extraction (Photo 1 and Photo 2). Due to the weathered nature of the fracture, it does not appear to have occurred recently and was likely hidden from view due to sand and debris that typically lines the banks of Wongawilli Creek.

Photo 1: Impact DA3B_LW9_01. Taken on 16/12/2014

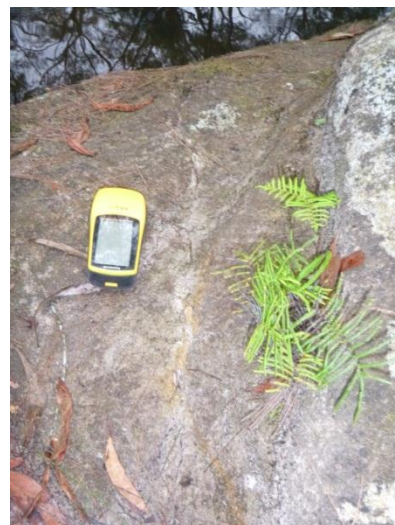
Photo 2: Impact DA3B_LW9_017. Taken on 16/12/2014

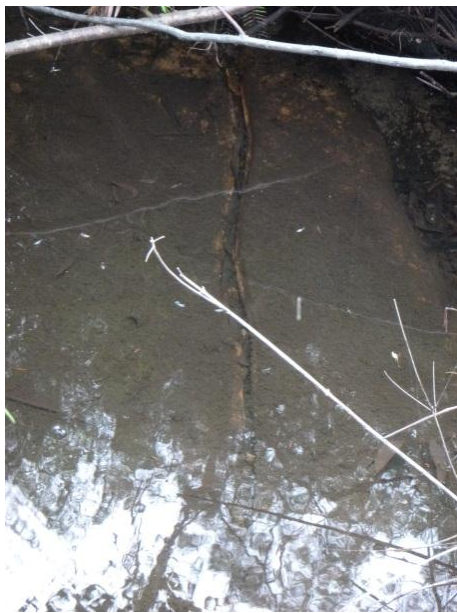
Three TARP Level 1 fractures have been observed in WC21 (Photo 3, Photo 4 and Photo 5) and have been identified as DA3B_LW10_010, 013 and 020 respectively (Figure 6). No water loss or flow diversion was observed from these impacts.

Photo 3: Impact DA3B_LW10_010 – Dilation of joint in base of pool. Taken on 25/11/2014

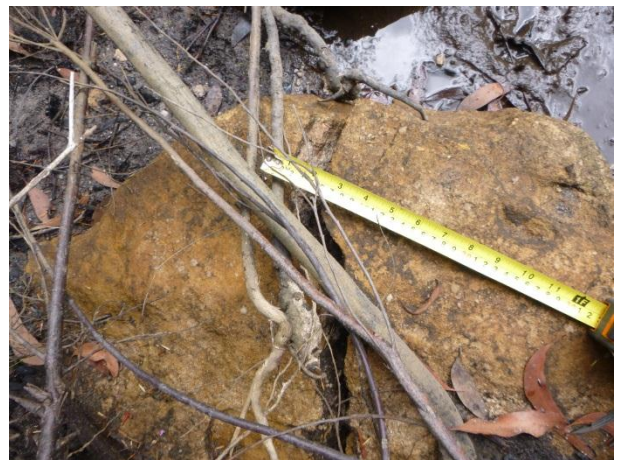
Photo 4: Impact DA3B_LW10_013 – Localised rock fracture at base of pool. Taken on 04/12/2014

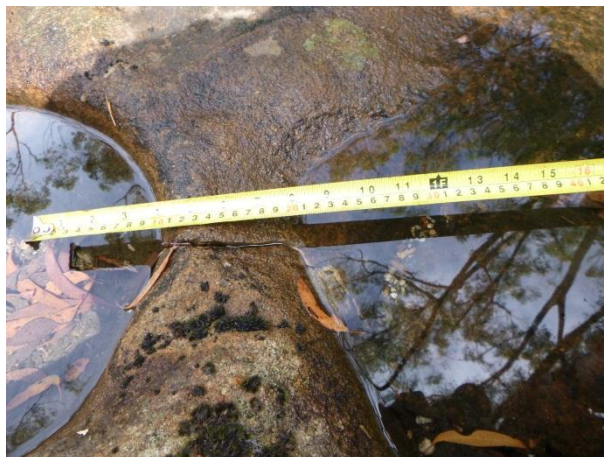
Photo 5: Impact DA3B_LW10_020 Fracturing to WC21_Rockbar 24. Taken on 02/02/2015

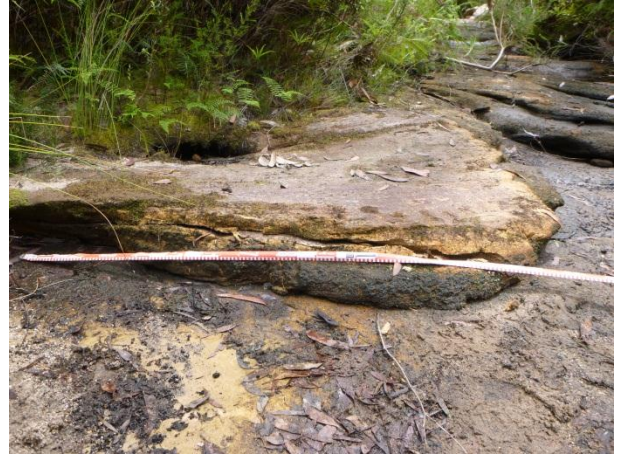
Thirteen TARP Level 2 fractures have been identified in WC21 (Figure 6), resulting in an observable diversion of surface water (Photo 6 and Photo 7). Two of these fractures were identified during Longwall 10 extraction as extensions of existing Longwall 9 impacts DA3B_LW9_014 and 016 (Photo 12 and Photo 13).

Photo 7: Impact DA3b_LW10_011 – Fracturing with dislodged fragment. Taken on 25/11/2014

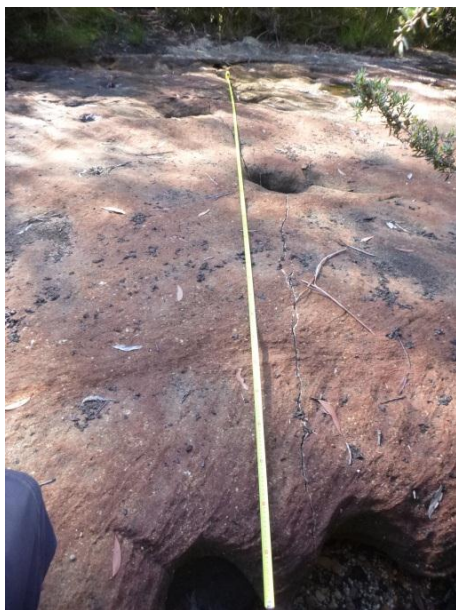
Following an inspection of landscape features on the 3rd of March 2015, multiple rock fractures to the downstream section of WC21_Rockbar 23 were identified (DA3B_LW10_026). The fractures ranged from 0.35m to approximately 6m long and hairline to 0.005m wide (Photo 8 and Photo 9). Surface flow was absent during the inspection. This impact is a Level 2 trigger according to the WIMMCP (June 2014), as shown in Table 13. Specifically:

- Any fracture which results in observable loss of surface water

Photo 8: impact DA3B_LW10_026 – Longest fracture to Rockbar 23. Taken on 03/03/2015

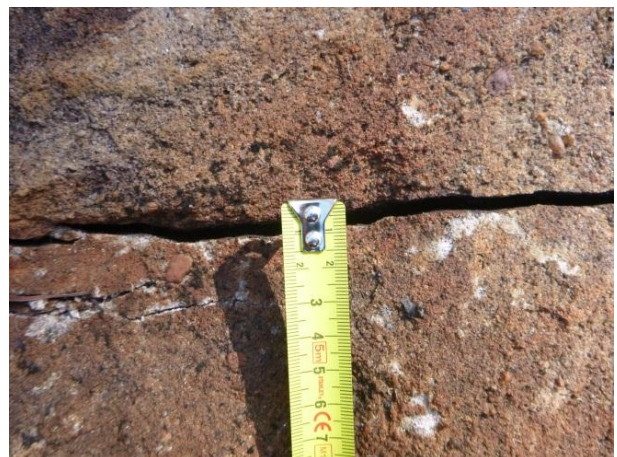
Photo 9: Impact DA3B_LW10_026 – Widest observable fracture. Taken on 03/03/2015

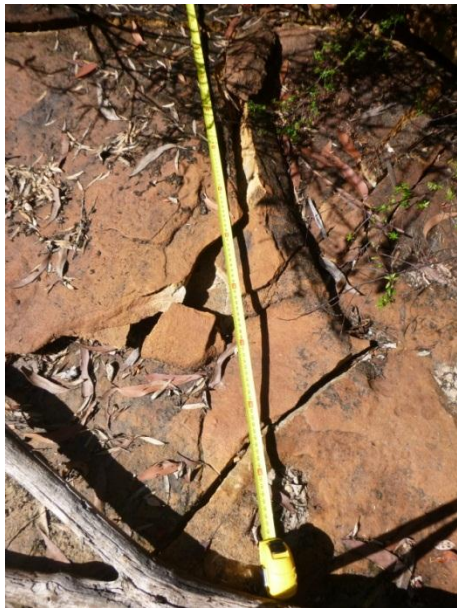
Additionally, during the inspection carried out on the 3rd of March 2015, an extension of an existing impact was observed. Within impact DA3B_LW10_009 a zone of fracturing and uplift was identified below the lip of WC21 Rockbar 23 (Photo 10 and Photo 11). The impact remains as a Level 2 trigger according to the WIMMCP TARPs dated June 2014.

Photo 10: Impact DA3B_LW10_009 – Length of longest fracture with uplift. Taken on 03/03/2015

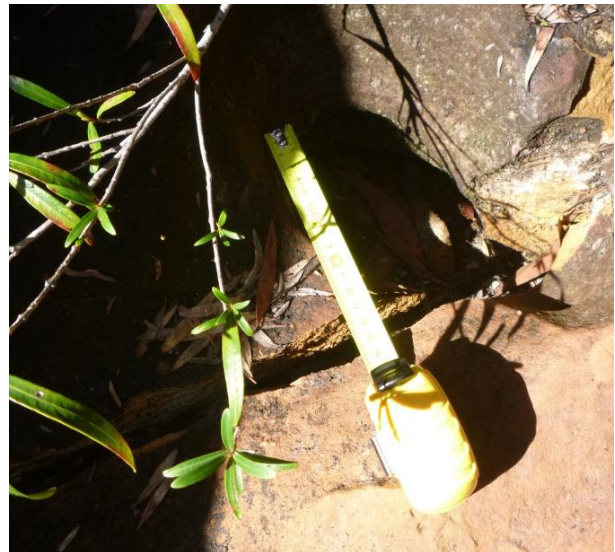
Photo 11: Impact DA3B_LW10_009 – width of widest fracture. Taken on 03/03/2015

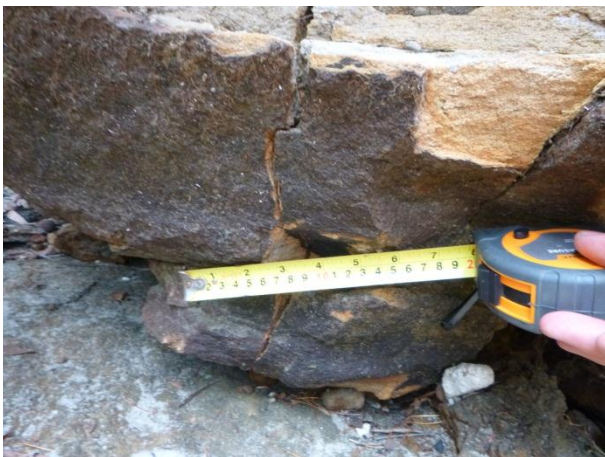
During Longwall 10 extraction, two extensions of existing Longwall 9 impacts were identified within WC21. Extensions of fractures were observed to impacts DA3B_LW9_014 and 016 (Photo 12 and Photo 13). The fractures ranged from 0.5m to 3.1m long and hairline to 0.03m in width. These impacts are Level 2 Triggers according to the WIMMCP TARPs dated December 2013.

Photo 12: Impact DA3B_LW9_014 – Widest point of vertical fracture. Taken on 04/05/2015

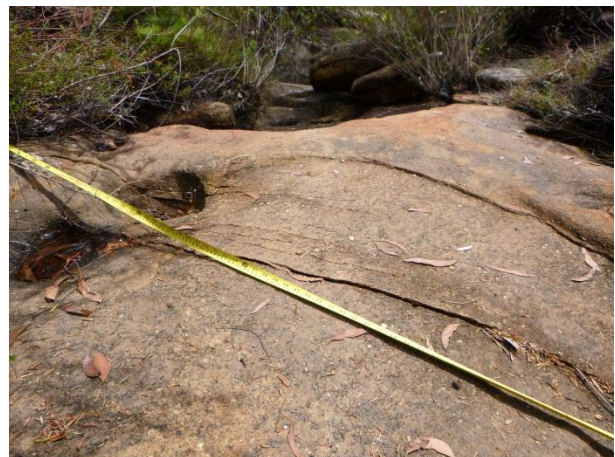
Photo 13: Impact DA3B_LW9_016 - Rock fracturing extending across rockbar. Taken on 04/02/2015

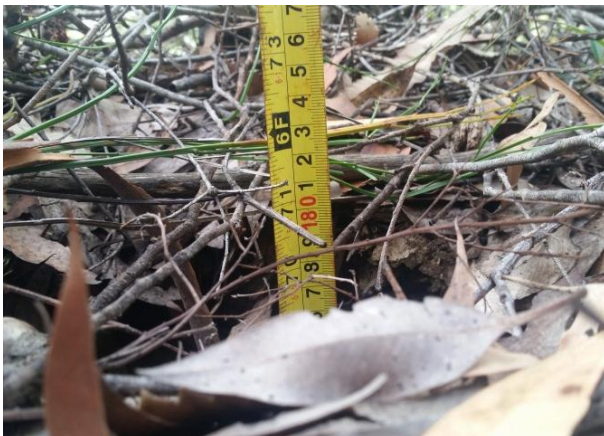
This impact is a Level 2 trigger under the TARPs set out in Table 1.2 of the DA3B SMP, Volume 2 (November 2012), as shown in Table 11, Specifically:

- Crack or fracture between 100 and 300mm width,
- Crack or fracture between 10 and 50m length, and
- A crack at the surface with the potential risk to safety and/or fauna entrapment.

Photo 14: Impact DA3B_LW10_024. Depth of crack. Taken on 18/02/2015

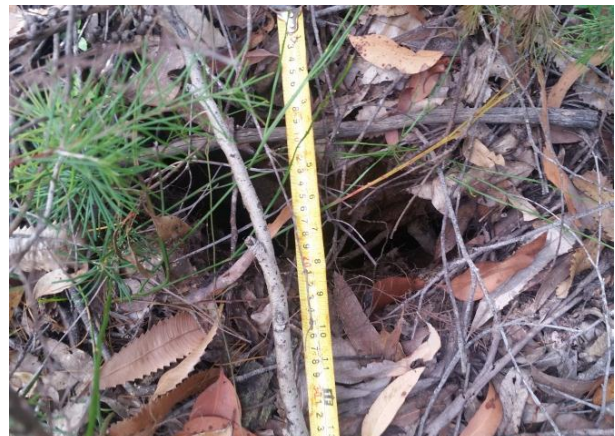
Photo 15: Impact DA3B_LW10_024. Width of crack. Taken on 18/02/2015

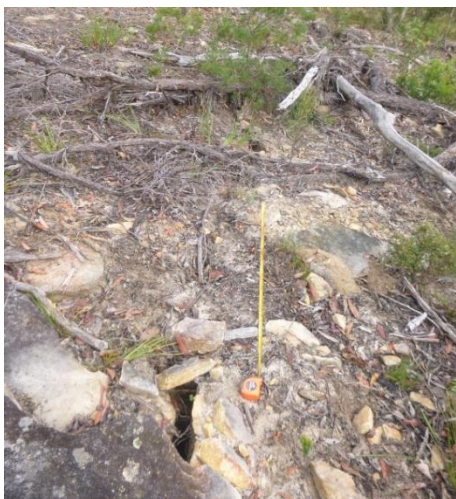
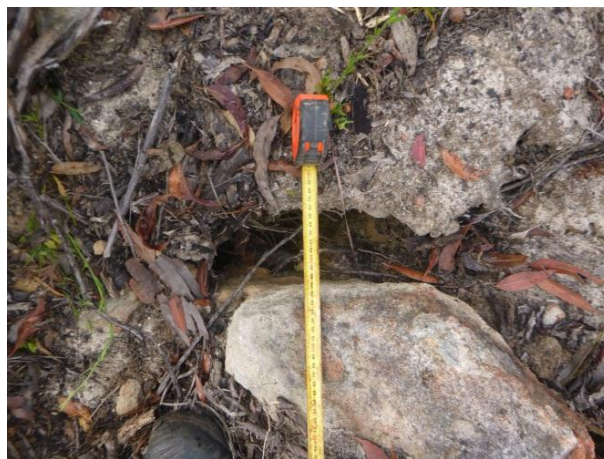
Photo 16: Impact DA3B_LW10_025. Taken on 20/02/2015

Impact DA3B_LW10_025 consisted of a single soil crack to a seismic track adjacent to Access Track 6000. The crack measured approximately 14m long, 0.1m wide and 1.4m deep (Photo 16 and Photo 17). At the time of identification, the crack was in the process of infilling and will most likely self-remediate.

This impact is a Level 2 Trigger under the TARPs set out in Table 1.2 of the Dendrobium Area 3B SMP, Volume 2 (November, 2012), specifically:

- Crack or fracture between 100 and 300mm width, and
- Crack or fracture between 10 and 50m length

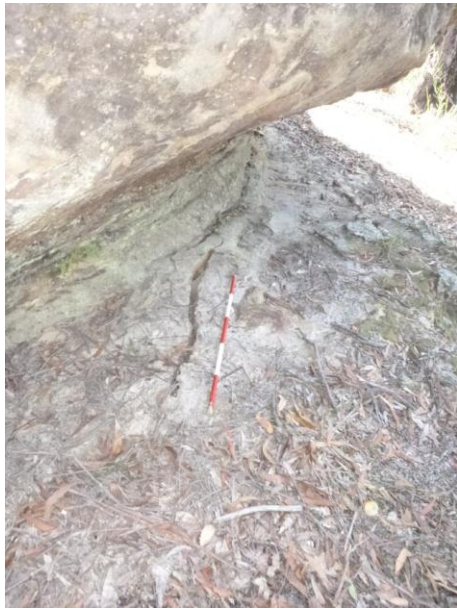
Both impacts attributed to Longwall 9 are Level 1 Triggers under TARPs in the Dendrobium Area 3B SMP, Volume 2 (November, 2012). Impacts DA3B_LW9_030 and 031 (Photo 18 and Photo 19) were attributed to Longwall 9 due to the location and timing of identification. That is, the impacts were far enough away from the Longwall 10 mining at the time of identification to conclude that they were not a result of Longwall 10 extraction.

Photo 18: Impact DA3B_LW9_030 – Fracturing and soil cracking beneath step. Taken on 11/09/2014

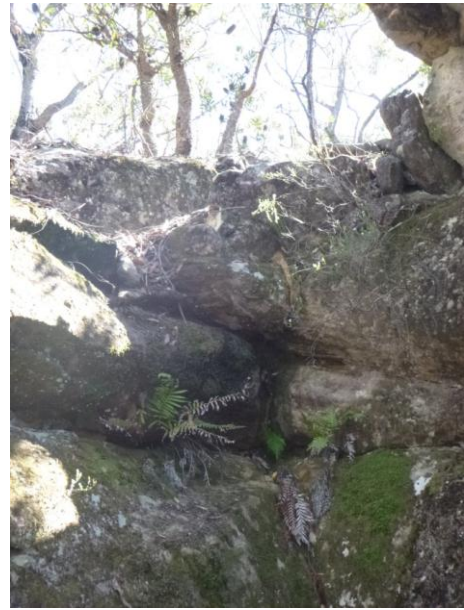
Photo 19: Impact DA3B_LW9_031 – Small fracture to step. Taken on 11/09/2014

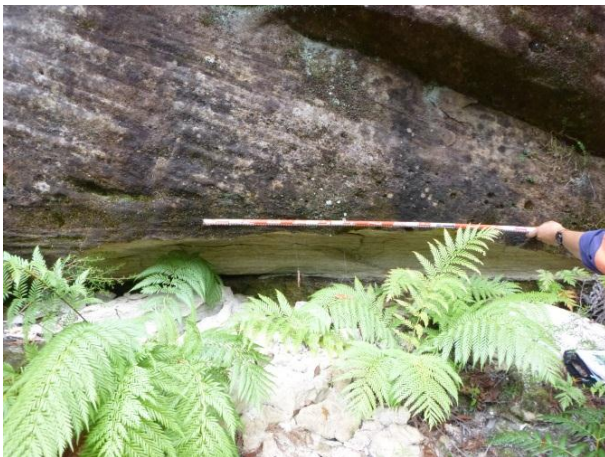
Two Level 1 rock falls, DA3B_LW9_032 and DA3B_LW10_004, were observed during the Longwall 10 monitoring period. Impact DA3B_LW9_032 consisted of a rock fall adjacent to Access Track 6000. The fall measured approximately 2.5m long, 0.47m wide and 0.25m deep. The volume of fallen rock was approximately 0.1m³ (Photo 21). Ground disturbance at the site was not significant (Photo 20).

Photo 20: Impact DA3B_LW9_032 – Rockfall on outcropping. Taken on 06/02/2015

This impact was identified after Longwall 10 extraction had completed. However, due to the location of the rock fall (far eastern side of the longwall block) and the weathered nature of the rock fall it was determined to be associated with Longwall 9.

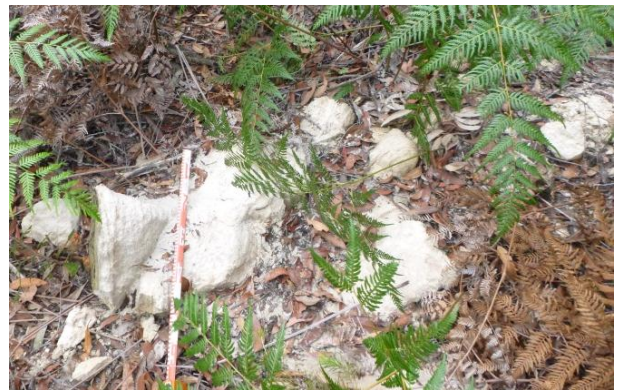
Photo 21: Impact DA3B_LW9_032 – Ground disturbance adjacent to rockfall. Taken on 06/02/2015

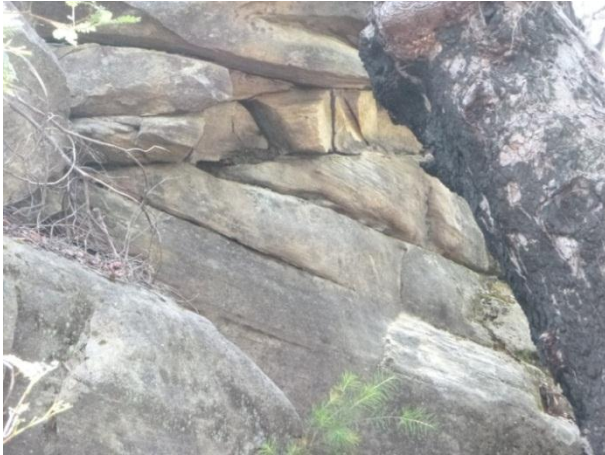
Impact DA3B_LW10_004 consists of a rock fall and multiple fractures in an area approximately 15m X 10m on a rock outcrop 90m east of Access Track 6000 above Longwall 10. The rock fall was approximately 0.5m long and 0.2m deep resulting in fallen rock fragments measuring approximately 0.002m³ (Photo 22 and Photo 23).

Photo 22: Impact DA3B_LW10_004 – Fracturing on cliff face. Taken on 27/10/2014

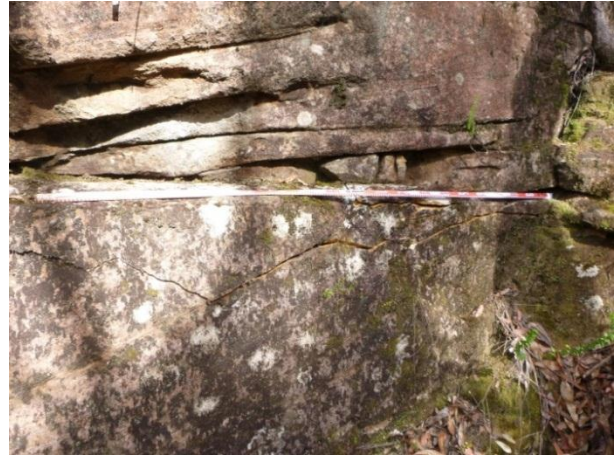
Photo 23: Impact DA3B_LW10_004 – Horizontal fracture on rock face. Taken on 27/10/2014

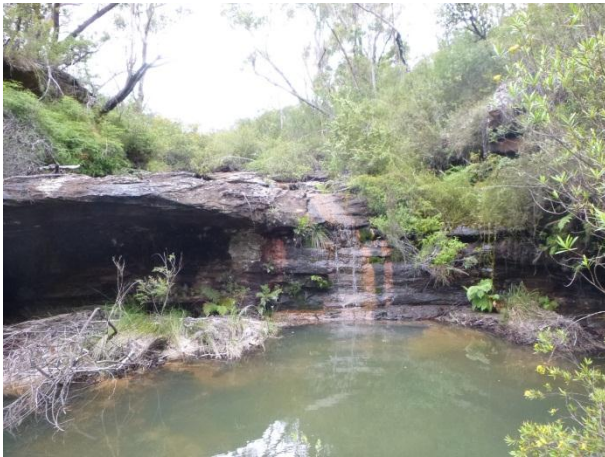
Iron staining and water cloudiness have been previously observed in WC21 (DA3B_LW9_019, Photo 24). During Longwall 10 extraction the iron staining and cloudiness has extended from WC21_Pool 10 downstream to WC21_Pool 4 (Photo 25 and Photo 26). An inspection of the confluence of WC21 and Wongawilli Creek indicated that the iron staining and water cloudiness is no longer visible at that point (Photo 27).

Photo 24: Impact DA3B_LW9_019 – WC21_Pool 10 looking upstream. Taken on 24/12/2013

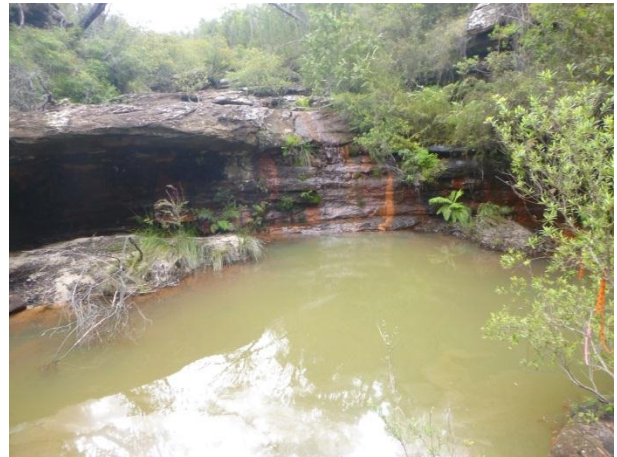
Photo 25: Impact DA3B_LW9_019 – WC21_Pool 10 looking upstream. Taken on 18/12/2014

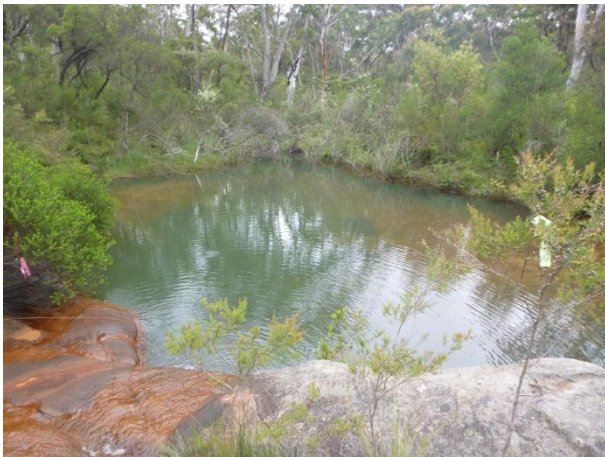
Photo 26: Impact DA3B_LW10_019 – WC21_Pool 4 looking downstream. Taken on 18/12/2014

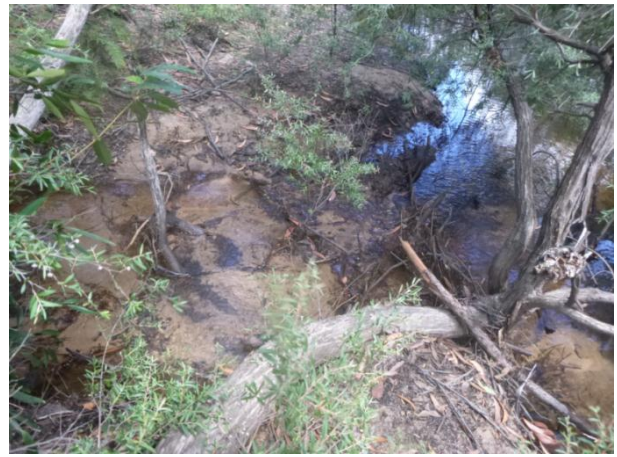
Photo 27: Confluence of WC21 and Wongawilli Creek. Taken on 16/01/2015
