DA3B LONGWALL 11 END OF PANEL LANDSCAPE REPORT

MARCH 2016

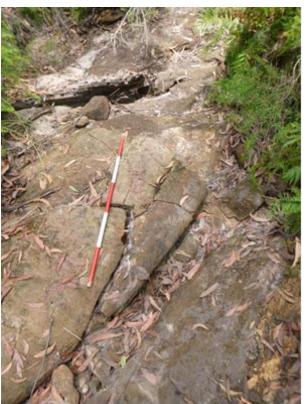
Two TARP Level 1 rock fractures have been observed in WC21- DA3B_LW11_008 (Photos 5 and 6) and DA3B_LW11_010 (Photos 7 and 8). In accordance with the TARPs these fractures are consistent with a Level 1 impact being:

- Crack or fracture up to 100mm width at its widest point with no observable loss of surface water or erosion.
- Crack or fracture up to 10m in length with no observable loss of surface water or erosion.

Photo 5: DA3B_LW11_008- Rock fracture, looking upstream along WC21. Taken on 14/01/2016.

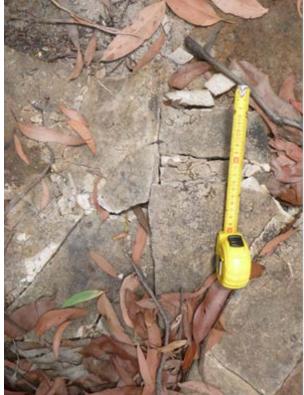
Photo 6: DA3B_LW11_008- Rock fracture, looking along WC21. Taken on 14/01/2016.

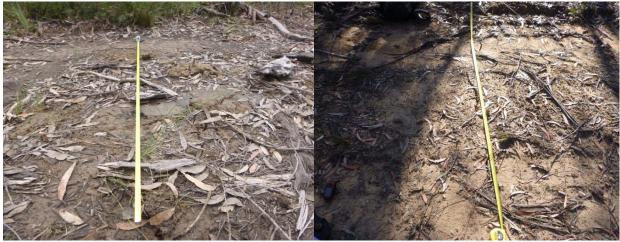
Six surface cracks identified during the extraction of Longwall 11 were identified as Level 1 impacts in the TARP as defined in the Dendrobium Area 3B SMP, Volume 2 (November 2012). Impact DA3B_LW11_003 was identified to the west of Swamp 5 and consists of a zone of soil cracking approximately 5m long by 3m wide, the largest crack is 1.9m with a depth of approximately 0.015m to 0.03m (Photo 9). Three soil cracking impacts; DA3B_LW11_004, 005 and 006, were identified on an access track between Swamp 5 and Access Track 6000 (Figure 3.1). The largest crack on this access track measured 4.0m long, with a maximum width of 0.03m and depth of 0.08m (Photos 10 and 11). Impact DA3B_LW11_009 was identified as a zone of soil cracking across a seismic track that runs alongside WC21, the largest crack is 2.7m long and 0.01m wide (Photo 12). Additional soil cracking was identified on a seismic track above the eastern edge of Longwall 11, east of WC21, consisting of surface cracks totalling a length of 2.5m with a maximum width of 0.04m and depth of 0.30m, DA3B_LW11_011.

These cracks are a Level 1 impact according to the Dendrobium Landscape Impacts, Triggers and Response Plan (Appendix A. Table 2), specifically:

Photo 9: DA3B_LW11_003- Soil crack, looking across seismic track. Taken on 24/06/2015.

Photo 10: DA3B_LW11_005- Soil crack, looking along seismic track. Taken on 19/09/15.

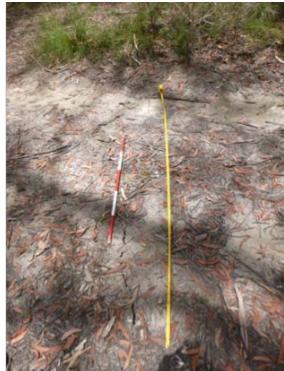
Photo 11: DA3B_LW11_005- Soil crack, looking across seismic track. Taken on 19/09/15.

Photo 12: DA3B_LW11_009- Soil Cracking, looking across seismic track. Taken on 14/01/2016

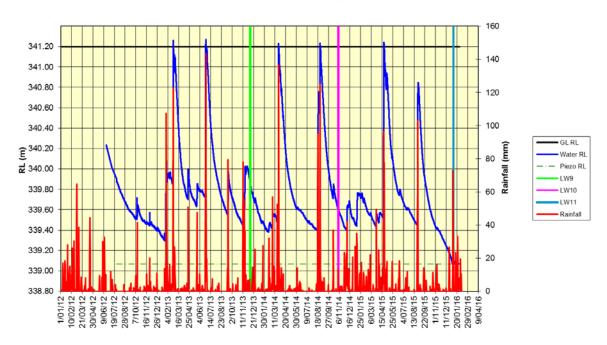
Figure 5.1: Groundwater levels measured borehole site 08_01.

Borehole 08_01 is located adjacent to Swamp 8 and was undermined by Longwall 11 on the 6th of January 2016. Since being undermined groundwater level has been recorded as dry, below the lowest level recorded during the baseline period (Figure 5.1). Borehole 08_01 recorded a rate of recession exceeding the rate before mining of Longwall 10.

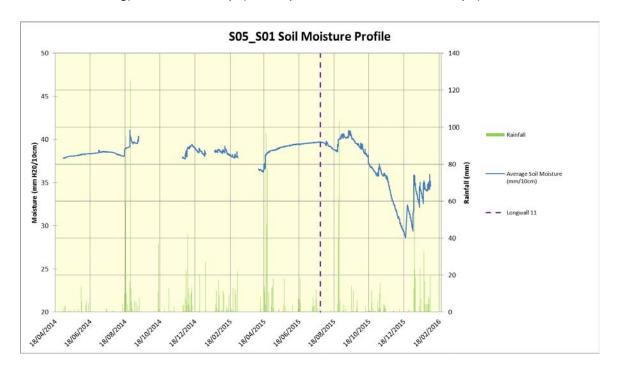
Figure 5.2: Soil moisture levels recorded at S05_S01.

Four soil moisture profiles are monitored in Swamp 5. At some sites baseline data is limited to less than 6 months before mining due to the timing of requests for additional monitoring from Government. Sites S05_S02 and S05_S08 were undermined by Longwall 10 and during extraction of Longwall 11 soil moisture levels dropped below baseline levels. Following extraction of Longwall 11 soil moisture at sites S05_S01 and S05_S05 also dropped to a level lower than recorded during the baseline period (Figures 5.2 and 5.3). For further details refer to relevant impact reports dated 12th of October 2015 and 19th of February 2016. Soil moisture at all four sites has responded to rainfall and has fluctuated between baseline and below baseline levels since being undermined. Swamp 5 is now at a

Level 3 Trigger according to the Dendrobium Swamp TARP (Appendix A, Table 2), specifically:

• Soil moisture level lower than baseline level at >80% of monitoring sites (within 400m of mining) within a swamp (in comparison to reference swamps).

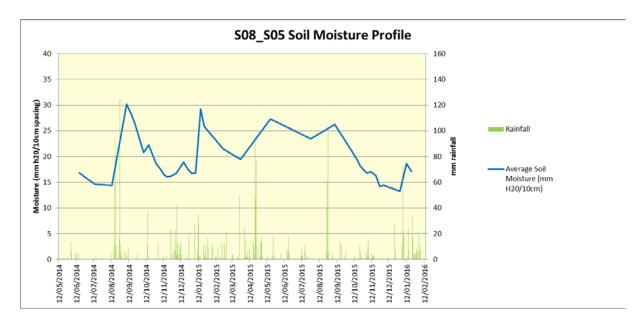
Figure 5.4: Soil moisture levels at S08_S05.

One soil moisture profile is monitored adjacent to Wongawilli tributary WC21. S08_S05 has not been undermined by Longwall 11 but is within 400m and the total soil moisture level has dropped below those recorded in the baseline period. Soil moisture levels have fluctuated in response to rainfall (Figure 5.4).
