DENDROBIUM MINE – LW11 EOP REPORT

ILLAWARRA COAL

LW11 EOP REPORT

ILLAWARRA COAL
 DENDROBIUM COLLIERY - AREA 3B
 LONGWALL 11 END OF PANEL REPORT
 GENERAL LAYOUT & MONITORING LINES

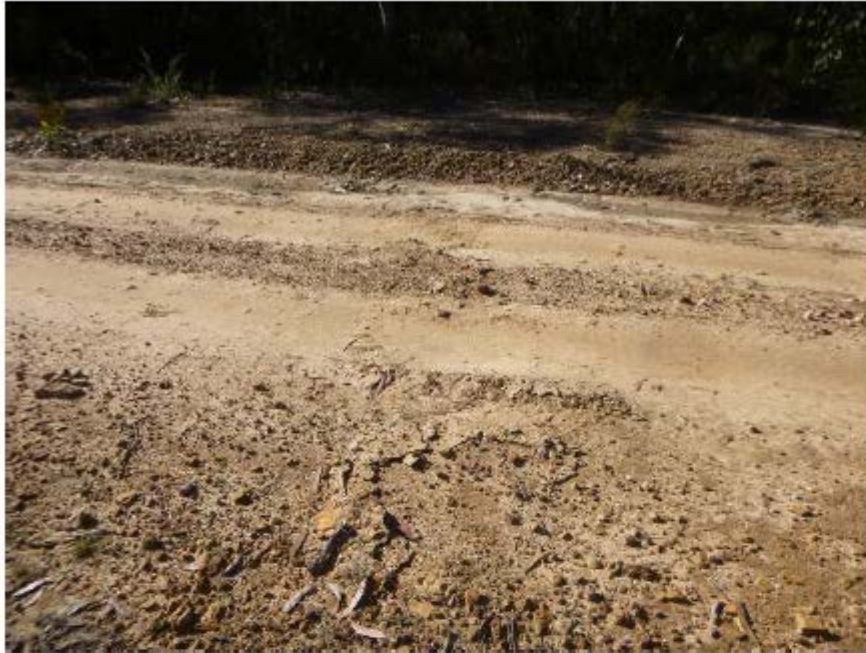
Photo 13: DA3B_LW11_001- Soil crack across Fire Road 6A. Uplift on the southern side of crack is only slightly evident in the photo. Taken on 1/06/2015.

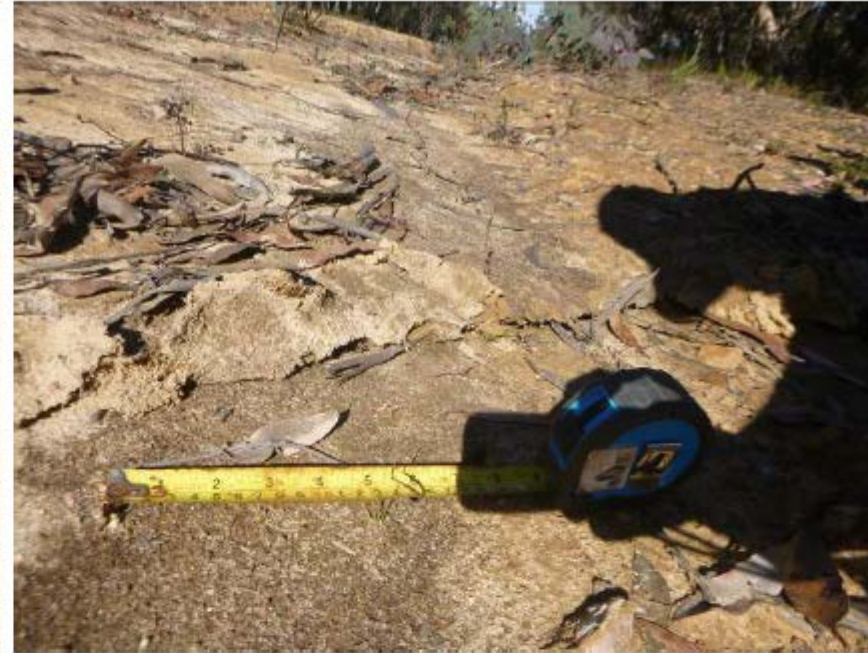
Photo 14: DA3B_LW11_001- Uplift on southern side of crack. Taken on 1/06/2015.

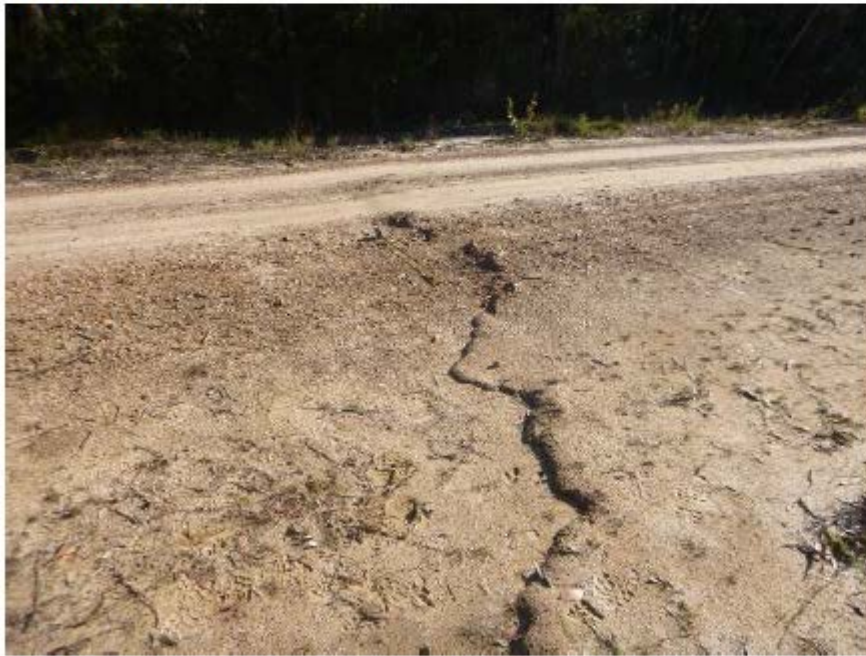
Photo 15: DA3B_LW11_002- Soil crack across Fire Road 6A. Uplift evident on the northern side of crack, more pronounced to the east of Fire Road 6A. Taken on 1/06/2015.

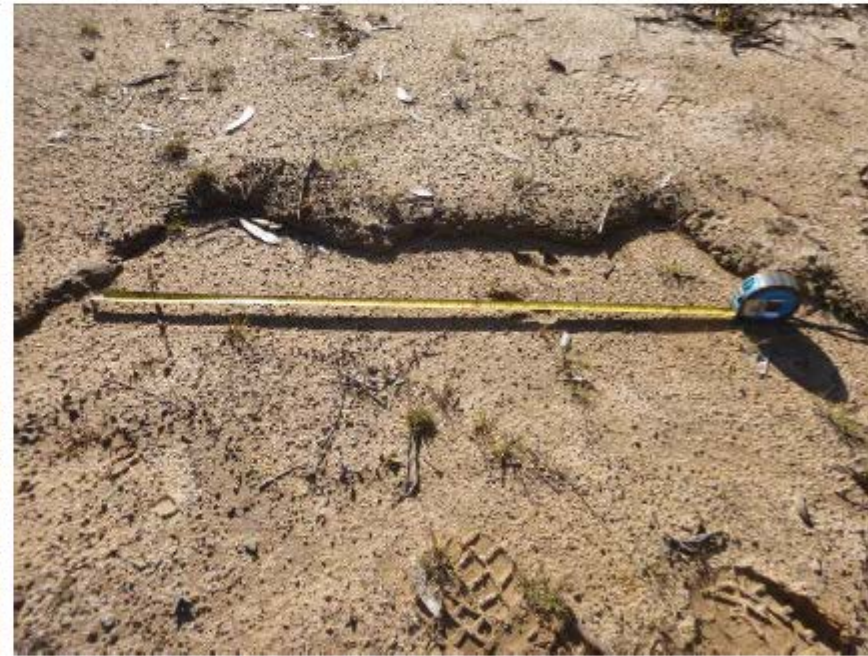
Photo 16: DA3B_LW11_002- Eastern end of soil crack. Taken on 1/06/2015.

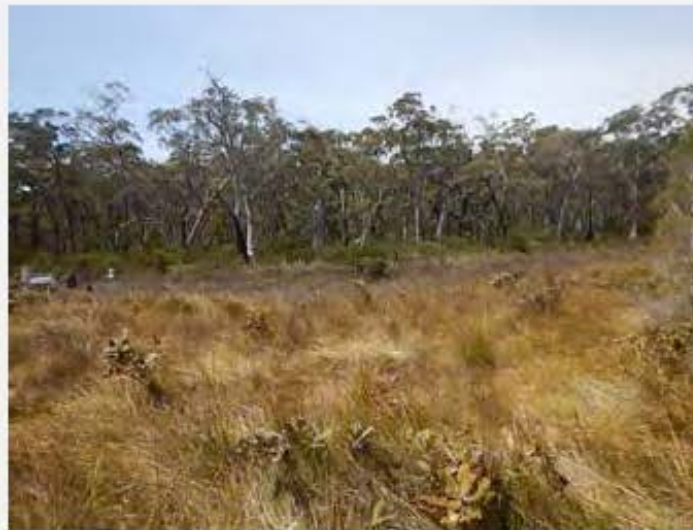
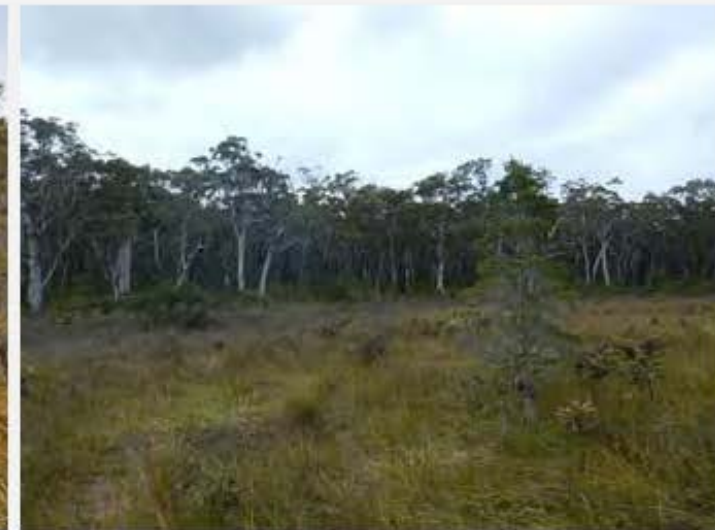
Plate 3 Comparison of vegetation colouration at S1B-F2 South between spring 2009, spring 2014 and spring 2015.
