Re: Dendrobium Colliery Longwall 12 End of Panel Report - Aboriginal Heritage Assessment

Dendrobium Colliery, Longwall 12 End of Panel Report: Aboriginal Heritage Assessment

Dendrobium Area 3B
Longwall 12 End of Panel Report
 Cultural Heritage Assessment

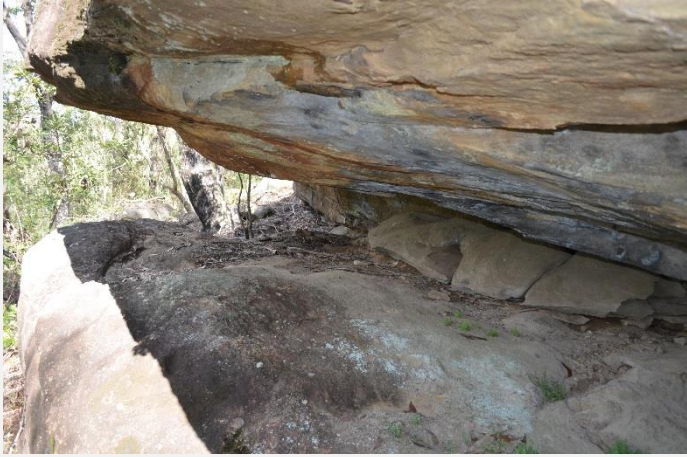
AHIMS site numbers	Site name	Results of inspections	Photograph of current condition of site
52-2-1628	Browns site 12	<p>This shelter was in the same condition as described by Bosis in 2012 and 2016. There has been no movement of the horizontal bedding plane joints of the shelter and no cracking or exfoliation observed in relation to the extraction of Longwall 12.</p> <p>There has been no altered seepage or water movements in the shelter, and there is no evidence of water flow or recent micro-vegetation growth associated with any movement.</p> <p>The site remains the same as previously described.</p> <p>The art panel remains in the same condition as described in Bosis Research 2008, and 2009.</p>

<p>Plate 1: General photograph of Browns Site 12, facing south.</p>

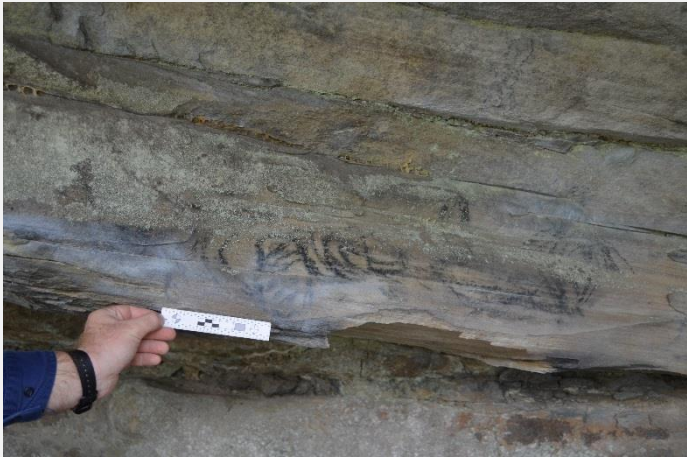
<p>Plate 2: General photograph of art panel Browns Site 12, at the northern end of the shelter.</p>

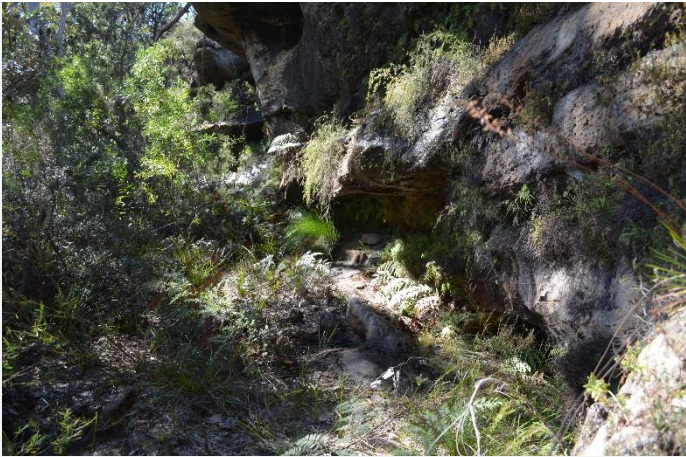
<p>52-2-1775</p>	<p>Upper Avon 39</p>	<p>This shelter was in the same condition as described by Biosis in 2012. There has been no movement of the horizontal bedding plane joints of the shelter and no cracking or exfoliation observed in relation to the extraction of Longwall 12.</p> <p>There has been no altered seepage or water movements in the shelter, and there is no evidence of water flow or recent micro-vegetation growth associated with any movement.</p> <p>The site remains the same as previously described.</p> <p>The artefact could not be relocated during this assessment.</p>

<p>Plate 3: General photograph of Upper Avon 39, facing east.</p>

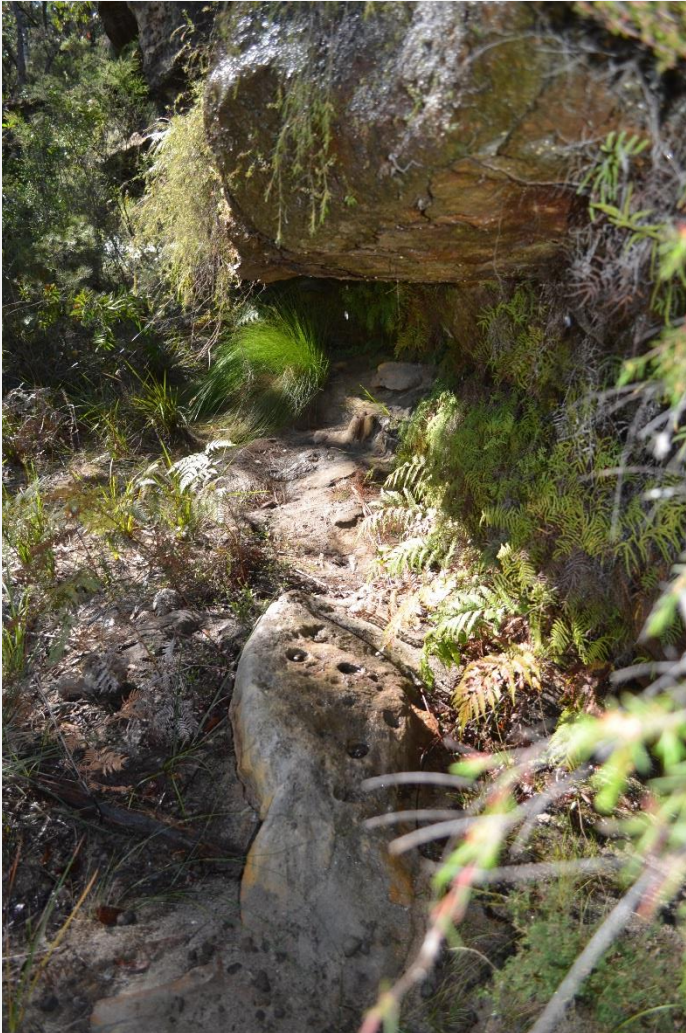
<p>Plate 4: General photograph of location of artefact, as highlighted on original site card.</p>
<p>52-2-1776</p>	<p>Upper Avon 40</p>	<p>This shelter was in the same condition as described by Biosis in 2012. There has been no</p>

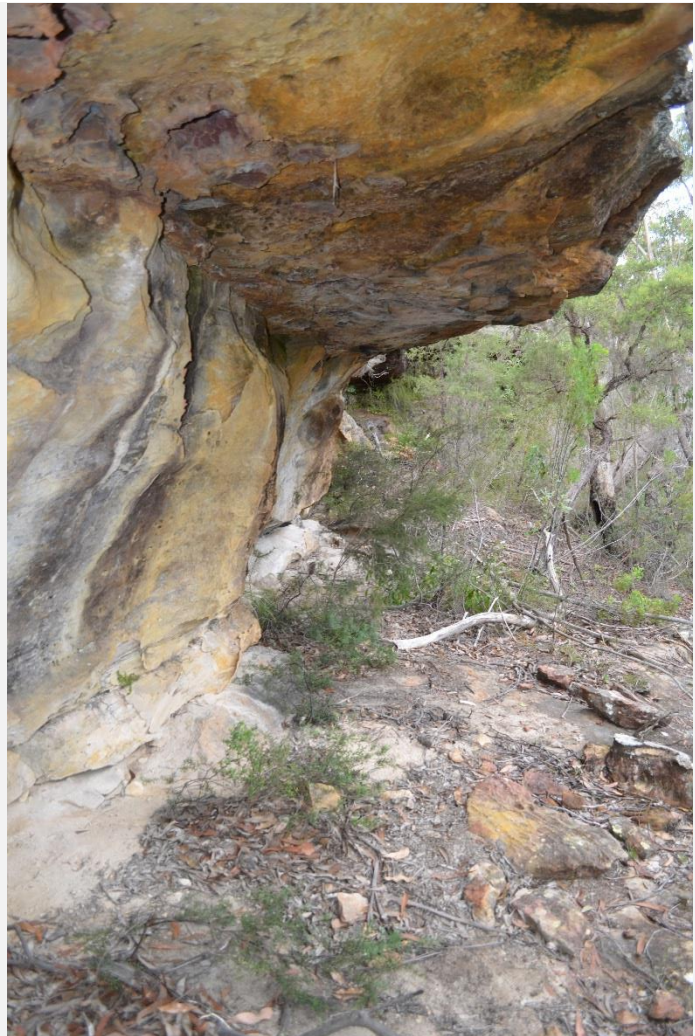
movement of the horizontal bedding plane joints of the shelter and no cracking or exfoliation observed in relation to the extraction of Longwall 12.

There has been no altered seepage or water movements in the shelter, and there is no evidence of water flow or recent micro-vegetation growth associated with any movement.

The site remains the same as previously described.

Plate 5: General photograph of shelter Upper Avon 40, photograph taken facing east.

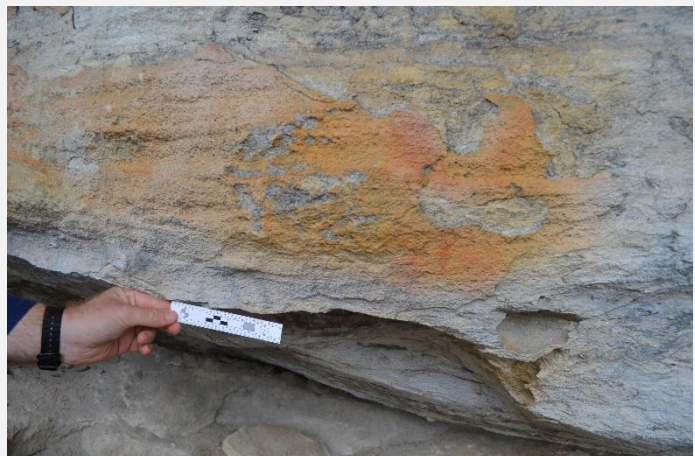
The art panel remains in the same condition as described in Bosis Research 2008, and 2009.

Plate 6: General photograph of art panel Upper Avon, at the northern end of the shelter.

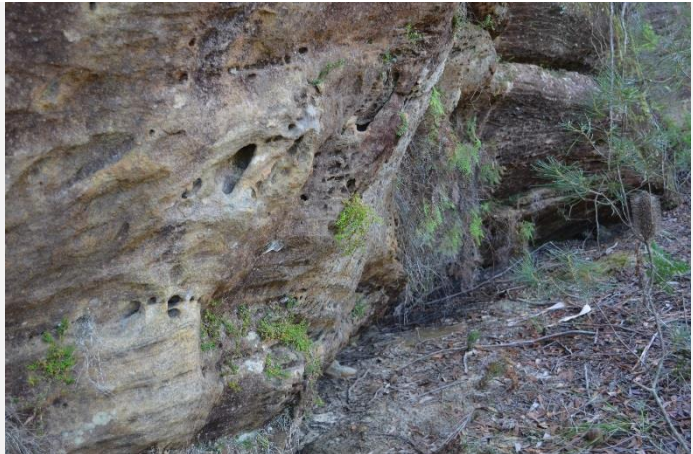
52-2-1778	Upper Avon 41	<p>This shelter was in the same condition as described by Biosis in 2012. There has been no movement of the horizontal bedding plane joints of the shelter and no cracking or exfoliation observed in relation to the extraction of Longwall 12.</p> <p>There has been no altered seepage or water movements in the shelter, and there is no evidence of water flow or recent micro-vegetation growth associated with any movement.</p> <p>The site remains the same as previously described.</p> <p>The artefacts located during the initial assessment could not be relocated during this assessment.</p>
-----------	---------------	---

Plate 7: General photograph of shelter Upper Avon 40, facing south.

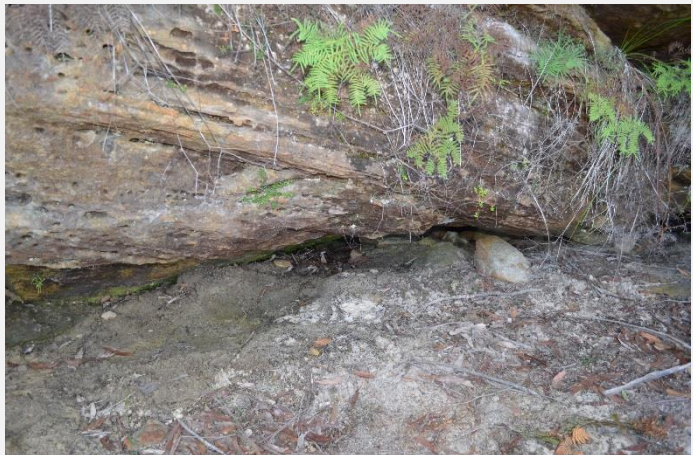
Plate 8: General photograph of floor disturbance due to wombats at Upper Avon 40.

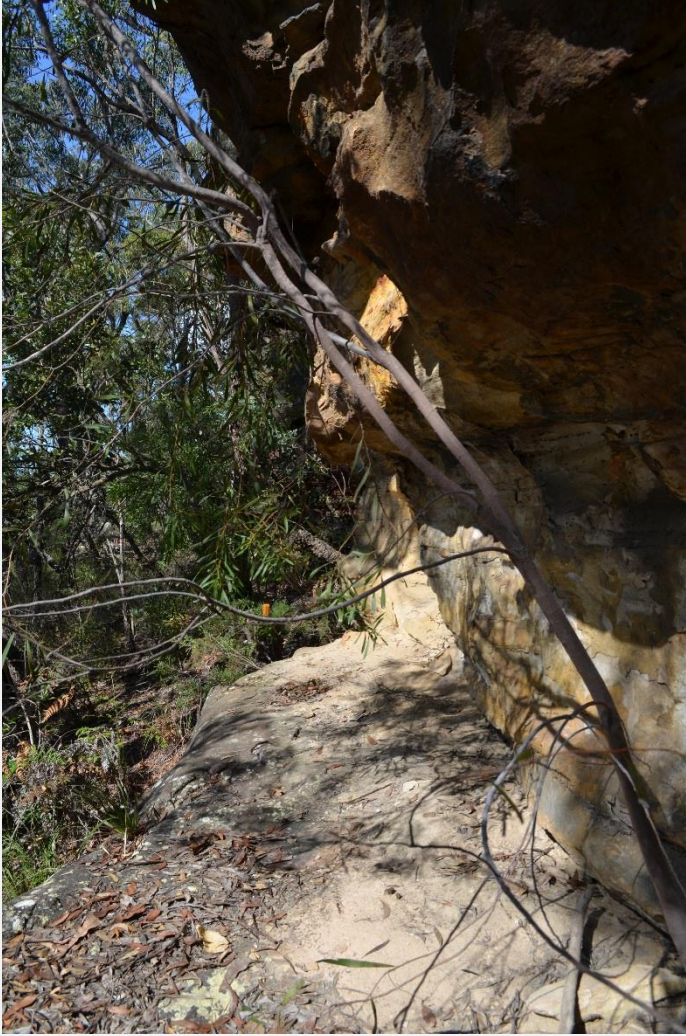
<p>52-2-2209</p>	<p>Dendrobium 2</p>	<p>This shelter was in the same condition as described by Biosis in 2012 and 2016. There has been no movement of the horizontal bedding plane joints of the shelter and no cracking or exfoliation observed in relation to the extraction of Longwall 12.</p> <p>There has been no altered seepage or water movements in the shelter, and there is no evidence of water flow or recent micro-vegetation growth associated with any movement.</p> <p>The site remains the same as previously described.</p> <p>The artefacts located during the initial assessment could not be relocated during this assessment.</p>

<p>Plate 9: General photograph of art panel Browns Site 12, at the northern end of the shelter.</p>
------------------	---------------------	--	--
