**DENDROBIUM LONGWALL 13
END OF PANEL LANDSCAPE
REPORT**

JUNE 2018

This report summarises the observed and measured subsidence effects on landscape features resulting from the extraction of Dendrobium Longwall 13.

Longwall 13 is the fifth panel extracted from Dendrobium Area 3B. Extraction began on the 4th of March 2017 and was completed on the 19th of April 2018.

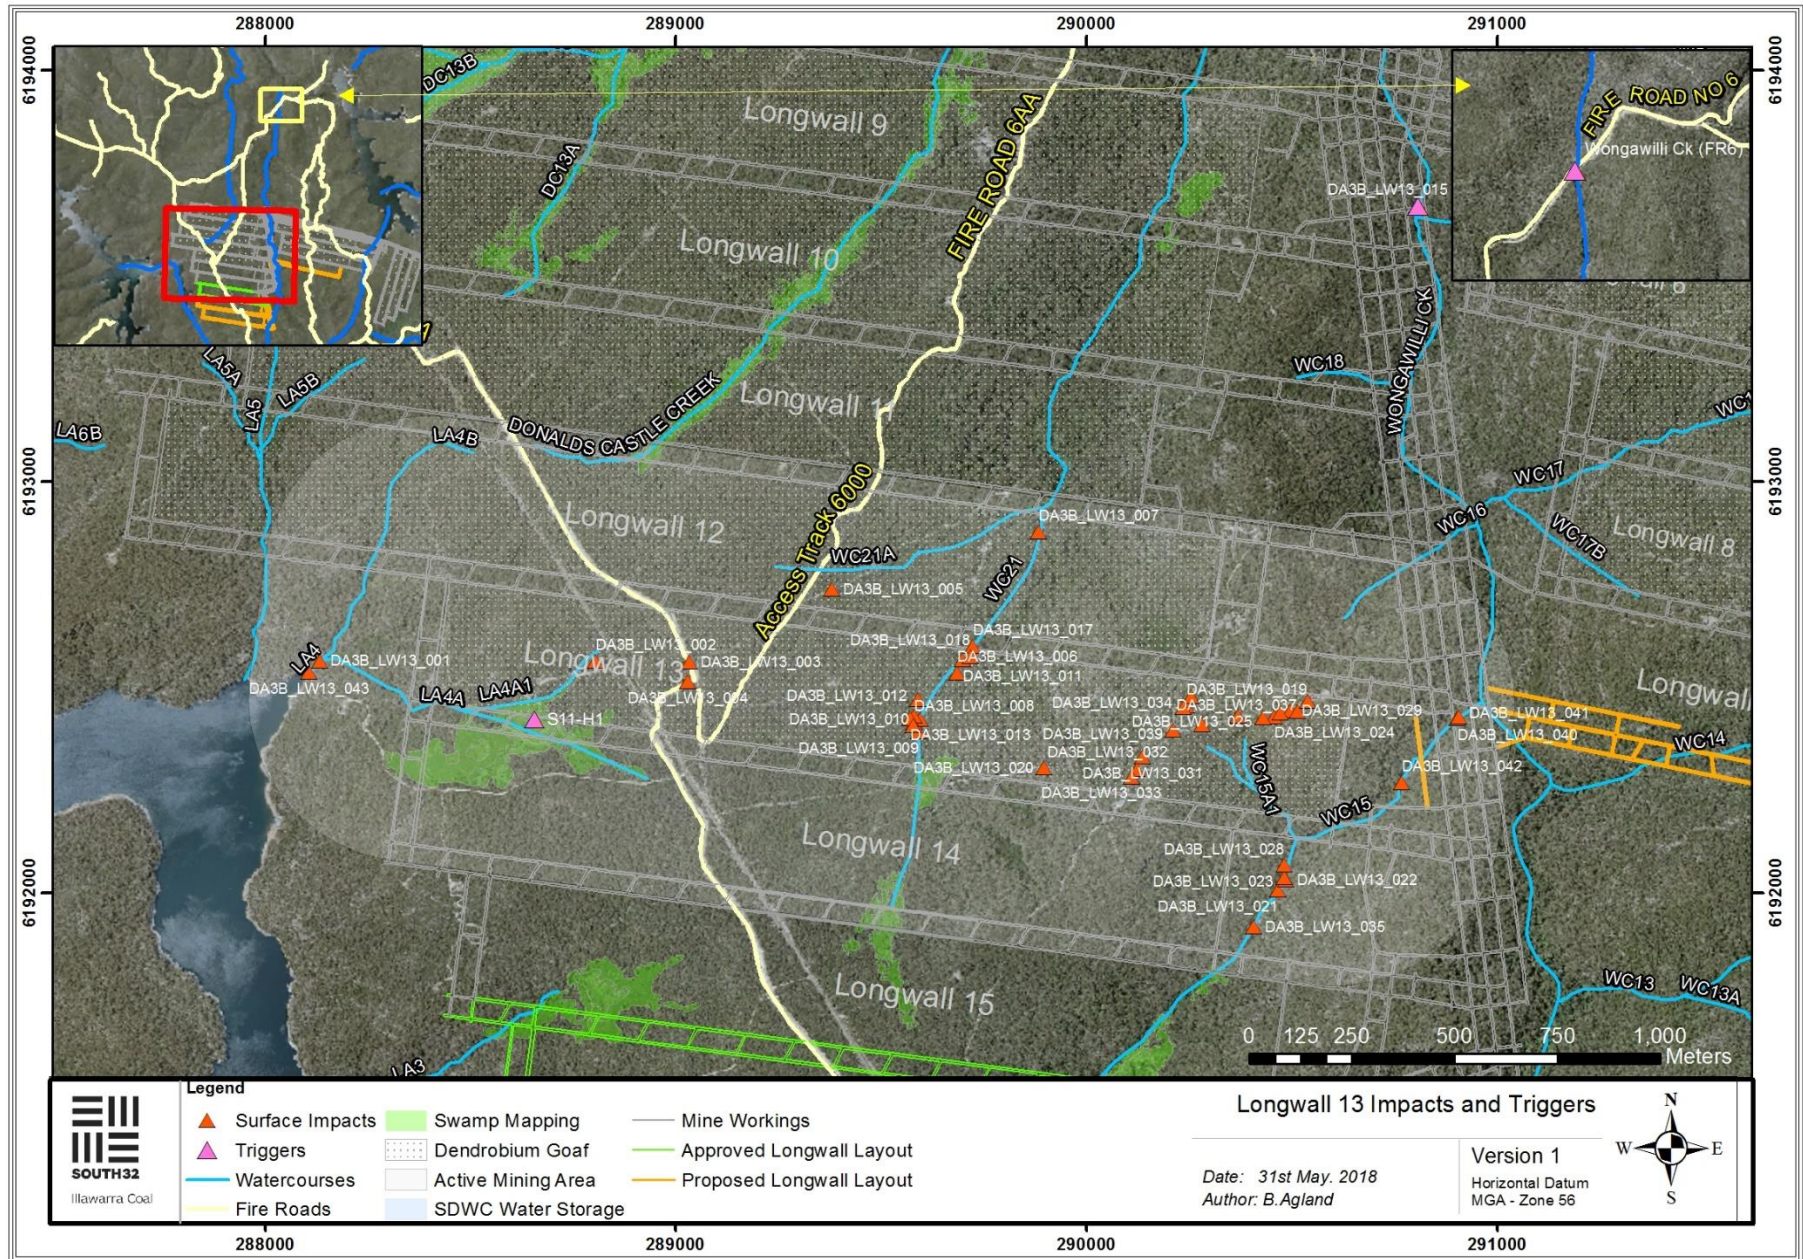
Figure 2: Map showing surface impacts and triggers recorded during Longwall 13.

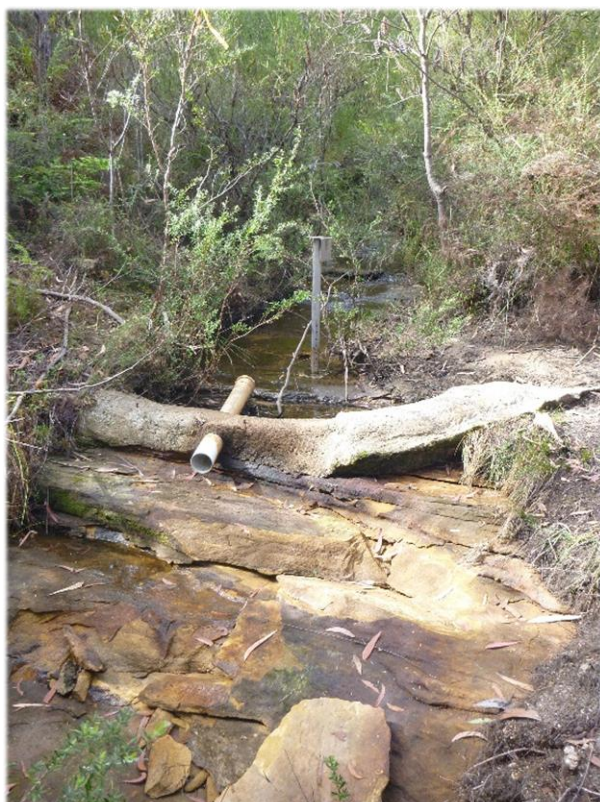
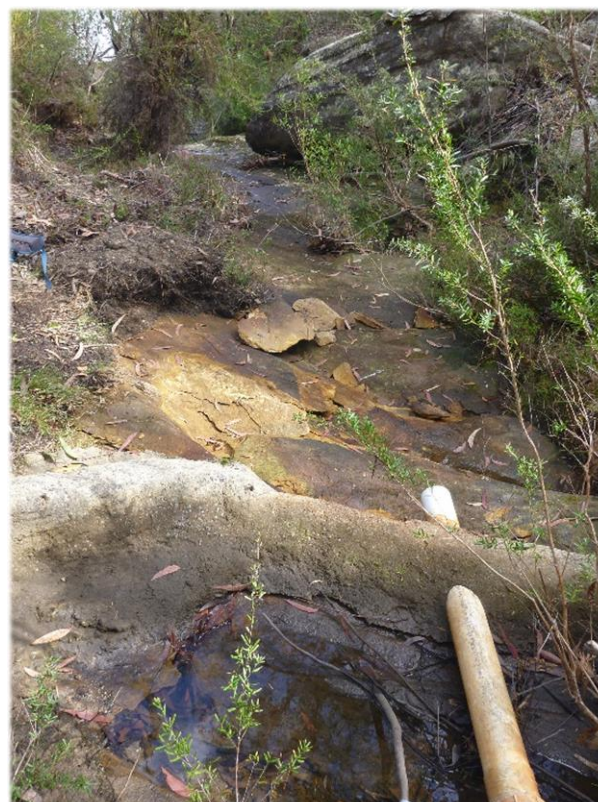
Rock fracturing to the downstream end of LA4 was reported for the first time on 4th May 2016. Heavy rainfall dislodged rock fragments at this site. An inspection on the 19th April 2017 revealed fracturing to the base of the pool at monitoring site LA4S1 (Photo 5 and Photo 6). Active flow diversion is evident through fracturing, directly upstream from the installed concrete weir, which forms part of the flow monitoring installation at the site (Photo 7 and Photo 8).

Level 2: Crack or fracture between 100 and 300mm width at its widest point or any fracture which results in observable loss of surface water or erosion.

Photo 5: Fracturing downstream from concrete weir, looking upstream. Taken on 19/04/2017.

Photo 6: Fracturing downstream from concrete weir, looking downstream. Taken on 19/04/2017.

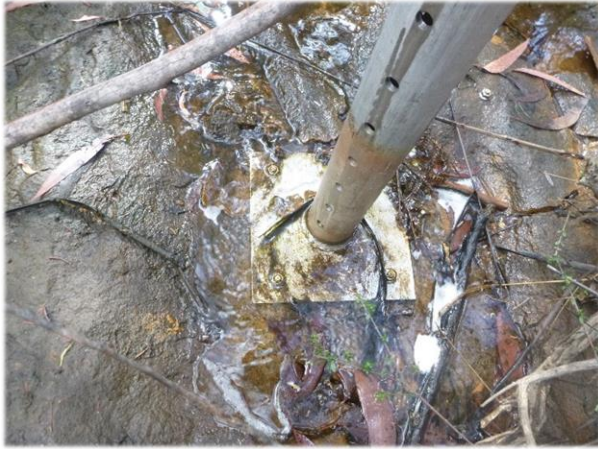
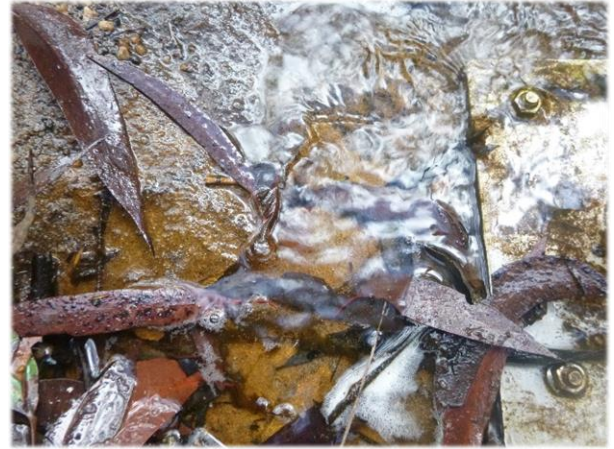
Photo 7: Flow diversion adjacent to monitoring equipment at LA4S1. Taken on 3/05/2017.

Photo 8: Flow diversion through fracturing in base of pool. Taken on 3/05/2017.

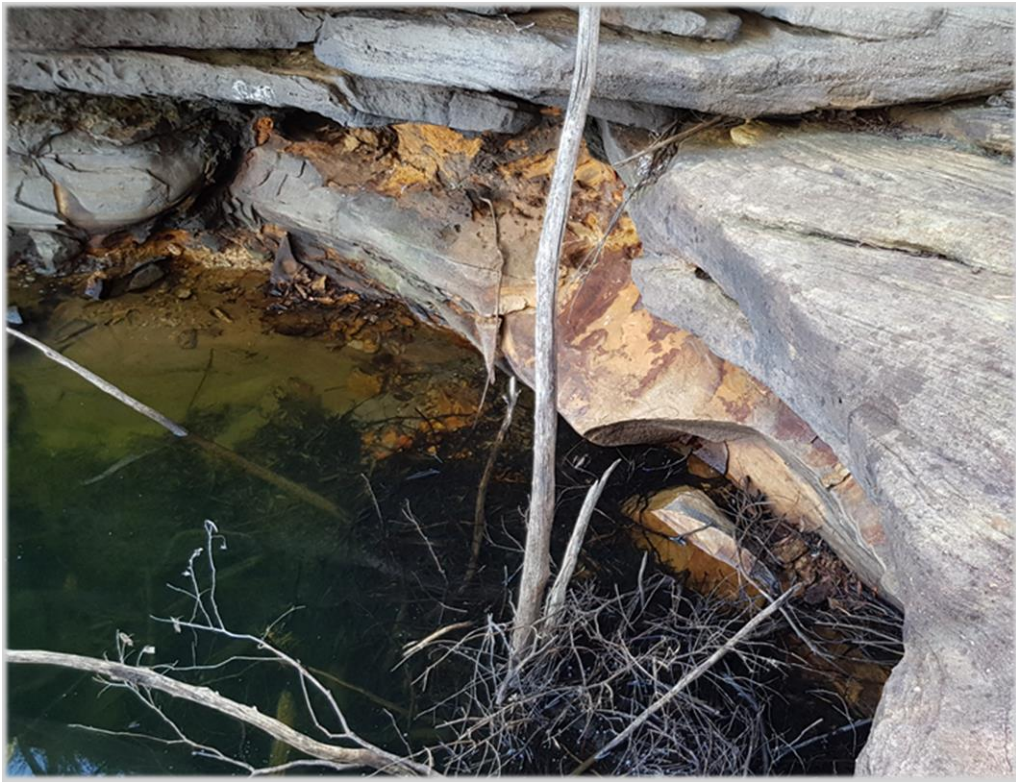
Impact *DA3B_LW13_043* is located on *LA4*, a tributary to *Lake Avon*, 300m from the commencing end of Longwall 13, and 300m from the southern edge of Longwall 12. The impact was identified on the 18th May 2018. The impact is comprised of rock fracturing, associated rock fragmentation and iron staining to *LA4_Step 0* (Photo 9), which is the most downstream feature before entering *Lake Avon*. The fracturing is 2m in length and 0.02m in width; the rock fragment is 1.5m in length, 0.5m in width and 0.3m in height (Photo 9). These impacts are not evident in baseline photos from 2011 (Photo 10). There was no surface flow at the site during the inspection; however, diversion of flow is likely to occur to some degree. Given the proximity of the site to the commencing end of Longwall 13 and previously recorded impacts (i.e. *DA3B_LW13_001*), it is probable that the impact originated approximately one year before it was first identified. Previously the site has been inundated by reservoir water, which would have obscured identification of the impact.

Level 2: Crack or fracture that results in observable loss of surface water or erosion and/or observable increase in iron staining within the mining area continues to outside the mining area.

Photo 9: LA4_Step 0, looking across stream; the pooling to the left of the image is *Lake Avon reservoir* water. Taken 18th May 2018.

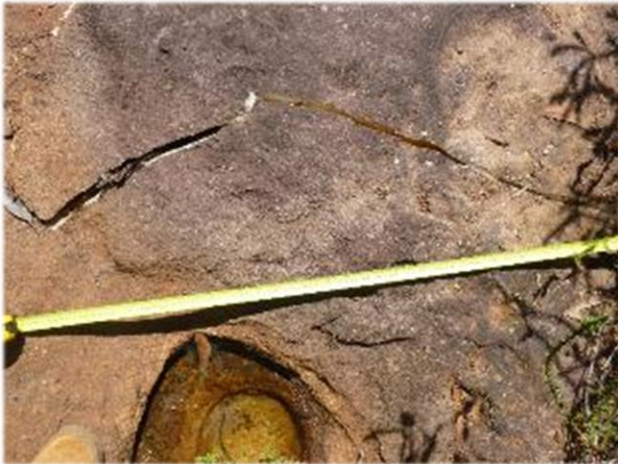
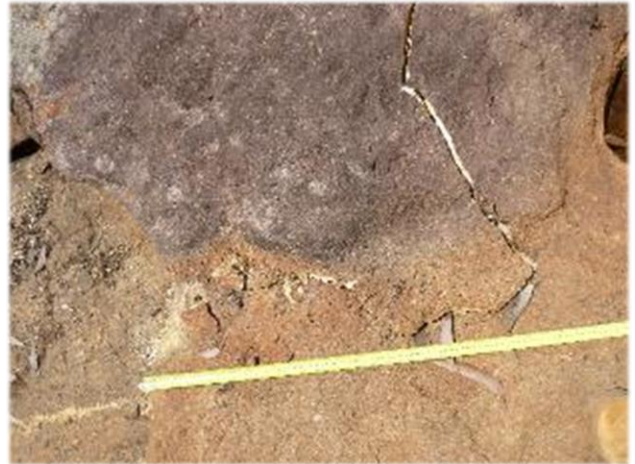
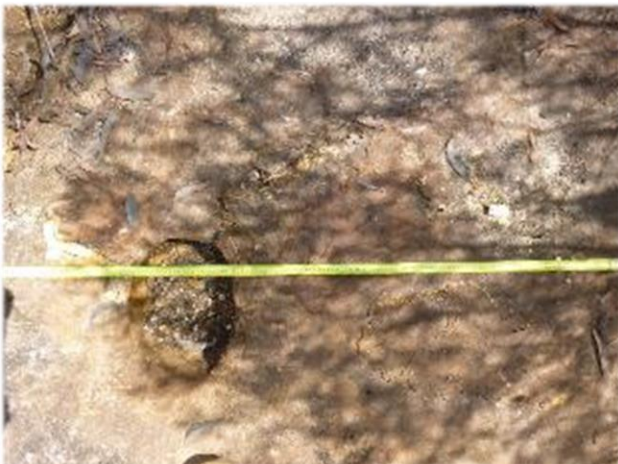
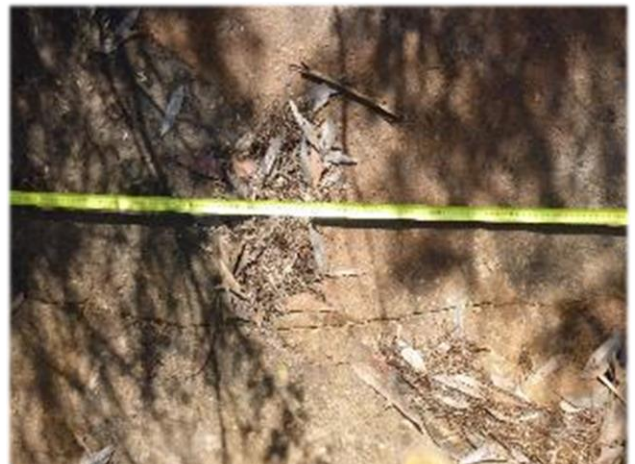
DA3B_LW13_021 is located towards the upstream extent of WC15_Rockbar 18. The site was passed by Longwall 13 at an approximate distance of 185m on the 29th March 2018. The impact consists of a rock fracture, which extends across the extent of the rockbar (Photo 11 to Photo 14). The fracture is approximately 5.7m in length, with widths ranging from hairline to a maximum of 0.015m. The maximum measurable depth is 0.06 m. Additionally, there is a small section of plating, which measures approximately 0.3m by 0.15m.

Level 2: Crack or fracture between 100 and 300mm width at its widest point or any fracture which results in observable loss of surface water or erosion.

Photo 11: DA3B_LW13_021, looking at the widest section of fracturing. Taken 29th March 2018.

Photo 12: DA3B_LW13_021, looking at the widest section of fracturing. Taken 29th March 2018.

Photo 13: DA3B_LW13_021, looking at the small section plating. Taken 29th March 2018.

Photo 14: DA3B_LW13_021, looking at the narrowest section of fracturing. Taken 29th March 2018.

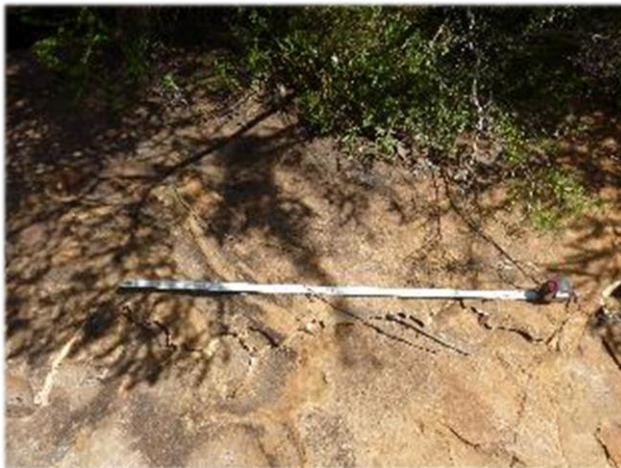
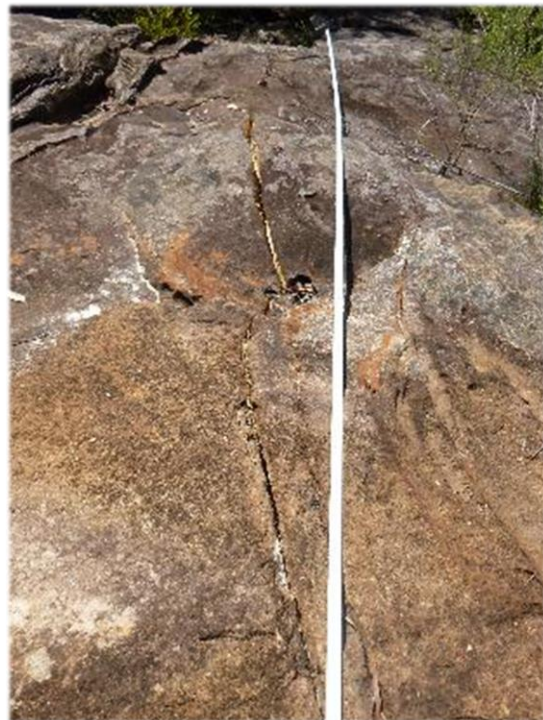
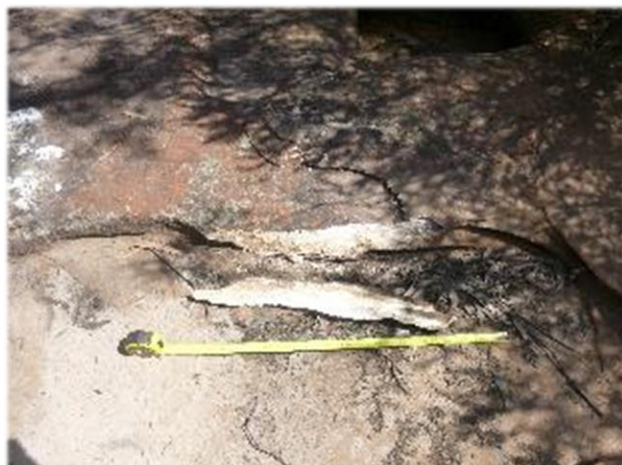
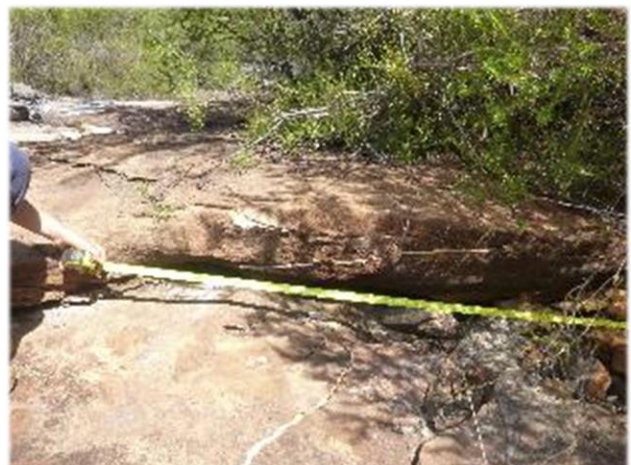
Impact DA3B_LW13_022

DA3B_LW13_022 is located on WC15_Rockbar 18, approximately 35m downstream of DA3B_LW13_021. The site was passed by Longwall 13 at an approximate distance of 157m on the 29th March 2018. The impact is a rock fracture zone, which is comprised of approximately 10 fractures, with associated uplift (Photo 15 to Photo 18) and rock fragmentation (Photo 17), within an area of approximately 7.2m by 6m. Each fracture within the zone is greater than 0.5m in length, the longest of which, is approximately 3m. The fractures range from hairline to a maximum of 0.015m in width; the maximum measurable depth is approximately 0.04m. Additionally, there are lateral fractures to the face of a 0.3m high step (Photo 18).

Level 2: Crack or fracture between 100 and 300mm width at its widest point or any fracture which results in observable loss of surface water or erosion.

Photo 15: DA3B_LW13_022, looking across stream towards section of uplift. Taken 29th March 2018.

Photo 16: DA3B_LW13_022, looking downstream towards longest fracture. Taken 29th March 2018.

Photo 17: DA3B_LW13_022, looking upstream towards a small rock fragment. Taken 29th March 2018.

Photo 18: DA3B_LW13_022, looking upstream towards lateral fracturing on face of step. Taken 29th March 2018.

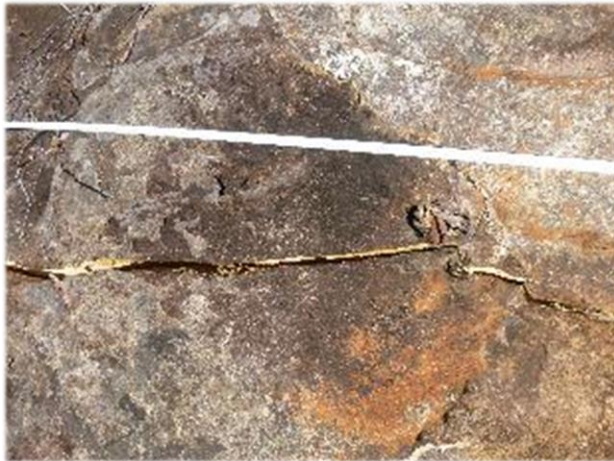
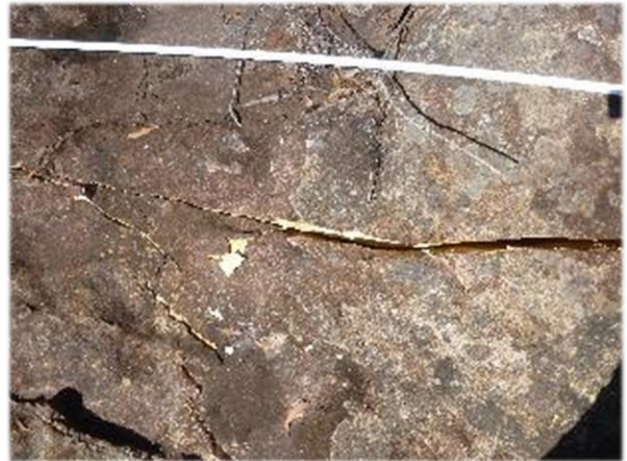
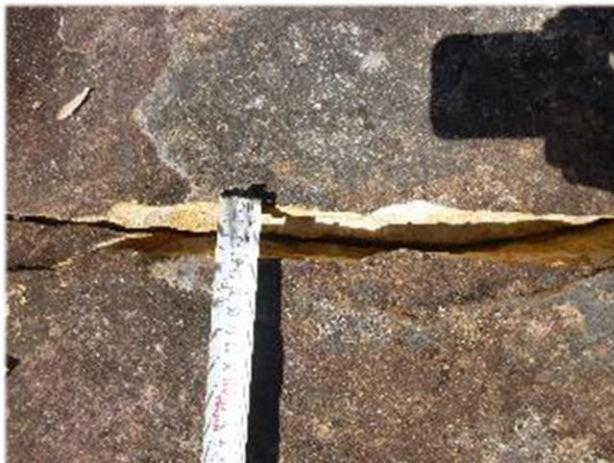
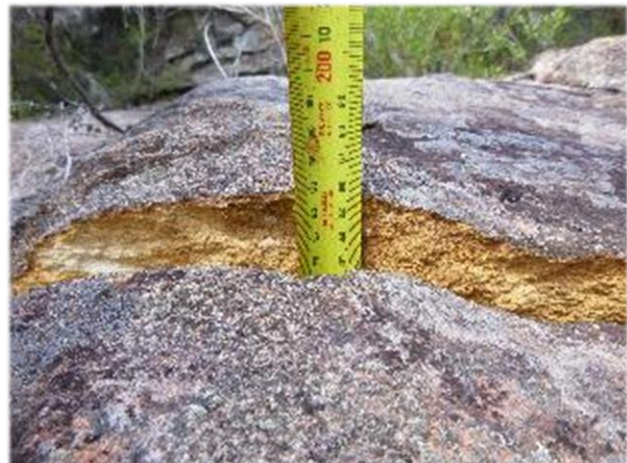
Impact DA3B_LW13_023

DA3B_LW13_023 is located on WC15_Rockbar 18, approximately 7m downstream of DA3B_LW13_022. The site was passed by Longwall 13 at an approximate distance of 150m on the 29th March 2018. The impact is comprised of a rock fracture approximately 5.6m in length and 0.03m at its widest point (Photo 19 to Photo 22); the maximum measurable depth of the fracture is 0.16m (Photo 22). There was no observable surface flow at WC15_Rockbar 18 during the inspection, however, surface flow has previously been observed at the feature. Given the extent and nature of the fractures, it is likely that these impacts would cause some degree of flow diversion if surface flow was present at WC15_Rockbar 18.

Level 2: Crack or fracture between 100 and 300mm width at its widest point or any fracture, which results in observable loss of surface water or erosion.

Photo 19: DA3B_LW13_023, widest section of fracturing. Taken 29th March 2018.

Photo 20: DA3B_LW13_023, widest section of fracturing. Taken 29th March 2018.

Photo 21: DA3B_LW13_023, closeup of the widest section of fracturing. Taken 29th March 2018.

Photo 22: DA3B_LW13_023, closeup of the deepest section of fracturing. Taken 29th March 2018.

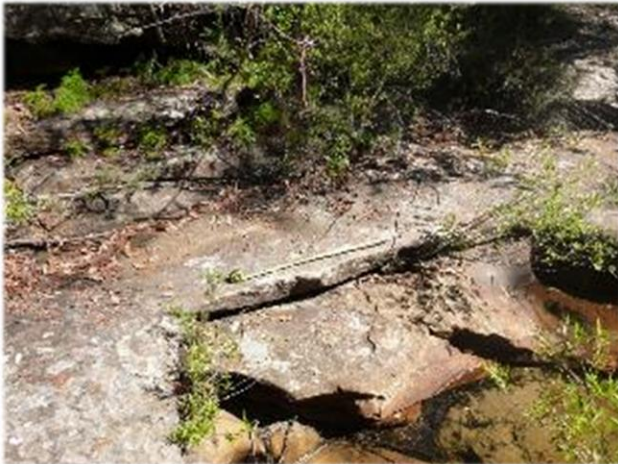
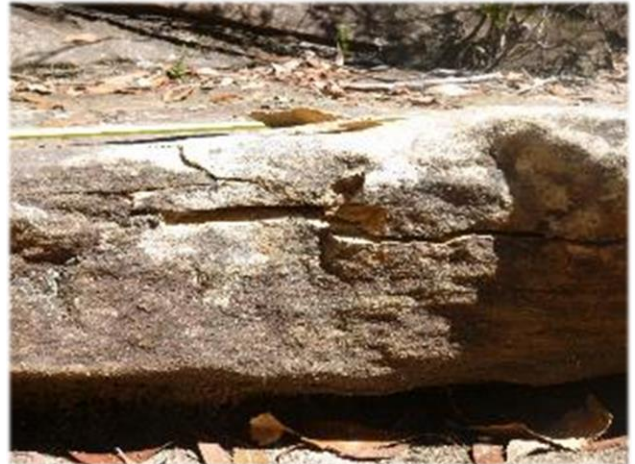
Impact DA3B_LW13_028

DA3B_LW13_028 was identified on the 5th April 2018 and is located on the tributary WC15; the site was passed by Longwall 13 on the 29th March 2018 at an approximate distance of 124 m. The impact is comprised of lateral fractures, with associated uplift and plating, to the rockbar shelf on the northern extent of WC15_Pool 18. The largest fracture is 1.4m in length and 0.018m in width (Photo 23 and Photo 24). There was no evidence of flow diversion at the site.

Level 1: Crack or fracture up to 100mm at its widest point with no observable loss of surface water or erosion;
Crack or fracture up to 10m length with no observable loss of surface water or erosion

Photo 23: DA3B_LW13_028, looking upstream at the extent of the impact. Taken 5th April 2018.

Photo 24: DA3B_LW13_028, looking upstream at largest section of fracturing. Taken 5th April 2018.

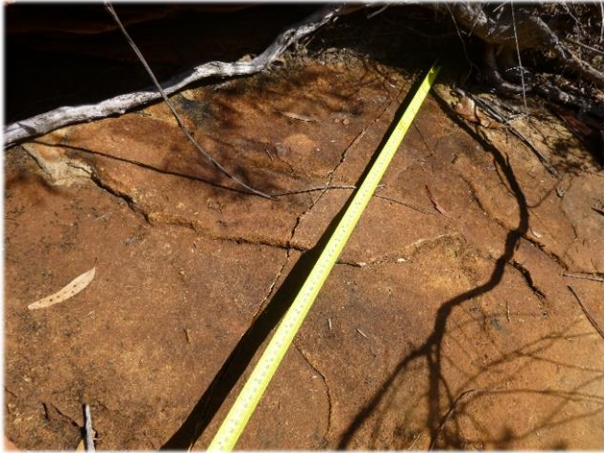
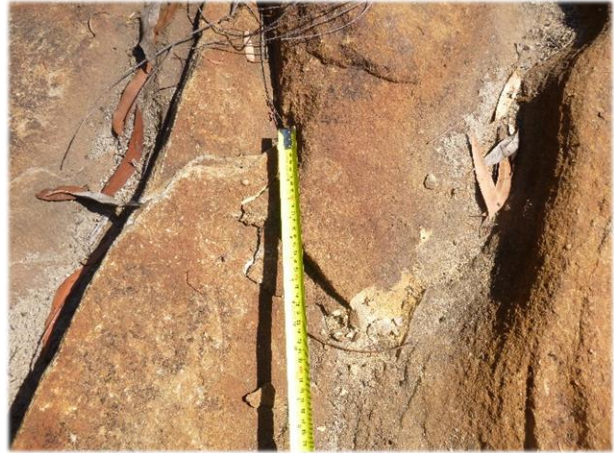
Impact DA3B_LW13_035

DA3B_LW13_035 was identified on the 23rd April 2018 and is located on the tributary WC15; the site was passed by Longwall 13 on the 18th March 2018 at an approximate distance of 280 m. The impact is comprised of multiple small fractures near the upstream extent of WC15_Rockbar 21 (Photo 25 and Photo 26). The largest fracture is 1.6m in length and 0.002m in width. Additionally, there is a small section of plating and uplift (approximately 0.1m by 0.05m) at the site. There was no evidence of flow diversion at the site.

Level 1: Crack or fracture up to 100mm at its widest point with no observable loss of surface water or erosion;
Crack or fracture up to 10m length with no observable loss of surface water or erosion.

Photo 25: DA3B_LW13_035, looking across stream at the largest fracture. Taken 23rd April 2018.

Photo 26: DA3B_LW13_035, looking across stream at the section of plating and uplift. Taken 23rd April 2018.

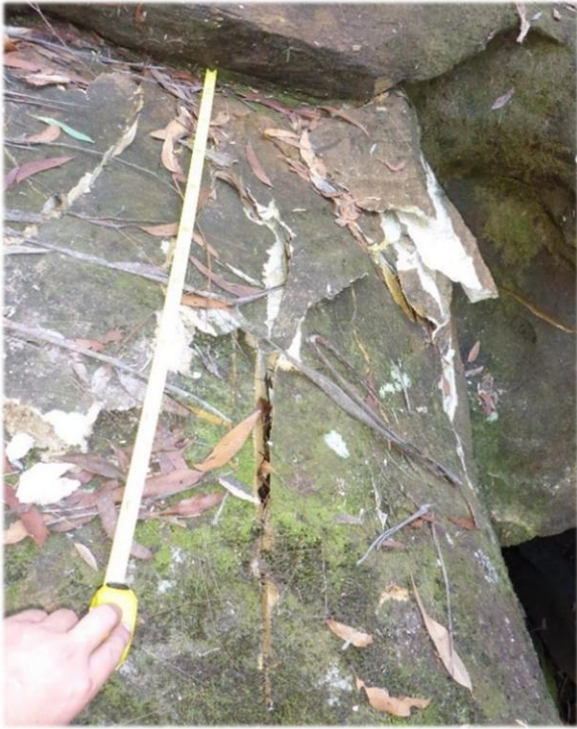
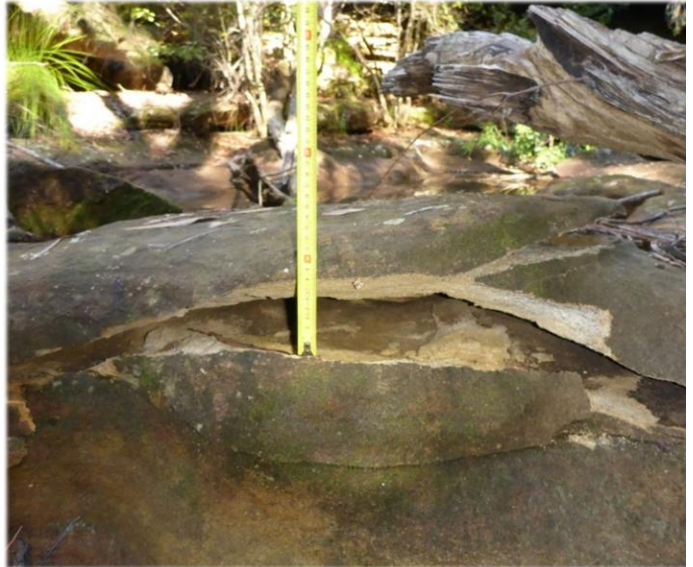
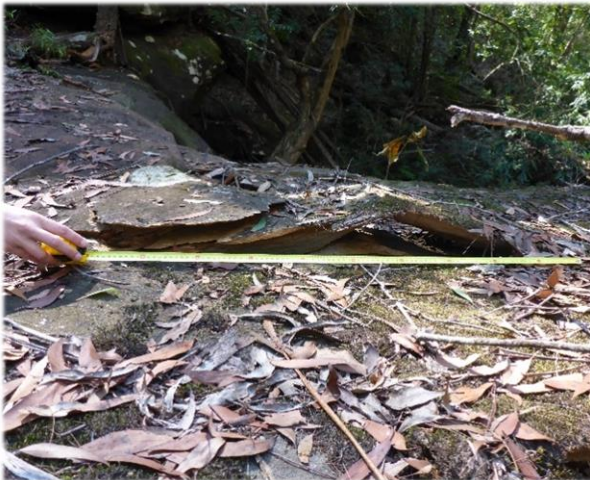
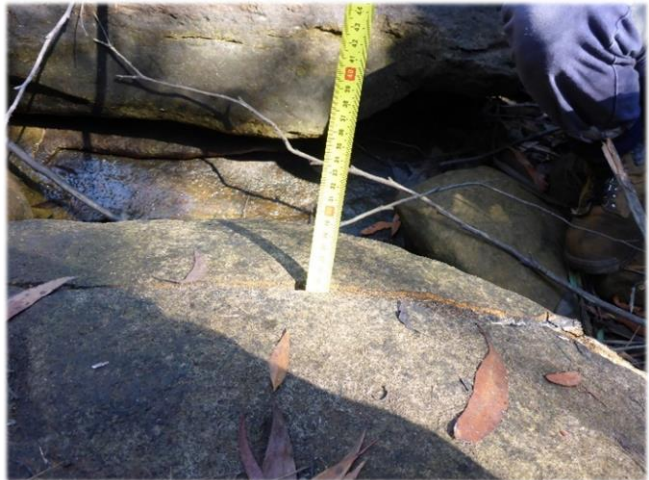
DA3B_LW13_040 is situated on *Wongawilli Creek* tributary *WC15*. The impact zone extends 20m from the top of *WC15_Step 0* to *WC15_Pool 2* which is approximately 80m from the confluence with *Wongawilli Creek*. The site is approximately 262m from the end of Longwall 13. The impact is comprised of rock fracturing and uplift, which has a maximum measurable length of 5.5m, a maximum width of 0.05m and a maximum measurable depth of 0.24m (Photo 27 to Photo 30). While not evident during the inspection, flow diversion would occur if surface flow was present.

Level 2: Crack or fracture between 100 and 300mm width at its widest point or any fracture which results in observable loss of surface water or erosion.

Photo 27: DA3B_LW13_040, looking at a section of rock fracturing and uplift. Taken 7th May 2018.

Photo 28: DA3B_LW13_040, looking at a section of rock uplift. Taken 7th May 2018.

Photo 29: DA3B_LW13_040, looking at a section of rock fracturing and uplift. Taken 7th May 2018.

Photo 30: DA3B_LW13_040, looking at the maximum measurable depth of the rock fracturing. Taken 7th May 2018.

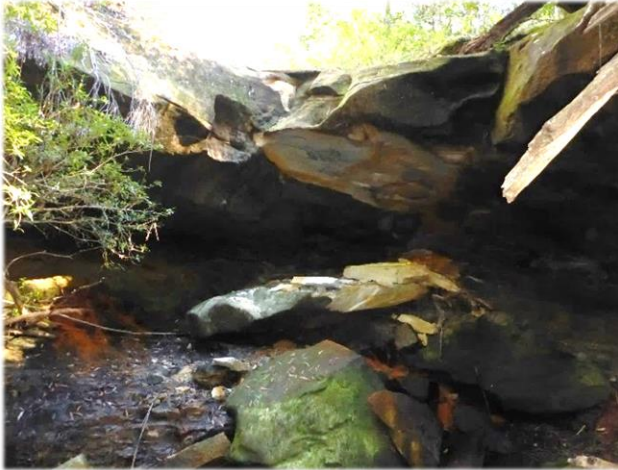
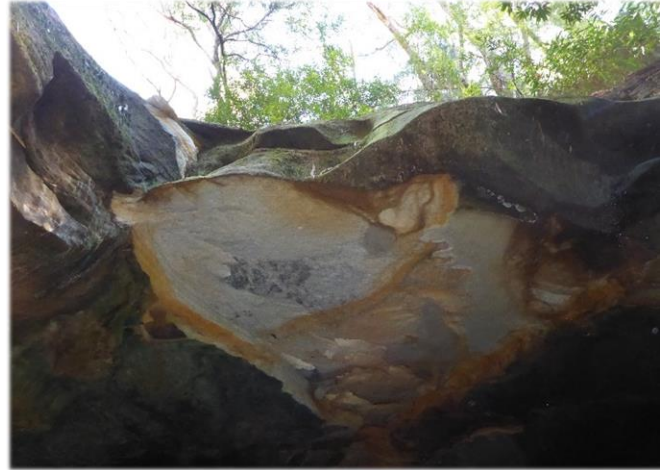
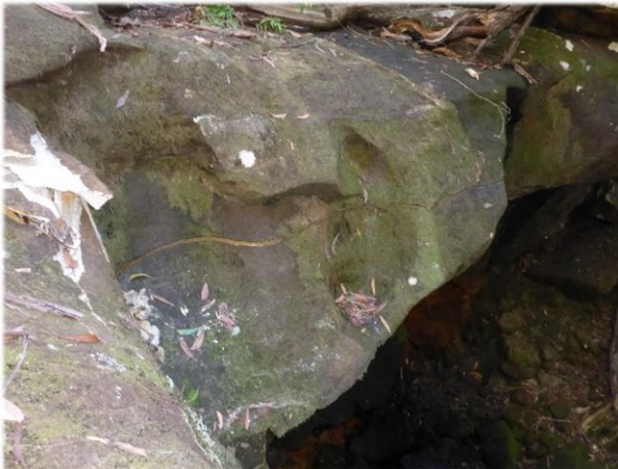
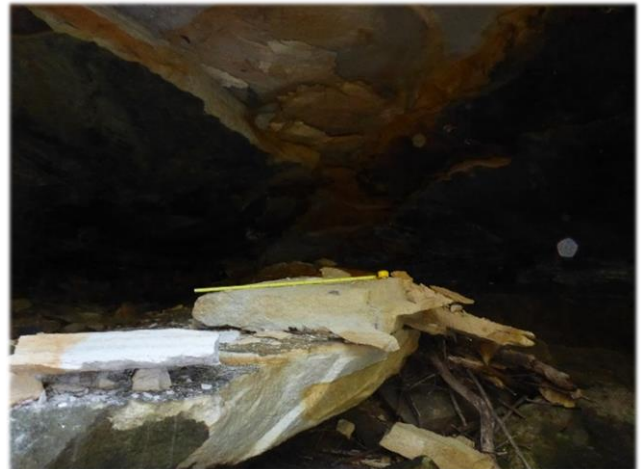
DA3B_LW13_041 is situated on Wongawilli Creek tributary WC15, specifically across WC15_Step 0, which is approximately 75m from the confluence with Wongawilli Creek. The site is situated approximately 267m from the end of Longwall 13. The impact is comprised of rock fracturing which has resulted in a rockfall. The rock fracturing has a maximum length of 12m, a maximum width of 0.05m and the maximum depth is unknown due to access difficulties (Photo 31 to Photo 34).

Level 2: Crack or fracture between 100 and 300mm width at its widest point or any fracture which results in observable loss of surface water or erosion. Crack or fracture between 10m and 50m length.

Photo 31: DA3B_LW13_041, an overview of the area impacted by the rockfall. Taken 7th May 2018

Photo 32: DA3B_LW13_041, looking at the extent of the rockfall. Taken 7th May 2018

Photo 33: DA3B_LW13_041, looking at the rock fracturing from the top of the step. Taken 7th May 2018

Photo 34: DA3B_LW13_041, looking the accumulation of rock that resulted from the rockfall. Taken 7th May 2018

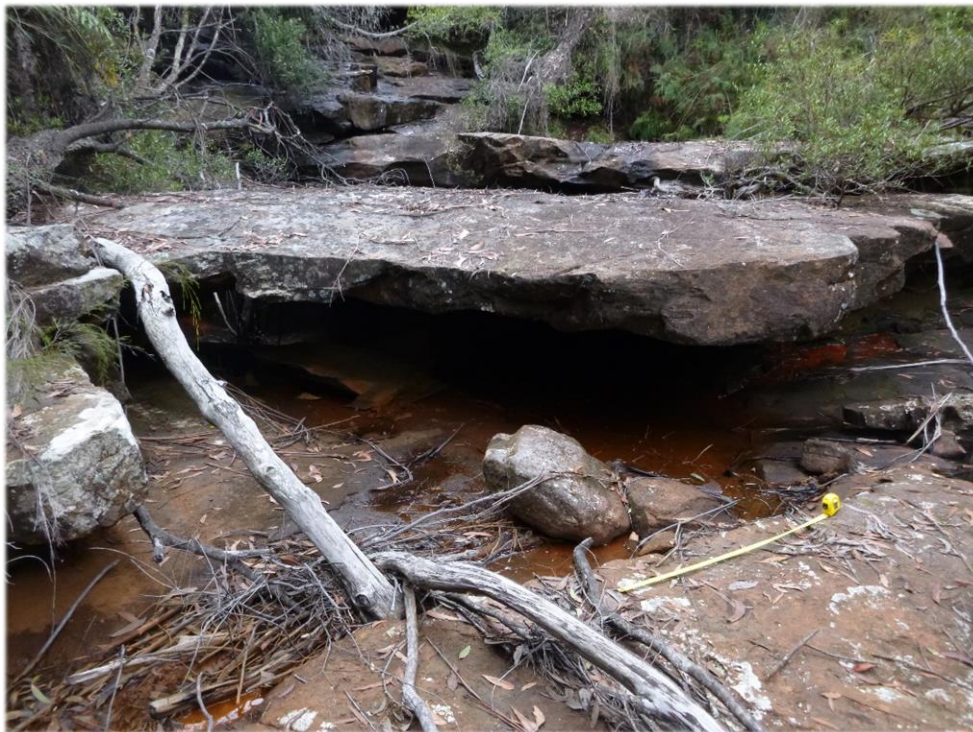
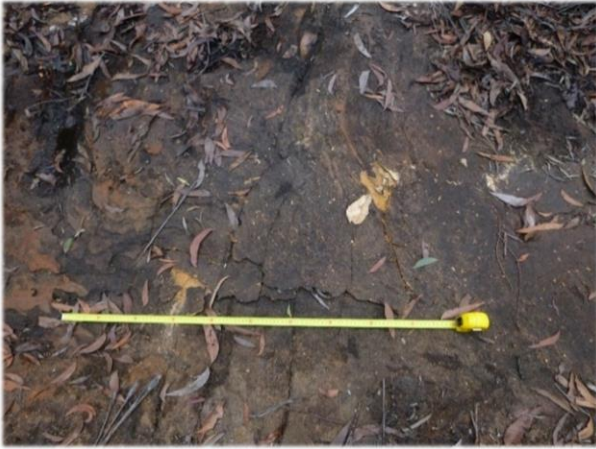
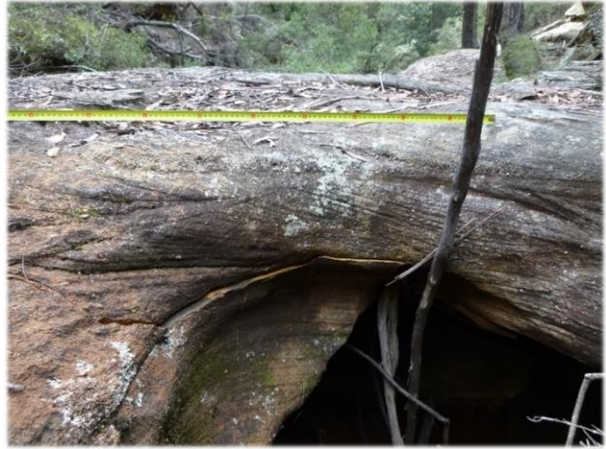
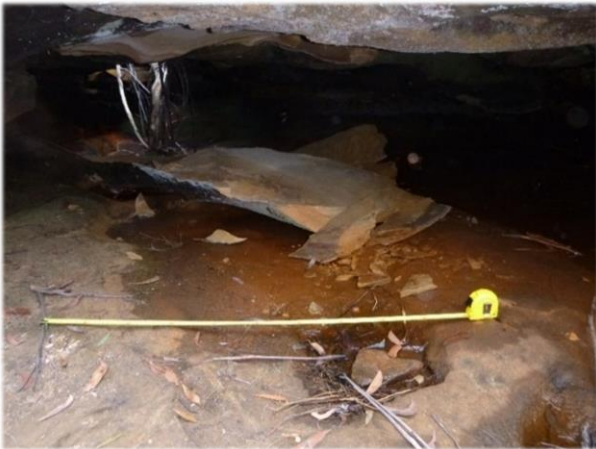
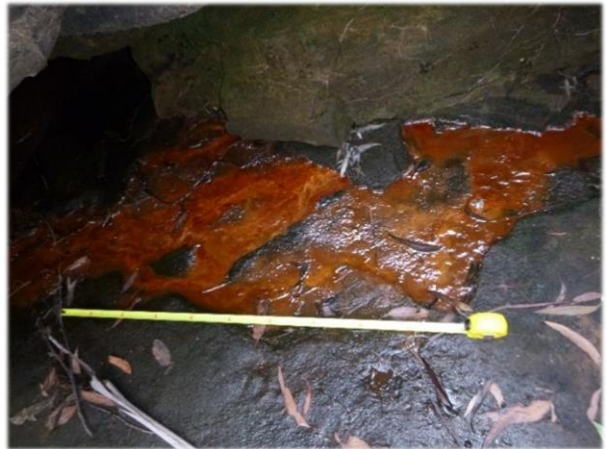
Level 2: Crack or fracture between 100 and 300mm width at its widest point or any fracture which results in observable loss of surface water or erosion.

Photo 35: *WC15_Rockbar 7*, looking upstream, highlighting the undercut nature of the rockbar.

Photo 36: *DA3B_LW13_042*, looking at a section of rock fracturing and uplift. Taken 16th May 2018.

Photo 37: *DA3B_LW13_042*, looking at a section of rock fracturing. Taken 16th May 2018.

Photo 38: *DA3B_LW13_042*, looking at largest rock fragment and iron staining. Taken 16th May 2018.

Photo 39: *DA3B_LW13_042*, looking at a section of iron staining. Taken 16th May 2018.

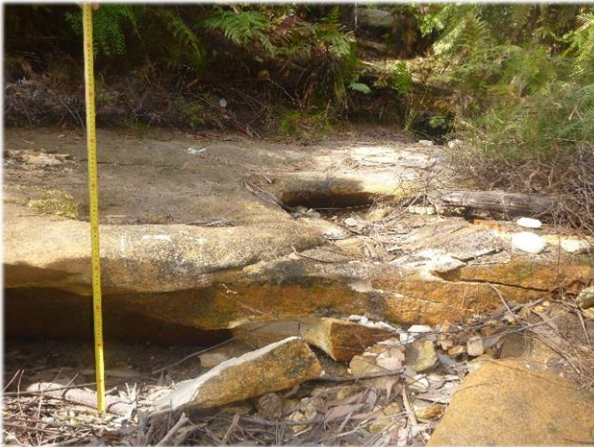
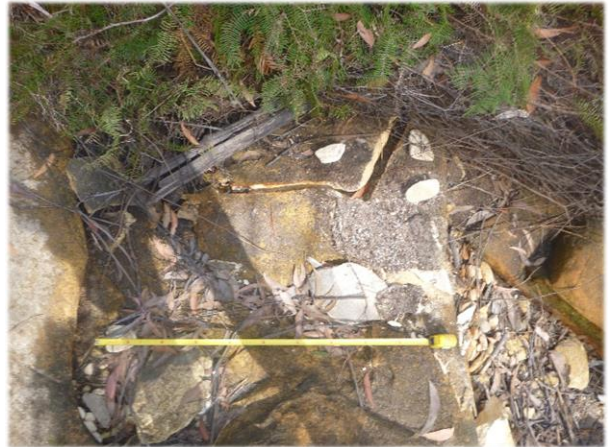
DA3B_LW13_006	289685	6192540	Rock Fracturing	WC21	25/09/2017	2	Rock fracture to the base of WC21_Pool 48. 5m length, 0.03m width. Also associated with an absence of water in pool.	05/10/2017
DA3B_LW13_007	289883	6192878	Iron Staining	WC21	03/10/2018	1	Iron staining at subsurface outflow, downstream from WC21_Pool 38, at BF37.	05/10/2017
DA3B_LW13_008	289584	6192414	Surface Cracking	Access Track	10/10/2017	1	Consists of two small zones of surface cracking and uplift on access track adjacent to WC21. Max length 1.4m, width 0.06m, depth 0.1m.	24/10/2017
DA3B_LW13_009	289592	6192392	Rock Fracturing	WC21	23/10/2017	1	Rock fracturing to the downstream extent of WC21_Pool 54, 0.38m long, 0.22m wide, 0.37m deep.	24/10/2017
DA3B_LW13_010	289591	6192424	Rock Fracturing	WC21	23/10/2017	2	Rock fracturing to the step at the upstream extent of WC21_Pool 53, 2.5m long, 0.01m wide, and 0.03m deep.	24/10/2017

Level 2: Crack or fracture between 100 and 300mm width at its widest point or any fracture which results in observable loss of surface water or erosion.

Photo 40: Impact *DA3B_LW13_006*, looking upstream. Taken on 3/10/2017.

Photo 41: Impact *DA3B_LW13_006*, looking across pool at fracturing. Taken on 3/10/2017.

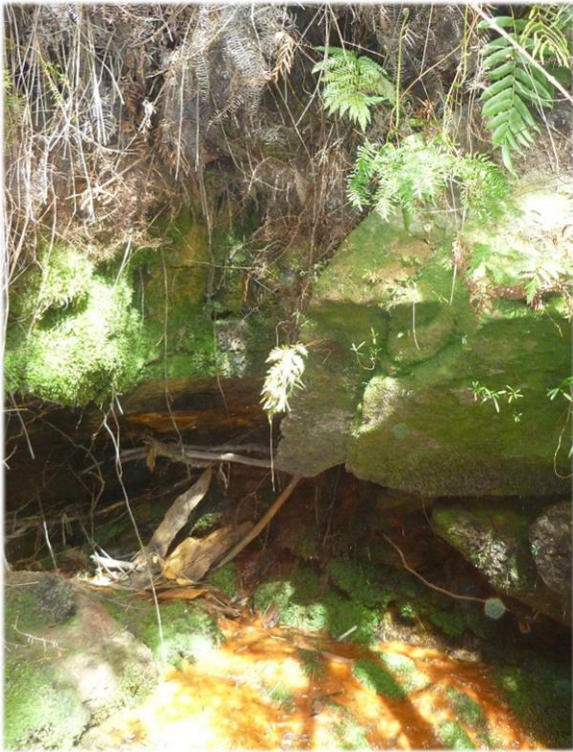
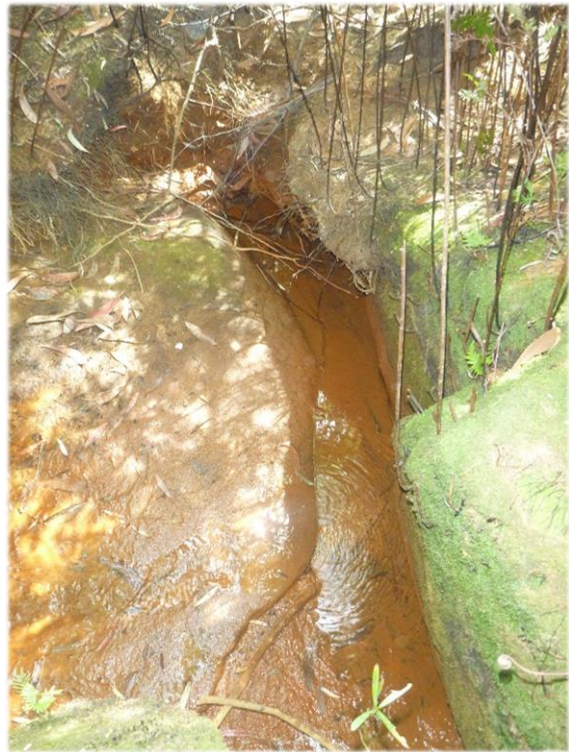
Level 1: Observable increase in iron staining within the mining area.

Photo 42: Impact *DA3B_LW13_007*, looking upstream. Taken on 3/10/2017.

Photo 43: Impact *DA3B_LW13_007*, looking downstream. Taken on 3/10/2017.

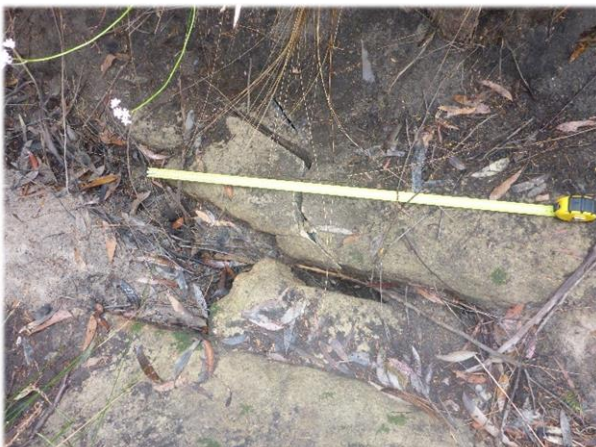
Level 1: Crack or fracture up to 100mm at its widest point with no observable loss of surface water or erosion.

Photo 44: Impact *DA3B_LW13_009*, looking across stream, taken on 23/10/2017.

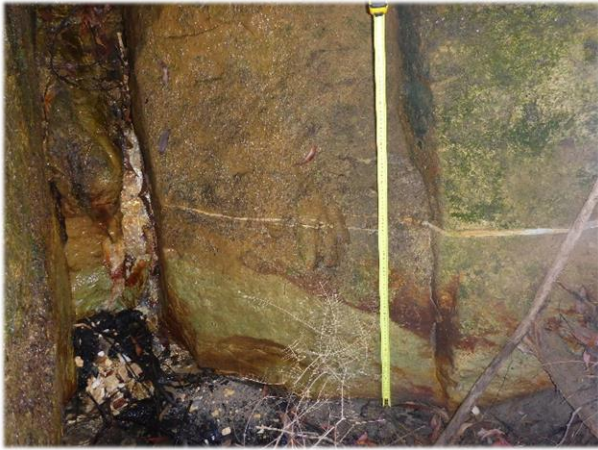
Level 2: Crack or fracture between 100 and 300mm width at its widest point or any fracture which results in observable loss of surface water or erosion.

Photo 46: Impact *DA3B_LW13_010* looking upstream, taken 27/10/2017.

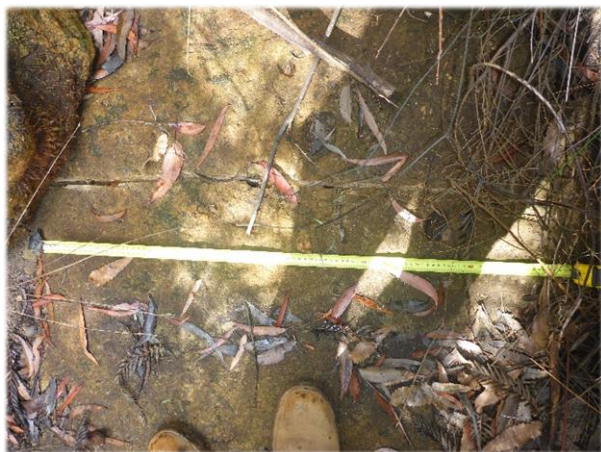
Level 2: Crack or fracture between 100 and 300mm width at its widest point or any fracture which results in observable loss of surface water or erosion.

Photo 52: *DA3B_LW13_011*, looking top-down, taken 23/10/2017.

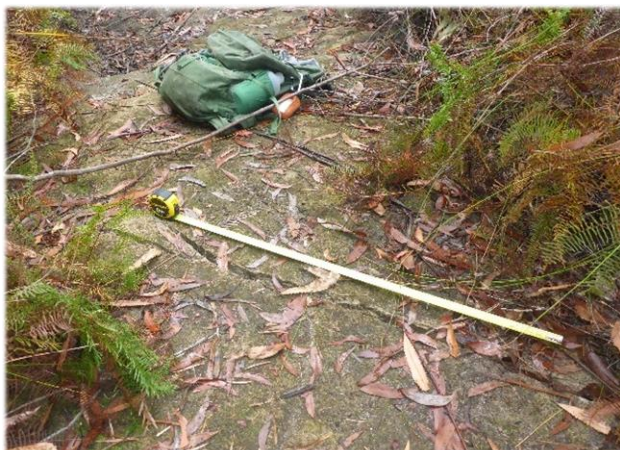
Level 2: Crack or fracture between 100 and 300mm width at its widest point or any fracture which results in observable loss of surface water or erosion.

Photo 56: Impact DA3B_LW13_017, overall extent. Taken on 8/01/2018.

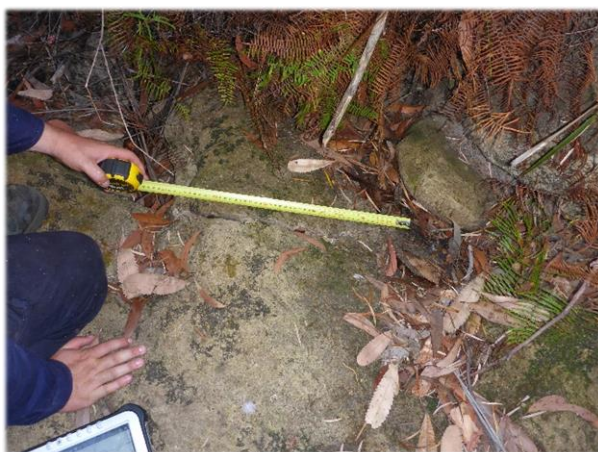
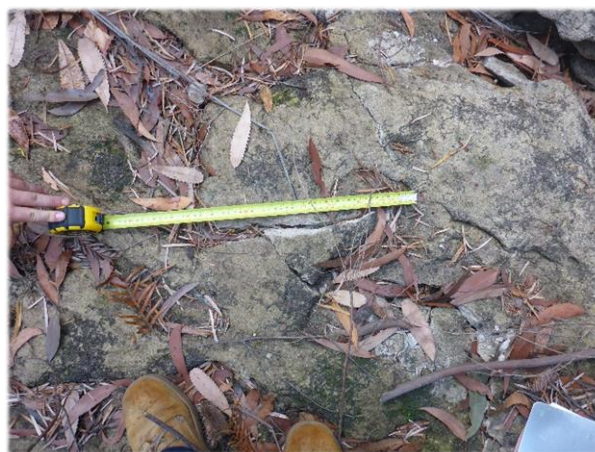
Level 2: Crack or fracture between 100 and 300mm width at its widest point or any fracture which results in observable loss of surface water or erosion.

Photo 58: DA3B_LW13_018, looking across stream at the largest fracture. Taken on 12/02/2018.

Photo 59: DA3B_LW13_018, looking top-down at the largest fracture. Taken on 12/02/2018.

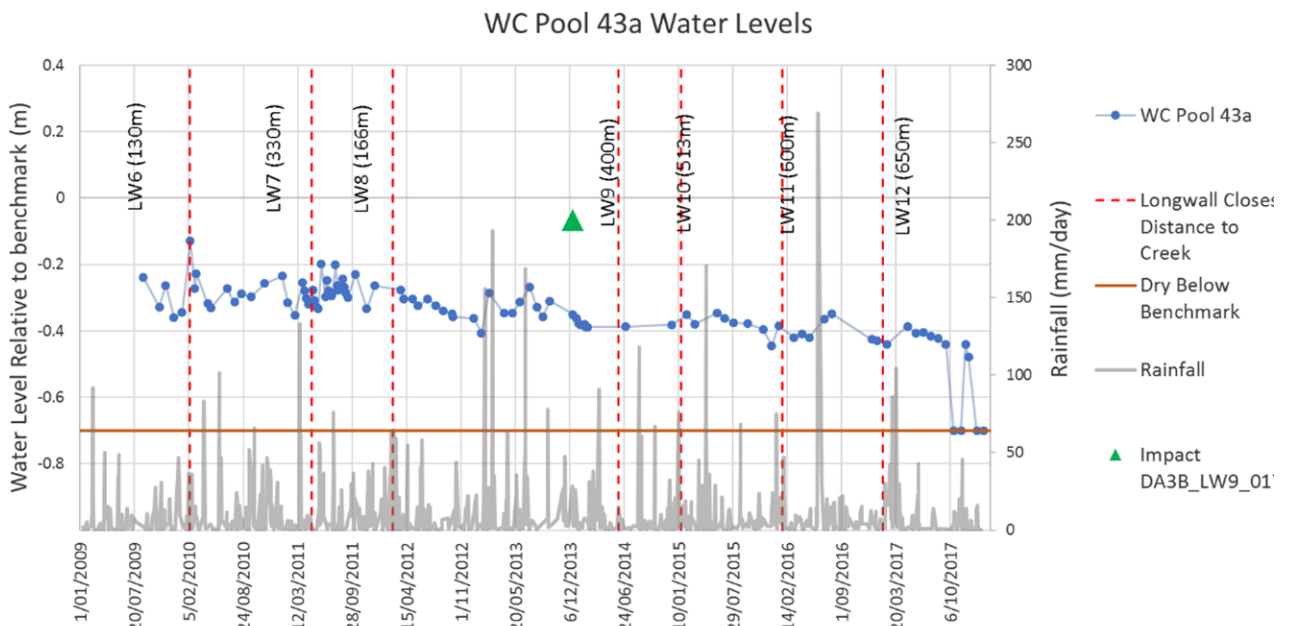
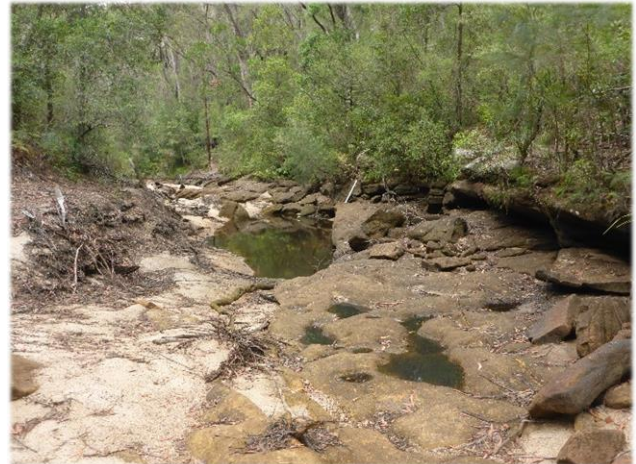
Level 3: Fracturing resulting in diversion of flow such that <10% of the pools have water levels lower than baseline period.

Figure 3: Pool water levels recorded in *WC_Pool 43a*. Initial observation date of impact DA3B_LW9_017 is also displayed.

Photo 61: *WC_Pool 43a*, looking upstream. Taken on 10/01/2018

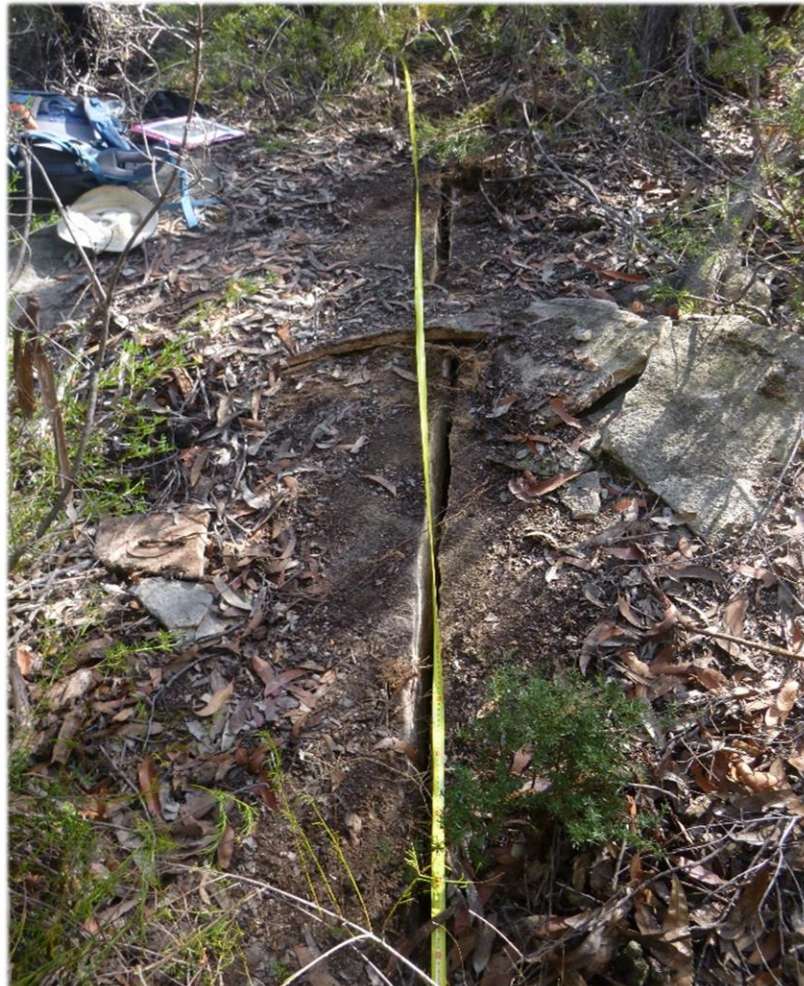
Level 1: Crack or fracture up to 100mm in width and/or crack or fracture up to 10m in length.

Photo 62: Photo DA3B_LW13_036, looking at the extent of the fracture. Taken 23rd April 2018
