**DENDROBIUM LONGWALL 13
END OF PANEL LANDSCAPE
REPORT**

JUNE 2018

This report summarises the observed and measured subsidence effects on landscape features resulting from the extraction of Dendrobium Longwall 13.

Longwall 13 is the fifth panel extracted from Dendrobium Area 3B. Extraction began on the 4th of March 2017 and was completed on the 19th of April 2018.

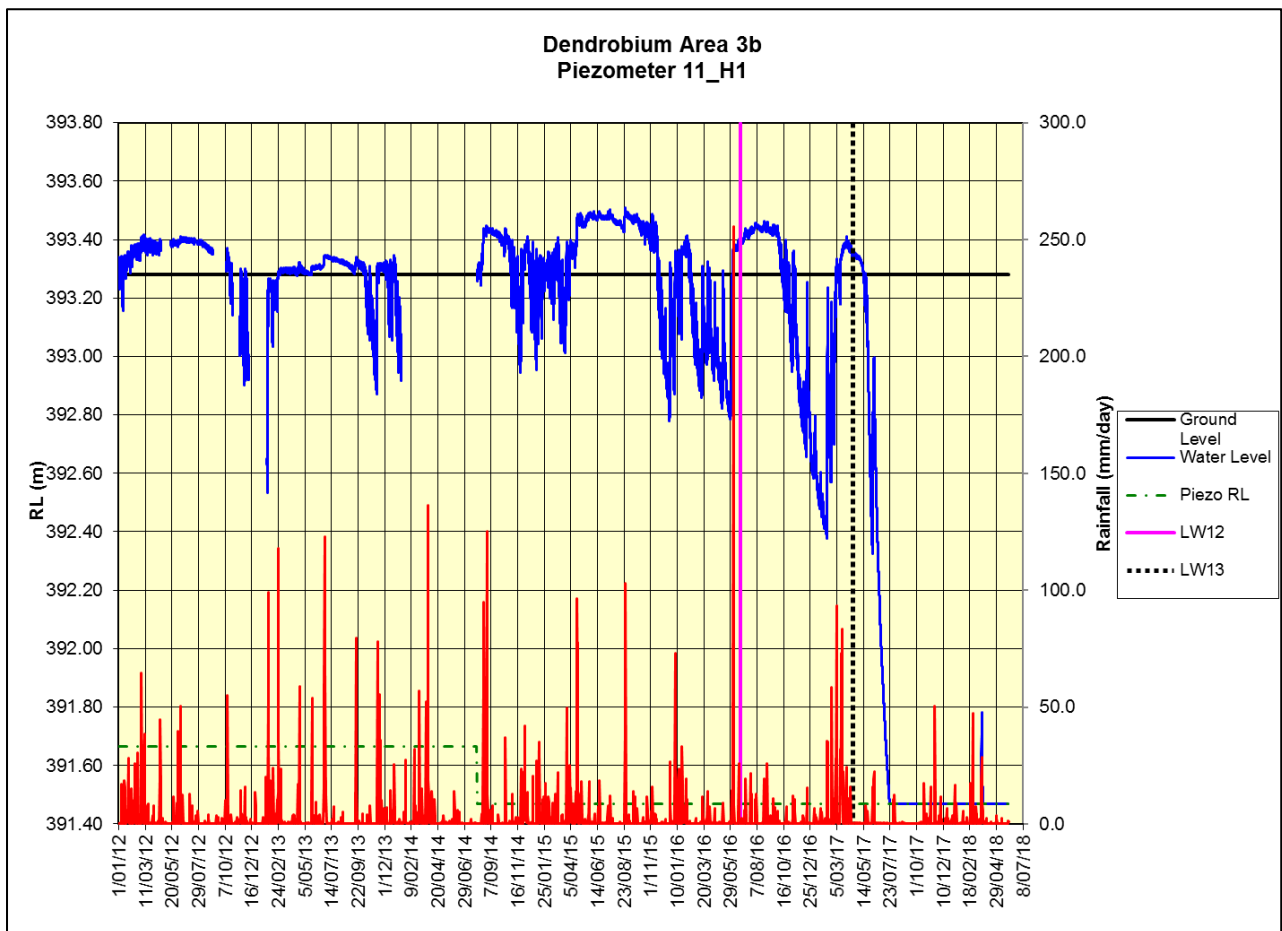
Level 1: Groundwater level lower than baseline level at any monitoring site within a swamp (in comparison to reference swamps); and/or Rate of groundwater level reduction exceeds rate of groundwater level reduction during baseline period at any monitoring site (measured as average mm/day during the recession curve).

Figure 4: Shallow groundwater levels at 11_01, logged hourly, date range: (Jan 2012 to June 2018).

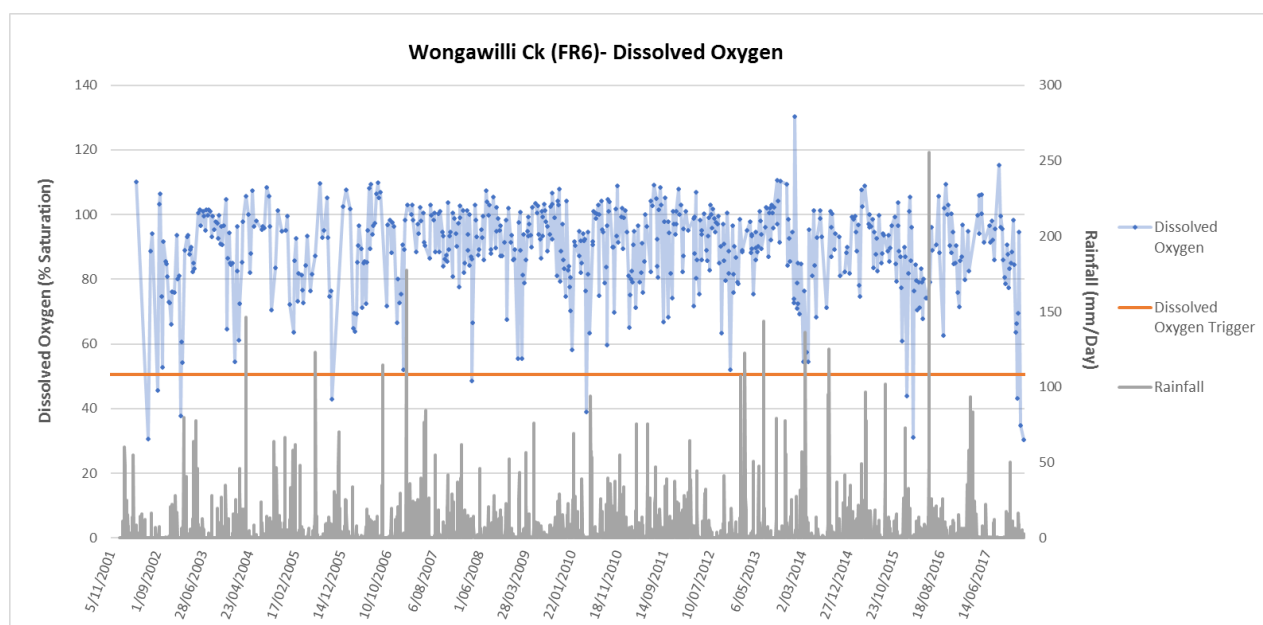
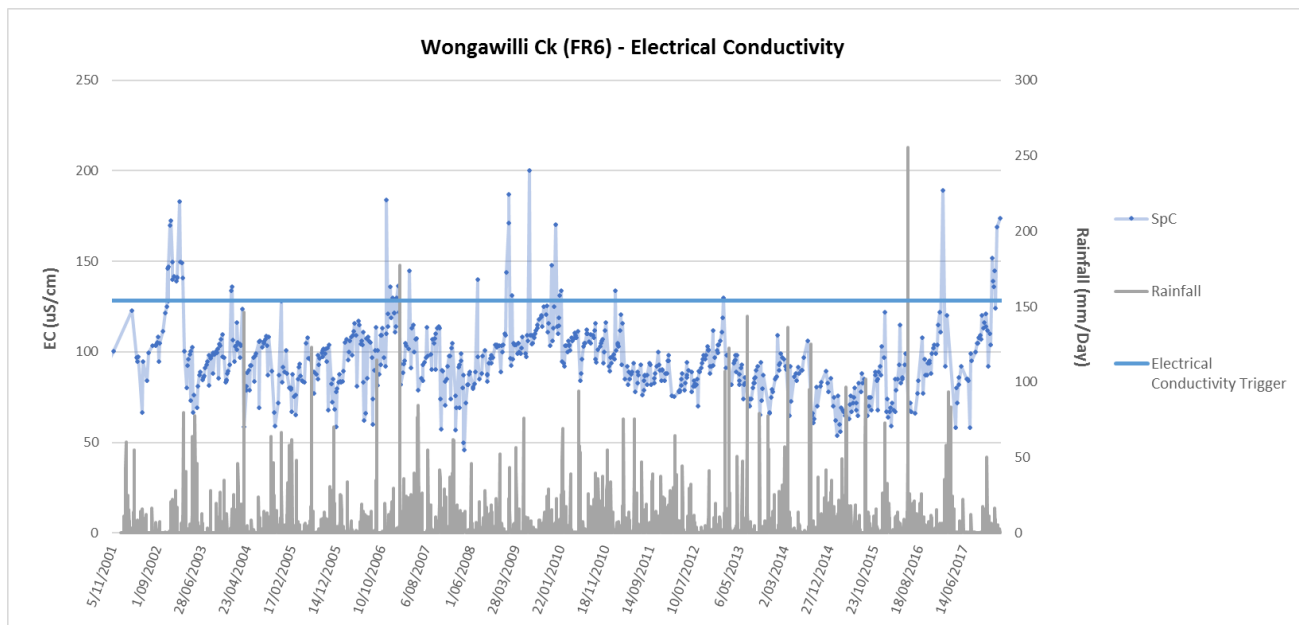
- Three exceedances of the ± 3 standard deviation level (positive for EC, negative for pH and DO) from the baseline mean during the monitoring period:
 - pH 4.45
 - **EC 154.1 $\mu\text{S}/\text{cm}$**
 - **DO 50.5%**

Figure 5: Dissolved oxygen results recorded at site Wongawilli Ck (FR6), downstream from DA3B operations.

Figure 6: Electrical conductivity results recorded at site *Wongawilli Ck (FR6)*, downstream from DA3B operations.

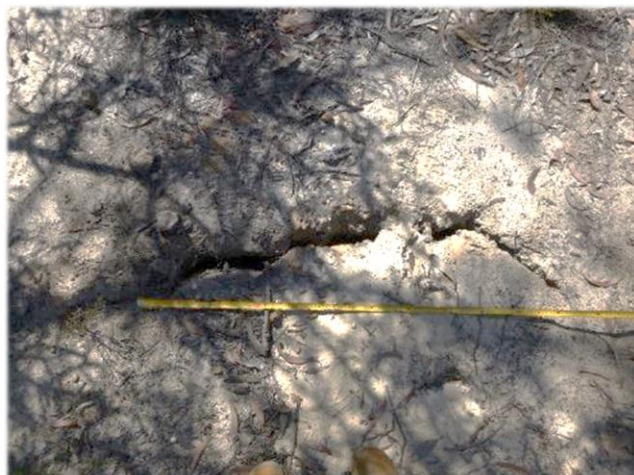
Photo 63: DA3B_LW13_032, soil cracking across Fire Road 6P. Taken 9th April 2018.

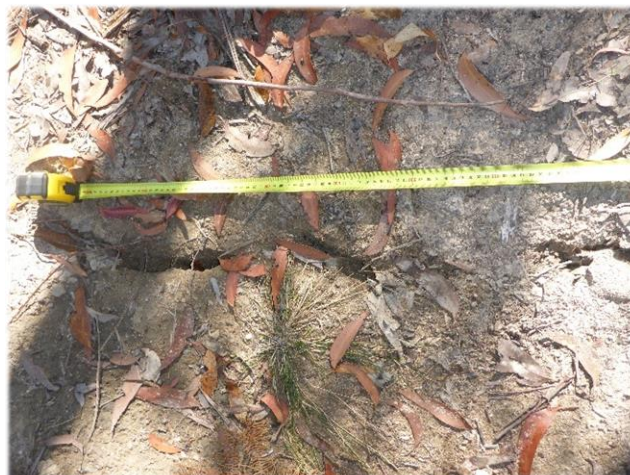
Photo 64: DA3B_LW13_012, largest section of surface cracking. Taken on 30/10/2017.

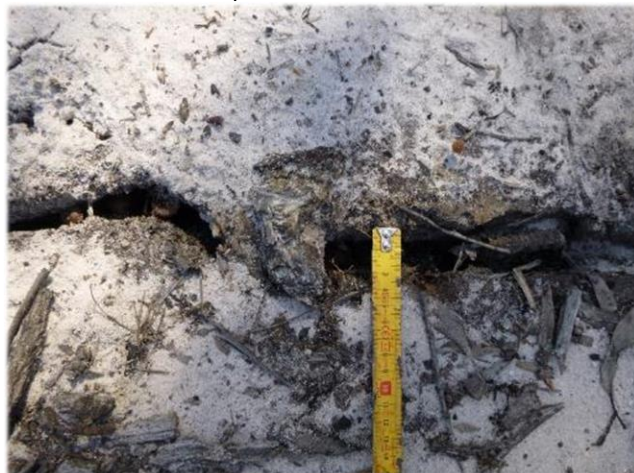
DA3B_LW13_034	290237	6192451	Surface Cracking	FR6P	09/04/2018	1	Surface cracking on FR6P, 1.5m length, 0.04m width, 0.8m depth.	10/04/2018
DA3B_LW13_035	290406	6191915	Rock Fracturing	WC15	23/04/2018	1	Rock fracturing to WC15_Rockbar 21. Max 1.6m long, up to 0.002m wide. Small section of uplift and plating. No evidence of flow diversion.	27/04/2018
DA3B_LW13_036	290515	6192442	Rock Fracturing	Sandstone Outcrop	23/04/2018	1	Rock fracturing to sandstone outcrop. Max 5.5m long, 0.05m width. 1.64m depth.	27/04/2018
DA3B_LW13_037	290539	6192466	Surface Cracking	Access Track	23/04/2018	1	Soil cracking on access track adjacent to FR6P, 2.1m length, 0.09m width, 0.34m depth.	27/04/2018
DA3B_LW13_038	290282	6192409	Surface Cracking	Access Track	23/04/2018	1	Soil cracking on access track adjacent to FR6P, 1.96m length, 0.03m width, 0.11m depth.	27/04/2018
DA3B_LW13_039	290212	6192396	Surface Cracking	Access Track	23/04/2018	1	Soil cracking on access track adjacent to FR6P, 2.12m length, 0.025m width, 0.46m depth.	27/04/2018

Photo 65: DA3B_LW13_034, close up of the widest section of the soil cracking impact. Taken 9th April 2018.

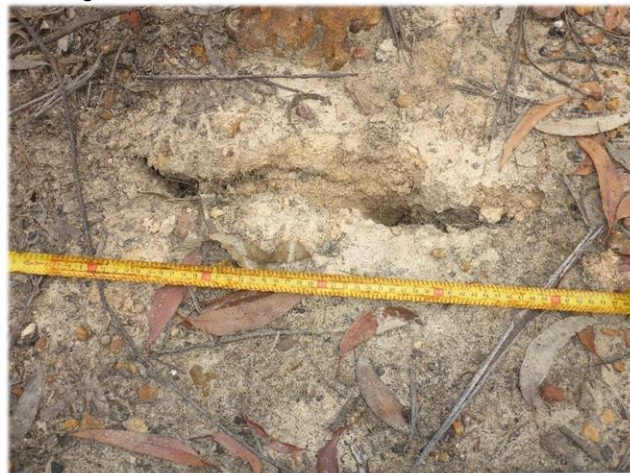
Photo 66: DA3B_LW13_020, looking across the access track. Taken on 16/03/2018.

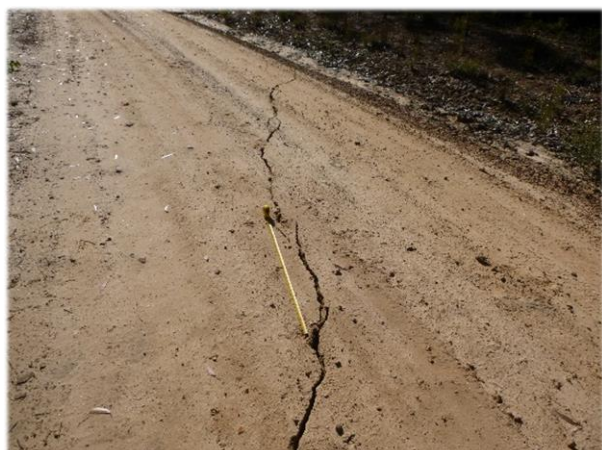
Photo 67: DA3B_LW13_003, showing the longest continuous section of cracking on FR6A, taken 26/06/2017.

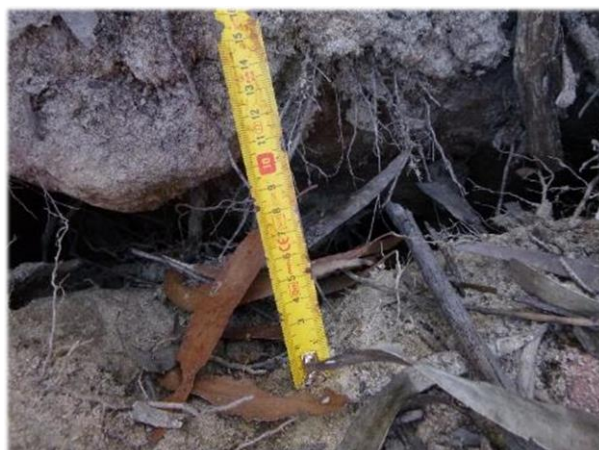
Photo 68: DA3B_LW13_029, close up of the widest section of cracking. Taken 9th April 2018.

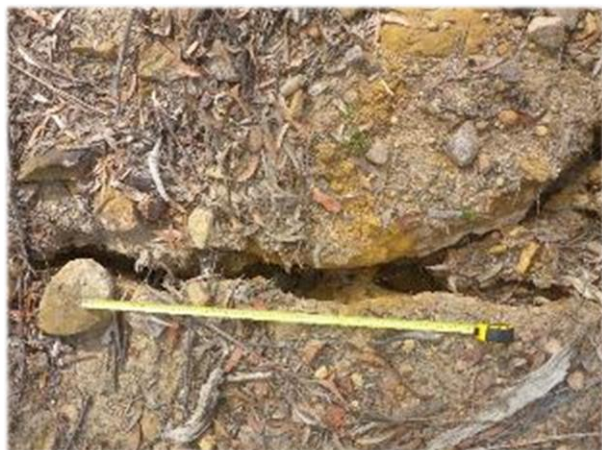
Photo 69: DA3B_LW13_024, looking across track. Taken 4th March 2018.

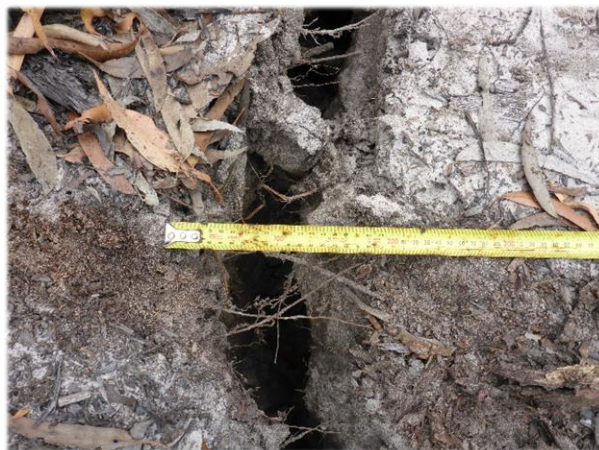
DA3B_LW13_019	290243	6192458	Surface Cracking	FR6P	02/03/2018	2	Surface cracking on FR6P, 8.5m long, 0.45m max depth 0.45m, max width 0.15m.	05/03/2018
DA3B_LW13_020	289899	6192305	Surface Cracking	Access Track	16/03/2018	1	Soil cracking on seismic track adjacent to FR6P, 0.35m long, 0.12m max depth, 0.07m width.	19/03/2018
DA3B_LW13_021	290466	6192007	Rock Fracturing	WC15	29/03/2018	2	Rock fracturing to the upstream extent of WC15_Rockbar 18, 5.7m long, up to 0.015m wide, depth 0.06m.	03/04/2018
DA3B_LW13_022	290496	6192026	Rock Fracturing	WC15	29/03/2018	2	Rock fracturing to WC15_Rockbar 18. Comprised of approx. 10 fractures. Max 3m long, up to 0.015m wide, depth 0.04m.	03/04/2018
DA3B_LW13_023	290482	6192033	Rock Fracturing	WC15	29/03/2018	2	Rock fracturing to WC15_Rockbar 18. Max 5.6m long, up to 0.03m wide, depth 0.16m.	03/04/2018
DA3B_LW13_024	289456	6192429	Surface Cracking	Access Track	04/04/2018	2	Soil cracking on access track adjacent to FR6P, 40m length, 0.2m wide, 0.85m depth.	06/04/2018

Photo 70: DA3B_LW13_019, looking inside soil crack. Taken on 2/03/2018
