Re: Dendrobium Colliery Longwall 13 End of Panel Report - Aboriginal Heritage Assessment

Dendrobium Colliery, Longwall 13 End of Panel Report: Aboriginal Heritage Assessment

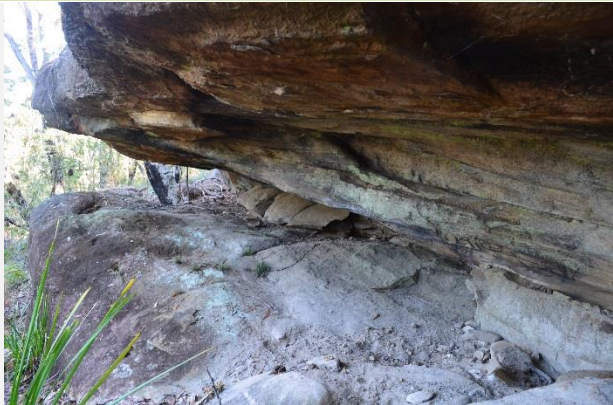
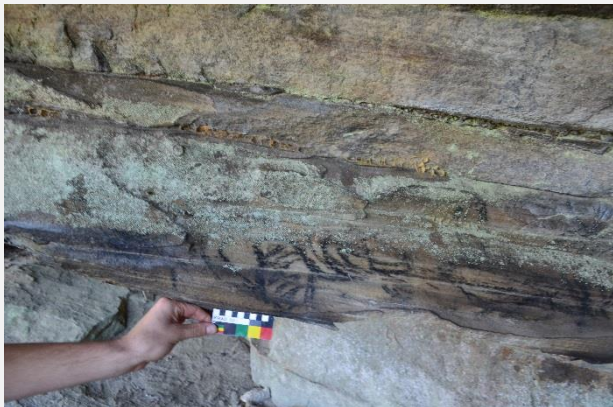
AHIMS site numbers	Site name	Results of inspections	Photograph of current condition of site
52-2-1628	Browns Road Site 12	<p>This shelter was in the same condition as described by Biosis in 2012 and 2016. There has been no movement of the horizontal bedding plane joints of the shelter and no cracking or exfoliation observed in relation to the extraction of Longwall 13. There has been no altered seepage or water movements in the shelter, and there is no evidence of water flow or recent micro-vegetation growth associated with any movement. The site remains the same as previously described. The art panel remains in the same condition as described in Biosis Research 2008, 2009 and Niche 2017.</p>

<p>Plate 1: General photograph of Browns Road Site 12, facing south.</p>

<p>Plate 2: General photograph of art panel Browns Road Site 12, at the northern end of the shelter.</p>
52-2-2229	Site 1-DB1	<p>This shelter was in the same condition as described by Biosis in 2012. There has been no movement of the horizontal bedding plane joints of the shelter and no cracking or exfoliation observed in relation to the extraction of Longwall 13. There has been no altered seepage or water movements in the shelter, and there is no evidence of water flow or recent micro-vegetation growth associated with any movement.</p>

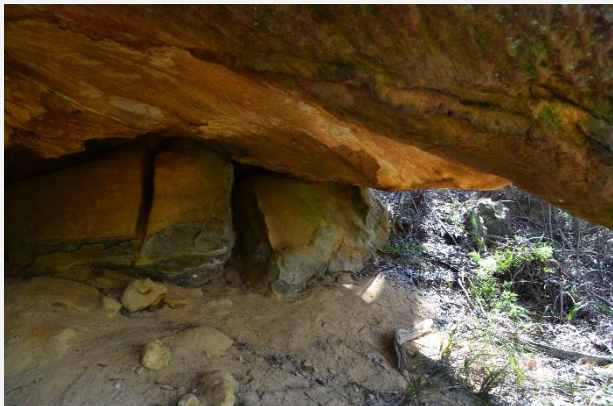
<p>Plate 3: General photograph of Site 1-DB1.</p>

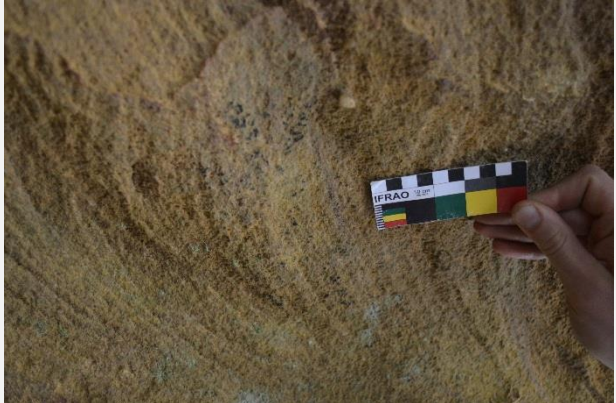
<p>The site remains the same as previously described.</p> <p>The art panel remains in the same condition as described in Biosis Research 2008, and 2009.</p>

<p>Plate 4: General photograph of location of art at Site 1-DB1.</p>
<p>52-2-3641</p>	<p>DM17</p>	<p>This shelter was in the same condition as described by Biosis in 2012. There has been no movement of the horizontal bedding plane joints of the shelter and no cracking or exfoliation observed in relation to the extraction of Longwall 13. There has been no altered seepage or water movements in the shelter, and there is no evidence of water flow or recent micro-vegetation growth associated with any movement. The site remains the same as previously described. The artefact could not be relocated during this assessment.</p>

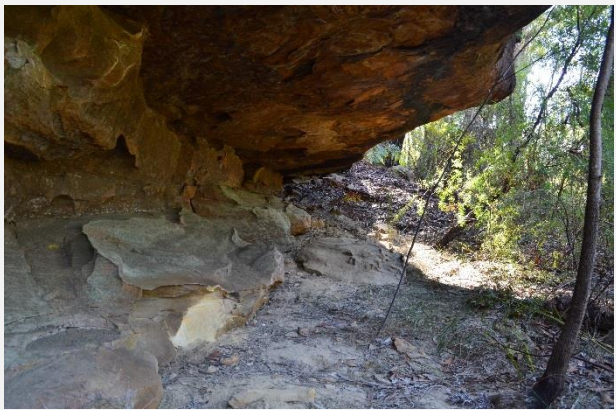
<p>Plate 5: General photograph of shelter DM17.</p>

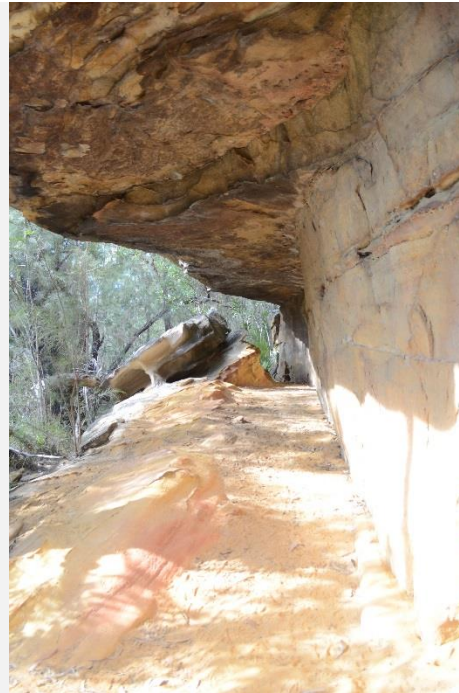
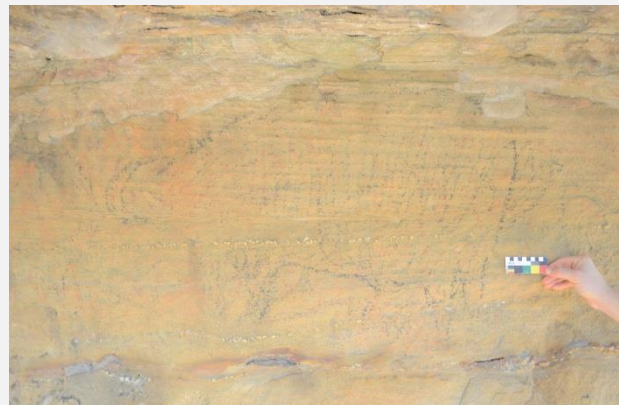
This shelter was in the same condition as described by Biosis in 2012. There has been no movement of the horizontal bedding plane joints of the shelter and no cracking or exfoliation observed in relation to the extraction of Longwall 13. There has been no altered seepage or water movements in the shelter, and there is no evidence of water flow or recent micro-vegetation growth associated with any movement. The site remains the same as previously described. The art panel remains in the same condition as described in Biosis Research 2008, and 2009.

Plate 6: General photograph of shelter DM16.

Plate 7: General photograph of the art at DM16.

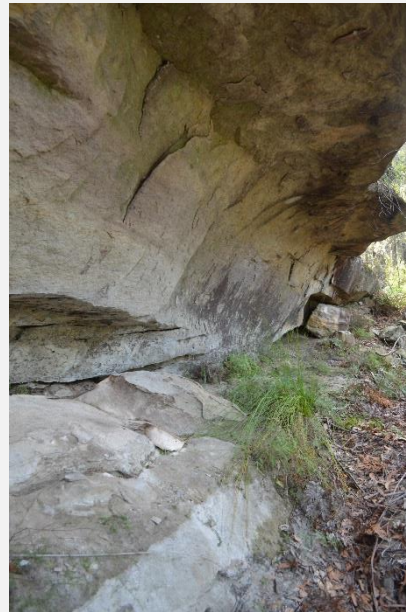
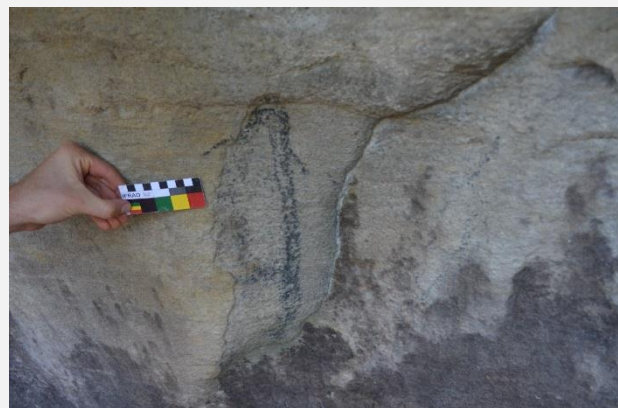
52-2-1626	Browns Road Site 11	<p>This shelter was in the same condition as described by Biosis in 2012 and 2016. There has been no movement of the horizontal bedding plane joints of the shelter and no cracking or exfoliation observed in relation to the extraction of Longwall 13. There has been no altered seepage or water movements in the shelter, and there is no evidence of water flow or recent micro-vegetation growth associated with any movement. The site remains the same as previously described. The art panel remains in the same condition as described in Biosis Research 2008, and 2009.</p>
-----------	---------------------	--

Plate 8: General photograph of Browns Road Site 11

Plate 8: General photograph of the art at Browns Road Site 11.
