**DENDROBIUM AREA 3B
LONGWALL 14 END OF PANEL
LANDSCAPE REPORT
APRIL 2019**

This report summarises the observed and measured subsidence effects on landscape features resulting from the extraction of Dendrobium Area 3B (DA3B) Longwall 14.

Longwall 14 is the sixth panel extracted from DA3B. Extraction began on 22 May 2018 and was completed on 26 February 2019.

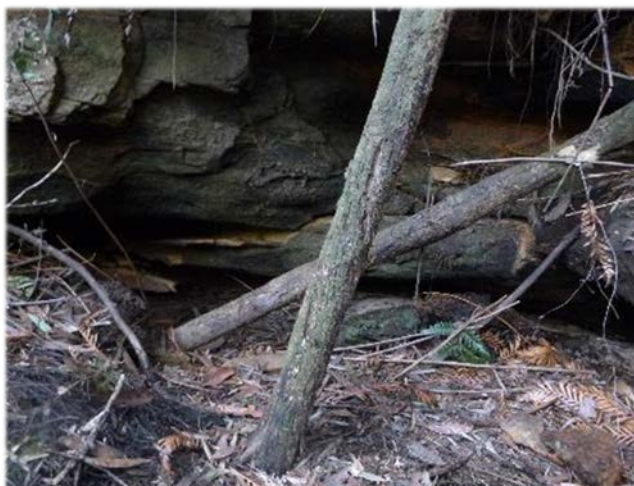
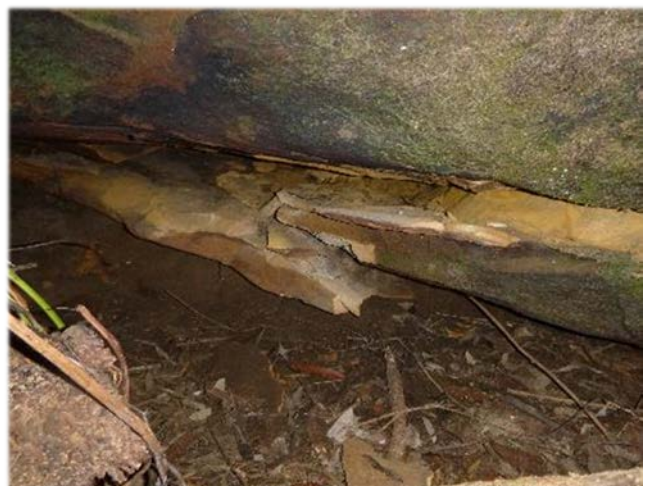
Impact *DA3B_LW13_044* was identified on 26 July 2018 and consists of rock fracturing to the base of a step on tributary *LA4B* (Photo 5 and Photo 6). The fracturing likely occurred during the extraction of Longwall 13 but wasn't identified during this time due to thick vegetation and safety concerns accessing this step during active subsidence. The fracturing has a maximum length of approximately 1.7m, with a horizontal depth of 1.05m at its deepest measurable point. The width of the fracturing is approximately 0.1m.

Level 2: Crack or fracture between 100mm and 300mm width

Photo 5: *DA3b_LW13_044*, looking at a section of rock fracturing. Taken 26/07/18.

Photo 6: *DA3b_LW13_044*, looking at a section of rock fracturing. Taken 26/07/18.

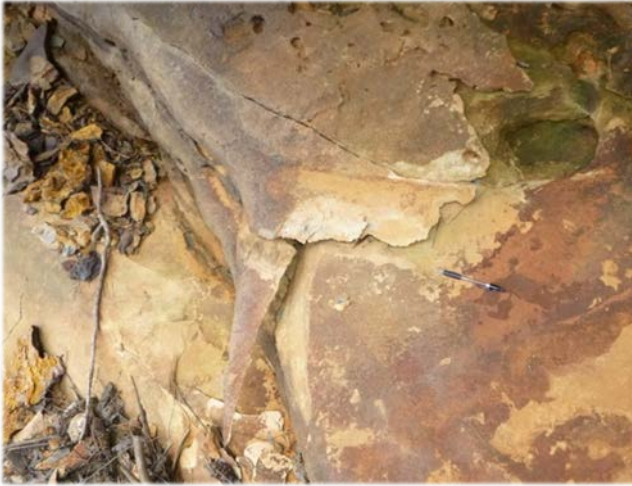
Impact *DA3B_LW13_043* is located on *LA4*, a tributary to *Lake Avon*, 300 m from the commencing end of Longwall 13 and 300 m from the southern edge of Longwall 12. The impact is comprised of rock fracturing at *LA4_Step 0* (Photo 7), which is the most downstream feature before entering *Lake Avon*. The impact was originally identified on 18 May 2018 however lowering lake water levels has enabled recent access to areas that were previously underwater. During an inspection on 6 December 2018, additional rock fracturing was observed. The additional fracturing has a maximum length of 1.5m and a maximum width of 0.01m. An increase in iron staining was also identified during this inspection (Photo 8).

Level 2: Crack or fracture that results in observable loss of surface water and observable increase in iron staining within the mining area continues to outside the mining area

Photo 7: DA3B_LW13_043, looking at a section of rock fracturing and uplift. Taken 6/12/2018

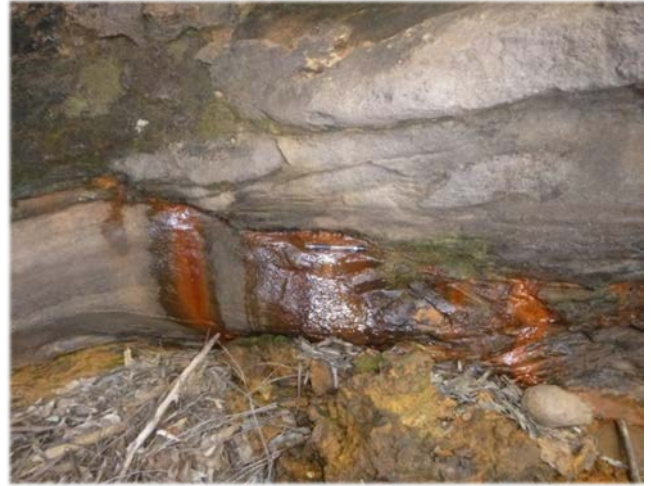
Photo 8: DA3B_LW13_043, looking at iron staining. Taken 6/12/2018.

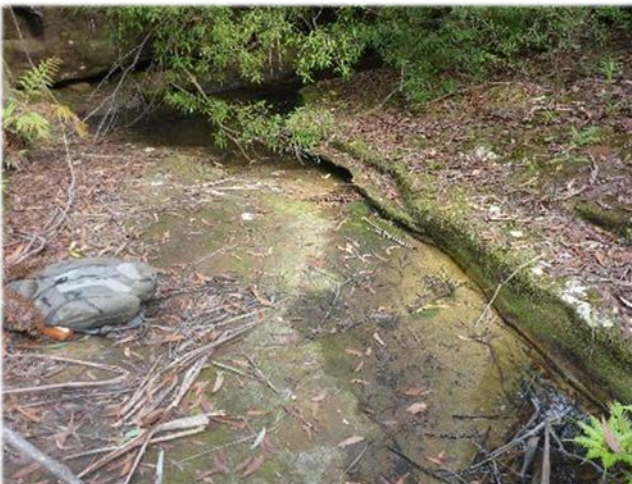
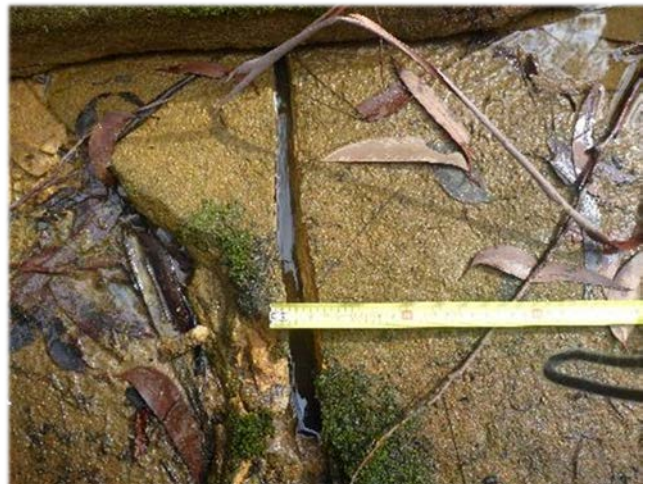
Impact DA3B_LW13_045 was identified on 8 August 2018 and consists of a rock fracture across a rock bar on tributary WC15. The fracturing likely occurred during the extraction of Longwall 13 but wasn't identified during this time due to access difficulties during active subsidence. The fracture is approximately 0.3m long, 0.03m wide and 0.03m at the deepest measurable point (Photo 9 and Photo 10). No flow diversion could be observed at the site however the fracture is across the main flow path and flow diversion is possible during higher flow conditions at the site.

Level 2: Crack or fracture that results in observable loss of surface water

Photo 9: DA3b_LW13_045, site overview. Taken 8/07/18.

Photo 10: DA3b_LW13_045, Looking at the rock fracturing. Taken 8/07/18.

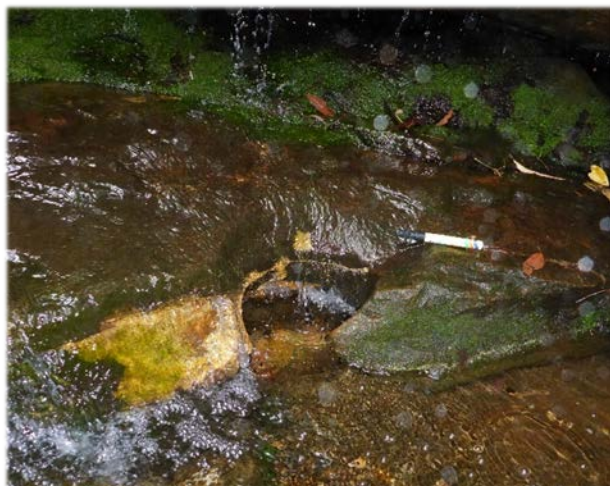
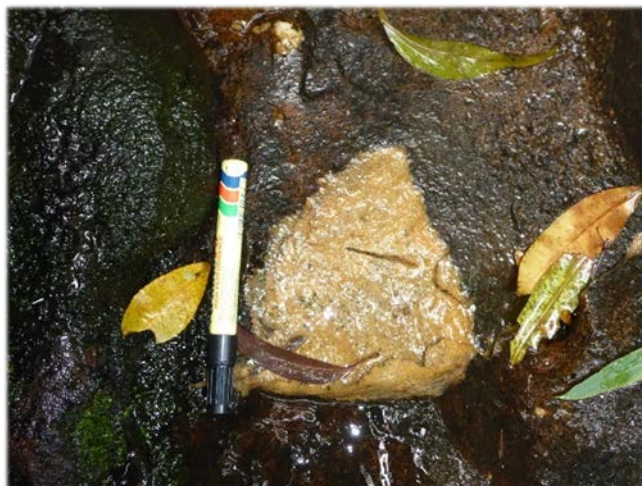
DA3B_LW13_046 is located on WC15, a tributary to Wongawilli Creek. The impacted feature is the base of WC15_Step 2 which is situated approximately 245m east of Longwall 13 and 590m north-east of Longwall 14. It is likely that this impact occurred during the extraction of Longwall 13 however has only now become visible due to heavy rainfall events (187.5mm between 15 March and 20 March 2019) which has dislodged vegetation and rock fragments (Photo 11 and 12). The impact is comprised of a rock fracture and minor rock displacement. The rock fracture has a maximum measurable length of 1.2m and a maximum width of 0.02m. No flow diversion was evident due to location of the fracture on the step.

Level 1: Crack or fracture up to 10m Length

Photo 11: DA3B_LW13_046, looking at the extent of the rock fracturing. Taken 01/04/2019.

Photo 12: DA3B_LW13_046, looking at the section of rock displacement. Taken 01/04/2019.

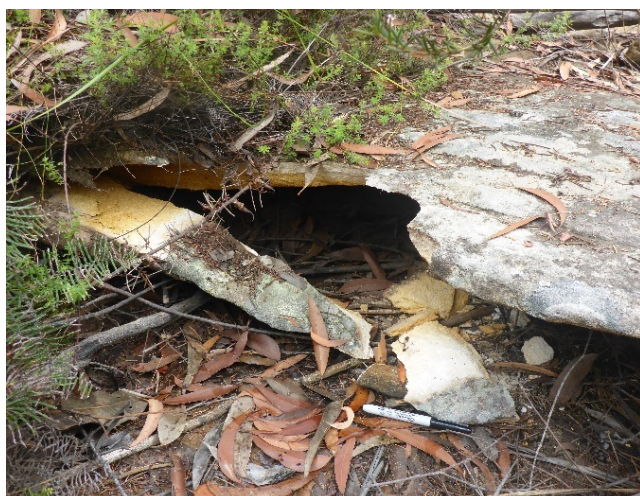
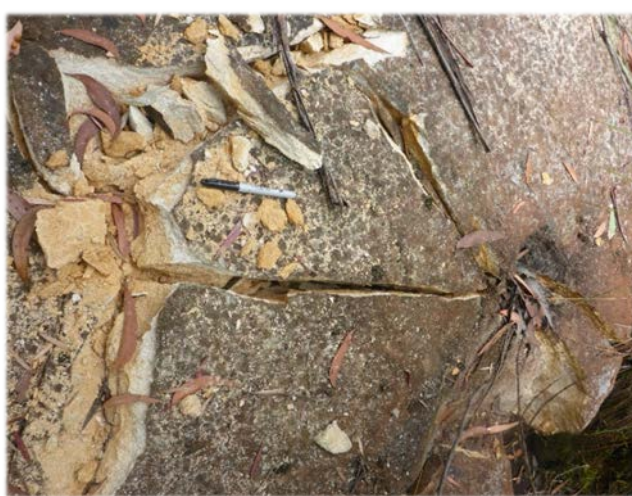
Impact DA3B_LW14_016 was identified on the 21st of January 2019 and is located on *Wongawilli Creek* tributary WC15. The impact consists of multiple fractures, uplift and dislodged sections of rock (Photo 13 and Photo 14). The longest fracture is up to 4.0m long and 0.03m wide. Surface flow diversion was recorded at the site during baseline mapping on WC15. While there was no active flow diversion observed through fractures, it is likely diversion would occur during higher flow conditions.

Level 2: Crack or fracture that results in observable loss of surface water

Photo 13: DA3B_LW14_016, looking at fracturing and dislodged rock segments. Taken on 21/01/2019.

Photo 14: DA3B_LW14_016, looking at fracturing and dislodged sections of rock. Taken on 21/01/2019.

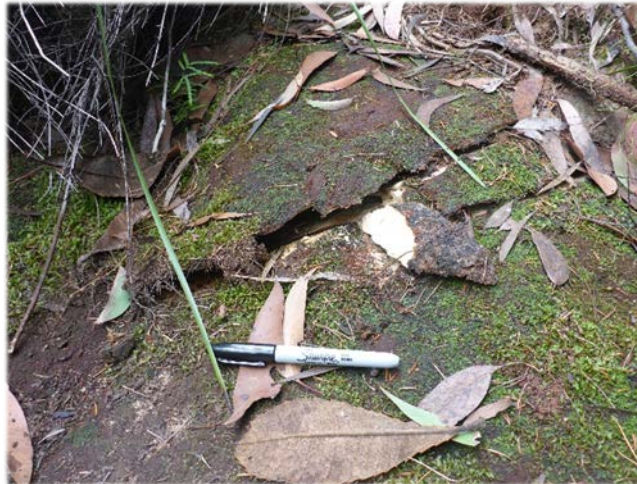
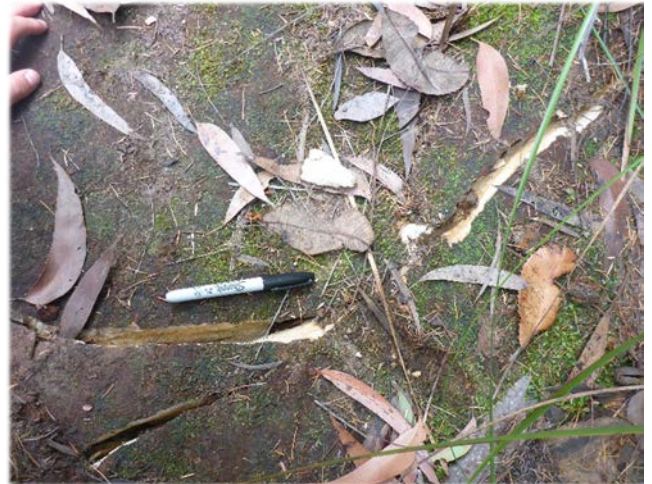
DA3B_LW14_017 is located on WC15, a tributary to Wongawilli Creek. The impacted feature is WC15_Channel 30 which is situated approximately 79m south of Longwall 14 at its closest point. The impact is comprised of two rock fractures (Photo 15 and 16). The rock fracturing has a maximum measurable length of 0.8m, a maximum width of 0.025m and a maximum measurable depth of 0.17m. While there was no active flow diversion observed through fractures, it is likely diversion would occur during higher flow conditions.

Level 2: Crack or fracture that results in observable loss of surface water

Photo 15: DA3B_LW14_017, looking at a section of rock fracturing. Taken 20/02/2019.

Photo 16: DA3B_LW14_017, looking at a section of rock fracturing. Taken 20/02/2019.

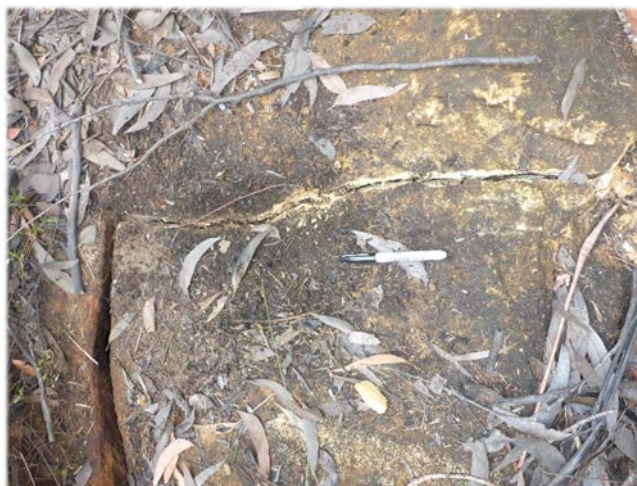
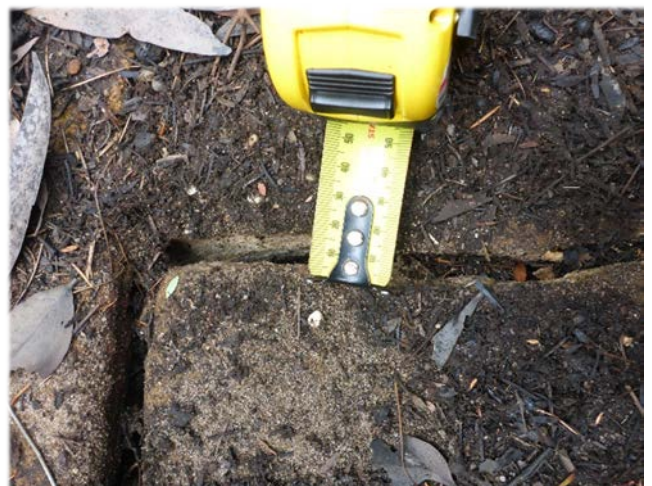
DA3B_LW14_018 is located on WC15, a tributary to Wongawilli Creek. The impacted feature is WC15_Pool 30 which is situated approximately 73m south of Longwall 14 at its closest point (Figure 1). The impact is comprised of a rock fracture (Photo 17 and 18). The rock fracture has a maximum measurable length of 0.7m, a maximum width of 0.015m and a maximum measurable depth of 0.10m. While there was no active flow diversion observed through fractures, it is likely diversion would occur during higher flow conditions.

Level 2: Crack or fracture that results in observable loss of surface water

Photo 17: DA3B_LW14_018, looking at the extent of the rock fracturing. Taken 20/02/2019.

Photo 18: DA3B_LW14_018, looking at the width of the fracturing. Taken 20/02/2019.

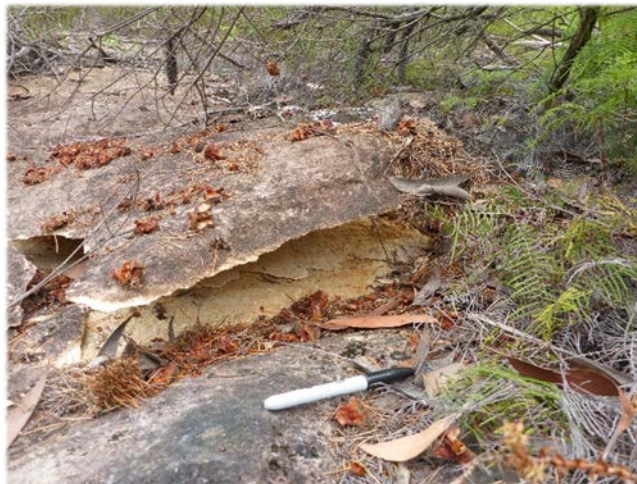
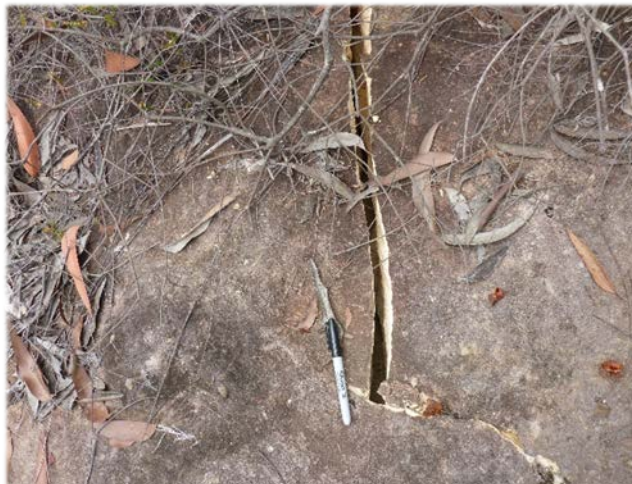
DA3B_LW14_019 is located on WC15, a tributary to Wongawilli Creek. The impacted feature is WC15_Rockbar 28 which is situated approximately 55m south of Longwall 14 at its closest point. The impact is comprised of rock fracturing and uplift (Photo 19 and 20). The rock fracture has a maximum measurable length of 4.5m, a maximum width of 0.05m, a maximum measurable depth of 0.7m.

Level 1: Crack or fracture up to 10m Length

Photo 19: DA3B_LW14_019, looking at a section of uplift. Taken 20/02/2019.

Photo 20: DA3B_LW14_019, looking at a section of rock fracturing. Taken 20/02/2019.

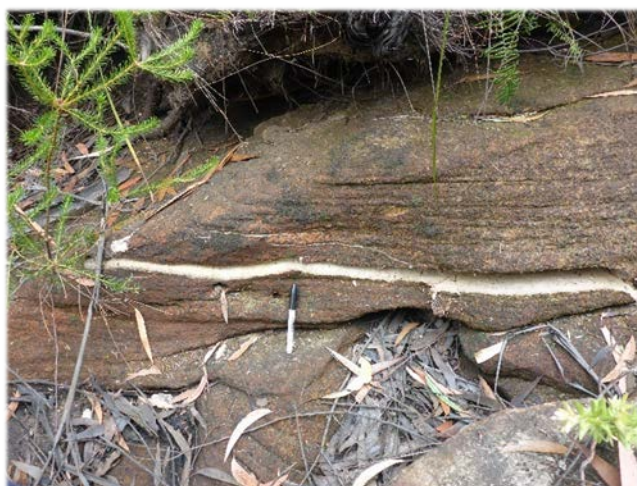
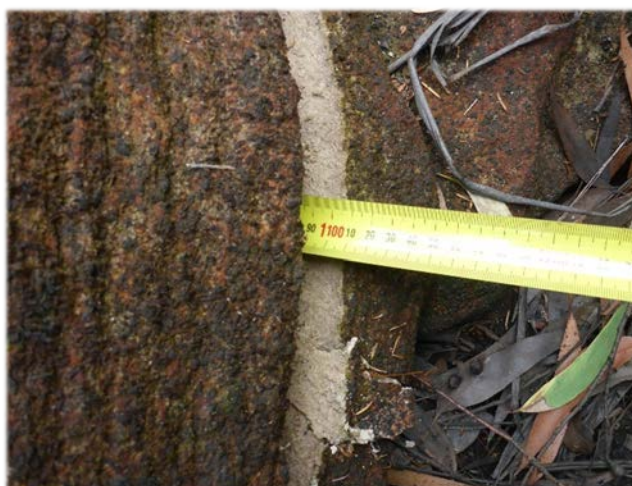
DA3B_LW14_020 is located on WC15, a tributary to Wongawilli Creek. The impacted feature is WC15_Rockbar 26 which is situated approximately 40m south east of Longwall 14 at its closest point. The impact is comprised of a rock fracture (Photo 21). The rock fracture has a maximum measurable length of 1.3m, a maximum width of 0.05m and a maximum measurable depth of 1.13m (Photo 22). While there was no active flow diversion observed through fractures, it is likely diversion would occur during higher flow conditions.

Level 2: Crack or fracture that results in observable loss of surface water

Photo 21: DA3B_LW14_020, looking at the extent of the rock fracturing. Taken 20/02/2019.

Photo 22: DA3B_LW14_020, looking at the depth of the fracturing. Taken 20/02/2019.

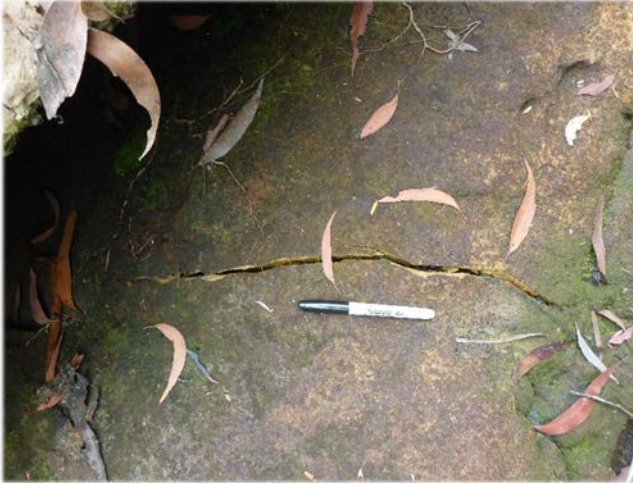
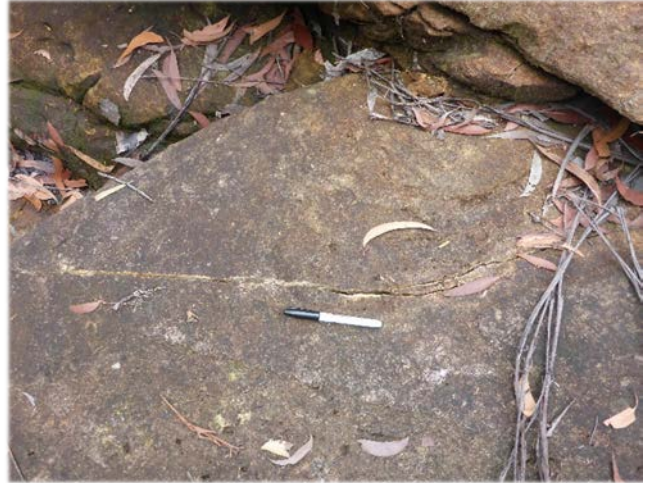
DA3B_LW14_021 is located on WC15, a tributary to Wongawilli Creek. The impacted features are WC15_Rockbar 21 and WC15_step 21 which are situated approximately 100m east of Longwall 14 at its closest point. The impact is comprised of two rock fractures (Photo 23 and 24). The rock fractures have a maximum measurable length of 1.1m and a maximum width of 0.01m. While there was no active flow diversion observed through fractures, it is likely diversion would occur during higher flow conditions.

Level 2: Crack or fracture that results in observable loss of surface water

Photo 23: DA3B_LW14_021, looking at the section of rock fracturing. Taken 20/02/2019.

Photo 24: DA3B_LW14_021, looking at the section of rock fracturing. Taken 20/02/2019.

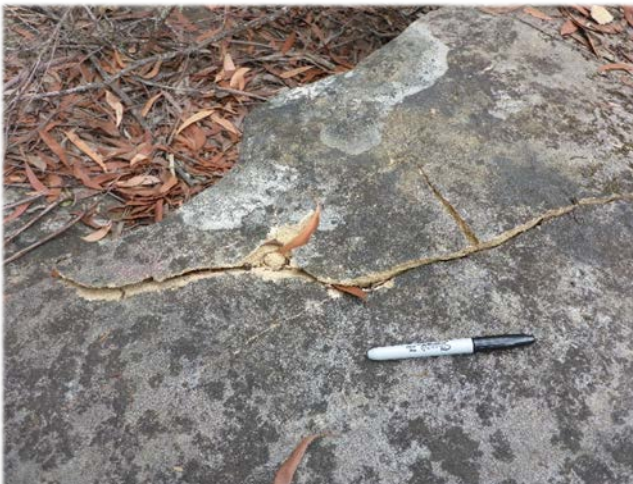
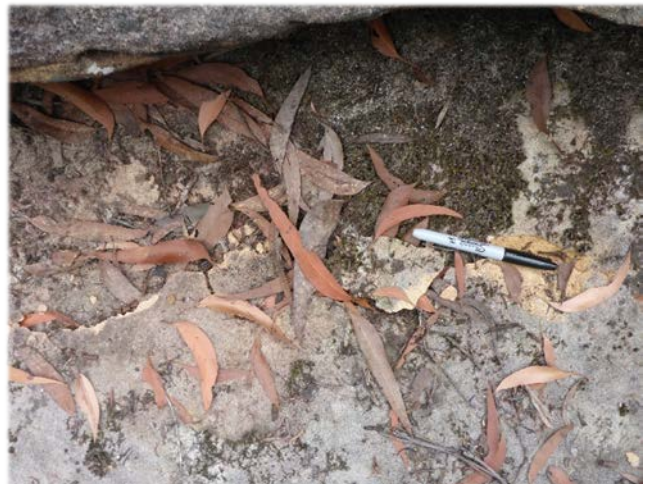
DA3B_LW14_022 is located on WC15, a tributary to Wongawilli Creek. The impacted feature is WC15_Rockbar 18 which is situated approximately 150m east of Longwall 14 at its closest point. The impact is comprised of a rock fracture (Photo 25 and 26). The rock fracture has a maximum measurable length of 2.9m, and a maximum width of 0.05m. While there was no active flow diversion observed through fractures, it is likely diversion would occur during higher flow conditions.

Level 2: Crack or fracture that results in observable loss of surface water

Photo 25: DA3B_LW14_022, looking at the section of rock fracturing. Taken 20/02/2019.

Photo 26: DA3B_LW14_022, looking at the section of rock fracturing. Taken 20/02/2019.

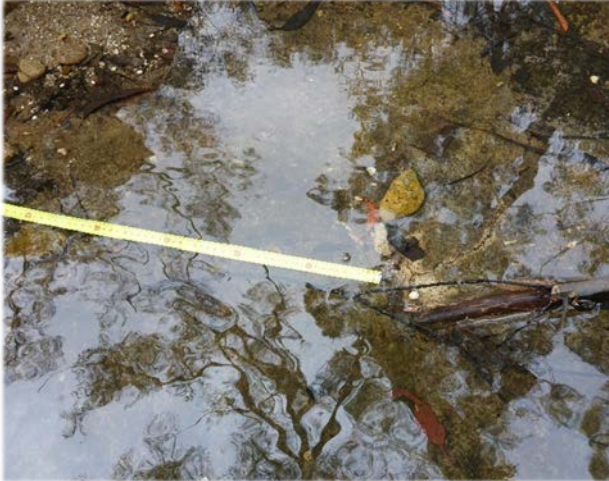
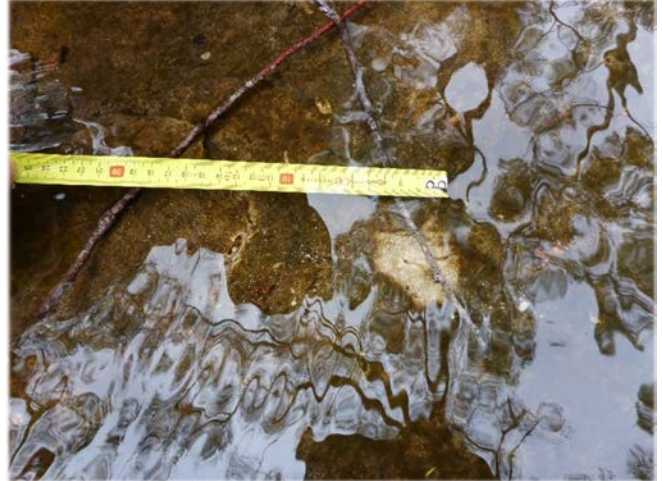
Level 1: Crack or fracture up to 10m Length

Photo 27: DA3B_LW14_023, looking at a section of rock fracturing. Taken 01/04/2019.

Photo 28: DA3B_LW14_023, looking at a section of rock fracturing. Taken 01/04/2019.

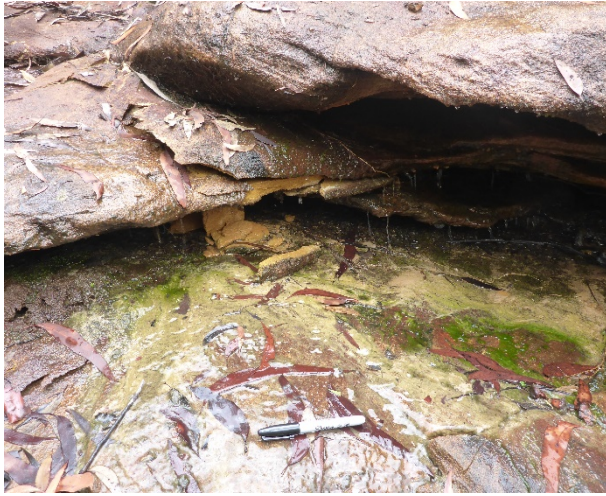
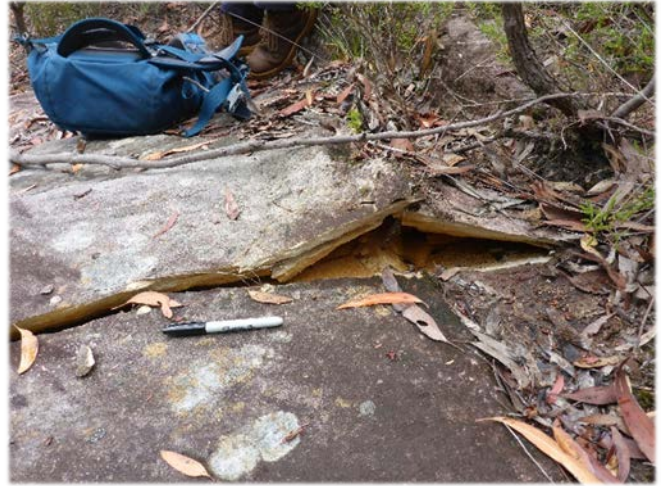
Additional fracturing with flow diversion was observed during a Longwall 14 inspection (Photo 29 and 30). The largest fracture is now 3.7m long, with the widest fracture up to 0.02m wide. Uplifted sections of rock and flow diversion are associated with the fracturing.

Level 2: Crack or fracture that results in observable loss of surface water

Photo 29: DA3B_LW13_035, fracturing with flow diversion across small step on rockbar. Taken on 21/01/2019.

Photo 30: DA3B_LW13_035, fracturing and uplift on rockbar. Taken on 21/01/2019.

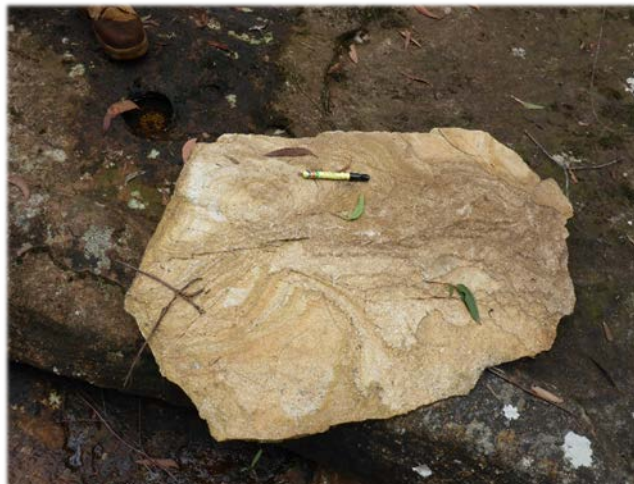
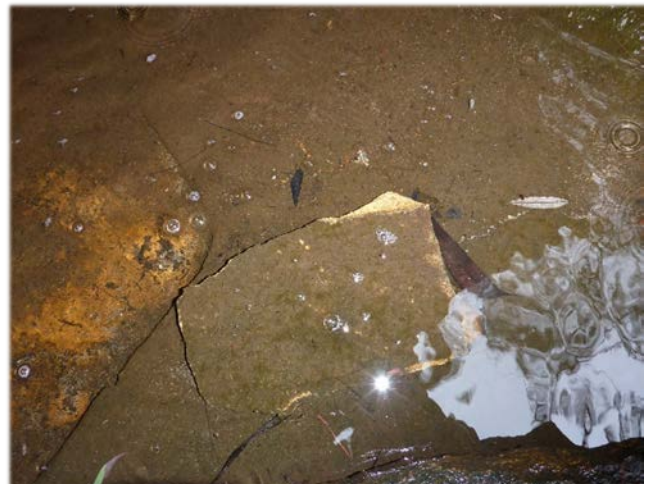
Level 2: Crack or fracture that results in observable loss of surface water

Photo 31: DA3B_LW13_042, looking at largest section of rock fragmentation. Taken 01/04/2019.

Photo 32: DA3B_LW13_042, looking at a section of new rock fracturing. Taken 01/04/2019.

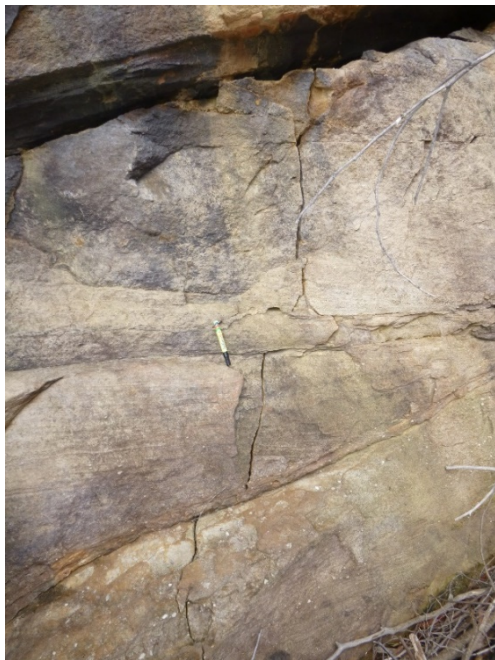
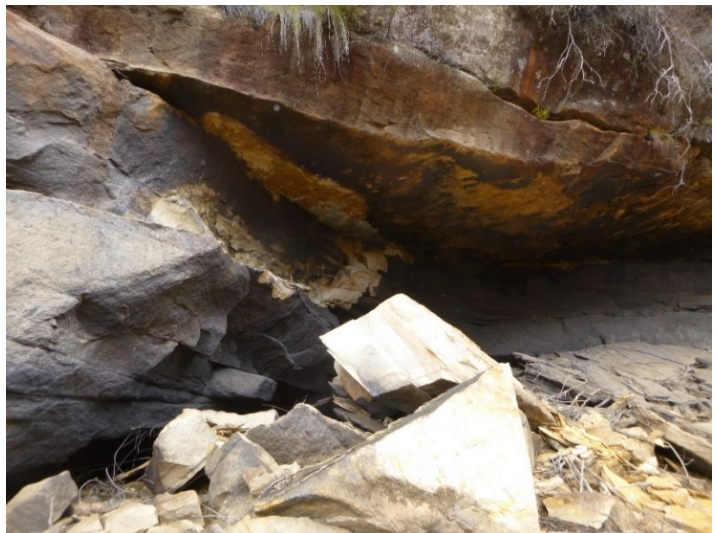
Level 1: Rockfall from a cliff which is left mostly intact (<10% length), resulting in insignificant ground disturbance.

Photo 33: *DA3B_LW14_015*, looking at a section of rock fracturing. Taken 6/12/2018.

Photo 34 : *DA3B_LW14_015*, looking at the rockfall. Taken 6/12/2018.

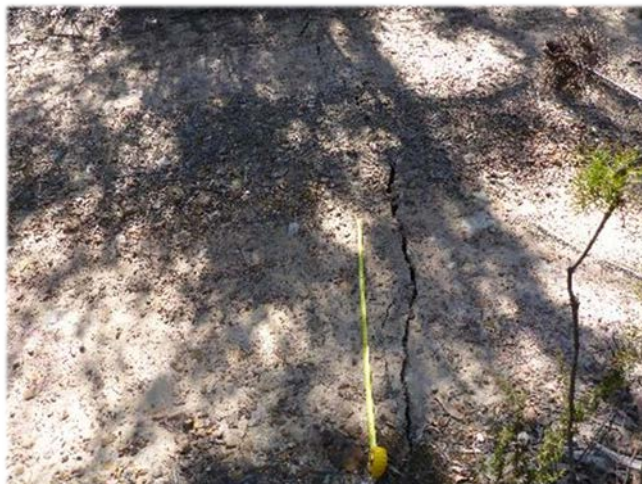
Photo 35: DA3b_LW14_003. Taken 7/07/18.

Erosion in a localised area, which would be expected to naturally stabilise without CMA and within the period of monitoring.

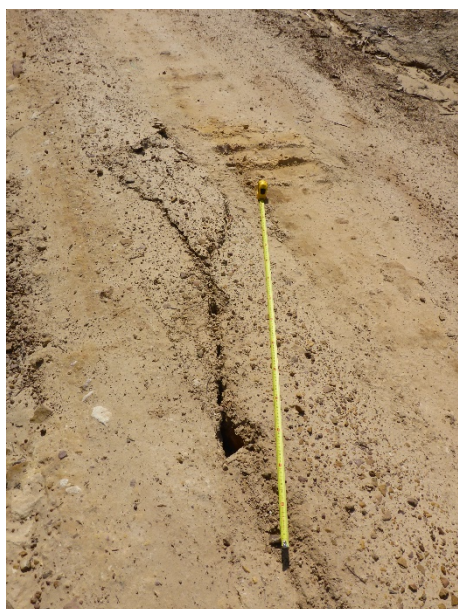
Photo 39: DA3B_LW14_010. Taken 10/09/18.

Crack or fracture between 10m and 50m length.

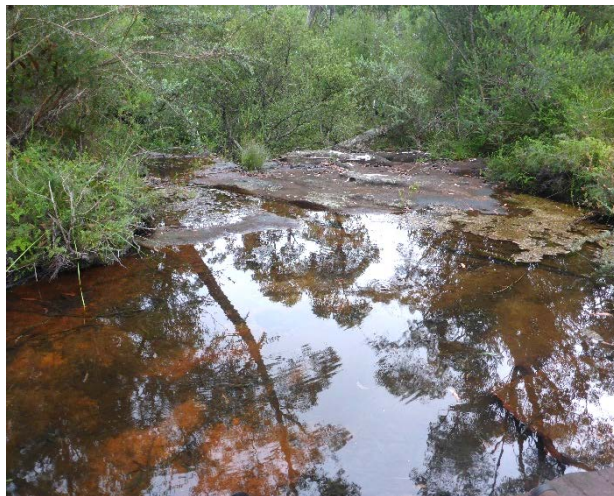
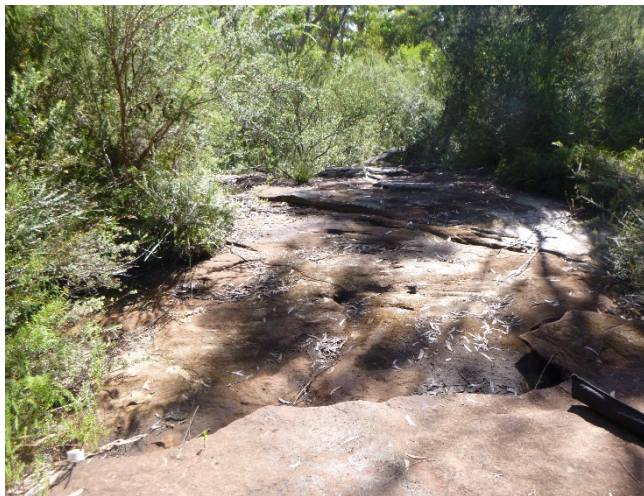
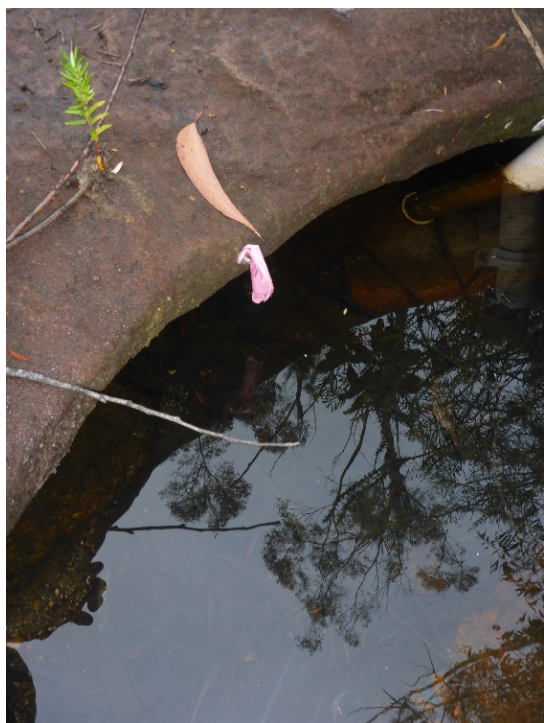
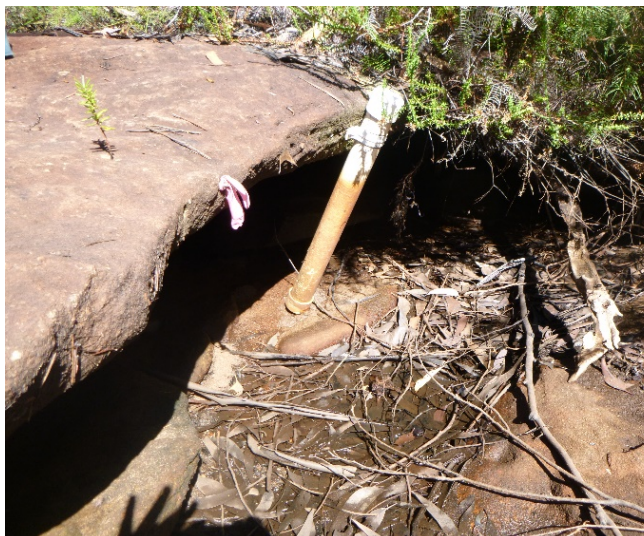
WC15_Pool 28 is located on WC15, a tributary to Wongawilli Creek. The pool is situated approximately 47m south east of Longwall 14. Recent data and observations show water levels have decreased despite rainfall events (Photo 41 to Photo 44, Figure 14). No fractures have been identified in the pool however three surface impacts to WC15 have been recorded upstream.

Photo 41: WC15_Pool 28, looking downstream. Taken 5/02/2019.

Photo 42: WC15_Pool 28, looking downstream. Taken 11/02/2019.

Photo 43: WC15_Pool 28, looking upstream. Taken 5/02/2019.

Photo 44: WC15_Pool 28, looking upstream. Water level logger housing also shown. Taken 11/02/2019.
