Monitoring of watercourses, swamps and landscape features is undertaken to identify subsidence impacts. These features are monitored by the Illawarra Coal Environmental Field Team (ICEFT) monthly prior to mining and weekly during mining. Monitoring is conducted in accordance with the approved Subsidence Management Plan (SMP) for Dendrobium Area 3B (DA3B). Extraction of Longwall 14 began on the 22nd of May 2018. During the most recent inspection, carried out on the 3rd of July, 2018, one new impact was identified.

DA3B_LW14_001 (288584 E, 6192249 N)

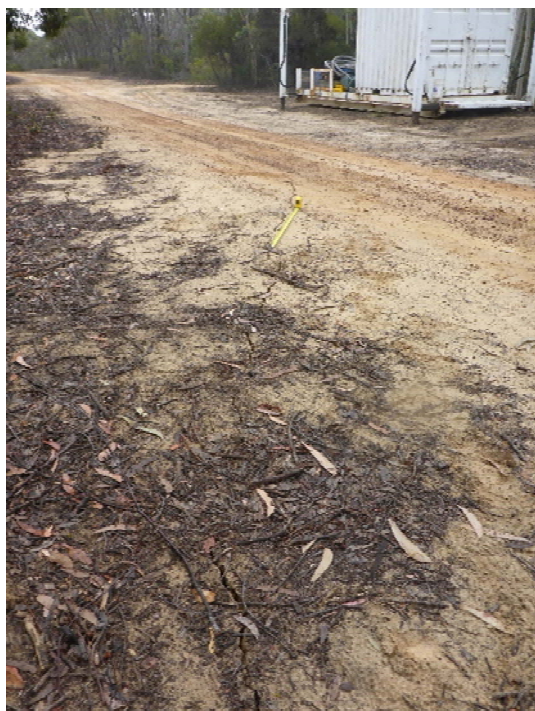
Impact DA3B_LW14_009 consists of three soil cracks along 20 m of Fire Road 6A, adjacent to the intersection with Fire Trail 6N (Figure 1). The largest continuous crack is approximately 5 m long, 0.02 m wide and 0.4 m at the deepest measurable point (Photo 1 and 2). The cracking does not impede access along the track and is a Level 1 trigger as per the Dendrobium Area 3B Landscape TARP (Appendix A: Table 1), specifically:

- Crack or fracture up to 10m in length and 100mm width
- Crack in a fire trail that should not result in erosion or impede access

Photo 1: Impact DA3B_LW14_009. Taken on 03/09/18.

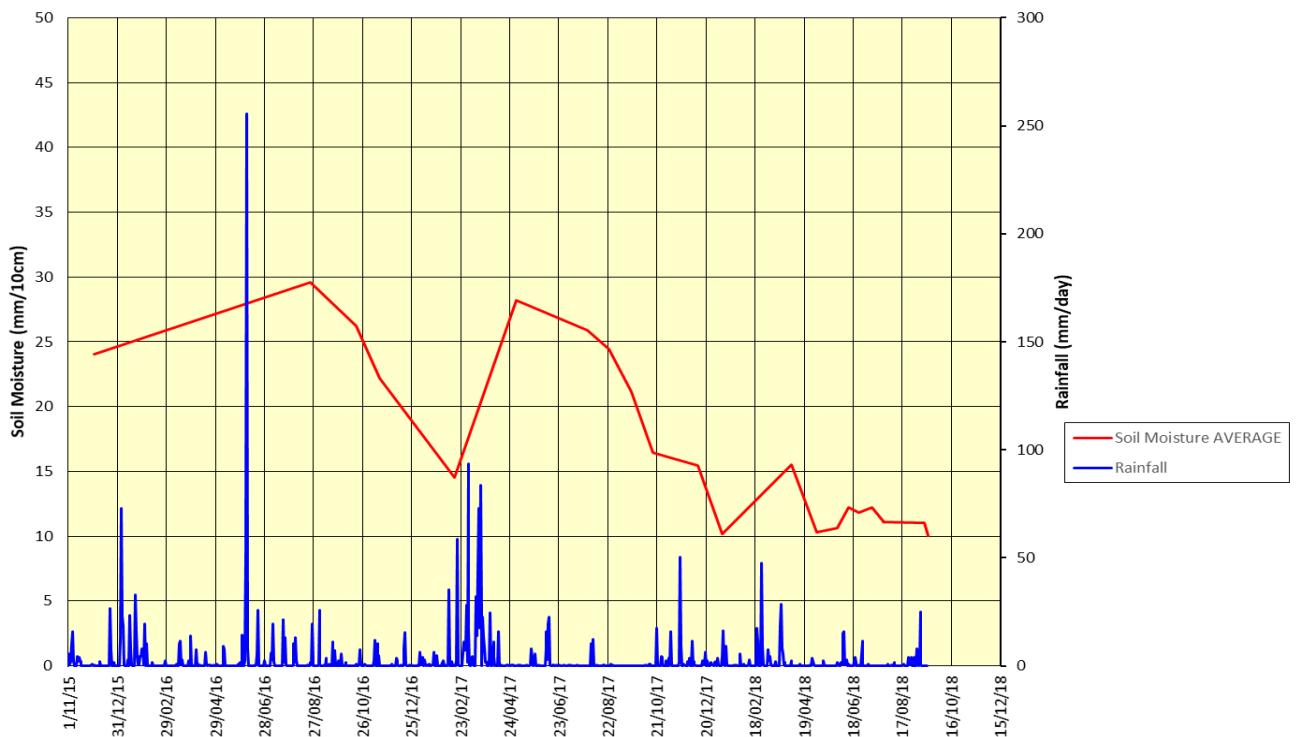
A soil moisture trigger was measured at site 23_02 during recent analysis of Swamp 23 soil moisture data. The site was established in July 2015, in a hand-augured hole. The site was passed by Longwall 14 on 8/7/18. Recent data indicates that soil moisture levels at this site have dropped below baseline levels, and is a Level 1 trigger as per the Dendrobium Area 3B Swamp TARP (Appendix A, Table 2), specifically:

- Soil moisture level lower than baseline level at any monitoring sites (within 400m of mining) within a swamp

Figure 1: Soil moisture levels at 23_02, date range 3/12/15 – 17/09/18

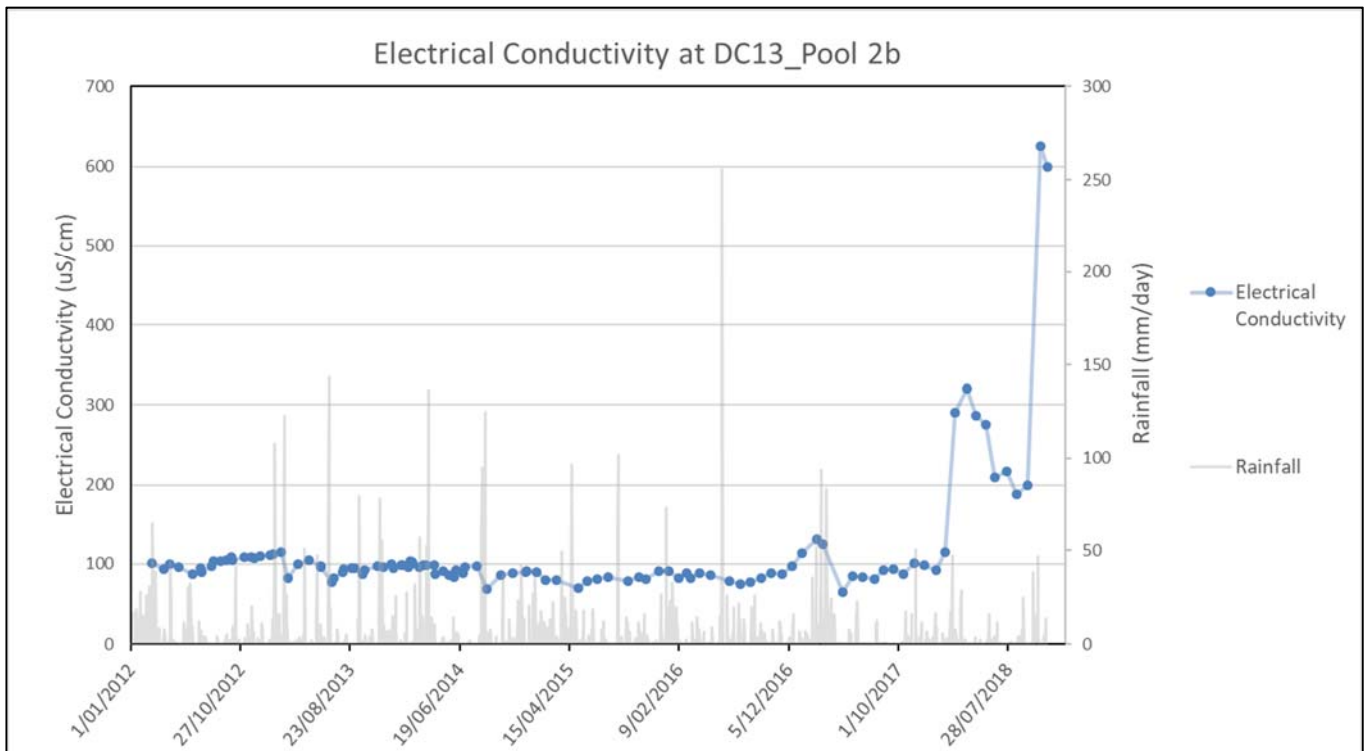
The site is approximately 2400m away from current Longwall 14. The changes in field parameters don't appear to be reflected at other nearby sites.

Graph 1: Electrical conductivity recorded at site *DC13_Pool 2b*, downstream from DA3B operations.

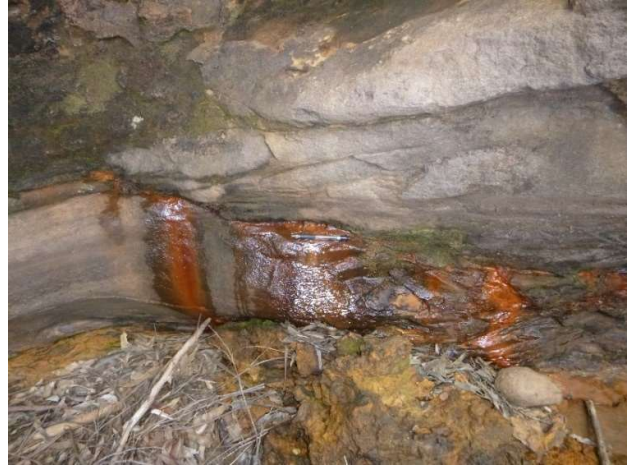
Photo 4: DA3B_LW13_043, looking at iron staining. Taken on 6 December 2018.

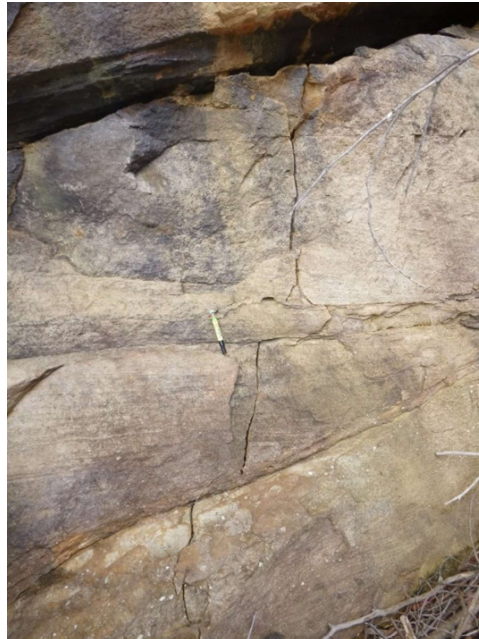
- Rockfall from a cliff which is left mostly intact (<10% length), resulting in insignificant ground disturbance.

Photo 5: DA3B_LW14_015, looking at a section of rock fracturing. Taken on 6 December 2018.

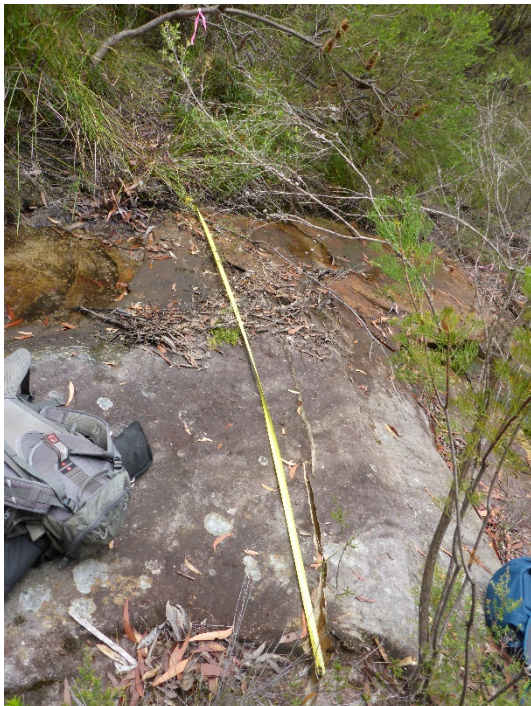
Photo 5: Fracturing across rockbar. Taken on 21/01/2019.

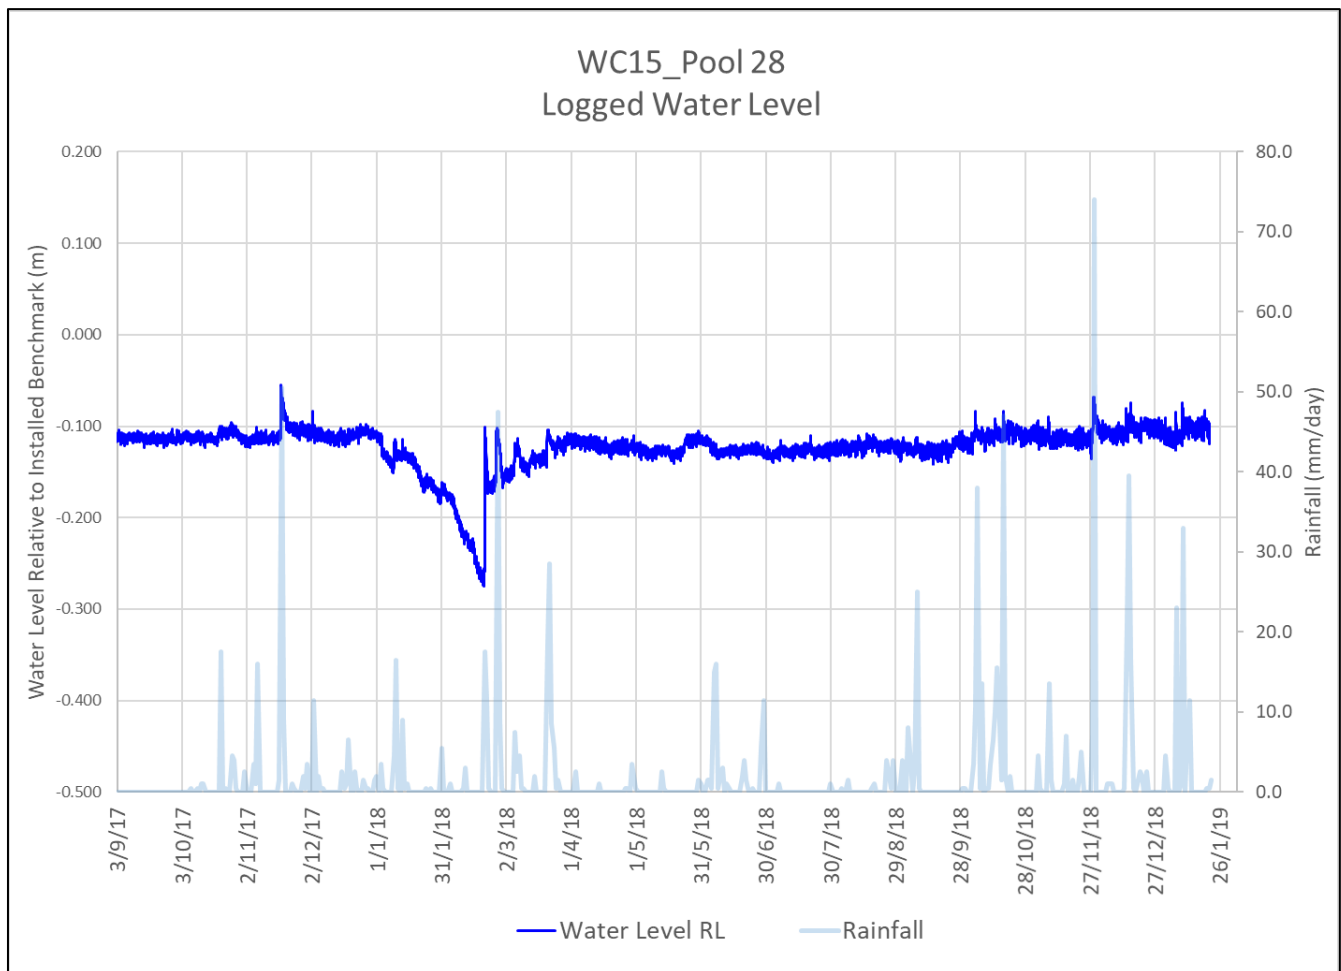
Graph 1: Pool water level results from logger installed at WC15_Pool 28.

WC15_Pool 28 is located on *WC15*, a tributary to *Wongawilli Creek*. The pool is situated approximately 47m south east of Longwall 14 (Figure 2 and Graph 1). Recent data and observations show water levels have decreased despite recent rainfall events (Graph 1 and Photos 1-2). No fracturing in the pool or surface flow was observed during the most recent inspection. No surface impacts have been recorded upstream, however rock fracturing was identified 30m downstream on an inspection carried out on 21 January 2019.

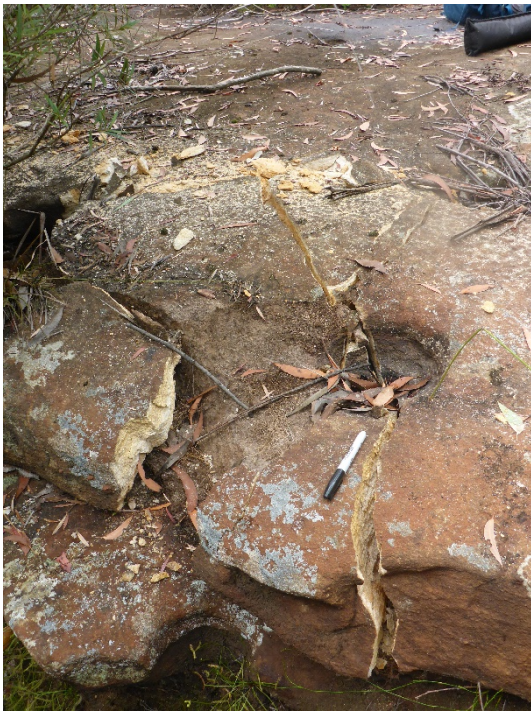
Photo 6: Fracturing and dislodged sections of rock extending down step. Taken on 21/01/2019.

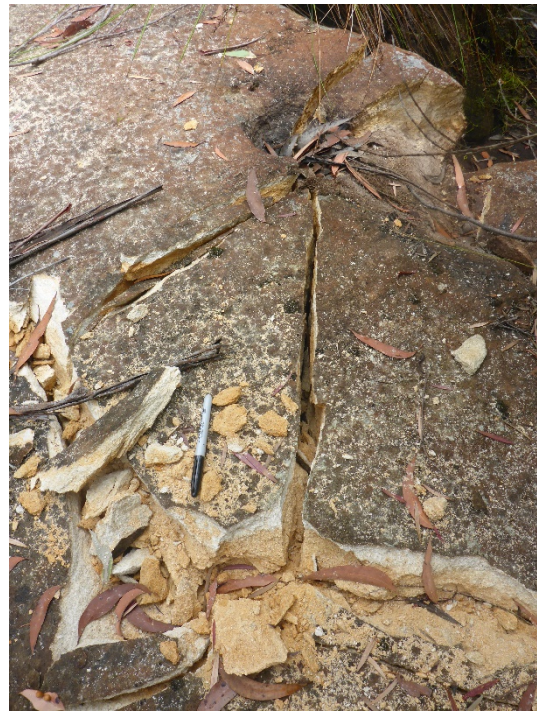
Photo 7: Fracturing and dislodged sections of rock extending along rockbar. Taken on 21/01/2019.

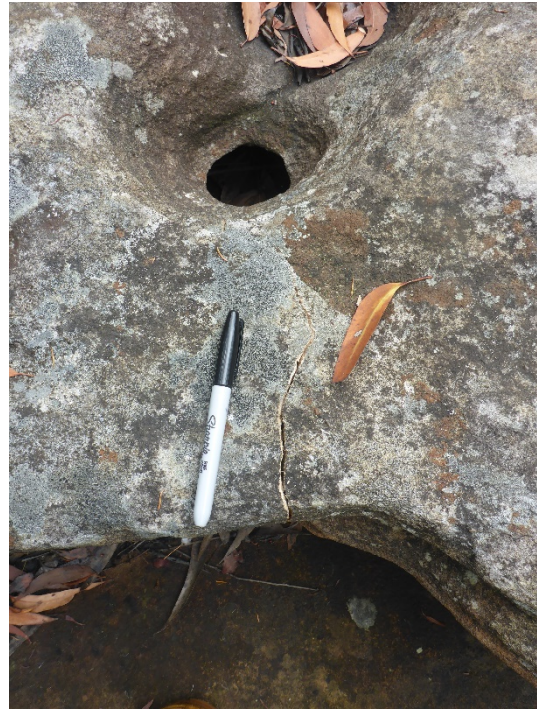
Photo 11: Fracture to incised step. Taken on 21/01/2019.

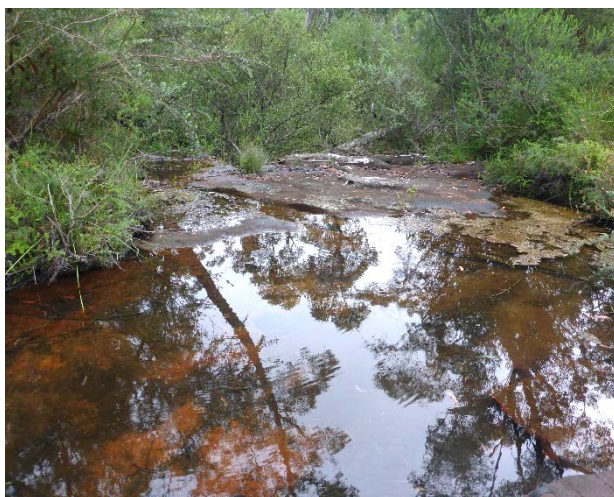
Photo 1: *WC15_Pool 28*, looking downstream. Taken 5/02/2019.

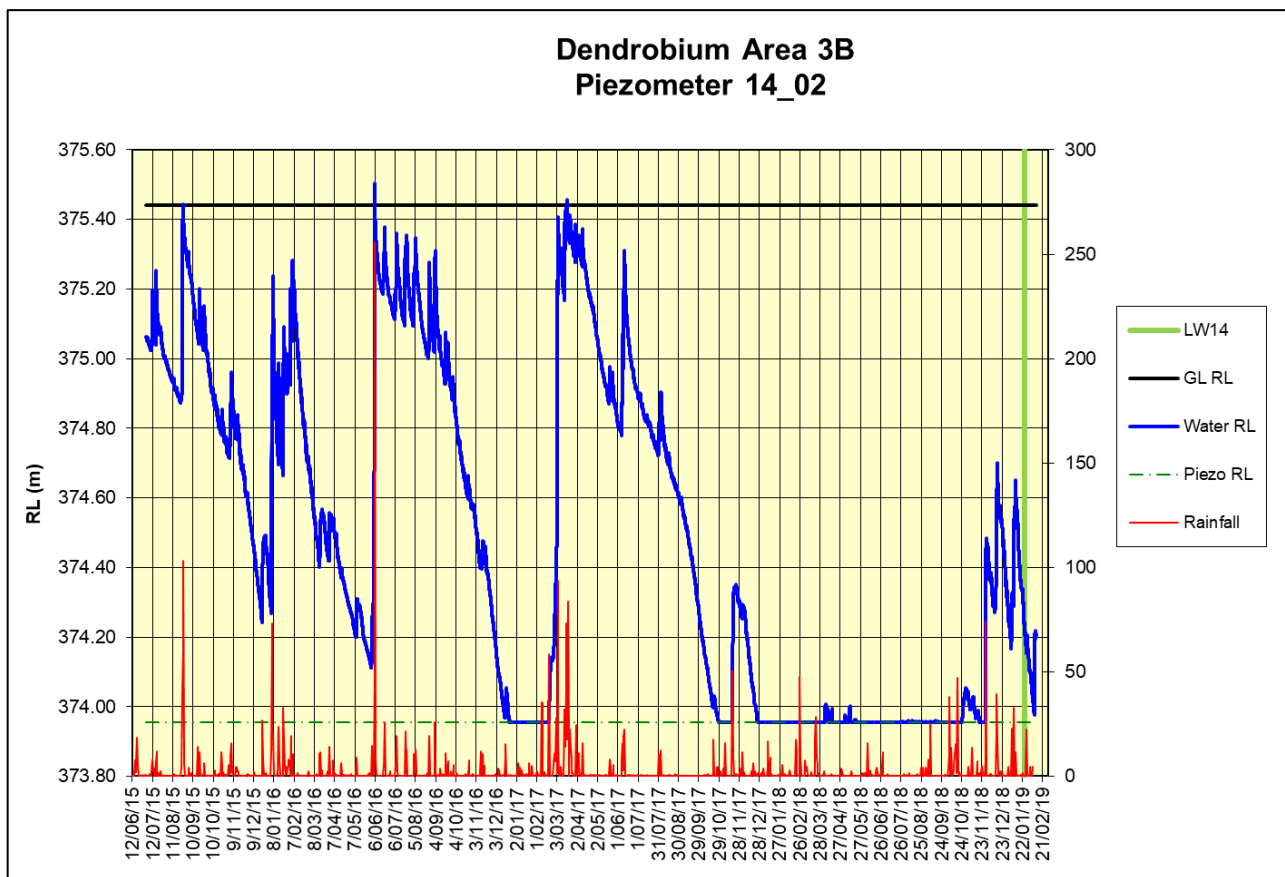
- Rate of groundwater level reduction exceeds rate of groundwater level reduction during baseline period at **50%** of monitoring sites (within 400m of mining) within the swamp

Graph 2: Shallow groundwater levels at 14_02, logged hourly, date range: 2/07/2015 to 11/02/2019

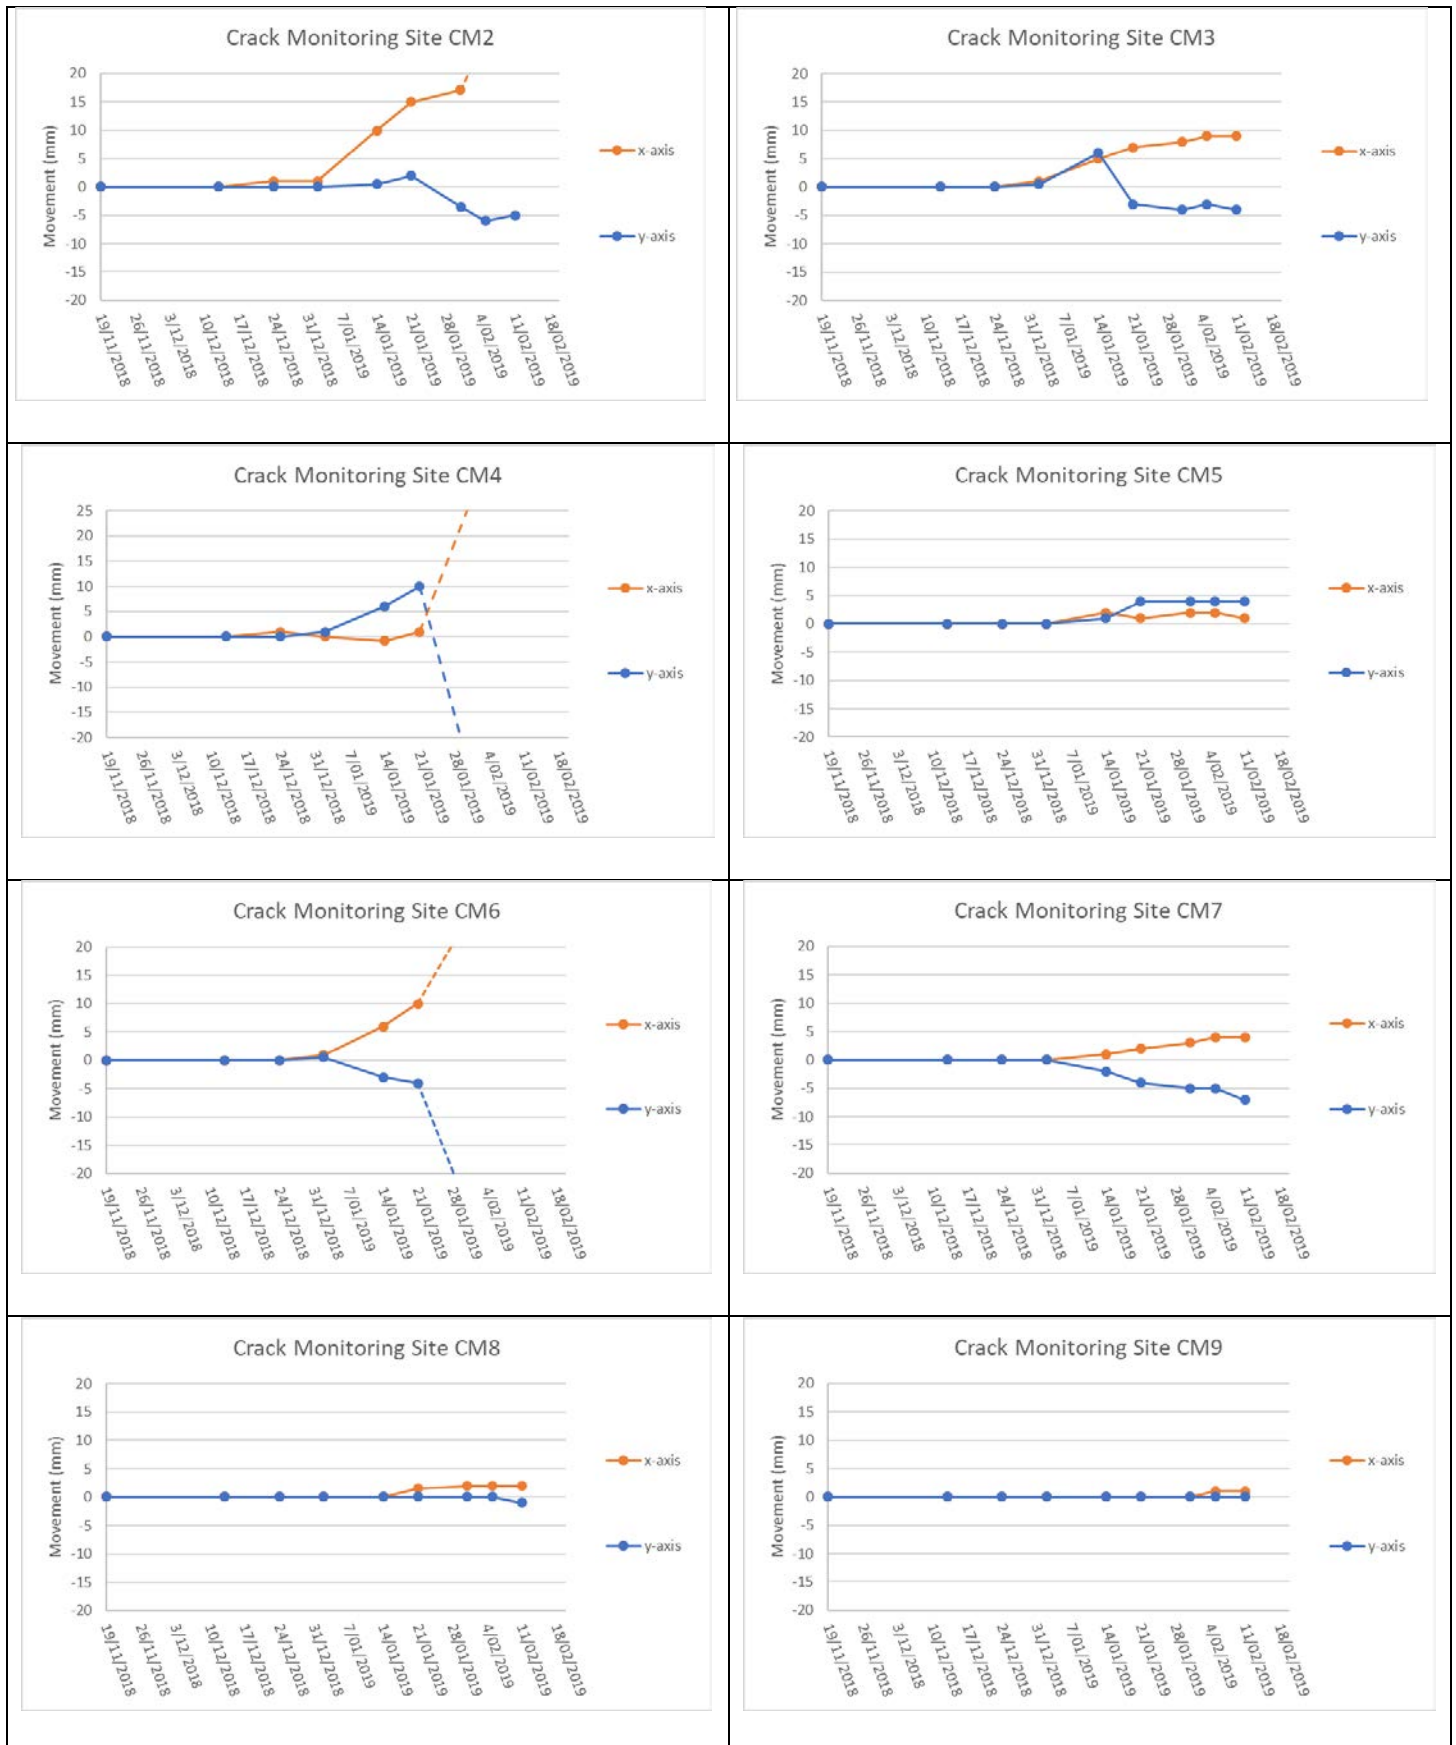
Crack monitoring devices were installed 9 November 2018 on pre-existing rock fractures resulting from Longwall 13. These devices were installed to measure the movement of fractures resulting from Longwall 14 (Figure 2). Figure 1 outlines the movement of each fracture. Devices dislodged by subsidence movements are represented with a dotted line.

Figure 1: WC15 crack monitoring - crack movements due to Longwall 14. Dotted lines indicate movement past measurable range.

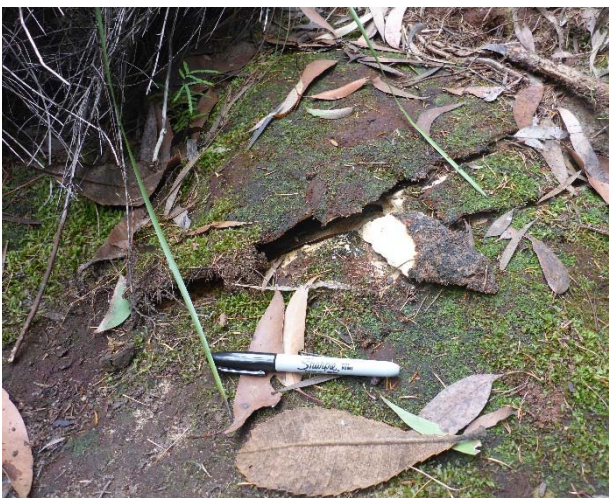
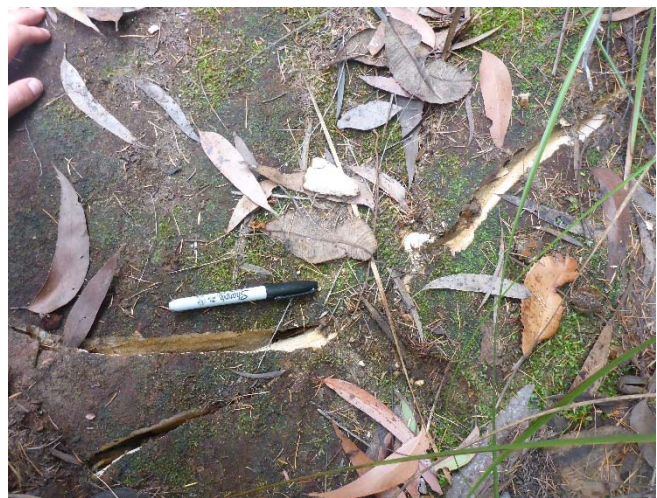
- Crack or fracture that results in observable loss of surface water or erosion

Photo 1: *DA3B_LW14_017*, looking at a section of rock fracturing. Taken 20/02/2019.

Photo 2: *DA3B_LW14_017*, looking at a section of rock fracturing. Taken 20/02/2019.

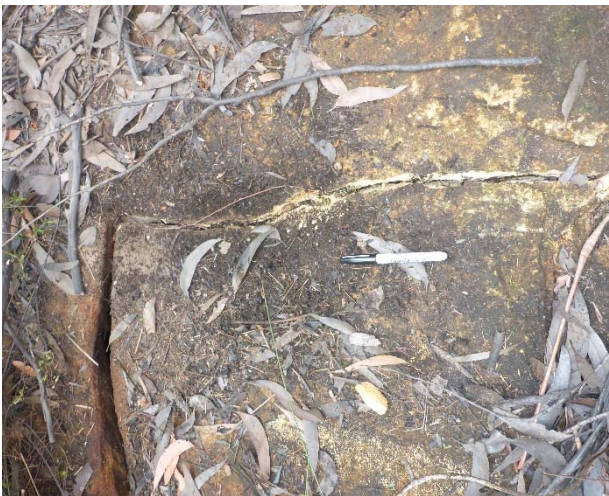
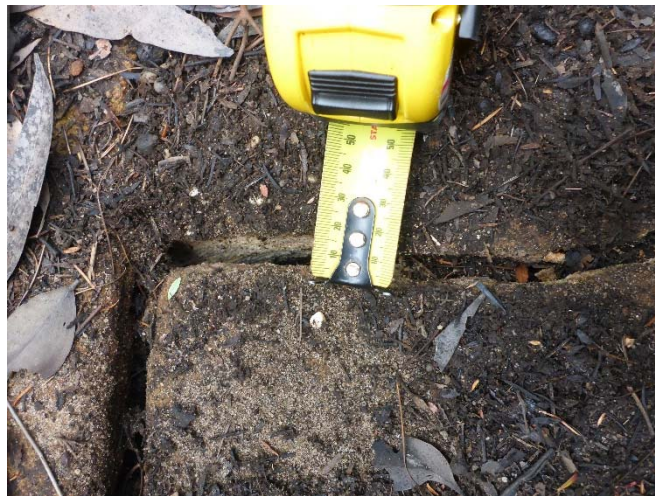
- Crack or fracture that results in observable loss of surface water or erosion

Photo 3: DA3B_LW14_018, looking at the extent of the rock fracturing. Taken 20/02/2019.

Photo 4: DA3B_LW14_018, looking at the width of the fracturing. Taken 20/02/2019.

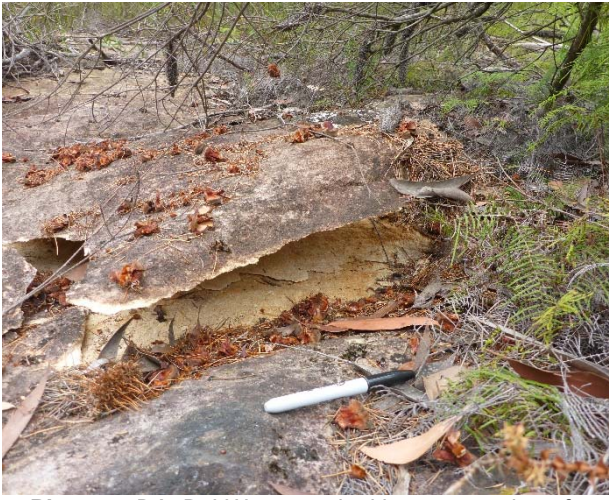
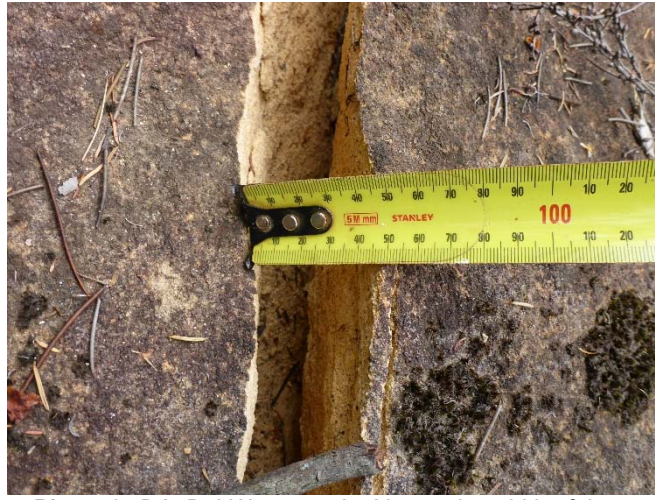
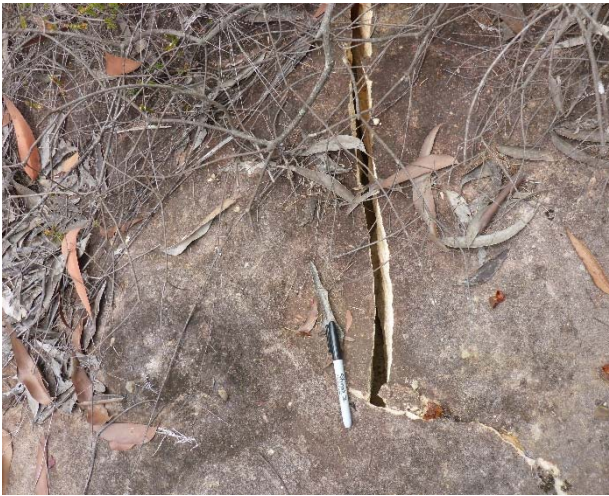
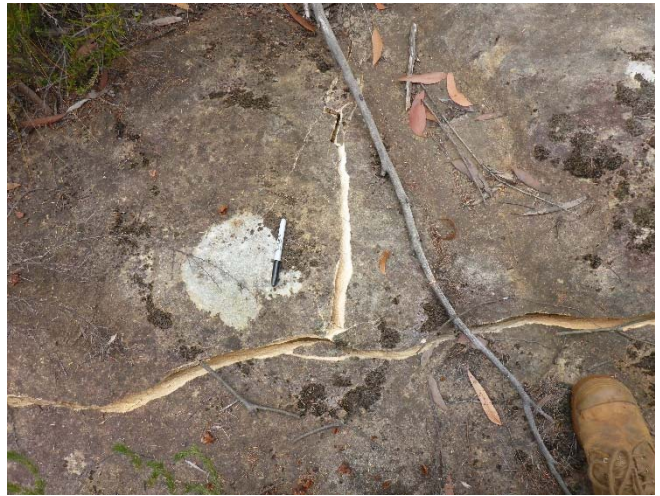
- Crack or fracture up to 10m length

Photo 5: DA3B_LW14_019, looking at a section of uplift. Taken 20/02/2019.

Photo 6: DA3B_LW14_019, looking at the width of the fracturing. Taken 20/02/2019.

Photo 7: DA3B_LW14_019, looking at a section of rock fracturing. Taken 20/02/2019.

Photo 8: DA3B_LW14_019, looking at a section of rock fracturing. Taken 20/02/2019.

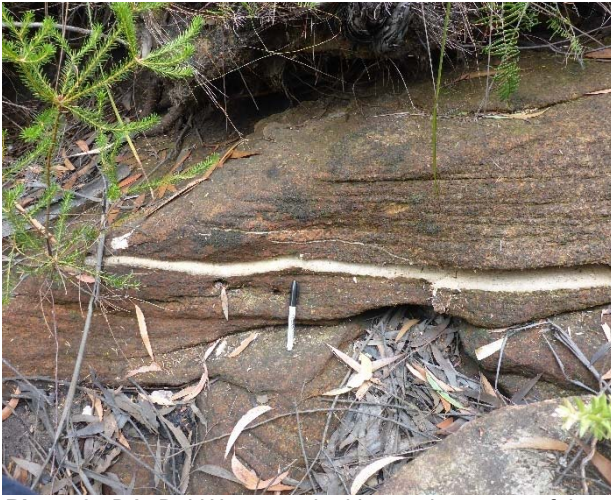
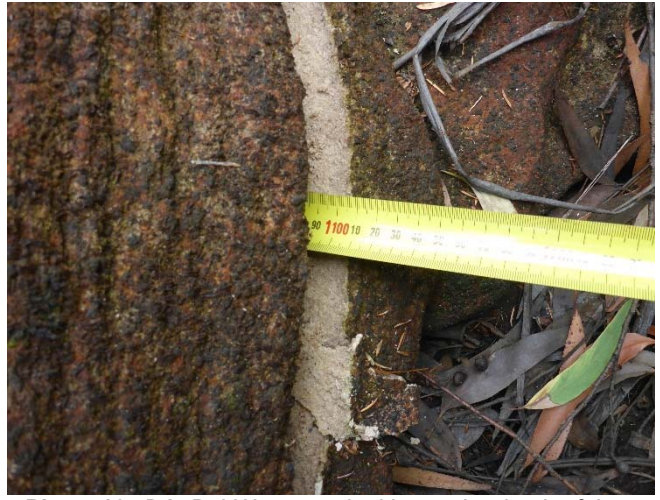
- Crack or fracture that results in observable loss of surface water or erosion

Photo 9: *DA3B_LW14_020*, looking at the extent of the rock fracturing. Taken 20/02/2019.

Photo 10: *DA3B_LW14_020*, looking at the depth of the fracturing. Taken 20/02/2019.

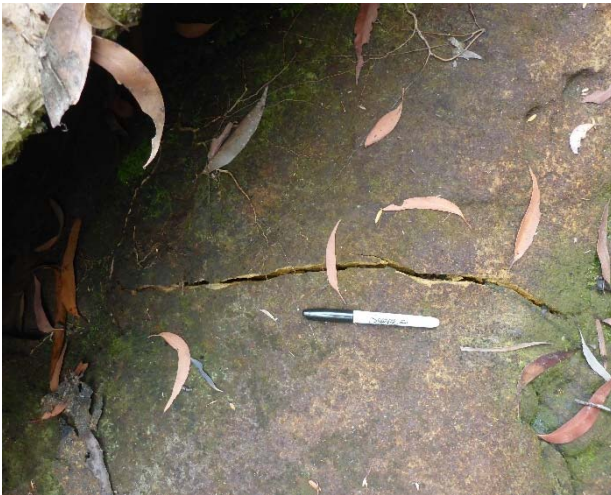
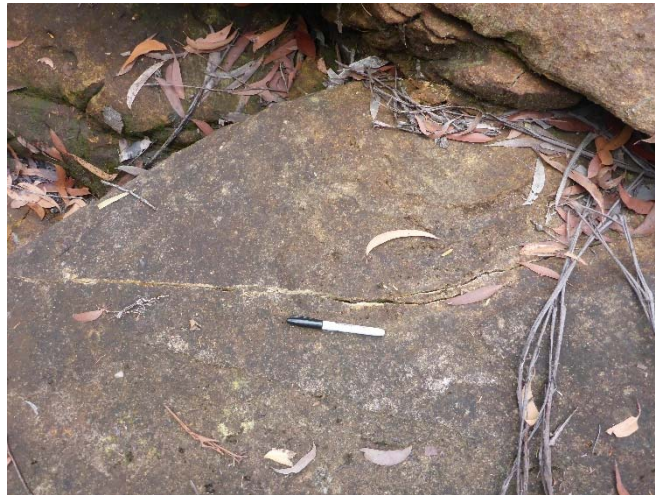
- Crack or fracture that results in observable loss of surface water or erosion

Photo 11: *DA3B_LW14_021*, looking at the section of rock fracturing. Taken 20/02/2019.

Photo 12: *DA3B_LW14_021*, looking at the section of rock fracturing. Taken 20/02/2019.

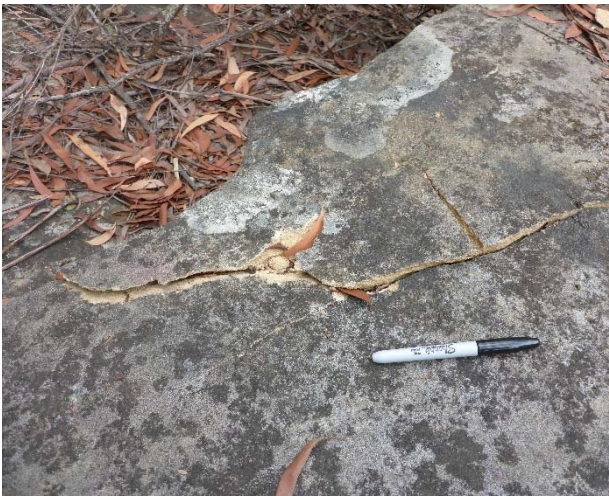
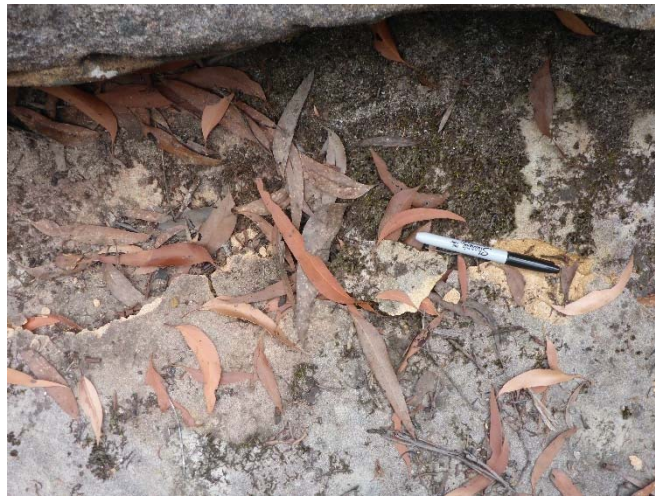
- Crack or fracture that results in observable loss of surface water or erosion

Photo 9: DA3B_LW14_022, looking at the rock fracturing. Taken 20/02/2019.

Photo 10: DA3B_LW14_022, looking at the rock fracturing. Taken 20/02/2019.

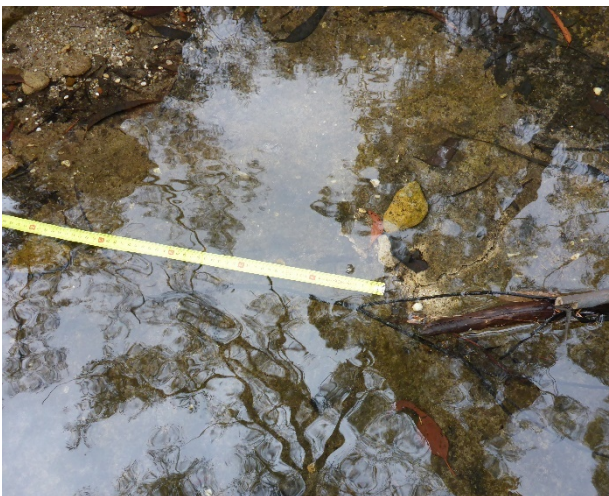
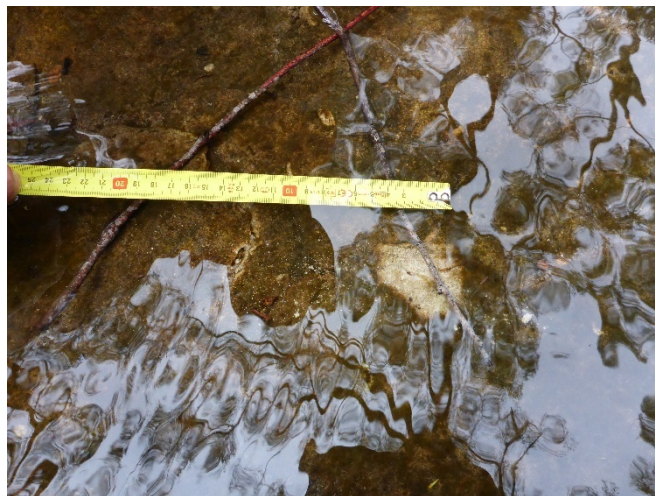
- Crack or fracture up to 100mm width at its widest point with no observable loss of surface water or erosion

Photo 1: *DA3B_LW14_023*, looking at a section of rock fracturing. Taken 01/04/2019.

Photo 2: *DA3B_LW14_023*, looking at a section of rock fracturing. Taken 01/04/2019.

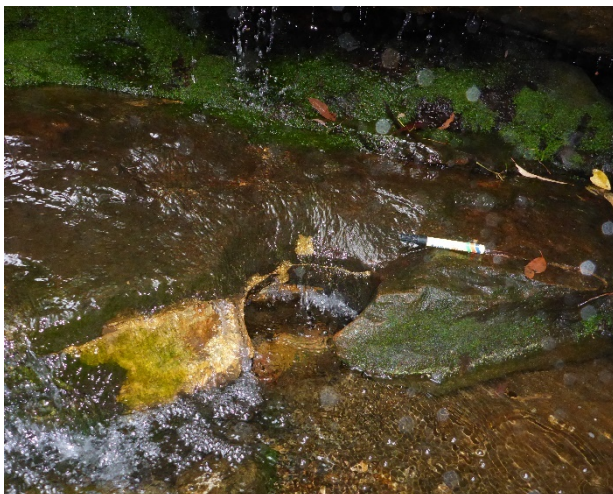
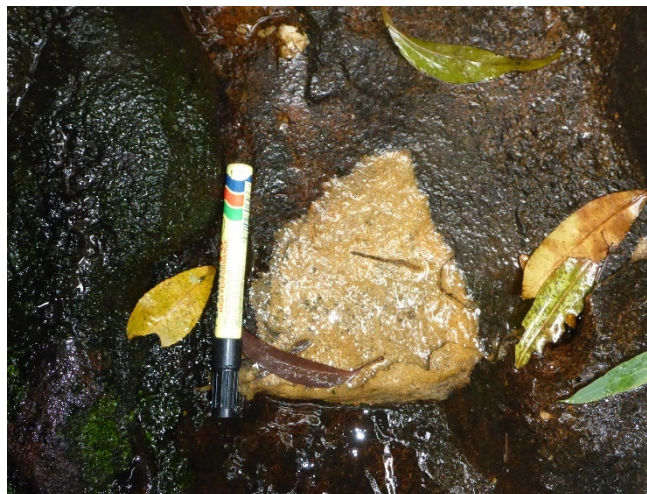
- Crack or fracture up to 100mm width at its widest point with no observable loss of surface water or erosion

Photo 3: *DA3B_LW13_046*, looking at the extent of the rock fracturing. Taken 01/04/2019.

Photo 4: *DA3B_LW13_046*, looking at the section of rock displacement. Taken 01/04/2019.

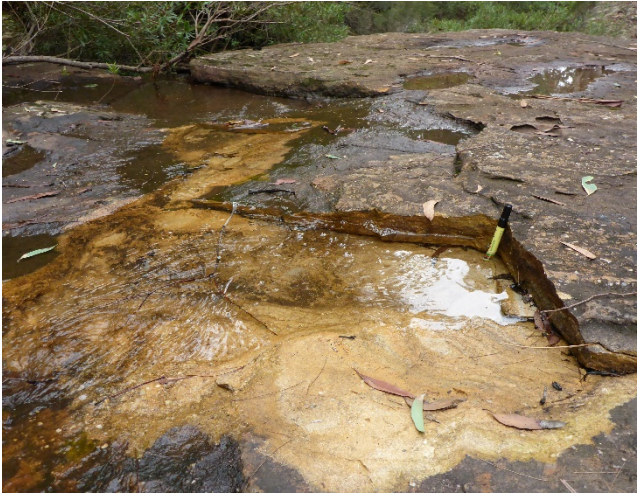
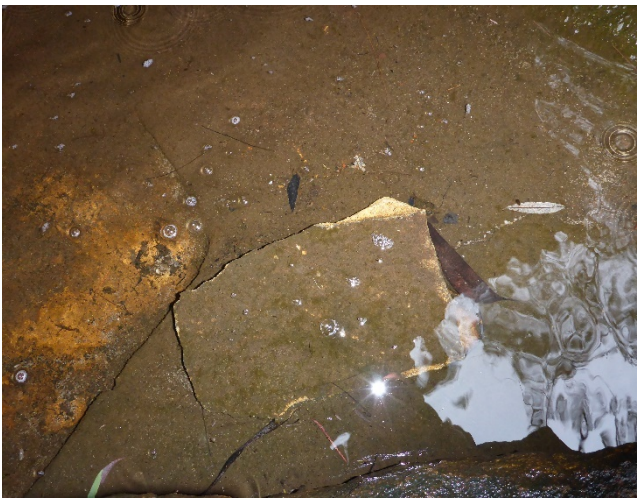
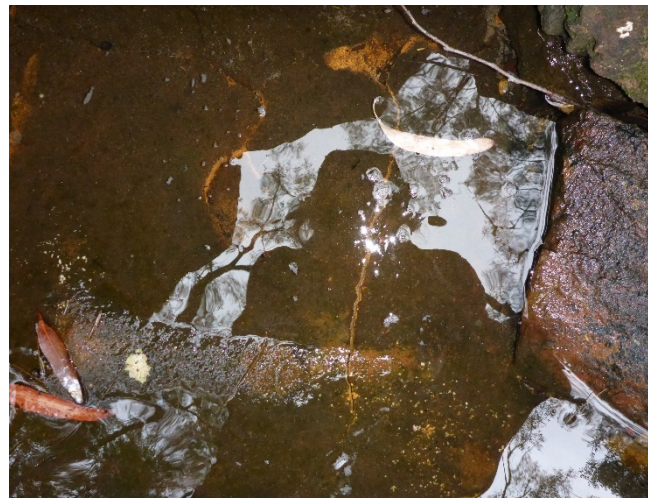
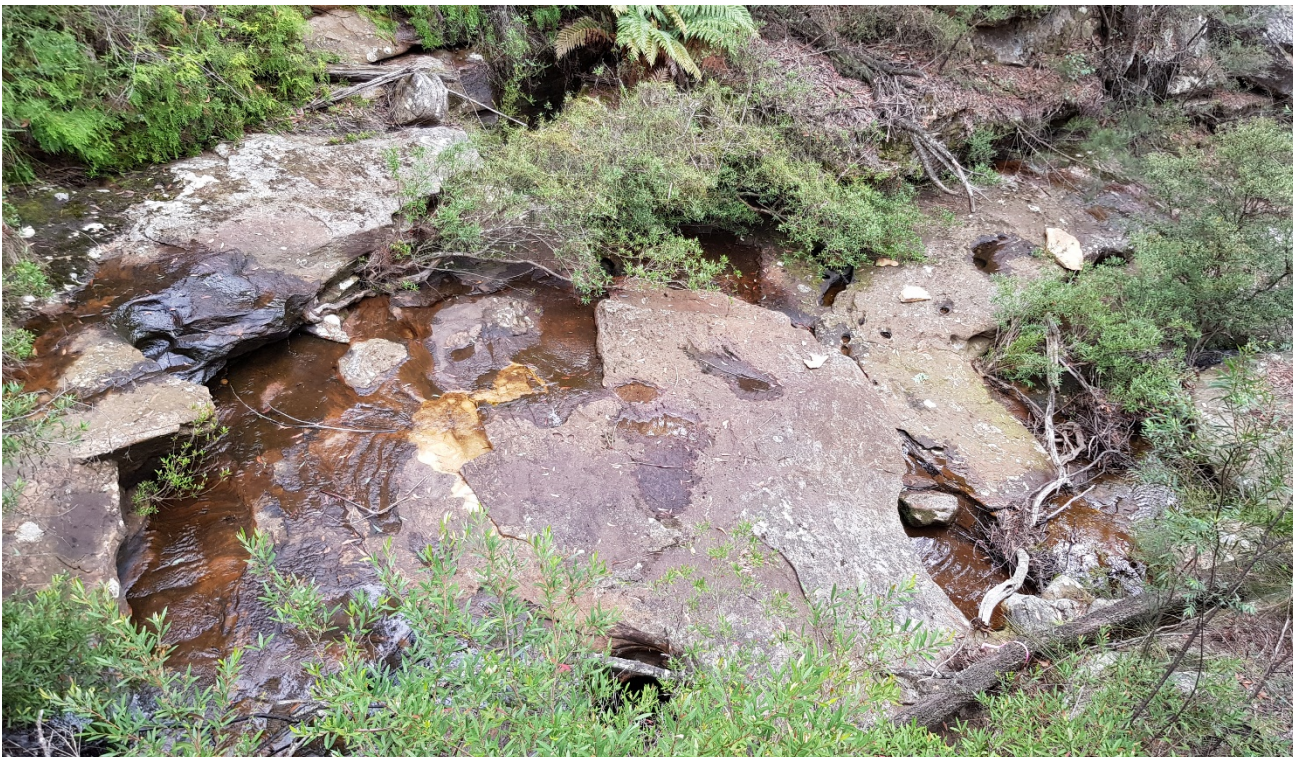
- Crack or fracture that results in observable loss of surface water or erosion

Photo 5: DA3B_LW13_042, looking at the largest section of rock dislodgement. Taken 01/04/2019.

Photo 6: DA3B_LW13_042, looking at largest section of rock fragmentation. Taken 01/04/2019.

Photo 7: DA3B_LW13_042, looking at a section of new rock fracturing. Taken 01/04/2019.

Photo 8: DA3B_LW13_042, looking at a section of new rock fracturing. Taken 01/04/2019.

Photo 9: DA3B_LW13_042, higher level view of the impact site. Looking at the area of rock dislodgement and transport downstream. Taken 01/04/2019.

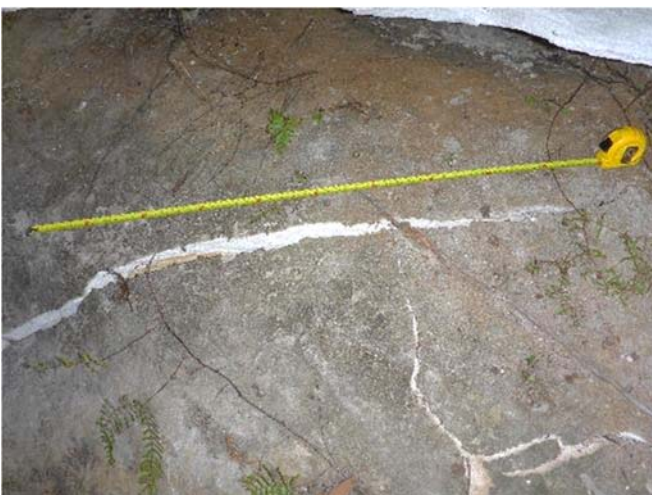
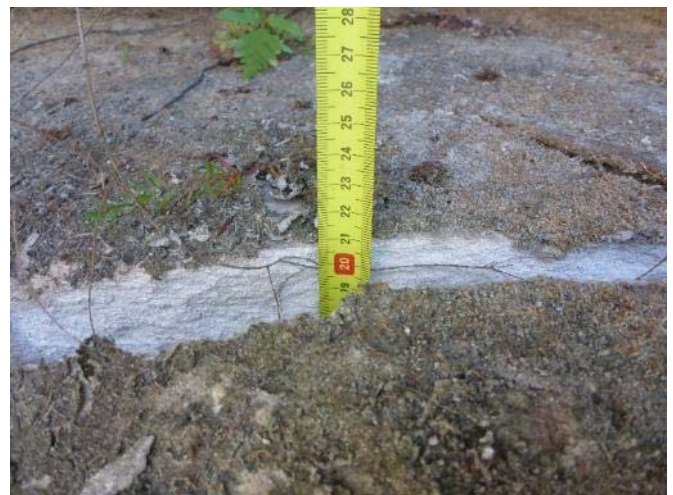
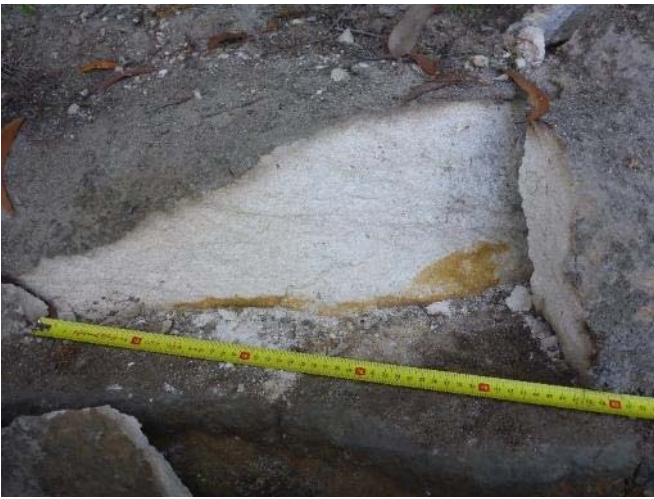
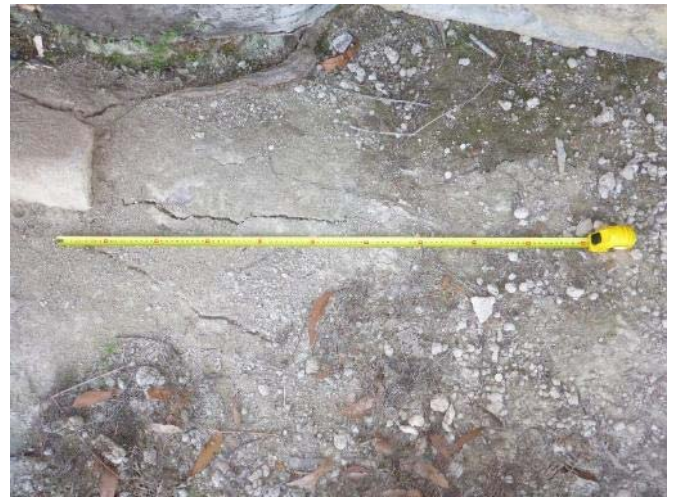
- Crack or fracture up to 100m width.
- Crack or fracture up to 10m length.
- Rock fall from a cliff (step) which is left mostly intact (<10% length) resulting in insignificant ground disturbance.

Photo 1: *DA3B_LW14_024*, looking at a section of rock fracturing. Taken 09/04/2019.

Photo 2: *DA3B_LW14_024*, looking at the depth of rock fracturing. Taken 09/04/2019.

Photo 3: DA3B_LW14_024, looking at the area of the rockfall. Taken 09/04/2019.

Photo 4: DA3B_LW14_024, looking at a section of soil cracking. Taken 09/04/2019.

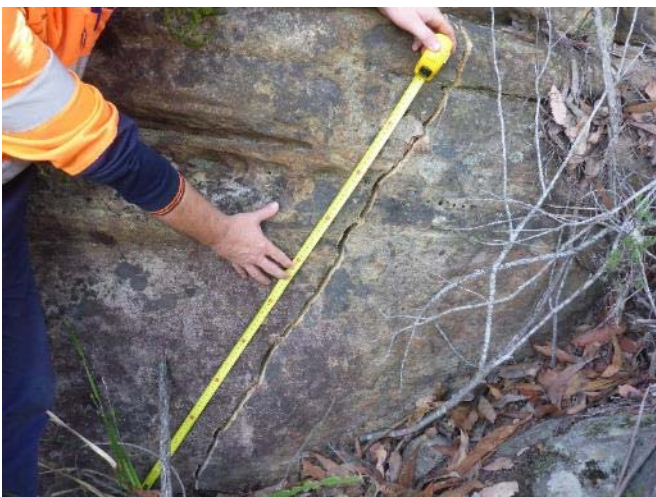
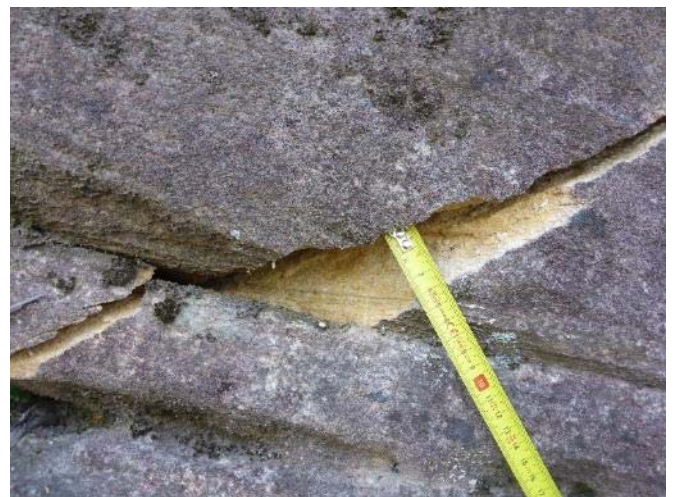
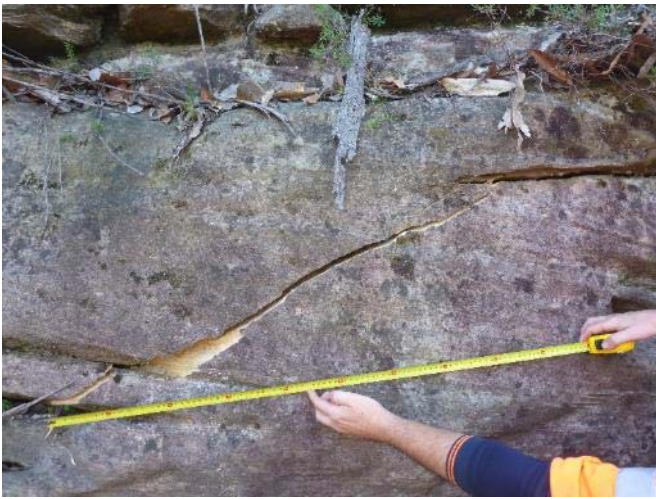
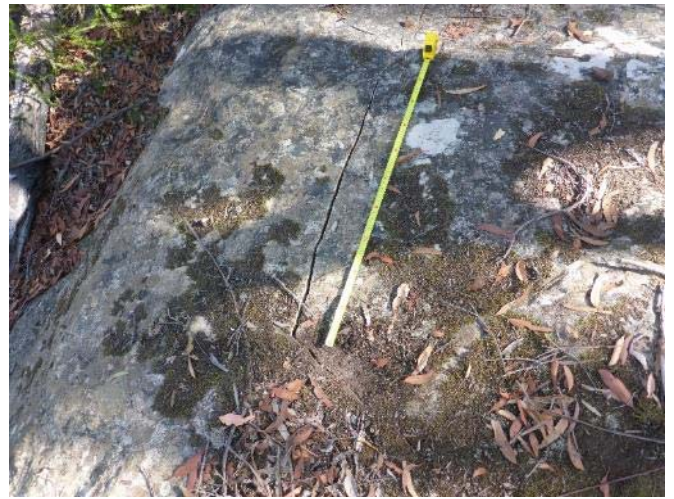
- Crack or fracture up to 100m width.
- Crack or fracture up to 10m length.

Photo 5: DA3B_LW14_025, looking at a section of the rock fracturing. Taken 09/04/2019.

Photo 6: DA3B_LW14_025, looking at the width of the rock fracturing. Taken 09/04/2019.

Photo 7: *DA3B_LW14_025*, looking at a section of the rock fracturing and displacement. Taken 09/04/2019.

Photo 8: *DA3B_LW14_025*, looking at a section of the rock fracturing. Taken 09/04/2019.
