Monitoring of watercourses, swamps and landscape features is undertaken to identify subsidence impacts. These features are monitored by the Illawarra Coal Environmental Field Team (ICEFT) monthly prior to mining and weekly during mining. Monitoring is conducted in accordance with the approved Subsidence Management Plan (SMP) for Dendrobium Area 3B (DA3B). Extraction of Longwall 14 began on the 22nd of May 2018. During the most recent inspection, carried out on the 3rd of July, 2018, one new impact was identified.

DA3B_LW14_001 (288584 E, 6192249 N)

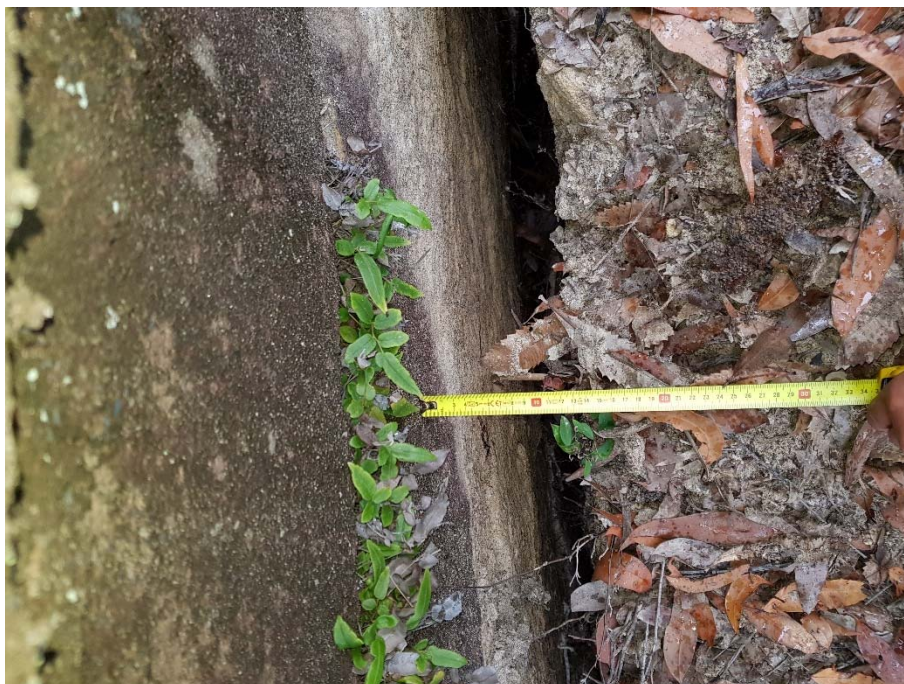
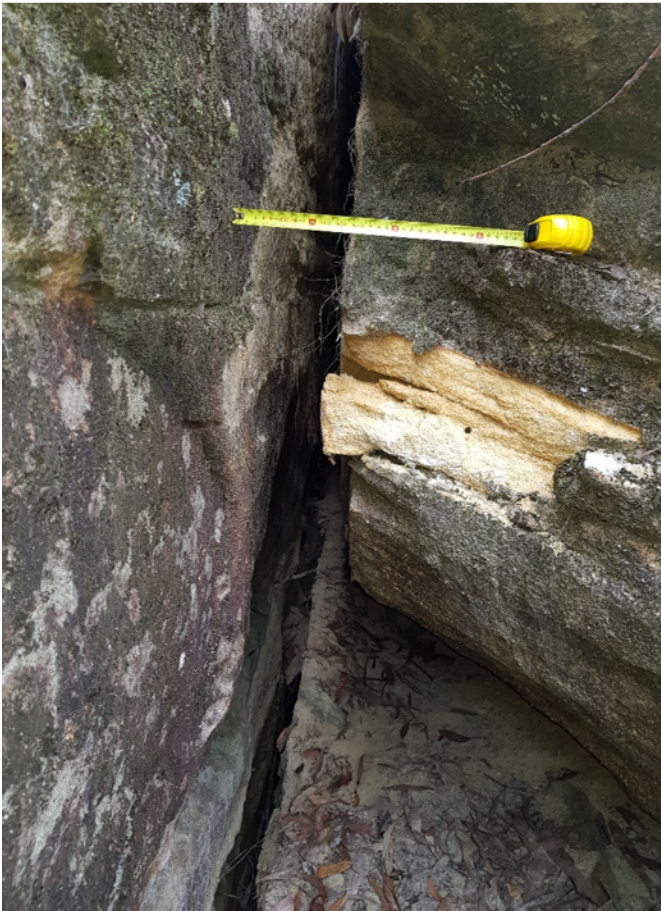
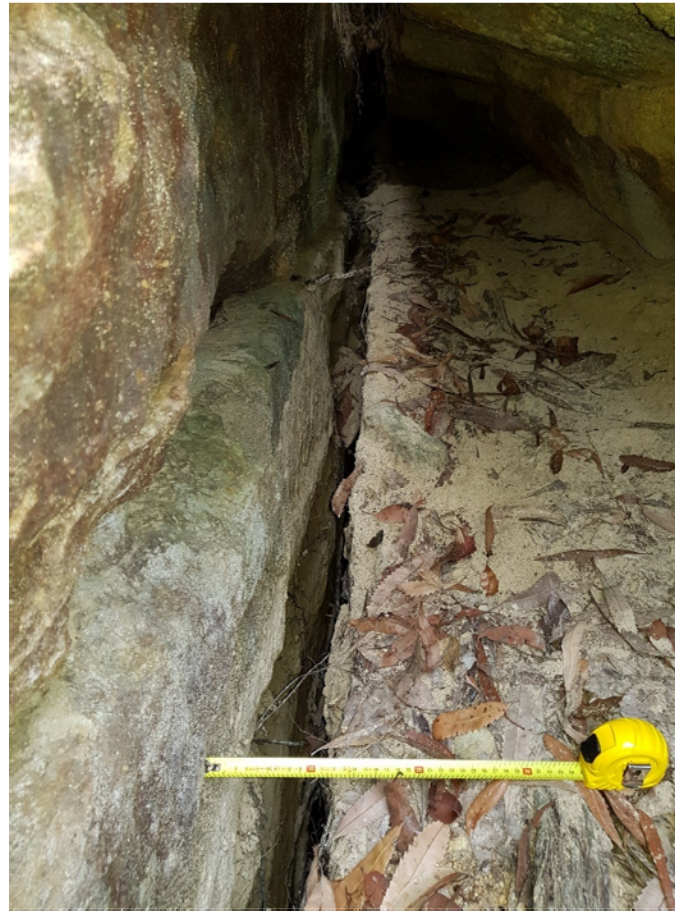
The fracturing and displacement appear stable and the site will be monitored for any further changes.

Photo 1: *DA3B_LW14_026*, looking at the width of the fracturing. Taken 10/05/2019.

Photo 2: DA3B_LW14_026, section of rock fracturing and displacement. Taken 10/05/2019.

Photo 3: DA3B_LW14_026, looking at a section of displacement. Taken 10/05/2019.

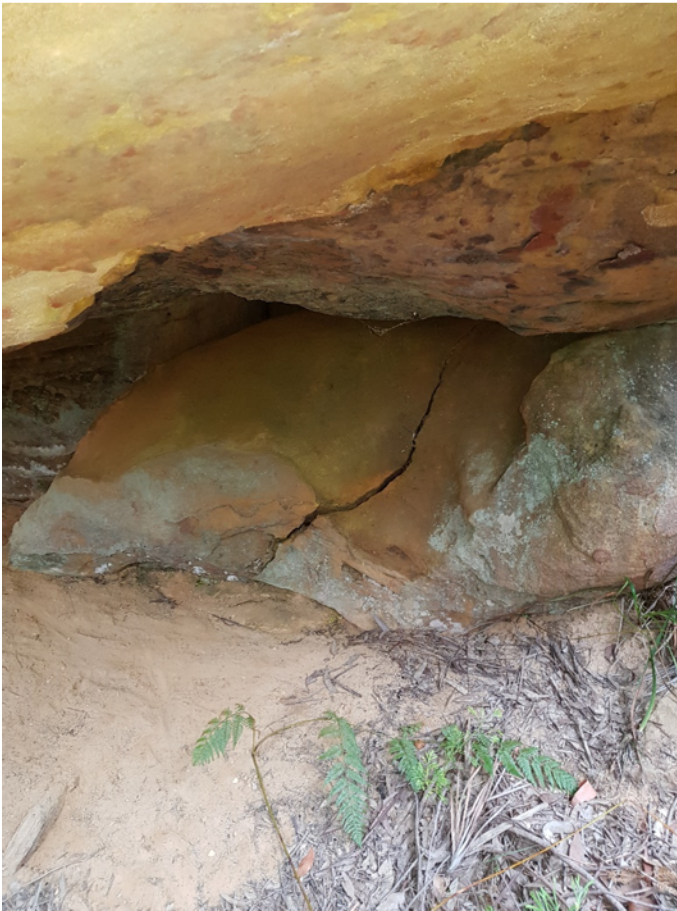
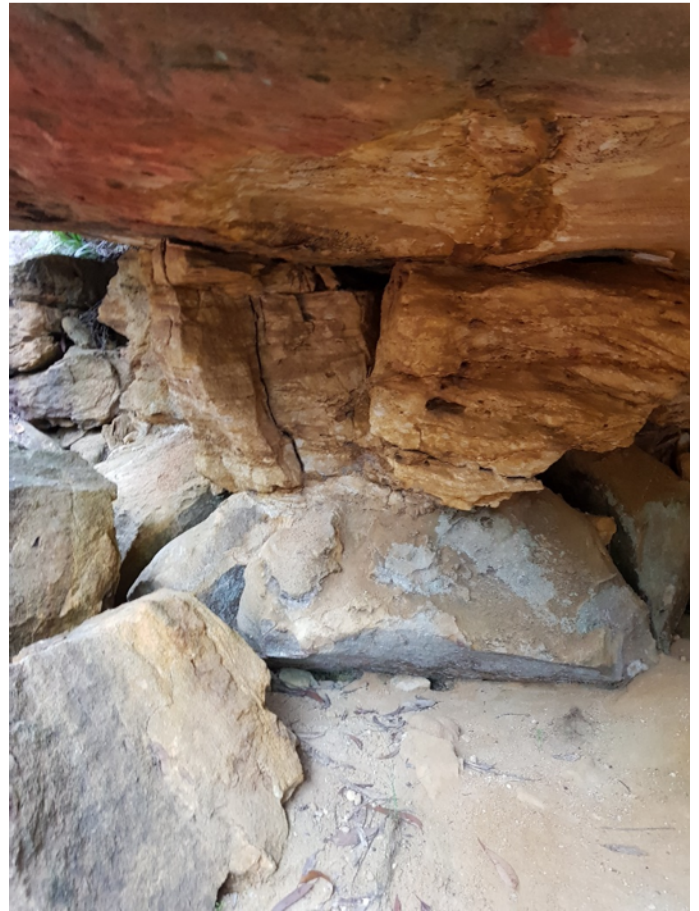
Photo 4: DA3B_LW14_027, looking at a section of rock fracturing. Taken 10/05/2019.

Photo 5: DA3B_LW14_027, looking at a section of rock fracturing. Taken 10/05/2019.

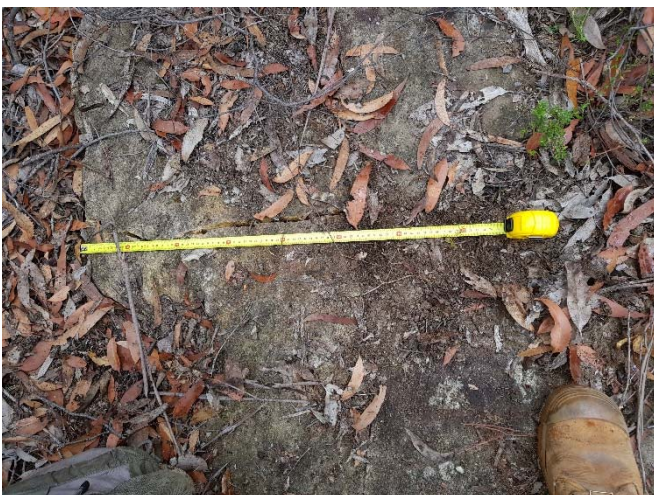
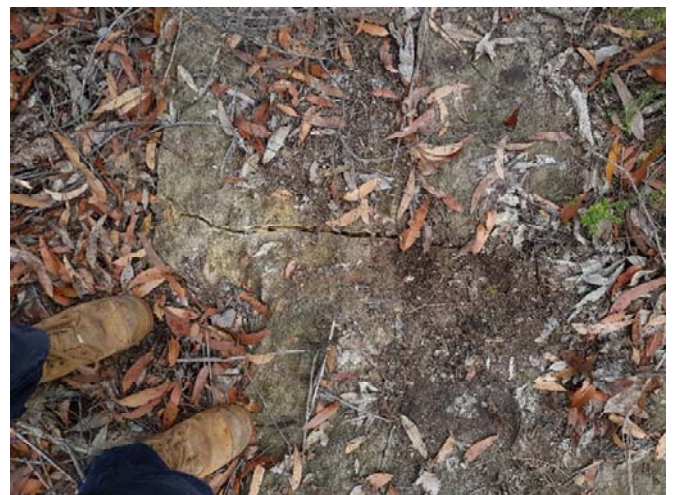
Photo 6: DA3B_LW14_028, looking at a section of rock fracturing. Taken 10/05/2019.

Photo 7: DA3B_LW14_028, looking at a section of rock fracturing. Taken 10/05/2019.

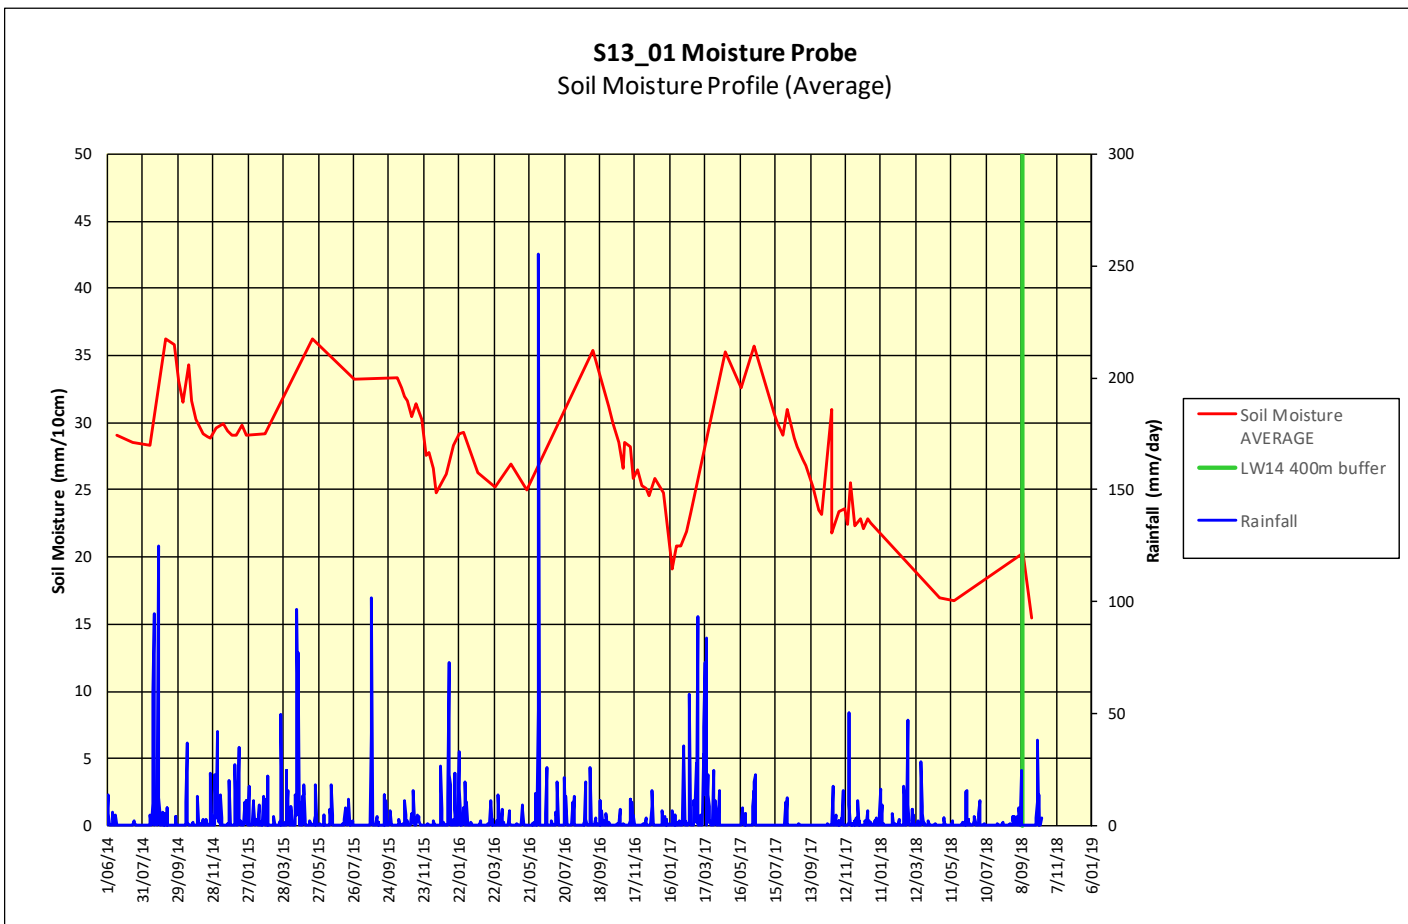
Graph 3: Soil moisture levels at site S13_01.

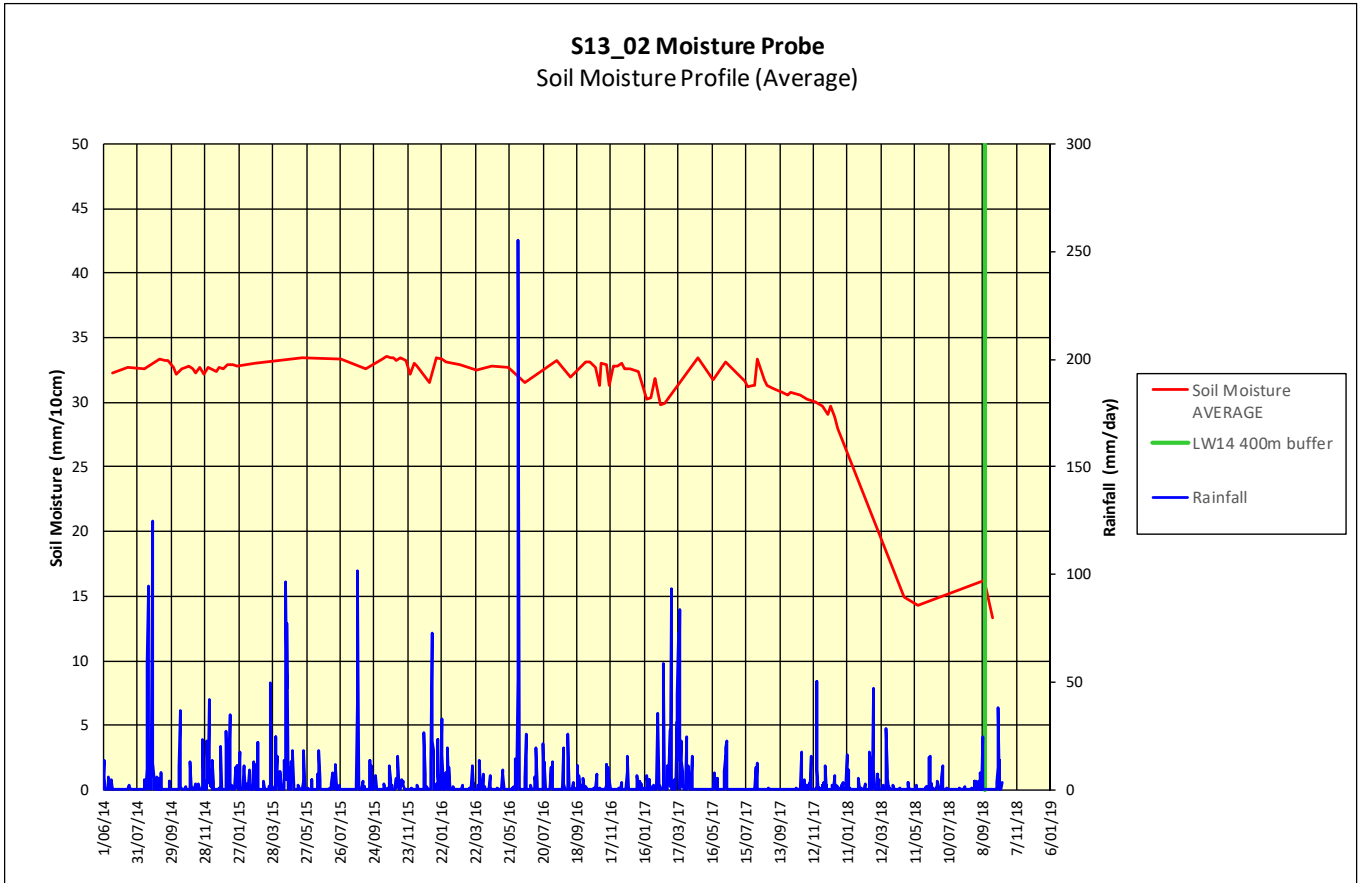
Graph 4: Soil moisture levels at site S13_02

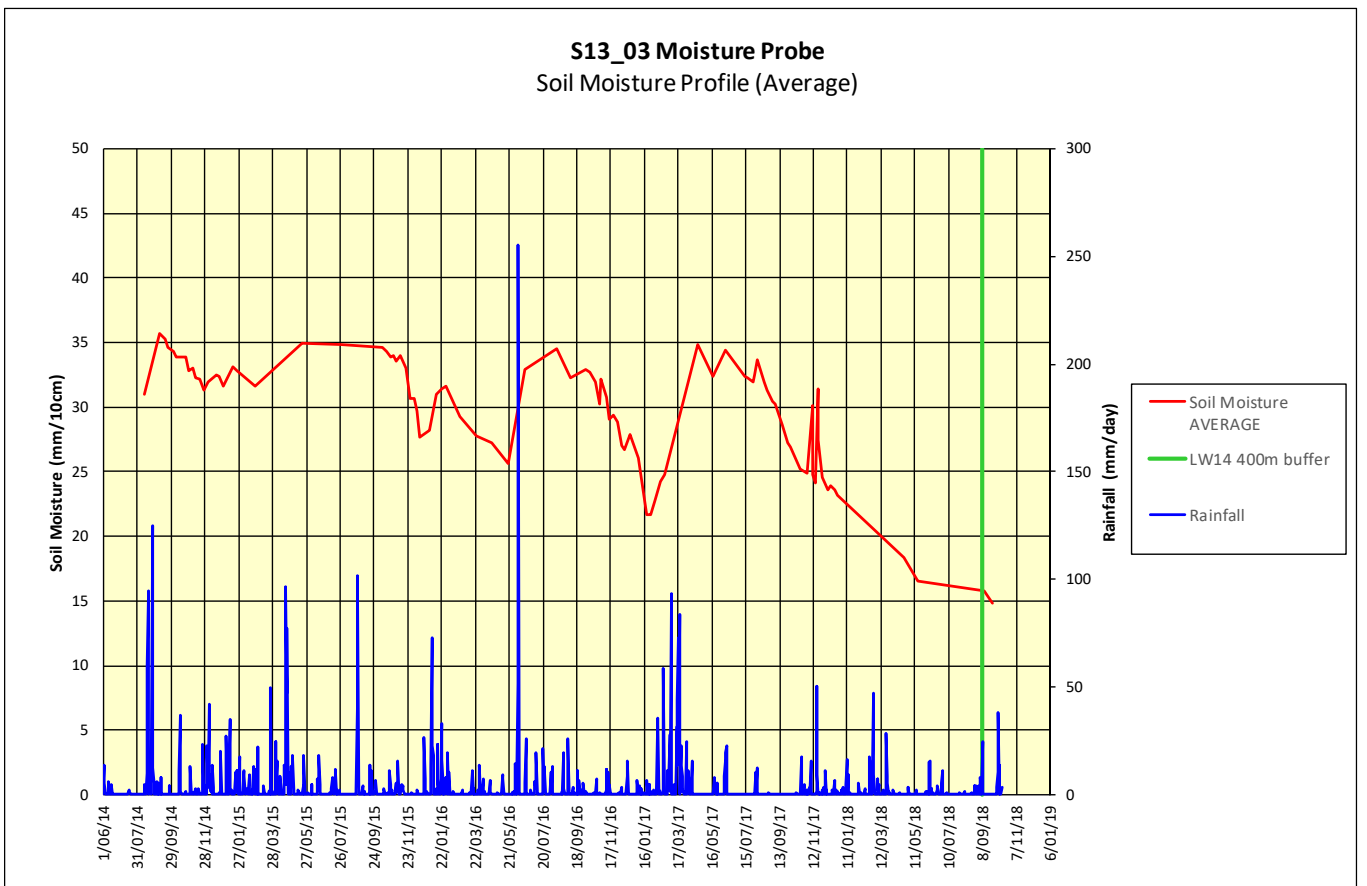
Graph 5: Soil moisture levels at site S13_03.
