Re: Dendrobium Colliery Longwall 14 End of Panel Report - Aboriginal Heritage Assessment (#4872)

1. Aboriginal Heritage Assessment

Longwall 14
Cultural Heritage Sites

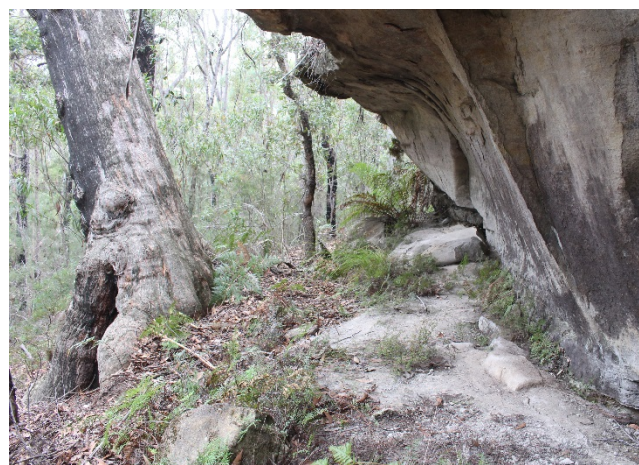
AHIMS site numbers	Site name	Results of inspections
52-2-1626	Browns Road Site 11	This shelter had visible impacts from subsidence movements. The impact is comprised of one main area of rock fracturing. Diagonal and vertical cracking are contained to the southern end of the floor of the shelter, including minor block fall. No lateral movement or opening of joints were visible within the shelter site. The sandstone shelter is actively exfoliating, possibly expedited by subsidence movements. Further localised cracking was observed to the north of the shelter, within a shared ridgeline. Cracking within the southern floor area measured to an approximate length of 0.7m and maximum width of 0.03m. The site was undermined by Longwall 14 on 28 January 2019. The two art panels remain in the same condition as described in Biosis Research 2011, and 2007. Macro vegetation was observed growing within the natural joint lines of the shelter.

Plate 1: General Photo of Browns Road Site 11.

Plate 2: General Photo of Browns Road Site 11 facing south.

Plate 3: General Photo of Browns Road Site 11 facing north.

Recommendations	
	Browns Road Site 11 (AHIMS ID# 52-2-1626) and Site 1 DB 1 (AHIMS ID #52-22229)
1.	Notify relevant specialists and key stakeholders (e.g Aboriginal community groups).
2.	Continue monitoring program with condition assessment and photographic records As Per TARPS.

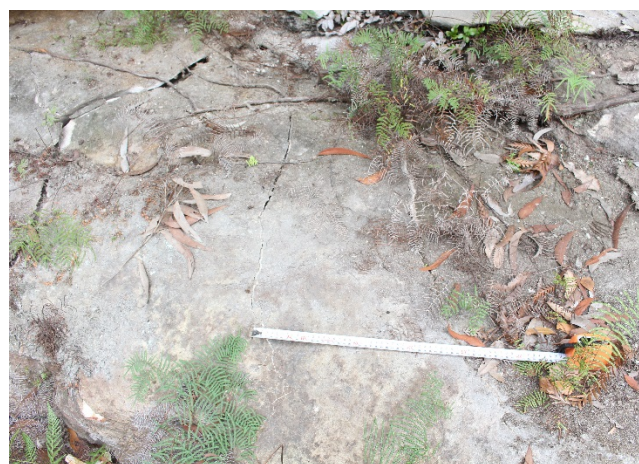
Plate 4: Subsidence cracking north of the shelter.

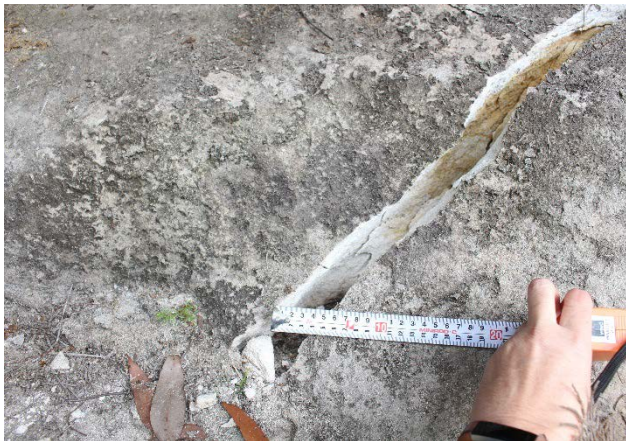
Plate 5: Subsidence cracking at the western end of the shelter.

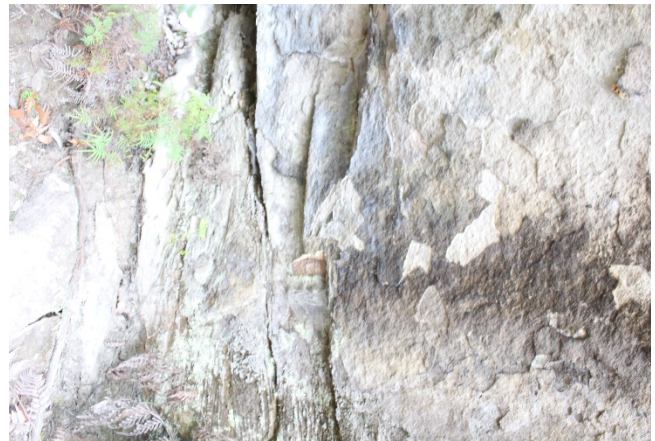
Plate 6: Bedding planes located in the centre of the shelter.

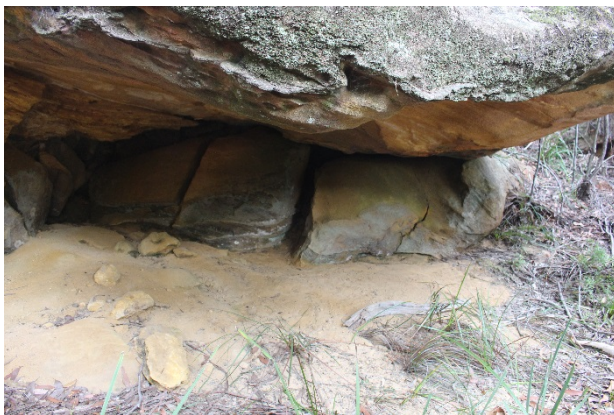
AHIMS site numbers	Site name	Results of inspections
52-2-2229	Site 1-DB1	This shelter had visible impacts from subsidence. The impact is comprised of two rock fractures with the largest having a maximum measurable length of 1m, and a maximum width of 0.03m. The fracturing is located within the back wall of the Aboriginal Site 1-DB1, this site comprises of a sandstone shelter containing art on the roof area. The shelter is 4.5m in length, 2m wide, 1.2m high with a sanded floor. The art is not directly impacted by the fracture, which is contained to the underlying, disconnected rock. The site was undermined by Longwall 14 on 28 January 2019. Access to the site was restricted during mining due to safety concerns. The art panel remains in the same condition as described in Biosis Research 2008, and 2009.

Plate 11: General Photo of Site 1-DB1.

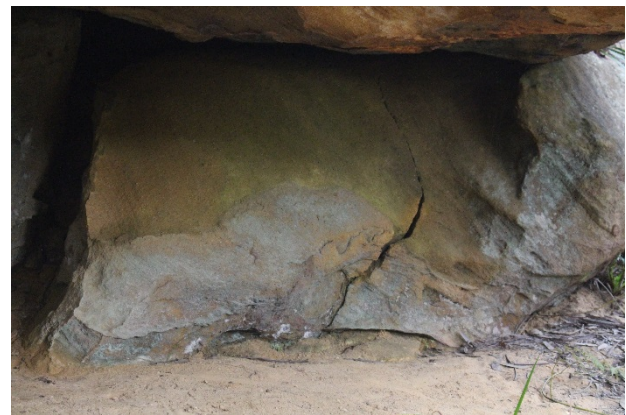
Plate 12: Subsidence related cracking to the northern side of the shelter.

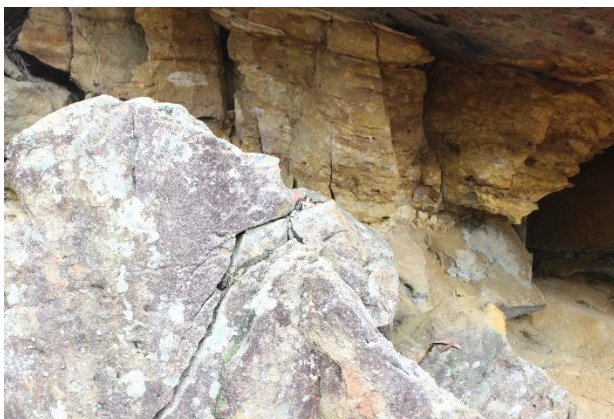
Plate 13: Subsidence related cracking on the back wall of the north side of the shelter.

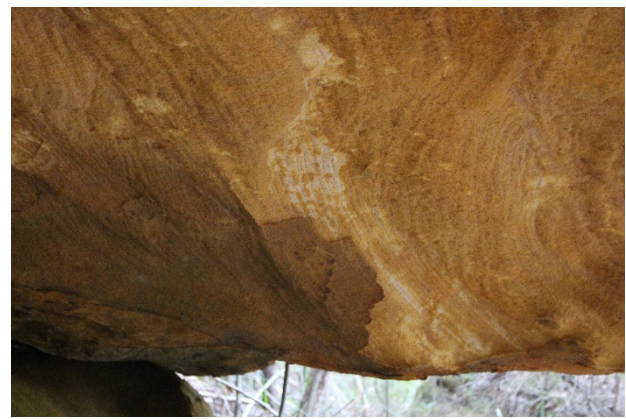
Plate 14: Subsidence related cracking to the northern side of the shelter.

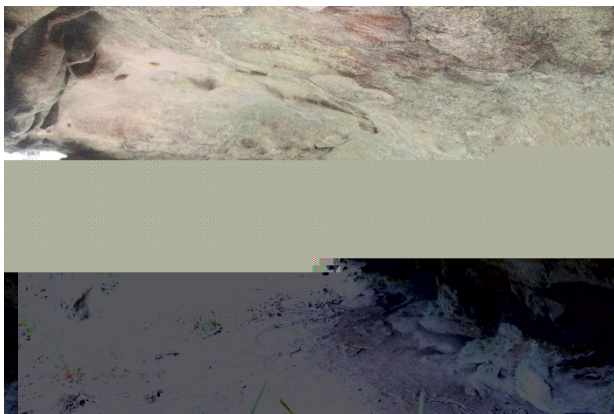
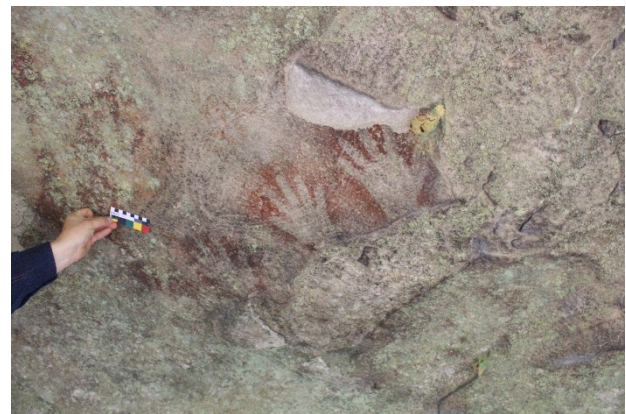
AHIMS site numbers	Site name	Results of inspections
52-2-3645	DM21	<p>This shelter was in the same condition as described by Biosis in 2011. There has been no movement of the horizontal bedding plane joints of the shelter and no cracking or exfoliation observed in relation to the extraction of Longwall 14.</p> <p>There has been no altered seepage or water movements in the shelter, and there is no evidence of water flow or recent micro-vegetation growth associated with any movement.</p> <p>The art panel remains in the same condition as described in Biosis Research 2008, and 2011.</p>

Plate 15: General Photo of DM21 facing east. Panels 1, 2 and 3.

Plate 16: Location of Panel 3, red ochre stencils with circular etching.

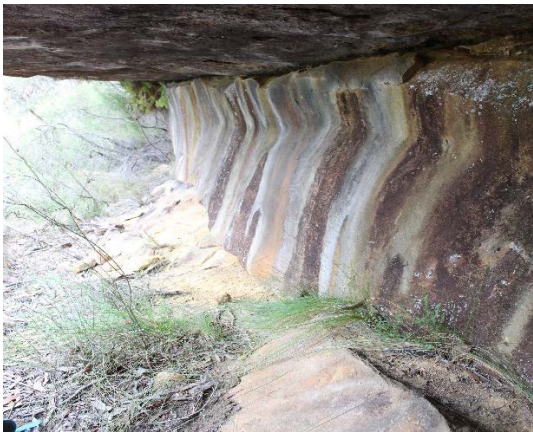
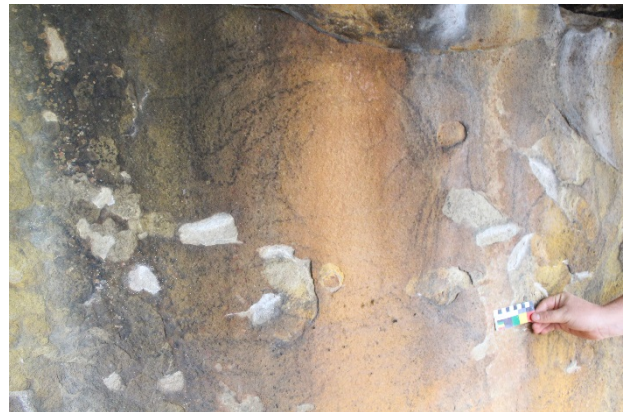
AHIMS site numbers	Site name	Results of inspections
52-2-3646	DM22	<p>This shelter was in the same condition as described by Biosis in 2011. There has been no movement of the horizontal bedding plane joints of the shelter and no cracking or exfoliation observed in relation to the extraction of Longwall 14.</p> <p>There has been no altered seepage or water movements in the shelter, and there is no evidence of water flow or recent micro-vegetation growth associated with any movement.</p> <p>The art panel remains in the same condition as described in Biosis Research 2007, and 2013.</p>

Plate 17: General Photo of DM22 facing east.

Plate 18: Panel 1, charcoal outline of anthropomorphic figure and Panel 2, charcoal indeterminate.

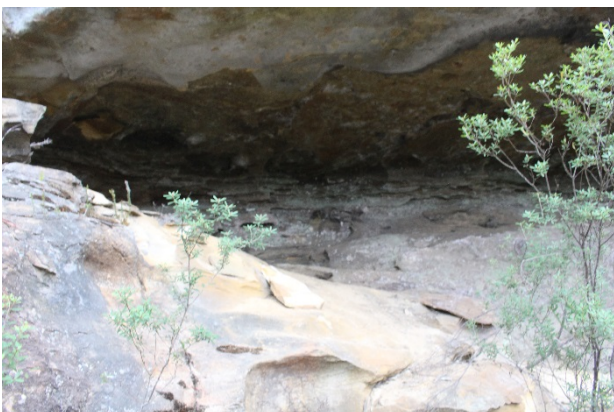
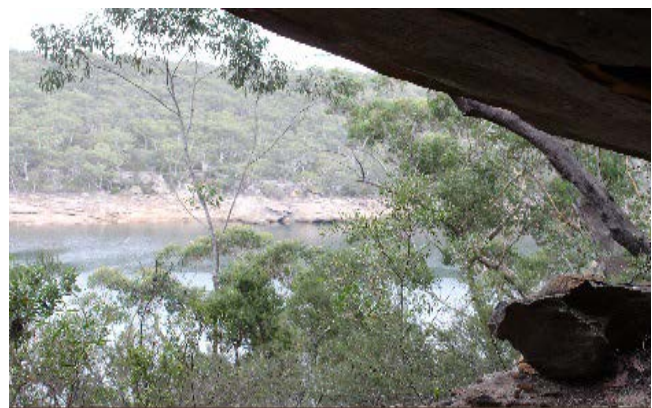
AHIMS site numbers	Site name	Results of inspections
52-2-1773	Upper Avon 37	<p>This shelter was in the same condition as described by Biosis in 2011. There has been no movement of the horizontal bedding plane joints of the shelter and no cracking or exfoliation observed in relation to the extraction of Longwall 14.</p> <p>There has been no altered seepage or water movements in the shelter, and there is no evidence of water flow or recent micro-vegetation growth associated with any movement.</p> <p>The artefact could not be relocated.</p>

Plate 19: General Photo of Upper Avon 37 facing east.

Plate 20: General Photo of Upper Avon 37 facing south towards Lake Avon.
