END OF PANEL
LANDSCAPE REPORT
DENDROBIUM AREA 3B

DENDROBIUM AREA 3B
LONGWALL 15 END OF PANEL
LANDSCAPE REPORT
MARCH 2020

This report summarises the observed and measured subsidence effects on landscape features resulting from the extraction of Dendrobium Area 3B (DA3B) Longwall 15.

Longwall 15 is the seventh panel extracted from DA3B. Extraction began on 4 April 2019 and was completed on 22 January 2020.

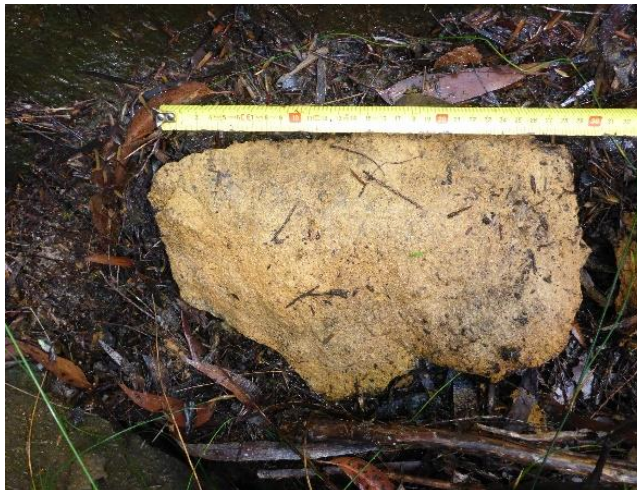
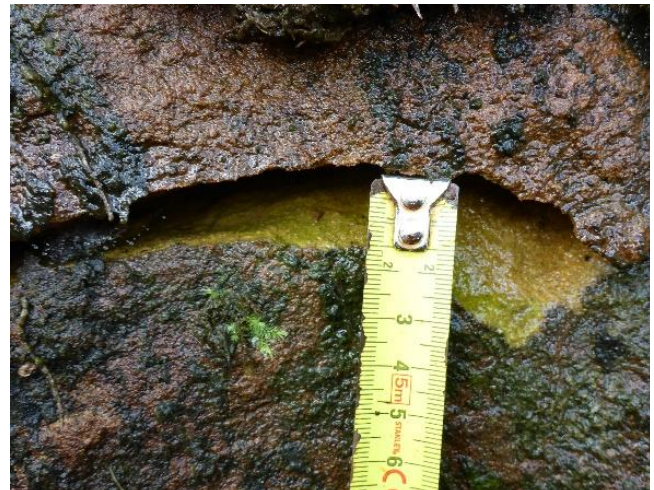
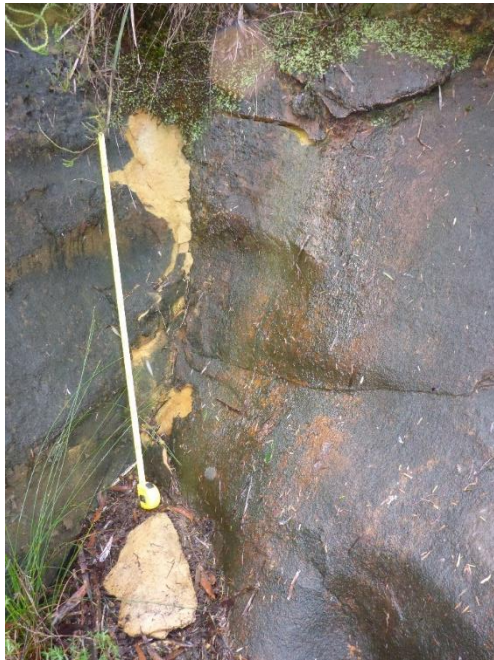
DA3B_LW15_003 is located on LA4A, a tributary to Lake Avon. The impacted feature, LA4A_Step 3A, is situated 80m north-west of the commencing end of Longwall 14 (Figure 2). It is likely this impact occurred during the extraction of Longwall 14, however, only later become visible due to rainfall events which dislodged vegetation and rock fragments. The impact includes rock fracturing and associated rock fragmentation (Photo 5 to Photo 7). The rock fracturing has a maximum measurable length of 0.5m and a maximum width of 0.02m. The largest rock fragment has a length of 0.30m, a width of 0.03m and a height of 0.19m. No flow diversion was evident due to the location of the fracture on the step. DA3B_LW15_003 was inspected on 27 February 2020 and remains unchanged from original identification (Photo 8).

Level 1: Crack or fracture up to 100 mm width at its widest point with no observable loss of surface water or erosion, and/ or, crack or fracture up to 10 m width at its widest point with no observable loss of surface water or erosion.

Photo 5: DA3B_LW15_003, looking at largest rock fragment. Taken on 17/06/2019.

Photo 6: DA3B_LW15_003, looking at a section of rock fracturing. Taken on 17/06/2019.

Photo 7: *DA3B_LW15_003*, overview of impacted area. Taken on 17/06/2019.

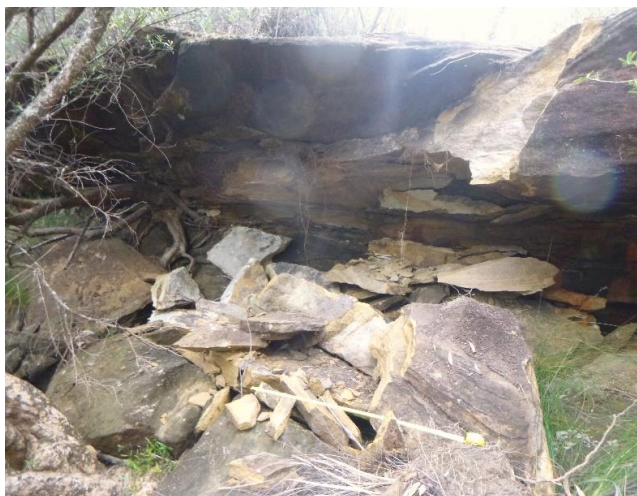
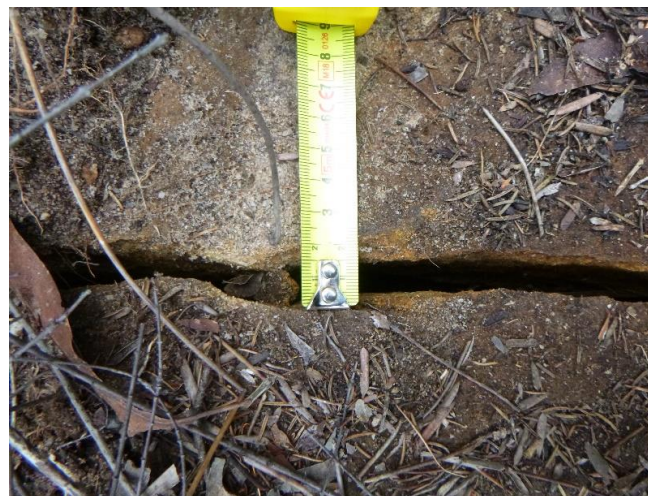
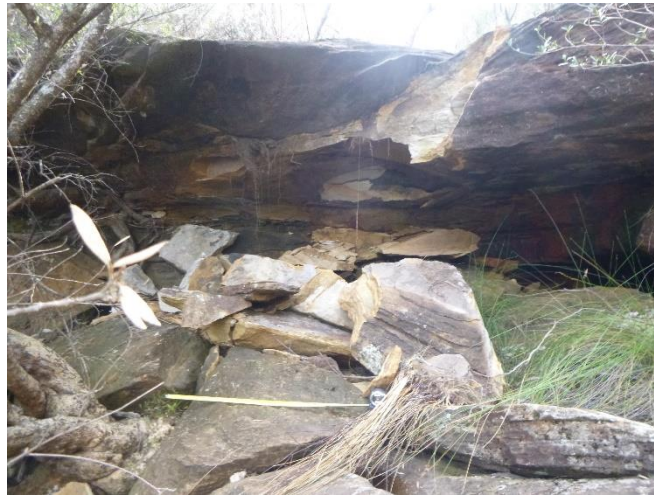
DA3B_LW15_014 is located on *LA4A*, a tributary to Lake Avon. The impacted features, *LA4A_Step 3B* and *LA4A_Channel 3A*, are situated approximately 454m north-west of the commencing end of Longwall 15 and 52m north-west of the commencing end of Longwall 14 (Figure 2). It is likely this impact occurred during the extraction of Longwall 14, however has only become visible due to rainfall events which dislodged rock fragments. The impact is comprised of rock fracturing, a rockfall and associated rock fragmentation (Photo 9 and Photo 10). Approximately 10 rock fragments were dislodged from the step. The largest rock fragment has a length of 1.3m, width of 0.8m and height of 0.4m. The rock fracturing has a maximum measurable length of 4.3m, a maximum measurable width of 0.015m and a maximum measurable depth of 0.25m. While not evident during the latest inspection, flow diversion would occur if surface flow was present. *DA3B_LW15_014* was inspected on 27 February 2020 and remains unchanged from original identification (Photo 11).

Level 2: Crack or fracture that results in observable loss of surface water or erosion.

Photo 9: *DA3B_LW15_014*, an overview of the rockfall. Taken on 11/10/2019.

Photo 10: *DA3B_LW15_014*, looking at widest rock fracture. Taken on 11/10/2019.

Photo 11: *DA3B_LW15_014*, an overview of the rockfall.
Taken on 27/02/2020.

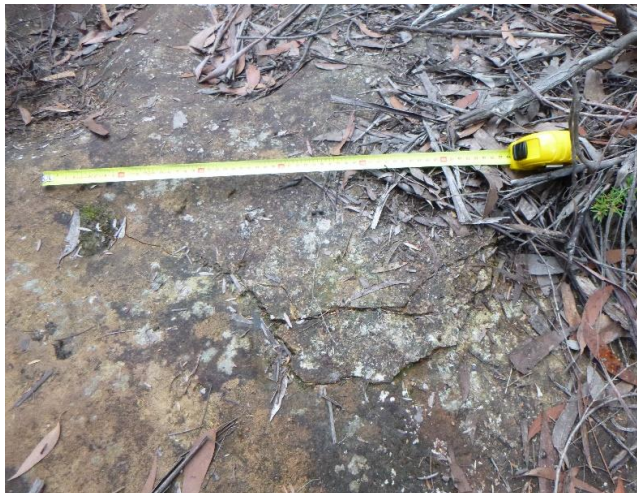
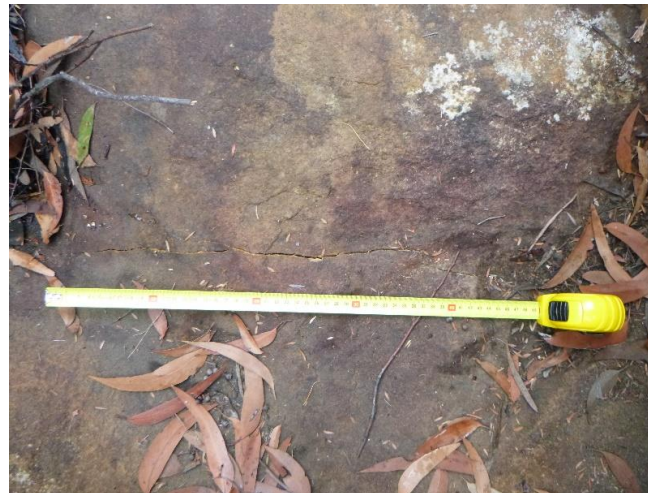
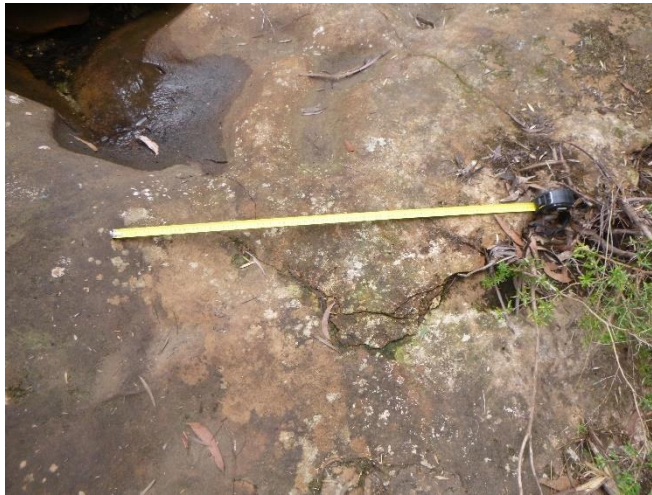
DA3B_LW15_015 is located on *LA4A*, a tributary to Lake Avon. The impacted feature, *LA4A_Rockbar 2*, is situated approximately 480m north-west of the commencing end of Longwall 15 and 80m north-west of the commencing end Longwall 14 (Figure 2). It is likely this impact occurred during the extraction of Longwall 14, however has only become visible due to rainfall events which dislodged vegetation and rock fragments. The impact is comprised of two rock fractures (Photo 12 and Photo 13). The rock fracturing has a maximum length of 1m and a maximum width of 0.002m. While not evident during the latest inspection, flow diversion would occur if surface flow was present. *DA3B_LW15_015* was inspected on 27 February 2020 and remains unchanged from original identification (Photo 14).

Level 2: Crack or fracture that results in observable loss of surface water or erosion.

Photo 12: *DA3B_LW15_015*, looking at a section of rock fracturing. Taken on 11/10/2019.

Photo 13: *DA3B_LW15_015*, looking at a section of rock fracturing. Taken on 11/10/2019.

Photo 14: DA3B_LW15_015, looking at a section of rock fracturing. Taken on 02/27/2020.

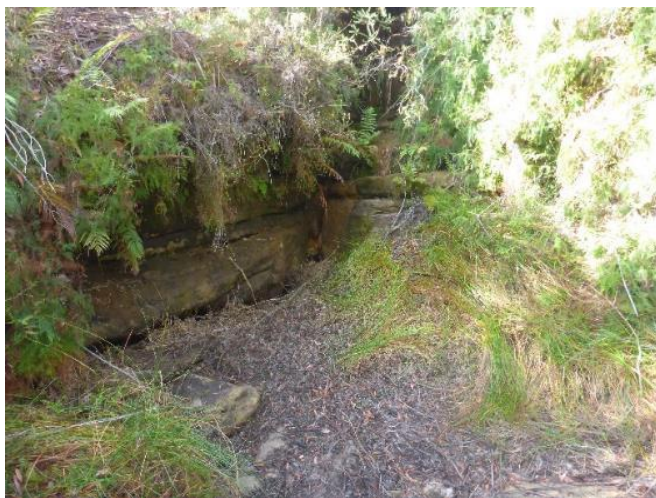
DA3B_LW13_010 was identified on 27 October 2017 consisting of lateral fracturing to the step at the upstream extent of WC21_ Pool 53 (Photo 15). This site was mined beneath by Longwall 13 on 24 September 2017 (Figure 2). On 21 August 2019, a rockfall was identified at the site (Photo 16). On 21 August 2019, a further five rock fragments were observed dislodged from the step. The largest fragment was approximately 0.4m². Survey results from the site indicated the changes are not subsidence related. On 26 February 2020, additional rock fragmentation was identified. It is likely these rock fragments dislodged from the step during recent rainfall events (455.5mm between 8 February 2020 to 10 February 2020) (Photo 17 and Photo 18).

Level 2: Crack or fracture between 100 and 300mm width at its widest point or any fracture which results in observable loss of surface water or erosion.

Photo 15: DA3B_LW13_010, step at WC21_Pool 53. Taken on 27/10/2017.

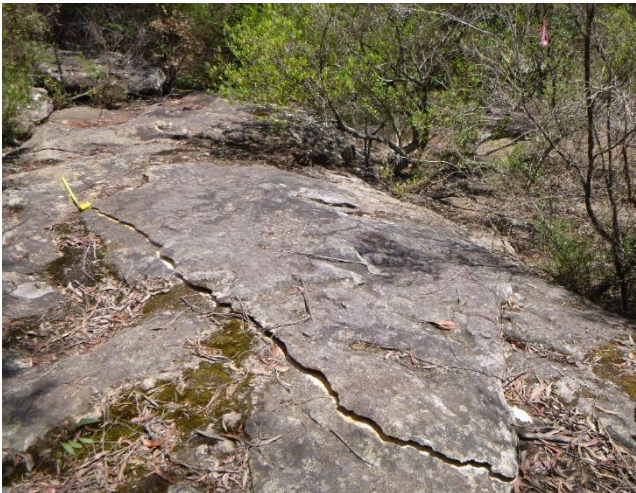
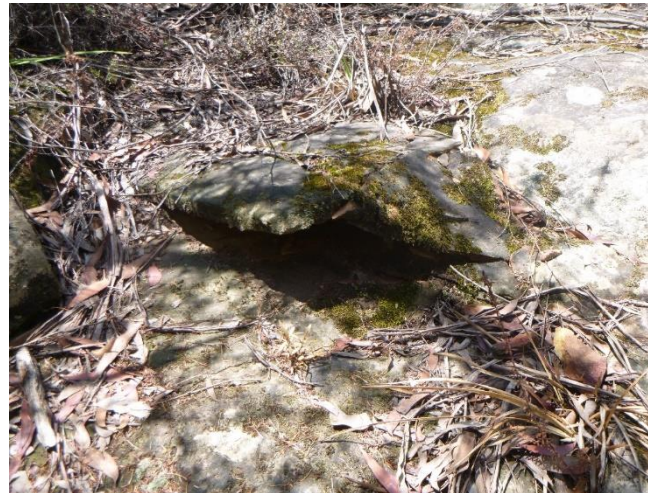
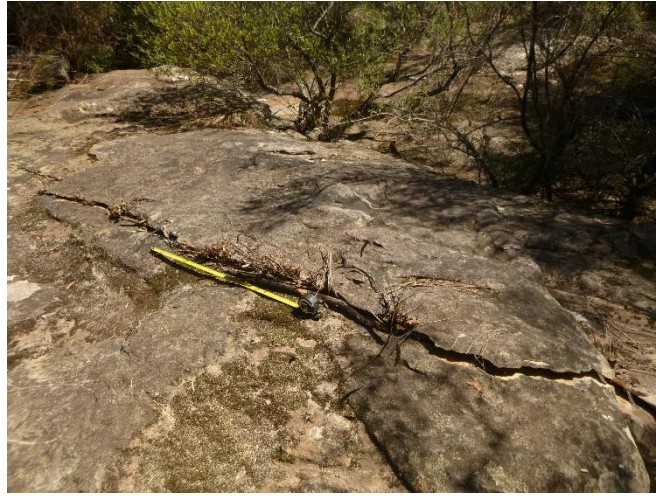
DA3B_LW15_027 is located on WC15, a tributary of Wongawilli Creek. The impacted feature, WC15_Rockbar 18, is situated approximately 260m north of Longwall 15 at its closest point (Figure 2). The impact is comprised of rock fracturing and uplift (Photo 19 and Photo 20). The rock fracture has a maximum measurable length of 6m, a maximum width of 0.04m and a depth of approximately 2.5m. The fracture is not located in the direct surface flow path. DA3B_LW15_027 was inspected on 28 February 2020 and remains unchanged from original identification (Photo 21).

Level 1: Crack or fracture up to 10m length, and/or, crack or fracture up to 100m width.

Photo 19: DA3B_LW15_027, looking at rock fracture.
Taken on 21/01/2020.

Photo 20: DA3B_LW15_027, looking at an area of uplift.
Taken on 21/01/2020.

Photo 21: DA3B_LW15_027, looking at the rock fracture. Taken on 28/02/2020.

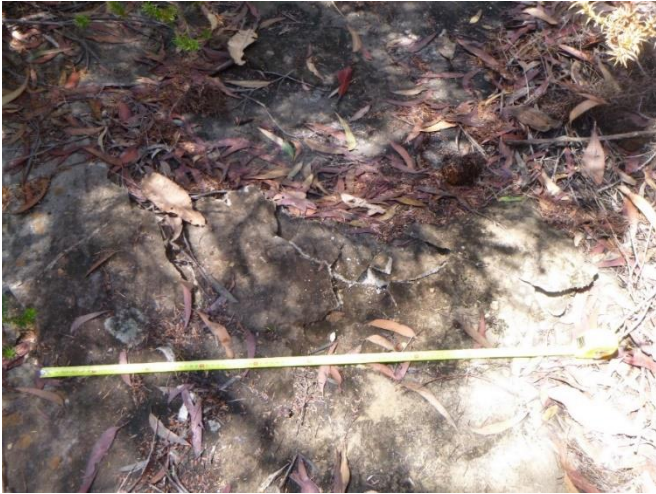
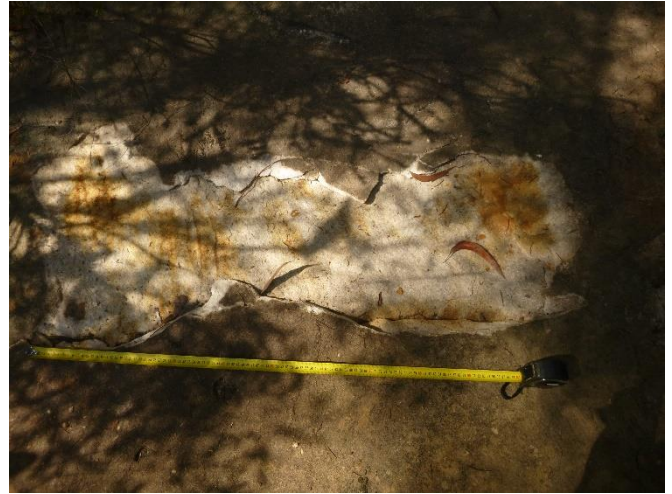
DA3B_LW13_035 Update

DA3B_LW13_035 is located on WC15_Rockbar 21 and was originally identified during the extraction of Longwall 13 on 23 April 2018 (Figure 2). The impact site is situated approximately 123m north of Longwall 15 at its closest point. Additional fracturing with flow diversion was identified and reported during the extraction of Longwall 14. On 21 January 2020, further fracturing and uplift was observed (Photo 24). The rock fracture has a length of 1m and a width of 0.02m. Uplifted sections are associated with the fracturing. On 26 February 2020, due to recent rainfall events, further rock fragmentation and displacement was evident. Previous rock fragmentation and uplift has been displaced downstream with the largest fragment having a maximum length of 2m, width of 1m and height of 0.4m (Photo 25 to Photo 26).

Level 2: Crack or fracture that results in observable loss of surface water.

Photo 24: *DA3B_LW13_035*, looking at the rock fracture and uplift. Taken on 21/01/2020.

Photo 25: *DA3B_LW13_035*, looking at the area of displaced rock. Taken on 28/02/2020.

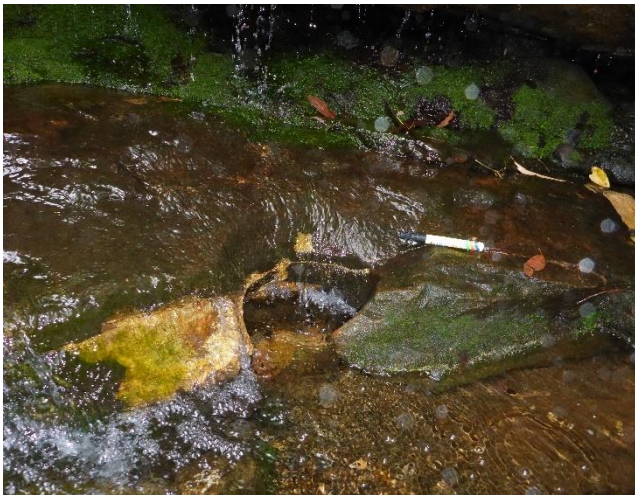
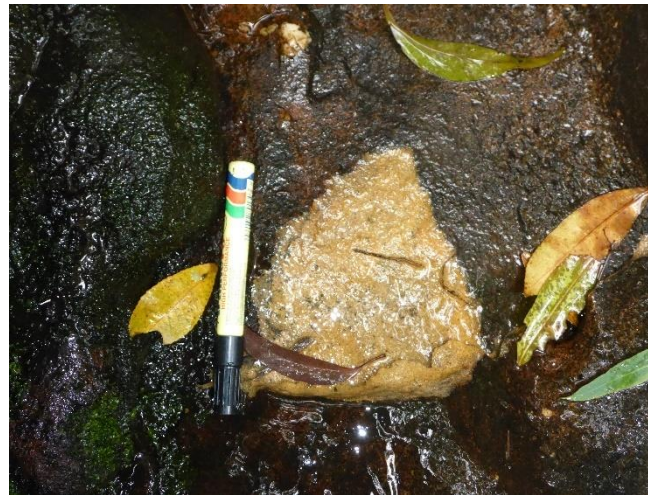
DA3B_LW13_046 is located on WC15, a tributary to Wongawilli Creek. The impacted feature, WC15_Step 2, is situated approximately 245m east of Longwall 13 and 590m north-east of Longwall 14 (Figure 2). It is likely that this impact occurred during the extraction of Longwall 13 however only become visible on 1 April 2019, due to heavy rainfall events (187.5mm between 15 March and 20 March 2019) which dislodged vegetation and rock fragments. The impact is comprised of a rock fracture and minor rock displacement (Photo 27 and Photo 28). The rock fracture has a maximum measurable length of 1.2m and a maximum width of 0.02m. On 10 March 2020, additional rock fracturing and displacement was evident at WC15_Pool 2, following a heavy rainfall event. A section of sandstone bedrock with a length of 1.42m, width of 1.05m and depth of 0.21m, had been displaced 3.2m downstream (Photo 29 and Photo 30). No flow diversion was observed during inspection.

Level 1: Crack or fracture up to 10m length with no observable loss of surface water or erosion.

Photo 27: DA3B_LW13_046, looking at the extent of rock fracturing. Taken on 01/04/2019.

Photo 28: DA3B_LW13_046, looking at the section of rock displacement. Taken on 01/04/2019.

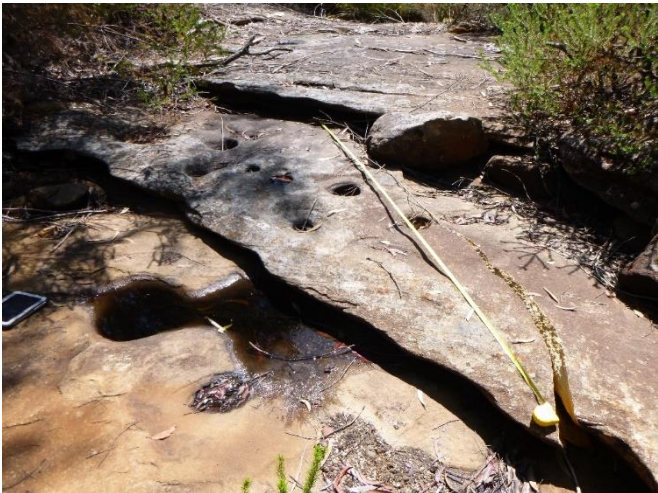
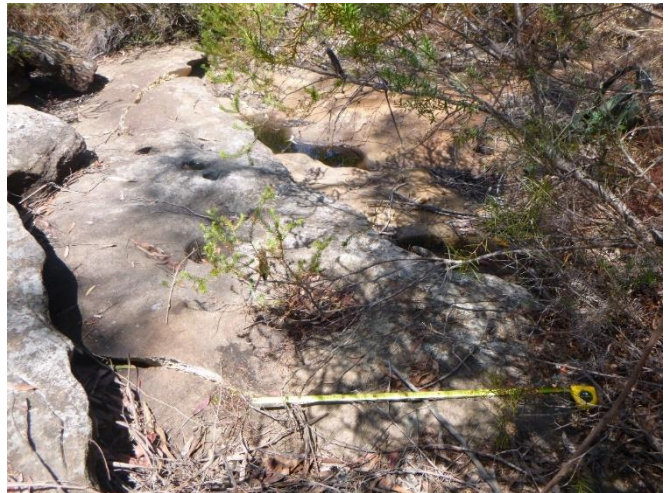
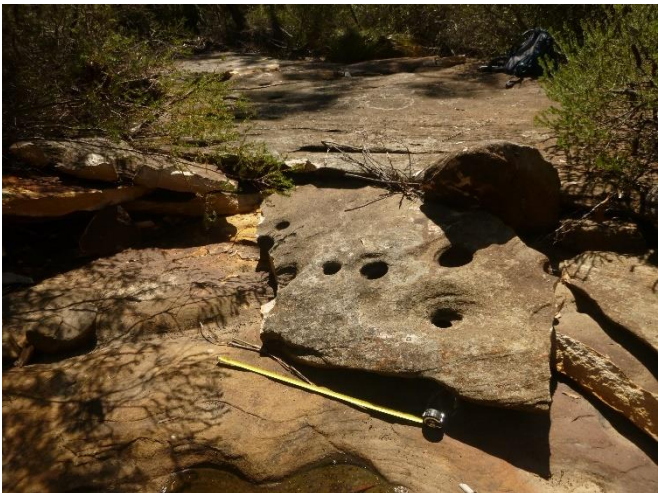
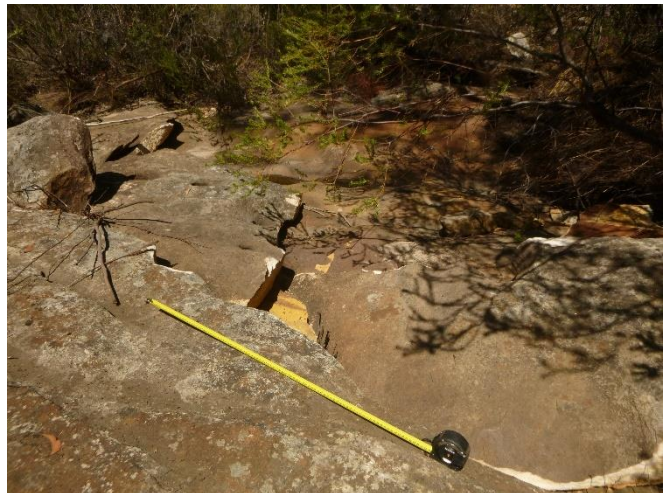
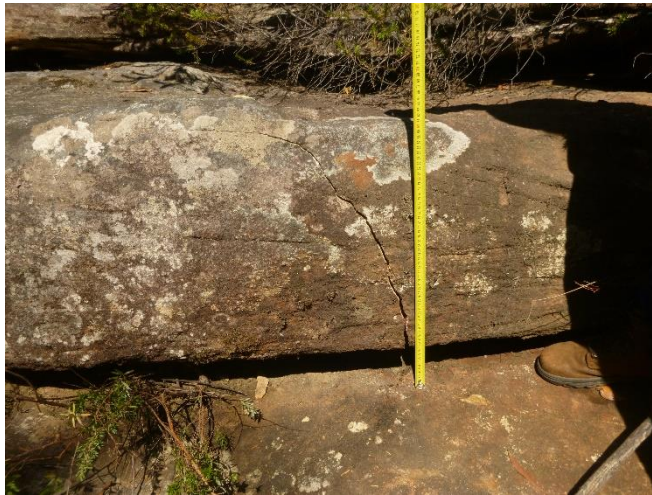
DA3B_LW14_016 is located on WC15_Rockbar 25 and Step 25 and was originally identified during the extraction of Longwall 14. The impact site is situated approximately 30m north of Longwall 15 at its closest point (Figure 2). On 21 January 2020, additional fracturing and associated displacement were identified on WC21_Rockbar 25, an undercut rockbar (Photo 31 and Photo 32). The fracturing has resulted in the 4m by 2m by 0.15m area of overhanging rock to be displaced approximately 0.1m onto underlying bedrock. On 28 February 2020, further rock fracturing and displacement was evident, likely due to heavy rainfall events. The section of rockbar previously displaced has been further fractured into approximately 6 large pieces, with the largest fragment having a length of 1.5m, width of 1.5m and depth of 0.2m (Photo 33 and Photo 34). A small rock fracture was also present 6m downstream, with a maximum length of 1m and width of 0.01m (Photo 35).

Level 2: Crack or fracture that results in observable loss of surface water.

Photo 31: DA3B_LW14_016, looking at the rock fracture and displacement. Taken on 21/01/2020.

Photo 32: DA3B_LW14_016, looking at the rock fracture and displacement. Taken on 21/01/2020.

Photo 33: DA3B_LW14_016, looking at the rock fracture and displacement. Taken on 28/02/2020.

Photo 34: DA3B_LW14_016, looking at the rock fracture and displacement. Taken on 28/02/2020.

Photo 35: DA3B_LW14_016, looking at the rock fracture.
Taken on 28/02/2020.

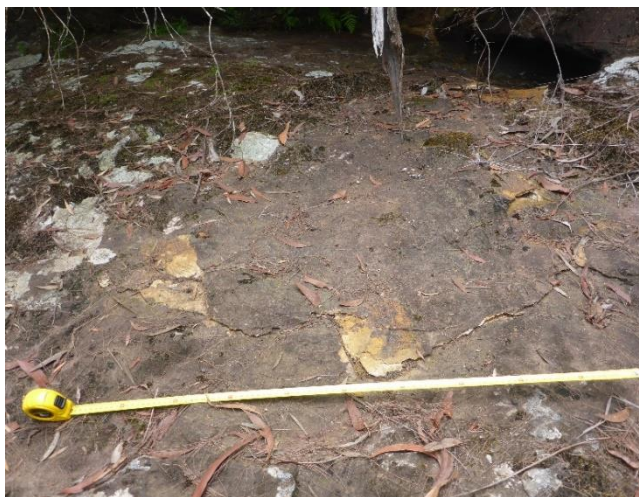
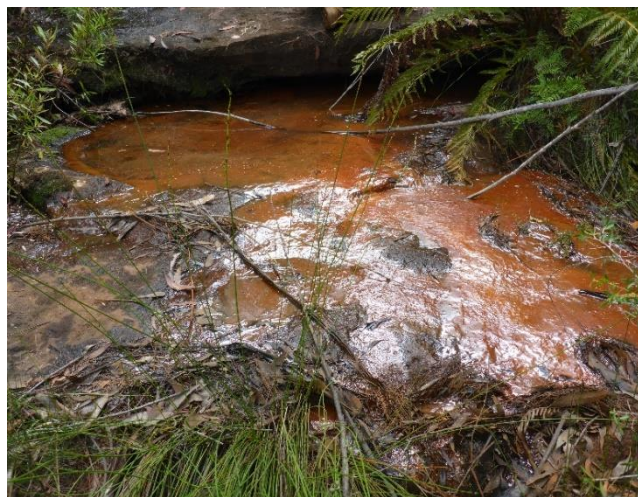
DA3A_LW8_001 is located within Dendrobium Area 3A on WC14, a tributary to Wongawilli Creek and was identified during some mapping of the watercourse. The rock fracturing and uplift is situated approximately 433m south of Longwall 8 at its closest point (Figure 3) and has a maximum length of 7m, and a maximum width of 0.005m (Photo 36). Iron staining was observed downstream (Photo 37).

Level 2: Crack or fracture that results in observable loss of surface water or erosion, and/or, observable increase in iron staining.

Photo 36: DA3A_LW8_001, looking at the rock fracturing and uplift. Taken on 28/01/2020.

Photo 37: DA3A_LW8_001, iron stained pool located approximately 7m downstream from the impact site. Taken on 28/01/2020.

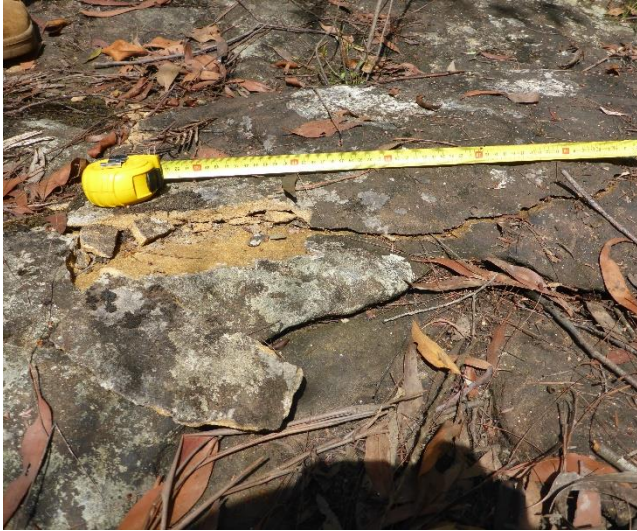
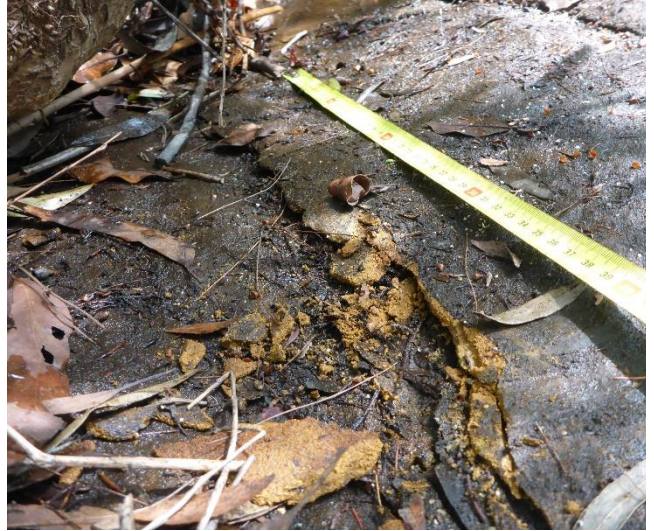
DA3B_LW8_002

DA3A_LW8_002 is located within Dendrobium Area 3A on WC14, a tributary to Wongawilli Creek. The fracturing is situated approximately 420m south of Longwall 8 at its closest point (Figure 3). The fracturing has a maximum length of 2m and a maximum width of 0.01m (Photo 38 and Photo 39).

Level 2: Crack or fracture that results in observable loss of surface water or erosion.

Photo 38: DA3A_LW8_002, looking at the rock fracturing and uplift. Taken on 28/01/2020.

Photo 39: DA3A_LW8_002, looking at the rock fracturing and uplift. Taken on 28/01/2020.

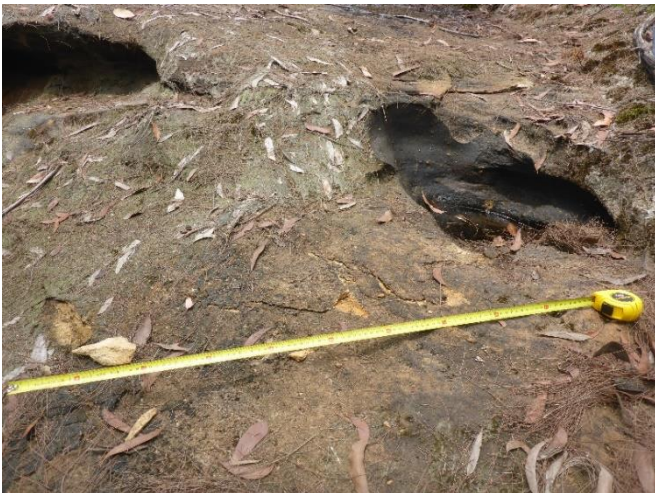
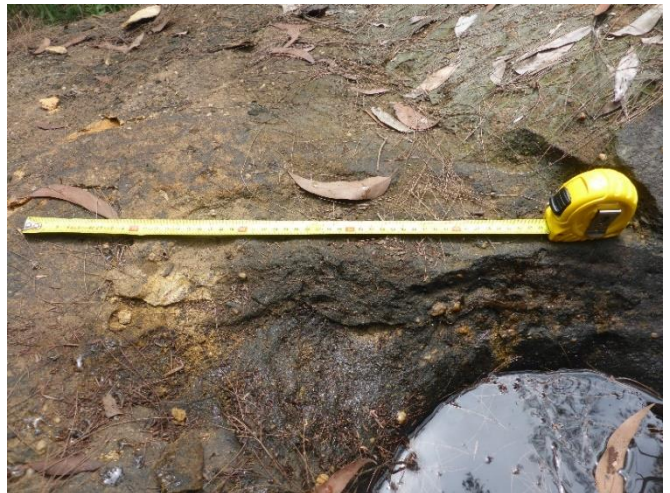
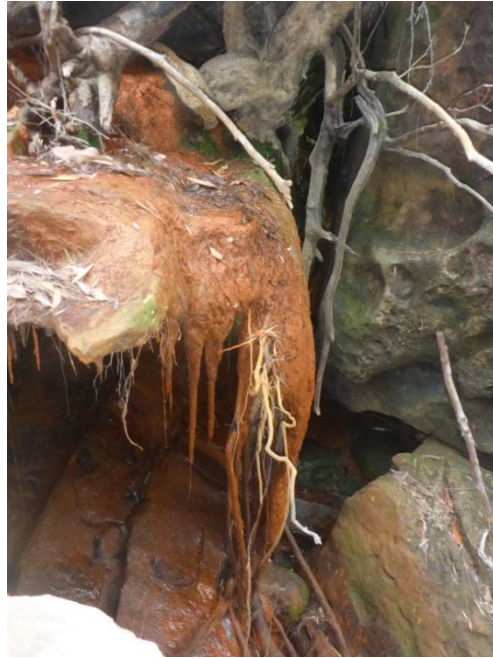
DA3B_LW8_003

DA3A_LW8_003 is located within Dendrobium Area 3A on WC14, a tributary to Wongawilli Creek. The rock fracturing is situated approximately 353m south of Longwall 8 at its closest point (Figure 3). The fracturing has a maximum length of 1.8m and a maximum width of 0.005m (Photo 40 and Photo 41). Iron staining was observed downstream (Photo 42).

Level 1: Crack or fracture up to 10m length, and/or, crack or fracture up to 100mm width, and/or, observable increase in iron staining within the mining area.

Photo 40: DA3A_LW8_003, looking at the rock fracturing and uplift. Taken on 28/01/2020.

Photo 41: DA3A_LW8_003, looking at the rock fracturing and uplift. Taken on 28/01/2020.

Photo 42: DA3A_LW8_003, looking at iron staining on step.
Taken on 28/01/2020.

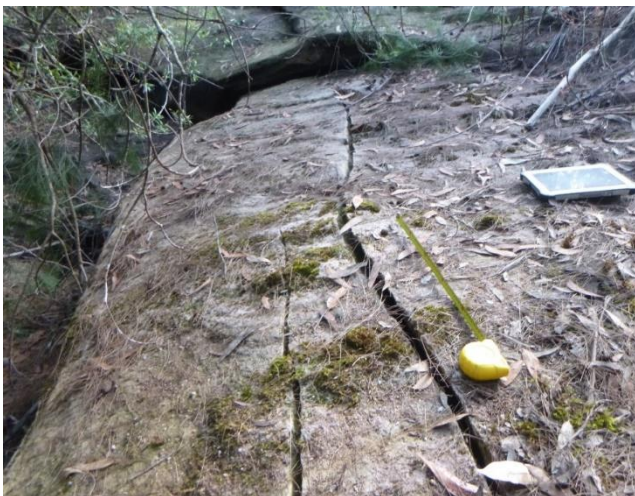
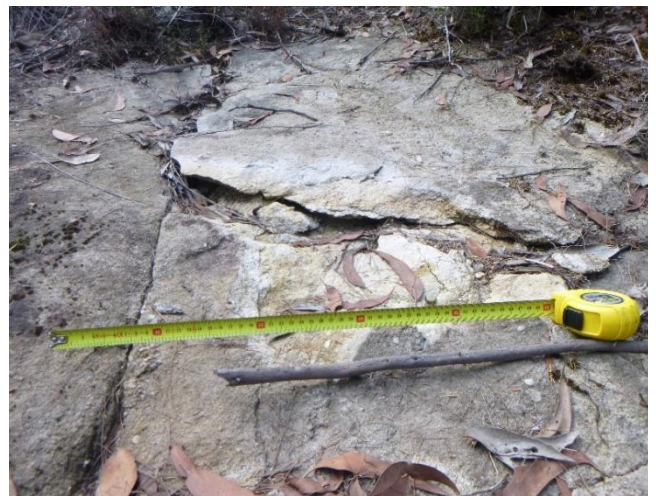
DA3A_LW8_004 is located within Dendrobium Area 3A on WC14, a tributary to Wongawilli Creek. The fracture is situated approximately 348m south of Longwall 8 at its closest point (Figure 3). The fracture has a maximum length of 4.4m, a maximum width of 0.03m and a maximum measurable depth of 0.15m (Photo 43 and Photo 44). The fracture is not located in the direct surface flow path.

Level 1: Crack or fracture up to 10m length, and/or, crack or fracture up to 100mm width.

Photo 43: DA3A_LW8_004, looking at the rock fracturing.
Taken on 28/01/2020.

Photo 44: DA3A_LW8_004, looking at the rock fracturing and uplift.
Taken on 28/01/2020.

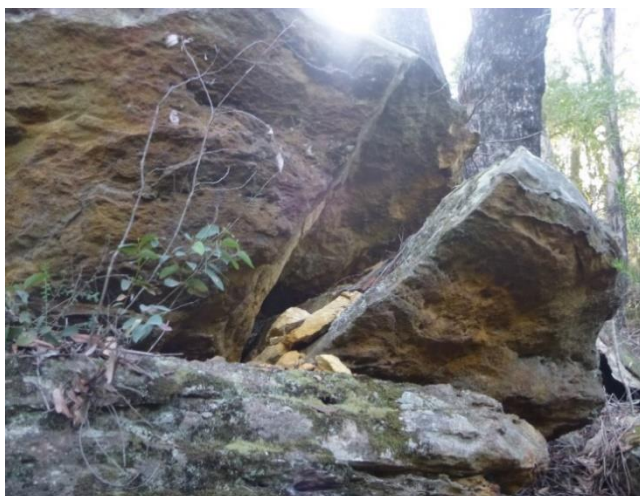
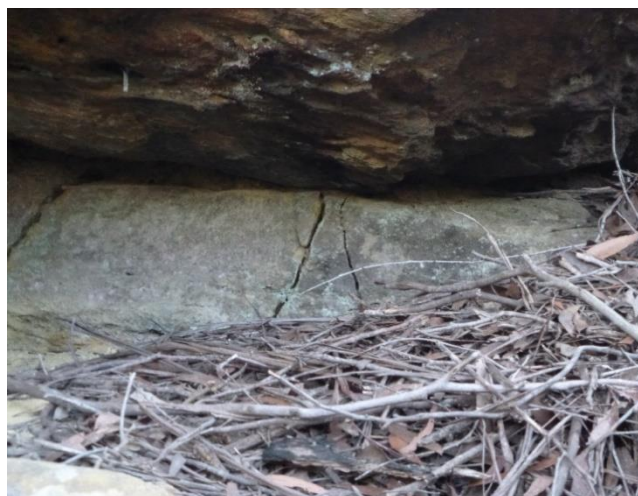
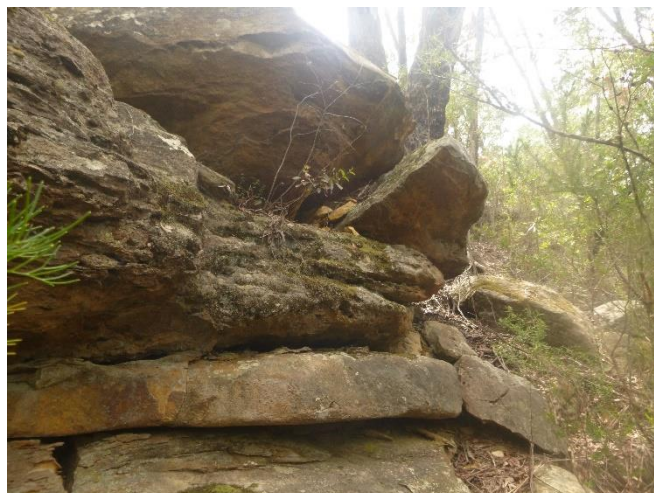
DA3B_LW15_001 is located on a 4m step adjacent to Swamp 23 (Figure 2). The site was mined beneath by Longwall 15 on 28 April 2019. The impact is comprised of rock fracturing and a small rockfall (Photo 45 and Photo 46). The rock fracturing has a maximum measurable length of 1m and a maximum width of 0.01m. The largest rock fragment resulting from the rockfall has a length of 0.40m, width of 0.15m and height of 0.15m. DA3B_LW15_001 was inspected on 26 February 2020 and remains unchanged from original identification (Photo 47).

Level 1: Crack or fracture up to 100m width, and/or, crack or fracture up to 10m length, and/or, rockfall from a cliff (step) which is left mostly intact (<10% length) resulting in insignificant ground disturbance.

Photo 45: DA3B_LW15_001, looking at a section of rockfall. Taken on 29/05/2019.

Photo 46: DA3B_LW15_001, looking at a section of rock fracturing. Taken on 29/05/2019.

Photo 47: DA3B_LW15_001, looking at a section of rock fracturing. Taken on 26/02/2020.

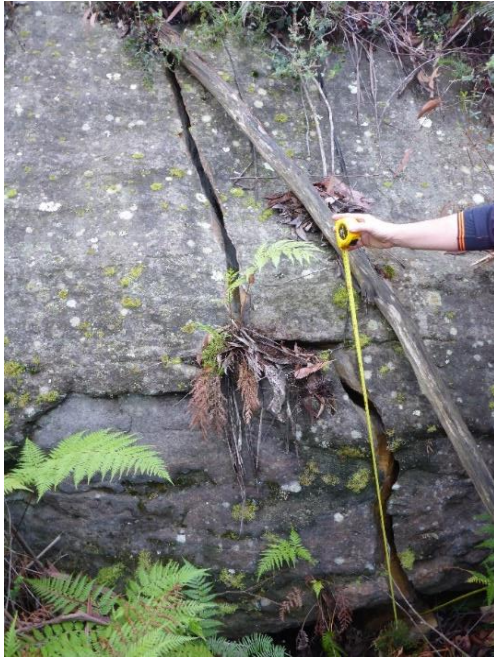
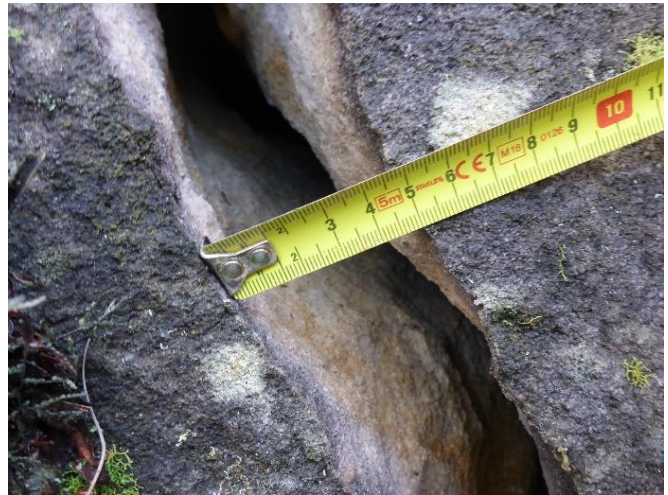
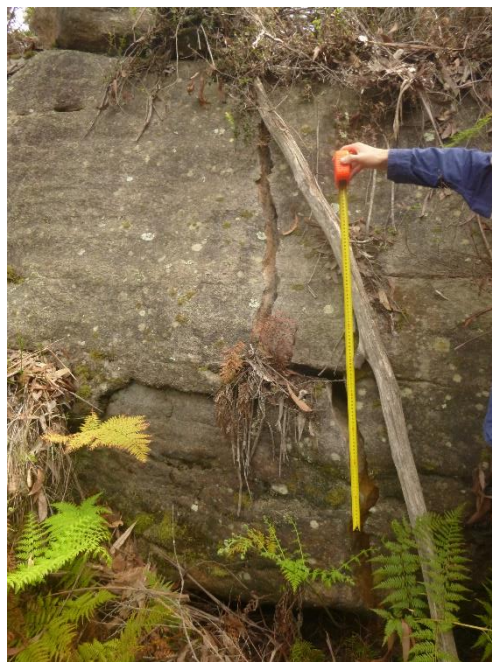
Photo 54: DA3B_LW15_007, looking at fracturing on step. Taken on 09/07/2019.

Photo 55: DA3B_LW15_007, looking at width of fracturing. Taken on 09/07/2019.

Photo 56: DA3B_LW15_007, looking at fracturing on step. Taken on 26/02/2020.

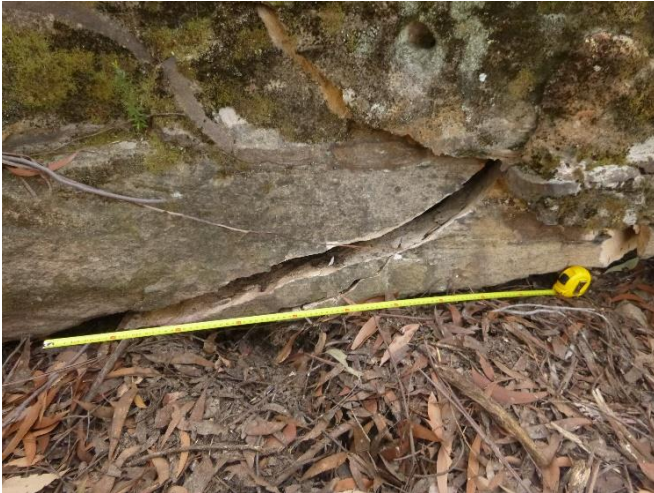
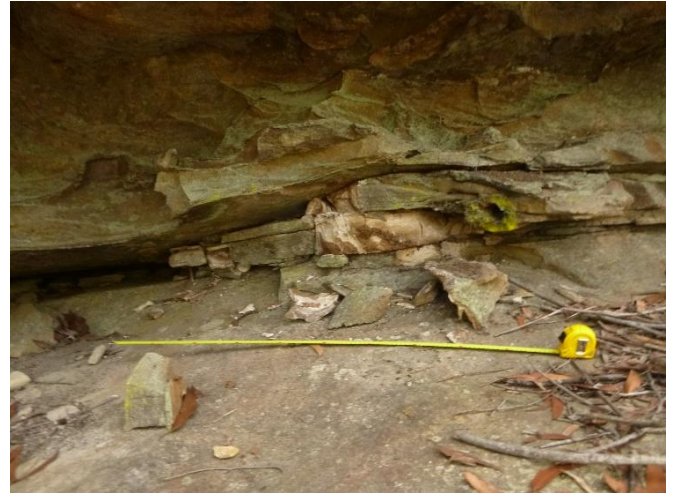
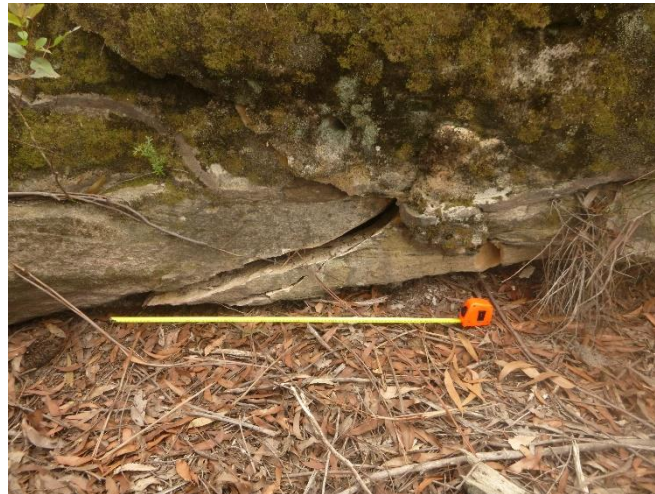
Level 1: Crack or fracture up to 100mm width, and/or, crack or fracture up to 10m length and/or rockfall from a cliff (step) which is left mostly intact (<10% length) resulting in insignificant ground disturbance.

Photo 60: DA3B_LW15_013, looking at a section of rock fracturing. Taken on 05/09/2019.

Photo 61: DA3B_LW15_013, looking at a section of rock fragmentation. Taken on 05/09/2019.

Photo 62: DA3B_LW15_013, looking at a section of rock fracturing. Taken on 26/02/2020.

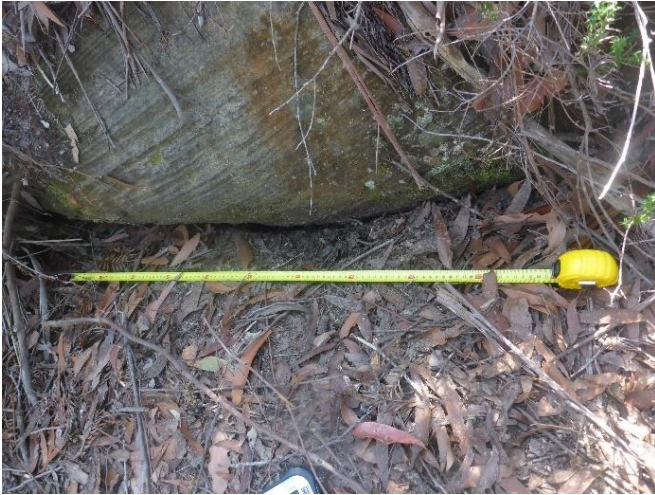
DA3B_LW15_016

Level 1: Crack or fracture up to 100mm width, and/or, crack or fracture up to 10m length.

Photo 63: DA3B_LW15_016, looking at a section of displacement. Taken on 25/10/2019.

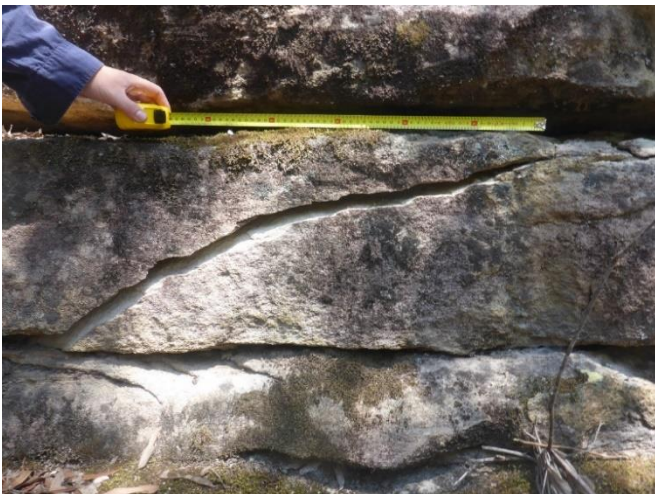
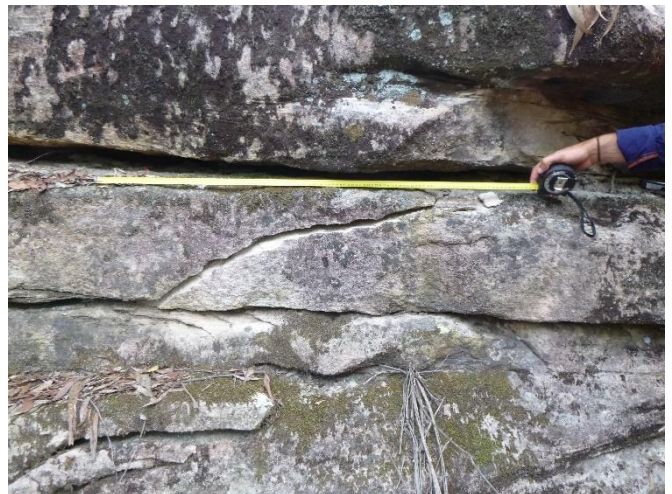
Level 1: Crack or fracture up to 100mm width, and/or, crack or fracture up to 10m length.

Photo 68: DA3B_LW15_018, looking at the rock fracture.
Taken on 25/10/2019.

Photo 69: DA3B_LW15_018, looking at the rock fracture.
Taken on 27/02/2020.

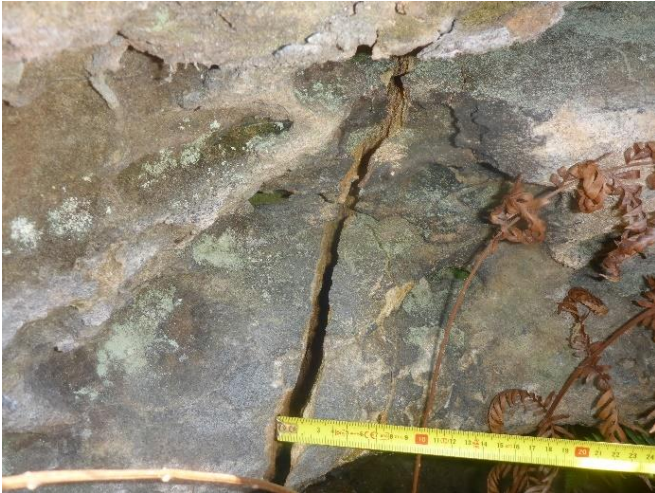
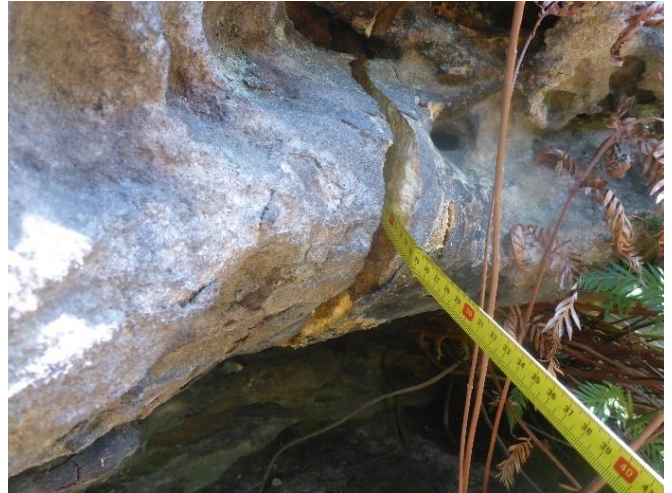
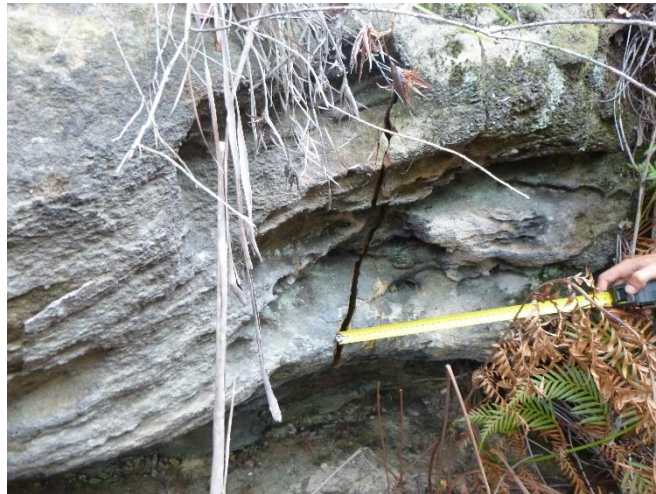
DA3B_LW15_019

Level 1: Crack or fracture up to 100mm width, and/or, crack or fracture up to 10m length.

Photo 70: DA3B_LW15_019, looking at width of rock fracture. Taken on 25/10/2019.

Photo 71: DA3B_LW15_019, looking at horizontal depth of rock fracture. Taken on 25/10/2019.

Photo 72: DA3B_LW15_019, looking at width of rock fracture. Taken on 27/02/2020.

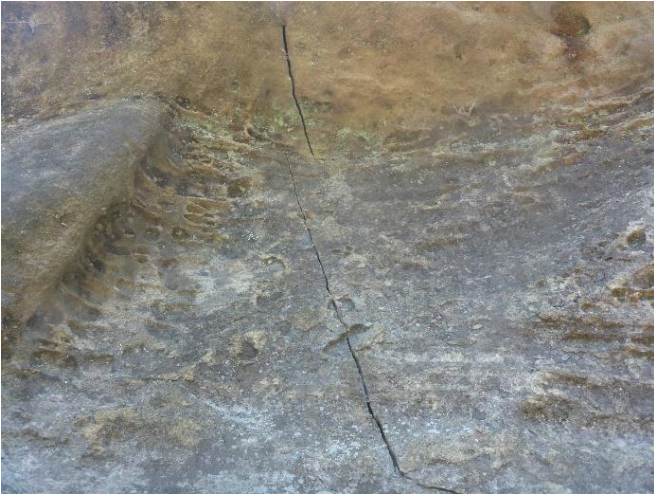
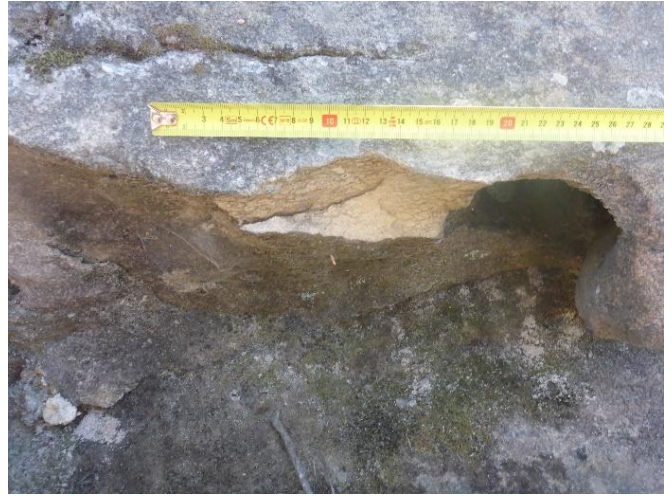
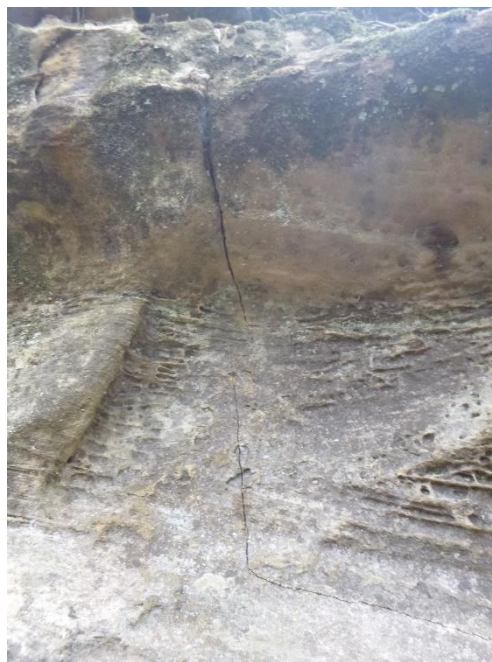
Level 1: Crack or fracture up to 100mm width, and/or, crack or fracture up to 10m length.

Photo 77: DA3B_LW15_022, looking at rock fracture. Taken on 25/10/2019.

Photo 78: DA3B_LW15_022, looking at area of rock displacement. Taken on 25/10/2019.

Photo 79: DA3B_LW15_022, looking at rock fracture. Taken on 27/02/2020.

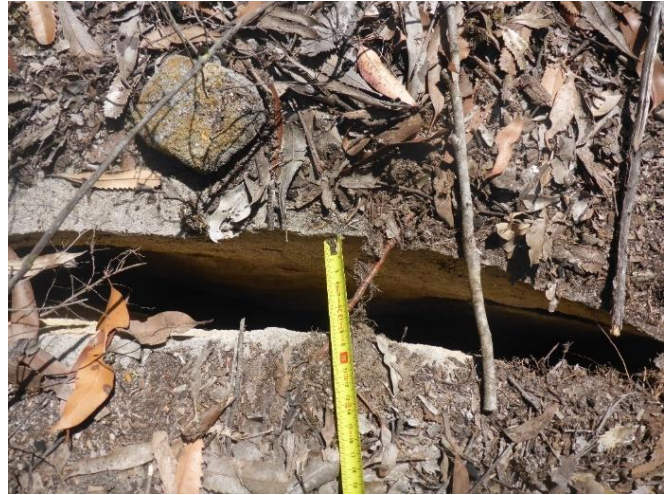
DA3B_LW15_023

Photo 81: DA3B_LW15_023, looking at width of rock fracture. Taken on 25/10/2019.

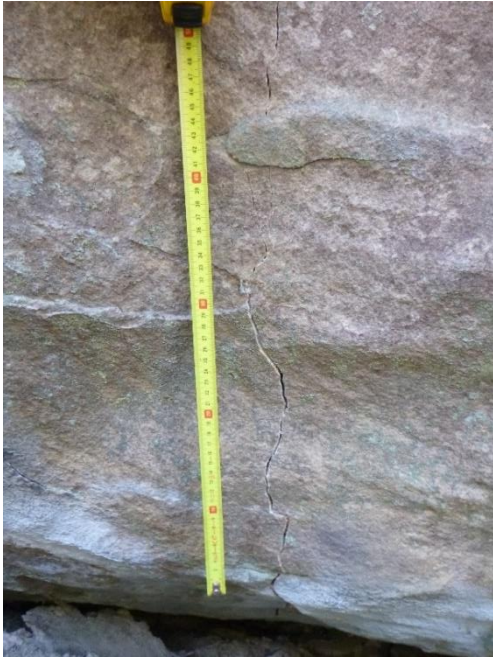
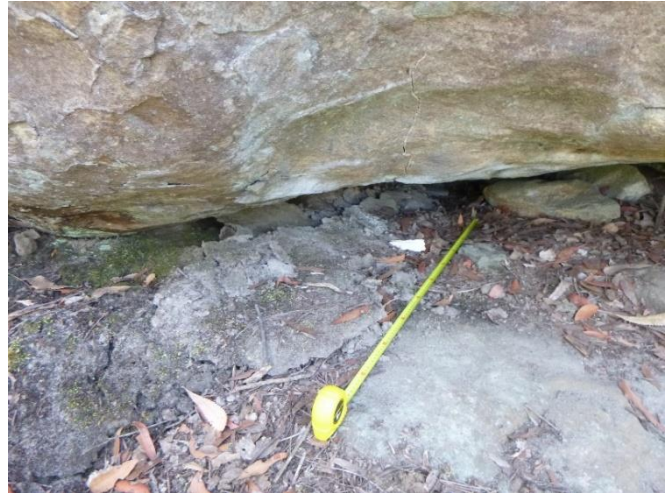
DA3B_LW15_024 Update

Level 1: Crack or fracture up to 100mm width, and/or, crack or fracture up to 10m length, and/or, surface movement or rock displacement with negligible soil surface exposed.

Photo 82: DA3B_LW15_024, looking at the rock fracturing. Taken on 21/01/2020.

Photo 83: DA3B_LW15_024, looking at area of soil uplift. Taken on 21/01/2020.

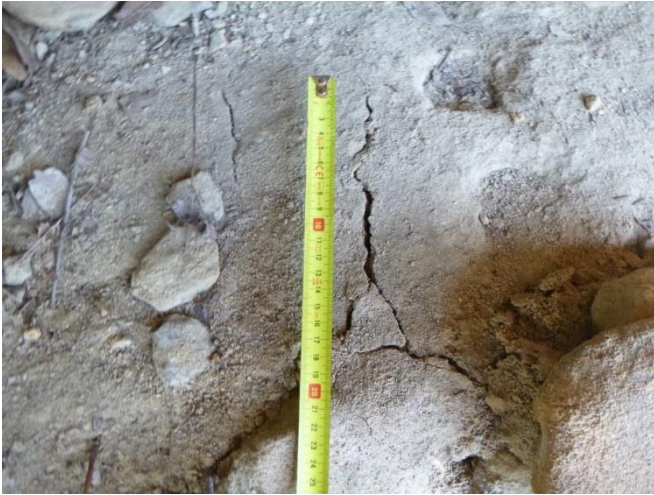
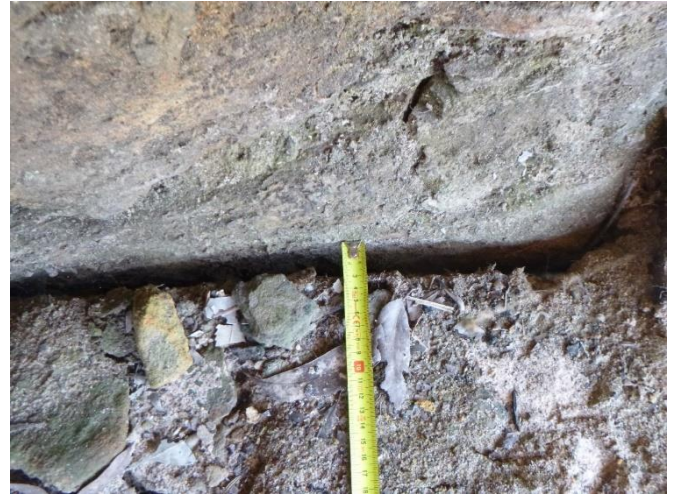
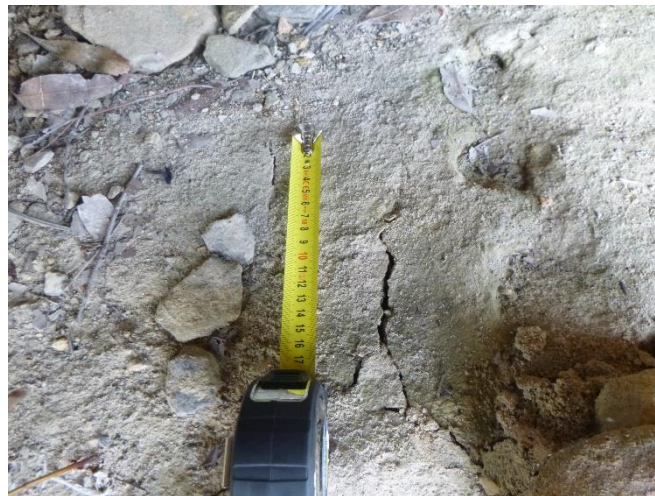
Level 1: Crack or fracture up to 100mm width, and/or, crack or fracture up to 10m length.

Photo 90: DA3B_LW15_026, looking at soil cracking.
Taken on 21/01/2020.

Photo 91: DA3B_LW15_026, looking at width of soil displacement. Taken on 21/01/2020.

Photo 92: DA3B_LW15_026, looking at soil cracking.
Taken on 27/02/2020.
