END OF PANEL
LANDSCAPE REPORT
DENDROBIUM AREA 3B

DENDROBIUM AREA 3B
LONGWALL 15 END OF PANEL
LANDSCAPE REPORT
MARCH 2020

This report summarises the observed and measured subsidence effects on landscape features resulting from the extraction of Dendrobium Area 3B (DA3B) Longwall 15.

Longwall 15 is the seventh panel extracted from DA3B. Extraction began on 4 April 2019 and was completed on 22 January 2020.

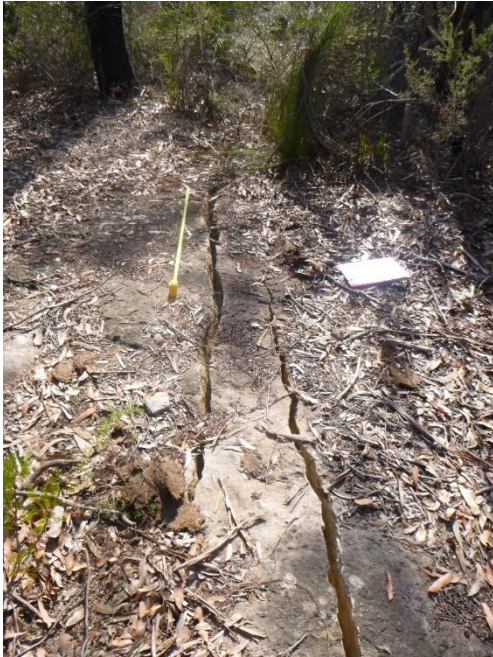
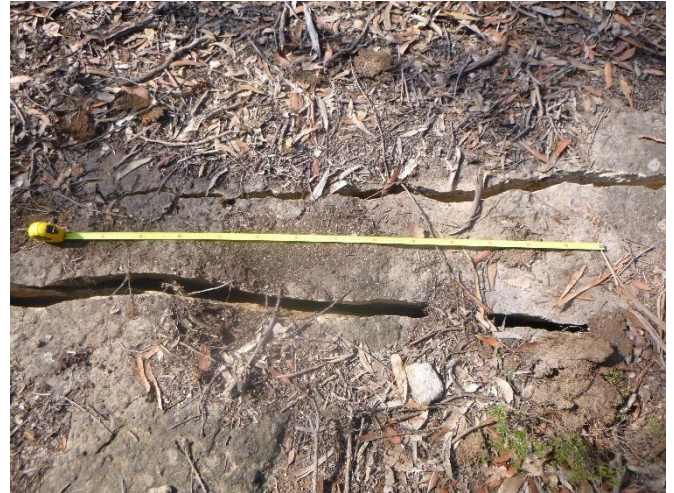
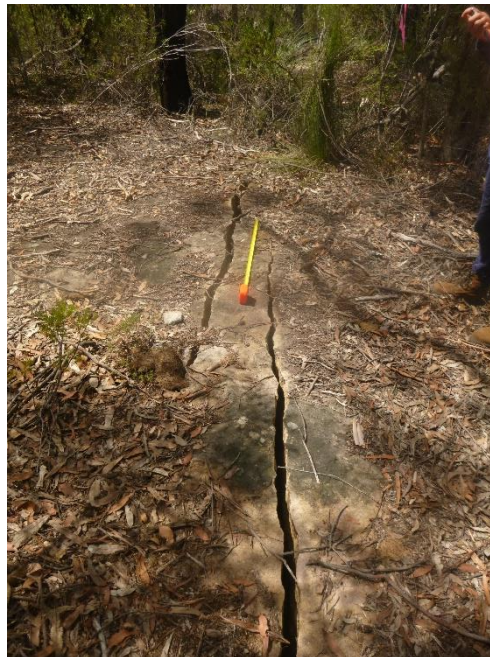
DA3B_LW15_028

Level 1: Crack or fracture up to 100mm width, and/or, crack or fracture up to 10m length.

Photo 93: DA3B_LW15_028, overview of the impact site. Taken on 30/01/2020.

Photo 94: DA3B_LW15_028, looking at rock fracturing. Taken on 30/01/2020.

Photo 95: DA3B_LW15_028, overview of the impact site. Taken on 26/02/2020.

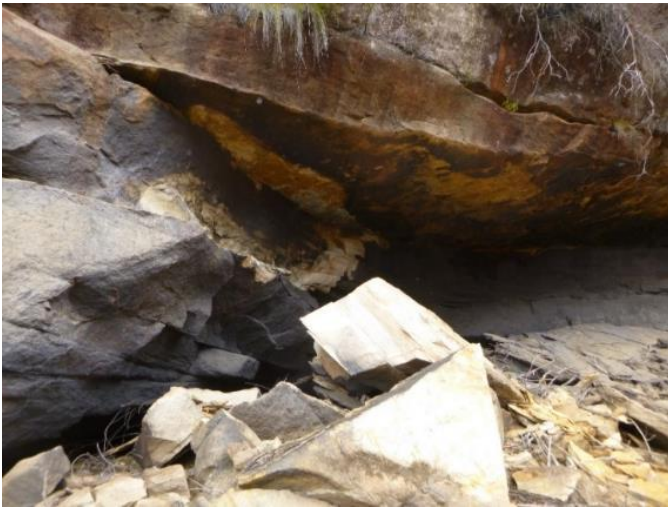
DA3B_LW14_015 Update

Level 2: Rockfall or overhang collapse at a cliff site where characteristics of the cliff have changed, and there has been significant ground disturbance.

Photo 96: DA3B_LW14_015, looking at the original rockfall.
Taken on 5/12/2018.

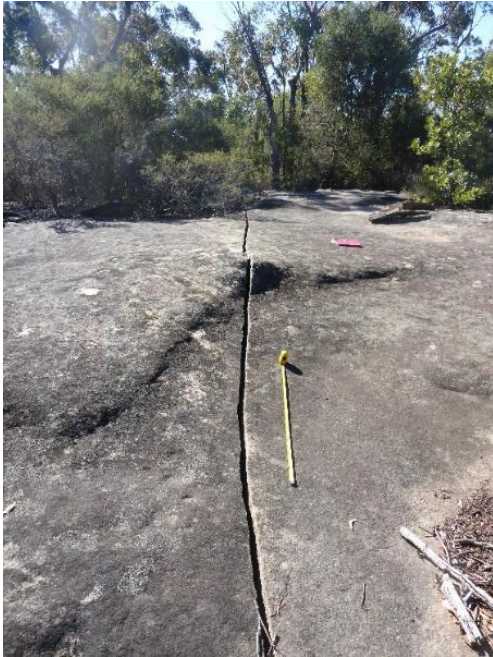
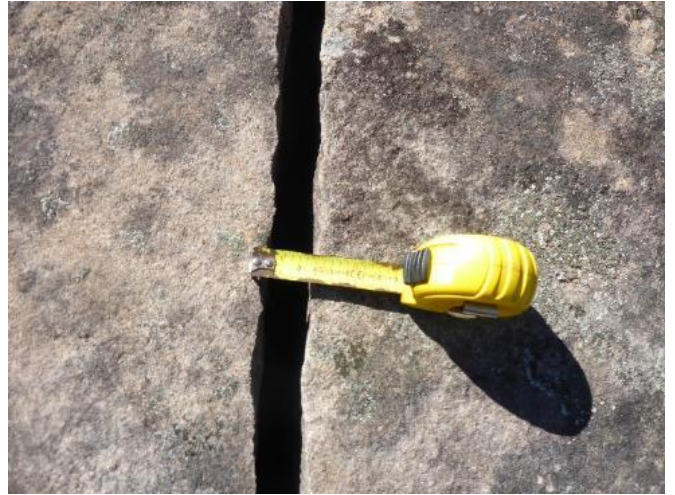
Level 2: Crack or fracture between 10 and 50m length.

Photo 100: DA3A_LW7_001, looking at section of cracking. Taken on 20/08/2019.

Photo 101: DA3A_LW7_001, looking at width of cracking. Taken on 20/08/2019.

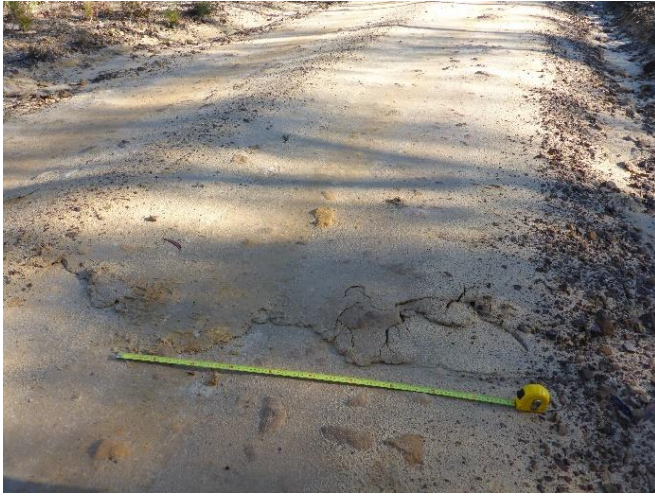
Photo 102: DA3B_LW15_005. Taken on 09/07/2019.

Erosion in a localised area, which would be expected to naturally stabilise without CMA and within the period of monitoring.

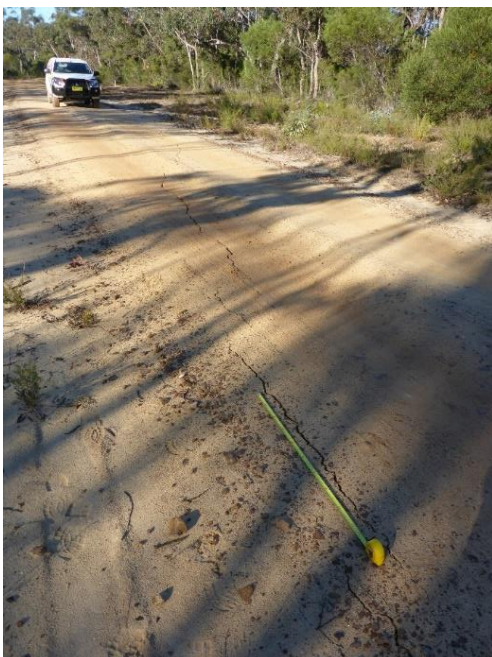
Photo 110: DA3B_LW15_004. Taken on 09/07/2019.

Crack or fracture between 10m and 50m length.

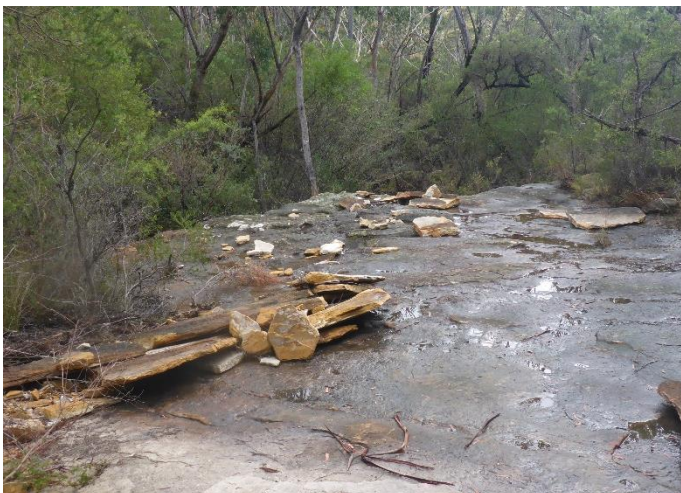
Increased rock fragmentation and displacement has been observed at *WC15*, following a heavy rainfall event (455.5mm between 8 February 2020 to 10 February 2020). Existing rock fracturing and uplift has been dislodged and displaced downstream from original site (Photo 118 and Photo 119). Monitoring will continue along *WC15* with any further changes reported.

Photo 118: *WC15_Rockbar 21*, looking downstream at rock debris. Taken on 10/03/2020.
