Re: Dendrobium Colliery Longwall 15 End of Panel Report - Aboriginal Heritage Assessment – (Niche ref #5721)

Niche Environment and Heritage (Niche) has undertaken a site assessment and review of the predicted and observed impacts on Aboriginal cultural heritage sites and their associated values resulting from the extraction of Longwall 15 at Dendrobium Colliery. This assessment was developed for inclusion in the South32 - Illawarra Metallurgical Coal (IMC) End of Panel Report (EoP) for Longwall 15.

1. Aboriginal heritage assessment

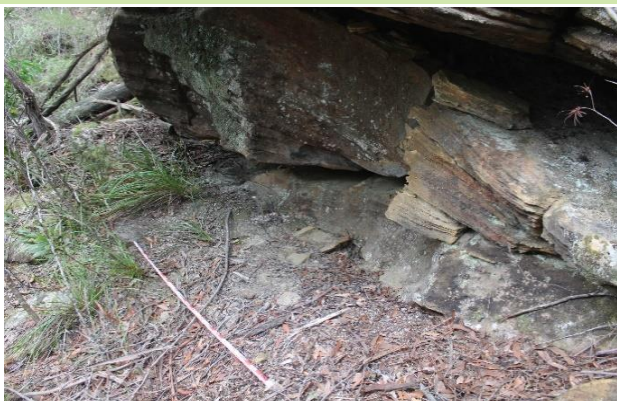
AHIMS number	Site name	Results of inspections
52-2-1623	Browns Road Site 8	This Shelter with Deposit site was previously recorded during the Longwall 9 -18 baseline recording completed by Biosis (2012). During the recent monitoring, no impacts related to the extraction of Longwall 15 were observed. The shelter had a dry interior, despite recent rain. Naturally occurring granular loss, exfoliation, mineral efflorescence and microvegetation were observed within the interior of the shelter. The chert flake noted in the AHIMS site card recording completed by Sefton during 1981 could not be relocated at the time of the site inspection due to deep leaf litter (Plate 1).

Plate 1: General photo of Browns Road Site 8 facing west showing leaf litter interior covering the deposit.

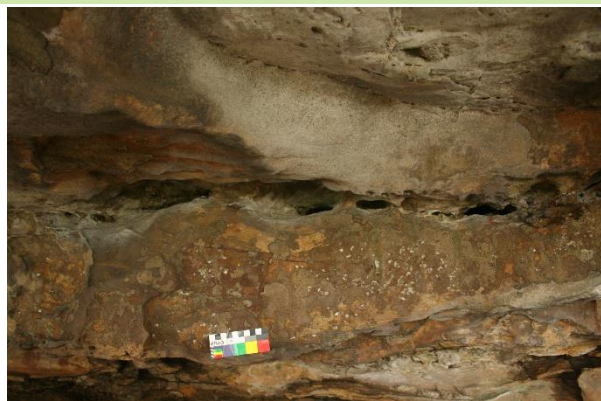
Plate 2: Comparison photograph from the Biosis (2012) Longwall 9- 18 baseline recording showing bedding lines in the back wall of shelter that have remained unchanged (source: Biosis 2012).

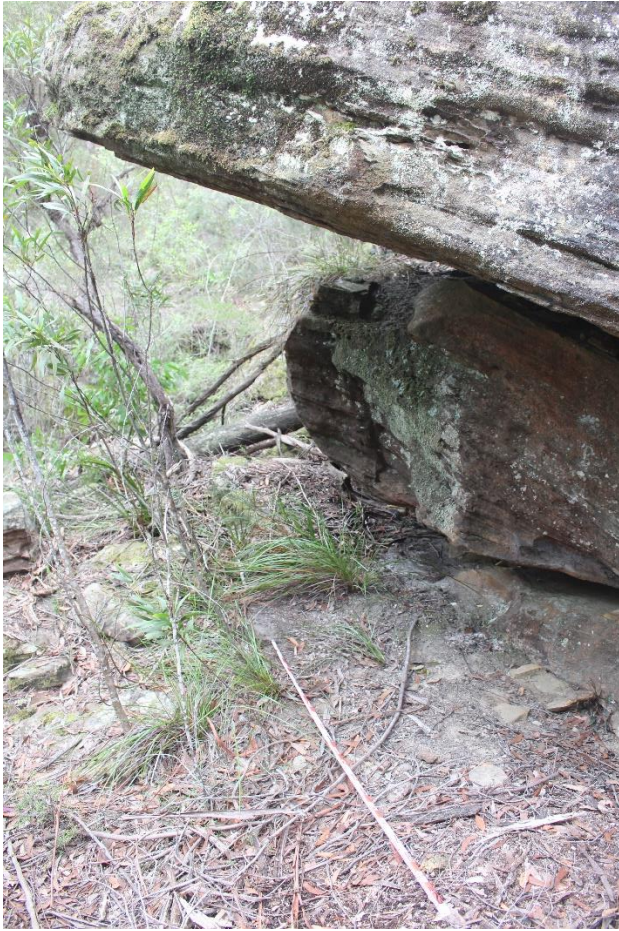
Plate 3: Close up of shelter roof and backwall facing north west.

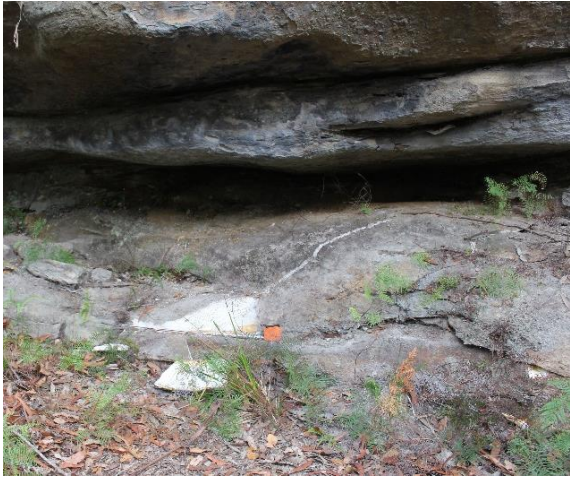
AHIMS number	Site name	Results of inspections
52-2-1626	Browns Road Site 11	<p>This Shelter with Art site was previously monitored as part of the Longwall 14 EoP reporting (Niche 2019). The main area of cracking caused by subsidence related effects due the extraction of Longwall 14 was observed in the southern floor area of the shelter. The diagonal cracking measured to an approximate length of 70 cm and a width of 3 cm. The Art Panels located at the northern extent if the shelter were not impacted.</p> <p>The latest inspection identified new subsidence related impacts due to the extraction of Longwall 15.</p> <p>Impacts to the south of the shelter consist of seven vertical and diagonal cracks to the floor of the shelter and two instances of minor block fall, summarised as follows:</p> <ol style="list-style-type: none"> 1) Vertical cracking measuring 76 x 2 cm 2) Diagonal cracking with minor block fall at termination measuring 180 x 6 cm (Plate 5) 3) Diagonal cracking with some deviations measuring 110 x 3.5 cm (Plate 6). The left side of the cracked sandstone has slipped upwards during convergence. 4) Vertical cracking with diagonal deviations resulting in further minor cracks at the base of the shelter (Plate 9) measuring 90 x 0.1 cm. 5) Diagonal cracking measuring 112 x 2 cm with minor block fall observed at termination point (Plate 7) 6) General area of rock fracturing located small sandstone platform at the base of the shelter measuring approximately 46 x 200 cm. Many minor cracks, exfoliation and opening of joints (3 cm wide) are present (Plate 10). 7) Diagonal cracking visible in shallow sandy loam deposit in floor measuring approximately 30 cm in length (Plate 11). <p>New areas of joint opening and fissuring were observed in areas surrounding the two Art Panels to the north of the shelter (Plate 12 and Plate 16). The Art Panels were in moderate condition and have not been directly affected by joint opening or fissuring, although change of seepage patters may further erode opened joints which may lead to direct impacts to Art Panels after large rain events.</p> <p>It is recommended that this Shelter with Art site is monitored after a large rain event (>142 mm rainfall in one day) due to the recognised</p>

Plate 4: Location of crack 1 and 2 facing west.

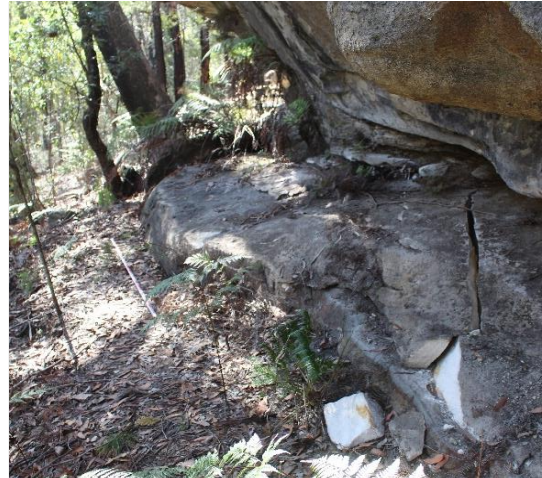
Plate 5: Comparison photo from Niche (2019) Longwall 14 monitoring of cracking and minor block fall at the south end of the shelter facing south.

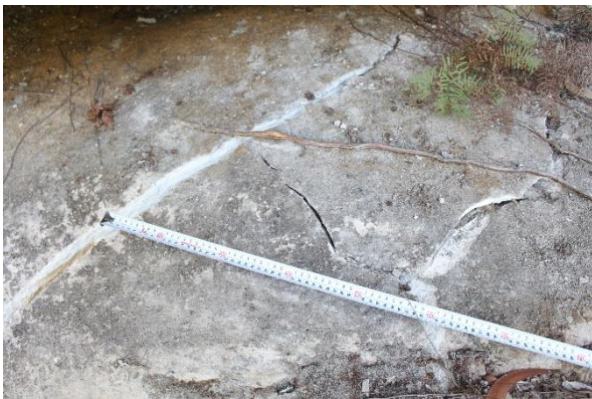
Plate 6: Location of cracks 3 and 4 from an aerial aspect.

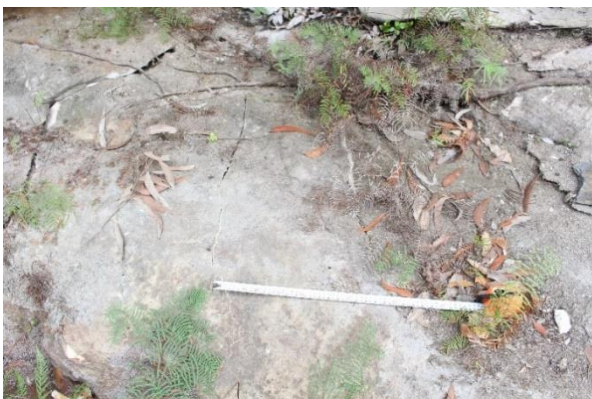
Plate 7: Location of cracks 5 and 6 from an aerial aspect.

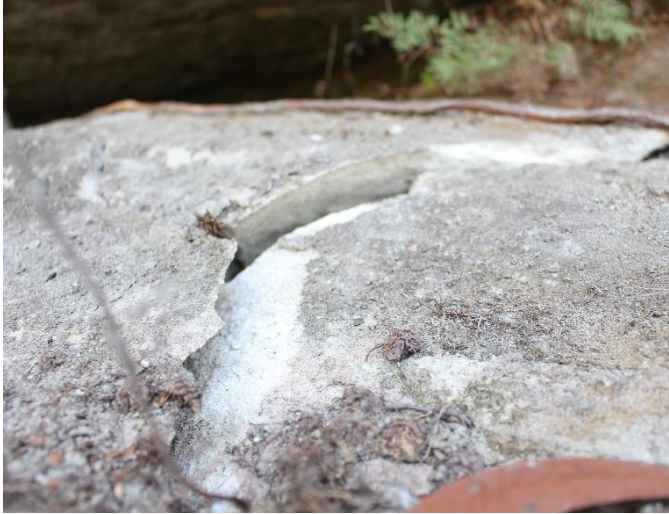
Plate 8: Convergent slip of rock platform at crack 3.

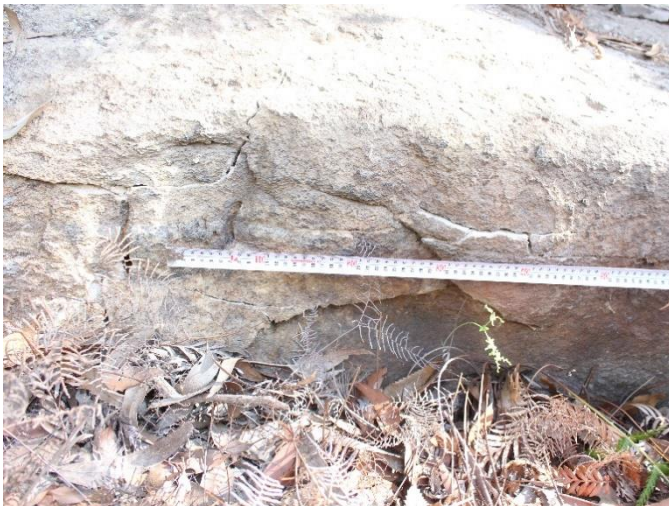
Plate 9: Many minor cracks at the base of shelter below crack 4.

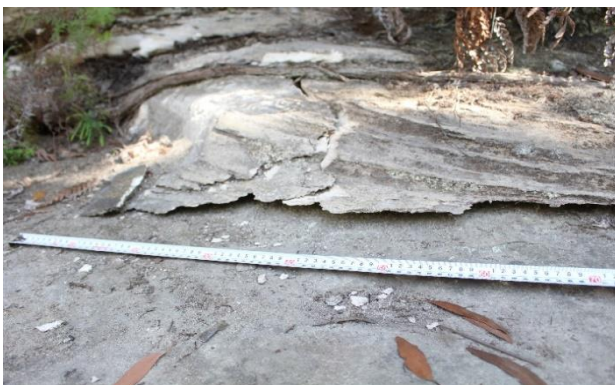
Plate 10: Sandstone exfoliation platform at crack 6.

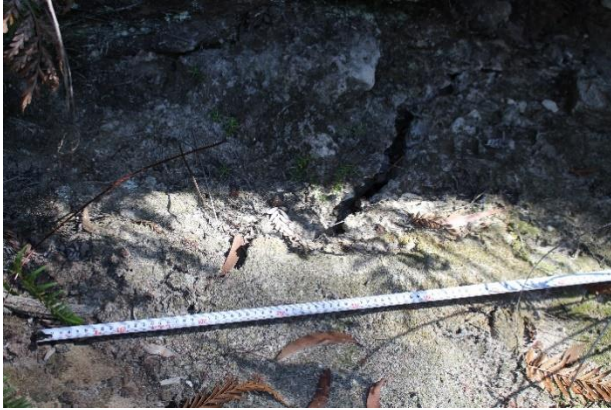
Plate 11: Soil displacement over suspected crack 7.

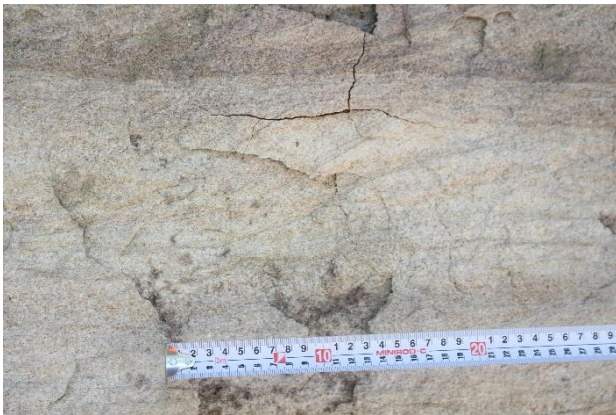
AHIMS number	Site name	Results of inspections
		potential of change in seepage patterns caused by subsidence induced opening of joints and fissuring. A change in seepage may cause direct impacts to the Art Panels in the form of water damage and flaking of the sandstone Art Panels.

Plate 12: Fissuring above Art Panel to the south of the shelter.

6.	Ongoing monitoring of Browns Road Site 11 (AHIMS ID #52-2-2-1626) after large rain events (>142 mm rainfall in one day) to observe and record a change in seepage patterns in areas of fissuring and opening of joints as a result of indirect mining impacts to the Art Panels.

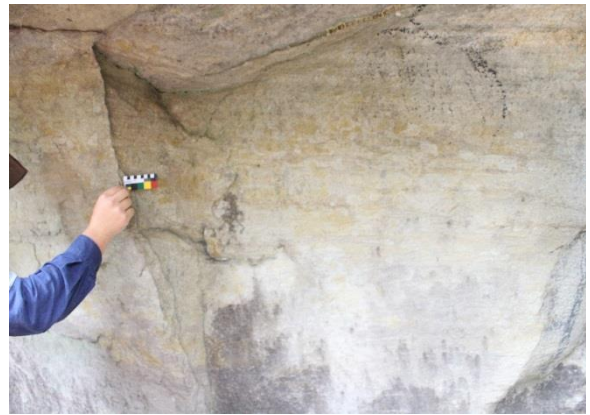
Plate 13: Comparison Image of Art Panel from Niche (2019) Longwall 14 monitoring.

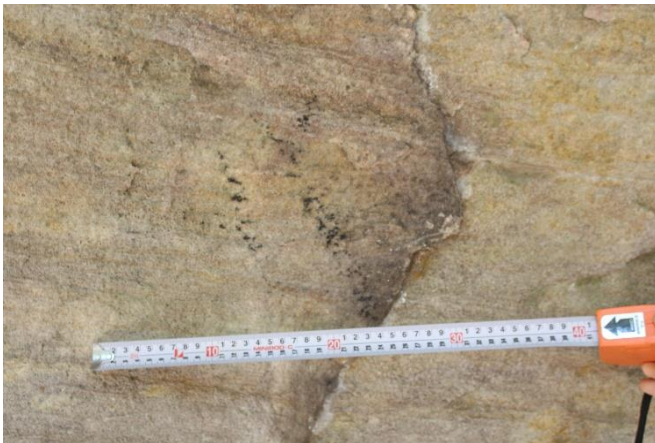
Plate 14: Slight opening of bedding plane adjacent to Art Panel located in the southern extent of the shelter.

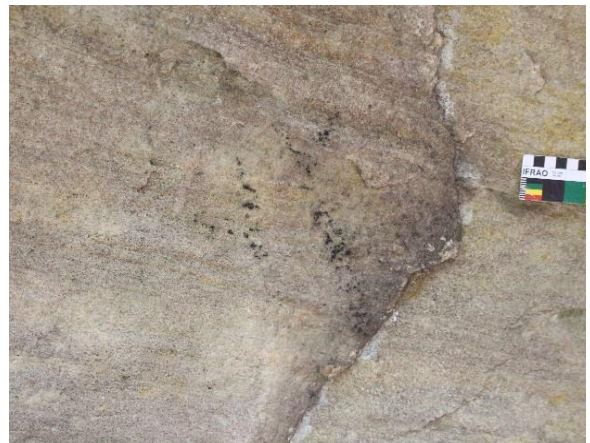
Plate 15: Comparison image bedding planes adjacent to indeterminate art motif from Niche (2019) Longwall 14 monitoring.

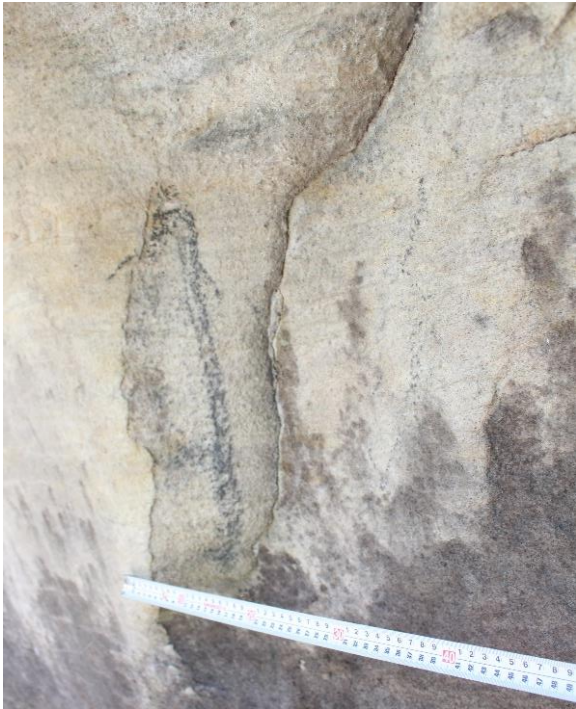
Plate 16: Opening of bedding plane adjacent to Art Panel to the south of the shelter.

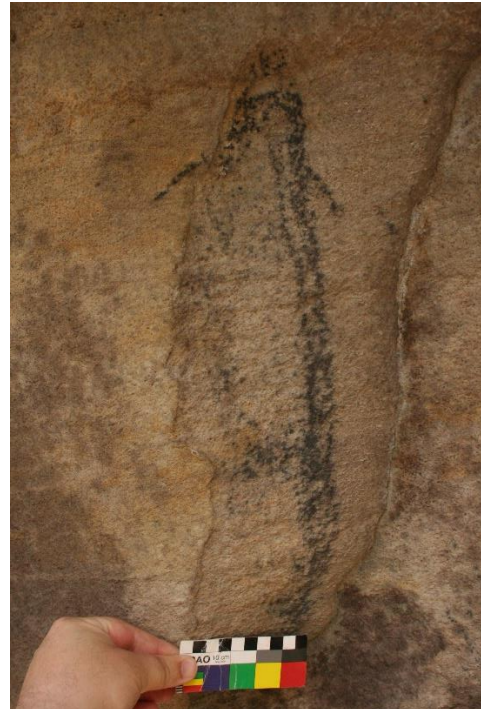
Plate 17: Comparison image from Bosis (2012) Longwall 9 -18 baseline recording showing bedding plane to the right of the art closed (source: Bosis 2012).

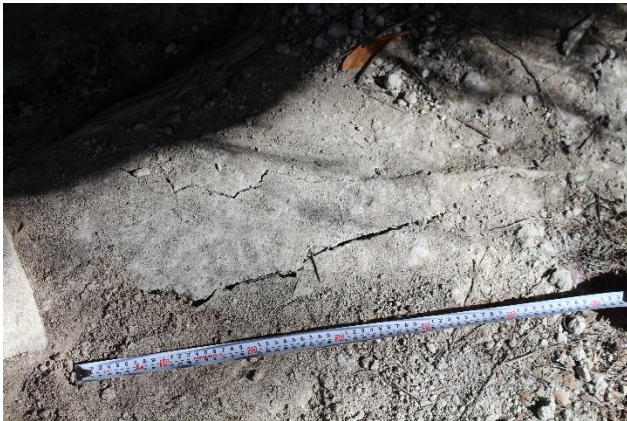
Plate 18: New floor cracking in the southern end of the shelter.

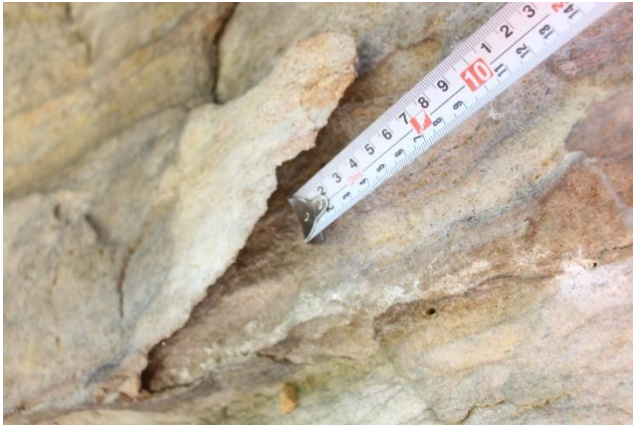
Plate 19: Flaking of sandstone the southern back wall of the shelter.

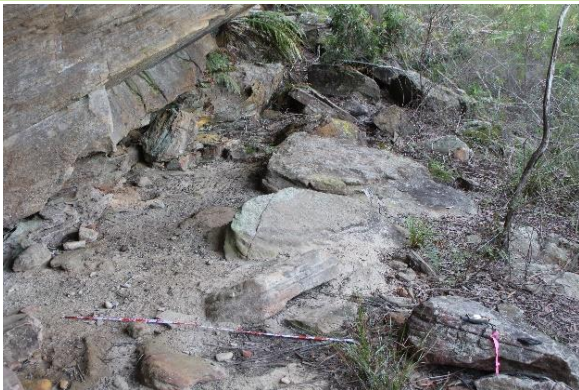
AHIMS number	Site name	Results of inspections
52-2-1771	Upper Avon 35	This Shelter with Deposit site was previously recorded during the Longwall 9 -18 baseline recording report completed by Biosis (2012). During the recent monitoring, no impacts related to the extraction of Longwall 15 were observed. The shelter had a dry interior despite recent rain. Granular loss, exfoliation and microvegetation were observed within the shelter. Four of the eight artefacts noted in the AHIMS site card recording completed by Biosis (2007) were relocated (Plate 22 and Plate 23).

Plate 20: General photo of shelter facing south.

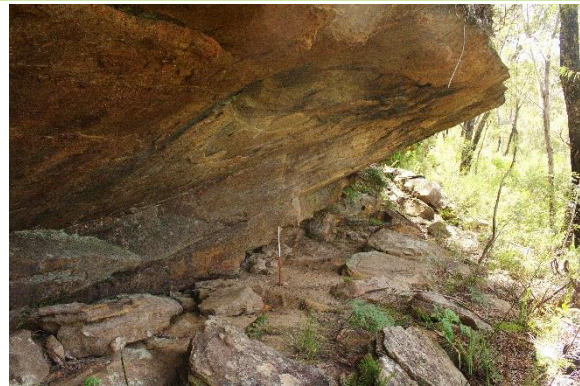
Plate 21 Comparison general photo of shelter from Biosis (2012) Longwall 9-18 baseline recording (source: Biosis 2012).

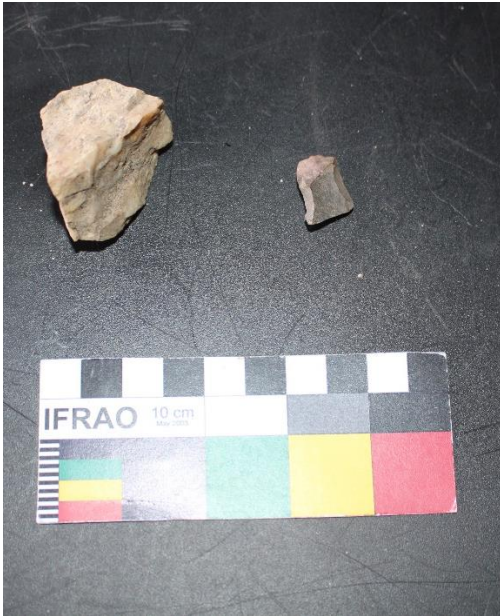
Plate 22: One chert core and petrified wood flake artefacts located in deposit during monitoring.

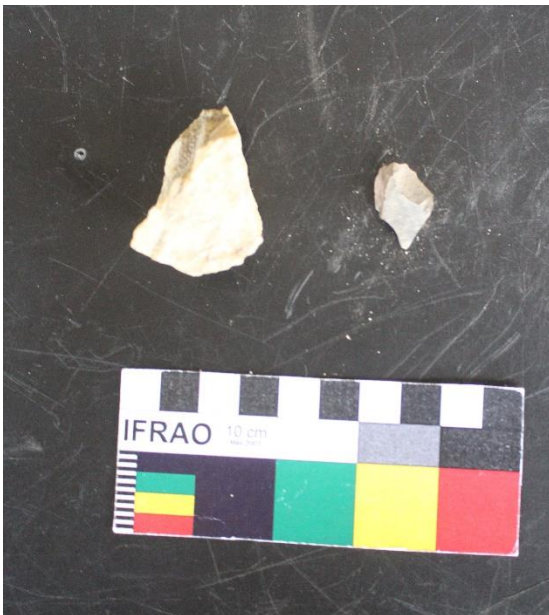
Plate 23: Two quartz flake artefacts located in deposit during monitoring.

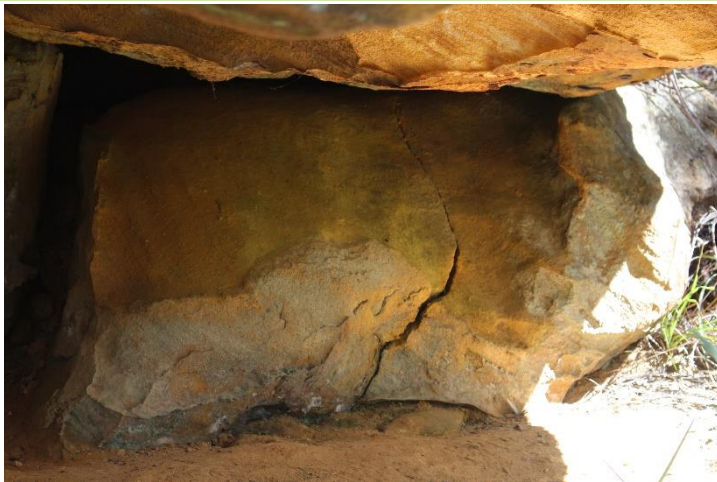
AHIMS number	Site name	Results of inspections
52-2-2229	Site 1-DB1	<p>This Shelter with Art site was identified to have been impacted from the extraction of Longwall 14 resulting in subsidence related vertical cracking located at the backwall of the shelter. It has since been resolved that this site was not impacted by the extraction of longwall mining. The observable crack in the backwall of the shelter was observed prior to longwall mining (Biosis 2012). The cracking at the backwall of the shelter (Plate 25) has occurred due to natural processes.</p> <p>Nor subsidence related impacts were observed during the Longwall 15 EoP monitoring. The shelter was deemed unsafe to enter due to the large crack in the back wall of the shelter. The Art could not be relocated from distant inspection. The roof of the shelter has naturally exfoliated. The interior of the shelter was dry despite recent rain.</p>

Plate 24: Close up photo of vertical crack in the back wall of shelter that occurred due to natural processes (Niche 2020). No changes observed.

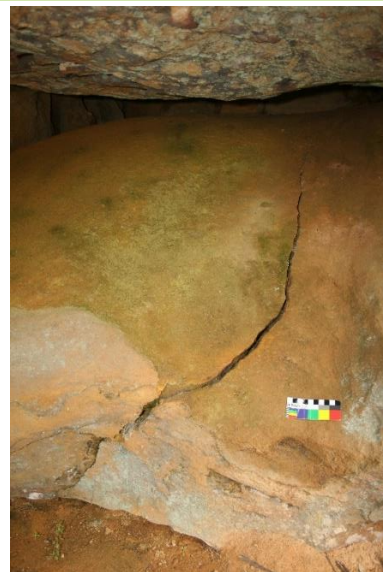
Plate 25: Comparison image of vertical crack in the back wall of shelter from Biosis (2012) Longwall 9-18 baseline recording (source: Biosis 2012).

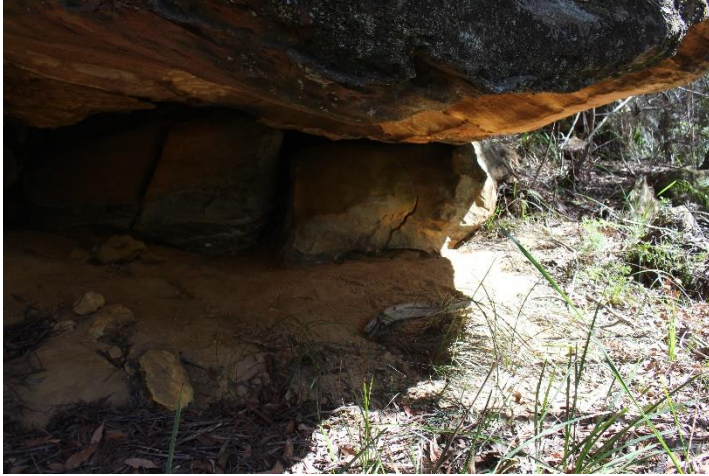
Plate 26: General photo of interior of Site 1-DB1 facing north.

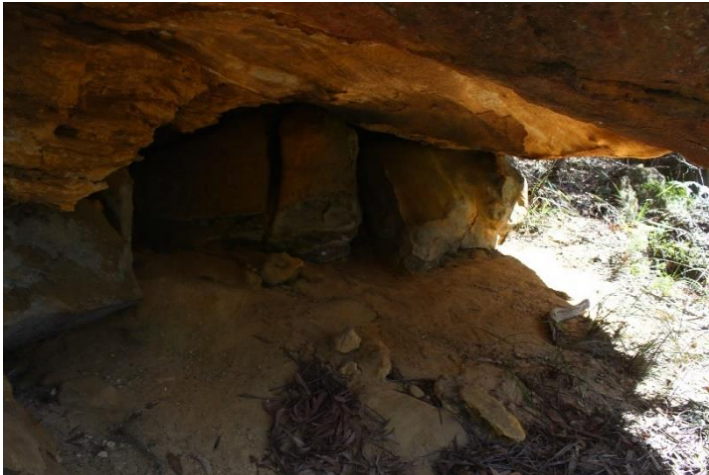
Plate 27: General photo from a distance showing the general location of Art Panel located on the roof of shelter facing north.

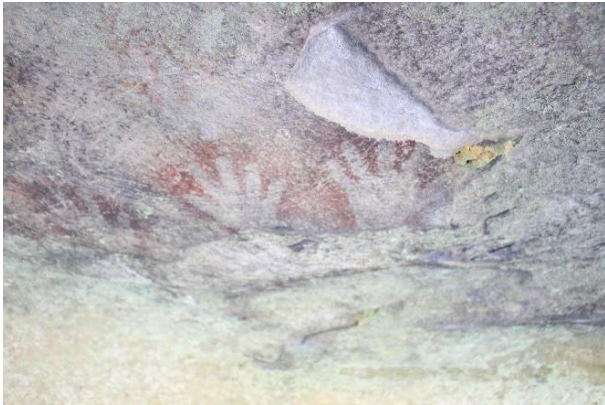
Plate 28: Image of fading ochre hand stencils located on the roof shelter.

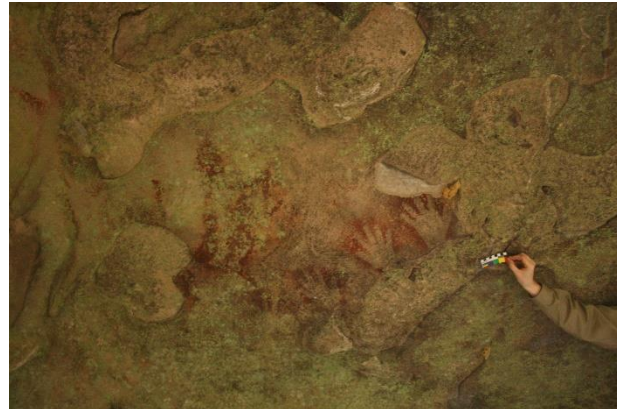
Plate 29: Comparison image ochre hand stencils taken during Biosis (2012) Longwall 14 EoP monitoring (source: Biosis 2012).

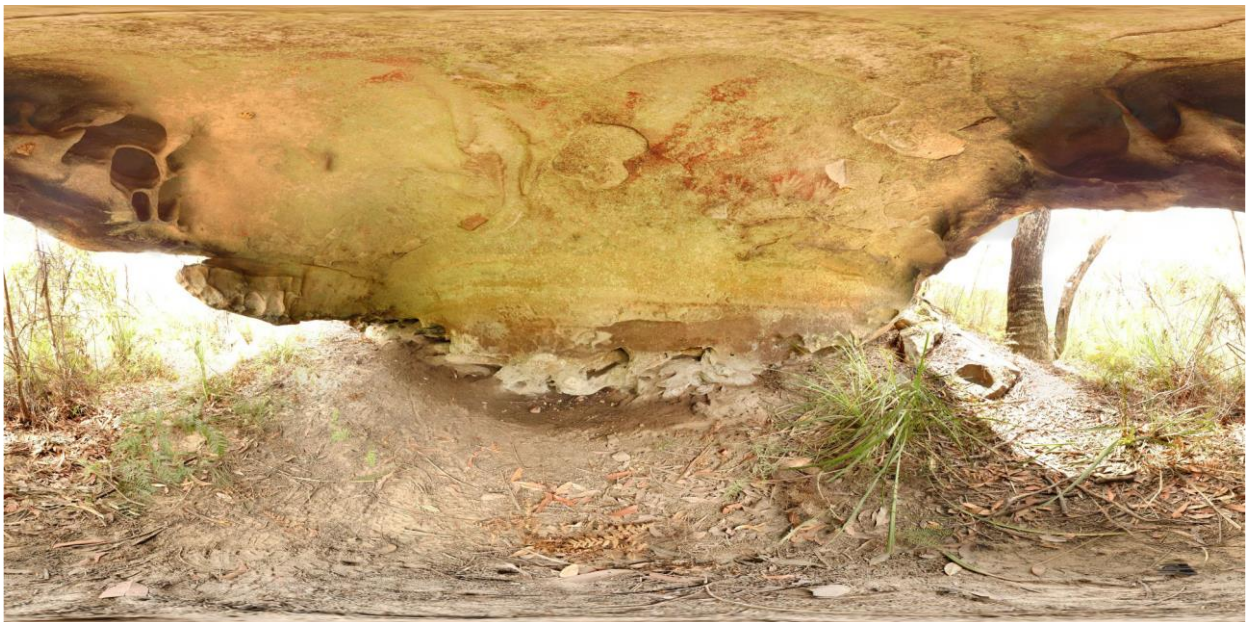
Plate 30 Comparison spherical photo of the interior cavern area taken during Biosis (2012) Longwall 9 -18 baseline recording (source: Biosis 2012).

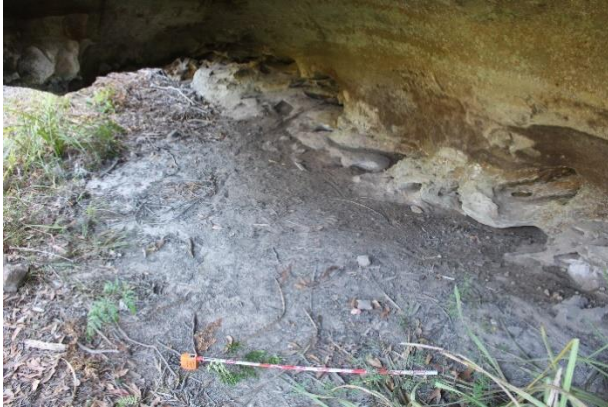
Plate 31: General photo of interior cavern area facing south west.

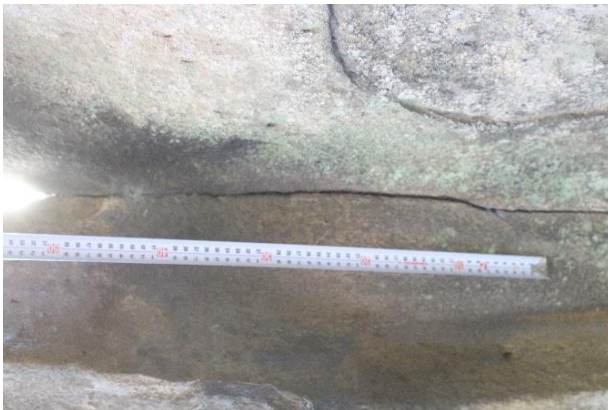
Plate 33: Natural fissuring located on southern extent of the shelter.

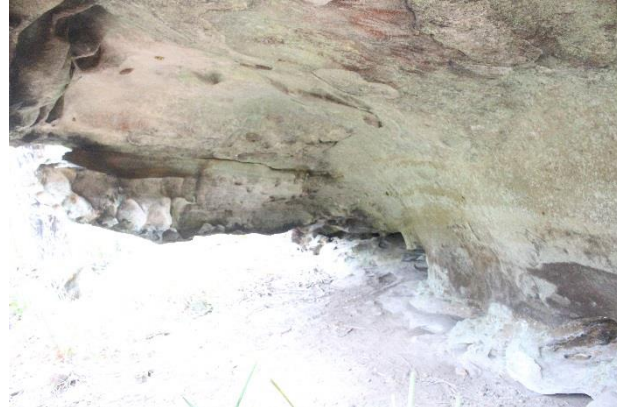
Plate 32: Comparison image of interior cavern area taken during Biosis (2012) Longwall 9 -18 baseline recording (source: Biosis 2012).

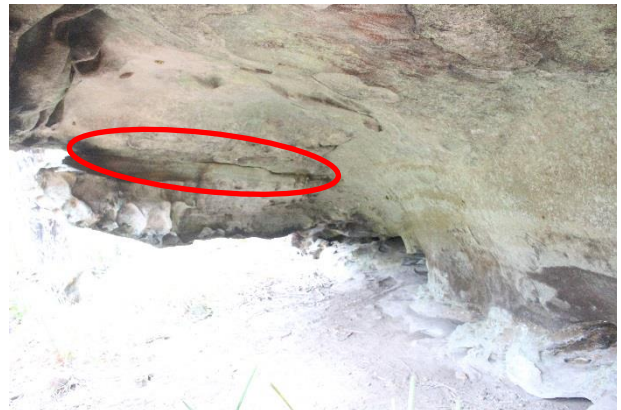
Plate 34: Comparison image of interior of the shelter taken during Biosis (2012) Longwall 9 -18 baseline recording. Location of natural fissuring circled in red (source: Biosis 2012).

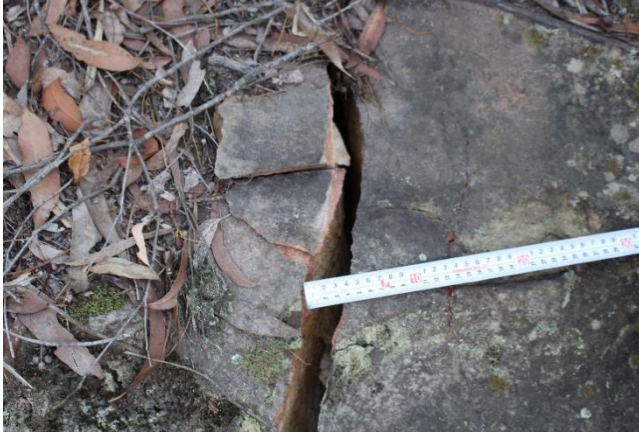
AHIMS number	Site name	Results of inspections
52-2-3645	DM 21	<p>This Shelter with Art and Deposit site was previously recorded as part of the Longwall 14 EoP monitoring program (Niche 2019). The site did not experience any impacts in result of the extraction of Longwall 14.</p> <p>The landscape surrounding the shelter site has experienced a range of subsidence impacts from the extraction of Longwall 15 such as localised rockfalls to the upper ridgelines (South 32 2020). The northern exterior of the shelter has experienced fracturing as result of subsidence from the extraction of Longwall 15. Four main instances of vertical and diagonal cracking were observed. The largest crack at the base of the ridgeline measures 3.7 cm in width.</p> <p>The interior cavern of the shelter did not have any direct impacts from subsidence. The monitoring point of natural fissuring (Plate 33 and Plate 34) did not have any further separation in comparison to previous monitoring. It was observed that Art Panels have substantially faded in comparison to baseline recording (Plate 28, Plate 29 and Plate 30). Vegetation surrounding the shelter is notably reduced from archaeological observations of shelter. The reduction of vegetation may have resulted in the interior of the shelter being increasingly exposed to natural erosive elements.</p> <p>It is recommended that this site is revisited as part of the Longwall 16 monitoring.</p>

Plate 35: Close up of vertical cracking located northern exterior of the shelter cavern area.

7.	Include DM 21 (AHIMS ID #52-2-3645) in the Longwall 16 End of Panel monitoring program and continue to monitor for further impacts as a result of subsidence at the site.
	General

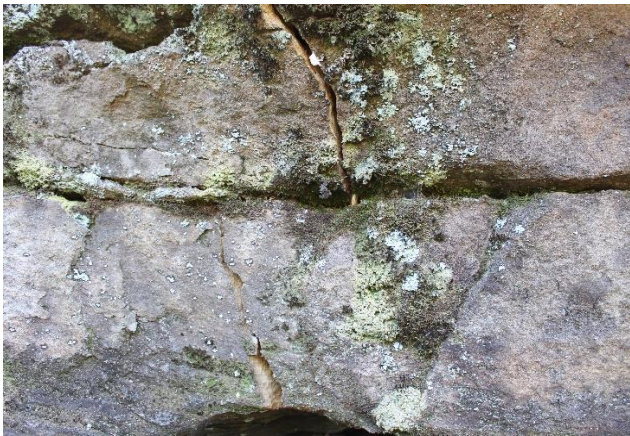
Plate 37: Two new instances of vertical cracking located northern exterior of the shelter cavern area.

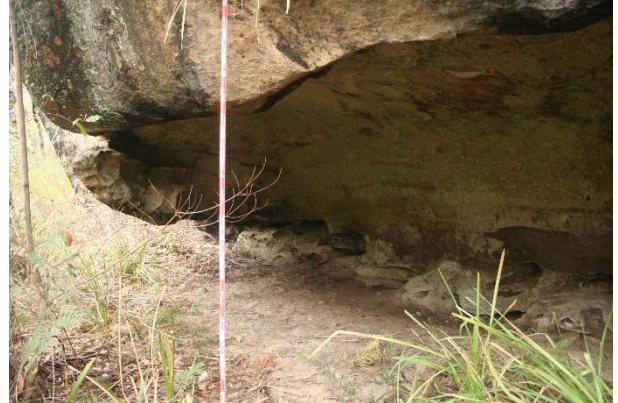
Plate 36: General image of DM 21, taken during Biosis (2012) Longwall 9 -18 baseline recording (source: Biosis 2012).

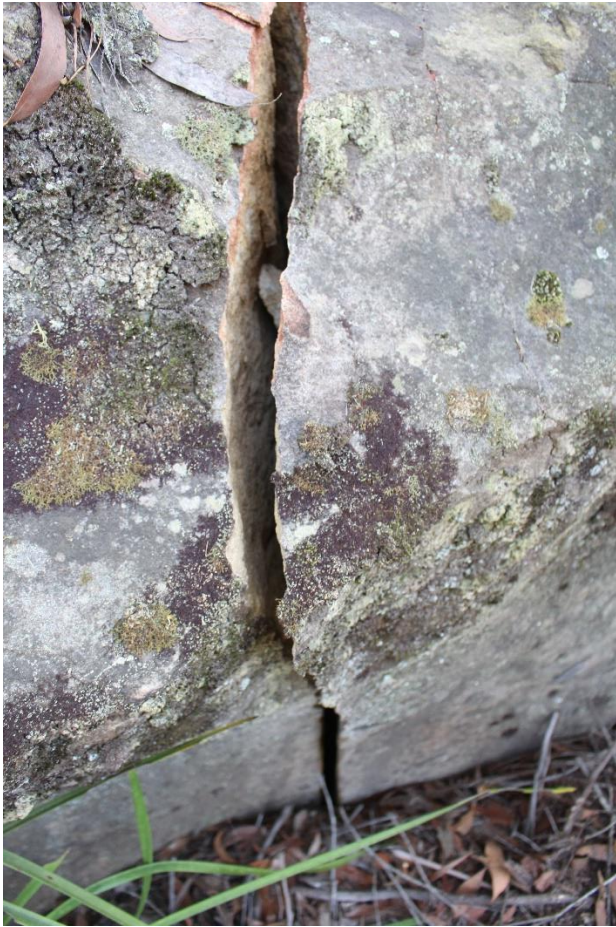
Plate 38: Close up of vertical cracking located at the base of the northern exterior of the shelter cavern area.

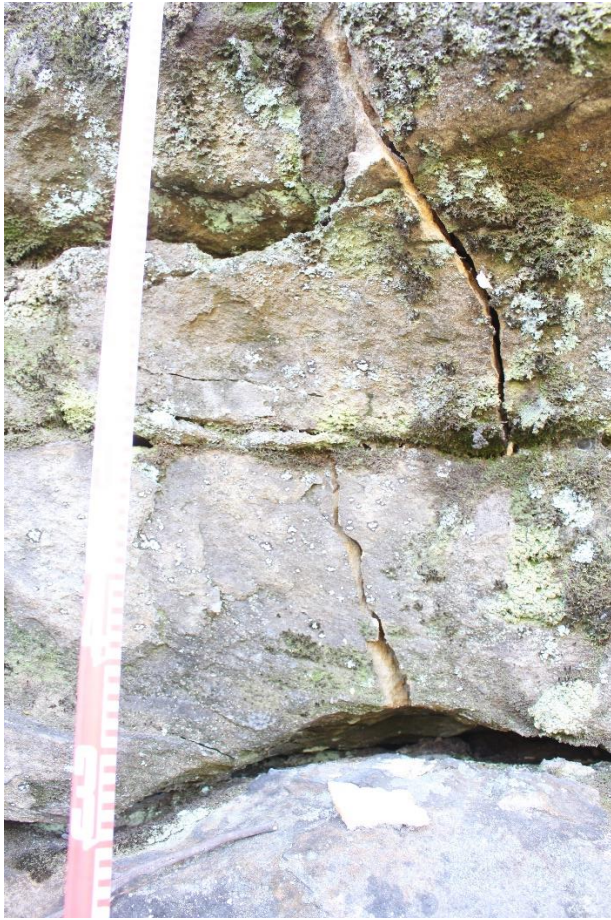
Plate 39: Close up of diagonal cracking located northern exterior of the shelter cavern area.
