DA3B_LW16_003 Update (E288849, N6191590)

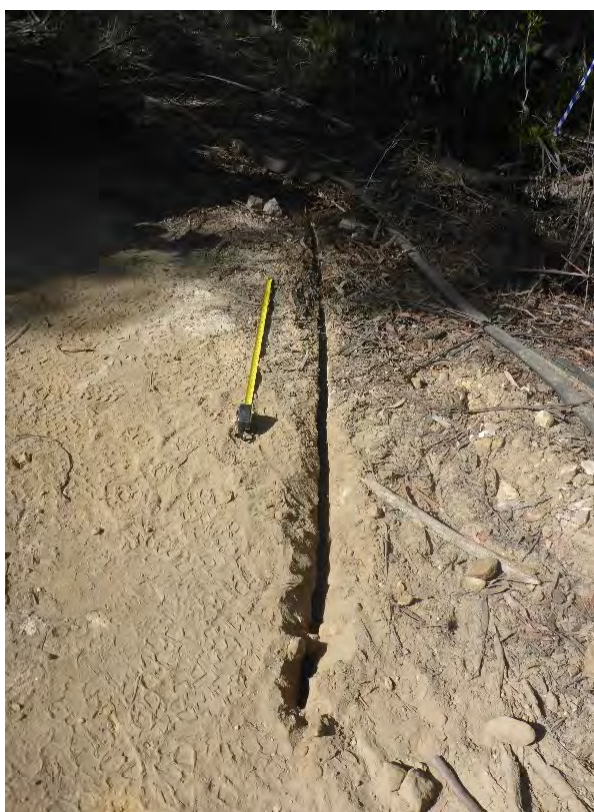
DA3B_LW16_003 is situated on an access track between *Lake Avon* and *Fire Road 6A* (Figure 1). The site was undermined by Longwall 16 on 21 March 2020. The impact was originally reported as two soil cracks. On the latest inspection, rock fracturing was identified adjacent to the previously identified soil cracking (Photo 1 and Photo 2). The rock fracturing has a maximum length of 5.1m, a maximum width of 0.05m and a maximum measurable depth of 8.8m.

DA3B_LW16_003 remains a Level 1 trigger as per the Dendrobium Area 3B Landscape TARP (Appendix A: Table 1), specifically:

Photo 1: *DA3B_LW16_003*, looking at a section of rock fracturing. Taken on 22/04/2020.

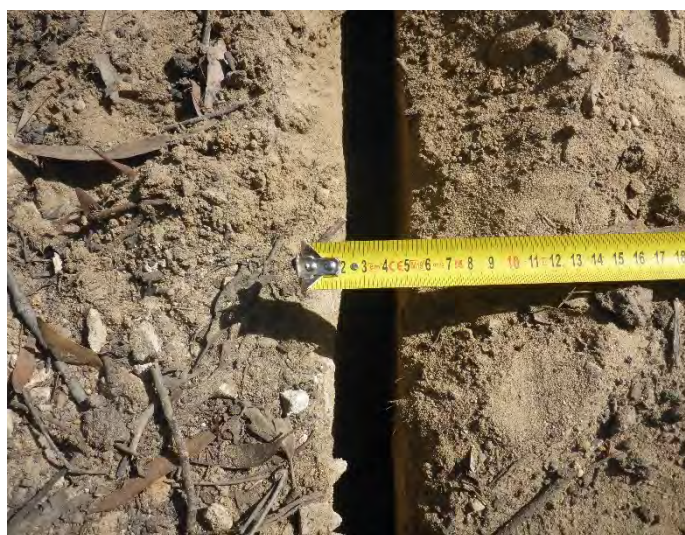
Photo 2: *DA3B_LW16_003*, looking at the width of the rock fracturing. Taken on 22/04/2020.

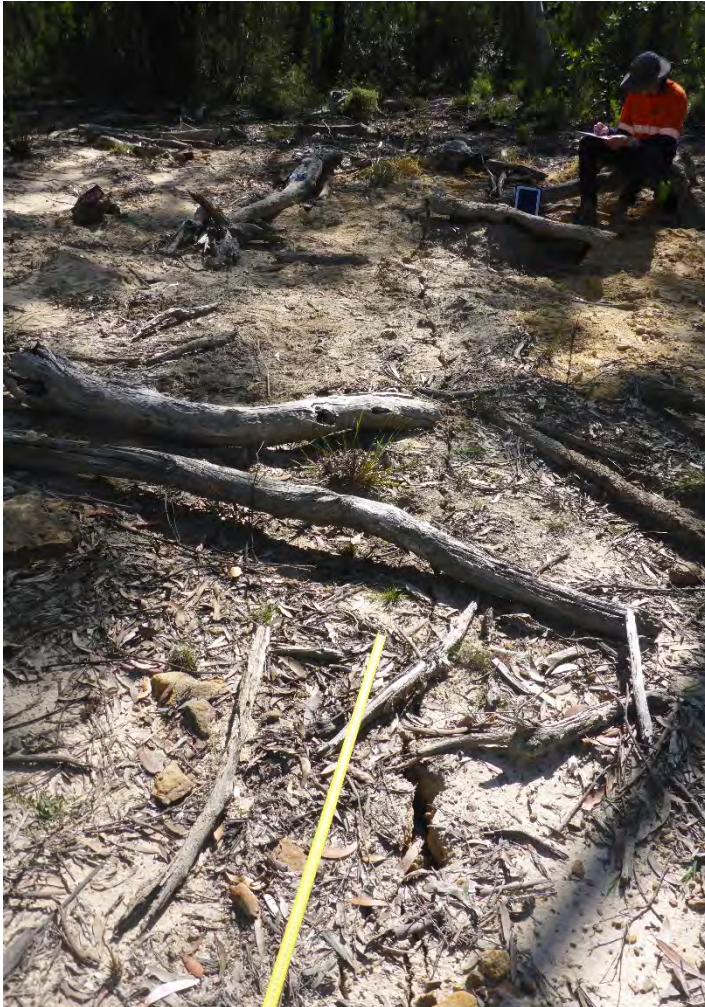
DA3B_LW16_005 is situated on an access track between *Lake Avon* and *Fire Road 6A* (Figure 1). The site was undermined by Longwall 16 on 27 March 2020. The impact is comprised soil cracking (Photo 3 to Photo 5). The soil cracking has a maximum length of 12.3m, a maximum width of 0.12m and a maximum measurable depth of 0.3m.

DA3B_LW16_005 is a Level 2 trigger as per the *Dendrobium Area 3B Landscape TARP* (Appendix A: Table 1), specifically:

Photo 3: DA3B_LW16_005, an overview of the soil cracking. Taken on 22/04/2020.

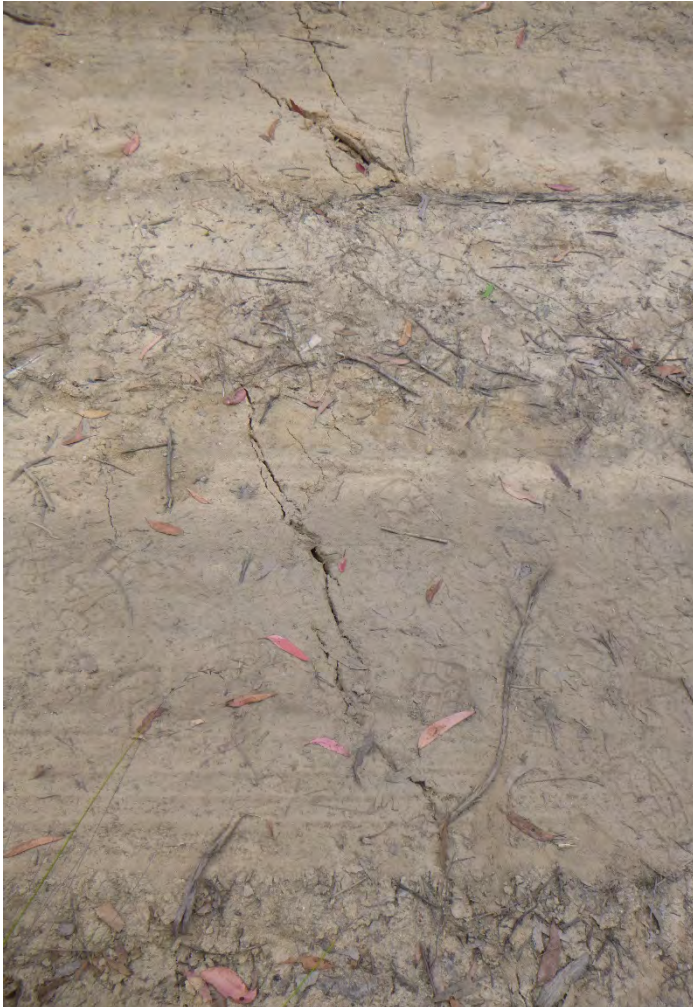
DA3B_LW16_008 is situated on an access track between *Lake Avon* and *Fire Road 6A* (Figure 1). The site was undermined by Longwall 16 on 16 April 2020. The impact is comprised of eight soil cracks within an area of 10m by 2m (Photo 1 to Photo 3). The soil cracking has a maximum length of 3.6m, a maximum width of 0.03m and a maximum measurable depth of 0.25m.

Photo 1: DA3B_LW16_008, an overview of the soil cracking. Taken on 27/04/2020.

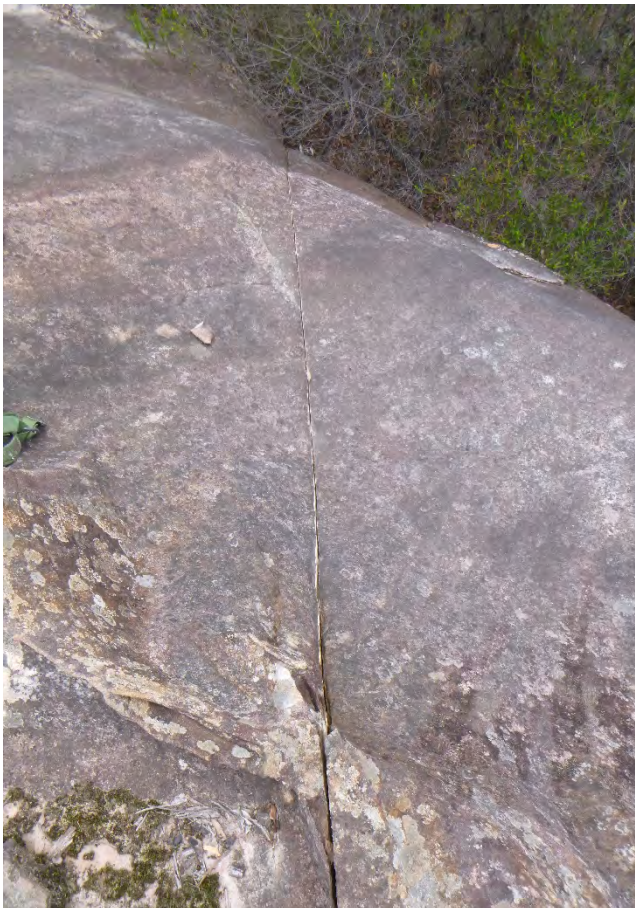
DA3B_LW16_010 is situated on a rock outcrop between *Lake Avon* and *Fire Road 6A* (Figure 1). The site was undermined by Longwall 16 on 14 April 2020. The impact is comprised of rock fracturing (Photo 6 and Photo 7). The rock fracturing has a maximum length of 16m, a maximum width of 0.02m and a maximum measurable depth of 2m.

Photo 6: DA3B_LW16_010, an overview of the rock fracture. Taken on 27/04/2020.

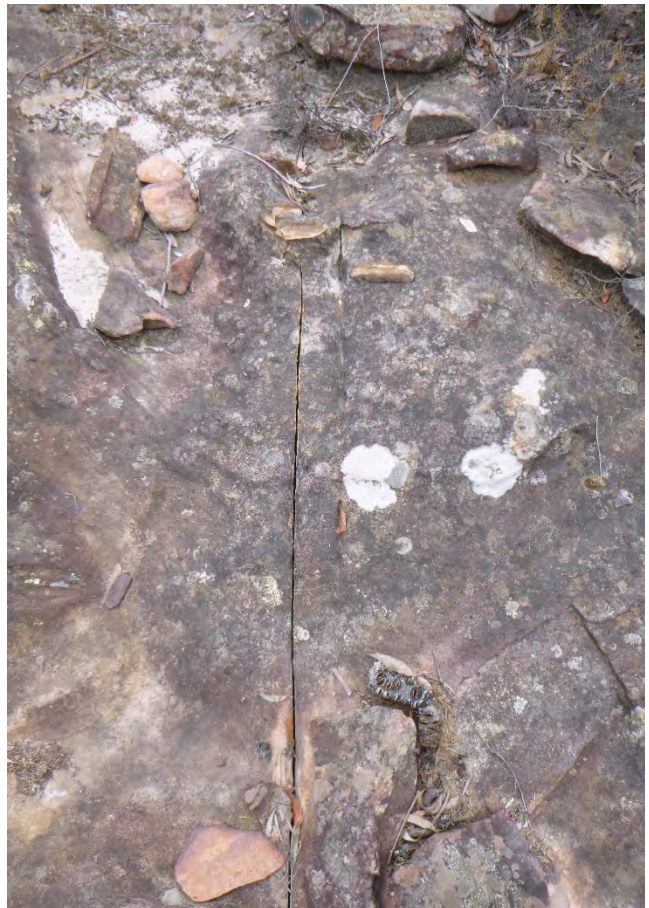
Photo 7: DA3B_LW16_010, an overview of the rock fracture. Taken on 27/04/2020.

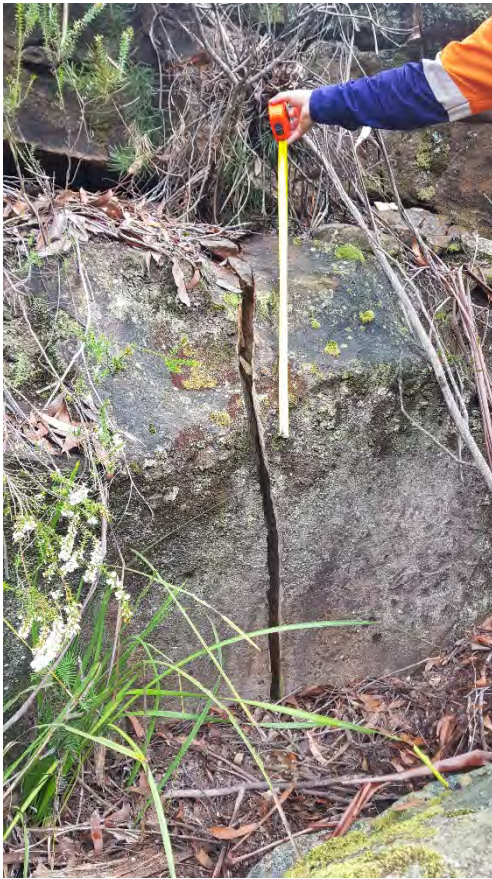
DA3B_LW16_012 is located at a steep slope/step between *Swamp 14* and *Fire Road 6P*, approximately 20m from SLMMP site *A3b-SS14* and 7m from cultural heritage site *DM21* (Figure 2). It is likely that this impact occurred during the extraction of Longwall 15, however access to the site was restricted during mining due to site safety concerns. The site was undermined by Longwall 15 on 31 October 2019. The impact is comprised of rock fracturing (Photo 10 to Photo 12). The rock fracturing has a maximum length of 2.75m, a maximum width of 0.037m and a maximum horizontal depth of 1.2m.

Photo 10: DA3B_LW16_012, looking at a section of rock fracturing. Taken on 28/04/2020.

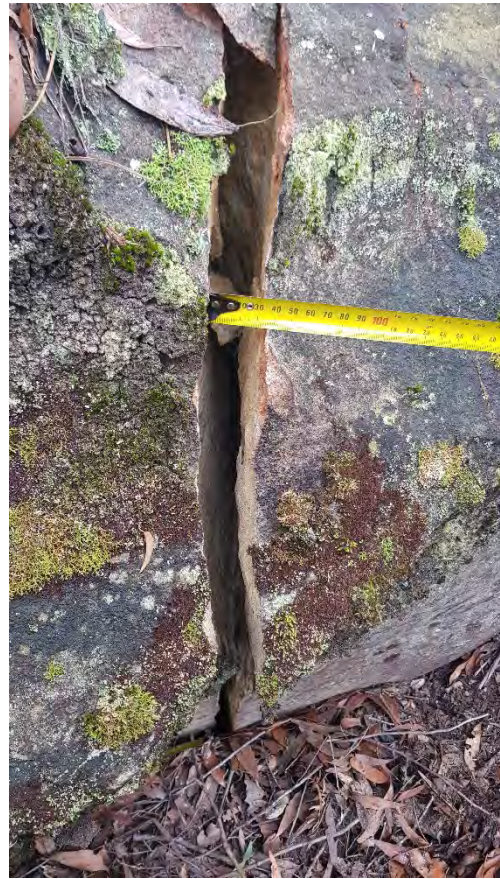
Photo 11: DA3B_LW16_012, looking at the maximum width of the rock fracture. Taken on 28/04/2020.

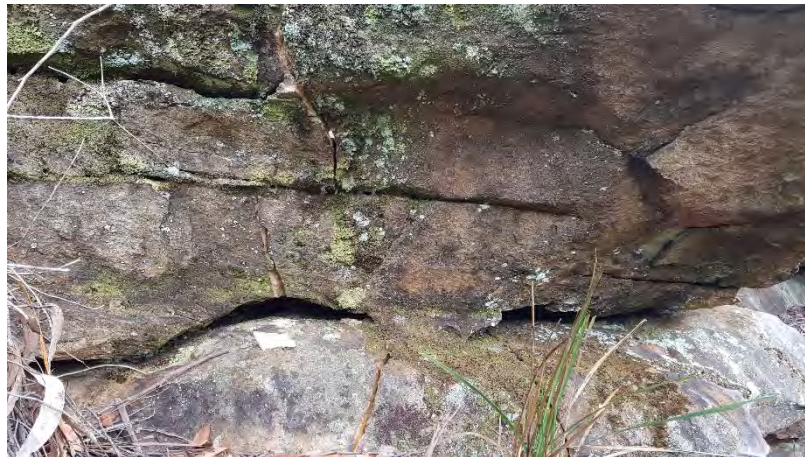
Photo 12: DA3B_LW16_012, looking at a section of rock fracturing. Taken on 28/04/2020.

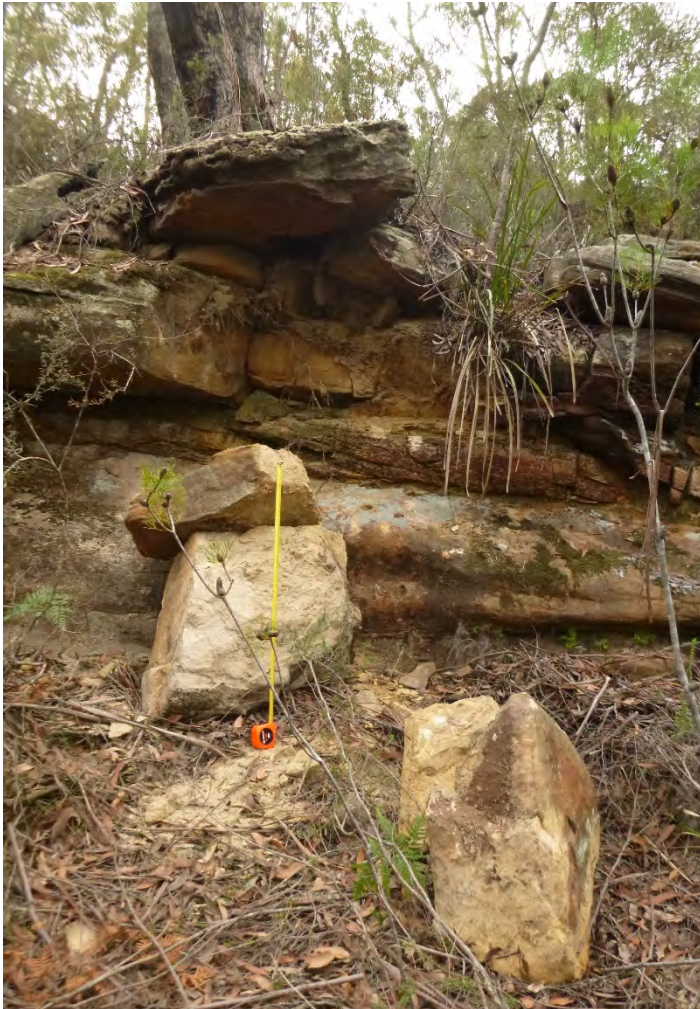
DA3B_LW16_016 is located at a steep slope/step between *Lake Avon* and *Fire Road 6A* (Figure 1). The site was undermined by Longwall 16 on 1 May 2020. The impact is comprised of a rock fall and rock fracturing (Photo 12 to Photo 14). Four boulders were dislodged from the step with the largest boulder measuring 0.8m by 0.9m by 0.5m. The rock fracturing has a length of 2m and a width of 0.015m.

Photo 12: DA3B_LW16_016, overview of the rockfall. Taken on 15/05/2020.

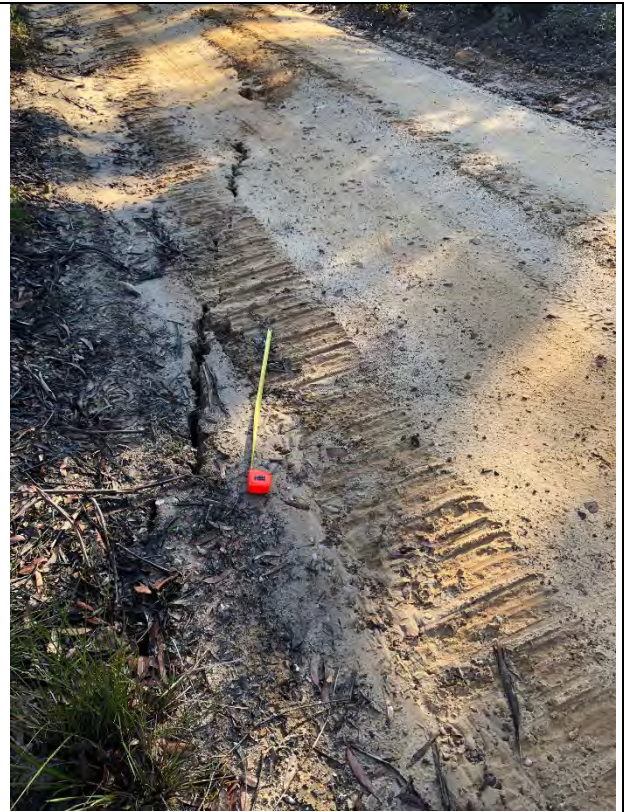
Photo 2: DA3B_LW16_019, looking at width of rock fracturing. Taken on 23/06/2020.

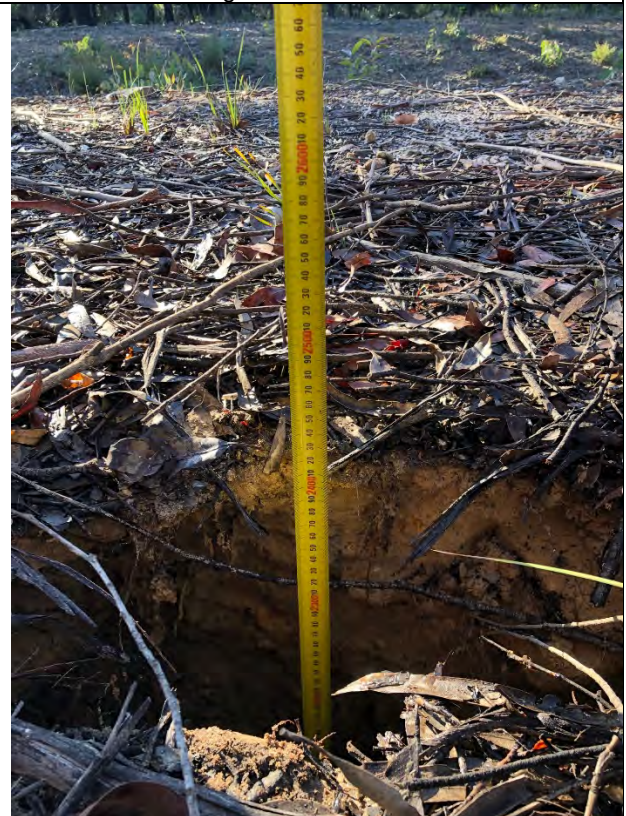
Photo 4: DA3B_LW16_019, looking at depth of cracking. Taken on 23/06/2020.

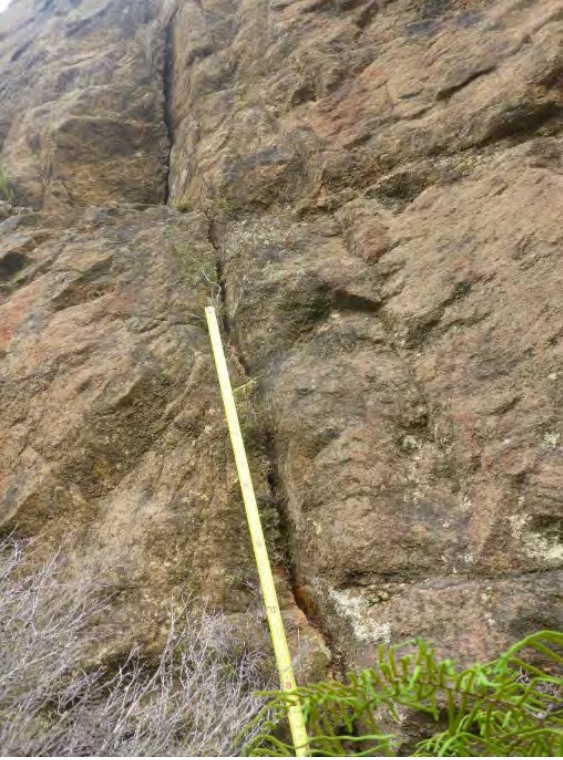
Photo 3: DA3B_LW16_022- fracturing down face of cut-through. Taken on 7/07/2020.

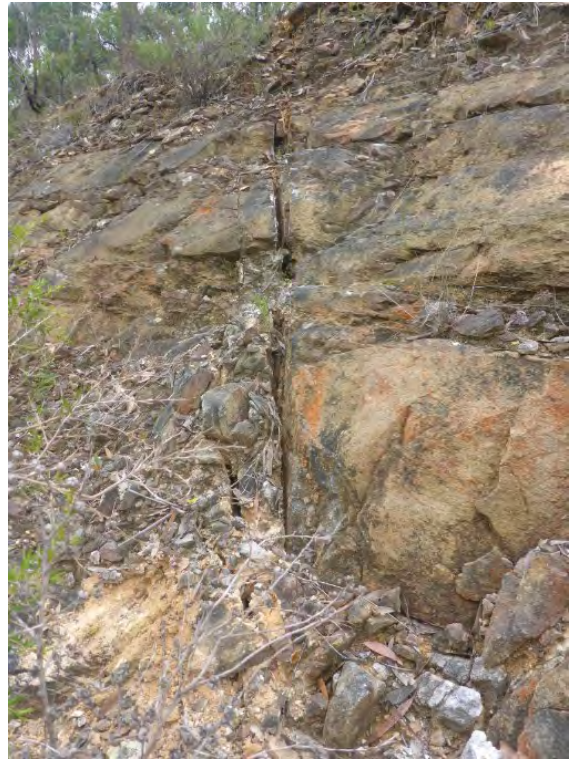
Photo 4: DA3B_LW16_022- fracturing down face of cut-through. Taken on 7/07/2020.

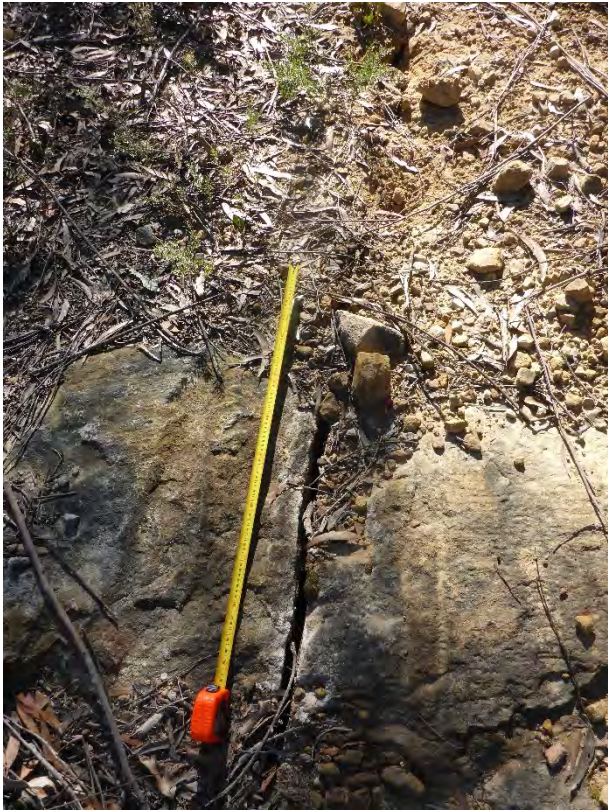
Photo 9: DA3B_LW16_024, looking at the rock fracturing and soil cracking. Taken on 6/08/2020.

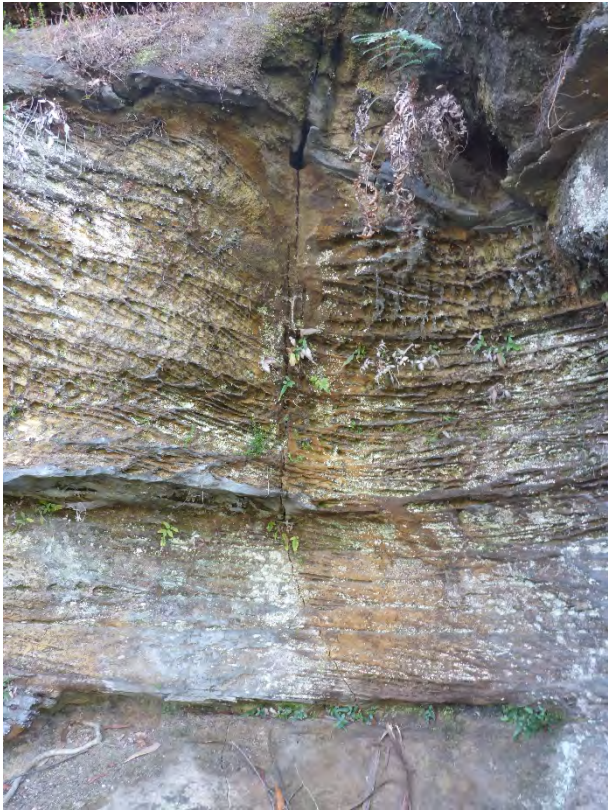
Photo 12: DA3B_LW16_025, looking at a section of rock fracturing. Taken on 6/08/2020.

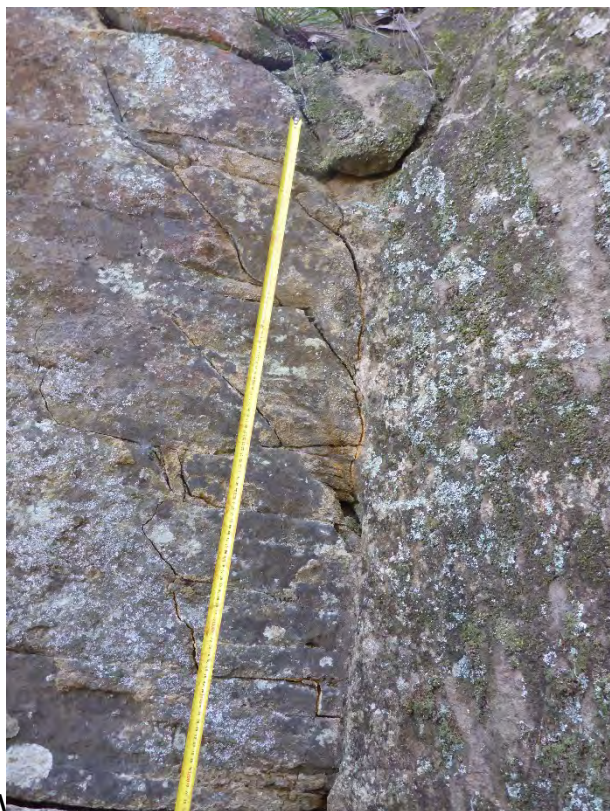
Photo 15: *DA3B_LW16_026*, looking at a section of rock fracturing. Taken on 6/08/2020.

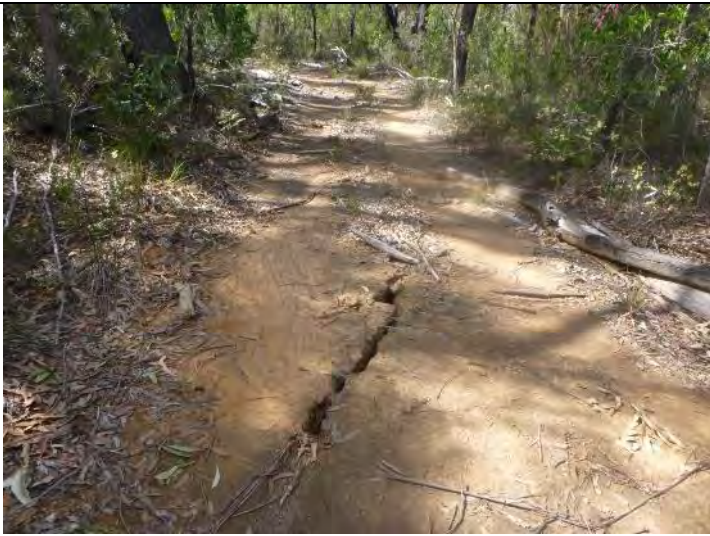
Photo 1: DA3B_LW16_027, looking along track. Taken on 21/08/2020.

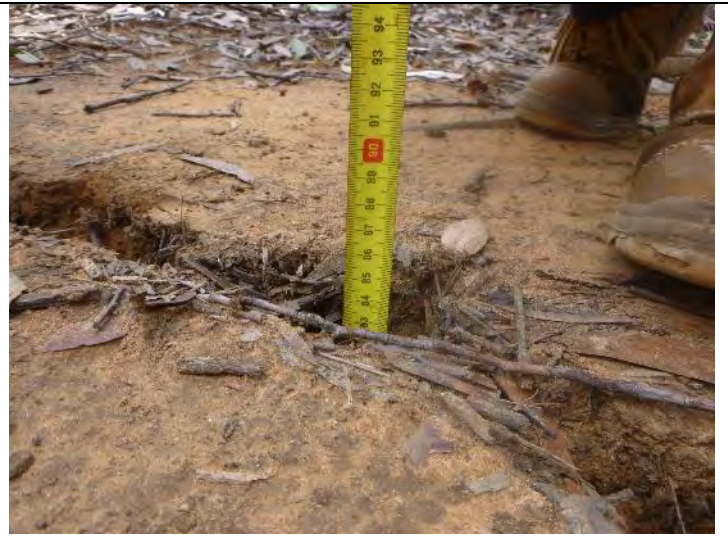
Photo 2: DA3B_LW16_027, showing depth of crack. Taken on 21/08/2020.

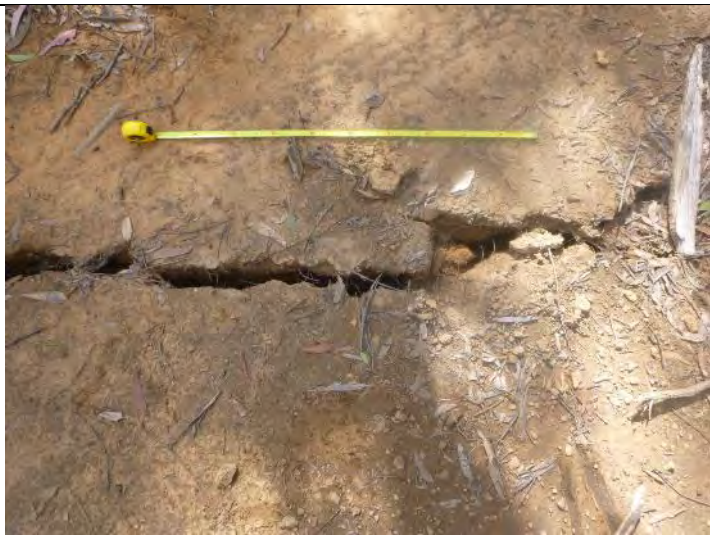
Photo 3: DA3B_LW16_027, looking down at cracking. Taken on 21/08/2020.

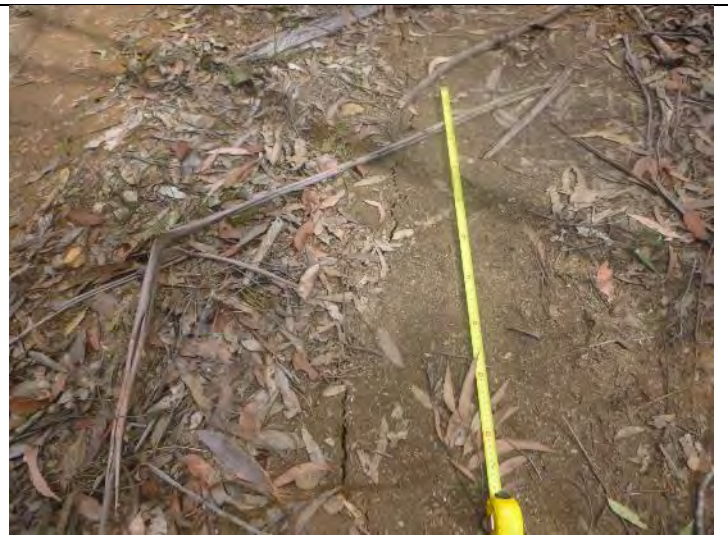
Photo 4: DA3B_LW16_027, showing narrower section of cracking. Taken on 21/08/2020.

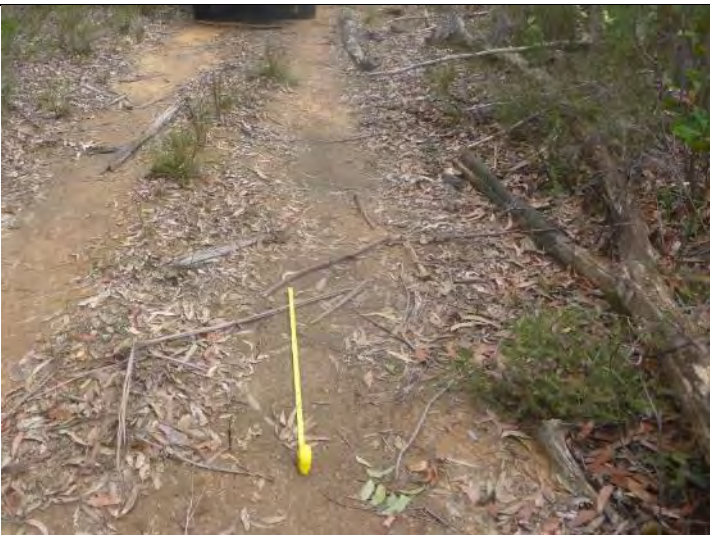
Photo 5: DA3B_LW16_027, looking along track, showing narrower section of cracking. Taken on 21/08/2020.

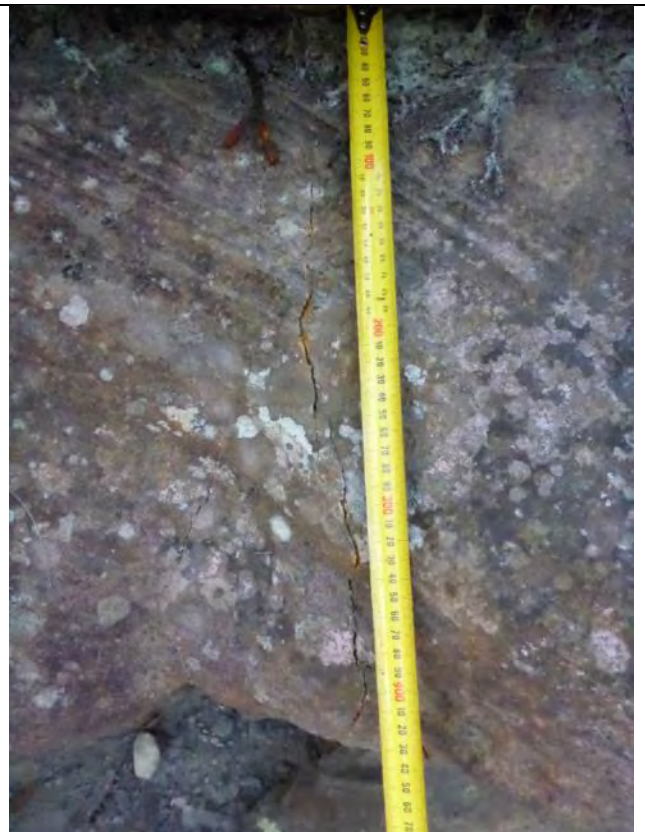
Photo 6: DA3B_LW15_026, looking at rock face. Taken on 24/08/2020.

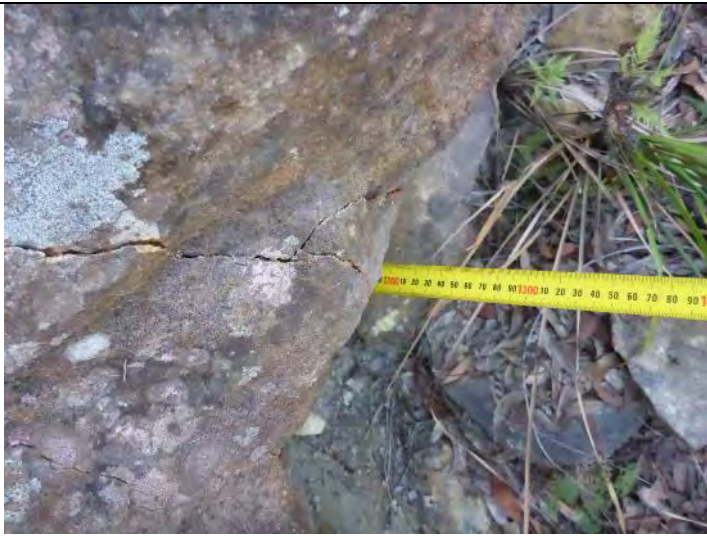
Photo 7: DA3B_LW15_026, showing fracture extending below ledge. Taken on 24/08/2020.

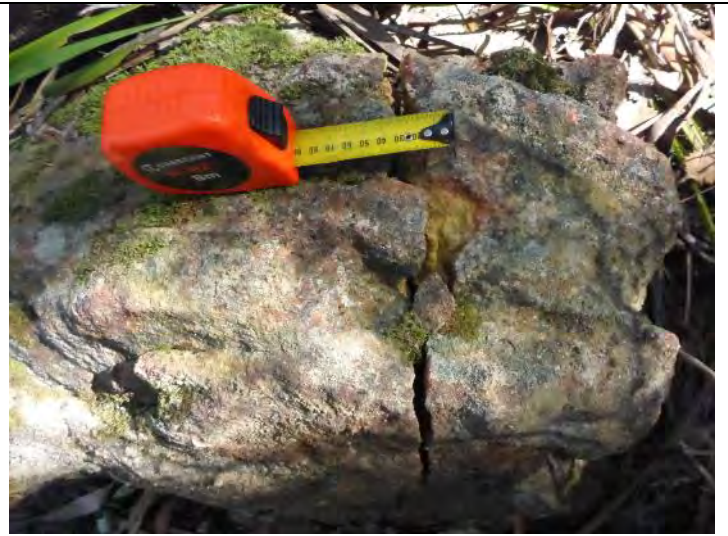
Photo 8: DA3B_LW15_026, showing fracture to boulder. Taken on 24/08/2020.

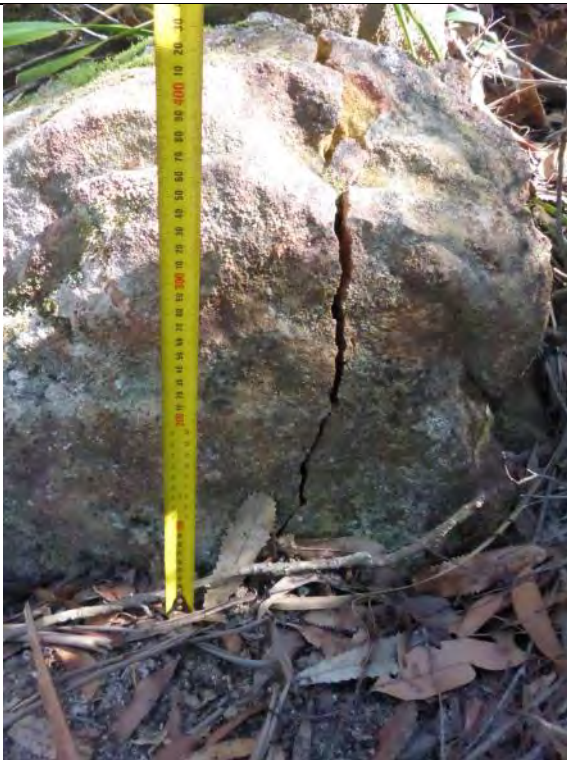
Photo 9: DA3B_LW15_026, showing fracture to boulder. Taken on 24/08/2020.

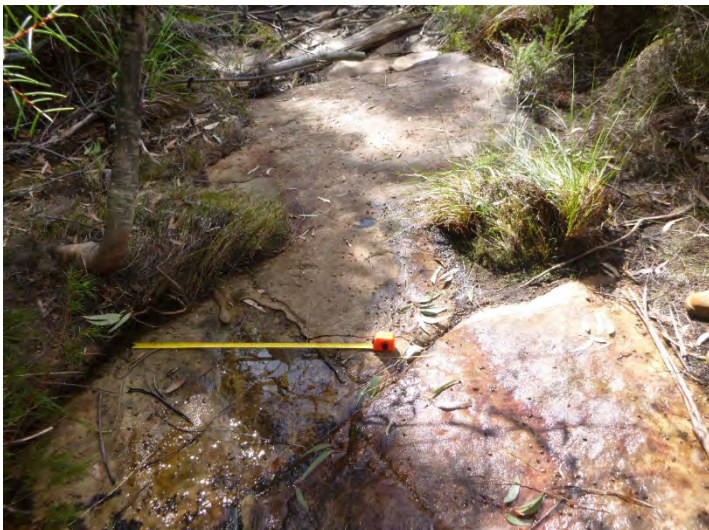
Photo 1: DA3B_LW16_028- rock fracture in foreground and edge of dry step and Pool 34 in background. Taken on 31/08/2020.

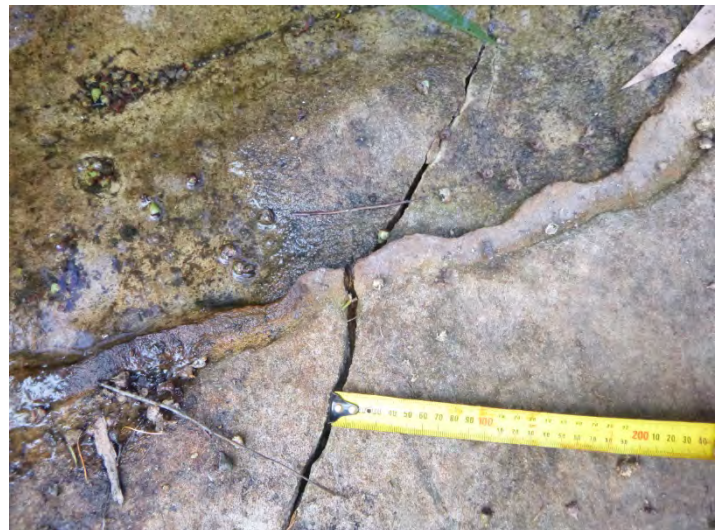
Photo 2: DA3B_LW16_028- rock fracture across rockbar. Taken on 31/08/2020.

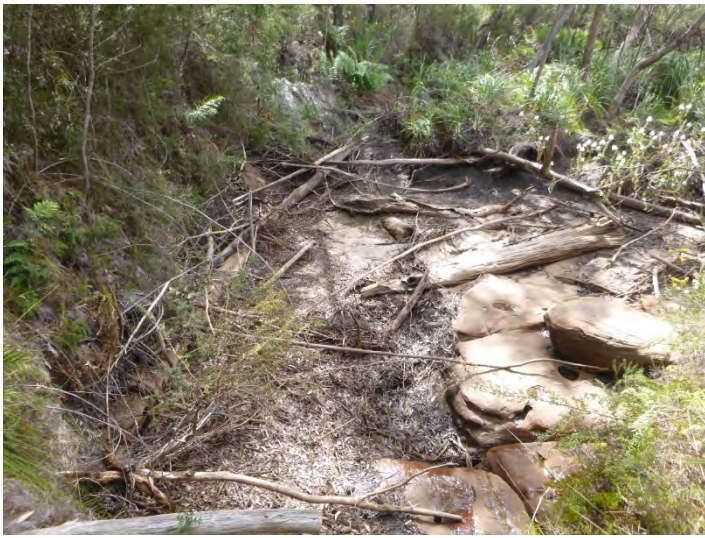
Photo 3: WC15_Pool 34, looking downstream over step. Taken on 31/08/2020.

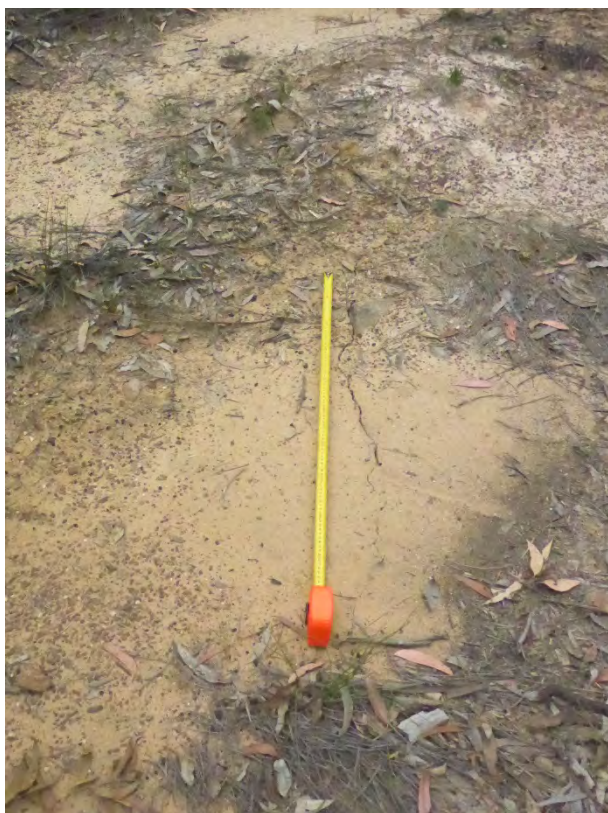
Photo 1: DA3B_LW16_039 soil cracking to access track. Taken on 7/10/2020.

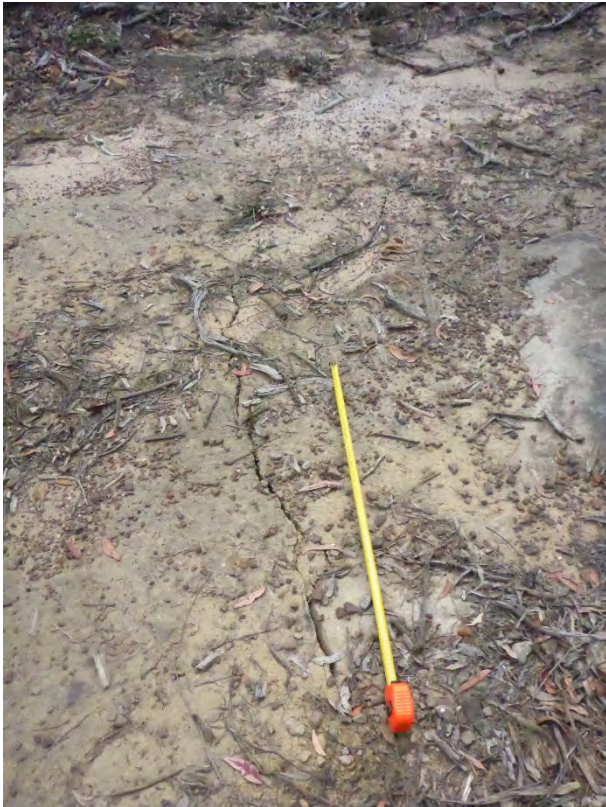
Photo 3: *DA3B_LW16_040*- soil cracking to access track. Taken on 7/10/2020.

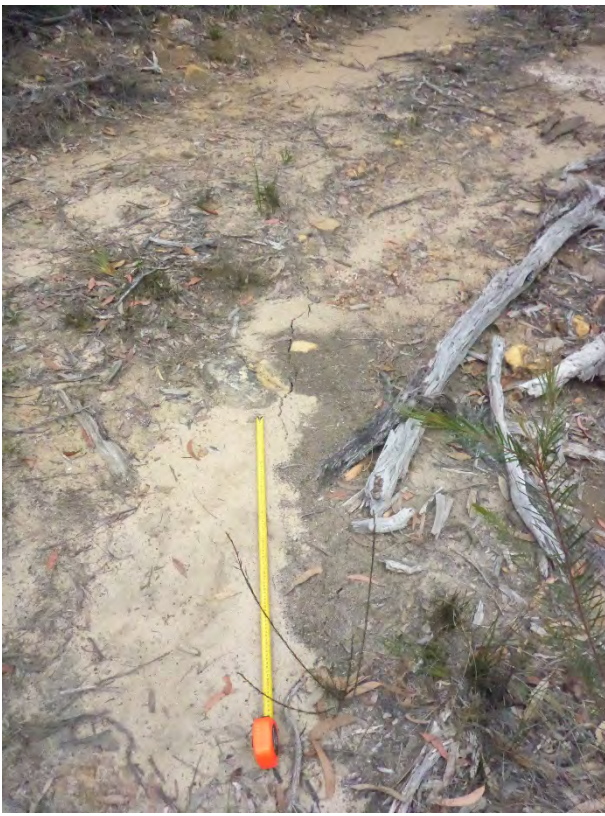
Photo 5: DA3B_LW16_041- soil cracking to access track. Taken on 7/10/2020.

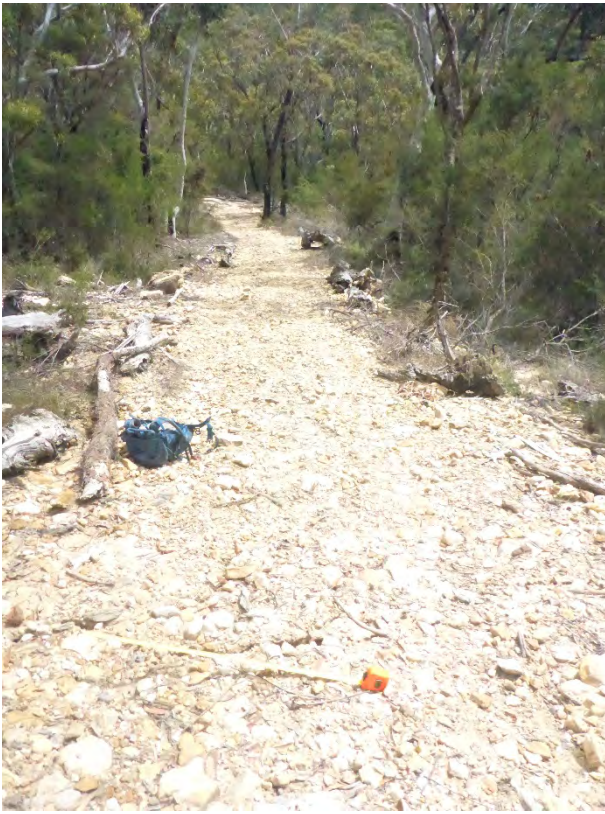
Photo 9: DA3B_LW16_042- looking down slope of access track. Taken on 7/10/2020.

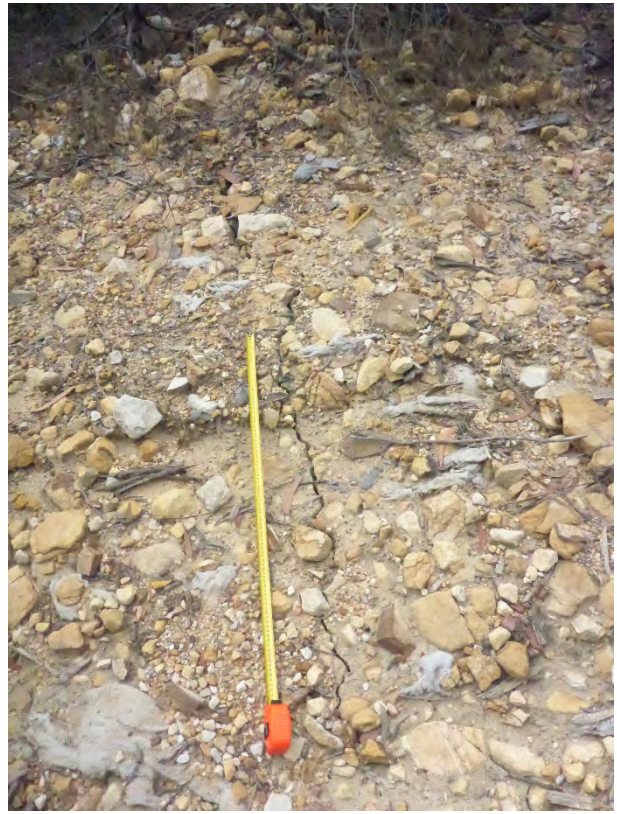
Photo 10: DA3B_LW16_042- soil cracking to access track. Taken on 7/10/2020.

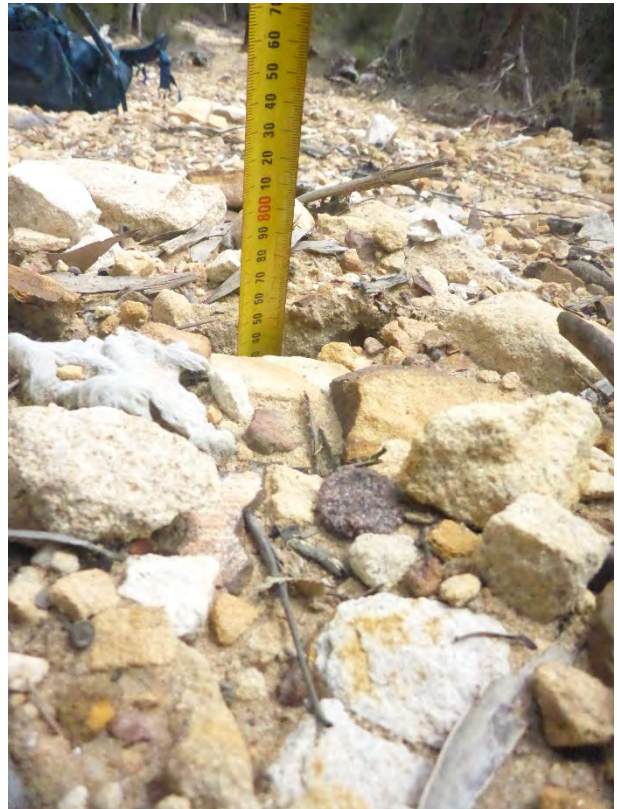
Photo 12: DA3B_LW16_042- depth measurement of soil cracking. Taken on 7/10/2020.

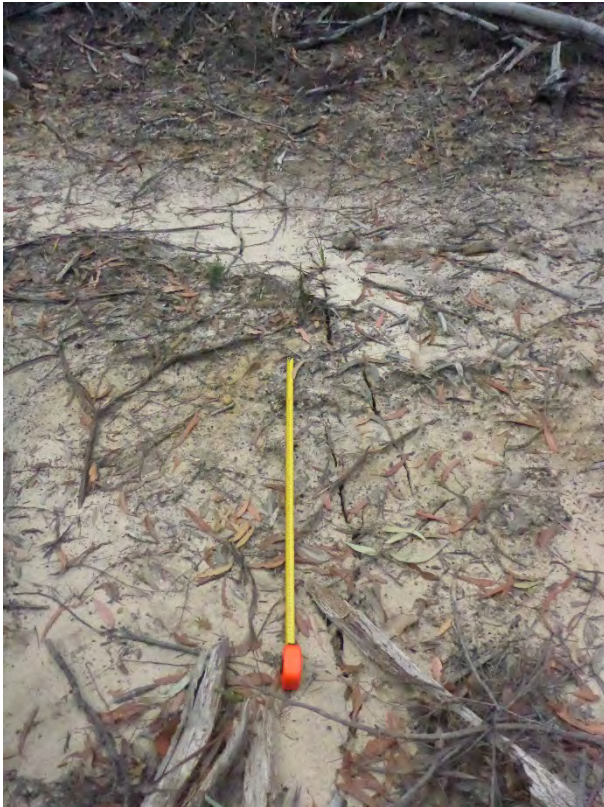
Photo 13: DA3B_LW16_043- soil cracking to access track.
Taken on 7/10/2020.

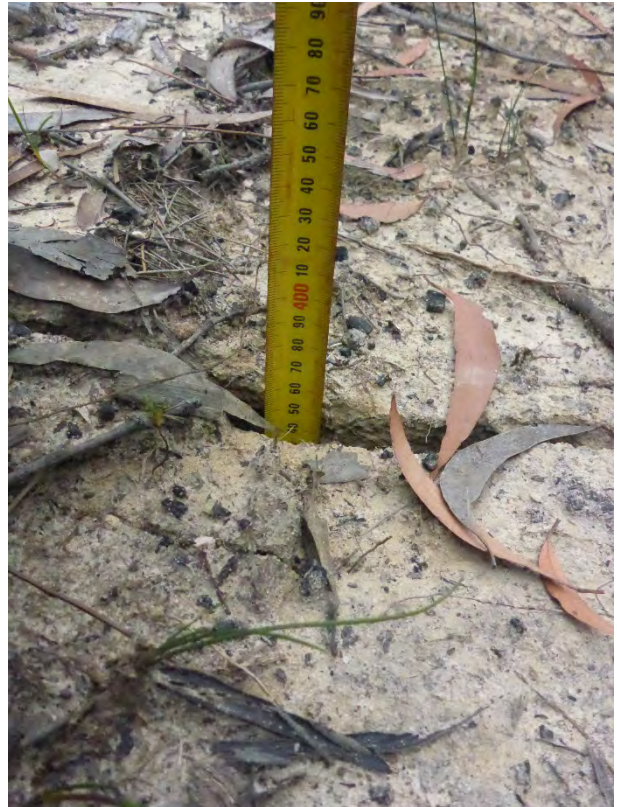
Photo 14: DA3B_LW16_043- depth measurement of soil cracking.
Taken on 7/10/2020.

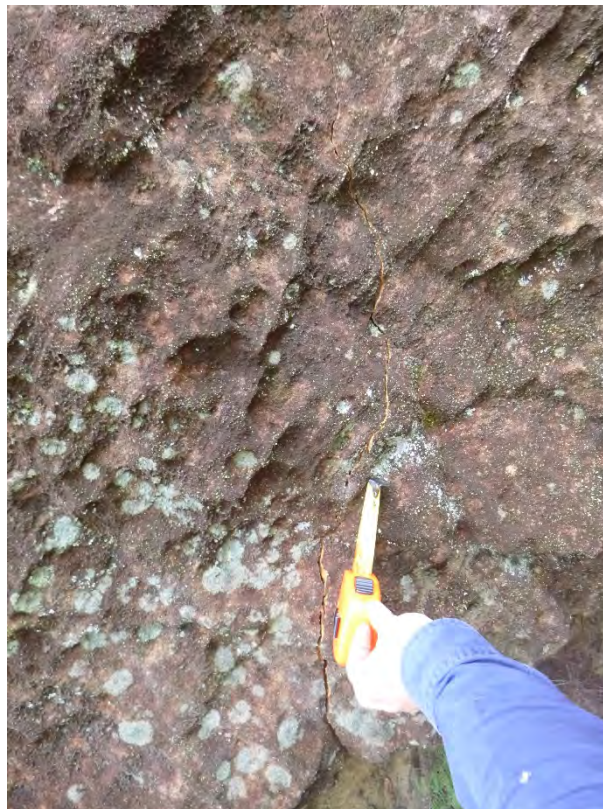
Photo 1: *DA3B_LW16_046*, looking at the rock fracture. Taken on 25/11/2020.

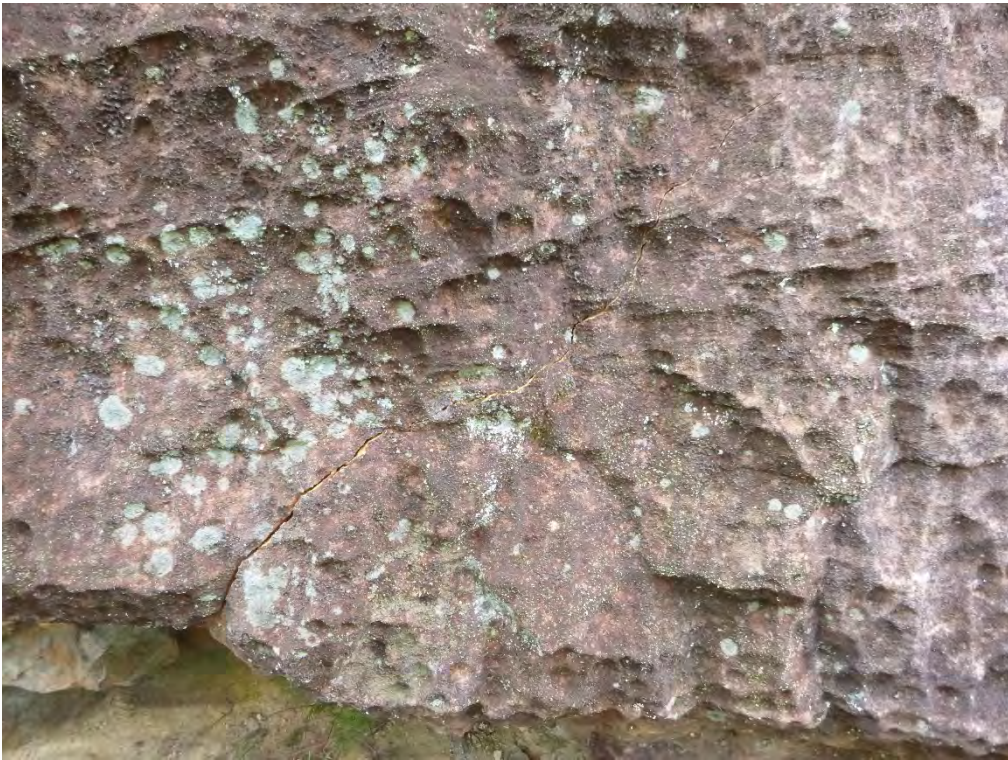
Photo 2: DA3B_LW16_046, looking at the rock fracture. Taken on 25/11/2020.

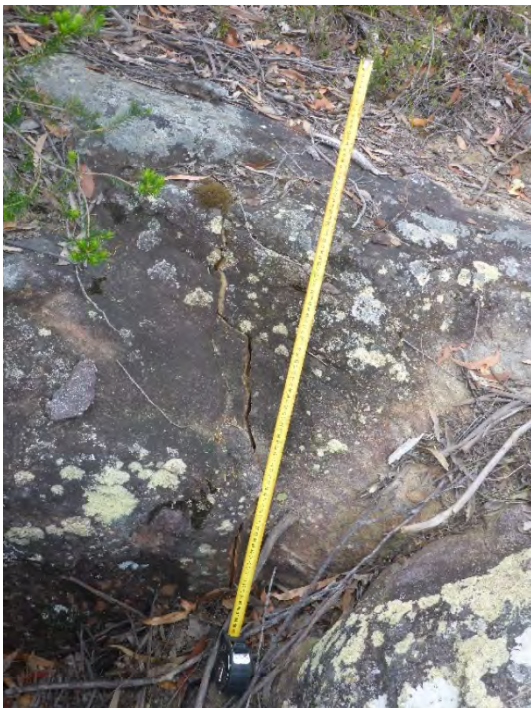
Photo 1: *DA3B_LW16_047*, looking at a section of the rock fracturing. Taken on 30/11/2020.

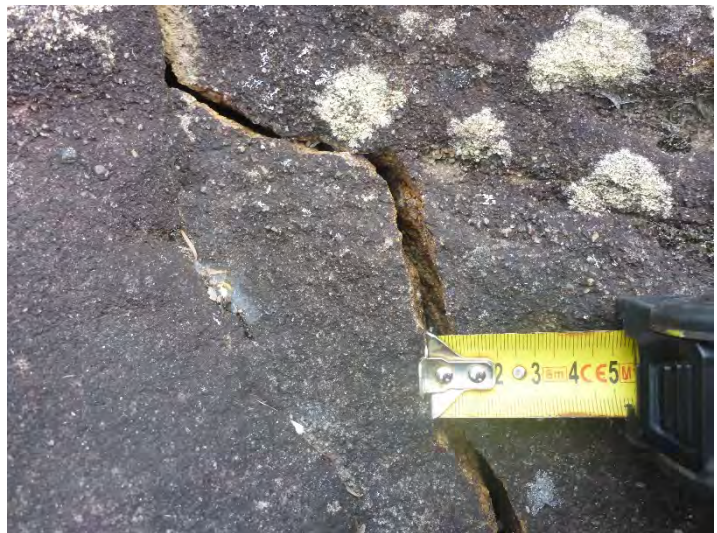
Photo 2: *DA3B_LW16_047*, looking at the width of the rock fracturing. Taken on 30/11/2020.

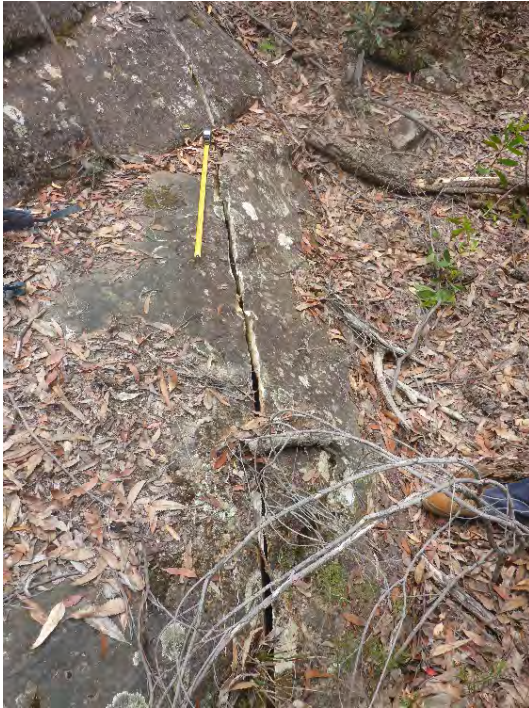
Photo 3: *DA3B_LW16_048*, looking at the length of rock fracturing. Taken on 30/11/2020.

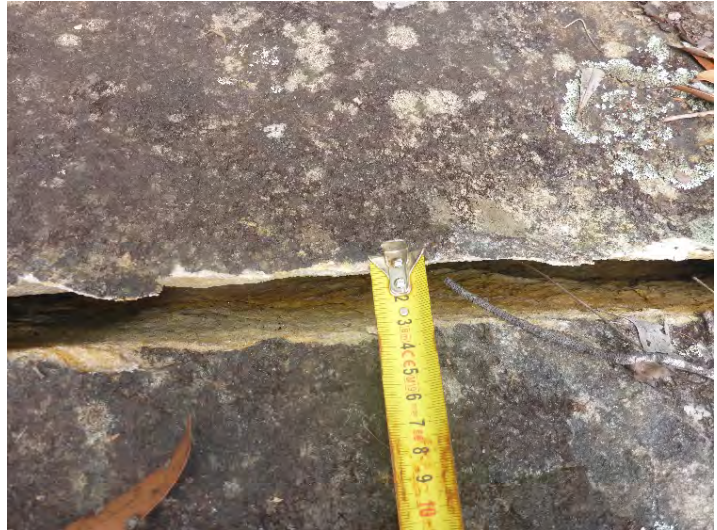
Photo 4: *DA3B_LW16_048*, looking at the width of rock fracturing. Taken on 30/11/2020.

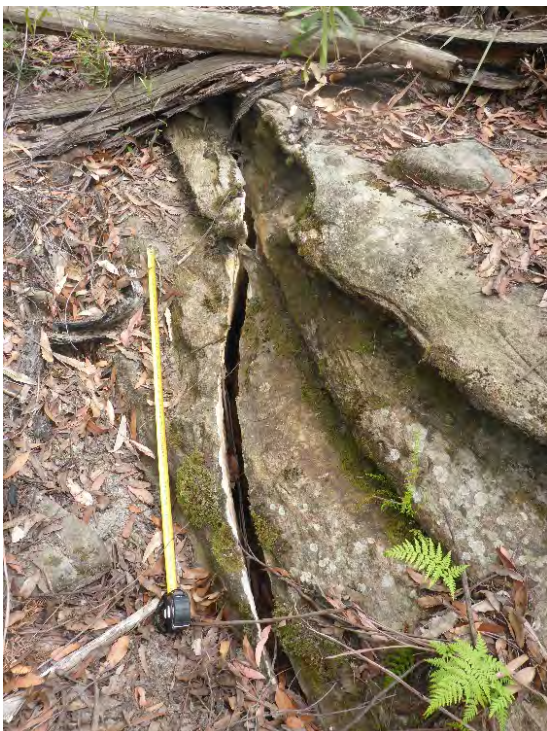
Photo 7: *DA3B_LW16_050*, looking at the length of the rock fracture. Taken on 30/11/2020.

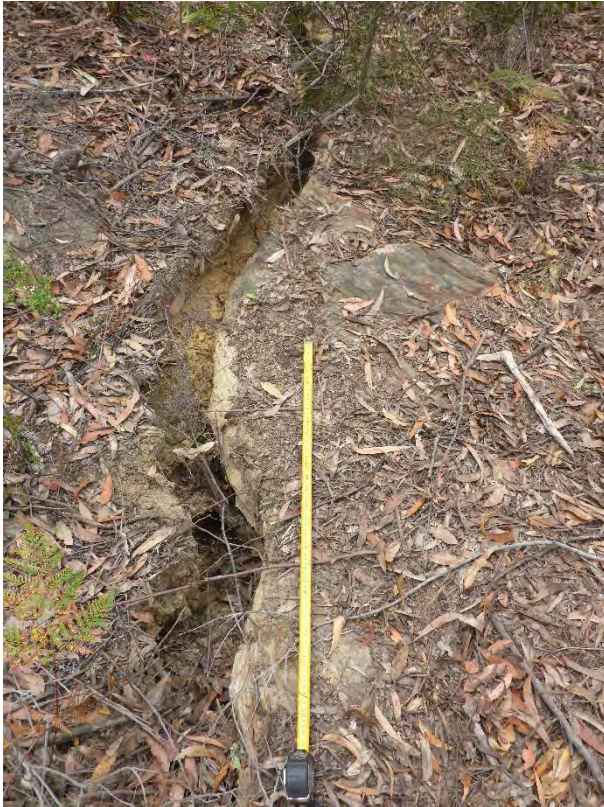
Photo 9: DA3B_LW16_051, looking at a section of soil cracking and rock fracturing. Taken on 30/11/2020.
