DA3B_LW16_003 Update (E288849, N6191590)

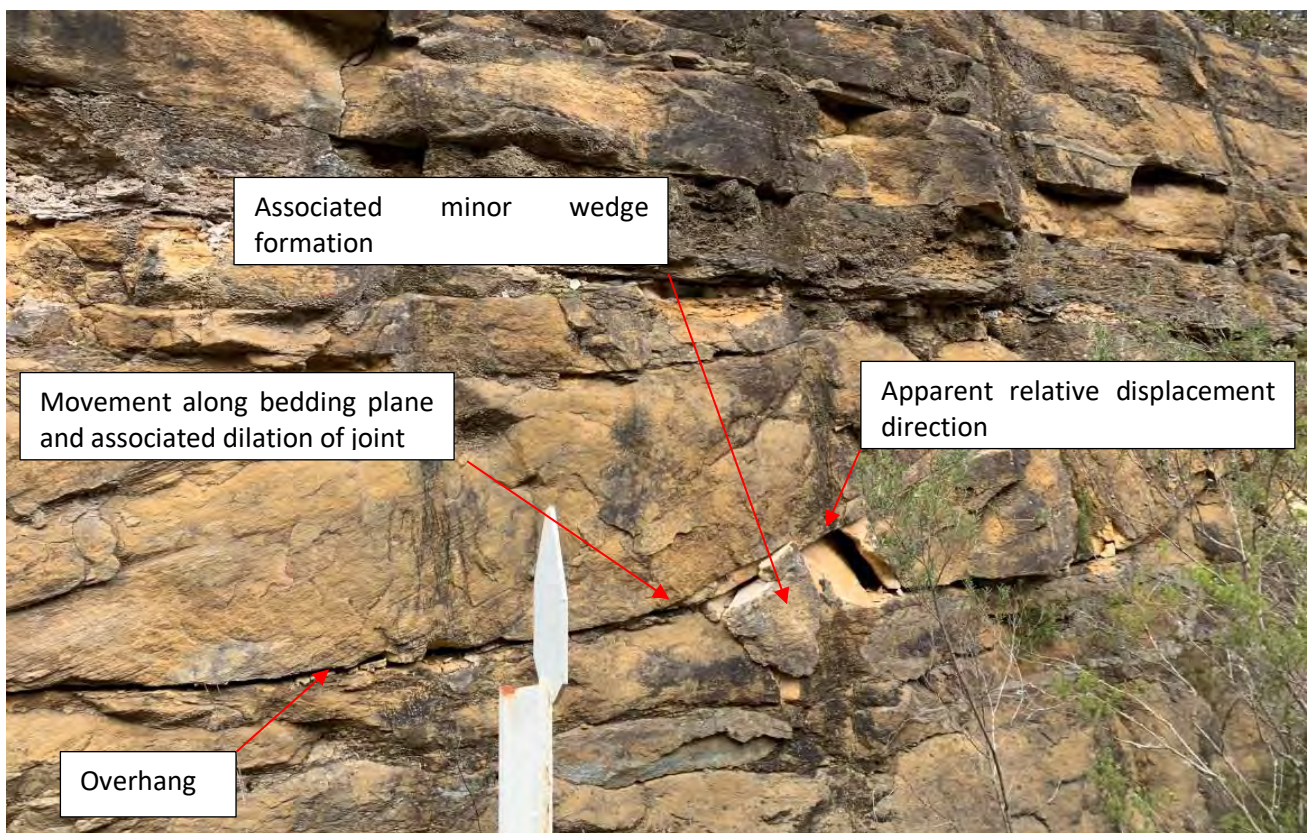
Figure 4 Dilation along dominant joint set (looking south)

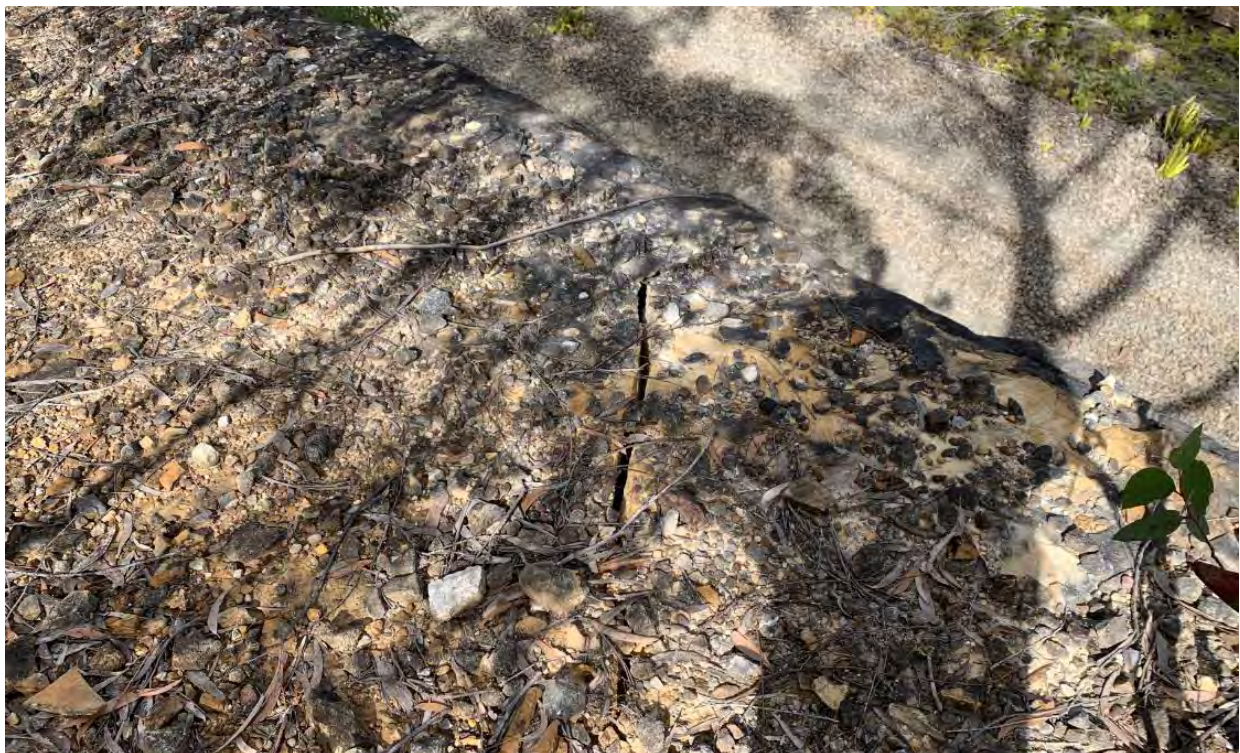
Figure 6 New fracturing through rock mass between bedding parting displacement (south west facing cut)

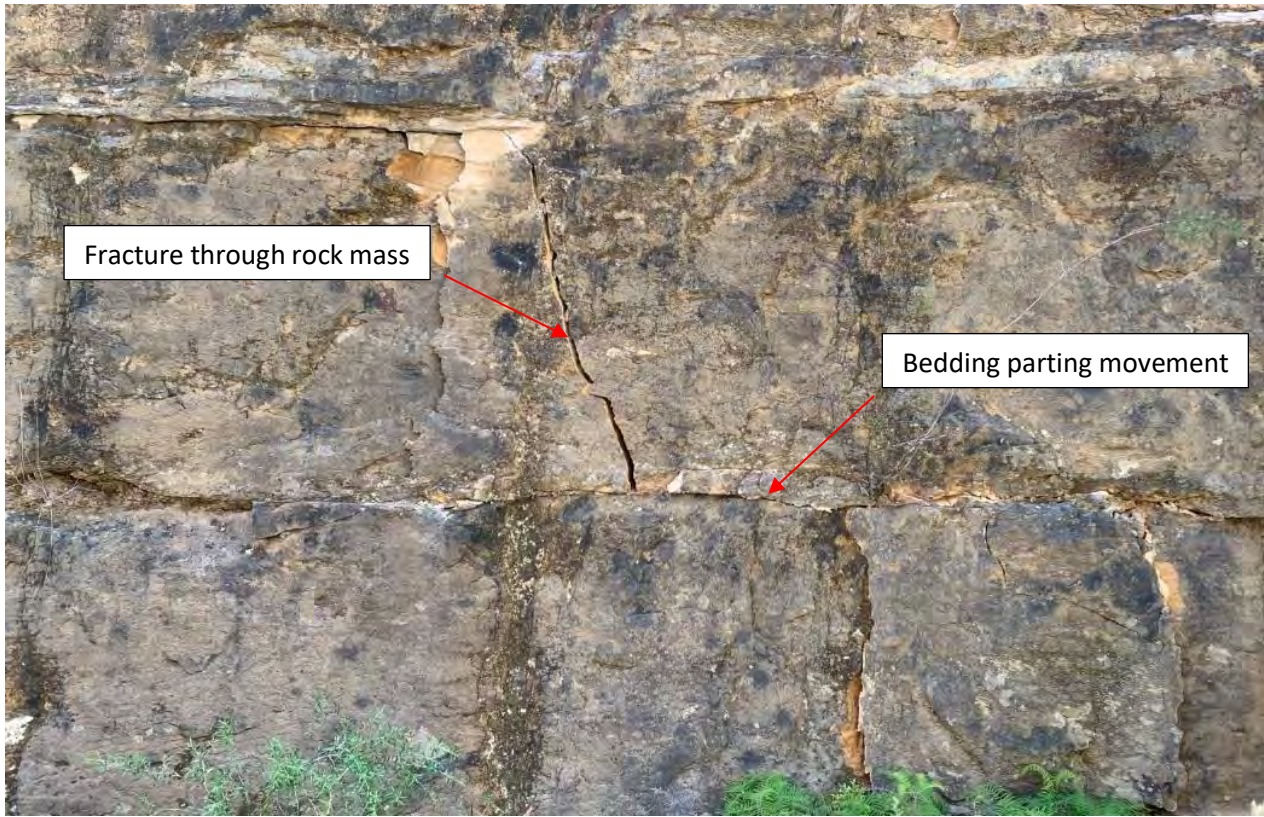
Figure 7 Recent wedge instability (intersection of bedding plane with high angle joint in southwest facing cut)
