**DENDROBIUM AREA 3B
LONGWALL 16 END OF PANEL
LANDSCAPE REPORT
DECEMBER 2020**

This report summarises the observed and measured subsidence effects on landscape features resulting from the extraction of Dendrobium Area 3B (DA3B) Longwall 16.

Longwall 16 is the eighth panel extracted from DA3B. Extraction began on 26 February 2020 and was completed on 4 November 2020.

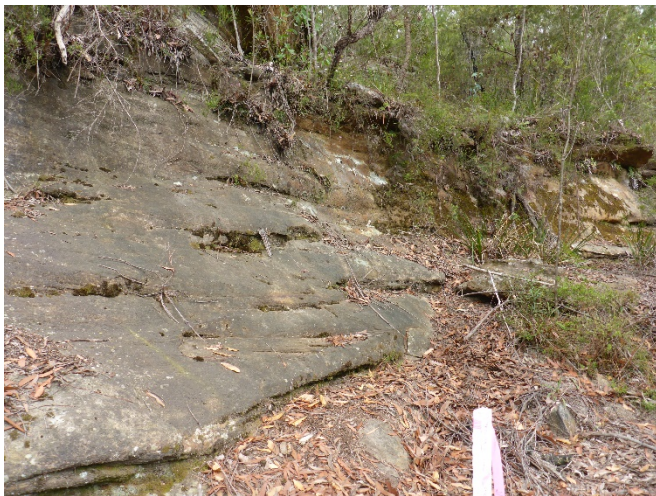
Photo 1: A3b-SS16, baseline inspection. Taken on 27/12/17.

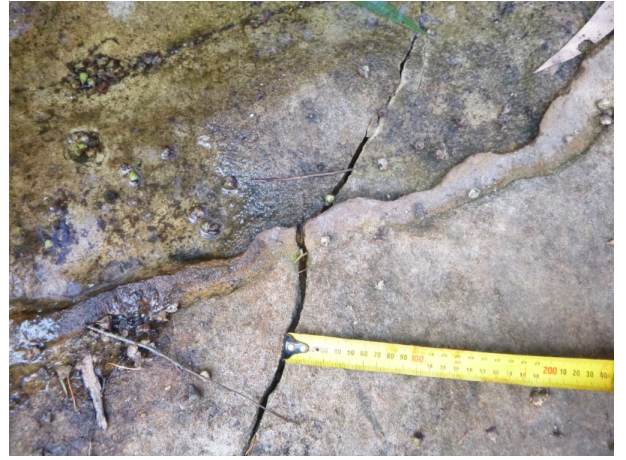
DA3B_LW16_028 consists of rock fracturing to a rockbar on tributary WC15, directly upstream from Pool 34 (Figure 3). The fracture is approximately 2.1m long and 0.01m wide (Photo 7 and Photo 8). There was a noticeable reduction in surface flow on the rockbar following identification of the fracture, with some surface seepage diverting in to the fracture. Pool 34, directly downstream, was also observed to be dry, with only surface seepage entering the pool from beneath the upstream step (Photo 9 and Photo 10). While Pool 34 has been observed to be dry during the baseline period, the rate of recession for this latest drying event is the fastest recorded and coincides with the passing of Longwall 16, approximately 10m at the closet horizontal distance (Figure 4). On 25 November 2020, the width of fracturing was observed to have increased to 0.02m with an uplift of 0.03m (Photo 11 and Photo 12).

Level 2: Crack or fracture that results in observable loss of surface water or erosion.

Photo 8: *DA3B_LW16_028*, rock fracture across rockbar. Taken on 31/08/2020.

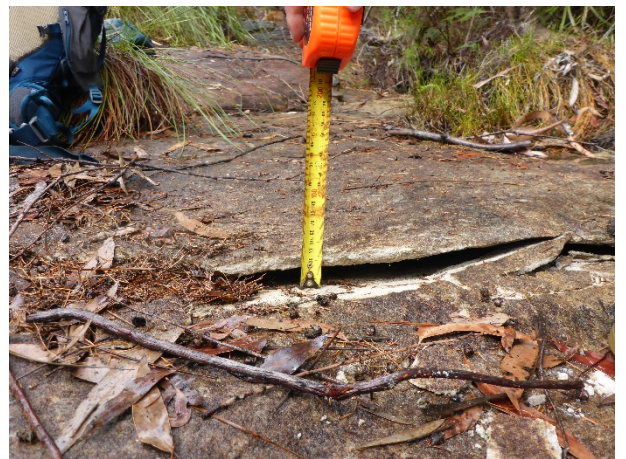
Photo 12: *DA3B_LW16_028*, looking at rock uplift. Taken on 25/11/2020.

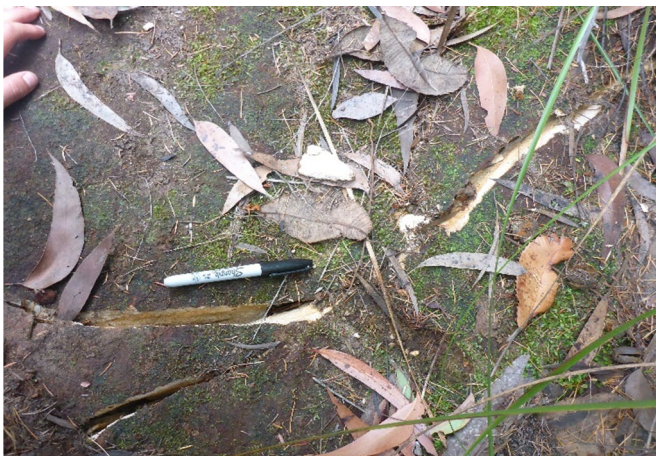
DA3B_LW14_017 is located on WC15, a tributary to Wongawilli Creek. The impacted feature is WC15_Channel 30 which is situated approximately 325m north of Longwall 16 at its closest point (Figure 3). The impact was originally comprised of two rock fractures (Photo 13). The original rock fracturing had a measurable length of 0.8m, a width of 0.025m and a maximum measurable depth of 0.17m. On 9 September 2020, an additional rock fracture and associated rock fragmentation was identified. The 1m rock fracture resulted in the displacement of a rock fragment, approximately 0.25m x 0.03m x 0.07m (Photo 14).

Level 2: Crack or fracture that results in observable loss of surface water or erosion.

Photo 13: DA3B_LW14_017, looking at the original rock fracturing. Taken on 20/02/2019.

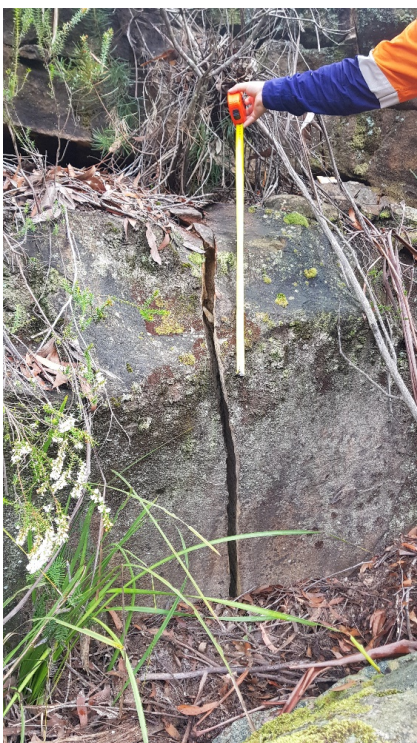
Level 1: Crack or fracture up to 100mm width, and/or, crack or fracture up to 10m length.

Photo 28: DA3B_LW16_012, looking at a section of rock fracturing. Taken on 28/04/2020.

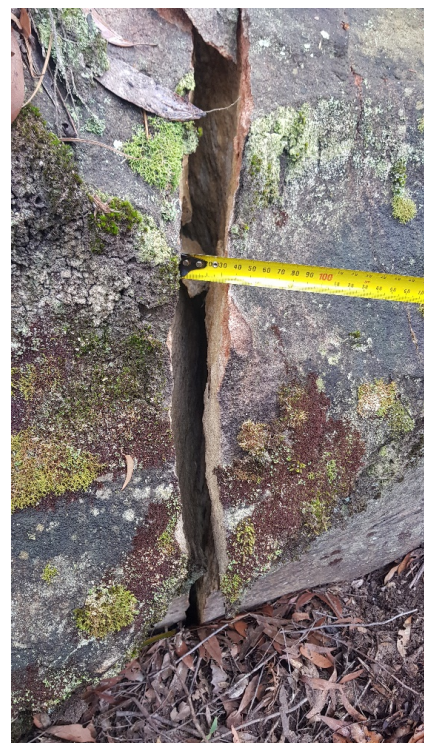
Photo 29: DA3B_LW16_012, looking at the maximum width of the rock fracture. Taken on 28/04/2020.

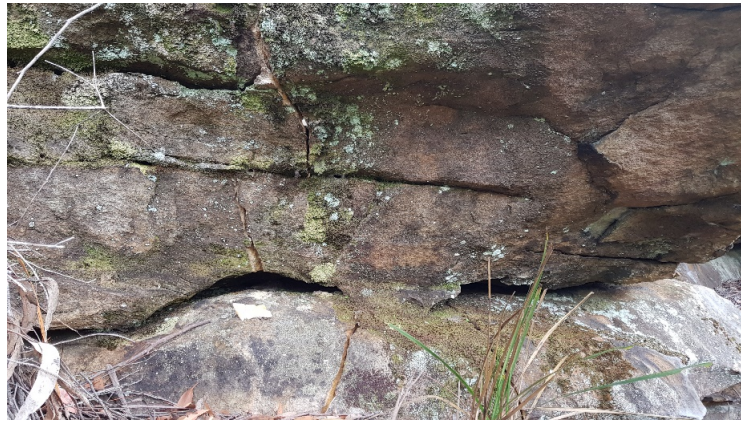
Photo 30: DA3B_LW16_012, looking at a section of rock fracturing. Taken on 28/04/2020.

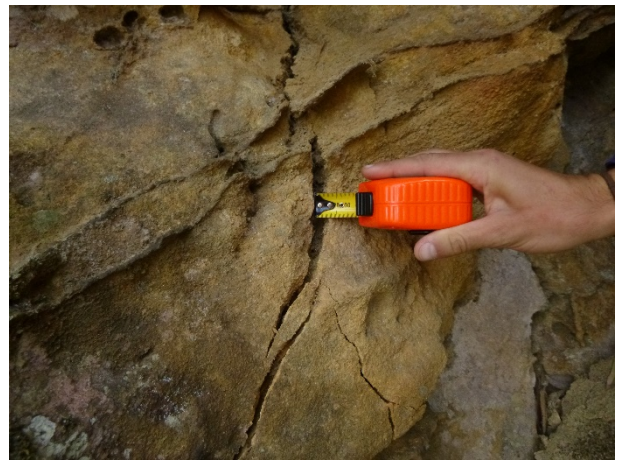
Photo 32: DA3B_LW16_015, looking at the width of rock fracturing. Taken on 15/05/2020.

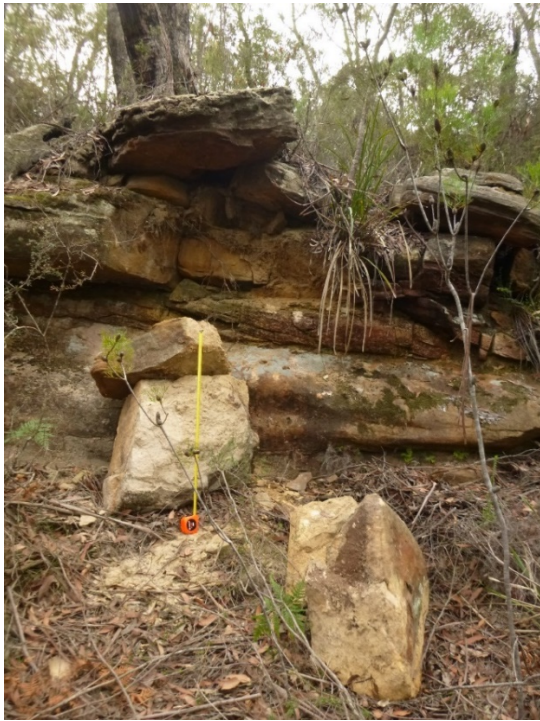
Level 1: *Crack or fracture up to 100mm width, and/or, crack or fracture up to 10m length.*

Photo 34: DA3B_LW16_016, overview of the rockfall. Taken on 15/05/2020.

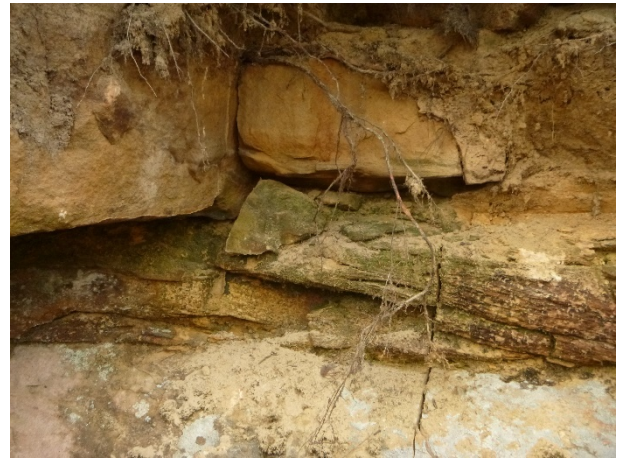
Photo 35: DA3B_LW16_016, looking at a section of rock fracturing. Taken on 15/05/2020.

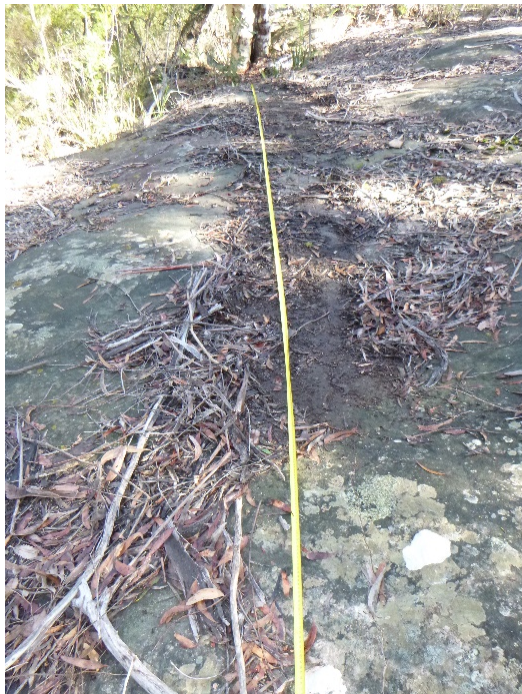
Photo 37: DA3B_LW16_017, looking at the length of rock fracturing. Taken on 16/06/2020.

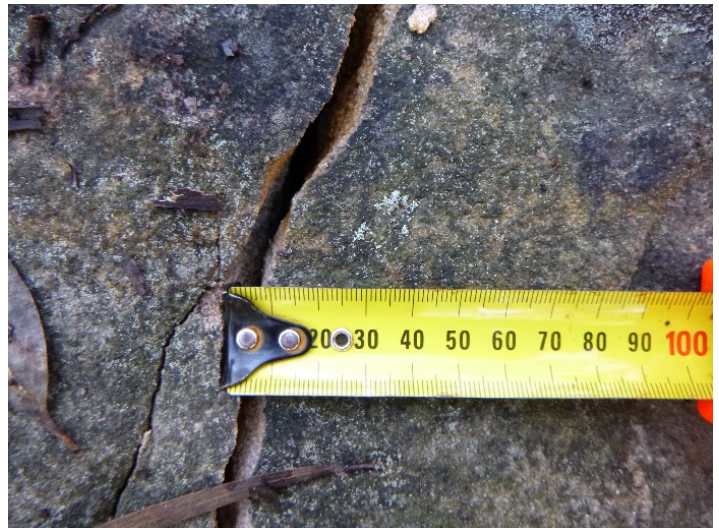
Photo 38: DA3B_LW16_017, looking at width of rock fracturing. Taken on 16/06/2020.

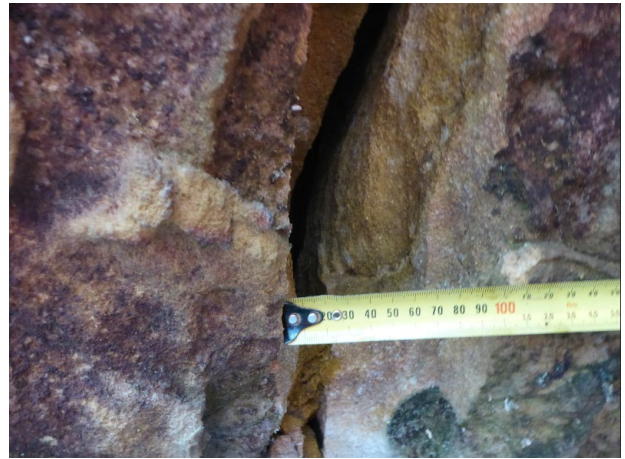
Photo 42: DA3B_LW16_021, looking at width of fracture on step. Taken on 30/06/2020.

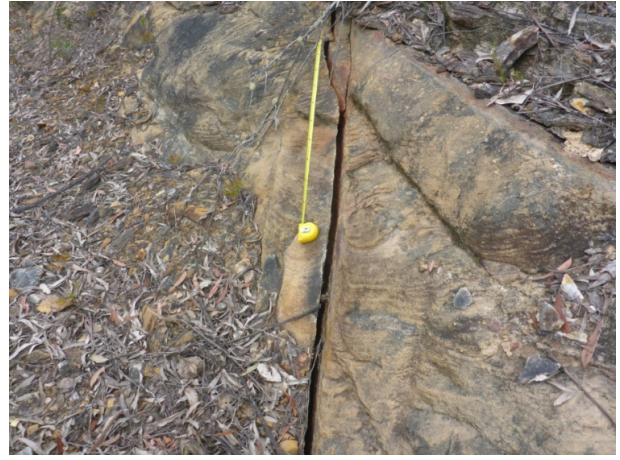
Level 3: Crack or fracture over 50m length.

Photo 46: DA3B_LW16_022, fracturing down face of cut-through. Taken on 7/07/2020.

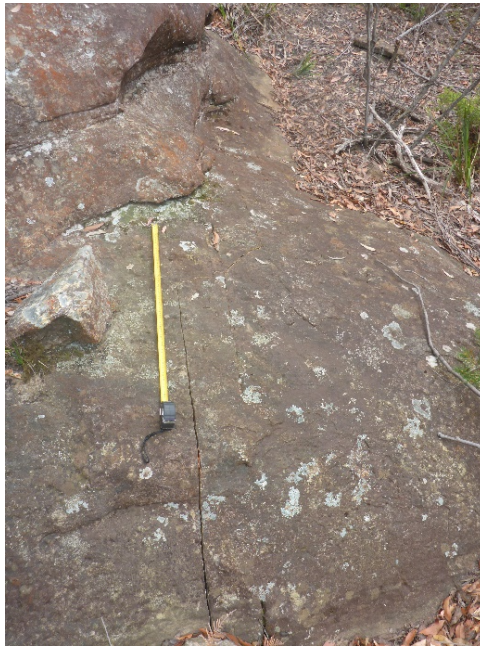
Photo 53: *DA3B_LW16_025*, looking at additional rock fracturing. Taken on 30/11/2020.

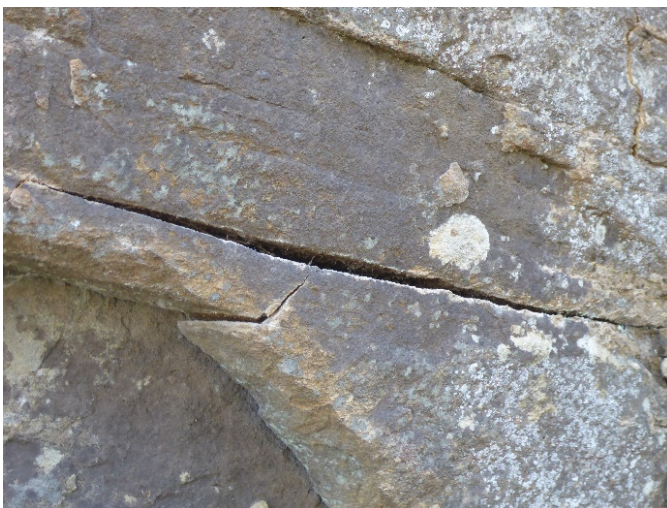
Level 1: Crack or fracture up to 100mm width, and/or, crack or fracture up to 10m length.

Photo 54: *DA3B_LW16_026*, looking at a section of rock fracturing. Taken on 06/08/2020.

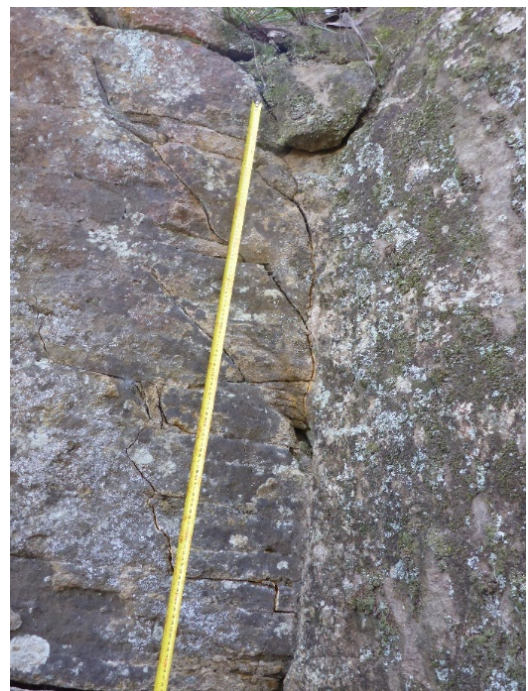
Photo 55: *DA3B_LW16_026*, looking at a section of rock fracturing. Taken on 06/08/2020.

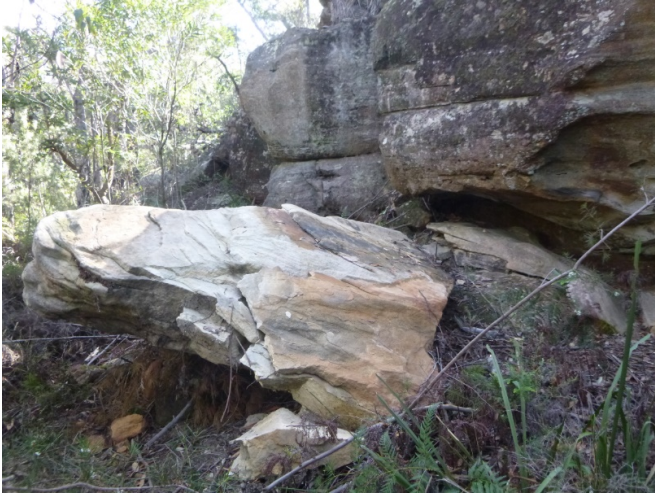
Level 1: Rock fall from a cliff (step) which is left mostly intact (<10% length), resulting in insignificant ground disturbance.

Photo 56: DA3B_LW16_029, rockfall from step, looking at main large rock fragment. Taken on 31/08/2020.

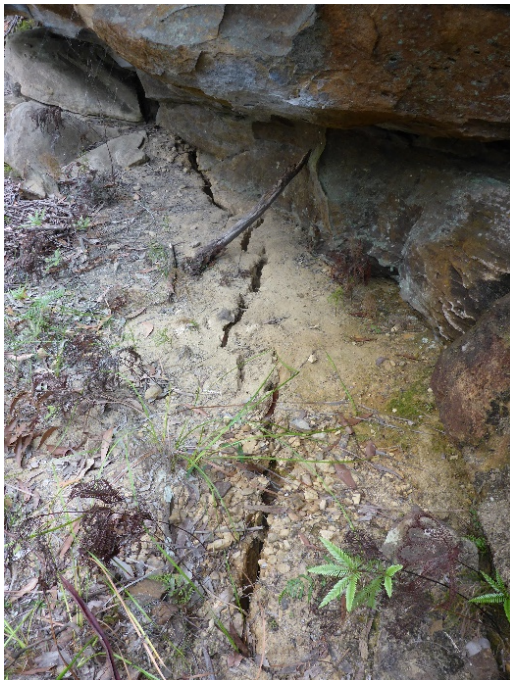
Photo 58: DA3B_LW16_029, looking at soil cracking. Taken on 25/11/2020.

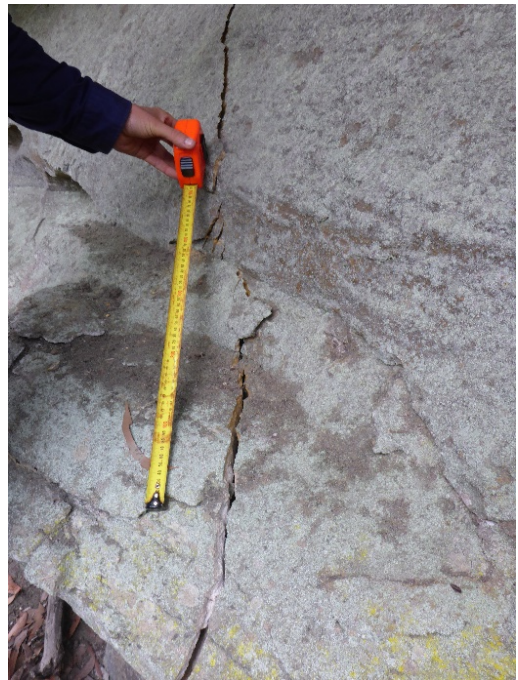
Photo 59: DA3B_LW16_029, looking at rock fracturing. Taken on 25/11/2020.

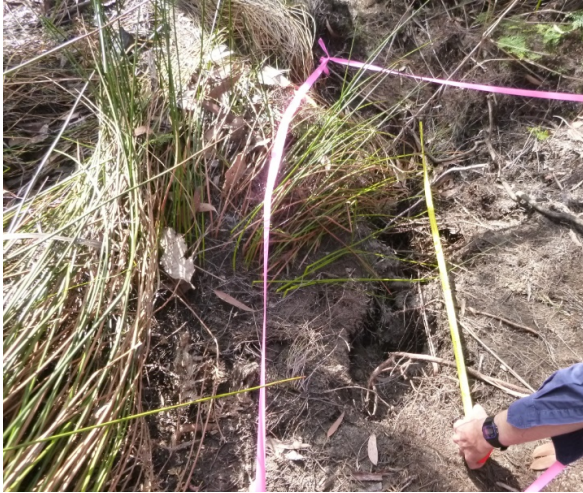
Level 1: Erosion in a localised area which would be expected to naturally stabilise without CMA and within the period of monitoring.

Photo 60: DA3B_LW16_030, localised erosion observed on tributary WC15. Taken on 31/08/2020.

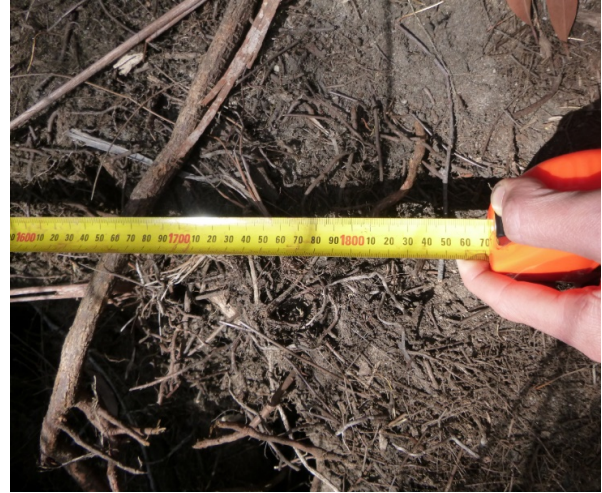
Photo 61: DA3B_LW16_030, looking at length of localised erosion. Taken on 31/08/2020.

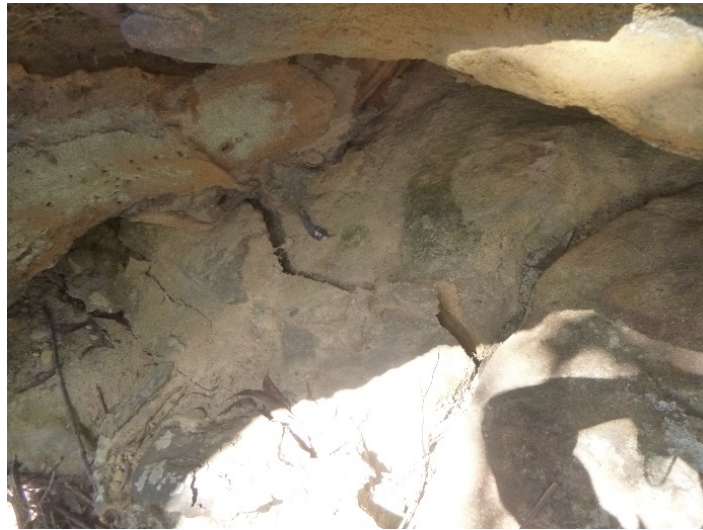
Level 1: Crack or fracture up to 100mm width, and/or, crack or fracture up to 10m length.

Photo 71: *DA3B_LW16_036*, looking at a section of rock fracturing. Taken on 28/09/2020.

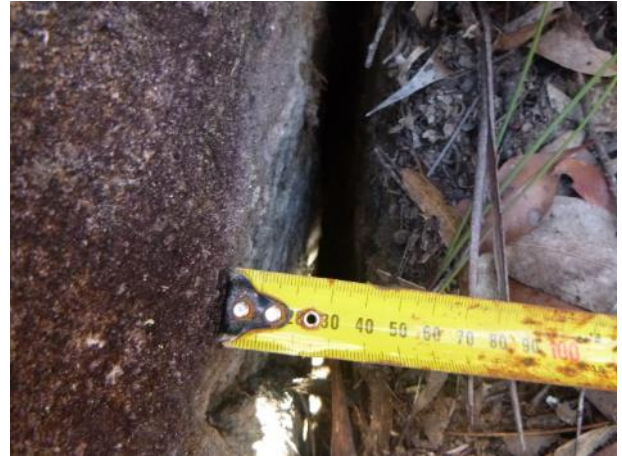
Photo 75: DA3B_LW16_044, looking at rock displacement from soil. Taken on 10/11/2020.

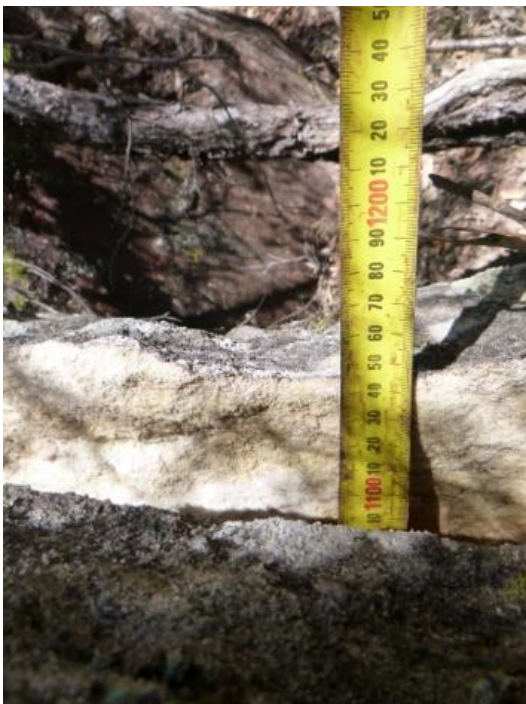
Level 1: Crack or fracture up to 100mm width, and/or, crack or fracture up to 10m length.

Photo 76: DA3B_LW16_045, looking at depth of rock fracturing. Taken on 10/11/2020.

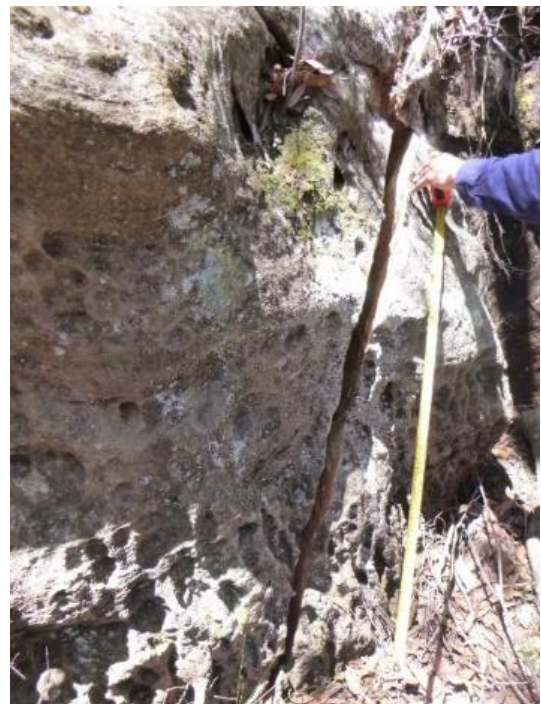
Photo 77: DA3B_LW16_045, looking at length of rock fracturing. Taken on 10/11/2020.

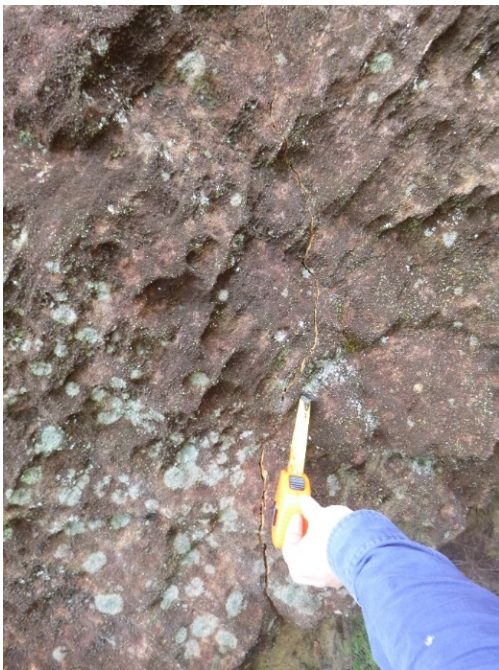
Level 1: Crack or fracture up to 100mm width, and/or, crack or fracture up to 10m length.

Photo 79: DA3B_LW16_046, looking at the rock fracture. Taken on 25/11/2020.

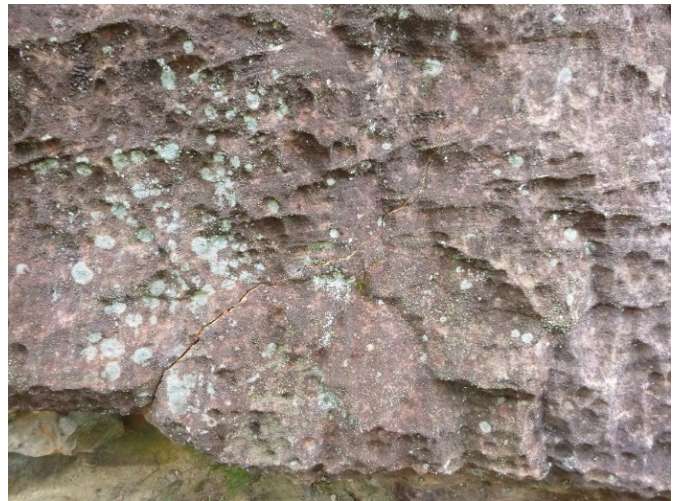
Photo 80: DA3B_LW16_046, looking at the rock fracture. Taken on 25/11/2020.

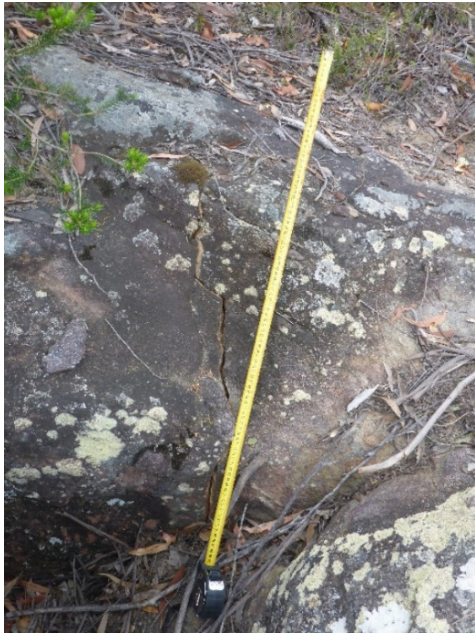
Level 1: Crack or fracture up to 100mm width, and/or, crack or fracture up to 10m length.

Photo 81: DA3B_LW16_047, looking at a section of the rock fracturing. Taken on 30/11/2020.

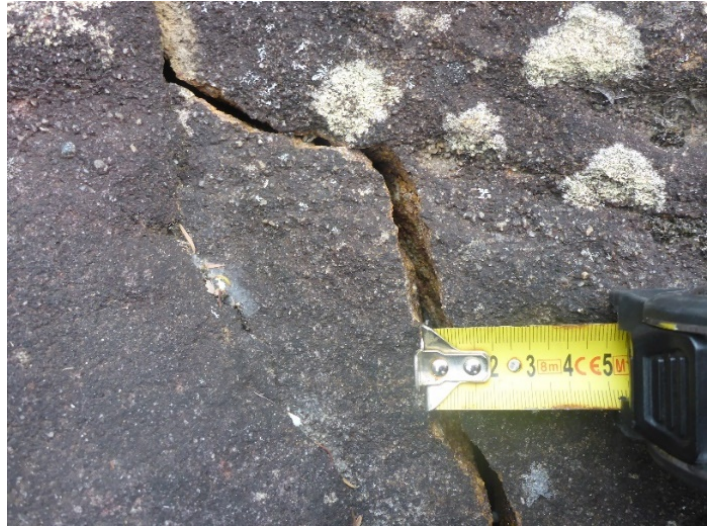
Photo 82: DA3B_LW16_047, looking at the width of the rock fracturing. Taken on 30/11/2020.

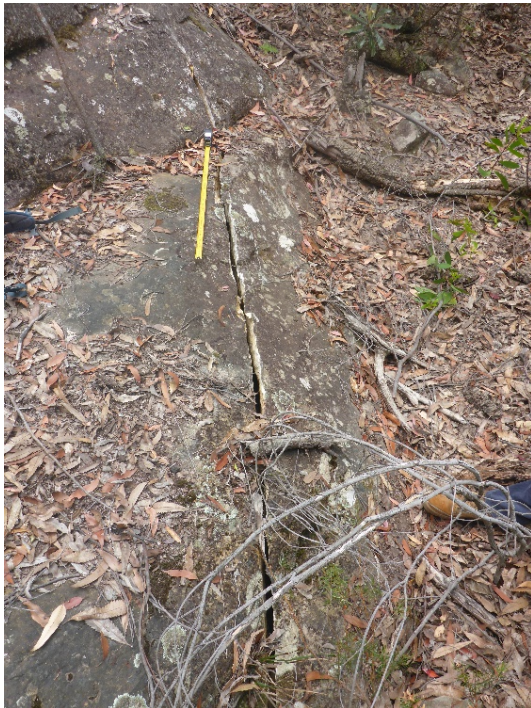
Level 1: Crack or fracture up to 100mm width, and/or, crack or fracture up to 10m length.

Photo 83: DA3B_LW16_048, looking at the length of rock fracturing. Taken on 30/11/2020.

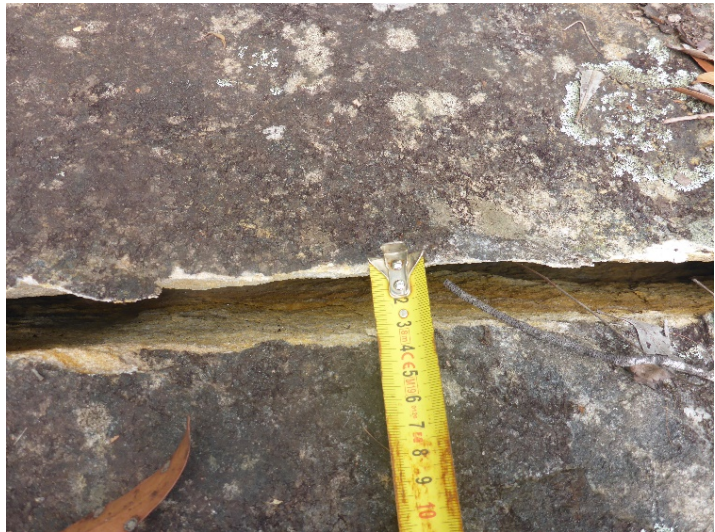
Photo 84: DA3B_LW16_048, looking at the width of rock fracturing. Taken on 30/11/2020.

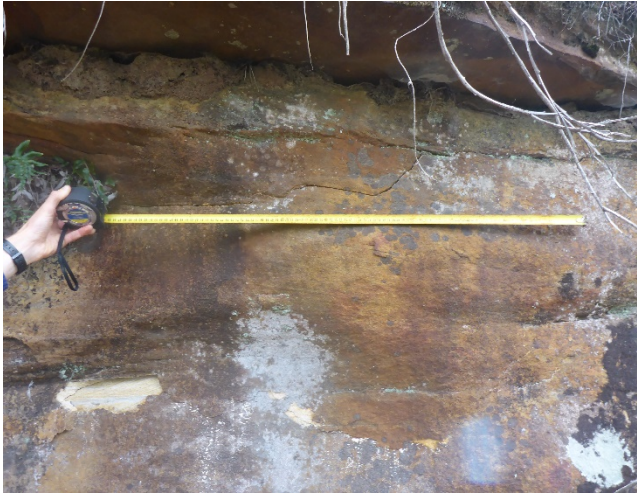
Level 2: Crack or fracture between 10m and 50m length.

Photo 85: DA3B_LW16_049, looking at a section of rock fracturing. Taken on 30/11/2020.

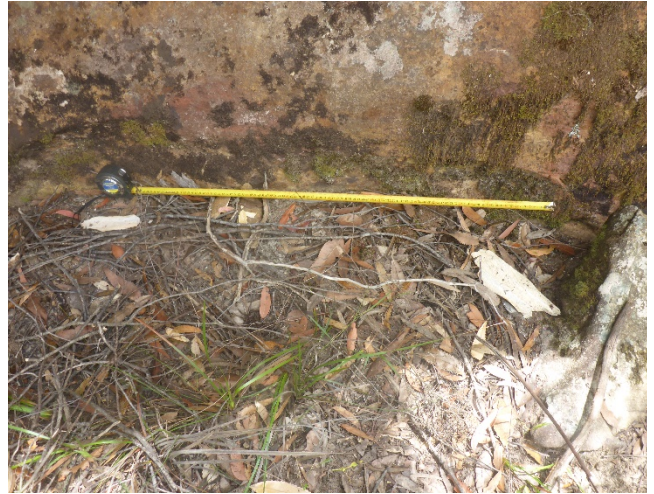
Photo 86: DA3B_LW16_049, looking at the rock fragmentation. Taken on 30/11/2020.

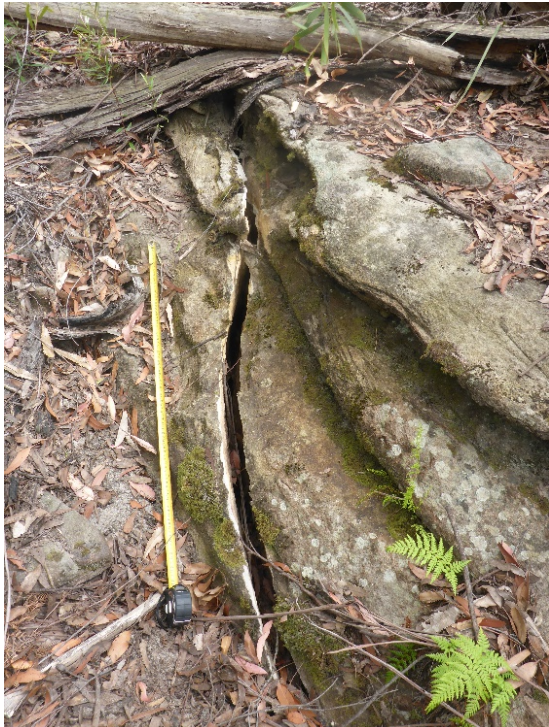
Level 1: Crack or fracture up to 100mm width, and/or, crack or fracture up to 10m length.

Photo 87: DA3B_LW16_050, looking at the length of the rock fracture. Taken on 30/11/2020.

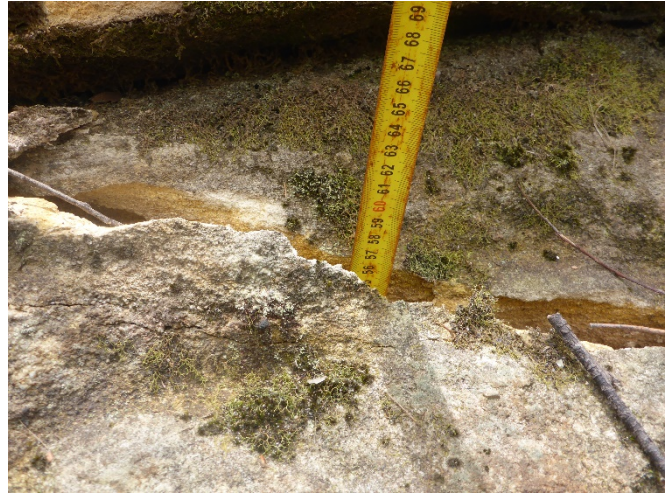
Photo 88: DA3B_LW16_050, looking at the depth of the rock fracture. Taken on 30/11/2020.

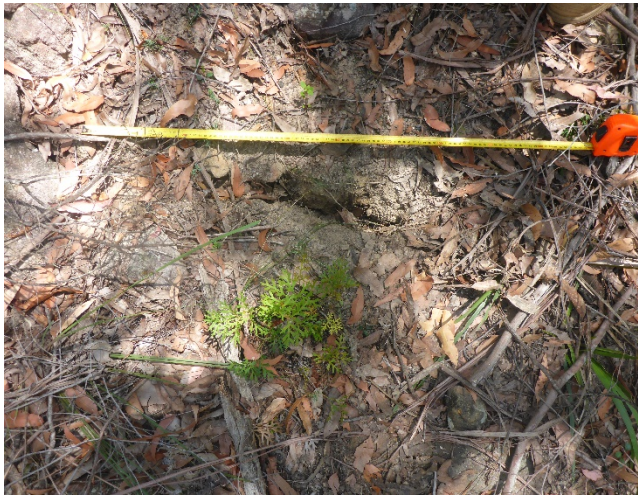
Level 1: Crack or fracture up to 100mm width, and/or, crack or fracture up to 10m length.

Photo 92: DA3B_LW16_052, looking at a section of soil cracking. Taken on 1/12/2020.

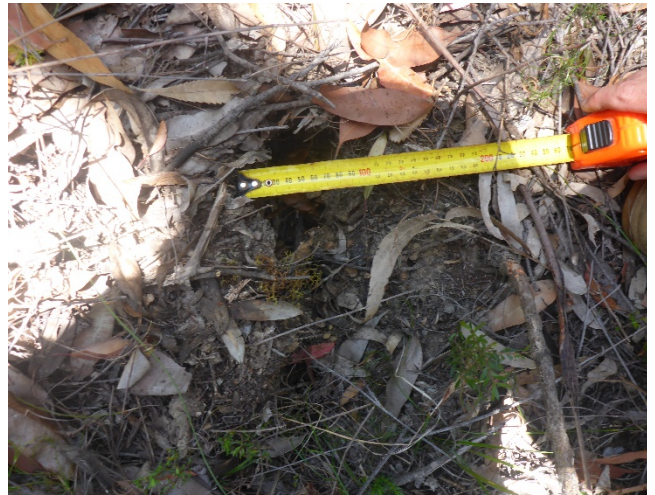
Photo 93: DA3B_LW16_052, looking at the maximum width. Taken on 1/12/2020.

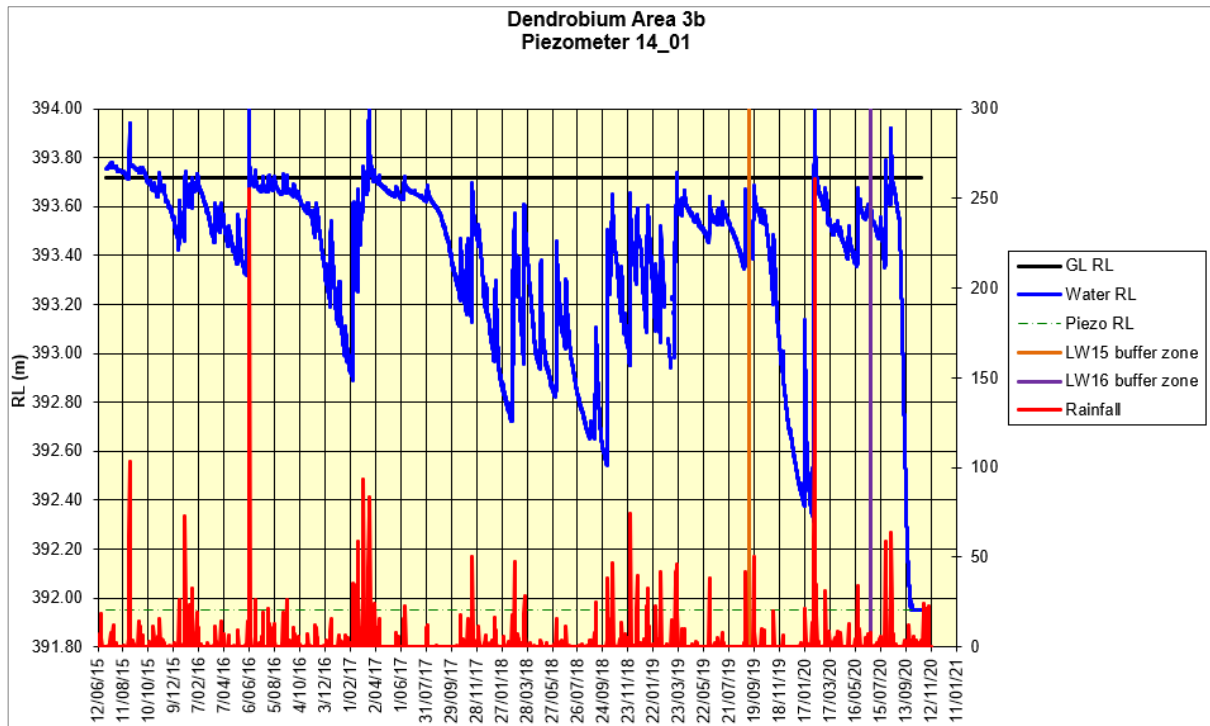
Level 3: Rate of groundwater level reduction exceeds rate of groundwater level reduction during baseline period at >80% of monitoring sites (within 400 m of mining) within the swamp.

Figure 5: Near-surface groundwater levels at 14_01, logged hourly. Date range: 02/07/2015 to 20/10/2020.

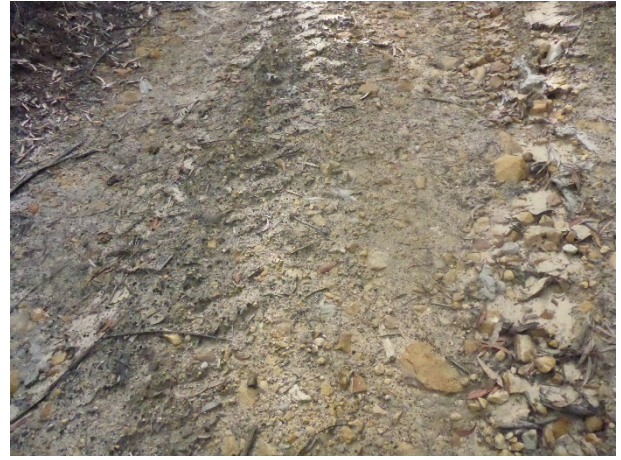
Photo 100: DA3B_LW16_001, soil cracking naturally remediated. Taken on 19/11/2020.

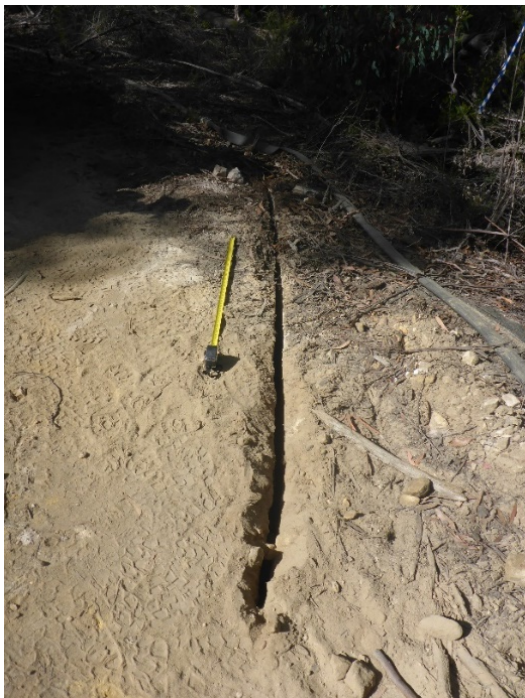
Photo 103: DA3B_LW16_003, soil cracking and rock fracturing on access track between Lake Avon and FR6A. Taken on 22/04/2020.

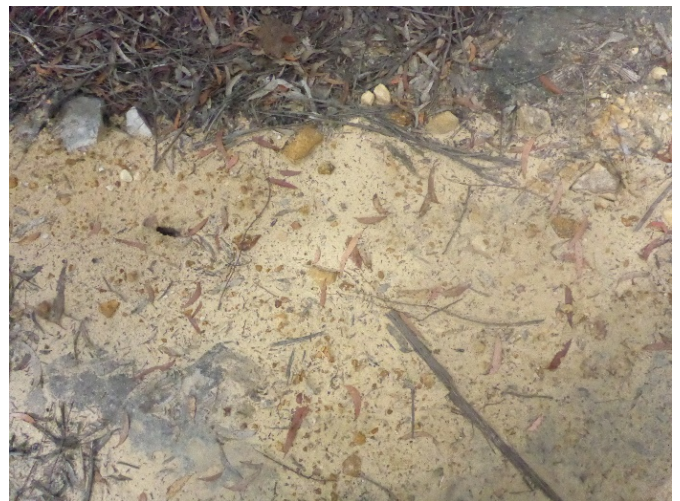
Photo 104: DA3B_LW16_003, soil cracking and rock fracturing mostly naturally infilled. Taken on 19/11/2020.

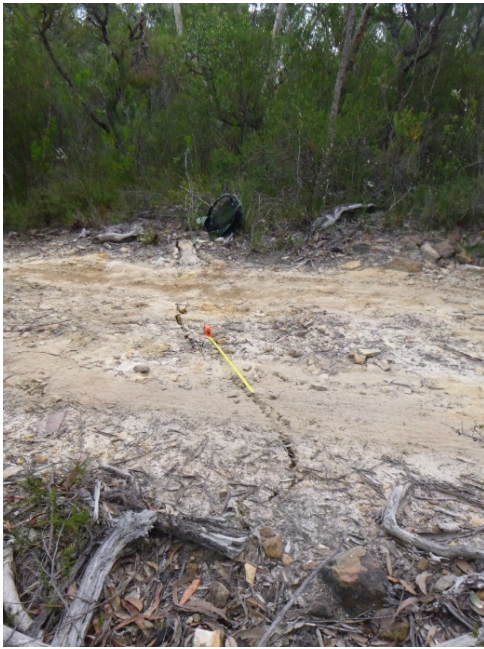
Photo 105: DA3B_LW16_004, soil cracking on access track between Lake Avon and FR6A. Taken on 16/04/2020.

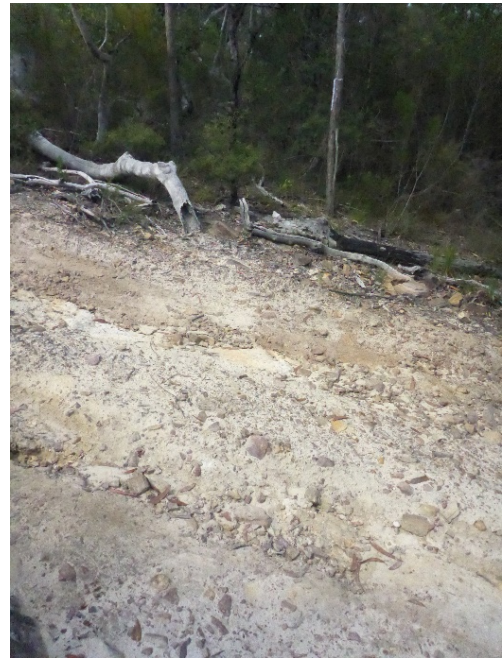
Photo 106: DA3B_LW16_004, soil cracking naturally remediated. Taken on 19/11/2020.

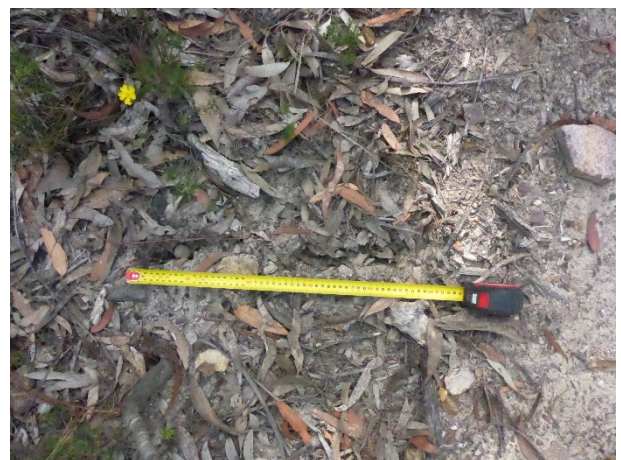
Photo 110: DA3B_LW16_007, soil cracking mostly naturally remediated. Taken on 19/11/2020.

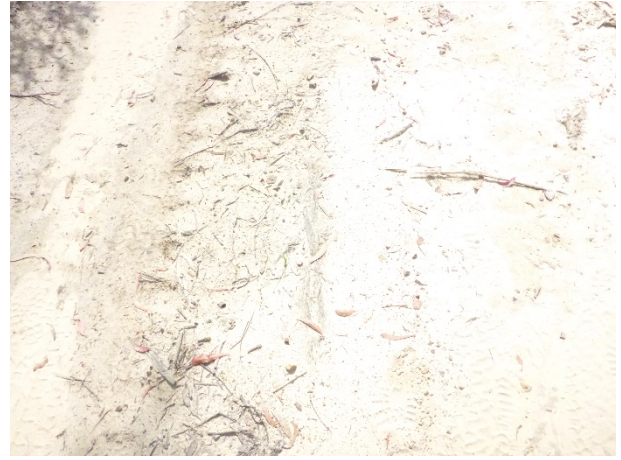
Photo 112: DA3B_LW16_008, soil cracking naturally remediated. Taken on 19/11/2020.

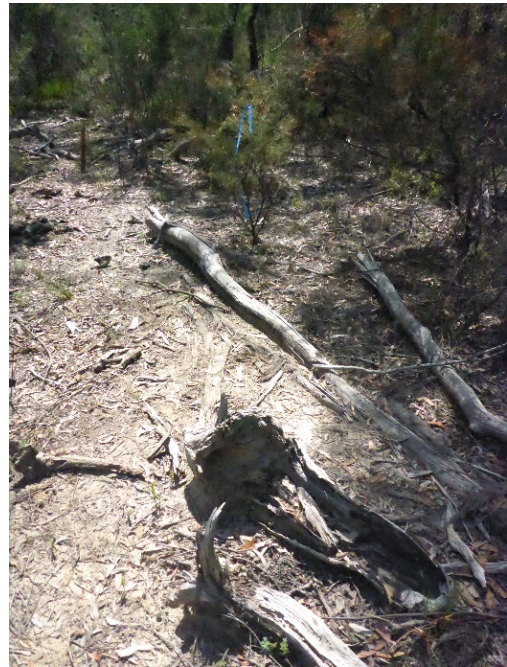
Photo 114: DA3B_LW16_009, soil cracking naturally remediated. Taken on 19/11/2020.

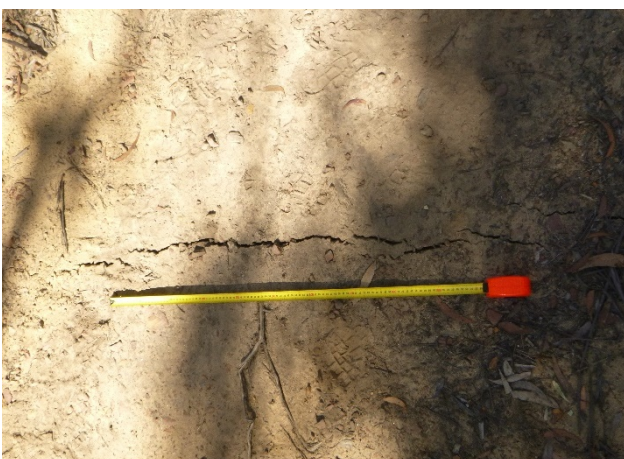
Photo 115: DA3B_LW16_014, soil cracking on access track between Lake Avon and FR6A. Taken on 12/05/2020.

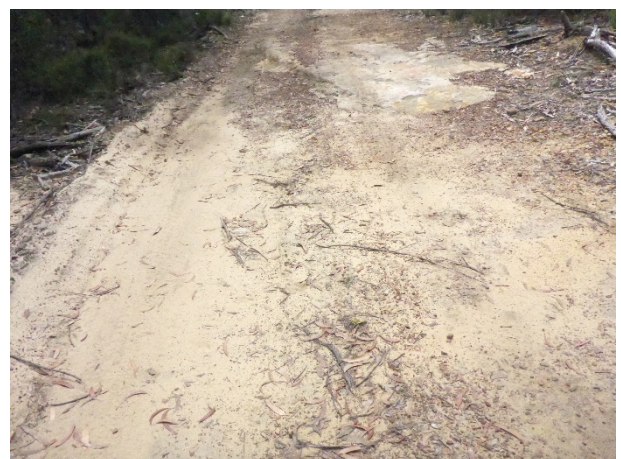
Photo 116: DA3B_LW16_014, soil cracking naturally remediated. Taken on 19/11/2020.

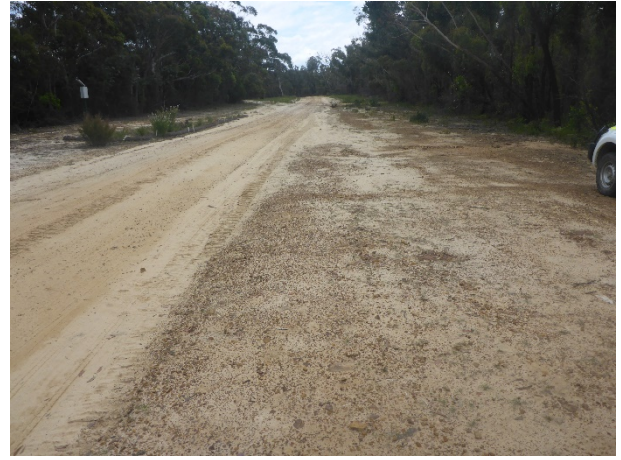
Photo 118: DA3B_LW15_008 (Update), soil cracking and uplift naturally remediated. Taken on 24/11/2020.

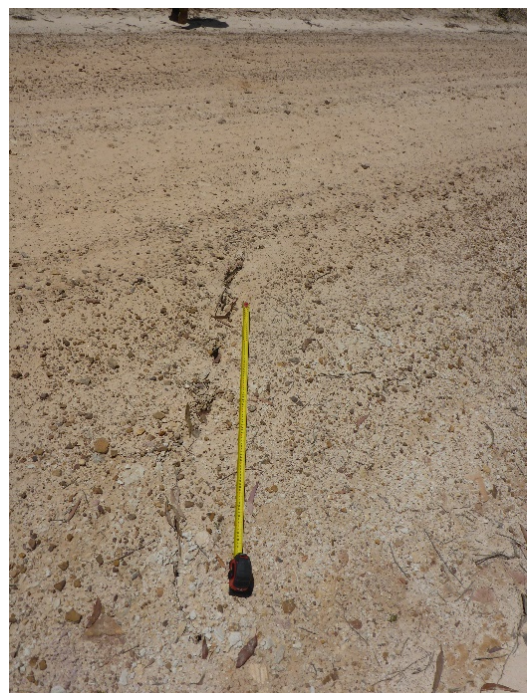
Photo 122: DA3B_LW16_023, cracking partly naturally remediated. Taken on 7/07/2020.

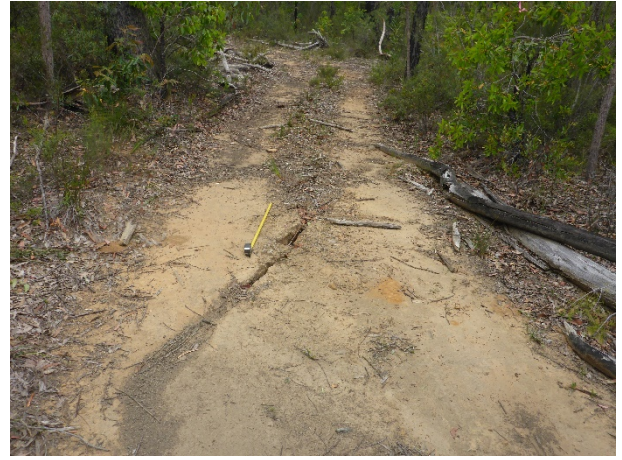
Photo 124: DA3B_LW16_027, signs of natural remediation observed. Taken on 30/11/2020.

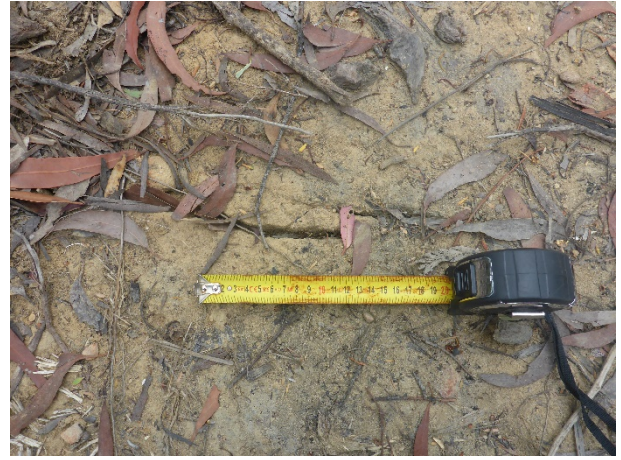
Photo 130: DA3B_LW16_037, small soil crack expected to naturally remediate. Taken on 28/09/2020.

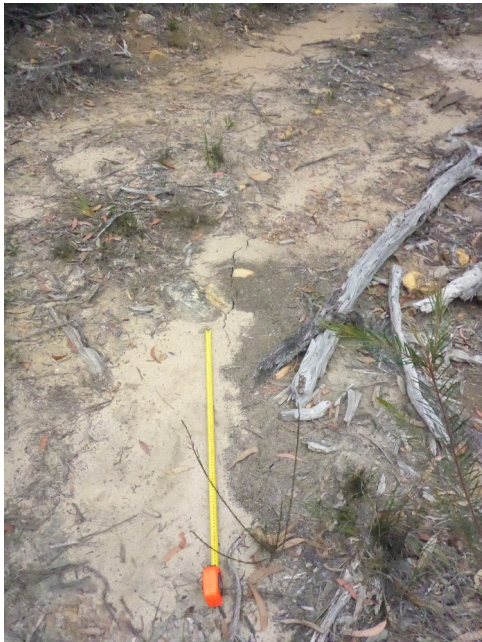
Photo 135: DA3B_LW16_041, soil cracking to access track east of Swamp 14. Taken on 7/10/2020.

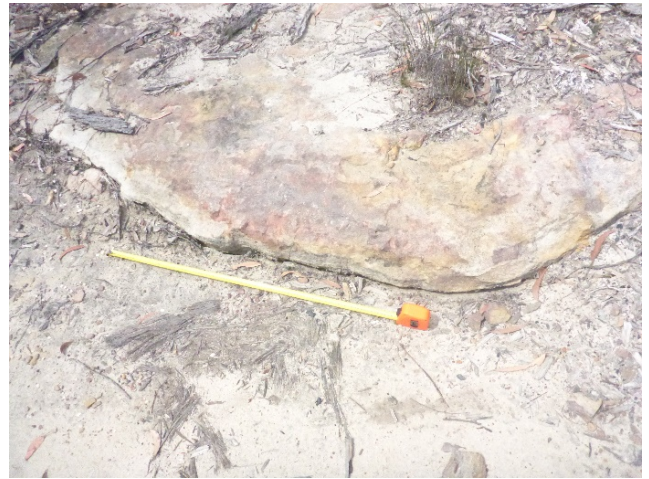
Photo 136: DA3B_LW16_041, displacement of soil from rock outcrop on access track east of Swamp 14. Taken on 7/10/2020.

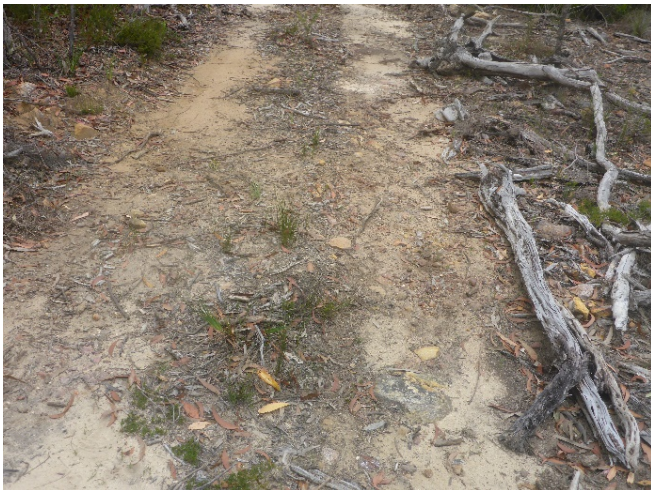
Photo 137: DA3B_LW16_041, soil cracking naturally remediated. Taken on 30/11/2020.

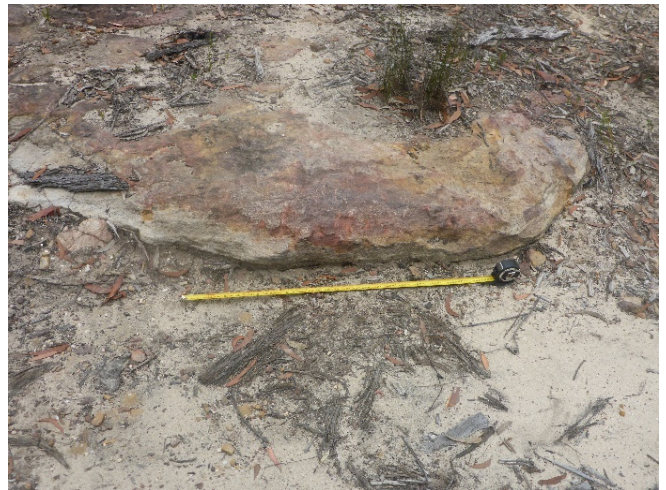
Photo 138: DA3B_LW16_041, soil displacement naturally remediated. Taken on 30/11/2020.

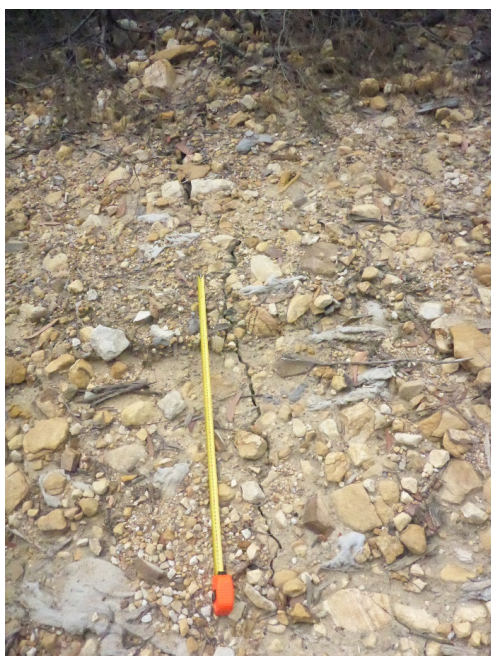
Photo 139: DA3B_LW16_042, soil cracking to access track east of Swamp 14. Taken on 7/10/2020.

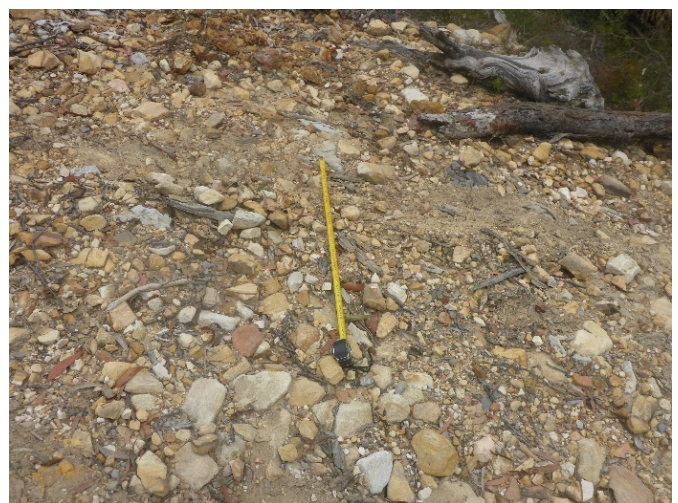
Photo 140: DA3B_LW16_042, soil cracking naturally remediated. Taken on 30/11/2020.

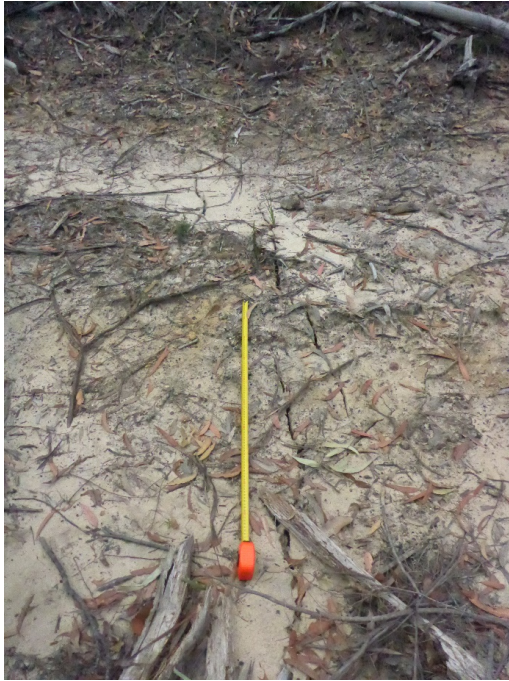
Photo 141: DA3B_LW16_043, soil cracking to access track east of Swamp 14. Taken on 7/10/2020.

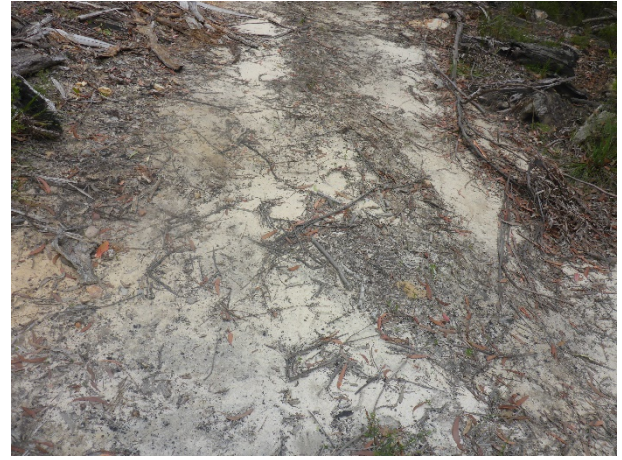
Photo 142: DA3B_LW16_043, soil cracking naturally remediated. Taken on 30/11/2020.
