**DENDROBIUM AREA 3B
LONGWALL 16 END OF PANEL
LANDSCAPE REPORT
DECEMBER 2020**

This report summarises the observed and measured subsidence effects on landscape features resulting from the extraction of Dendrobium Area 3B (DA3B) Longwall 16.

Longwall 16 is the eighth panel extracted from DA3B. Extraction began on 26 February 2020 and was completed on 4 November 2020.

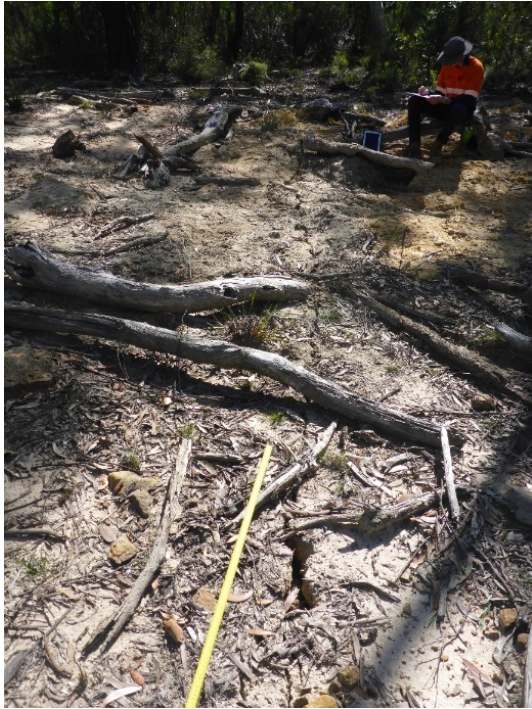
Crack or fracture between 10m and 50m length.

Photo 143: DA3B_LW16_005, soil cracking to access track between Lake Avon and FR6A. Taken on 22/04/2020.

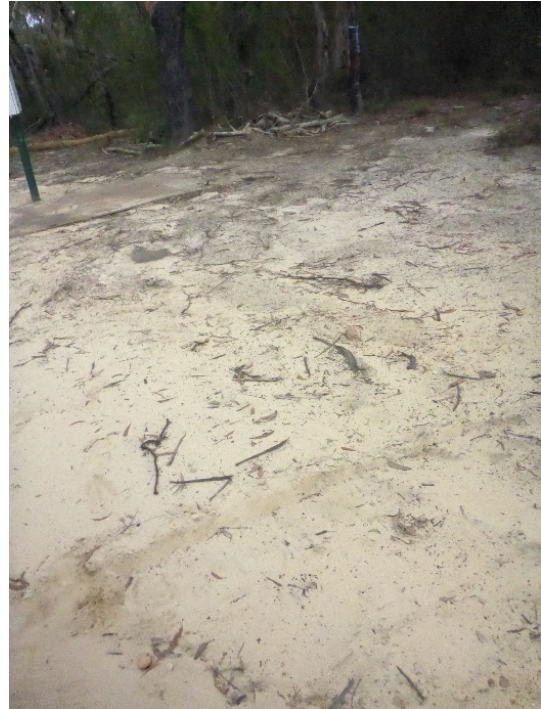
Photo 144: DA3B_LW16_005, soil cracking remediated naturally. Taken on 19/11/2020.

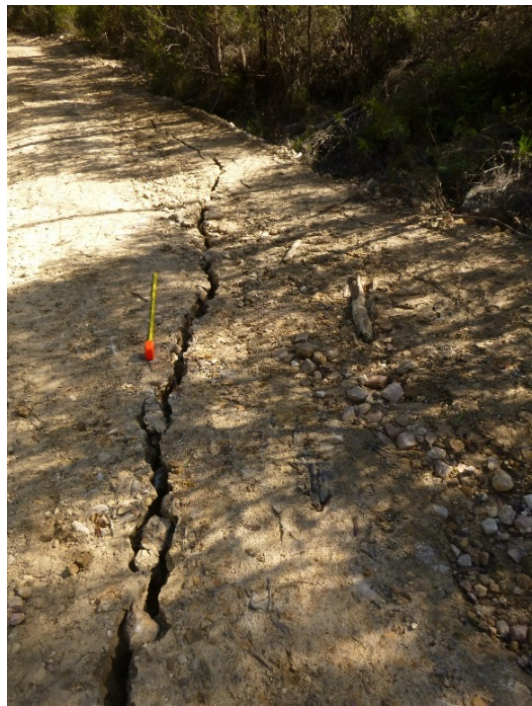
Photo 145: DA3B_LW16_013, soil cracking to access track between Lake Avon and FR6A. Taken on 12/05/2020.

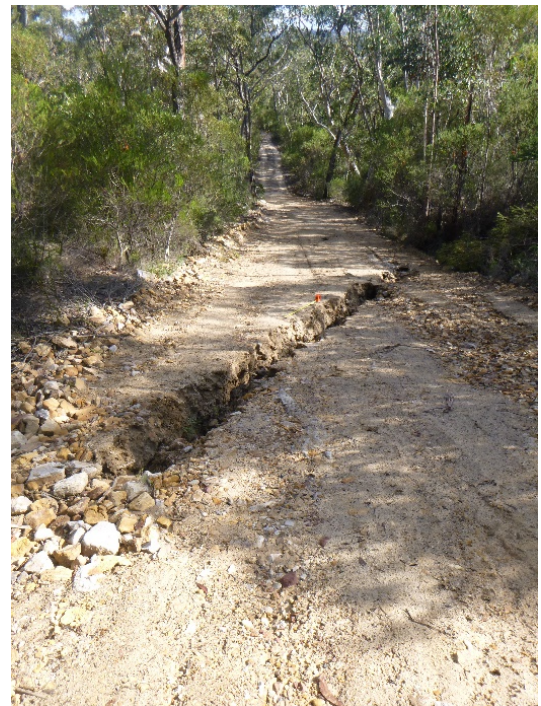
Photo 146: DA3B_LW16_013, soil cracking following a rainfall event. Taken on 28/05/2020.

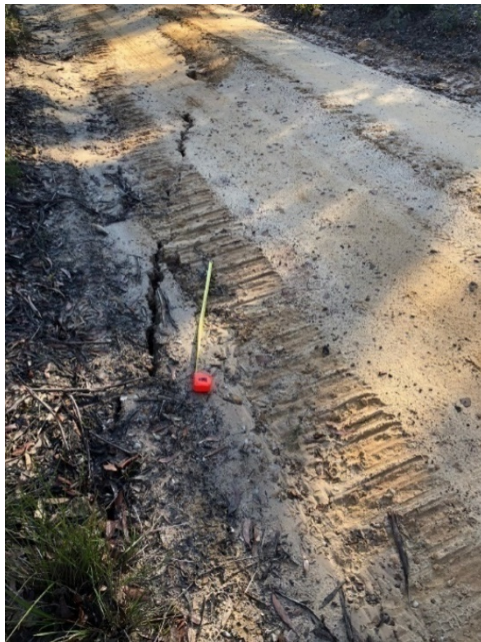
Photo 149: DA3B_LW16_019, looking at length of soil cracking on FR6A. Taken on 23/06/2020.

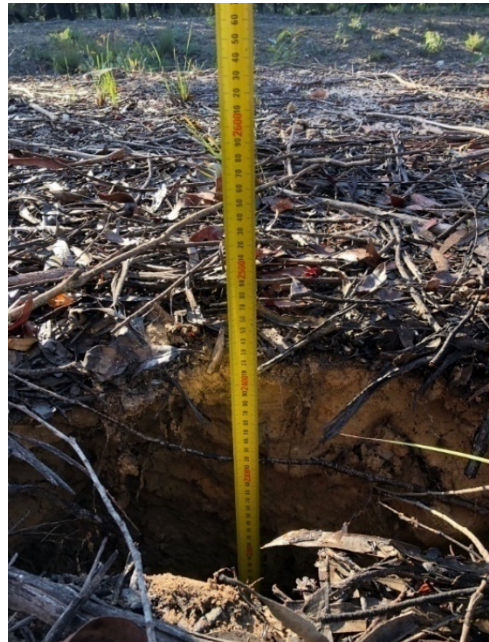
Photo 150: DA3B_LW16_019, looking at depth of cracking on FR6A. Taken on 23/06/2020.

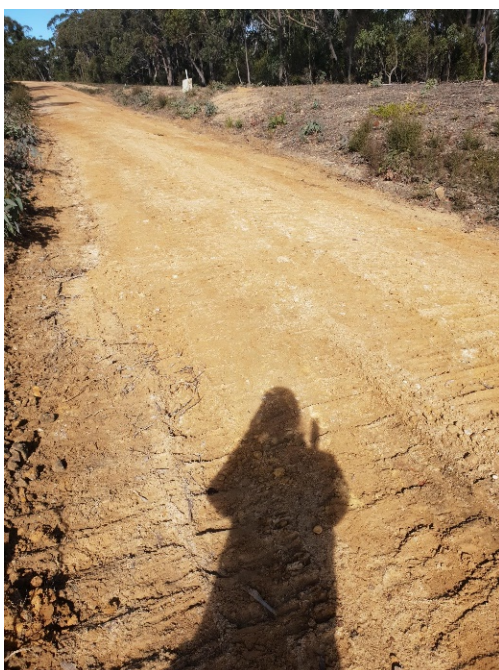
Photo 151: DA3B_LW16_019, remediated soil cracking on FR6A. Taken on 29/06/2020.

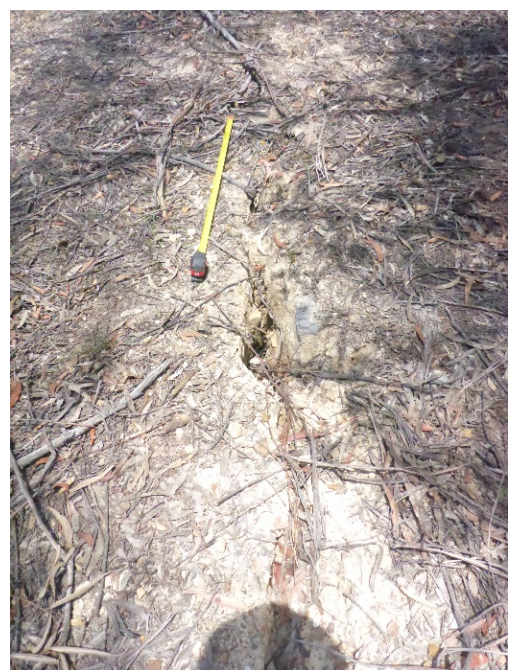
Photo 152: DA3B_LW16_019, looking at soil cracking adjacent to FR6A. Taken on 19/11/2020
