**DENDROBIUM AREA 3B
LONGWALL 16 END OF
PANEL REPORT**

March 2021

Dendrobium Longwall 16 is located within Consolidated Coal Lease 768 and is the eighth panel to be extracted in DA3B. Extraction of Longwall 16 commenced on 26 February 2020 and was completed on 4 November 2020. The extracted longwall has a length of 1864 metres (m), a void width of 305m (including first workings) and a maximum cutting height up to 3.9m

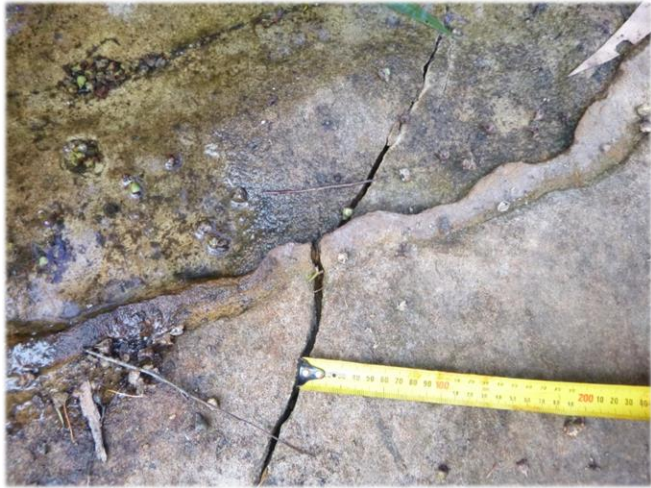
Photo 1: DA3B_LW16_028, rock fracture across rockbar. Taken on 31/08/2020.

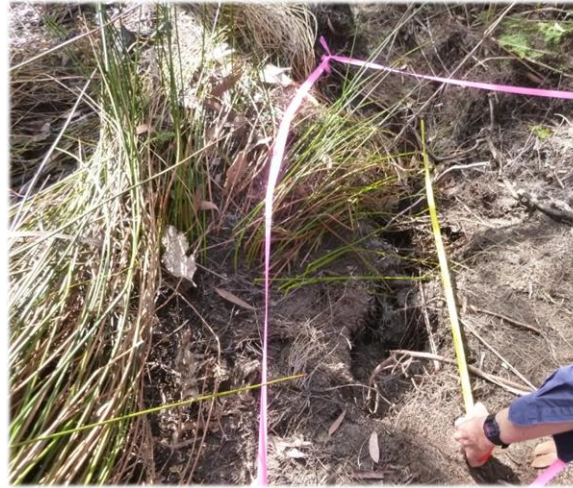
Photo 2: DA3B_LW16_030, localised erosion observed on tributary WC15. Taken on 31/08/2020.

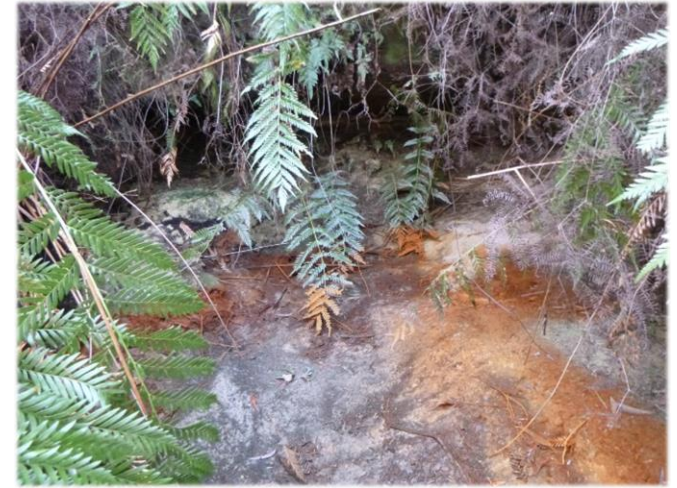
Photo 3: DA3B_LW16_038, iron staining at LA2_Pool 34, looking upstream. Taken on 14/09/2020.

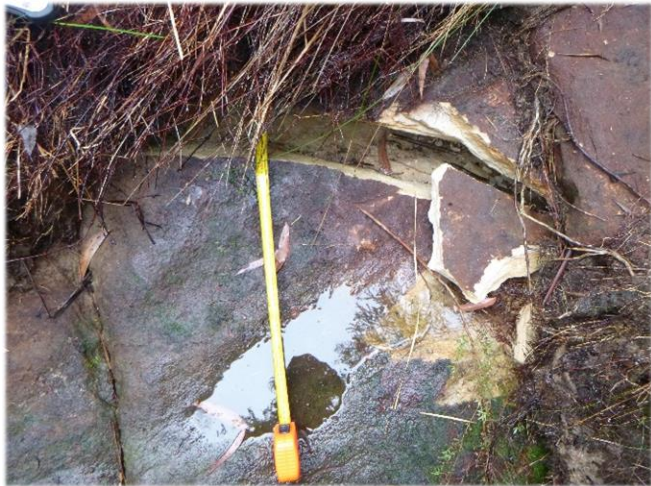
Photo 4: DA3B_LW14_017, looking at the rock fracturing and displacement. Taken on 9/09/2020.

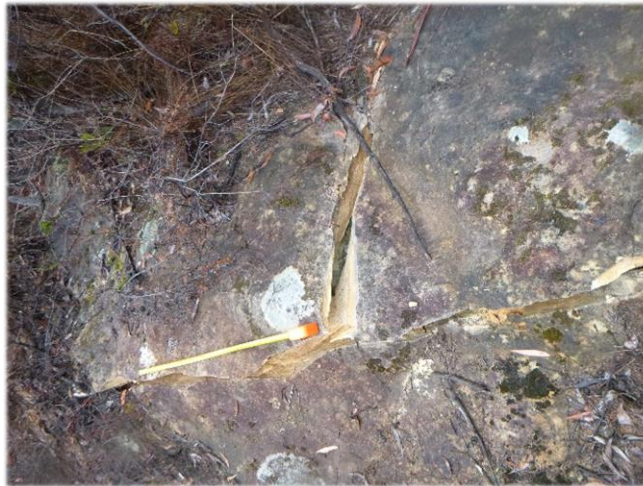
Photo 5: DA3B_LW14_019, looking at a section of rock fracturing and uplift. Taken on 9/09/2020.

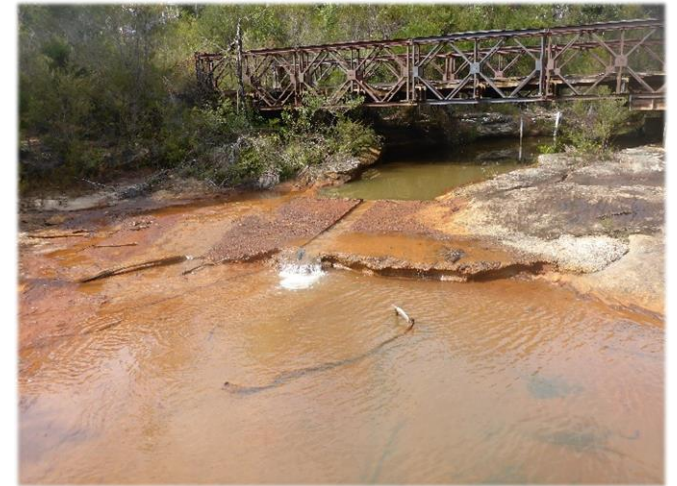
Photo 6: SCK_Rockbar 5, looking upstream at the increase in iron staining. Taken on 14/10/2020.

On 19/10/2020 iron staining was noted in Sandy Creek tributary SC10C (Level 2 TARP), extending downstream to Sandy Creek. Staining was first reported at SC10C on 11/3/2013, following the extraction of Longwall 8. The recent recurrence of staining at SC10C seven years after the first occurrence is likely the result of recovering groundwater flooding previously drained fractures in the vicinity of SC10C. This is supported by groundwater monitoring data.

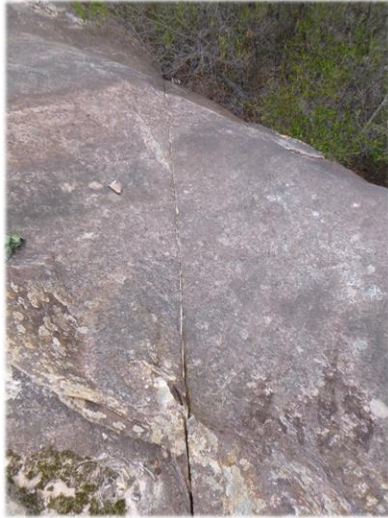
Photo 7: DA3B_LW16_010, an overview of the rock fracture. Taken on 27/04/2020.

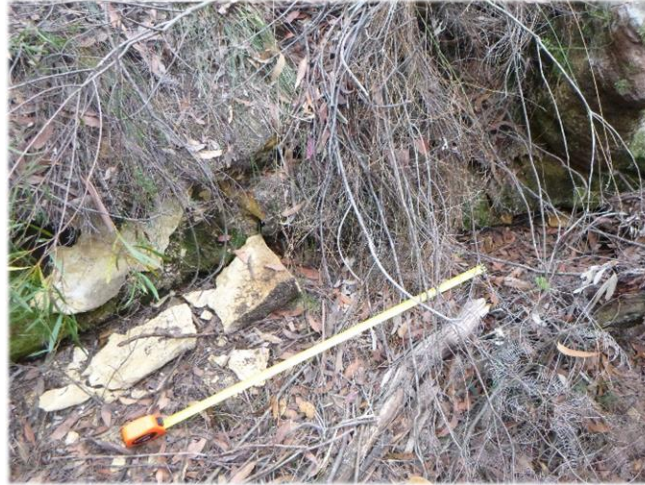
Photo 8: DA3B_LW16_011, overview of the rockfall. Taken on 27/04/2020.

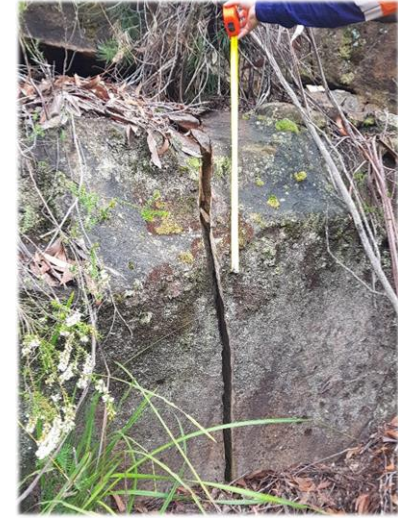
Photo 9: DA3B_LW16_012, looking at a section of rock fracturing. Taken on 28/04/2020.

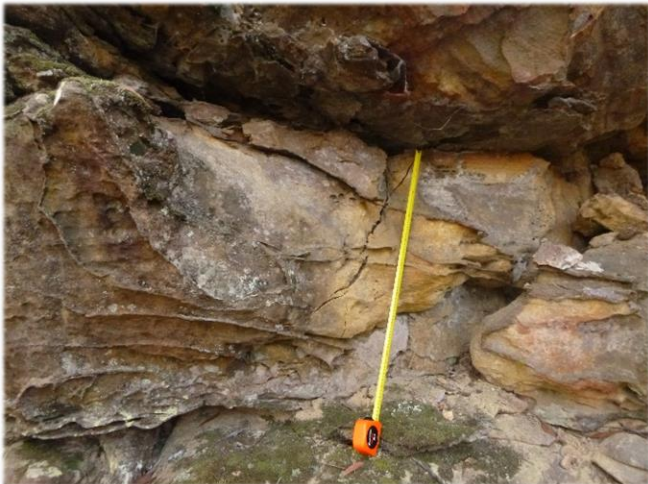
Photo 10: DA3B_LW16_015, overview of the rock fracturing. Taken on 15/05/2020.

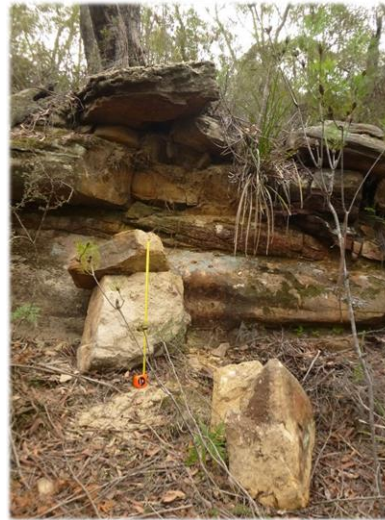
Photo 11: DA3B_LW16_016, overview of the rockfall. Taken on 15/05/2020.

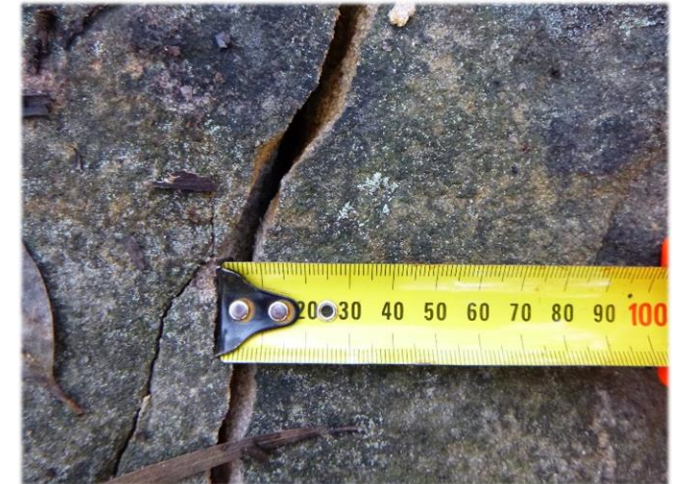
Photo 12: DA3B_LW16_017, looking at width of rock fracturing. Taken on 16/06/2020.

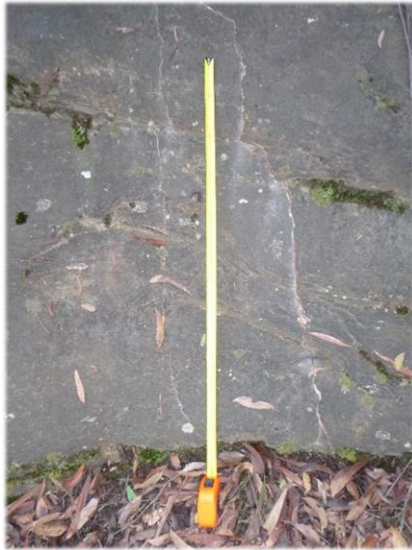
Photo 13: DA3B_LW16_018, looking at a section of rock fracturing. Taken on 16/06/2020.

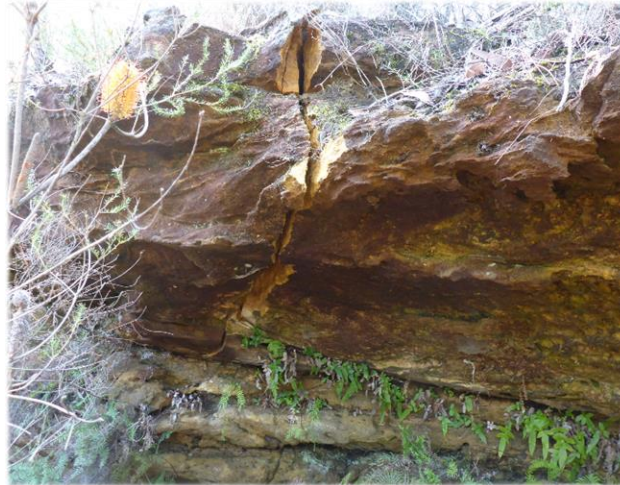
Photo 14: DA3B_LW16_021, looking at fracture on step. Taken on 30/06/2020.

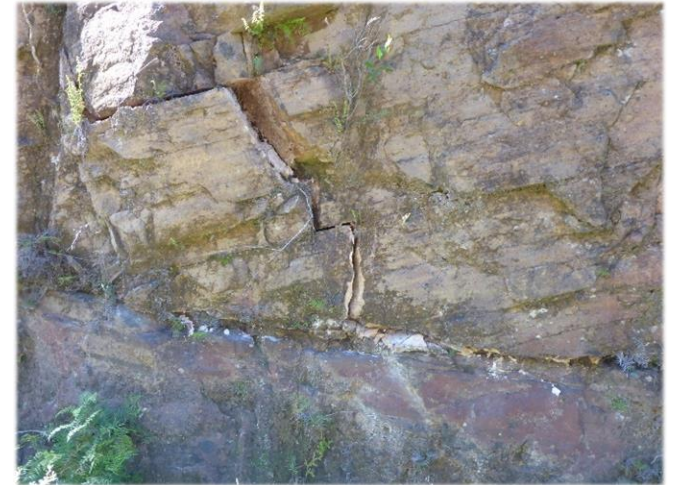
Photo 15: DA3B_LW16_022, fracturing down face of cut-through. Taken on 6/08/2020.

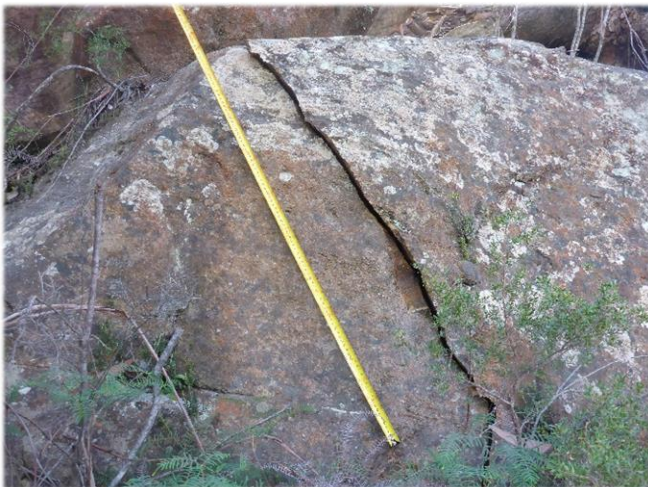
Photo 16: DA3B_LW16_025, looking at a section of rock fracturing. Taken on 06/08/2020.

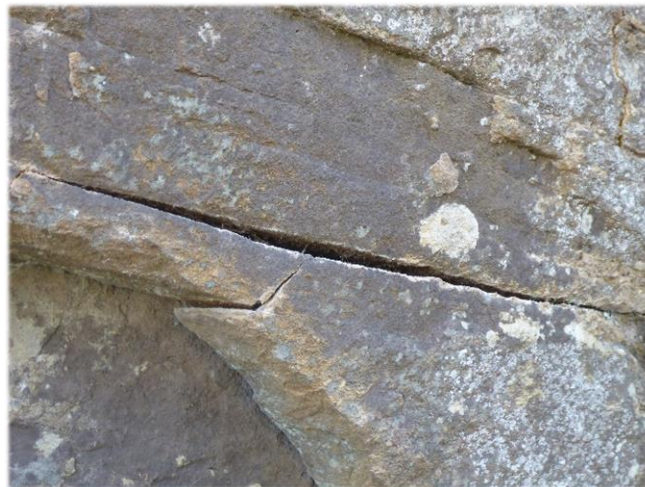
Photo 17: DA3B_LW16_026, looking at a section of rock fracturing. Taken on 06/08/2020.

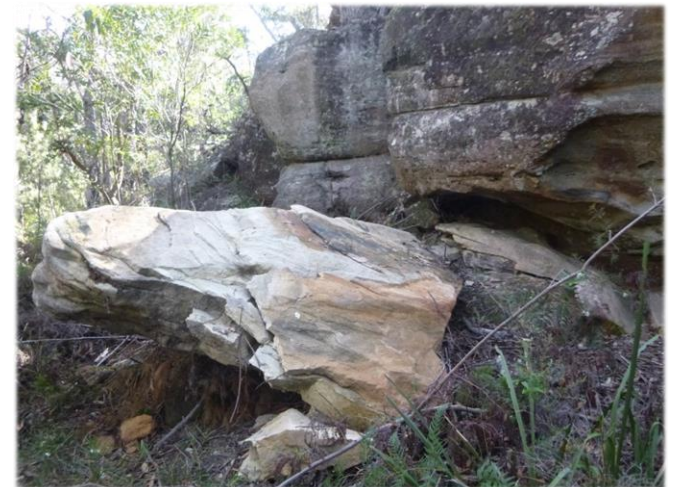
Photo 18: DA3B_LW16_029, rockfall from step, looking at main large rock fragment. Taken on 31/08/2020.

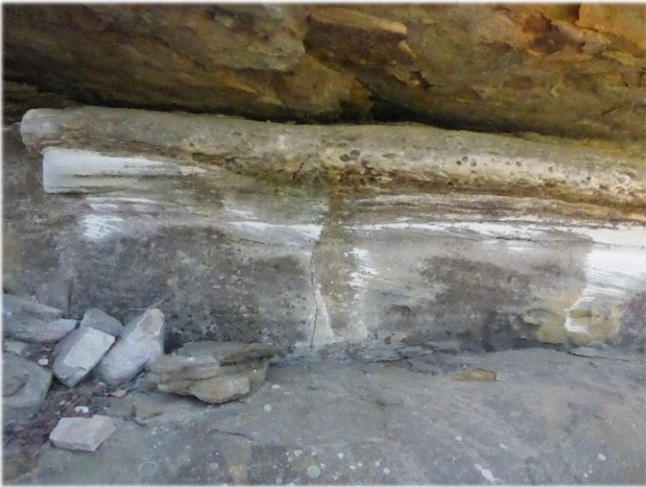
Photo 19: DA3B_LW16_031, looking at the rock fracturing. Taken on 28/09/2020.

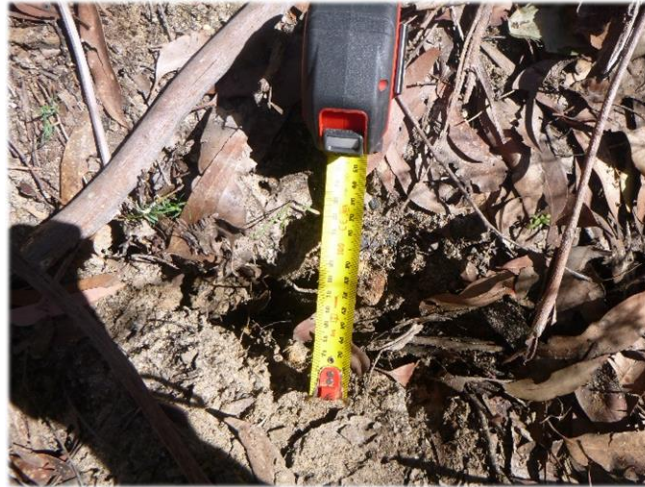
Photo 20: DA3B_LW16_032, looking at the width of soil cracking. Taken on 28/09/2020.

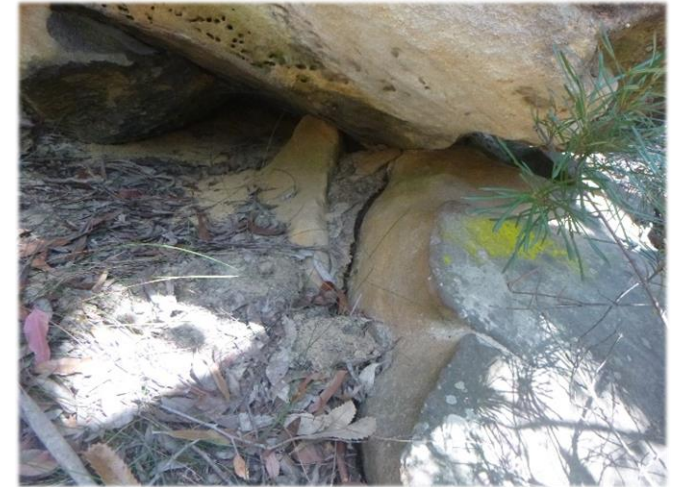
Photo 21: DA3B_LW16_035, looking at a section of displacement. Taken on 28/09/2020.

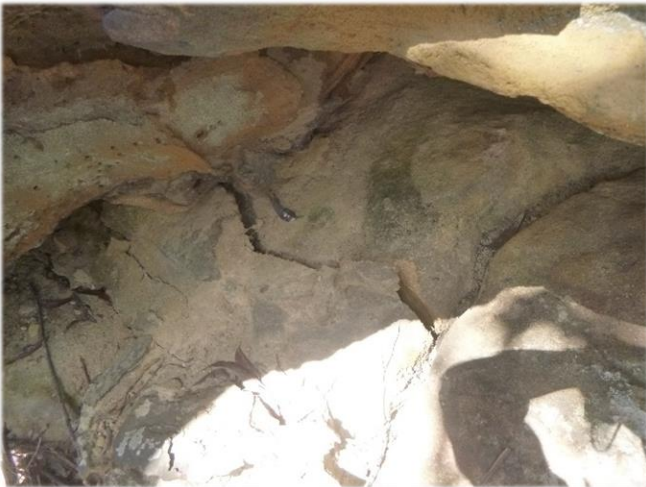
Photo 22: DA3B_LW16_036, looking at a section of rock fracturing. Taken on 28/09/2020.

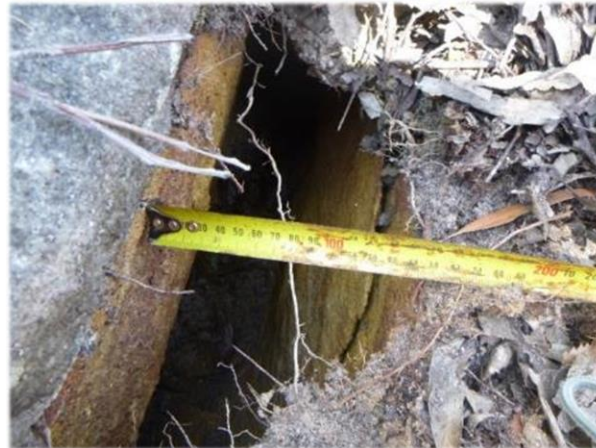
Photo 23: DA3B_LW16_044, looking at width of rock fracturing. Taken on 10/11/2020.

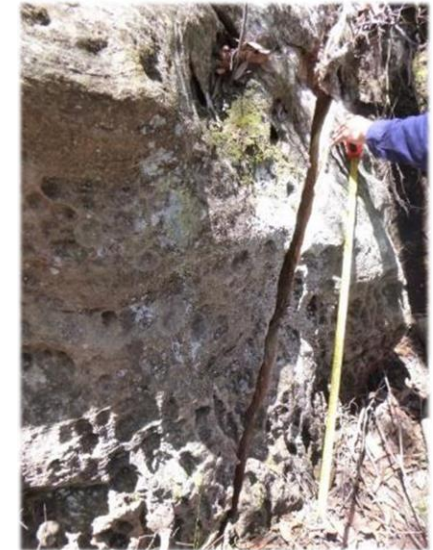
Photo 24: DA3B_LW16_045, looking at length of rock fracturing. Taken on 10/11/2020.

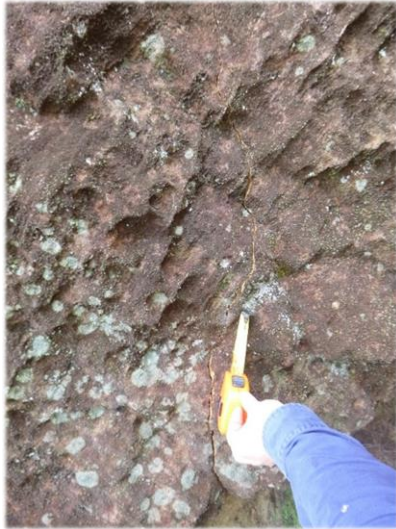
Photo 25: DA3B_LW16_046, looking at the rock fracture.
Taken on 25/11/2020.

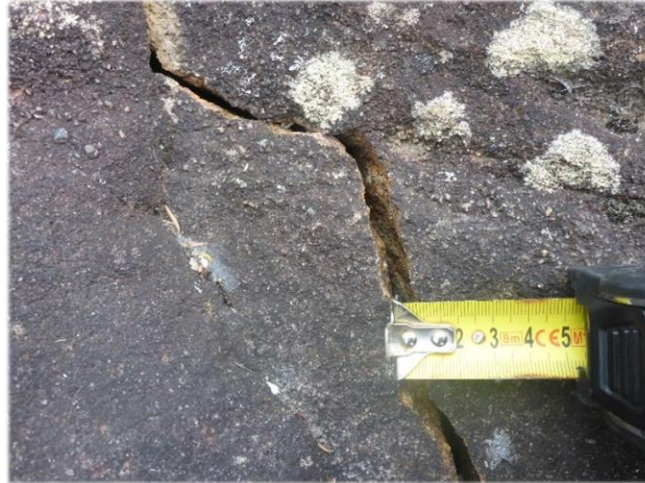
Photo 26: DA3B_LW16_047, looking at the rock fracture.
Taken on 25/11/2020.

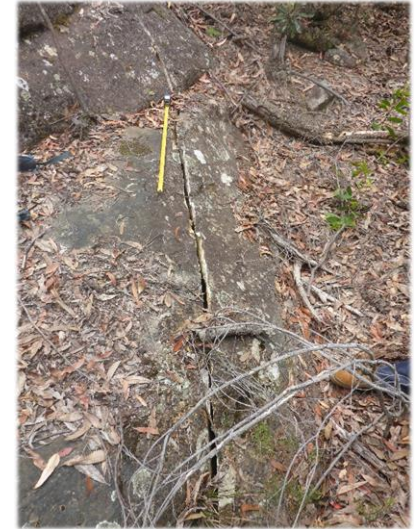
Photo 27: DA3B_LW16_048, looking at the length of rock fracturing. Taken on 30/11/2020.

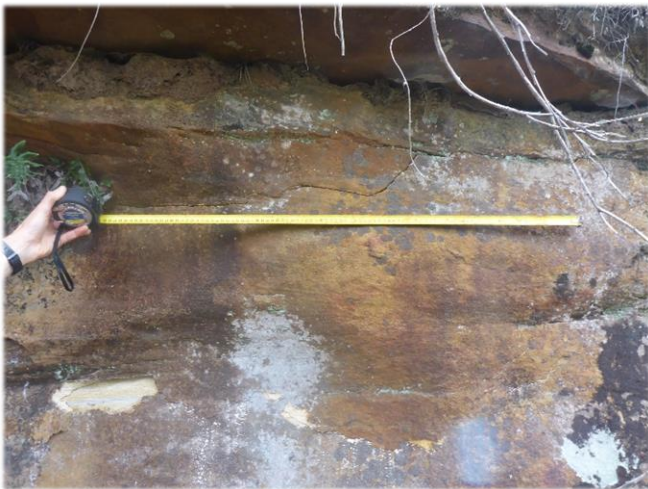
Photo 28: DA3B_LW16_049, looking at a section of rock fracturing. Taken on 30/11/2020.

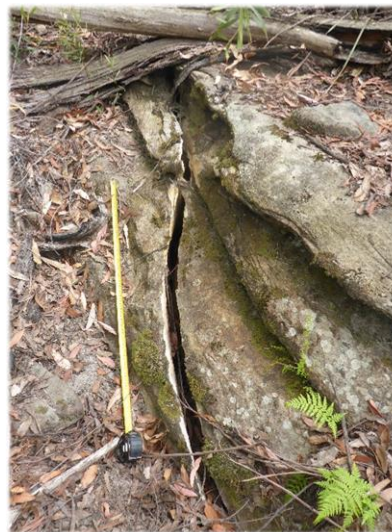
Photo 29: DA3B_LW16_050, looking at the length of the rock fracture. Taken on 30/11/2020.

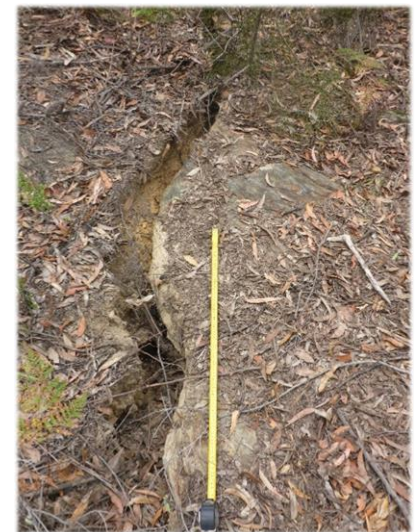
Photo 30: DA3B_LW16_051, looking at a section of soil cracking and rock fracturing. Taken on 30/11/2020.

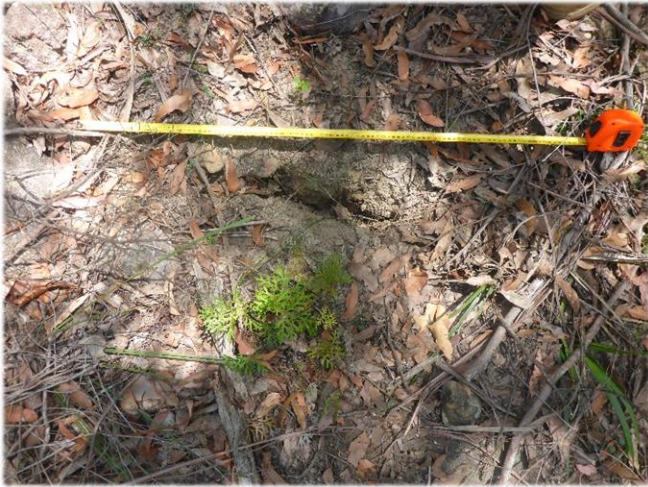
Photo 31: *DA3B_LW16_052*, looking at a section of soil cracking. Taken on 1/12/2020.

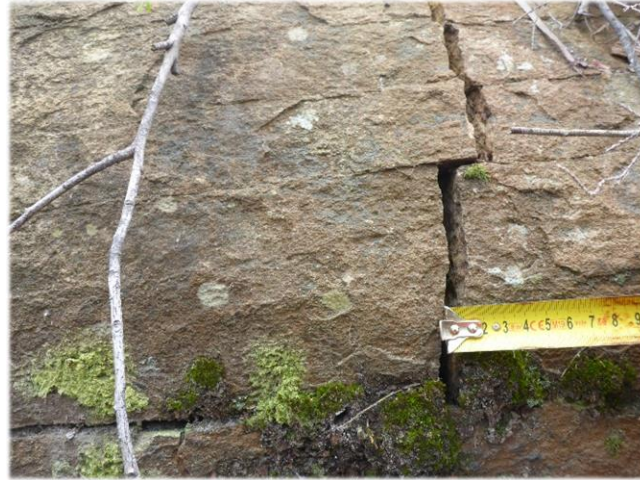
Photo 32: *DA3B_LW15_002*, looking at a section of rock fracturing. Taken on 2/12/2020.

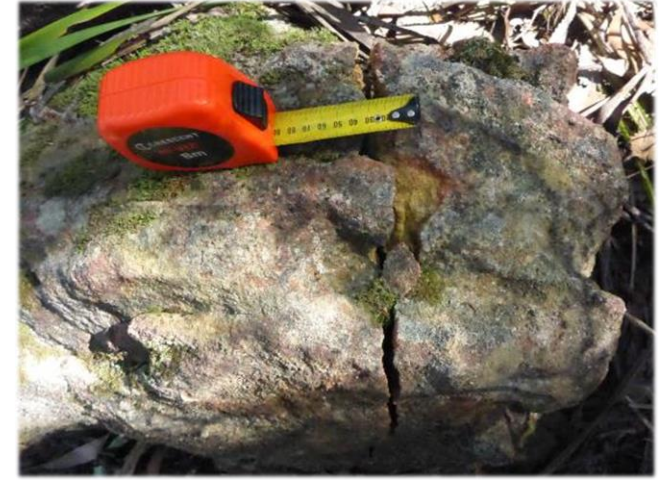
Photo 33: *DA3B_LW15_026*, looking at fracture to boulder. Taken on 24/08/2020.

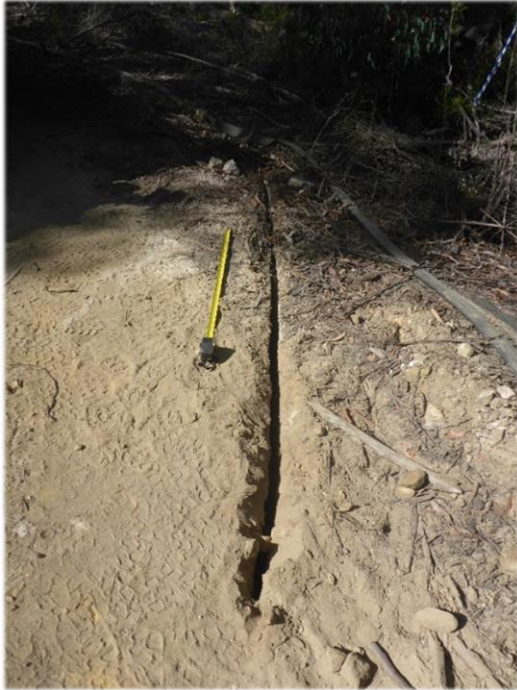
Photo 34: *DA3B_LW16_003*, soil cracking and rock fracturing on access track between *Lake Avon* and *FR6A*. Taken on 22/04/2020.

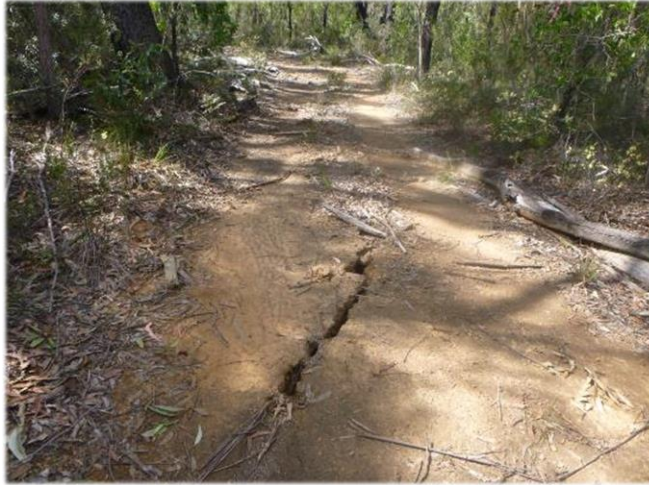
Photo 35: *DA3B_LW16_027*, soil cracking across Fire Road 6P. Taken on 21/08/2020.

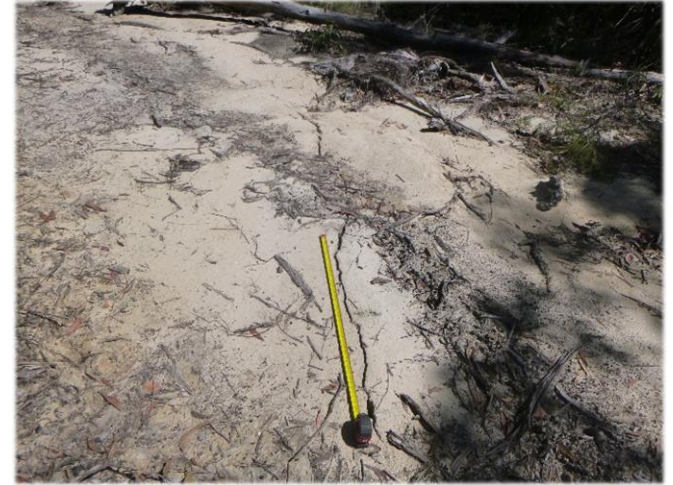
Photo 36: *DA3B_LW16_034*, looking at the length of soil cracking on access track parallel to *WC15*. Taken on 28/09/2020.

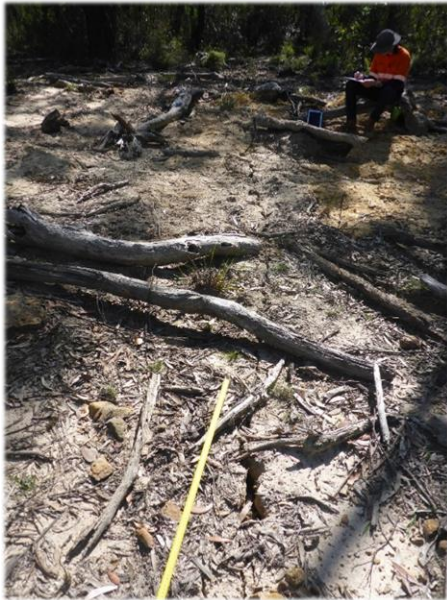
Photo 37: DA3B_LW16_005, soil cracking to access track between *Lake Avon* and *FR6A*. Taken on 22/04/2020.

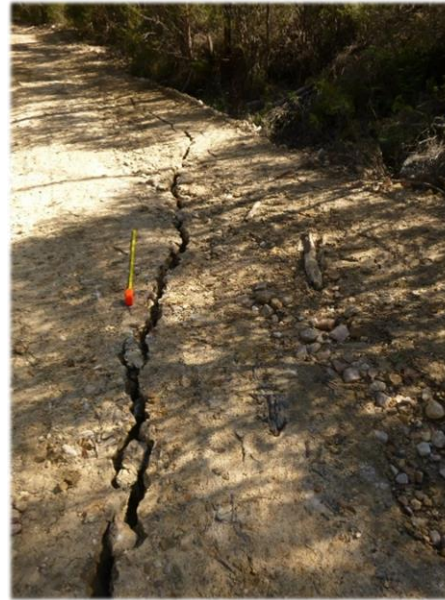
Photo 38: DA3B_LW16_013, soil cracking to access track between *Lake Avon* and *FR6A*. Taken on 12/05/2020.

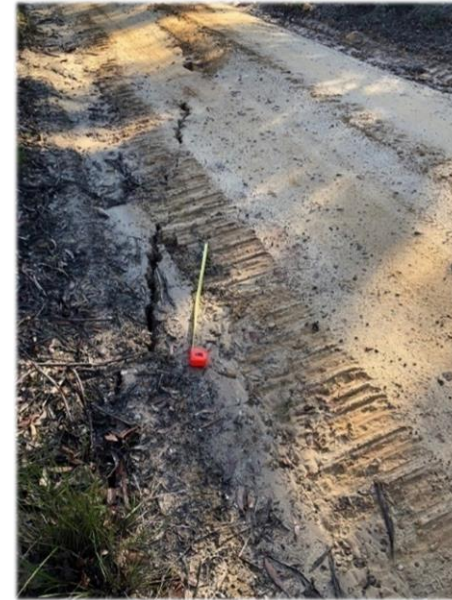
Photo 39: DA3B_LW16_019, looking at length of soil cracking on *FR6A*. Taken on 23/06/2020.
