**DENDROBIUM AREA 3B  
LONGWALL 17 END OF  
PANEL  
LANDSCAPE REPORT  
NOVEMBER 2021**

## **EXECUTIVE SUMMARY**

This report summarises the observed and measured subsidence effects on landscape features resulting from the extraction of Dendrobium Area 3B (DA3B) Longwall 17. Longwall 17 is the ninth panel extracted from DA3B. Extraction began on 12 December 2020 and was completed on 13 October 2021. The Illawarra Metallurgical Coal Environmental Field Team (IMCEFT) conducts detailed monitoring and inspections of landscape features including swamps, watercourses, rock outcrops and landscape features within the mining area of DA3B. This monitoring was conducted in accordance with:

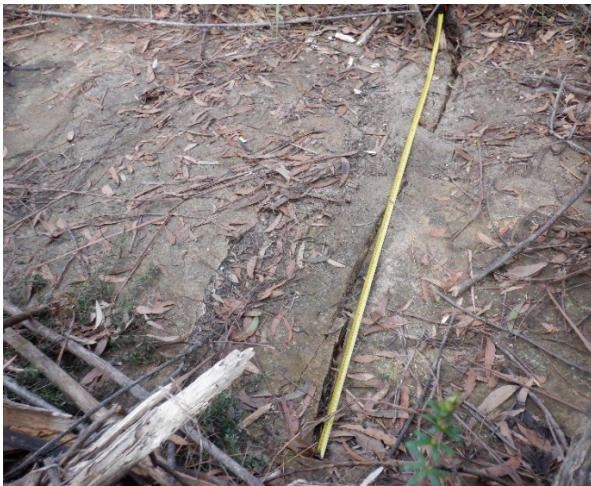
DA3B\_LW17\_001 is located on LA2, a tributary to Lake Avon. The impacted feature is LA2\_Channel 6B which is situated approximately 40m west of the commencing end of Longwall 17 (Figure 2). The impact is comprised of two rock fractures, uplift and associated rock fragmentation (Photo 5 to Photo 8). The rock fracturing has a maximum measurable length of 1.7m, a width of 0.01m and a maximum measurable depth of 0.47m. The uplift has a width of 0.045m. While not evident during the latest inspection, flow diversion would occur if surface flow was present. On the 10<sup>th</sup> of September, the impact had increased by 0.007m in length, width had increased from 0.01m to 0.04m with measurable depth staying the same.

DA3B\_LW17\_001 is a Level 2 trigger as per the Dendrobium Area 3B Watercourse TARP (Table 9), specifically:

- Crack or fracture that results in observable loss of surface water or erosion.

Photo 5: DA3B\_LW17\_001, looking at a section of rock fracturing. Taken on 10/09/2021.

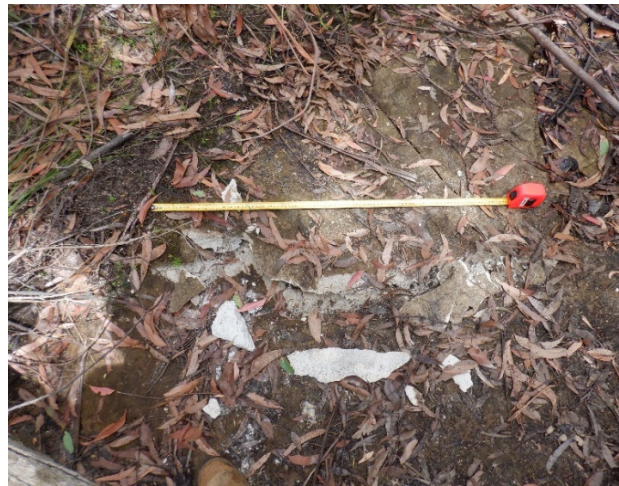
Photo 6: DA3B\_LW17\_001, looking at a section of rock fracturing, uplift and fragmentation. Taken on 5/02/2021.

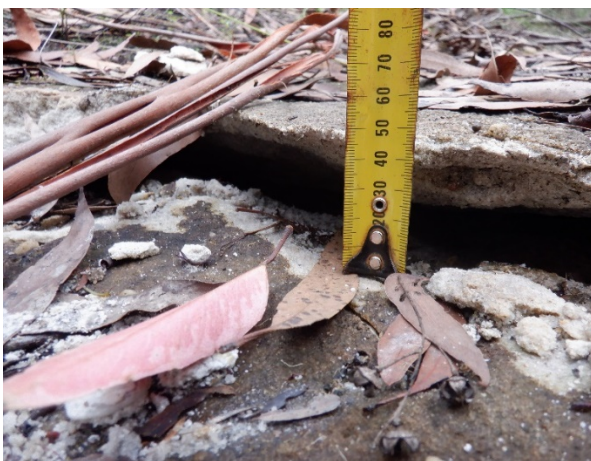
Photo 7: DA3B\_LW17\_001, looking at the width of uplift. Taken on 5/02/2021.

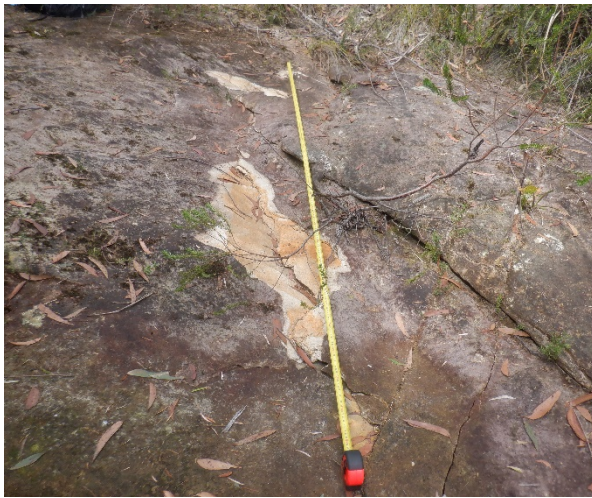
*DA3B\_LW17\_004* is located on LA2, a tributary to Lake Avon (Figure 2). The impacted feature, LA2\_Rockbar 10, was mined beneath by Longwall 17 on 5 January 2021. The impact is comprised of multiple rock fractures and uplift within an area of 4m by 1m (Photo 9 and Photo 10). The largest rock fracture has a maximum length of 0.326m, a maximum width of 0.06m and a maximum measurable depth of 0.074m. No flow was present during the inspection; however some flow diversion could be expected during surface flow; as the fracture runs across the main flow path of the tributary. On the 10<sup>th</sup> of September the impact length had increased to 1.2m, no other changes had been identified. *DA3B\_LW17\_004* is a Level 2 trigger as per the DA3B Watercourse TARP (Table 9), specifically:

- Crack or fracture that (could) result in observable loss of surface water or erosion.

Photo 9: DA3B\_LW17\_004, looking at a section of rock fracturing. Taken on 10/09/2021.

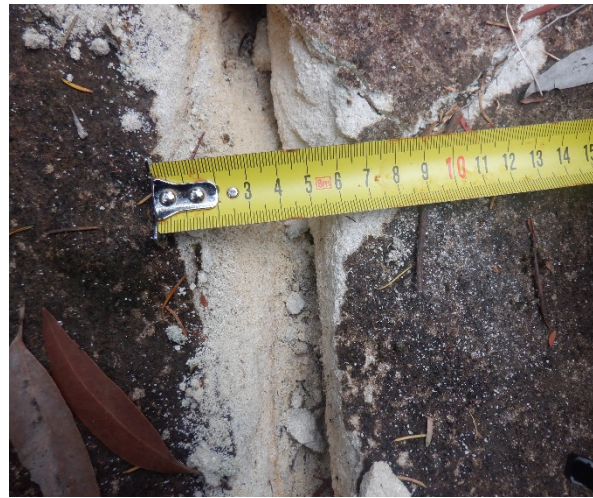
Photo 10: DA3B\_LW17\_004, looking at the maximum width of the rock fracturing. Taken on 10/03/2021.

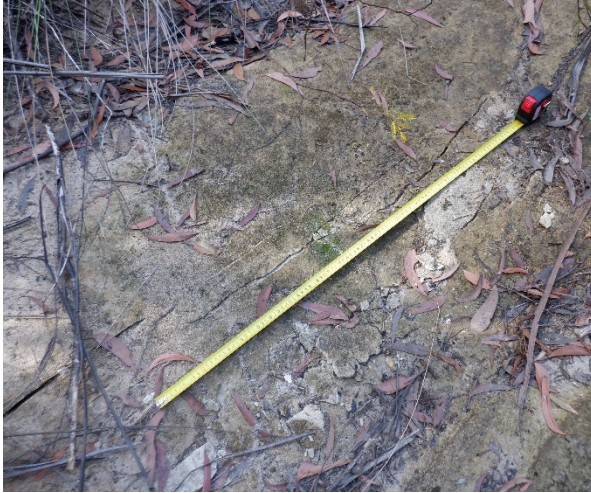
*DA3B\_LW17\_005* is located on LA2, a tributary to Lake Avon (Figure 2). The impacted feature, LA2\_Pool 12, was mined beneath by Longwall 17 on 9 January 2021. The impact is comprised of multiple fractures within an area of 2.5m by 3m (Photo 11 and Photo 12). The largest rock fracture has a maximum length of 0.888m, a maximum width of 0.005m and a maximum measurable depth of 0.037m. No flow was present during the inspection however some flow diversion could be expected during surface flow; as the fracture runs across the main flow path of the tributary. The impact was inspected on 10<sup>th</sup> of September 2021 and remains unchanged from original identification.

- Crack or fracture that (could) result in observable loss of surface water or erosion.

Photo 11: DA3B\_LW17\_005, looking at a section of rock fracturing. Taken on 10/03/2021.

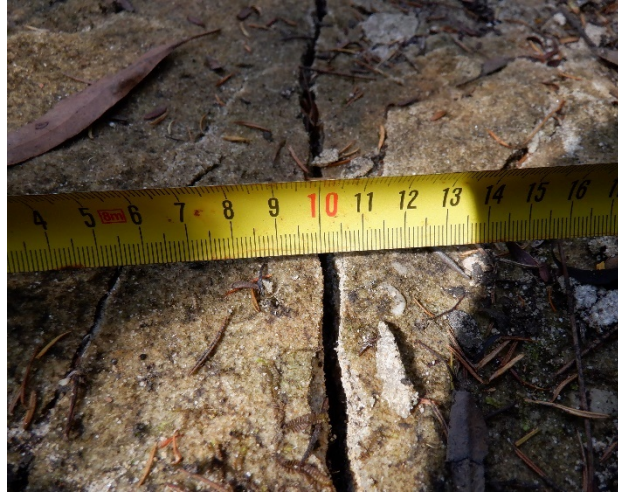
Photo 12: DA3B\_LW17\_005, looking at the maximum width of the rock fracturing. Taken on 10/03/2021.

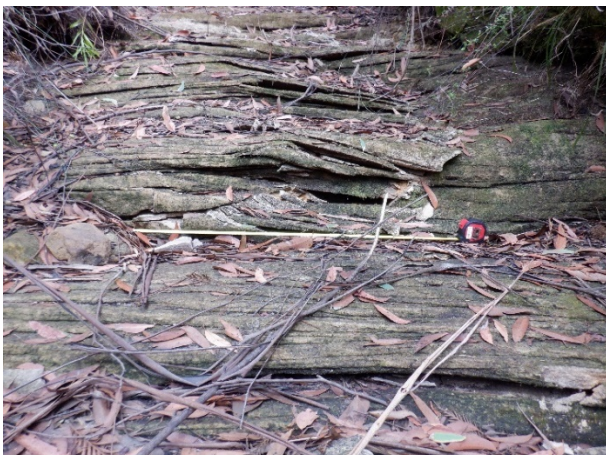
DA3B\_LW17\_006 is located on LA2, a tributary to Lake Avon (Figure 2). The impacted feature, LA2\_Pool 14, was mined beneath by Longwall 17 on 17 January 2021. The impact is comprised of rock fracturing, soil cracking and uplift within an area of 4m by 2m (Photo 13 to Photo 15). The rock fracturing has a maximum length of 1m, a maximum width of 0.045m and a maximum measurable horizontal depth of 0.43m. The soil cracking has a maximum length of 0.59m, a maximum width of 0.002m and a maximum measurable depth of 0.124m. No flow was present during the inspection however some flow diversion could be expected during surface flow; as the fracture runs across the main flow path of the tributary. The impact was inspected on 10<sup>th</sup> of September 2021, the width of the impact had increased to 0.06 with no soil cracking visible.

- Crack or fracture that (could) result in observable loss of surface water or erosion.

Photo 13: DA3B\_LW17\_006, looking at a section of rock fracturing and uplift. Taken on 10/03/2021.

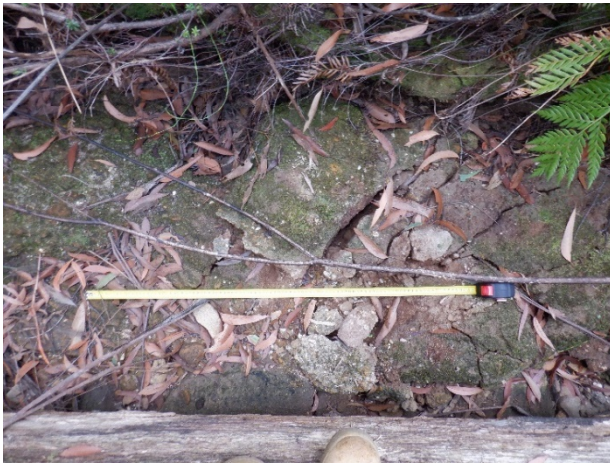
Photo 15: DA3B\_LW17\_006, looking at a section of soil cracking. Taken on 10/03/2021.

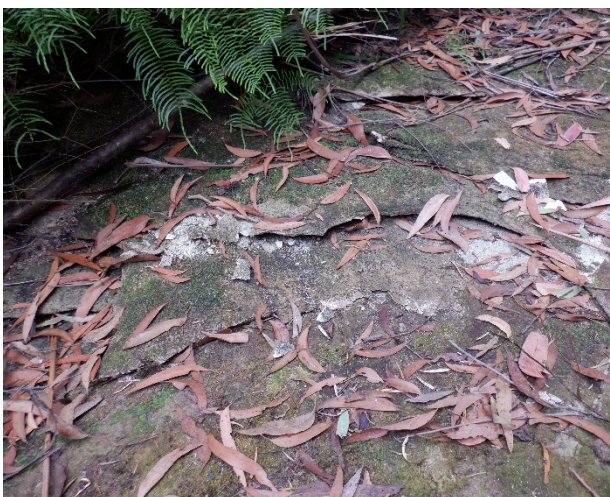
*DA3B\_LW17\_007* is located on LA2, a tributary to Lake Avon (Figure 2). The impacted feature, *LA2\_Rockbar 14*, was mined beneath by Longwall 17 on 20 January 2021. The impact is comprised of 10 rock fractures and uplift within an area of 4m by 1.5m (Photo 16 and Photo 17). The largest rock fracture has a maximum length of 0.94m, a maximum width of 0.035m and a maximum measurable depth of 0.15m. No flow was present during the inspection however some flow diversion could be expected during surface flow; as the fracture runs across the main flow path of the tributary. The impact was inspected on 10<sup>th</sup> of September 2021 and remains unchanged from original identification. *DA3B\_LW17\_007* is a Level 2 trigger as per the Dendrobium Area 3B Watercourse TARP (Table 9), specifically:

- Crack or fracture that (could) result in observable loss of surface water or erosion.

Photo 16: DA3B\_LW17\_007, looking at a section of rock fracturing. Taken on 10/03/2021.

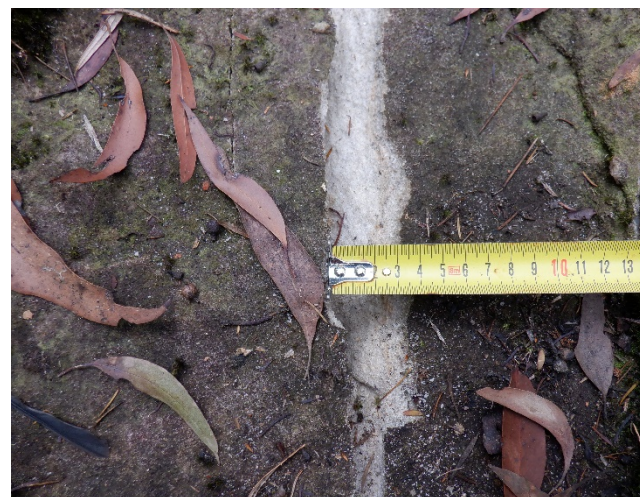
Photo 17: DA3B\_LW17\_007, looking at the width of the rock fracturing. Taken on 10/03/2021.

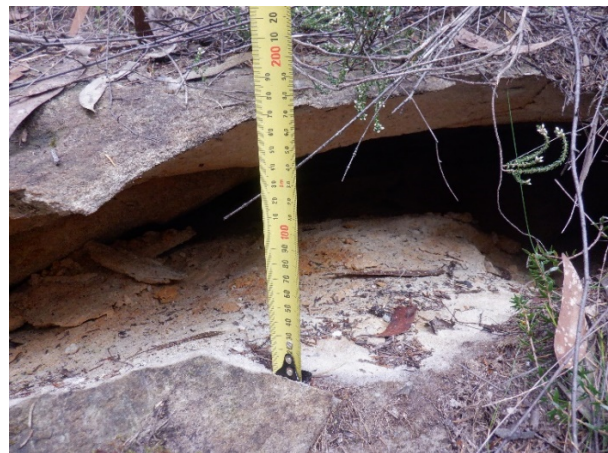
DA3B\_LW17\_002 is located on LA2, a tributary to Lake Avon and was originally reported on 16 February 2021. The site was mined beneath by Longwall 17 on 21 February 2021. During the latest inspection, further fracturing, uplift and changes to existing fracturing were observed (Photo 18 and Photo 19). The impact site was originally localised to LA2\_Rockbar 25 but now extends into the downstream feature LA2\_Pool 25. However it is now connected to impact DA3B\_LW17\_003 through fracturing. The rock fracturing now has a maximum length of 4.2m, width of 0.136m and a maximum measurable depth of 1.640m. The impact was inspected on 10<sup>th</sup> of September 2021, an increase in length from 4.2m to 4.8m was observed as well as width increasing to 0.170m.

- Crack or fracture that (could) result in observable loss of surface water or erosion.
- Crack or fracture between 100 and 300m width at its widest point.

Photo 19: DA3B\_LW17\_002, looking at the width of rock fracturing. Taken on 10/09/2021.

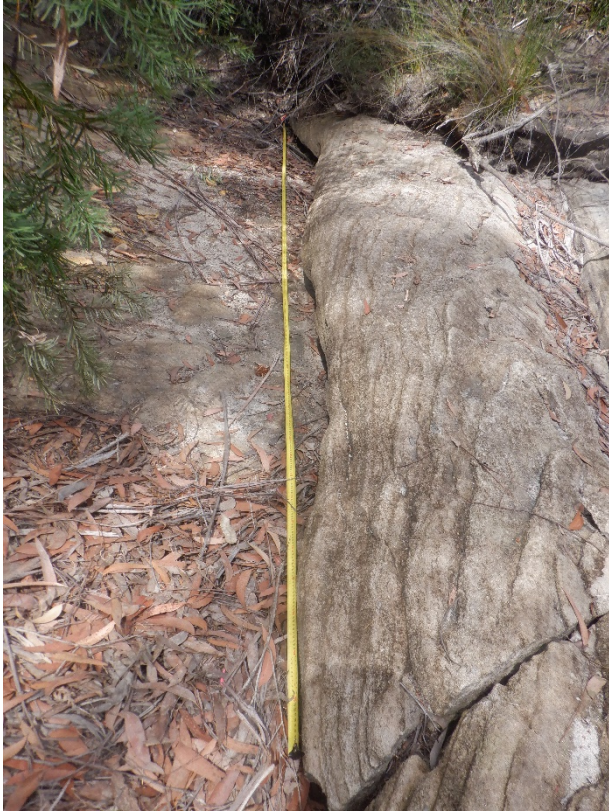
Impact *DA3B\_LW17\_012* includes fracturing which has resulted in a displaced section of rockbar on tributary LA2 (Figure 2). The displaced rock slab is 5.7m long, 1.2m wide and 0.35m thick and has dropped approximately 0.05m (Photo 22 to Photo 24). The longest observable fracture is approximately 7m long and 0.02m wide. Smaller additional fractures and uplift are also evident at the site (Photo 25). The fracturing extends across the flow path with flow diversion possible during surface flow at the site. The impact was inspected on 10<sup>th</sup> of September 2021 and remains unchanged from original identification.

- Crack or fracture that (could) result in observable loss of surface water or erosion.

Photo 22: DA3B\_LW17\_012, looking across rockbar. Taken on 10/09/2021.

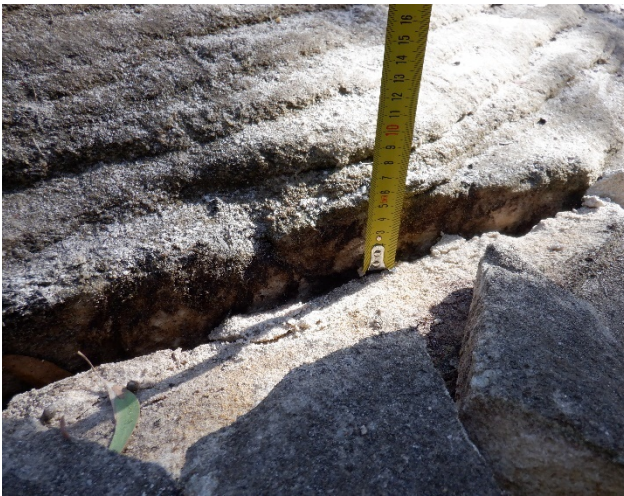
Photo 24: DA3B\_LW17\_012, looking at level of displacement fracture to step. Taken on 13/04/2021.

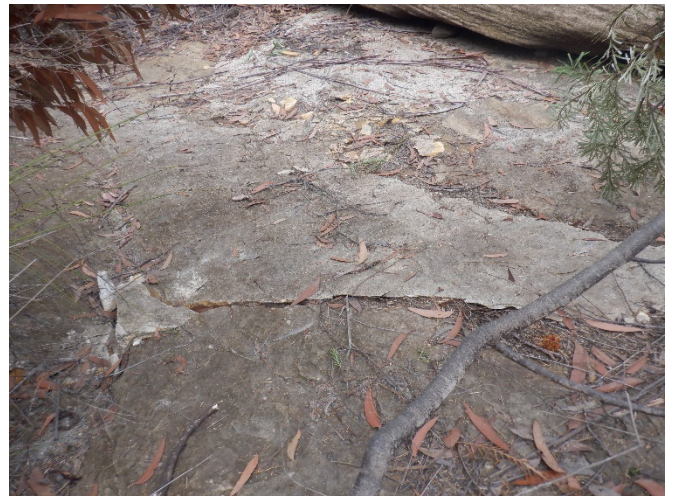
Photo 25: DA3B\_LW17\_012, additional smaller fracture and uplift. Taken on 10/09/2021.

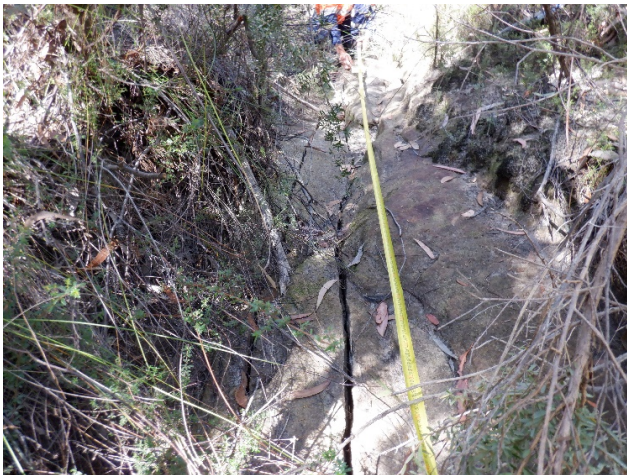
Impact DA3B\_LW17\_013 includes two rock fractures running along a sandstone channel on tributary LA2 (Figure 2). The fracturing is up to 8.3m long, 0.035m wide and has a measurable depth of up to 0.61m (Photo 26 to Photo 28). The fractures run along the flow path and if surface flow was present, would likely result in diversion of surface flow. The impact was inspected on 10<sup>th</sup> of September 2021 and remains unchanged from original identification.

- Crack or fracture that (could) result in observable loss of surface water or erosion.

Photo 26: DA3B\_LW17\_013, fractures running along channel. Taken on 13/04/2021.

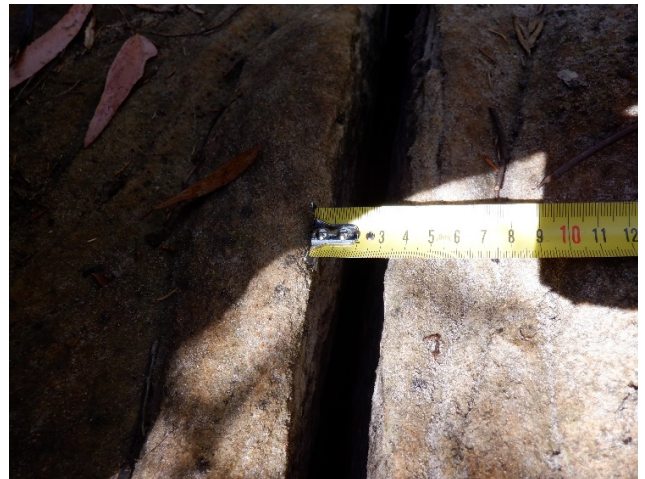
Photo 27: DA3B\_LW17\_013, looking at width of fracture. Taken on 13/04/2021.

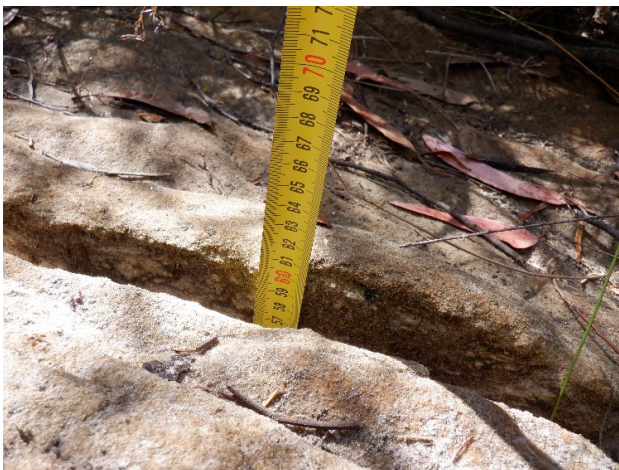
Photo 28: DA3B\_LW17\_013, looking at fracture depth. Taken on 13/04/2021.

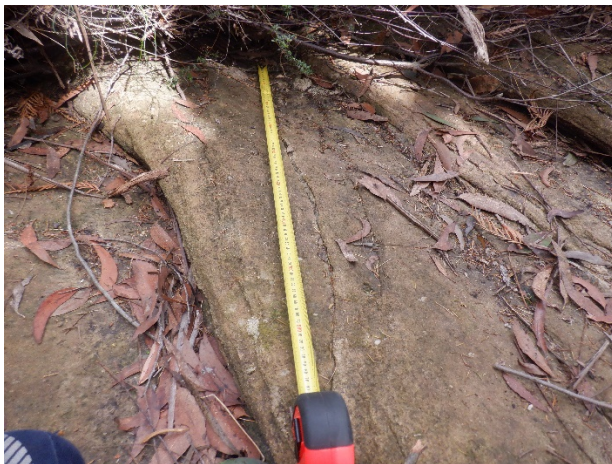
DA3B\_LW17\_034 is located on LA2, a tributary to Lake Avon (Figure 2). The impacted feature, LA2\_Pool 13, was mined beneath by Longwall 17 on 13 January 2021. The impact is comprised of a rock fracture running across the width of the pool (Photo 29 and Photo 30). The largest rock fracture has a maximum length of 0.9m, a maximum width of 0.004m and a maximum measurable depth of 0.07m. While not evident during the latest inspection, flow diversion may occur if surface flow was present.

- Crack or fracture that results in observable loss of surface water or erosion.

Photo 29: DA3B\_LW17\_034, showing the length of rock fracturing. Taken 10/9/2021.

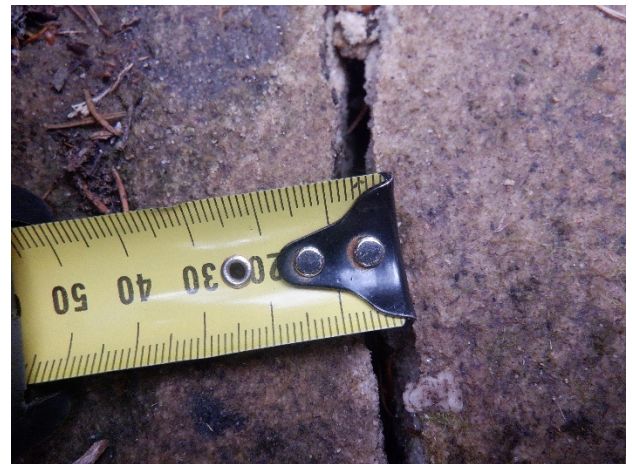
Photo 30: DA3B\_LW17\_034, showing the width of rock fracturing. Taken 10/9/2021.

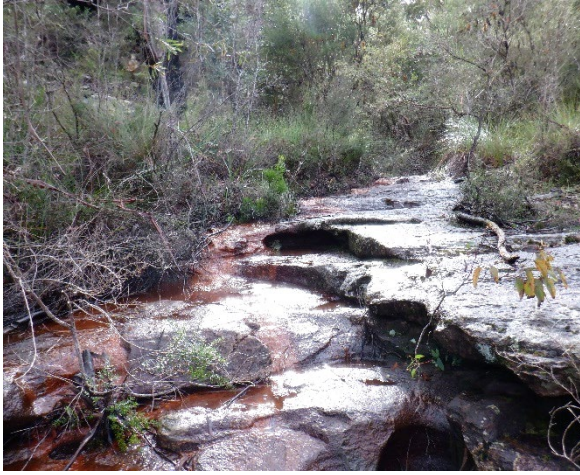
- Observable increase in iron staining within the mining area.

The iron staining has been assigned an impact ID of DA3B\_LW17\_025. Further discussion around water quality at LA5 will be included in a specialist report.

Photo 31: LA5\_S1, looking upstream. Taken on 1/07/2021.

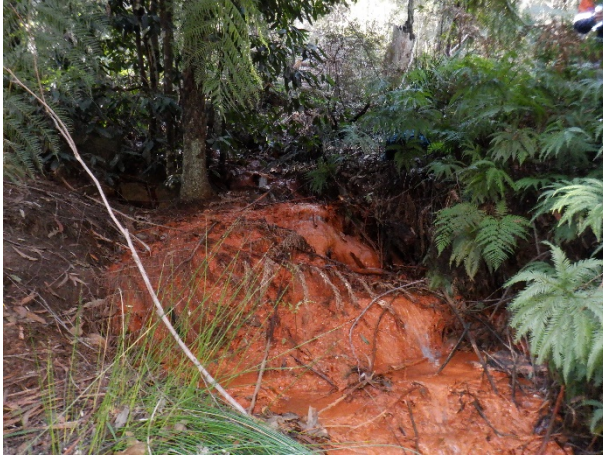
- Observable increase in iron staining within the mining area continues more than 600m from the longwall.

Photo 35: Hillslope spring with iron staining, looking upslope from Wongawilli Creek. Taken: 28/07/2021.

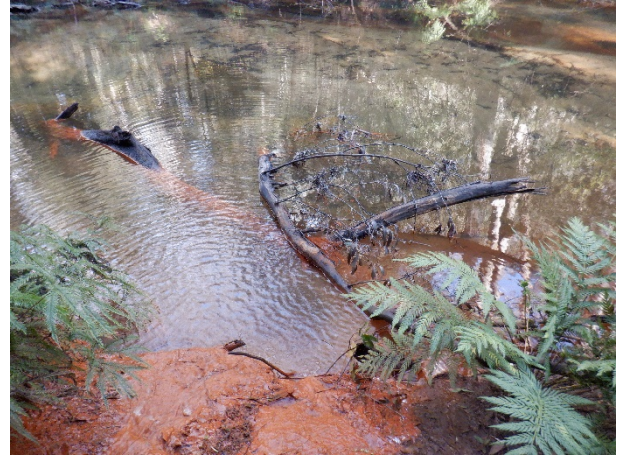
Photo 36: Outflow from spring, looking downstream to Wongawilli Creek. Taken: 28/07/2021.

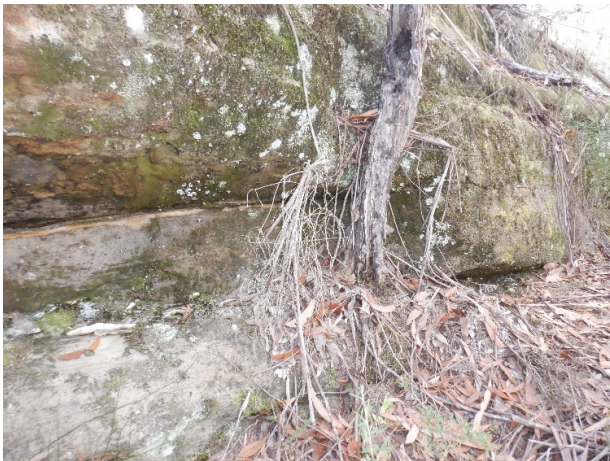
- Crack or fracture up to 10m in length
- Crack or fracture up to 100mm wide

Photo 61: DA3B\_LW17\_010, fracturing along step. Taken on 13/04/2021.

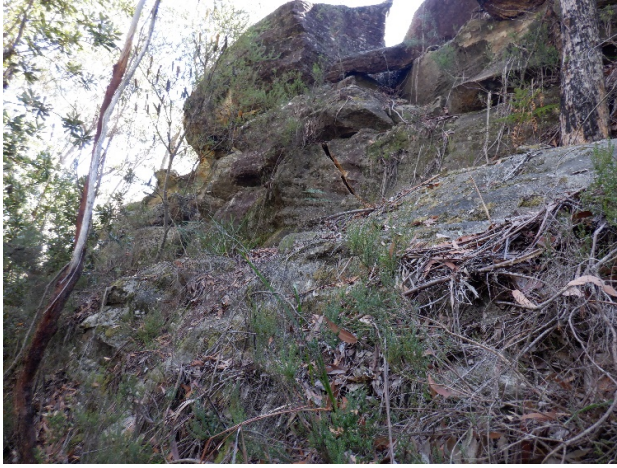
- Crack or fracture between 100mm and 300mm in width.

Photo 63: DA3B\_LW17\_011, fracture to step.  
Taken on 13/04/2021.

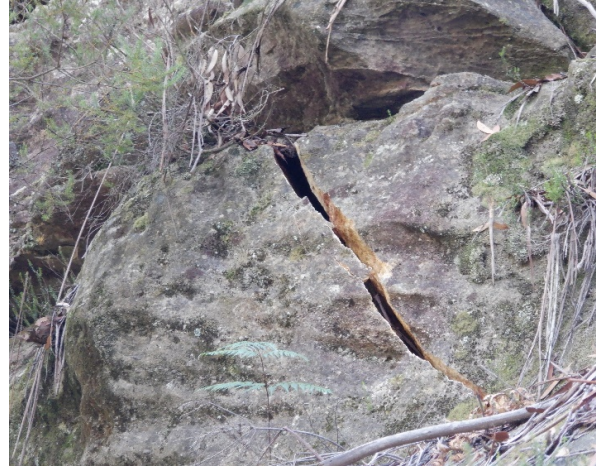
Photo 64: DA3B\_LW17\_011, zoomed in photo  
of fracture to step. Taken on 13/04/2021.

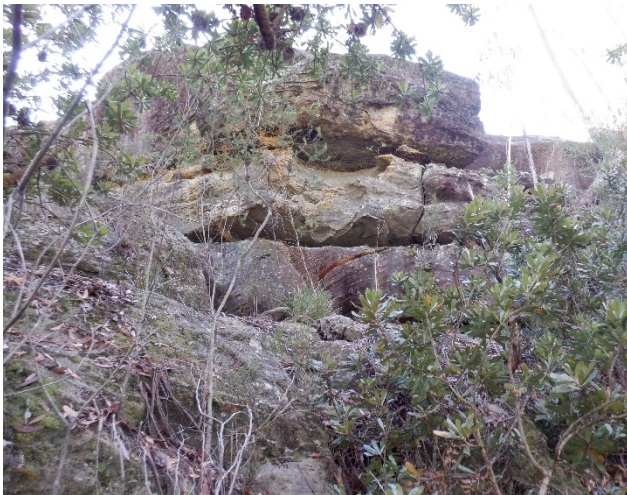
Photo 65: DA3B\_LW17\_011, fracture to step.  
Taken on 13/04/2021.

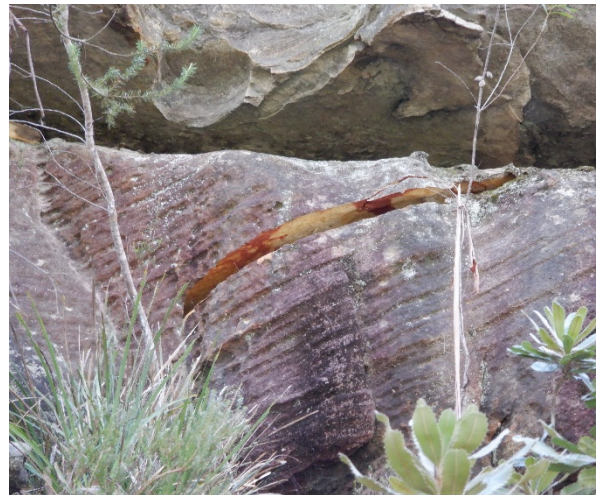
Photo 66: DA3B\_LW17\_011, zoomed in photo  
of fracture to step. Taken on 13/04/2021.

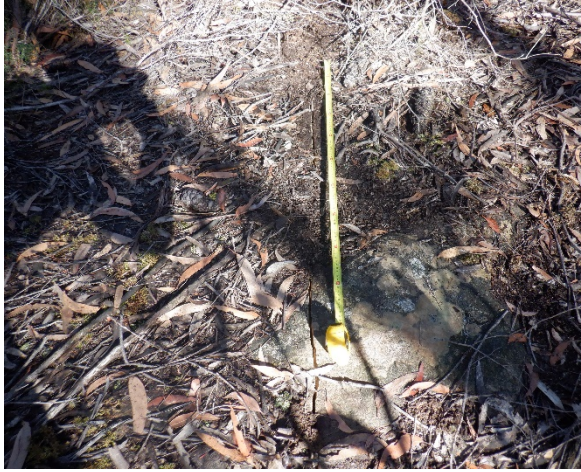
- Crack or fracture up to 10m in length
- Crack or fracture up to 100mm width

Photo 67: DA3B\_LW17\_016 – section of rock fracturing. Taken on 25/05/2021.

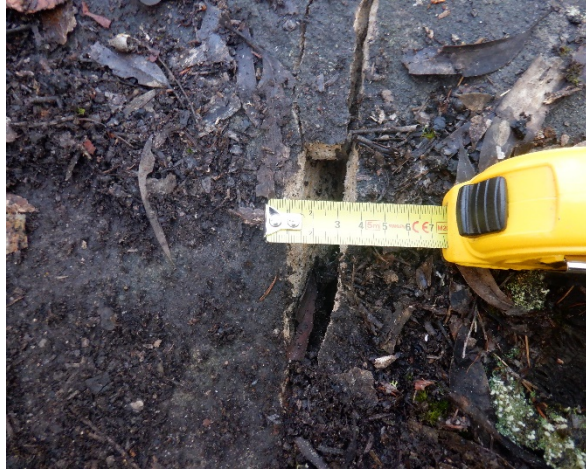
Photo 68: DA3B\_LW17\_016 – width of rock fracturing. Taken on 25/05/2021.

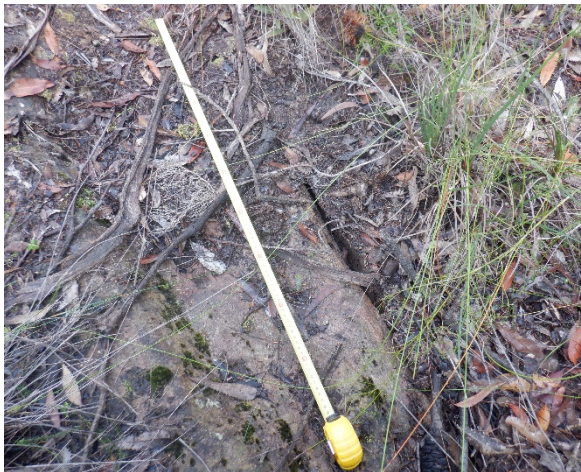
- Crack or fracture up to 10m in length
- Crack or fracture up to 100mm width

Photo 69: DA3B\_LW17\_017 – section of rock displacement. Taken on 25/05/2021.

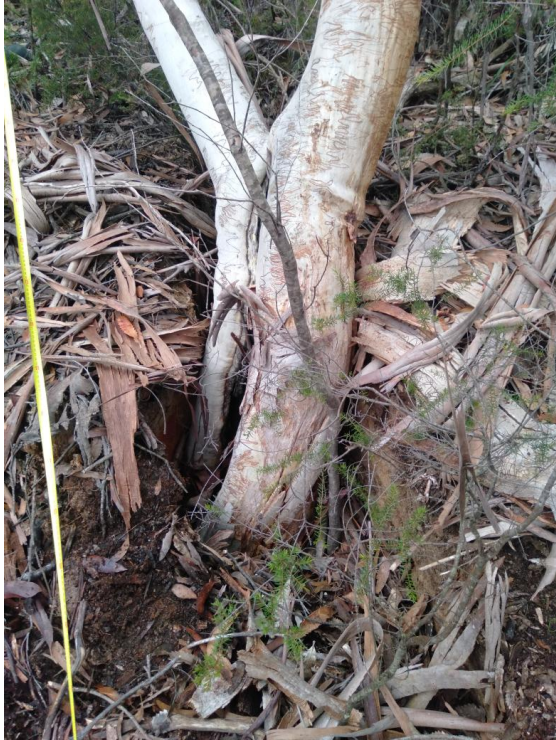
- Crack or fracture over 300mm width

Photo 71: DA3B\_LW17\_019, looking at a section of soil cracking. Taken on 8/06/2021.

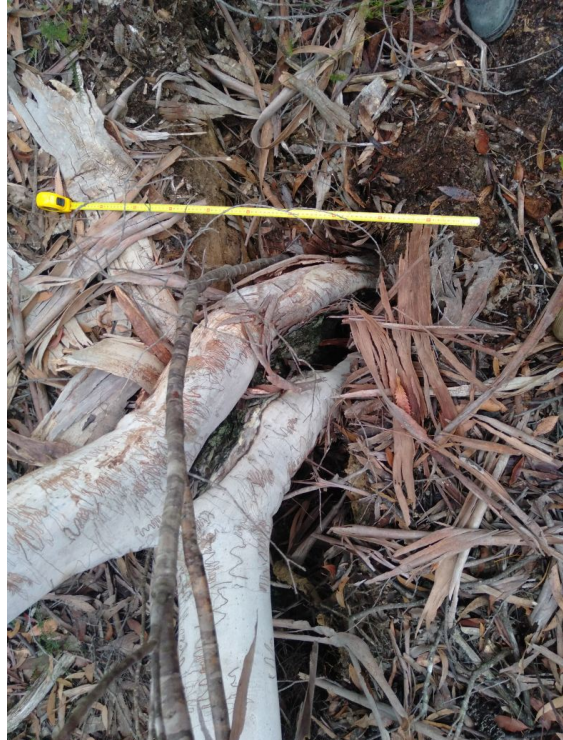
Photo 72: DA3B\_LW17\_019, looking at the maximum width of the soil cracking. Taken on 8/06/2021.

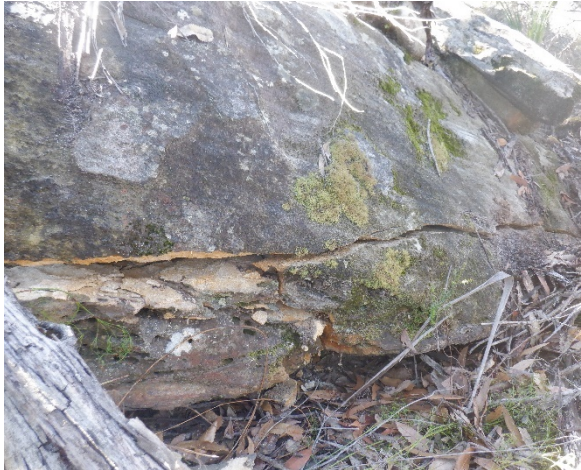
- Crack or fracture up to 10m in length
- Crack or fracture up to 100mm width

Photo 74: DA3B\_LW17\_021, looking at a section of rock fracturing. Taken on 8/06/2021

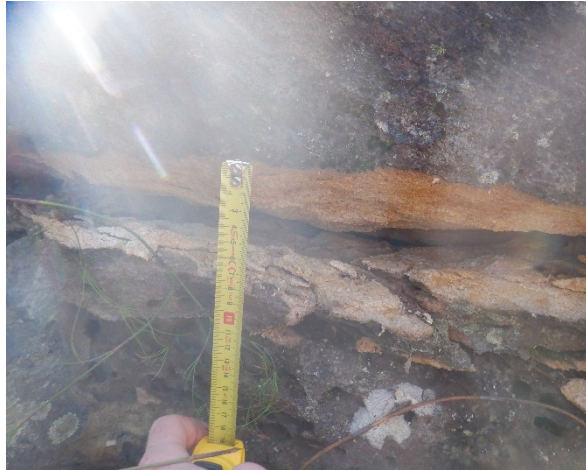
Photo 75: DA3B\_LW17\_021, showing width of rock fracturing. Taken on 8/06/2021.

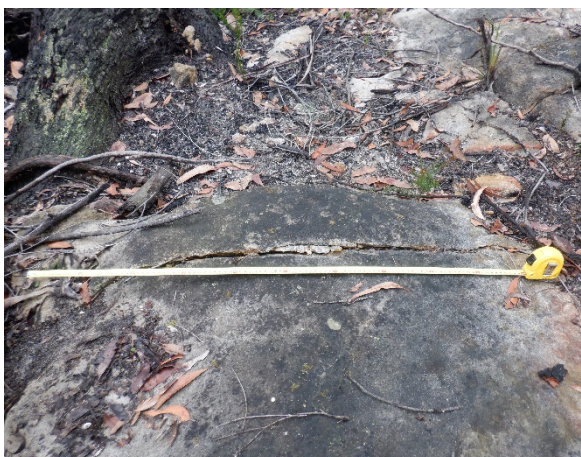
- Crack or fracture up to 10m in length

Photo 76: DA3B\_LW17\_022, looking at length of fracture. Taken on 22/06/2021.

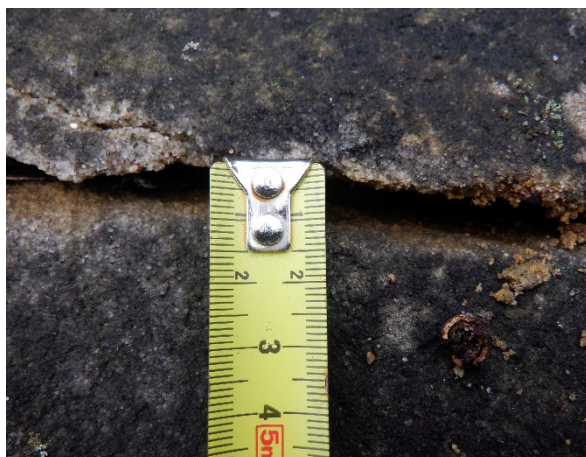
Photo 77: DA3B\_LW17\_022, looking at width of fracture. Taken on 22/06/2021.

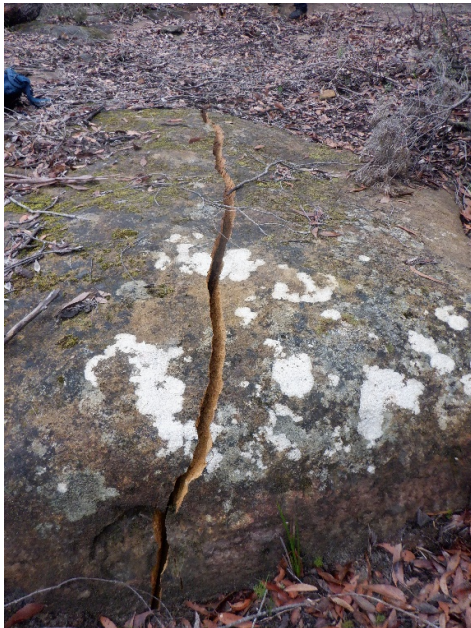
- Crack or fracture between 10 and 30m in length

Photo 78: DA3B\_LW17\_023- looking at length of fracture. Taken on 22/06/2021

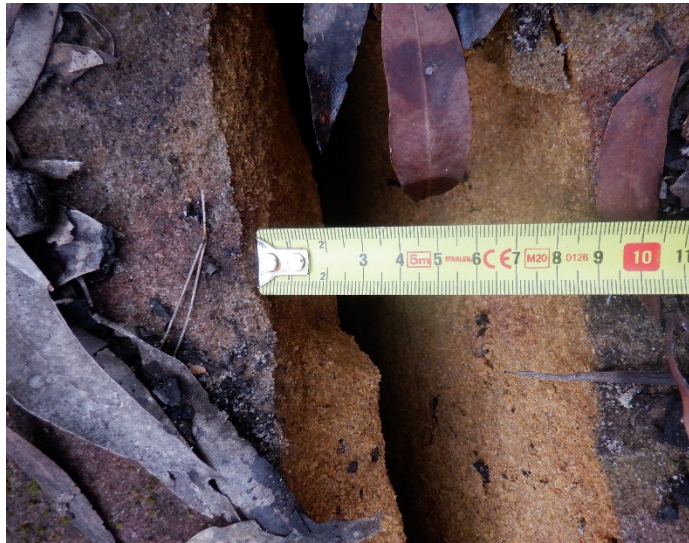
Photo 79: DA3B\_LW17\_023- showing width of fracture. Taken on 22/06/2021.

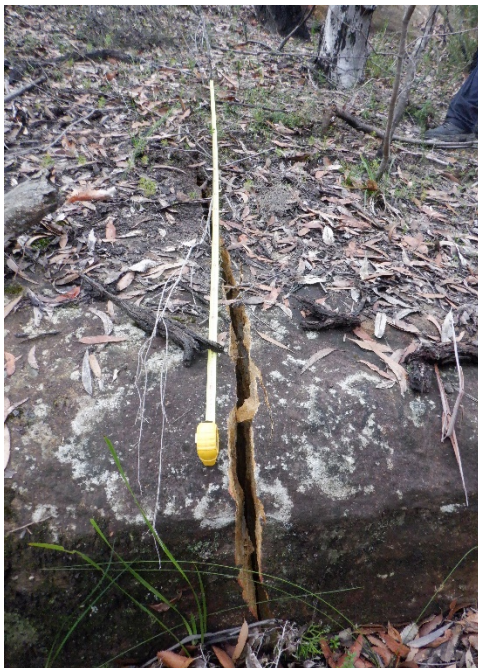
Photo 80: DA3B\_LW17\_023- looking fracture. Taken on 22/06/2021

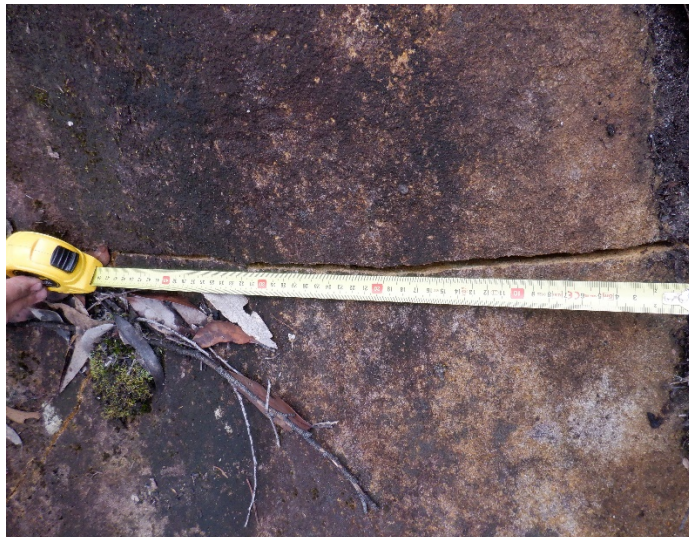
Photo 81: DA3B\_LW17\_023- looking at smaller fracture. Taken on 22/06/2021

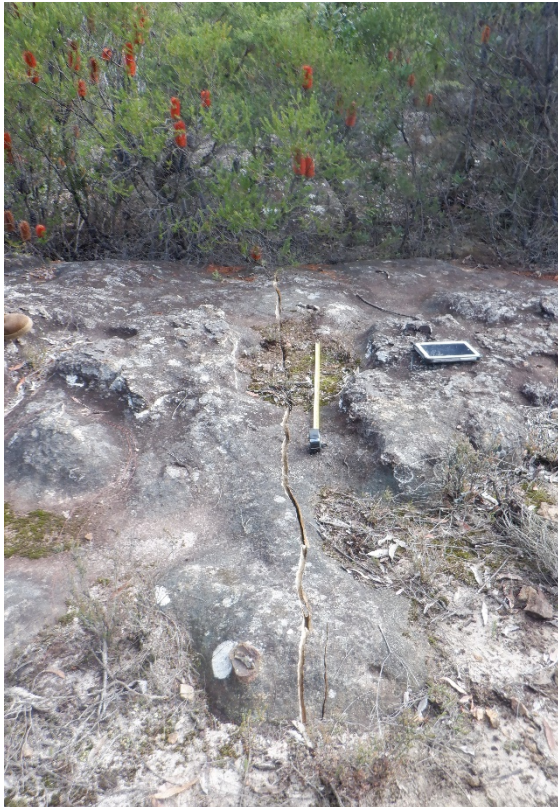
- Crack or fracture up to 10m in length

Photo 82: *DA3B\_LW17\_024*, looking at a section of rock fracturing. Taken on 24/06/2021

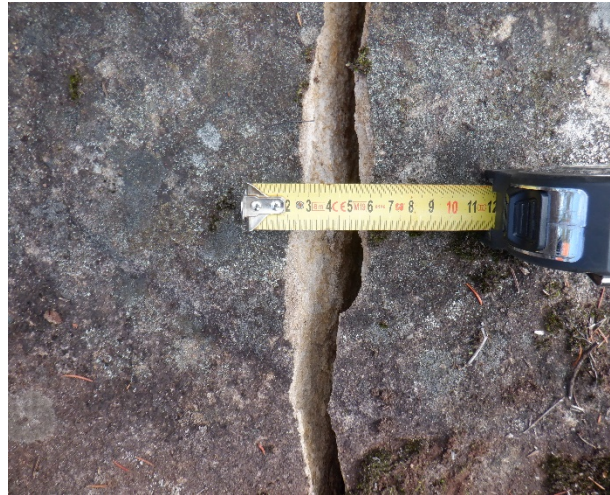
Photo 83: *DA3B\_LW17\_024*, showing width of rock fracturing. Taken on 24/06/2021.

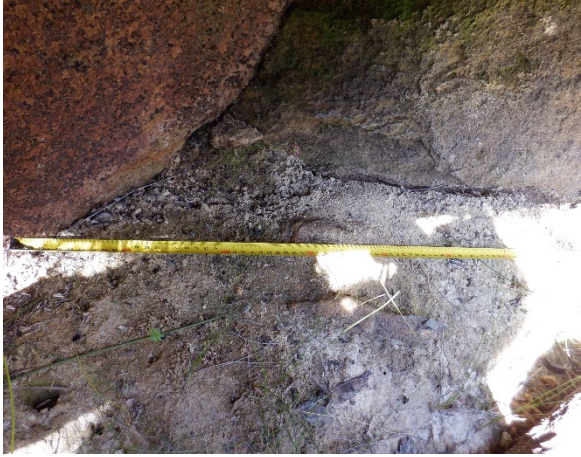
- Crack or fracture up to 10m in length;
- Crack or fracture up to 100mm width.

Photo 84: DA3B\_LW17\_032, showing the length of displacement. Taken on 17/08/2021.

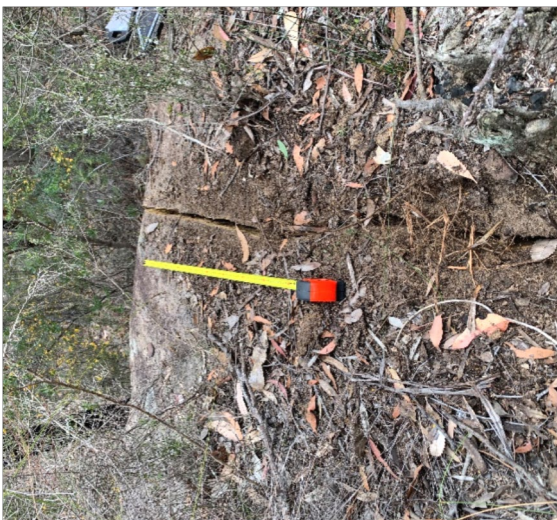
- Crack or fracture up to 10m in length;
- Crack or fracture up to 100mm width.

Photo 89: DA3B\_LW17\_036, looking at a section of rock fracturing, showing length. Taken 15/9/2021.

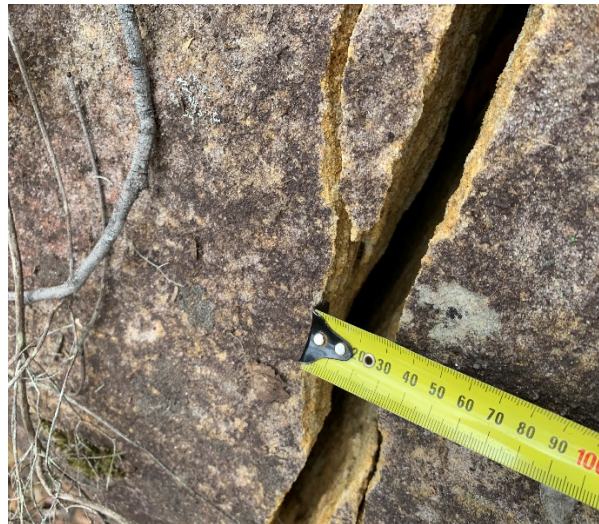
Photo 90: DA3B\_LW17\_036, looking at the width of the rock fracture. Taken 15/9/2021.

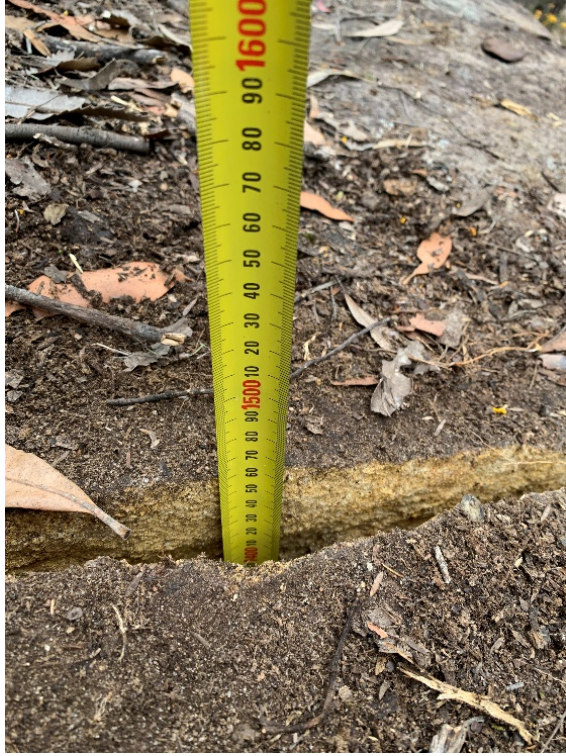
Photo 91: DA3B\_LW17\_036, Looking at a section of rock fracturing. Taken 15/9/2021

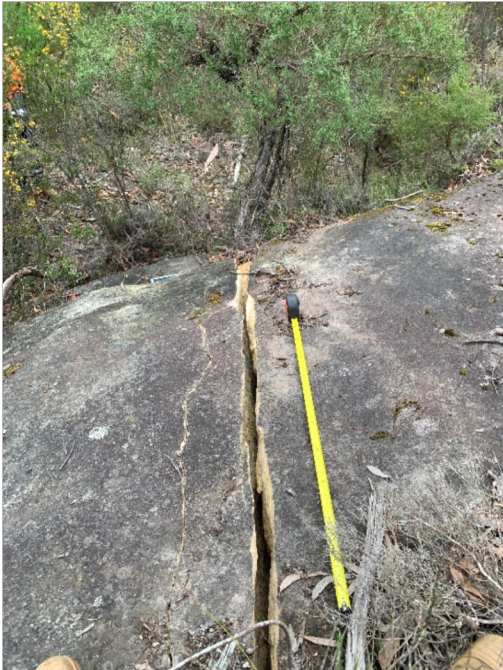
- Crack or fracture between 100 to 300mm width.

Photo 92: DA3B\_LW17\_037, looking at the length of rock fracturing. Taken 15/9/2021.

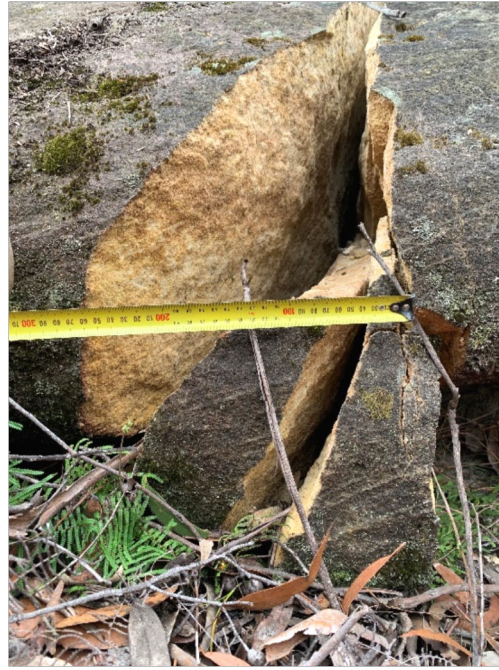
Photo 93: DA3B\_LW17\_037, looking at a section of rock fracturing, showing width. Taken 15/9/2021.

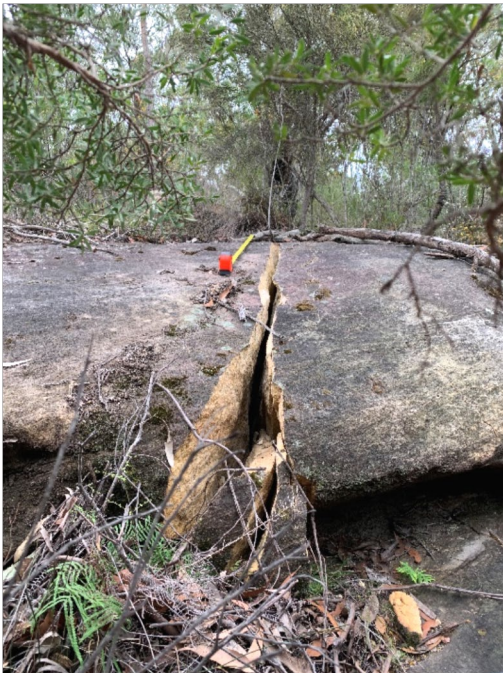
Photo 94: DA3B\_LW17\_037, looking at a section of rock fracturing. Taken 15/9/2021.

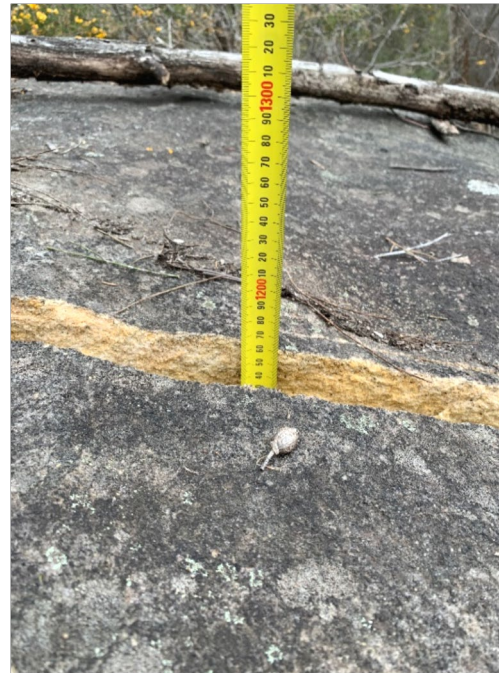
Photo 95: DA3B\_LW17\_037, looking at the depth of rock fracturing. Taken 15/9/2021.

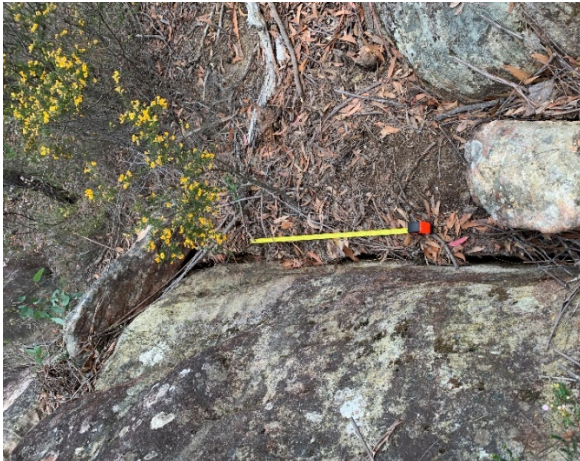
- Crack or fracture up to 10m in length;
- Crack or fracture up to 100mm width.

Photo 96: DA3B\_LW17\_038, looking at a section of rock displacement/ soil cracking. Taken 15/9/2021.

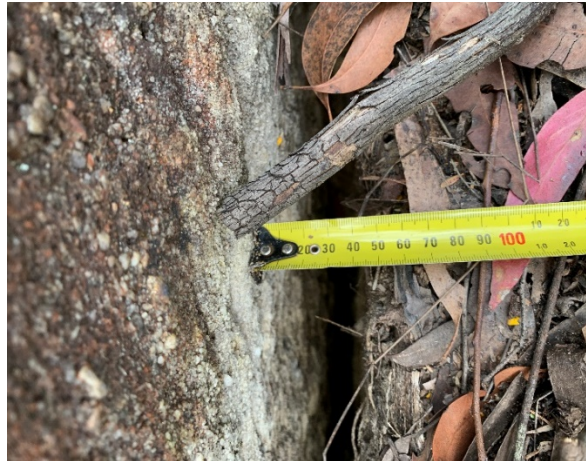
Photo 97: DA3B\_LW17\_038, looking at a section of rock displacement, showing the width. Taken 15/9/2021.

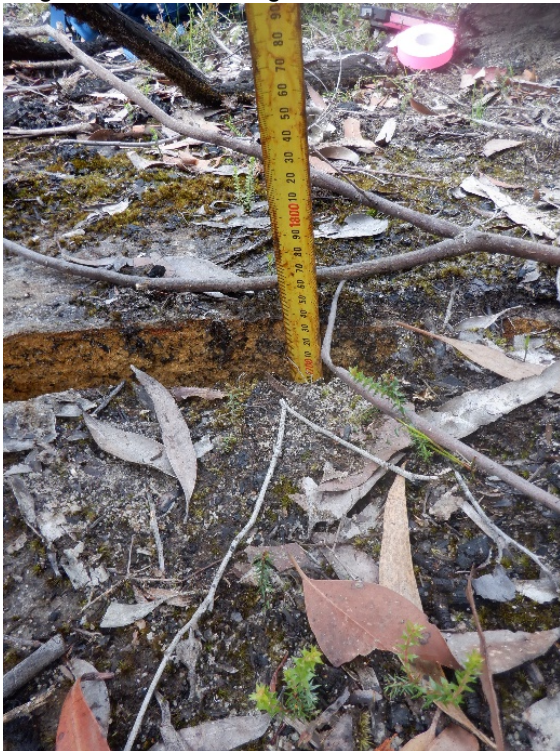
Photo 104: DA3B\_LW17\_040, showing the depth of the rock fracturing. Taken 21/10/2021.

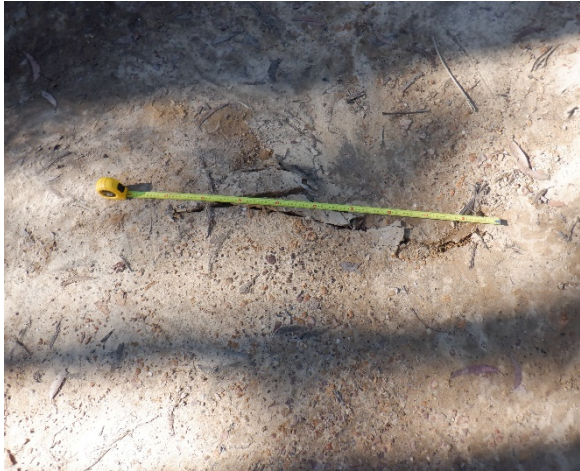
Erosion in a localised area, which would be expected to naturally stabilise without CMA and within the period of monitoring.

Photo 107: DA3B\_LW17\_015- soil crack on access track. Taken on 18/05/2021.

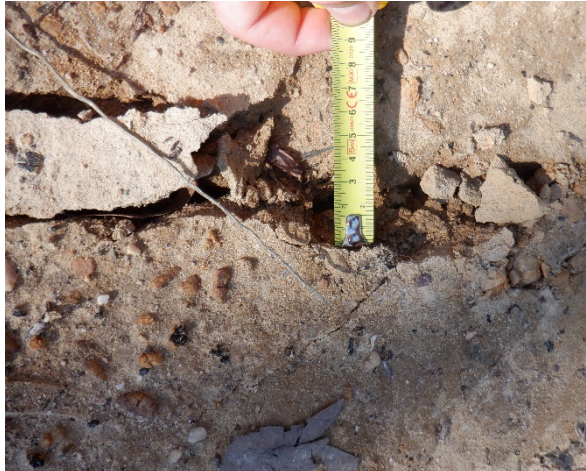
Photo 108: DA3B\_LW17\_015- showing width of soil crack on access track. Taken on 18/05/2021.

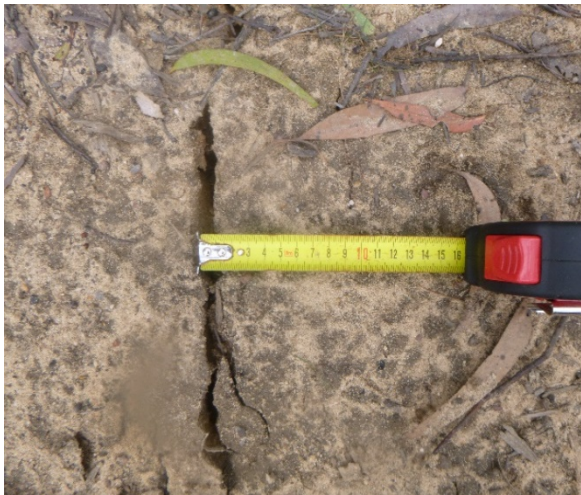
Photo 115: DA3B\_LW17\_028- soil cracking on access track. Taken on 26/07/2021.

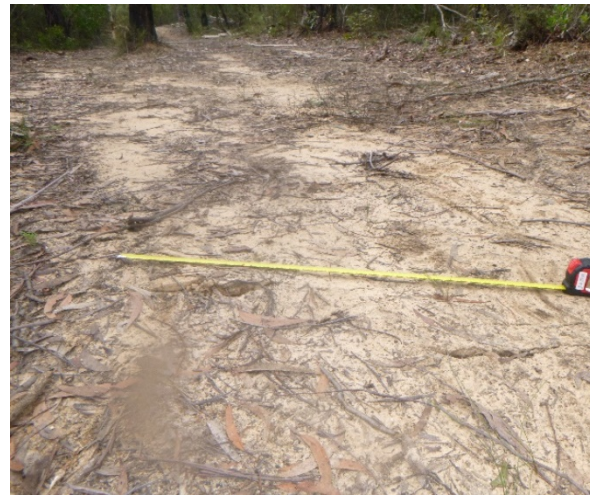
Photo 116: DA3B\_LW17\_028- soil cracking on access track. Taken on 26/07/2021.

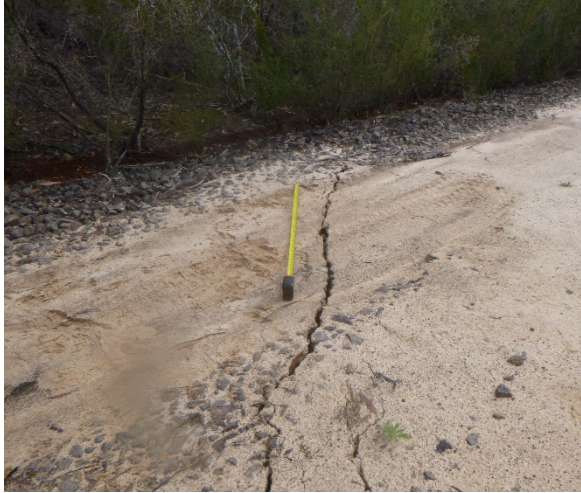
Photo 117: DA3B\_LW17\_029- soil cracking across rail corridor ballast. Taken on 26/07/2021.

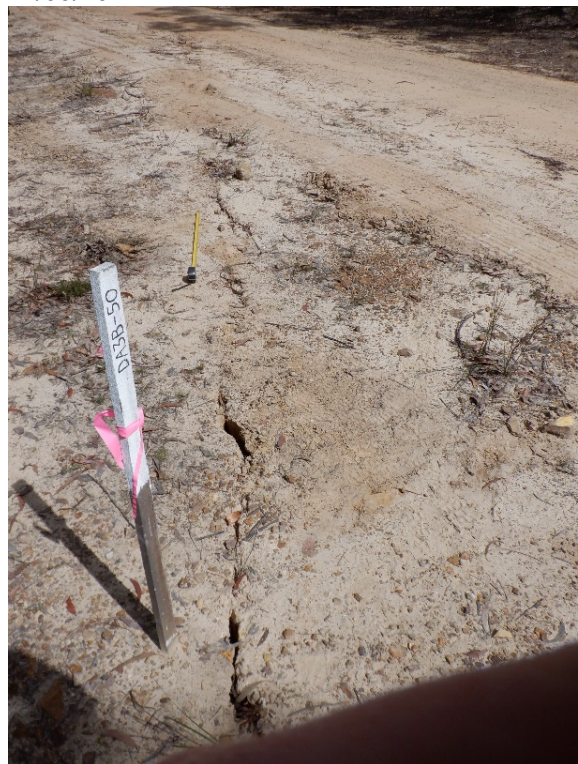
Photo 120: DA3B\_LW17\_030- soil cracking on Fire Road 6A has been remediated, soil cracking to the side of the fire road remains. Taken on 21/09/2021.
