**DENDROBIUM AREA 3B  
LONGWALL 17 END OF  
PANEL  
LANDSCAPE REPORT  
NOVEMBER 2021**

## **EXECUTIVE SUMMARY**

This report summarises the observed and measured subsidence effects on landscape features resulting from the extraction of Dendrobium Area 3B (DA3B) Longwall 17. Longwall 17 is the ninth panel extracted from DA3B. Extraction began on 12 December 2020 and was completed on 13 October 2021. The Illawarra Metallurgical Coal Environmental Field Team (IMCEFT) conducts detailed monitoring and inspections of landscape features including swamps, watercourses, rock outcrops and landscape features within the mining area of DA3B. This monitoring was conducted in accordance with:

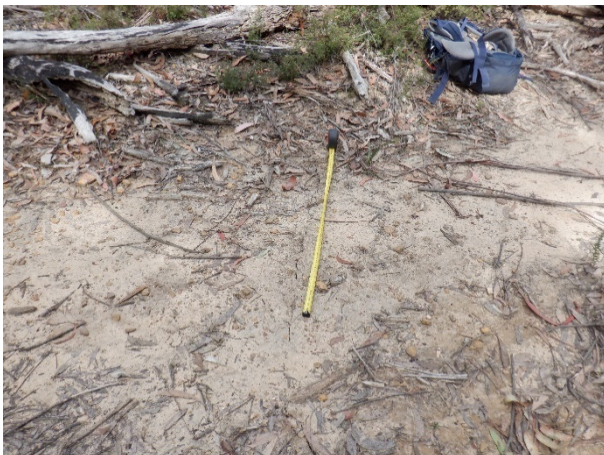
Photo 121: DA3B\_LW17\_033, overview of the soil cracking. Taken on 23/08/2021.

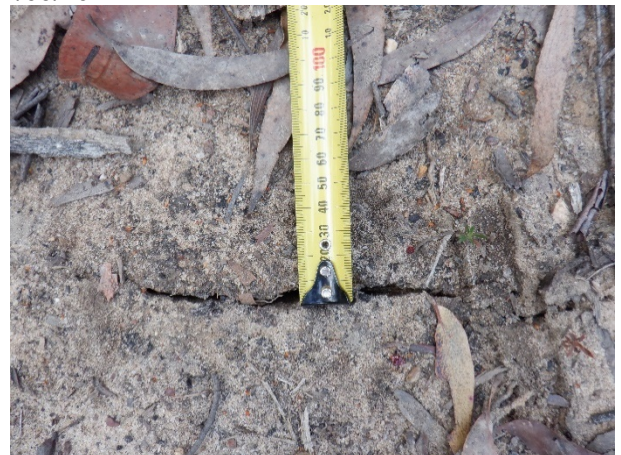
Photo 122: DA3B\_LW17\_033, showing the width of soil cracking. Taken on 23/08/2021.

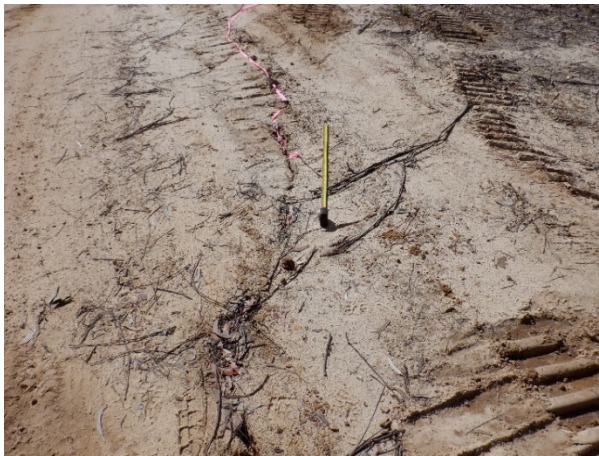
*Crack or fracture between 10m and 50m length.*

Photo 123: DA3B\_LW17\_014- Impact has been partially remediated. Some smaller cracks remain. Taken on 16/09/2021.

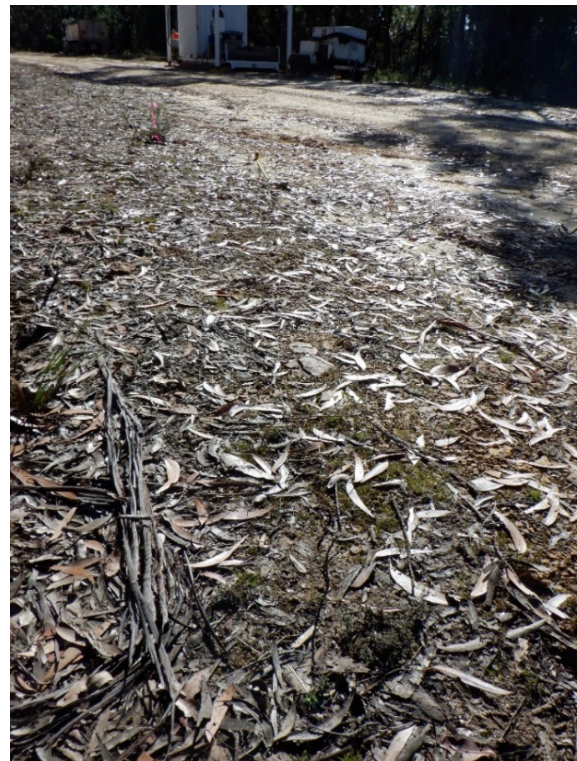
Photo 124: DA3B\_LW17\_014- soil cracking extending across Fire Road 6A and adjacent area. Taken on 18/05/2021.

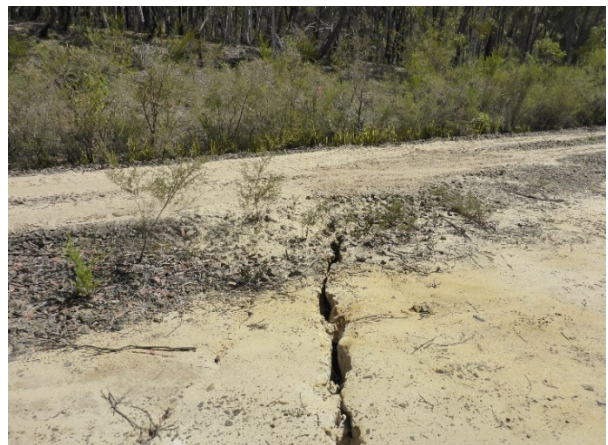
Photo 125: DA3B\_LW17\_27- showing the width of cracking. Taken on 15/07/2021.
