**DENDROBIUM AREA 3B
LONGWALL 18 END OF PANEL
LANDSCAPE REPORT
OCTOBER 2022**

This report summarises the observed and measured subsidence effects on landscape features resulting from the extraction of Dendrobium Area 3B (DA3B) Longwall 18. Longwall 18 is the tenth panel extracted from DA3B. Extraction began on 2 December 2021 and was completed on 17 May 2022.

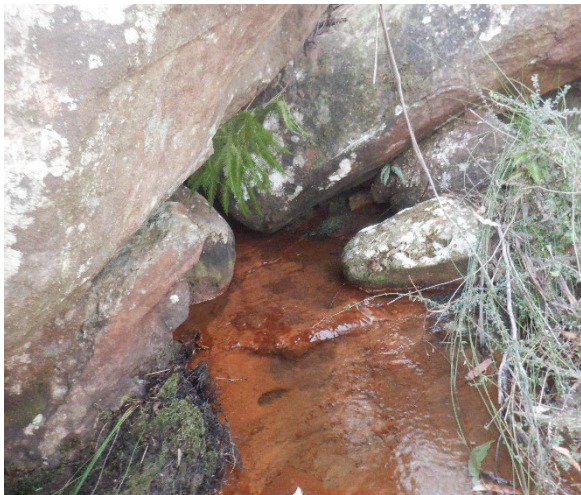
LA3 is a tributary of Lake Avon, that flows southward from DA3B mining operations (Figure 2). The upper reaches of the LA3 sub catchment were mined beneath by Longwall 15 and Longwall 16. During an inspection on 16 August 2022, iron staining was observed to originate at *LA3_Boulderfield 4a* and extend downstream to *LA3_Step 2* (Photo 5 to Photo 8). Iron staining was not observed upstream or downstream of these features (Photo 9 and Photo 10). No surface impacts have been observed on LA3 prior to this.

DA3B_LW18_024 is a Level 1 trigger as per the DA3B Watercourse Impact, Monitoring Management and Contingency Plan (Table 9), specifically:

Photo 5: *LA3_Boulderfield 4a* looking upstream at the origin of the iron staining. Taken 16/08/2022.

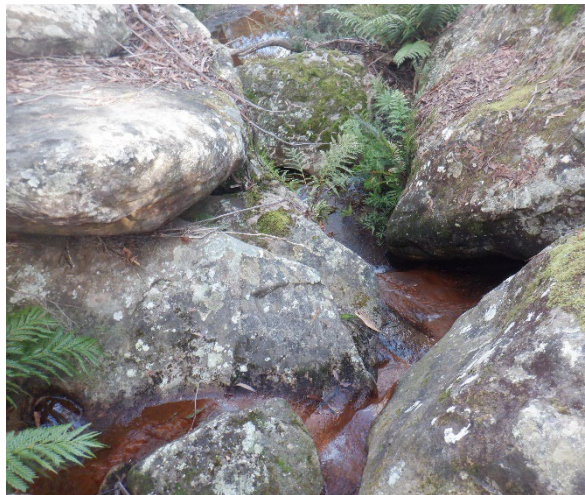
Photo 6: *LA3_Boulderfield 4a* looking downstream from the origin of the iron staining. Taken 16/08/2022.

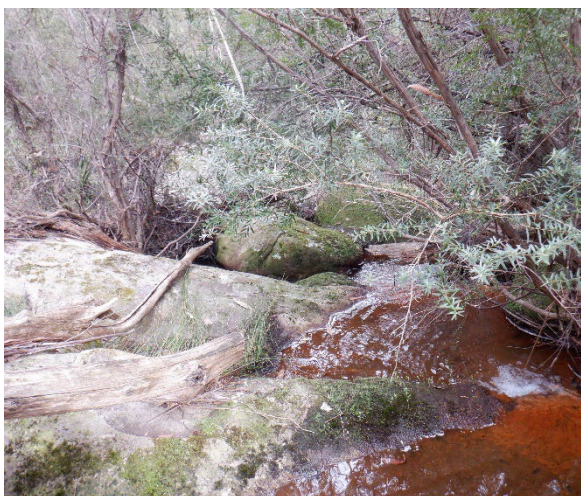
Photo 7: *LA3_Pool 4*, looking downstream. Taken 15/08/2022.

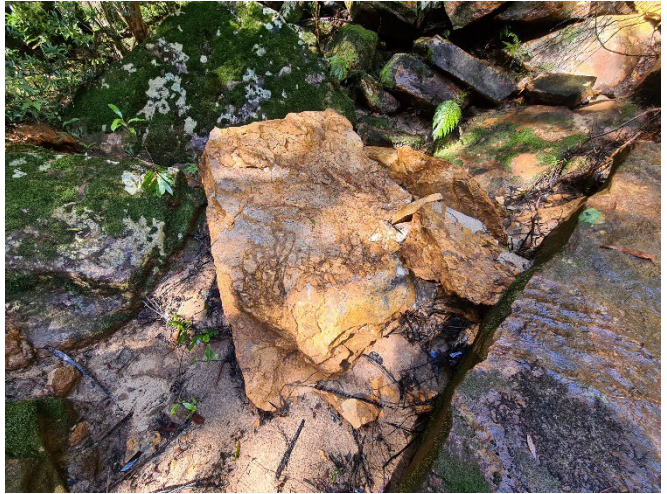
Photo 12: *DA3B_LW17_041*, showing a section of potential rock fall. Taken 2/08/2022.

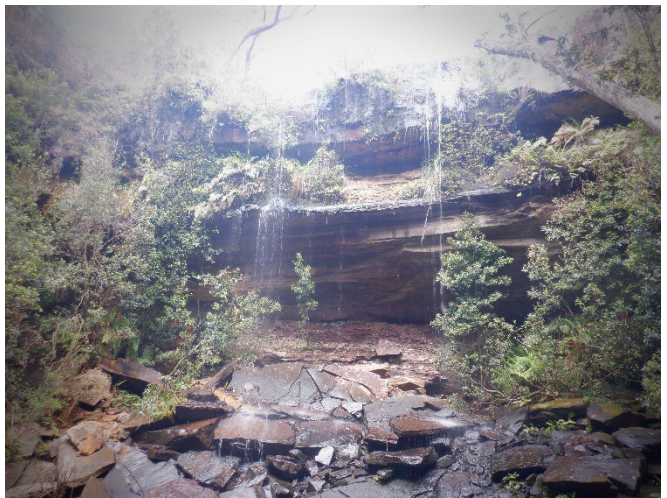
Photo 14: *Waterfall 54* inspection displaying visual change in rock debris (bottom left corner of image). Taken 28/10/2021.

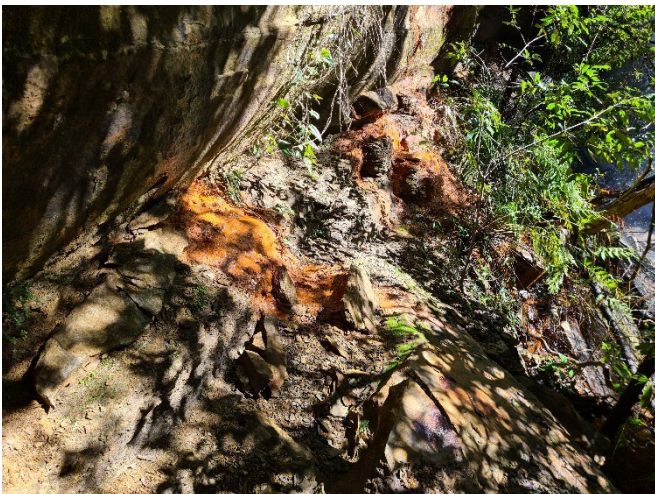
An increase in iron staining was also observed at *Waterfall 54* (Photo 15), compared to observations recorded in the baseline period. No visual changes to water flow were identified (Photo 6). A specialist review was undertaken.

Photo 15: *DA3B_LW17_041*, showing a section of iron staining. Taken 2/08/2022.

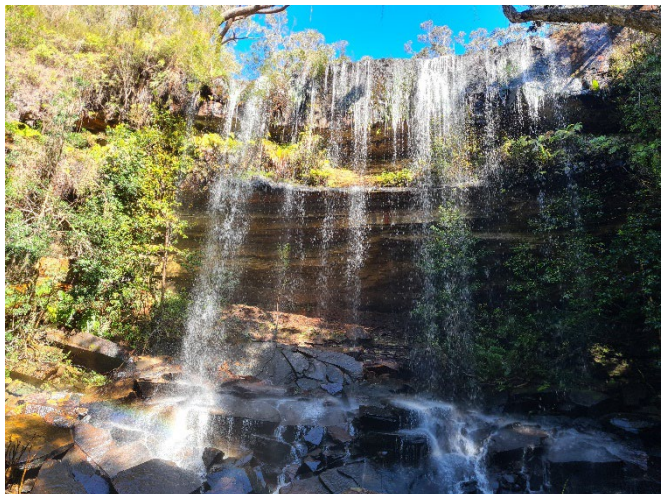
Photo 16: *DA3B_LW17_041*, showing overview of *Waterfall 54*. Taken 2/08/2022.

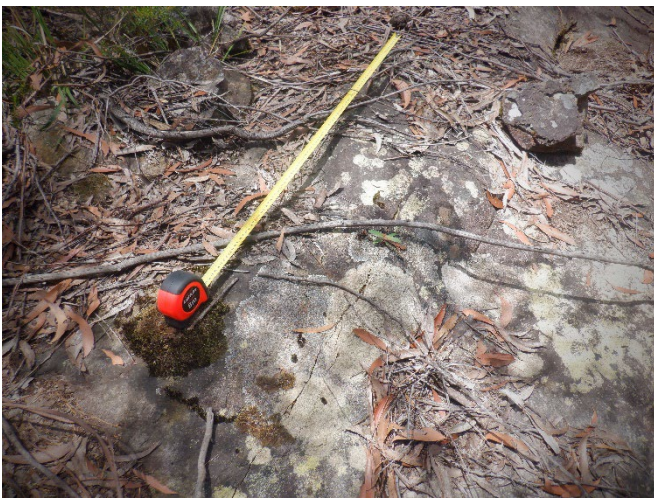
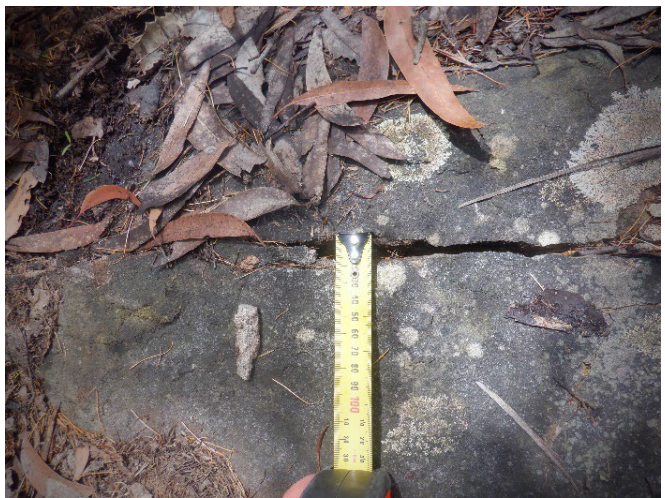
DA3B_LW18_001 is located on a rock outcrop to the south of Swamp 23 (Figure 2). The impact is comprised of rock fracturing. The fracturing has a continuous length of 4.70m, a width of up to 0.01m and a maximum measurable depth of 0.16m (Photo 17 and Photo 18). This impact likely occurred during the extraction of Longwall 16, therefore no follow up inspection was conducted following completion of Longwall 18.

DA3B_LW18_001 is a Level 1 trigger as per the Dendrobium Area 3B Landscape TARP (Table 9), specifically:

- Crack or fracture up to 10m in length;
- Crack or fracture up to 100mm width.

Photo 17: DA3B_LW18_001, showing a section of rock fracturing. Taken 14/12/2021.

Photo 18: DA3B_LW18_001, showing the width of the fracturing. Taken 14/12/2021.

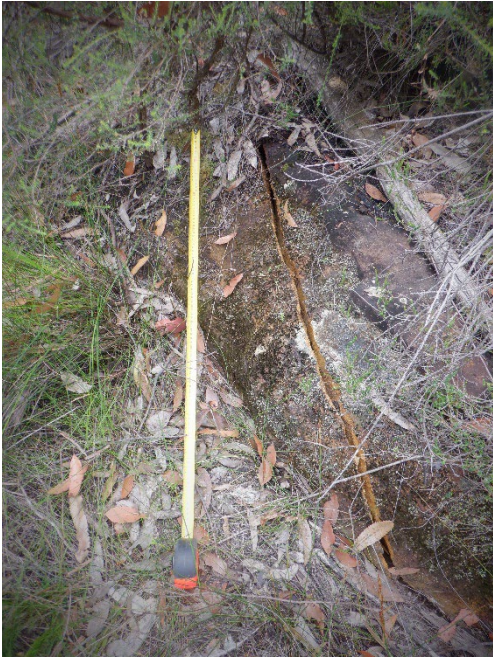
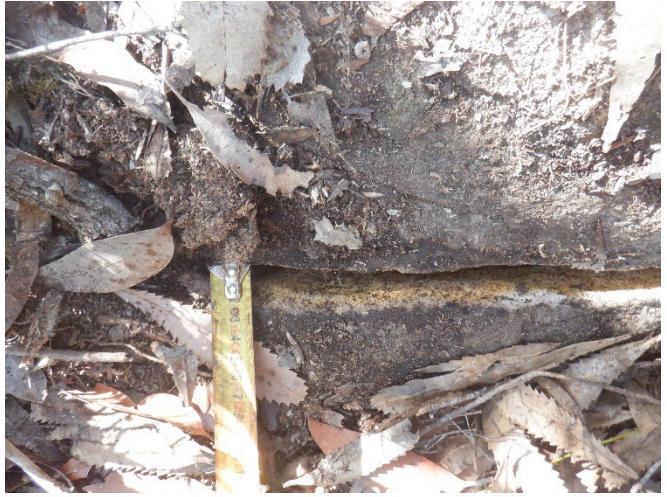
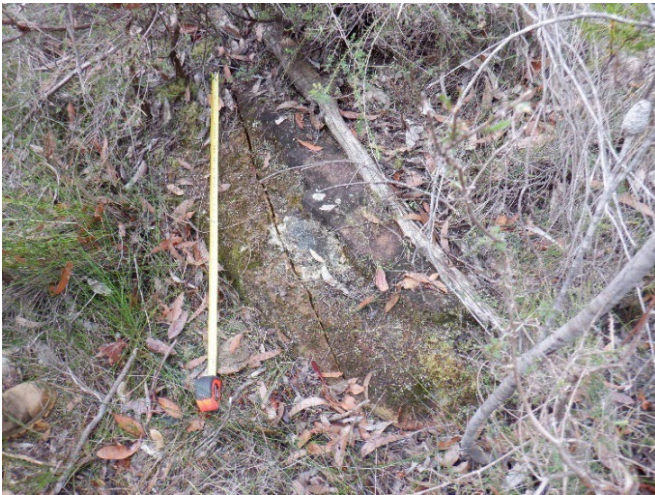
DA3B_LW18_002 (E 288976, N 6190704)

DA3B_LW18_002 is located on a rock outcrop/ steep slope west of Fire Road 6A (Figure 2). The impact area consists of two rock fractures with associated soil cracking. The largest fracture has a maximum continuous length of 3.46m, a width of up to 0.025m and a maximum measurable depth of 0.68m (Photo 19 and Photo 20). The impact was re-inspected on 21 June 2022 and no changes were observed (Photo 21).

DA3B_LW18_002 is a Level 1 trigger as per the Dendrobium Area 3B Landscape TARP (Table 9), specifically:

- Crack or fracture up to 10m in length;
- Crack or fracture up to 100mm width.

Photo 19: *DA3B_LW18_002*, showing a section of rock fracturing. Taken 31/01/2022.

Photo 20: *DA3B_LW18_002*, showing the width of the fracturing. Taken 31/01/2022.

Photo 21: *DA3B_LW18_002*, showing a section of rock fracturing. Taken 21/06/2022.

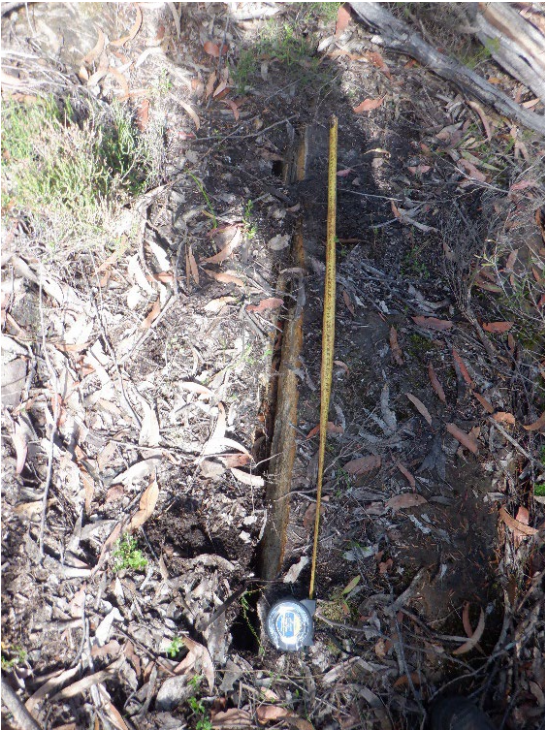
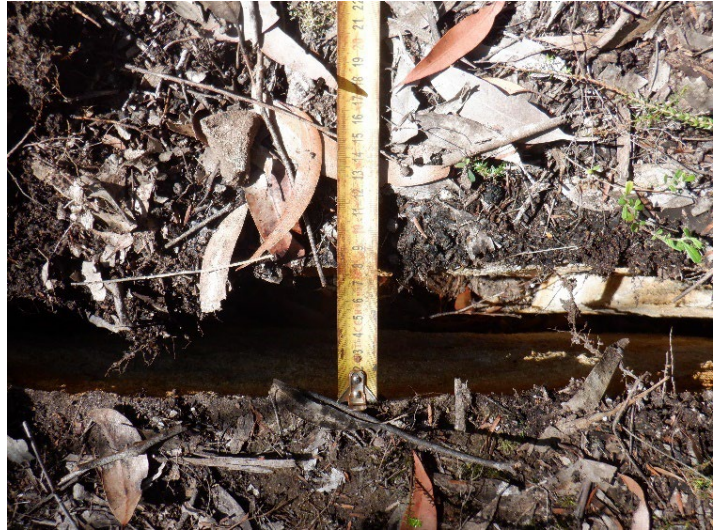
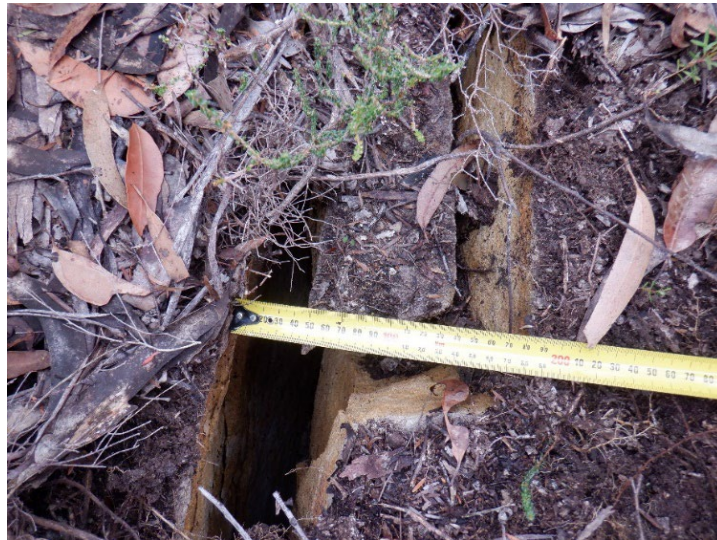
DA3B_LW18_003 (E 288940, N 6190704)

DA3B_LW18_003 is located on a rock outcrop west of Fire Road 6A (Figure 2). The impact consists of a rock fracture. The rock fracture has a continuous length of 15.5m, a width of up to 0.08m and a maximum measurable depth of 1.1m (Photo 22 and Photo 23). The impact was re-inspected on 21 June 2022 and dislodgment and fragmentation of the original fracture was observed (Photo 24). Maximum recorded values remain unchanged from the first inspection.

DA3B_LW18_003 is a Level 2 trigger as per the Dendrobium Area 3B Landscape TARP (Table 9), specifically:

- Crack or fracture between 10m and 50m in length.

Photo 22: *DA3B_LW18_003*, showing a section of rock fracturing. Taken 31/01/2022.

Photo 23: *DA3B_LW18_003*, showing the width of the fracturing. Taken 31/01/2022.

Photo 24: *DA3B_LW18_003*, showing the additional fragmentation and dislodgment. Taken 21/06/2022.

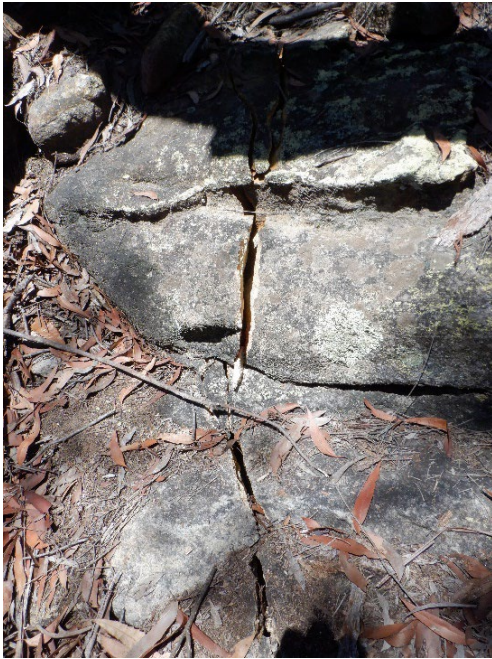
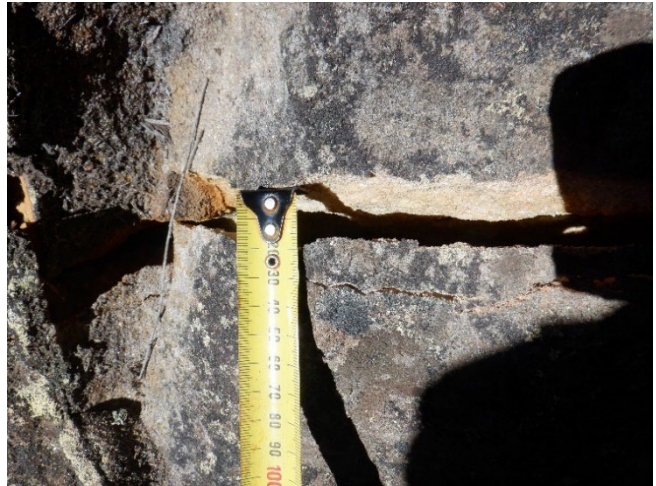
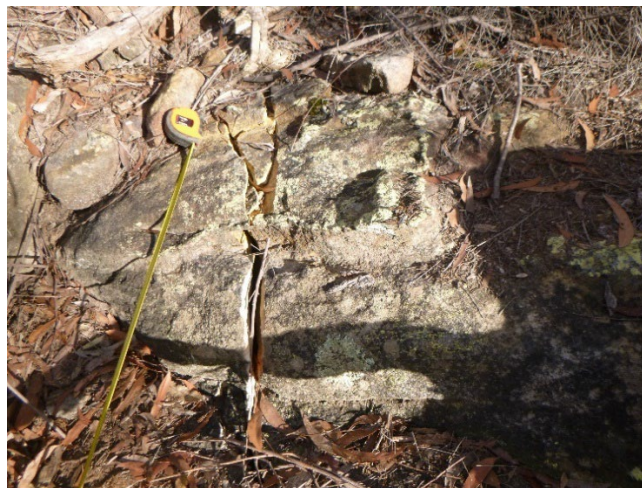
DA3B_LW18_004 (E 288864, N 6190839)

DA3B_LW18_004 is located on a rock outcrop west of Fire Road 6A (Figure 2). The impact is comprised of a rock fracture. The fracture has a maximum continuous length of 2.9m, a width of up to 0.02m and a maximum measurable depth of 0.45m (Photo 25 and Photo 26). The impact was re-inspected on 30 June 2022. The fracture now has a maximum continuous length of 3.4m, a width of up to 0.03m and maximum measurable depth of 0.9m (Photo 27).

DA3B_LW18_004 is a Level 1 trigger as per the Dendrobium Area 3B Landscape TARP (Table 9), specifically:

- Crack or fracture up to 10m in length;
- Crack or fracture up to 100mm width.

Photo 25: *DA3B_LW18_004*, showing the length of rock fracturing. Taken 9/02/2022.

Photo 26: *DA3B_LW18_004*, showing the width of the fracturing. Taken 9/02/2022.

Photo 27: *DA3B_LW18_004*, overview of the impact. Taken 30/06/2022.

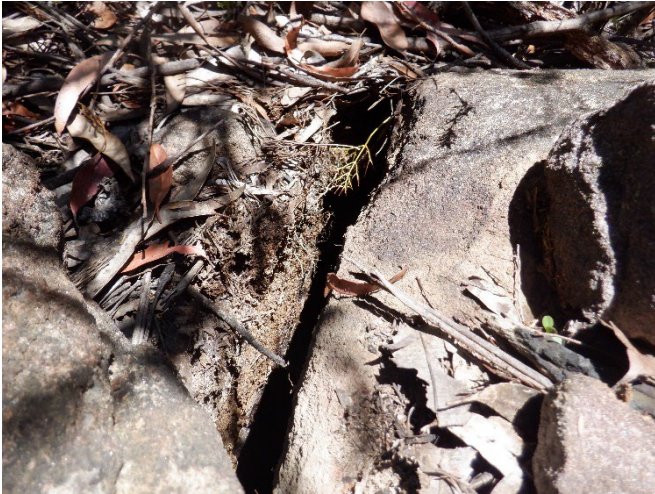
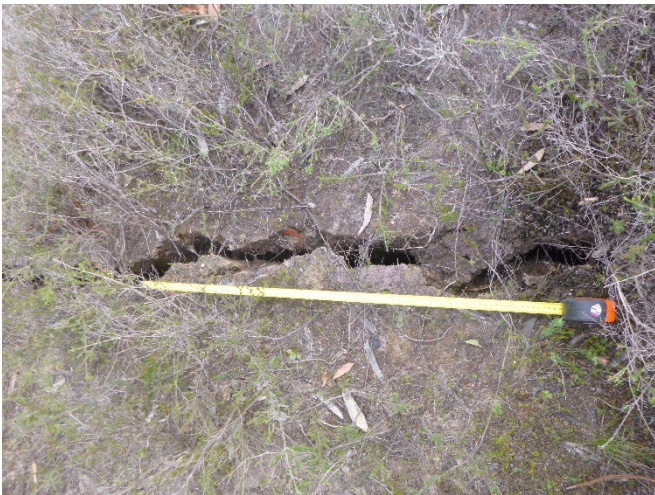
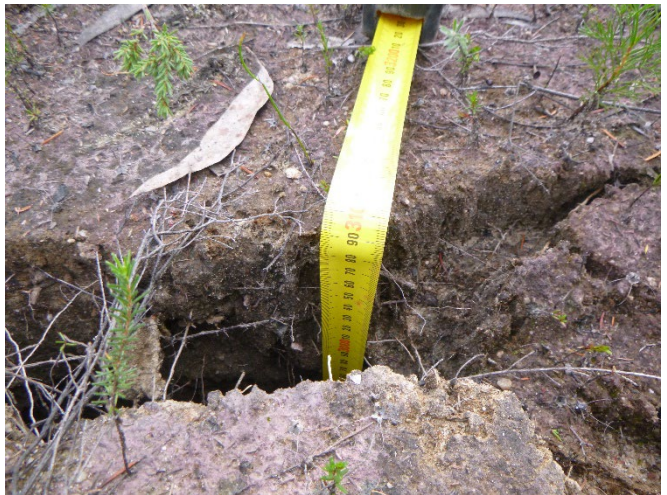
DA3B_LW18_005 (E 288816, N 6190851)

DA3B_LW18_005 is located on a steep slope/ridgeline west of Fire Road 6A (Figure 2). The impact consists of displacement between soil and adjacent rock strata. The displacement has a discontinuous length of 5.5m, a continuous length of 1.9m, a width of up to 0.06m and a maximum measurable depth of 1.1m (Photo 28 and Photo 29). The impact was re-inspected on 30 June 2022 and additional soil cracking was observed. The soil cracking has a maximum continuous length of 16m, discontinuous length of 42.4m, maximum width of 0.09m and maximum measurable depth of 3.09m (Photo 30 and Photo 31).

DA3B_LW18_005 is a Level 2 trigger as per the Dendrobium Area 3B Landscape TARP (Table 9), specifically:

- Crack or fracture between 10m and 50m in length.

Photo 28: DA3B_LW18_005, showing a section of displacement. Taken 9/02/2022.

Photo 30: DA3B_LW18_005, showing a section of soil cracking. Taken 30/06/2022.

Photo 31: DA3B_LW18_005, showing the depth of soil cracking. Taken 30/06/2022.

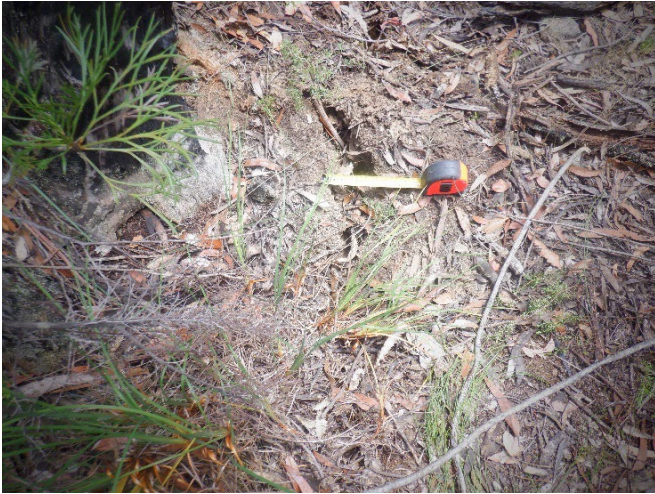
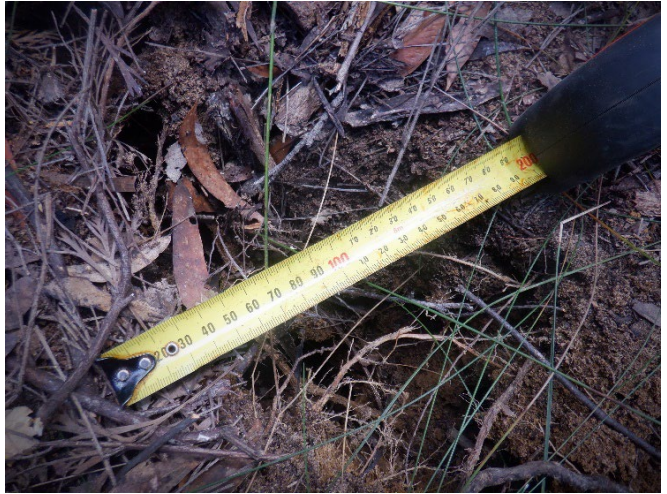
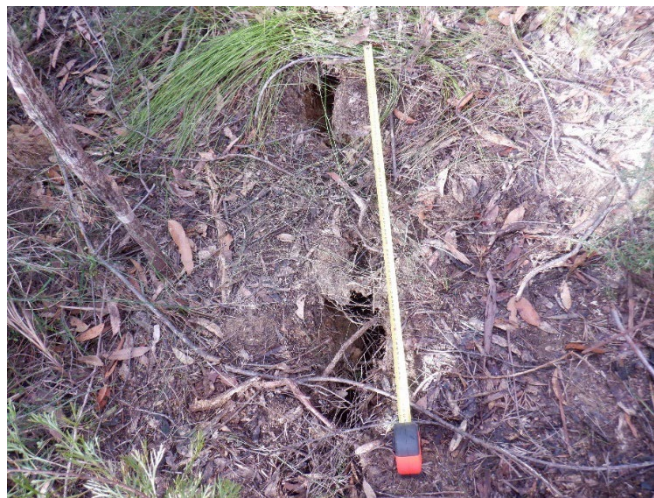
DA3B_LW18_006 (E 288948, N 6190672)

DA3B_LW18_006 is located near an access track west of Fire Road 6A (Figure 2). The impact is comprised of soil cracking. The soil cracking has a continuous length of 15m, a width of up to 0.15m and a maximum measurable depth of 0.60m (Photo 32 and Photo 33). The impact was re-inspected on 21 June 2022 and no changes were observed (Photo 34).

DA3B_LW18_006 is a Level 2 trigger as per the Dendrobium Area 3B Landscape TARP (Table 9), specifically:

- Crack or fracture between 10m and 50m in length;
- Crack or fracture between 100mm and 300mm width.

Photo 32: *DA3B_LW18_006*, showing a section of soil cracking. Taken 15/02/2022.

Photo 33: *DA3B_LW18_006*, showing the width of soil cracking. Taken 15/02/2022.

Photo 34: *DA3B_LW18_006*, showing a section of soil cracking. Taken 21/06/2022.

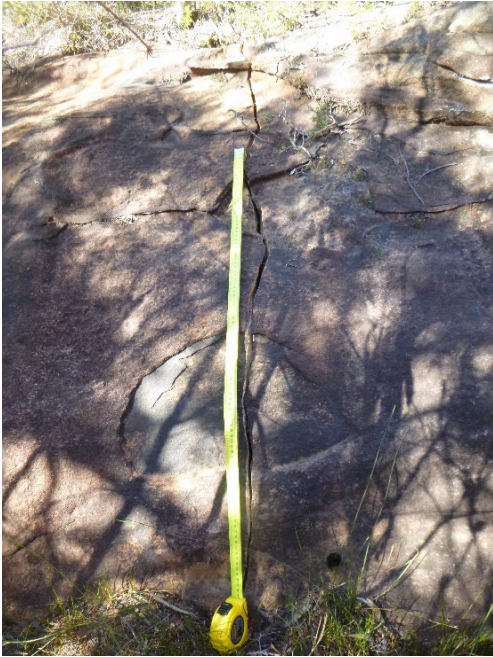
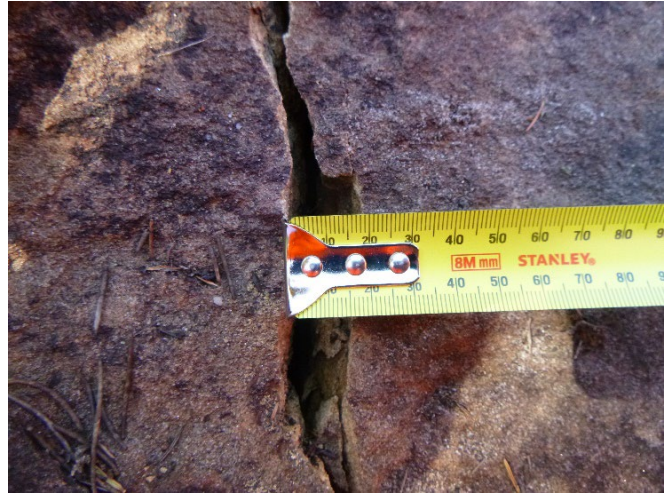
DA3B_LW18_007 (E 288950, N 6190822)

DA3B_LW18_007 is located in bushland west of Fire Road 6A (Figure 2). The impact is comprised of rock fracturing. The rock fracturing has a continuous maximum length of 2.03m, a width of up to 0.02m and a maximum measurable depth of 0.50m (Photo 35 and Photo 36).

DA3B_LW18_007 is a Level 1 trigger as per the Dendrobium Area 3B Landscape TARP (Table 9), specifically:

- Crack or fracture up to 100mm width;
- Crack or fracture up to 10m length.

Photo 35: *DA3B_LW18_007*, showing a section of rock fracturing. Taken 8/06/2022.

Photo 36: *DA3B_LW18_007*, showing the width of rock fracturing. Taken 8/06/2022.

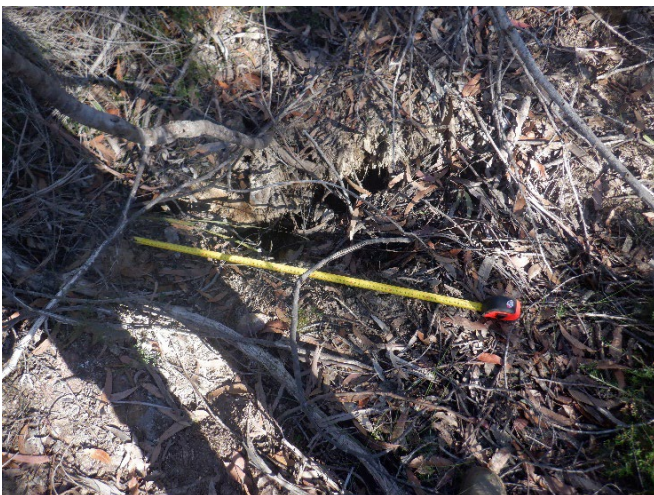
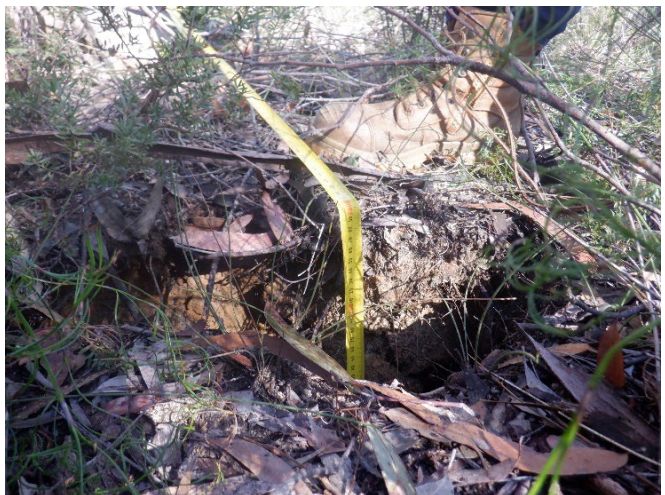
DA3B_LW18_008 (E 288822, N 6190753)

DA3B_LW18_008 is located near an access track west of Fire Road 6A (Figure 2). The impact is comprised of soil cracking. The soil cracking has a continuous length of 15.52m, a maximum width of 0.28m and a maximum measurable depth of 2.8m (Photo 37 and Photo 38).

DA3B_LW18_008 is a Level 2 trigger as per the Dendrobium Area 3B Landscape TARP (Table 9), specifically:

- Crack or fracture between 100 and 300mm width;
- Crack or fracture between 10 and 50m length.

Photo 37: *DA3B_LW18_008*, showing a section of soil cracking. Taken 9/06/2022.

Photo 38: *DA3B_LW18_008*, showing the depth of soil cracking. Taken 9/06/2022.

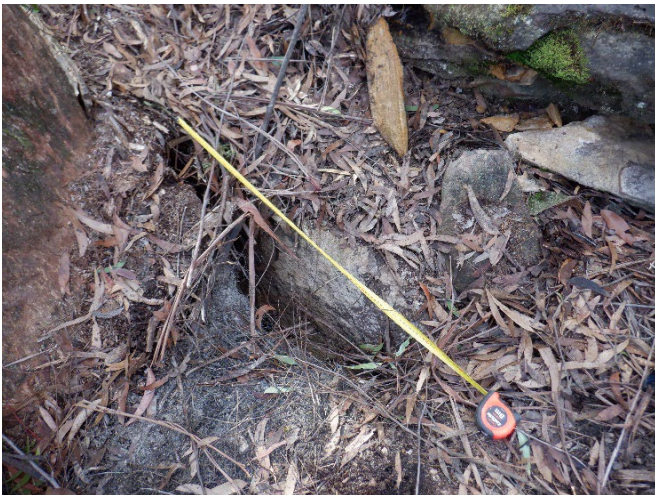
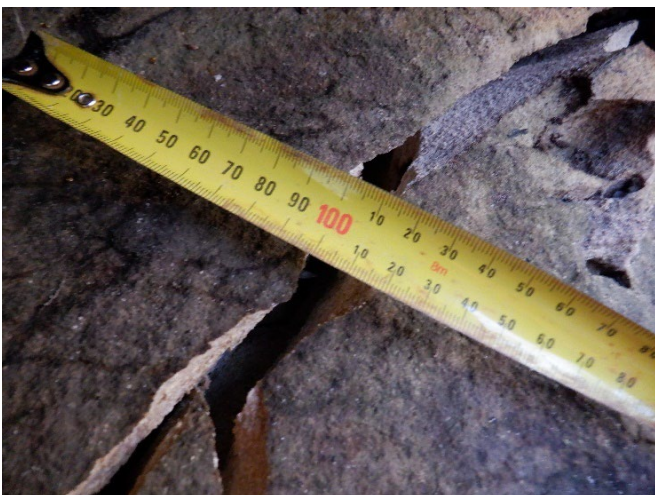
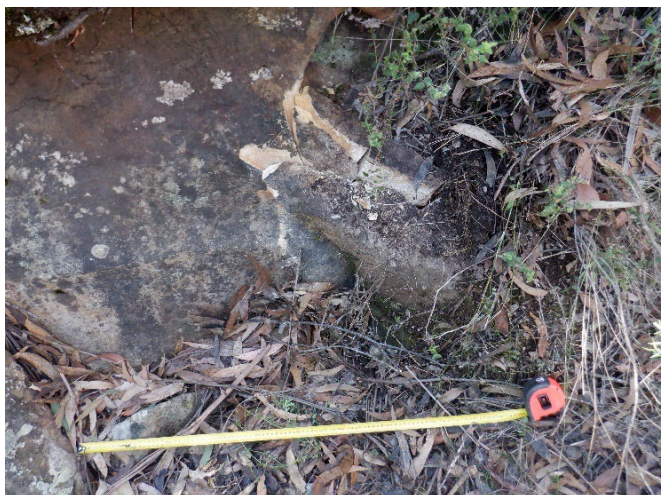
DA3B_LW18_009 (E 289595, N 6190657)

DA3B_LW18_009 is located in bushland near ND1C (Figure 2). The impact is comprised of rock displacement, fracturing and fragmentation. The rock displacement has a maximum continuous length of 0.9m, a maximum width of 0.2m and a maximum measurable depth of 1.0m (Photo 39 and Photo 40). The rock fracture has a maximum continuous length of 4.2m, a maximum width of 0.02m and a maximum measurable depth of 0.22m (Photo 41 and Photo 42).

DA3B_LW18_009 is a Level 2 trigger as per the Dendrobium Area 3B Landscape TARP (Table 9), specifically:

- Crack or fracture between 100 and 300mm width.

Photo 39: DA3B_LW18_009, showing a section of rock displacement. Taken 9/06/2022.

Photo 41: DA3B_LW18_009, showing width of rock fracturing. Taken 9/06/2022.

Photo 42: DA3B_LW18_009, showing a section of rock fragmentation. Taken 9/06/2022.

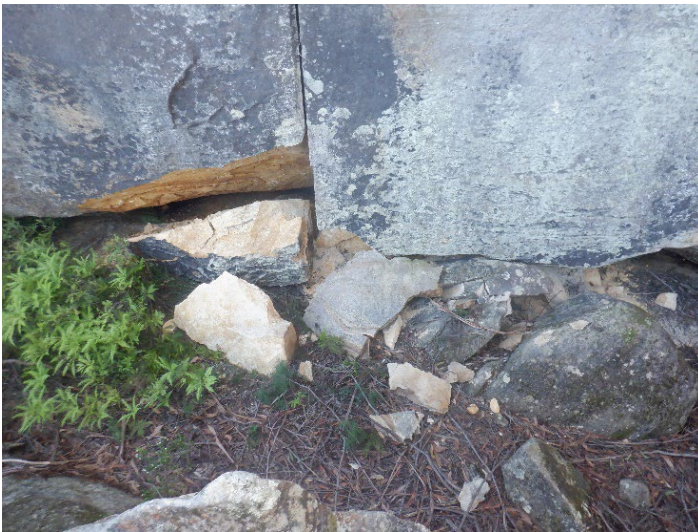
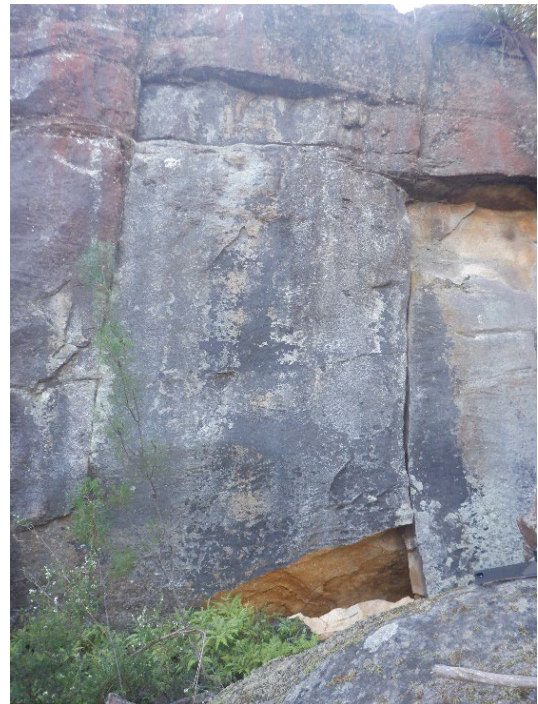
DA3B_LW18_010 (E 289751, N 6190685)

- Rockfall from a cliff (steep slope) which is left mostly intact (<10% length), resulting in insignificant ground disturbance.

Photo 43: *DA3B_LW18_010*, showing rock fall and fragmentation. Taken 10/06/2022.

Photo 44: *DA3B_LW18_010*, showing rock fall and fragmentation site. Taken 10/06/2022.

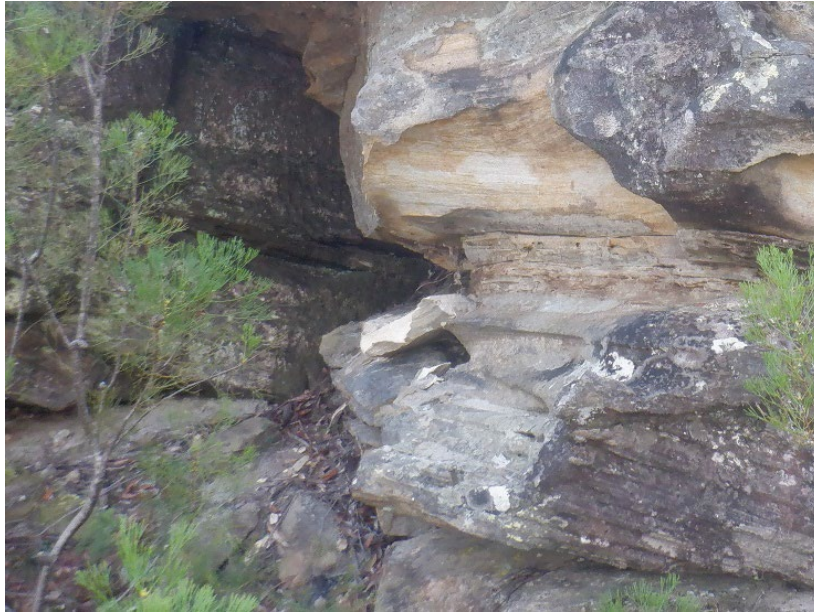
DA3B_LW18_011 (E 289776, N 6190685)

- Rockfall from a cliff (step/outcrop) which is left mostly intact (<10% length), resulting in insignificant ground disturbance.

Photo 45: *DA3B_LW18_011*, showing rock fall. Taken 10/06/2022.

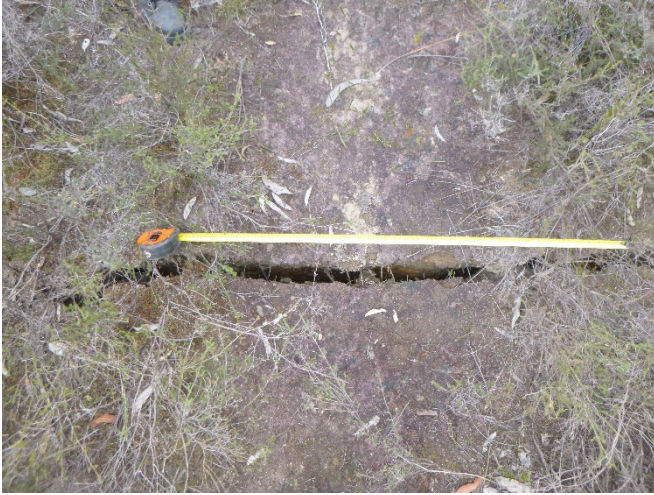
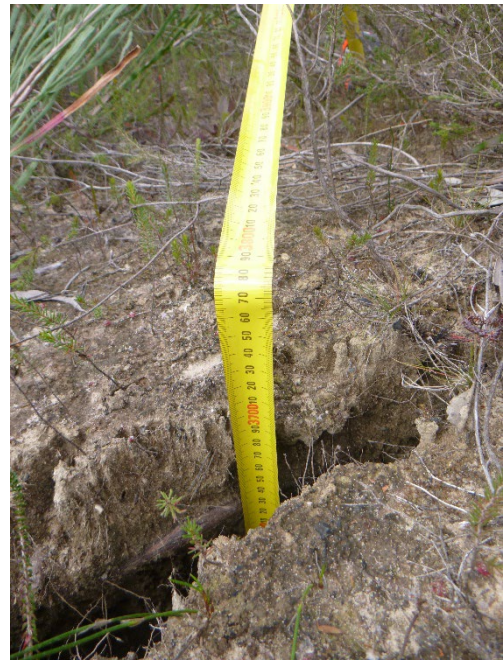
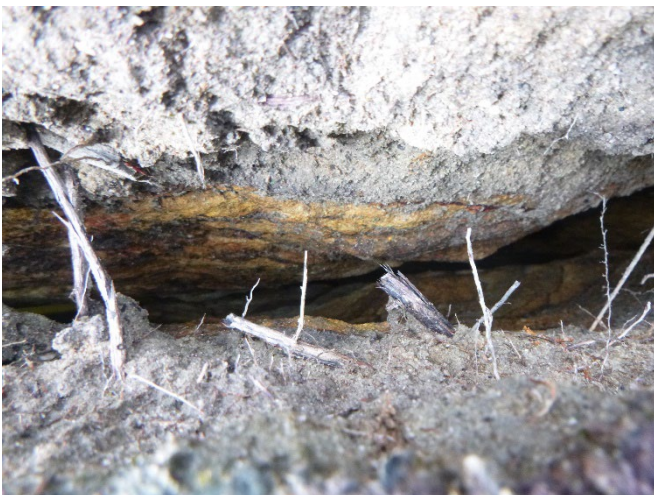
DA3B_LW18_012 (E 288802, N 6190825)

DA3B_LW18_012 is located in bushland west of Fire Road 6A (Figure 2). The impact is comprised of two soil cracks running in parallel, with discontinuous lengths of 26m and 9.5m. The soil cracking has a maximum continuous length of 10.8m, a width of up to 0.06m and a maximum measurable depth of 3.70m (Photo 46 and Photo 47). Visible rock fracturing can be seen in lower sections of the soil cracking (Photo 48).

DA3B_LW18_012 is a Level 2 trigger as per the Dendrobium Area 3B Landscape TARP (Table 9) specifically:

- Crack or fracture between 10 and 50m length.

Photo 46: *DA3B_LW18_012*, showing a section of soil cracking. Taken 30/06/2022.

Photo 47: *DA3B_LW18_012*, showing depth of soil cracking. Taken 30/06/2022.

Photo 48: *DA3B_LW18_012*, showing exposed rock within the cracking. Taken 30/06/2022.

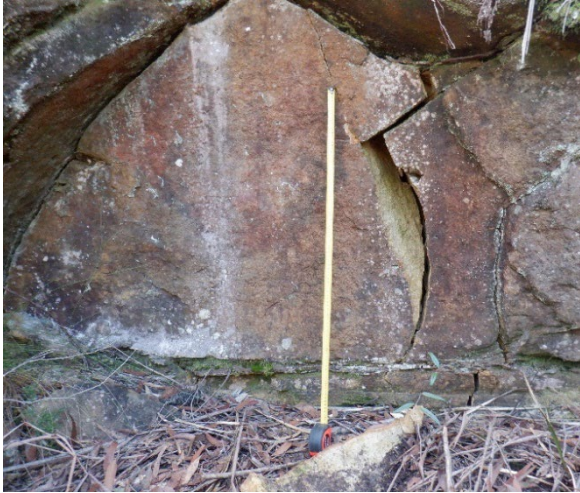
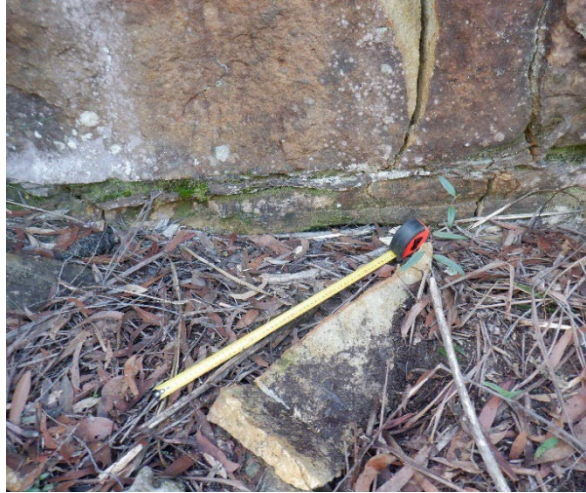
DA3B_LW18_013 (E 289038, N 6191123)

DA3B_LW18_013 is located on a steep slope/step on the northern slope of LA2 valley (Figure 2). The impact was mined beneath by Longwall 17. The impact is comprised of a rock fracture and fragmentation (Photo 49 and Photo 50). The rock fracture has a maximum length of 1.1m, a maximum measurable depth of 0.5m and a maximum width of 0.015m. The rock fragmentation has an approximate volume of 0.015m³ (0.14m x 0.2m x 0.55m).

- Crack or fracture up to 10m length
- Crack or fracture up to 100mm width

Photo 49: *DA3B_LW18_013*, showing overview of rock fracture. Taken 16/08/2022.

Photo 50: *DA3B_LW18_013*, showing rock fragmentation. Taken 16/08/2022.

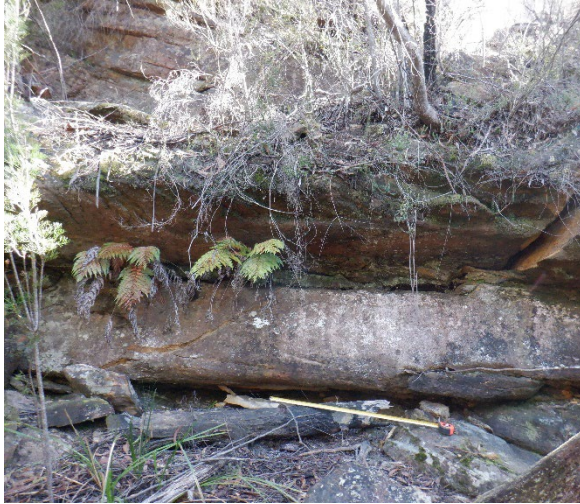
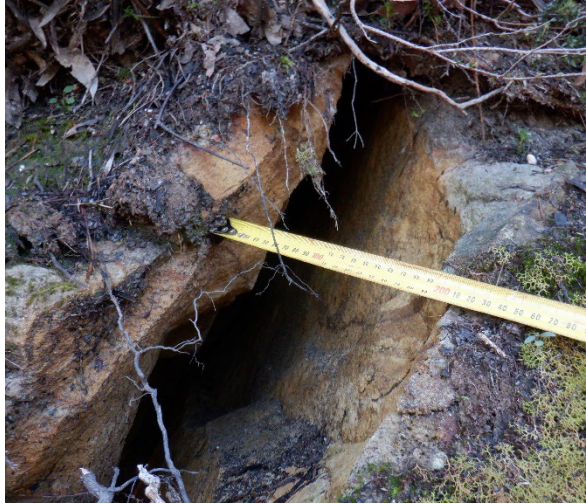
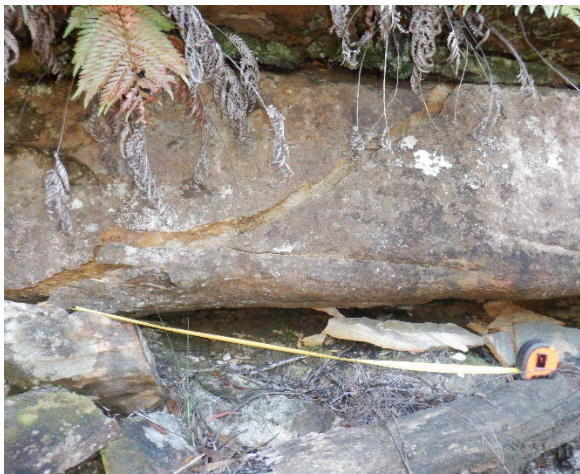
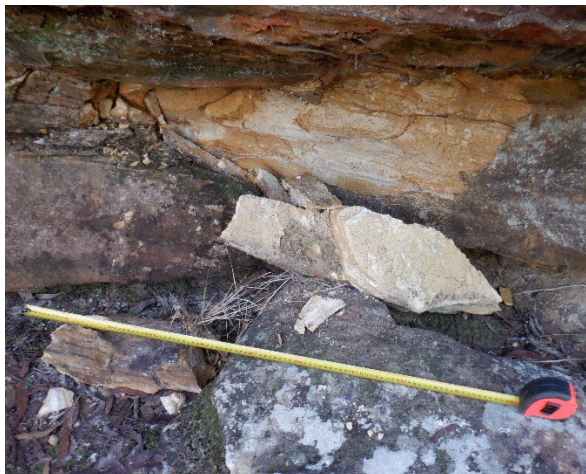
DA3B_LW18_014 (E 288978, N 6191094)

DA3B_LW18_014 is located on a steep slope/step on the northern slope of LA2 valley (Figure 2). The impact was mined beneath by Longwall 17. The impact is comprised of multiple rock fractures and a rockfall (Photo 51 to Photo 54). The rock fracture has a maximum length of 1.4m, a maximum width of 0.19m and a maximum measurable depth of 2m.

- Crack or fracture between 100 and 300mm width

Photo 51: *DA3B_LW18_014*, showing overview of site. Taken 16/08/2022.

Photo 52: *DA3B_LW18_014*, maximum width of fracture. Taken 16/08/2022

Photo 53: *DA3B_LW18_014*, showing section of rock fracturing. Taken 16/08/2022.

Photo 54: *DA3B_LW18_014*, showing rockfall debris. Taken 16/08/2022.

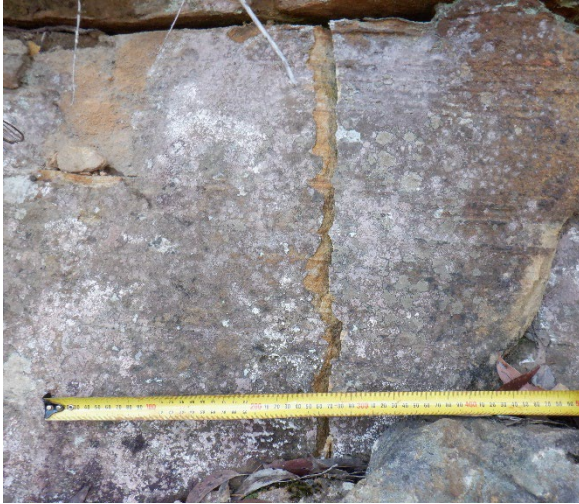
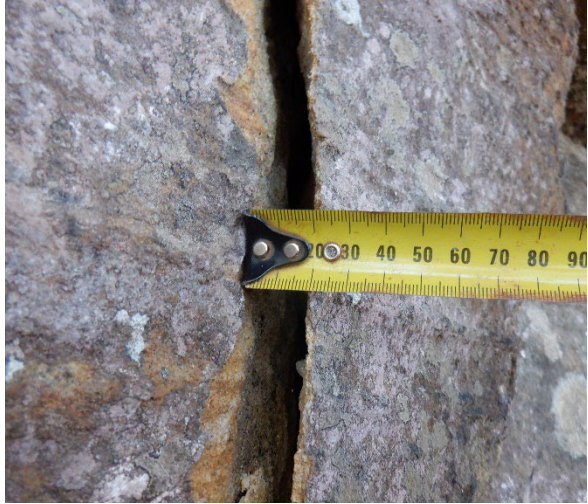
DA3B_LW18_015 (E 288920, N 6191077)

DA3B_LW18_015 is located on a steep slope/step on the northern slope of LA2 valley (Figure 2). The impact site was mined beneath by Longwall 17. The impact is comprised of a vertical rock fracture at the base of a steep slope/step (Photo 55 and Photo 56). The rock fracture has a maximum length of 0.45m, a maximum measurable depth of 0.25m and a maximum width of 0.02m.

- Crack or fracture up to 10m length
- Crack or fracture up to 100mm width

Photo 55: *DA3B_LW18_015*, showing overview of rock fracture. Taken 16/08/2022.

Photo 56: *DA3B_LW18_015*, showing width of rock fracture. Taken 16/08/2022.

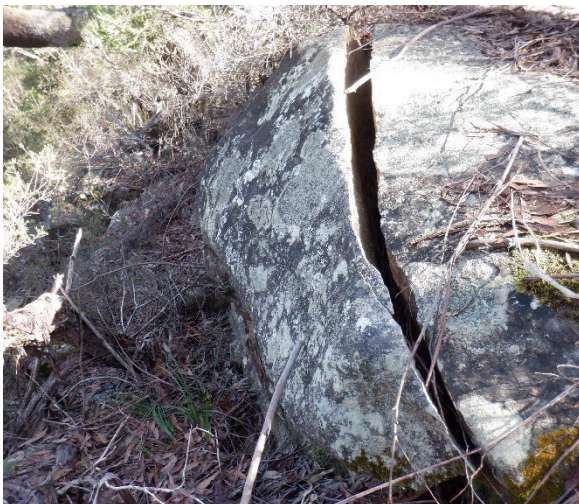
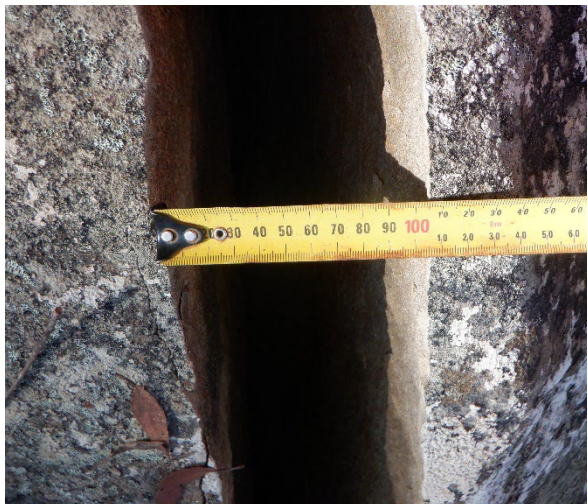
DA3B_LW18_016 (E 288886, N 6191095)

DA3B_LW18_016 is located on a steep slope/step on the northern slope of LA2 valley (Figure 2). The impact was mined beneath by Longwall 17. The impact is comprised of multiple rock fractures in an area of 15m² (Photo 57 and Photo 58). The rock fracturing has a maximum length of 2.9m, a maximum width of 0.11m and a maximum measurable depth of 0.94m.

- Crack or fracture between 100 and 300mm width

Photo 57: *DA3B_LW18_016*, showing largest rock fracture. Taken 16/08/2022.

Photo 58: *DA3B_LW18_016*, showing maximum width of rock fracturing. Taken 16/08/2022

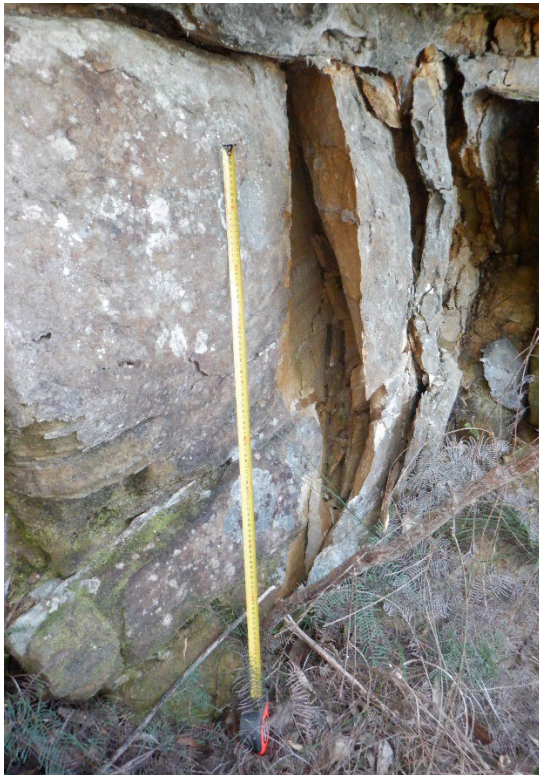
DA3B_LW18_017 (E 288877, N 6191083)

DA3B_LW18_017 is located on a steep slope/step on the northern slope of LA2 valley (Figure 2). The impact was mined beneath by Longwall 17. The impact is comprised of a rockfall, rock displacement and rock fracturing (Photo 59 and Photo 60). The dislodged rock has a volume of approximately 0.13m³ (1.1m x 0.16m x 0.75m). Minor rock fracturing is present.

- Rockfall from a cliff which is left mostly intact (<10% length), resulting in insignificant ground disturbance
- Crack or fracture up to 100mm width
- Crack or fracture up to 10m length

Photo 59: DA3B_LW18_017, showing rock displacement. Taken 16/08/2022.

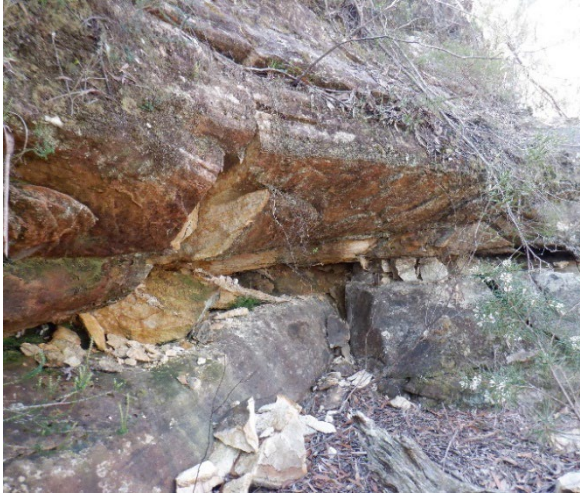
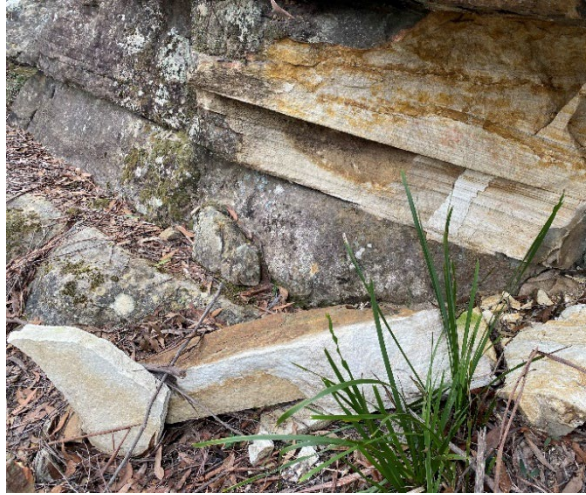
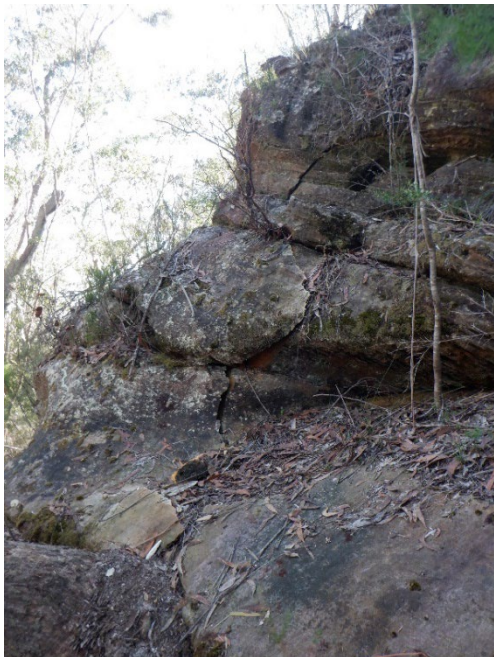
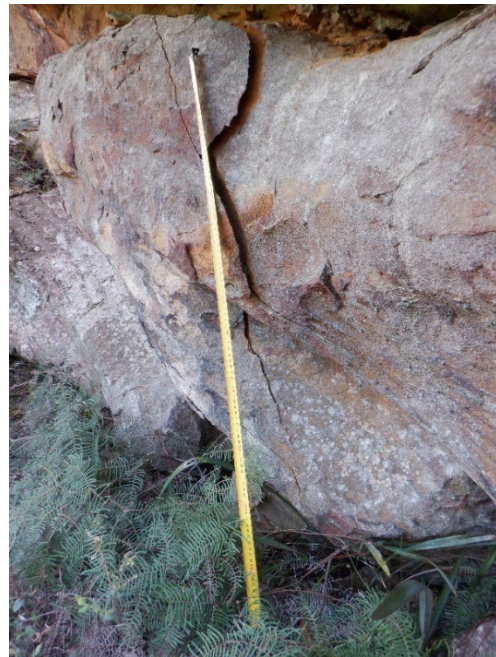
DA3B_LW18_018 is located on a steep slope/step on the northern slope of LA2 valley (Figure 2). The impact was mined beneath by Longwall 17. The impact is comprised of multiple rock fractures and rockfalls in an area of 20m x 5m (Photo 61 to Photo 64). The rock fracturing has an estimated maximum length of 3.5m and an estimated maximum width of 0.08m. The largest rockfall has an estimated volume of 0.26m³ (1.5m x 0.7m x 0.25m). Measurements were estimated due to safety concerns.

- Crack or fracture up to 10m in length
- Crack or fracture up to 100mm width
- Rockfall from a cliff which is left mostly intact (<10% length), resulting in insignificant ground disturbance

Photo 61: *DA3B_LW18_018*, showing section of rockfall and rock fracturing. Taken 16/08/2022.

Photo 62: *DA3B_LW18_018*, showing section of rockfall. Taken 16/08/2022.

Photo 63: *DA3B_LW18_018*, showing section of rock fracturing. Taken 16/08/2022.

Photo 64: *DA3B_LW18_018*, showing section of rock fracturing. Taken 16/08/2022.

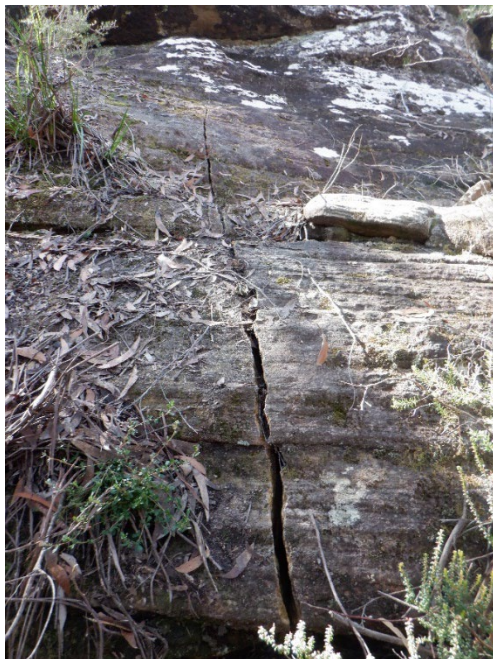
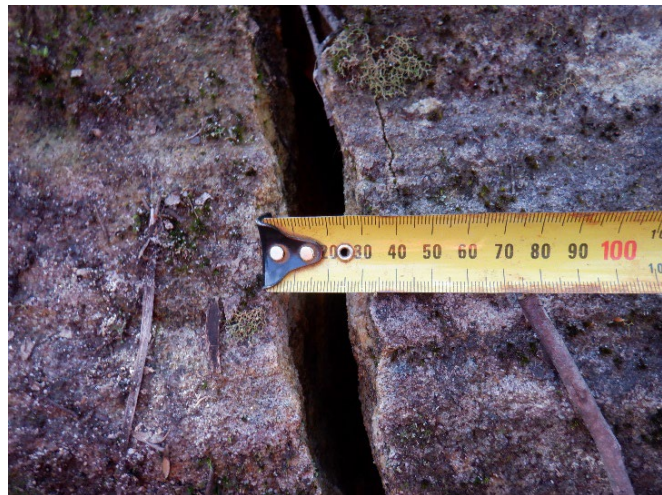
DA3B_LW18_019 (E 288821, N 6191105)

- Crack or fracture up to 10m in length
- Crack or fracture up to 100mm width

Photo 65: *DA3B_LW18_019*, showing overview of rock fracture. Taken 16/08/2022.

Photo 66: *DA3B_LW18_019*, showing maximum width of rock fracture. Taken 16/08/2022.
