**DENDROBIUM AREA 3B
LONGWALL 18 END OF PANEL
LANDSCAPE REPORT
OCTOBER 2022**

This report summarises the observed and measured subsidence effects on landscape features resulting from the extraction of Dendrobium Area 3B (DA3B) Longwall 18. Longwall 18 is the tenth panel extracted from DA3B. Extraction began on 2 December 2021 and was completed on 17 May 2022.

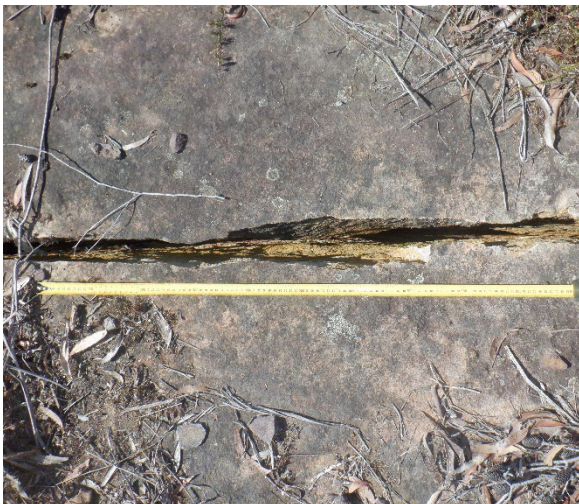
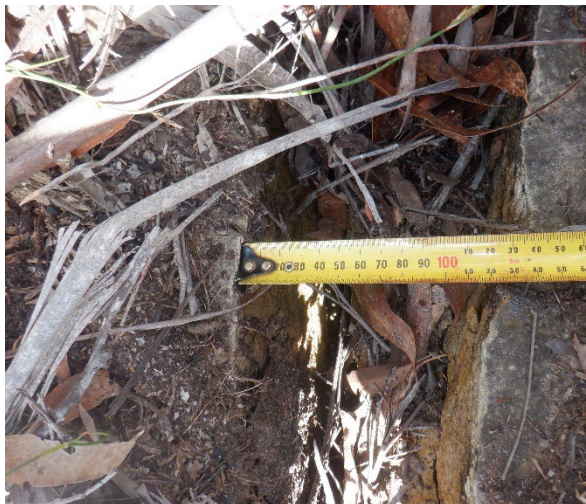
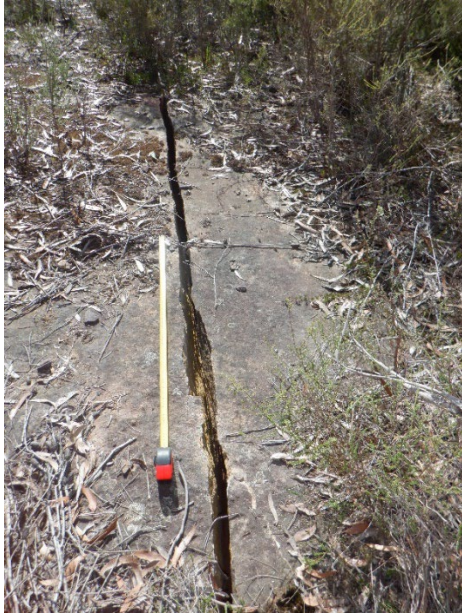
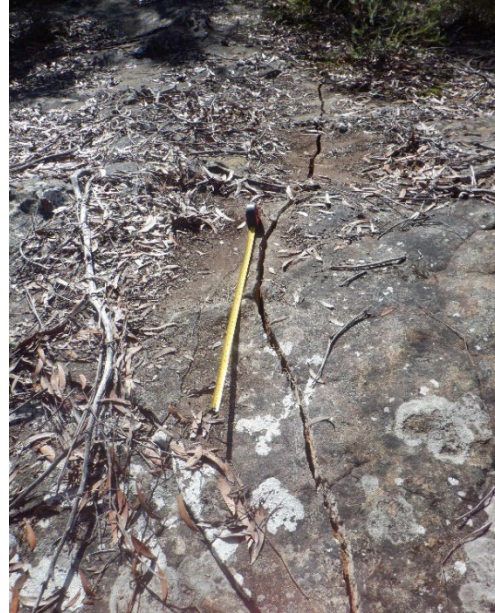
Photo 69: *DA3B_LW18_021*, showing section of rock fracturing. Taken 16/08/2022.

Photo 70: *DA3B_LW18_021*, showing maximum width of rock fracturing. Taken 16/08/2022.

Photo 71: *DA3B_LW18_021*, showing overview of largest fracture. Taken 16/08/2022.

Photo 72: *DA3B_LW18_021*, showing section of rock fracturing. Taken 16/08/2022.

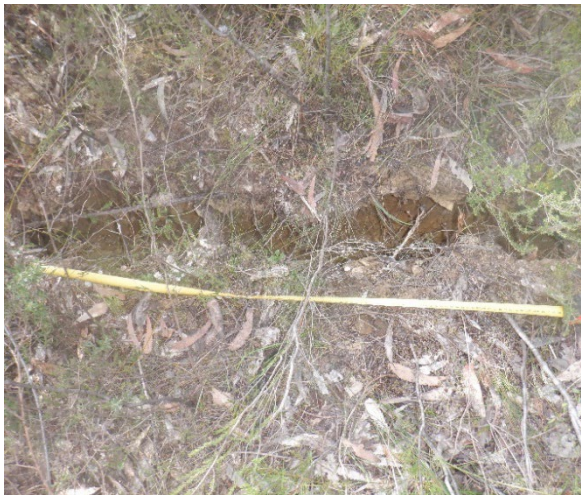
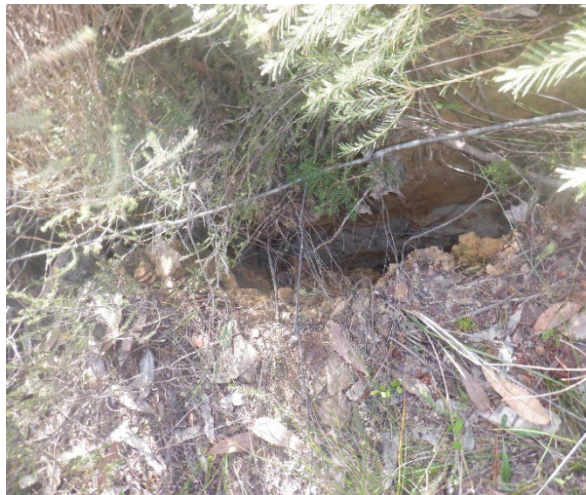
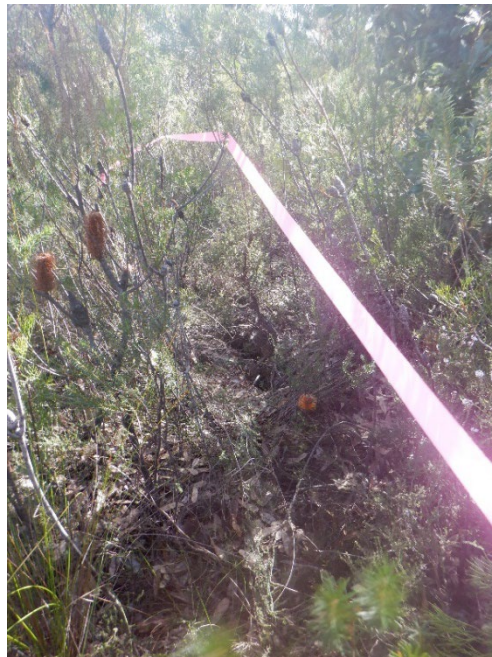
Photo 75: DA3B_LW18_023, showing section of soil cracking. Taken 16/08/2022.

Photo 76: DA3B_LW18_023, showing maximum width of soil cracking. Taken 16/08/2022.

Photo 77: DA3B_LW18_023, showing overview of soil cracking. Taken 16/08/2022.
