#### **DA3B\_LW18\_001 (E 288784, N 6191476)**

Table 2: Summary of Longwall 18 impacts and triggers. Highlighted rows indicate the latest impacts featured in this report.

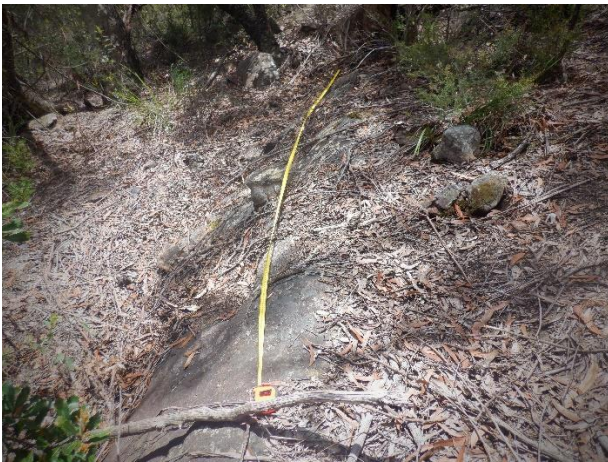
*DA3B\_LW18\_001* is located on a rock outcrop to the south of Swamp 23 (Figure 1). The impact is comprised of rock fracturing. The fracturing has a continuous length of 4.70m, a width of up to 0.01m and a maximum measurable depth of 0.16m (Photo 1 and Photo 2).

*DA3B\_LW18\_001* is a Level 1 trigger as per the Dendrobium Area 3B Landscape TARP (Table 1), specifically;

- Crack or fracture up to 10m in length;
- Crack or fracture up to 100mm width.

Photo 1: *DA3B\_LW18\_001*, showing the length of the fracturing. Taken 14/12/2021.

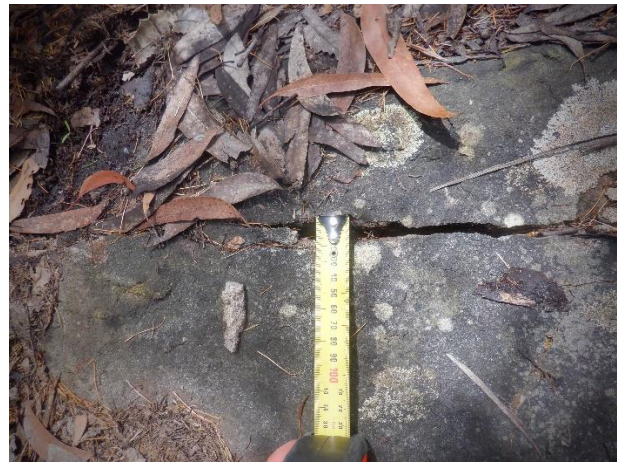
Photo 2: *DA3B\_LW18\_001*, showing the width of the fracturing. Taken 14/12/2021.

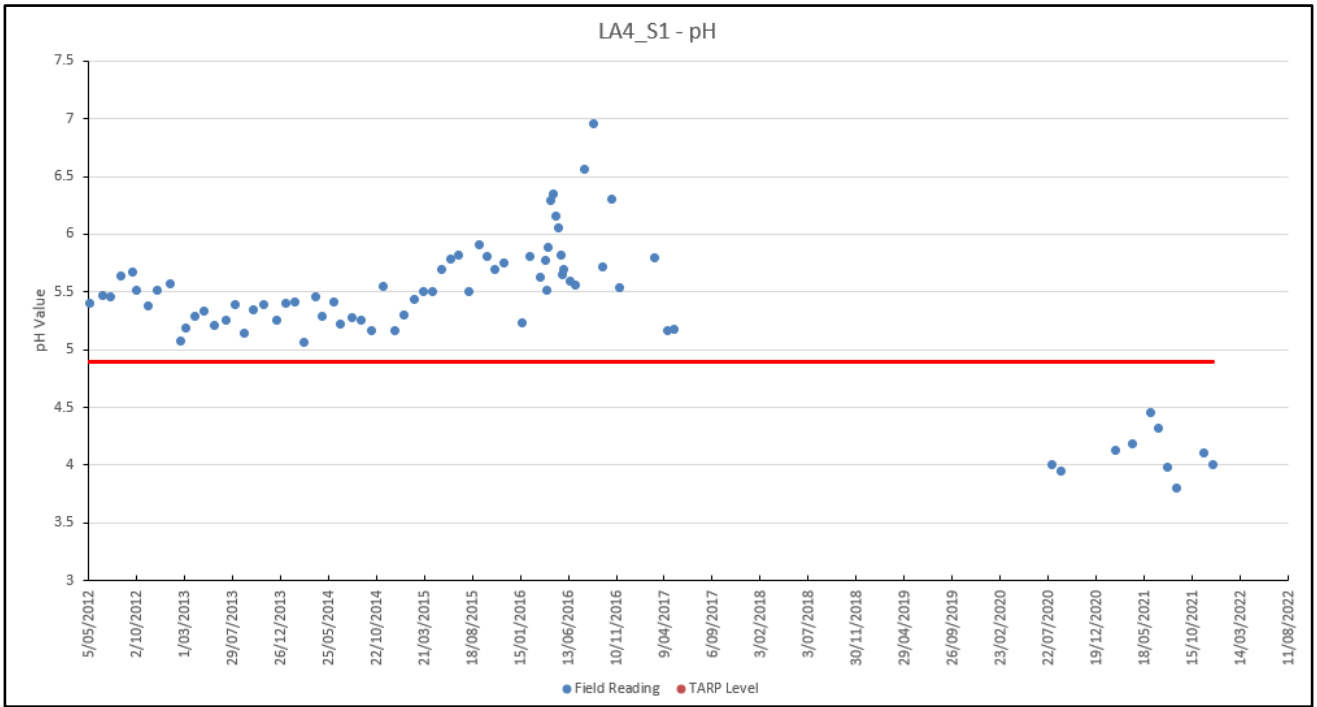
– pH 4.90

**Graph 1:** pH results recorded at LA4\_S1, a water quality monitoring site on Lake Avon tributary LA4.

CMAs will be implemented as per the Dendrobium Area 3B Watercourse TARP (Table 2). CMAs were previously undertaken in response to the pH and EC Level 3 triggers; as reported 9 June 2021 and 6 July 2021, respectively. An additional specialist review will be undertaken to analyse the most recent dataset.

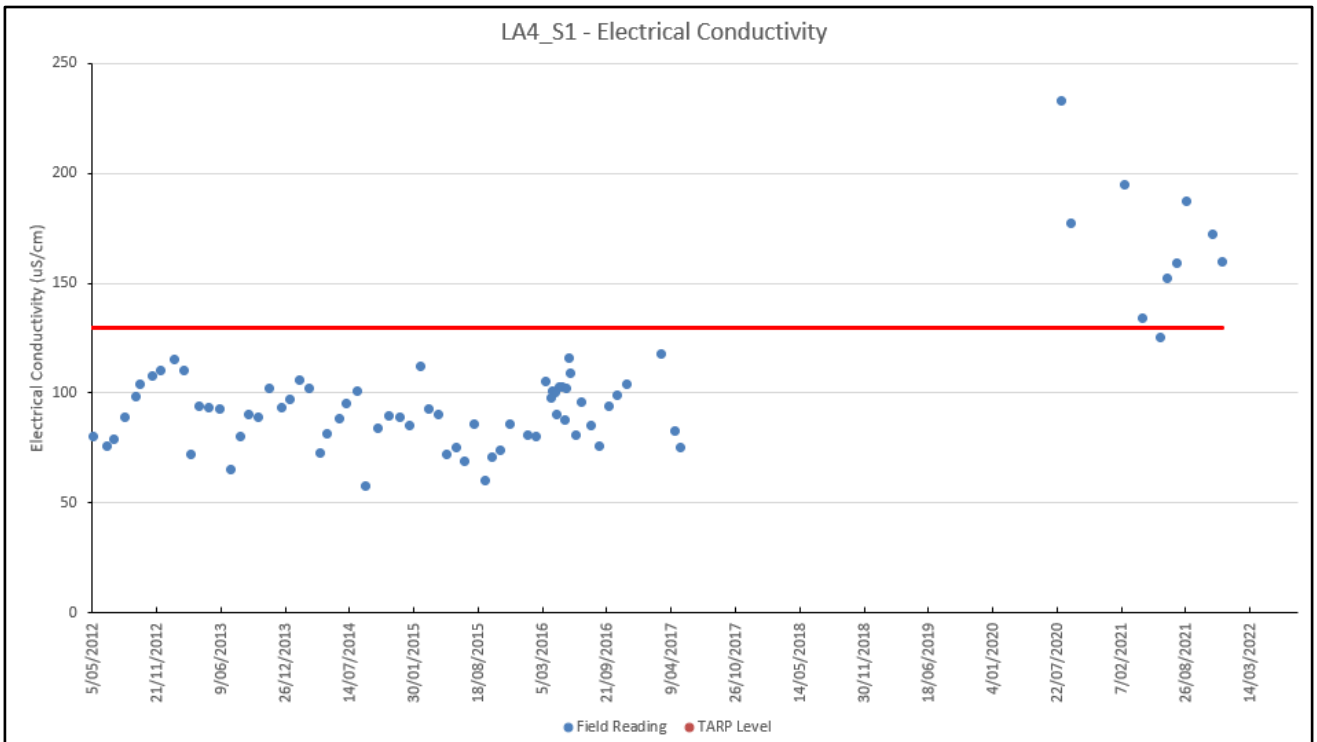
– EC 129.8  $\mu$ S/cm

**Graph 2:** Electrical Conductivity results recorded at LA4\_S1, a water quality monitoring site on Lake Avon tributary LA4.

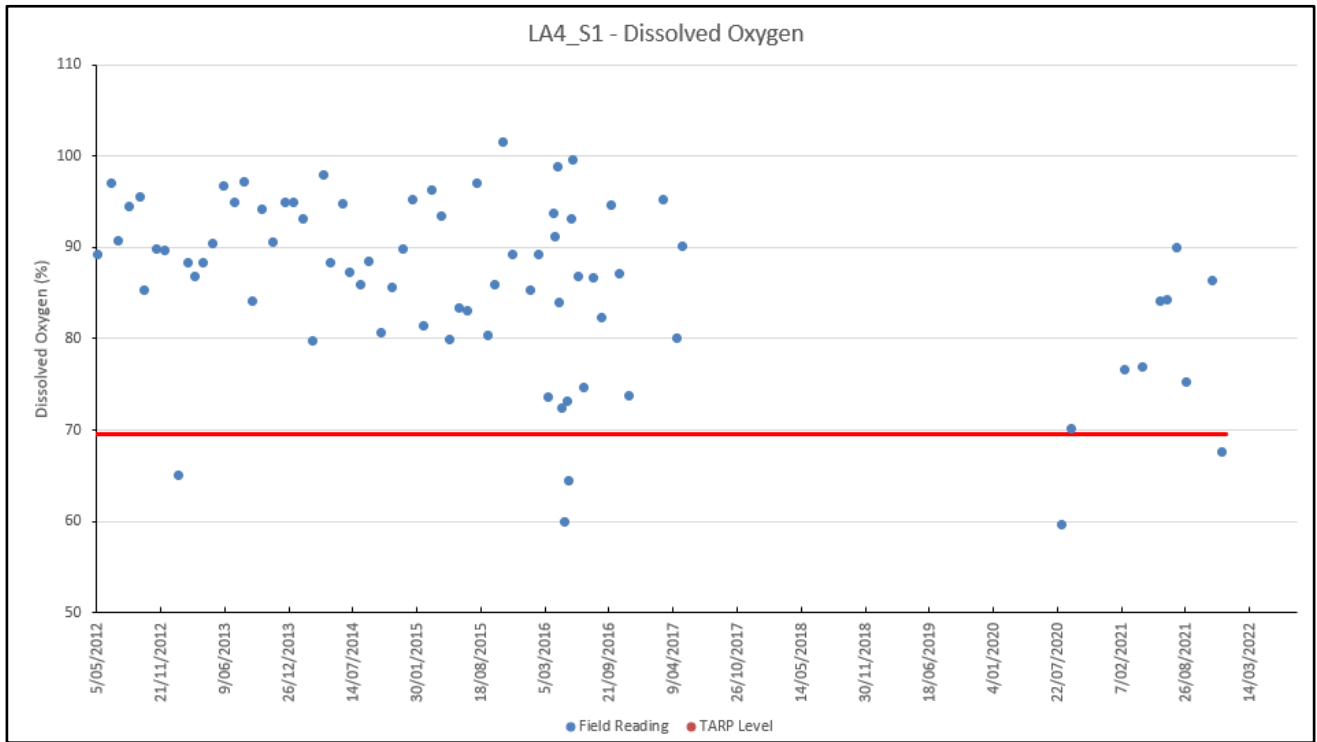
– DO 69.5 %

**Graph 3:** Dissolved Oxygen results recorded at LA4\_S1, a water quality monitoring site on Lake Avon tributary LA4.

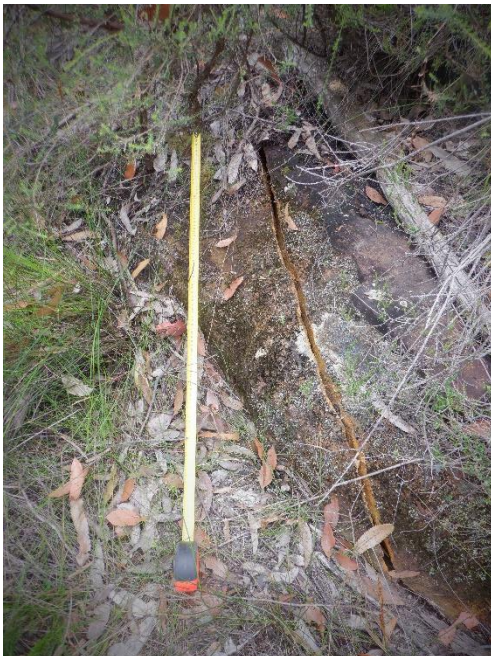
*DA3B\_LW18\_002* is located on a rock outcrop/steep slope west of Fire Road 6A (Figure 1). The impact area consists of two rock fractures with associated soil cracking. The largest fracture has a maximum continuous length of 3.46m, a width of up to 0.025m and a maximum measurable depth of 0.68m (Photo 1 and Photo 2).

- Crack or fracture up to 10m in length;
- Crack or fracture up to 100mm width.

Photo 1: *DA3B\_LW18\_002*, showing a section of rock fracturing. Taken 31/01/2022.

- Continue monitoring program as required in the DA3B SMP.
- Report impacts to key stakeholders.
- Summarise impacts and report in the End of Panel Report and Annual Review.
- Review monitoring frequency
- Notify relevant technical specialists and seek advice on any CMA required
- Provide safety signage and barricades as appropriate
- Implement agreed CMAs as approved (subject to agency feedback)

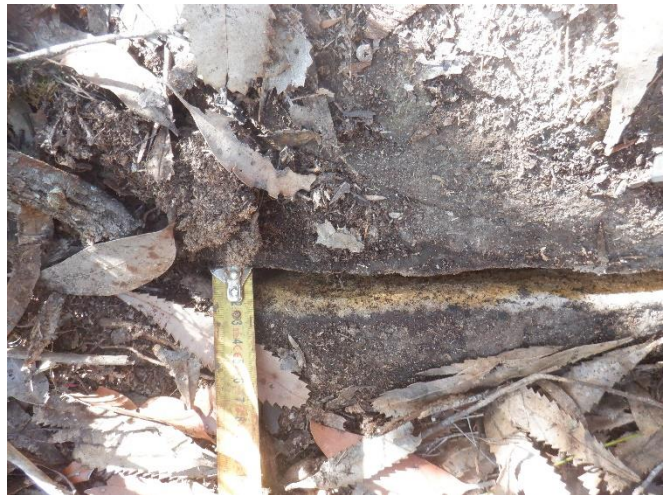
Photo 2: *DA3B\_LW18\_002*, showing the width of the fracturing. Taken 31/01/2022.

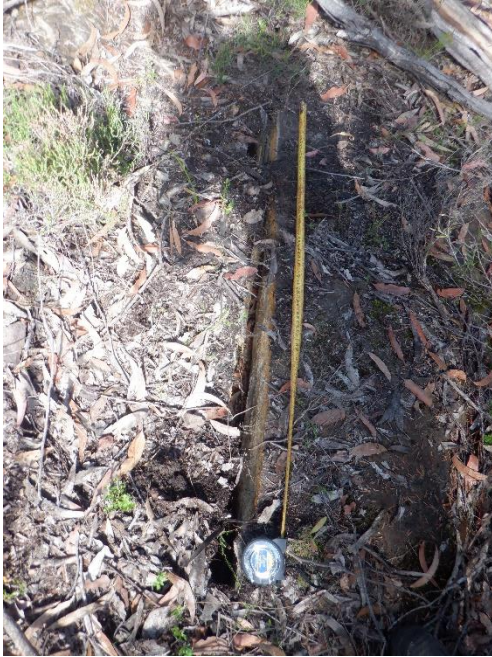
*DA3B\_LW18\_003* is located on a rock outcrop west of Fire Road 6A (Figure 1). The impact consists of a rock fracture. The rock fracture has a continuous length of 15.5m, a width of up to 0.08m and a maximum measurable depth of 1.1m (Photo 3 and Photo 4).

- Crack or fracture between 10m and 50m in length.

Photo 3: *DA3B\_LW18\_003*, showing a section of rock fracturing. Taken 31/01/2022.

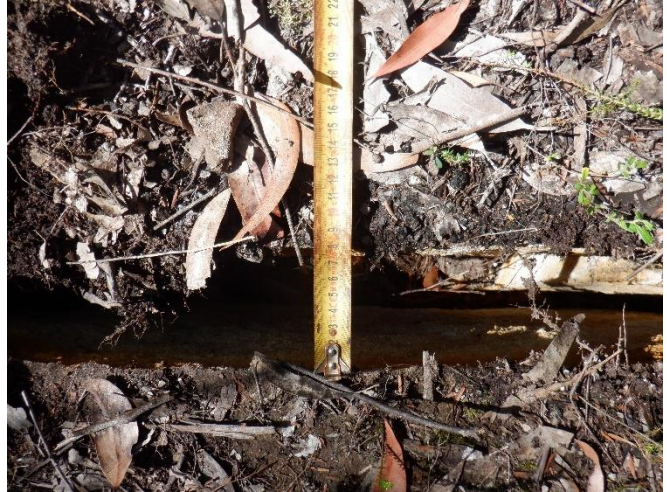
Photo 4: *DA3B\_LW18\_003*, showing the width of the fracturing. Taken 31/01/2022.

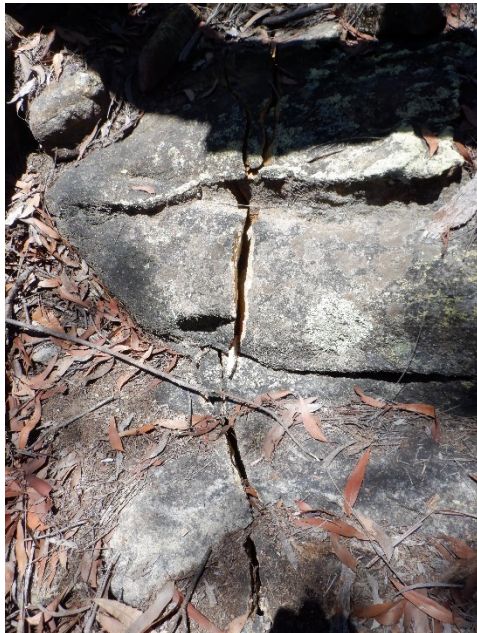
*DA3B\_LW18\_004* is located on a rock outcrop west of Fire Road 6A (Figure 1). The impact is comprised of a rock fracture. The fracture has a maximum continuous length of 2.9m, a width of up to 0.02m and a maximum measurable depth of 0.45m (Photo 1 and Photo 2).

- Crack or fracture up to 10m in length;
- Crack or fracture up to 100mm width.

Photo 1: *DA3B\_LW18\_004*, showing the length of rock fracturing. Taken 9/02/2022.

- Continue monitoring program as required in the DA3B SMP.
- Report impacts to key stakeholders.
- Summarise impacts and report in the End of Panel Report and Annual Review.

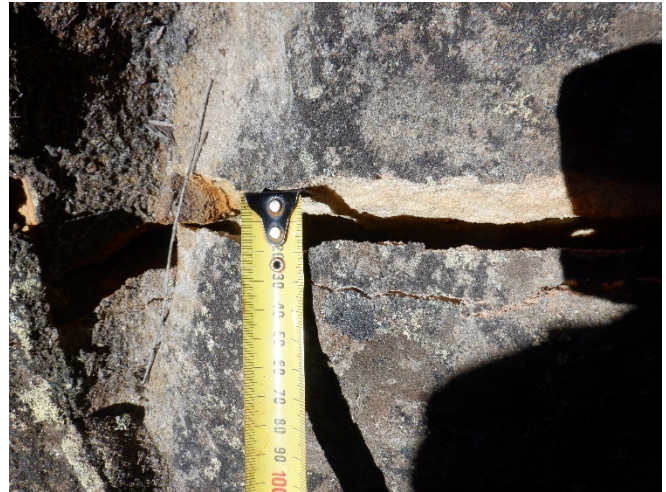
Photo 2: *DA3B\_LW18\_004*, showing the width of the fracturing. Taken 9/02/2022.

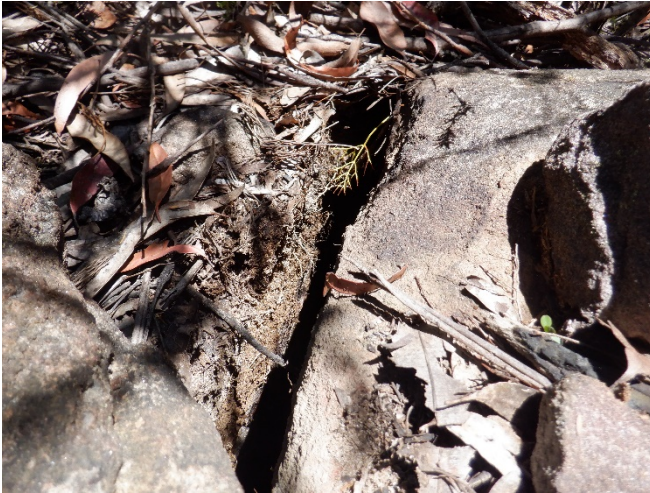
- Crack or fracture up to 10m in length;
- Crack or fracture up to 100mm width.

Photo 3: DA3B\_LW18\_005, showing a section of displacement. Taken 9/02/2022.

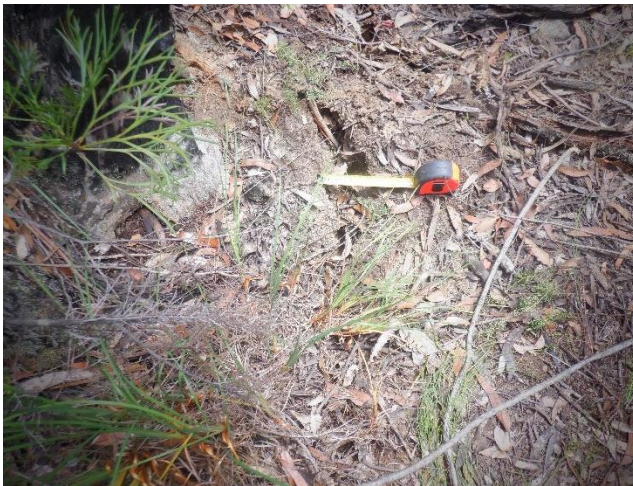
*DA3B\_LW18\_006* is located near an access track west of Fire Road 6A (Figure 1). The impact is comprised of soil cracking. The soil cracking has a continuous length of 15m, a width of up to 0.15m and a maximum measurable depth of 0.60m (Photo 1 and Photo 2).

- Crack or fracture between 10m and 50m in length;
- Crack or fracture between 100mm and 300mm width.

Photo 1: *DA3B\_LW18\_006*, showing a section of soil cracking. Taken 15/02/2022.

- Notify relevant technical specialists and seek advice on any CMA required.
- Provide safety signage and barricades as appropriate.
- Implement agreed CMAs as approved.

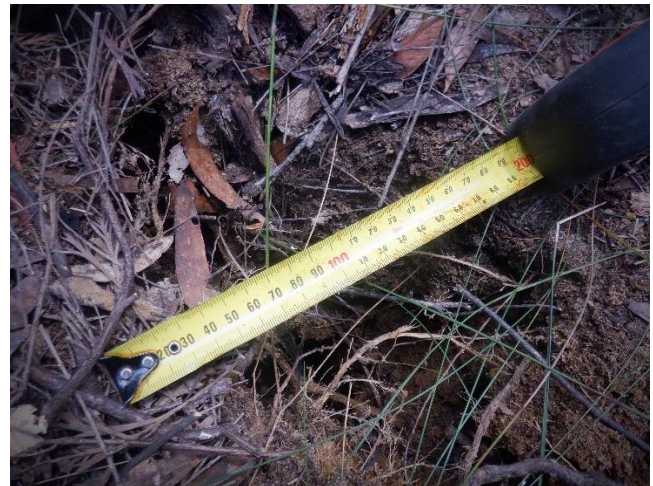
Photo 2: *DA3B\_LW18\_006*, showing the width of the soil cracking. Taken 15/02/2022.

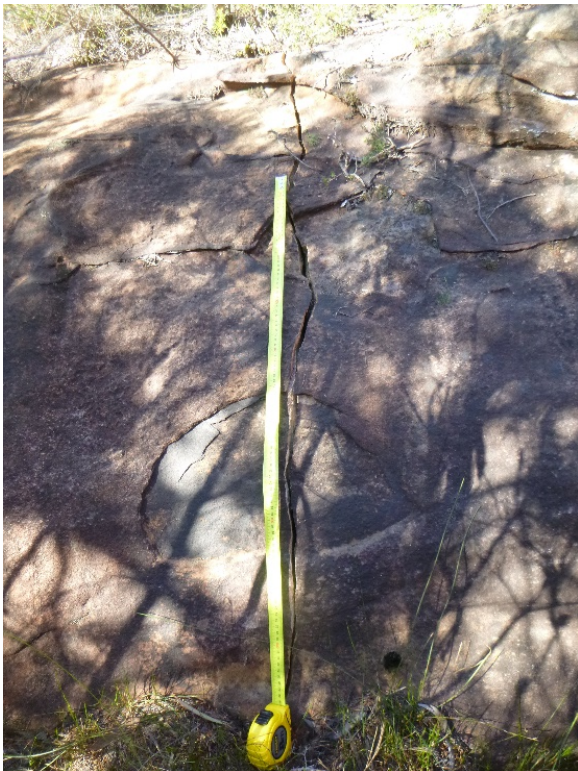
*DA3B\_LW18\_007* is located in bushland west of Fire Road 6A (Figure 1). The impact is comprised of rock fracturing. The rock fracturing has a continuous length of 2.03m, a width of up to 0.02m and a maximum measurable depth of 0.50m (Photo 1 and Photo 2).

- Crack or fracture up to 100mm width;
- Crack or fracture up to 10m length.

Photo 1: *DA3B\_LW18\_007*, showing a section of rock fracturing. Taken 8/06/2022.

- Notify relevant technical specialists and seek advice on any CMA required.
- Provide flagging at Level 2 Impact sites.
- Implement agreed CMAs as approved.

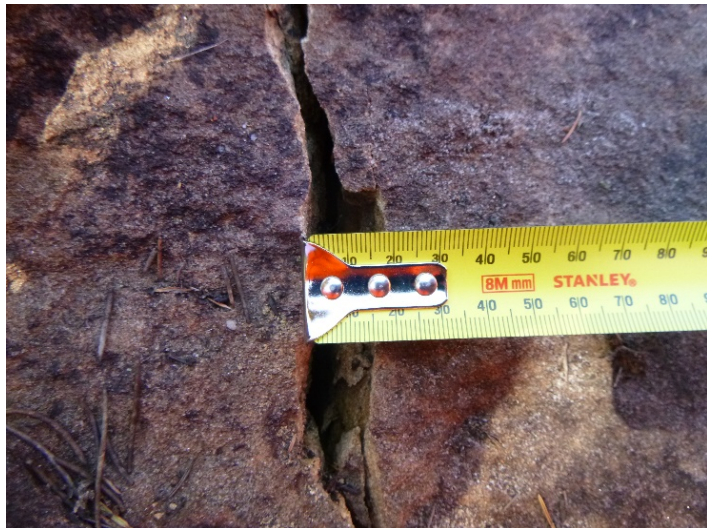
Photo 2: *DA3B\_LW18\_007*, showing the width of rock fracturing. Taken 8/06/2022.

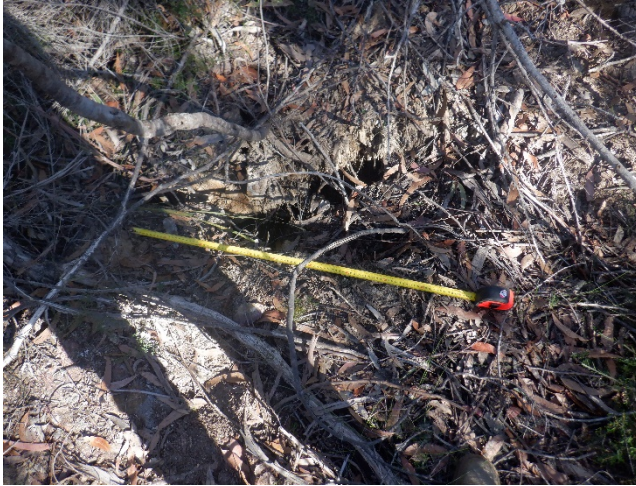
*DA3B\_LW18\_008* is located near an access track west of Fire Road 6A (Figure 1). The impact is comprised of soil cracking. The soil cracking has a continuous length of 15.52m, a maximum width of 0.28m and a maximum measurable depth of 2.8m (Photo 3 and Photo 4).

- Crack or fracture between 100 and 300mm width;
- Crack or fracture between 10 and 50m length.

Photo 3: *DA3B\_LW18\_008*, showing a section of soil cracking. Taken 9/06/2022.

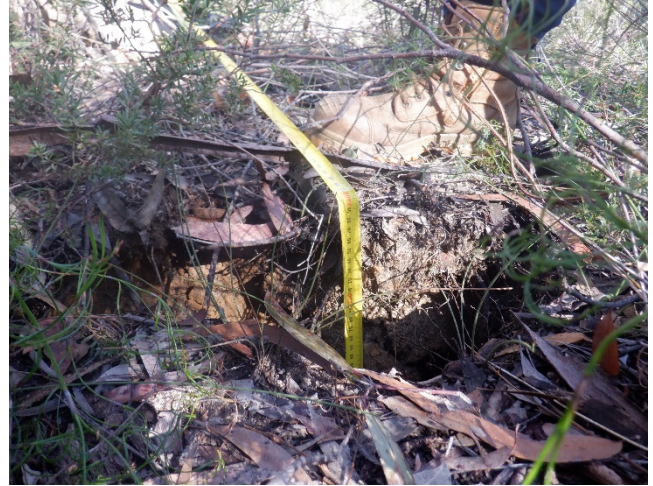
Photo 4: *DA3B\_LW18\_008*, showing the depth of soil cracking. Taken 9/06/2022.

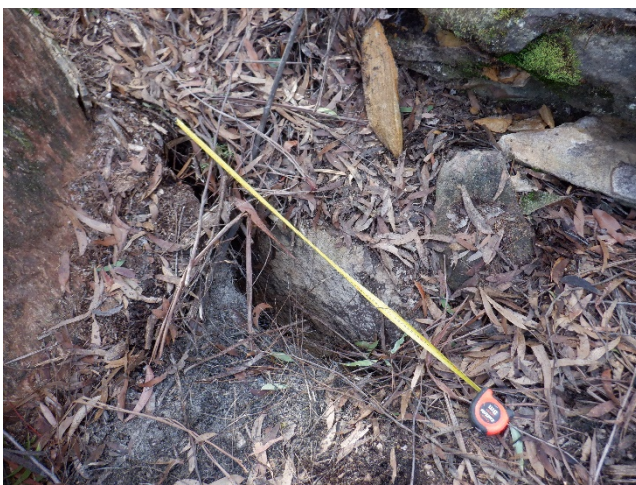
*DA3B\_LW18\_009* is located in bushland near NDC1 (Figure 1). The impact is comprised of rock displacement, fracturing and fragmentation. The rock displacement has a maximum continuous length of 0.9m, a maximum width of 0.2m and a maximum measurable depth of 1.0m (Photo 5 and Photo 6). The rock fracture has a maximum continuous length of 4.2m, a maximum width of 0.02m and a maximum measurable depth of 0.22m (Photo 7 and Photo 8).

- Crack or fracture between 100 and 300mm width.

Photo 5: *DA3B\_LW18\_009*, showing a section of rock displacement. Taken 9/06/2022.

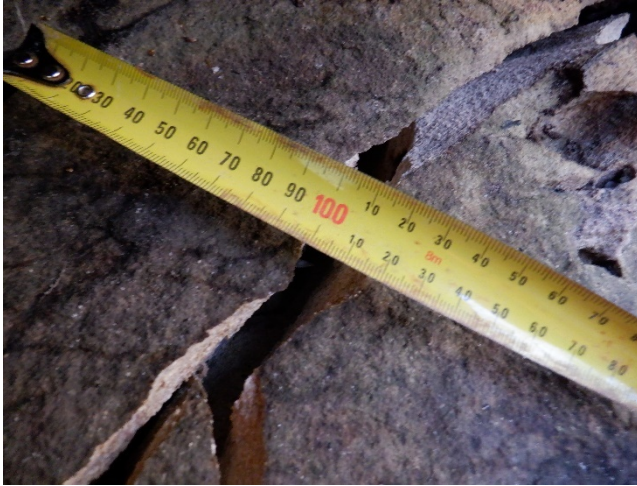
Photo 7: *DA3B\_LW18\_009*, showing width of rock fracturing. Taken 9/06/2022.

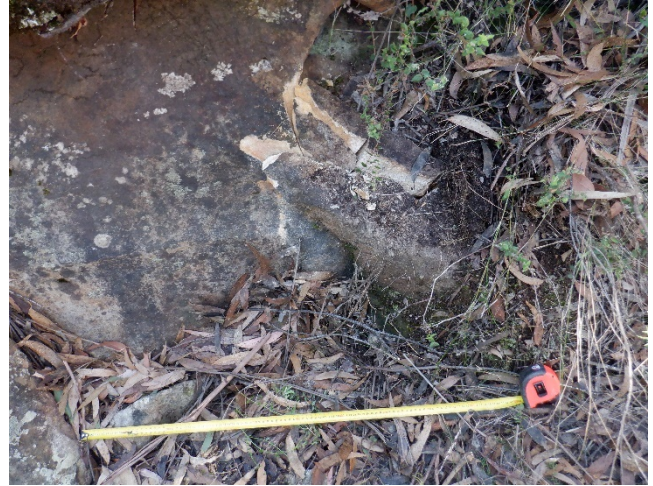
Photo 8: *DA3B\_LW18\_009*, showing a section of rock fragmentation. Taken 9/06/2022.

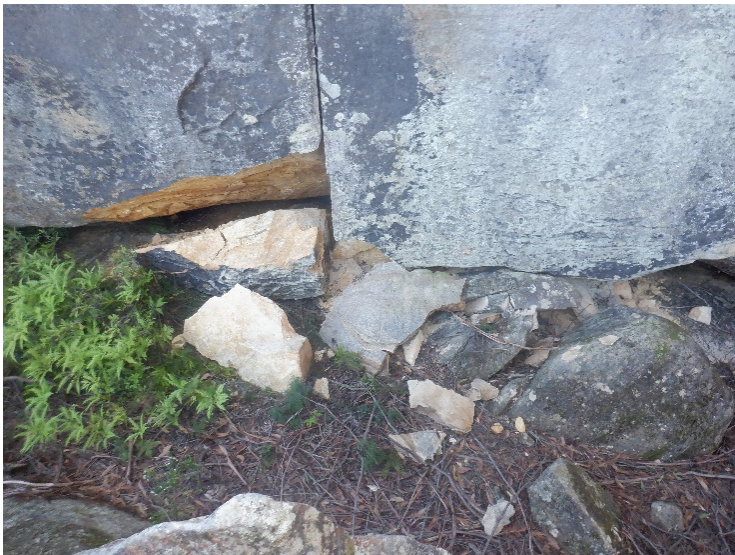
- Rock fall from a cliff (steep slope) which is left mostly intact (<10% length), resulting in insignificant ground disturbance

Photo 9: *DA3B\_LW18\_010*, showing rock fall and fragmentation. Taken 10/06/2022.

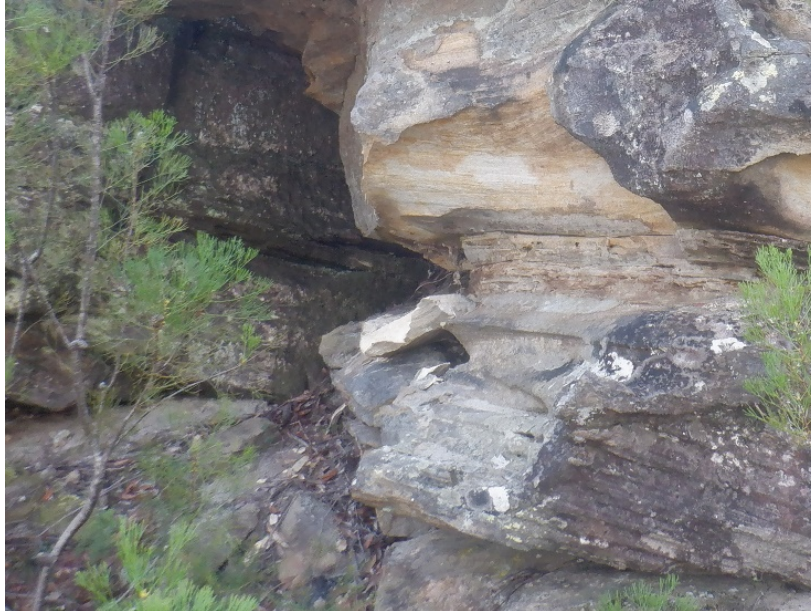
- Rock fall from a cliff (step/outcrop) which is left mostly intact (<10% length), resulting in insignificant ground disturbance

Photo 11: *DA3B\_LW18\_011*, showing rockfall. Taken 10/06/2022.

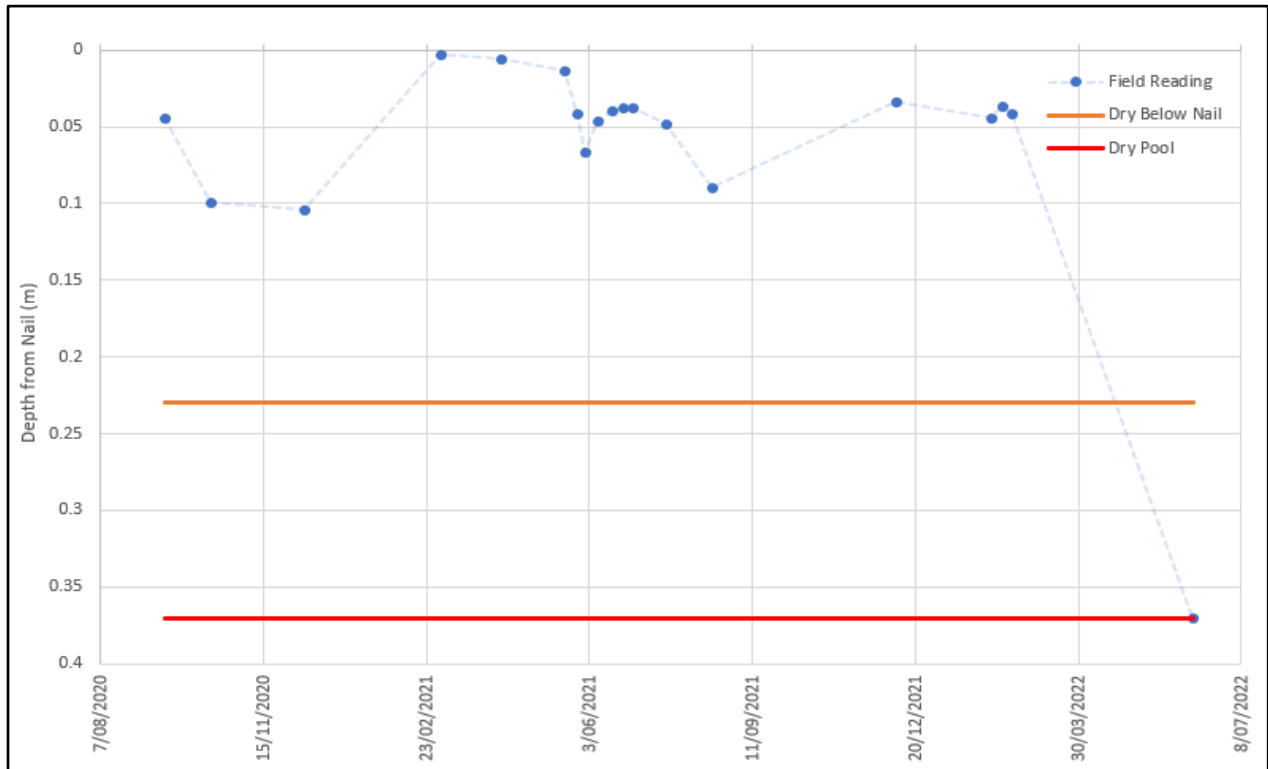
*ND1C* is a tributary to Native Dog Creek. *ND1C\_Pool 2* was mined beneath by Longwall 18 on approximately 1 April 2022 (Figure 1). On 8 June 2022, *ND1C\_Pool 2* was observed as dry for the first time since monitoring began at the site (Graph 1, Photo 12 and Photo 13). No fracturing or cracking was identified in the area.

Graph 1: ND1C\_Pool 2 field water level readings.

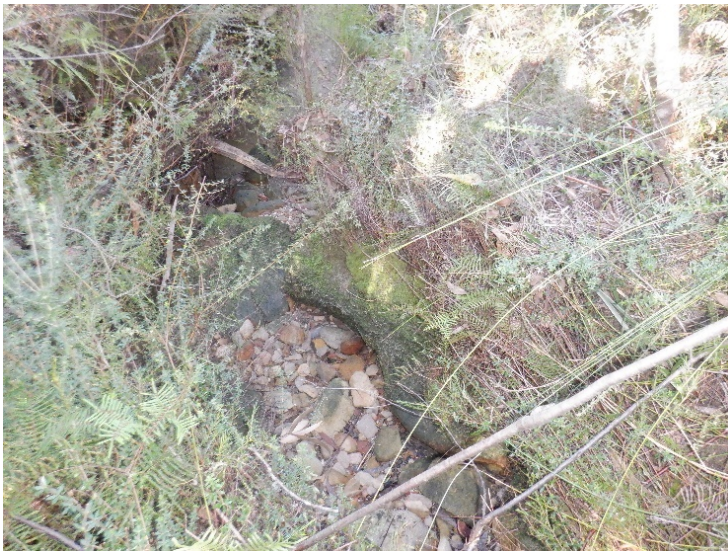
Photo 12: ND1C\_Pool 2, looking downstream. Taken 8/06/2022.

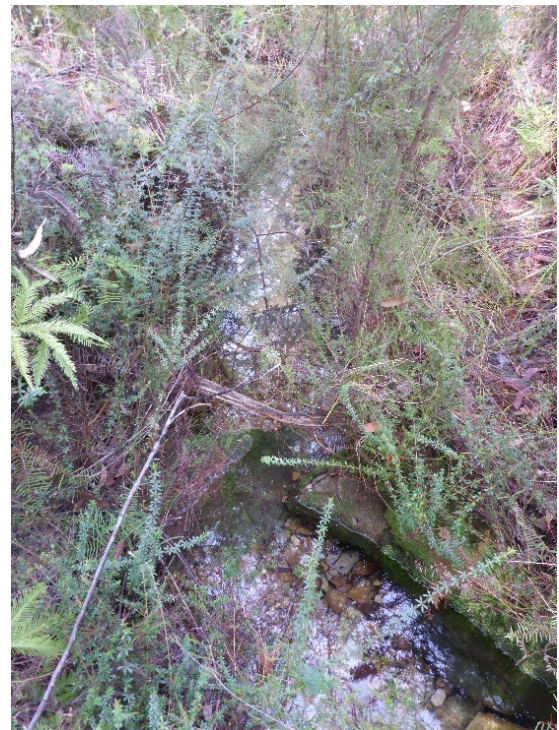
Photo 13: ND1C\_Pool 2, looking downstream. Taken 19/07/2021.

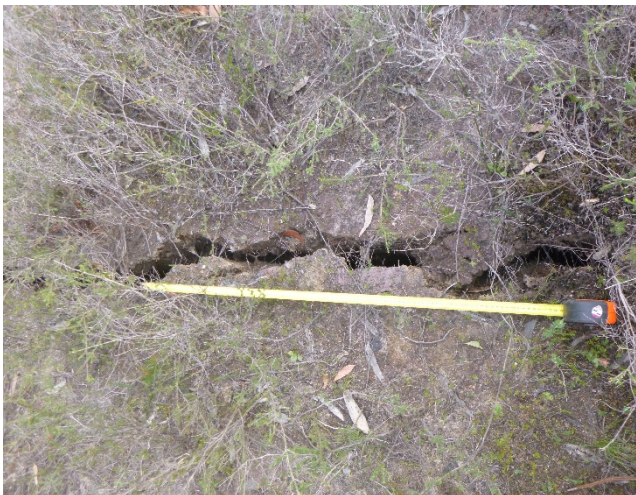
DA3B\_LW18\_005 is located on a steep slope/ridgeline west of Fire Road 6A (Figure 1). The impact was identified on 9 February 2022, consisting of displacement between soil and adjacent rock strata. The displacement has a discontinuous length of 5.5m, a continuous length of 1.9m, a width of up to 0.06m and a maximum measurable depth of 1.1m. On 30 June 2022, additional soil cracking was observed. The soil cracking has a maximum continuous length of 16m, discontinuous length of 42.4m, maximum width of 0.09m and maximum measurable depth of 3.09m (Photo 1 and Photo 2).

- Crack or fracture between 10 and 50m length.

Photo 1: DA3B\_LW18\_005, showing a section of soil cracking. Taken 30/06/2022.

- Continue monitoring program as required in the DA3B SMP.
- Report impacts to key stakeholders (Biodiversity and Conservation Division; WaterNSW; NSW Resources Regulator; Regional NSW – Mining, Exploration and Geoscience)
- Summarise impacts and report in the End of Panel Report and Annual Review.
- Review monitoring frequency.
- Notify relevant technical specialists and seek advice on any CMA required.
- Provide flagging at Level 2 Impact sites.
- Implement agreed CMAs as approved.

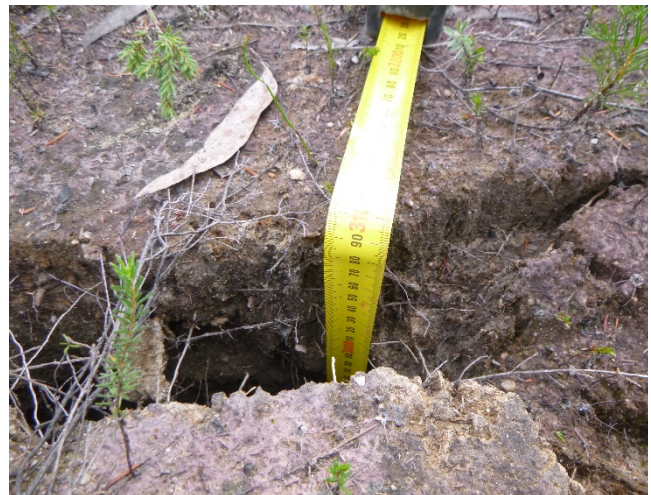
Photo 2: DA3B\_LW18\_005, showing the depth of soil cracking. Taken 30/06/2022.

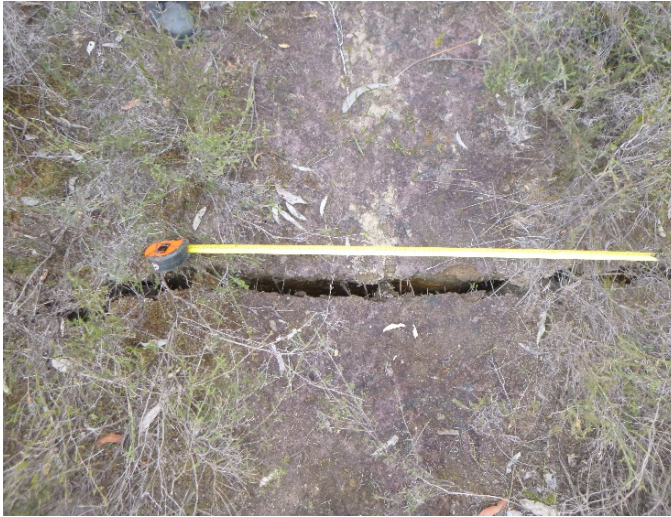
DA3B\_LW18\_012 is located in bushland west of Fire Road 6A (Figure 1). The impact is comprised of two soil cracks running in parallel, with discontinuous lengths of 26m and 9.5m. The soil cracking has a maximum continuous length of 10.8m, a width of up to 0.06m and a maximum measurable depth of 3.70m (Photo 3 and Photo 4). Visible rock fracturing can be seen in lower sections of the soil cracking (Photo 5).

- Crack or fracture between 10 and 50m length.

Photo 3: DA3B\_LW18\_012, showing a section of soil cracking. Taken 30/06/2022.

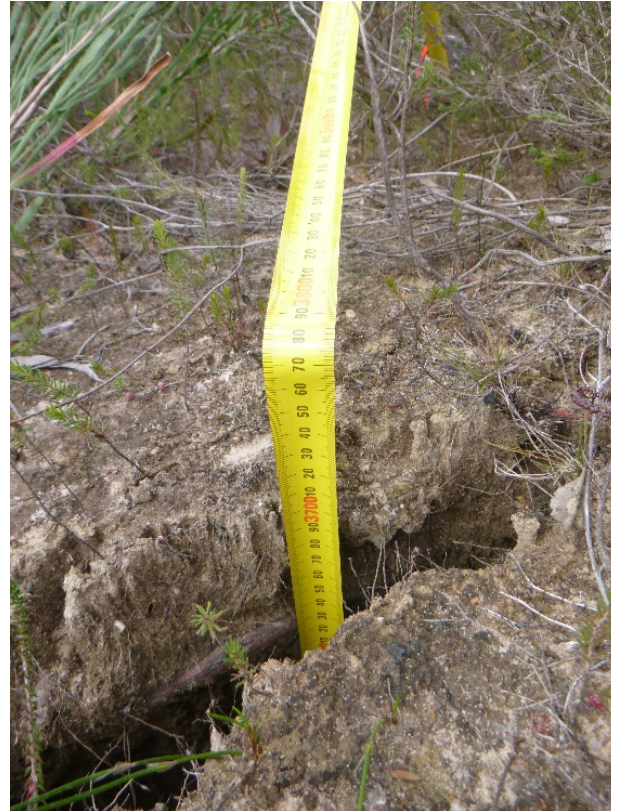
Photo 4: DA3B\_LW18\_012, showing depth of soil cracking. Taken 30/06/2022.

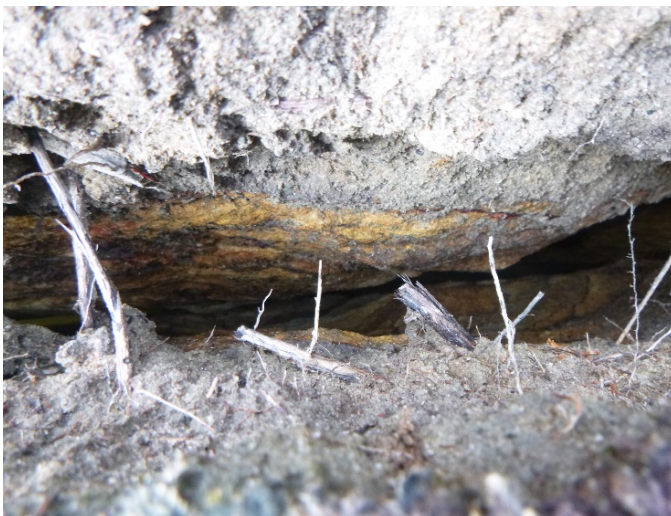
Photo 5: DA3B\_LW18\_012, showing exposed rock within the cracking. Taken 30/06/2022.

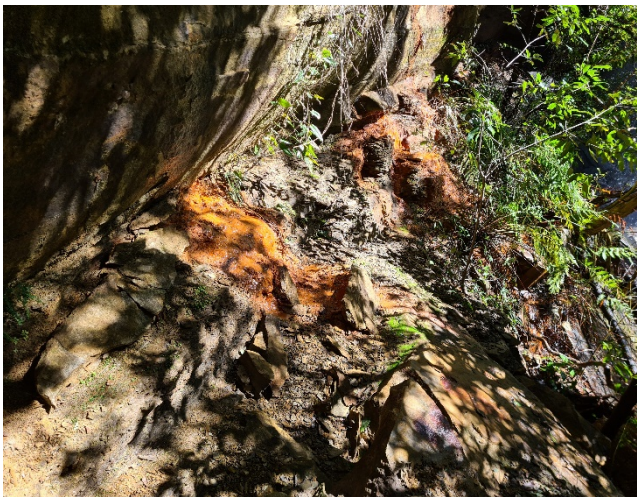
An increase in iron staining was also observed at the waterfall (Photo 5), compared to observations recorded in the baseline period. No visual changes to water flow were identified (Photo 6). A specialist review will be undertaken for this impact.

Photo 5: DA3B\_LW17\_041, showing a section of iron staining. Taken 2/08/2022.

- Update future predictions based on the outcomes of the investigation.
- Provide residual environmental offset for any mining impact where CMAs are unsuccessful as required by Condition 14 Schedule 3 of the Development Consent.

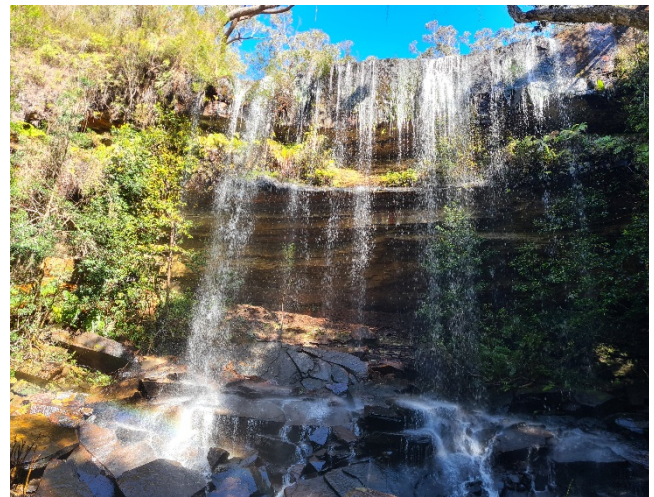
Photo 6: DA3B\_LW17\_041, showing overview of Waterfall 54. Taken 2/08/2022.

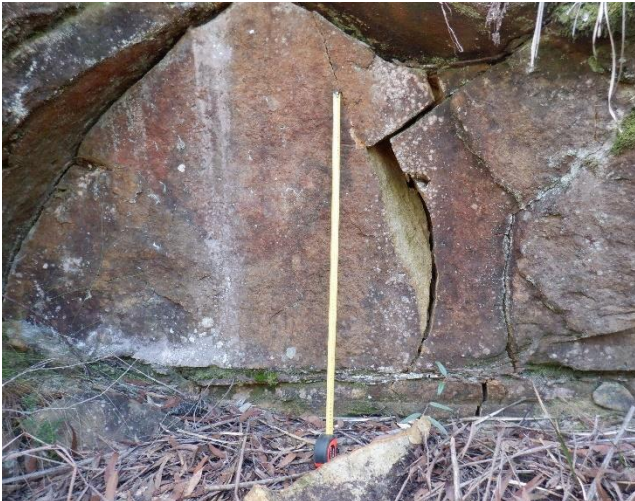
*DA3B\_LW18\_013* is located on a steep slope/step on the northern slope of LA2 valley (Figure 1). The impact was mined beneath by Longwall 17. The impact is comprised of a rock fracture and fragmentation (Photo 1 and Photo 2). The rock fracture has a maximum length of 1.1m, a maximum measurable depth of 0.5m and a maximum width of 0.015m. The rock fragmentation has an approximate volume of 0.015m<sup>3</sup> (0.14m x 0.2m x 0.55m).

- Crack or fracture up to 10m length
- Crack or fracture up to 100mm width

Photo 1: *DA3B\_LW18\_013*, showing overview of rock fracture. Taken 16/08/2022.

- Continue monitoring program as required in the DA3B SMP.
- Report impacts to key stakeholders (Biodiversity and Conservation Division; WaterNSW; NSW Resources Regulator; Regional NSW – Mining, Exploration and Geoscience)
- Summarise impacts and report in the End of Panel Report and Annual Review.
- Provide flagging as appropriate
- Review monitoring frequency.
- Notify relevant technical specialists and seek advice on any CMA required.
- Implement agreed CMAs as approved.

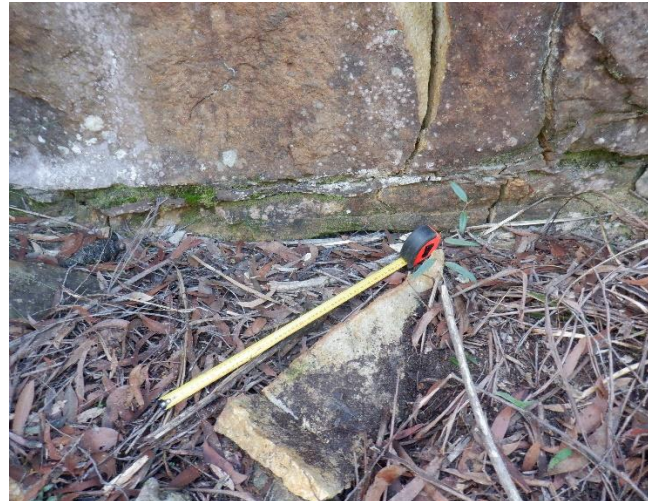
Photo 2: *DA3B\_LW18\_013*, showing rock fragmentation. Taken 16/08/2022.

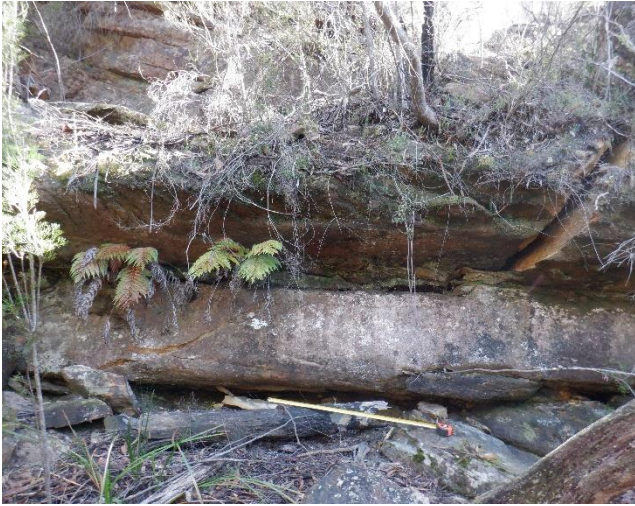
DA3B\_LW18\_014 is located on a steep slope/step on the northern slope of LA2 valley (Figure 1). The impact was mined beneath by Longwall 17. The impact is comprised of multiple rock fractures and a rockfall (Photo 3 to Photo 6). The rock fracture has a maximum length of 1.4m, a maximum width of 0.19m and a maximum measurable depth of 2m.

- Crack or fracture between 100 and 300mm width

Photo 3: DA3B\_LW18\_014, showing overview of site. Taken 16/08/2022.

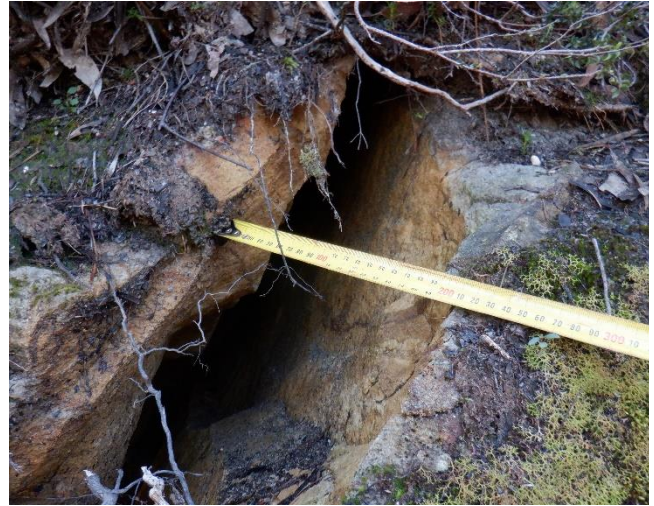
Photo 4: DA3B\_LW18\_014, maximum width of fracture. Taken 16/08/2022

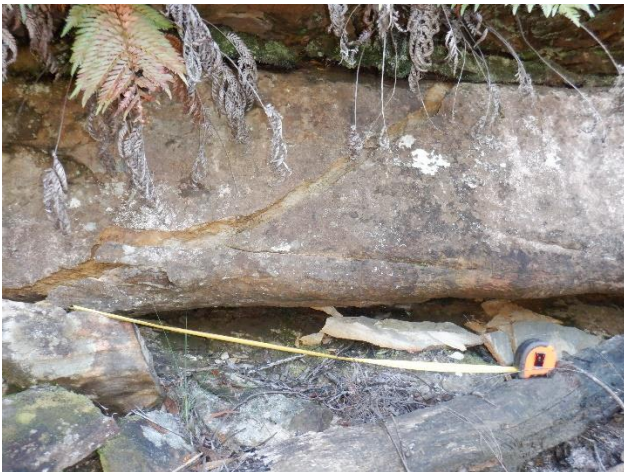
Photo 5: DA3B\_LW18\_014, showing section of rock fracturing. Taken 16/08/2022.

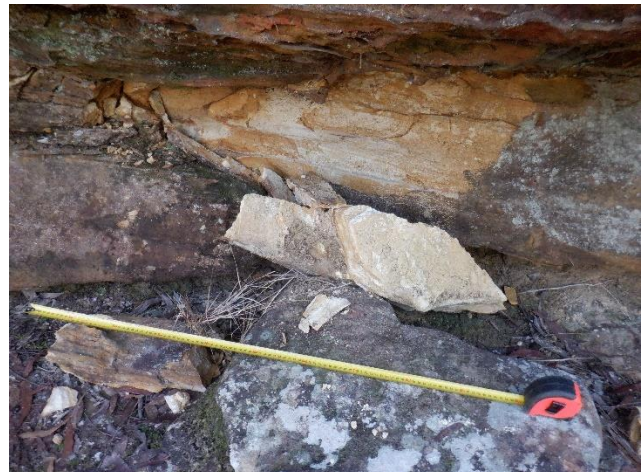
Photo 6: DA3B\_LW18\_014, showing rockfall debris. Taken 16/08/2022.

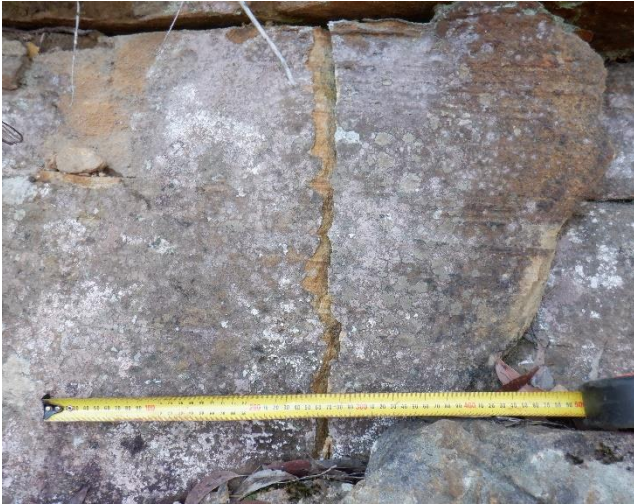
*DA3B\_LW18\_015* is located on a steep slope/step on the northern slope of LA2 valley (Figure 1). The impact site was mined beneath by Longwall 17. The impact is comprised of a vertical rock fracture at the base of a steep slope/step (Photo 7 and Photo 8). The rock fracture has a maximum length of 0.45m, a maximum measurable depth of 0.25m and a maximum width of 0.02m.

- Crack or fracture up to 10m length
- Crack or fracture up to 100mm width

Photo 7: *DA3B\_LW18\_015*, showing overview of rock fracture. Taken 16/08/2022.

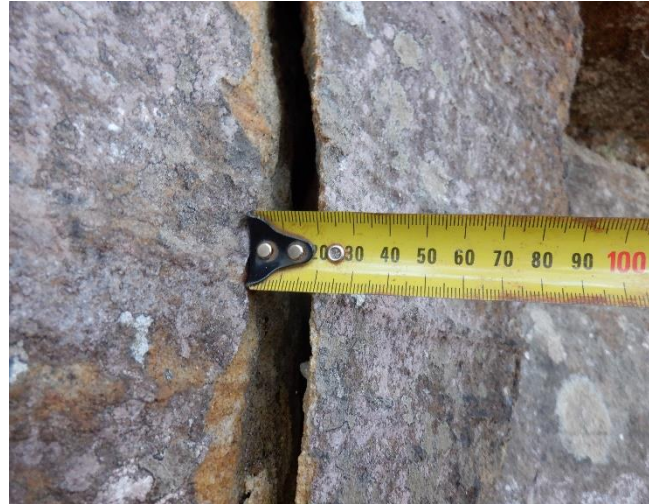
Photo 8: *DA3B\_LW18\_015*, showing width of rock fracture. Taken 16/08/2022.

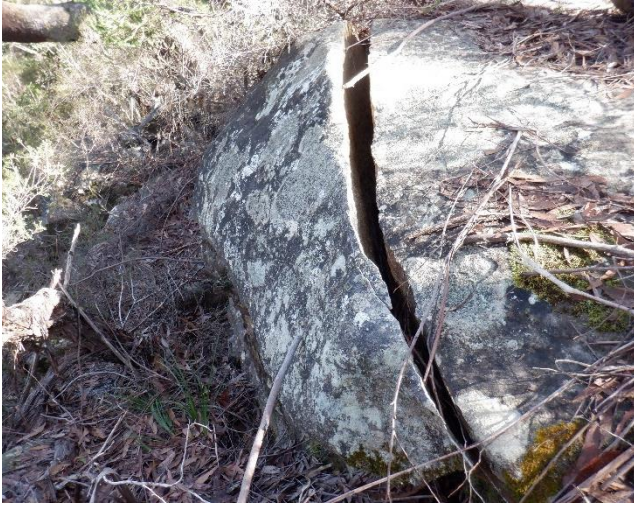
*DA3B\_LW18\_016* is located on a steep slope/step on the northern slope of LA2 valley (Figure 1). The impact was mined beneath by Longwall 17. The impact is comprised of multiple rock fractures in an area of 15m<sup>2</sup> (Photo 9 to Photo 10). The rock fracturing has a maximum length of 2.9m, a maximum width of 0.11m and a maximum measurable depth of 0.94m.

- Crack or fracture between 100 and 300mm width

Photo 9: DA3B\_LW18\_016, showing largest rock fracture. Taken 16/08/2022.

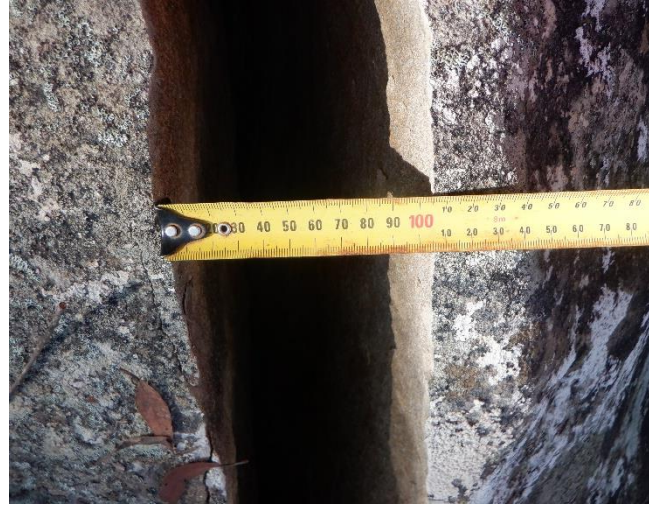
Photo 10: DA3B\_LW18\_016, showing maximum width of rock fracturing. Taken 16/08/2022

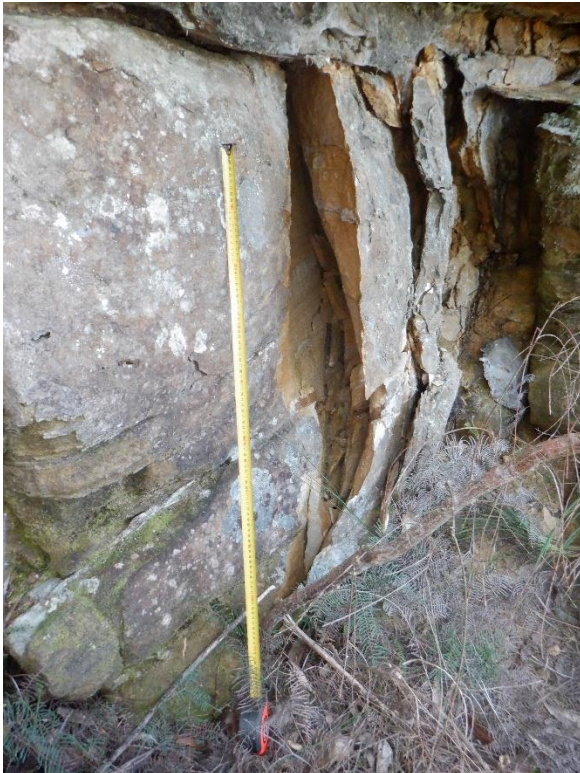
- Rockfall from a cliff which is left mostly intact (<10% length), resulting in insignificant ground disturbance
- Crack or fracture up to 100mm width
- Crack or fracture up to 10m length

Photo 11: DA3B\_LW18\_017, showing rock displacement. Taken 16/08/2022.

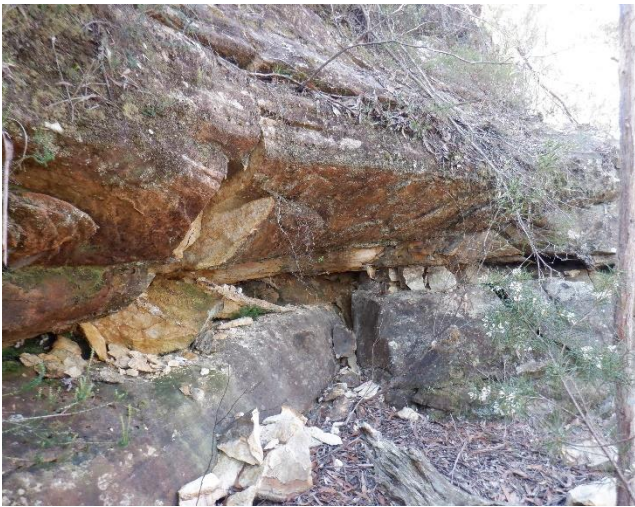
- Crack or fracture up to 10m in length
- Crack or fracture up to 100mm width
- Rockfall from a cliff which is left mostly intact (<10% length), resulting in insignificant ground disturbance

Photo 13: *DA3B\_LW18\_018*, showing section of rockfall and rock fracturing. Taken 16/08/2022.

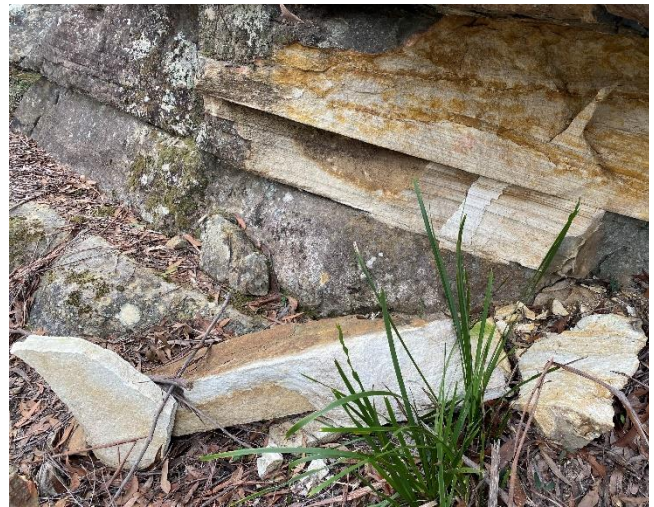
Photo 14: *DA3B\_LW18\_018*, showing section of rockfall. Taken 16/08/2022.

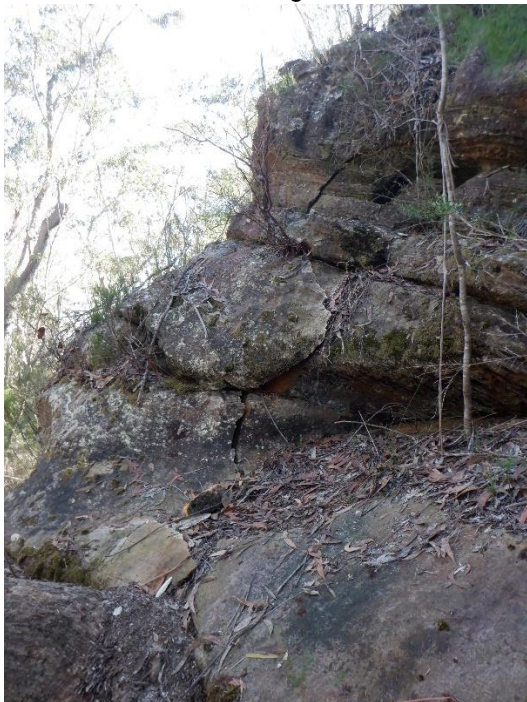
Photo 15: *DA3B\_LW18\_018*, showing section of rock fracturing. Taken 16/08/2022.

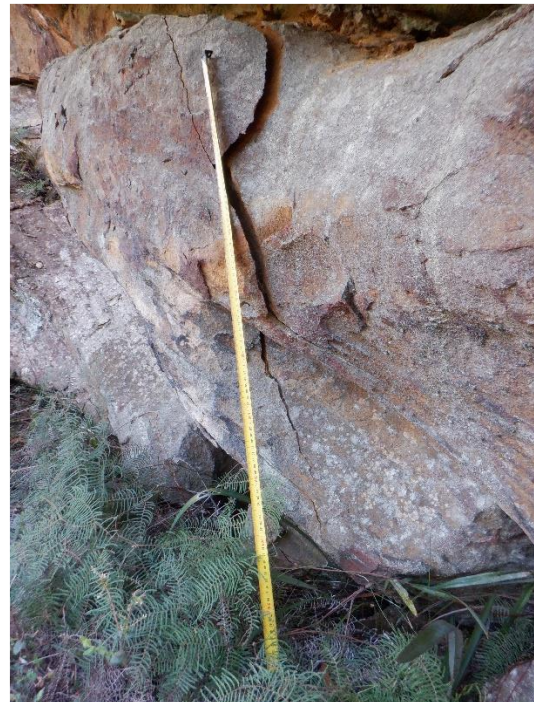
Photo 16 *DA3B\_LW18\_018*, showing section of rock fracturing. Taken 16/08/2022.
