#### **DA3B\_LW18\_001 (E 288784, N 6191476)**

Table 2: Summary of Longwall 18 impacts and triggers. Highlighted rows indicate the latest impacts featured in this report.

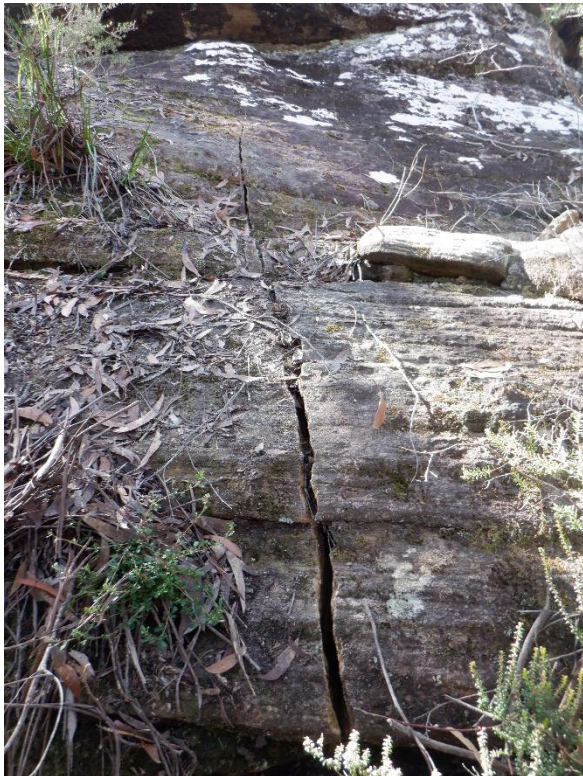
- Crack or fracture up to 10m in length
- Crack or fracture up to 100mm width

Photo 17: *DA3B\_LW18\_019*, showing overview of rock fracture. Taken 16/08/2022.

- Continue monitoring program as required in the DA3B SMP.
- Report impacts to key stakeholders (Biodiversity and Conservation Division; WaterNSW; NSW Resources Regulator; Regional NSW – Mining, Exploration and Geoscience)
- Summarise impacts and report in the End of Panel Report and Annual Review.
- Provide flagging as appropriate
- Review monitoring frequency.
- Notify relevant technical specialists and seek advice on any CMA required.
- Implement agreed CMAs as approved.

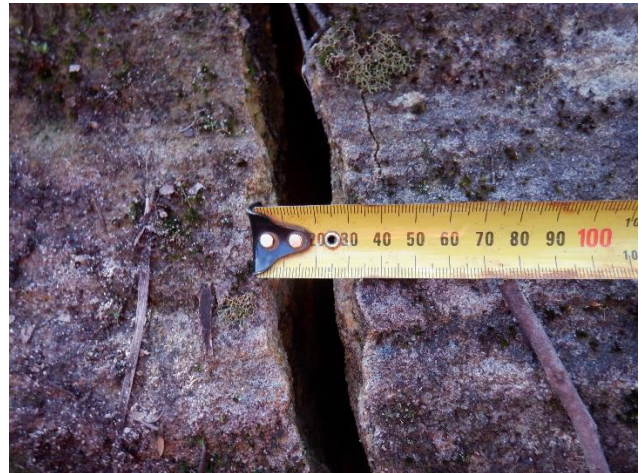
Photo 18: *DA3B\_LW18\_019*, showing maximum width of rock fracture. Taken 16/08/2022.

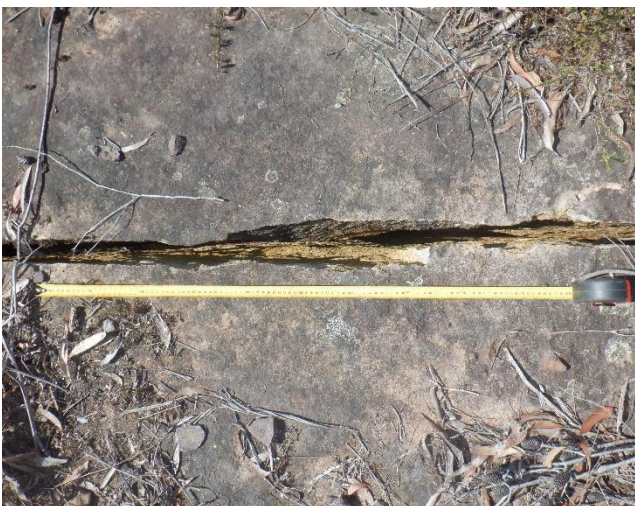
- Crack or fracture between 10 and 50m in length
- Crack or fracture between 100 and 300mm width

Photo 21: *DA3B\_LW18\_021*, showing section of rock fracturing. Taken 16/08/2022.

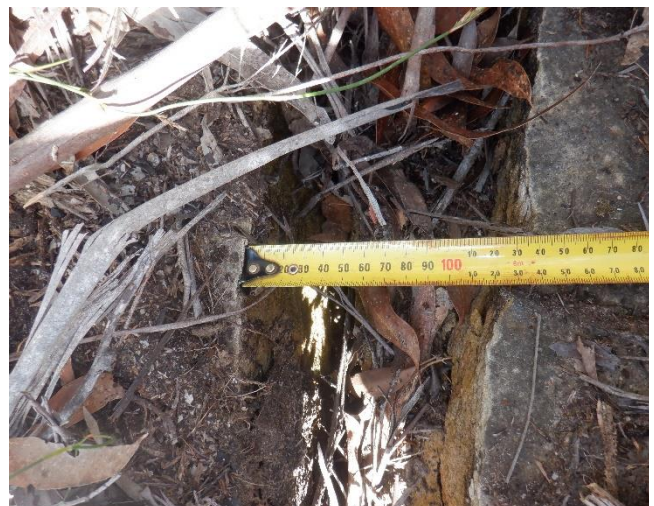
Photo 22: *DA3B\_LW18\_021*, showing maximum width of rock fracturing. Taken 16/08/2022.

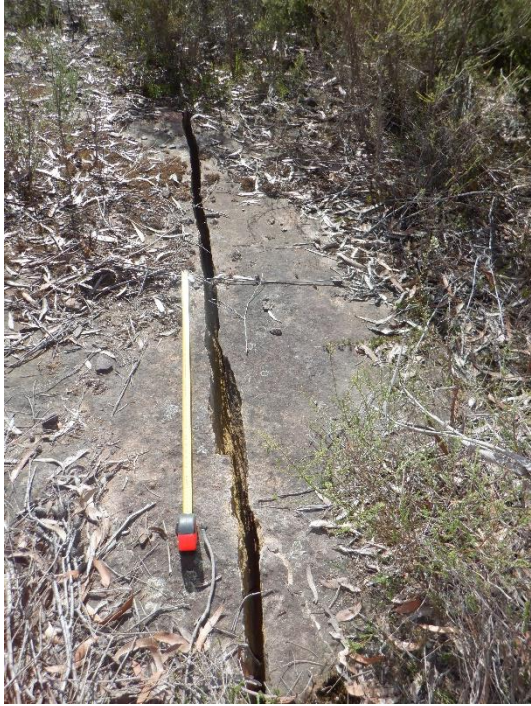
Photo 23: *DA3B\_LW18\_021*, showing overview of largest fracture. Taken 16/08/2022.

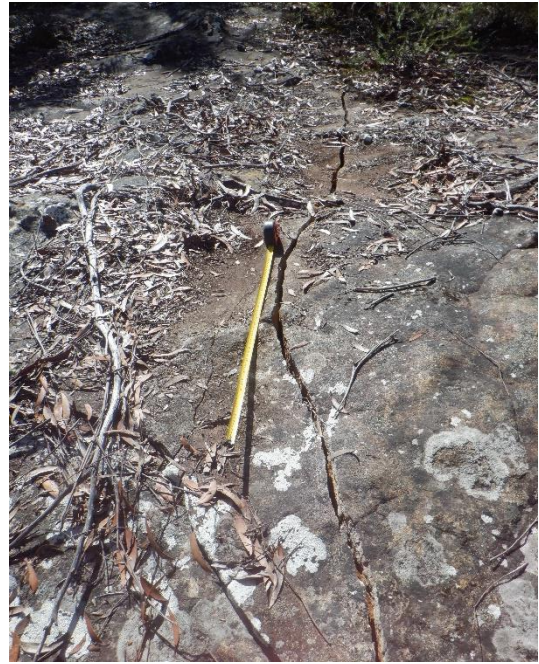
Photo 24 *DA3B\_LW18\_021*, showing section of rock fracturing. Taken 16/08/2022.

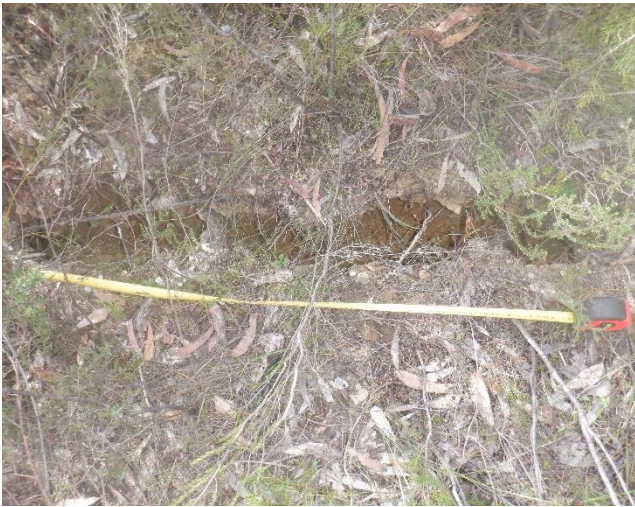
- Crack or fracture between 10 and 50m in length
- Crack or fracture between 100 and 300mm width

Photo 27: DA3B\_LW18\_023, showing section of soil cracking. Taken 16/08/2022.

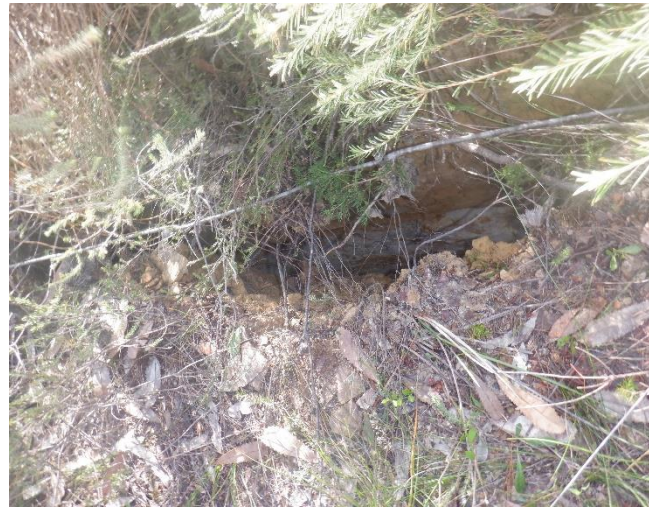
Photo 28: DA3B\_LW18\_023, showing maximum width of soil cracking. Taken 16/08/2022.

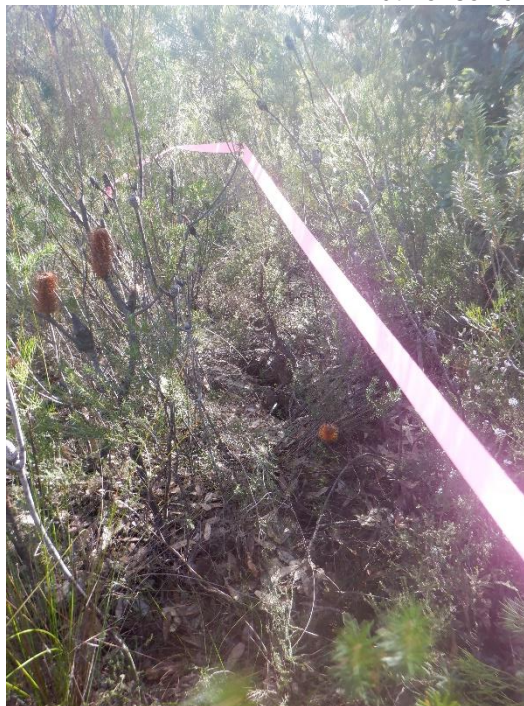
Photo 29: DA3B\_LW18\_023, showing overview of soil cracking. Taken 16/08/2022.

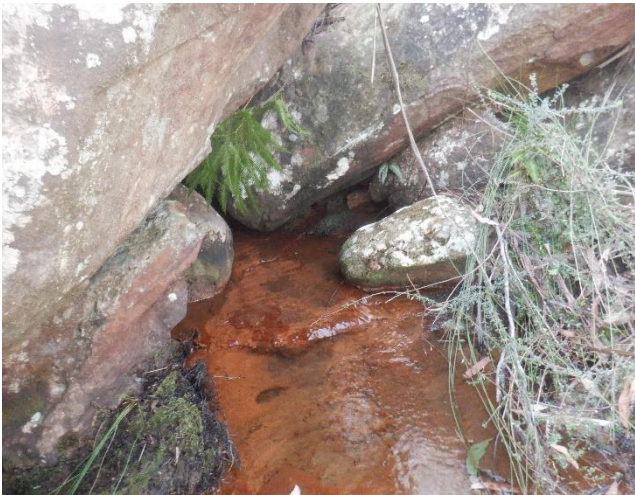
- Observable increase in iron staining within the mining area.

Photo 30: *LA3\_Boulderfield 4a* looking upstream at the origin of the iron staining. Taken 16/08/2022.

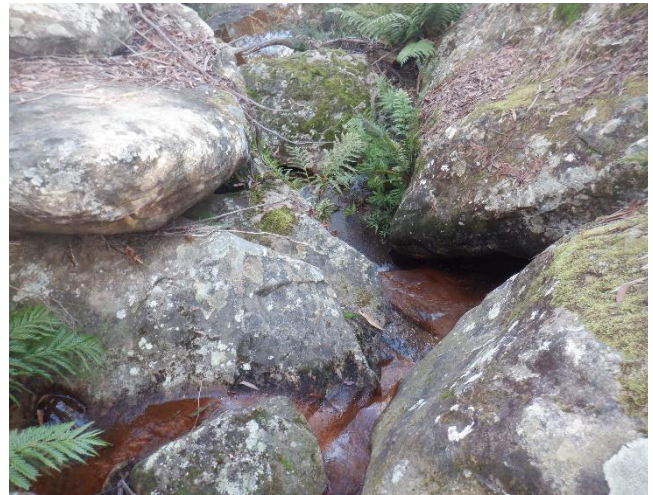
Photo 31: *LA3\_Boulderfield 4a* looking downstream from the origin of the iron staining. Taken 16/08/2022.

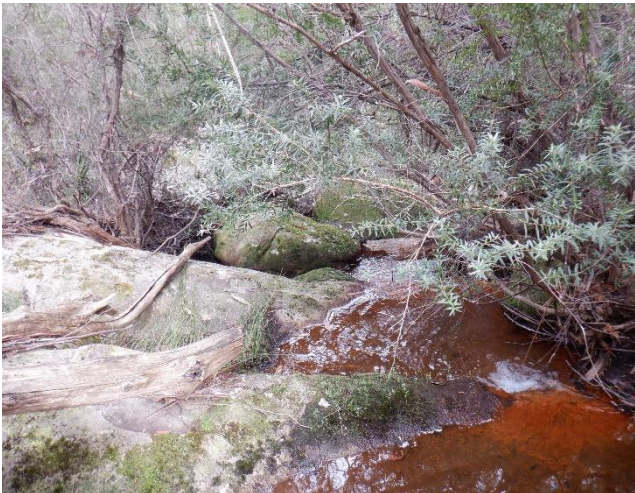
Photo 32: *LA3\_Pool 4*, looking downstream. Taken 15/08/2022.

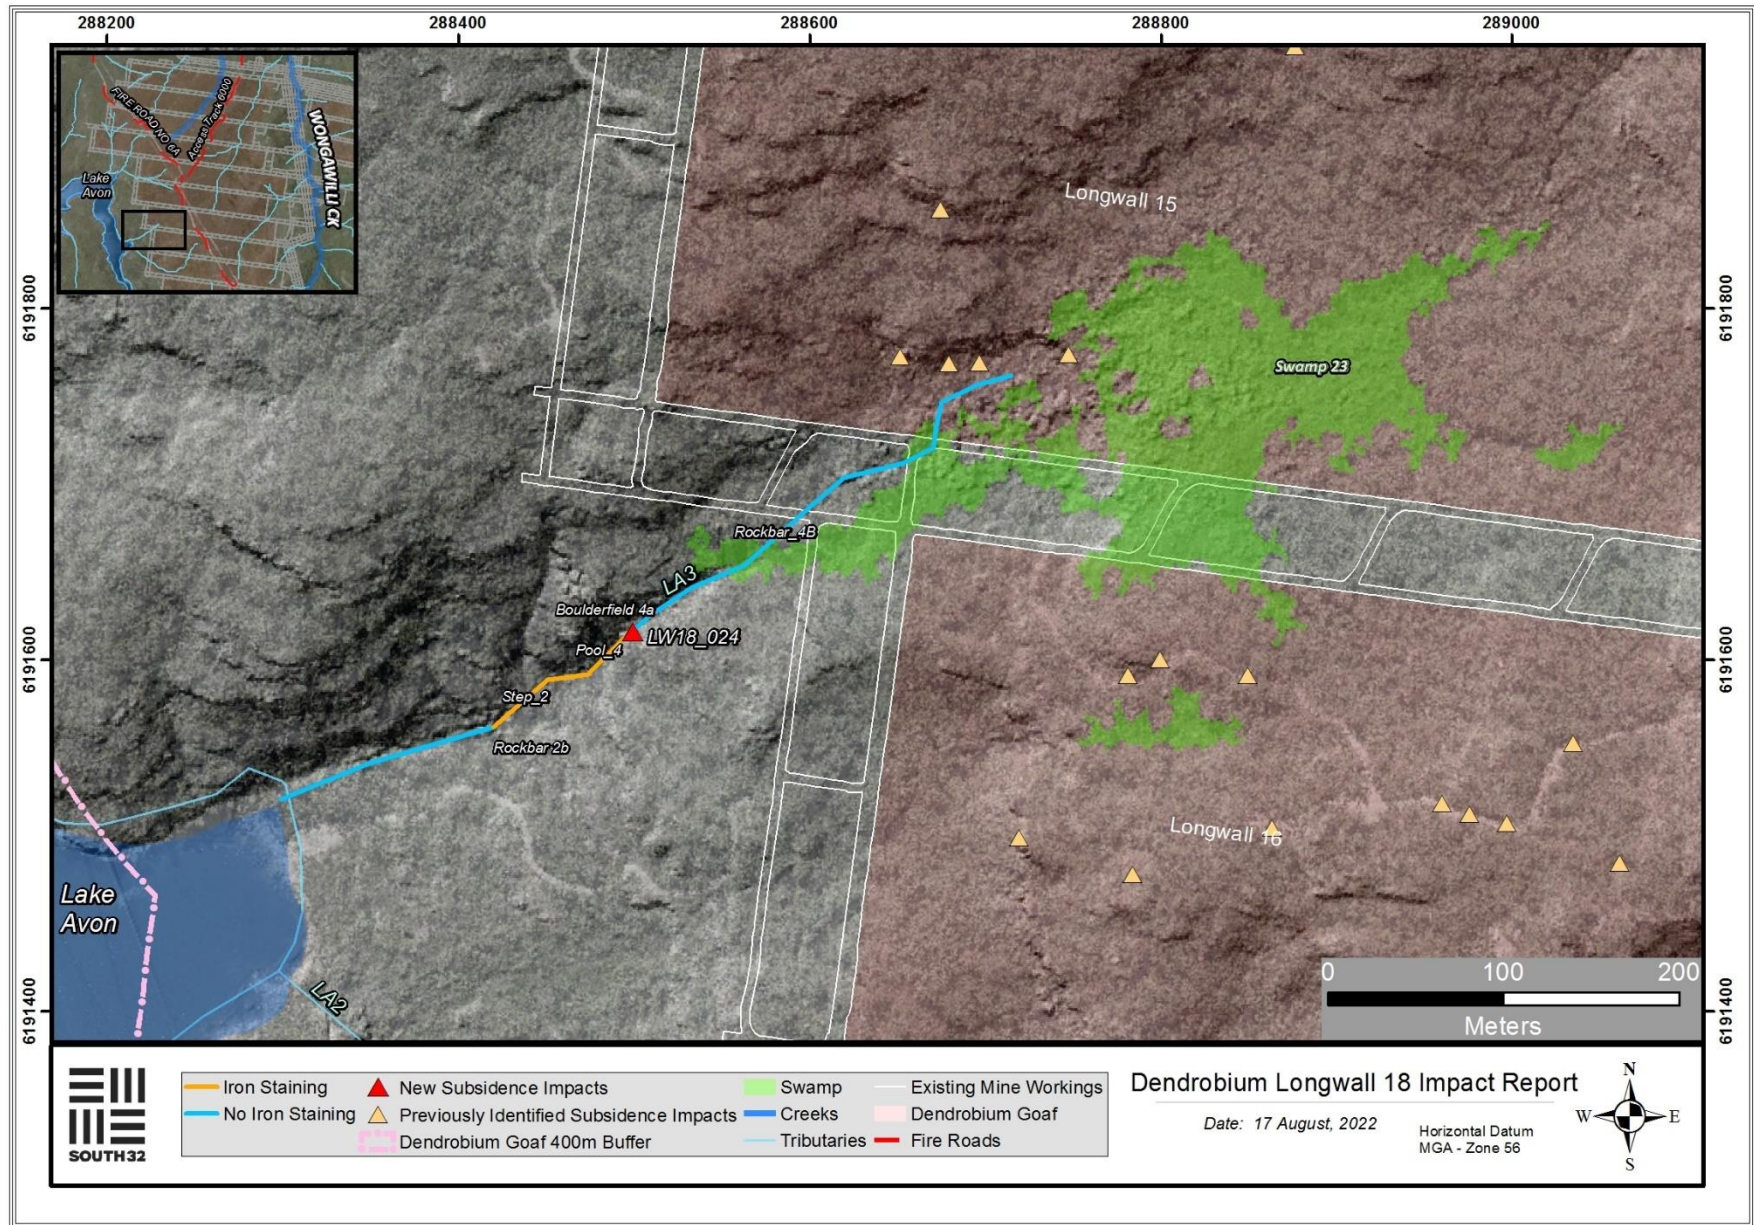
Figure 2: Map showing iron staining on LA3 tributary.
