END OF PANEL
LANDSCAPE REPORT
DENDROBIUM AREA 3A

DENDROBIUM AREA 3A
LONGWALL 19 END OF PANEL
LANDSCAPE REPORT
JUNE 2023

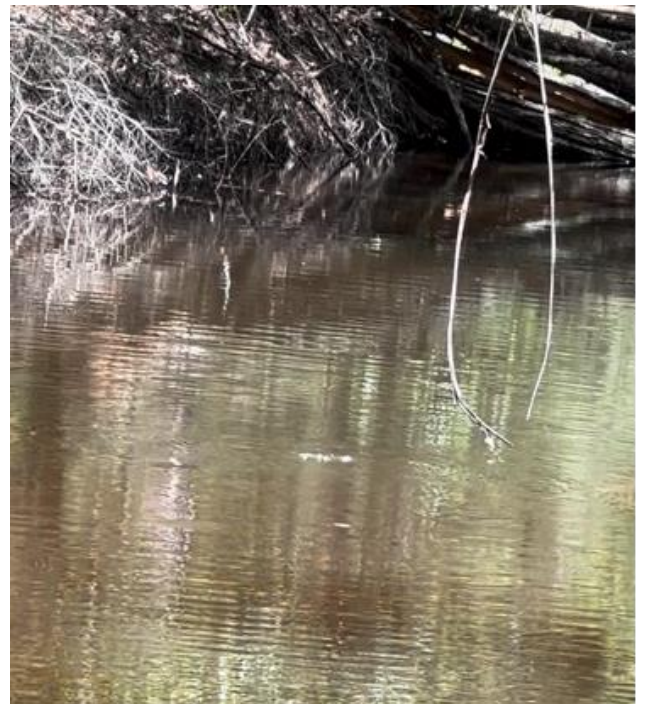
A gas release was observed in Wongawilli Creek at WC_Pool 50 on 18 January 2023 (Figure 4). The release was observed originating from the base of a sandstone step on the western side of the pool (Photo 3). The release was constant for approximately 15 seconds and ceased for approximately one minute, before starting again in a similar interval. A period of approximately 10 minutes was then observed without release. Very light, intermittent bubbling was also observed from the centre of the pool however these were very small and not able to be photographed.

A follow-up inspection of the site was undertaken on 1 February 2023 to collect a gas sample for laboratory analysis and to determine whether the release was strata gas, as opposed to, for example, biological decomposition. During this inspection a similar release was observed from the same location on the western side of the pool (Photo 4). A light, intermittent release was observed towards the centre of the pool (Photo 5). A gas sample was taken from the release on the western margin of the pool. The release was intermittent during sampling as a constant release was not observed. Results of the analysis show mostly carbon dioxide and very low levels of methane. Methane content was lower than that expected from strata or in-seam gas. A light sheen was also observed on the surface of the pool during this inspection however this was similar to that observed at other sites around the catchment and is likely the result of natural oils derived from plant material or iron floc, originating upstream from a previously reported iron spring.

Photo 5: DA3A_LW19_029 small gas release observed towards the centre of WC_Pool 50, Wongawilli Creek. Taken on 1/02/2023.

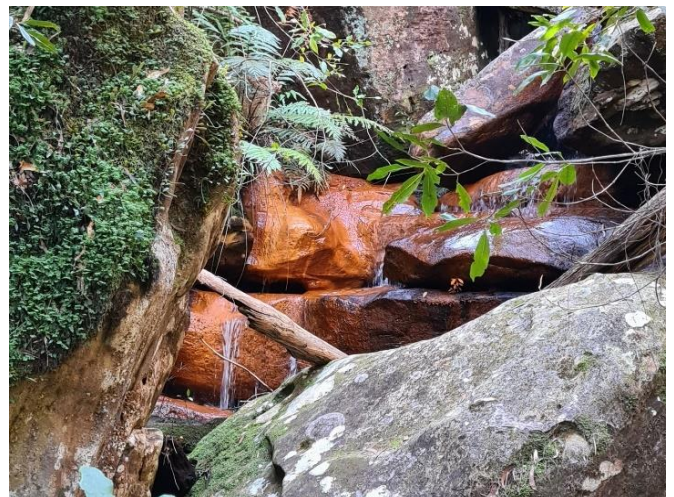
WC14 is a tributary of Wongawilli Creek, that flows westward from DA3A mining operations (Figure 4). Rock fracturing and iron staining on WC14 was previously identified and reported in January 2020, however likely occurred during the extraction of Longwall 8. During recent inspections of WC14, an increase in the extent of the iron staining was observed between WC14_Pool 10 and the confluence of WC14 and Wongawilli Creek (Photo 6 to Photo 21). Iron staining was not evident in Wongawilli Creek (Photo 9). Isolated sections of iron staining were evident upstream between WC14_Pool 10 and WC14_Step 3. Similar observations were recorded during baseline mapping in 2020 (Photo 18 and Photo 19). No iron was observed upstream of WC14_Step 3 (Photo 20 and Photo 21). The impact was re-inspected on 11 May 2023 and no changes were observed.

This observation is a Level 2 trigger as per the DA3A Watercourse Impact, Monitoring Management and Contingency Plan (Table 7Error! Reference source not found.), specifically:

- Observable increase in iron staining within the mining area continues to outside the mining area. i.e. 400 m from the Longwall.

Photo 13: WC14_Boulderfield 1, looking at the same section of iron staining. Taken on 16/08/2022.

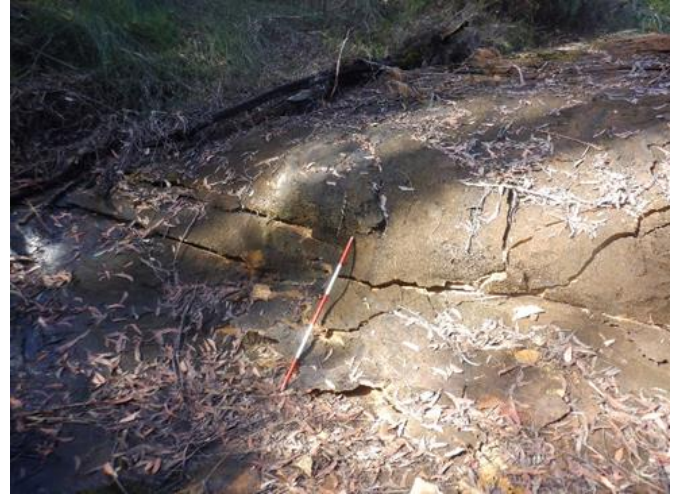
DA3A_LW19_043 consists of multiple rock fractures and some associated uplift on *WC14*, a tributary to *Wongawilli Creek* (Figure 4). The largest fracture has a maximum continuous length of 7.7m, a maximum width of 0.08m and a maximum measurable depth of 0.81m (Photo 22 to Photo 25). Some rock fracturing has uplifted on the rockbar with a measured uplift of 0.13m occurring at the downstream end of the impacted rockbar. No flow was present during the inspection however some flow diversion could be expected during surface flow as the fracture runs across the main flow path of the tributary.

- Crack or fracture that (could) result in observable loss of surface water or erosion.

Photo 23: DA3A_LW19_043, looking upstream at rock fracturing on rockbar. Taken 17/04/2023.

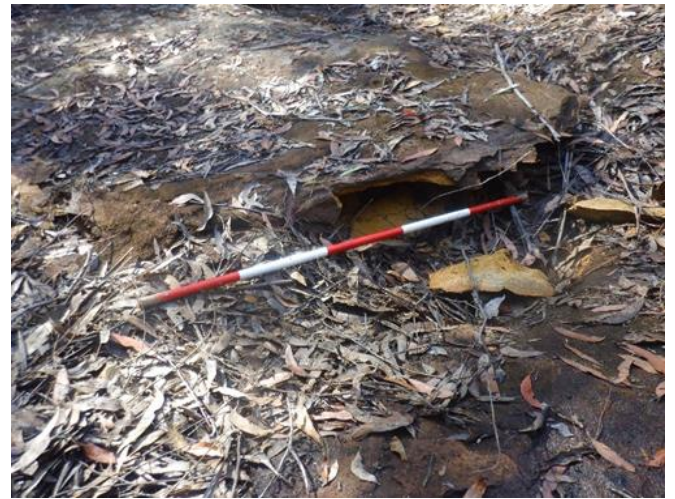
Photo 25: DA3A_LW19_043, looking at section of uplift. Taken 17/04/2023.

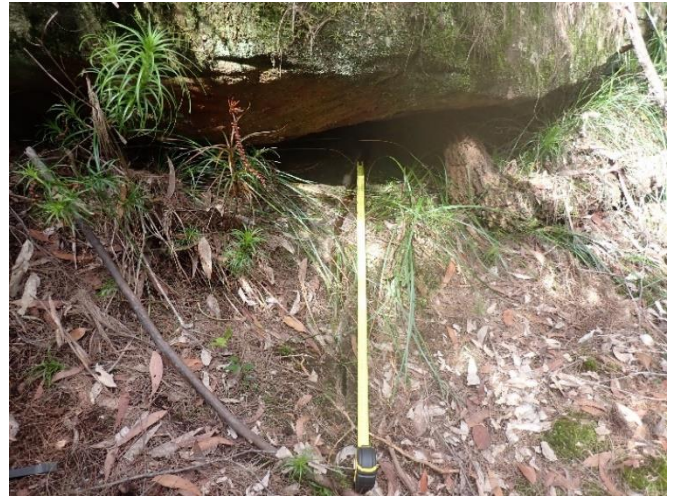
DA3A_LW8_003 was originally recorded on 28 January 2020, with changes to the impact recently observed. DA3A_LW8_003 is located on WC14, a tributary to Wongawilli Creek (Figure 4). During the initial inspection the impact consisted of rock fracturing and uplift at the top of a step, located approximately 3m south of Longwall 19. The impact site now displays a continuation in rock fracturing which extends beneath a step with small associated rockfalls/fragments. Originally the rock fracturing was recorded with a maximum continuous length of 1.8m and a maximum width of 0.005m. The latest fracturing has a maximum continuous length of 2.73m, a maximum width of 0.04m and maximum measurable depth of 0.49m (Photo 26 to Photo 28). The associated rockfall/fragments dimensions were estimated due to safety concerns, with an approximate rockfall volume of 0.2m³ (Photo 29). No follow up inspection was undertaken as the impact was identified following the completion of Longwall 19.

- Crack or fracture up to 100mm width;
- Crack or fracture up to 10m length;
- Rockfall from a cliff (step) which is left mostly intact (<10% length), resulting in insignificant ground disturbance.

Photo 27: DA3A_LW8_003, looking at the extent of rock fracturing. Taken 12/04/2023.

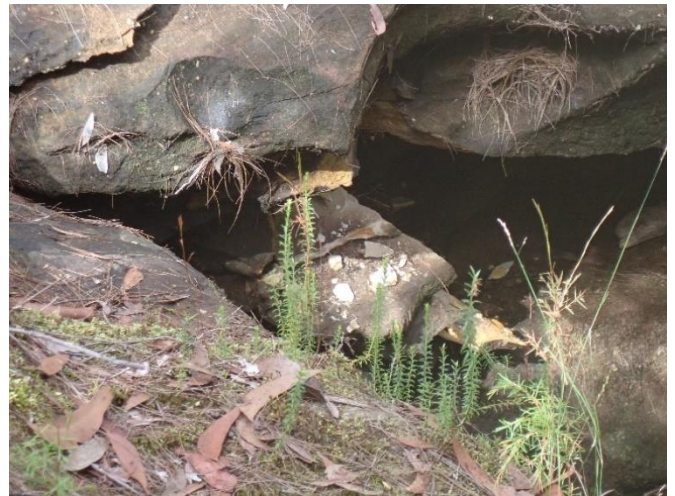
Photo 29: DA3A_LW8_003, looking at the rockfall and associated fragments. Taken on 12/04/2023.

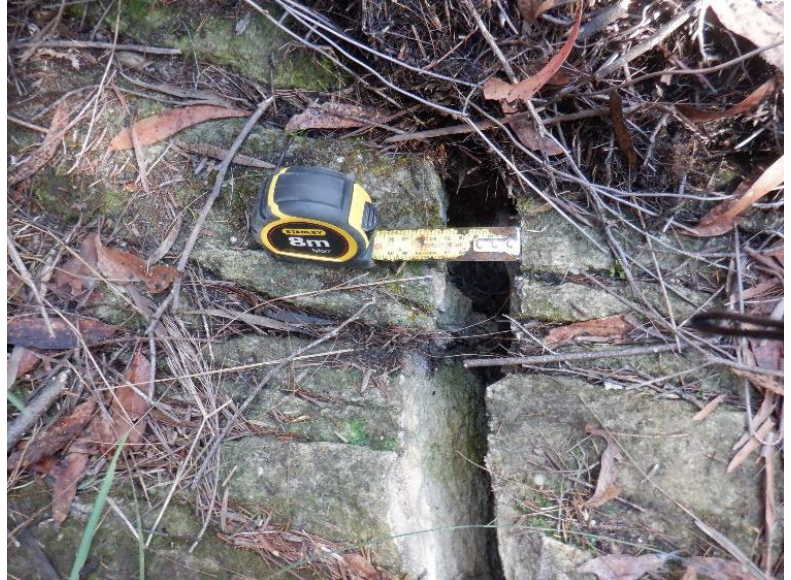
DA3A_LW19_051 is located on WC14, a tributary to Wongawilli Creek (Figure 4). The impact consists of multiple rock fractures to a rock outcrop within Swamp 148 with the largest fracture having a maximum continuous length of 1.15m, a maximum width of 0.06m and a maximum measurable depth of 1.27m (Photo 30 and Photo 31). During both the baseline inspection and the recent Longwall 19 impact inspection there was no flow present at the site, therefore the fracture is not associated with loss of surface water. No follow up inspection was undertaken as the impact was identified following the completion of Longwall 19.

Photo 31: DA3A_LW19_051, showing width of rock fracture. Taken on 4/5/2023.

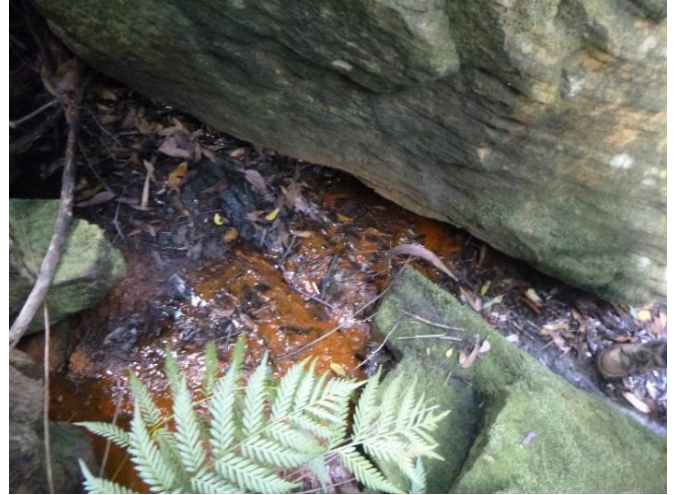
Photo 33: DA3A_LW19_045, showing iron staining disappearing beneath a boulder. Taken on 26/04/2023.

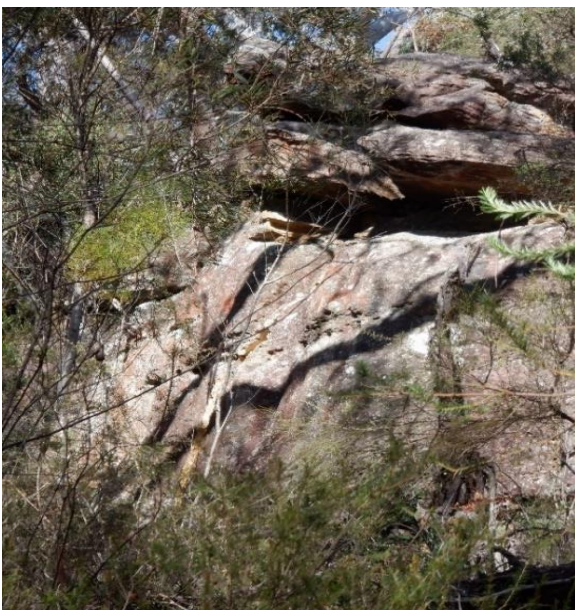
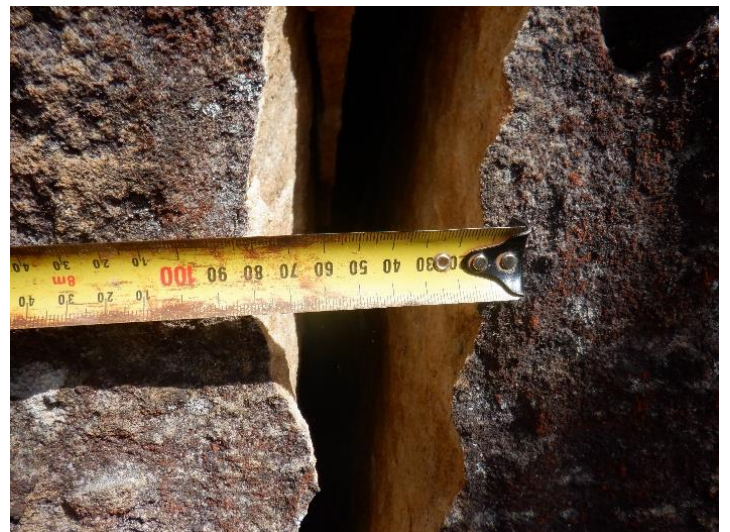
- Crack or fracture up to 10m length
- Crack or fracture up to 100m width

Photo 35: DA3A_LW19_001, showing width of rock fracturing. Taken 19/04/2023.

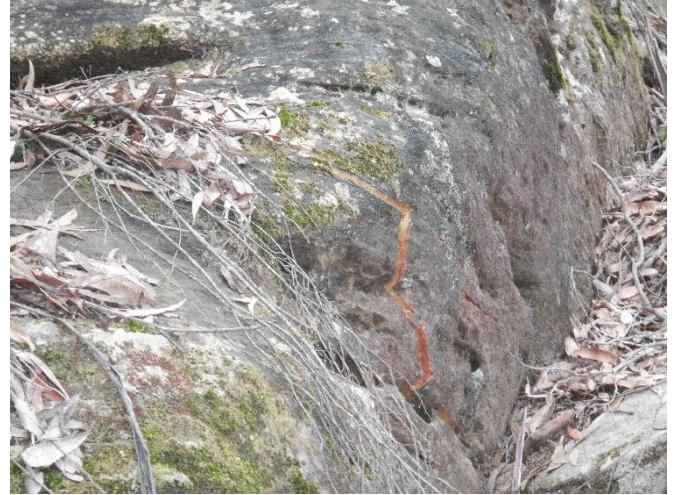
Photo 42: DA3A_LW19_005, looking at section of rock fracturing. Taken on 19/08/2022.

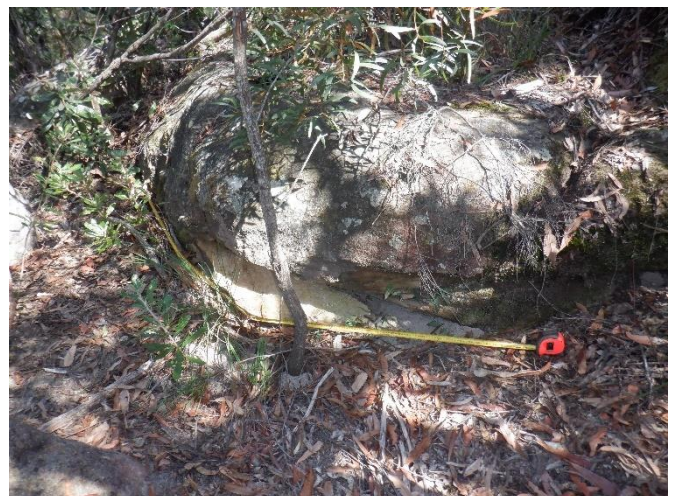
Photo 44: DA3A_LW19_005, looking at rock fracture which has fallen creating a rockfall. Taken on 19/04/2023.

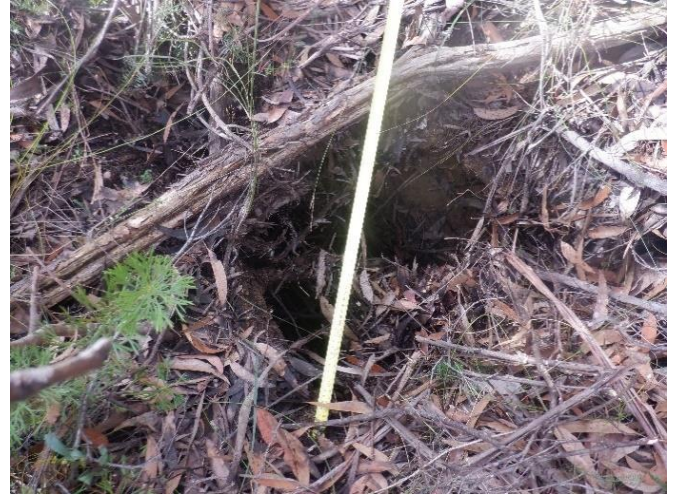
Photo 46: Width of surface erosion. Taken 31/08/2022.

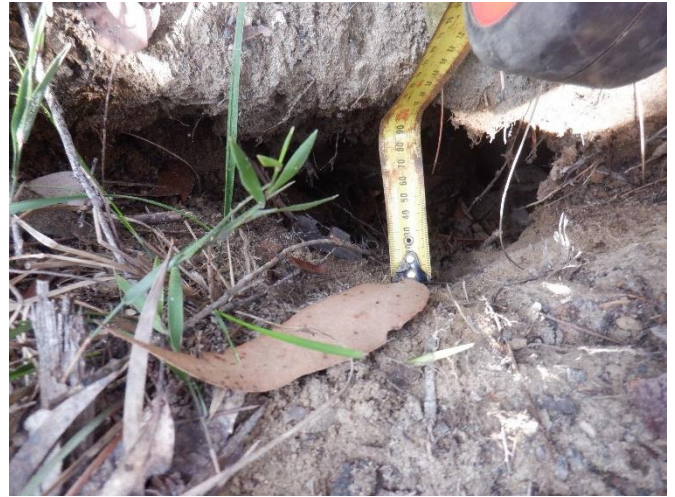
Photo 49: *DA3A_LW19_007*, width of soil cracking. Taken on 19/04/2023.

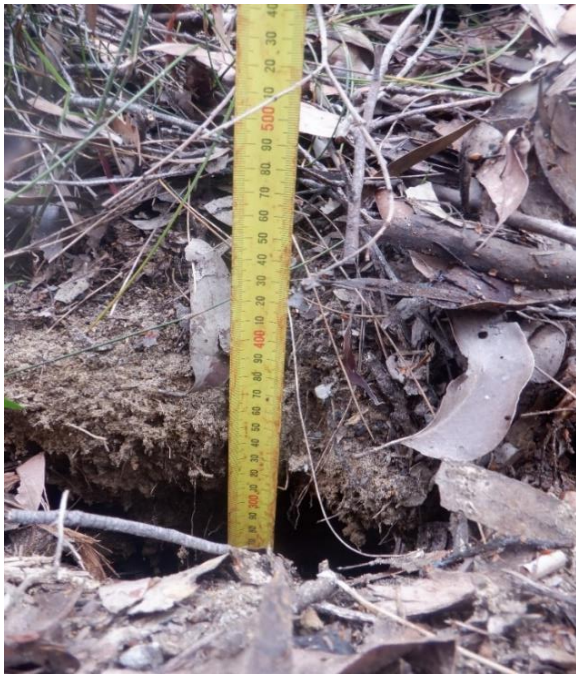
Photo 50: *DA3A_LW19_007*, depth of soil cracking. Taken on 18/10/2022.

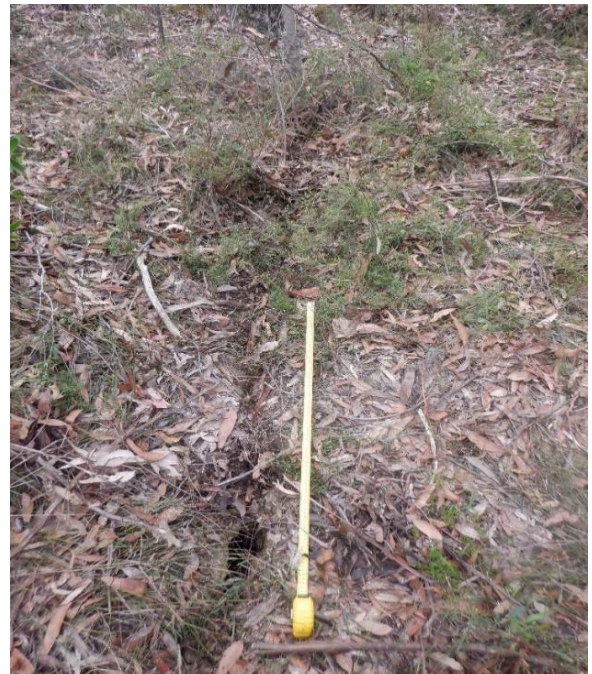
Photo 51: *DA3A_LW19_007*, section of soil cracking. Taken on 18/10/2022.

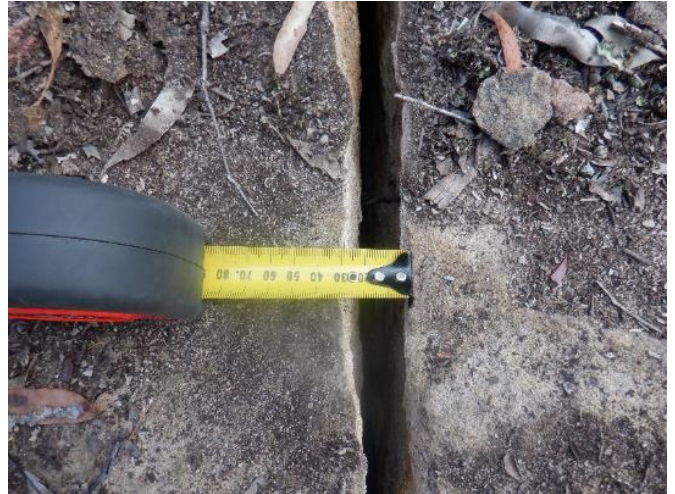
Photo 53: DA3A_LW19_008, width of rock fracturing. Taken on 7/11/2022.

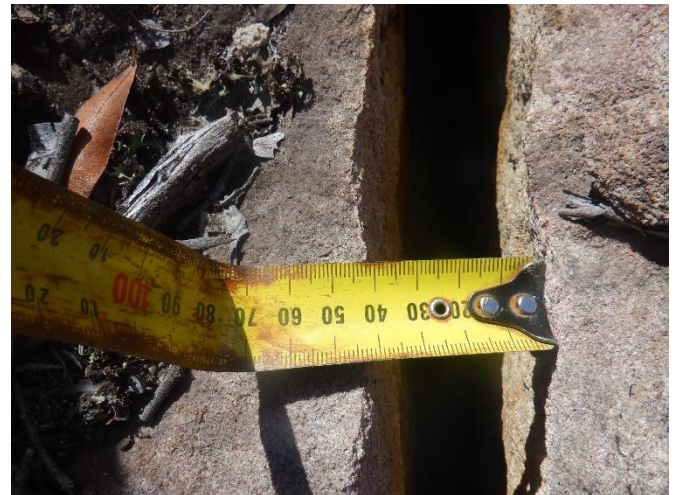
Photo 55: DA3A_LW19_008, width of rock fracturing taken on 09/05/2023.

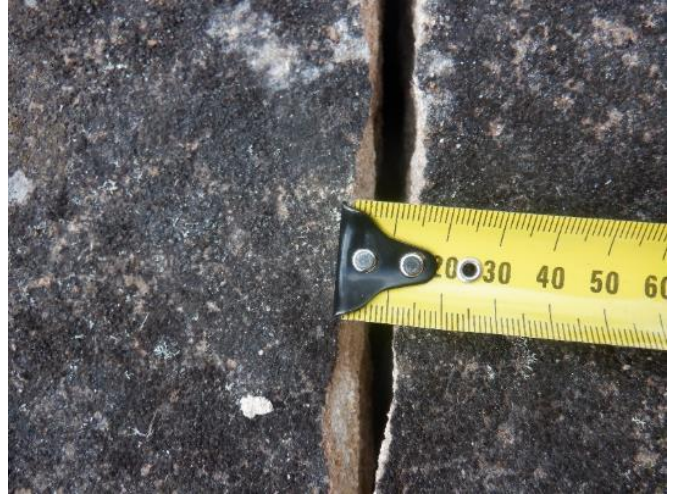
Photo 57: DA3A_LW19_009, width of rock fracturing. Taken on 7/11/2022.

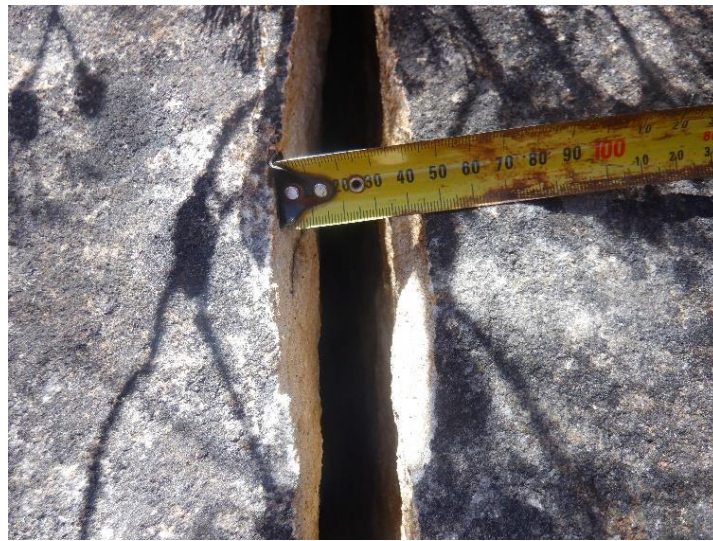
Photo 58: DA3A_LW19_009, width of rock fracturing. Taken on 09/05/2023.

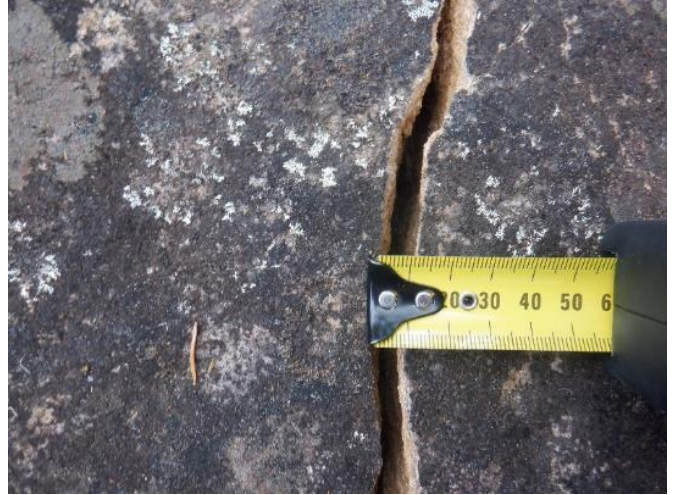
Photo 60: DA3A_LW19_010, width of rock fracturing. Taken on 7/11/2022.

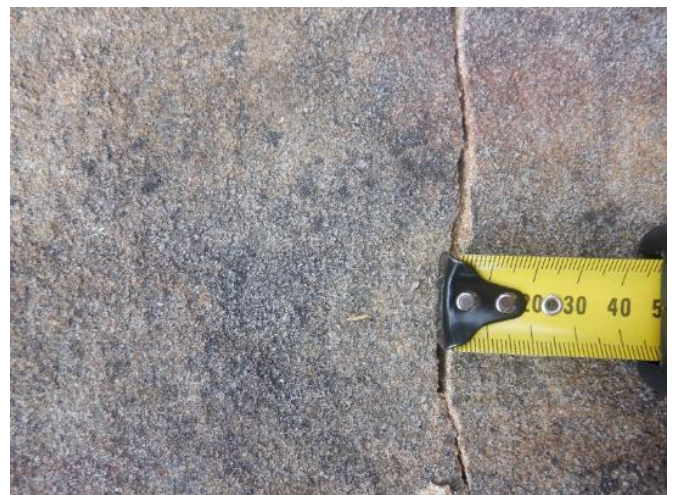
Photo 62: DA3A_LW19_011, width of rock fracturing. Taken on 7/11/2022.

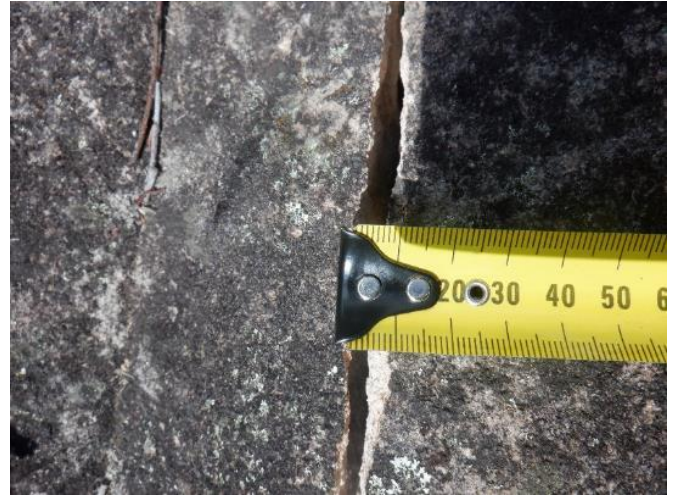
Photo 64: *DA3A_LW19_012*, width of rock fracturing. Taken on 7/11/2022.

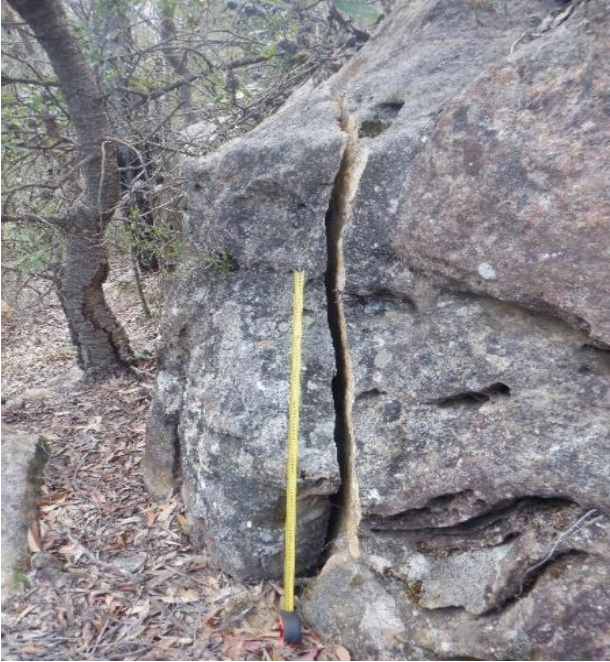
- Crack or fracture between 100mm and 300mm width.

Photo 65: DA3A_LW19_013, section of rock fracturing. Taken on 7/11/2022.

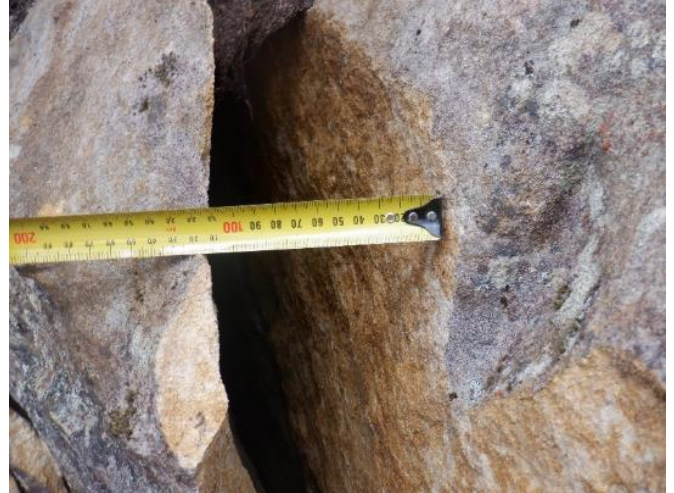
Photo 66: DA3A_LW19_013, width of rock fracturing. Taken on 7/11/2022.

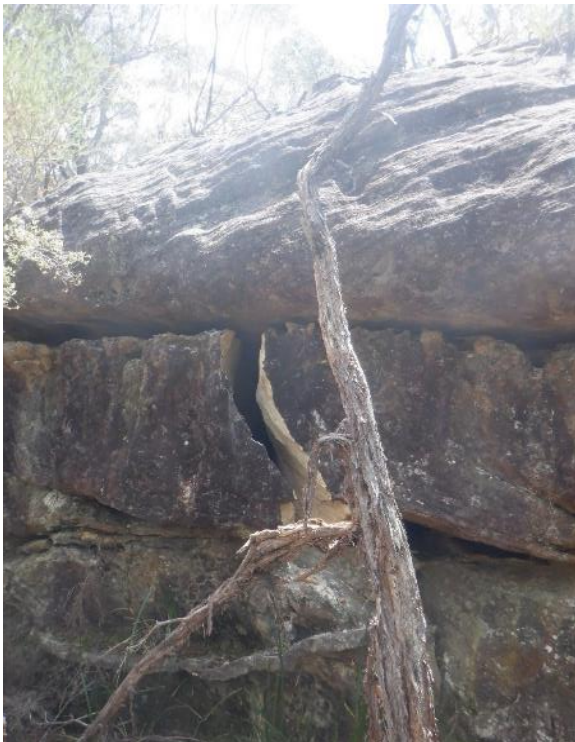
- Crack or fracture between 100mm and 300mm width

Photo 69: DA3A_LW19_015, section of rock fracturing. Taken on 7/11/2022.

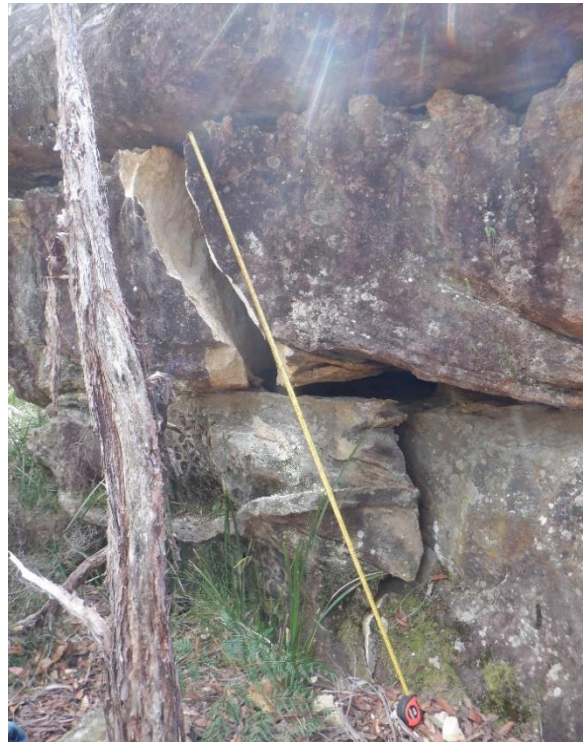
Photo 70: DA3A_LW19_015, section of rock fracturing. Measuring tape set at 2.3m. Taken on 19/04/2023.

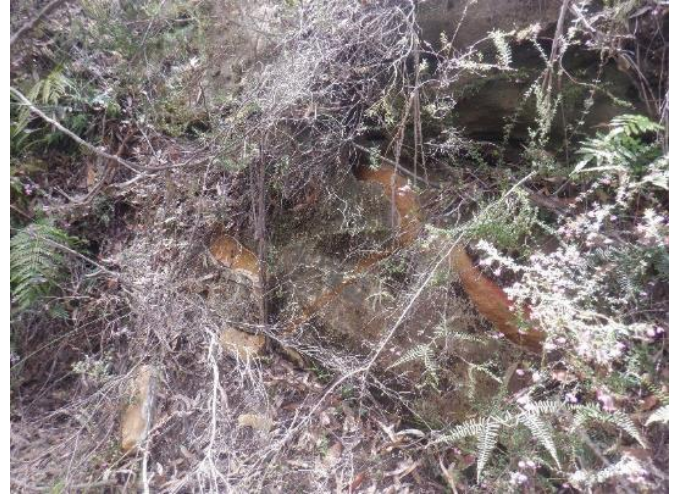
Photo 72: DA3A_LW19_016, section of rock fracturing. Taken on 7/11/2022.

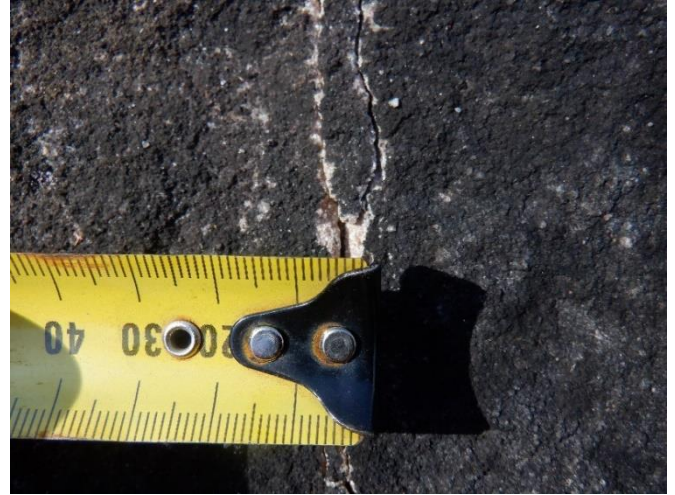
Photo 75: DA3A_LW19_017, width of rock fracturing. Taken on 13/12/2022.

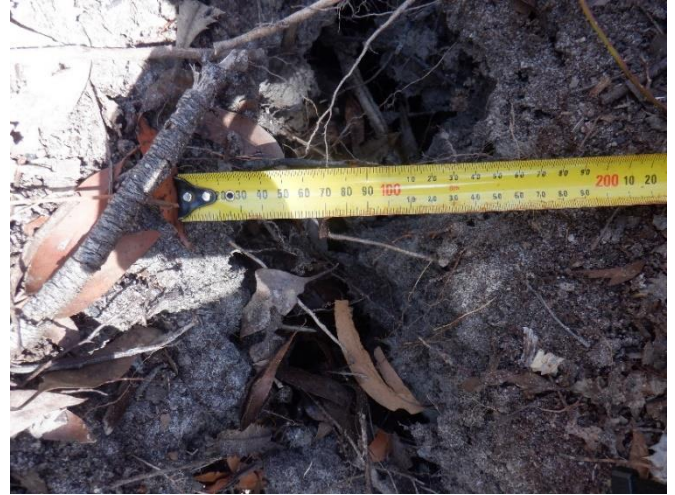
Photo 81: DA3A_LW19_020, width of soil cracking. Taken on 13/12/2022.

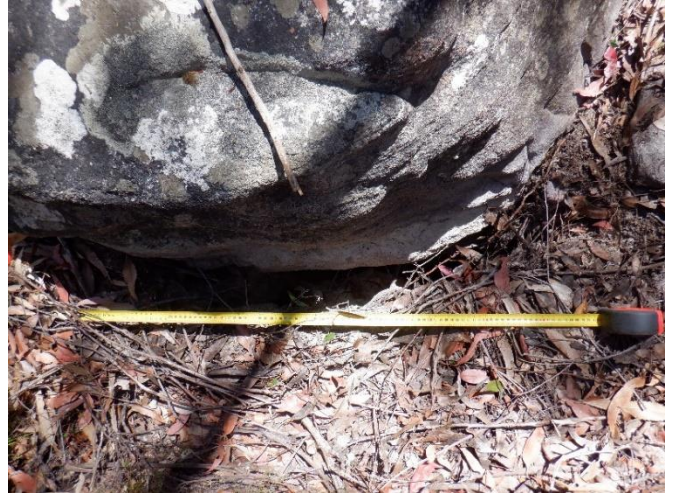
Photo 84: DA3A_LW19_021, section of rock displacement. Taken on 13/12/2022.

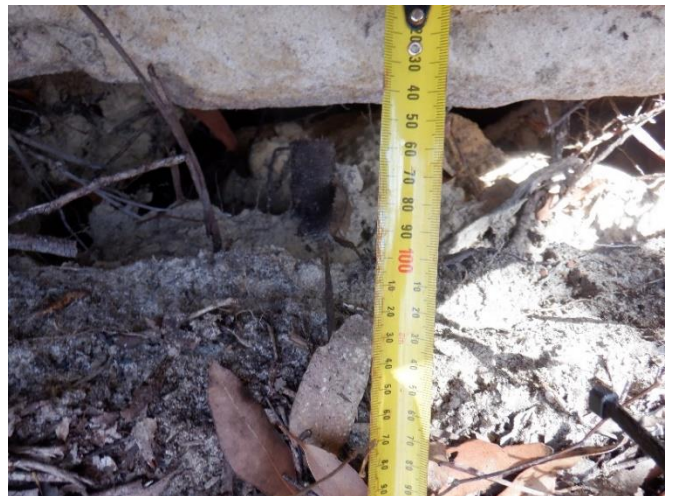
Photo 86: DA3A_LW19_021, width of soil cracking. Taken on 13/12/2022.

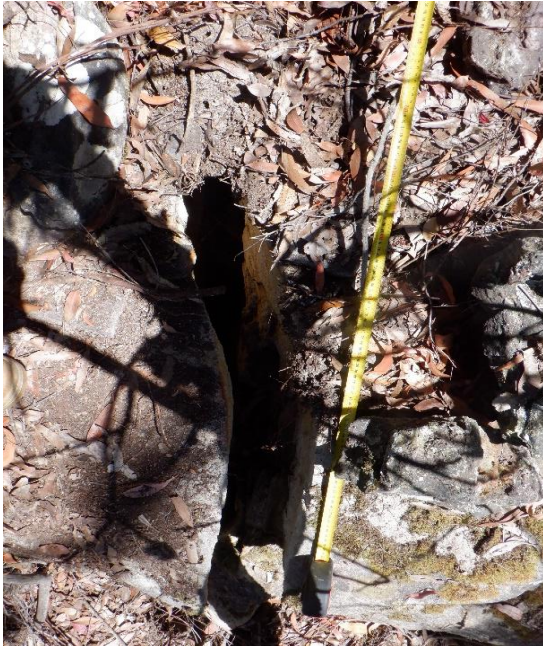
- Crack or fracture between 100 and 300mm width

Photo 87: *DA3A_LW19_022*, section of rock fracturing. Taken on 13/12/2022.

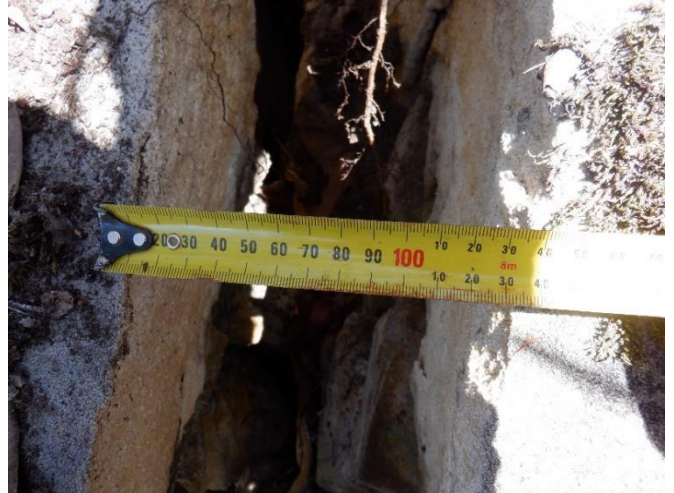
Photo 88: *DA3A_LW19_022*, width of rock fracturing. Taken on 13/12/2022.

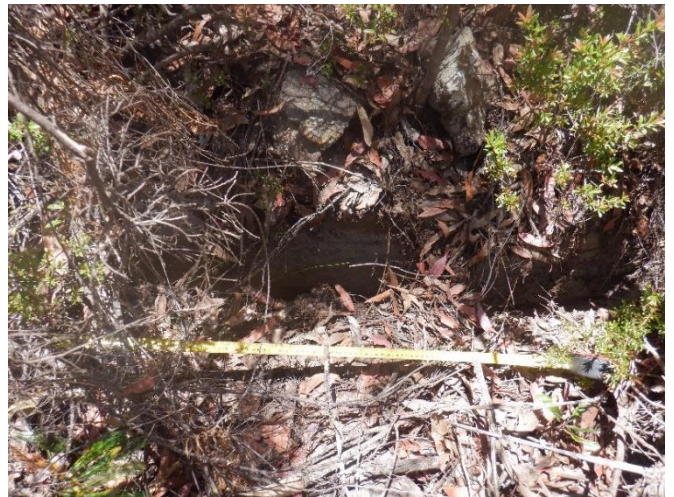
Photo 90: *DA3A_LW19_022*, section of soil cracking. Taken on 13/12/2022.

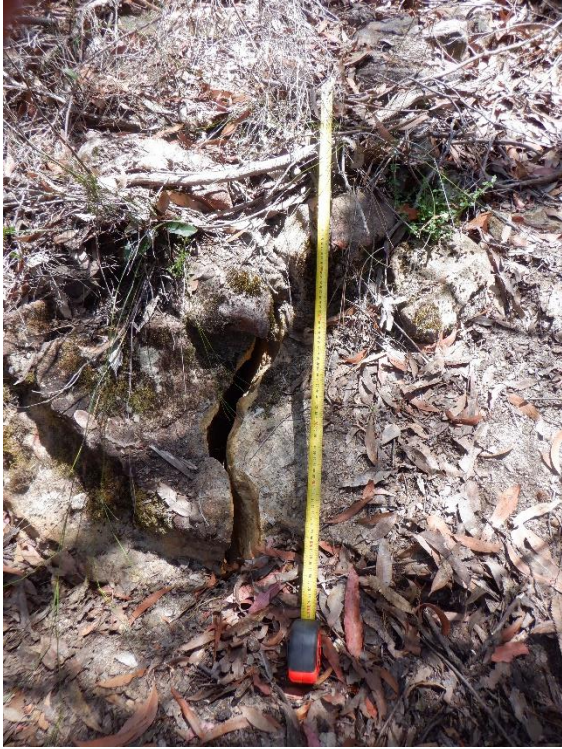
- Crack or fracture up to 100mm width;
- Crack or fracture up to 10m length.

Photo 91: *DA3A_LW19_023*, section of rock displacement. Taken on 13/12/2022.

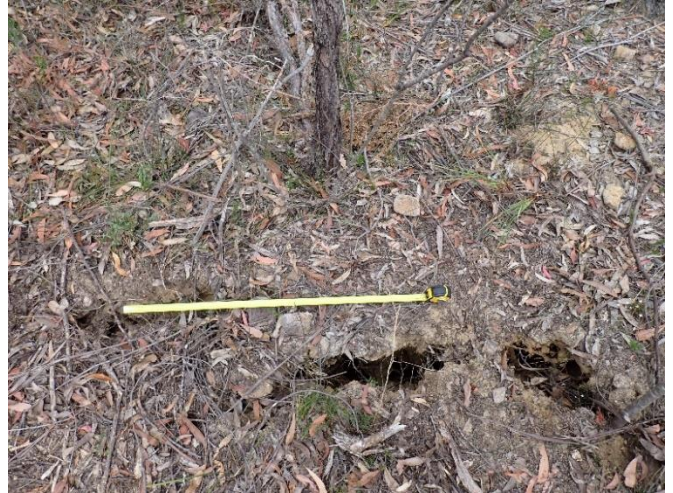
Photo 94: DA3A_LW19_024, section of soil cracking. Taken on 20/12/2022.

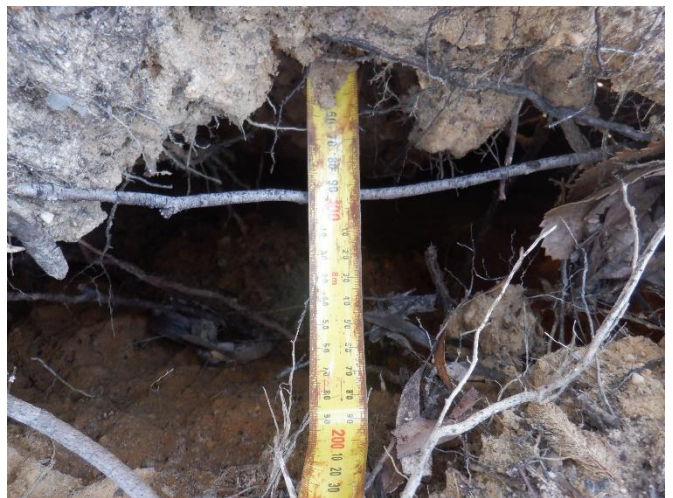
Photo 96: DA3A_LW19_024, width of soil crack after erosion. Taken 19/04/2023.

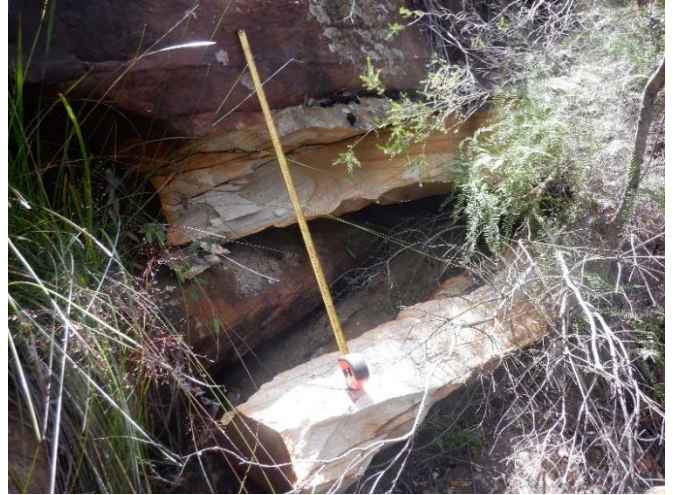
Photo 100: DA3A_LW19_027, section of rock fracturing and rockfall. Taken on 10/01/2023.

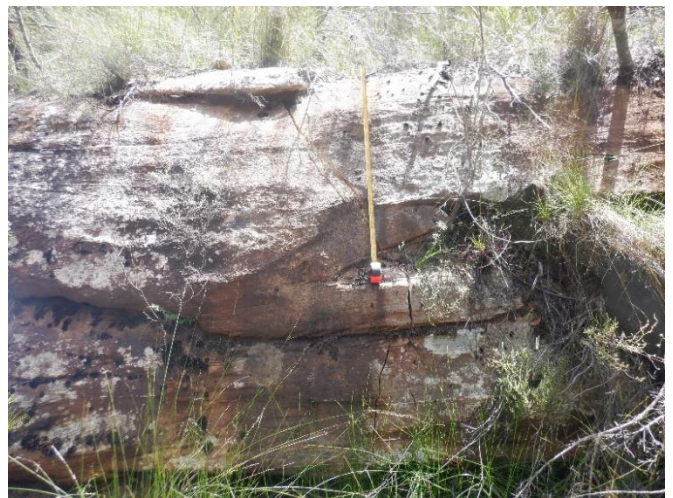
Photo 102: DA3A_LW19_027, section of rock fracturing. Taken on 10/01/2023.

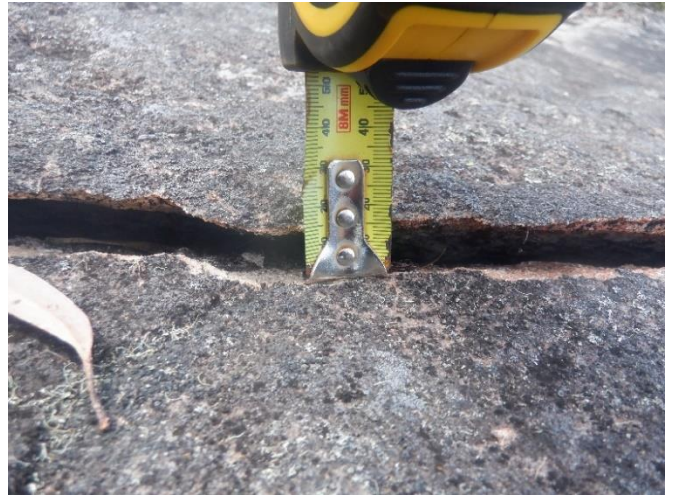
Photo 104: DA3A_LW19_028, width of rock fracturing. Taken on 6/02/2023.

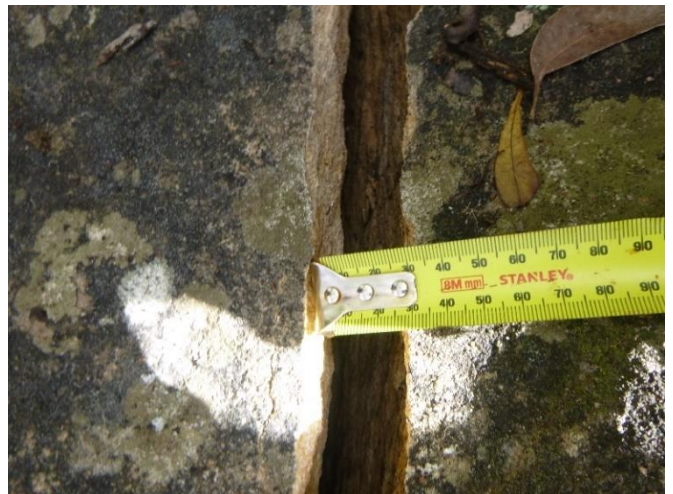
Photo 106: DA3A_LW19_030, width of rock fracturing on outcrop. Taken on 15/2/2023.

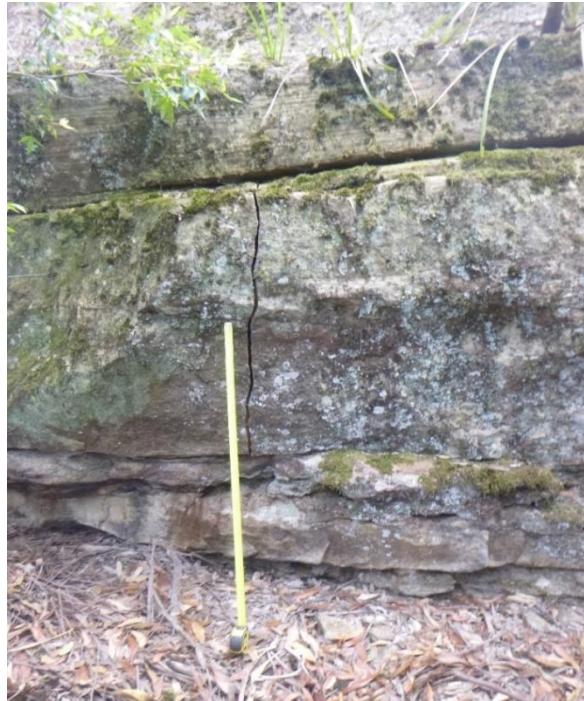
- Crack or fracture up to 100mm width;
- Crack or fracture up to 10m length.

Photo 110: DA3A_LW19_032, rock fracturing on side of outcrop. Taken on 15/2/2023.

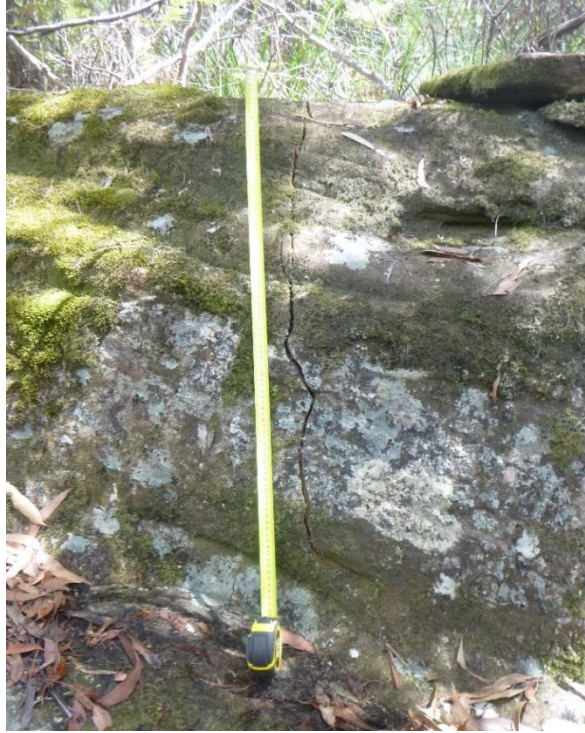
- Crack or fracture up to 100mm width;
- Crack or fracture up to 10m length.

Photo 115: DA3A_LW19_034, rock fracturing on side of an outcrop. Taken on 15/2/2023.

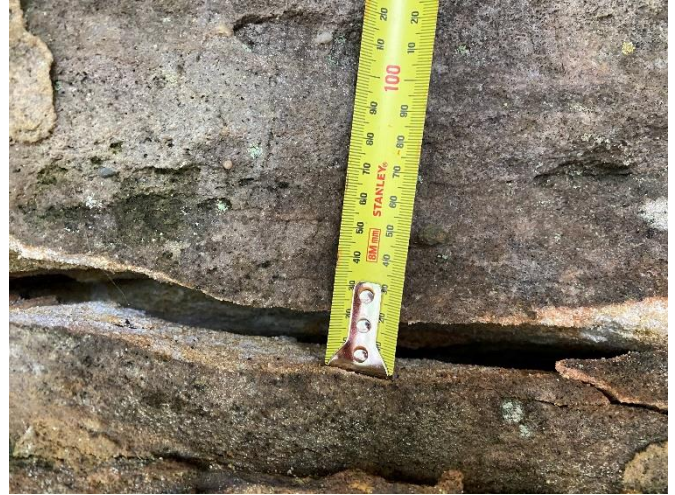
Photo 117: DA3A_LW19_037, rock fracturing. Taken on 28/03/2023.

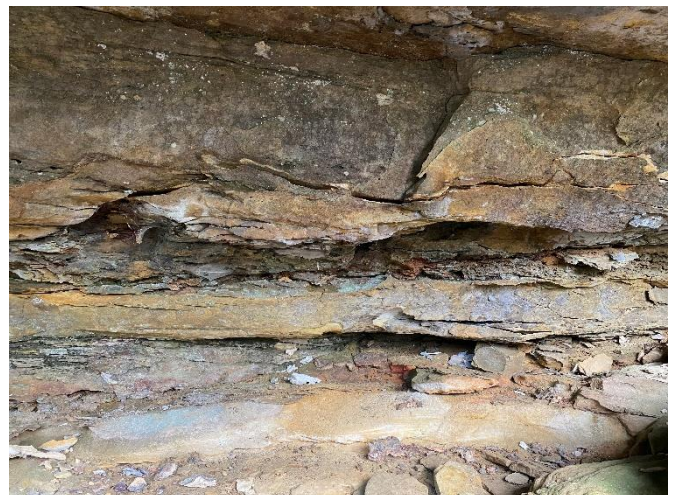
Photo 121: DA3A_LW19_037, rock fracturing through overhang at Sandy Creek 21. Taken on 28/03/2023.

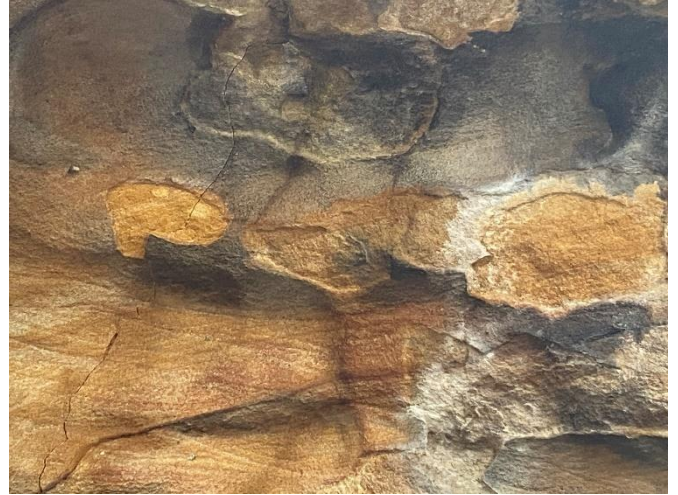
Photo 125: DA3A_LW19_038, rock fracturing extending to the upper part of overhang. Taken on 28/03/2023.

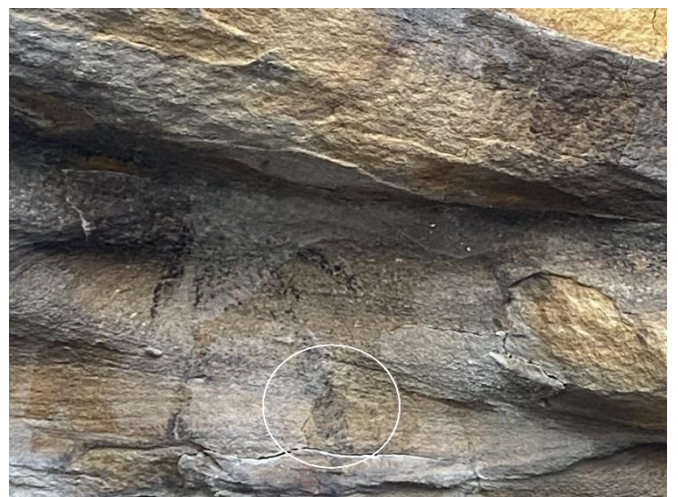
Photo 129: Art at DM15- image taken in latest inspection showing current fracturing. Recent fracture is circled. Taken on 28/03/2023.

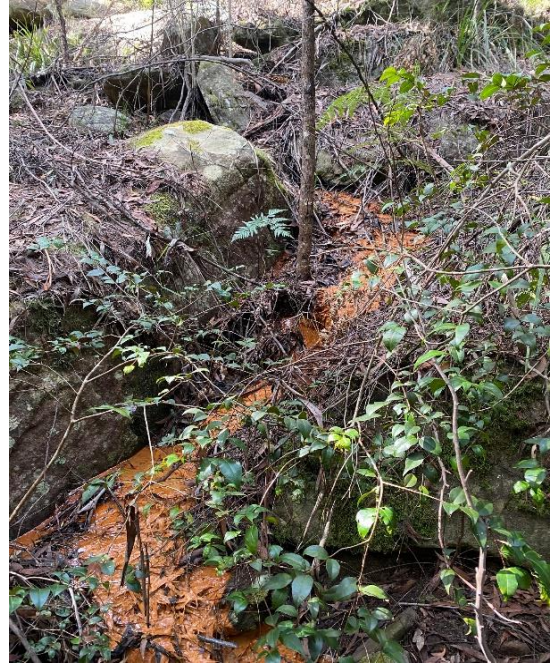
Photo 143: *DA3A_LW19_044*, looking at extent of iron staining. Taken 19/04/2023.

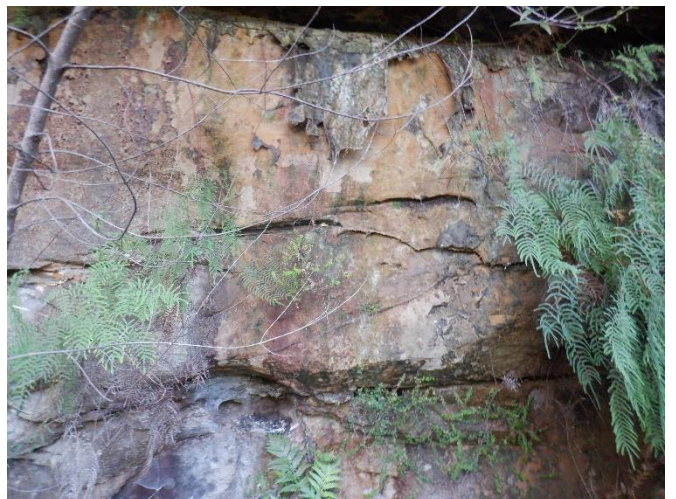
Photo 150: DA3A_LW19_052, showing area of rock fracturing. Taken on 4/5/2023.

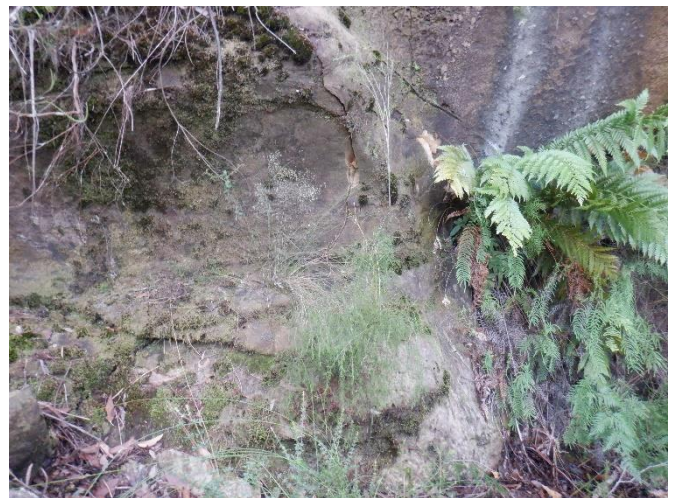
Photo 152: DA3A_LW19_053, showing rock fracturing. Taken on 4/5/2023

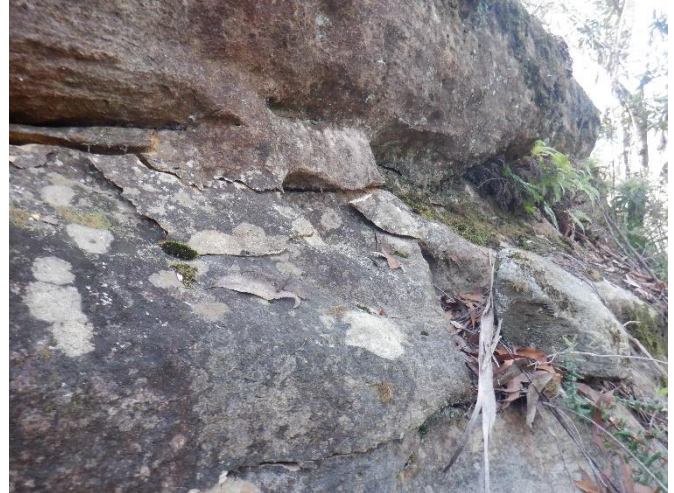
Photo 154: DA3A_LW19_054, showing rock fracturing and fragmentation. Taken on 4/5/2023.

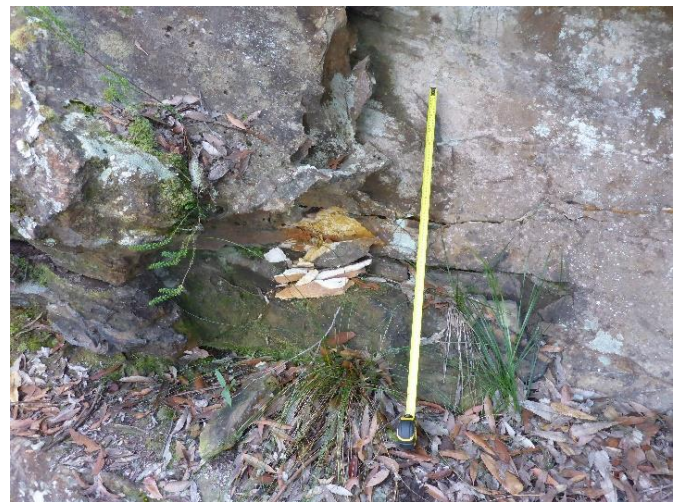
Photo 164: *DA3A_LW19_059*, showing fallen debris. Taken on 5/05/2023.

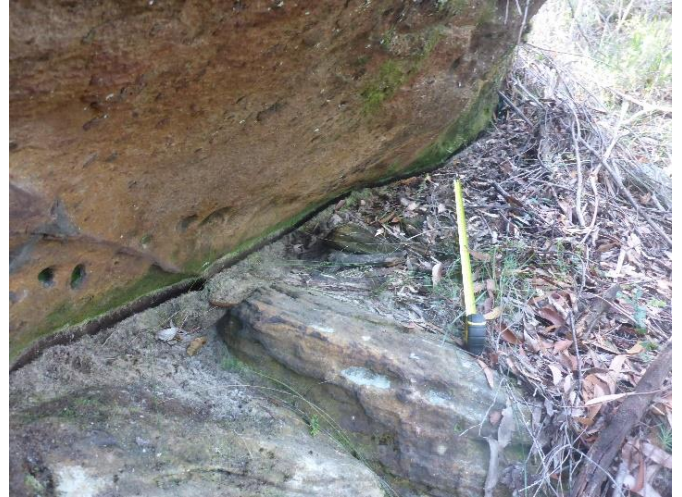
Photo 166: DA3A_LW19_060, showing extent of displacement. Taken on 5/05/2023.

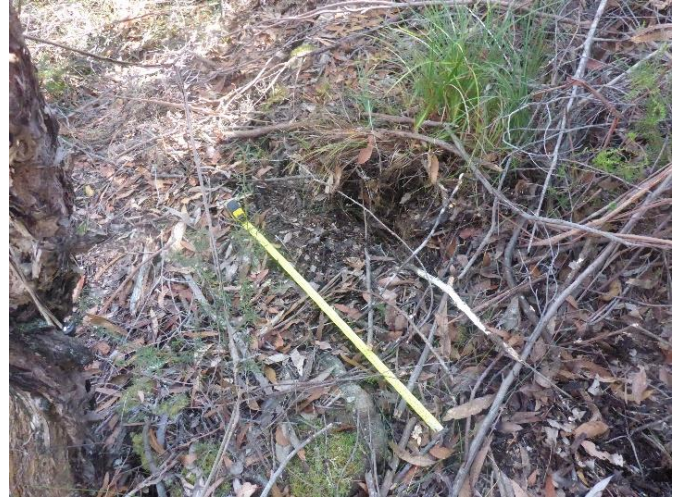
Photo 169: DA3A_LW19_061, showing extent of soil crack. Taken on 05/05/2023.

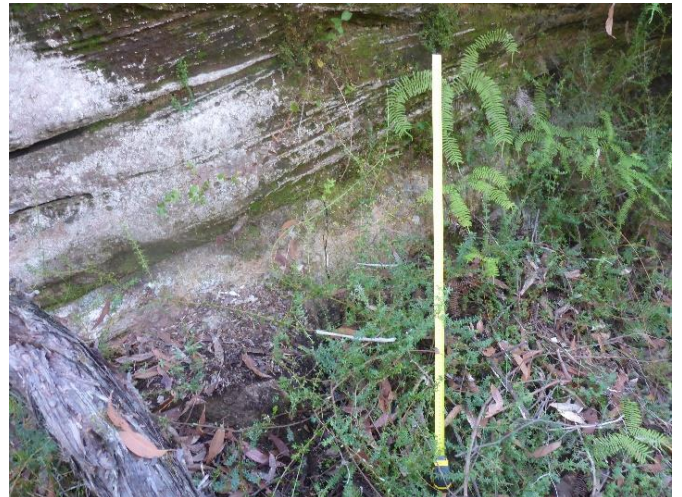
Photo 171: DA3A_LW19_062, showing extent of rock fracture. Taken on 05/05/2023.
