END OF PANEL
LANDSCAPE REPORT
DENDROBIUM AREA 3A

DENDROBIUM AREA 3A
LONGWALL 19 END OF PANEL
LANDSCAPE REPORT
JUNE 2023

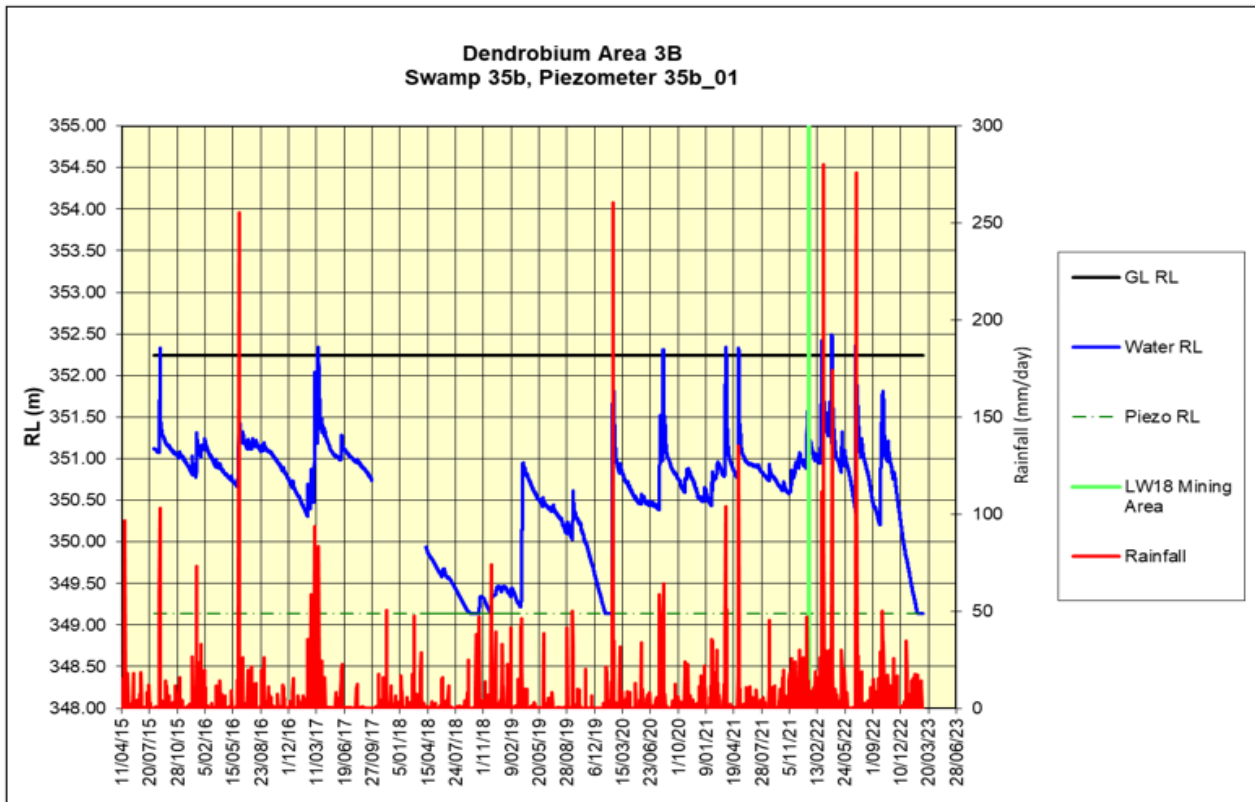
mining) within the swamp. (It should be noted that there is only one shallow borehole/piezometer in Swamp 35b, therefore only a Level 3 trigger applies).

Graph 1: Near-surface groundwater levels at 35b_01, logged hourly, date range: 06/08/2015 to 28/02/2023

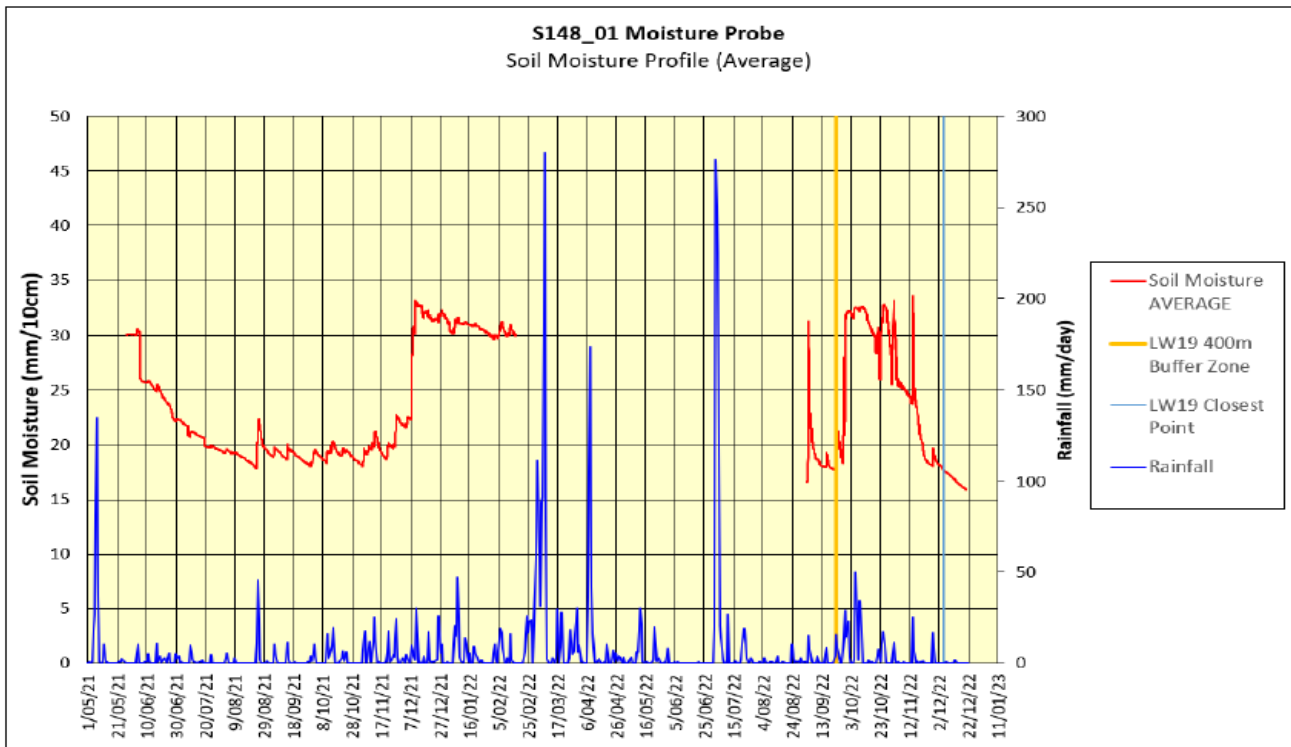
- Soil moisture level lower than baseline level at >80% of monitoring sites (within 400m of mining) within a swamp (in comparison to reference swamps). Note- there is only one probe installed in the swamp.

Graph 2: Average soil moisture records at S148_01, logged hourly. Date range: 27/05/2021 to 20/12/2022

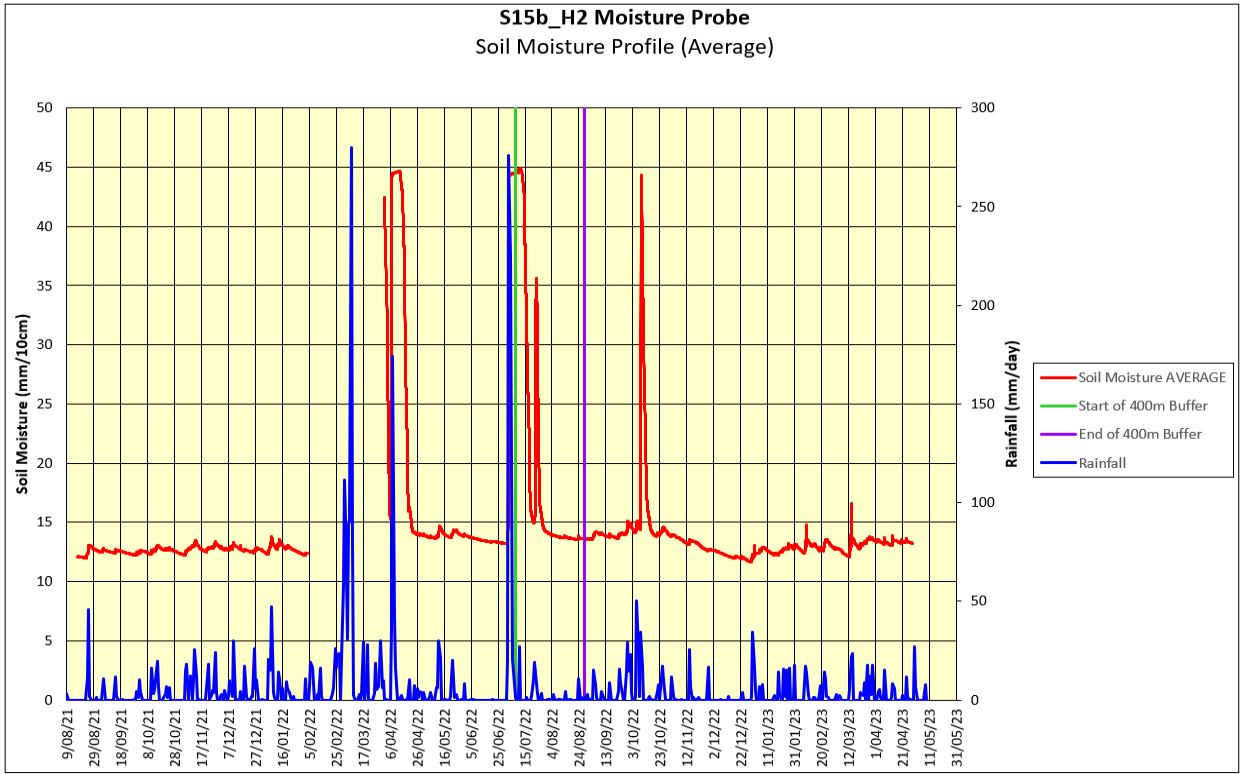
Graph 3: Average soil moisture records at S15b_H2, logged hourly. Date range: 16/08/2021 to 28/04/2023.

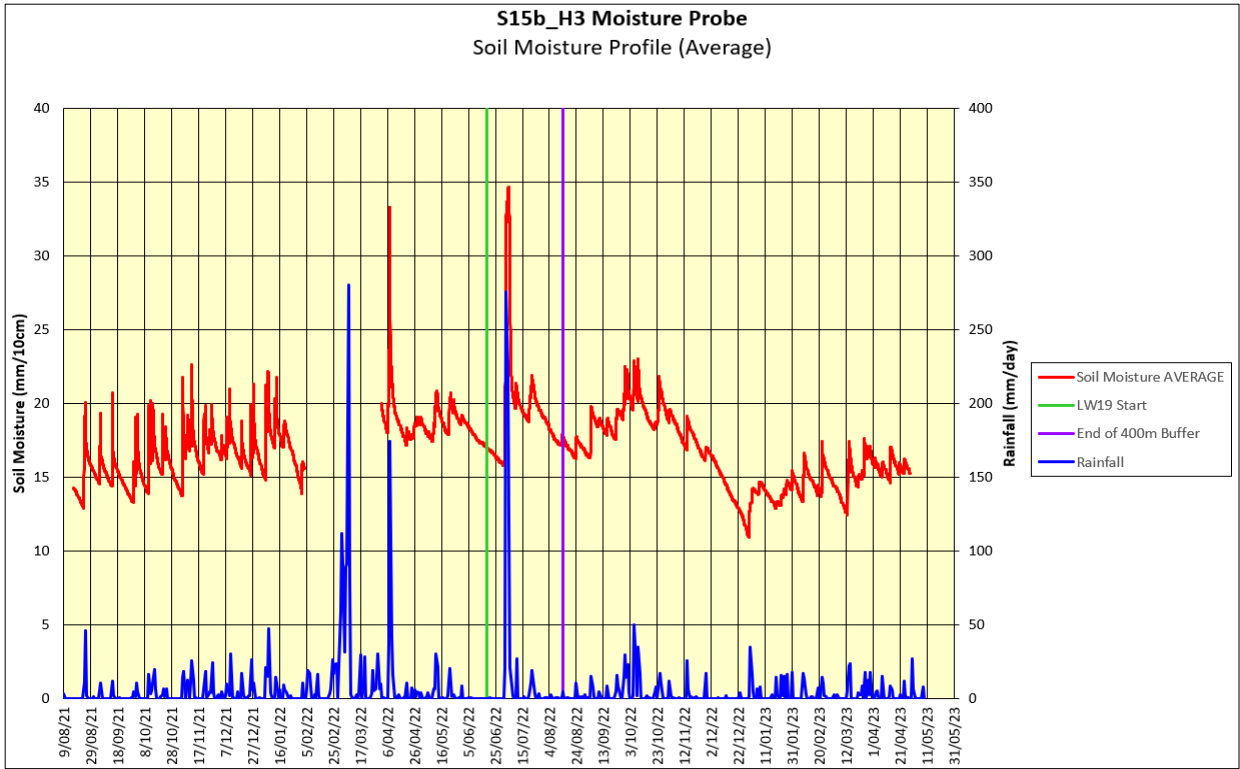
Graph 4: Average soil moisture records at S15b_H3, logged hourly. Date range: 16/08/2021 to 28/04/2023.

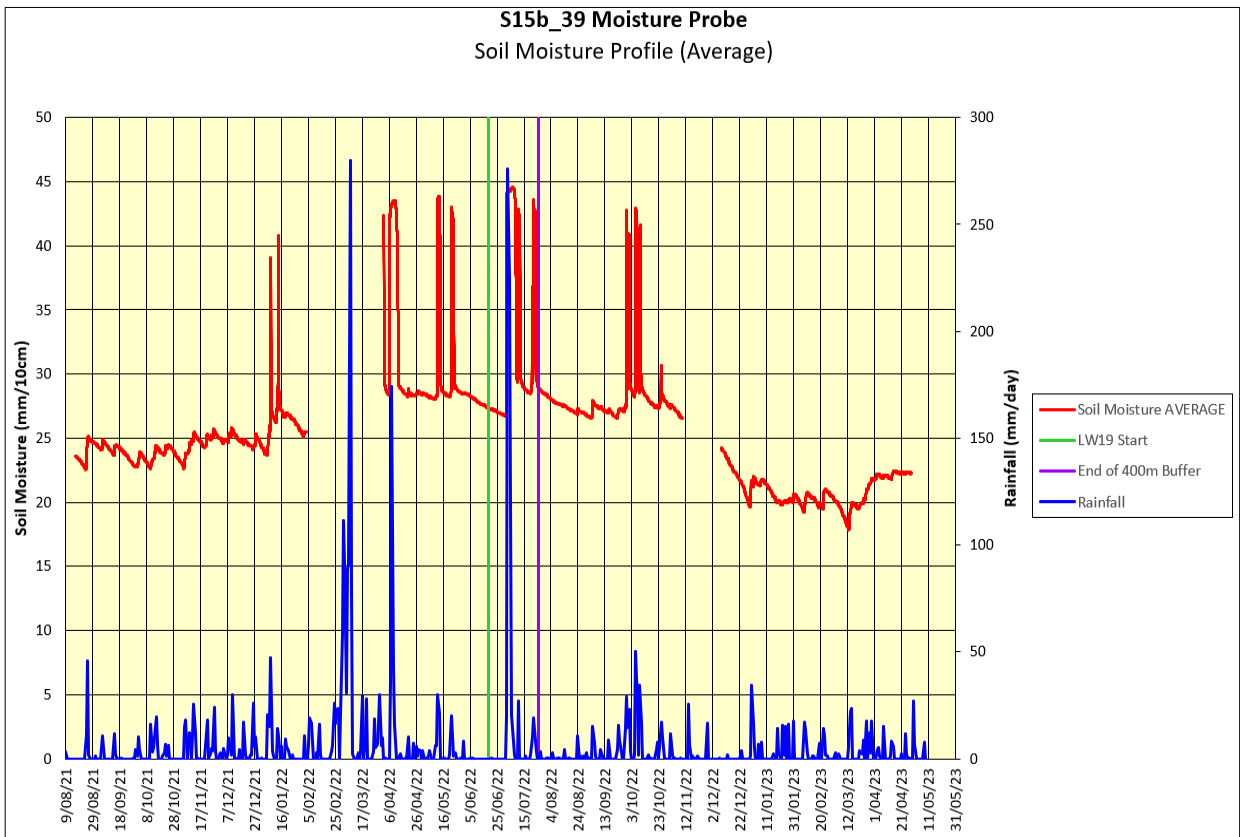
Graph 5: Average soil moisture records at S15b_39, logged hourly. Date range: 16/08/2021 to 28/04/2023.

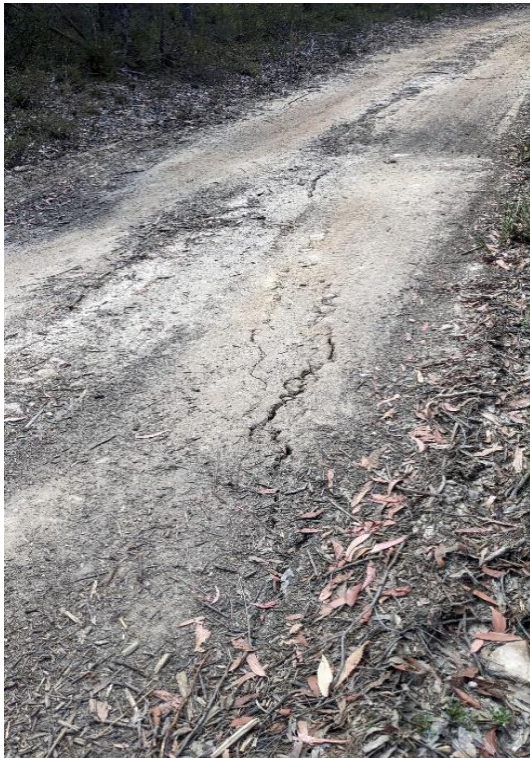
- Crack or fracture up to 100mm width;
- Crack or fracture up to 10m length.

Photo 174: DA3A_LW19_026, section of soil cracking. Taken on 21/12/2022.

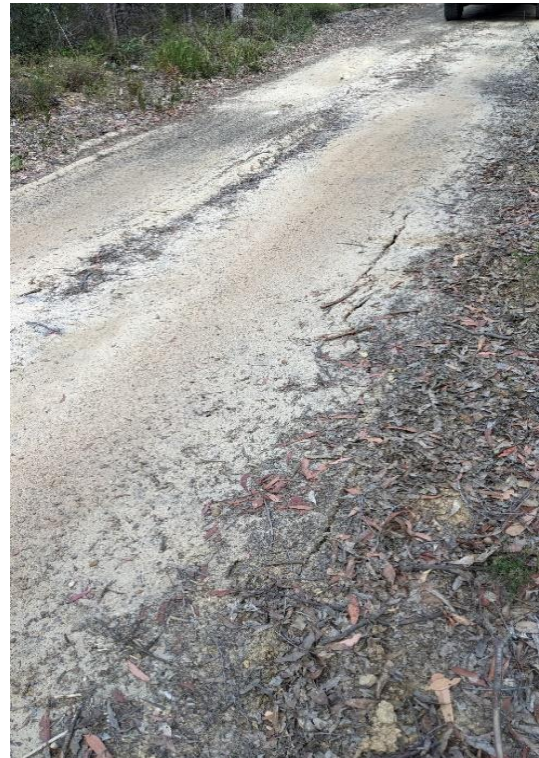
Photo 175: DA3A_LW19_026, section of soil cracking. Taken on 21/12/2022.

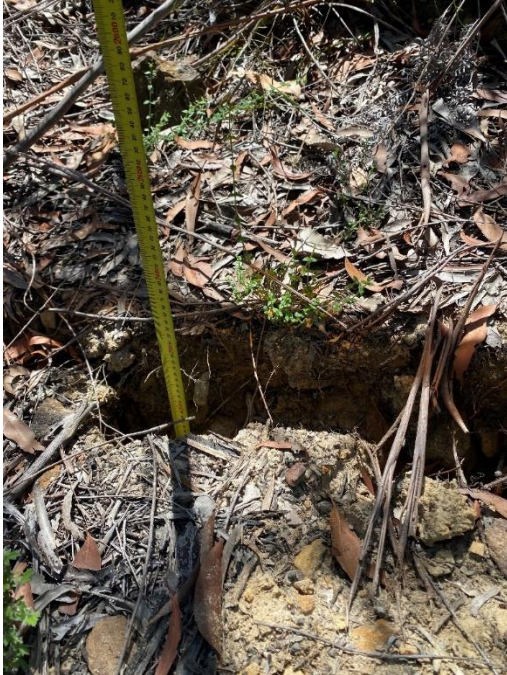
Photo 176: DA3A_LW19_035, depth of the soil cracking. Taken on 16/03/2023.

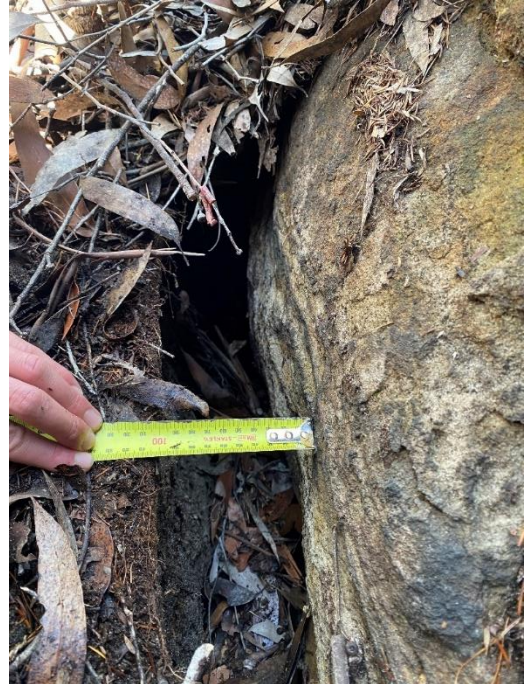
Photo 177: DA3A_LW19_035, width of the soil cracking/rock displacement. Taken on 16/03/2023.

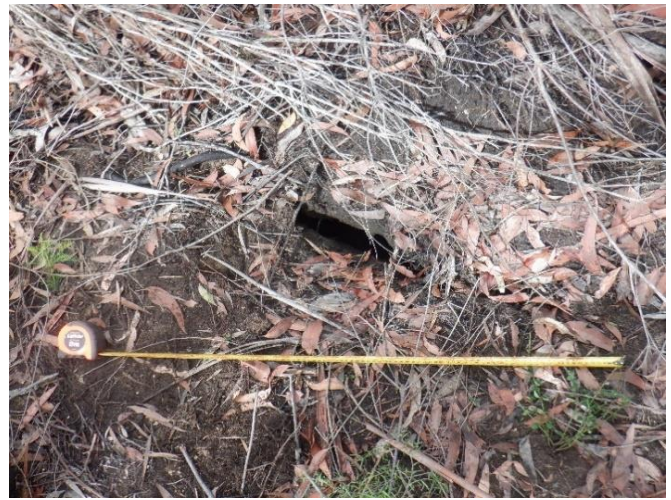
Photo 181: DA3A_LW19_036, soil cracking. Taken on 21/03/2023.

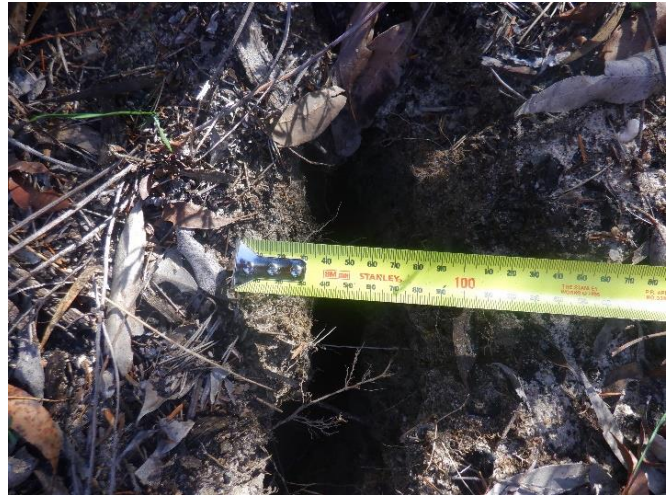
Photo 186: DA3A_LW19_049, showing width of soil crack.
Taken on 27/04/2023.

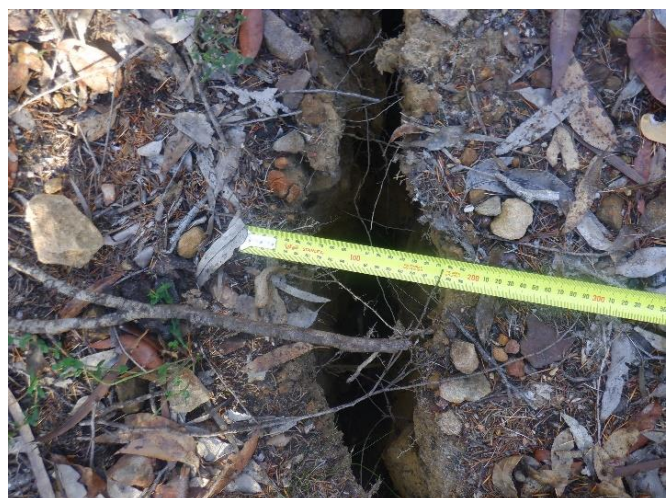
Photo 188: DA3A_LW19_050, showing width of soil crack.
Taken on 27/04/2023.
