Monitoring of watercourses, swamps and landscape features is undertaken to identify subsidence impacts. These features are monitored by the Illawarra Metallurgical Coal Environmental Field Team (IMCEFT) on a monthly basis prior to mining and weekly during mining. Monitoring is conducted in accordance with the approved Subsidence Management Plan (SMP) for Dendrobium Area 3A (DA3A). Extraction of Longwall 19 commenced 20 June 2022 and as of 2 August 2022 had progressed approximately 284m. During a recent inspection, two new subsidence impacts were identified.

**DA3A\_LW19\_001 (E 292826, N6192225)**

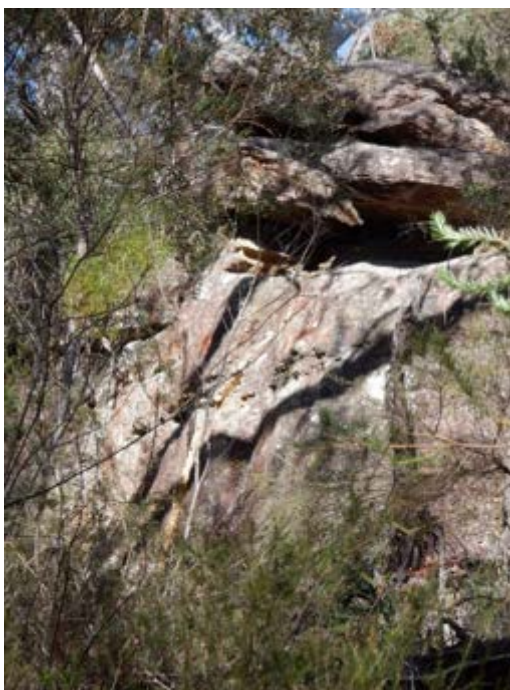
*DA3A\_LW19\_001* is located on a steep slope/ step east of Fire Road 6F (Figure 1). The impact was identified on 3 August 2022, consisting of rock fracturing. The rock fracturing has an approximate maximum length of 3m and a maximum width of less than 0.1m (Photo 1). Measurements have been estimated due to safety concerns.

*DA3A\_LW19\_001* is a Level 1 trigger as per the Dendrobium Area 3A Landscape TARP (Table 1), specifically;

Photo 1: *DA3A\_LW19\_001*, showing a section of rock fracturing. Taken 3/08/2022.

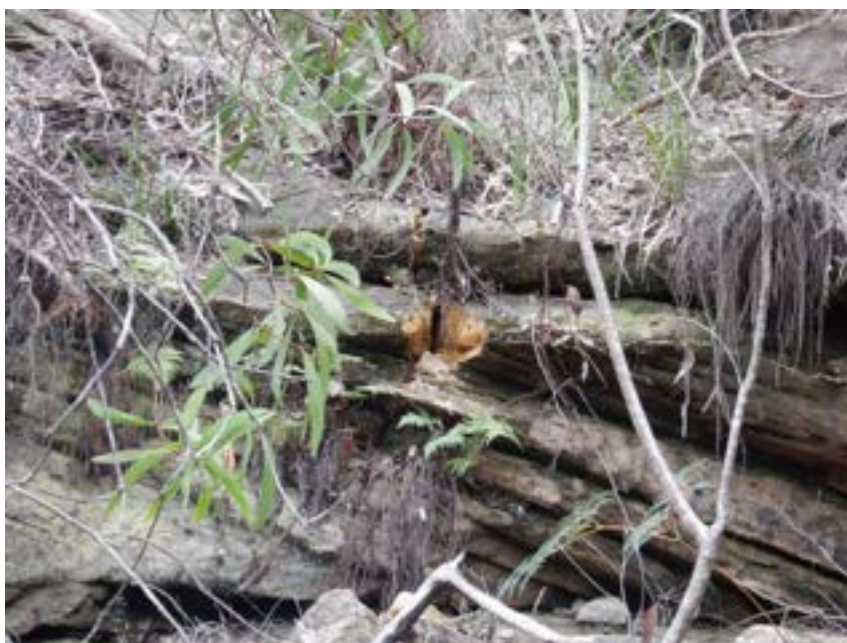
*DA3A\_LW19\_004* is located on a steep slope/ step west of Swamp 15b (Figure 1). The impact was identified on 19 August 2022, consisting of rock fracturing and fragmentation. The rock fracturing has an approximate maximum length of 1.5m and a maximum width of 0.05m (Photo 1). The rock fragmentation has an approximate volume of 0.3m x 0.2m x 0.15m. Measurements have been estimated due to safety concerns.

Photo 1: *DA3A\_LW19\_004*, looking at rock fracturing and fragmentation. Taken on 19/08/2022.

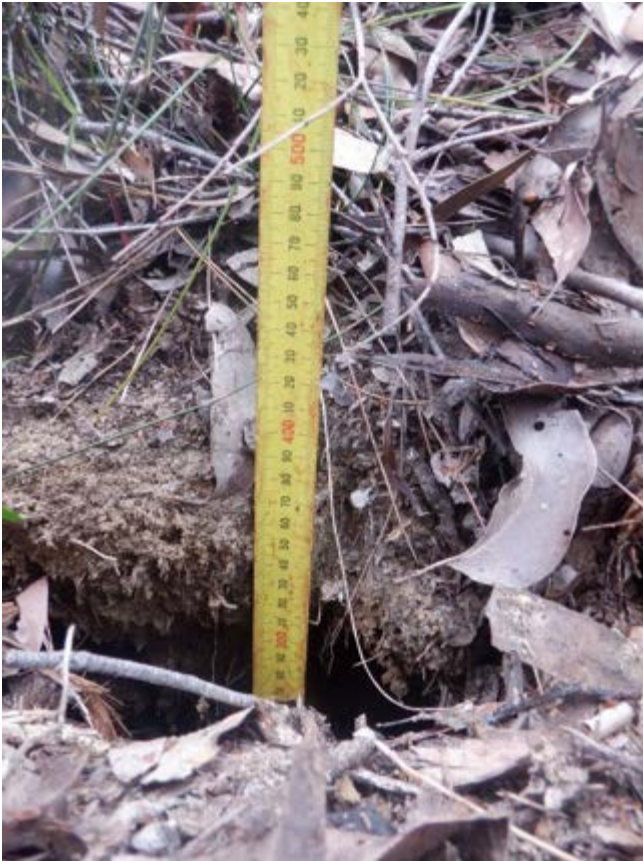
*DA3A\_LW19\_007* was identified on 18 October 2022 and consists of soil cracking, located 100m to the north of Longwall 19 (Figure 1). The soil cracking is situated in bushland and runs parallel to a closed access track. The cracking has a maximum continuous length of 2.4m, a maximum width of 0.08m and maximum measurable depth of 0.4m (Photo 1 to Photo 4). It has a total discontinuous length of approximately 50m. In some sections, the soil is displaced from adjacent rock outcropping (Photo 2). This impact likely occurred during Longwall 8 but was only identified during the latest inspection of the area. Some sections of the soil cracking indicate more recent movements, likely due to Longwall 19.

Photo 3: DA3A\_LW19\_007, depth of soil cracking. Taken on 18/10/2022.

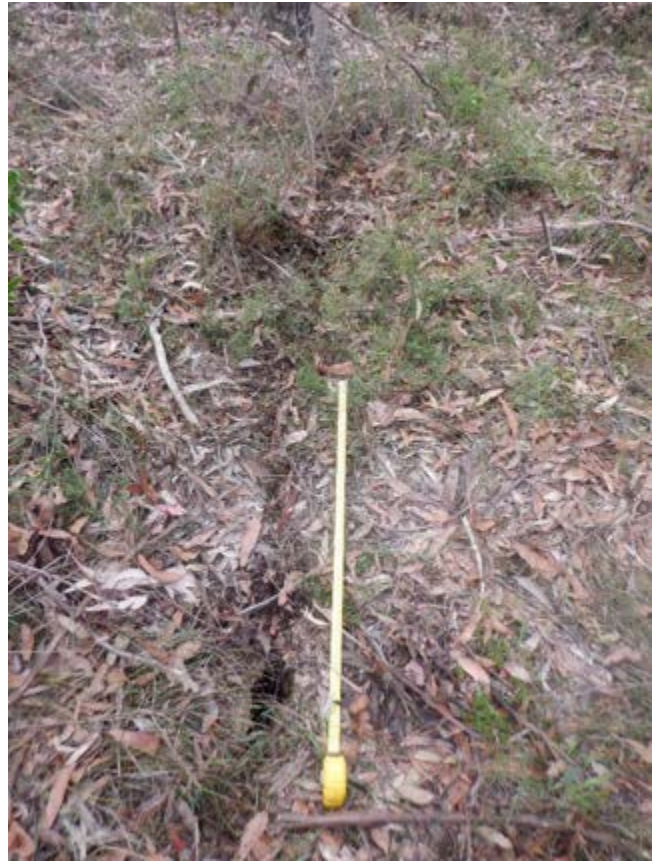
Photo 4: DA3A\_LW19\_007, section of soil cracking. Taken on 18/10/2022.

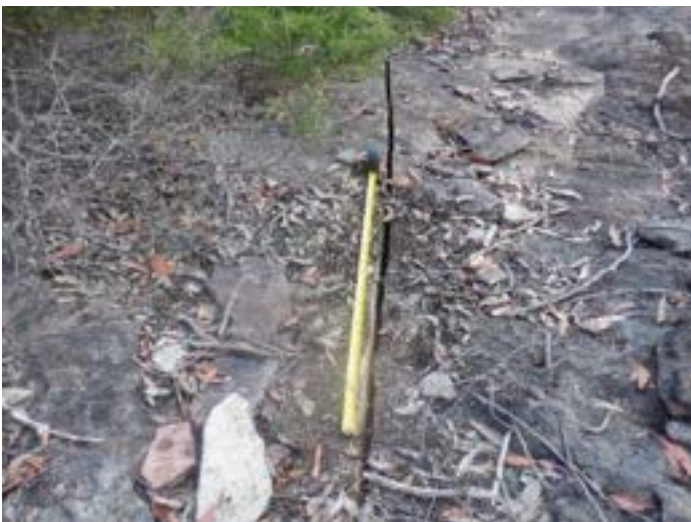
DA3A\_LW19\_008 is located 80m east of Fire Road 6F and consists of rock fracturing to a rock outcrop (Figure 1). The fracturing has a maximum continuous length of 5.4m, a maximum width of 0.028m and maximum measurable depth of 1.539m (Photo 1 and Photo 2). The fracture has a total discontinuous length of approximately 22m. Flagging tape is in place at the site as a safety precaution.

Photo 1: DA3A\_LW19\_008, section of rock fracturing. Taken on 7/11/2022.

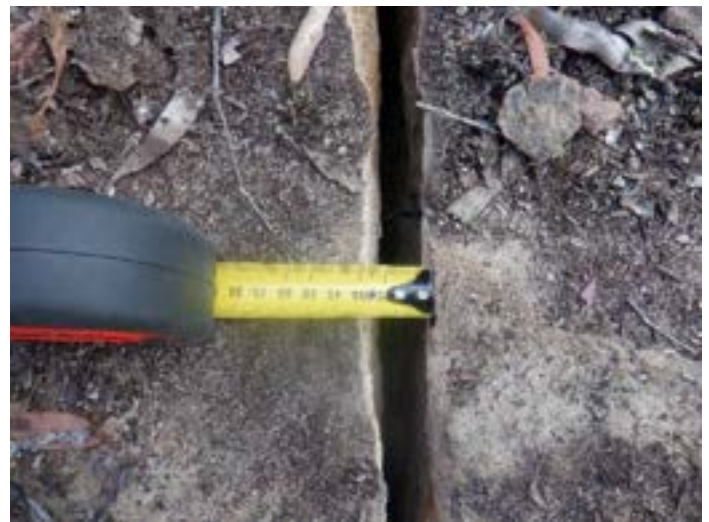
Photo 2: DA3A\_LW19\_008, width of rock fracturing. Taken on 7/11/2022.

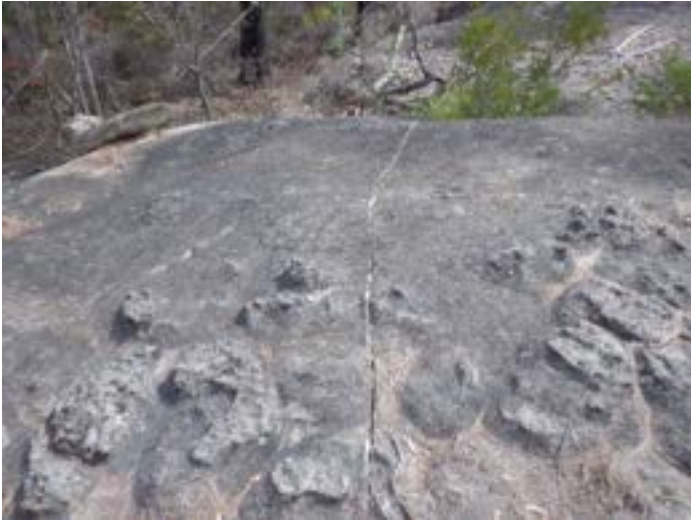
DA3A\_LW19\_009 is located 95m east of Fire Road 6F and consists of rock fracturing to a rock outcrop (Figure 1). The fracturing has a maximum continuous length of 7.44m, a maximum width of 0.016m and maximum

measurable depth of 0.043m (Photo 3 and Photo 4). The fracture has a total discontinuous length of approximately 48m. Flagging tape is in place at the site as a safety precaution.

Photo 3: *DA3A\_LW19\_009*, section of rock fracturing. Taken on 7/11/2022.

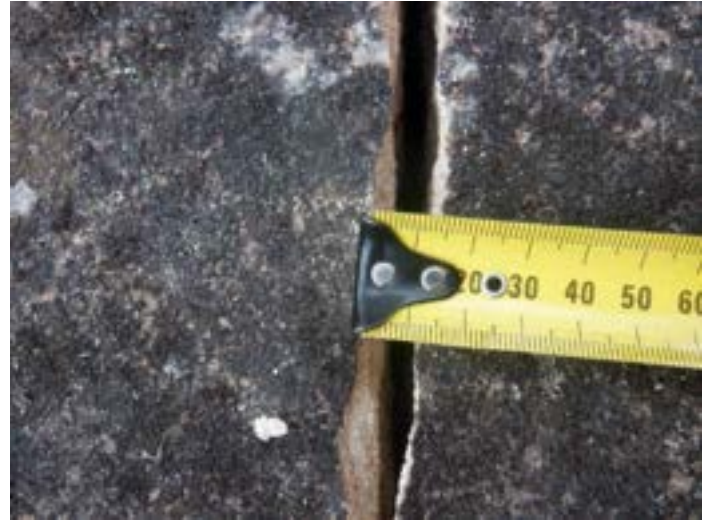
Photo 4: *DA3A\_LW19\_009*, width of rock fracturing. Taken on 7/11/2022.

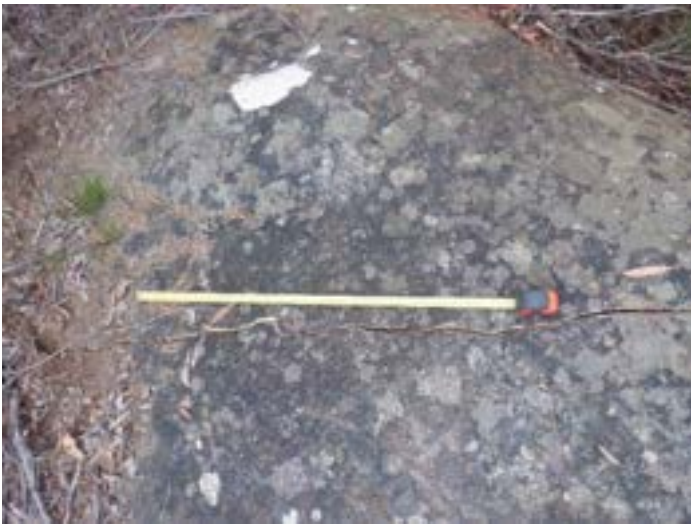
*DA3A\_LW19\_010* is located 115m east of Fire Road 6F and consists of rock fracturing to a rock outcrop (Figure 1). The fracturing has a maximum continuous length of 2.8m, a maximum width of 0.012m and maximum measurable depth of 0.29m (Photo 5 and Photo 6). Flagging tape is in place at the site as a safety precaution.

Photo 5: *DA3A\_LW19\_010*, section of rock fracturing. Taken on 7/11/2022.

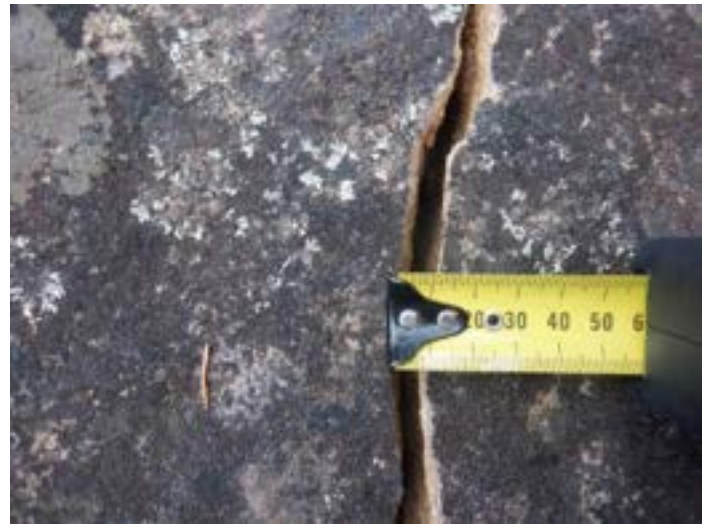
Photo 6: *DA3A\_LW19\_010*, width of rock fracturing. Taken on 7/11/2022.

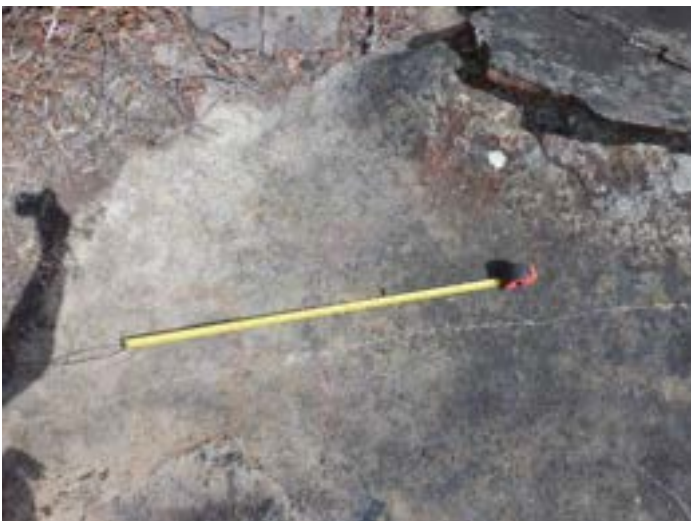
*DA3A\_LW19\_011* is located 115m east of Fire Road 6F and consists of two rock fractures to a rock outcrop (Figure 1). The fracturing has a maximum continuous length of 4m and a maximum width of 0.003m (Photo 7 and Photo 8). Flagging tape is in place at the site as a safety precaution.

Photo 7: *DA3A\_LW19\_011*, section of rock fracturing. Taken on 7/11/2022.

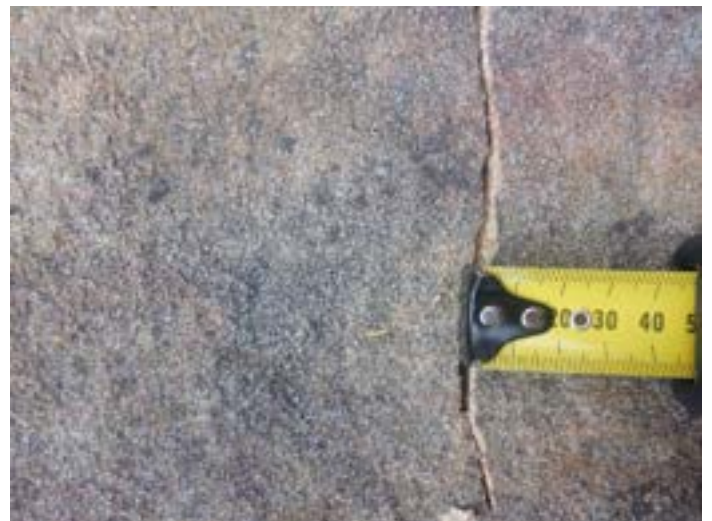
Photo 8: *DA3A\_LW19\_011*, width of rock fracturing. Taken on 7/11/2022.

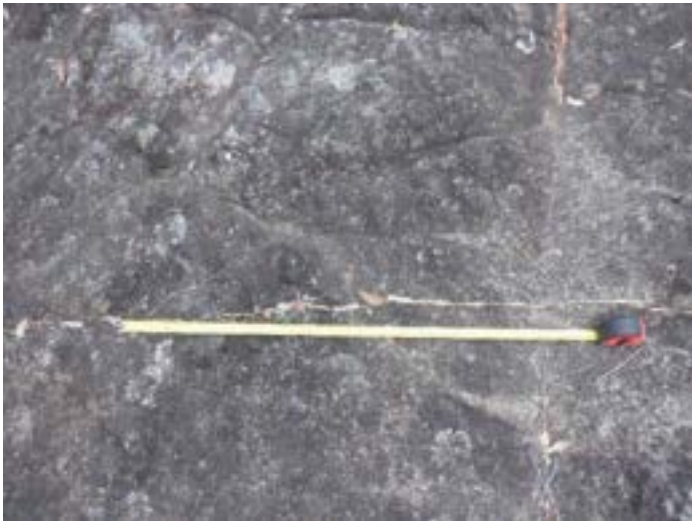
DA3A\_LW19\_012 is located 165m east of Fire Road 6F and consists of rock fracturing to a rock outcrop (Figure 1). The fracturing has a maximum continuous length of 5.7m, a maximum width of 0.008m and maximum measurable depth of 0.17m (Photo 9 and Photo 10). The fracture has a total discontinuous length of approximately 9.5m. Flagging tape is in place at the site as a safety precaution.

Photo 9: DA3A\_LW19\_012, section of rock fracturing. Taken on 7/11/2022.

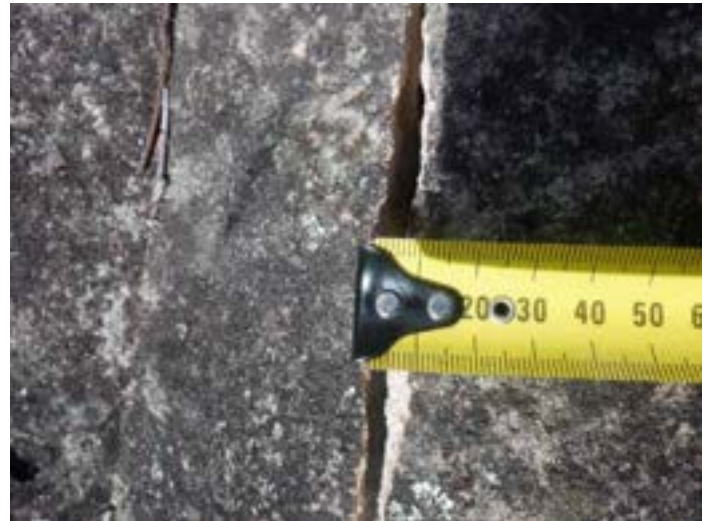
Photo 10: DA3A\_LW19\_012, width of rock fracturing. Taken on 7/11/2022.

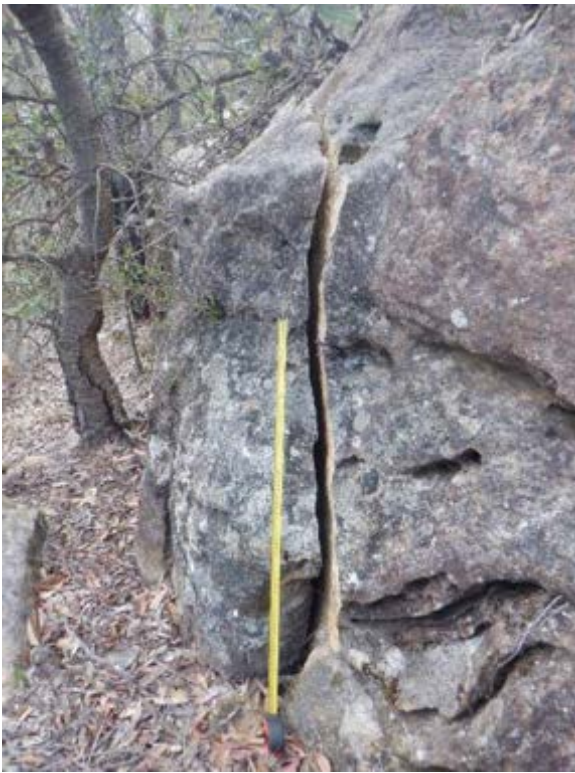
DA3A\_LW19\_013 is located 120m east of Fire Road 6F and consists of rock fracturing and rock movement to a steep slope/step (Figure 1). The fracturing has a maximum continuous length of 1.8m, a maximum width of 0.105m and maximum measurable depth of 2.3m (Photo 11 and Photo 12). Flagging tape is in place at the site as a safety precaution.

Photo 11: *DA3A\_LW19\_013*, section of rock fracturing. Taken on 7/11/2022.

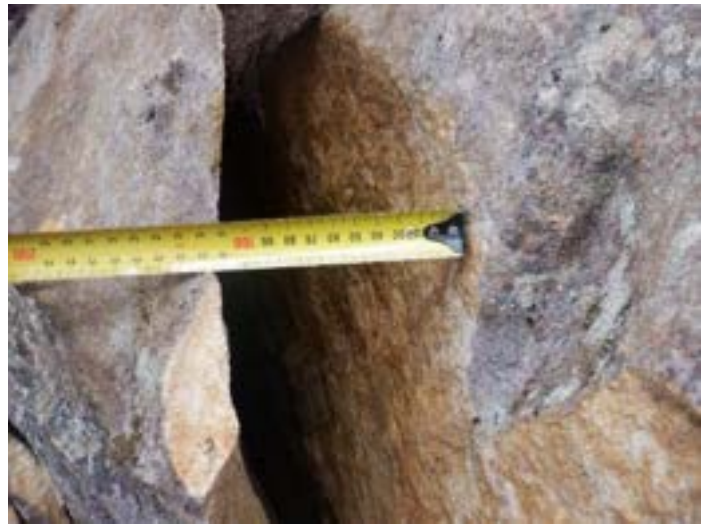
Photo 12: *DA3A\_LW19\_013*, width of rock fracturing. Taken on 7/11/2022.

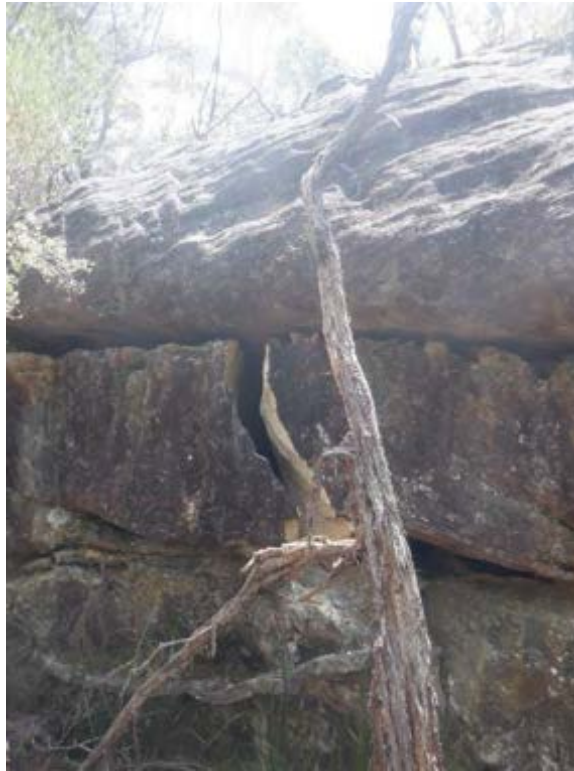
DA3A\_LW19\_015 is located 100m north of Swamp 15a and consists of a rock fracture to a steep slope/step (Figure 1). The following measurements have been estimated from a distance due to safety concerns. The fracturing has a length of 1m, a maximum width of 0.30m and maximum depth of 3m (Photo 15). Flagging tape is in place at the site as a safety precaution.

Photo 15: DA3A\_LW19\_015, section of rock fracturing.  
Taken on 7/11/2022.

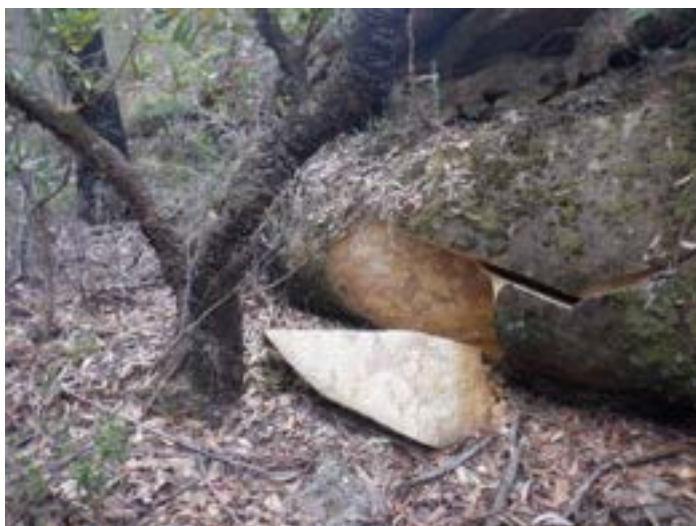
DA3A\_LW19\_016 is located 320m east of Fire Road 6F and consists of two rock fractures and associated displacement at a steep slope/step (Figure 1). The following measurements have been estimated from a distance due to safety concerns. The largest fracture has a length of 2m and a maximum width of 0.1m. The rock displacement/fragmentation has approximate dimensions of 1.3m x 0.8m x 0.5m. Flagging tape is in place at the site as a safety precaution.

Photo 16: DA3A\_LW19\_016, section of rock fracturing. Taken on 7/11/2022.

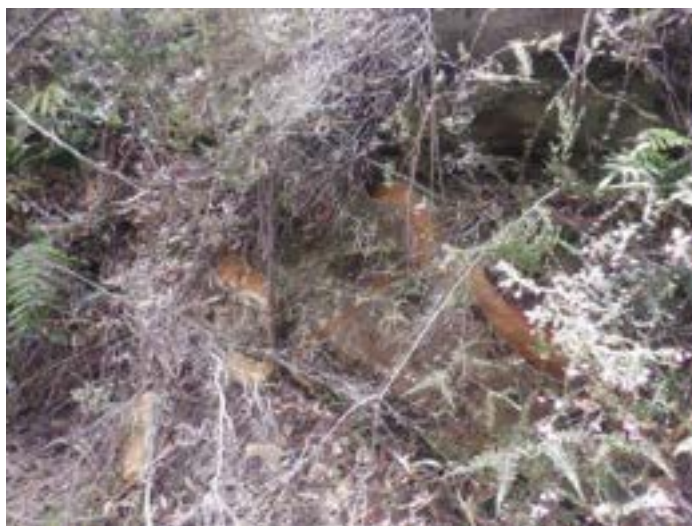
Photo 17: DA3A\_LW19\_016, section of rock fracturing. Taken on 7/11/2022.

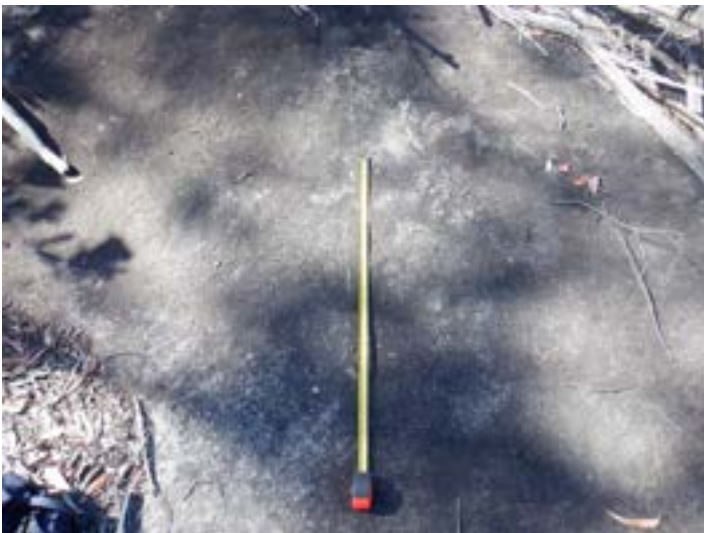
Photo 1: DA3A\_LW19\_017, section of rock fracturing. Taken on 13/12/2022.

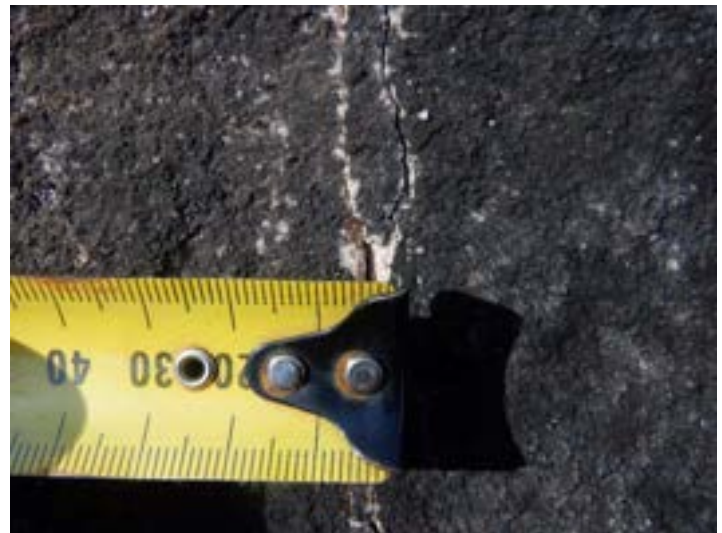
Photo 2: DA3A\_LW19\_017, width of rock fracturing. Taken on 13/12/2022.

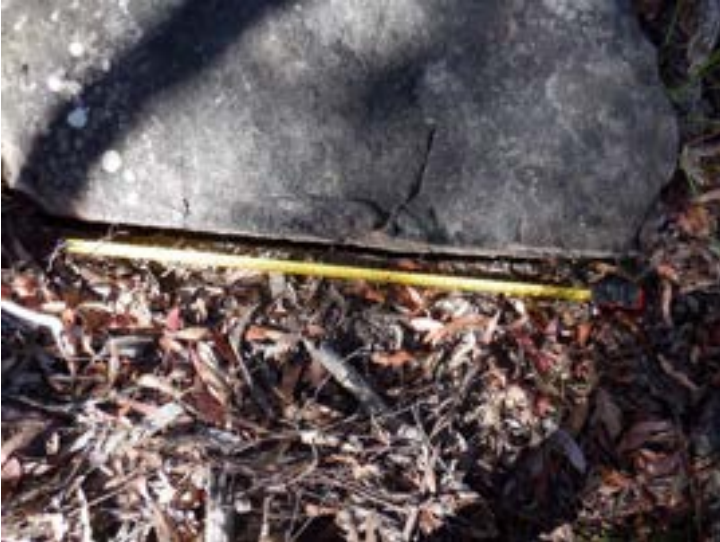
Photo 3: *DA3A\_LW19\_018*, section of rock displacement. Taken on 13/12/2022.

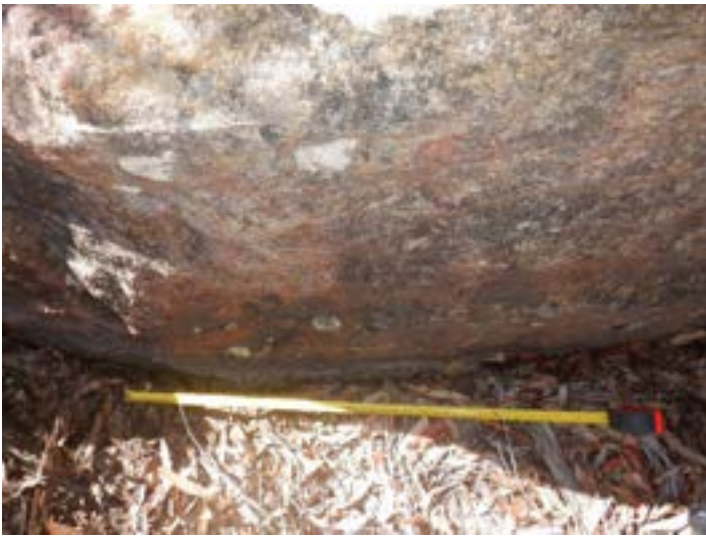
Photo 5: DA3A\_LW19\_019, section of rock displacement. Taken on 13/12/2022.

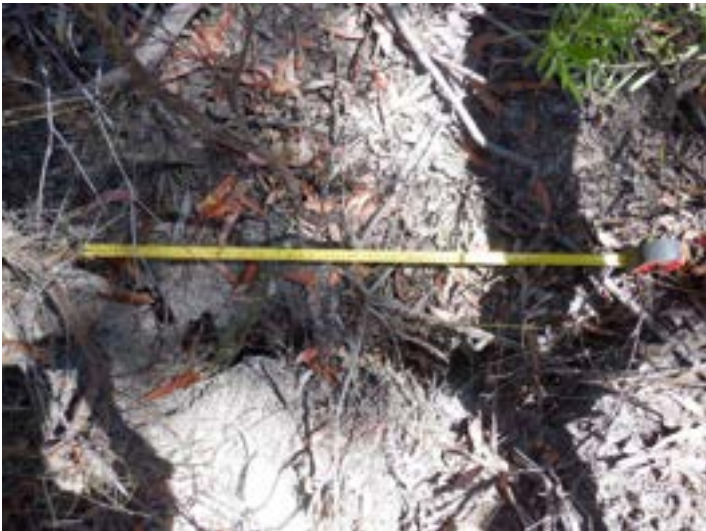
Photo 7: DA3A\_LW19\_020, section of soil cracking. Taken on 13/12/2022.

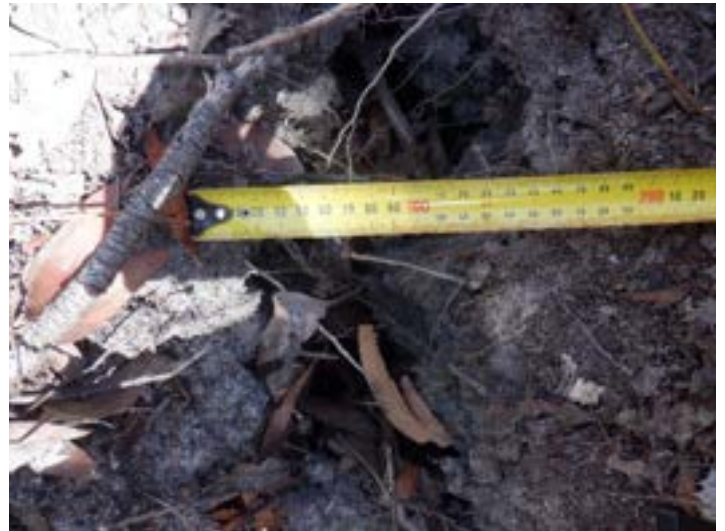
Photo 8: DA3A\_LW19\_020, width of soil cracking. Taken on 13/12/2022.

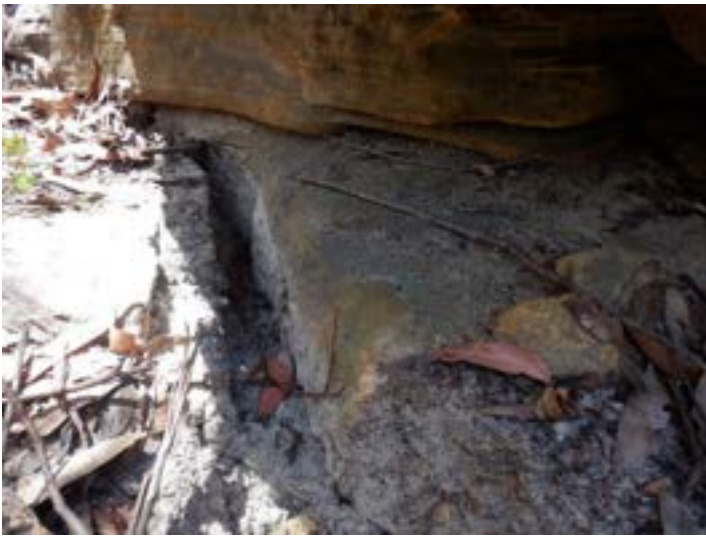
Photo 9: DA3A\_LW19\_021, section of soil cracking. Taken on 13/12/2022.

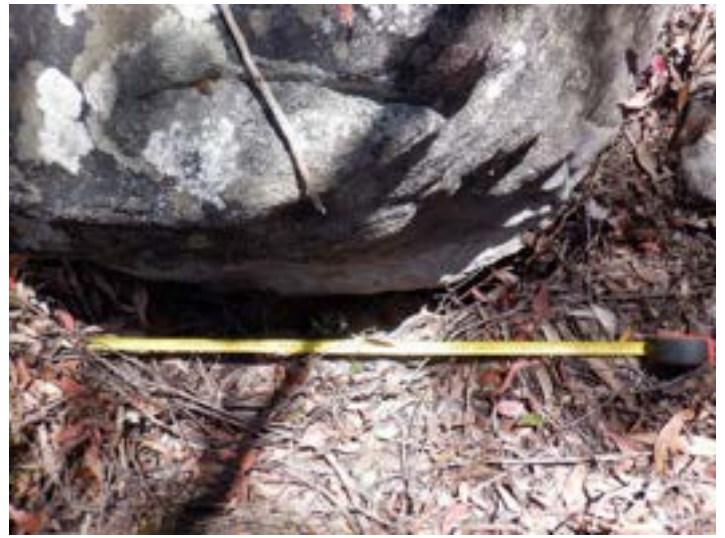
Photo 10: DA3A\_LW19\_021, section of rock displacement. Taken on 13/12/2022.

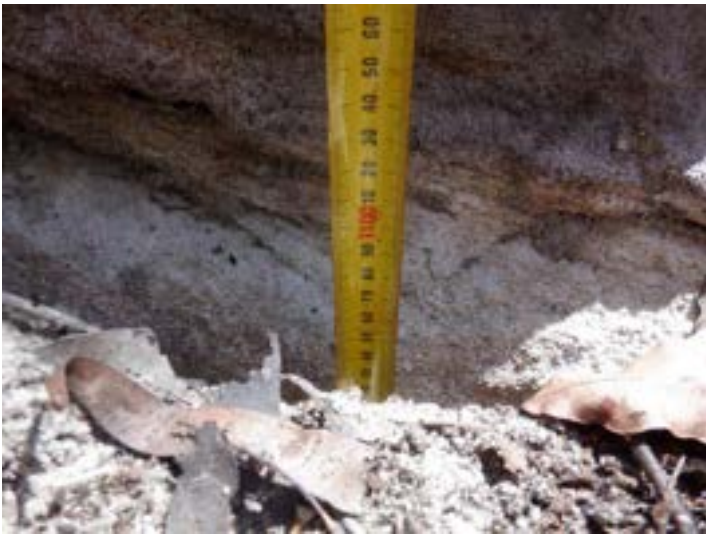
Photo 11: DA3A\_LW19\_021, depth of soil cracking. Taken on 13/12/2022.

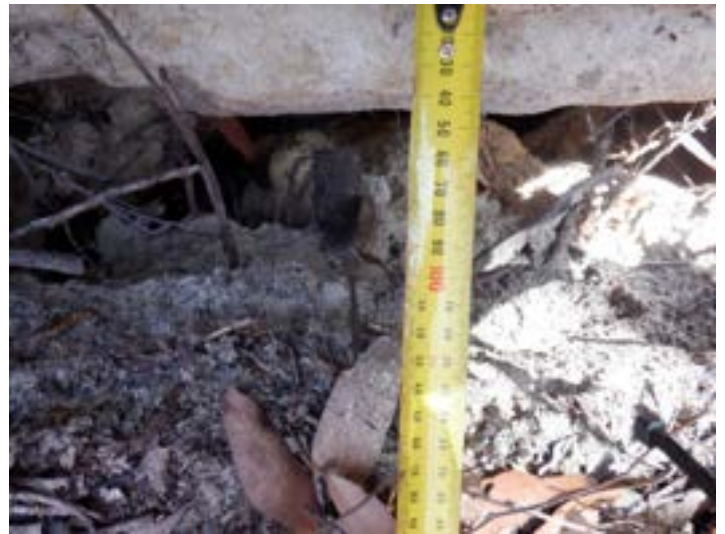
Photo 12: DA3A\_LW19\_021, width of soil cracking. Taken on 13/12/2022.

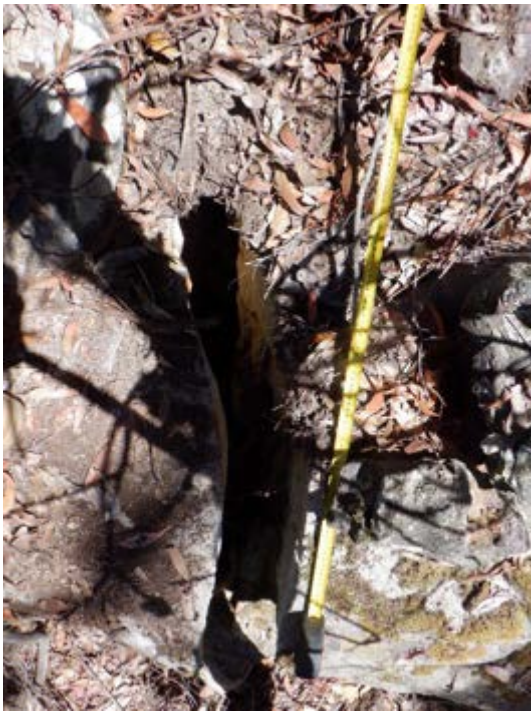
Photo 13: DA3A\_LW19\_022, section of rock fracturing. Taken on 13/12/2022.

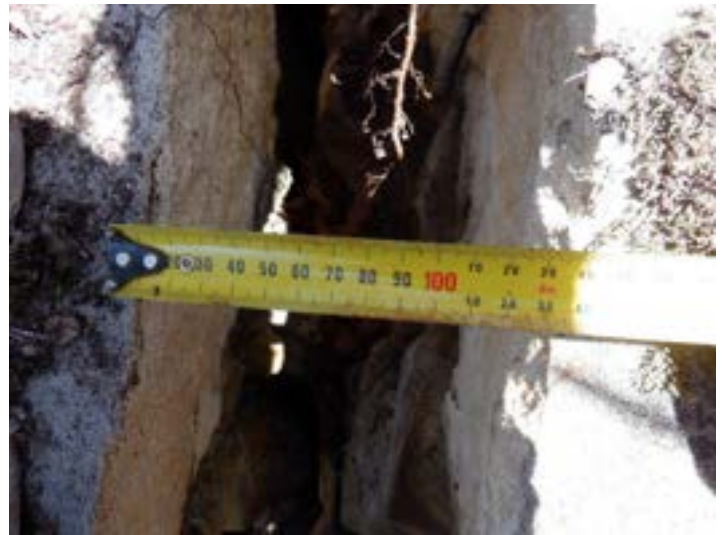
Photo 14: DA3A\_LW19\_022, width of rock fracturing. Taken on 13/12/2022.

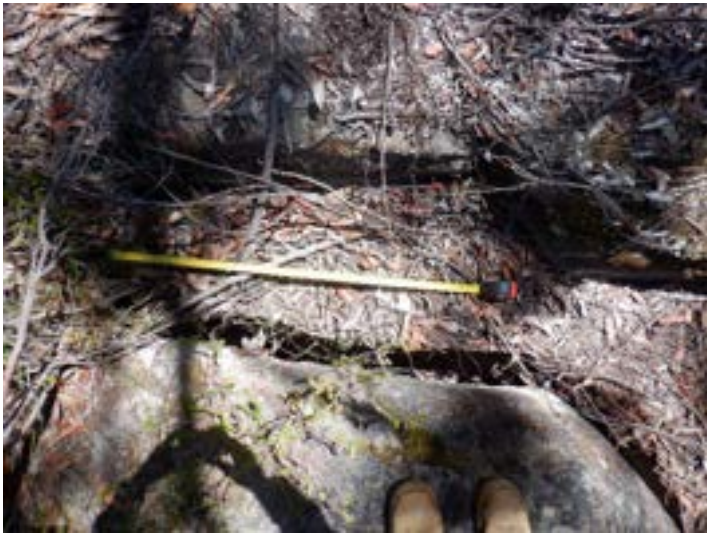
Photo 15: DA3A\_LW19\_022, section of rock displacement. Taken on 13/12/2022.

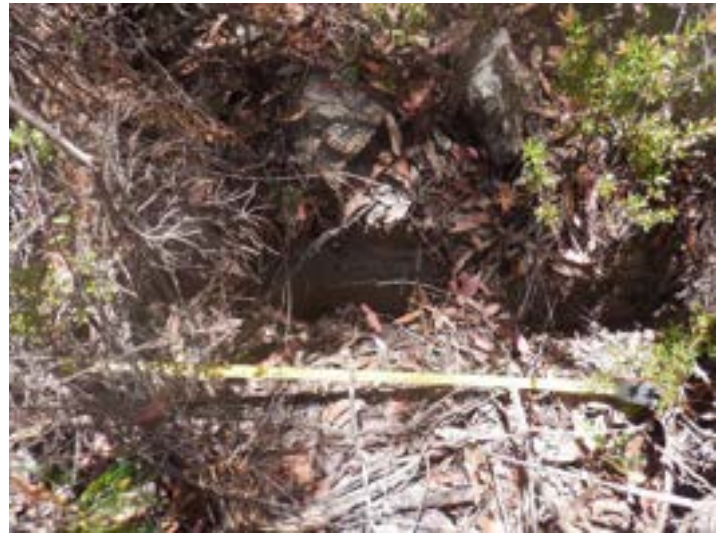
Photo 16: DA3A\_LW19\_022, section of soil cracking. Taken on 13/12/2022.

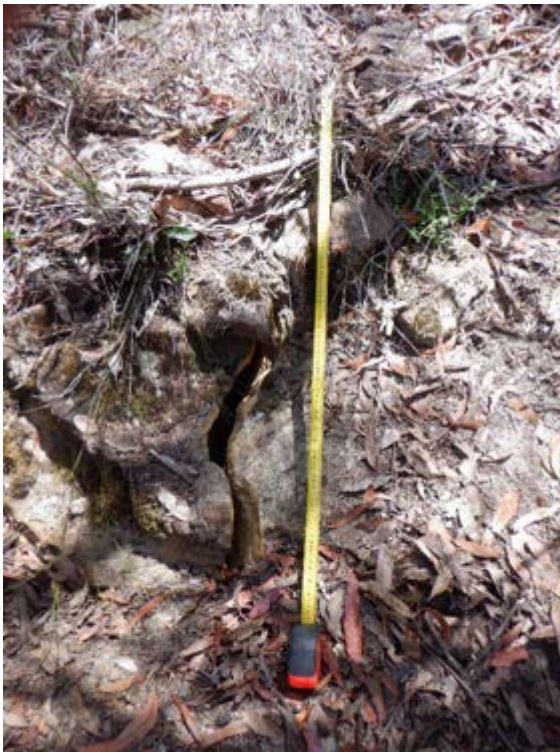
Photo 17: *DA3A\_LW19\_023*, section of rock displacement. Taken on 13/12/2022.

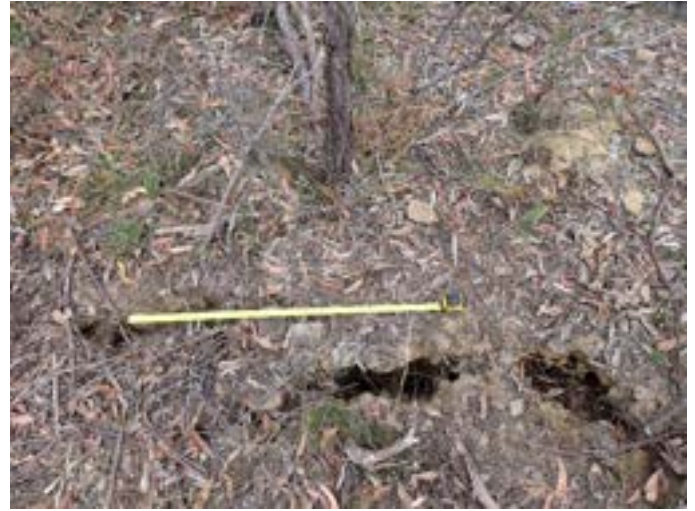
Photo 2: DA3A\_LW19\_024, section of soil cracking. Taken on 20/12/2022.

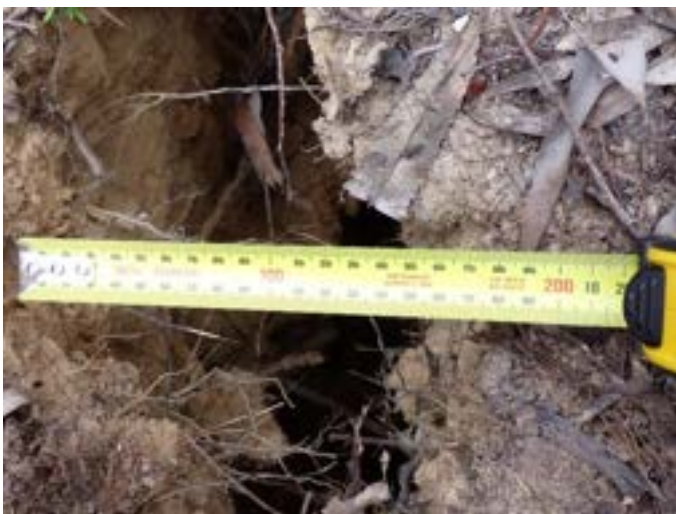
Photo 3: DA3A\_LW19\_024, width of soil cracking. Taken on 20/12/2022.

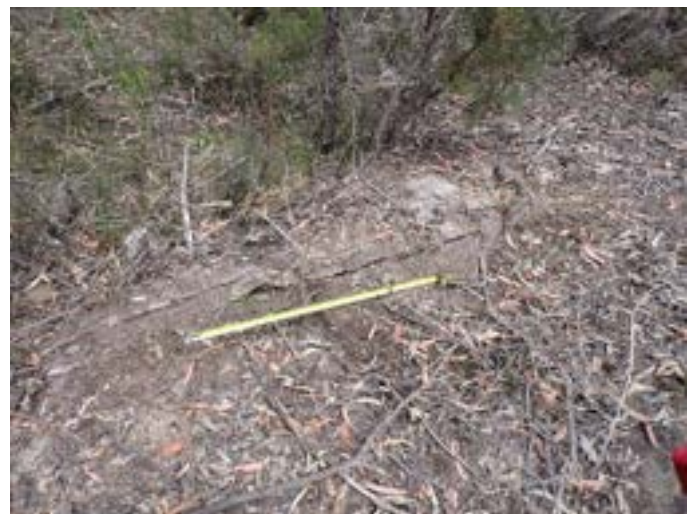
Photo 4: DA3A\_LW19\_024, section of rock fracturing. Taken on 20/12/2022.

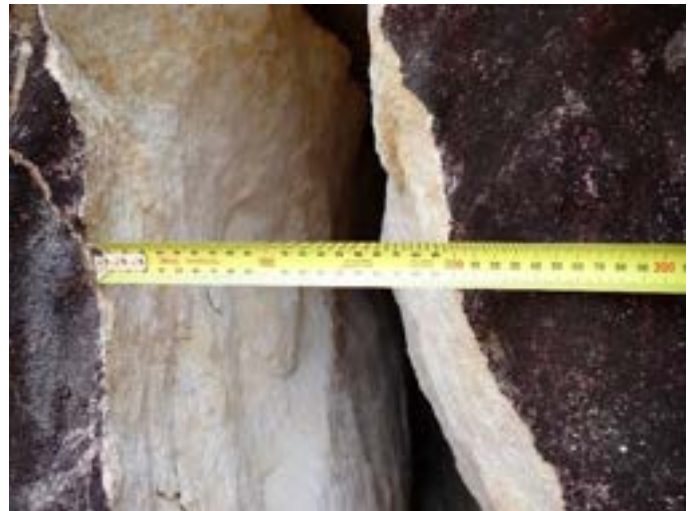
Photo 10: DA3A\_LW19\_015, width of rock fracturing. Taken on 20/12/2022.

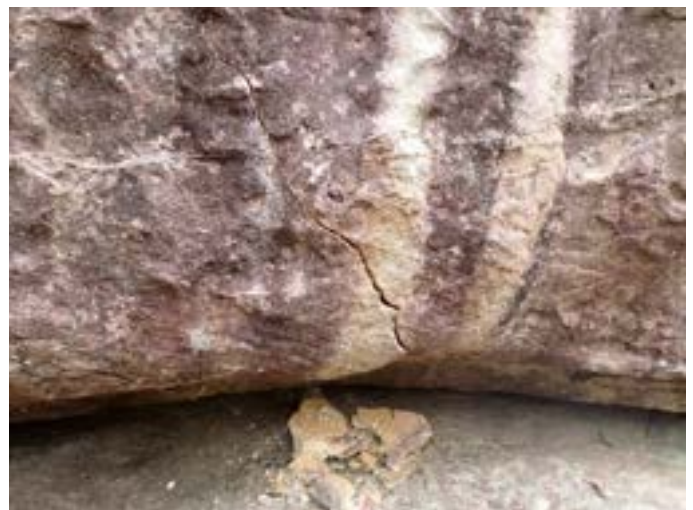
Photo 12: DA3A\_LW19\_015, section of rock fracturing. Taken on 20/12/2022.

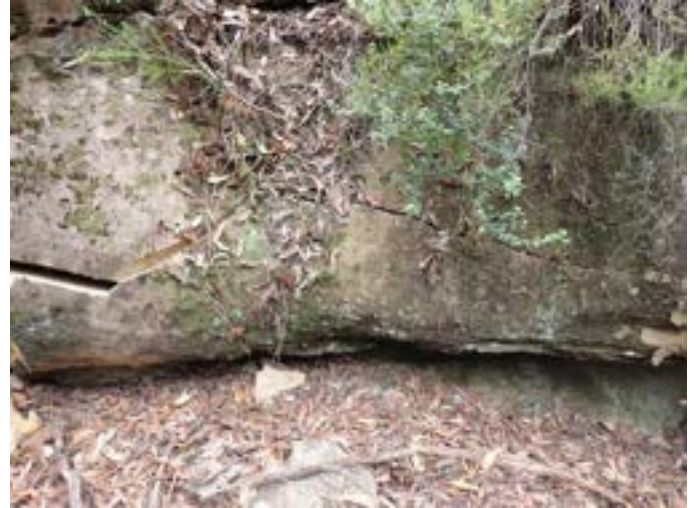
Photo 14: *DA3A\_LW19\_016*, width of rock fracturing. Taken on 20/12/2022.

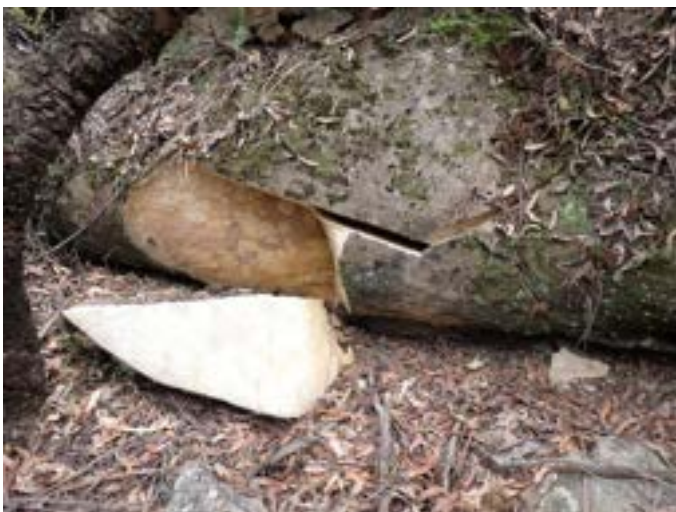
Photo 15: *DA3A\_LW19\_016*, section of rock fragmentation. Taken on 20/12/2022.

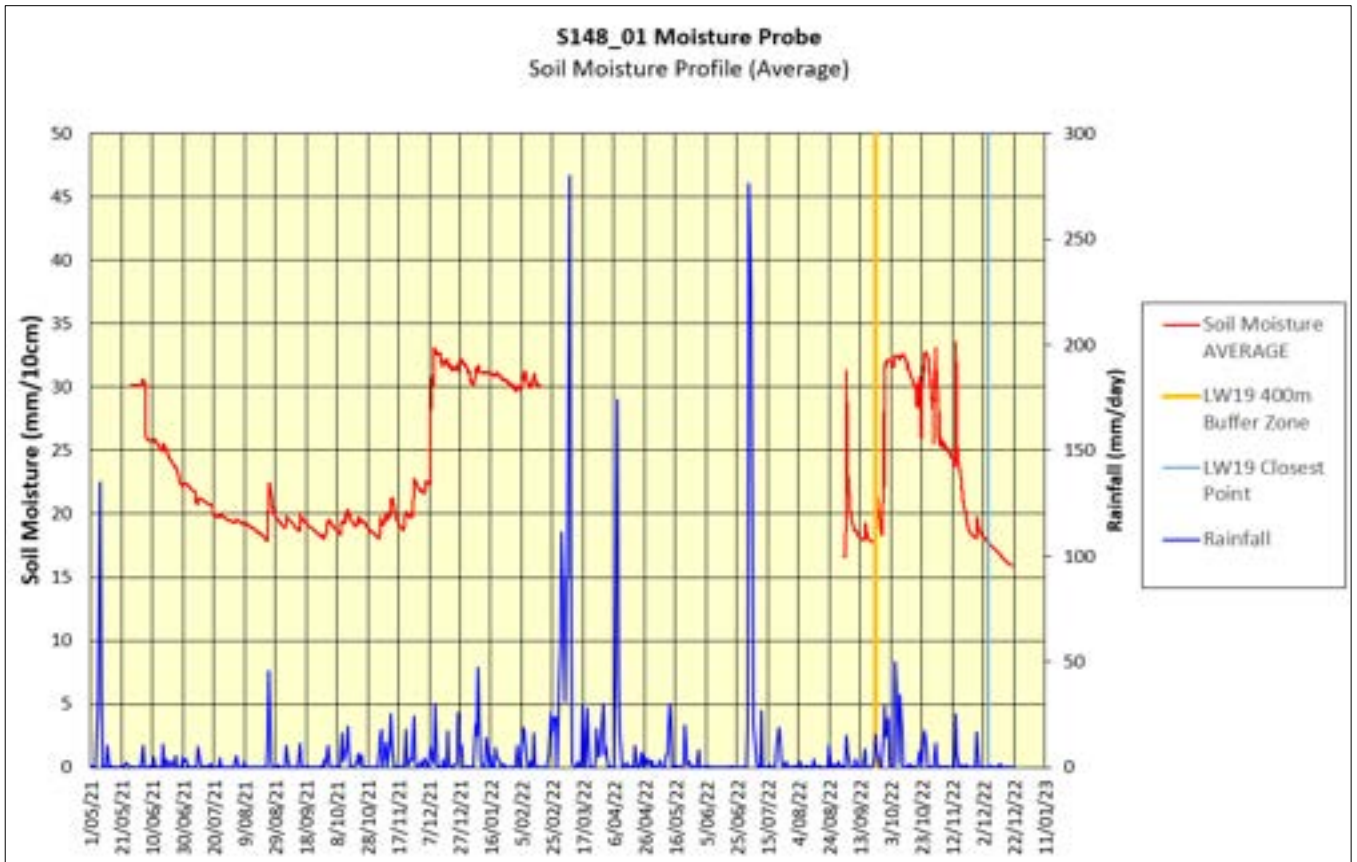
- Soil moisture level lower than baseline level at >80% of monitoring sites (within 400m of mining) within a swamp (in comparison to reference swamps). NOTE there is only one probe installed in the swamp.

Graph 1: Average soil moisture records at S148\_01, logged hourly. Date range: 27/05/2021 to 20/12/2022

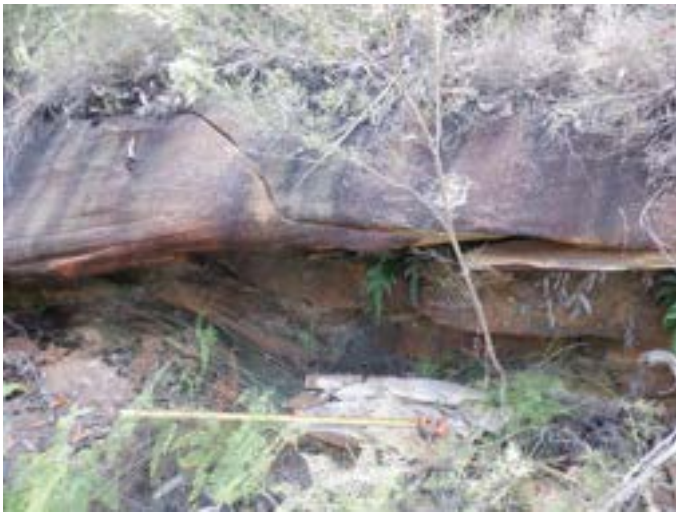
Photo 1: DA3A\_LW19\_027, section of rock fracturing and rockfall. Taken on 10/01/2023.

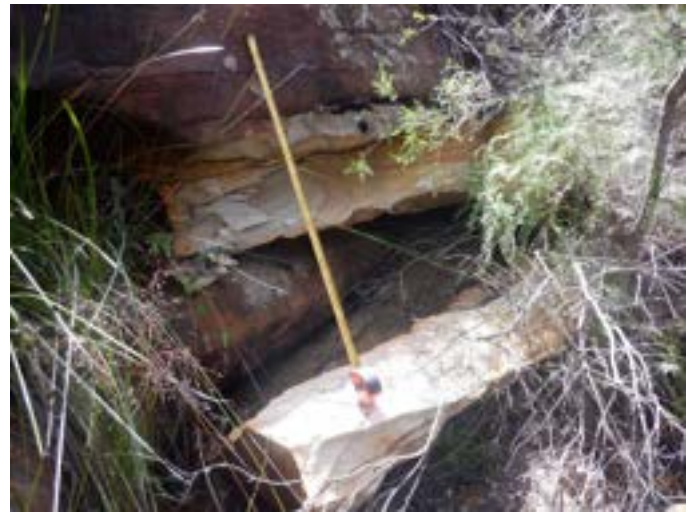
Photo 2: DA3A\_LW19\_027, section of rock fracturing and rockfall. Taken on 10/01/2023.

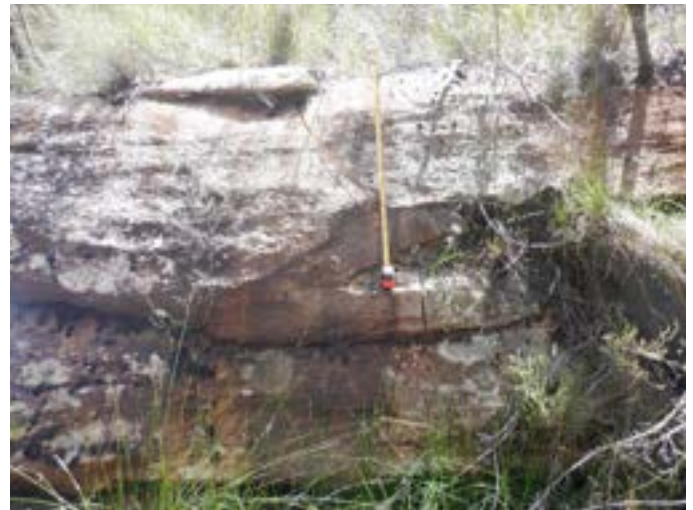
Photo 4: DA3A\_LW19\_027, section of rock fracturing. Taken on 10/01/2023.

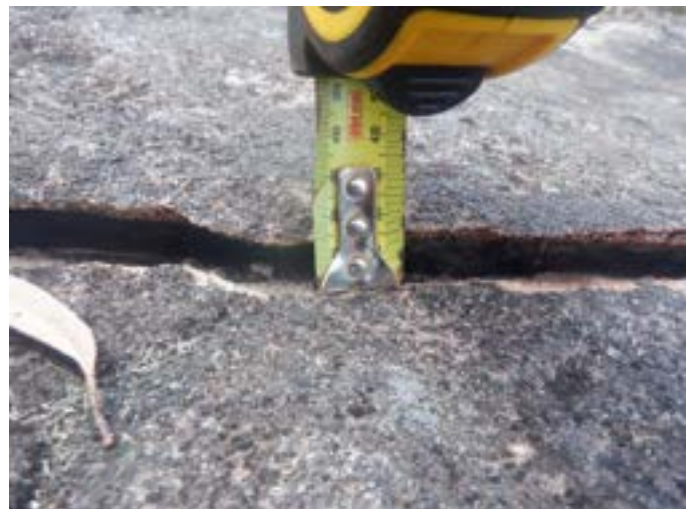
Photo 2: DA3A\_LW19\_028, width of rock fracturing.  
Taken on 6/02/2023.

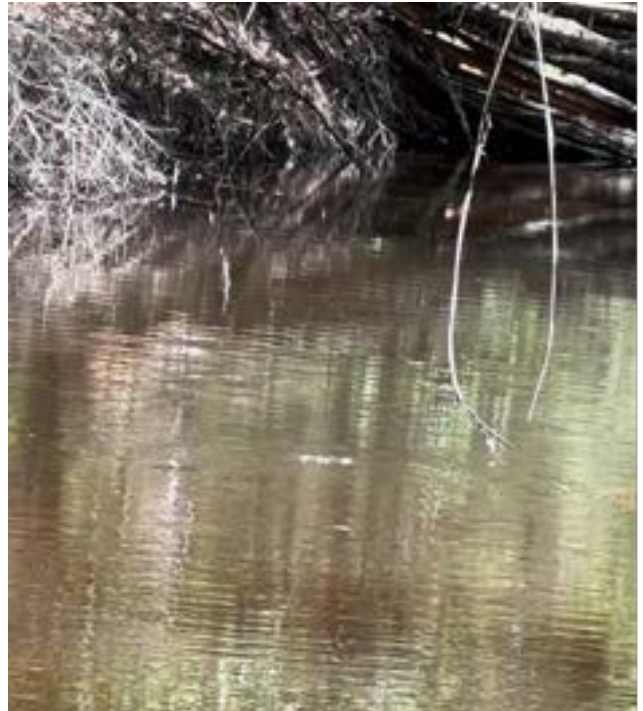
Photo 5: *DA3A\_LW19\_029*- small gas release observed towards the centre of WC\_Pool 50, Wongawilli Creek. Taken on 1/02/2023

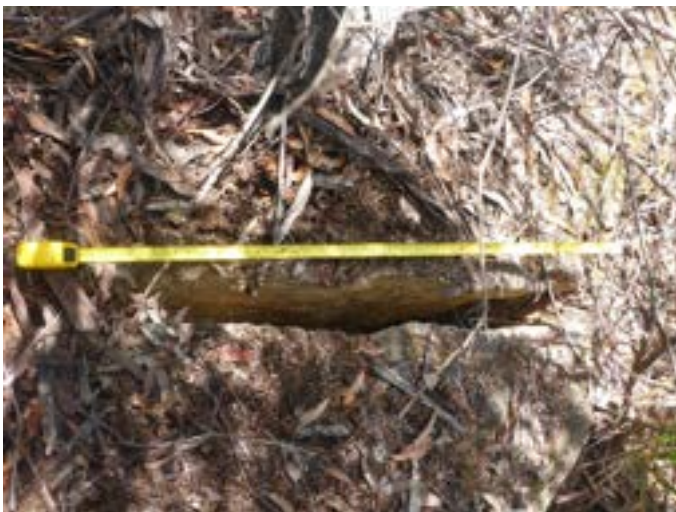
Photo 6: DA3A\_LW19\_025, section of rock fracturing.  
Taken on 17/01/2023.

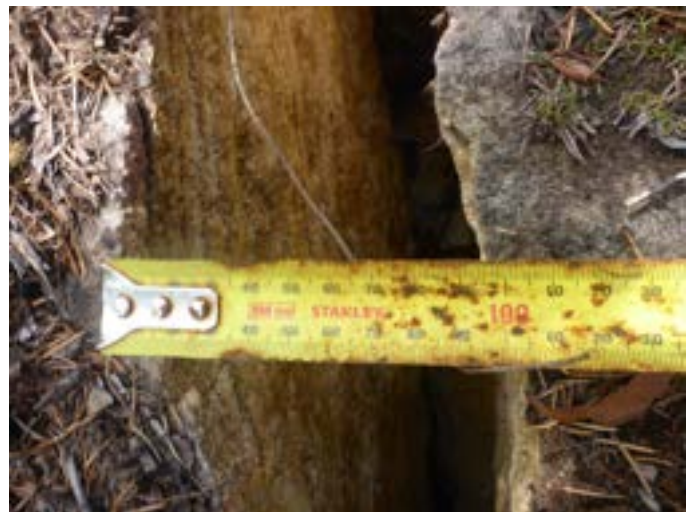
Photo 7: DA3A\_LW19\_025, width of rock fracturing.  
Taken on 17/01/2023.

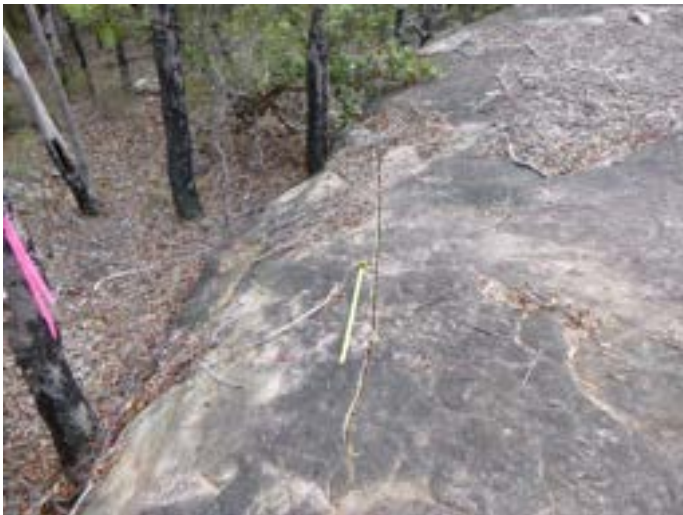
Photo 1: DA3A\_LW19\_030, rock fracturing to an outcrop. Taken on 15/2/2023.

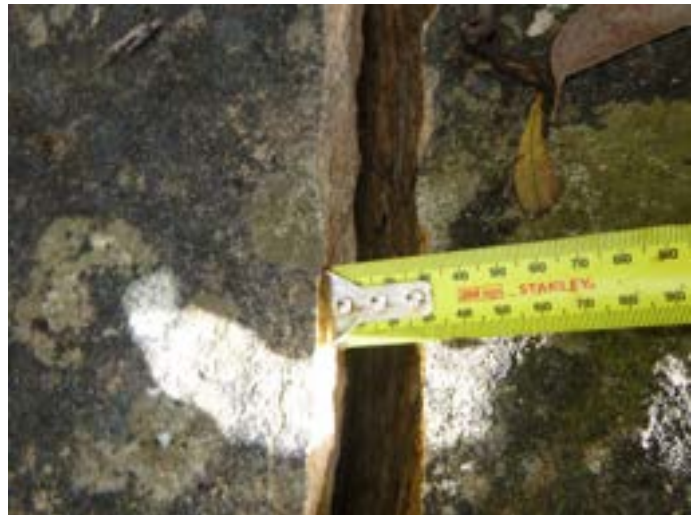
Photo 2: DA3A\_LW19\_030, width of rock fracturing on outcrop. Taken on 15/2/2023.
