Monitoring of watercourses, swamps and landscape features is undertaken to identify subsidence impacts. These features are monitored by the Illawarra Metallurgical Coal Environmental Field Team (IMCEFT) on a monthly basis prior to mining and weekly during mining. Monitoring is conducted in accordance with the approved Subsidence Management Plan (SMP) for Dendrobium Area 3A (DA3A). Extraction of Longwall 19 commenced 20 June 2022 and as of 2 August 2022 had progressed approximately 284m. During a recent inspection, two new subsidence impacts were identified.

**DA3A\_LW19\_001 (E 292826, N6192225)**

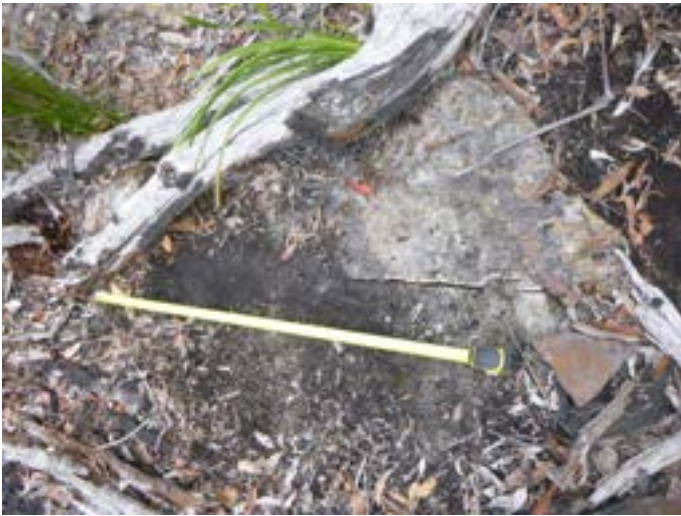
Photo 3: DA3A\_LW19\_031, rock fracturing to an outcrop.  
Taken on 15/2/2023

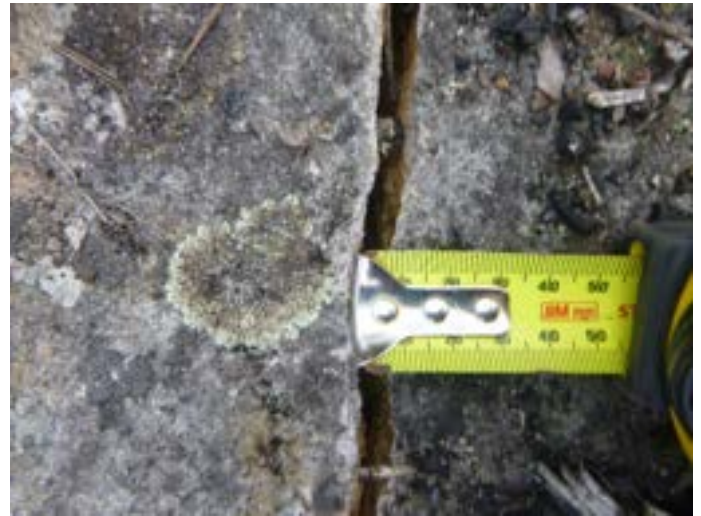
Photo 4: DA3A\_LW19\_031, width of rock fracture on outcrop. Taken on 15/2/2023

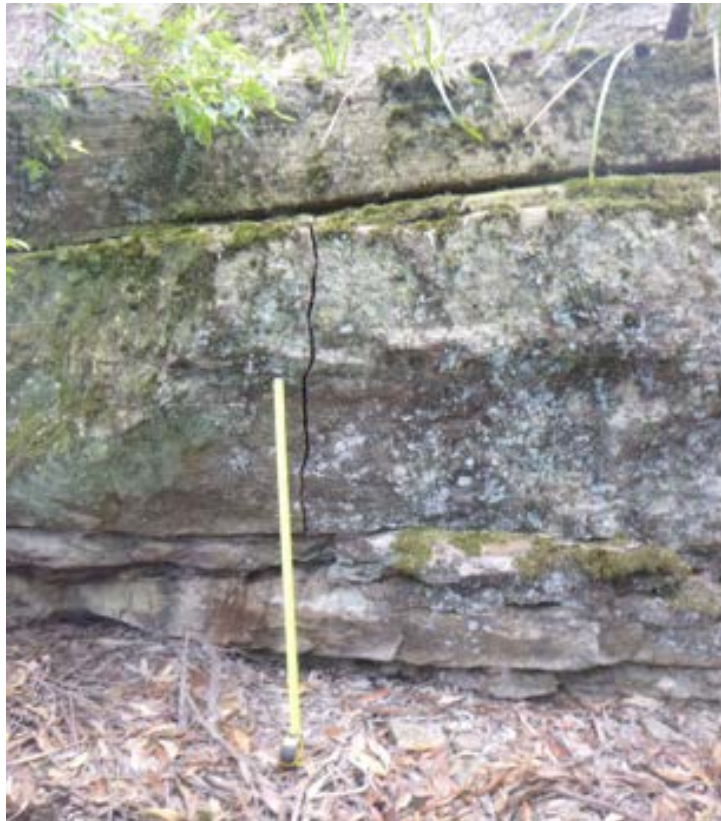
Photo 5: *DA3A\_LW19\_032*, rock fracturing on side of outcrop. Taken on 15/2/2023

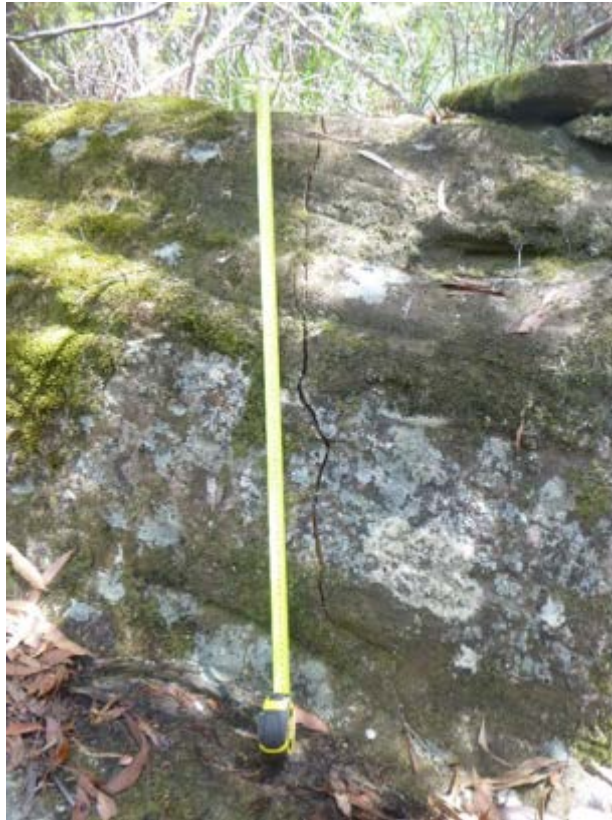
Photo 10: *DA3A\_LW19\_034*, rock fracturing on side of an outcrop. Taken on 15/2/2023.

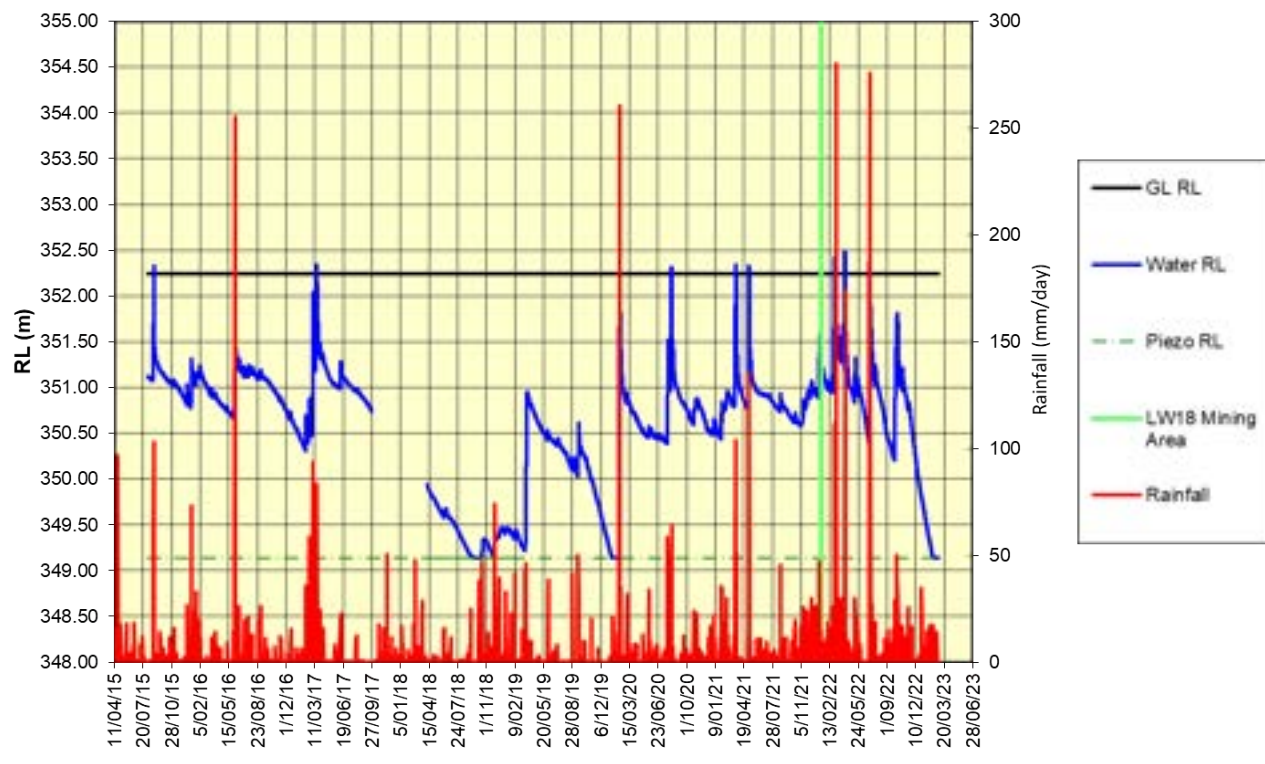
Dendrobium Area 3B  
Swamp 35b, Piezometer 35b\_01

Graph 1: Near-surface groundwater levels at 35b\_01, logged hourly, date range: 06/08/2015 to 28/02/2023

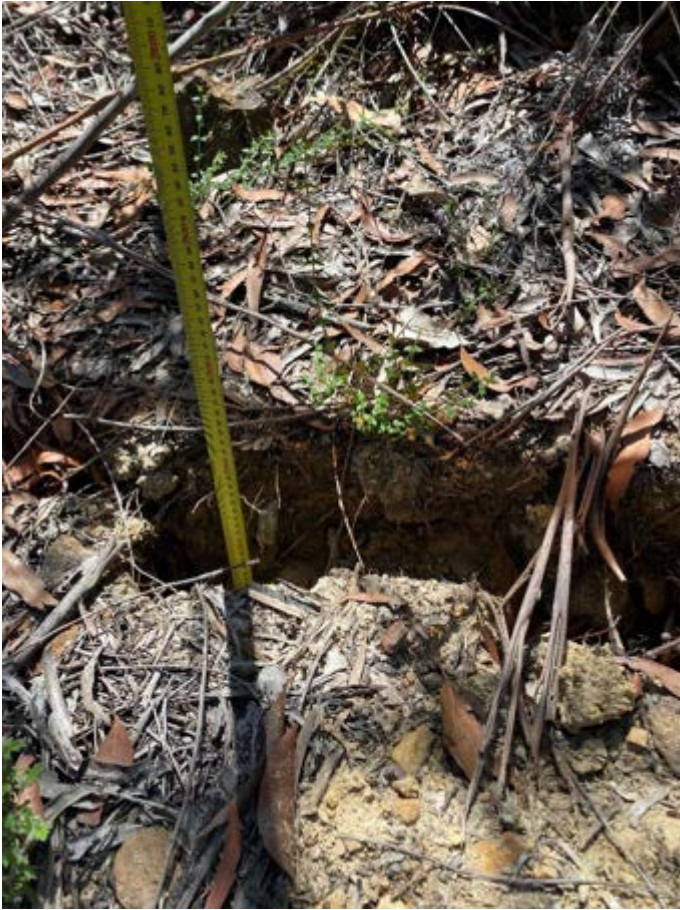
Photo 1: DA3A\_LW19\_035, depth of the soil cracking.  
Taken on 16/03/2023.

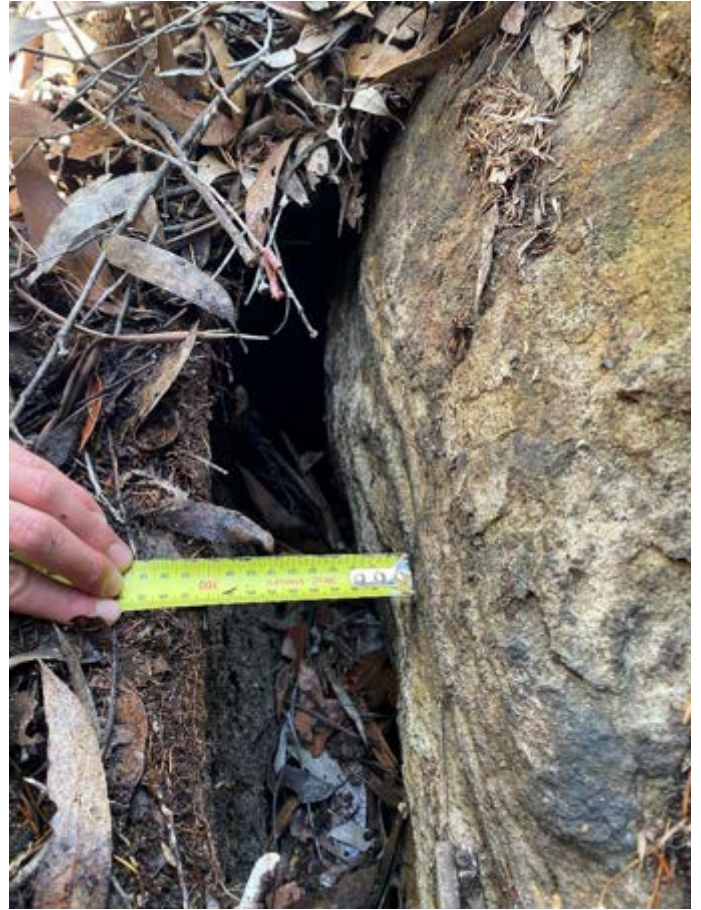
Photo 2: DA3A\_LW19\_035, width of the soil cracking/rock displacement. Taken on 16/03/2023.

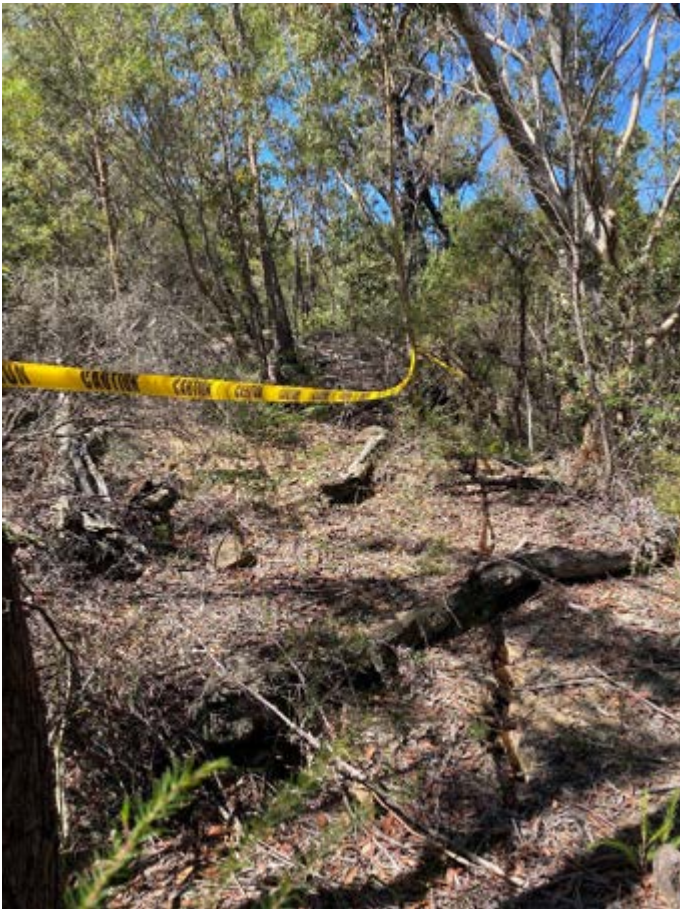
Photo 3: DA3A\_LW19\_035, overview of the impact.  
Taken on 16/03/2023.

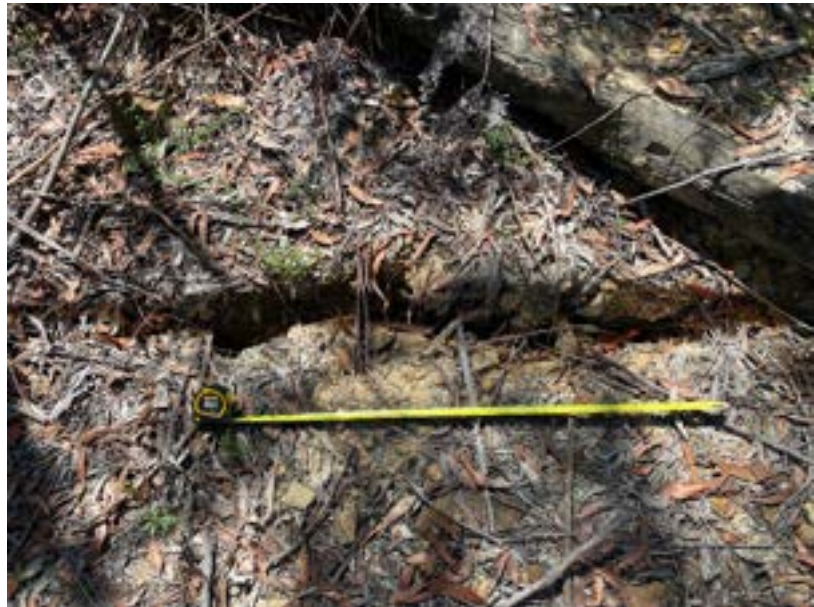
Photo 4: DA3A\_LW19\_035, section of soil cracking. Taken on 16/03/2023.

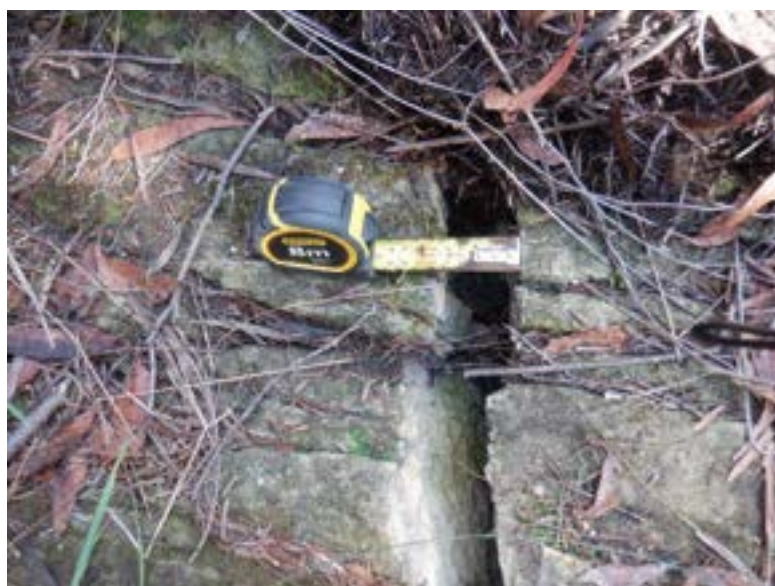
Photo 2: *DA3A\_LW19\_051*, showing width of rock fracture. Taken on 4/5/2023.

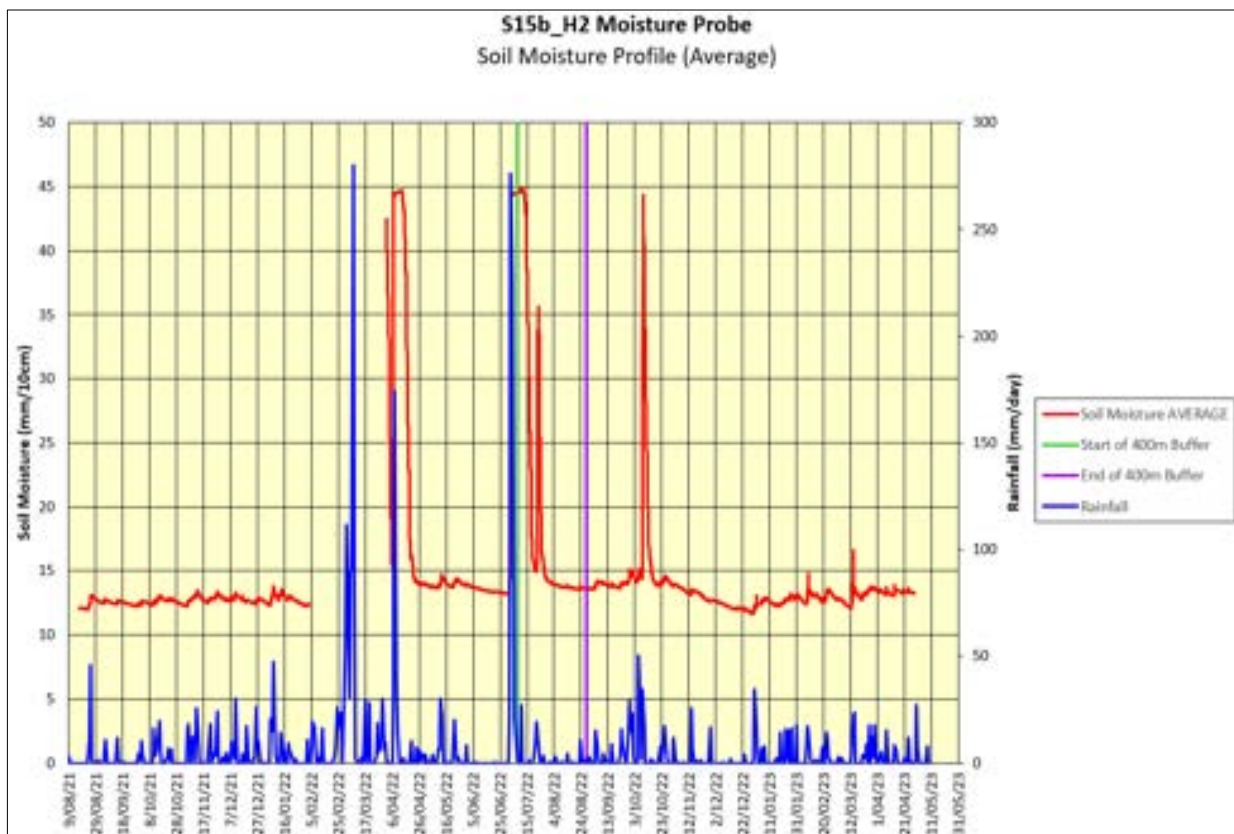
Graph 1: Average soil moisture records at *S15b\_H2*, logged hourly. Date range: 16/08/2021 to 28/04/2023.

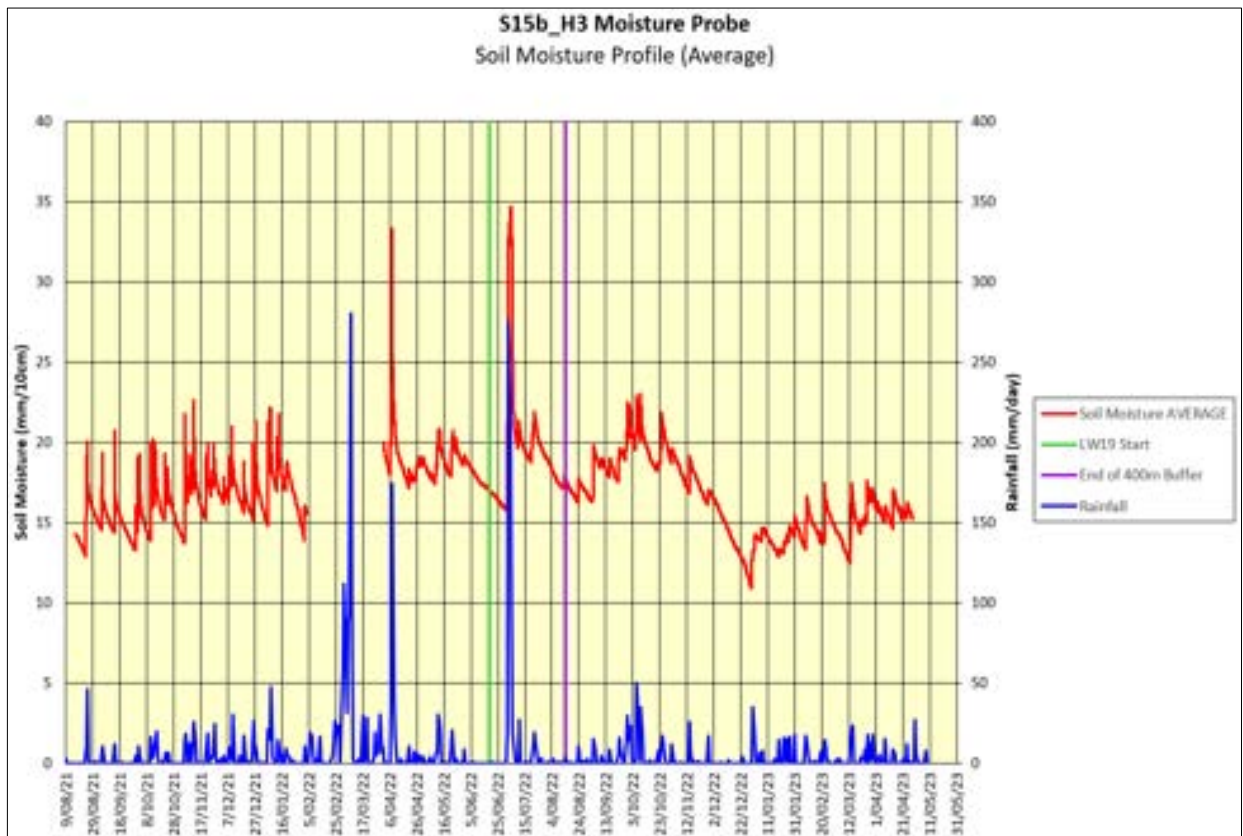
Graph 2: Average soil moisture records at S15b\_H3, logged hourly. Date range: 16/08/2021 to 28/04/2023.

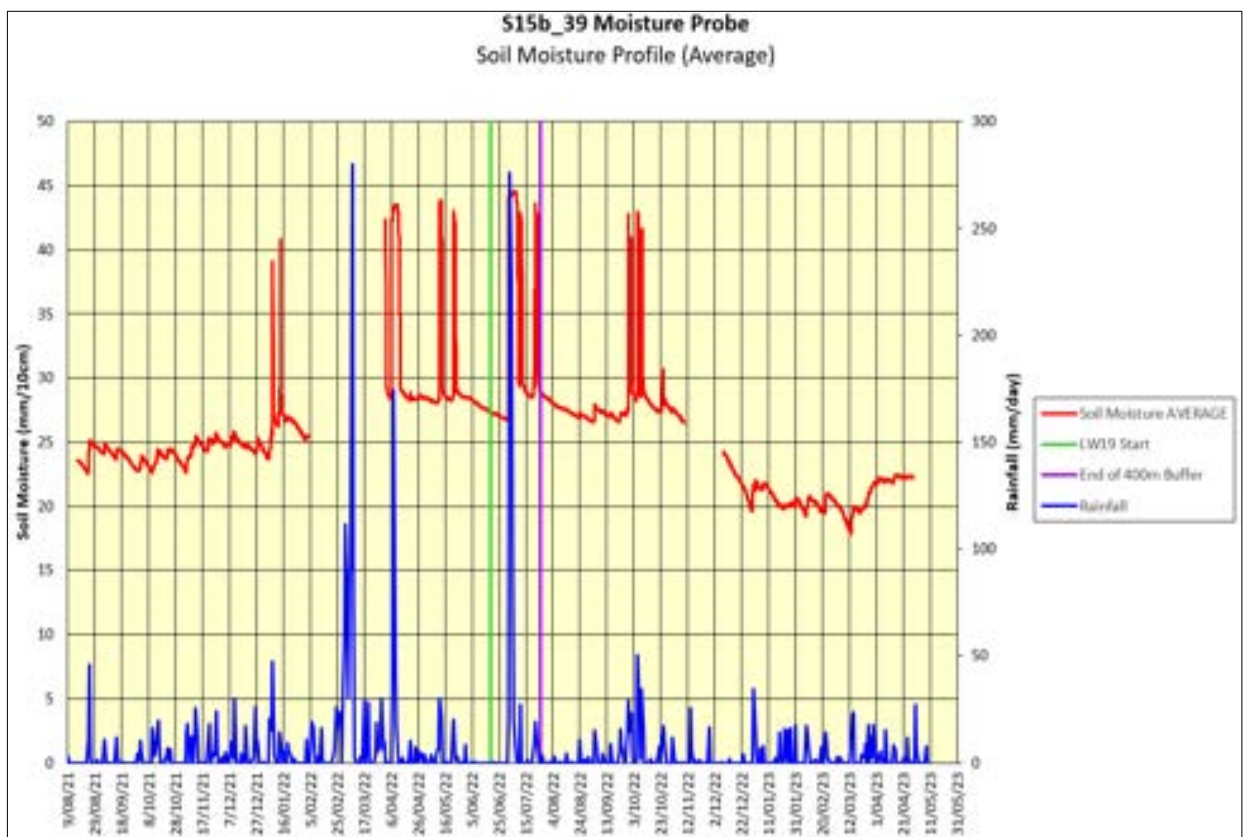
Graph 3: Average soil moisture records at S15b\_39, logged hourly. Date range: 16/08/2021 to 28/04/2023.
