**DENDROBIUM AREA 3A
LONGWALL 19
END OF PANEL REPORT
July 2023**

This End of Panel (EoP) report has been prepared in accordance with Schedule 3 Condition 9 of the Dendrobium Development Consent (DA 60-03-2001). The EoP report outlines the measured and observed impacts during the extraction of Dendrobium Area 3A (DA3A) Longwall 19 and presents monitoring results and analyses compared to relevant impact assessment criteria and predictions in the DA3A Subsidence Management Plan (SMP).

Dendrobium Longwall 19 is located within Consolidated Coal Lease 768 and is the fourth panel to be extracted in DA3A. Extraction of Longwall 19 commenced on 20 June 2022 and was completed on 29 March 2023. The extracted longwall has a length of 1651 metres (m), a void width of 305 m (including first workings) and a maximum cutting height up to 3.9m.

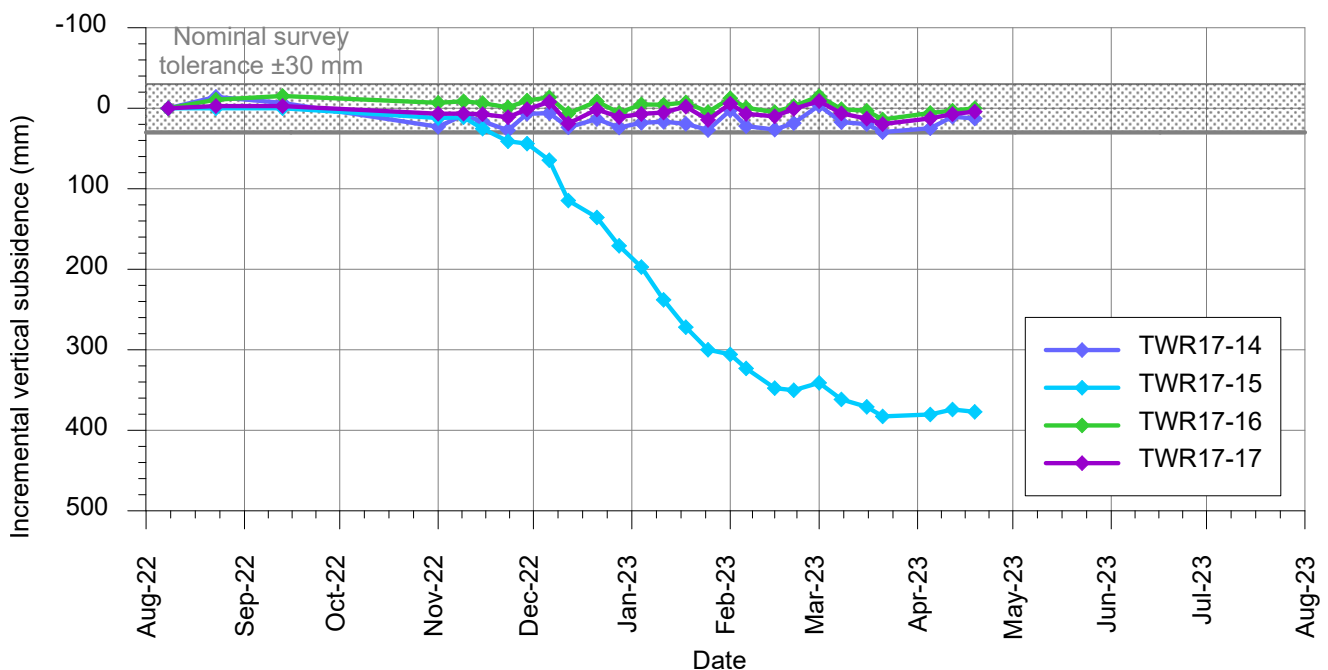
Figure 6: Measured incremental vertical subsidence for TWR17-14, TWR17-15, TWR17-16 and TWR17-17 due to the mining of Longwall 19 only.

The vertical subsidence developed progressively at Tower TWR17-15 as Longwall 19 mined adjacent to and beyond it. Only low-level vertical subsidence was measured at the remaining towers which were in the order of survey tolerance for absolute height of ± 30 mm. The accuracies of the measured relative levels and changes in distances are in the order of ± 5 mm. The maximum measured incremental vertical subsidence of 377 mm at Tower TWR17-15 is less than one third the maximum predicted value.

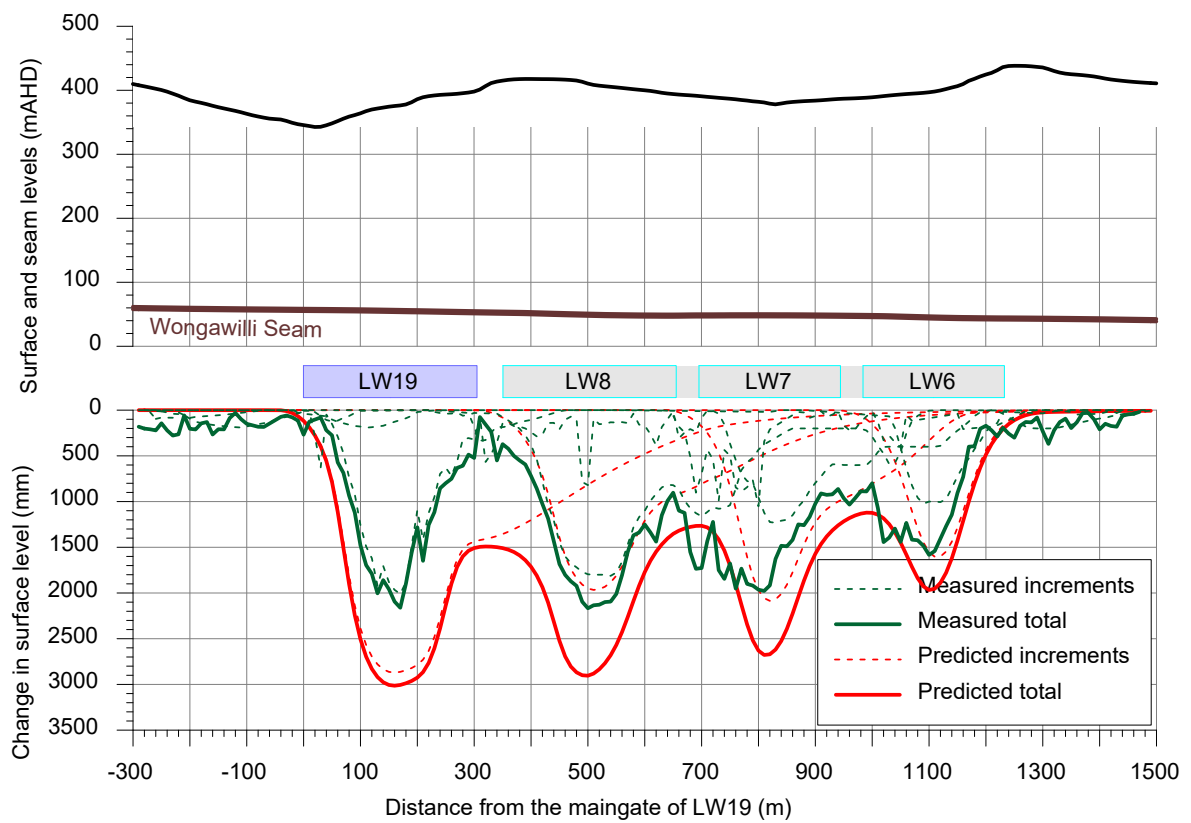
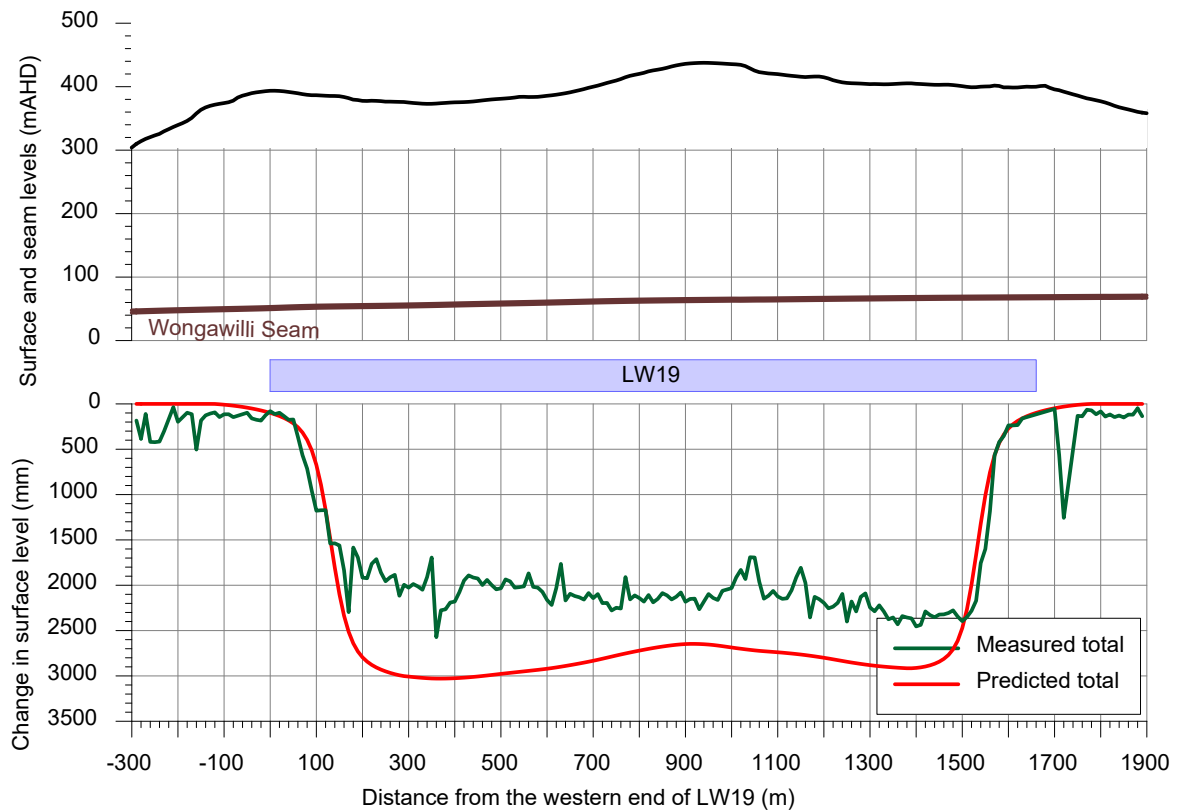
The profiles of the measured changes in surface level reasonably match the predicted profiles of vertical subsidence along the cross-sections and long-section (Figure 9 and Figure 10). The maximum measured changes in surface level above each of the longwalls are less than the maximum predicted values. Also, the measured changes in surface level above each of the chain pillars are similar to or less than the predicted values in these locations.

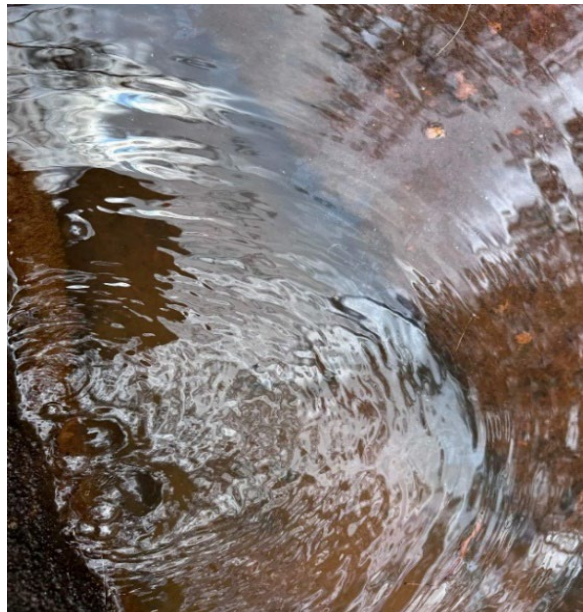
During the Longwall 19 monitoring period there was one impact identified on Wongawilli Creek which consisted of a gas release on WC_Pool 50 (Photo 1).

Photo 1: DA3A_LW19_029, showing a gas release on Wongawilli Creek. Taken on 18/01/2023.

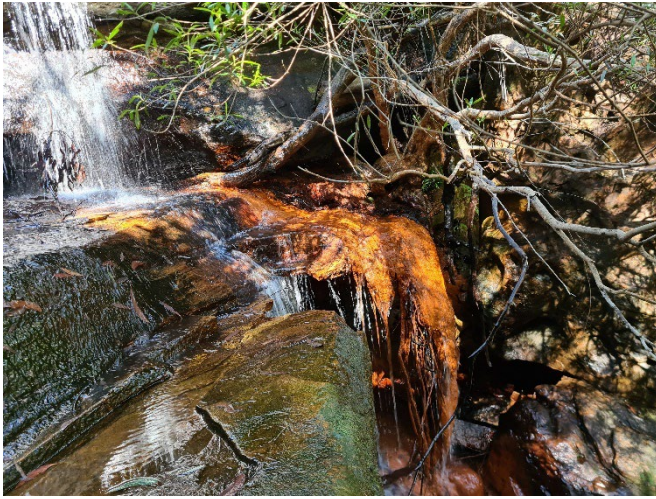
Photo 2: DA3A_LW19_003, showing iron staining on WC14.
Taken on 16/08/2022.

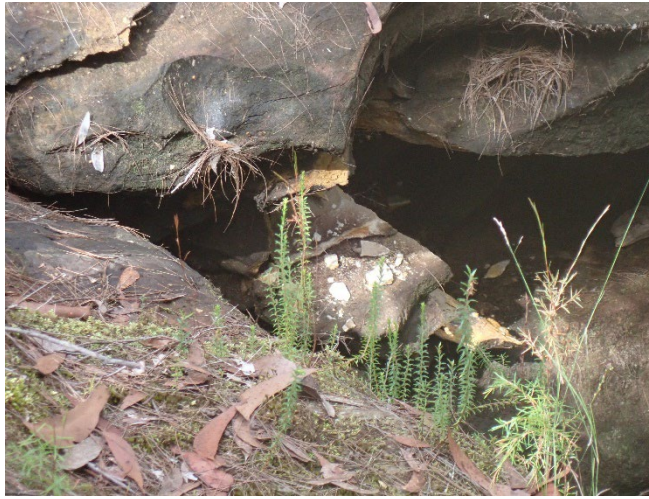
Photo 3: DA3A_LW8_003, showing rock fracturing and
rockfall on WC14. Taken on 12/04/2023.

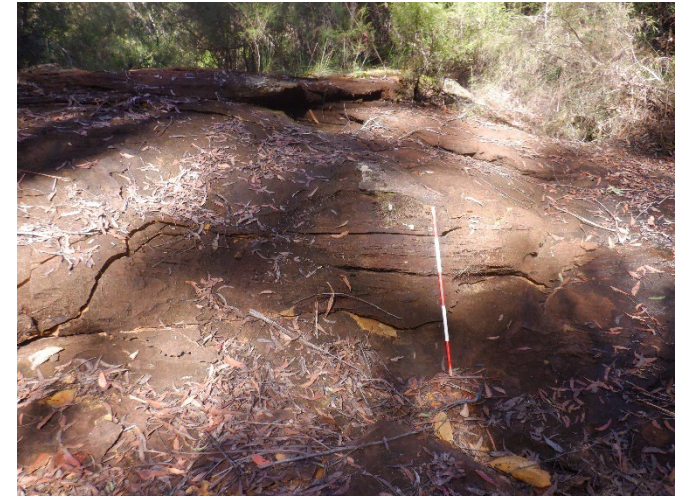
Photo 4: DA3A_LW19_043, showing rock fracturing and uplift
on WC14. Taken on 17/04/2023.

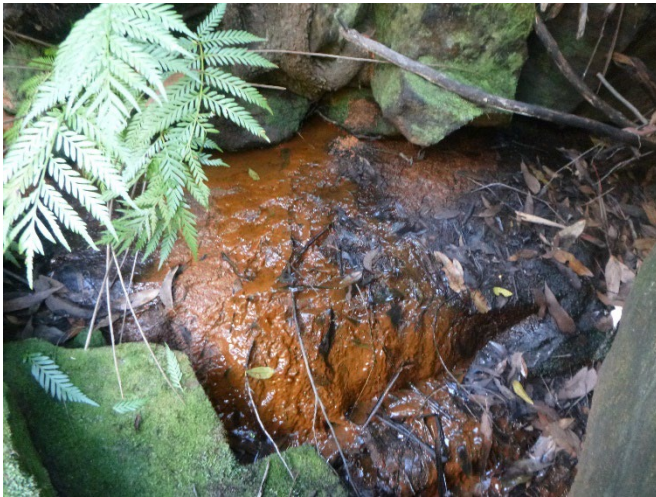
Photo 5: DA3A_LW19_045, showing iron staining on WC15.
Taken on 26/04/2023.

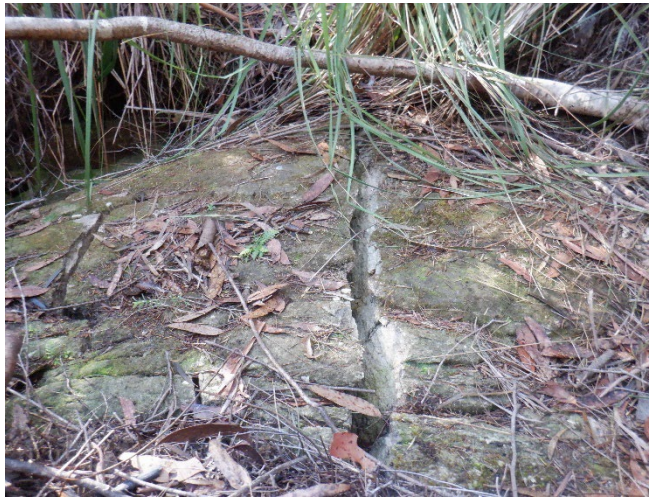
Photo 6: DA3A_LW19_051, showing rock fracturing on
WC14. Taken on 04/05/2023.

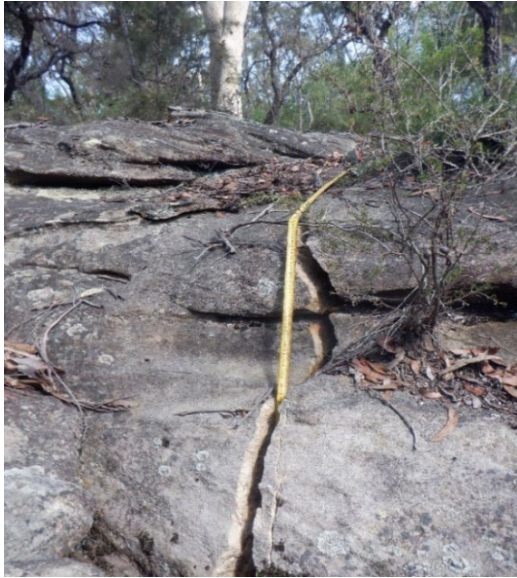
Photo 7: DA3A_LW19_001 showing rock fracturing. Tape set at 2m. Taken on 19/04/2023.

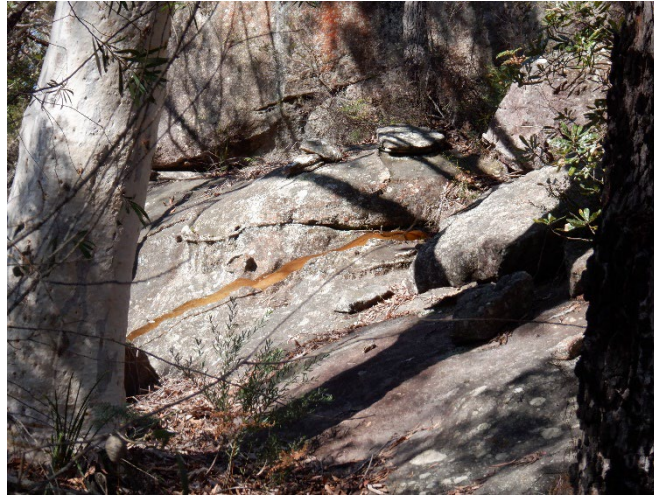
Photo 8: DA3A_LW19_002 showing width of rock fracturing. Taken on 03/08/2022.

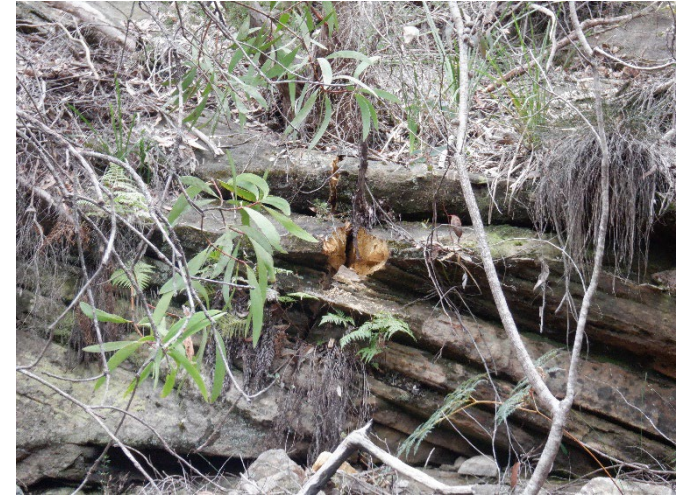
Photo 9: DA3A_LW19_004, showing rock fracturing and fragmentation. Taken on 19/08/2022.

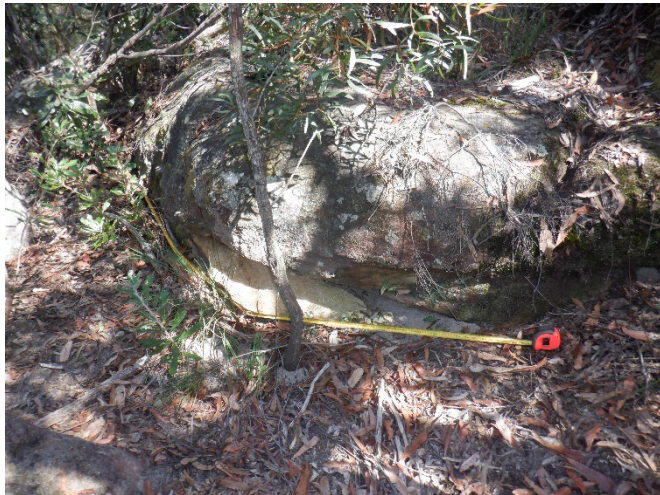
Photo 10: DA3A_LW19_005, showing rockfall. Tape set at 2.7m. Taken on 19/04/2023.

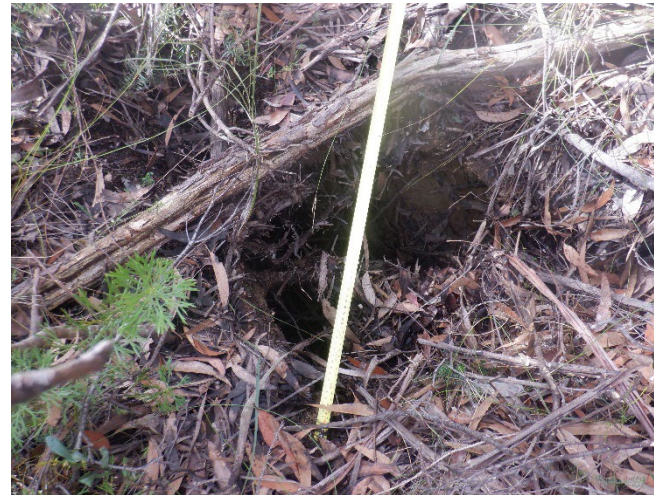
Photo 11 DA3A_LW19_006, showing soil cracking. Taken on 31/08/2022.

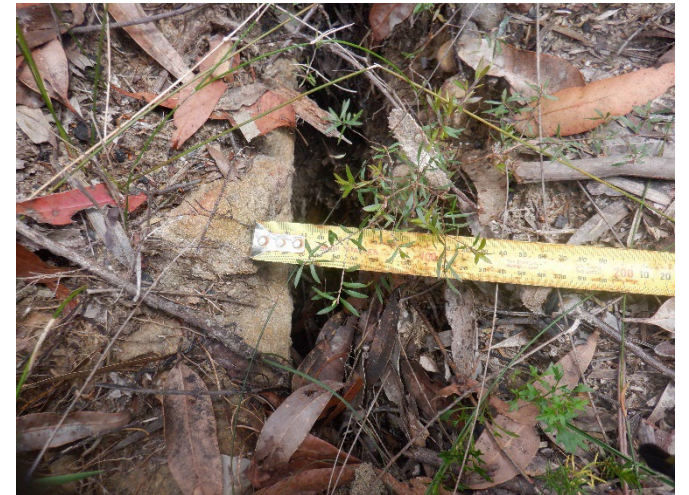
Photo 12: DA3A_LW19_007, showing soil cracking. Taken on 19/04/2023.

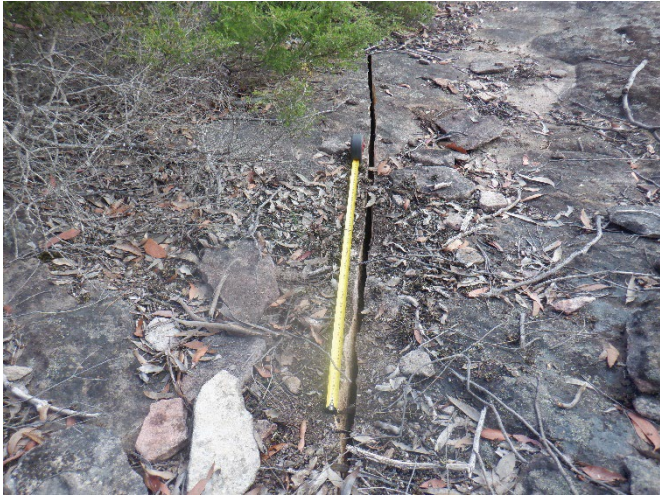
Photo 13: DA3A_LW19_008, showing rock fracturing. Taken on 7/11/2022.

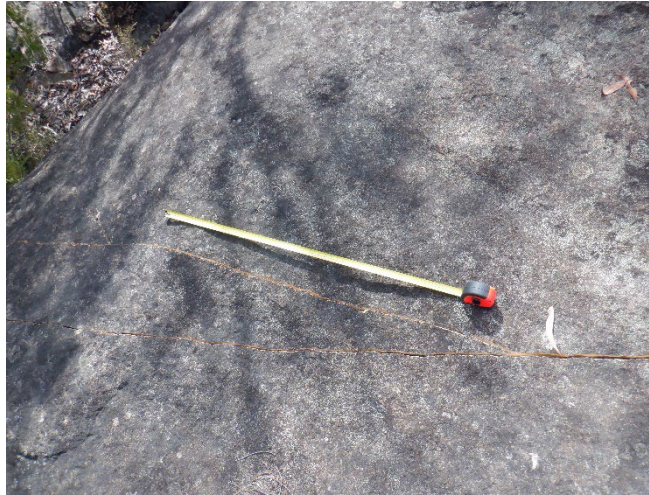
Photo 14: DA3A_LW19_009, showing rock fracturing. Taken on 7/11/2022.

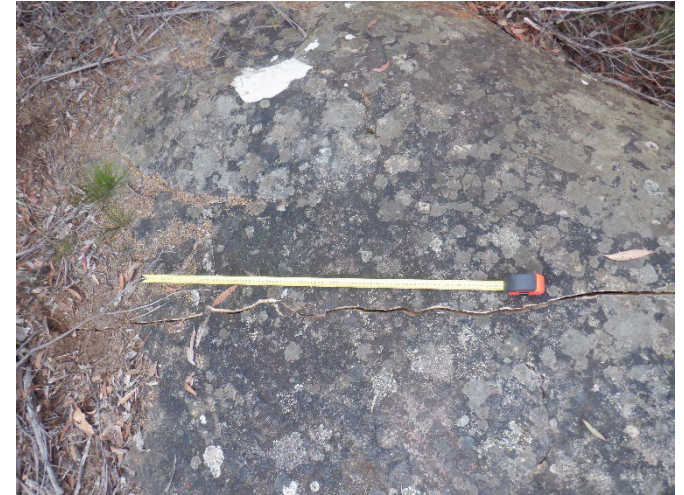
Photo 15: DA3A_LW19_010, showing rock fracturing. Taken on 7/11/2022.

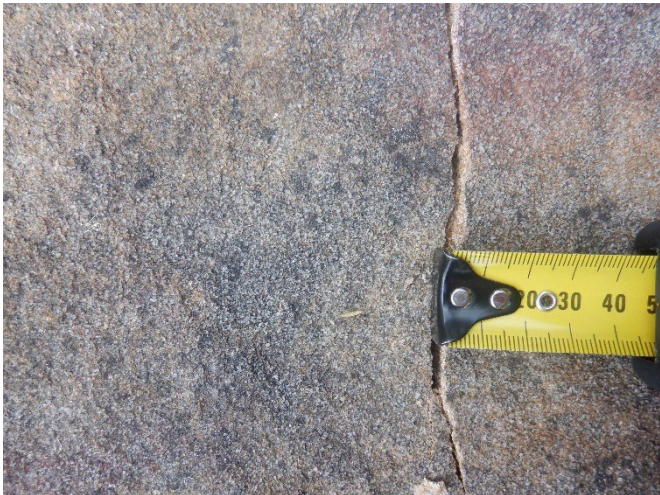
Photo 16: DA3A_LW19_011, showing rock fracturing. Taken on 7/11/2022.

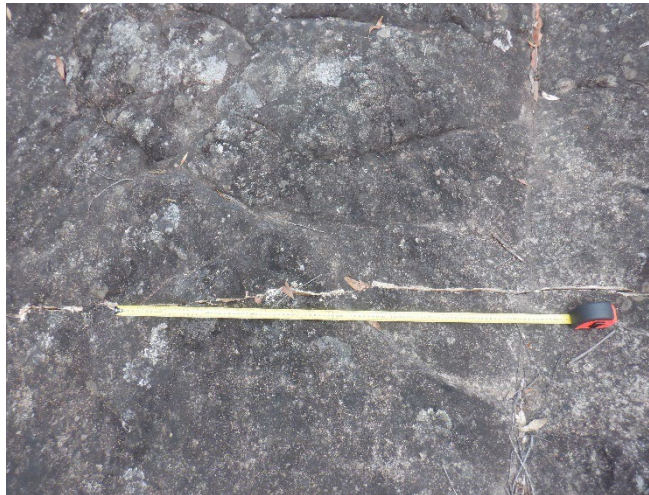
Photo 17: DA3A_LW19_012, showing rock fracturing. Taken on 7/11/2022.

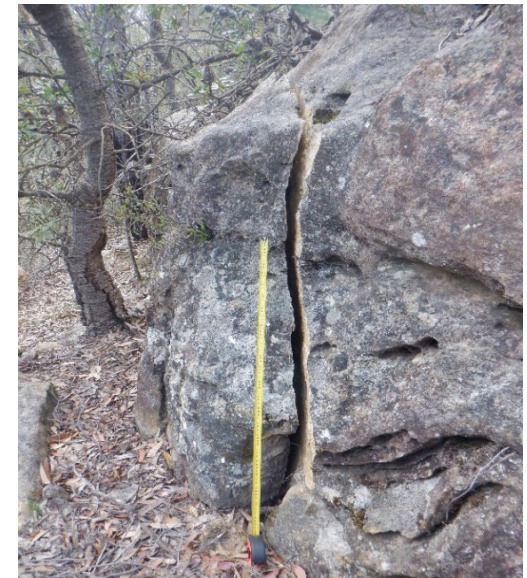
Photo 18: DA3A_LW19_013, showing rock fracturing. Taken on 7/11/2022.

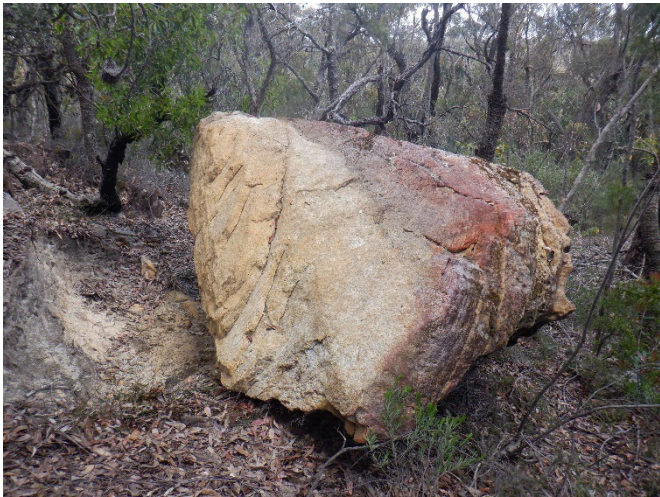
Photo 19: DA3A_LW19_014, showing rock movement.
Taken on 7/11/2022.

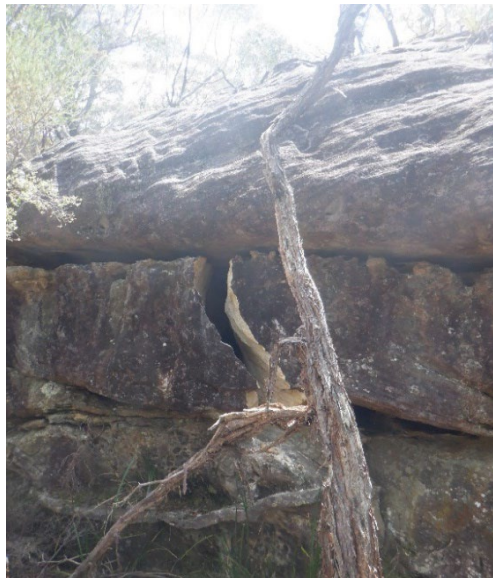
Photo 20: DA3A_LW19_015, showing rock fracturing.
Taken on 7/11/2022.

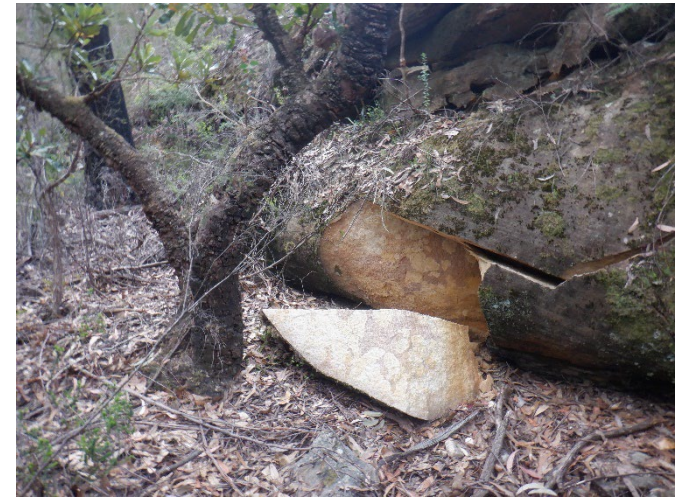
Photo 21: DA3A_LW19_016, showing rock fracturing and
rockfall. Taken on 7/11/2022.

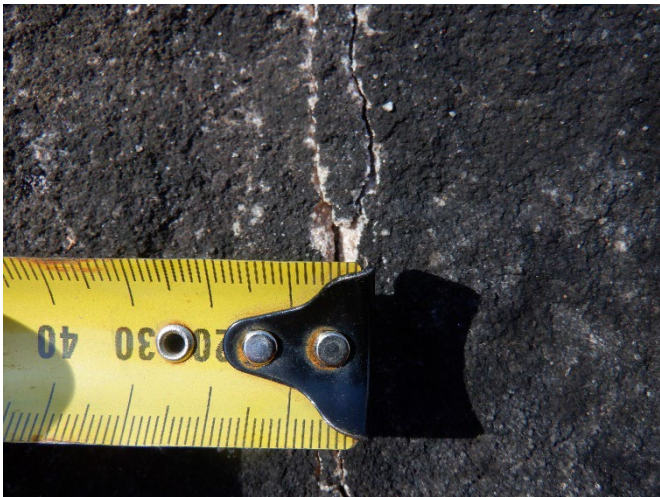
Photo 22: DA3A_LW19_017, showing rock fracturing. Taken
on 13/12/2022.

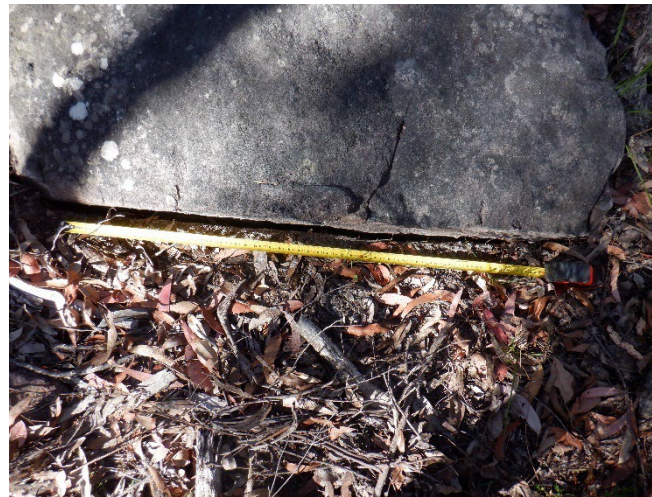
Photo 23: DA3A_LW19_018, showing rock displacement.
Taken on 13/12/2022.

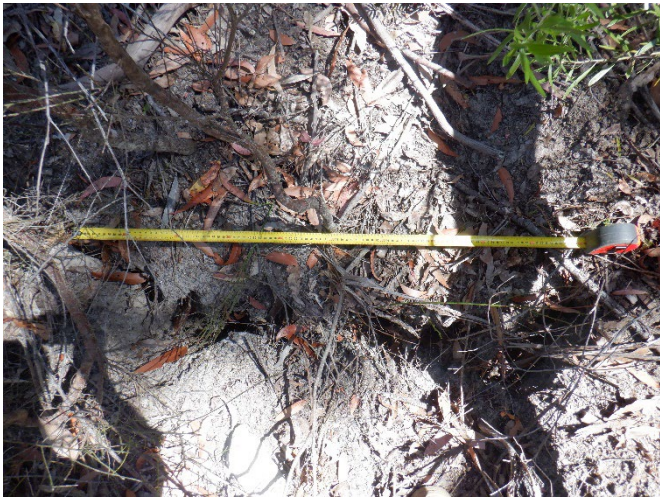
Photo 25: DA3A_LW19_020, showing soil cracking. Taken on 13/12/2022.

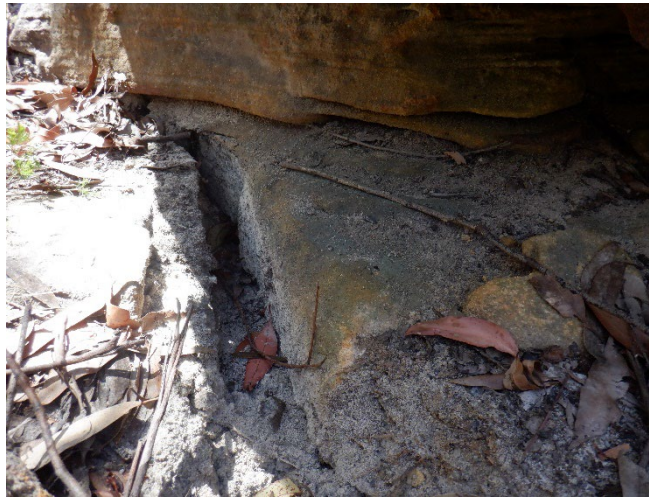
Photo 26: DA3A_LW19_021, showing soil cracking and displacement. Taken on 13/12/2022.

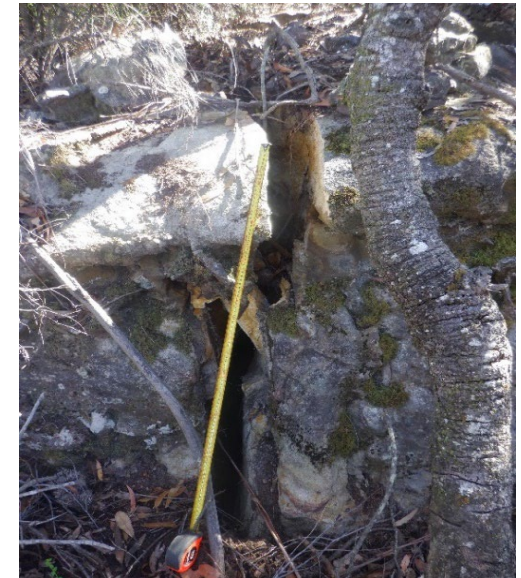
Photo 27: DA3A_LW19_022, showing rock fracturing. Taken on 09/05/2023.

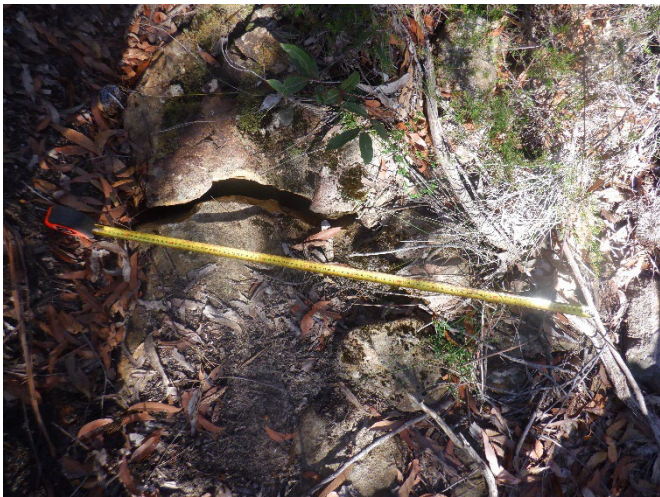
Photo 28: DA3A_LW19_023, showing rock fracturing. Taken on 09/05/2023.

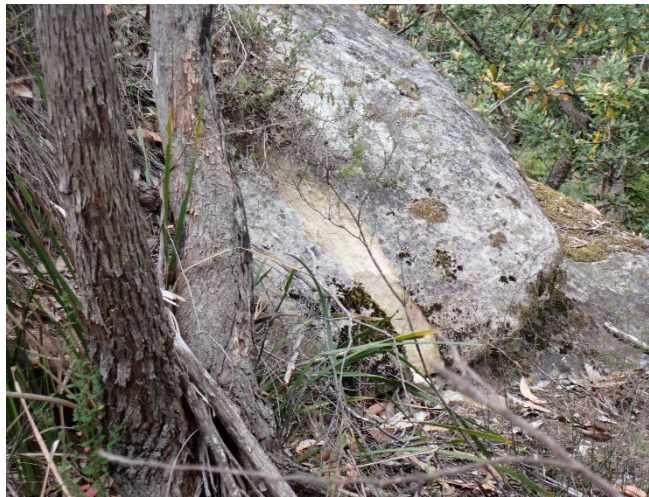
Photo 29: DA3A_LW19_024, showing rock fracturing. Taken on 20/12/2022.

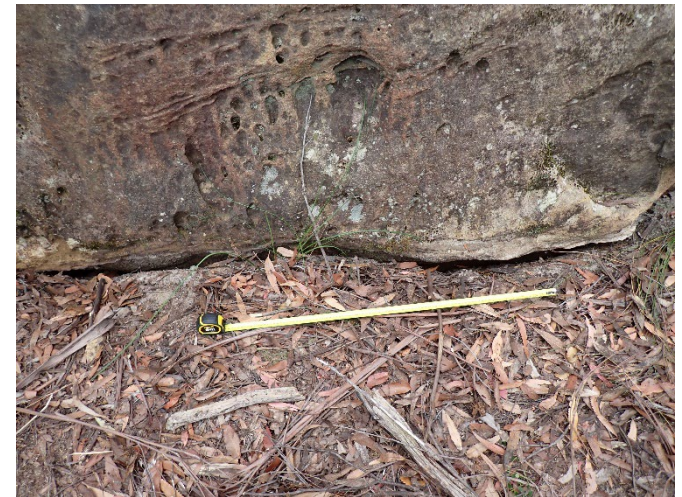
Photo 30: DA3A_LW19_025, showing rock fracturing. Taken on 20/12/2022.

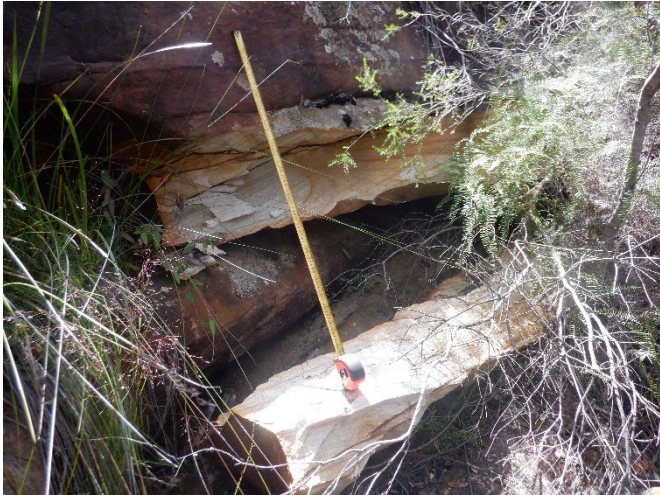
Photo 31: DA3A_LW19_027, showing rock fracturing and rockfall. Taken on 10/01/2023.

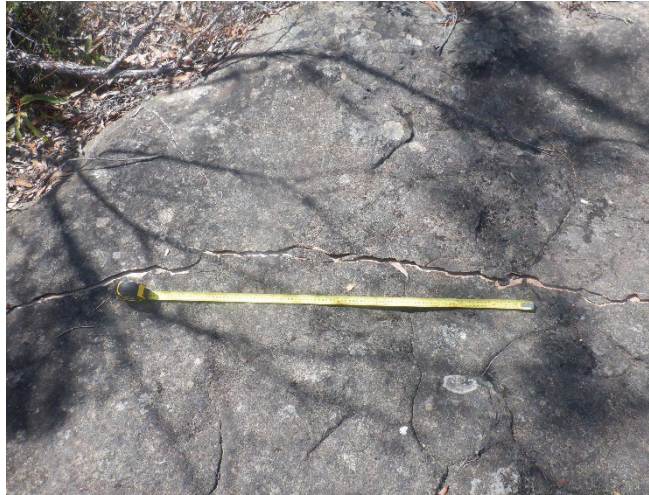
Photo 32: DA3A_LW19_028, showing rock fracturing. Taken on 06/02/2023.

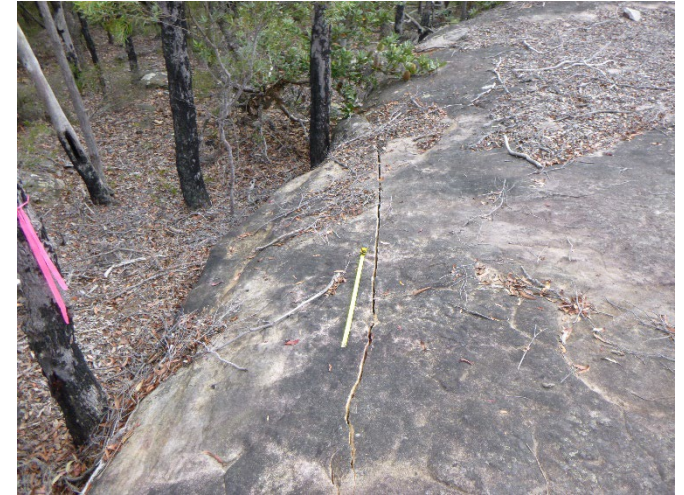
Photo 33: DA3A_LW19_030, showing rock fracturing. Taken on 15/02/2023.

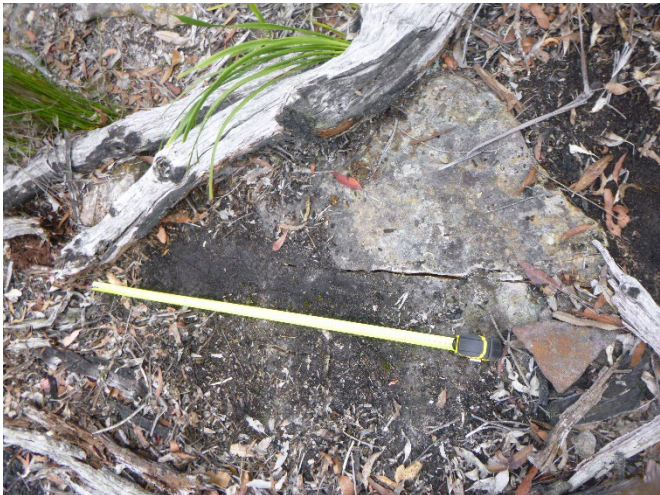
Photo 34: DA3A_LW19_031, showing rock fracturing. Taken on 15/02/2023.

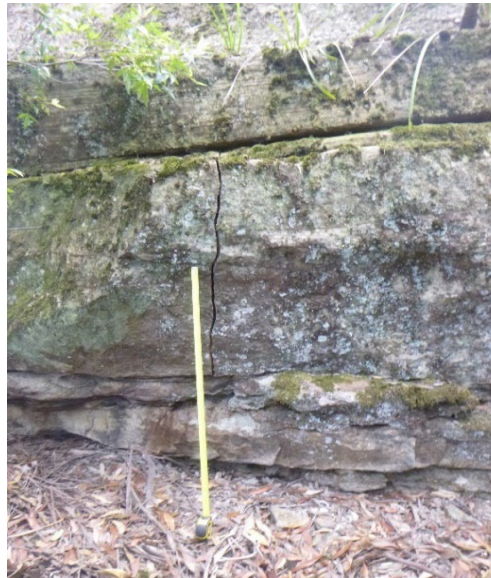
Photo 35: DA3A_LW19_032, showing rock Fracturing. Taken on 15/02/2023.

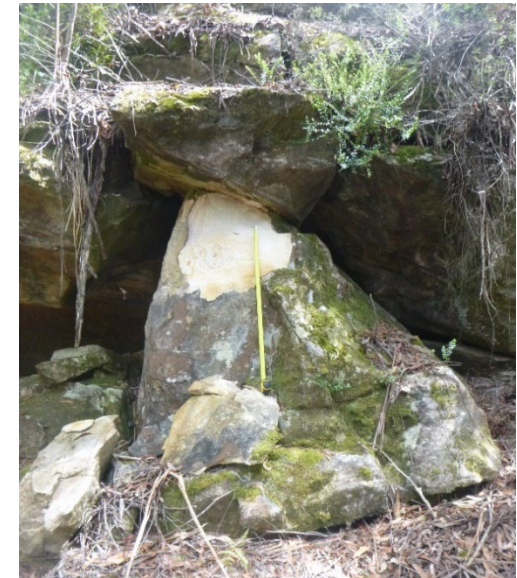
Photo 36: DA3A_LW19_033, showing rock fracturing. Taken on 15/02/2023.

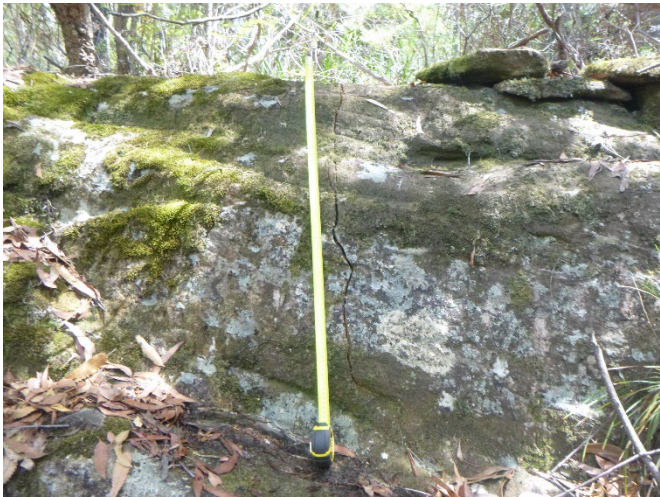
Photo 37: DA3A_LW19_034, showing rock fracturing. Taken on 15/02/2023.

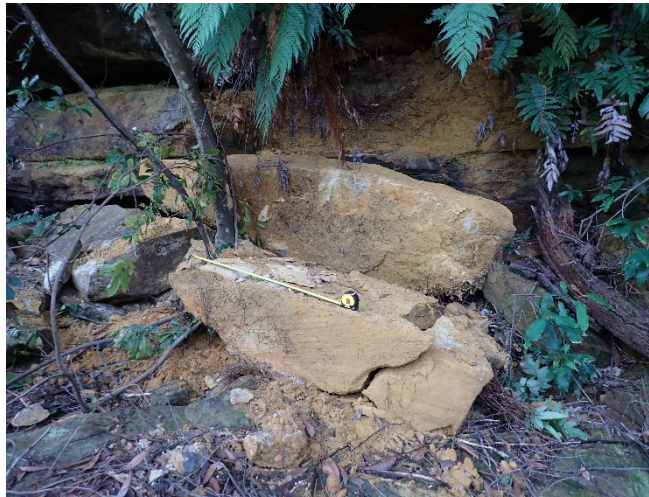
Photo 38: DA3A_LW19_039, showing rockfall. Taken on 12/04/2023.

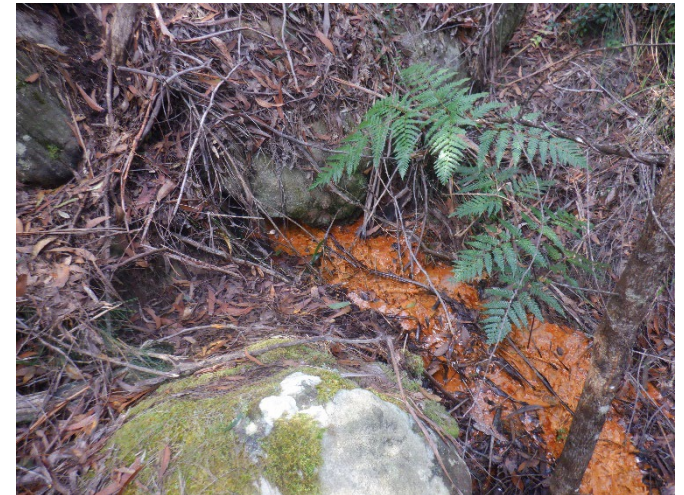
Photo 42: DA3A_LW19_044, showing iron staining. Taken on 19/04/2023.

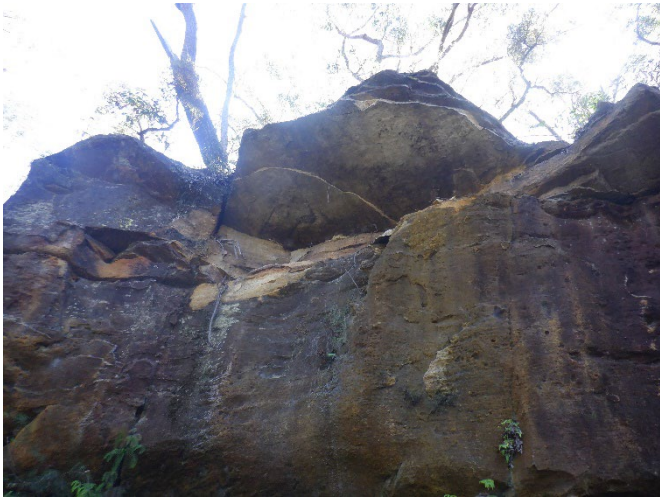
Photo 43: DA3A_LW19_046, showing rockfall. Taken on 27/04/2023.

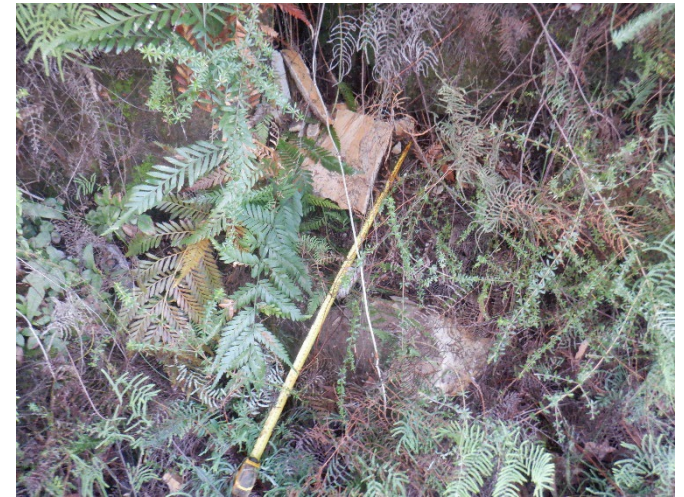
Photo 45: DA3A_LW19_052, showing rock fracturing and rockfall. Taken on 04/05/2023.

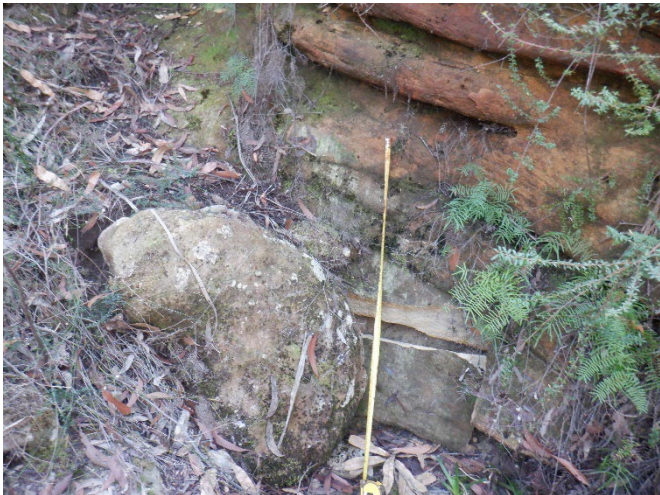
Photo 46: DA3A_LW19_053, showing rock fracturing and rockfall. Taken on 04/05/2023.

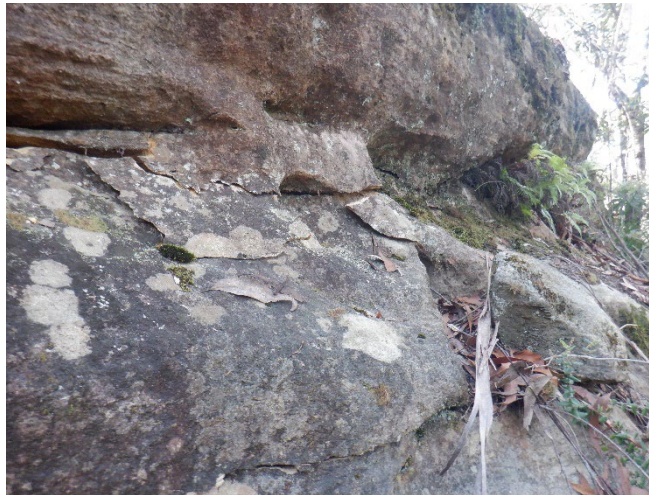
Photo 47: DA3A_LW19_054, showing rock fracturing and fragmentation. Taken on 04/05/2023.

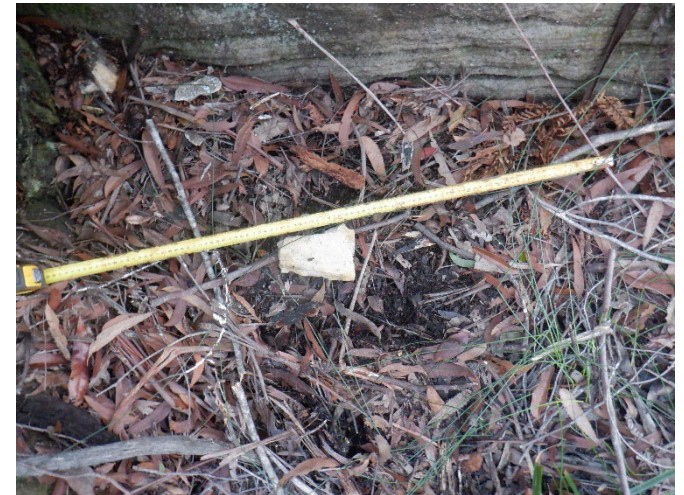
Photo 48: DA3A_LW19_055, showing area of rockfall. Taken on 04/05/2023.

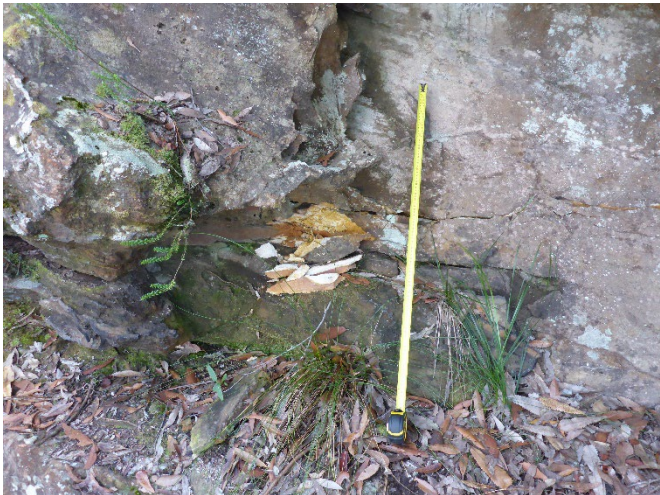
Photo 52: DA3A_LW19_059, showing rock fracturing and rockfall. Taken on 05/05/2023.

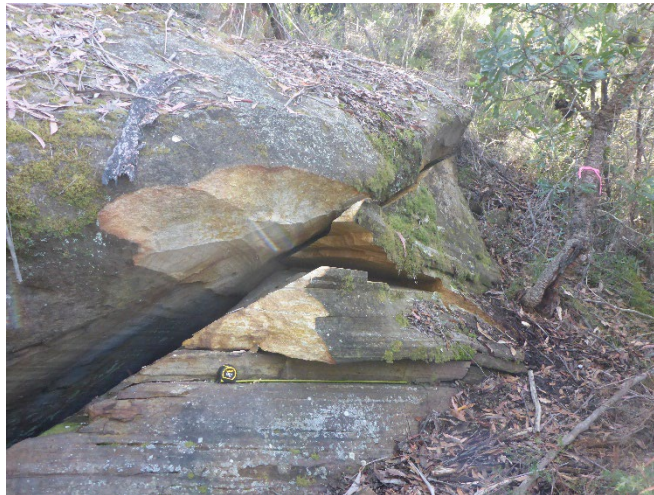
Photo 53: DA3A_LW19_060, showing rock fracturing and rockfall. Taken on 05/05/2023.

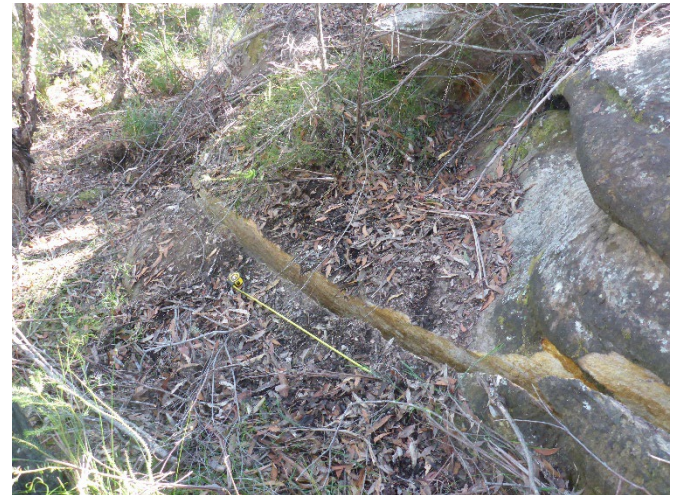
Photo 54: DA3A_LW19_061, showing rock fracturing. Taken on 05/05/2023.

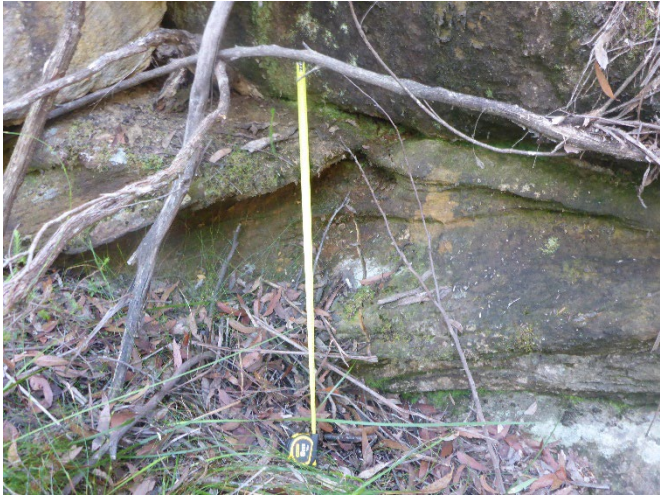
Photo 55: DA3A_LW19_062, showing rock fracturing. Taken on 05/05/2023.

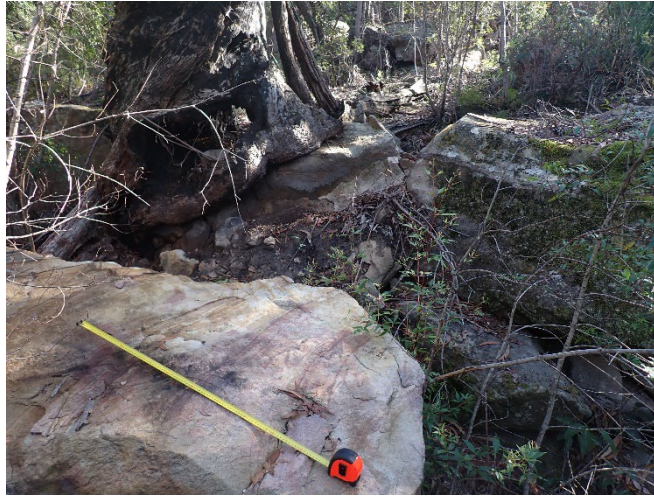
Photo 56: DA3A_LW19_063, showing rock movement. Taken on 10/05/2023.

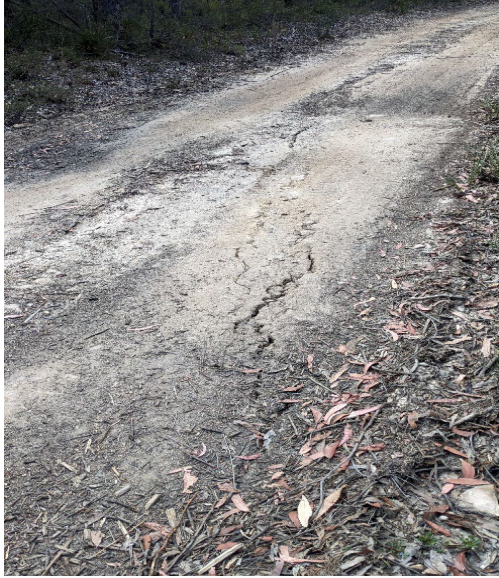
Photo 62: DA3A_LW19_026, showing soil cracking on Fire Road 6F.
Taken on 16/06/2022

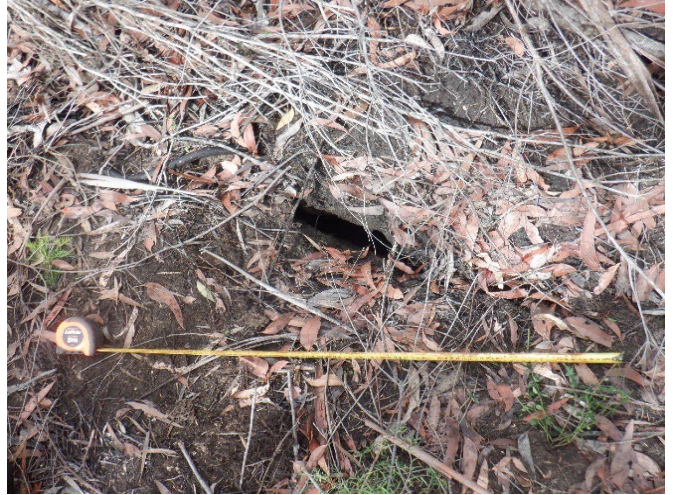
Photo 63: DA3A_LW19_036, showing soil cracking on a closed vehicle access track. Taken on 21/03/2023.

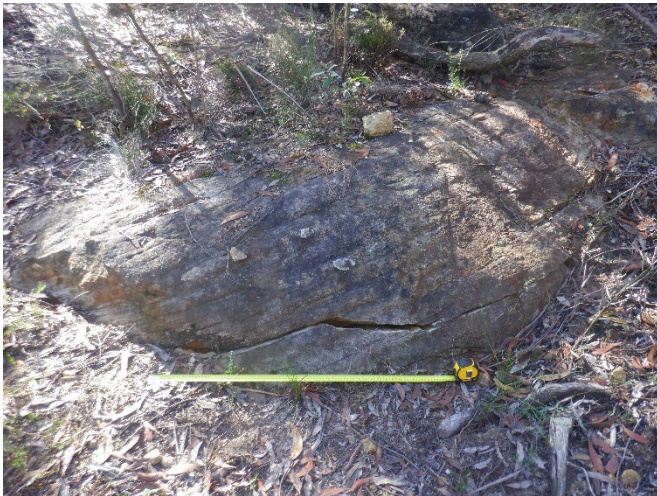
Photo 64: DA3A_LW19_048, showing rock fracturing on a closed vehicle access track. Taken on 27/04/2023.

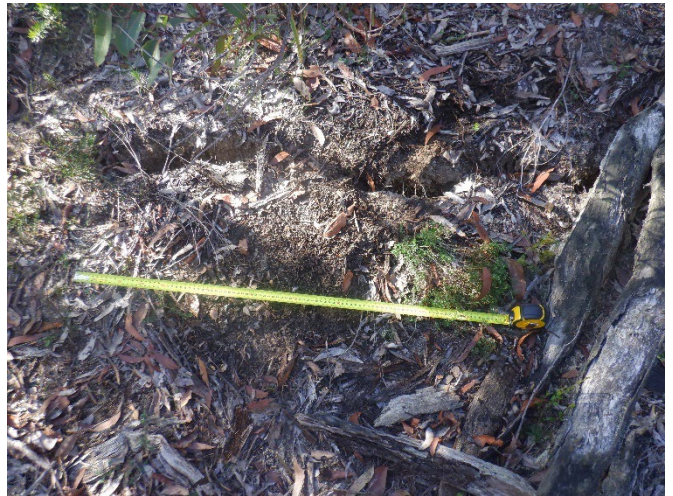
Photo 65: DA3A_LW19_049, showing soil cracking on a closed vehicle access track. Taken on 27/04/2023.

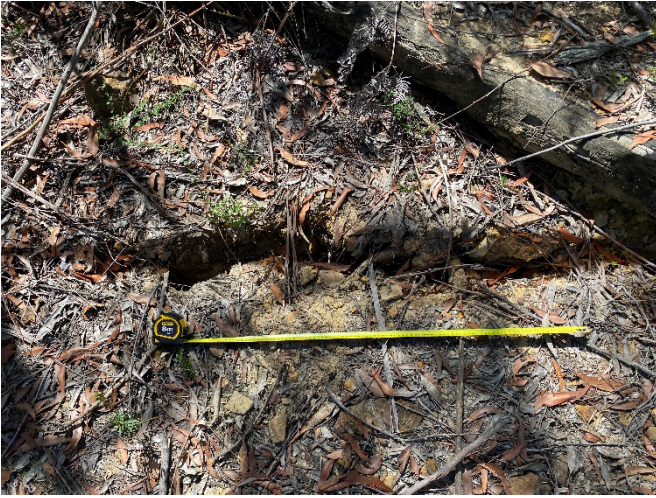
Photo 66: DA3A_LW19_035, showing soil cracking on a closed vehicle access track. Taken on 16/03/2023.

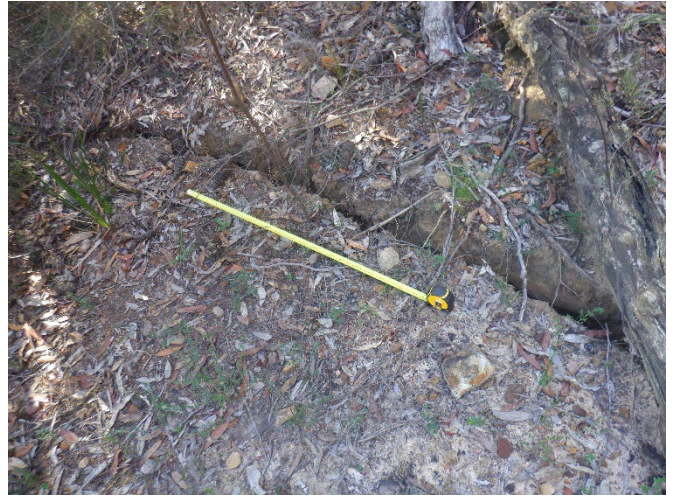
Photo 67: DA3A_LW19_050, showing soil cracking on a closed vehicle access track. Taken on 27/04/2023.
