**DENDROBIUM AREA 3C
LONGWALL 21 END OF PANEL
LANDSCAPE REPORT
NOVEMBER 2023**

EXECUTIVE SUMMARY

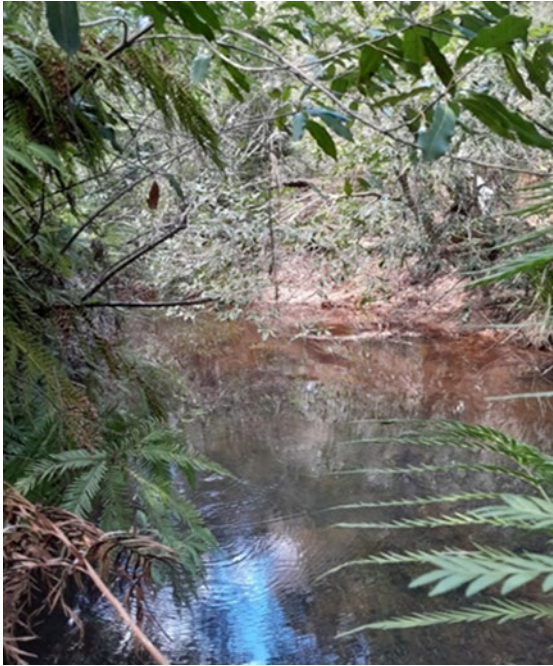
During inspections undertaken in September 2023, no iron was evident on Wongawilli Creek upstream of spring at *WC_Pool 53* (Photo 3 and Photo 4). Downstream of *WC_Pool 20* (Photo 9 and Photo 10), isolated sections of iron staining were restricted to shallow sections of pools and rockbars with the deeper pools remaining unaffected. No observable iron was evident at *Wongawilli Creek (FR6)* (Photo 11 and Photo 12) and *WC_Pool 2* (Photo 13 and Photo 14) (Figure 5).

Photo 3: *WC_Pool 53* looking upstream.
Taken 11/09/2023.

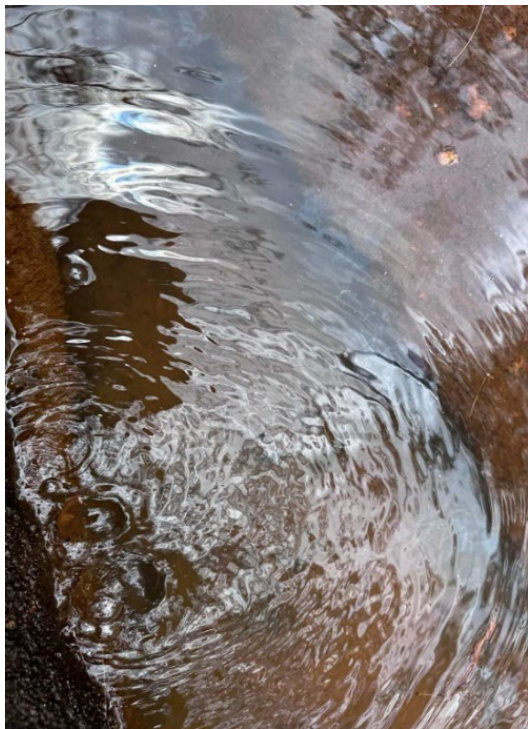
A gas release was initially observed in Wongawilli Creek at *WC_Pool 50* on 18 January 2023 (Figure 5). *DA3A_LW19_029* consisted of a gas release originating from the base of a sandstone step on the western side of the pool (Photo 15). The release was constant for approximately 15 seconds and ceased for approximately one minute, before starting again in a similar interval. A period of approximately 10 minutes was then observed without release. Very light, intermittent bubbling was also observed from the centre of the pool however these were very small and not able to be photographed.

Photo 15: *DA3A_LW19_029*, gas release from base of sandstone ledge on the western side of *WC_Pool 50*, Wongawilli Creek. Taken on 18/01/2023.

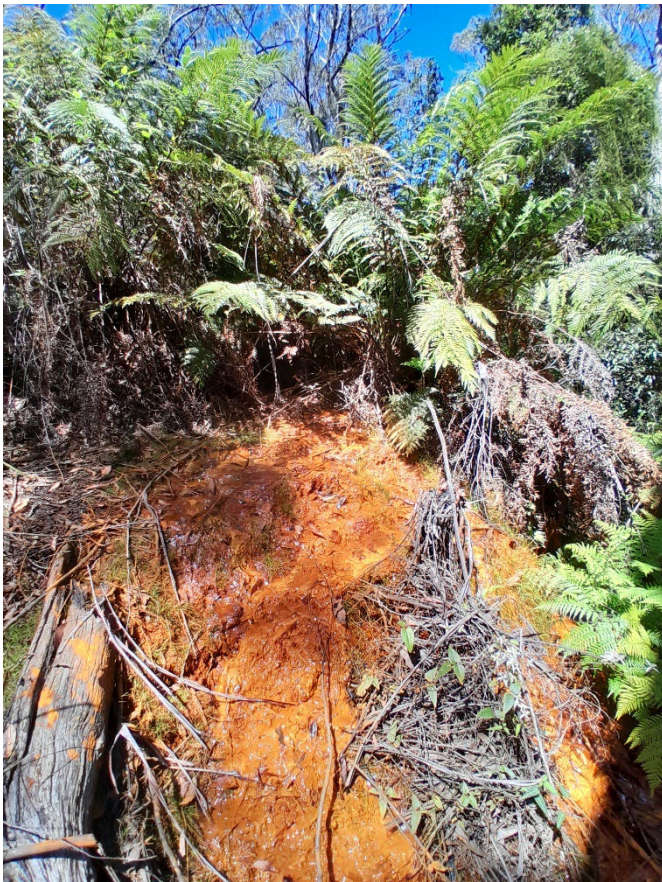
DA3C_LW21_035 is located upslope approximately 15m east of WC_Pool 50 on Wongawilli Creek and is not associated with any mapped tributary (Figure 3). The impact consists of an iron spring and associated iron staining originating from a rock outcrop with seepage extending westward from an area associated with previous DA3A mining operations, specifically Longwall 6. The spring was active during the inspection with both the seepage and iron staining extending to Wongawilli Creek (Photo 17 and Photo 18). The iron spring and associated staining is approximately 95m north of a previously identified iron spring reported during the LW17 monitoring period, specifically DA3B_LW17_031 and is outside the Longwall 21 mining area.

Photo 17: DA3C_LW21_035, looking upslope, showing source of iron spring & staining.

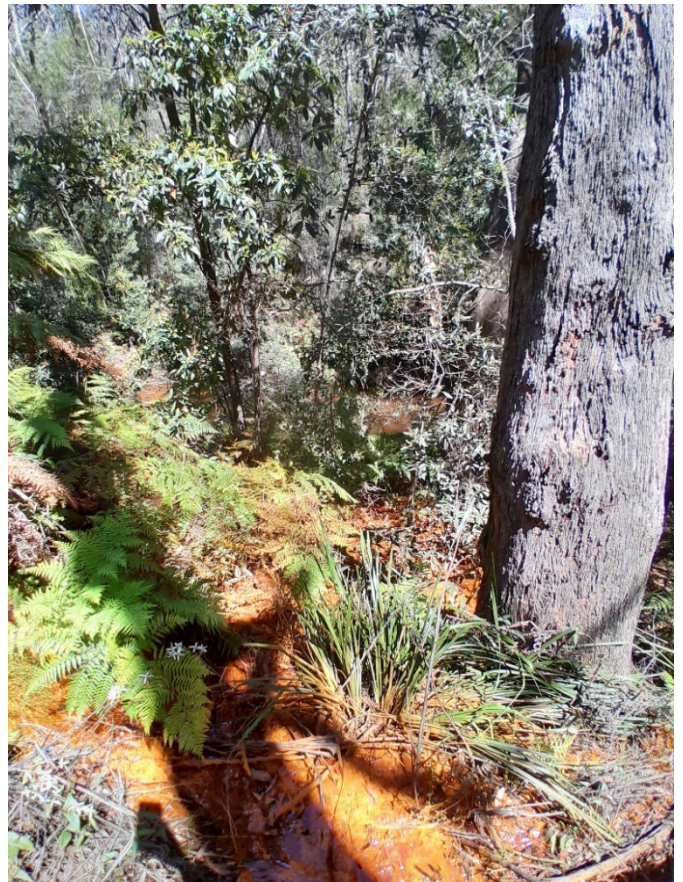
Photo 18: DA3C_LW21_035, looking downslope, showing extent of staining with Wongawilli Creek in the background.

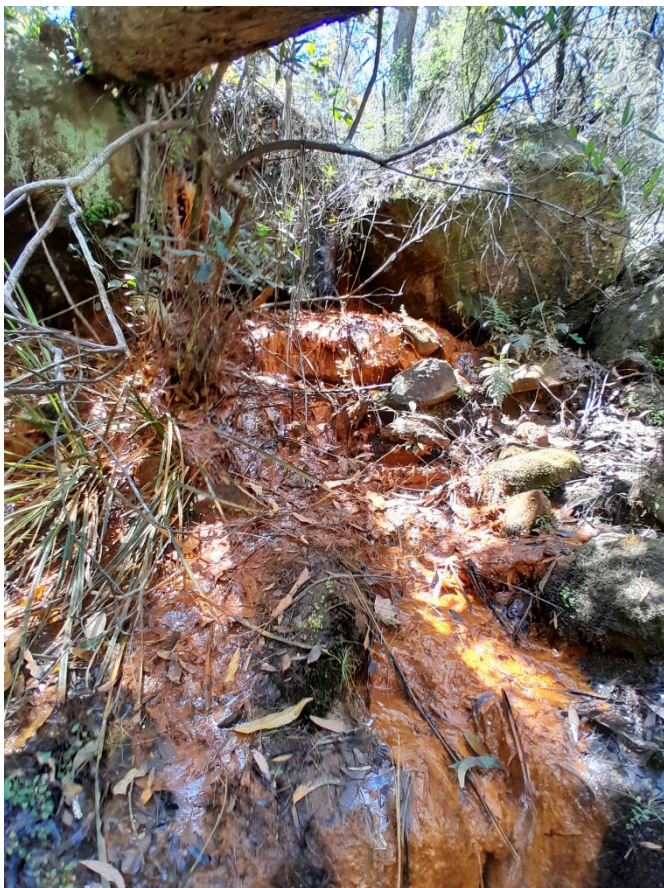
DA3C_LW21_036 is located upslope approximately 8m east of WC_Pool 50 on Wongawilli Creek and is not associated with any mapped tributary (Figure 3). The impact consists of an iron spring and associated iron staining originating from a rock outcrop with seepage extending westward from an area associated with previous DA3A mining operations, specifically Longwall 6. The spring was active during the inspection with both the seepage and iron staining extending to Wongawilli Creek (Photo 19 & Photo 20). This iron spring and associated staining is approximately 85m north of a previously identified iron spring reported during the Longwall 17 monitoring period, specifically DA3B_LW17_031 and is outside the Longwall 21 mining area.

Photo 19: DA3C_LW21_036, looking upslope, showing source of spring and iron staining.

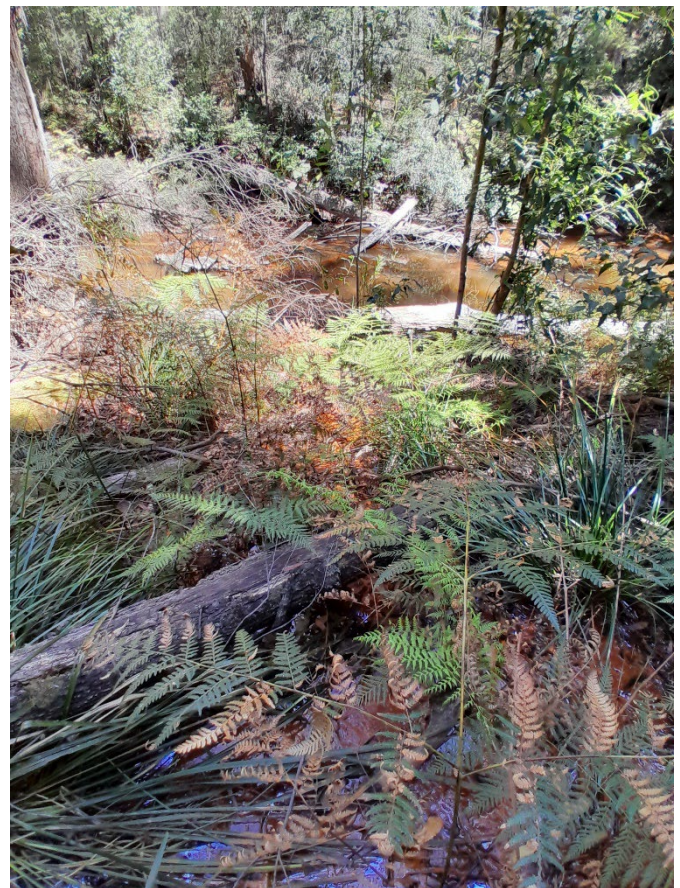
Photo 20: DA3C_LW21_036, looking downslope, showing extend of staining with Wongawilli Creek in the background.

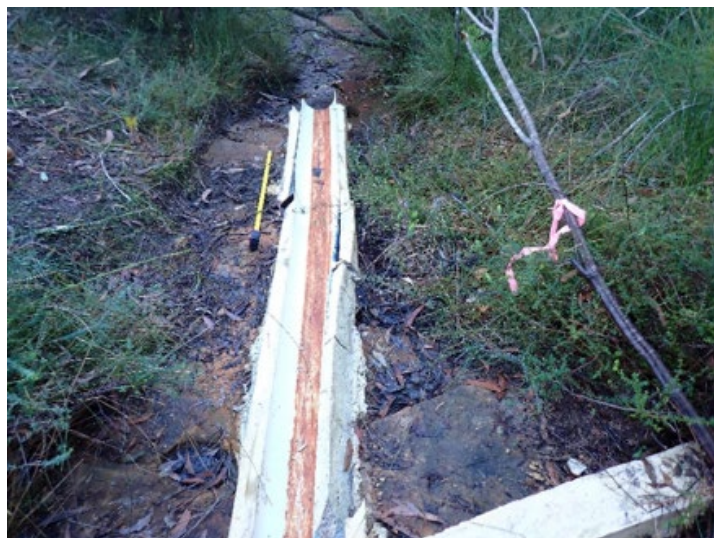
Impact *DA3C_LW21_014* consists of rock fracturing on tributary WC20 (Figure 3). The fracturing was observed on mapped feature '*WC20_Rockbar 22*' (Photo 20 and Photo 21), with damage to the concrete footing of flow monitoring site *WC20S2* observed directly upstream (Photo 19). The fracturing on the rockbar has a maximum continuous length of 3.45m, a maximum width of 0.06m and a maximum measured depth of 0.57m. There was no surface flow at the site during this inspection and flow diversion is likely.

Photo 23: *DA3C_LW21_014*, damage to concrete footing of flow monitoring site *WC20S2*. Taken on 11/07/2023.

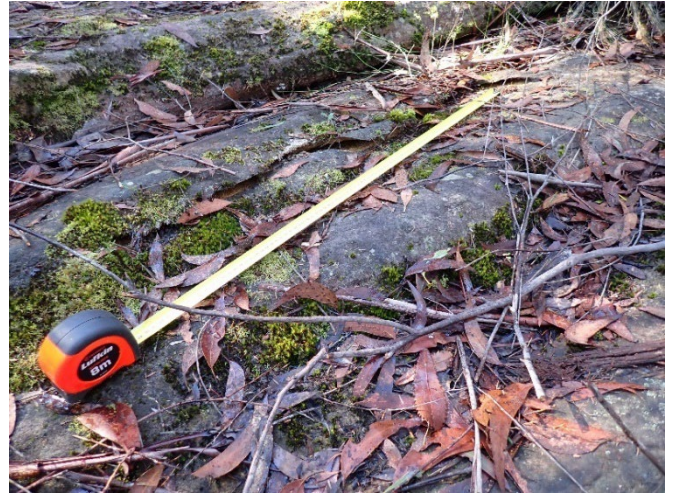
Impact *DA3C_LW21_017* consists of rock fracturing and uplift to '*WC20_Rockbar 15*' on tributary WC20 (Figure 3). The fracturing has a maximum length of 2.6m, a maximum width of 0.012m and uplift of 0.02m (Photo 27 to Photo 30). No surface flow was present during the inspection however the impact is not situated in the direct flow path, therefore flow diversion is unlikely to occur.

Photo 28: DA3C_LW21_017, section of rock fracturing. Taken on 26/07/2023.

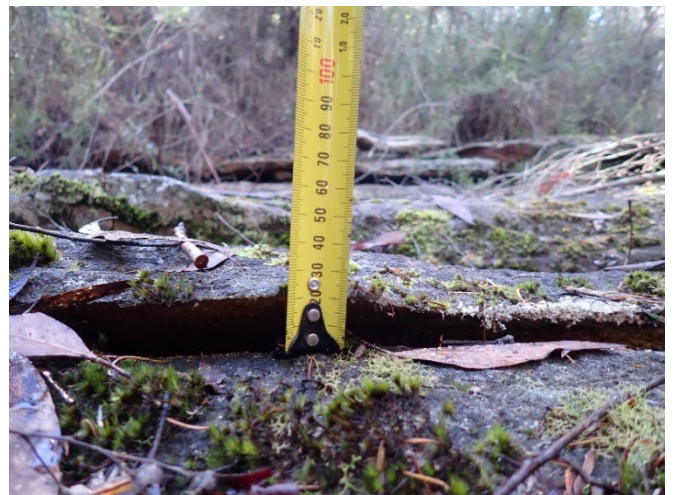
Photo 30: DA3C_LW21_017, section of uplift. Taken on 26/07/2023.

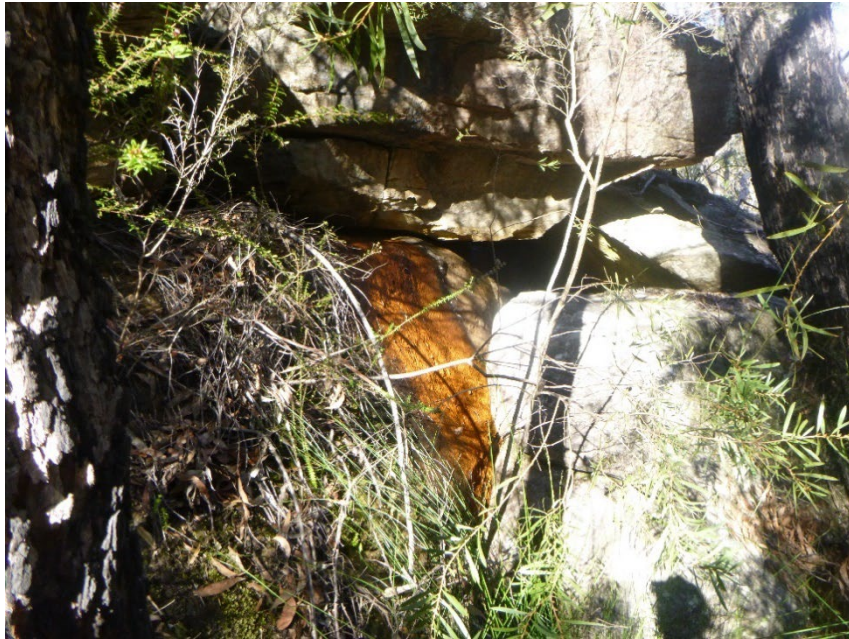
DA3C_LW21_021 consists of localised iron staining on the downstream basal step of Swamp 144 and the headwaters of tributary WC20 (Figure 3). The iron staining originates from beneath a large boulder mid-way down the basal step (Photo 31). The iron staining is approximately 2m in length, 1m in width and disappears downslope into bushland. No other surface impacts were observed on or above the basal step.

Photo 31: *DA3C_LW21_021*, overview of the iron staining.
Taken on 1/08/2023.

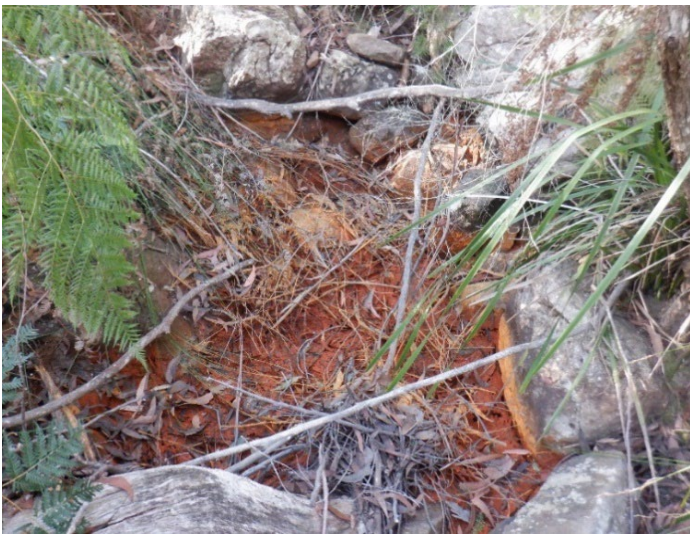
WC24 is a tributary of Wongawilli Creek that flows westward from DA3C mining operations (Figure 3). The upper reaches of the WC24 sub catchment were mined beneath by Longwall 21. Localised iron staining was observed along a 45m stretch of dry streambed on WC24. The iron staining originates at *WC24_Pool 35* and extends downstream to *WC24_Rockbar 15* (Photo 32 to Photo 35). During the baseline mapping of WC24, no surface water was observed in this part of the tributary. However, the recently recorded iron staining was not present in the baseline mapping. No other surface impacts have been observed in WC24.

Photo 32: *DA3C_LW21_020*, section of iron staining in *WC24_Pool 35*. Taken on 1/08/2023.

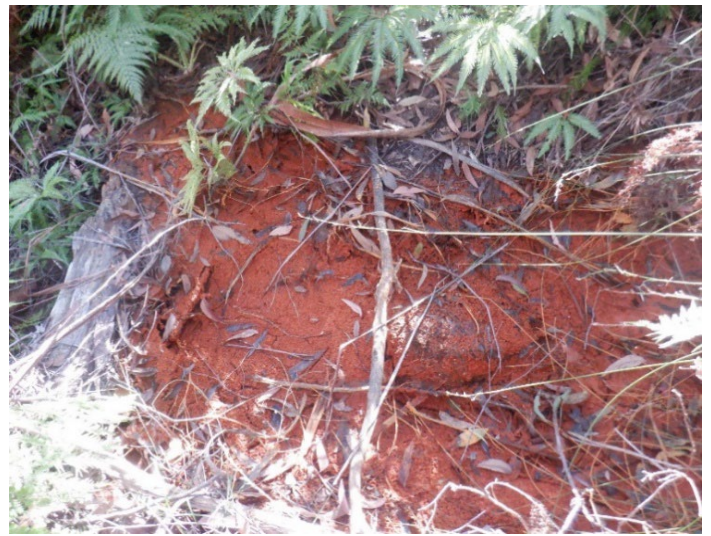
Photo 33: *DA3C_LW21_020*, section of iron staining in *WC24_Channel 18*. Taken on 1/08/2023.

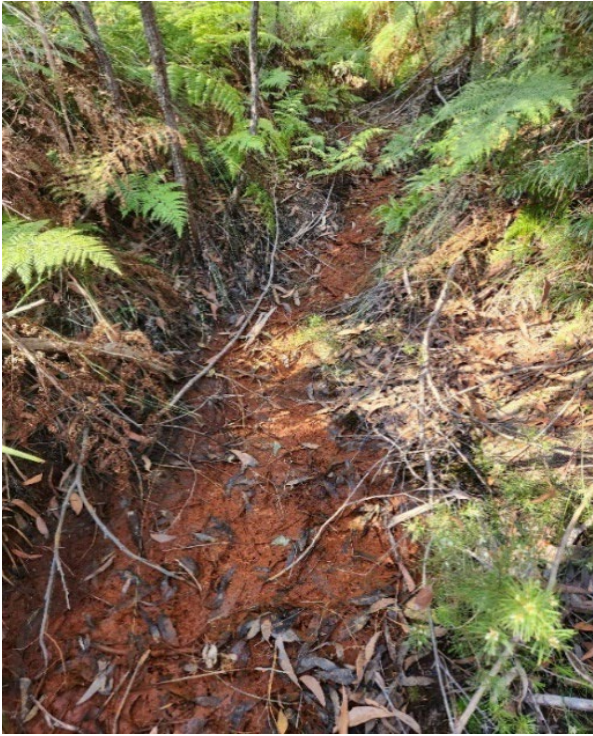
Photo 34: *DA3C_LW21_020*, section of iron staining in *WC24_Channel 18*. Taken on 1/08/2023.

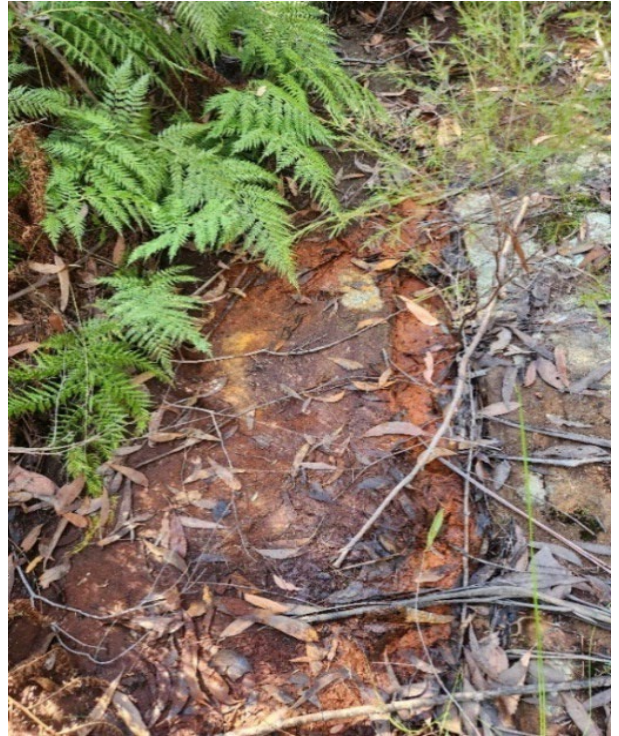
Photo 35: *DA3C_LW21_020*, section of iron staining in *WC24_Rockbar 15*. Taken on 1/08/2023.

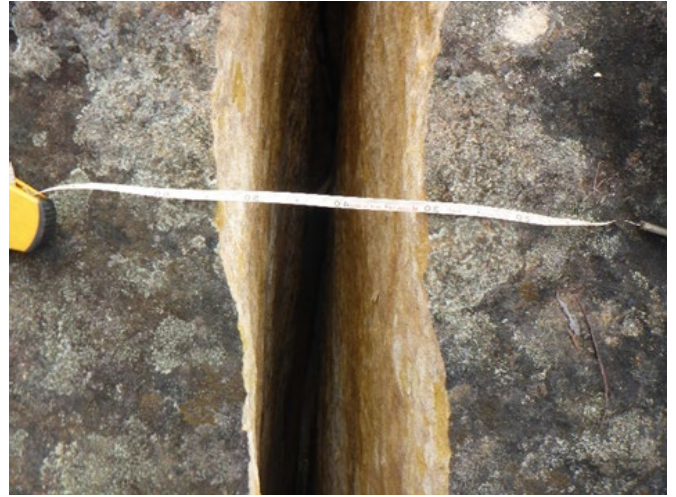
Photo 38: DA3C_LW21_002, showing maximum rock fracture width. Taken on 06/06/2023.

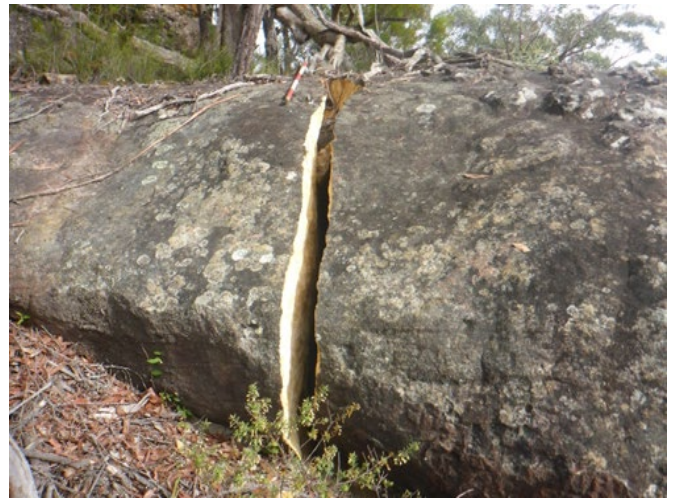
Photo 40: DA3C_LW21_002, showing rock fracture. Taken on 06/06/2023.

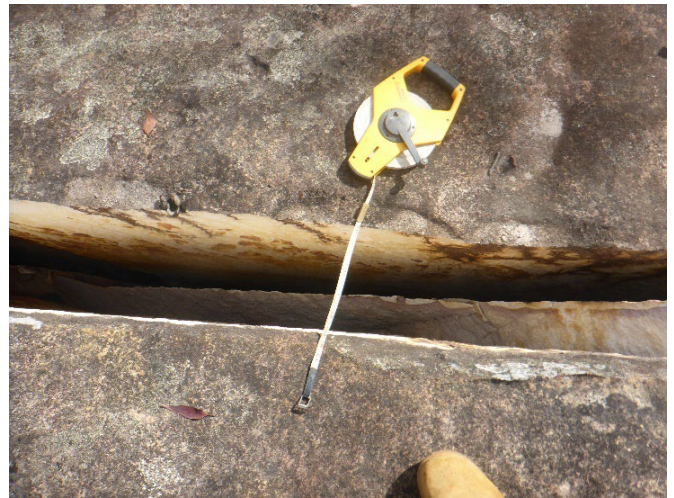
Photo 43: DA3C_LW21_003, width of rock fracture. Taken on 06/06/2023.

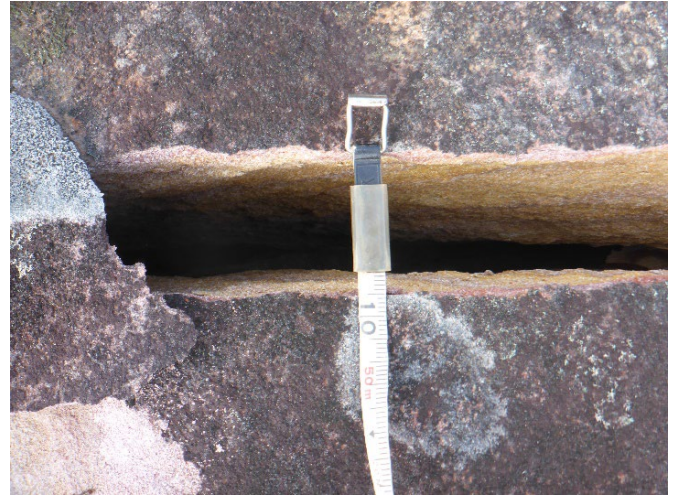
Photo 47: DA3C_LW21_004, rock fracture width. Taken on 06/06/2023.

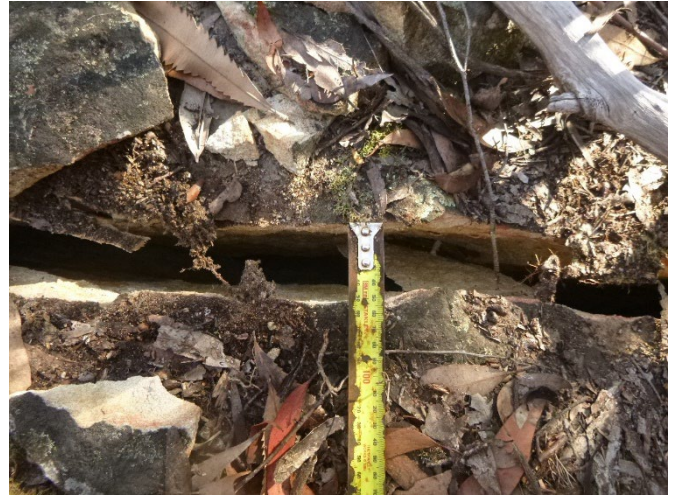
Photo 49: *DA3C_LW21_005*, showing width of rock fracture. Taken on 15/06/2023.

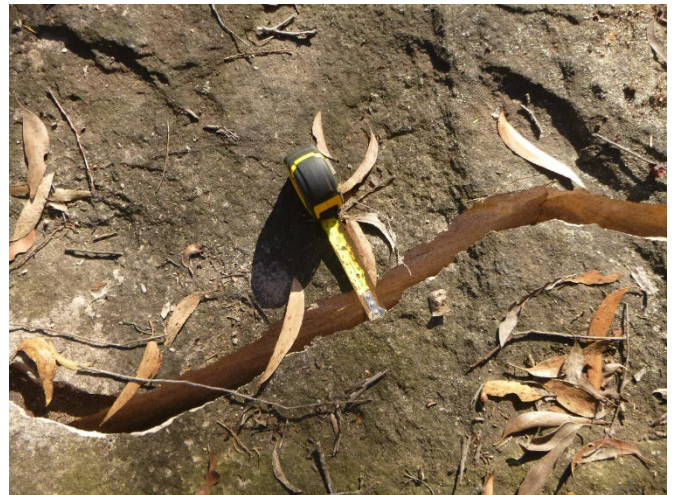
Photo 51: *DA3C_LW21_006*, maximum width of rock fracture. Taken on 15/06/2023.

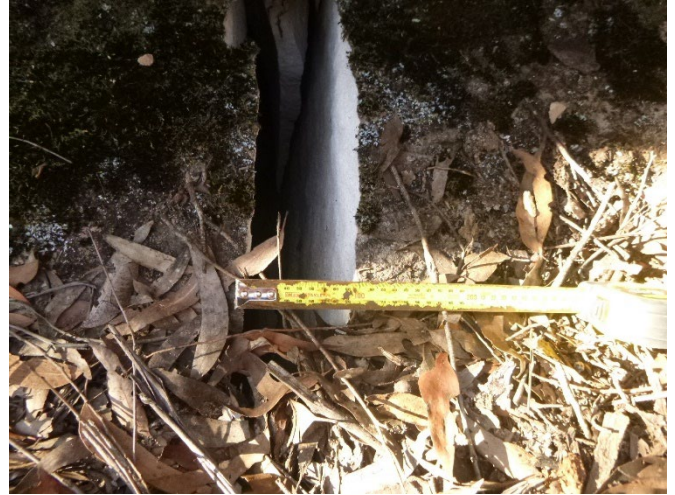
Photo 53: DA3C_LW21_007, maximum width of rock fracture. Taken on 15/06/2023.

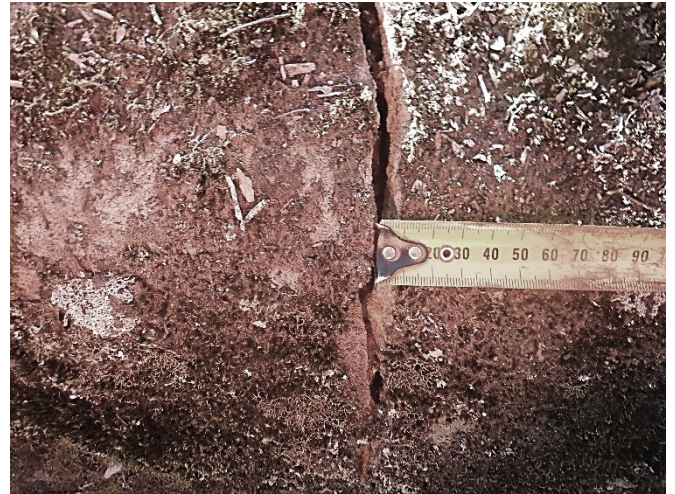
Photo 59: DA3C_LW21_009, maximum width of the rock fracture. Taken on 19/06/2023.

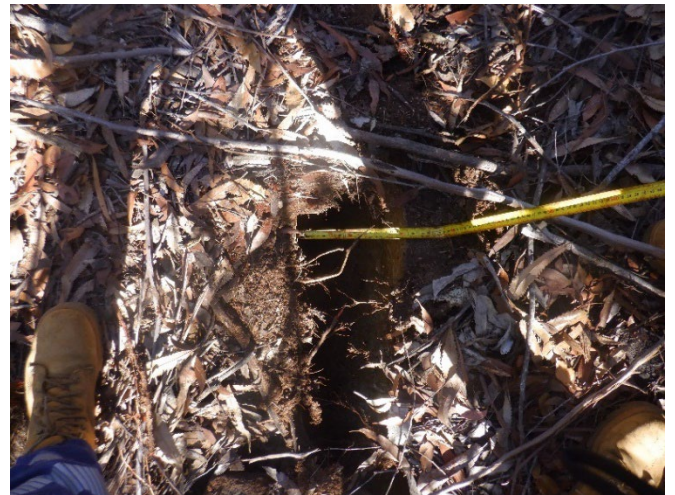
Photo 62: DA3C_LW21_010, maximum width of the rock fracture. Taken on 19/06/2023.

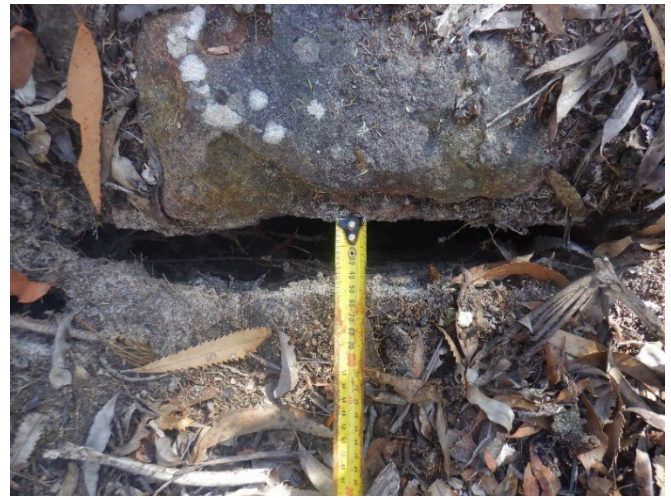
Photo 65: DA3C_LW21_011, maximum width of the fracture. Taken on 19/06/2023.

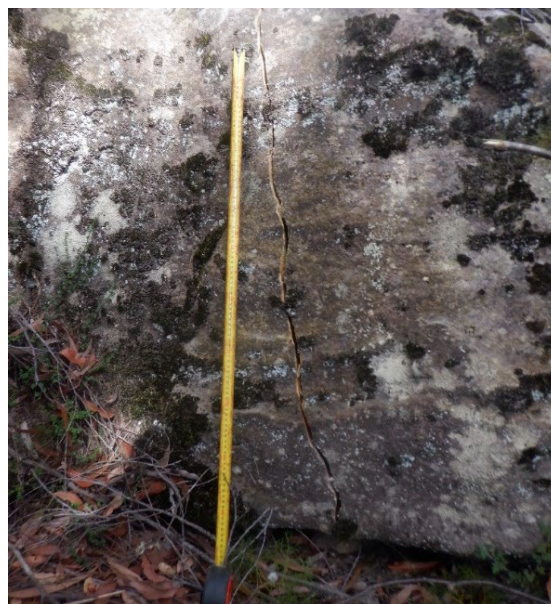
Photo 70: DA3C_LW21_012, overview of the rock fracture. Taken on 27/06/2023.

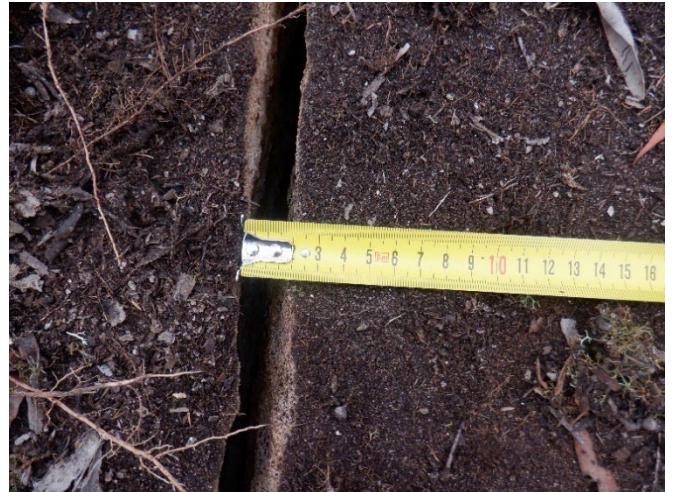
Photo 72: DA3C_LW21_013, maximum width of the rock fracture. Taken on 03/07/2023.

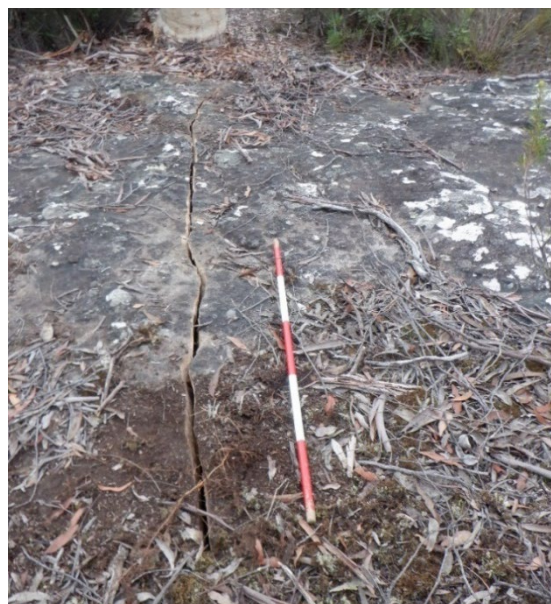
Photo 73: DA3C_LW21_013, overview of section of impact. Taken on 03/07/2023.

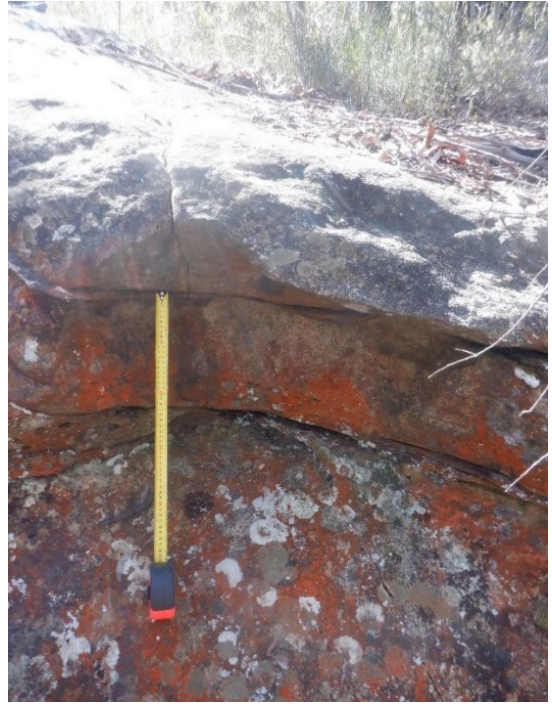
Photo 79: DA3C_LW21_018, section of rock fracturing. 26/07/2023.

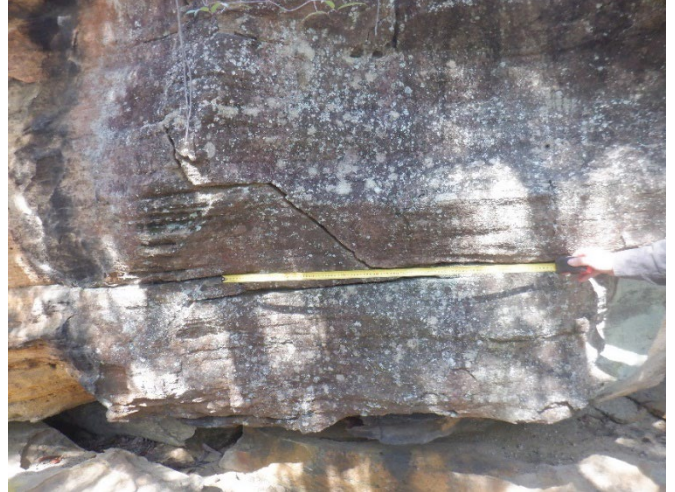
Photo 82: DA3C_LW21_019, looking at the rock fracture.
Taken on 1/08/2023.

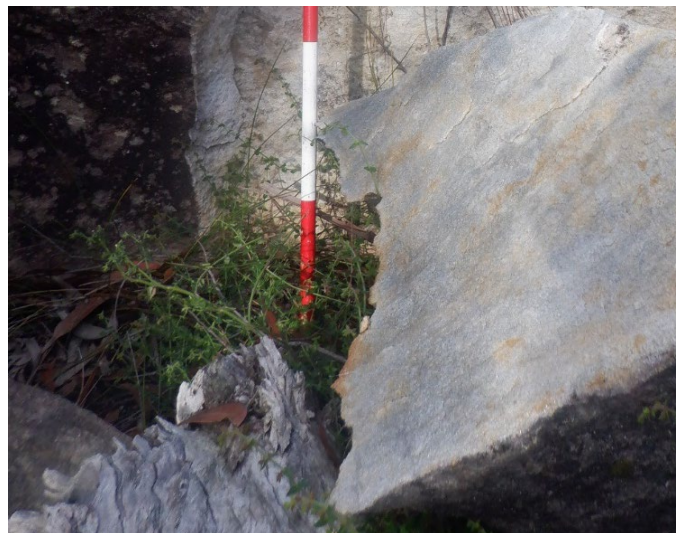
Photo 86: *DA3C_LW21_022*, Close-up of boulder showing fresh edge of fracture. Taken 7/08/2023

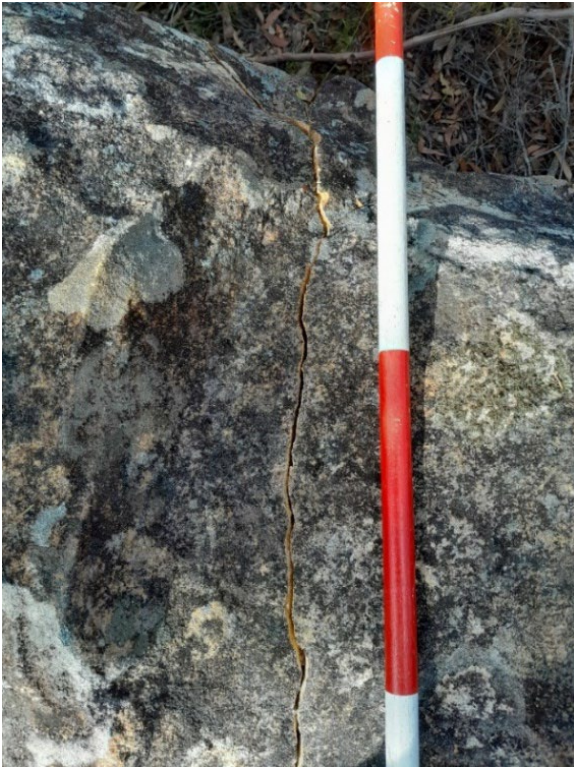
- Crack or fracture up to 100mm width;
- Crack or fracture up to 10m length.

Photo 87: *DA3C_LW21_023*, section of the rock fracture. Taken: 31/08/2023.

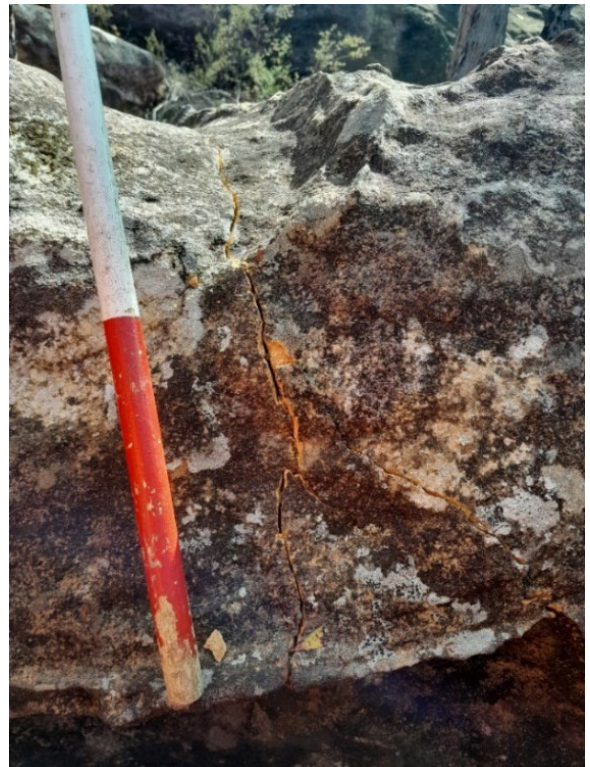
Photo 88: *DA3C_LW21_023*, section of the rock fracture. Taken: 31/08/2023.

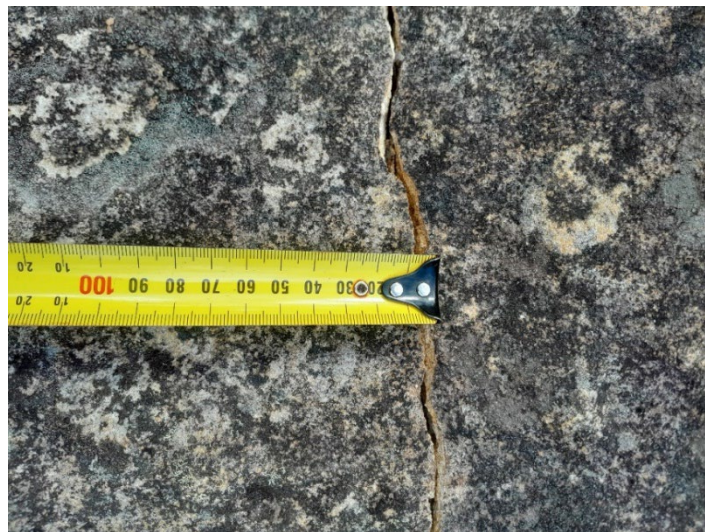
Photo 89: *DA3C_LW21_023*, maximum width of the rock fracture. Taken: 31/08/2023.

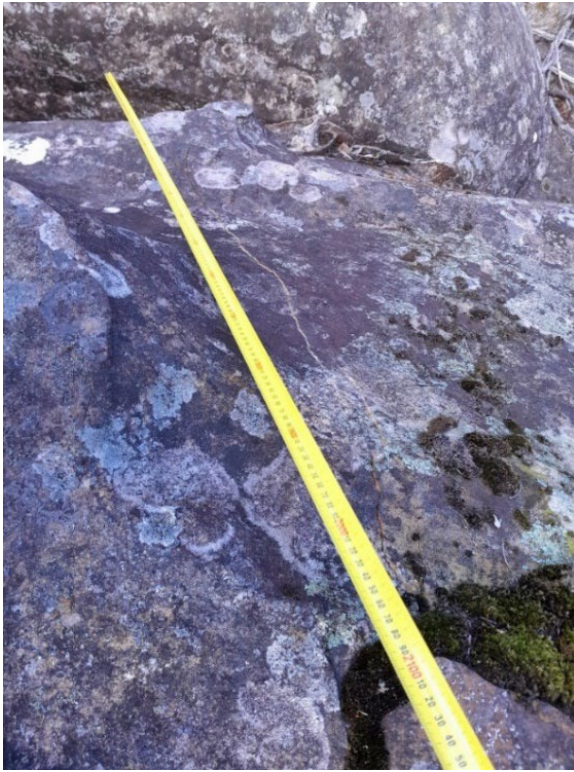
- Crack or fracture up to 100mm width;
- Crack or fracture up to 10m length;

Photo 90: DA3C_LW21_024, section of the rock fracture. Taken: 31/08/2023.

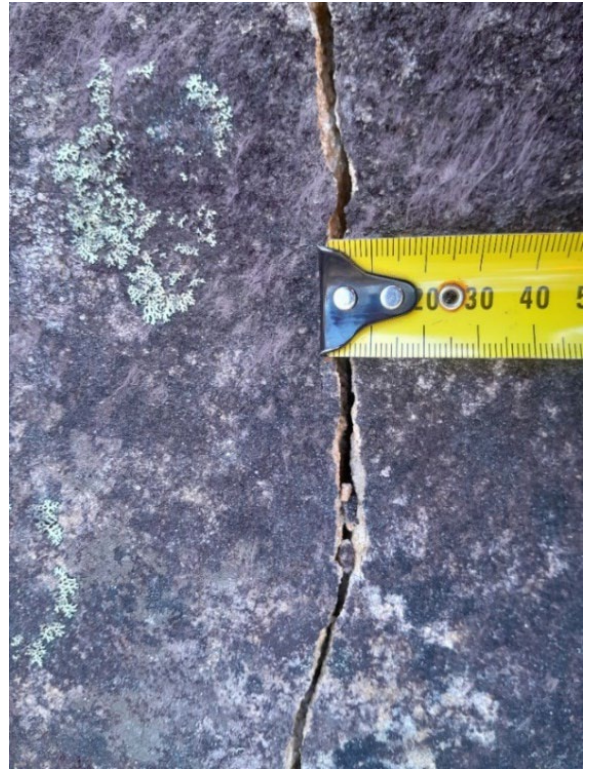
Photo 91: DA3C_LW21_024, maximum width of the rock fracture. Taken: 31/08/2023.

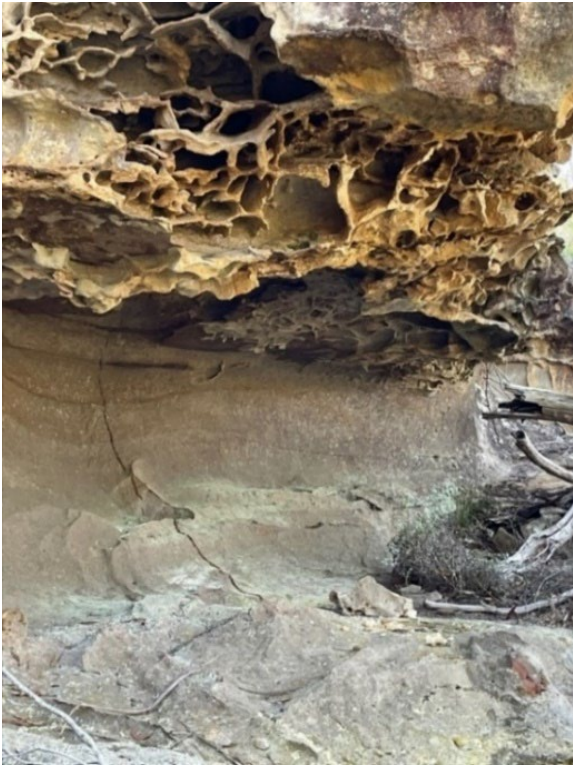
- Crack or fracture up to 100mm width;
- Crack or fracture up to 10m length;
- Rockfall from a cliff (step) which is left mostly intact resulting in insignificant ground disturbance.

Photo 92: *DA3C_LW21_025*, section of the rock fracture in overhang. Taken: 06/09/2023.

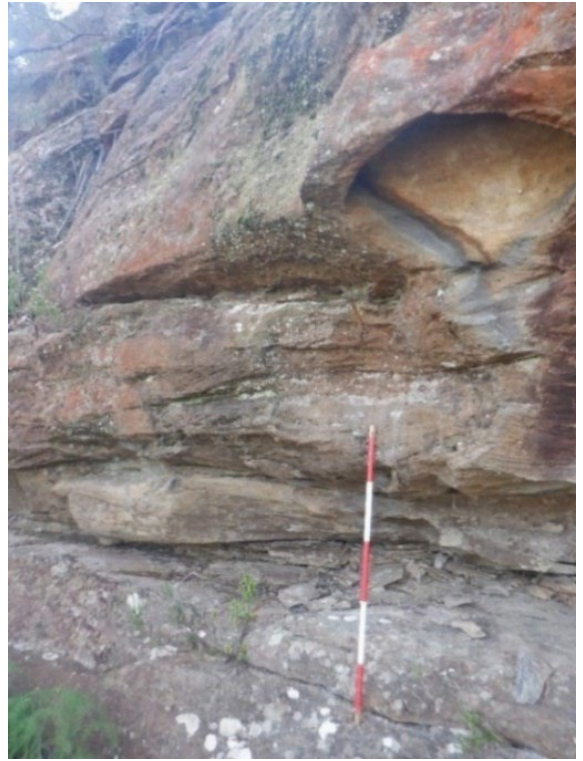
Photo 93: *DA3C_LW21_025*, section of the rock fracture. Taken: 06/09/2023.

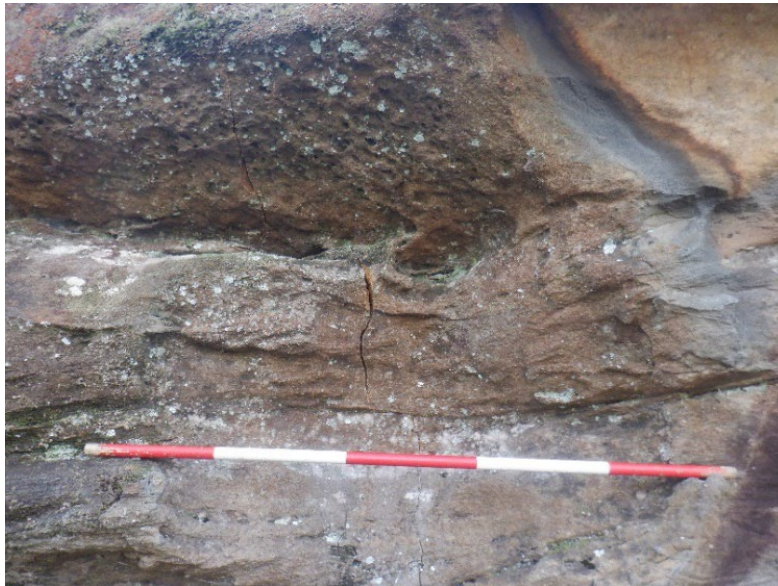
Photo 94: *DA3C_LW21_025*, section of the rock fracture. Taken: 06/09/2023.

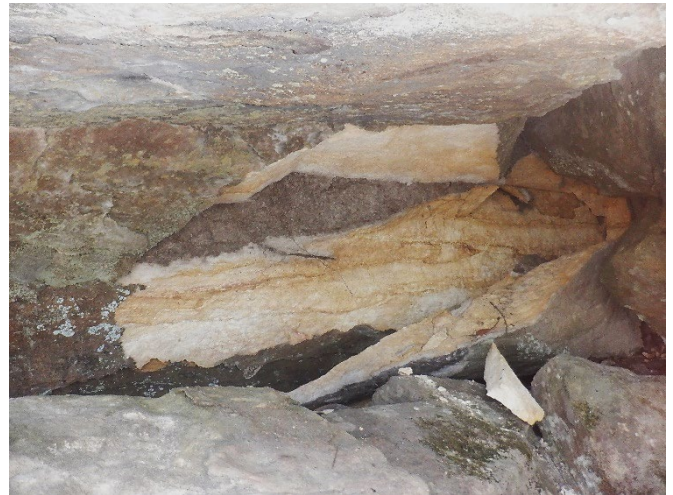
Photo 96: DA3C_LW21_026, close-up section of rockfall. Taken 06/09/2023.

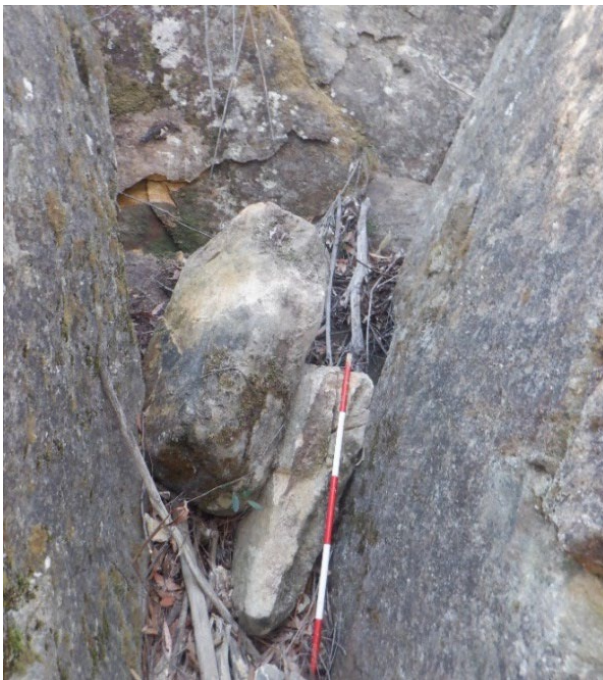
Photo 97: DA3C_LW21_026, section of rock fracture and rockfall. Taken 06/09/2023.

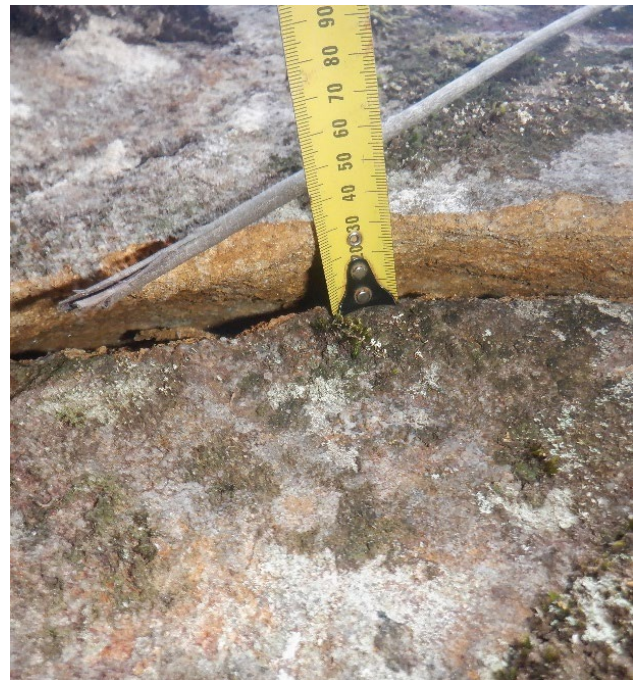
Photo 98: DA3C_LW21_026, Width of rock fracture. Taken 06/09/2023.

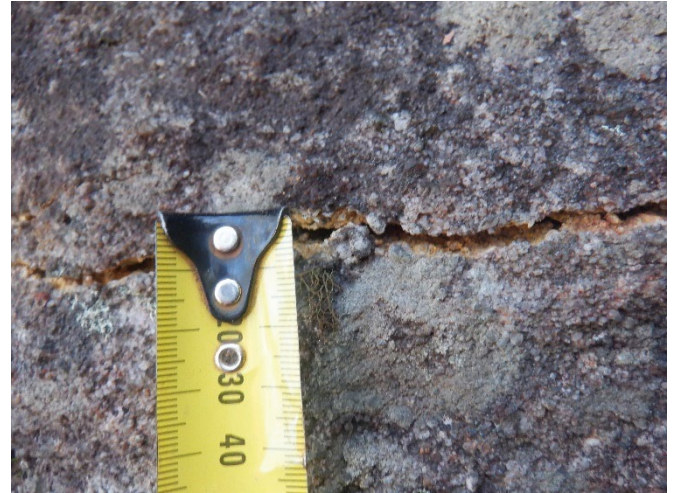
Photo 102: *DA3C_LW21_028*, width of rock fracture. Taken 06/09/2023.

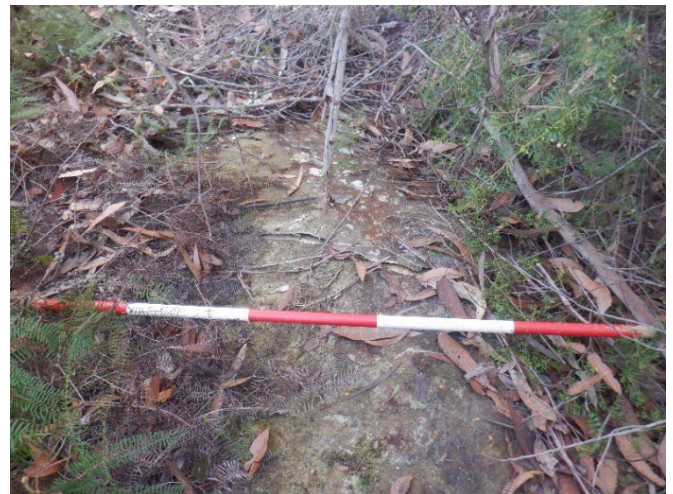
Photo 104: *DA3C_LW21_029*, section of rock fracture. Taken 6/09/2023.

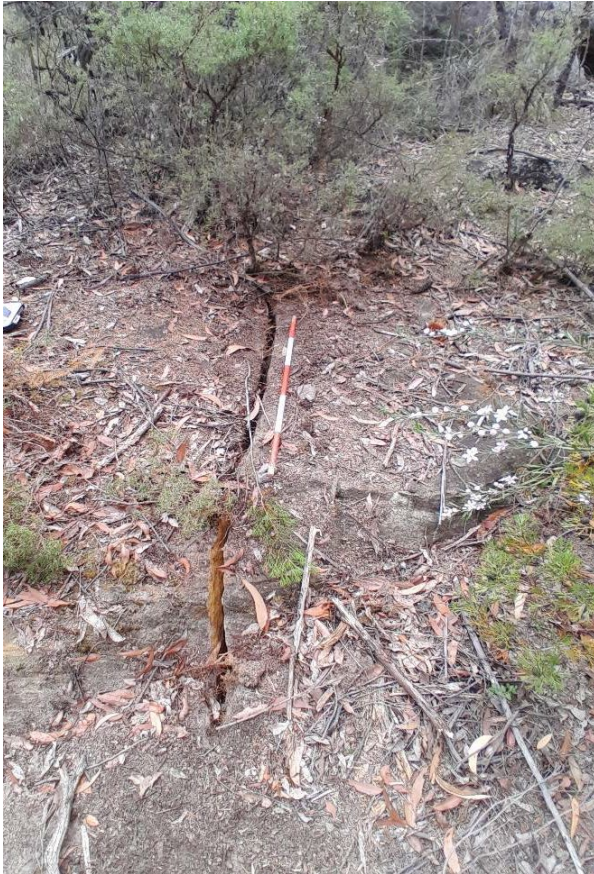
- Crack or fracture up to 100mm width;
- Crack or fracture up to 10m length.

Photo 105: DA3C_LW21_030, overview of rock fracture. Taken: 12/09/2023.

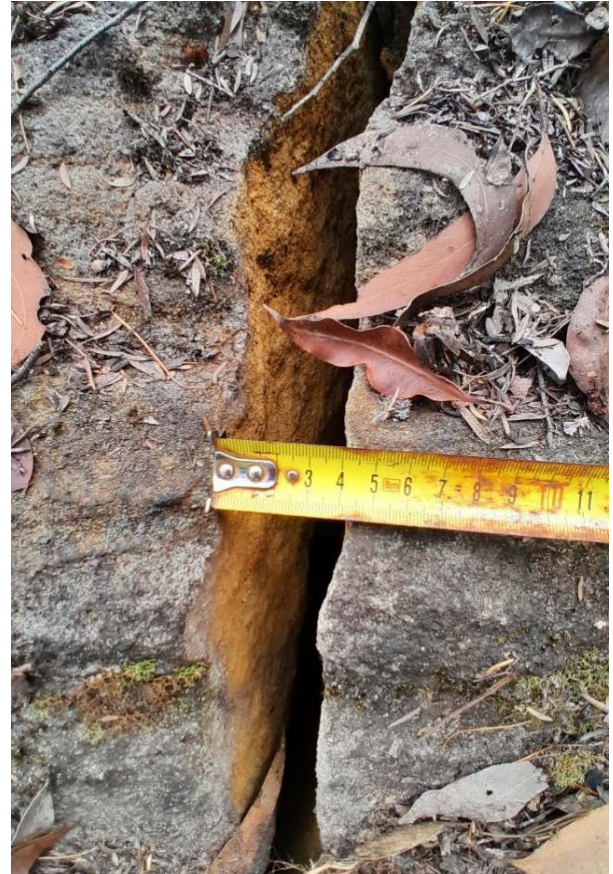
Photo 106: DA3C_LW21_030, width of rock fracture. Taken: 12/09/2023.

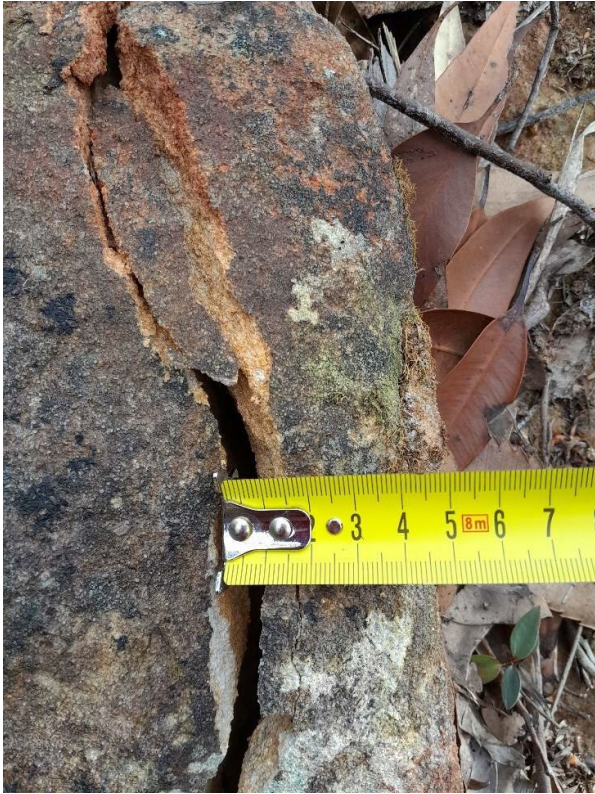
- Crack or fracture up to 100mm width;
- Crack or fracture up to 10m length;

Photo 107: DA3C_LW21_031, width of rock fracture. Taken: 12/09/2023.

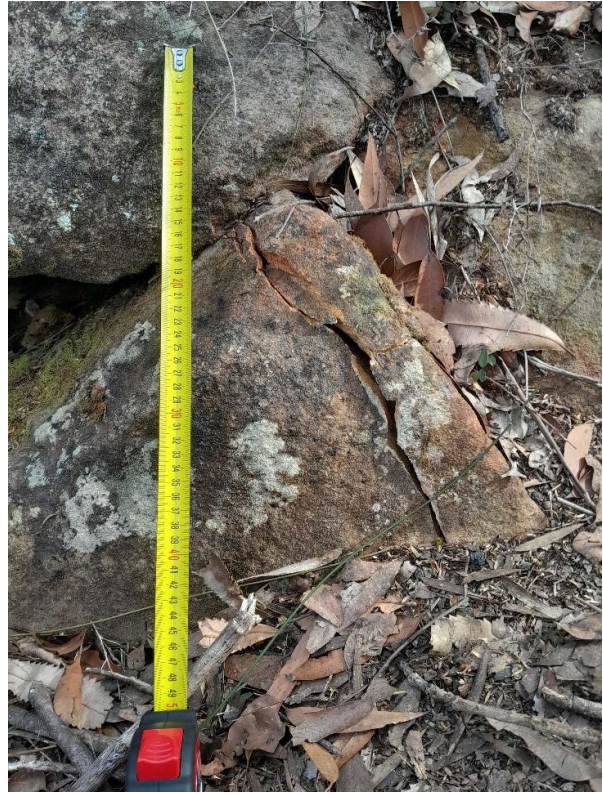
Photo 108: DA3C_LW21_031, overview of rock fracture. Taken: 12/09/2023. Note - measurement tape set to 0.5m for scale.

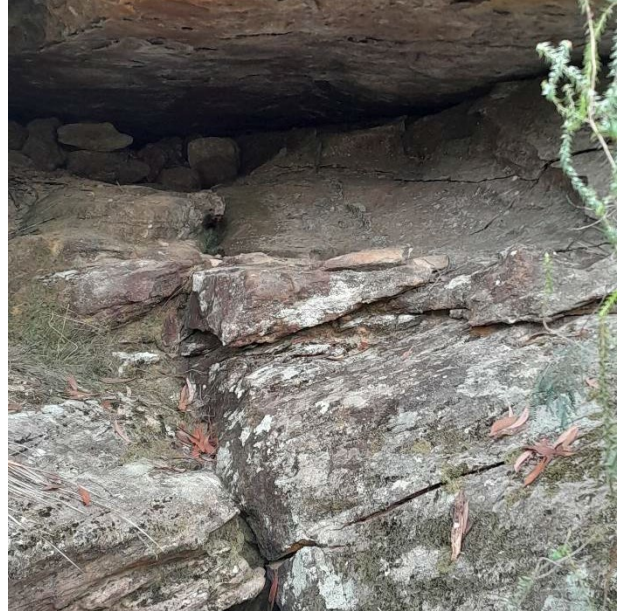
Photo 110: *DA3C_LW21_032*, overview of fracturing to rock step/overhang.
Taken 12/09/2023.

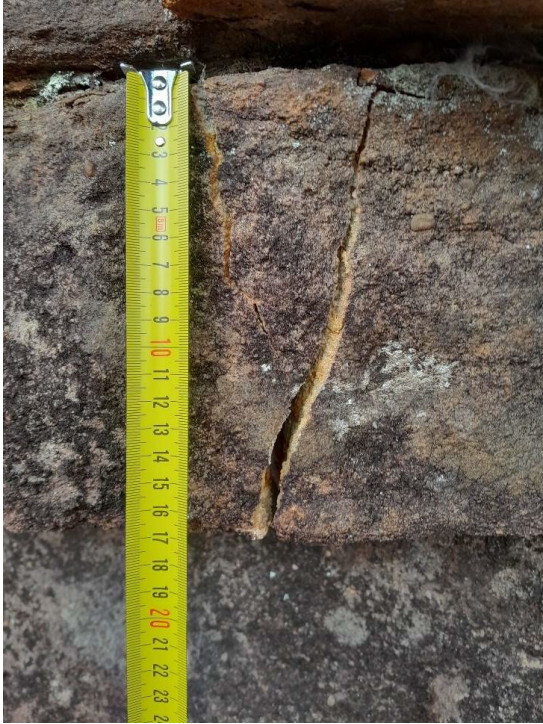
- Crack or fracture up to 100mm width;
- Crack or fracture up to 10m length.

Photo 111: DA3C_LW21_033, overview of rock fracture. Taken 12/09/2023.

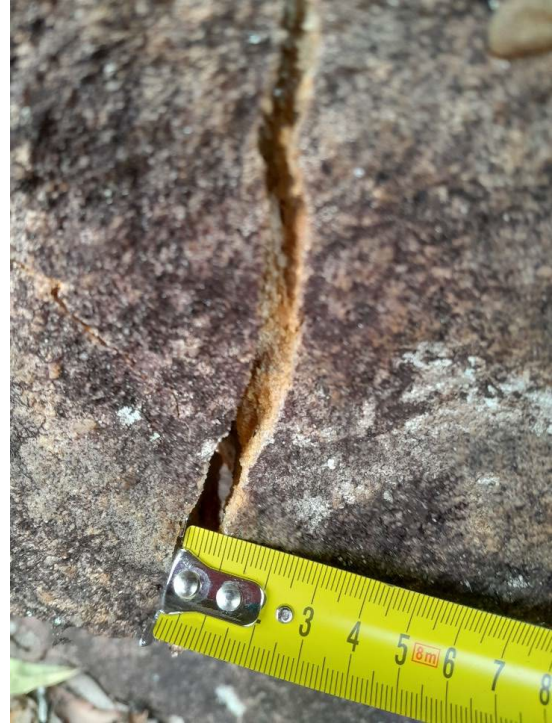
Photo 112: DA3C_LW21_033, width of rock fracture. Taken 12/09/2023.
