**DENDROBIUM AREA 3C
LONGWALL 21 END OF PANEL
LANDSCAPE REPORT
NOVEMBER 2023**

EXECUTIVE SUMMARY

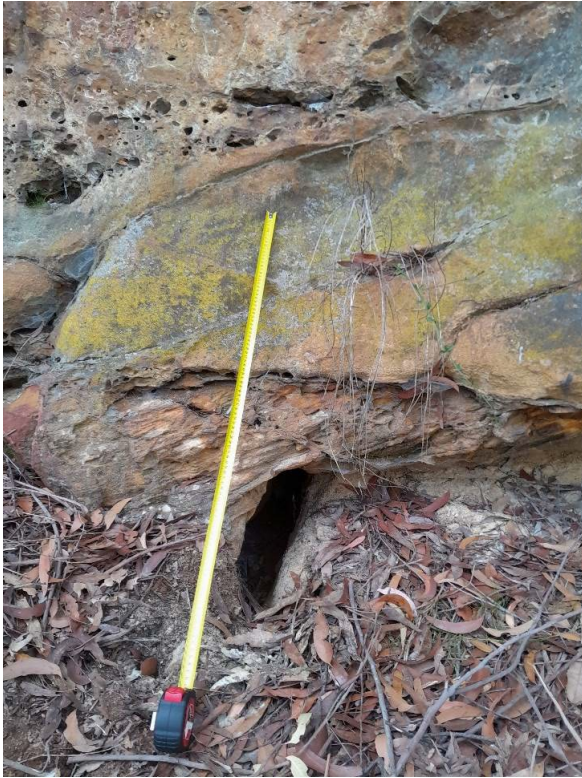
- Crack or fracture between 100 and 300mm width.

Photo 113: DA3C_LW21_034 overview of rock movement and soil crack. Taken: 12/09/2023.

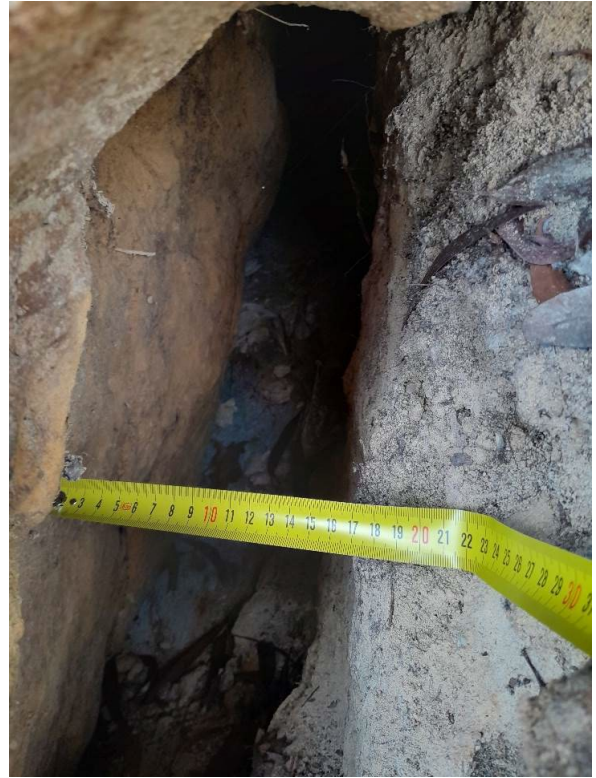
Photo 114: DA3C_LW21_034 width of soil crack. Taken 12/09/2023.

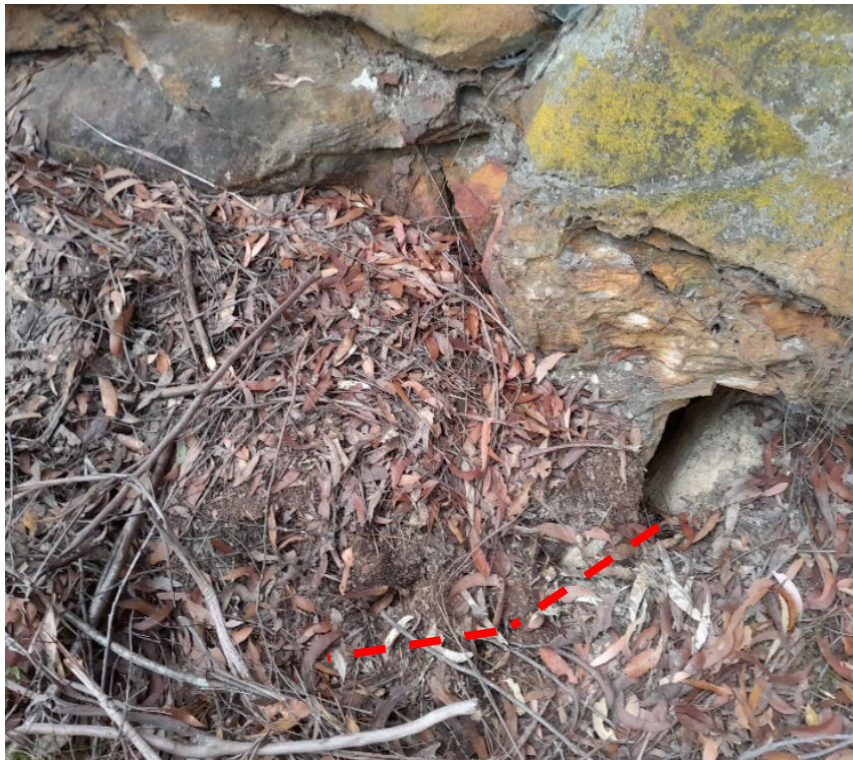
Photo 115: DA3C_LW21_034. Dashed line shows approximate section of unstable soil/leaf litter extending from rock movement. Taken 12/09/2023.
