Monitoring of watercourses, swamps and landscape features is undertaken to identify subsidence impacts. These features are monitored by the Illawarra Metallurgical Coal Environmental Field Team (IMCEFT) monthly prior to mining and weekly during mining. Monitoring is conducted in accordance with the approved Subsidence Management Plan (SMP) for Dendrobium Area 3C (DA3C). Extraction of Longwall 21 commenced on 25 April 2023 and as of 6 June 2023 there were four new subsidence impacts identified.

This Version 2 of the report includes a summary of consultation with stakeholders undertaken since the initial report.

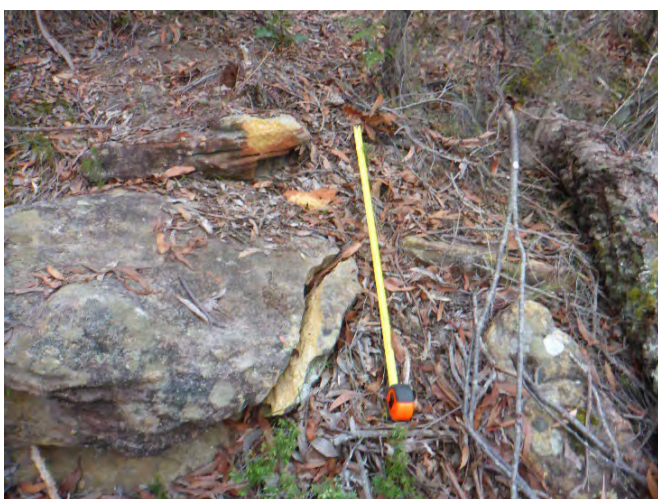
DA3C_LW21_001 is located approximately 80m west of *Fire Road 6F* (Figure 1). The impact consists of rock fracturing to an outcrop. The rock fracturing had a total continuous length of 0.56m, with the piece of rock dislodged from the outcrop. The fracturing has minimal impact to vegetation or ground disturbance. (Photo 1 and Photo 2).

DA3C_LW21_001 is a Level 1 trigger as per the Dendrobium Landscape TARP (Table 1), specifically:

Photo 1: *DA3C_LW21_001*, showing rock fracture.
Taken on 06/06/2023.

- Continue Monitoring Program
- Submit an Impact Report to key stakeholders
- Summarise impacts and report in the EoP and the AR
- Review monitoring frequency
- Notify relevant technical specialists and seek advice on any CMA required
- Provide safety signage and barricades as appropriate
- Implement approved repairs to ensure safety and serviceability on fire trails
- Implement agreed CMAs as approved

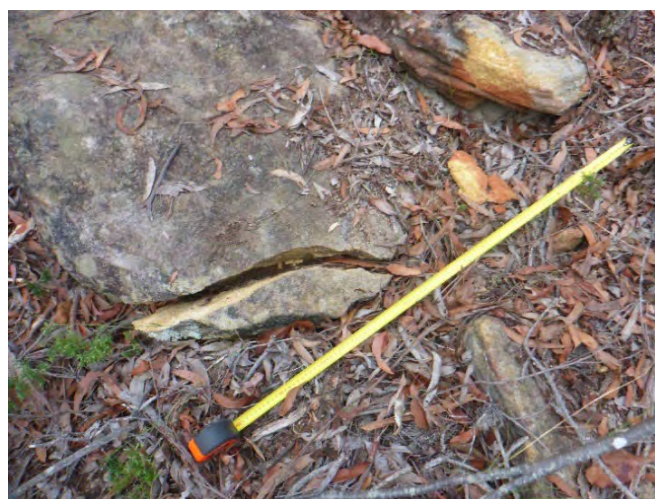
Photo 2: *DA3C_LW21_001*, showing detached rock piece. Taken on 06/06/2023.

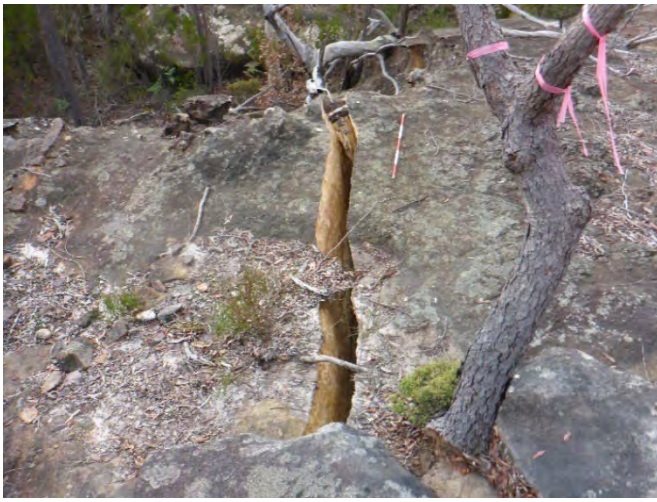
DA3C_LW21_002 is located approximately 140m west of *Fire Road 6F* (Figure 1). The impact consists of multiple large fractures on a rock outcrop at Landscape Monitoring site *LW21_RO1*. The largest fracture has a maximum continuous length of 16m, a maximum width of 0.265m and a maximum measurable depth of 9m (Photo 3 and Photo 4). Rock movement from boulders directly above the fracturing were displaced by 0.26m with exposed soil (Photo 5). Minimal impact to vegetation however moderate ground disturbance to rock outcrop from additional smaller rock fractures (Photo 6 and Photo 7).

DA3C_LW21_002 is a Level 2 trigger as per the Dendrobium Landscape TARP (Table 1), specifically:

Photo 3: DA3C_LW21_002, showing largest rock fracture in series. Taken on 06/06/2023.

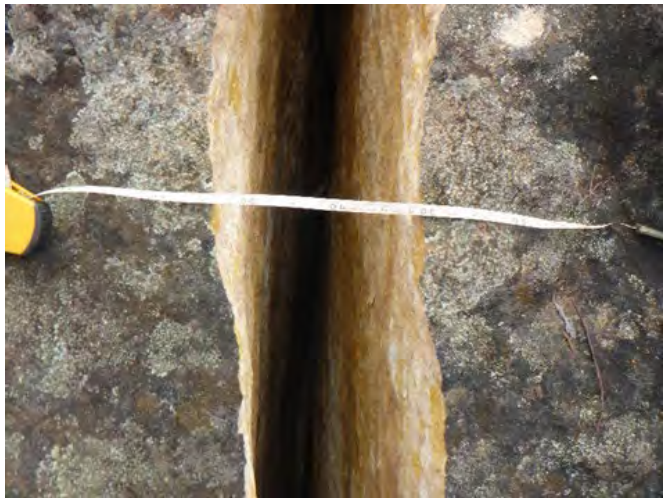
Photo 4: DA3C_LW21_002, showing maximum rock fracture width. Taken on 06/06/2023.

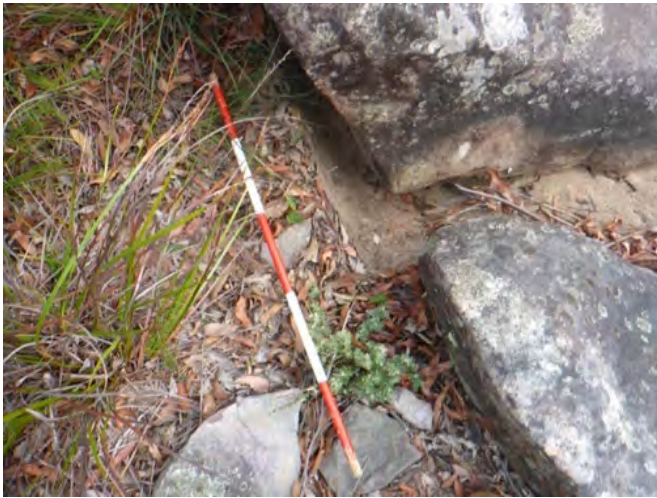
Photo 5: DA3C_LW21_002, showing rock movement on largest fracture. Taken on 6/06/2023.

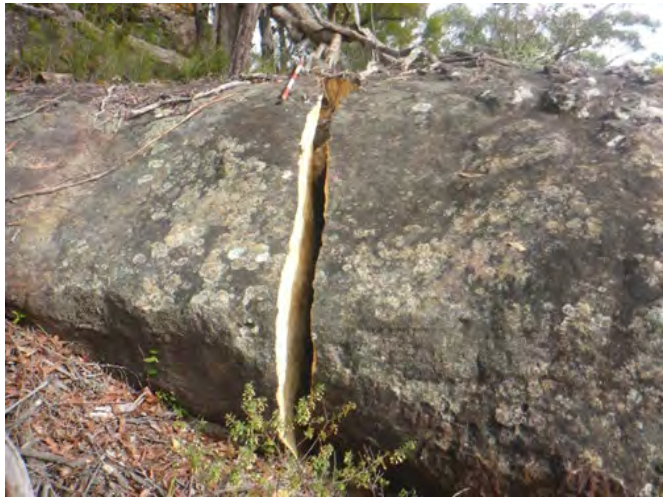
Photo 6: DA3C_LW21_002, showing rock fracture. Taken on 06/06/2023.

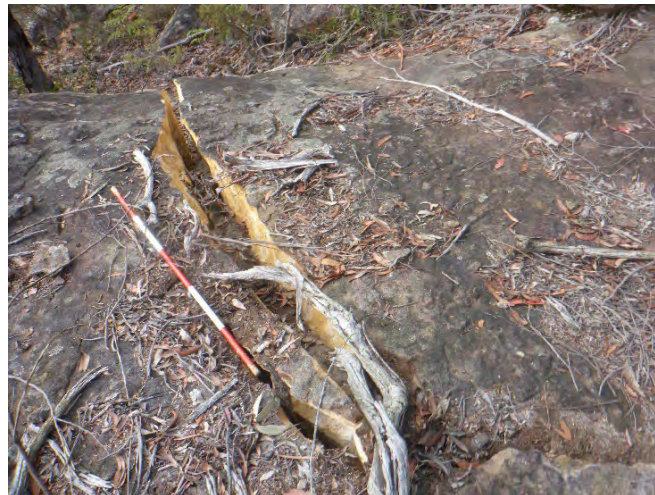
Photo 7: DA3C_LW21_002 showing section of rock fracturing. Taken on 06/06/2023.

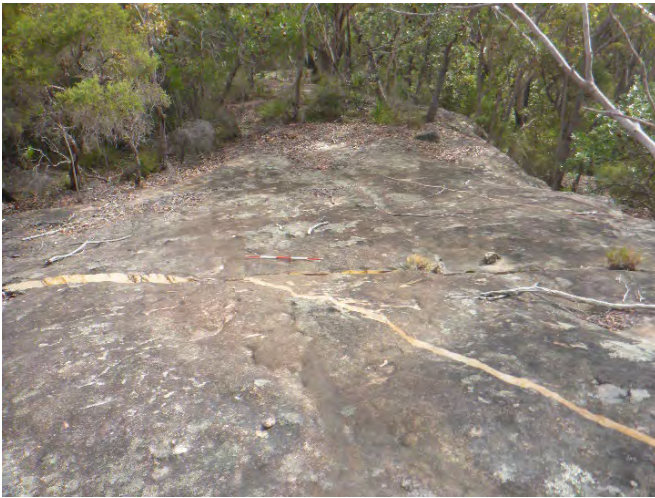
DA3C_LW21_003 is located approximately 225m west of *Fire Road 6F* (Figure 1). The impact consists of multiple large rock fractures on a rock outcrop and a rockfall from the edge of a step on the same outcrop. The largest rock fracture has a maximum continuous length of 22m, a maximum width of 0.26m and a maximum measurable depth of 3m. (Photo 8 and Photo 9). One boulder from the step has dislodged with a rockfall volume of less than 0.1m³ and an approximate debris area of 0.5m² (Photo 10 and Photo 11). The impact has minimal impact to vegetation.

DA3C_LW21_003 is a Level 2 trigger as per the Dendrobium Landscape TARP (Table 1), specifically:

Photo 8: DA3C_LW21_003, rock fracture on an outcrop. Taken on 06/06/2023.

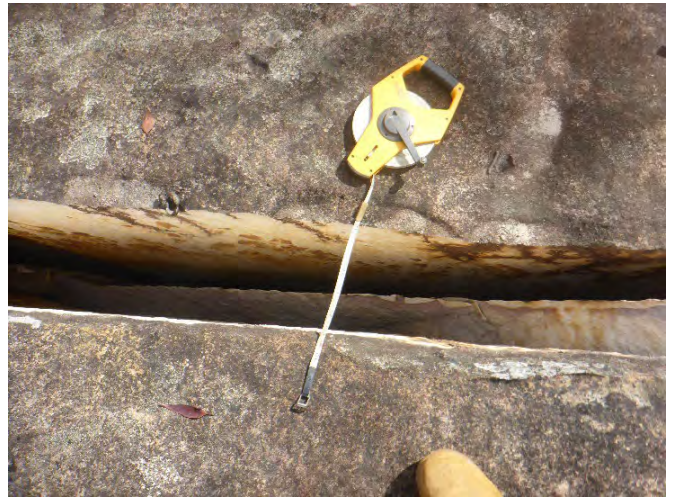
Photo 9: DA3C_LW21_003, width of rock fracture. Taken on 06/06/2023.

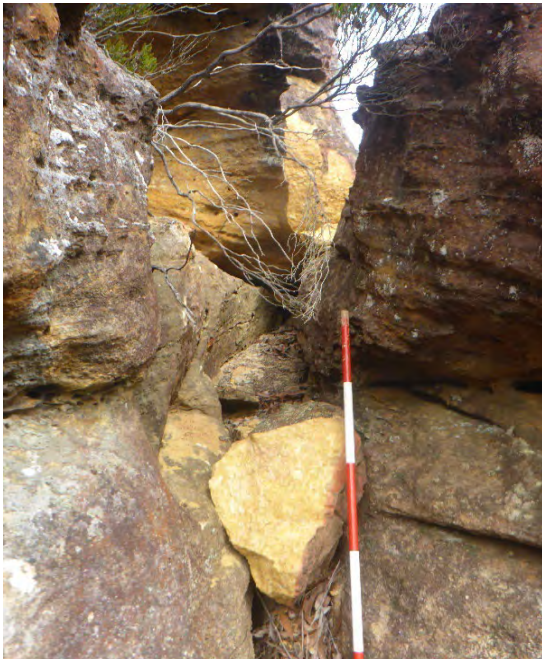
Photo 10: DA3C_LW21_003, showing rockfall and fragmentation. Taken on 06/06/2023.

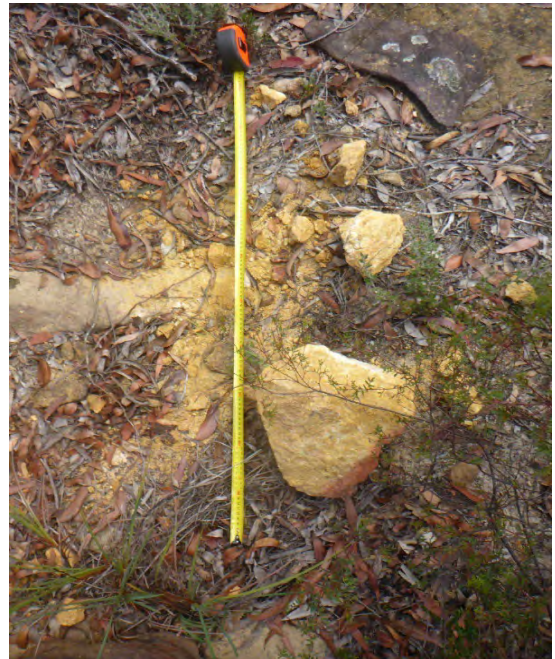
Photo 11: DA3C_LW21_003, showing rockfall debris. Taken on 06/06/2023.

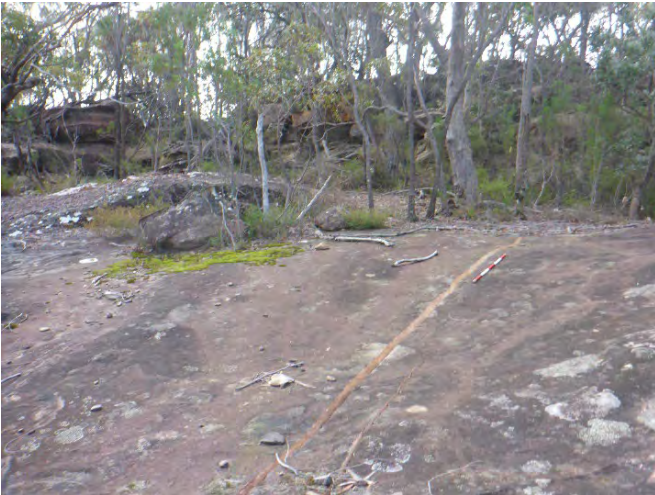
DA3C_LW21_004 is located approximately 210m west of *Fire Road 6F* (Figure 1). The impact consists of rock fracturing on an outcrop. The rock fracture has a continuous length of approximately 12m, a maximum width of 0.09m and a maximum measurable depth of 2.4m (Photo 12 and Photo 13).

DA3C_LW21_004 is a Level 2 trigger as per the Dendrobium Area 3A Landscape TARP (Table 1), specifically:

Photo 12: DA3C_LW21_004, rock fracture on an outcrop. Taken on 06/06/2023.

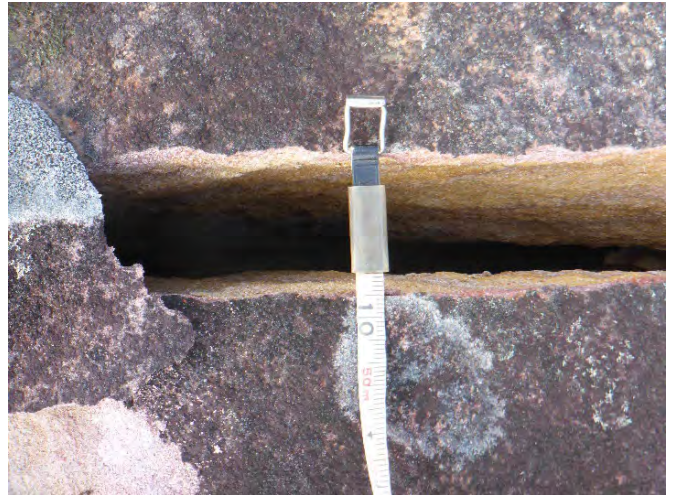
Photo 13: DA3C_LW21_004, rock fracture width. Taken on 06/06/2023

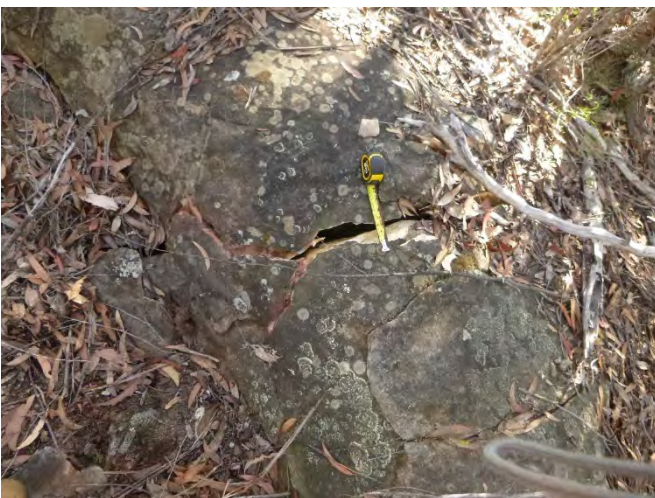
DA3C_LW21_005 is located approximately 150m northeast of *WC20*, a tributary of *Wongawilli Creek* (Figure 1). The impact consists of a fracture to a rock outcrop (Photo 1 and Photo 2). The rock fracture has a continuous length of 2.1m, a maximum width of 0.05m and a maximum measurable depth of 1.84m. The fracture also resulted in a displacement of small rock fragments.

DA3C_LW21_005 is a Level 1 Trigger as per the Dendrobium Landscape TARP (Table 1), specifically:

Photo 1: *DA3C_LW21_005*, fracture to rock outcrop. Taken on 15/06/2023.

- Continue Monitoring Program
- Submit an Impact Report to key stakeholders
- Summarise impacts and report in the End of Panel and the Annual Review
- Review monitoring frequency
- Notify relevant technical specialists and seek advice on any Corrective Management Actions (CMAs) required
- Provide safety signage and barricades as appropriate
- Implement approved repairs to ensure safety and serviceability on fire trails
- Implement agreed CMAs as approved

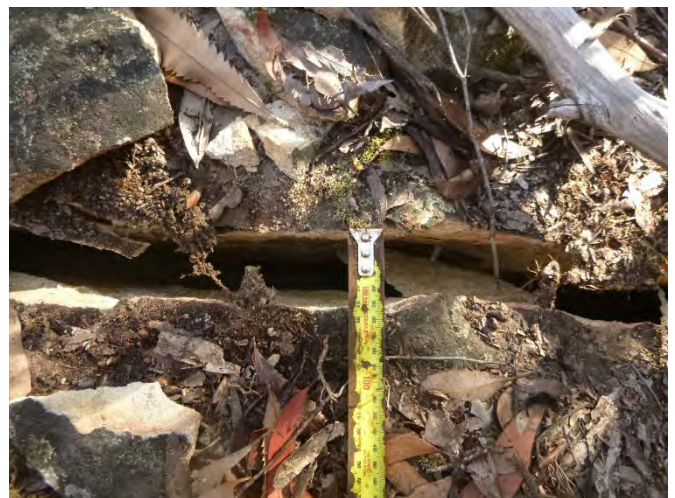
Photo 2: *DA3C_LW21_005*, showing width of rock fracture. Taken on 15/06/2023

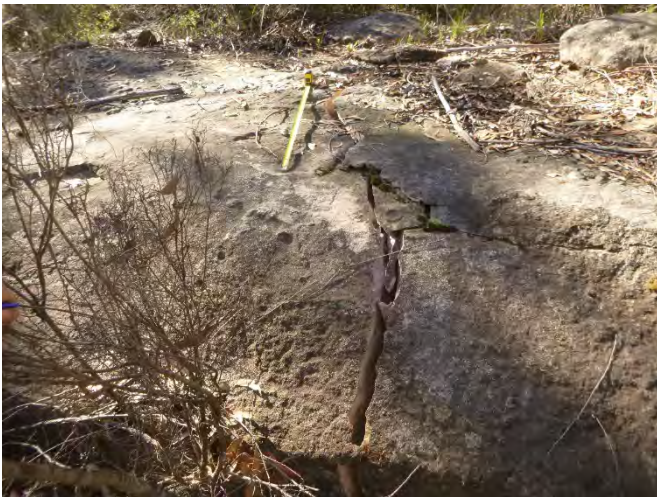
DA3C_LW21_006 is located approximately 150m northeast of *WC20*, a tributary of *Wongawilli Creek* (Figure 1). The impact consists of fracturing to a rock outcrop. (Photo 3 and Photo 4). Two intersecting fractures were observed, the longest continuous length measured was 9.0m. The maximum measured width was 0.04m and the maximum measured depth was 1.12m.

DA3C_LW21_006 is a Level 1 trigger as per the Dendrobium Landscape TARP (Table 1), specifically:

Photo 3: *DA3C_LW21_006*, fracturing to rock outcrop. Taken on 15/06/2023.

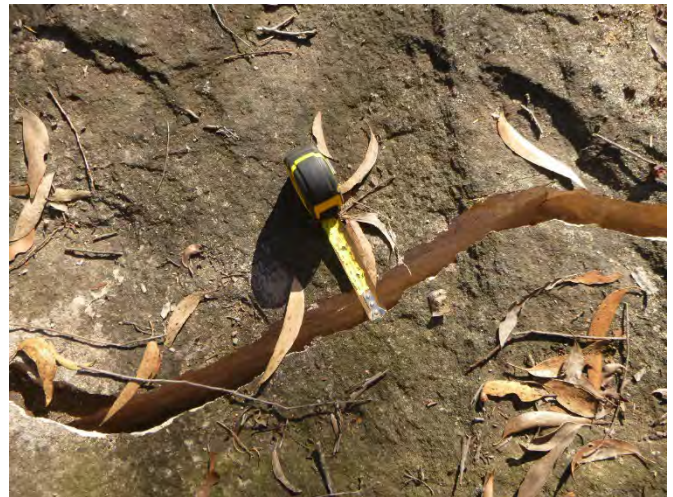
Photo 4: *DA3C_LW21_006*, maximum width of rock fracture. Taken on 15/06/2023.

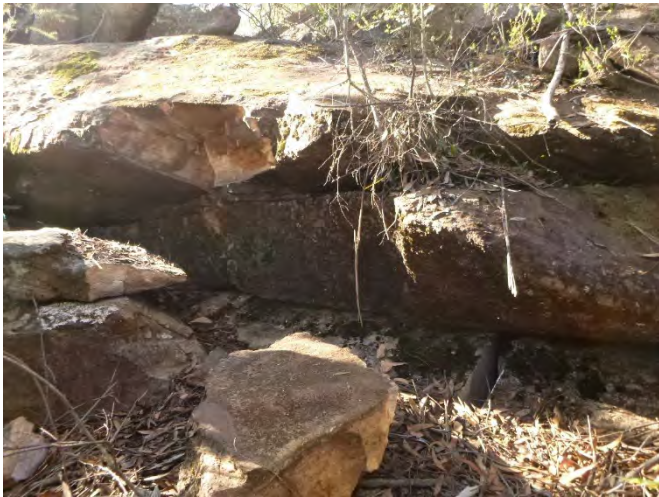
DA3C_LW21_007 is located approximately 160m northeast of *WC20*, a tributary of *Wongawilli Creek* (Figure 1). The impact consists of two rock fractures and associated rock fall to a rock outcrop (Photo 5). The maximum continuous length of the fractures was 2.74m, with a maximum width of 0.14m (Photo 6). The largest measurable depth was 1.83m. The total volume of the rockfall was less than 0.60m³ with a total debris area of approximately 3m² (Photo 5 and Photo 7).

DA3C_LW21_007 is a Level 2 trigger as per the Dendrobium Landscape TARP (Table 1), specifically:

Photo 5: DA3C_LW21_007, fracturing and rock fall to outcrop. Taken on 15/06/2023.

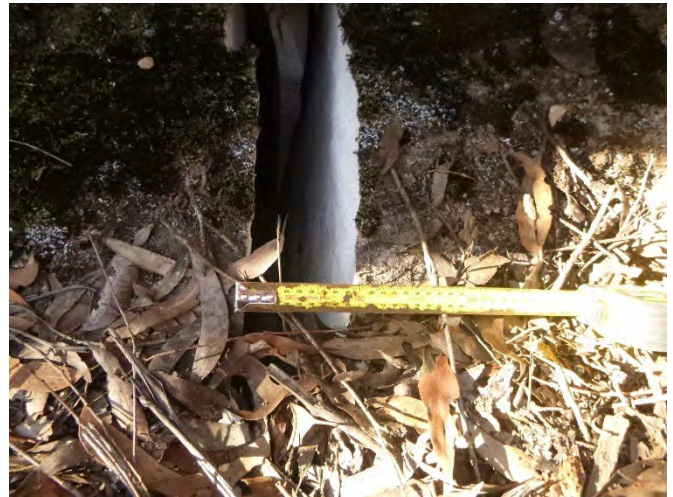
Photo 6: DA3C_LW21_007, maximum width of rock fracture. Taken on 15/06/2023.

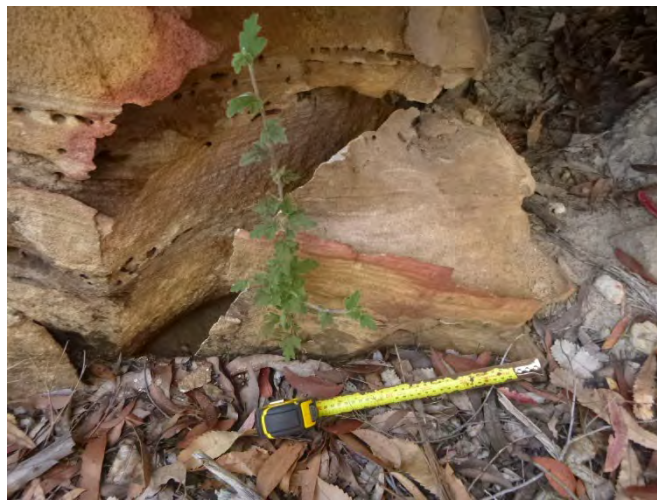
Photo 7: DA3C_LW21_007, rock fall. Taken on 15/06/2023.

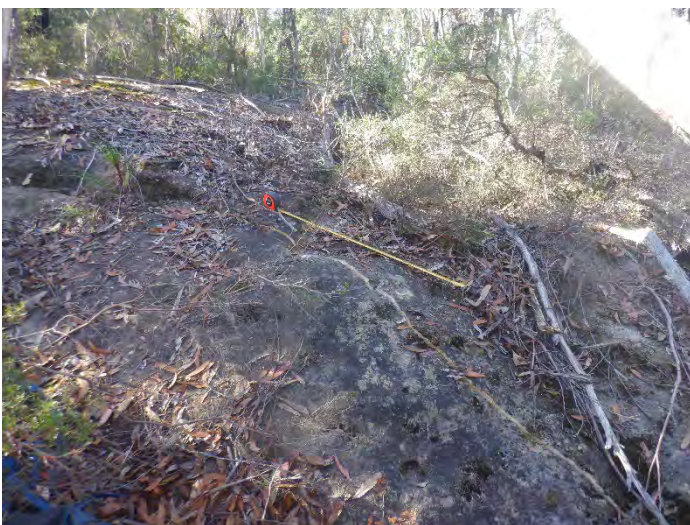
DA3C_LW21_008 is located approximately 120m northeast of WC20, a tributary of Wongawilli Creek (Figure 1). The impact consists of a vertical rock fracture at a rock step which then transitions upslope into discontinuous soil cracking (Photo 1 to Photo 3). The impact has a maximum continuous length of 7m, a maximum width of 0.022m and a maximum measurable depth of 0.69m.

DA3C_LW21_008 is a Level 1 trigger as per the Dendrobium Landscape TARP (Table 1), specifically:

Photo 1: DA3C_LW21_008, overview of the rock fracture. Taken on 19/06/2023.

- Continue Monitoring Program
- Submit an Impact Report to key stakeholders
- Summarise impacts and report in the End of Panel and the Annual Review
- Review monitoring frequency
- Notify relevant technical specialists and seek advice on any Corrective Management Actions (CMAs) required
- Provide safety signage and barricades as appropriate
- Implement approved repairs to ensure safety and serviceability on fire trails
- Implement agreed CMAs as approved

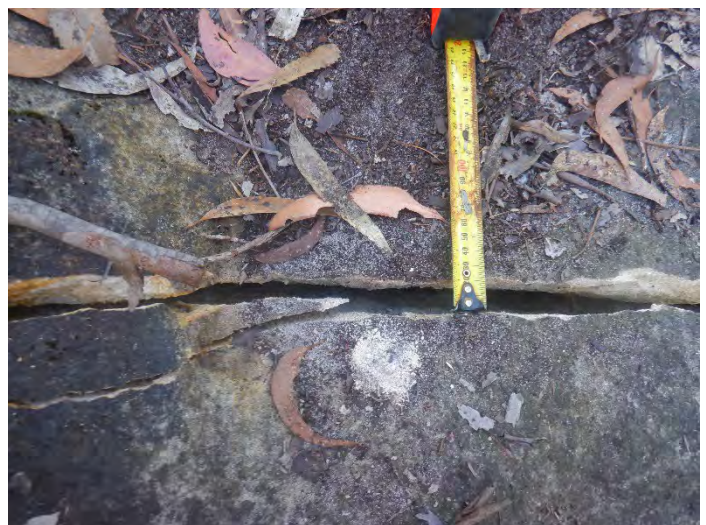
Photo 2: DA3C_LW21_008, maximum width of the rock fracture. Taken on 19/06/2023.

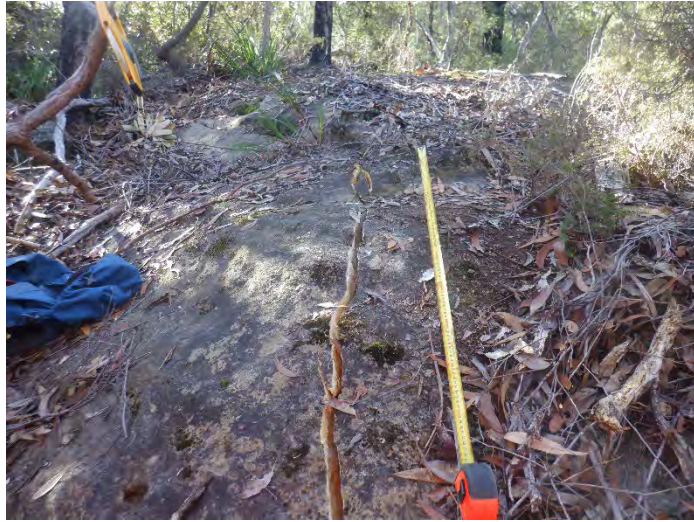
Photo 3: *DA3C_LW21_008*, section of the rock fracture.
Taken on 19/06/2023.

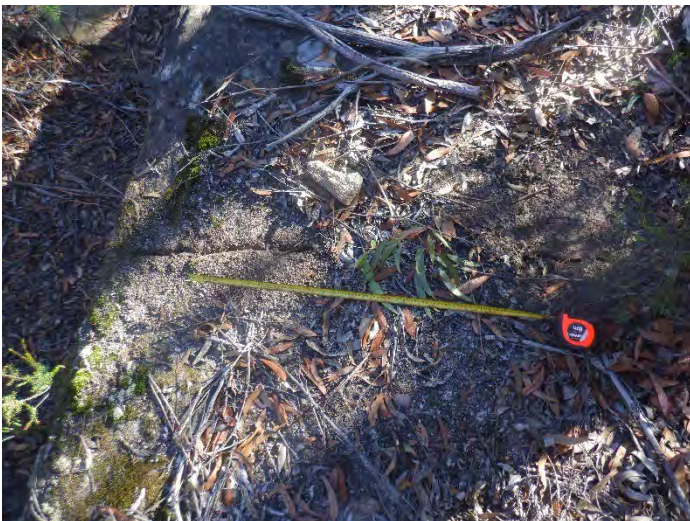
DA3C_LW21_009 is located approximately 245m west of Fire Road 6F (Figure 1). The impact consists of a rock fracture at a small rock step which disappears upslope into bushland (Photo 4 to Photo 6). The impact has a maximum continuous length of 1.65m, a maximum width of 0.012m and a maximum measurable depth of 0.73m.

DA3C_LW21_009 is a Level 1 trigger as per the Dendrobium Landscape TARP (Table 1), specifically:

Photo 4: *DA3C_LW21_009*, section of the rock fracture.
Taken on 19/06/2023.

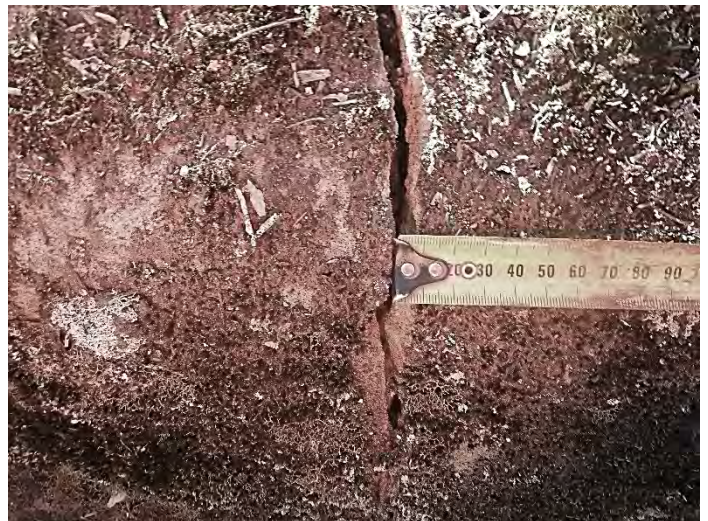
Photo 5: *DA3C_LW21_009*, maximum width of the rock fracture. Taken on 19/06/2023.

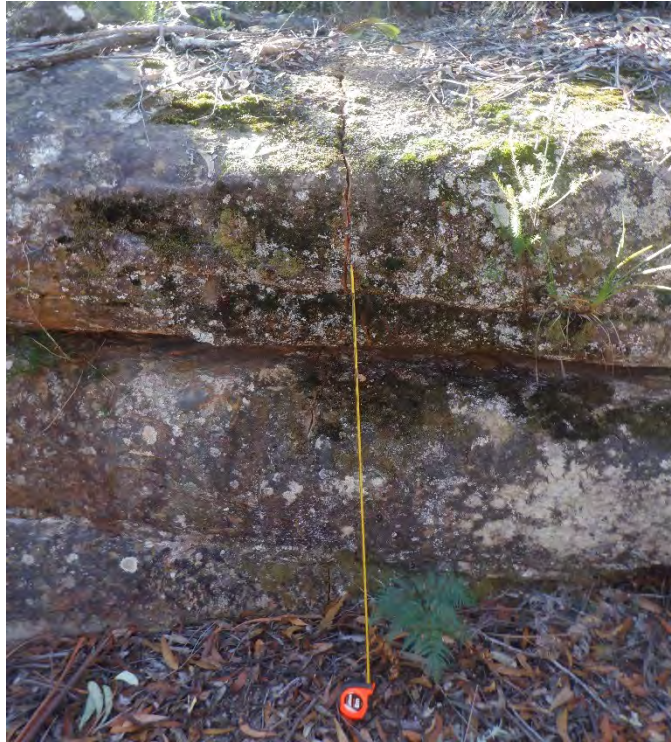
Photo 6: *DA3C_LW21_009*, overview of the rock fracture. Taken on 19/06/2023.

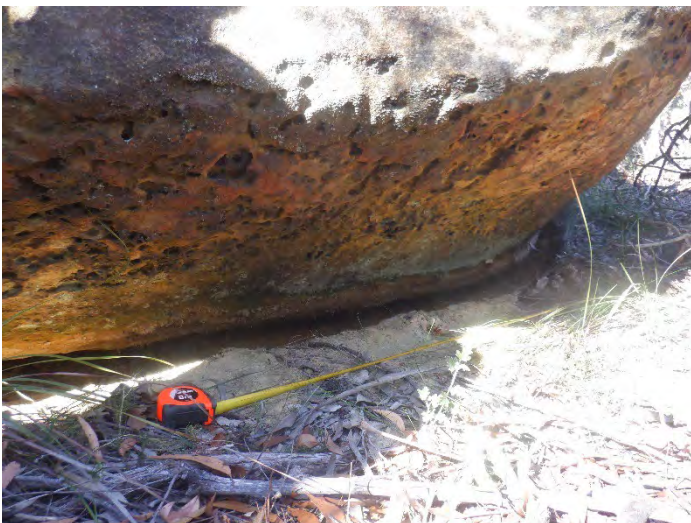
DA3C_LW21_010 is located approximately 125m west of Fire Road 6F (Figure 1). The impact consists of rock fracturing at a rock outcrop covered in shallow soil and leaf litter (Photo 8 and Photo 9). Rock movement/displacement is also evident between a large boulder and adjacent soil at the southern extent of the impact (Photo 7). The total impact area is approximately 60m². The rock fracture has a maximum continuous length of 7.6m, a maximum width of 0.20m and a maximum measurable depth of 1.4m. Flagging tape barricading is in place at the site as a safety precaution.

DA3C_LW21_010 is a Level 2 trigger as per the Dendrobium Landscape TARP (Table 1), specifically:

Photo 7: *DA3C_LW21_010*, Overview of the rock movement/displacement. Taken on 19/06/2023.

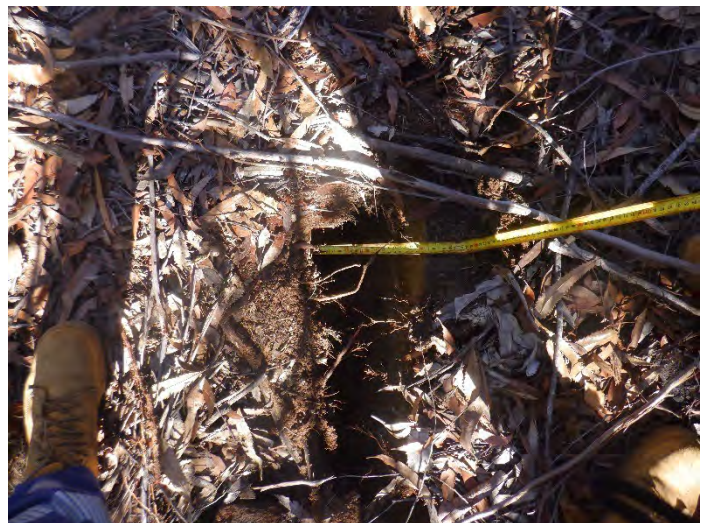
Photo 8: *DA3C_LW21_010*, maximum width of the rock fracture. Taken on 19/06/2023.

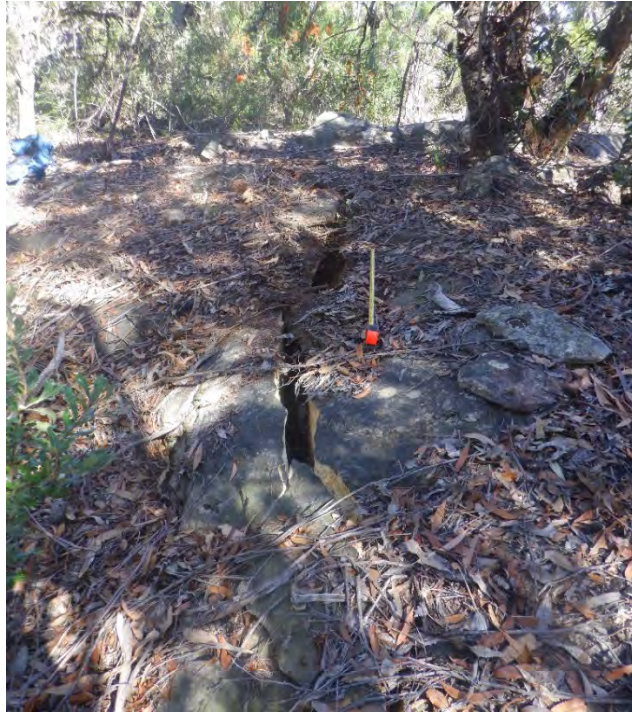
Photo 9: *DA3C_LW21_010*, overview of the rock fracture.
Taken on 19/06/2023.

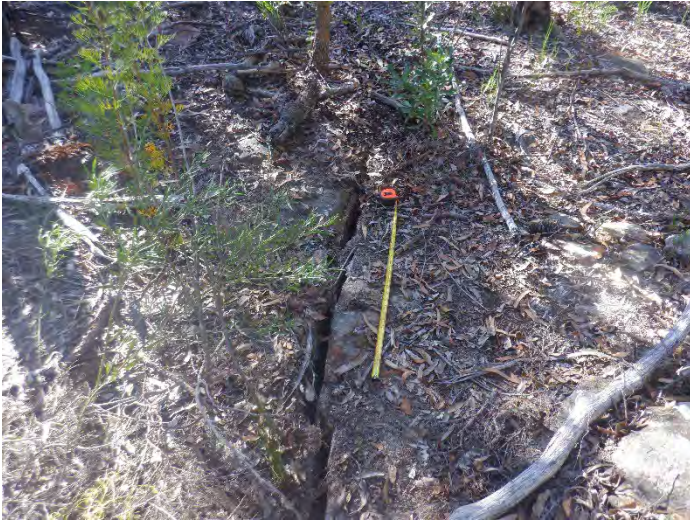
DA3C_LW21_011 is located approximately 95m west of Fire Road 6F (Figure 1). The impact consists of 25m of discontinuous rock fracturing and soil cracking to a rock outcrop and adjacent bushland (Photo 10 to Photo 13). The fracturing has a maximum continuous length of 8m, a maximum width of 0.06m and a maximum measurable depth of 0.44m. The rock fracturing has resulted in the displacement of rock from the edge of the rock outcrop (Photo 12 and Photo 13).

DA3C_LW21_011 is a Level 1 trigger as per the Dendrobium Landscape TARP (Table 1), specifically:

Photo 10: DA3C_LW21_011, section of rock fracturing. Taken on 19/06/2023.

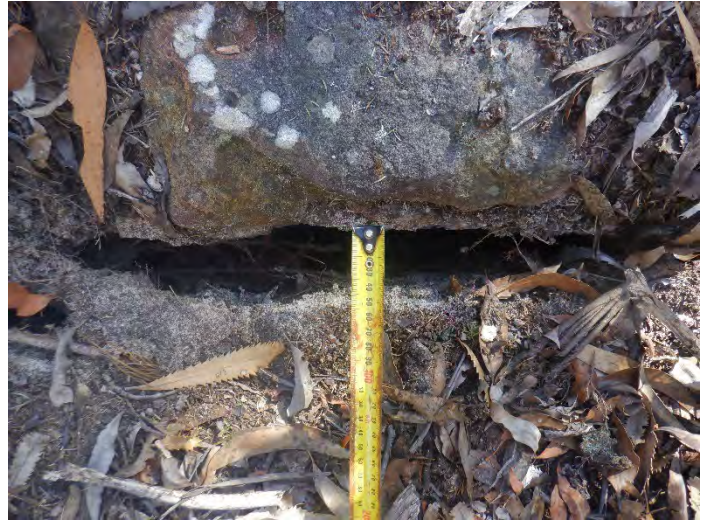
Photo 11: DA3C_LW21_011, maximum width of the fracture. Taken on 19/06/2023.

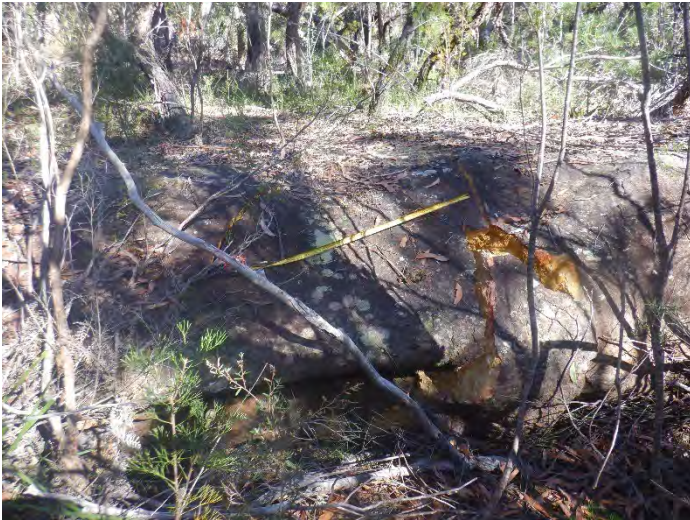
Photo 12: DA3C_LW21_011, section of rock fracturing and rock displacement. Taken on 19/06/2023.

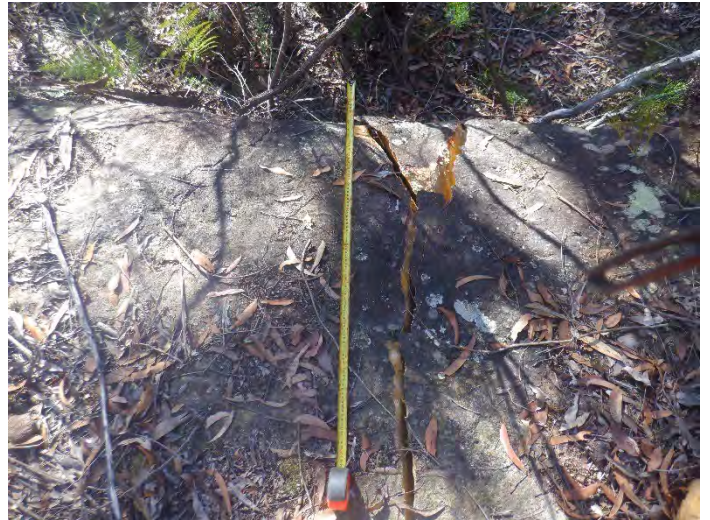
Photo 13: DA3C_LW21_011, section of rock fracturing and rock displacement. Taken on 19/06/2023.

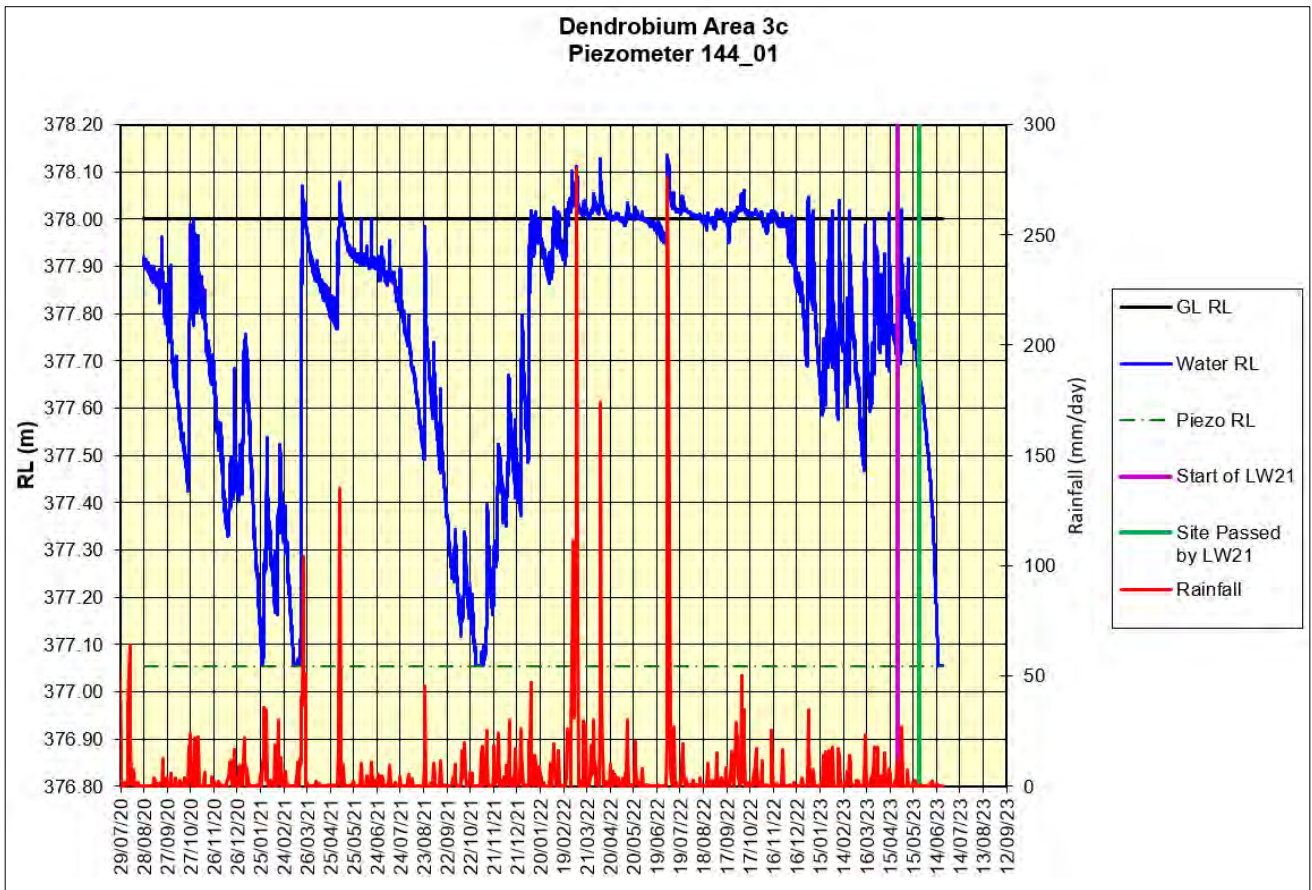
It should be noted that there is only one shallow borehole/piezometer and one soil moisture probe in Swamp 144, therefore only a Level 3 trigger can apply.

Graph 1: Near-surface groundwater levels at 144_01, logged hourly, date range: 28/08/2020 to 27/06/2023

- Submit an Impact Report to key stakeholders
- Analysis of Swamp 144 data by relevant technical experts and results provided in End of Panel Report
- Summarise impacts and report in the End of Panel and the Annual Review
- Review monitoring frequency
- Notify relevant technical specialists and seek advice on any Corrective Management Actions (CMAs) required
- Provide safety signage and barricades as appropriate
- Implement approved repairs to ensure safety and serviceability on fire trails
- Implement agreed CMAs as approved

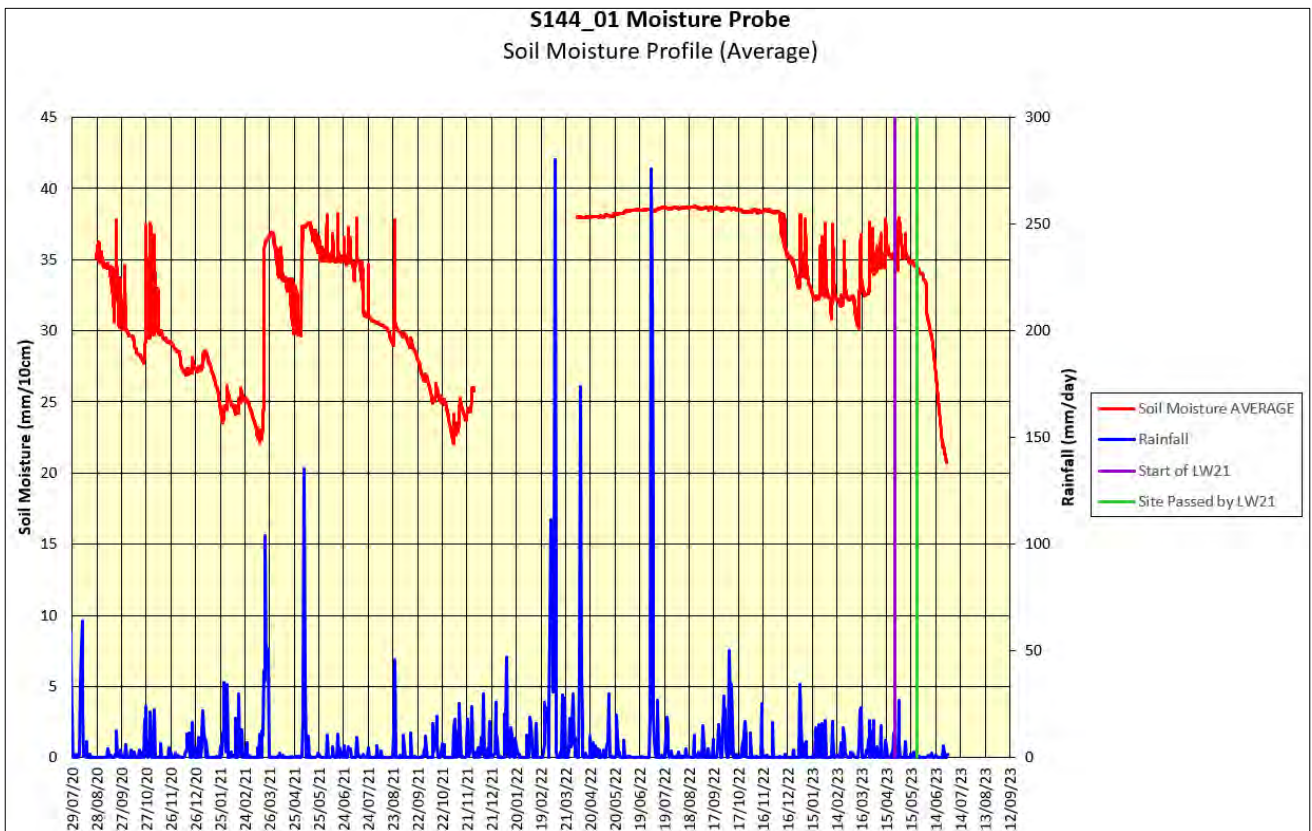
Graph 2: Average soil moisture levels at S144_01, logged hourly, date range: 28/08/2020 to 27/06/2023

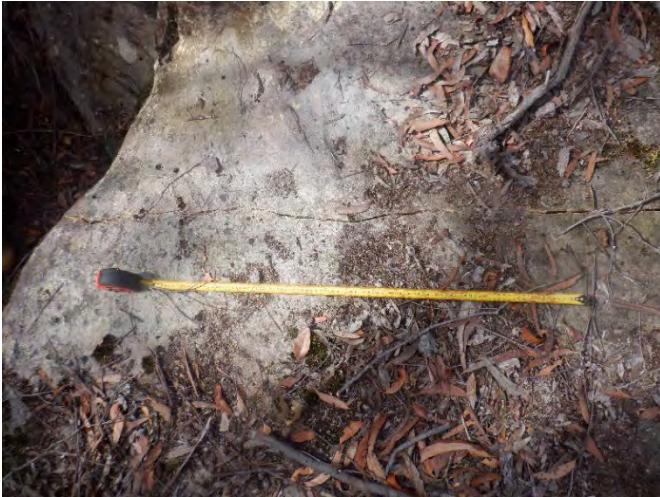
DA3C_LW21_012 is a Level 1 trigger as per the Dendrobium Landscape TARP (Table 2), specifically:

Photo 1: DA3C_LW21_012, section of the rock fracture. Taken on 27/06/2023.

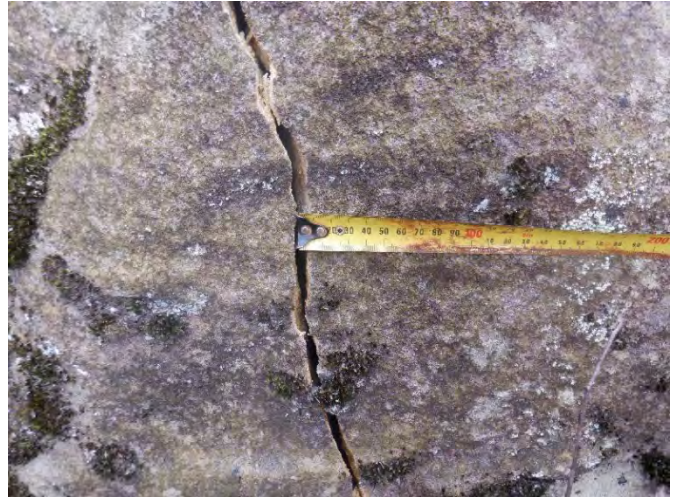
Photo 2: DA3C_LW21_012, maximum width of the rock fracture. Taken on 27/06/2023.

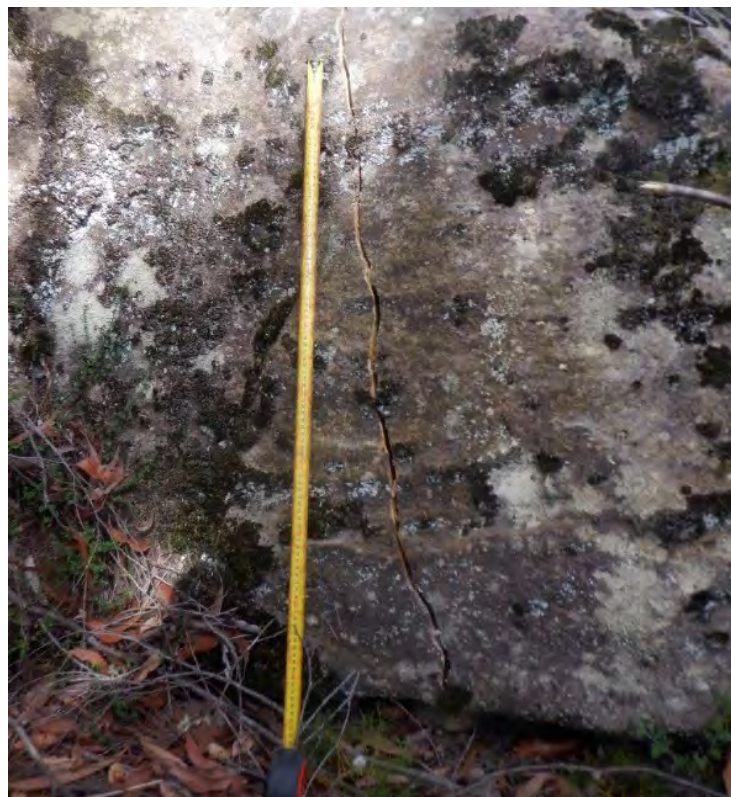
Photo 3: DA3C_LW21_012, overview of the rock fracture. Taken on 27/06/2023.

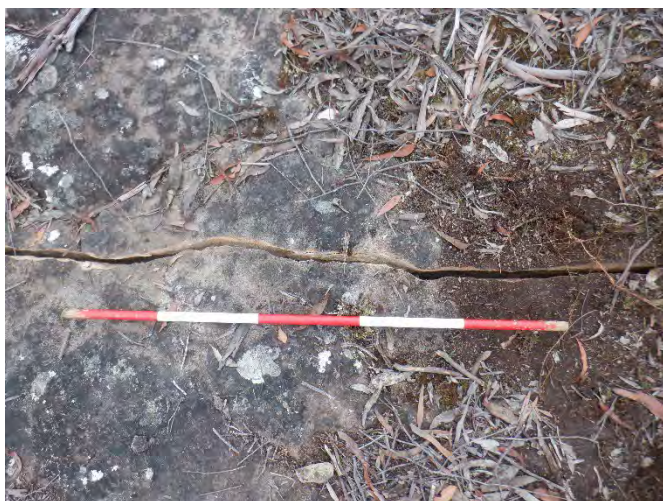
DA3C_LW21_013 is a Level 1 trigger as per the Dendrobium Landscape TARP (Table 1), specifically:

Photo 1: *DA3C_LW21_013*, section of the rock fracture.
Taken on 03/07/2023.

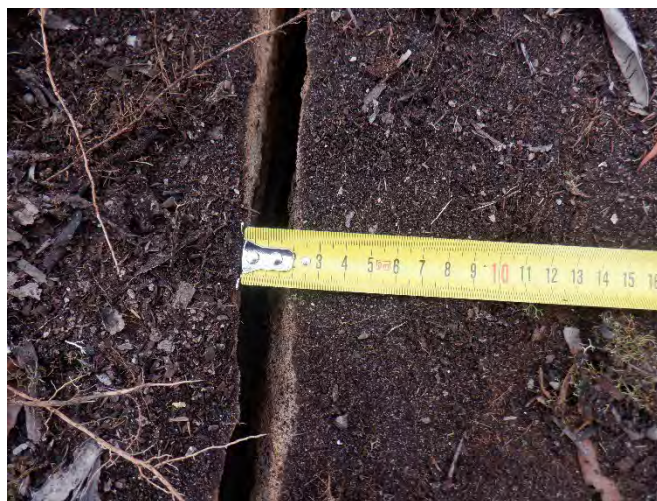
Photo 2: *DA3C_LW21_013*, maximum width of the rock fracture.
Taken on 03/07/2023.

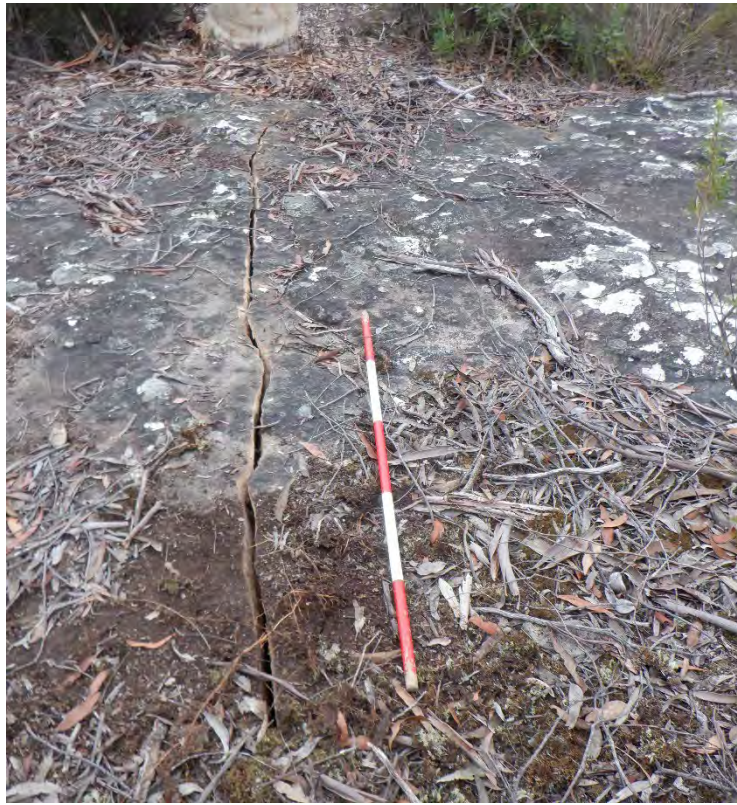
Photo 3: DA3C_LW21_013, overview of section of impact. Taken on 03/07/2023.

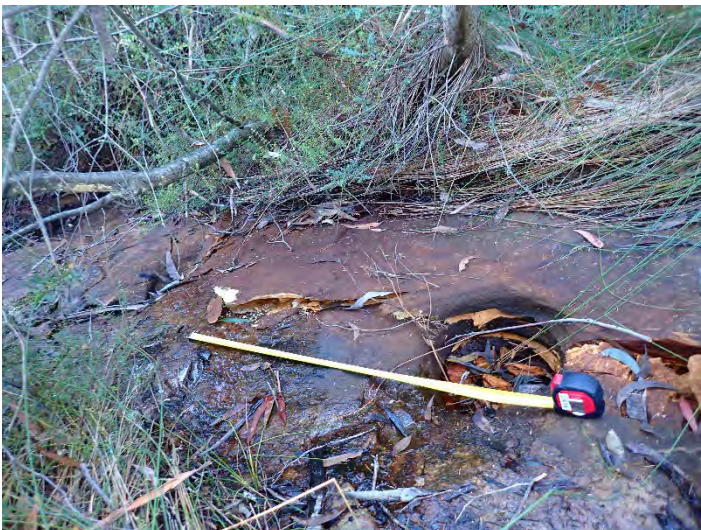
DA3C_LW21_014 is a Level 2 trigger as per the Dendrobium Watercourse TARP (Table 1), specifically:

- ...fracture that results in observable loss of surface water or erosion.

Photo 1: *DA3C_LW21_014*, section of the rock fracturing. Taken on 11/07/2023.

- Continue monitoring program
- Submit an Impact Report to key stakeholders – BCD, DPE, Resources Regulator and WaterNSW
- Report in the End of Panel Report
- Summarise actions and monitoring in AEMR
- Review monitoring frequency
- Notify technical specialists and seek advice on any CMA required
- Submit letter report to DPE, BCD, Resource Regulator and WaterNSW and seek advice on any CMA required
- Implement agreed CMAs as approved (subject to agency feedback)

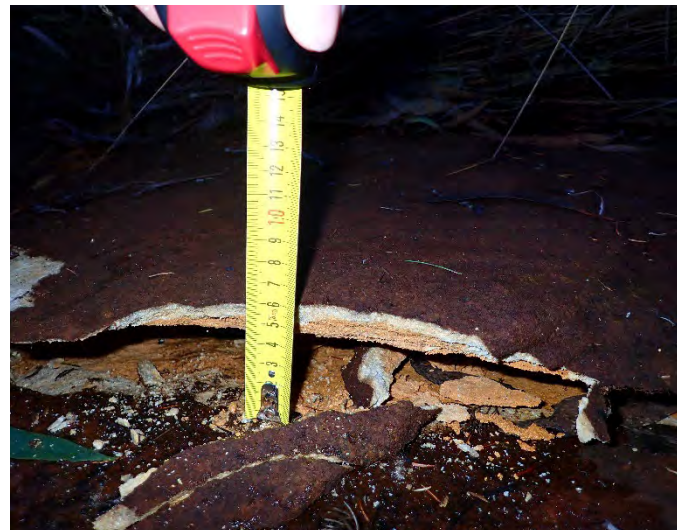
Photo 2: *DA3C_LW21_014*, width of the rock fracture. Taken on 11/07/2023.

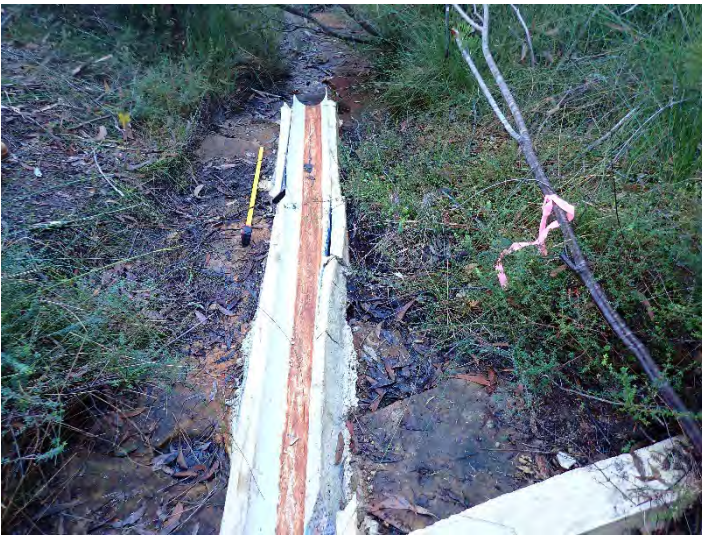
Photo 3: *DA3C_LW21_014*, damage to concrete footing of flow monitoring site WC20S2. Taken on 11/07/2023.

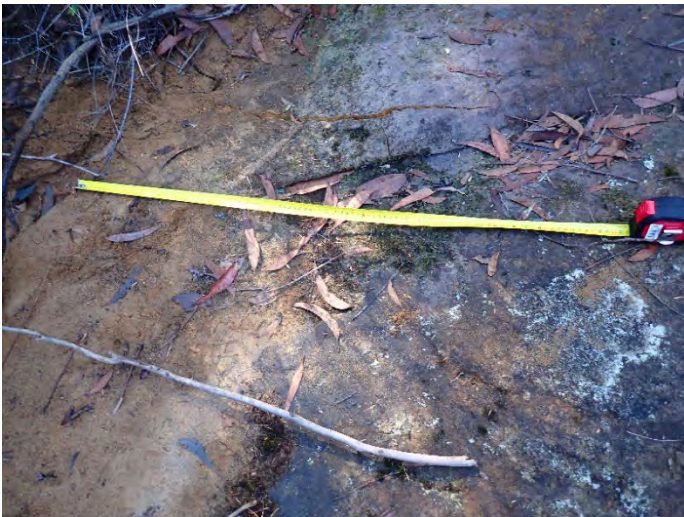
DA3C_LW21_015 is a Level 2 trigger as per the Dendrobium Watercourse TARP (Table 1), specifically:

- ...fracture that results in observable loss of surface water or erosion.

Photo 4: *DA3C_LW21_015*, section of rock fracturing. Taken on 11/07/2023.

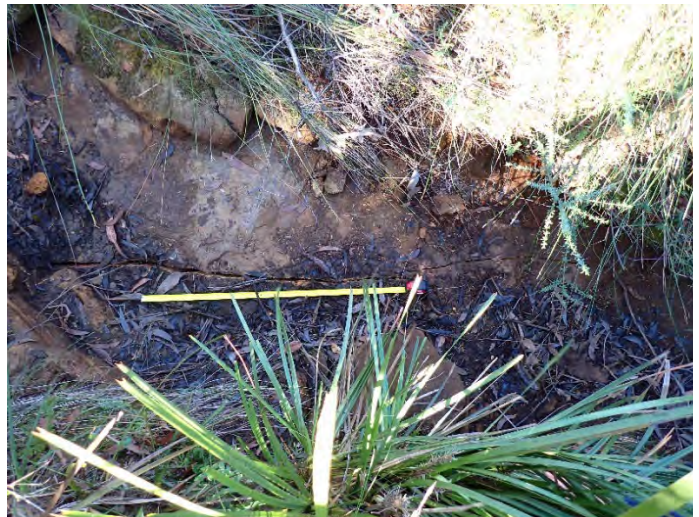
Photo 5: *DA3C_LW21_015*, other section of rock fracturing. Taken on 11/07/2023.

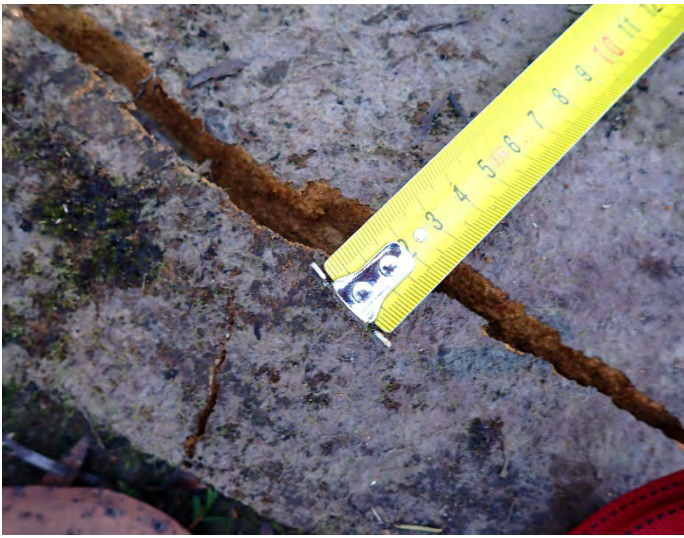
Photo 6: DA3C_LW21_015, width of the rock fracture. Taken on 11/07/2023.

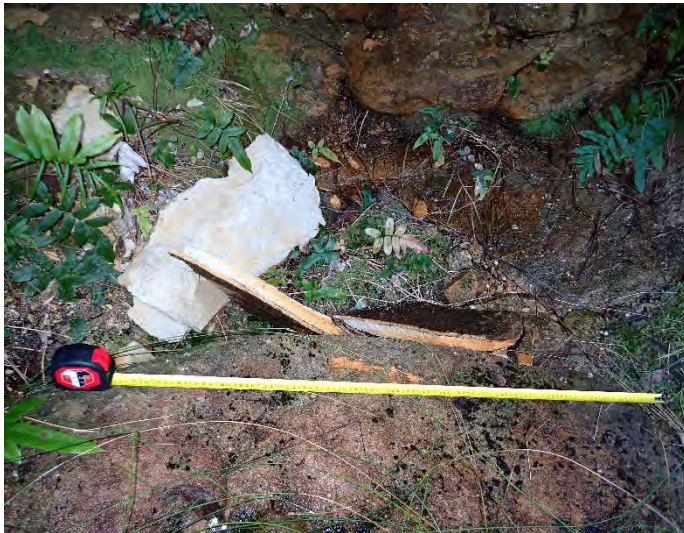
DA3C_LW21_016 is a Level 1 trigger as per the Dendrobium Landscape TARP (Table 2), specifically:

- Rockfall from a cliff (step) which is mostly left intact, resulting in insignificant ground disturbance.

Photo 7: DA3C_LW21_016, fragments of rockfall from step. Taken on 11/07/2023.
