Monitoring of watercourses, swamps and landscape features is undertaken to identify subsidence impacts. These features are monitored by the Illawarra Metallurgical Coal Environmental Field Team (IMCEFT) monthly prior to mining and weekly during mining. Monitoring is conducted in accordance with the approved Subsidence Management Plan (SMP) for Dendrobium Area 3C (DA3C). Extraction of Longwall 21 commenced on 25 April 2023 and as of 6 June 2023 there were four new subsidence impacts identified.

This Version 2 of the report includes a summary of consultation with stakeholders undertaken since the initial report.

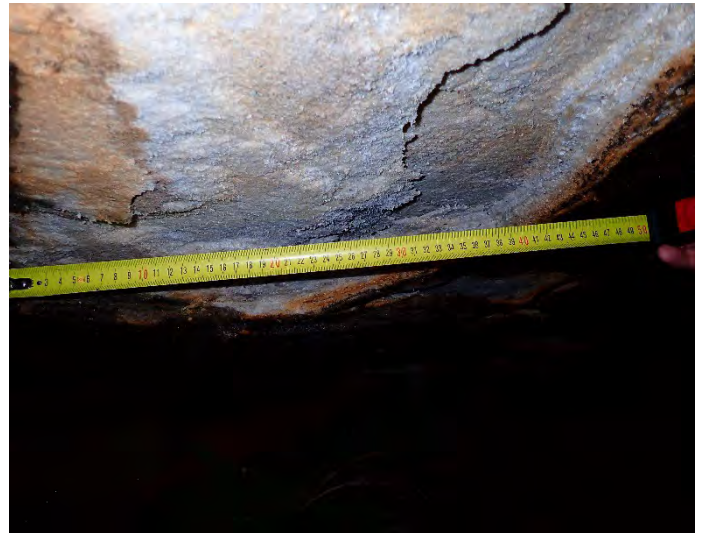
DA3C_LW21_016 is a Level 1 trigger as per the Dendrobium Landscape TARP (Table 2), specifically:

Photo 8: DA3C_LW21_016, underside of step from which rock fragments fell. Taken on 11/07/2023.

- Continue monitoring program
- Submit an Impact Report to key stakeholders – BCD, DPE, Resources Regulator and WaterNSW
- Report in the End of Panel Report
- Summarise actions and monitoring in AEMR
- Review monitoring frequency
- Notify technical specialists and seek advice on any CMA required
- Submit letter report to DPE, BCD, Resource Regulator and WaterNSW and seek advice on any CMA required
- Implement agreed CMAs as approved (subject to agency feedback)

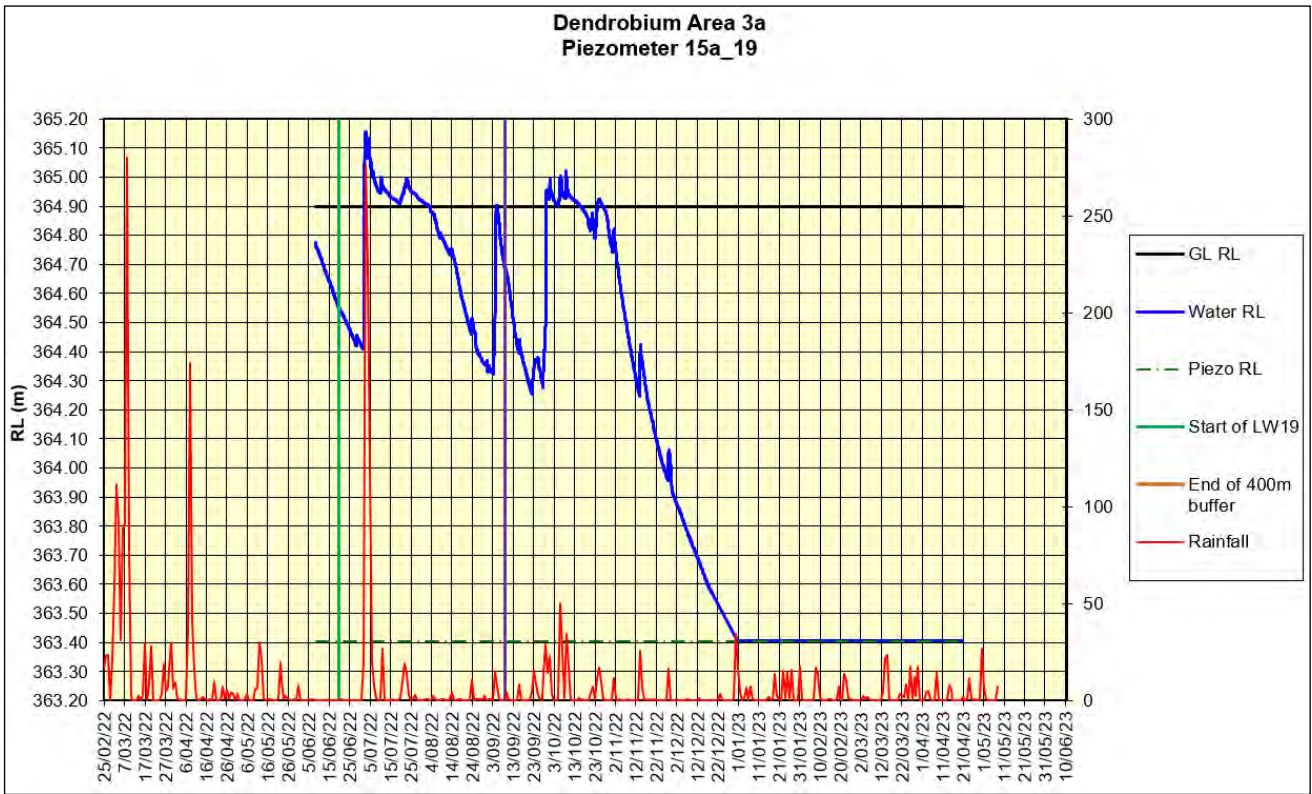
The above assessment should take into consideration the very short baseline monitoring period at site 15a_19 and that the monitoring commenced during a period of high rainfall.

Graph 1: Near-surface groundwater levels at 15a_19, logged hourly, date range: 08/06/2022 to 20/04/2023

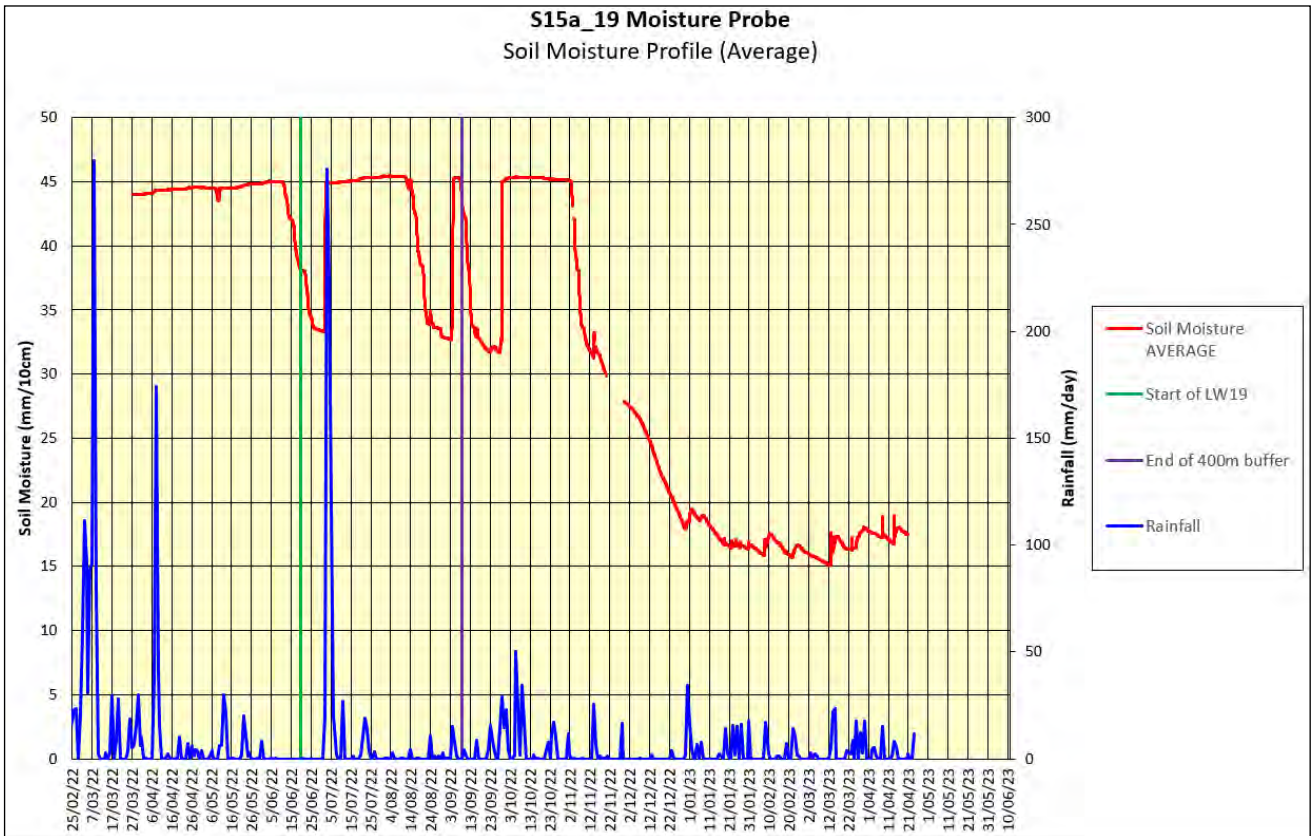
Graph 2: Average soil moisture levels at S15a_19, logged hourly, date range: 27/03/2022 to 20/04/2023

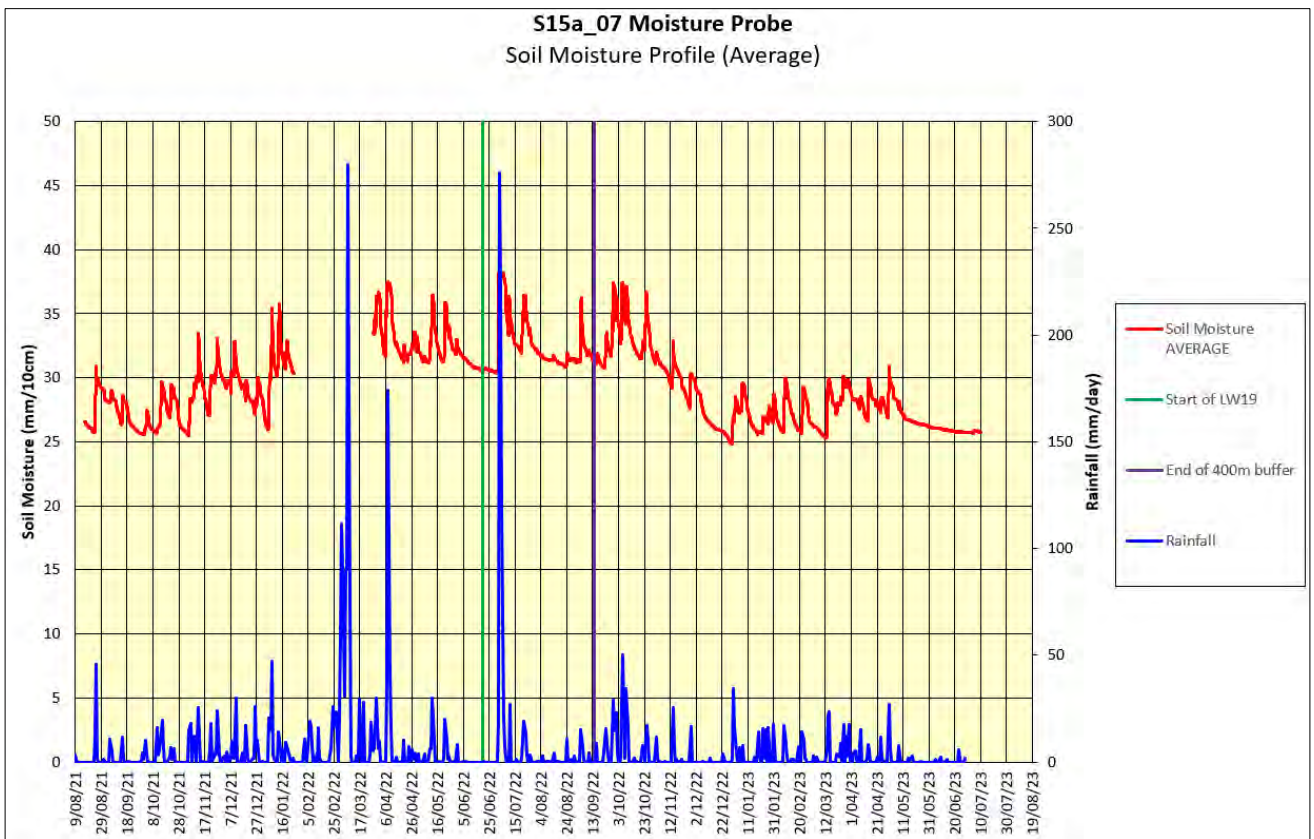
Graph 3: Average soil moisture levels at 15a_07, logged hourly, date range: 16/08/2021 to 10/07/2023.

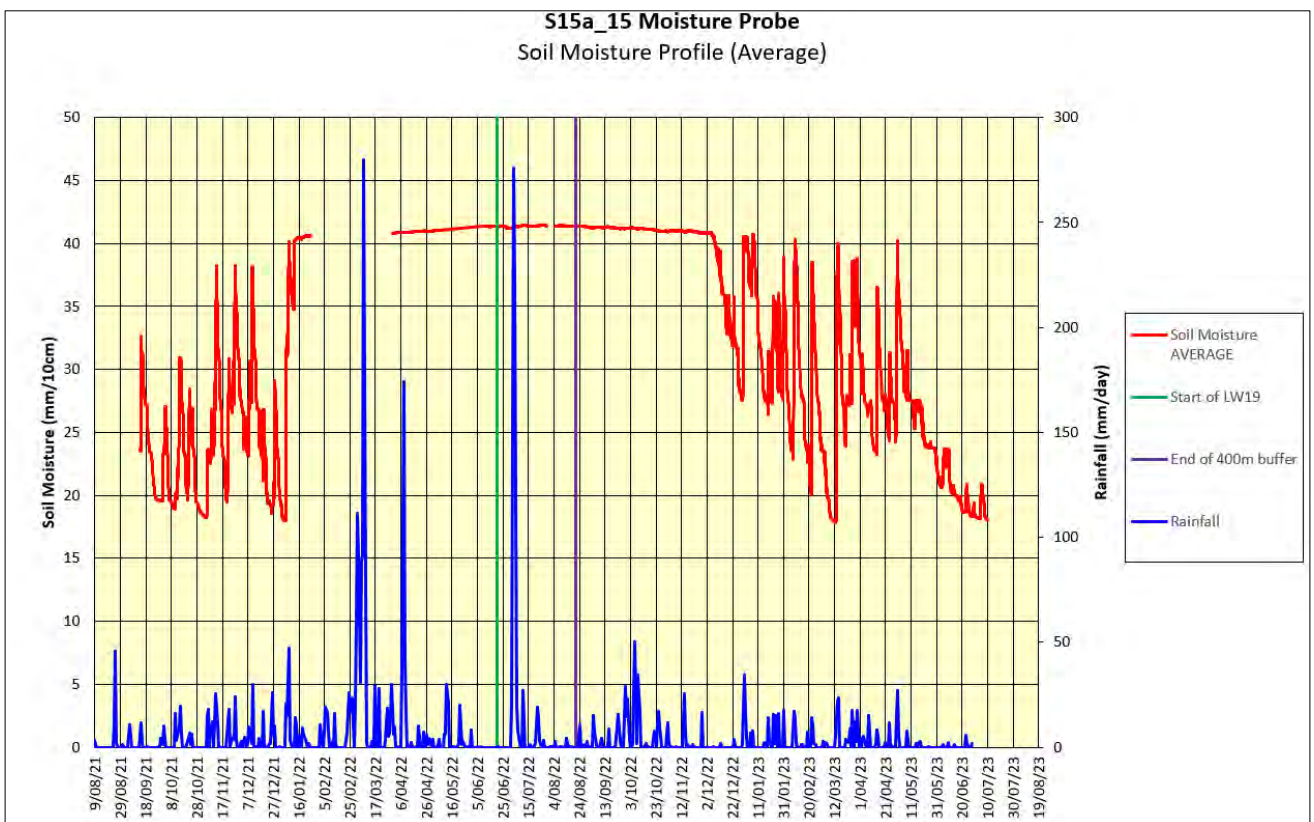
Graph 4: Average soil moisture levels at S15a_15, logged hourly, date range: 13/09/2021 to 10/07/2023.
