This Version 2 of the report includes a summary of consultation with stakeholders undertaken since the initial report.

DA3C_LW21_016 (Update) (E 291249, N 6194096)

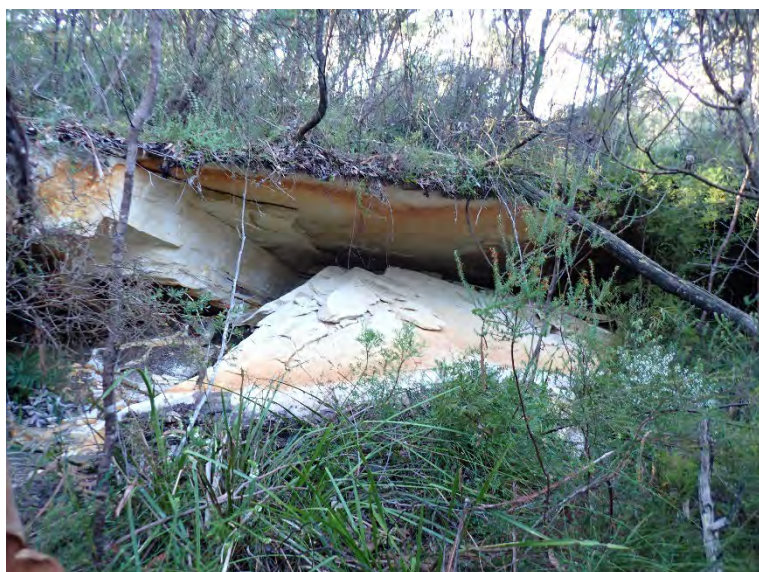
Impact *DA3C_LW21_016* was first observed on 11 July 2023 and consisted of a small rock fall ($\approx 0.14\text{m}^3$) at a step 10m north of tributary WC20 (Figure 1). On a follow up inspection on 26 July 2023, an increase in the rockfall area was identified. The following measurements were estimated at a distance due to safety concerns. The rockfall now has a length of $\approx 7\text{m}$, a width of $\approx 1\text{m}$, a height of $\approx 2.5\text{m}$, a total volume of $\approx 17.5\text{m}^3$ and a ground disturbance area of $\approx 20\text{m}^2$ (Photo 1 and Photo 2). Flagging tape is in place at the site as a safety precaution. Note- coordinates have been updated from previous report to better reflect the impact location.

DA3C_LW21_016 is now a Level 2 trigger as per the Dendrobium Landscape TARP (Table 1), specifically:

- Rockfall or overhang collapse at a cliff (step) site, where characteristics of the cliff have changed, and there has been significant ground disturbance.

Photo 1: *DA3C_LW21_016*, looking at the rockfall.
Taken on 26/07/2023.

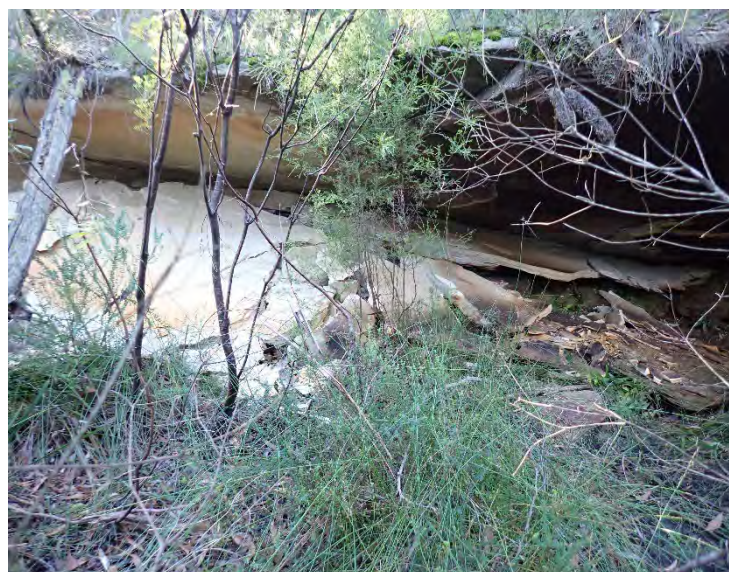
Photo 2: *DA3C_LW21_016*, looking at the rockfall.
Taken on 26/07/2023.

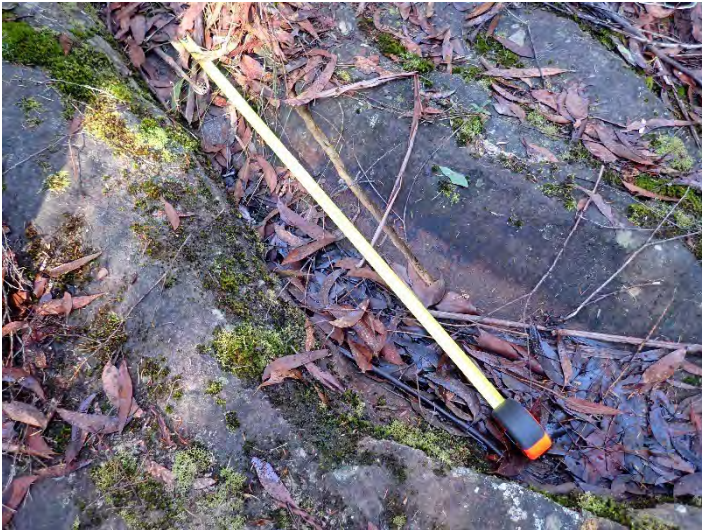
Impact *DA3C_LW21_017* consists of rock fracturing and uplift to 'WC20_Rockbar 15' on tributary WC20 (Figure 1). The fracturing has a maximum length of 2.6m, a maximum width of 0.012m and uplift of 0.02m (Photo 3 to Photo 6). No surface flow was present during the inspection however the impact is not situated in the direct flow path, therefore flow diversion is unlikely to occur.

DA3C_LW21_017 is a Level 1 trigger as per the Dendrobium Watercourse TARP (Table 2), specifically:

Photo 3: *DA3C_LW21_017*, section of rock fracturing.
Taken on 26/07/2023.

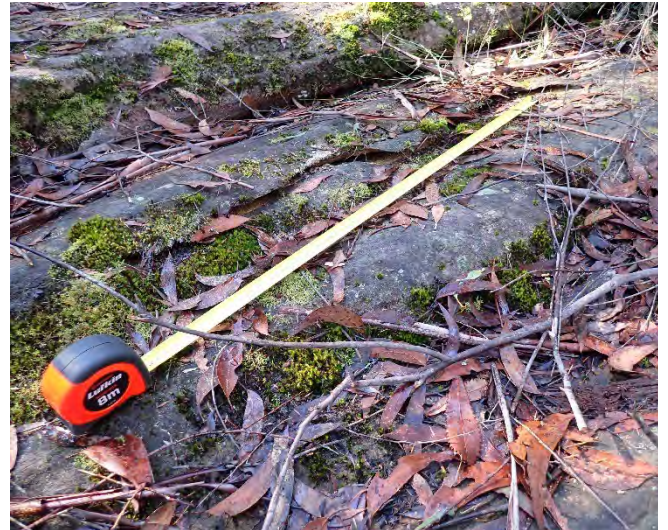
Photo 4: *DA3C_LW21_017*, section of rock fracturing.
Taken on 26/07/2023.

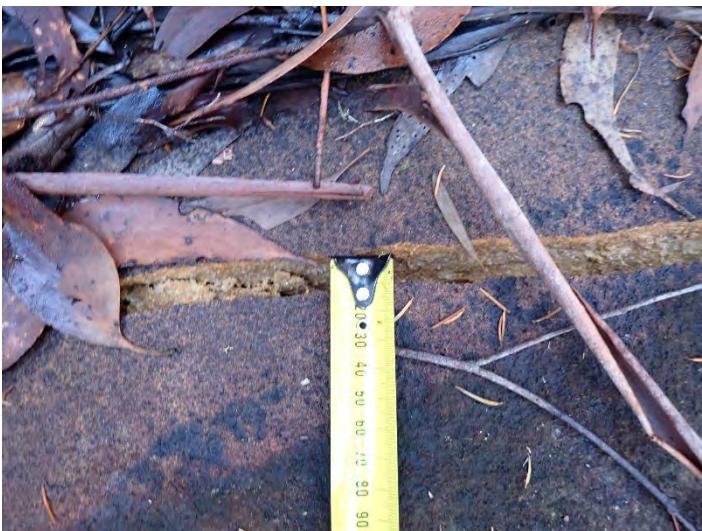
Photo 5: *DA3C_LW21_017*, width of the rock fracture.
Taken on 26/07/2023.

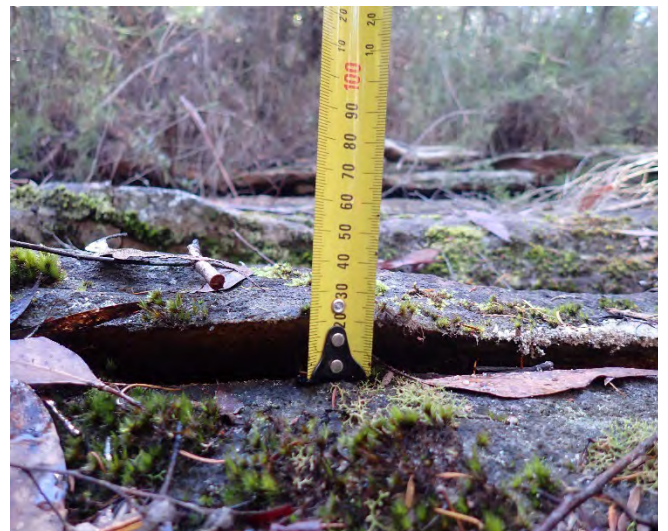
Photo 6: *DA3C_LW21_017*, section of uplift.
Taken on 26/07/2023.

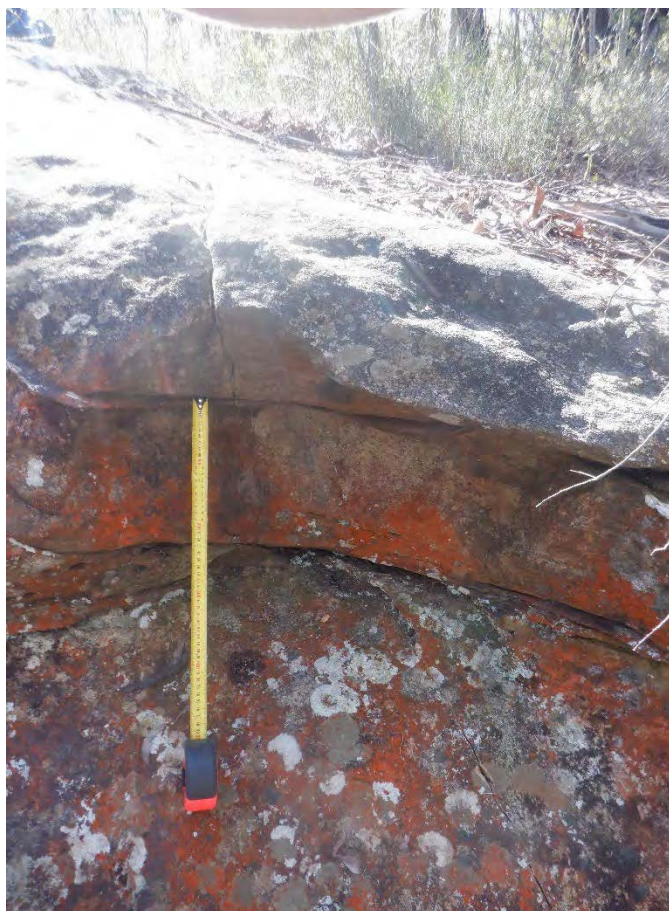
DA3C_LW21_018 is located approximately 105m north of tributary WC20 (Figure 1). The impact consists of two rock fractures to a rock outcrop/ledge. The fracturing has a maximum continuous length of 2.87m and a maximum width of 0.003m (Photo 7 to Photo 9). Flagging tape is in place at the site as a safety precaution.

DA3C_LW21_018 is a Level 1 trigger as per the Dendrobium Landscape TARP (Table 1), specifically:

Photo 7: DA3C_LW21_018, overview of rock fracturing.
Taken on 26/07/2023.

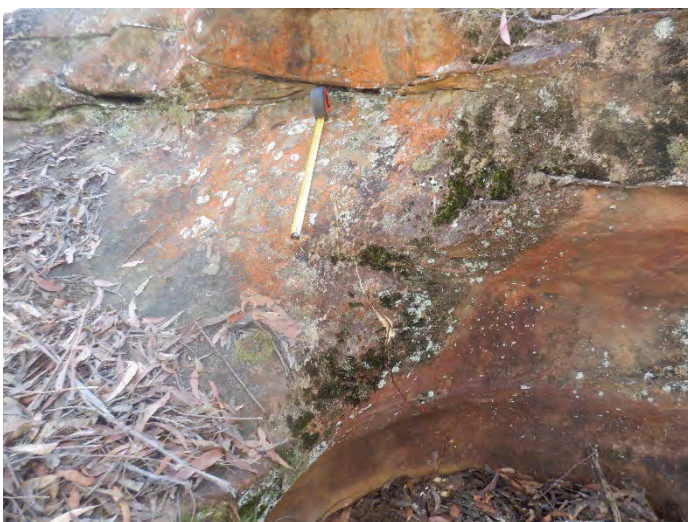
Photo 8: DA3C_LW21_018, section of rock fracturing.
Taken on 26/07/2023.

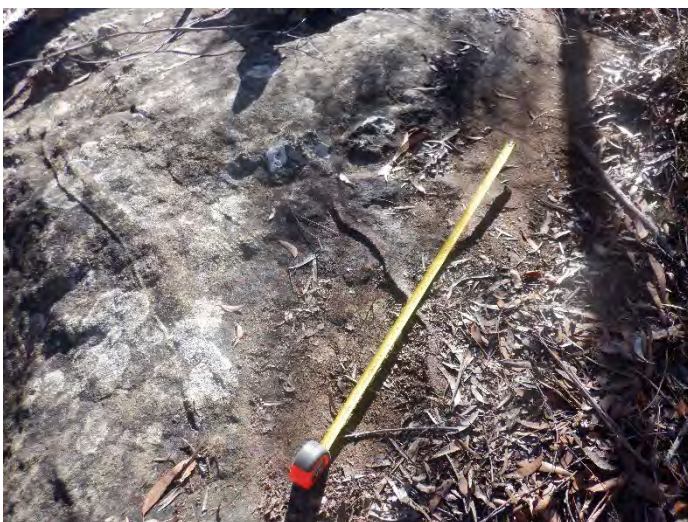
Photo 9: DA3C_LW21_018, section of rock fracturing.
Taken on 26/07/2023.

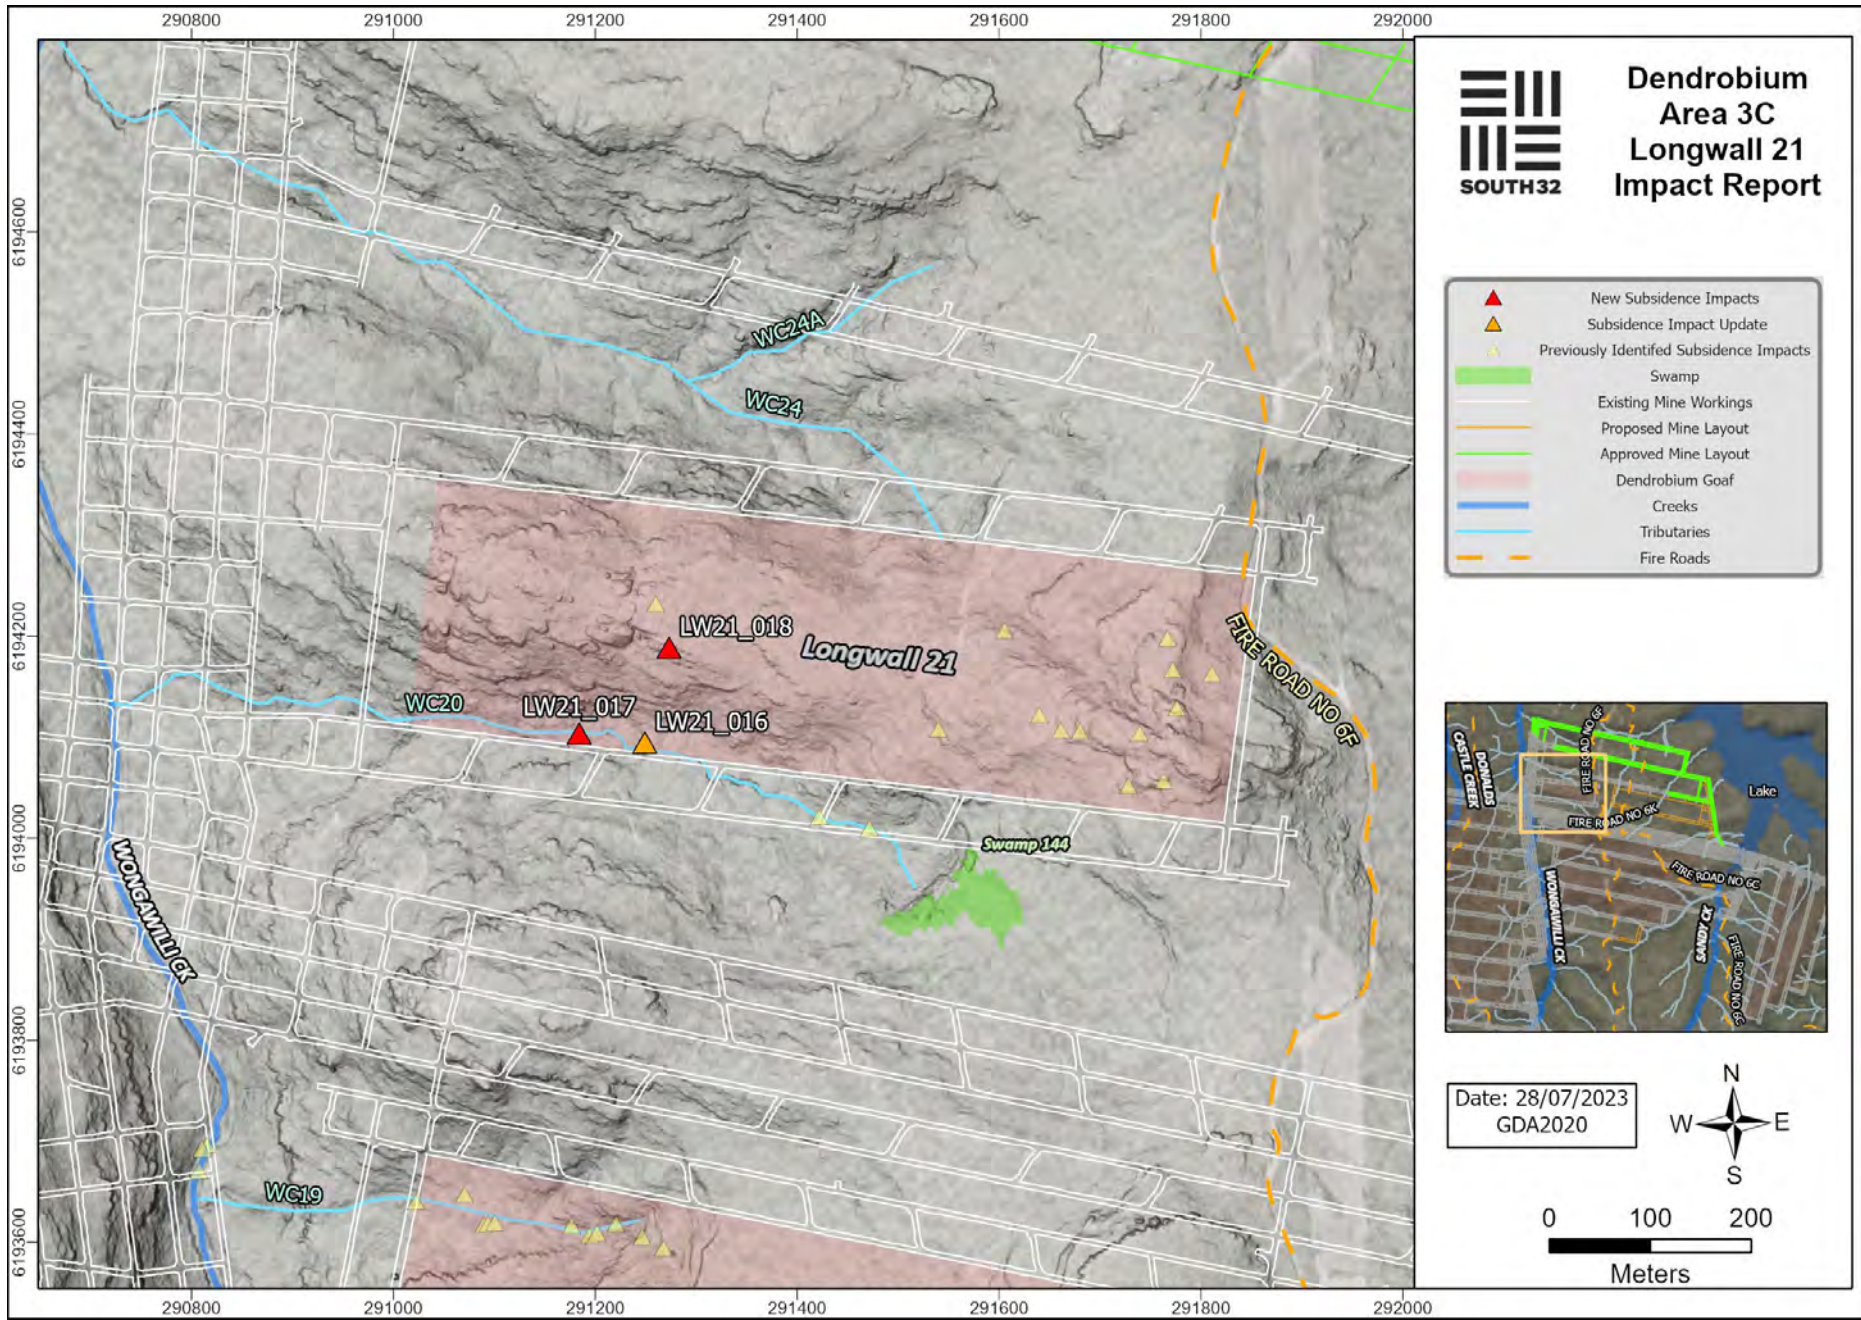
Figure 1: Latest subsidence impacts over Longwall 21 mining area in DA3C. Inset shows frame in relation to Dendrobium mining operations.
