From: [Zanotto, Linda](#)
To: [Camilla Edmunds](#); [Maria Dubikova](#); [Girja Sharma](#); [Glen Capararo](#); [Ravi Sundaram](#)
Cc: [Brassington, Gary](#); gabrielle.allan@dpie.nsw.gov.au
Subject: Dendrobium Mine - Review of distance to swamp impacts
Date: Friday, 8 September 2023 12:17:00 PM
Attachments: [Ltr WaterNSW - DA3 Distance to Swamp Impacts_08092023.pdf](#)
[Att 1 - Dendrobium Area 3A Update Report 230314_V2.pdf](#)
[Att 2 - WaterNSW letter - Dendrobium Impact Report 231314.pdf](#)
[Att 3 - 20230706c_ImpactReport-Hydrology-Swamp35b01_and 15a_19.pdf](#)
[Att 4 - R053c_Dendrobium-Distance to Swamp Impacts to June2023.pdf](#)

Re: Dendrobium Area 3C – Impact report – 31st July 2023

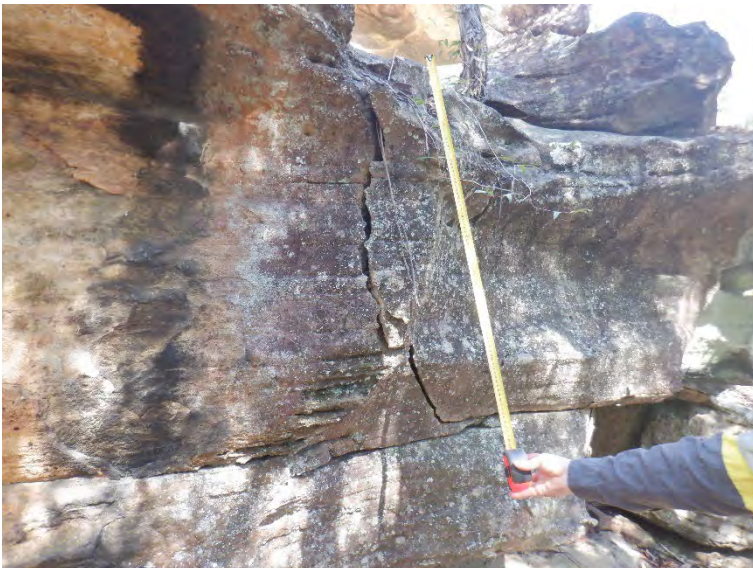
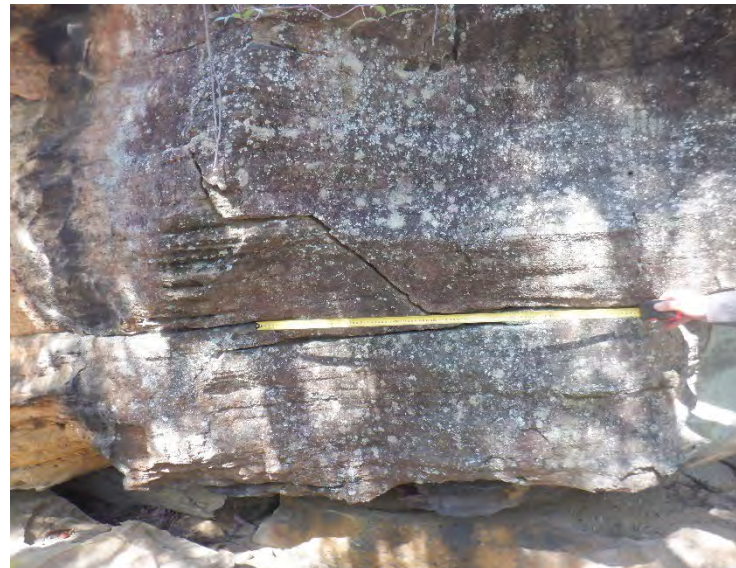
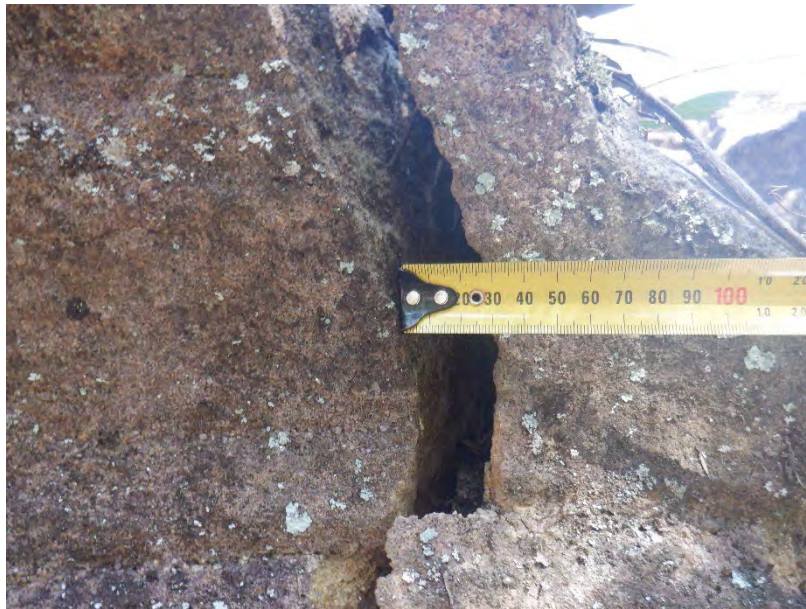
DA3C_LW21_019 (E 291634, N 6194239)

DA3C_LW21_019 is located approximately 210m west of Fire Road 6F (Figure 1). The impact consists of a single rock fracture to a rock step. The fracture has a continuous length of 2m, a maximum width of 0.03m and a maximum measurable horizontal depth of 0.3m (Photo 1 to Photo 3). Flagging tape is in place at the site as a safety precaution.

DA3C_LW21_019 is a Level 1 trigger as per the Dendrobium Landscape TARP (Table 1), specifically:

- Crack or fracture up to 100mm width;
- Crack or fracture up to 10m length.

Photo 1: DA3C_LW21_019, looking at the rock fracture.
Taken on 1/08/2023.

Photo 2: DA3C_LW21_019, looking at the rock fracture.
Taken on 1/08/2023.

Photo 3: *DA3C_LW21_019*, looking at the width of the rock fracture.
Taken on 1/08/2023.

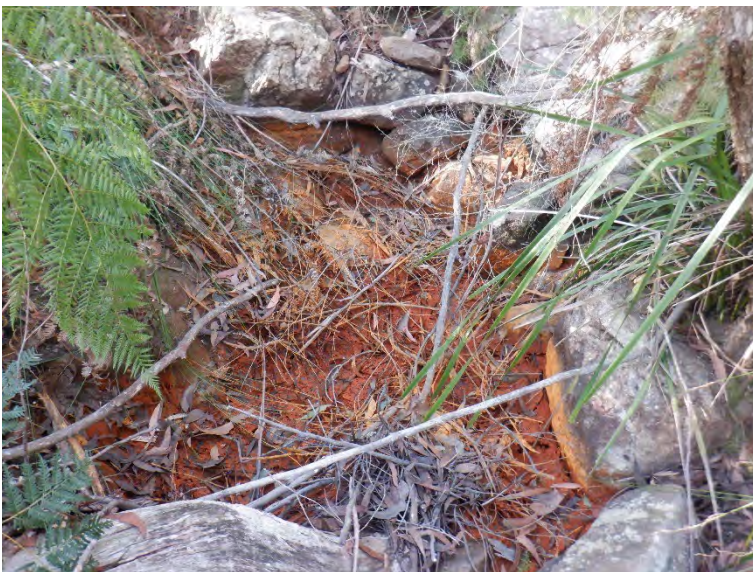
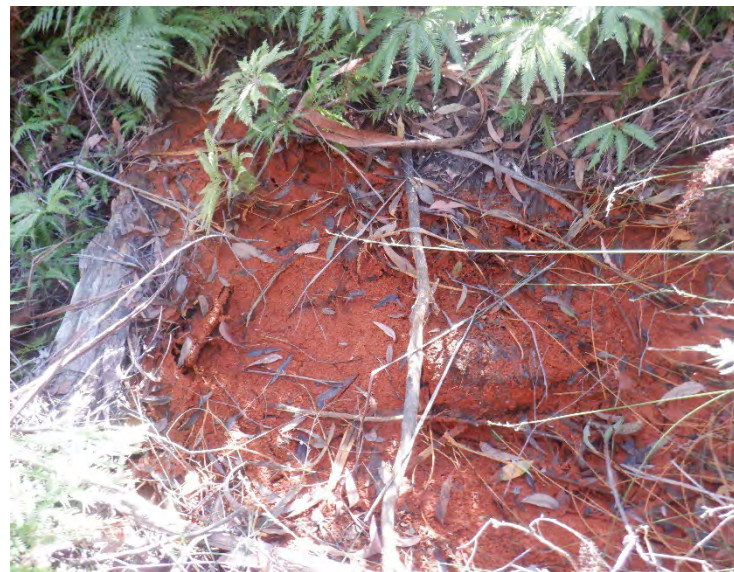
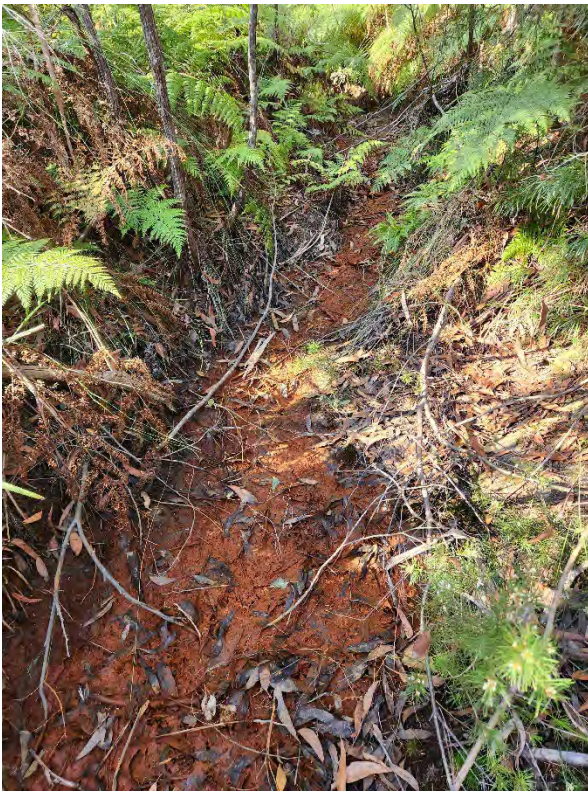
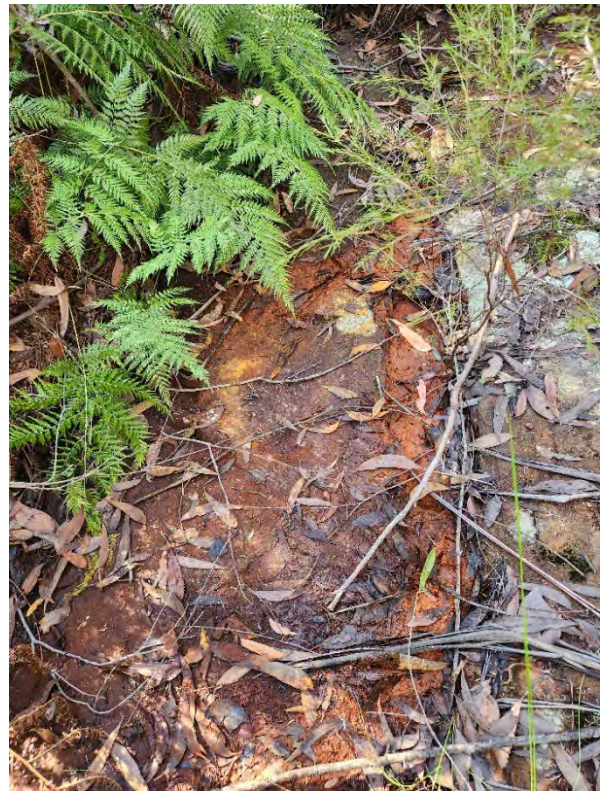
DA3C_LW21_020 (E 291318, N 6194429)

WC24 is a tributary of Wongawilli Creek that flows westward from DA3C mining operations (Figure 1). The upper reaches of the WC24 sub catchment were mined beneath by Longwall 21. Localised iron staining was observed along a 45m stretch of dry streambed on WC24 during the latest inspection (Photo 4 to Photo 7). The iron staining originates at *WC24_Pool 35* and extends downstream to *WC24_Rockbar 15*. During the baseline mapping of WC24, no surface water was observed in this part of the tributary, like latest observations. However, the recently recorded iron staining was not present in the baseline mapping. No other surface impacts have been observed in WC24.

DA3C_LW21_020 is a Level 1 trigger as per the Dendrobium Watercourse TARP (Table 2), specifically:

- Observable increase in iron staining within the mining area.

Photo 4: *DA3C_LW21_020*, section of iron staining in *WC24_Pool 35*. Taken on 1/08/2023.

Photo 5: *DA3C_LW21_020*, section of iron staining in *WC24_Channel 18*. Taken on 1/08/2023.

Photo 6: *DA3C_LW21_020*, section of iron staining in *WC24_Channel 18*. Taken on 1/08/2023.

Photo 7: *DA3C_LW21_020*, section of iron staining in *WC24_Rockbar 15*. Taken on 1/08/2023.

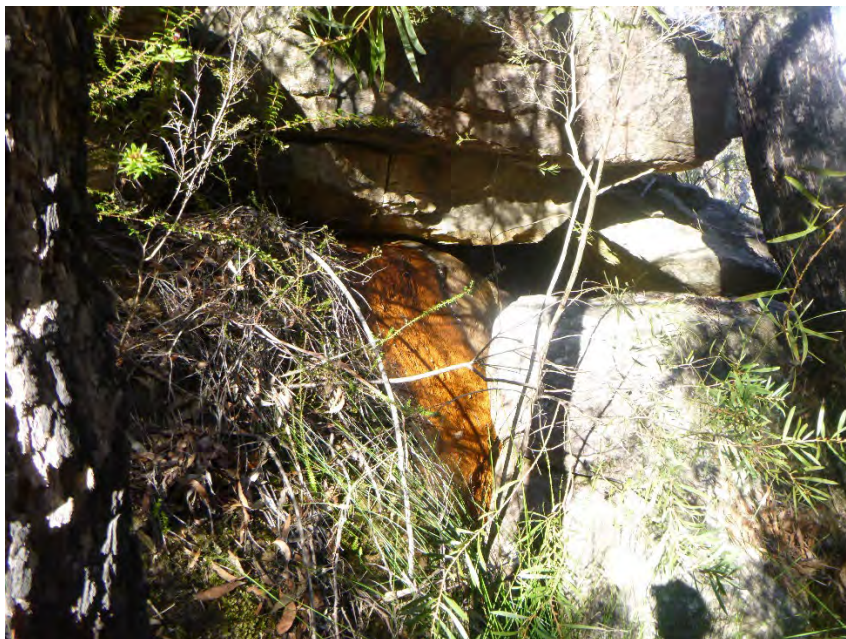
DA3C_LW21_021 (E 291547, N 6193965)

DA3C_LW21_021 consists of localised iron staining on the downstream basal step of Swamp 144 and the headwaters of tributary *WC20* (Figure 1). The iron staining originates from beneath a large boulder mid-way down the basal step (Photo 8). The iron staining is approximately 2m in length, 1m in width and disappears downslope into bushland. No other surface impacts were observed on or above the basal step.

DA3C_LW21_021 is a Level 1 trigger as per the Dendrobium Watercourse TARP (Table 2), specifically:

- Observable increase in iron staining within the mining area.

Photo 8: *DA3C_LW21_021*, overview of the iron staining. Taken on 1/08/2023.

- Continue monitoring program
- Submit an Impact Report to key stakeholders
- Report in the End of Panel Report
- Summarise actions and monitoring in AEMR

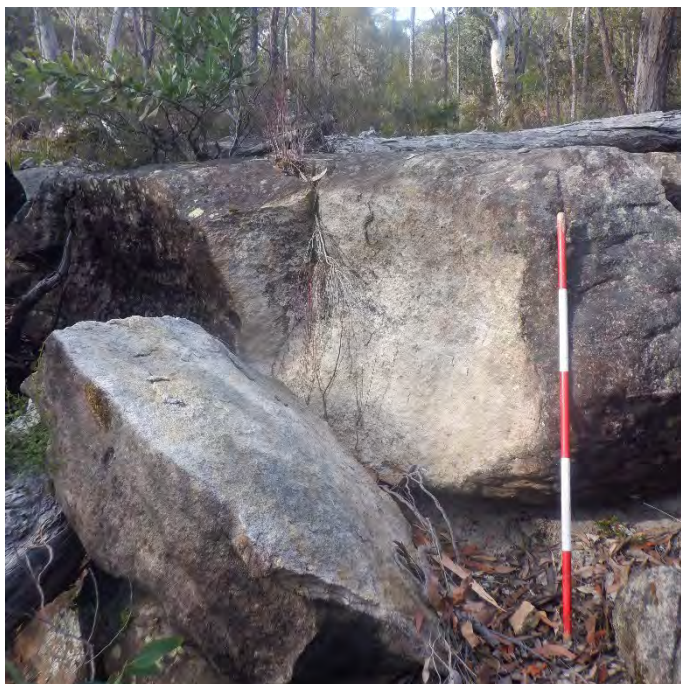
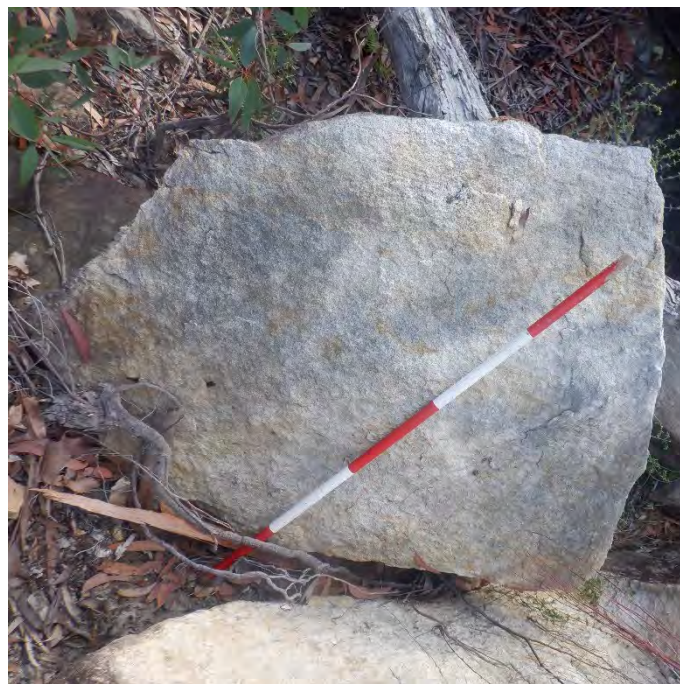
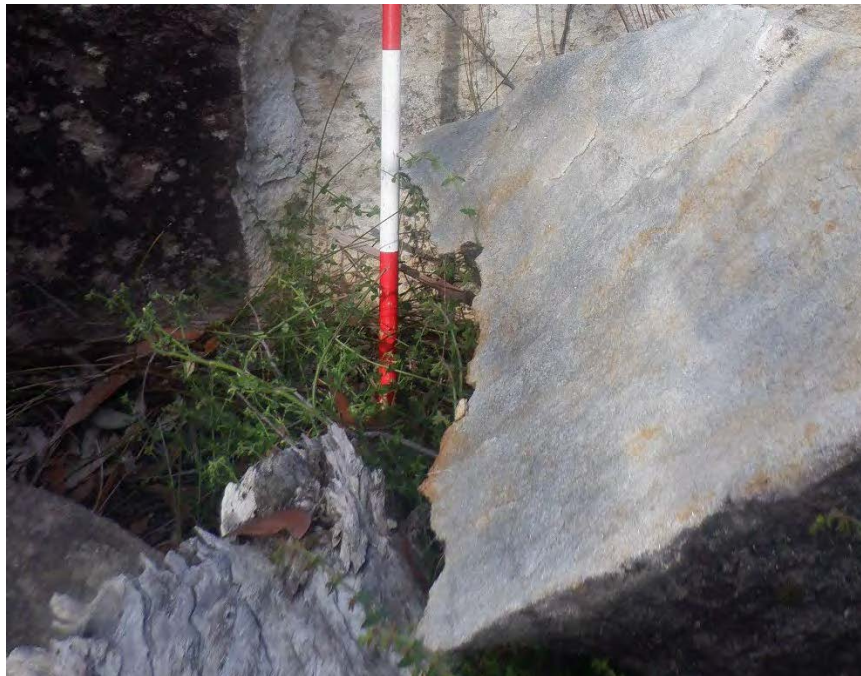
DA3C_LW21_022 (E 291477, N 6193846)

Impact DA3C_LW21_022 consists of a rockfall from a rock outcrop/step approximately 420m west of Fire Road 6F (Figure 1). Weathered sections of rock face are observed along with fresh rock face. The impact is likely from a natural fracture which has opened further and fallen away due to mining. Approximate volume of the rock is less than 0.5m³ (Photo 1 to Photo 3).

DA3C_LW21_022 is a Level 1 trigger as per the Dendrobium Landscape TARP (Table 1), specifically:

- Rockfall from a cliff (step) which is mostly left intact, resulting in insignificant ground disturbance

Photo 1: Overview of boulder fallen away from step. Taken 7/08/2023.

Photo 2: Rockfall showing unweathered rock, looking down from step above. Taken 7/08/2023.

Photo 3: Close-up of boulder showing fresh edge of fracture. Taken 7/08/2023

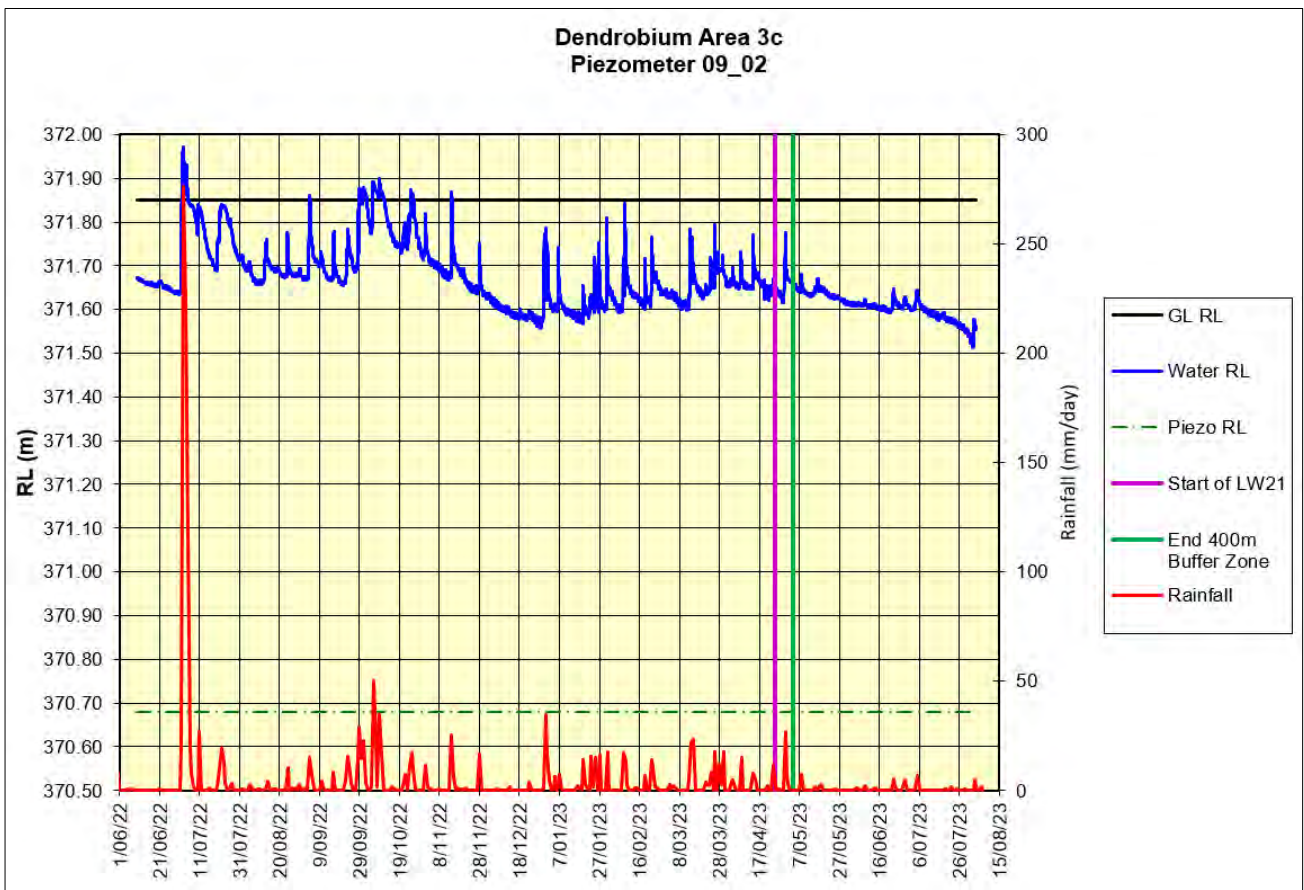
A near-surface groundwater trigger was recorded in Swamp 9 (Piezometer *09_02*) during recent analysis of groundwater data from the swamp. Site *09_02* is located 350 m east of the starting (eastern) end of Longwall 21 (Figure 1), i.e. within the longwall's 400 m buffer zone since the start of mining. The site exited the buffer on 4 May 2023. On 27 July 2023 the water level in the borehole receded below the lowest level recorded before mining (graph 1). There are two piezometers installed in Swamp 9 (one triggered and one not triggered).

These results contribute to a Level 2 trigger according to the SIMMCP (Table 1), specifically:

Level 2: Groundwater level lower than baseline level at 50% of monitoring sites (within 400m of mining) within a swamp (in comparison to reference swamps).

Graph 1: Shallow groundwater levels at 09_02, logged hourly, date range: 08/06/2022 to 03/08/2023

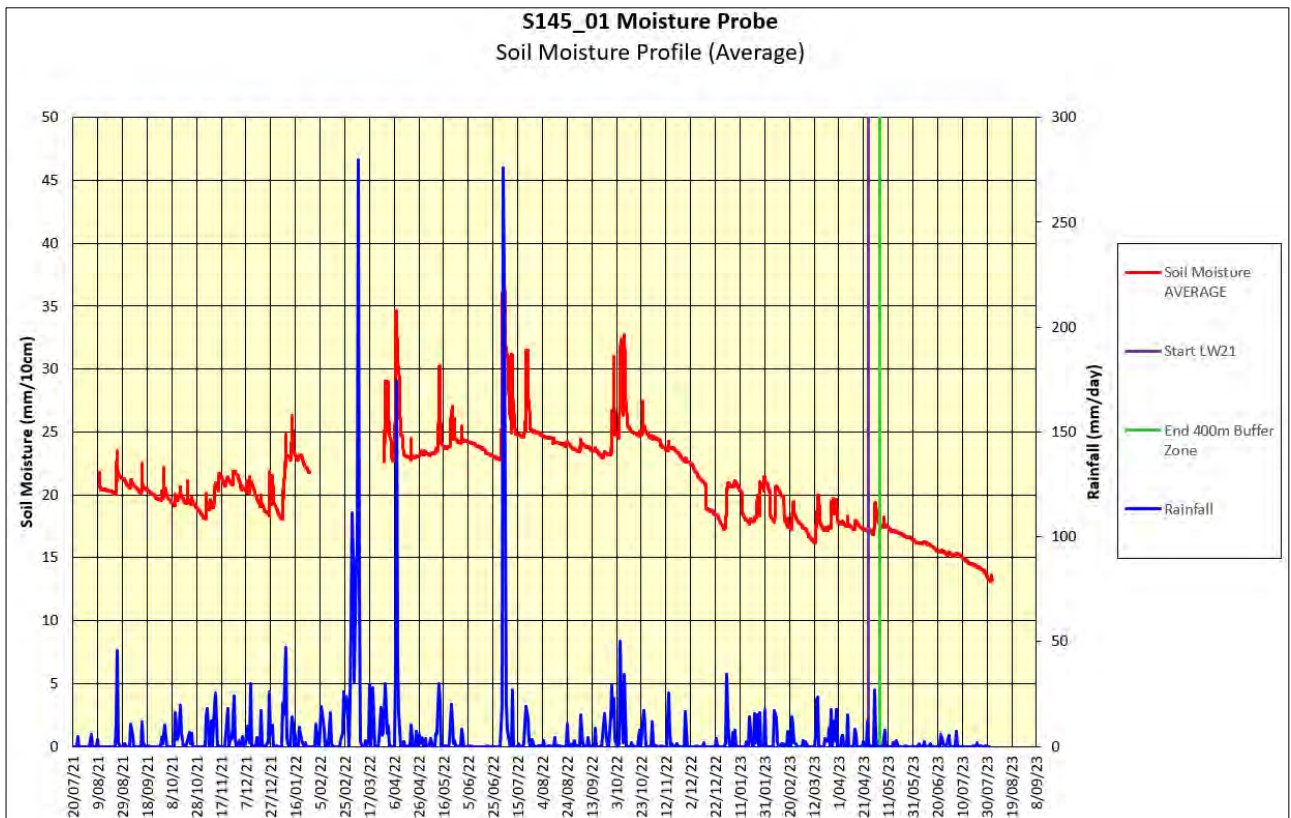
A soil moisture trigger was recorded in Swamp 145 (moisture probe *S145_01*). Site *S145_01* is located 359 m to the south-east of the starting (eastern) end of Longwall 21 (Figure 1), i.e. within the longwall's 400 m buffer zone since the start of mining. The site exited the buffer on 4 May 2023. On 3 June 2023 the average soil moisture value receded below the lowest level recorded before mining (Graph 2).

These results contribute to a Level 3 trigger according to the SIMMCP (Table 1), specifically:

Level 3: Soil moisture level lower than baseline level at >80% of monitoring sites (within 400 m of mining) within a swamp (in comparison to reference swamps).

Graph 2: Average soil moisture levels at S145_01, logged hourly, date range: 10/08/2021 to 03/08/2023

- Continue monitoring program
- Submit an Impact Report to key stakeholders
- Seek advice on any other CMAs
- Report in the End of Panel Report
- Summarise actions and monitoring in AEMR

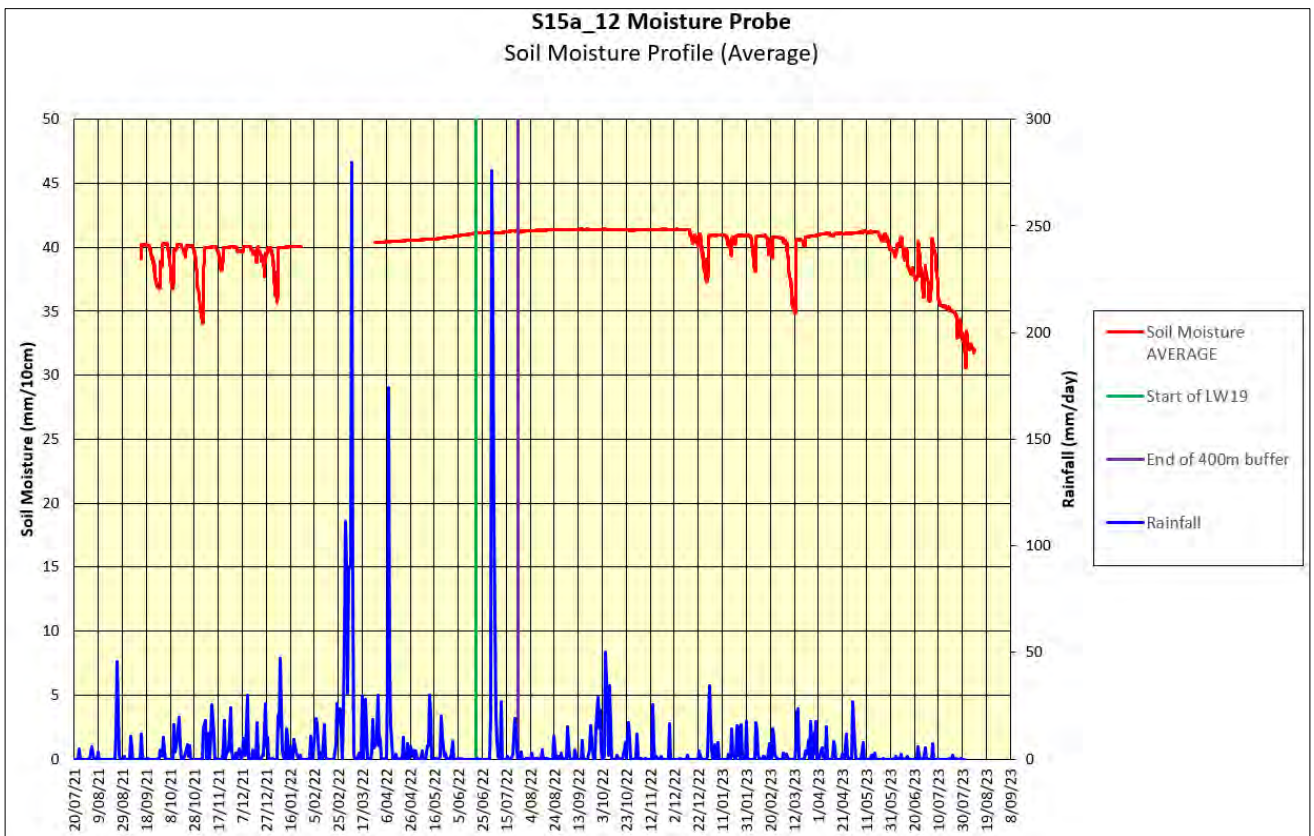
A soil moisture trigger was recorded in Swamp 15a (soil moisture probes *S15a_12* and *S15a_18*) during recent analysis of moisture data for the swamp. Site *15a_12* is located 172 m south-east from Longwall 19 (Figure 1), i.e. within the longwall's 400 m mining area since the start of mining. The site exited the mining area on 25 July 2022. On 25 July 2023 the average soil moisture value recessed below the lowest level recorded during the monitored period before mining. Site *15a_18* is located 275 m east of Longwall 19, within the longwall's 400 m mining area since the start of mining. The site exited the mining area on 9 July 2022. On 18 July 2023 the average soil moisture value recessed below the lowest level recorded during the monitored period before mining.

As soil moisture triggers in the other three sites within 400 m of mining in Swamp 15a were reported previously, these results contribute to a Level 3 trigger according to the Dendrobium SIMMCP TARP (Table 1), specifically:

Level 3: Soil moisture level lower than baseline level at 80% of monitoring sites (within 400 m of mining) within a swamp (in comparison to reference swamps).

Graph 1: Average soil moisture levels at site S15a_12, logged hourly, date range: 13/09/2021 to 9/08/2023

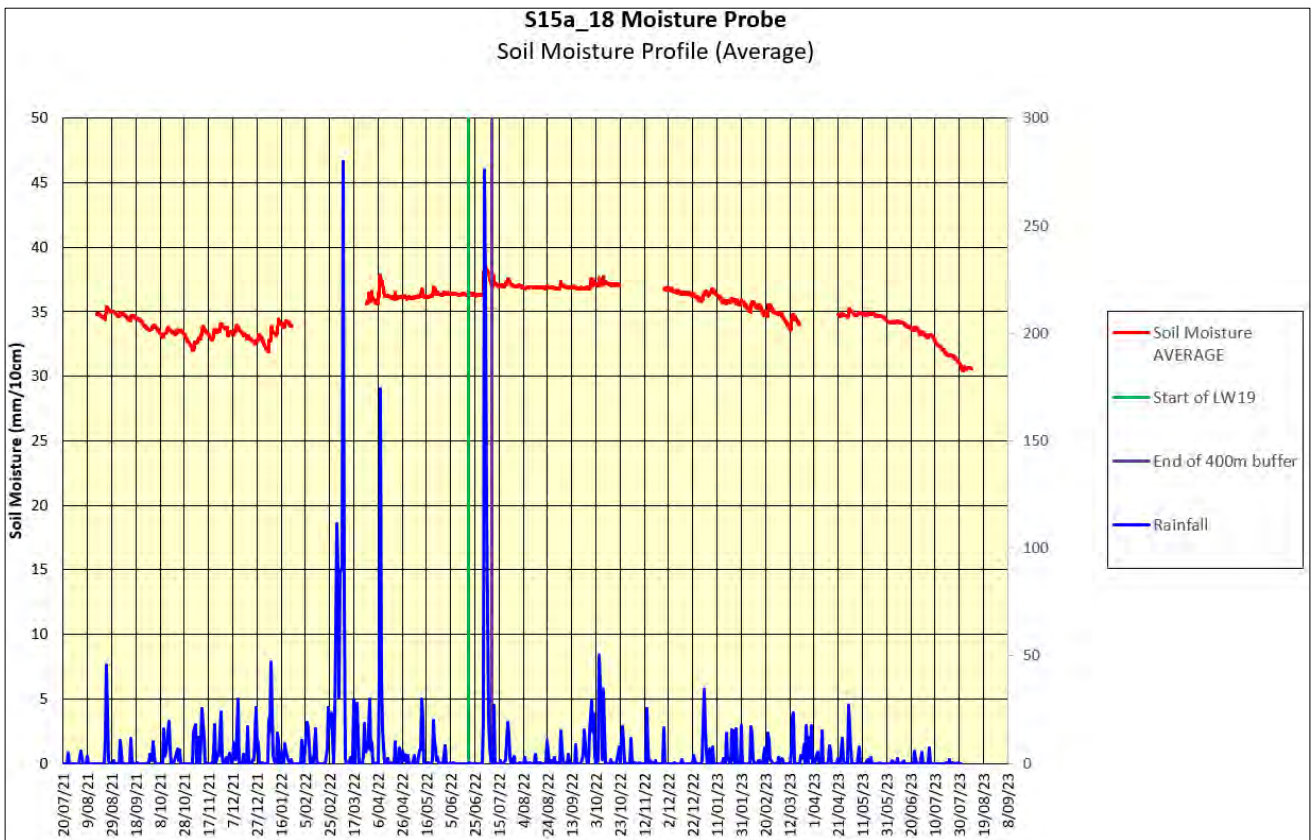
Graph 2: Average soil moisture levels at site S15a_18, logged hourly, date range: 16/08/2021 to 9/08/2023

- Continue monitoring program
- Submit an Impact Report to key stakeholders
- Seek advice on any other CMAs
- Report in the End of Panel Report
- Summarise actions and monitoring in AEMR
