Figure 1: Map Showing latest swamp triggers in Swamp 15a. Inset shows frame in relation to Dendrobium mining operations.

Swamp 12 (Longwall 19)

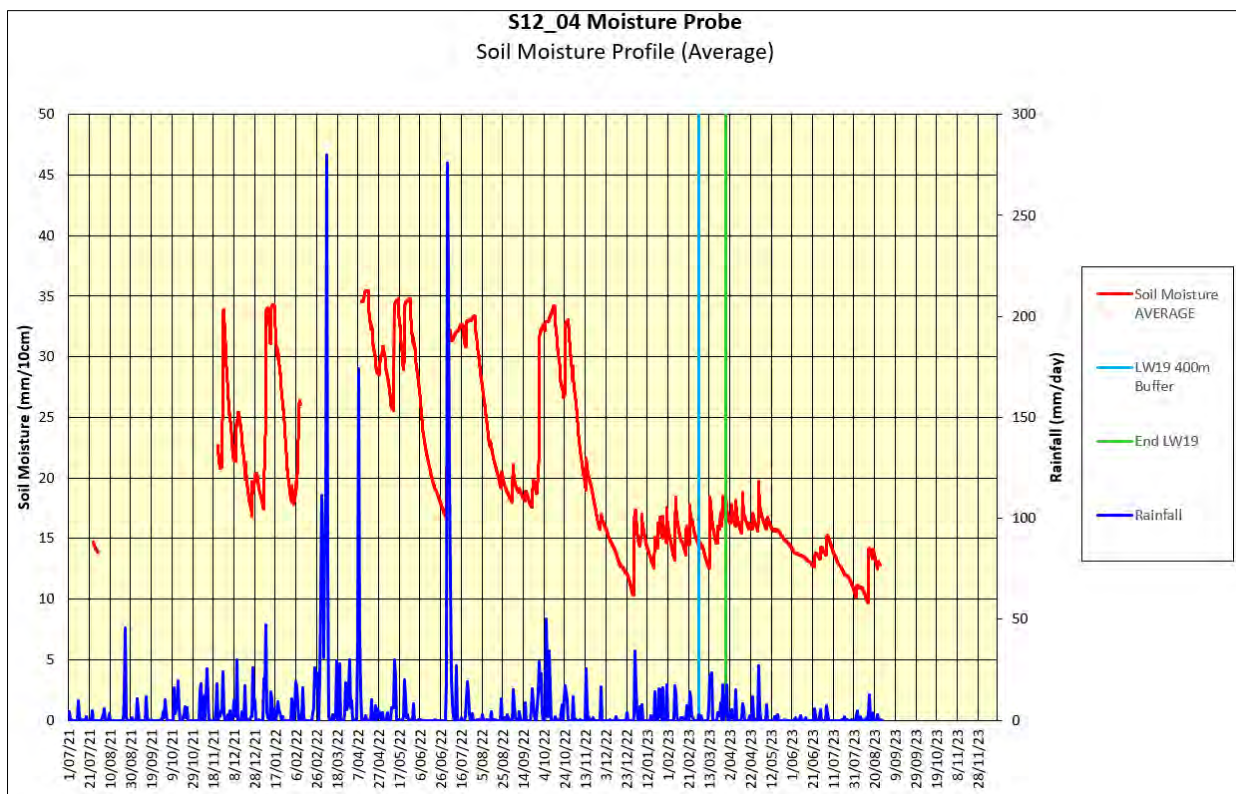
A soil moisture trigger was identified at monitoring site *S12_04* in Swamp 12 during recent analysis of moisture data. *S12_04* is located 395 m north from the western end of Longwall 19 (Figure 1). The site entered the Longwall 19, 400m active mining area on 3 March 2023 and remained within the active mining area until the end of extraction. On 1 August 2023 the average soil moisture value receded below the lowest level recorded during the baseline monitoring period (Graph 1).

As *S12_04* is the only soil moisture site in Swamp 12 within 400 m of Longwall 19 mining, these results contribute to a Level 3 trigger according to the Dendrobium Swamps TARP (Table 1), specifically:

Graph 1: Average soil moisture levels at site S12_04, logged hourly, date range: 27/07/2021 to 25/08/2023

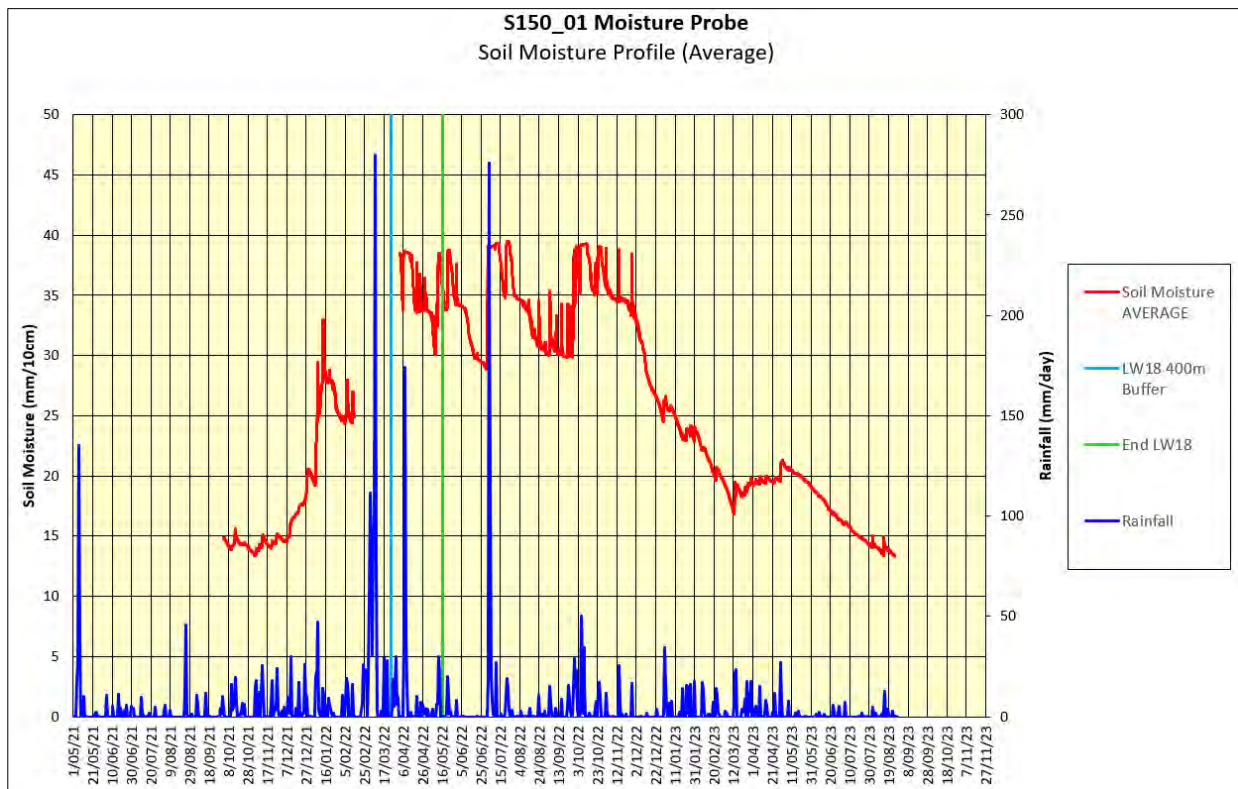
A soil moisture trigger was identified at monitoring site *S150_01* in Swamp 150 during recent analysis of soil moisture data. *S150_01* is located 280 m south of the eastern end of Longwall 18 (Figure 2). The site entered the Longwall 18, 400m active mining area on 24 March 2022 and remained in the active mining area until the end of extraction. On 24 August 2023, (one year and three months after completion of Longwall 18), the average soil moisture value receded below the lowest level recorded during the baseline monitoring period (Graph 2).

As the soil moisture probe *S150_01* is the only one installed in Swamp 150, these results contribute to a Level 3 trigger according to the Dendrobium Swamps TARP (Table 1), specifically:

Monitoring for this site has predominately occurred during a period of unusually high rainfall in 2021 and 2022. In contrast, 2023 has been the driest year during the *S150_01* monitored period and the third driest year-to-date in the 22 years of rainfall records from Cordeaux Colliery. There were no impacts recorded when the soil moisture probe was within the Longwall 18 active mining area.

Graph 2: Average soil moisture levels at site S150_01, logged hourly, date range: 02/10/2021 to 25/08/2023

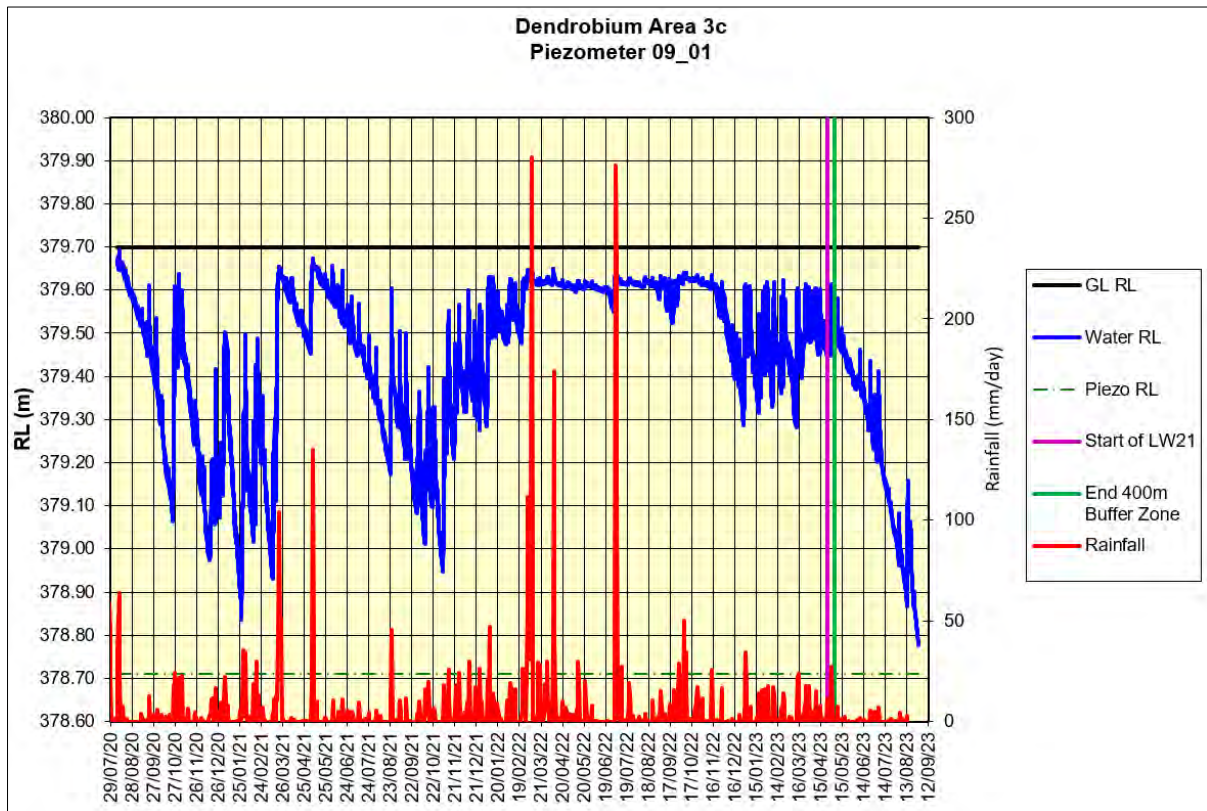
Site 09_01 is located 368 m east of the eastern end of Longwall 21 (Figure 3). The site was within the 400m active mining area between 25 April 2023 and 2 May 2023. On 25 August 2023 the water level in the borehole 09_01 receded below the lowest level recorded during the baseline monitoring period (Graph 3) and on 28 August 2023 the average soil moisture value at S09_01 receded below the lowest level recorded before mining (Graph 4).

Graph 3: Shallow groundwater levels at 09_01, logged hourly, date range: 07/08/2020 to 29/08/2023

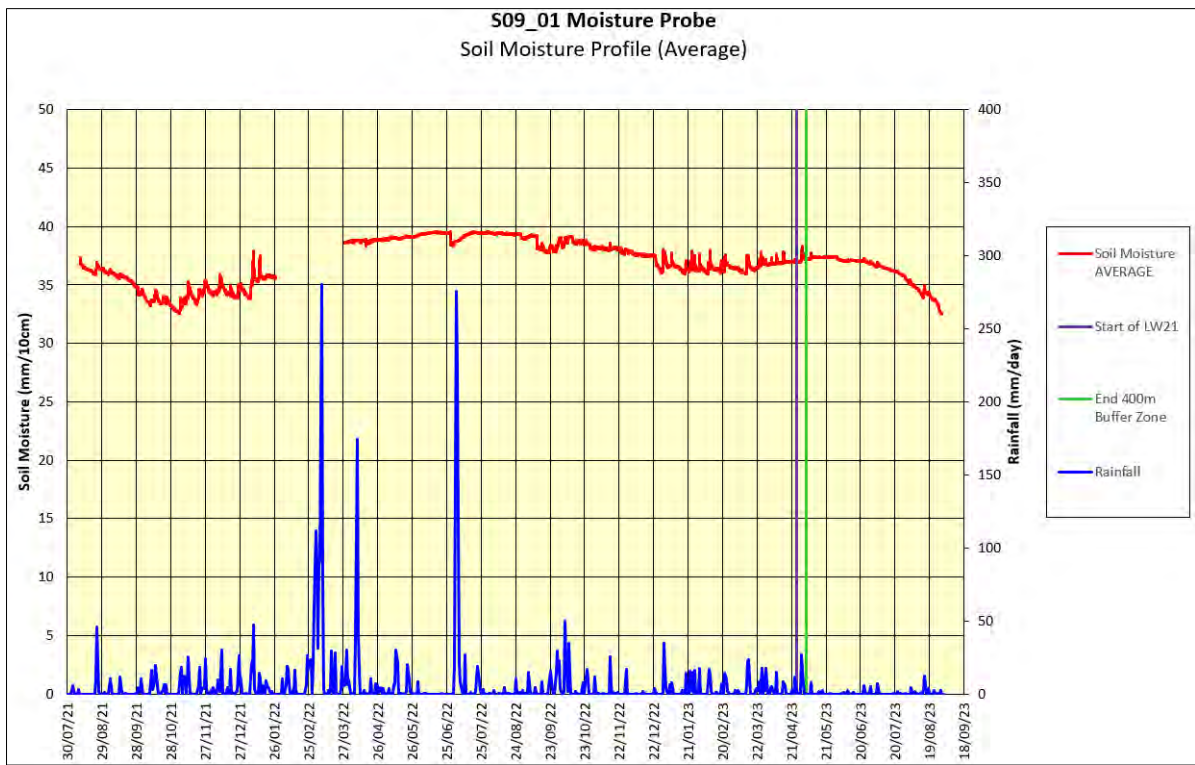
Graph 4: Average soil moisture levels at site S09_01, logged hourly, date range: 10/08/2021 to 29/08/2023.

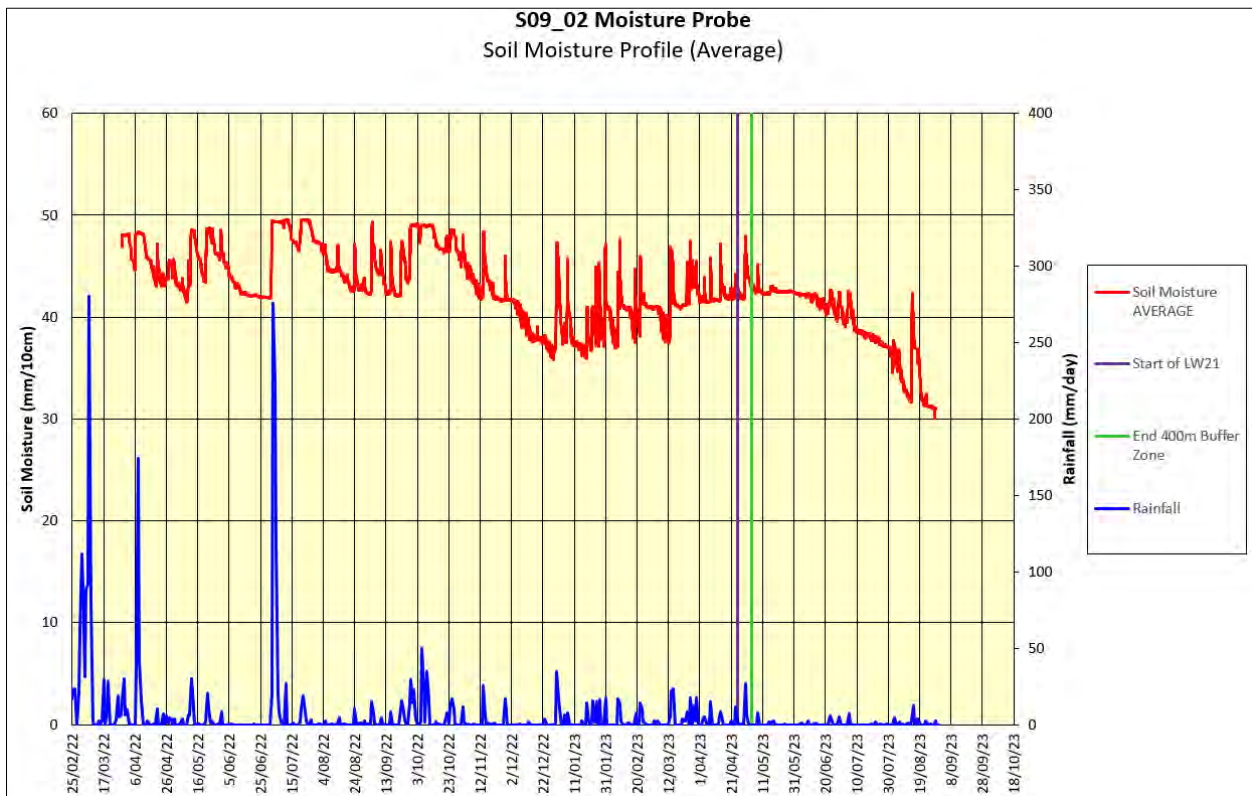
Site S09_02 is located 350 m east of the eastern end of Longwall 21 (Figure 3). The site was within the 400m active mining area between 25 April 2023 and 4 May 2023. On 1 August 2023 the average soil moisture value in the probe S09_02 receded below the lowest level recorded before mining (Graph 5). The groundwater trigger in site 09_02 was reported on 9 August 2023.

Graph 5: Average soil moisture levels at site S09_02, logged hourly, date range: 28/03/2022 to 29/08/2023

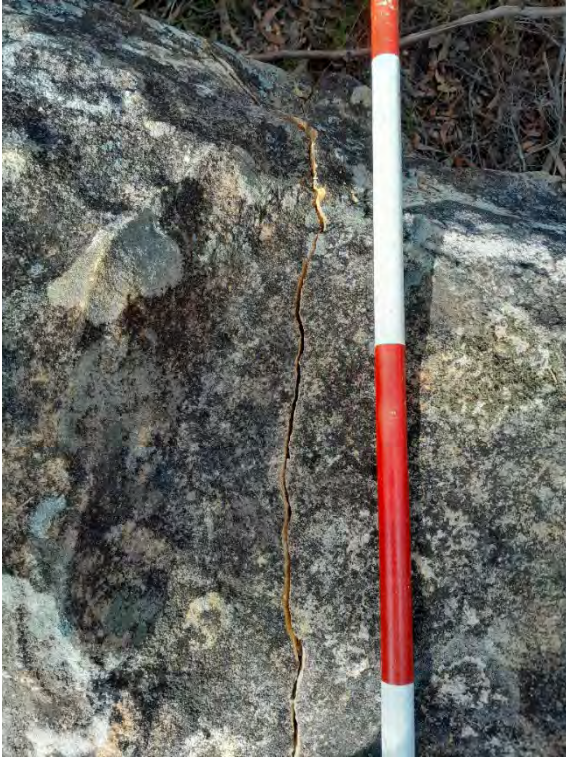
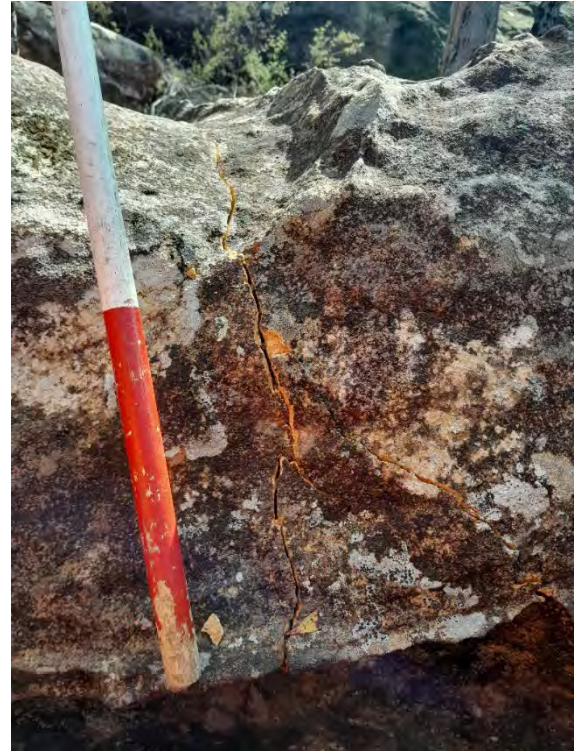
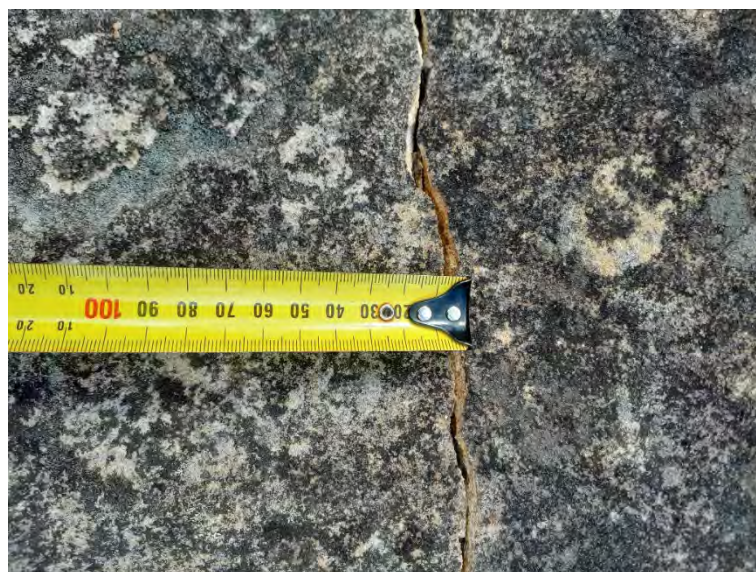
DA3C_LW21_023 (E 291206, N 6194204)

DA3C_LW21_023 is located approximately 100m north of tributary WC20 (Figure 3). The impact consists of a fracture to a rock outcrop (Photo 1 to Photo 3). The impact has a maximum continuous length of 2.10m, a maximum width of 0.004m and a maximum measurable depth of 1.30m.

DA3C_LW21_023 is a Level 1 trigger as per the Dendrobium Landscape TARP (Table 2), specifically:

Photo 1: DA3C_LW21_023, section of the rock fracture.
Taken: 31/08/2023.

Photo 2: DA3C_LW21_023, section of the rock fracture.
Taken: 31/08/2023.

Photo 3: DA3C_LW21_023, maximum width of the rock fracture. Taken: 31/08/2023.

- Continue monitoring program
- Submit an Impact Report to key stakeholders
- Seek advice on any other CMAs
- Report in the End of Panel Report
- Summarise actions and monitoring in AEMR

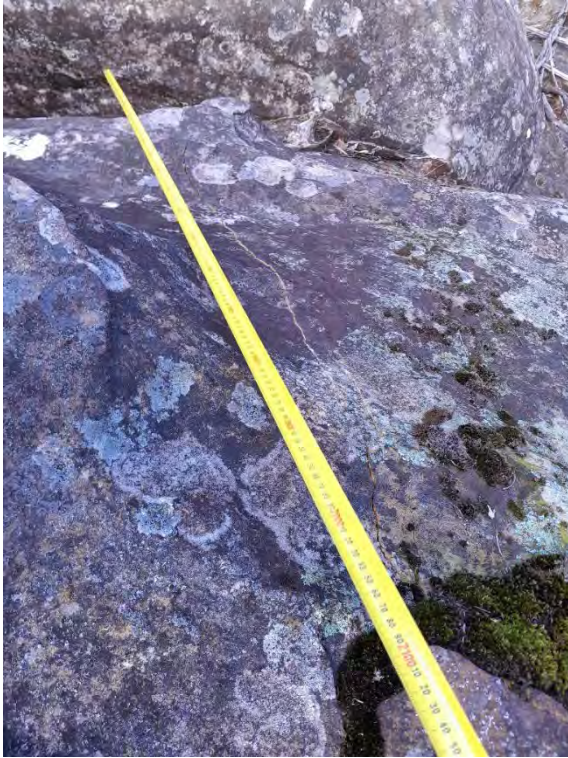
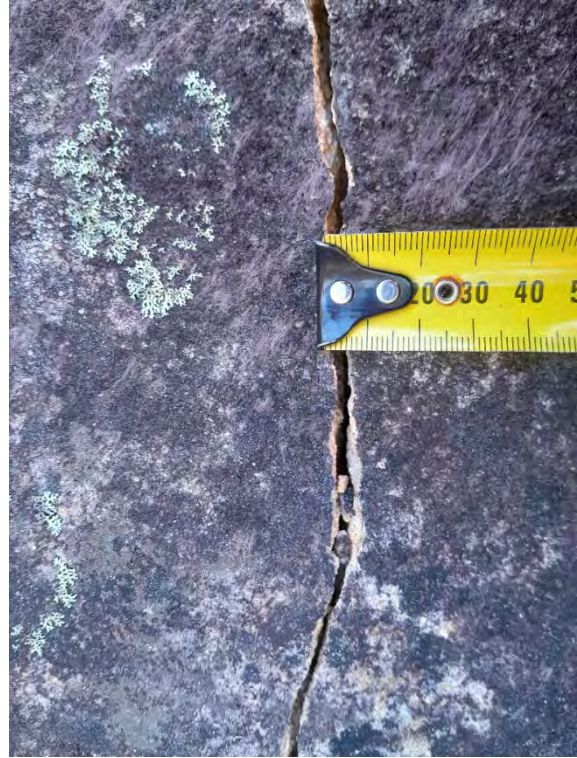
DA3C_LW21_024 (E 291250, N 6194199)

DA3C_LW21_024 is located approximately 100m north of WC20 (Figure 3). The impact consists of a fracture to a rock outcrop (Photo 4 and Photo 5). The impact has a maximum continuous length of 3.80m and a maximum width of 0.005m.

DA3C_LW21_024 is a Level 1 trigger as per the Dendrobium Landscape TARP (Table 2), specifically:

Photo 4: DA3C_LW21_024, section of the rock fracture.
Taken: 31/08/2023.

Photo 5: DA3C_LW21_024, maximum width of the rock fracture.
Taken: 31/08/2023.

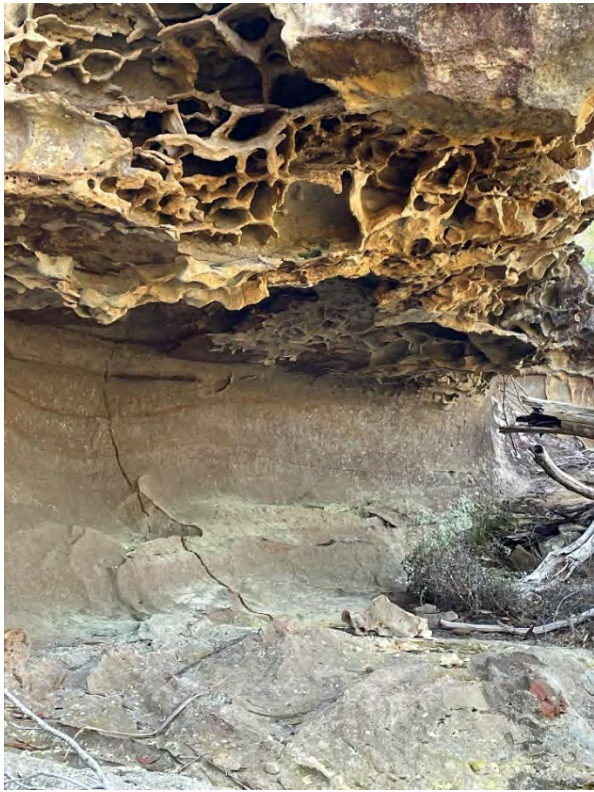
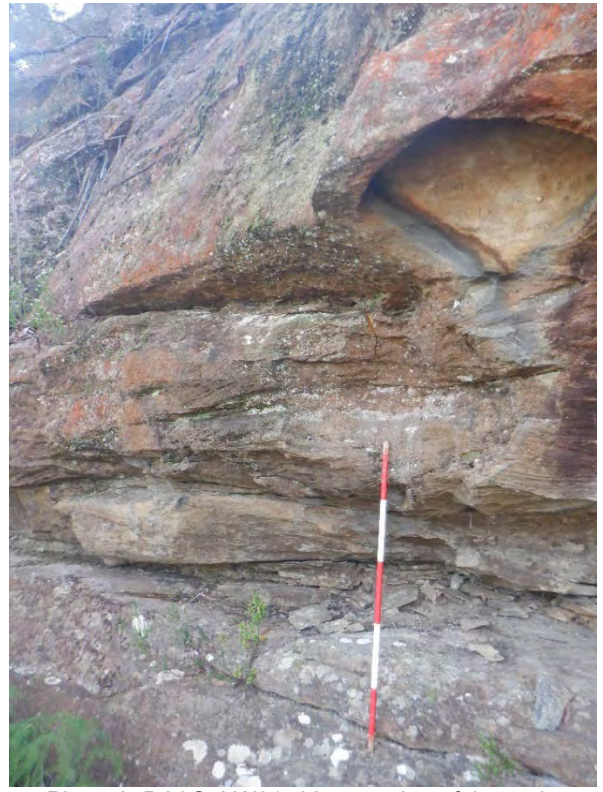
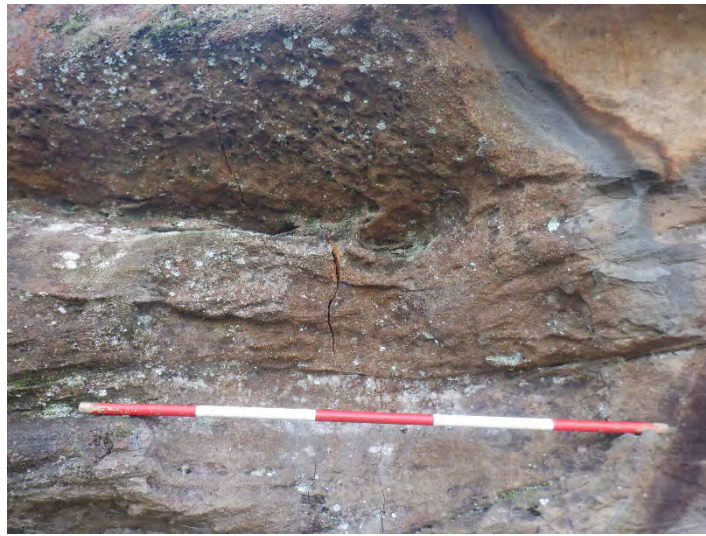
DA3C_LW21_025 (E 291112, N 6194193)

DA3C_LW21_025 is located approximately 80m north of tributary WC20 (Figure 1). The impact consists of fracturing, rockfall and rock displacement to a rock overhang and outcrop (Photo 1 to Photo 3). Some of the measurements have been estimated due to safety concerns. The impact has a maximum continuous length of ≈ 5 m, a maximum width of ≈ 0.03 m. Total rockfall volume was estimated to be ≈ 0.7 m³. Caution tape barricading is in place at the site as a safety precaution.

DA3C_LW21_025 is a Level 1 trigger as per the Dendrobium Landscape TARP (Table 1), specifically:

Photo 1: DA3C_LW21_025, section of the rock fracture in overhang. Taken: 06/09/2023.

Photo 2: DA3C_LW21_025, section of the rock fracture. Taken: 06/09/2023.

Photo 3: DA3C_LW21_025, section of the rock fracture. Taken: 06/09/2023.

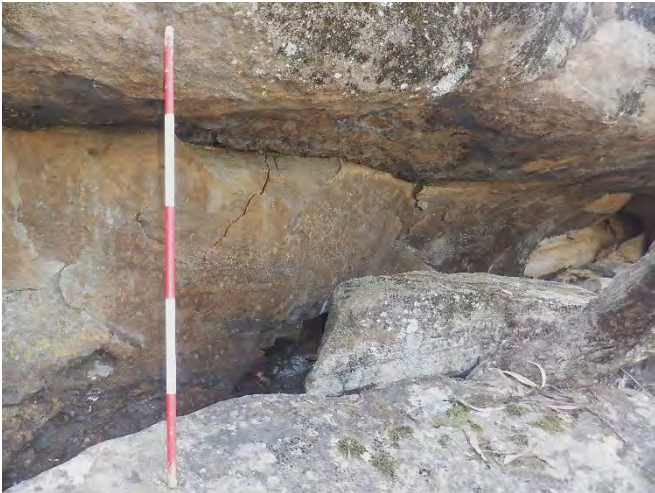
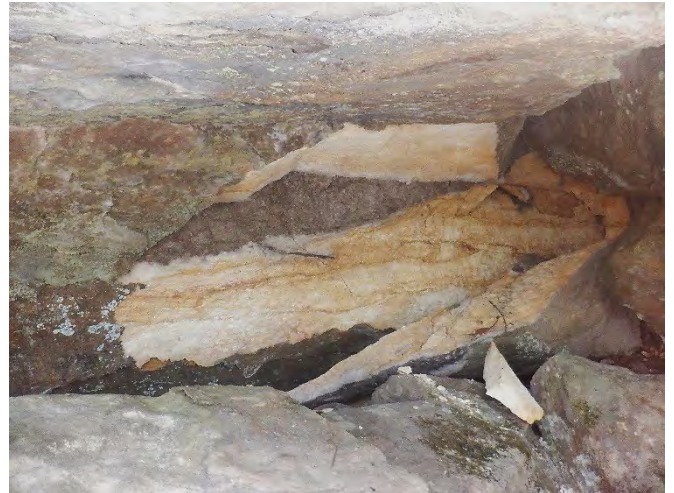
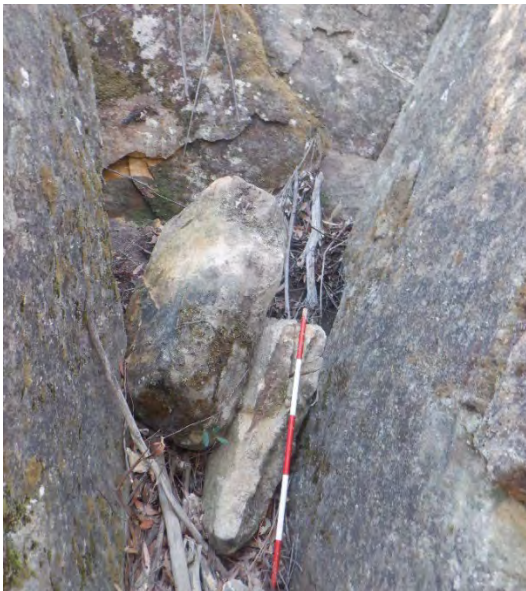
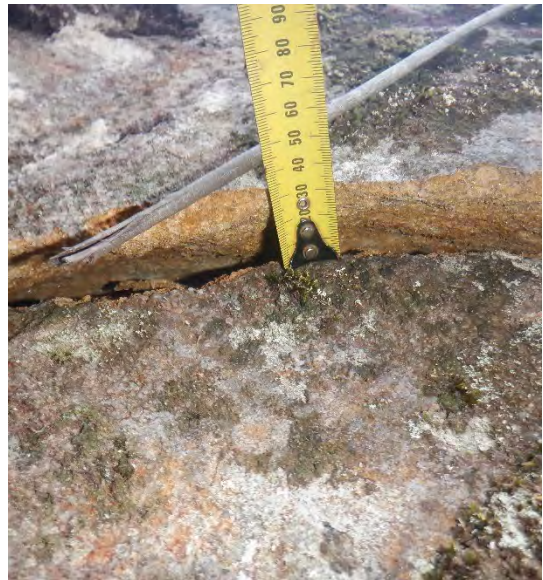
DA3C_LW21_026 (E 291034, N 6194170)

DA3C_LW21_026 is located approximately 50m north of tributary WC20 (Figure 1). The impact consists of a rockfall and rock fracturing to a rock overhang (Photo 4 to Photo 7). Some measurements were estimated due to safety concerns. The rockfall volume was estimated to be $\approx 1\text{m}^3$ in total, the rock fracturing has a maximum length of 1.7m and maximum width of 0.032m.

DA3C_LW21_026 is a Level 1 trigger as per the Dendrobium Landscape TARP (Table 1), specifically:

Photo 4: DA3C_LW21_026, section of rock fracture and rockfall. Taken 06/09/2023

Photo 5: DA3C_LW21_026, close up section of rockfall. Taken 06/09/2023.

Photo 6: DA3C_LW21_026, section of rock fracture and rockfall. Taken 06/09/2023

Photo 7: DA3C_LW21_026, Width of rock fracture. Taken 06/09/2023
