DA3C_LW21_027 (E 291221, N 6194124)

DA3C_LW21_027 is located approximately 20m north of tributary WC20 (Figure 1). The impact consists of a rockfall to the rock step at Landscape Monitoring site LW21_SS1 (Photo 8 and Photo 9). The measurements were estimated due to safety concerns. The rockfall has a maximum length of $\approx 6.5\text{m}$, a maximum width of $\approx 3\text{m}$ and a maximum height of $\approx 3\text{m}$, with a total volume of $\approx 15\text{m}^3$ and ground disturbance area of $\approx 10\text{m}^2$. Caution tape barricading is in place at the site as a safety precaution.

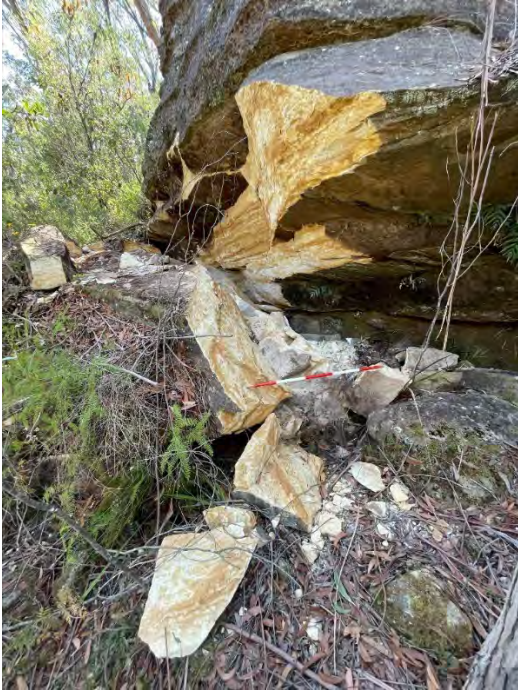
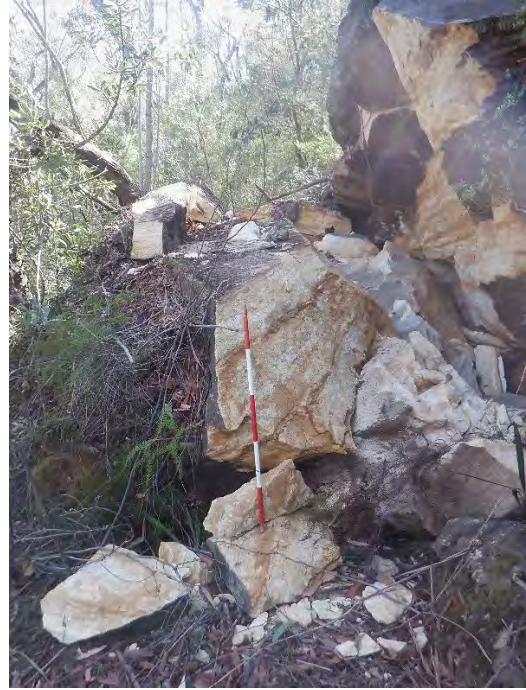
DA3C_LW21_027 is a Level 2 trigger as per the Dendrobium Landscape TARP (Table 1), specifically:

- Rockfall or overhang collapse at a cliff (step) site, where characteristics of the cliff have changed, and there has been significant ground disturbance.

Photo 8: DA3C_LW21_027, overview of rockfall.
Taken 06/09/2023

Photo 9: DA3C_LW21_027, overview of rockfall.
Taken 06/09/2023

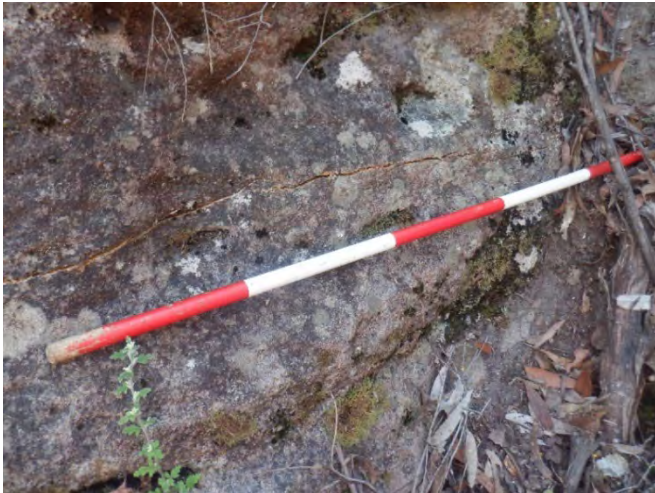
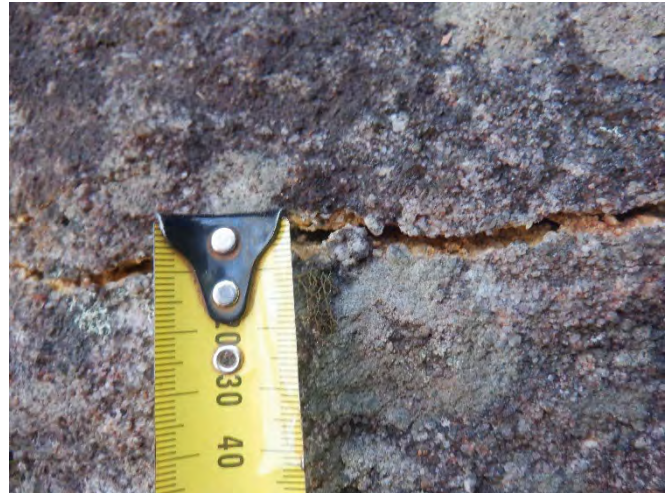
DA3C_LW21_028 is located approximately 55m north of tributary WC20 (Figure 1). The impact consists of a horizontal fracture to a rock outcrop (Photo 10 and Photo 11). The fracture has a maximum length of 1m, a maximum width of 0.003m and a maximum measurable depth of 0.06m.

DA3C_LW21_028 is a Level 1 trigger as per the Dendrobium Landscape TARP (Table 1), specifically:

- Crack or fracture up to 100mm width;
- Crack or fracture up to 10m length.

Photo 10: DA3C_LW21_028, rock fracture. Taken 06/09/2023

Photo 11: DA3C_LW21_028, width of rock fracture. Taken 06/09/2023

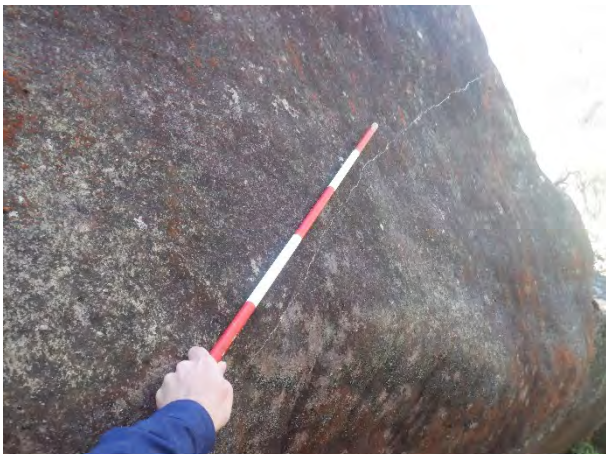
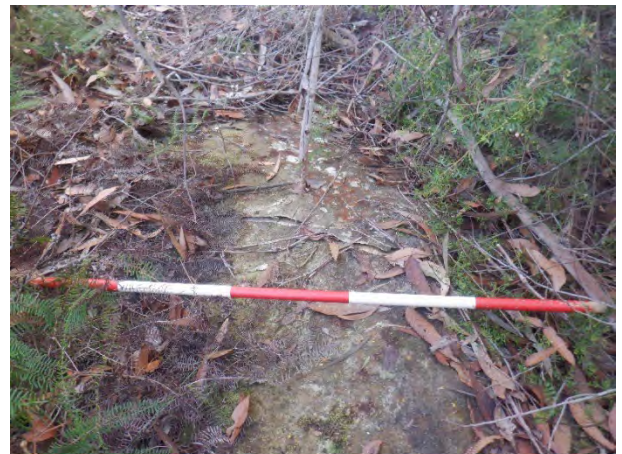
DA3C_LW21_029 is located approximately 80m north of tributary WC20 (Figure 1). The impact consists of fracturing to a rock outcrop at Landscape Monitoring site LW21_SS3 (Photo 12 and Photo 13). Some measurements were estimated due to safety. The fracturing has a maximum length of ≈ 6 m and a maximum width of ≈ 0.01 m.

DA3C_LW21_029 is a Level 1 trigger as per the Dendrobium Landscape TARP (Table 1), specifically:

- Crack or fracture up to 100mm width;
- Crack or fracture up to 10m length;

Photo 12: DA3C_LW21_029, section of rock fracture. Taken 6/09/2023

Photo 13: DA3C_LW21_029, section of rock fracture. Taken 6/09/2023

- Continue monitoring program
- Submit an Impact Report to key stakeholders
- Seek advice on any other CMAs
- Report in the End of Panel Report
- Summarise actions and monitoring in AEMR
- Review monitoring frequency
- Notify technical specialists and seek advice on any CMA required
- Provide safety barricades as appropriate
- Implement agreed CMAs as approved (subject to agency feedback)

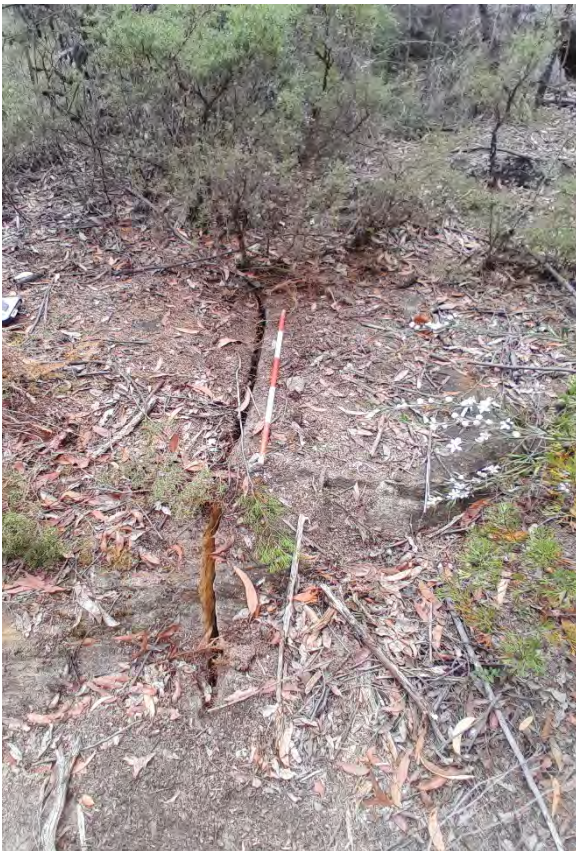
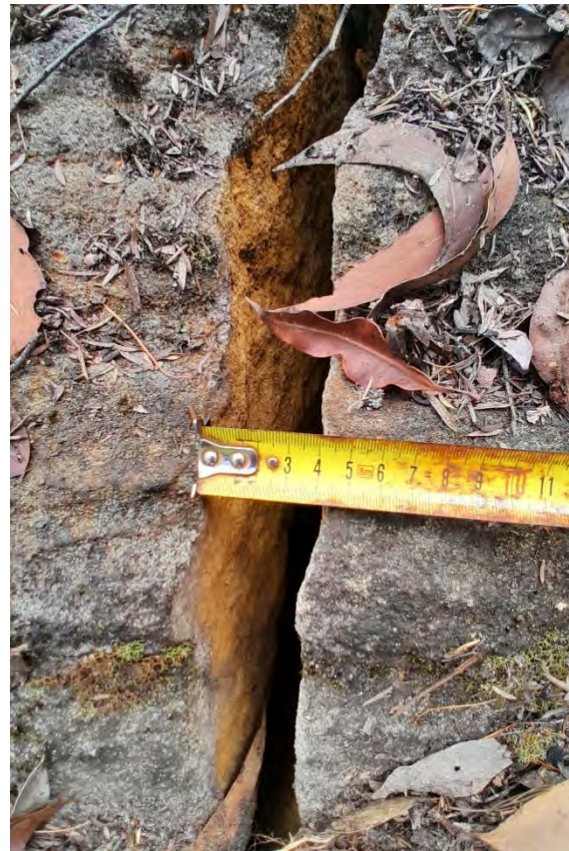
DA3C_LW21_030 is located approximately 155m northeast of tributary WC20 (Figure 1). The impact consists of a fracture to a rock outcrop (Photo 1 and Photo 2). The rock fracture has a maximum continuous length of 1.85m, a maximum width of 0.04m and a maximum measurable depth of 0.91m.

DA3C_LW21_030 is a Level 1 trigger as per the Dendrobium Landscape TARP (Table 1), specifically:

- Crack or fracture up to 100mm width;
- Crack or fracture up to 10m length.

Photo 1: *DA3C_LW21_030*, overview of rock fracture.
Taken: 12/09/2023.

Photo 2: *DA3C_LW21_030*, width of rock fracture.
Taken: 12/09/2023.

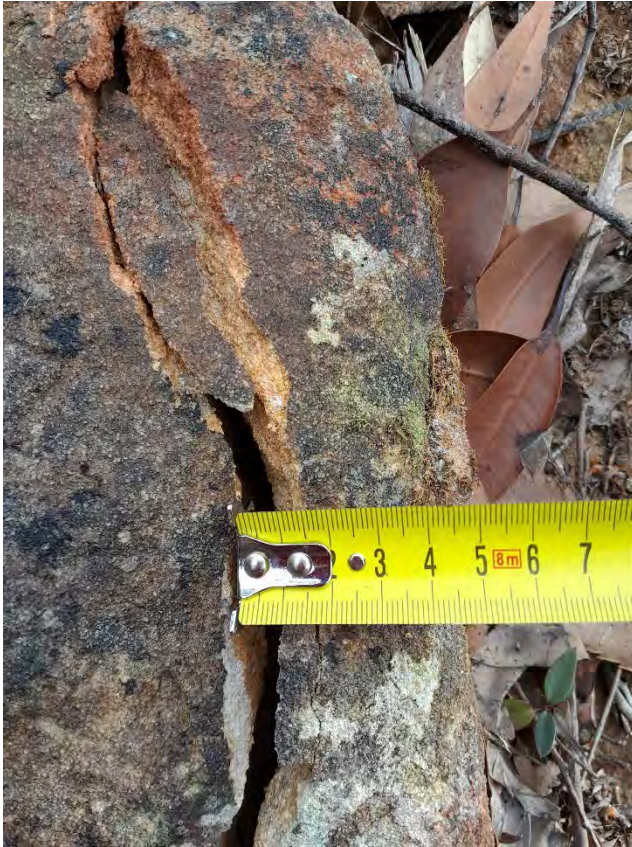
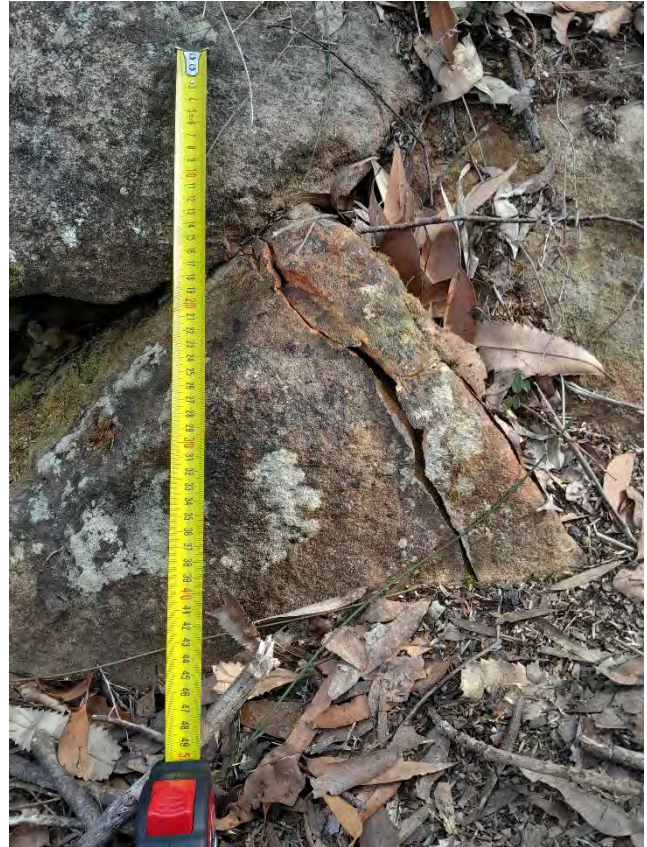
DA3C_LW21_031 is located approximately 75m north of tributary WC20 (Figure 1). The impact consists of a small rock fracture to the bottom of a step (Photo 3 and Photo 4). The fracture has a maximum continuous length of 0.32m, a maximum width of 0.015m and a maximum measurable depth of 0.012m.

DA3C_LW21_031 is a Level 1 trigger as per the Dendrobium Landscape TARP (Table 1), specifically:

- Crack or fracture up to 100mm width;
- Crack or fracture up to 10m length;

Photo 3: DA3C_LW21_031, width of rock fracture. Taken: 12/09/2023.

Photo 4: DA3C_LW21_031, overview of rock fracture. Taken: 12/09/2023. Note- measurement tape set to 0.5m for scale.

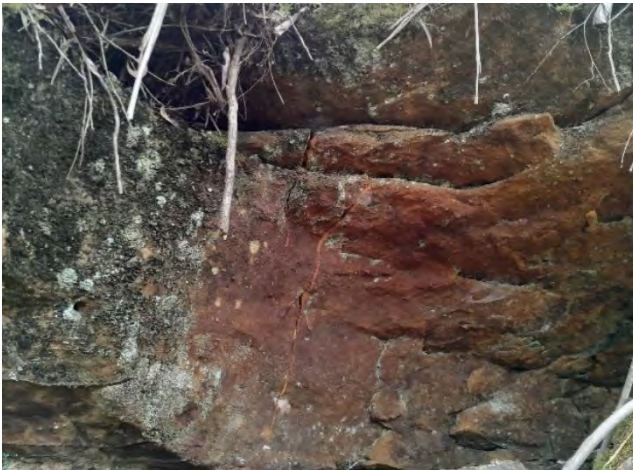
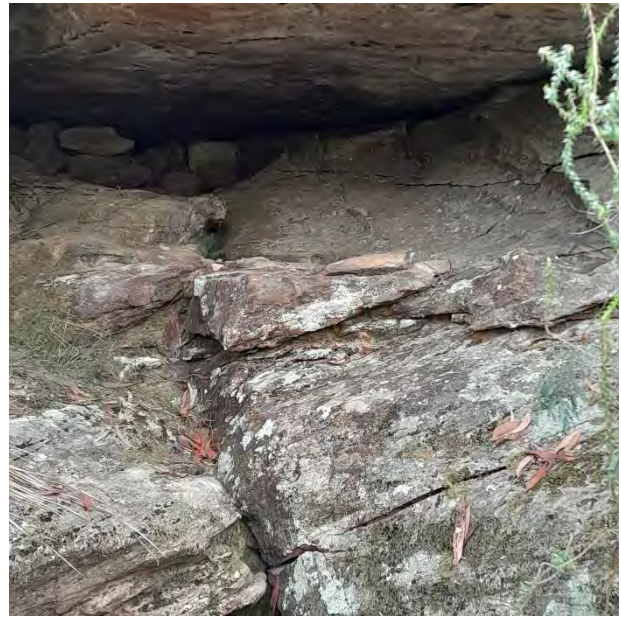
DA3C_LW21_032 is located approximately 30m north of tributary WC20 (Figure 1). The impact consists of multiple fractures to a rock step/overhang, with varying lengths and orientations (Photo 5 and Photo 6). Measurements were estimated from distance for safety reasons. The rock fracturing has an approximate maximum continuous length of $\approx 1\text{m}$ and a maximum width of $\approx 0.035\text{m}$. Caution tape barricading is in place at the site as a safety precaution due to the overhanging nature of the step.

DA3C_LW21_032 is a Level 1 trigger as per the Dendrobium Landscape TARP (Table 1), specifically:

- Crack or fracture up to 100mm width;
- Crack or fracture up to 10m length.

Photo 5: DA3C_LW21_032, overview of fracturing to rock step/overhang. Taken 12/09/2023.

Photo 6: DA3C_LW21_032, overview of fracturing to rock step/overhang. Taken 12/09/2023.

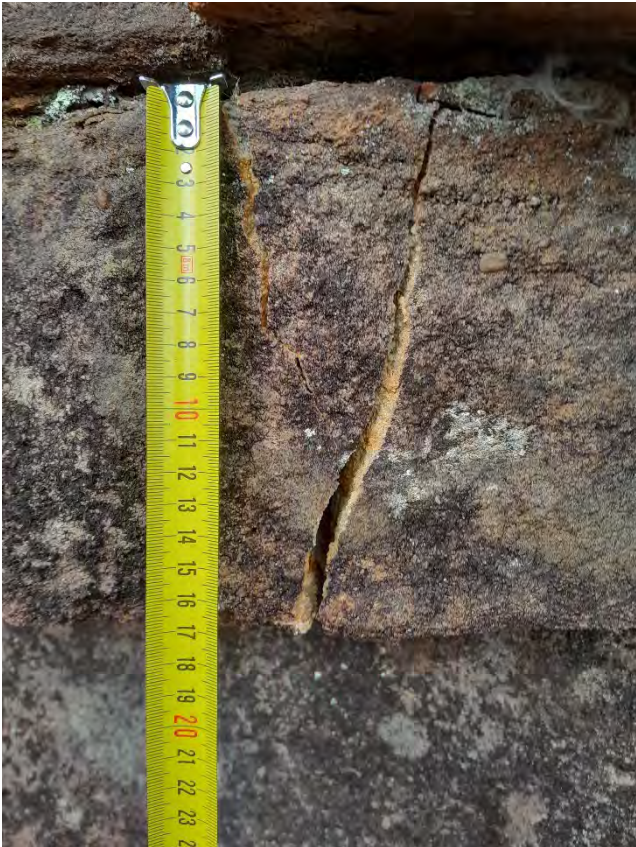
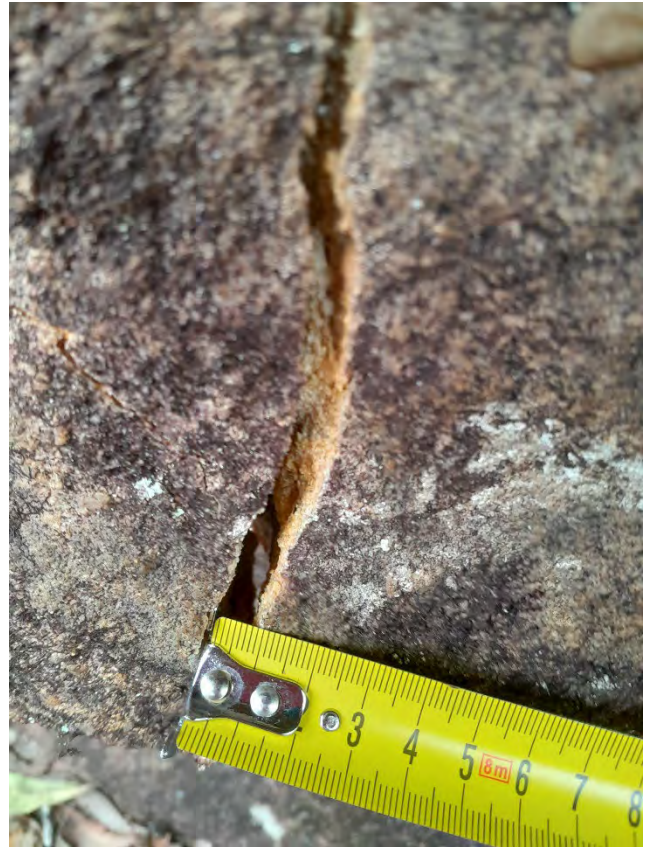
DA3C_LW21_033 is located approximately 55m north of tributary WC20 (Figure 1). The impact consists of a small rock fracture beneath a rock step/overhang (Photo 7 and Photo 8). The rock fracturing has a maximum continuous length of 0.2m, a maximum width of 0.01m and a maximum measurable depth of 0.1m.

DA3C_LW21_033 is a Level 1 trigger as per the Dendrobium Landscape TARP (Table 1), specifically:

- Crack or fracture up to 100mm width;
- Crack or fracture up to 10m length.

Photo 7: DA3C_LW21_033, overview of rock fracture.
Taken: 12/09/2023.

Photo 8: DA3C_LW21_033, width of rock fracture. Taken:
12/09/2023.

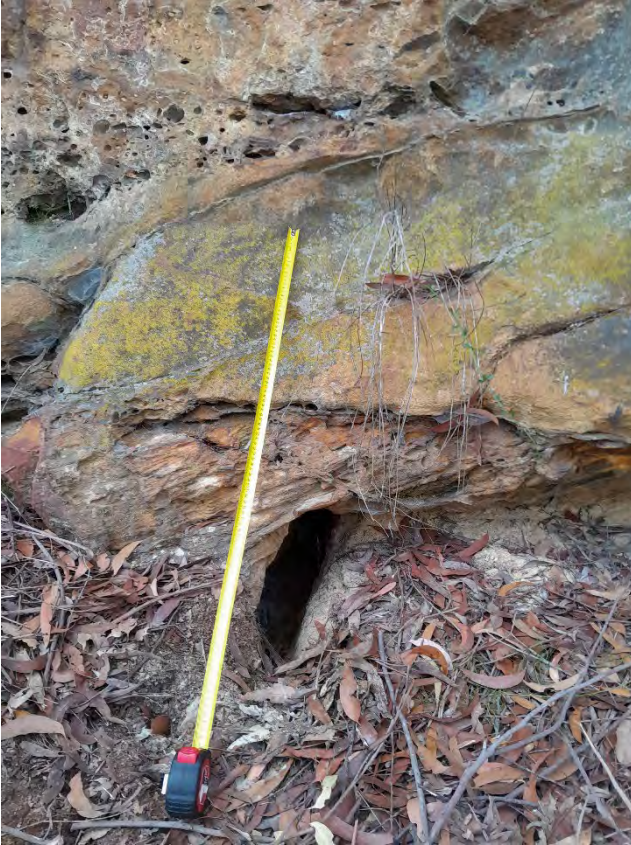
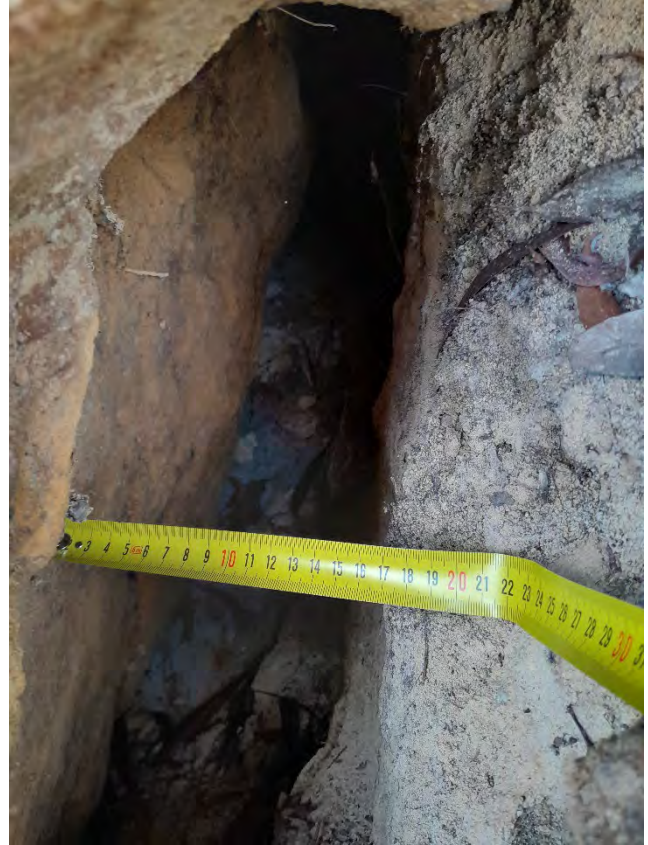
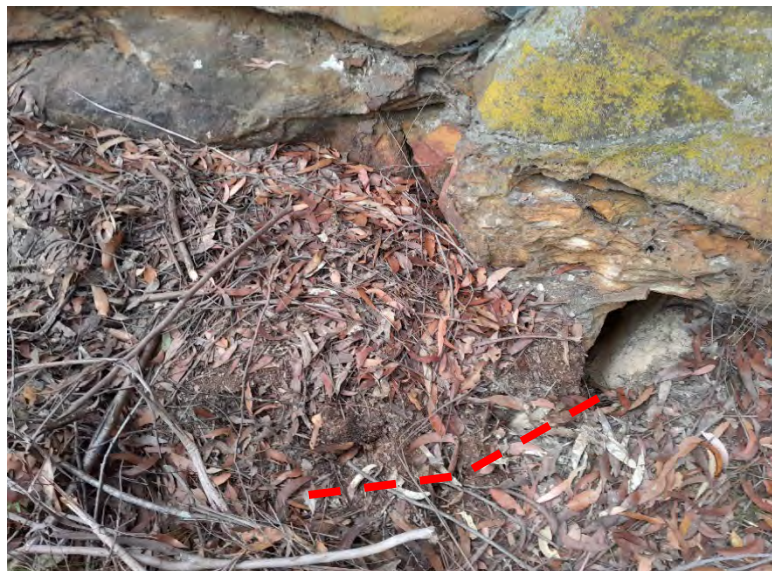
DA3C_LW21_034 is located approximately 120m north of the tributary WC20 (Figure 1). The impact consists of rock movement and soil cracking (Photo 9 to Photo 10). The soil crack extends for 1.9m beneath the rock feature, with a maximum width of 0.17m. The soil cracking potentially extends away from the rock feature as unstable soil was observed during the inspection (Photo 11).

DA3C_LW21_034 is a Level 2 trigger as per the Dendrobium Landscape TARP (Table 1), specifically:

- Crack or fracture between 100 and 300mm width.

Photo 9: DA3C_LW21_034 overview of rock movement and soil crack. Taken: 12/09/2023.

Photo 10: DA3C_LW21_034 width of soil crack. Taken 12/09/2023.

Photo 11: DA3C_LW21_034. Dashed line shows approximate section of unstable soil/leaf litter extending from rock movement. Taken 12/09/2023

- Continue monitoring program
- Submit an Impact Report to key stakeholders
- Seek advice on any other CMAs
- Report in the End of Panel Report
- Summarise actions and monitoring in AEMR
- Review monitoring frequency
- Notify technical specialists and seek advice on any CMA required
- Provide safety barricades as appropriate
- Implement agreed CMAs as approved (subject to agency feedback)

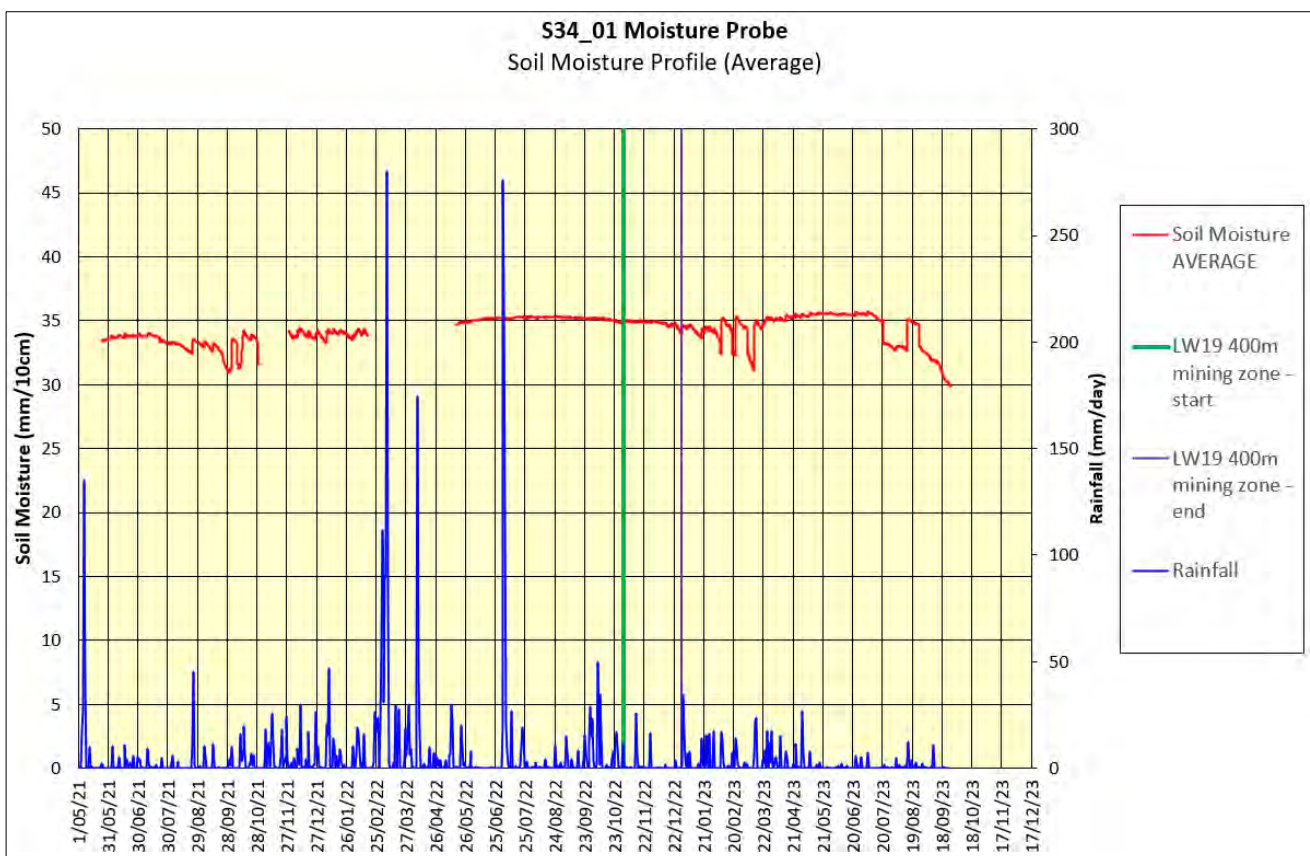
A soil moisture trigger was identified at monitoring site *S34_01* in Swamp 34 during recent analysis of moisture data by the IMCEFT. *S34_01* is located approximately 360 m south of Longwall 19 (Figure 1). It entered the Longwall 19, 400m active mining area on 1 November 2022 and remained in the mining area until 29 December 2022. Recent analysis of records shows that the average soil moisture data after the completion of extraction is now lower than the lowest data recorded during the baseline period. As *S34_01* is the only soil moisture site in Swamp 34, these results may contribute to a Level 3 trigger according to the Longwall 19 SIMMCP, specifically:

Level 3: Soil moisture level lower than baseline level at >80% of monitoring sites (within 400m of mining) within a swamp (in comparison to reference swamps#).

Graph 1: Average soil moisture records at *S34_01*, logged hourly. Date range: 25/05/2021 to 26/09/2023.

Baseline monitoring for this site has predominately occurred during a period of unusually high rainfall in 2021 and 2022. In contrast, 2023 has been the driest year during the S34_01 monitored period and the third driest year-to-date in the 22 years of rainfall records from Cordeaux Colliery. There were no impacts recorded when the soil moisture probe was within the Longwall 19 active mining area.

- Continue monitoring program
- Submit an Impact Report to key stakeholders
- Seek advice on any other CMAs
- Report in the End of Panel Report
- Summarise actions and monitoring in AEMR

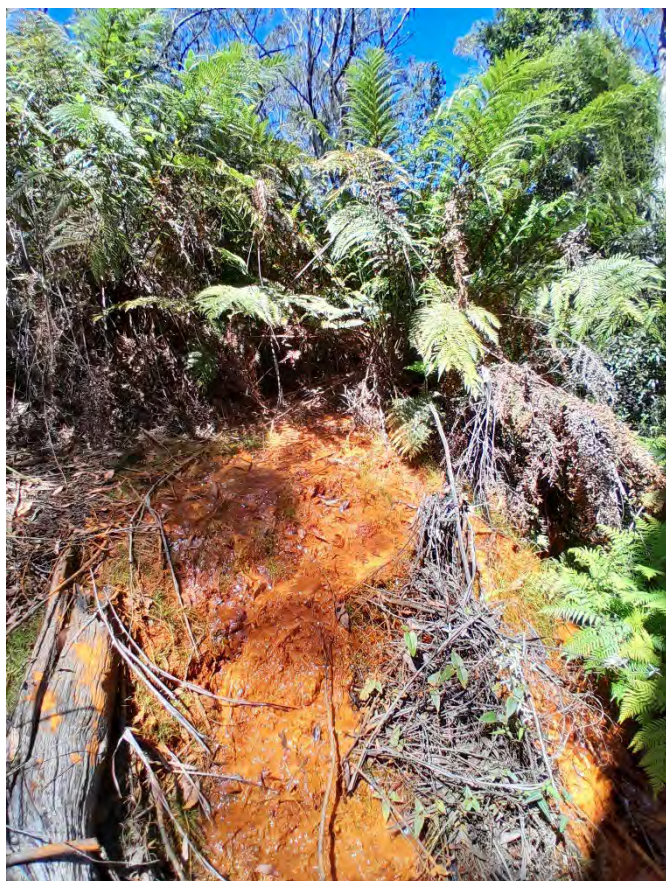
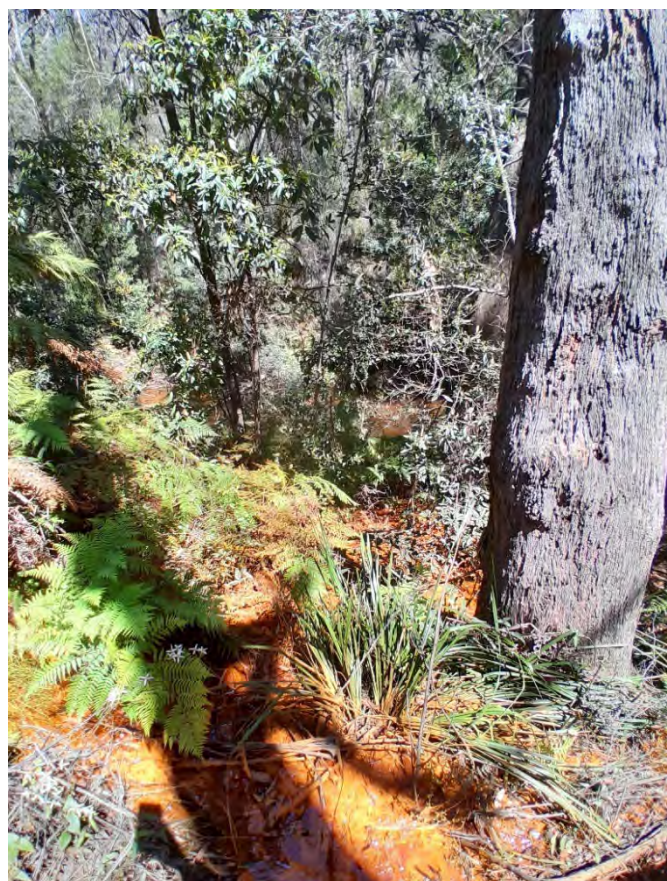
DA3C_LW21_035 is located upslope approximately 15m east of *WC_Pool 50* on *Wongawilli Creek* and is not associated with any mapped tributary (Figure 1). The impact consists of an iron spring and associated iron staining originating from a rock outcrop with seepage extending westward from an area associated with previous *DA3A* mining operations, specifically Longwall 6. The spring was active during the inspection with both the seepage and iron staining extending to *Wongawilli Creek* (Photo 1 & Photo 2). The iron spring and associated staining is approximately 95m north of a previously identified iron spring reported during the *LW17* monitoring period, specifically *DA3B_LW17_031* (Figure 1) and is outside the Longwall 21 mining area.

DA3C_LW21_035 is a Level 1 trigger as per the Dendrobium Watercourse TARP (Table 1), specifically:

- Observable increase in iron staining within the mining area.

Photo 1: *DA3C_LW21_035*, looking upslope, showing source of iron spring & staining.

Photo 2: *DA3C_LW21_035*, looking downslope, showing extent of staining with *Wongawilli Creek* in the background.

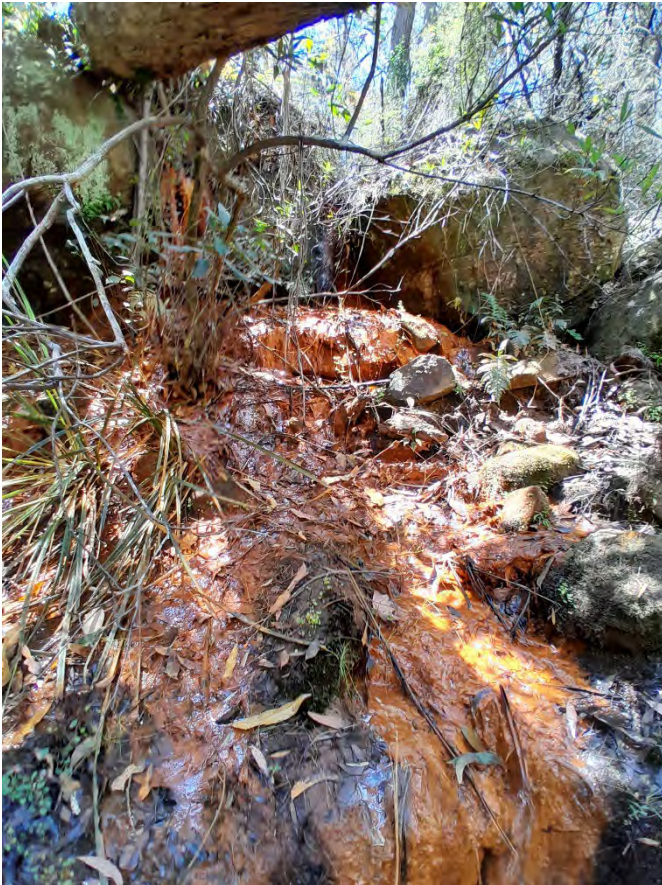
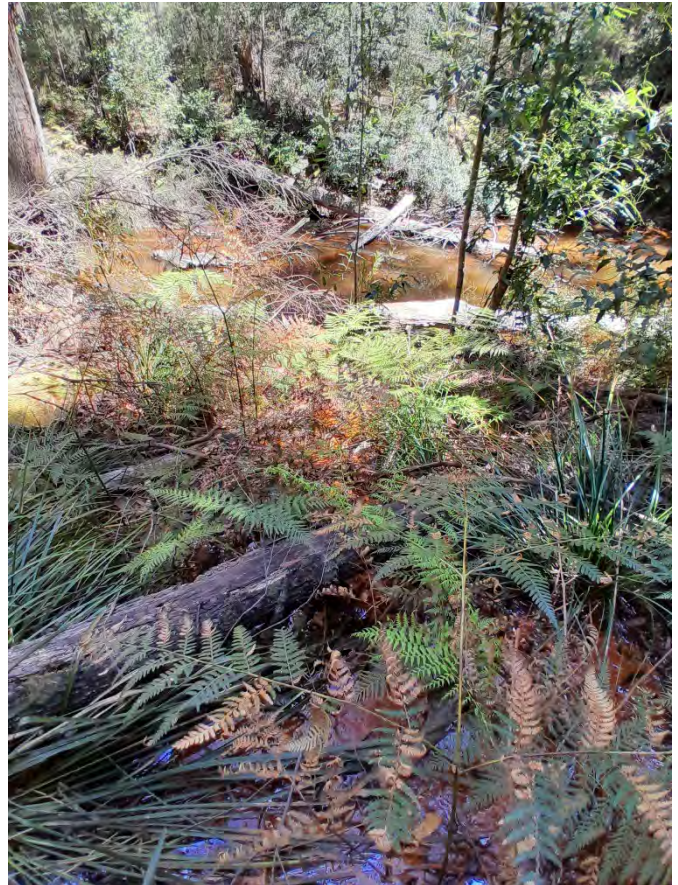
DA3C_LW21_036 is located upslope approximately 8m east of WC_Pool 50 on Wongawilli Creek and is not associated with any mapped tributary (Figure 1). The impact consists of an iron spring and associated iron staining originating from a rock outcrop with seepage extending westward from an area associated with previous DA3A mining operations, specifically Longwall 6. The spring was active during the inspection with both the seepage and iron staining extending to Wongawilli Creek (Photo 3 & Photo 4). This iron spring and associated staining is approximately 85m north of a previously identified iron spring reported during the LW17 monitoring period, specifically DA3B_LW17_031 (Figure 1) and is outside the Longwall 21 mining area.

DA3C_LW21_036 is a Level 1 trigger as per the Dendrobium Watercourse TARP (Table 1), specifically:

- Observable increase in iron staining within the mining area

Photo 3: DA3C_LW21_036, looking upslope, showing source of spring and iron staining.

Photo 4: DA3C_LW21_036, looking downslope, showing extend of staining with Wongawilli Creek in the background.
