**ATTACHMENT C1 –  
LONGWALL 37 END OF  
PANEL REPORT**

**LANDSCAPE MONITORING  
IMPACT REPORTS**

**ILLAWARRA COAL ENVIRONMENTAL  
FIELD TEAM, JUNE 2014 TO  
JANUARY 2015**

## West Cliff Area 5 Longwall 36 Impact Report

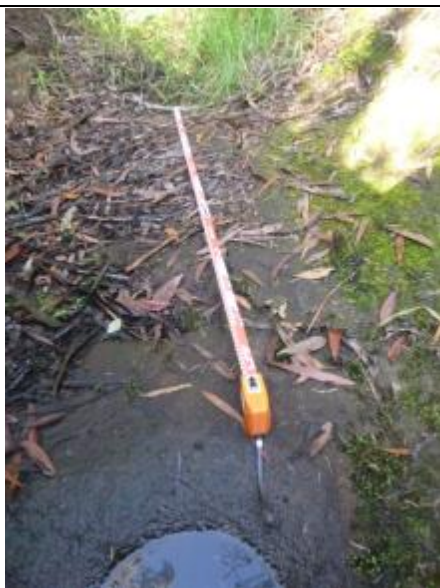
Rock fracturing and uplift was observed on a Georges River tributary at site GR104\_Pool 1 (**Figure 1**), approximately 65m from the end of Longwall 36. The impact (**Photos 1 to 4**) is comprised of two fractures approximately 1.5m and 0.5m long with a maximum uplift of 0.03m.

The observed impact is consistent with a Minor Trigger in the West Cliff Area 5 Longwalls 34 to 36 SMP.

Photo 1: WCA5\_LW36\_001, fracturing and uplift of rock bed at GR104\_Pool 1 looking southeast. Taken on 19/06/2014.

Monitoring is being conducted as outlined in the West Cliff Area 5 Longwall 34 to 36 SMP. The rock fracture (WCA5\_LW36\_001) is consistent with a minor trigger as defined in the SMP. Standard monitoring will continue and no corrective actions are recommended.

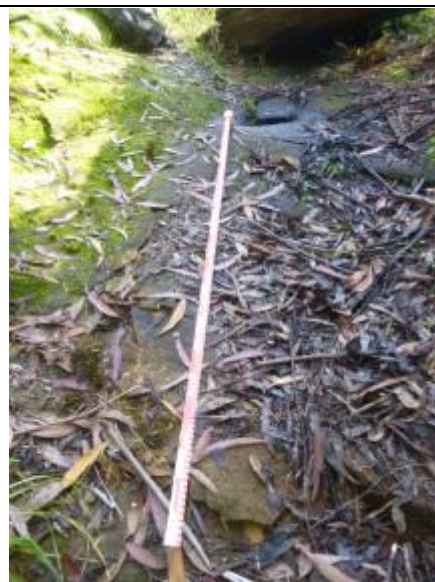
Photo 2: WCA5\_LW36\_001, fracturing and uplift of rock bed at GR104\_Pool 1 looking northwest. Taken on 19/06/2014.

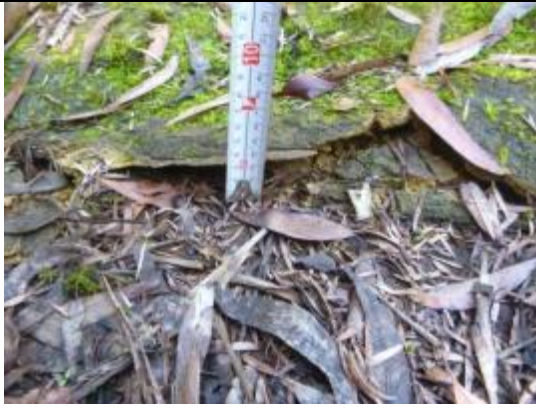
Photo 3: WCA5\_LW36\_001, fracturing and uplift of rock bed at GR104\_Pool 1 looking south. Taken on 19/06/2014.

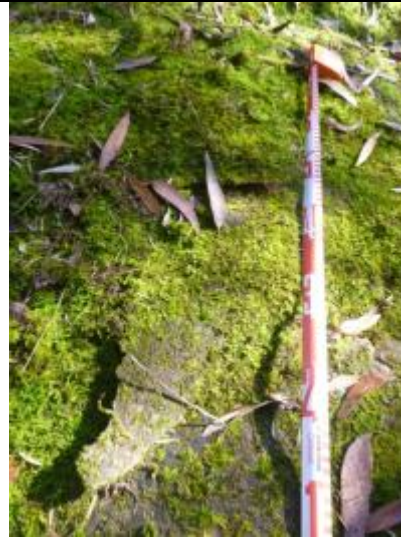
Photo 4: WCA5\_LW36\_001, fracturing and uplift of rock bed at GR104\_Pool 1 looking south. Taken on 19/06/2014.

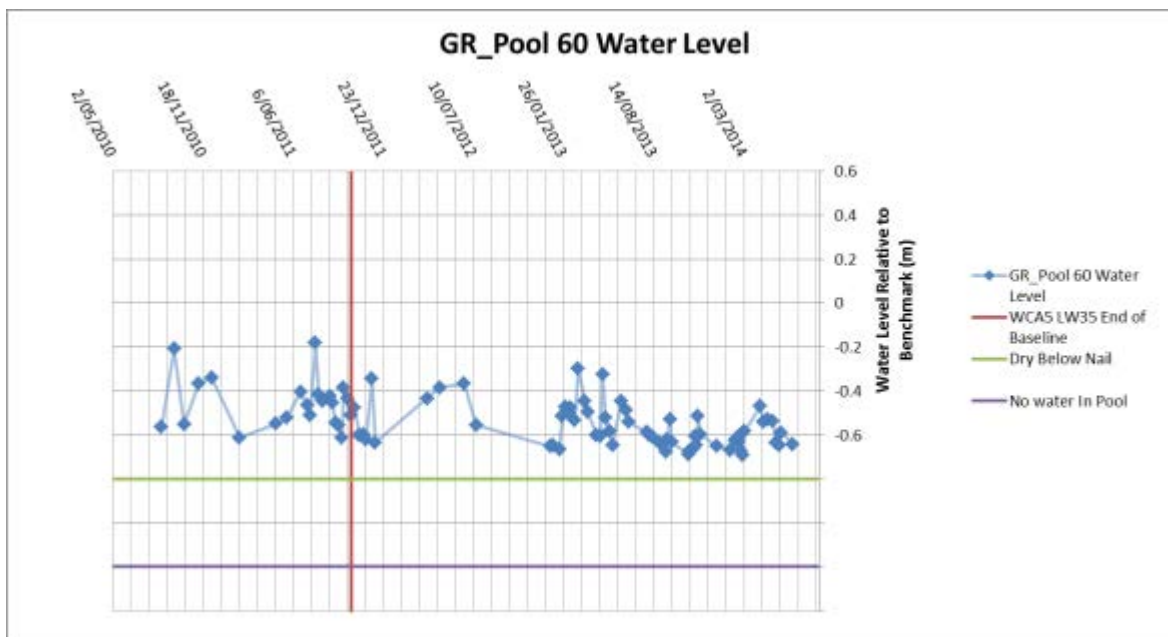
Graph 1: Water levels recorded in GR\_Pool 60.

On the latest inspection GR\_Pool 60 in the Georges River was observed to be at a level below that experienced in the baseline period (**Photos 5 and 6**). As shown in Graph 1, this lower-than-baseline water level has been observed previously and was reported as Impact WCA5\_LW35\_023.

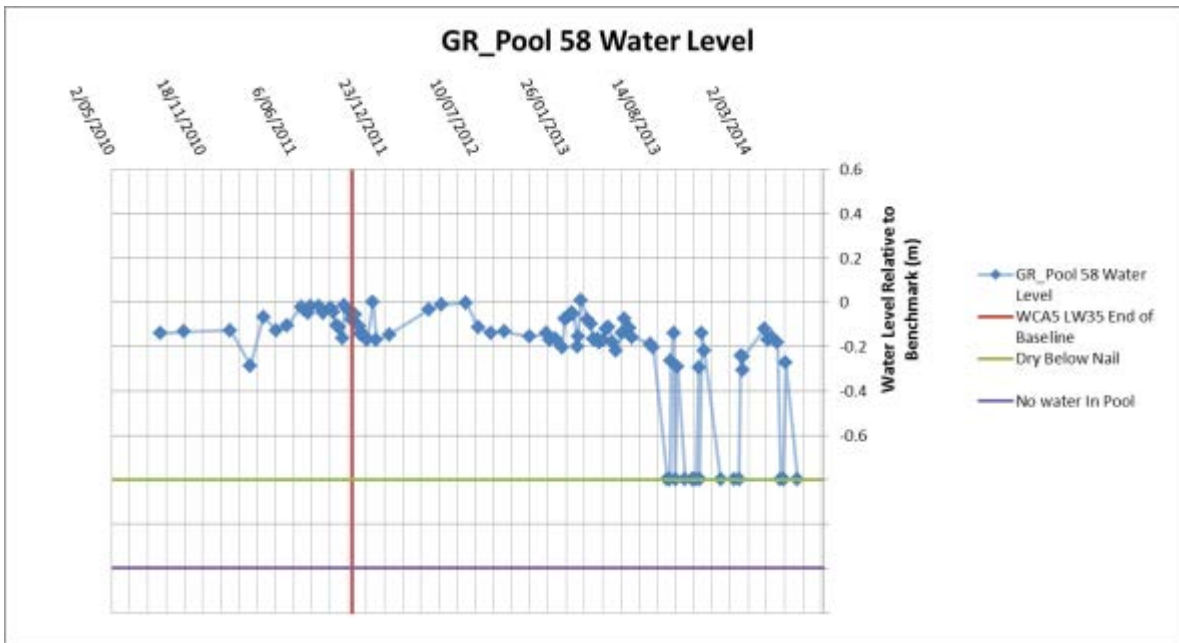
Graph 2: Water levels recorded in GR\_Pool 58.

On the latest inspection of GR\_Pool 58 in the Georges River the water level was 'Dry Below Nail' (**Graph 2**). This water level has previously been reported (**Photos 7 and 8**). The latest observation is a trigger according to the GRMP and is discussed in the TARP section of this report.

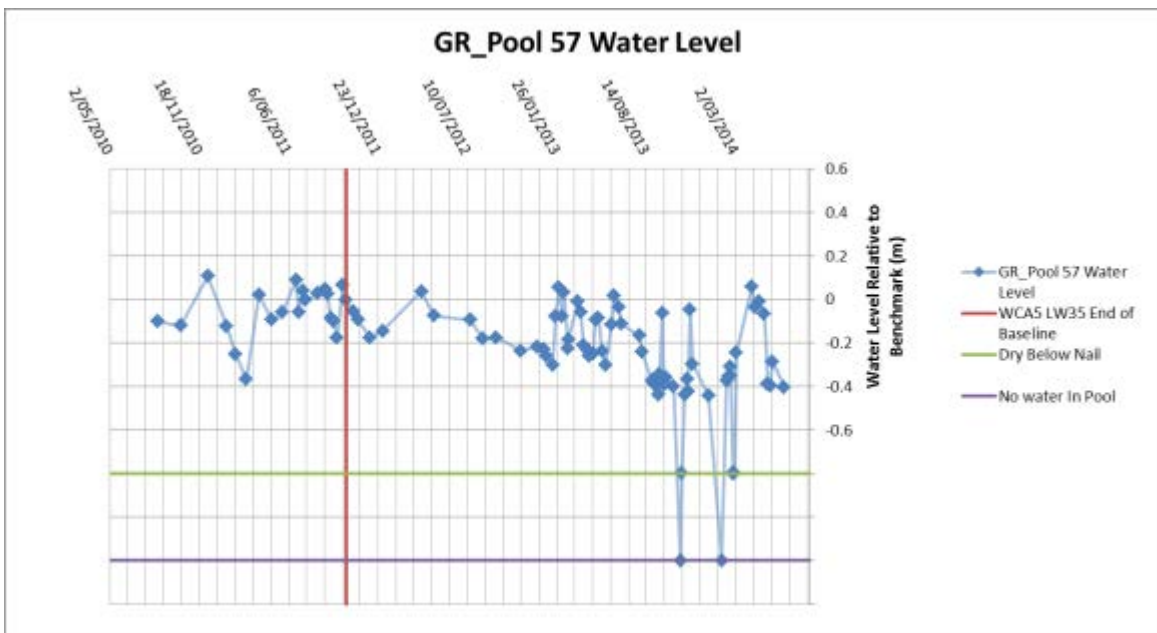
Graph 3: Water levels recorded in GR\_Pool 57.

On the latest inspection of GR\_Pool 57 in the Georges River it was observed to be at a level below that experienced in the baseline period (**Graph 3**). The latest observation (**Photos 9 and 10**) is a trigger according to the GRMP and is discussed in the TARP section of this report.

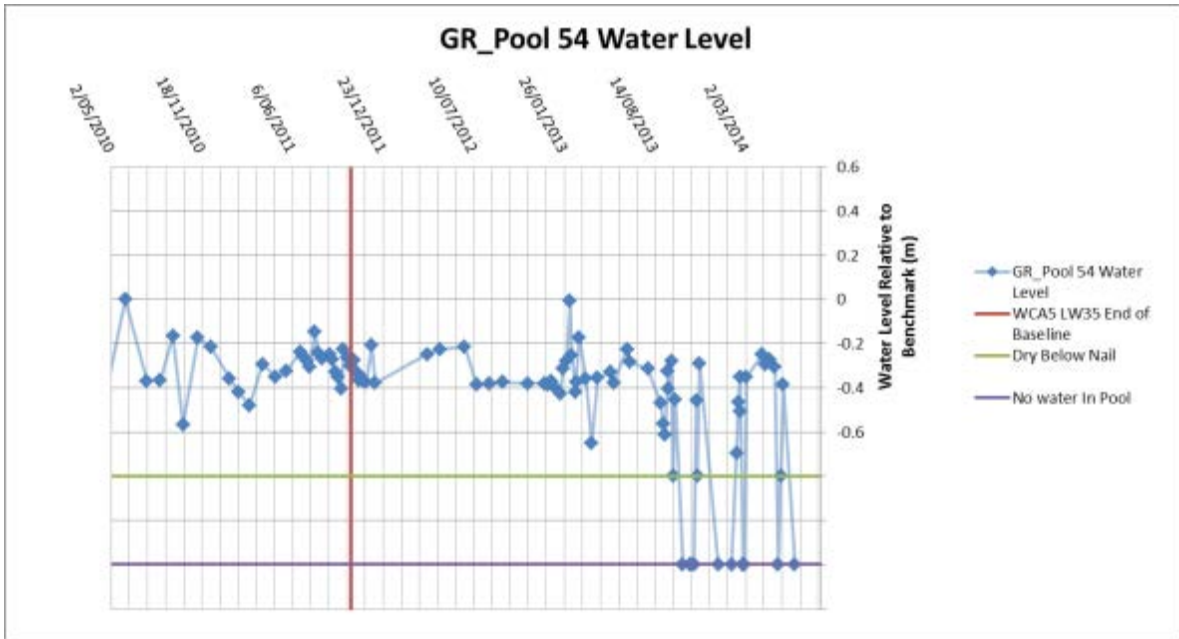
Graph 5: Water levels recorded in GR\_Pool 54.

On the latest inspection of GR\_Pool 54 in the Georges River it was observed to be dry. The latest observation (**Photos 11 and 12**) is a trigger according to the GRMP and is discussed in the TARP section of this report.

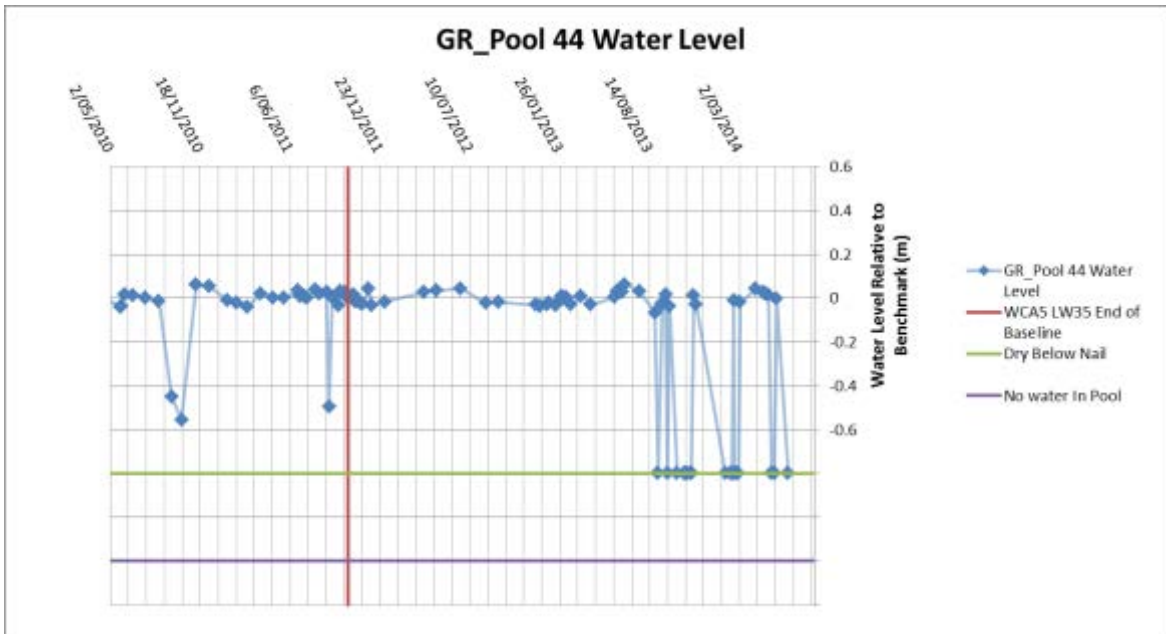
Graph 6: Water levels recorded in GR\_Pool 44.

On the latest inspection of GR\_Pool 44 in the Georges River it was 'Dry Below Nail' (**Graph 6**). The latest observation (**Photos 13 and 14**) is a trigger according to the GRMP and is discussed in the TARP section of this report.

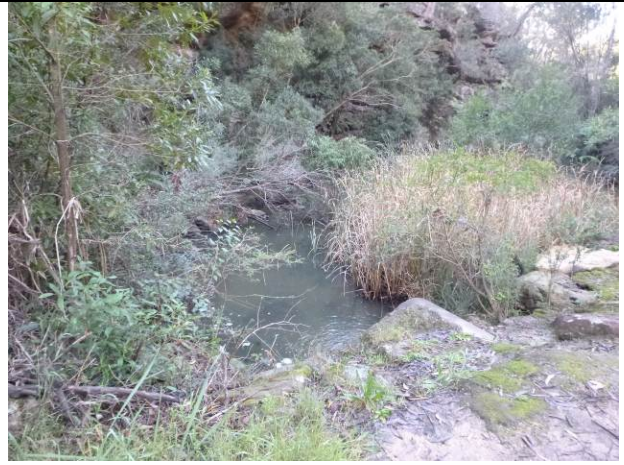
Photo 6: Pool 60 looking downstream. Taken on  
18/06/2014.

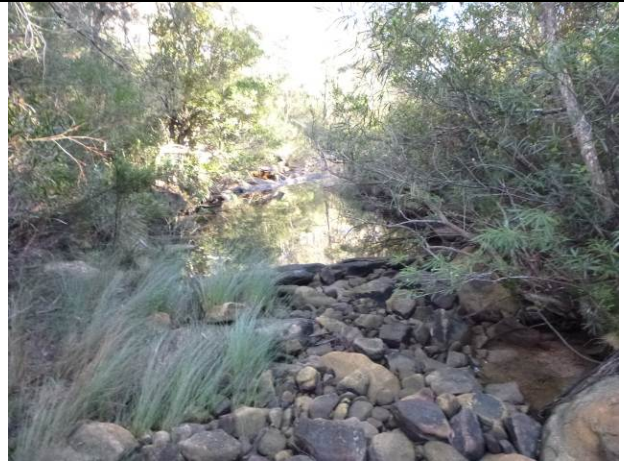
Photo 8: GR\_Pool 58 looking downstream. Taken  
on 18/06/2014.

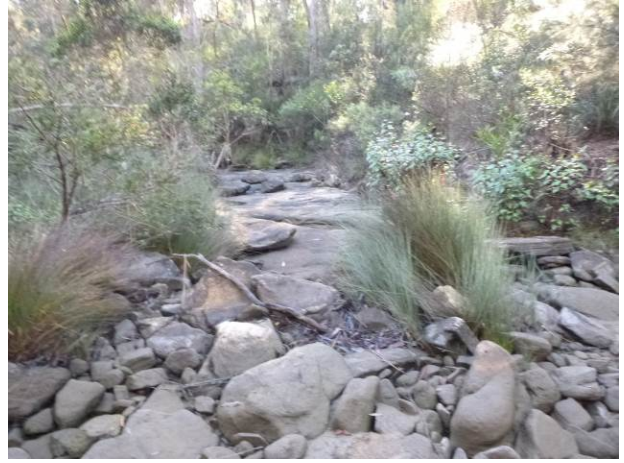
Photo 12: GR\_Pool 54 looking downstream. Taken on 18/06/2014.

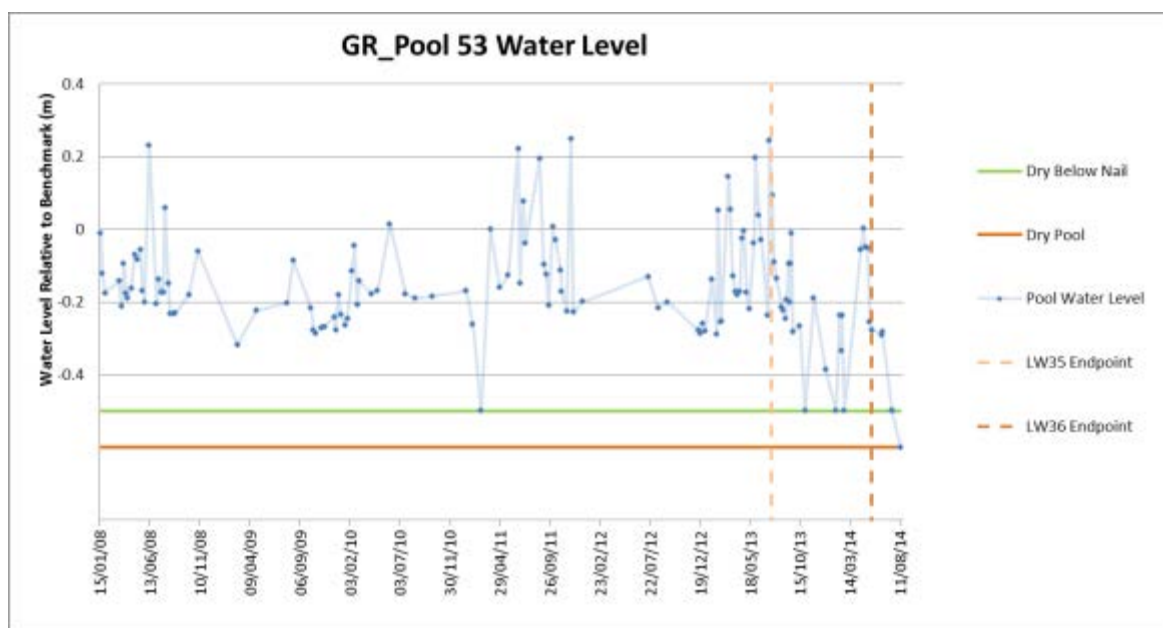
**Graph 1:** Water levels recorded in GR\_Pool 53.

On the 12th of August 2014, GR\_Pool 53 was observed to be dry. This is the first time these conditions have been observed at the site (Graph 1). Photos 1 and 2 show the latest pool conditions. The observation is a trigger according to the GRMP and is discussed in the TARP section of this report. This trigger is likely a result of low flow conditions and Longwall 35 related impacts.

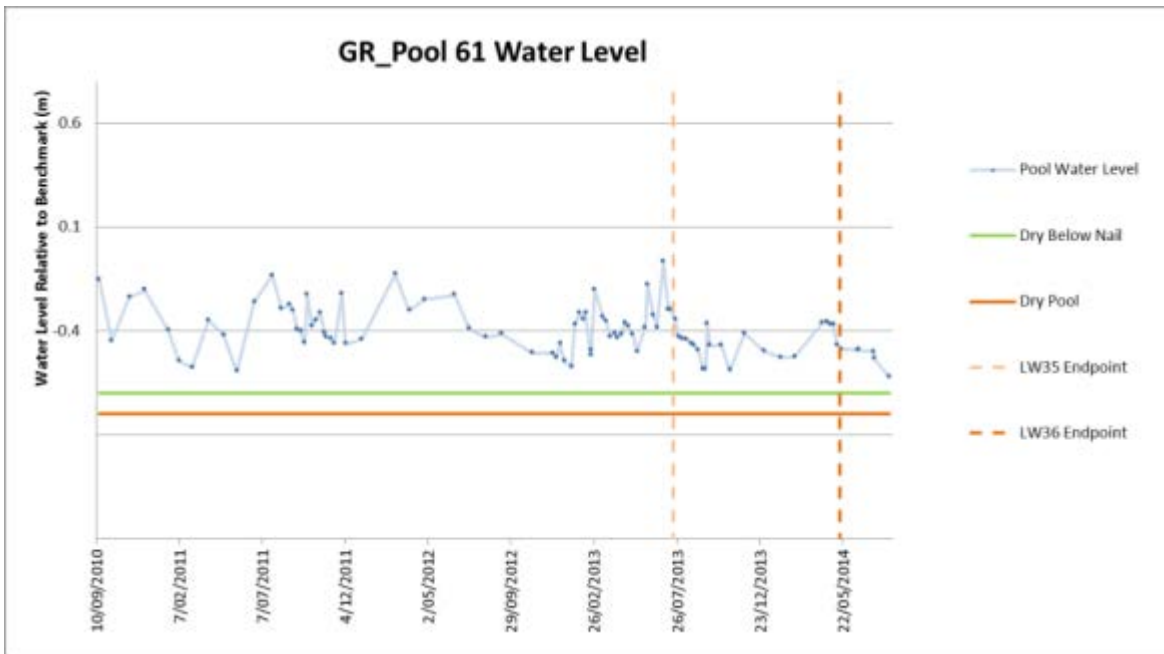
**Graph 2:** Water levels recorded in GR\_Pool 61.

On the 12th of August 2014, GR\_Pool 61 water level was observed to be at a level below baseline. This is the first time these conditions have been observed at the site (Graph 2). Photos 3 and 4 show the latest pool conditions. The observation is a trigger according to the GRMP and is discussed in the TARP section of this report. No associated fracturing has been identified in this area. This trigger is likely a result of low flow conditions and Longwall 35 related impacts identified upstream.

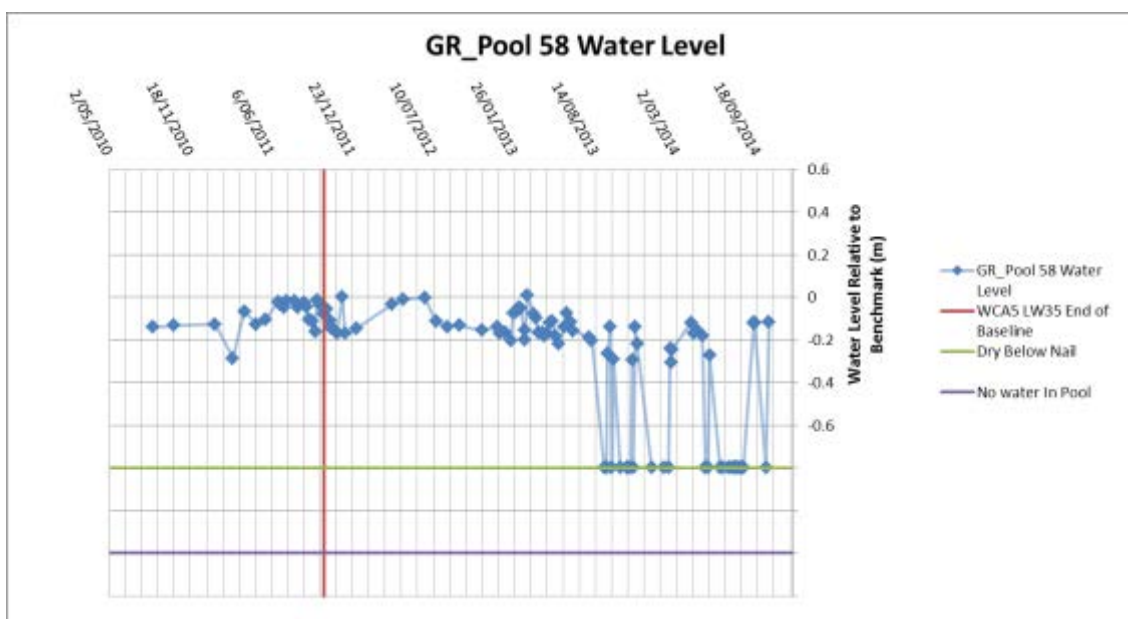
Graph 1: Water levels recorded in GR\_Pool 58.

On the 9<sup>th</sup> October 2014 an inspection of GR\_Pool 58 in the Georges River was conducted and the water level was found to be 'Dry Below Nail'. This water level has previously been reported. This observation is a trigger according to the GRMP and is discussed in the TARP section of this report. An inspection was conducted on 16<sup>th</sup> October 2014 and water level was found to have returned to above pre-mining level (**Graph 1**). A comparison of pool water levels for the two inspections is presented in photos 1 to 4.

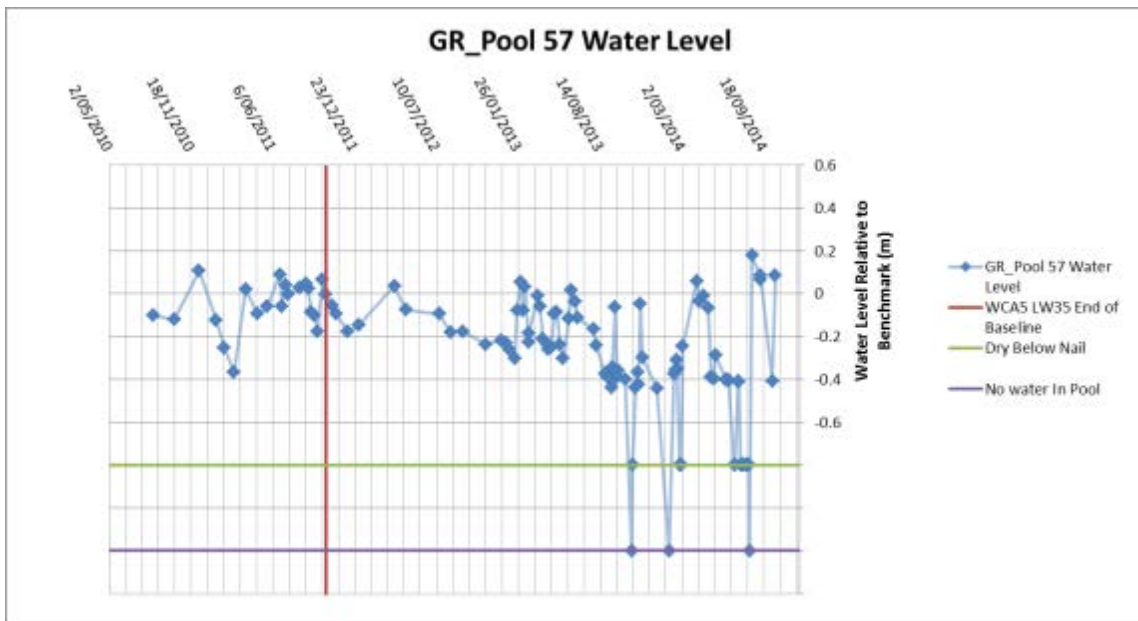
Graph 2: Water levels recorded in GR\_Pool 57.

On the 9<sup>th</sup> October 2014 an inspection of GR\_Pool 57 in the Georges River was conducted and the water level was found to be at a level below that experienced in the baseline period. This water level has previously been reported. This observation is a trigger according to the GRMP and is discussed in the TARP section of this report. An inspection was conducted on 16<sup>th</sup> October 2014 and water level was found to have returned to above pre-mining level (**Graph 2**). A comparison of pool water levels for the two inspections is presented in photos 5 and 6.

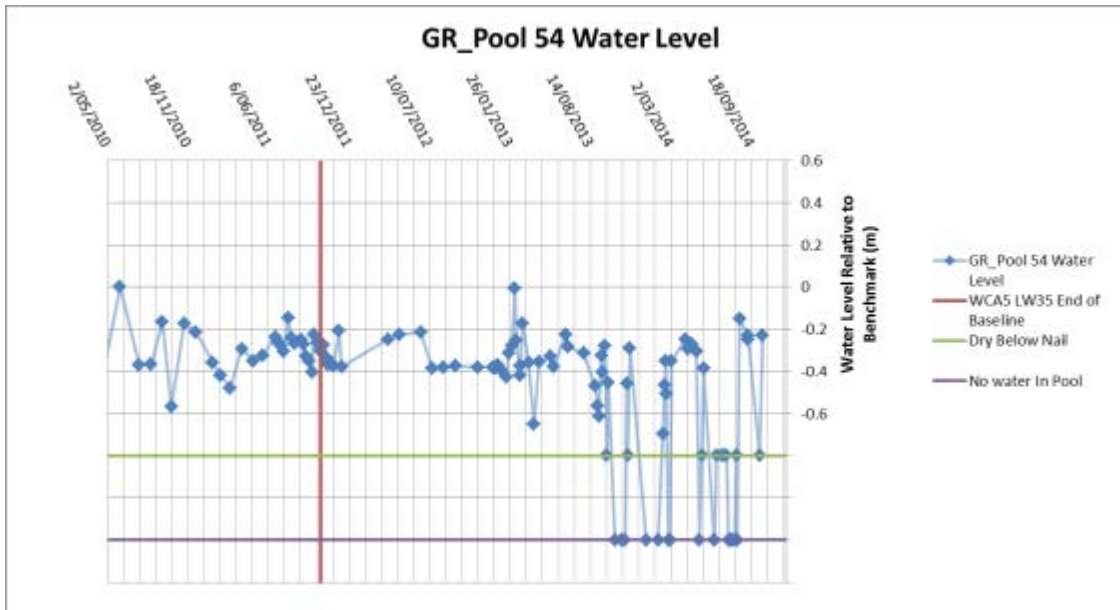
Graph 3: Water levels recorded in GR\_Pool 54.

On the 9<sup>th</sup> October 2014 an inspection of GR\_Pool 54 in the Georges River was conducted and the water level was found to be 'Dry Below Nail'. This water level has previously been reported. This observation is a trigger according to the GRMP and is discussed in the TARP section of this report. An inspection was conducted on 16<sup>th</sup> October 2014 and water level was found to have returned to above pre-mining level (**Graph 3**). A comparison of pool water levels for the two inspections is presented in photos 7 to 10.

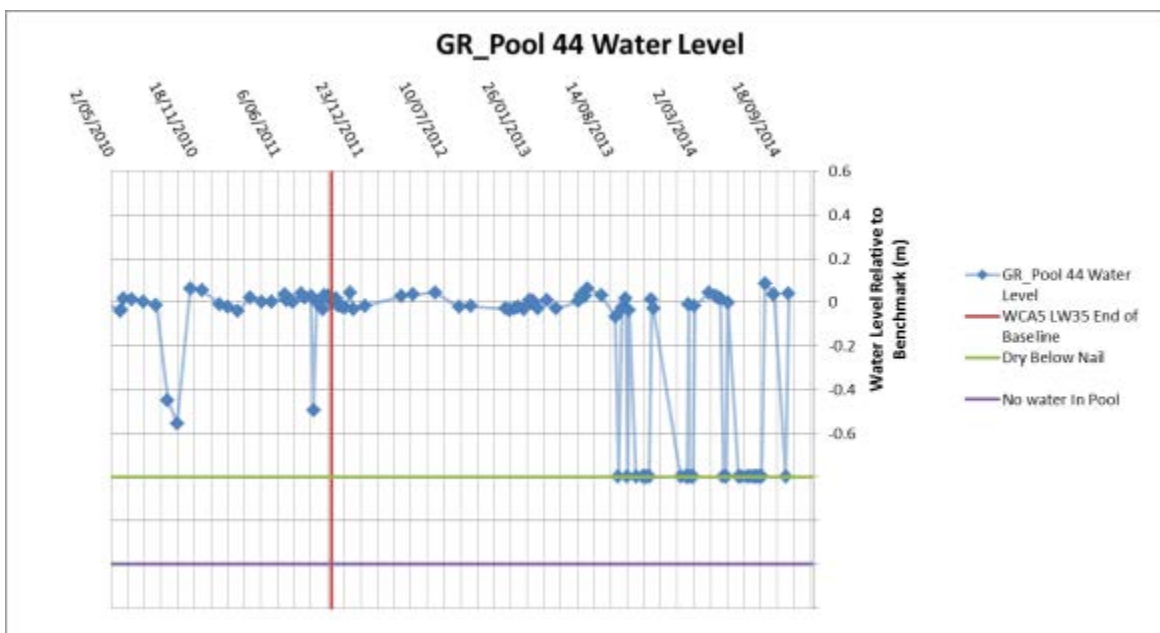
Graph 4: Water levels recorded in GR\_Pool 44.

On the 9<sup>th</sup> October 2014 an inspection of GR\_Pool 44 in the Georges River was conducted and the water level was found to be 'Dry Below Nail'. This water level has previously been reported. This observation is a trigger according to the GRMP and is discussed in the TARP section of this report. An inspection was conducted on 16<sup>th</sup> October 2014 and water level was found to have returned to above pre-mining level (**Graph 4**). A comparison of pool water levels for the two inspections is presented in photos 11 to 14.

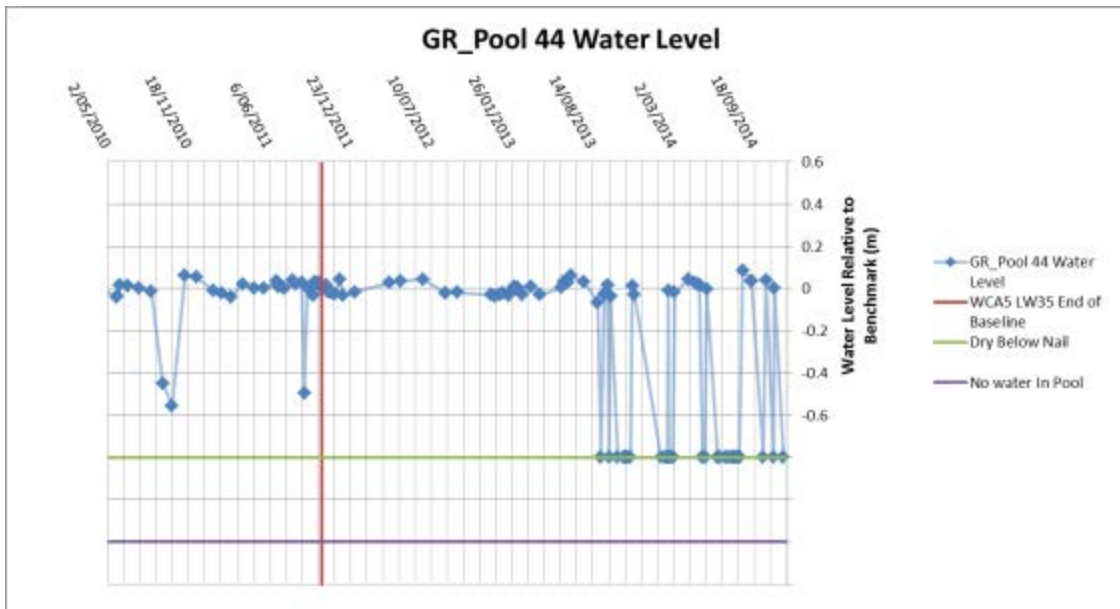
Graph 1: Water levels recorded in GR\_Pool 44.

On the latest inspection of GR\_Pool 44 the pool water level was 'Dry Below Nail' (Graph 1). This water level has been reported previously, is below the baseline period and is a trigger in the GRMP. Photos 1 and 2 show the latest pool conditions.

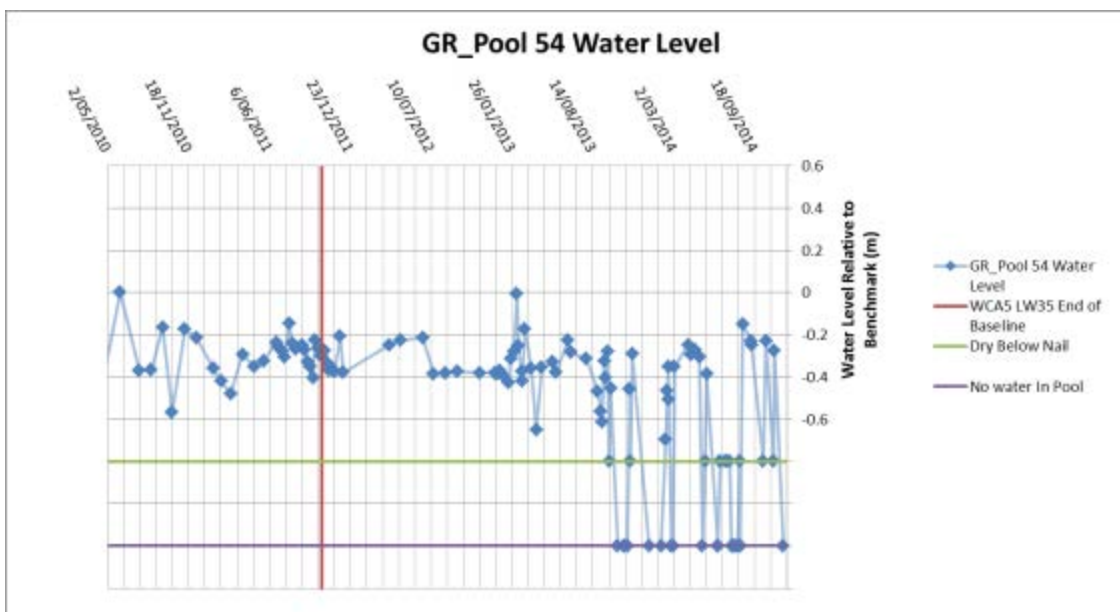
Graph 2: Water levels recorded in GR\_Pool 54.

On the latest inspection of GR\_Pool 54 the pool was dry (Graph 2). This has been reported previously, is below the lowest level experienced in the baseline period and is a trigger according to the GRMP. Photos 3 and 4 show the latest pool conditions.

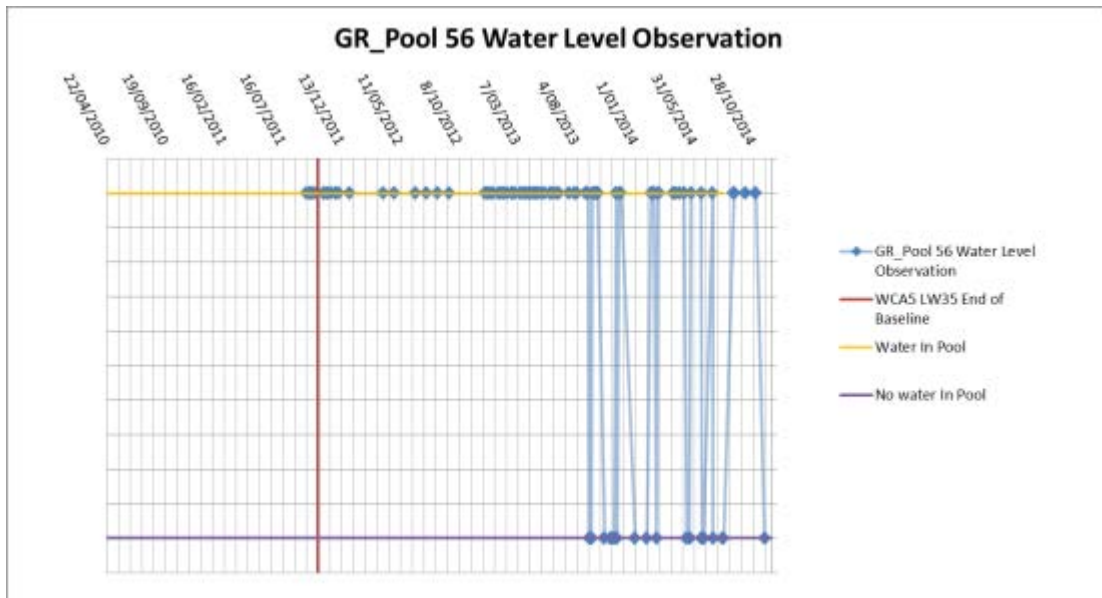
Graph 3: Water level observations recorded in GR\_Pool 56.

On the latest inspection of GR\_Pool 56 the pool was dry (Graph 3). This water level has been reported previously, is below the lowest level experienced in the baseline period and is a trigger according to the GRMP. Photos 5 and 6 show the latest pool conditions.

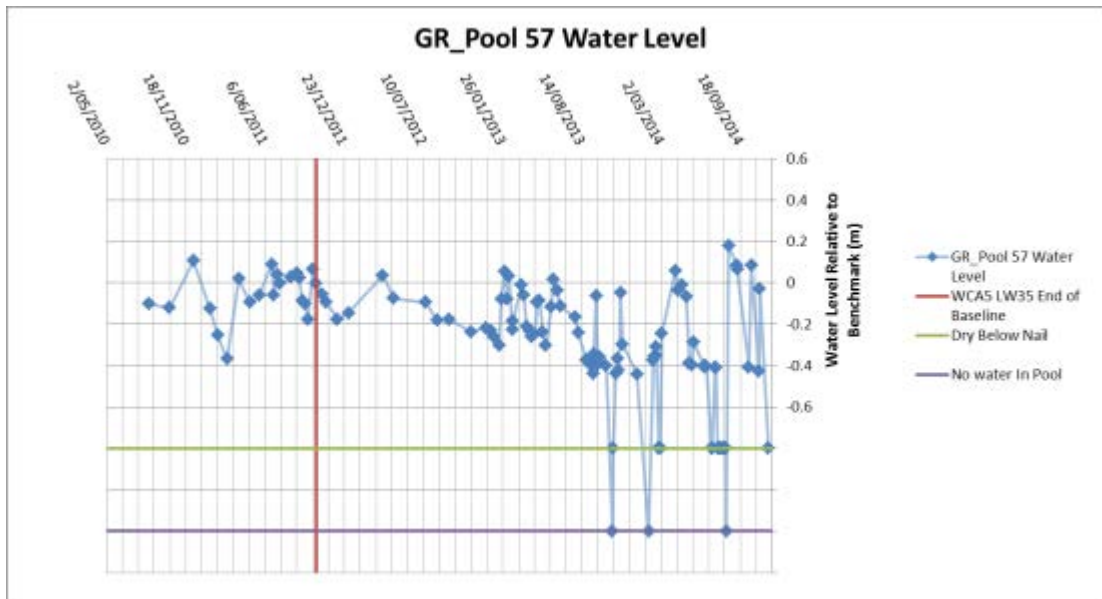
Graph 4: Water levels recorded in GR\_Pool 57.

On the latest inspection of GR\_Pool 57 the pool was 'Dry Below Nail' (Graph 4). This water level has been reported previously, is below the lowest level experienced in the baseline period and is a trigger according to the GRMP. Photos 7 and 8 show the latest pool conditions.

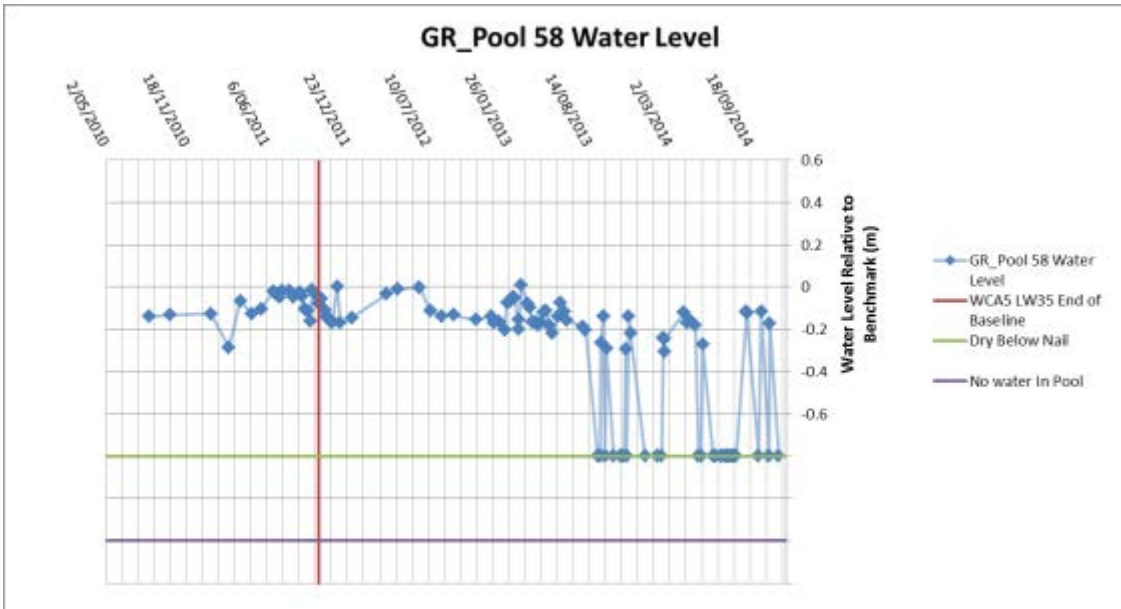
Graph 5: Water levels recorded in GR\_Pool 58.

On the latest inspection of GR\_Pool 58 the pool was 'Dry Below Nail' (Graph 5). This water level has been reported previously, is below the lowest level experienced in the baseline period and is a trigger according to the GRMP. Photos 9 and 10 show the latest pool conditions.

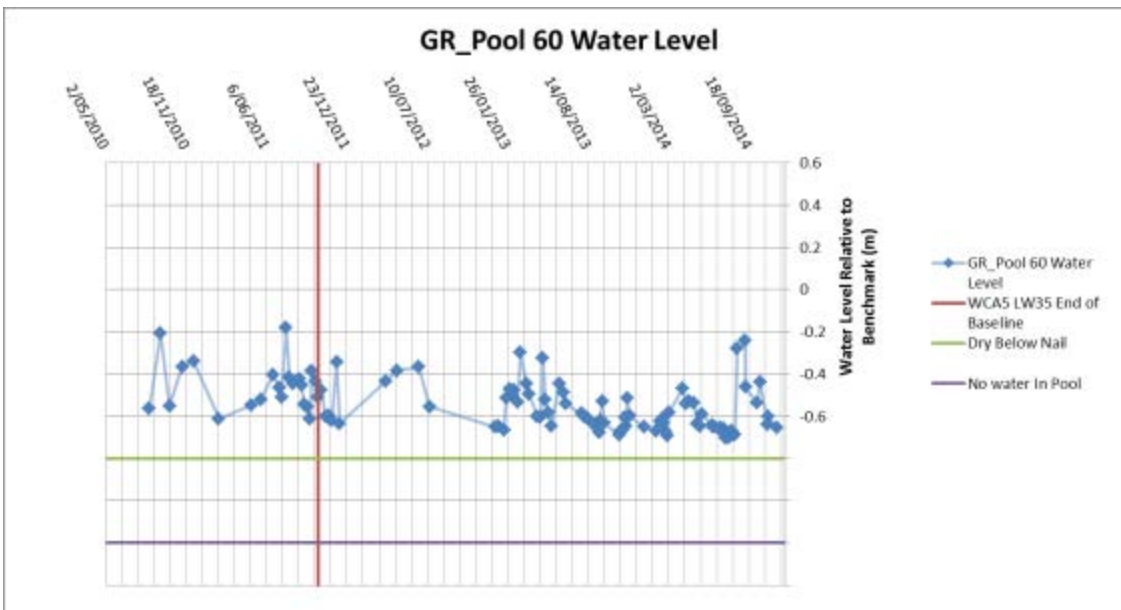
Graph 6: Water levels recorded in GR\_Pool 60.

On the latest inspection of GR\_Pool 60 the pool water level was lower than that experienced in the baseline record (Graph 6). This water level has been reported previously, is below the lowest level experienced in the baseline period and is a trigger according to the GRMP. Photos 11 and 12 show the latest pool conditions.

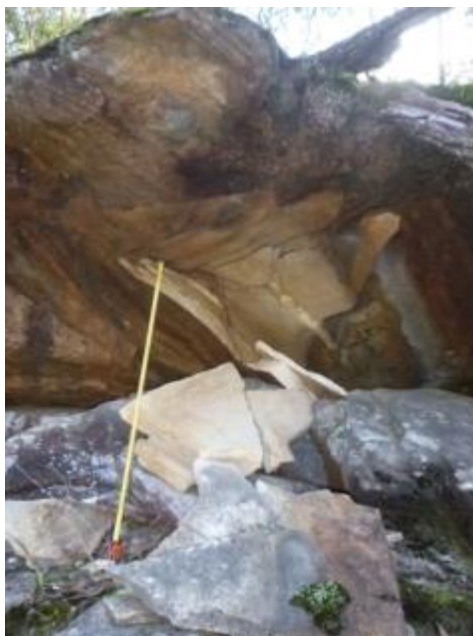
On the 17<sup>th</sup> July 2014 a small rockfall was identified from the underside of an overhang approximately 10m upslope from the Georges River (**Figure 1**). The volume of rock which has fallen from the overhang is approximately 0.17m<sup>3</sup> with an area of disturbance of approximately 2.25m<sup>2</sup> (**Photos 1 to 3**). The impact is approximately 190m from Longwall 35 and more than 1000m from Longwall 36 and 37. Aboriginal archaeological site 52-2-2234 is approximately 5m from the impact site and has not been affected. For further discussion on archeological sites see the West Cliff Area 5 Longwall 36 End of Panel Report.

**Photo 1:** WCA5\_LW35\_026, close up of impact. Photo taken 17/08/14.

The observed impact is minor and within predictions according to the West Cliff Area 5 LW34-36 Subsidence Management Plan (**Table 2**): Rock fall from a cliff which is left mostly intact, resulting in insignificant ground disturbance.

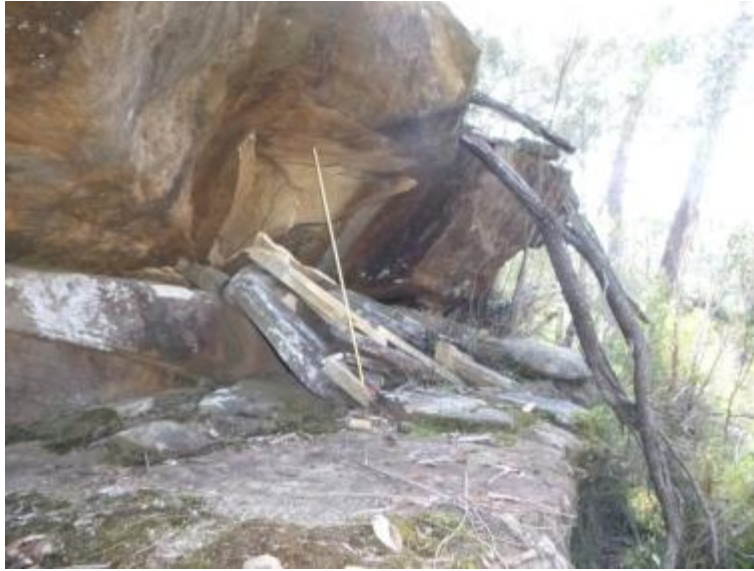
**Photo 2:** WCA5\_LW35\_026, view of impact looking north. Photo taken 17/08/14.

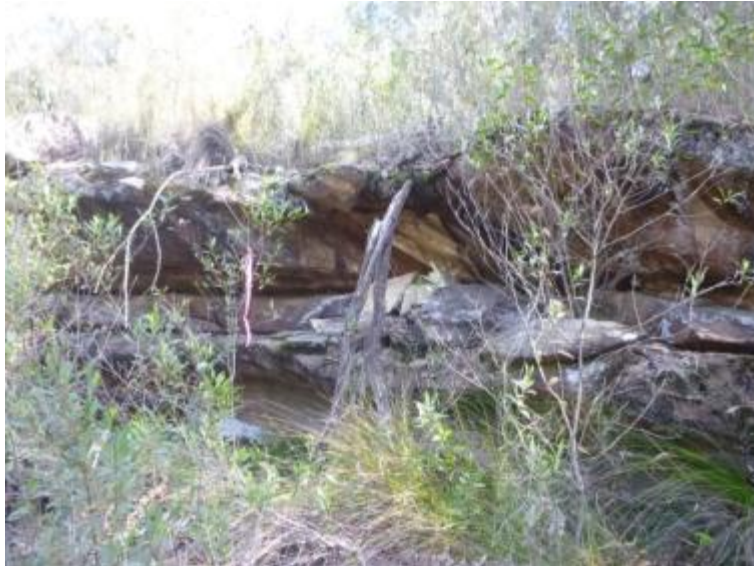
**Photo 3:** WCA5\_LW35\_026, view of impact looking southwest. Photo taken 17/08/14

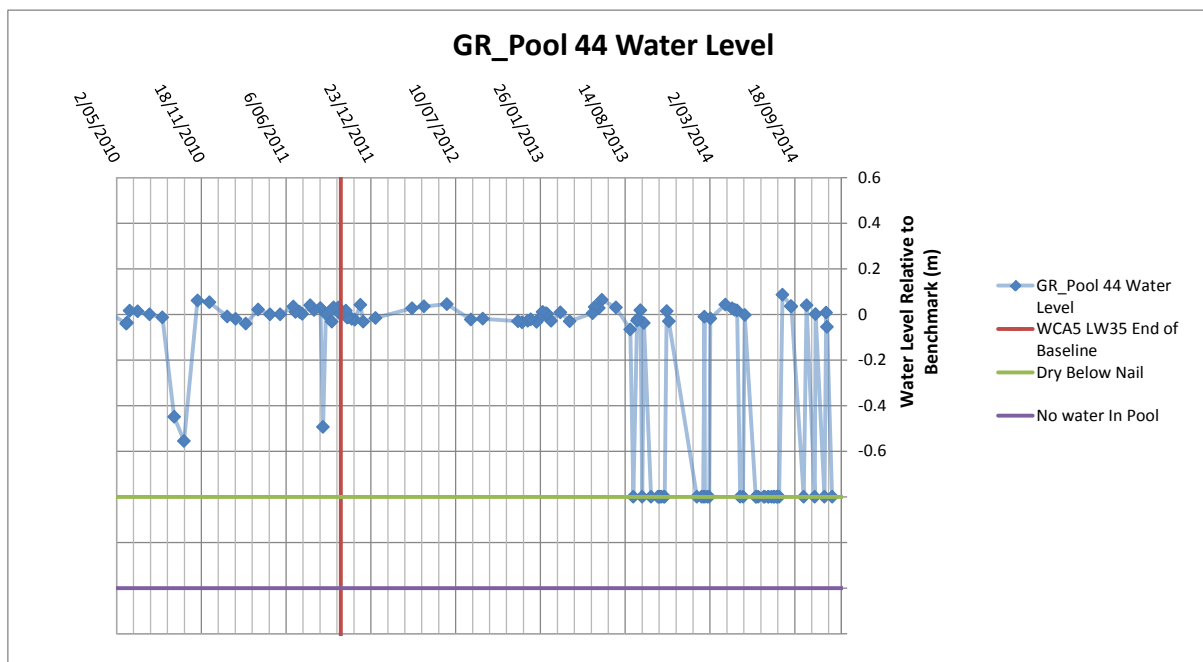
Graph 1: Water levels recorded in GR\_Pool 44.

On the latest inspection of GR\_Pool 44 the pool water level was 'Dry Below Nail' (Graph 1). This water level has been reported previously, is below baseline levels and is a trigger in the GRMP. Photos 1 and 2 show the latest pool conditions.

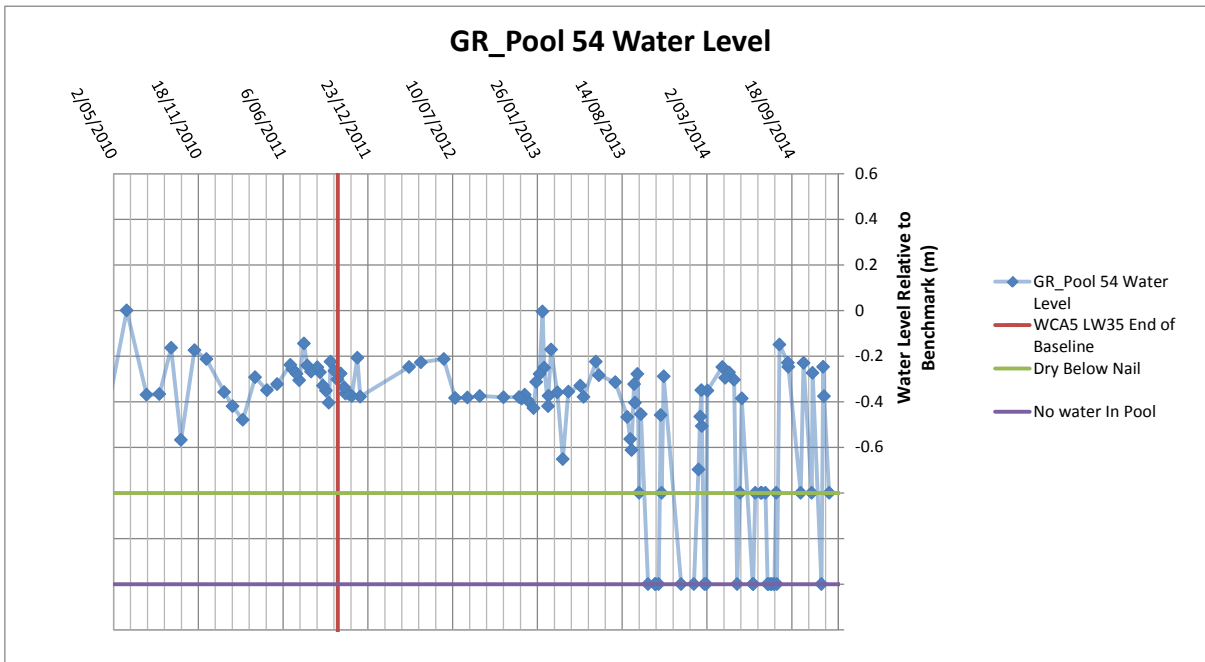
Graph 2: Water levels recorded in GR\_Pool 54.

On the latest inspection of GR\_Pool 54 the pool water level was 'Dry Below Nail' (Graph 2). This has been reported previously, is below the lowest level experienced in the baseline period and is a trigger according to the GRMP. Photos 3 and 4 show the latest pool conditions.

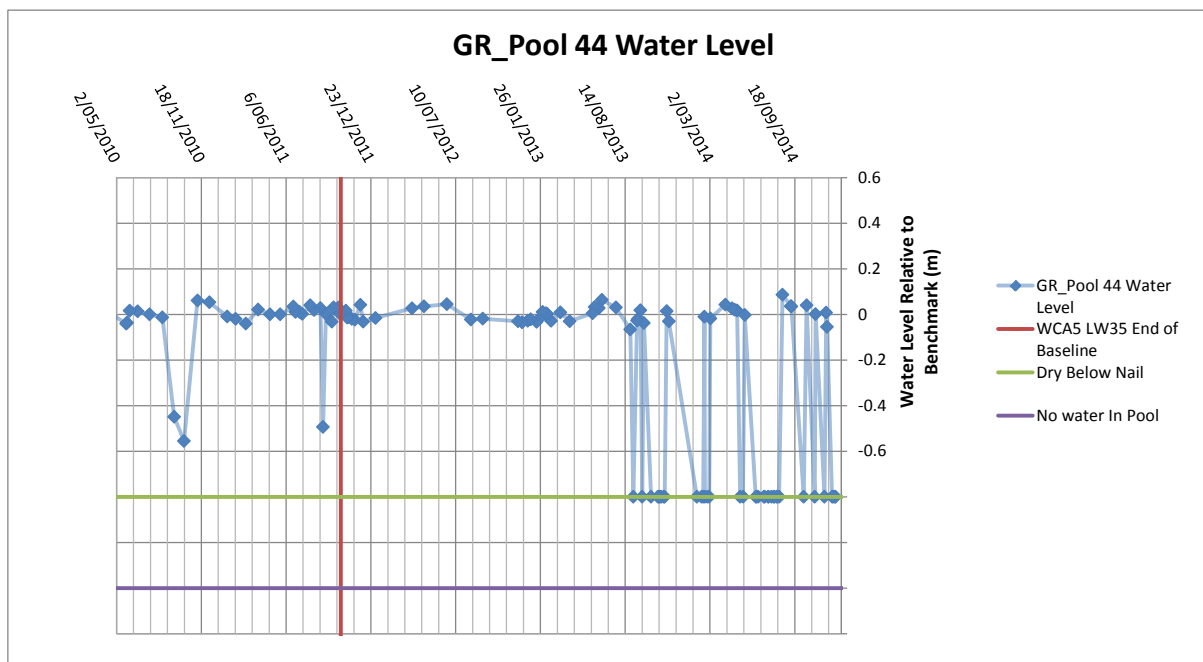
Graph 1: Water levels recorded in GR\_Pool 44.

On the latest inspection of GR\_Pool 44 the pool water level was 'Dry Below Nail' (Graph 1). This water level has been reported previously, is below baseline levels and is a trigger in the GRMP. Photos 1 and 2 show the latest pool conditions.

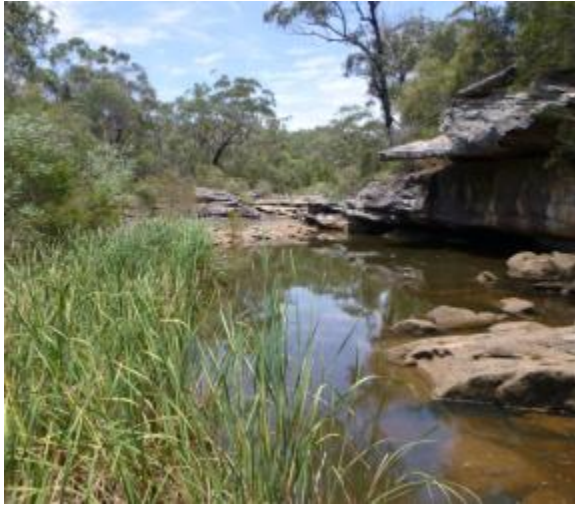
Photo 1: GR\_Pool 44 looking upstream. Taken on 23/12/2014

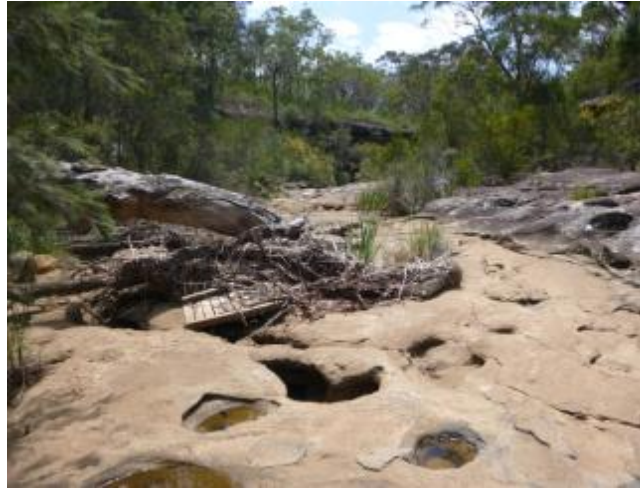
Photo 2: GR\_Pool 44 looking downstream. Taken on 23/12/2014

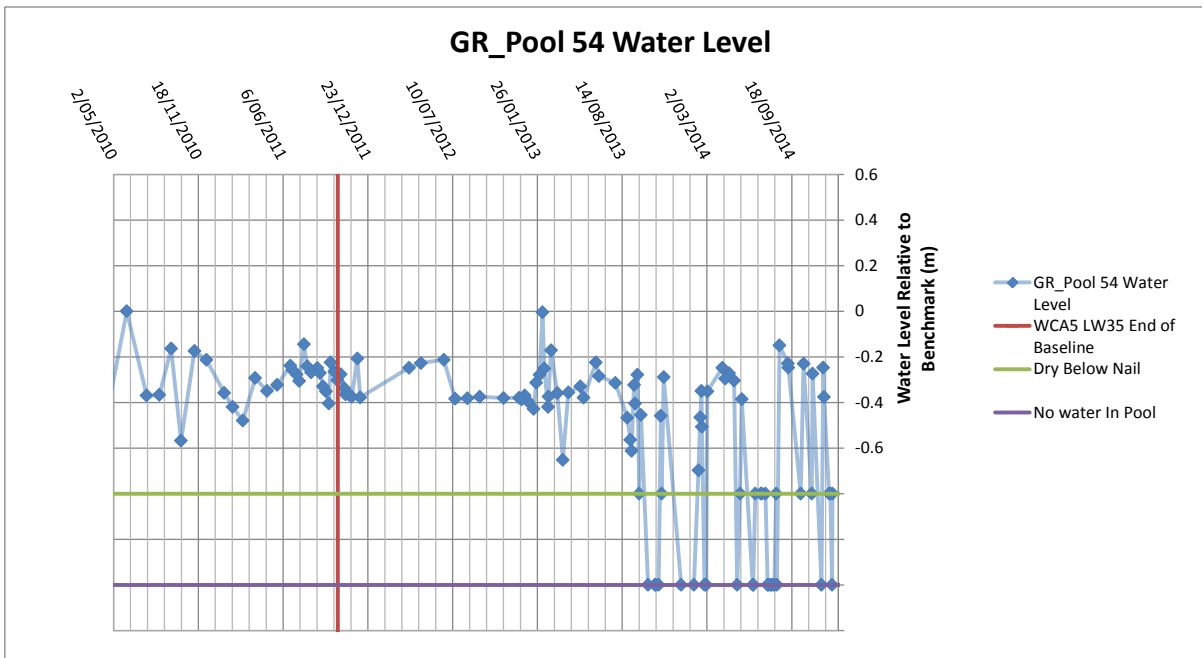
Graph 2: Water levels recorded in GR\_Pool 54.

On the latest inspection of GR\_Pool 54 the pool was dry (Graph 2). This has been reported previously, is below the lowest level experienced in the baseline period and is a trigger according to the GRMP. Photos 3 and 4 show the latest pool conditions.

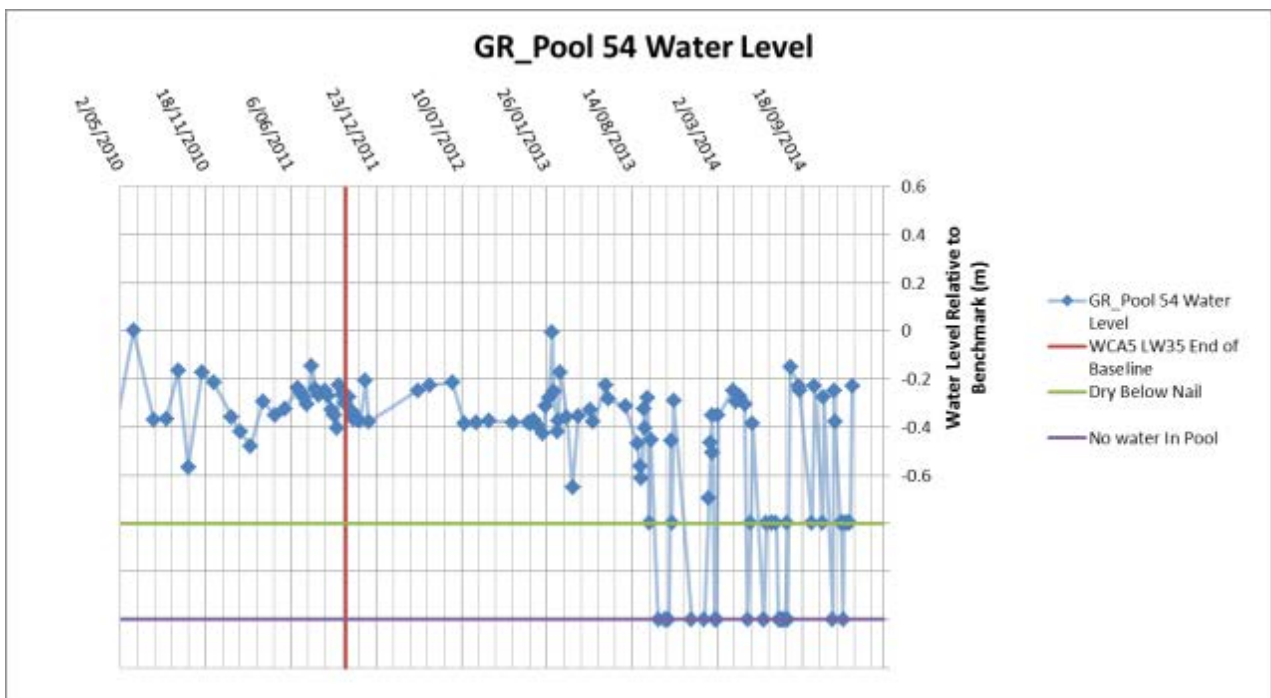
Graph 2: Water levels recorded in GR\_Pool 54.

On the latest inspection of GR\_Pool 54 the pool water level was above baseline levels (Graph 2). Photos 3 and 4 show the latest pool conditions.
